US010024028B2

(54) **METHOD FOR REPAIRING BUCKETS**

(71) Applicant: **Minetec S.A.**, Santiago (CL)

A method for repairing a bucket of a piece of earthwork equipment is provided, the method being specifically applicable to the repair of electric shovel buckets.

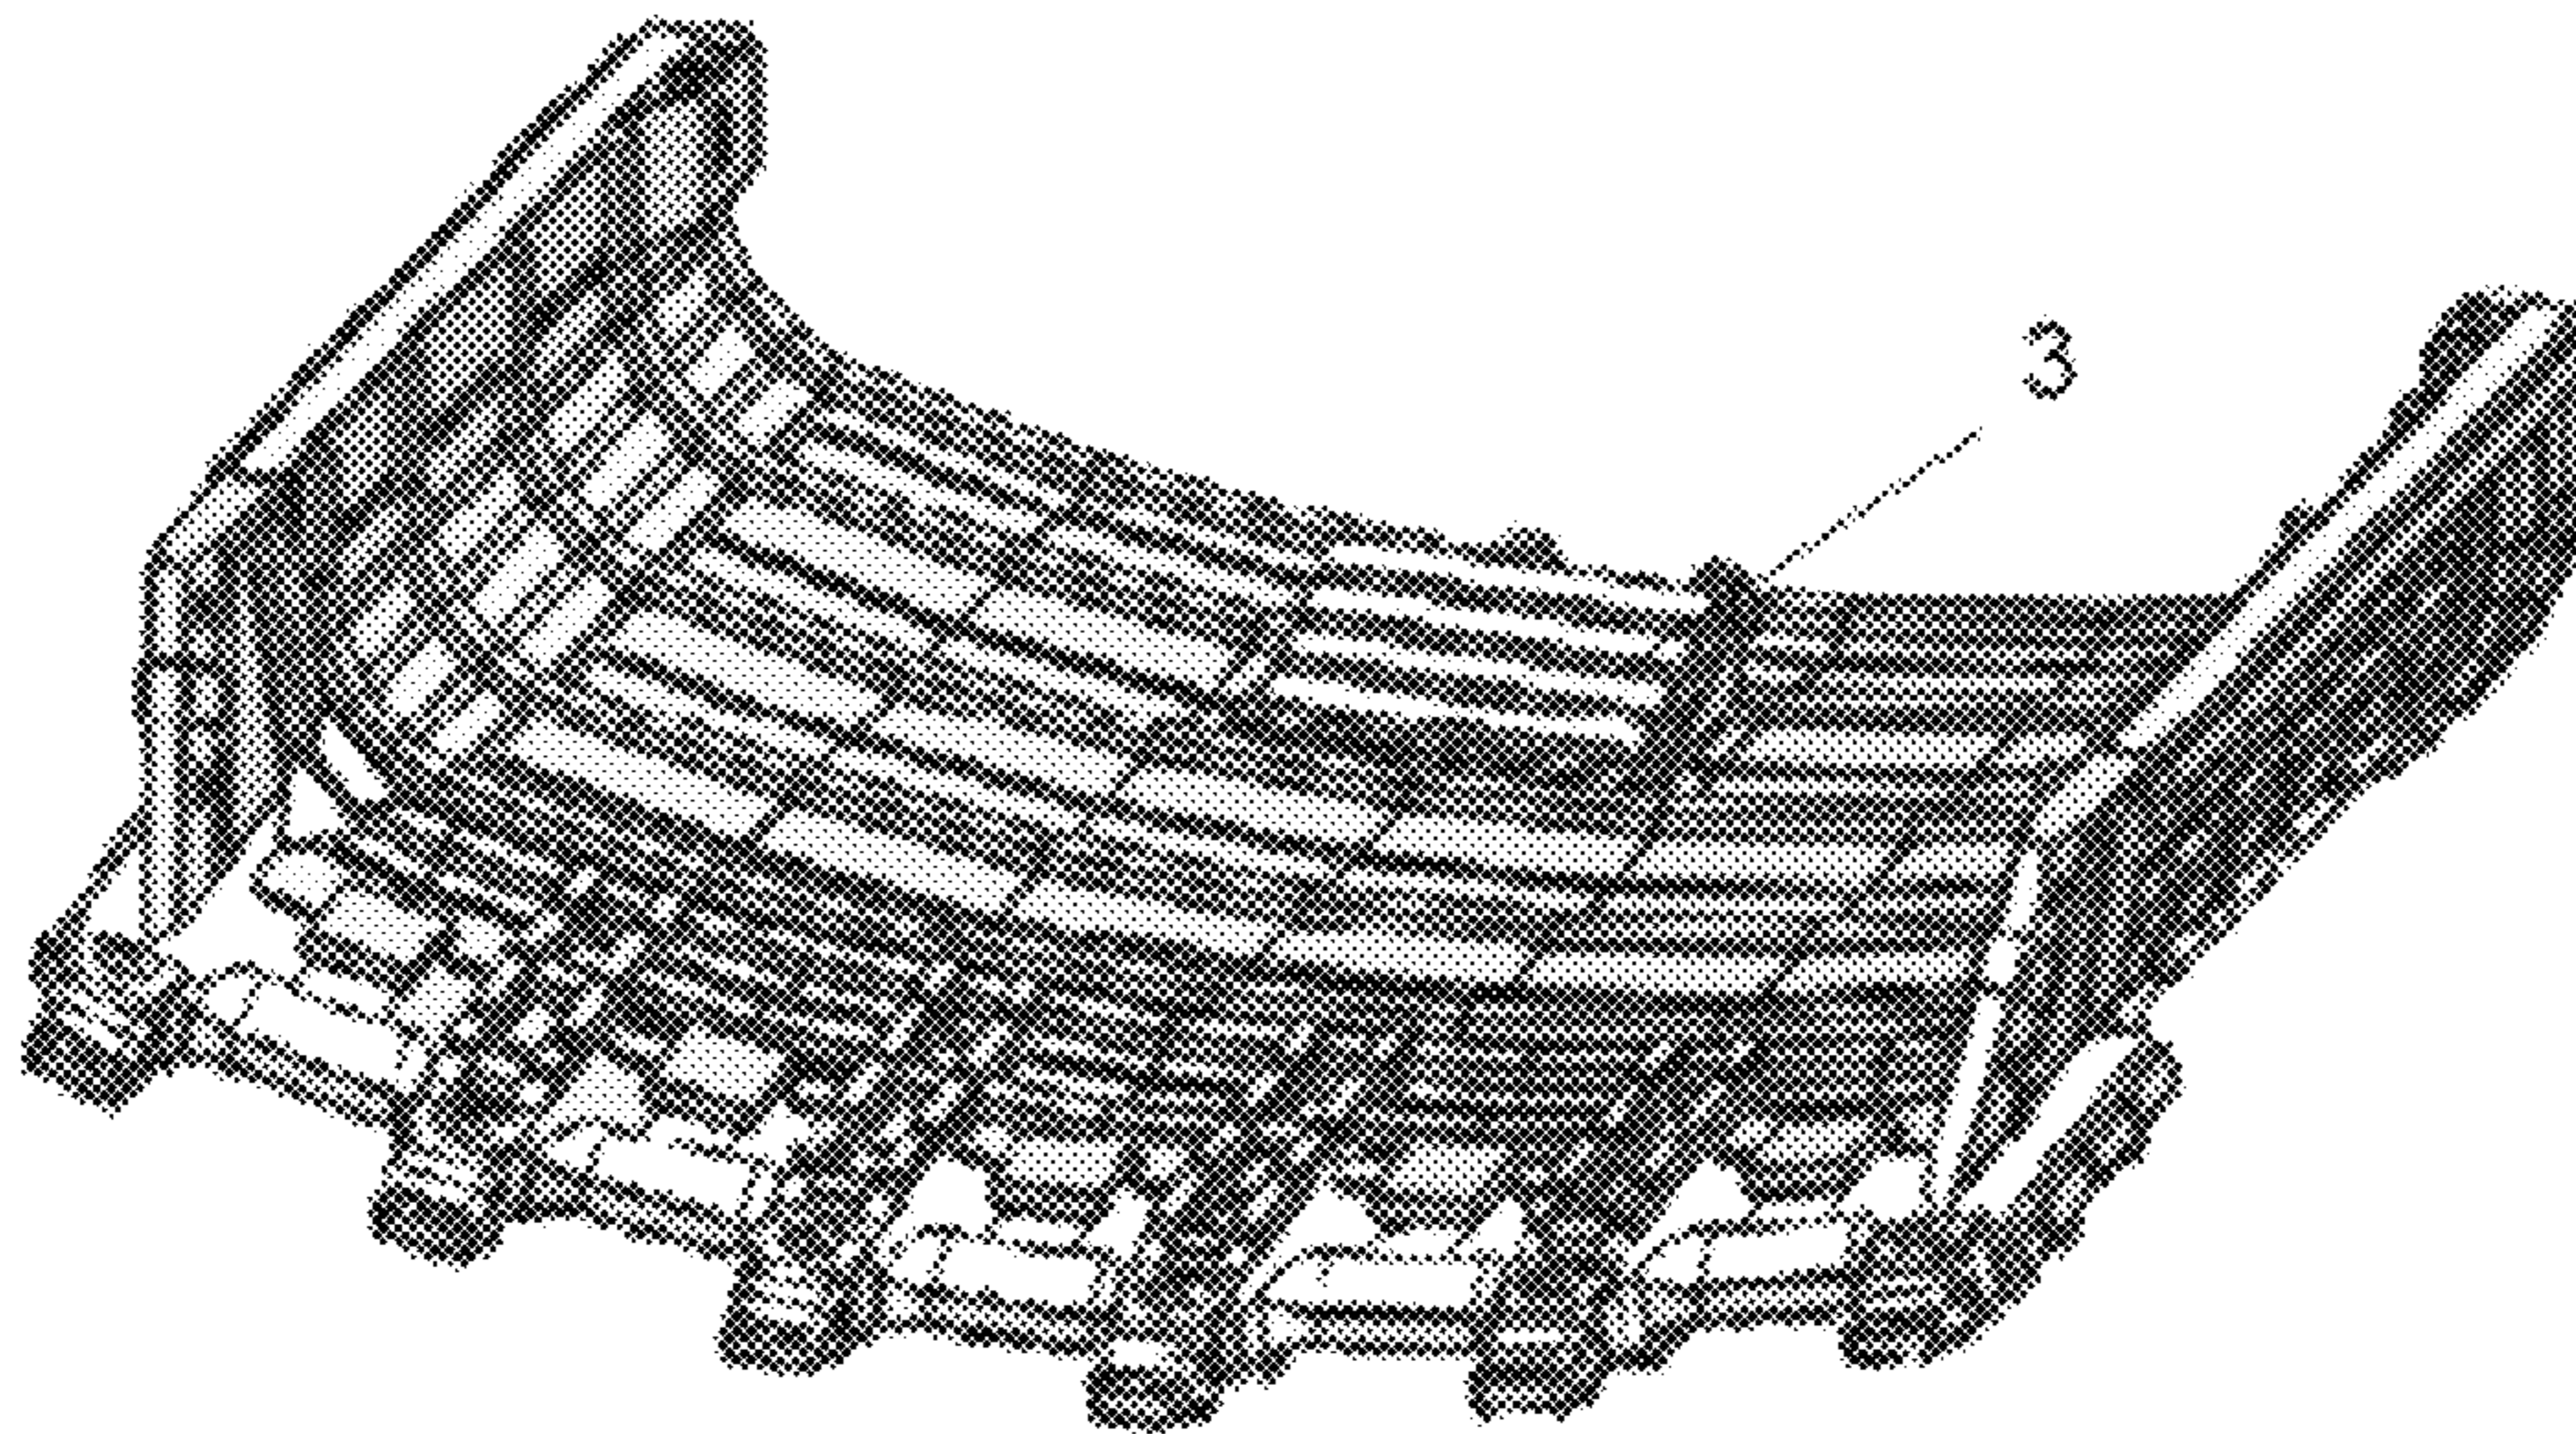
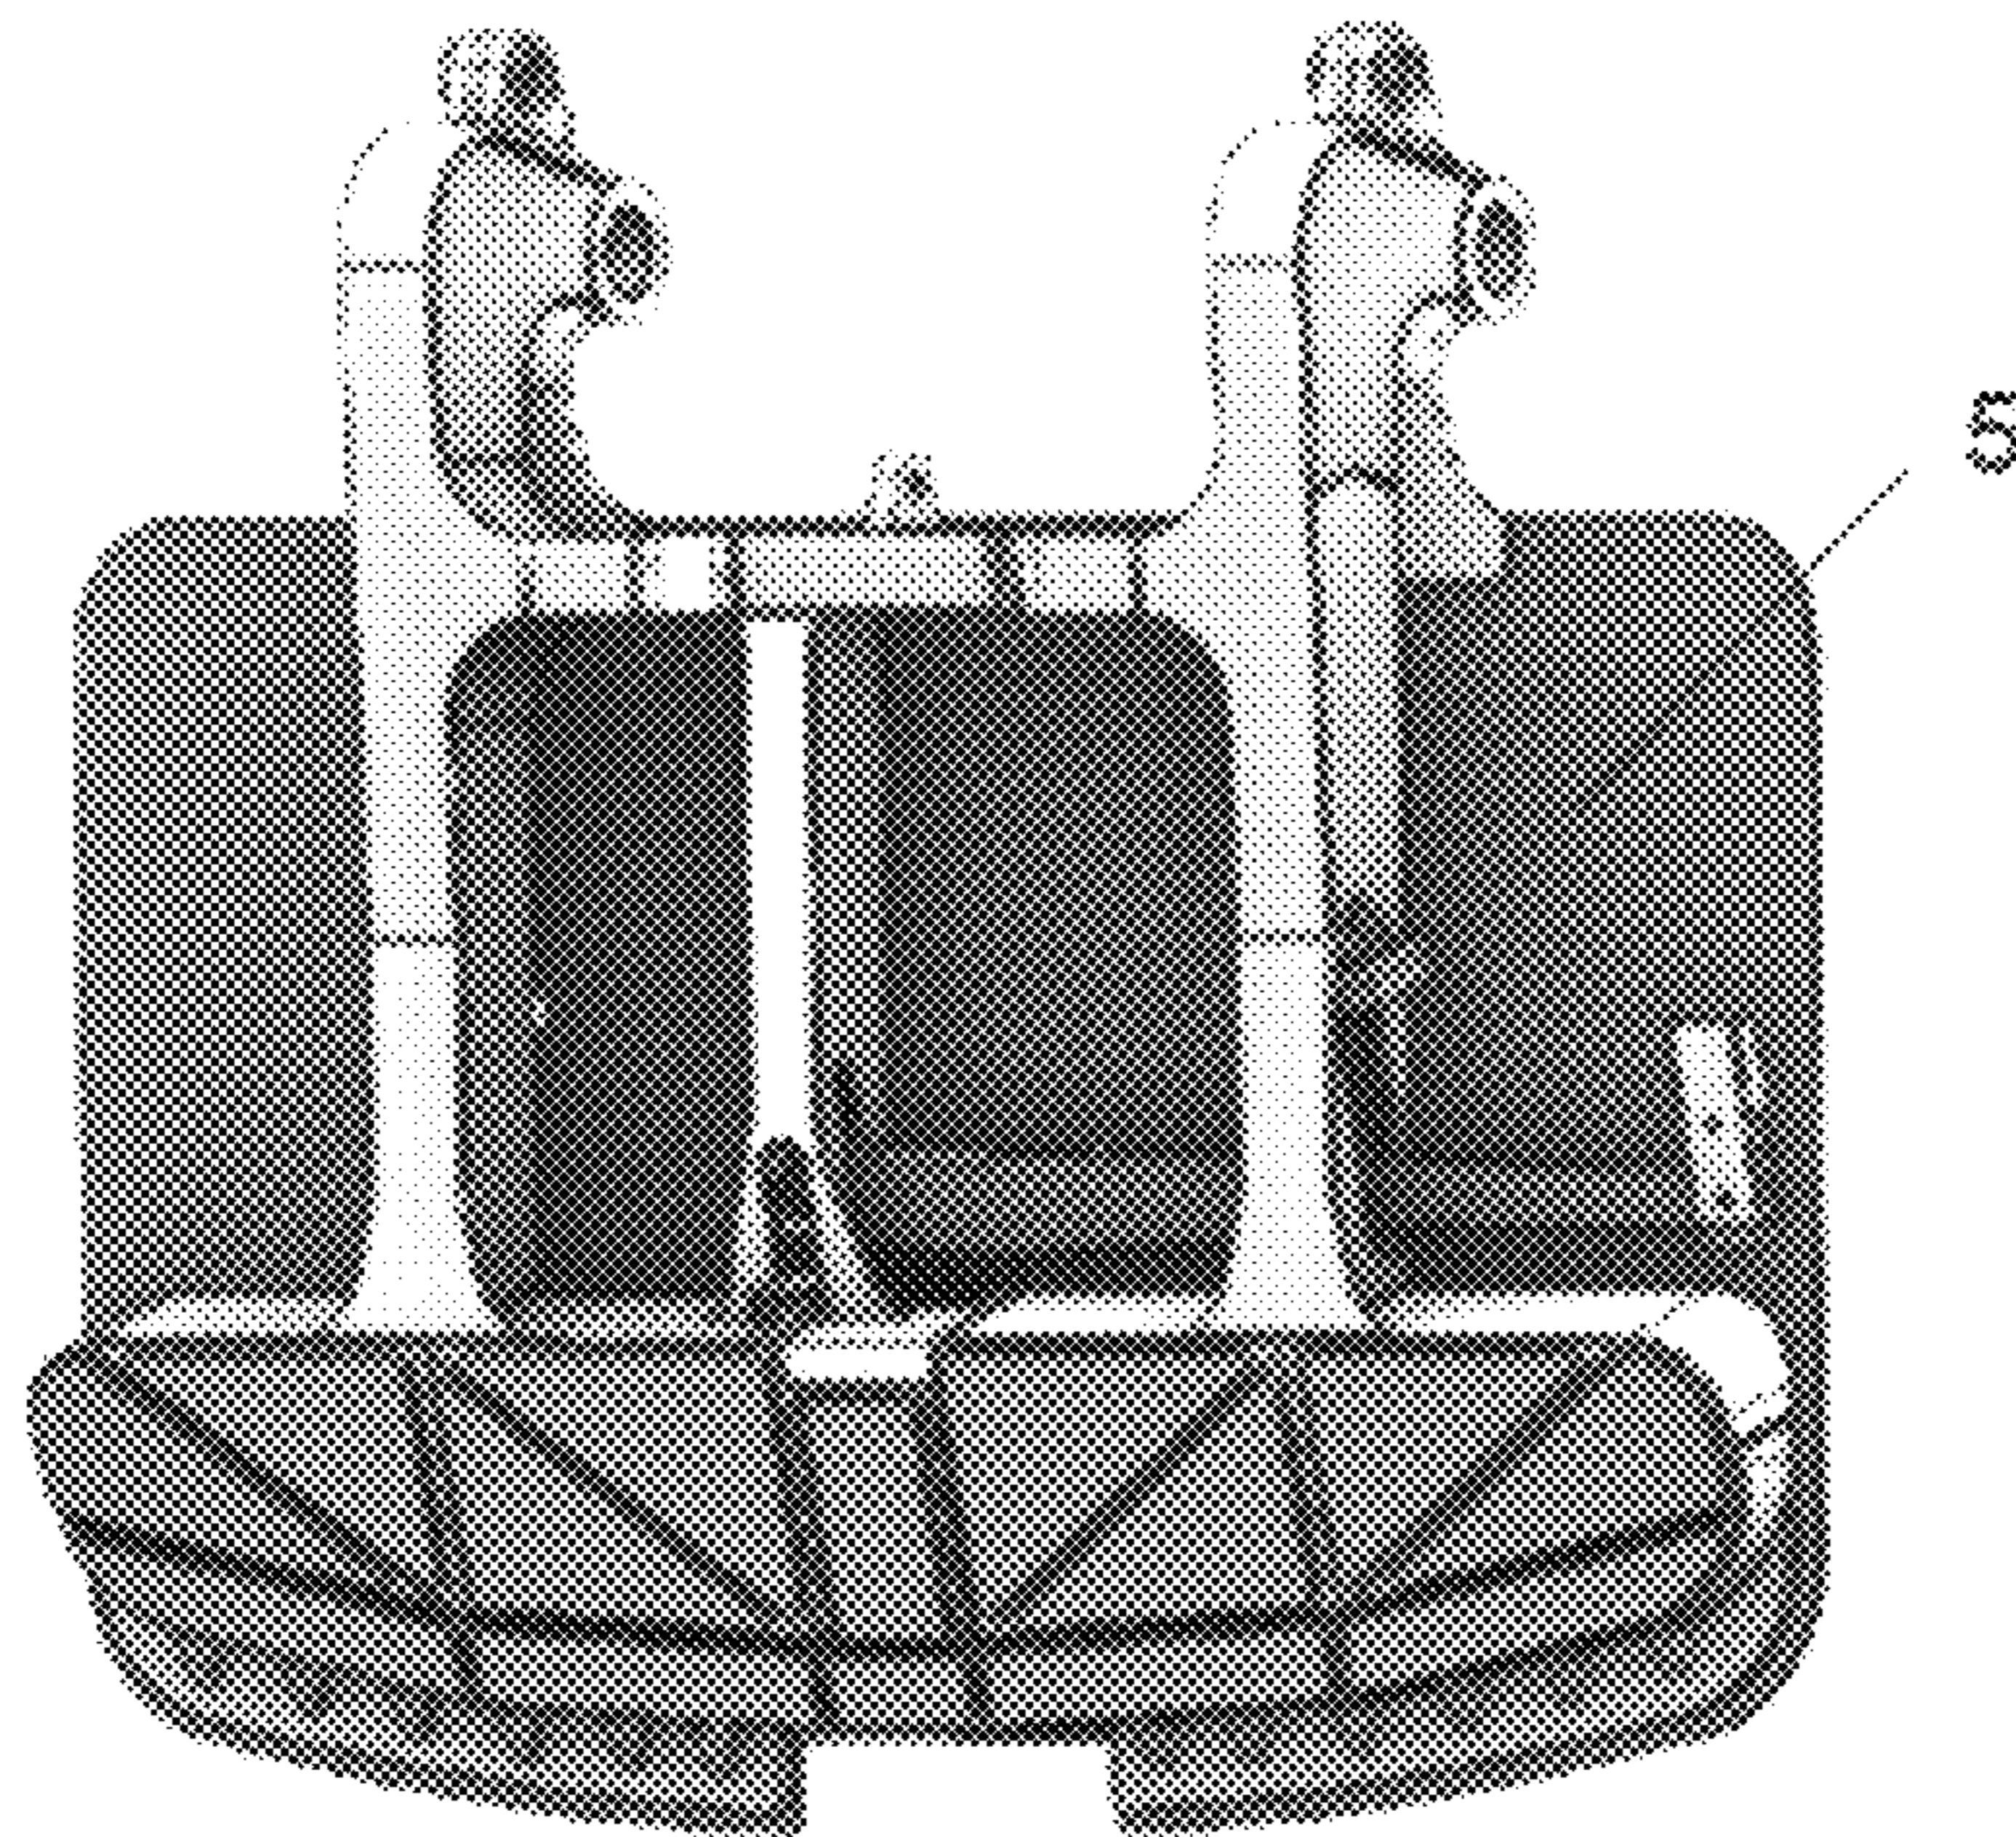
Figure 5

FIG. 5 shows the new door and the lower part of the new bucket which are not repaired and removed from stock once repaired.

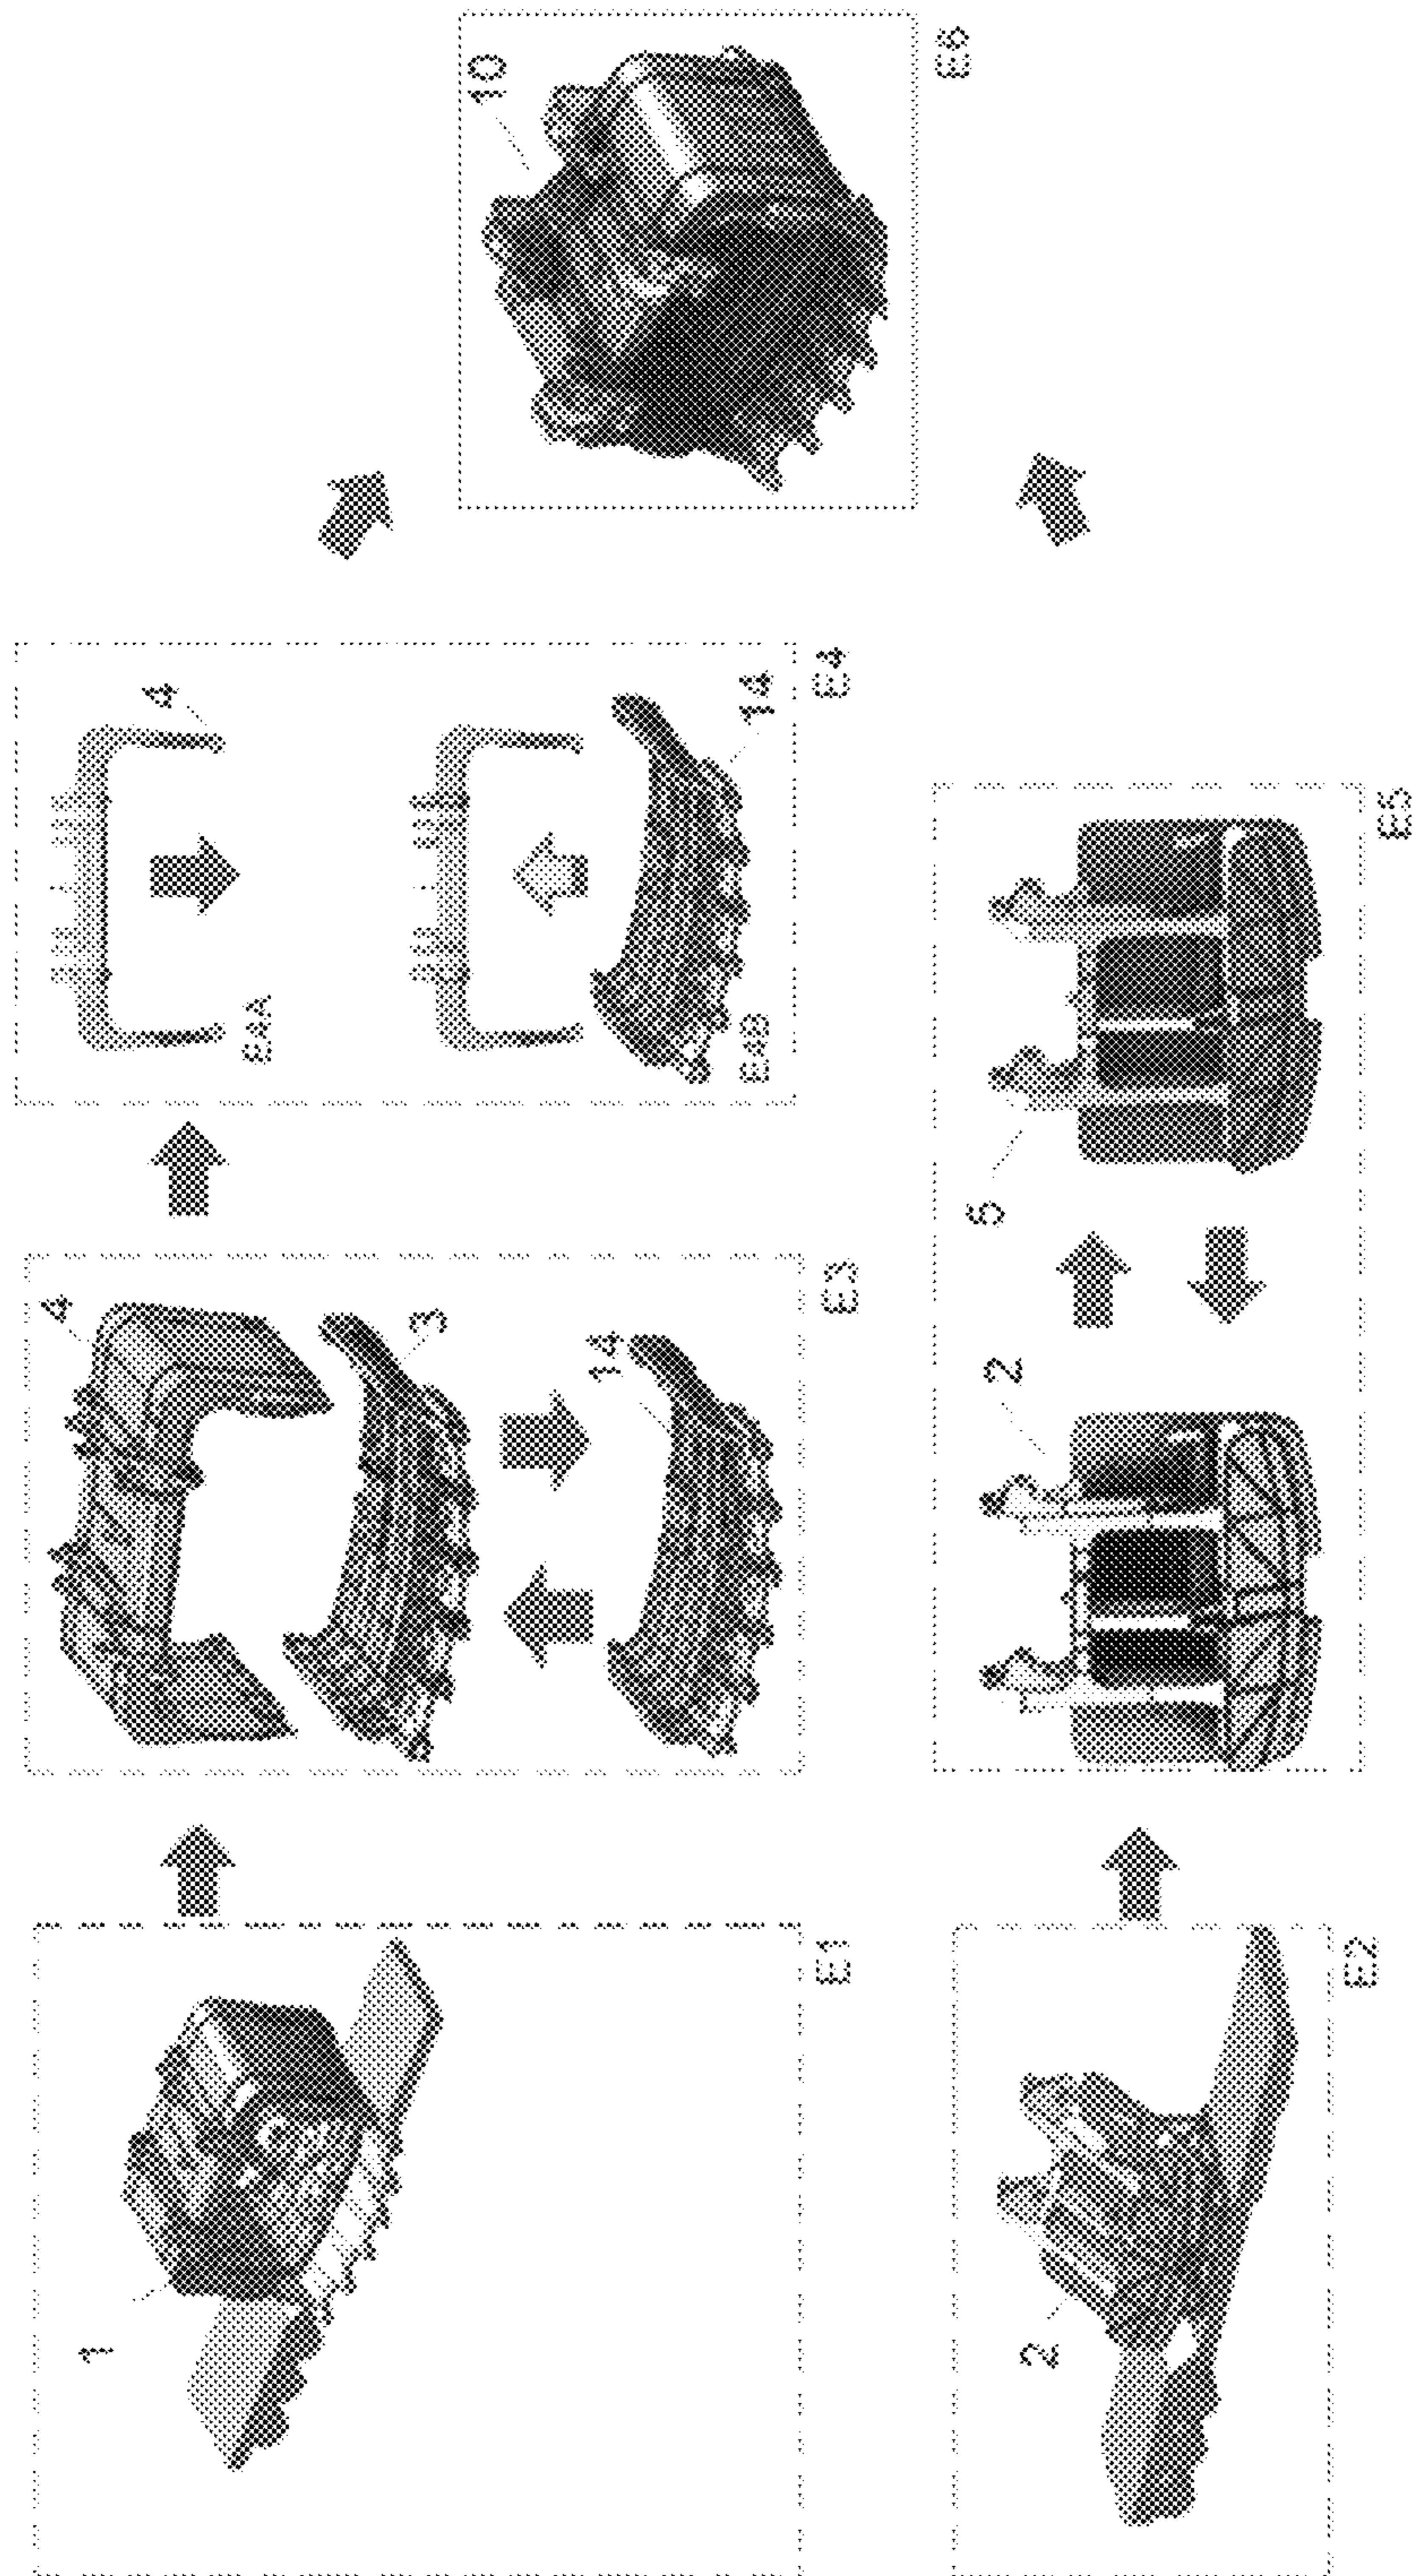
Figure 6

FIG. 6 shows the steps of the invention.

A method is detailed to repair a bucket for electric shovel. As shown in FIG. 6, the bucket (1) and the door (2) arrive separately to be repaired (E1, E2).

(E3) The bucket (1) is cut by separating it into two parts, an upper part (4) which is maintained and repaired, and a lower part (3), which is removed replacing it after completion of repairs to the upper part (4) by a new lower part (14).

(E4A) Repairs are made on the upper part (4) which has been maintained and once said repairs are finished (E4B) the upper part (4) is welded to the new lower part (14).

(E5) The original door (2) is removed and replaced by a new door or one previously repaired (5) which is kept in stock.

(E6) Accessory parts and the new door (5) are mounted and corresponding tests are done to obtain a new reconditioned bucket (10).

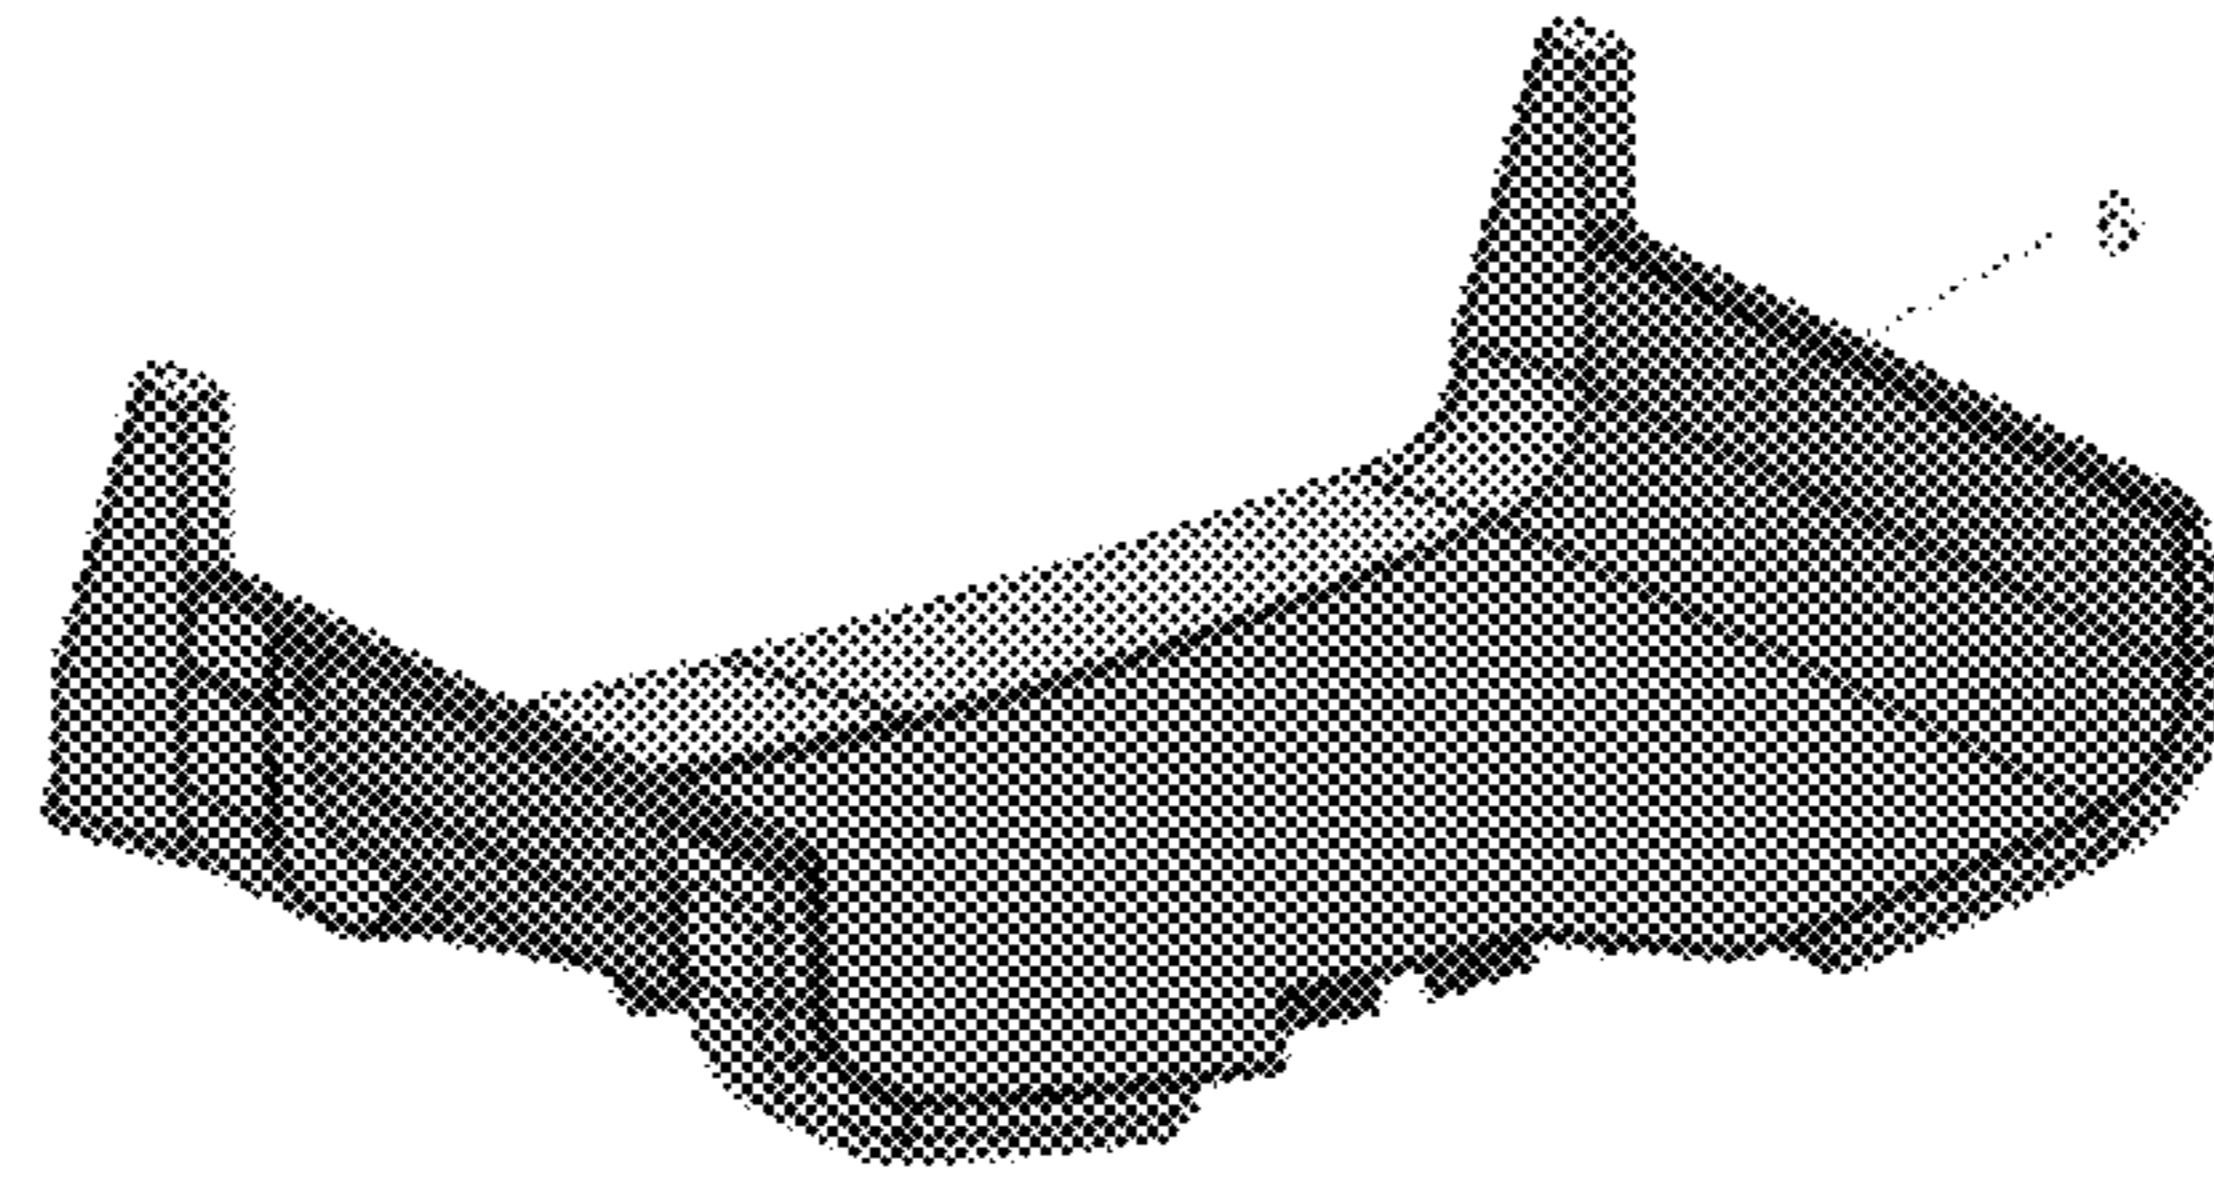
Figure 7

FIG. 7 shows a lower part unshielded.

As shown in FIGS. 7, 8, 9 and 10, operations are performed both on the upper part (4) which is maintained, as well as on the two removed elements, that is, the original lower part (3) and the original door (2), it should be noted that repair of these two removed elements (3, 2) does not generate operation times in the bucket reconditioning, since these removed elements (3, 2) are repaired outside the bucket repair line and kept in stock once repaired. The operation performed in more detail are:

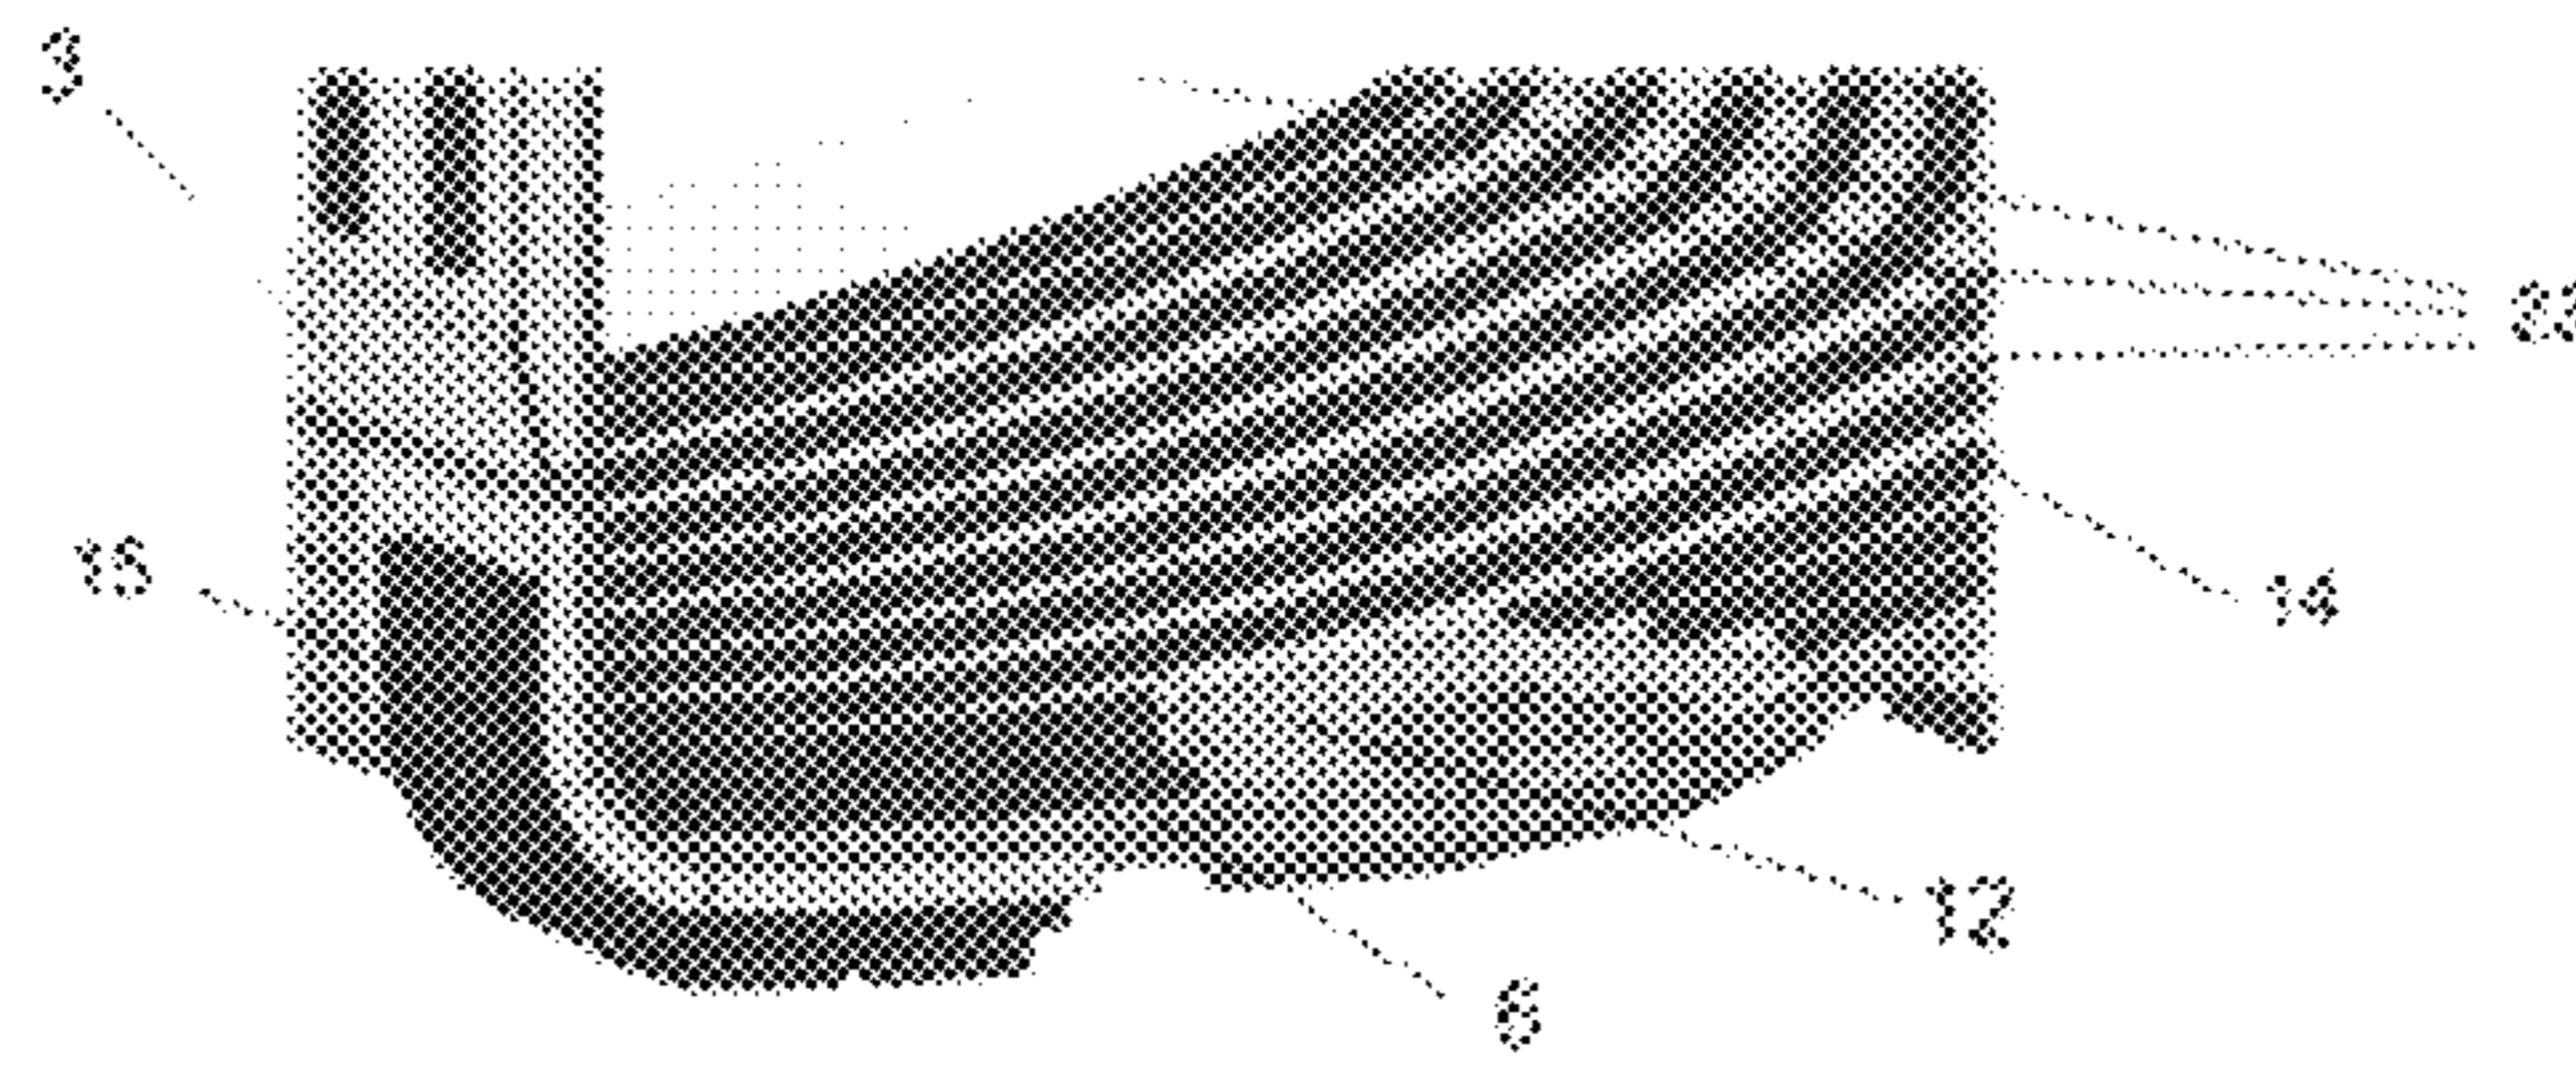
Figure 8

FIG. 8 shows the elements changed on the lower part.

Changing the original floor (8), or part of it, which is usually melted by a new floor (6), or part of it, made of laminated steel.

Changing the original bead band which is usually melted by a new bead band (15) made of laminated steel.

Changing the original flow stoppers (11) usually melted and of high cost by new flow stoppers (23) formed by anti-abrasive steel straps.

If the lip is damaged, changing the original lip (21) melted by a new laminated lip (22) or repairing the original.

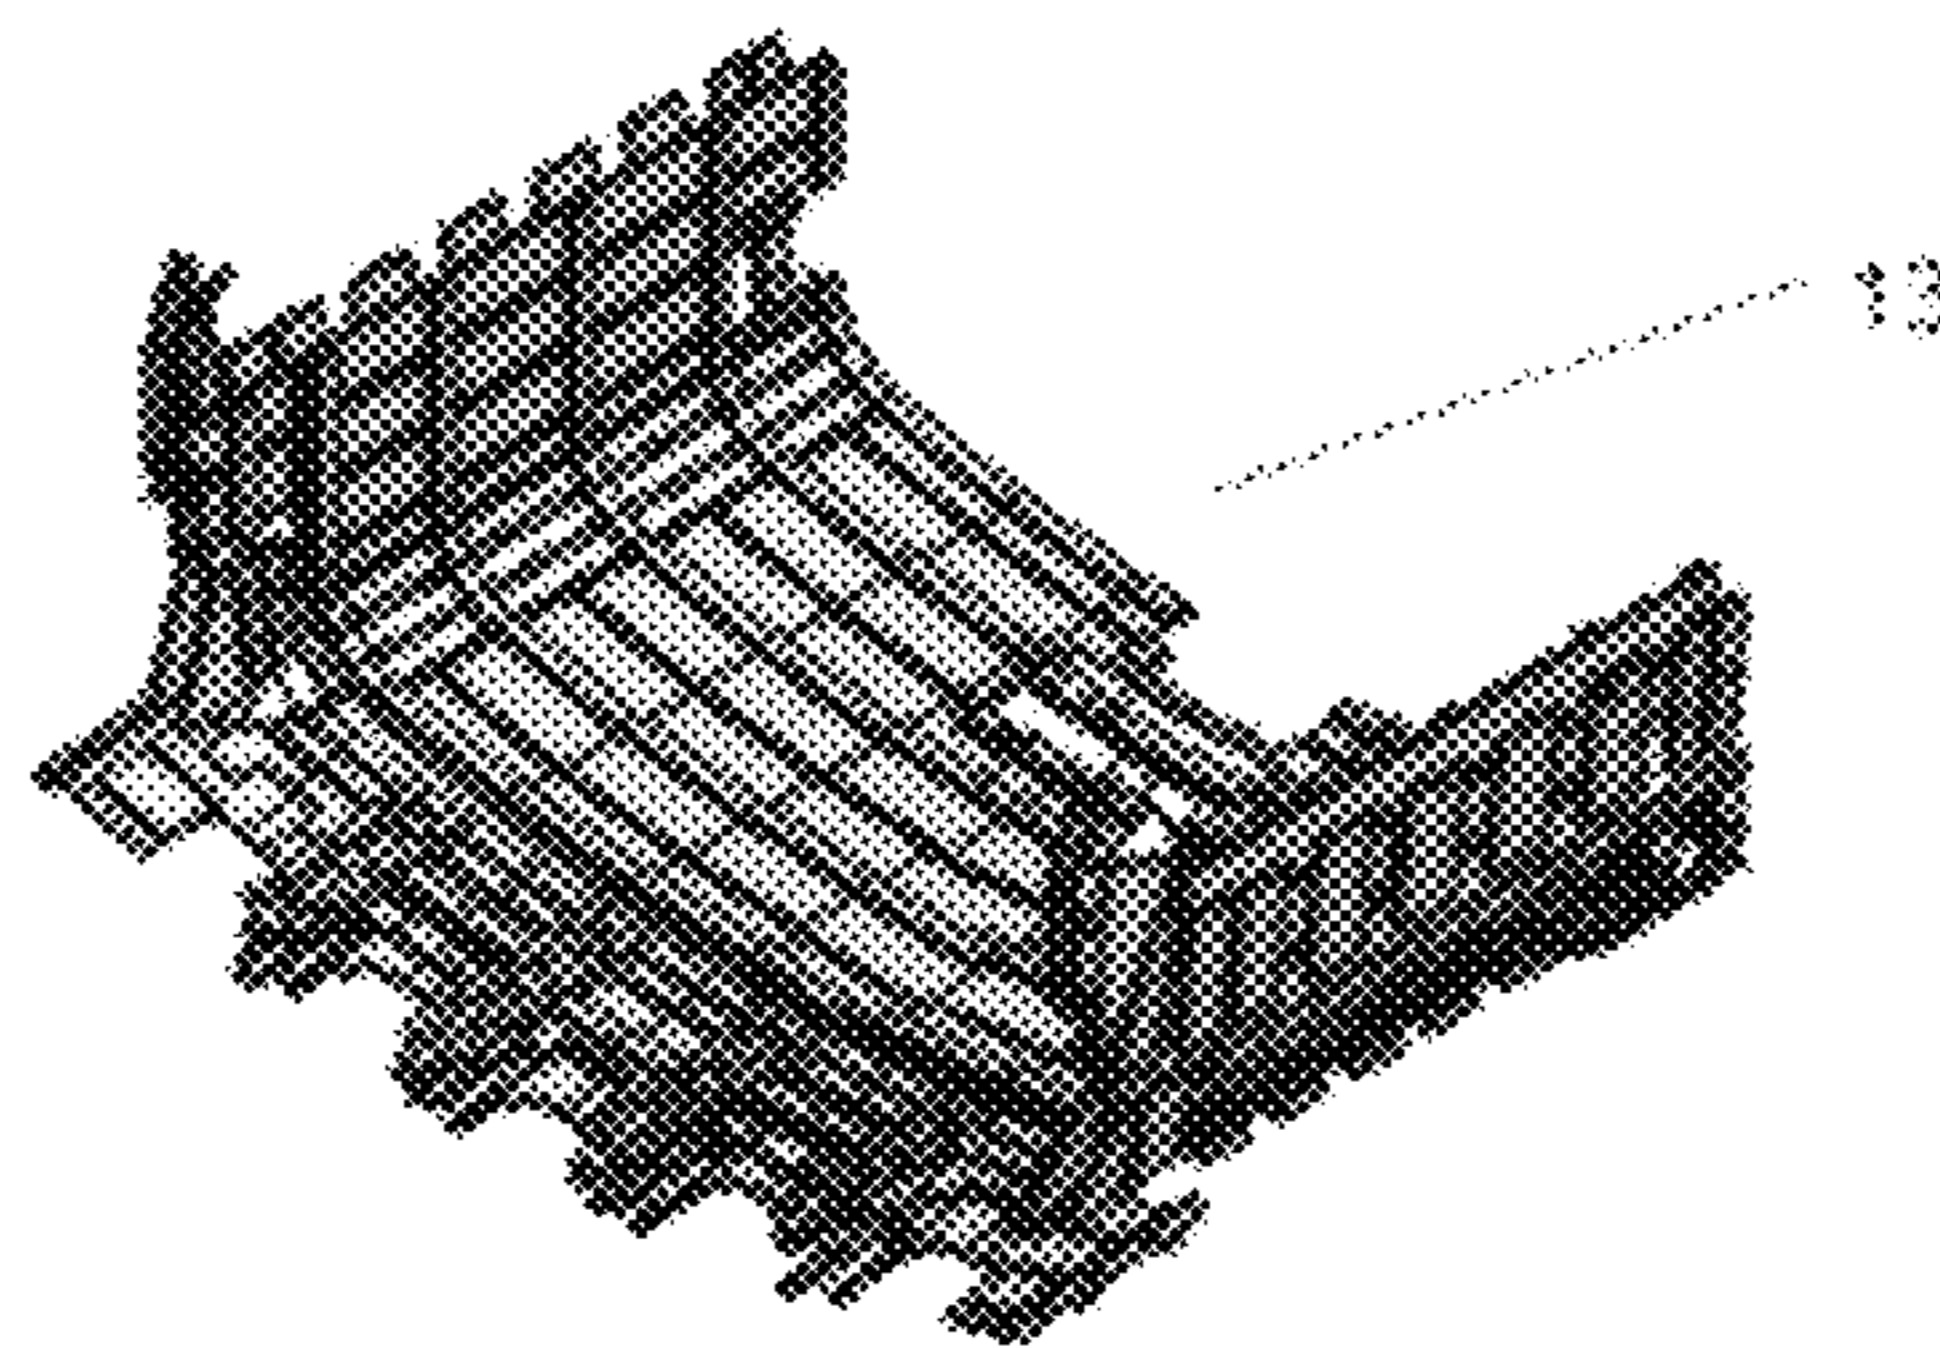
Figure 9

FIG. 9 shows the shield applied to the lower part.

Installing a shield (13) formed of a plurality of parts made of anti-abrasive steel.

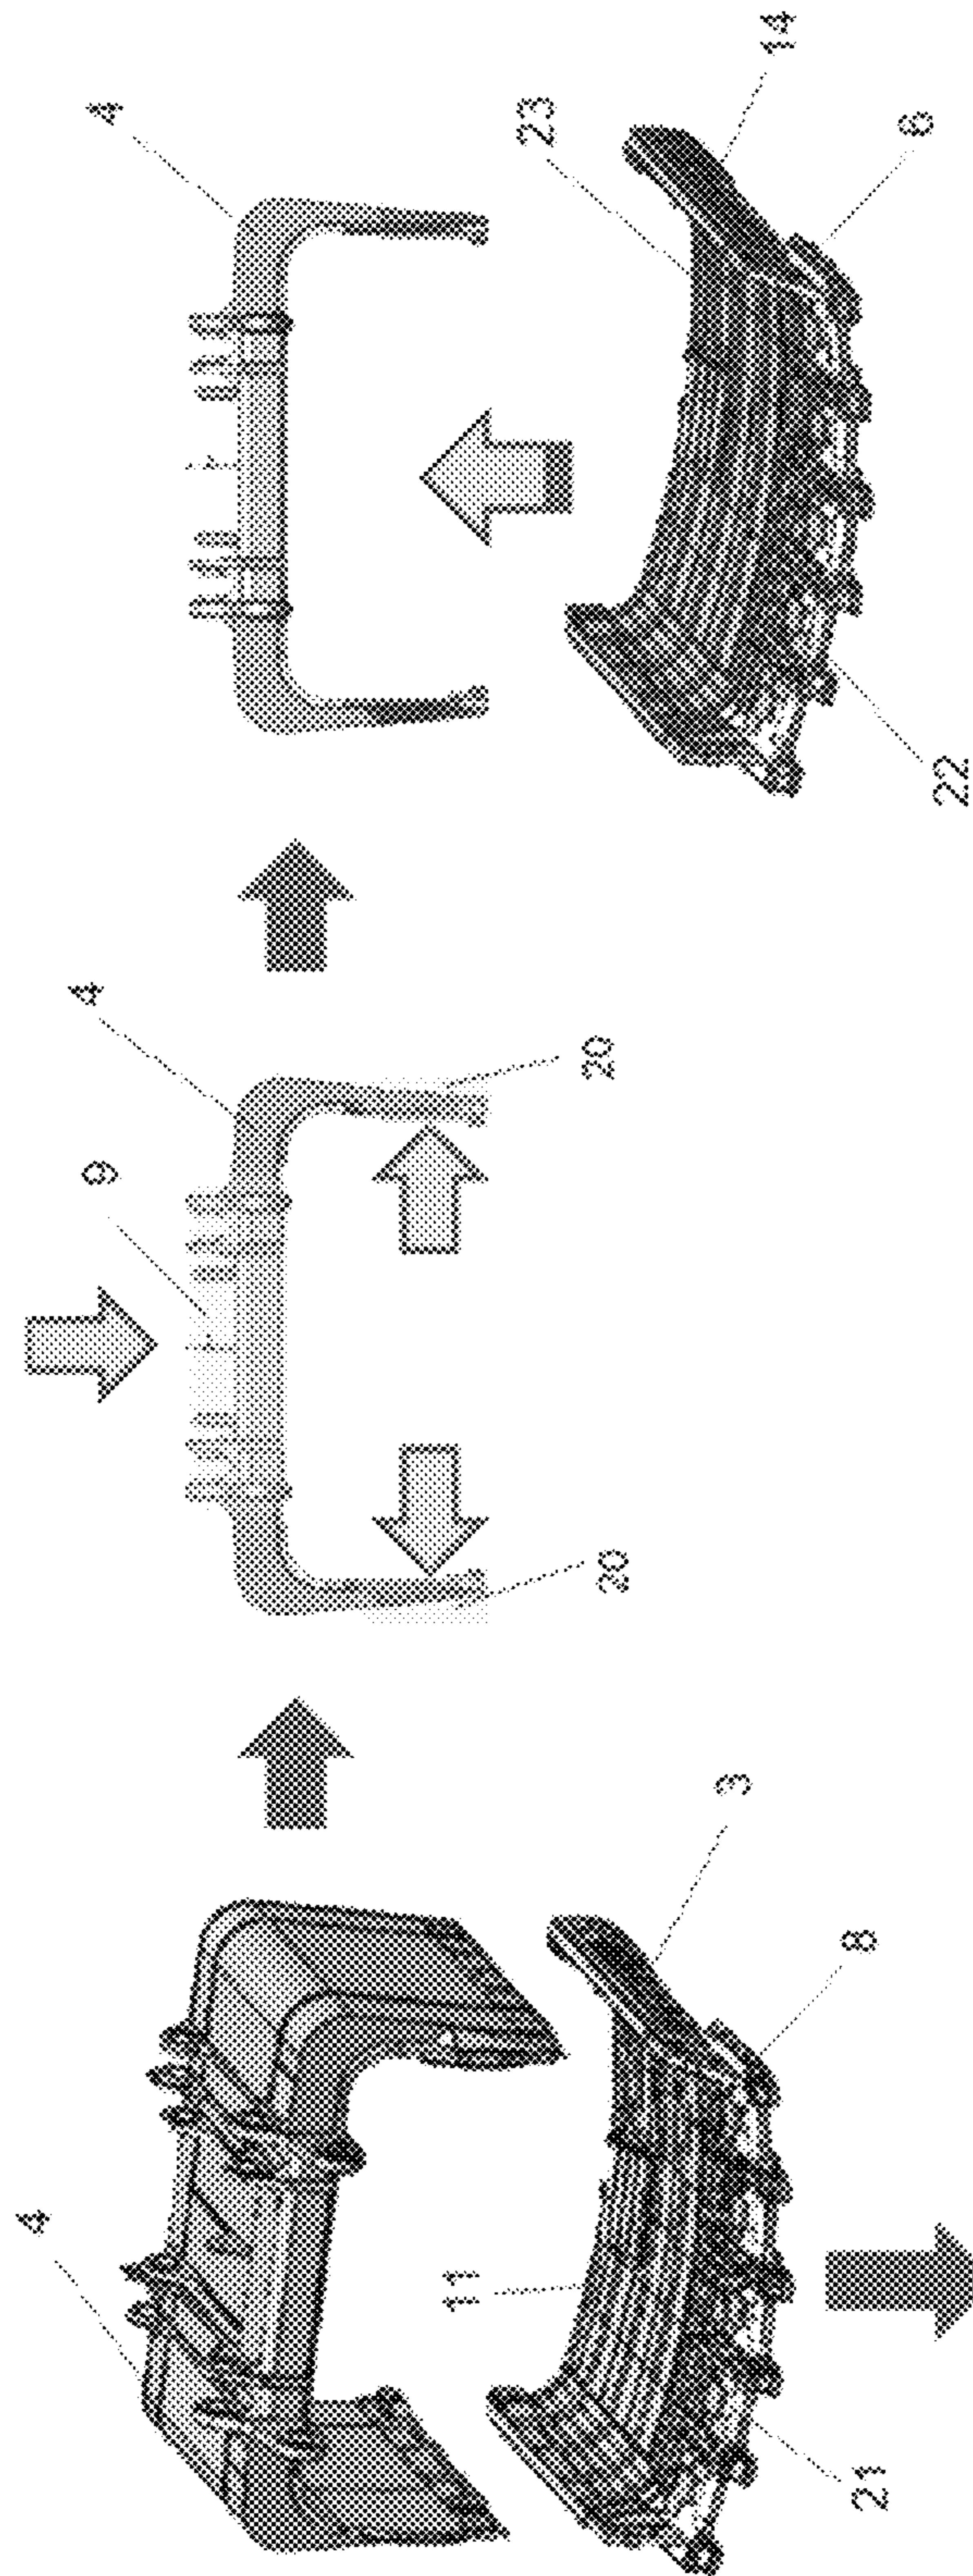
FIG. 10A shows the separation of used parts.

FIG. 10B shows the repair of the used upper part.

FIG. 10C shows the attachment of the repaired upper part with the previously repaired lower part.

1) On the upper part (4) maintained, repairs are made in the damaged areas (20) and in the connection area (9).
