US010024028B2

(54) **METHOD FOR REPAIRING BUCKETS**

(71) Applicant: **Minetec S.A.**, Santiago (CL)

A method for repairing a bucket of a piece of earthwork equipment is provided, the method being specifically applicable to the repair of electric shovel buckets.

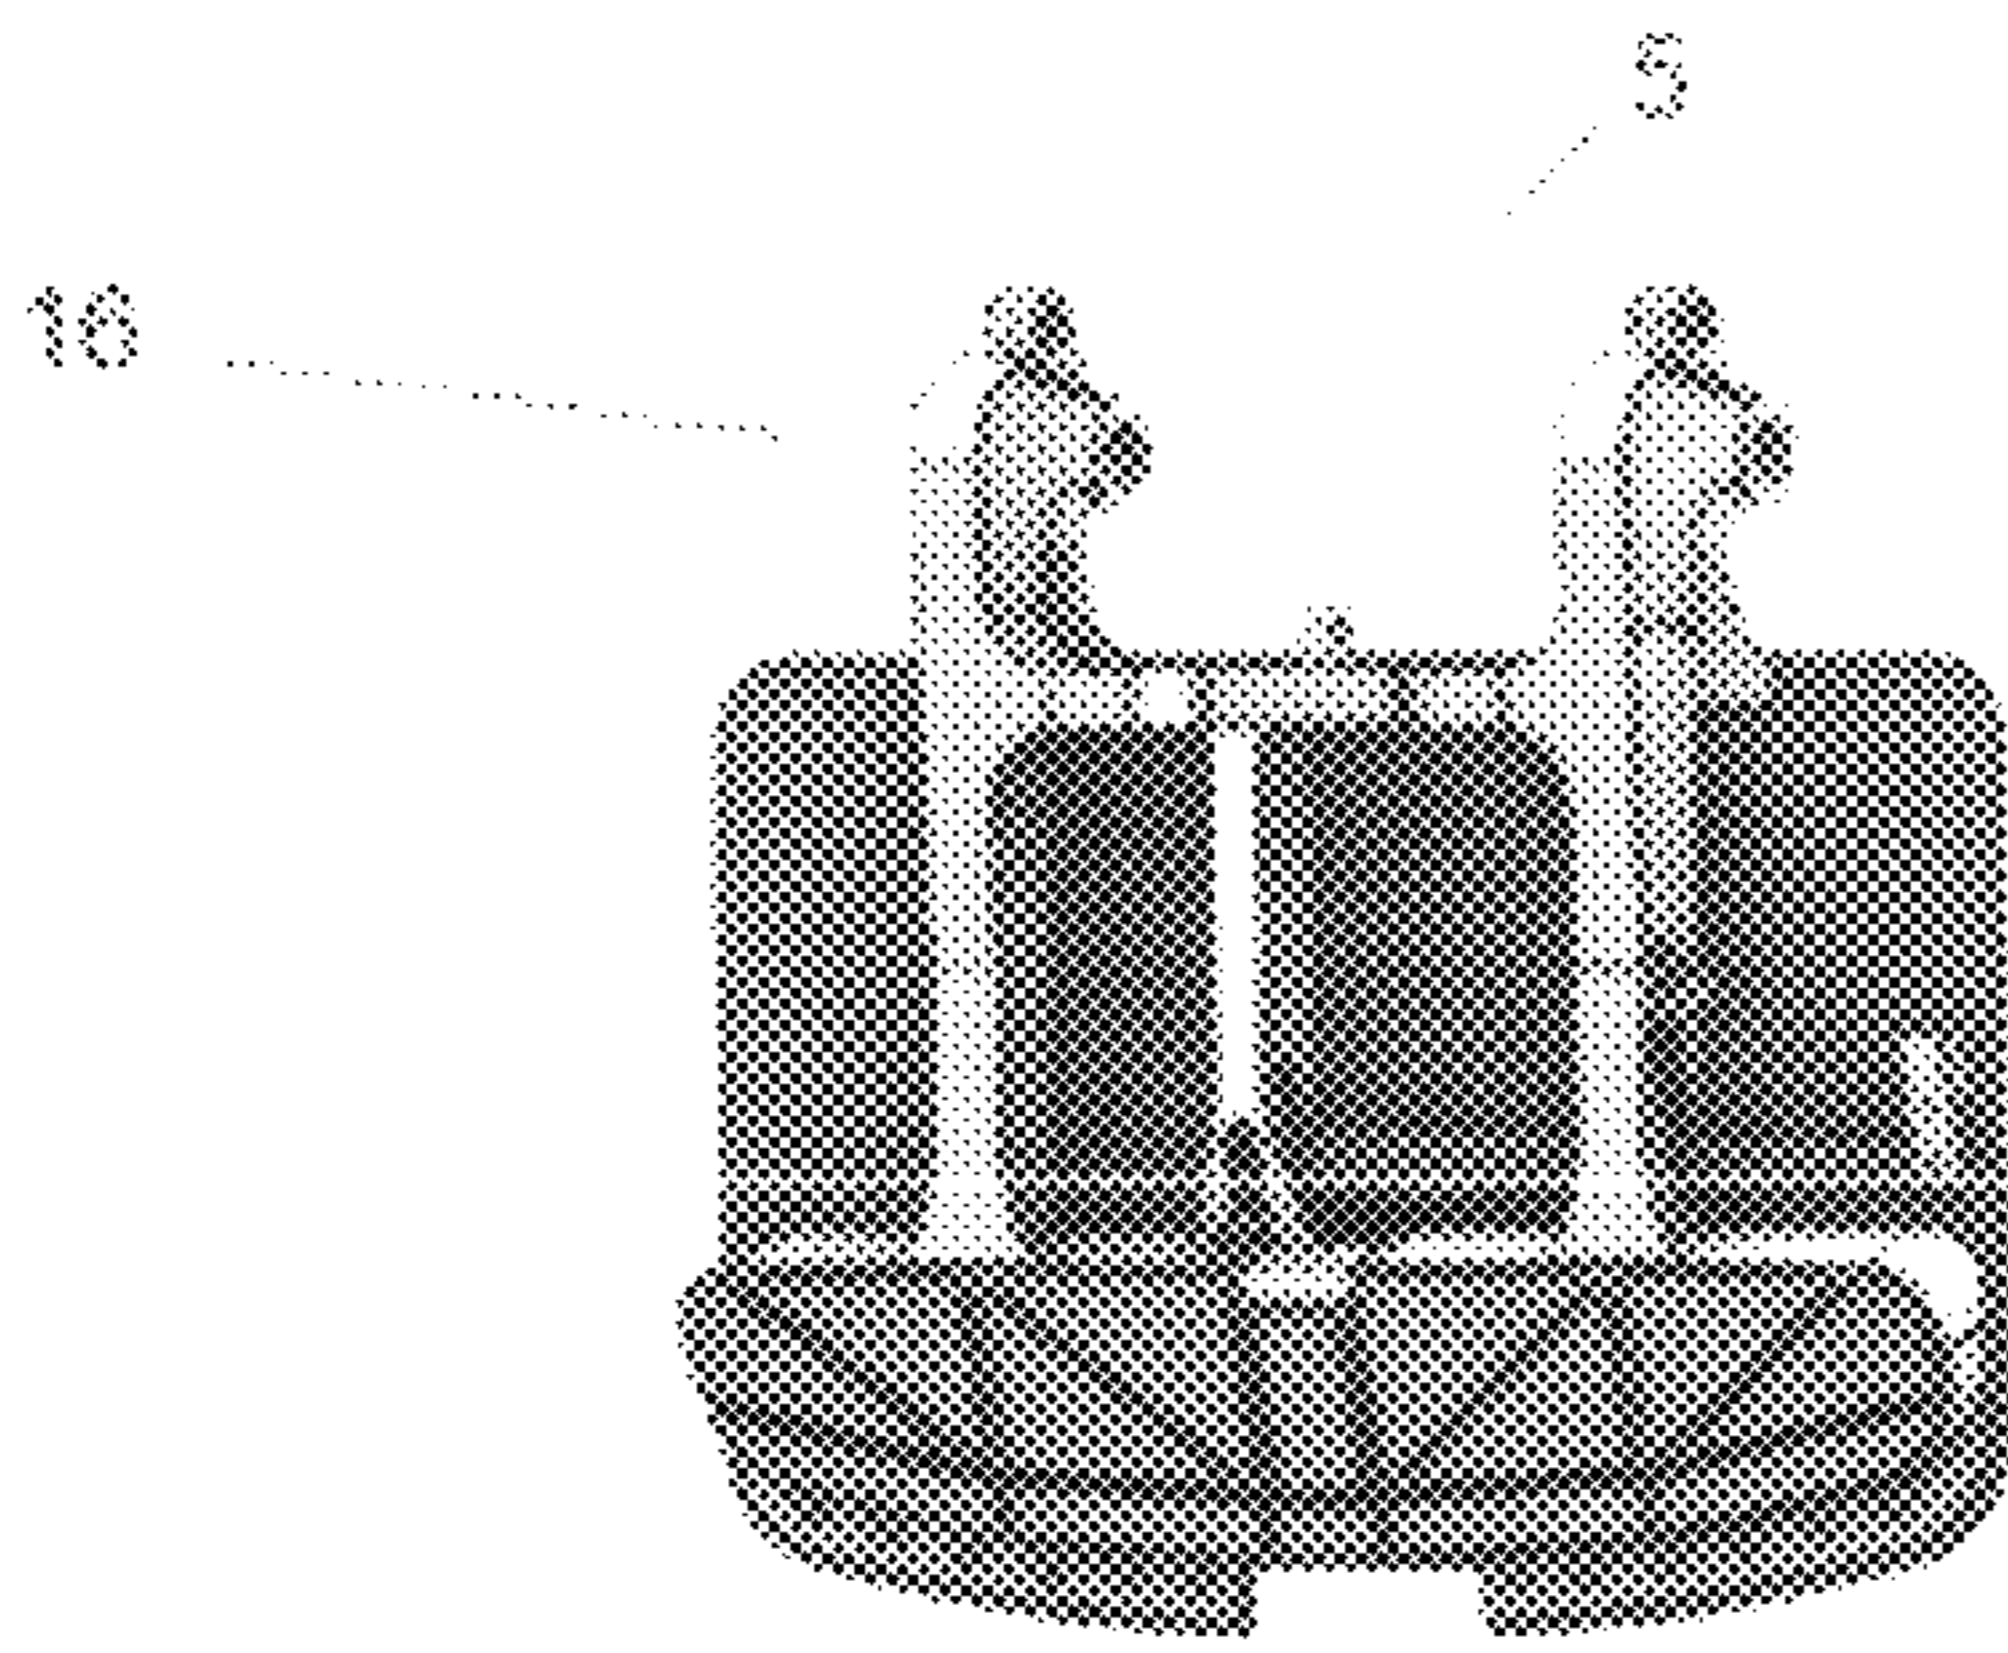
Figure 11A

FIG. 11A shows the outer part of the lid.

Installing a new base plate (17) and making repairs in the connection area (16) using high-strength structural steel.

Installing shielding sheets and slabs (18) made of anti-abrasive steel.

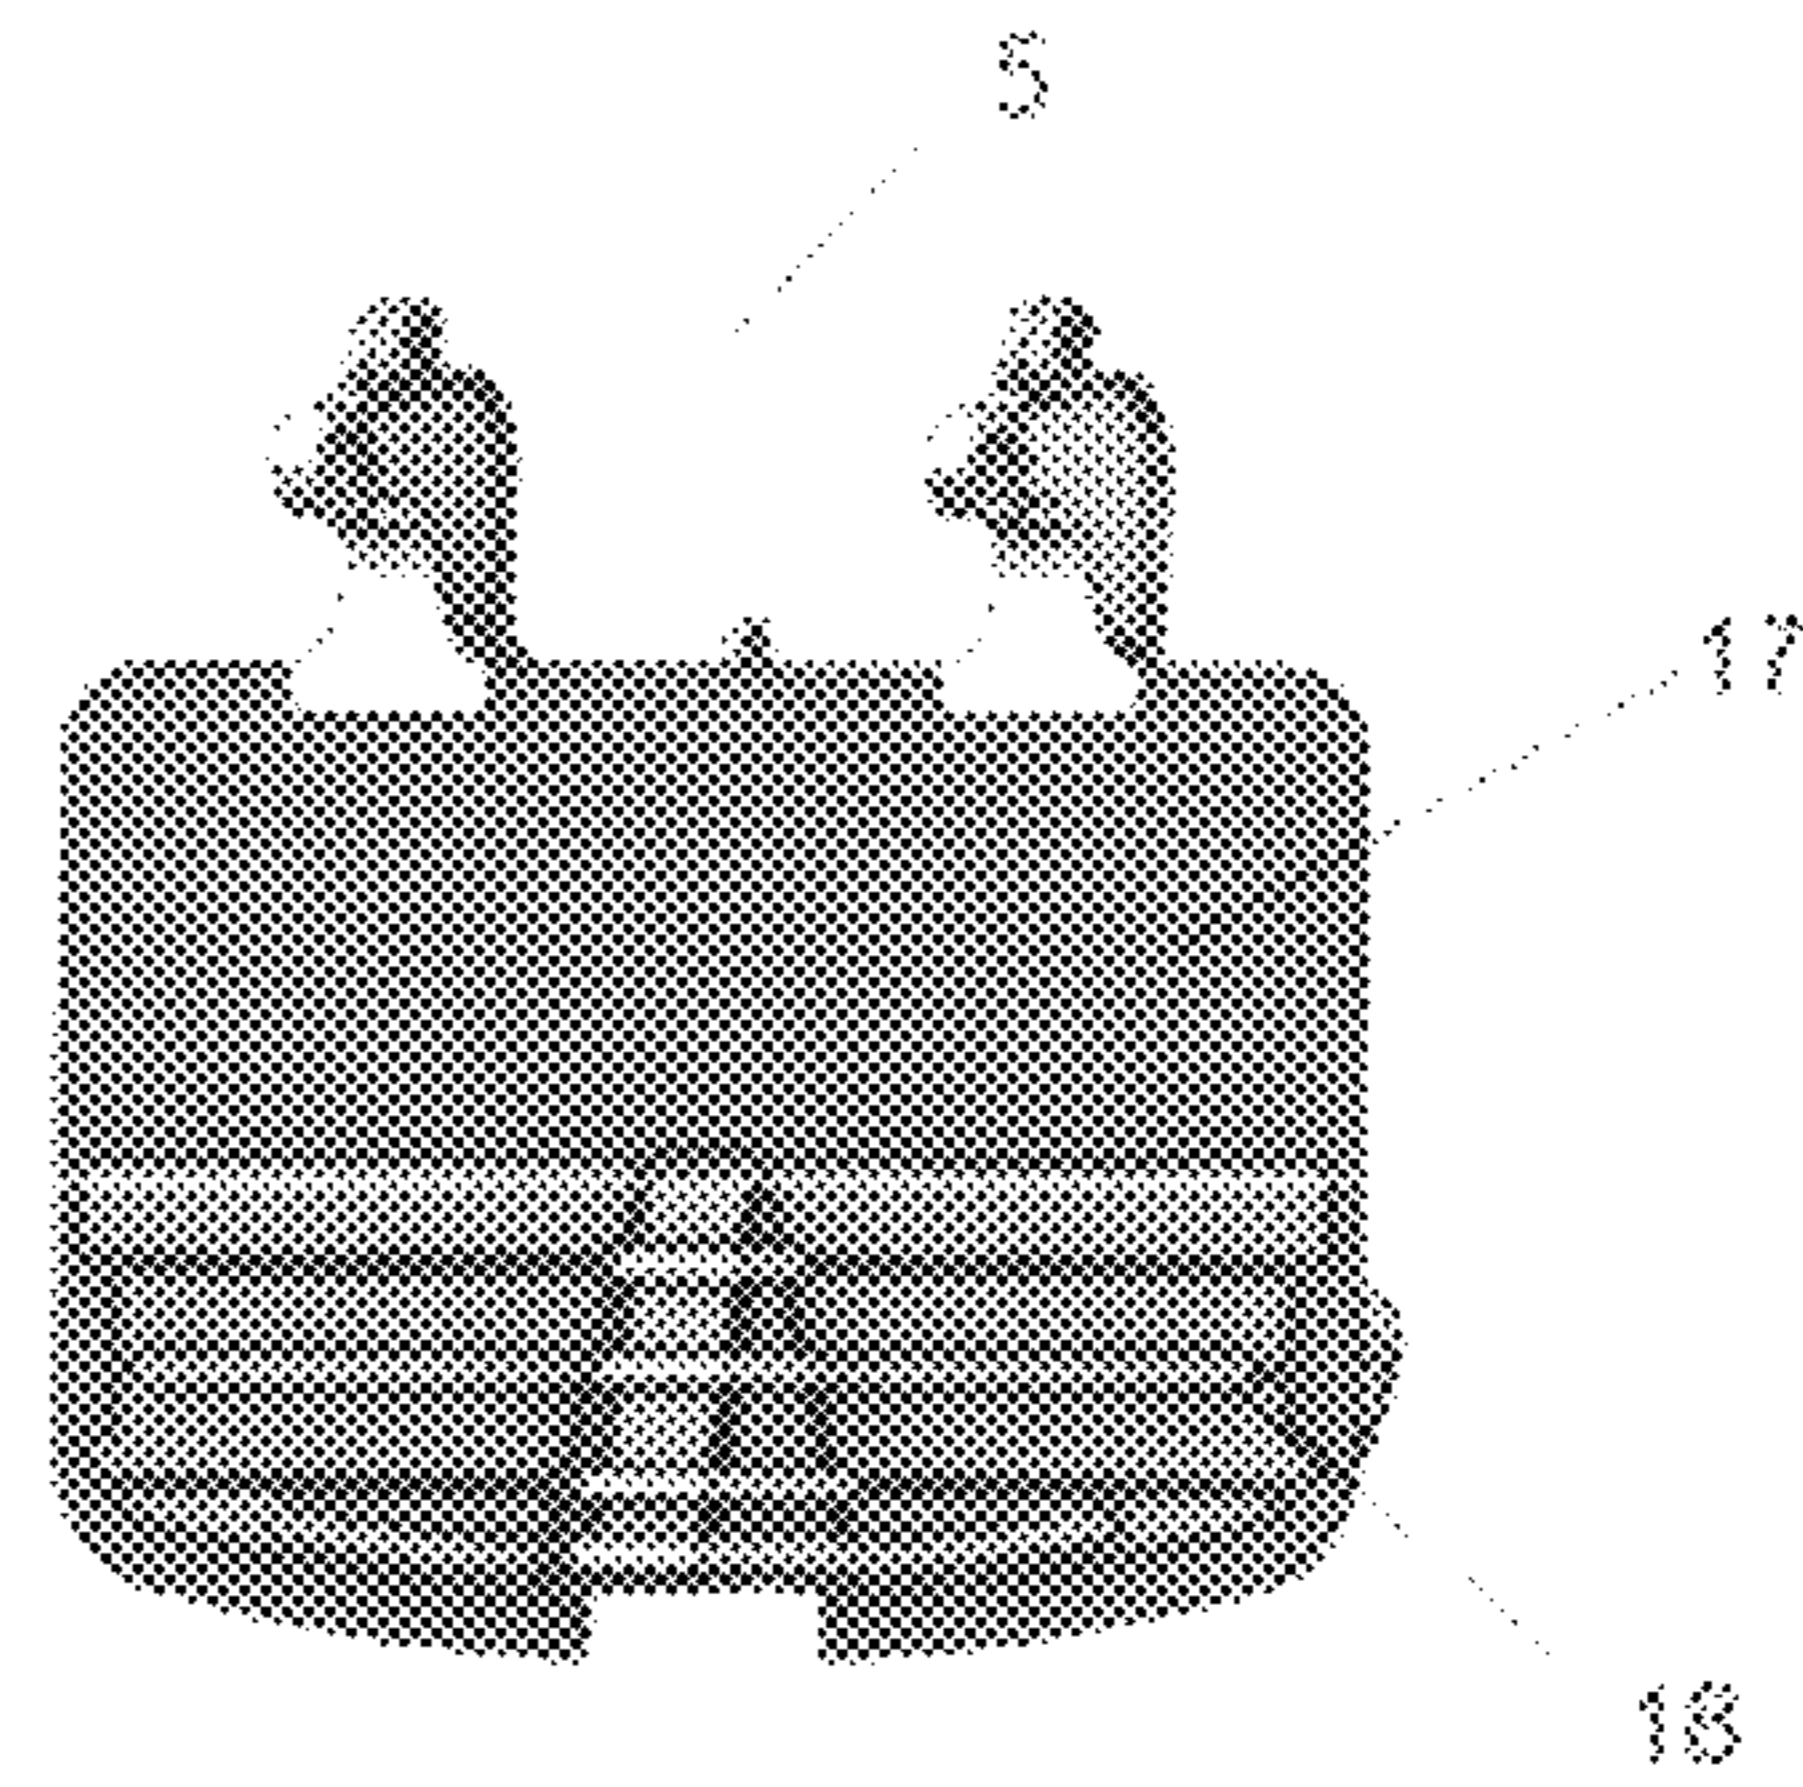
Figure 11B

FIG. 11B shows the inner part of the lid.
