(10) **Patent No.:** **US 10,072,418 B2**  
(45) **Date of Patent:** **Sep. 11, 2018**

(54) **INTEGRAL NAIL/DISK STRUCTURE FOR ELIMINATING EXPOSED ROOF NAILS**

(71) Applicant: **Thomas R. Mathieson**, Louisville, CO (US)

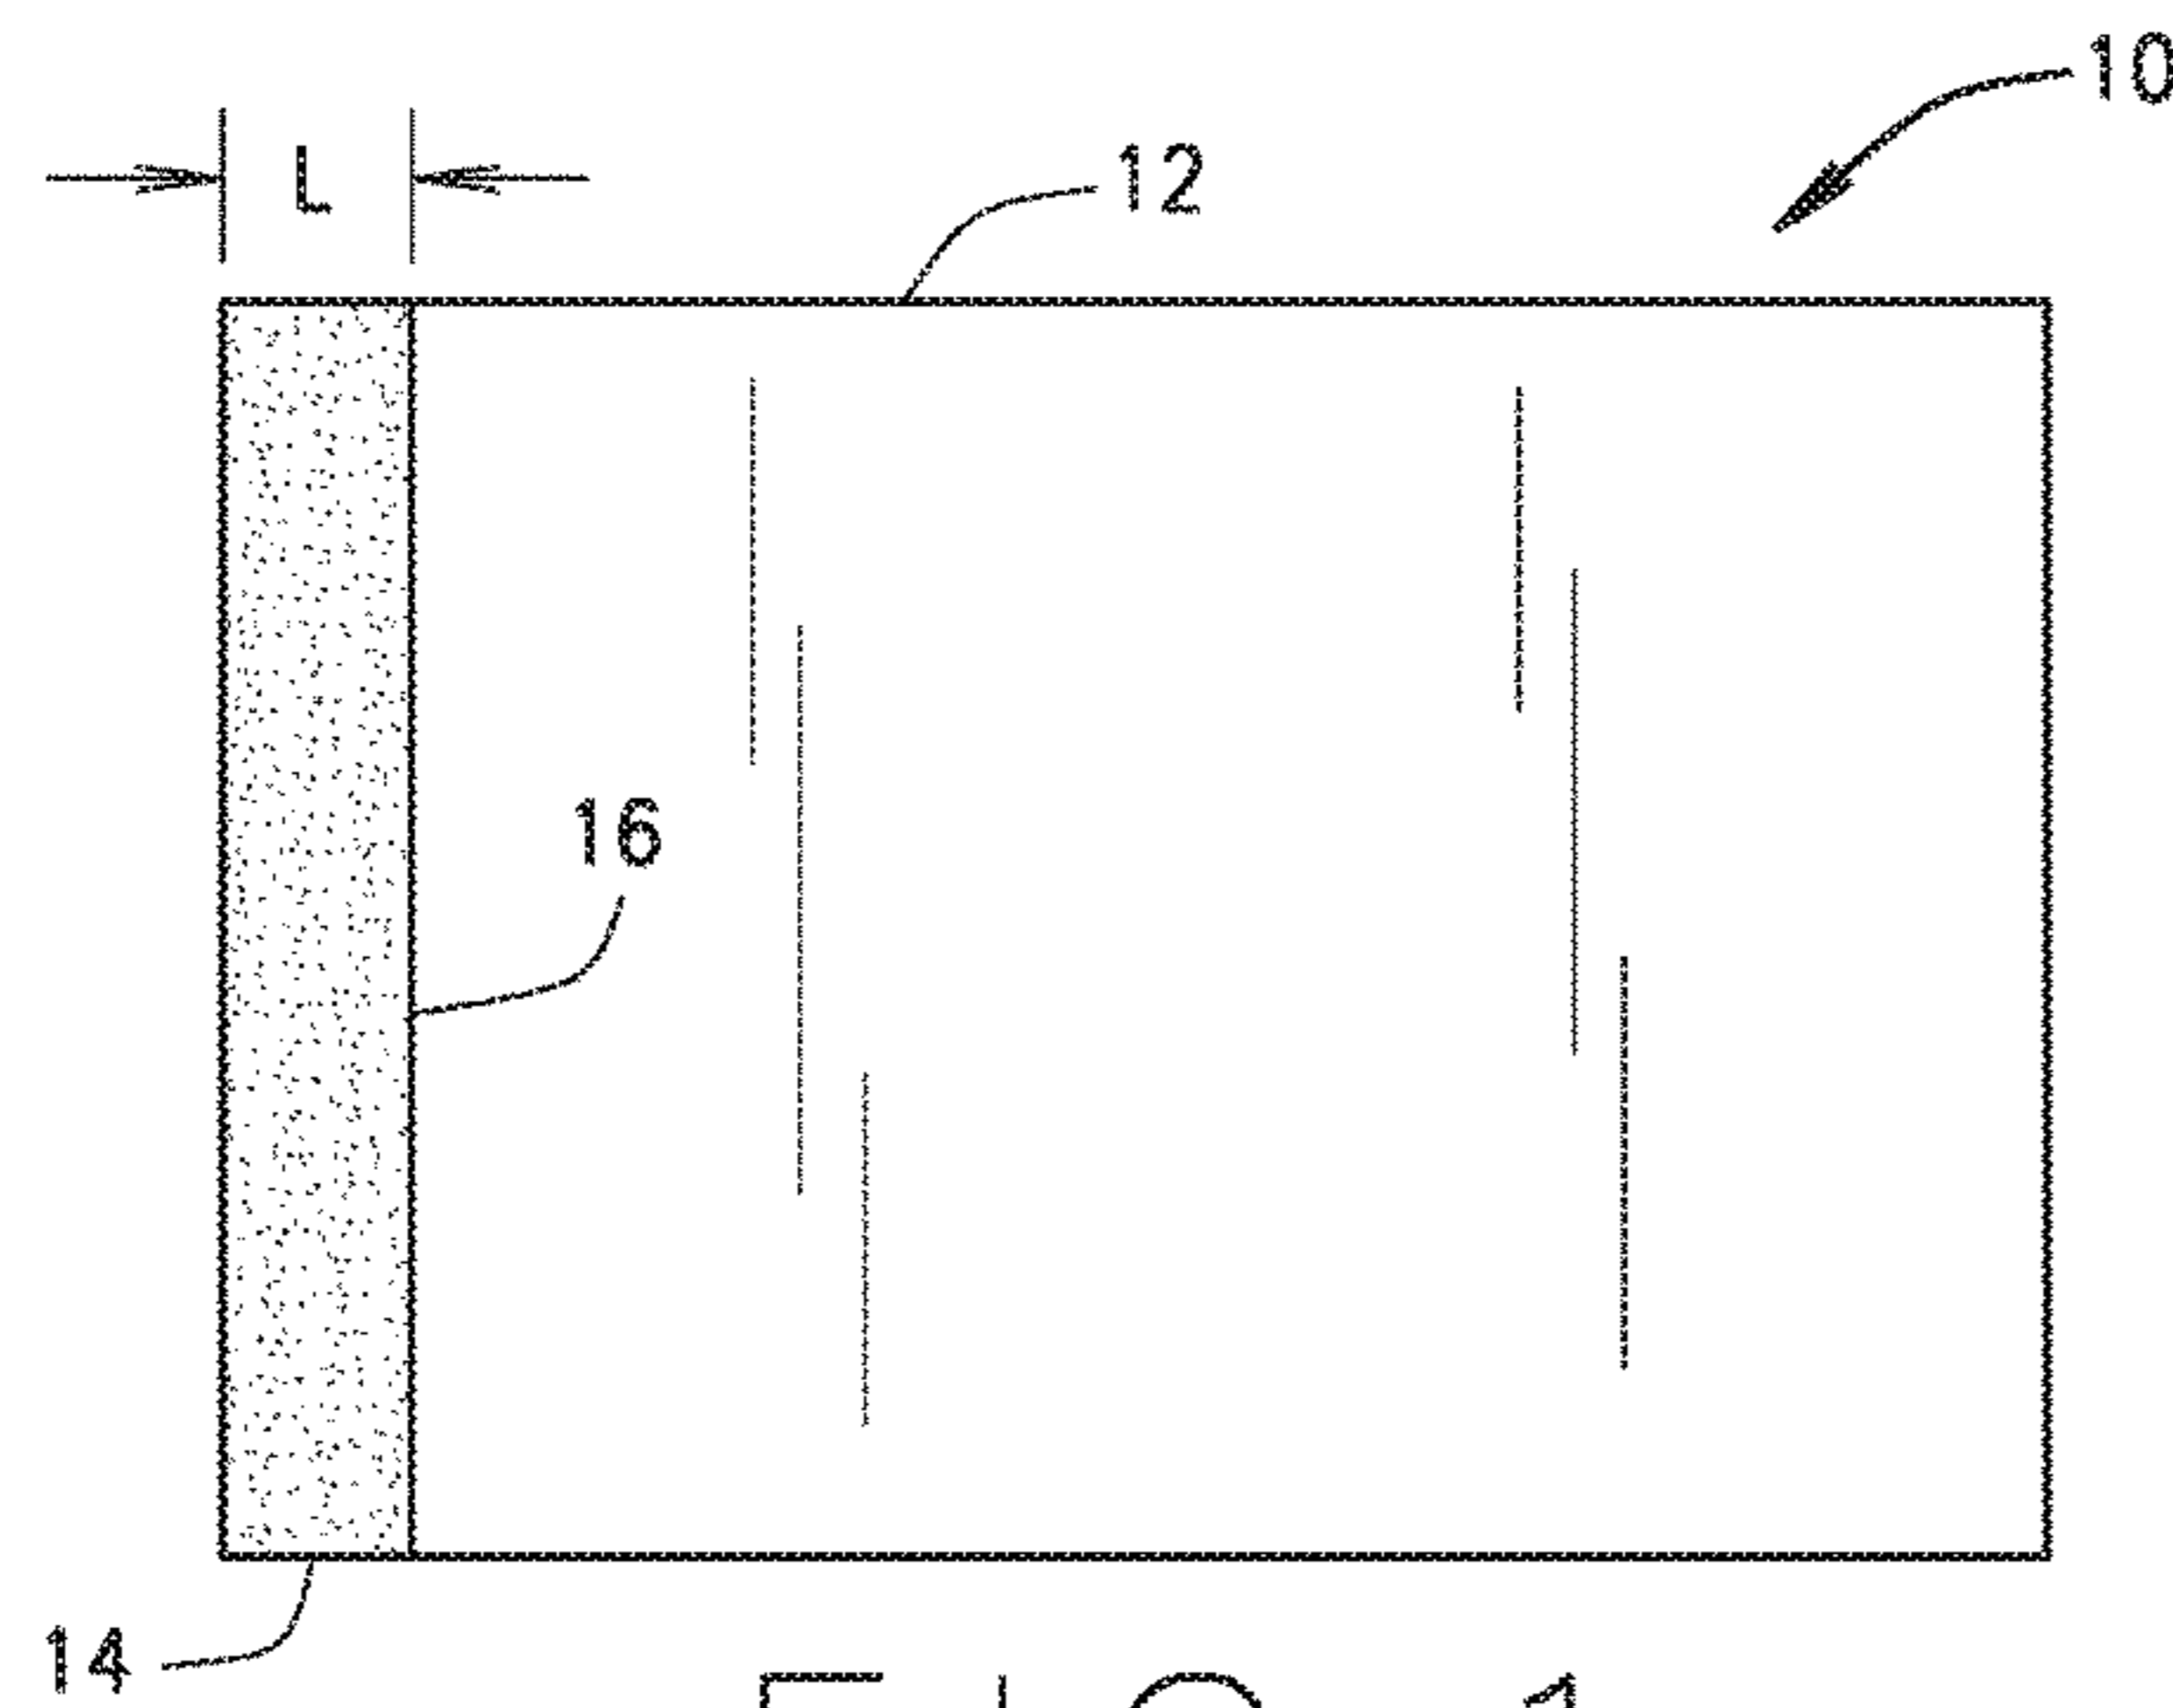
FIG. 1 is a top planform view of one embodiment of the present shingle patch constructed in accordance with the teachings of the present invention.

Referring to the drawings more particularly by reference numbers wherein like numbers refer to like parts, the number 10 in FIGS. 1 and 2 refers to one embodiment of a shingle patch used to repair damaged asphalt shingles constructed in accordance with the teachings of the present application. The shingle patch 10 includes a base member 12 sized and shaped similarly to a conventional asphalt shingle or smaller depending upon the particular application, one end portion which includes a notched portion 14 which is specifically shaped and designed for sliding under an existing shingle, such as the shingle located immediately above the damaged shingle, as will be hereinafter further explained. The notched portion 14 of base member 12 includes an overall height or thickness which is less than the

overall height or thickness of the remainder of base member 12 as clearly illustrated in FIG. 2. The notched portion 14 is sized so as to be inserted under an existing shingle located immediately above the damaged shingle such that at least a portion of the existing shingle will mate with and rest on top of notched portion 14. Notched portion 14 is thinner than the remainder of base member 12 to likewise avoid creating a hump under the existing shingle when it is overlaid on top of notched portion 14. A wall or ledge portion 16 (FIG. 2) is formed between notched portion 14 and the remainder of base member 12 and functions as a stop or abutment surface for the existing shingle when overlaid on top of notched portion 14 thereby limiting the travel of the existing shingle when the notched portion 14 is inserted under the existing shingle. This arrangement also helps to prevent rain water from infiltrating under the patch 10. The overall length L of notched portion 14 can be varied depending upon the particular application and depending upon the particular size and style of asphalt shingles to be repaired.

The opposite end portion 20 of base member 12 includes a roofing nail 22 built into the base member 12. Roofing nail 22 can be any known conventional roofing nail suitable for asphalt shingles. The roofing nail 22 is attached or integrally formed with the shingle patch base member 12 during the manufacturing process or, nail 22 can be otherwise attached to member 12 after the manufacturing process so long as nail 22 and base member 12 form a one-piece unit.

The top portion of base member 12 includes colored granules (not shown) that are embedded into the patch material so as to match the color of the existing damaged shingle to be repaired. In this regard, the present shingle patch 10 can be produced in multiple colors so as to match the known existing asphalt shingle colors present in the marketplace, or the base member 12 can be color-coordinated with the shingles to be repaired on-site in the field by using a pre-made shingle base member 12 with no color granules associated therewith and thereafter affixing colored granules to the member 12 in the field so as to match the existing colors of the roof to be repaired. Colored granules can be applied to any portion or the entire top surface of base

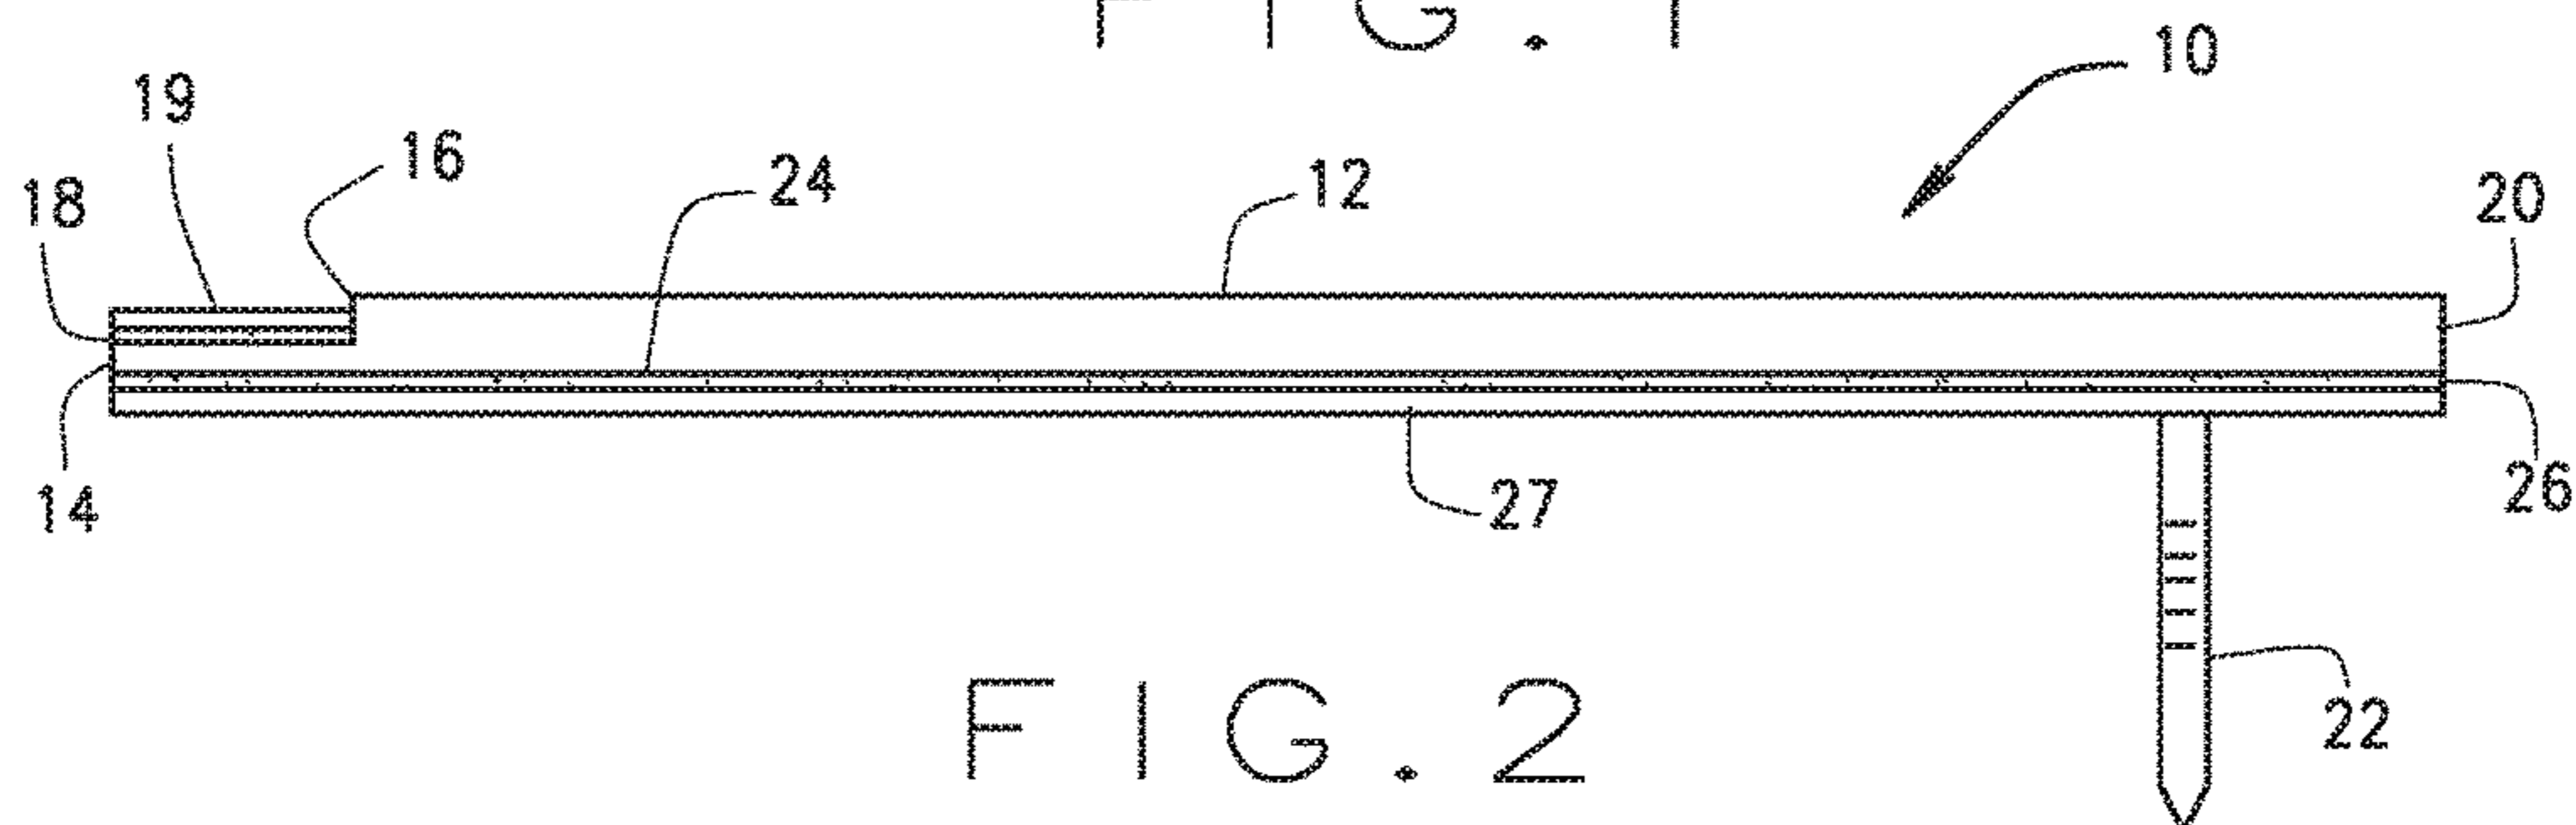
FIG. 2 is a side elevational view of the shingle patch of FIG. 1.

The notched portion 14 also includes a sealant and/or adhesive 18 distributed across at least a portion of its upper surface as best illustrated in FIG. 2 for mating with and attaching to the undersurface of the existing shingle when the existing shingle is overlaid on top of notched portion 14. The sealant 18 is preferably a heat activated sealant which can be factory applied and is typically activated by the sun, although other heat sources can be applied to the notched portion 14 to activate the sealant material. Preferably, the sealant 18 covers the entire upper surface of the notched portion 14. A cellophane tape or other release material 19 can be placed over the sealant 18 so as to prevent the sealant from binding to any other material or object during shipment and storage. The tape 19 is removed prior to installing the shingle patch 10 as will be hereinafter further explained.

A sealant 26 is likewise associated with at least a portion of the bottom surface 24 of base member 12 as best illustrated in FIG. 2. Similar to sealant 18, sealant 26 is preferably a heat activated sealant and is likewise preferably factory applied and is typically activated by the sun. Here again, sealant 26 preferably covers the entire bottom surface 24 of base member 12. A cellophane tape or other material 27 is likewise placed over sealant 26 so as to again prevent the sealant from binding to any other material or object during shipment and storage. The tape 27 is removed prior to installing the shingle patch 10 over a damaged shingle as will be hereinafter further explained.

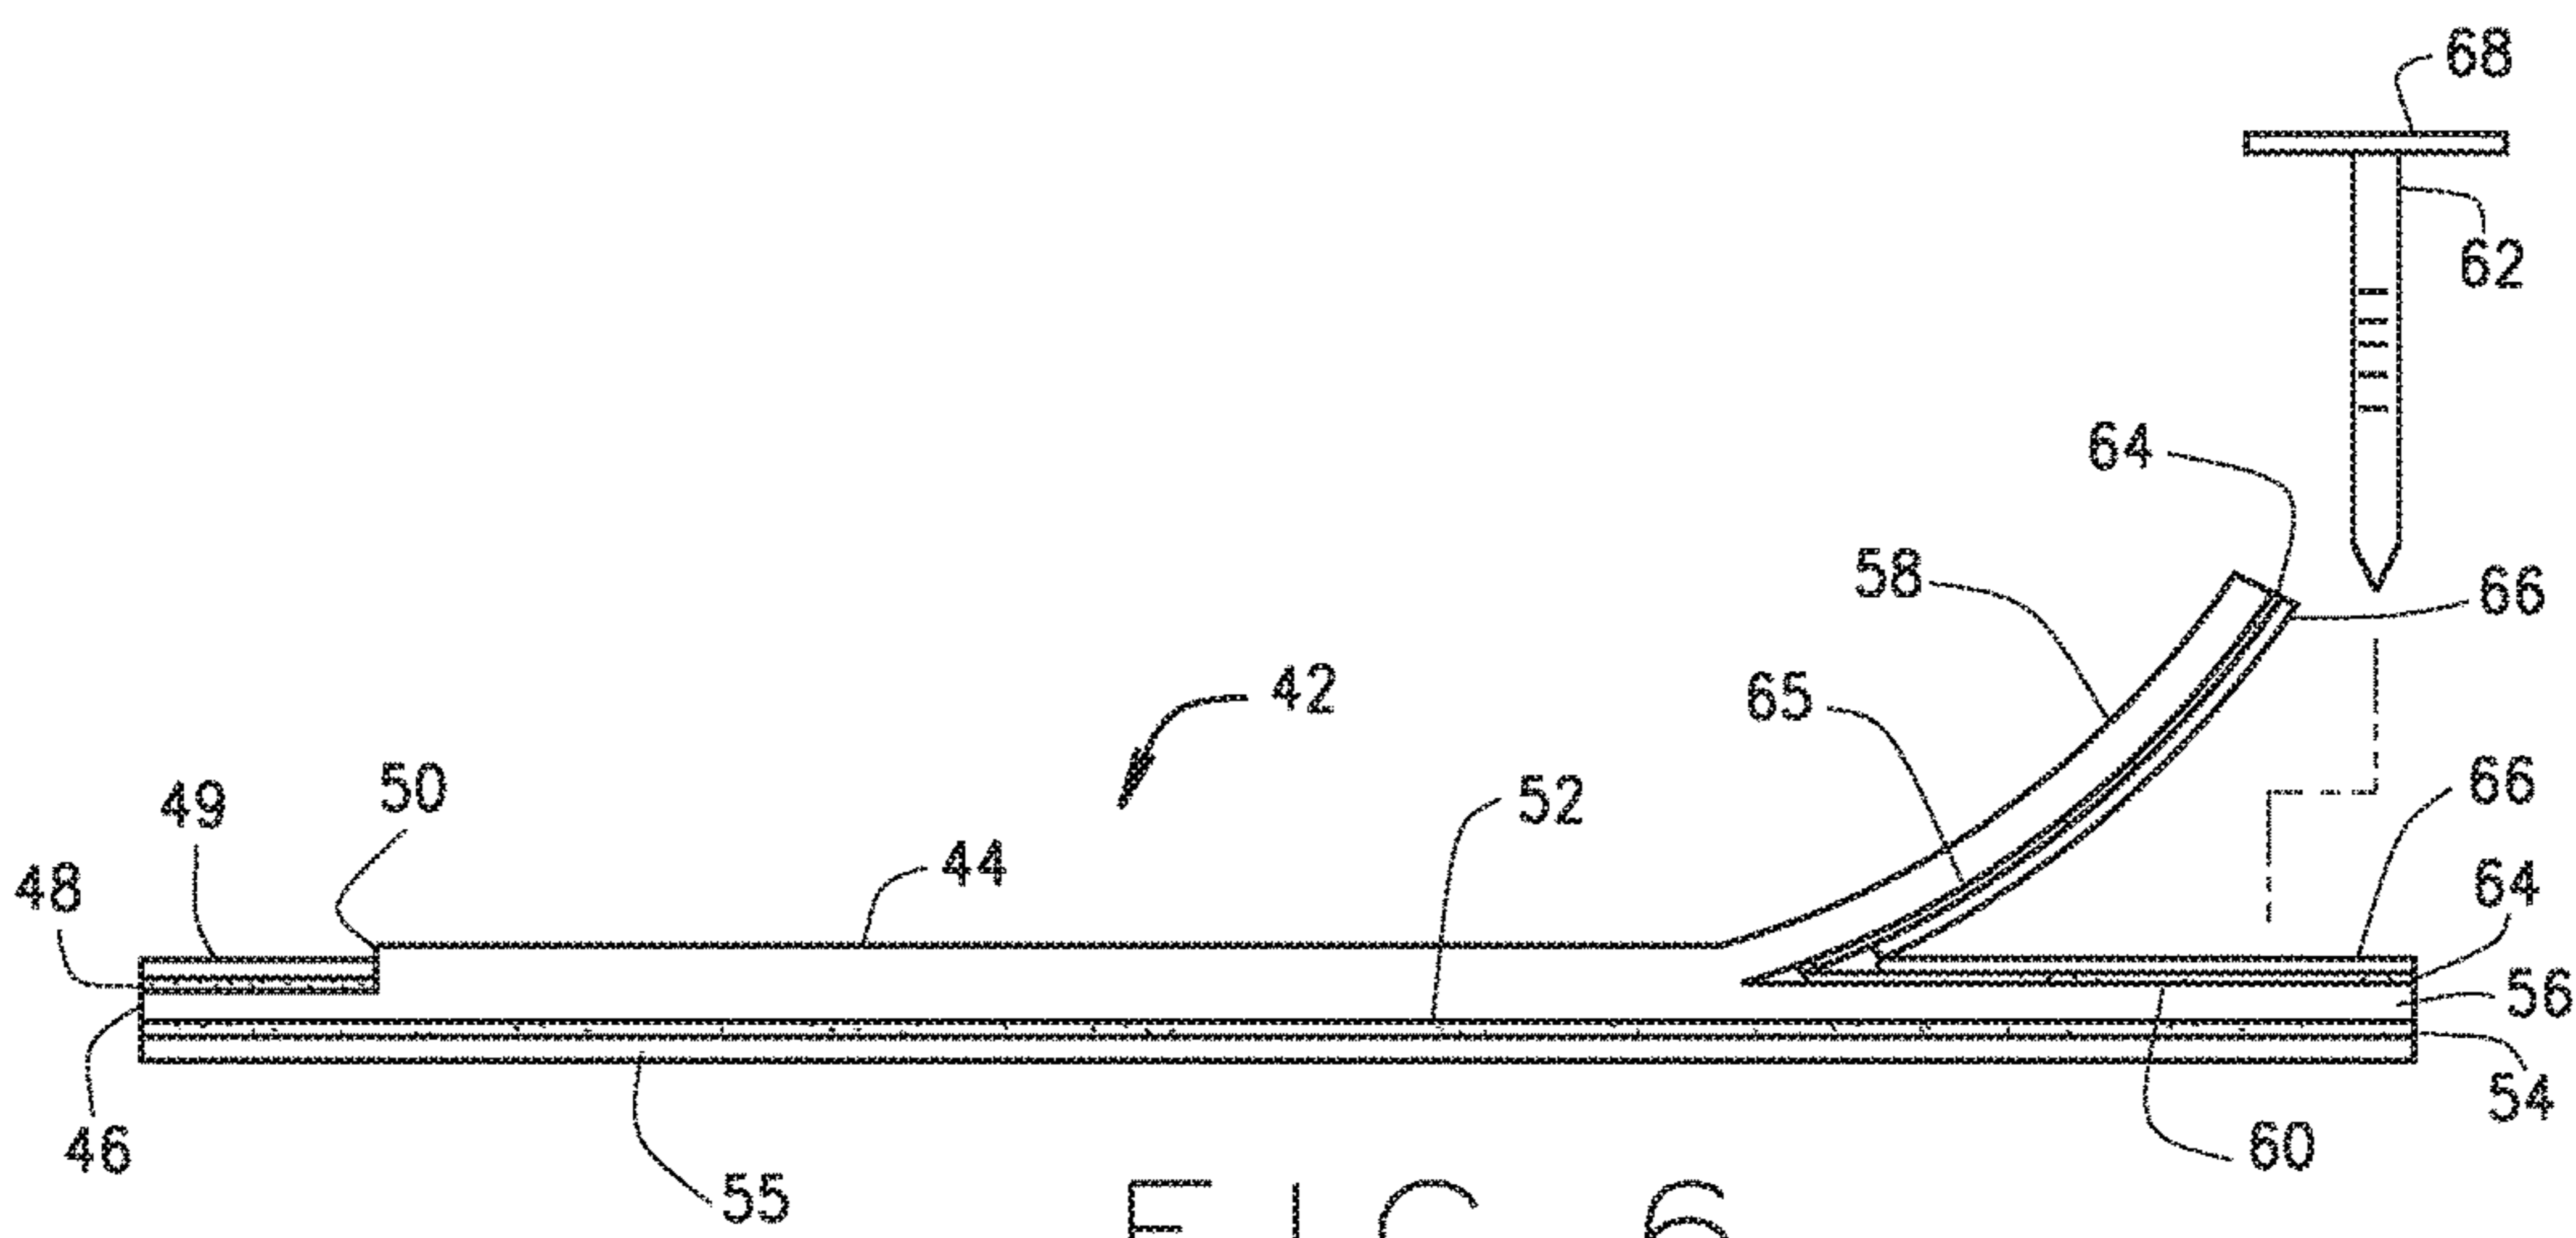
FIG. 6 is a side elevational view of another embodiment of the present shingle patch constructed in accordance with the teachings of the present invention.

FIG. **6** illustrates another embodiment **42** of the present shingle patch, namely, shingle patch **42**. Patch **42** includes as a base member **44** again having a notched portion **46** associated with one end portion thereof which is constructed substantially similar to notched portion **14** associated with shingle patch **10** including having a sealant **48** covering at least a portion of the upper surface of notched portion **46** and likewise including an abutment surface, ledge or stop portion **50** for positioning and overlaying the existing adjacent shingle which will be positioned on top of notched portion **46** as previously explained. Shingle patch **42** likewise

Shingle patch **42** differs from shingle patch **10** in that it does not include an integrated roofing nail. Instead, the opposite end portion **56** of base member **44** includes a flap portion **58** that can be moved or lifted away from its mating surface **60** as best illustrated in FIG. **6** so that a standard roofing nail **62** can be nailed through the mating surface **60** of base member **44** into the underlying damaged shingle as will be hereinafter explained. The flap portion **58** includes a sealant **64** associated with its inner surface **65** and its mating base portion **60** can likewise optionally include a sealant **64** as well for mating with and sealing with flap portion **58**. Both flap surfaces **65** and **60** covered with a sealant **64** are likewise covered with a cellophane tape or other release tape **66** so as to prevent these mating surfaces from bonding together until required. Again, sealant **64** can be a heat activated sealant. Flap portion **58** should be sufficiently large enough so as to allow a roofing technician to hammer a conventional roofing nail through base member mating surface **60** and end portion **56** so as to complete the attachment of shingle patch **42** to the damaged shingle.

Importantly, flap portion **58** covers the head **68** of roofing nail **62** and serves as a seal thereby preventing the roofing nail **62** from being exposed to the elements. Again, the respective heat activated sealants **48**, **54** and **64**, if used, can all be activated either by the sun or by other heat sources thereby bonding the shingle patch **42** to the existing damaged shingle, the adjacent existing shingle, and the various portions of the mating flap portion **58**. Here again, shingle patch **42** overlays the damaged shingle and provides an extra layer of protection to the roof structure. The method of positioning and attaching the shingle patch **42** over a damaged shingle is substantially identical to the procedure outlined with respect to shingle patch **10** as illustrated in FIGS. **3-5** except for using a standard roofing nail **62** as explained above. Like shingle patch **10**, shingle patch **42** can

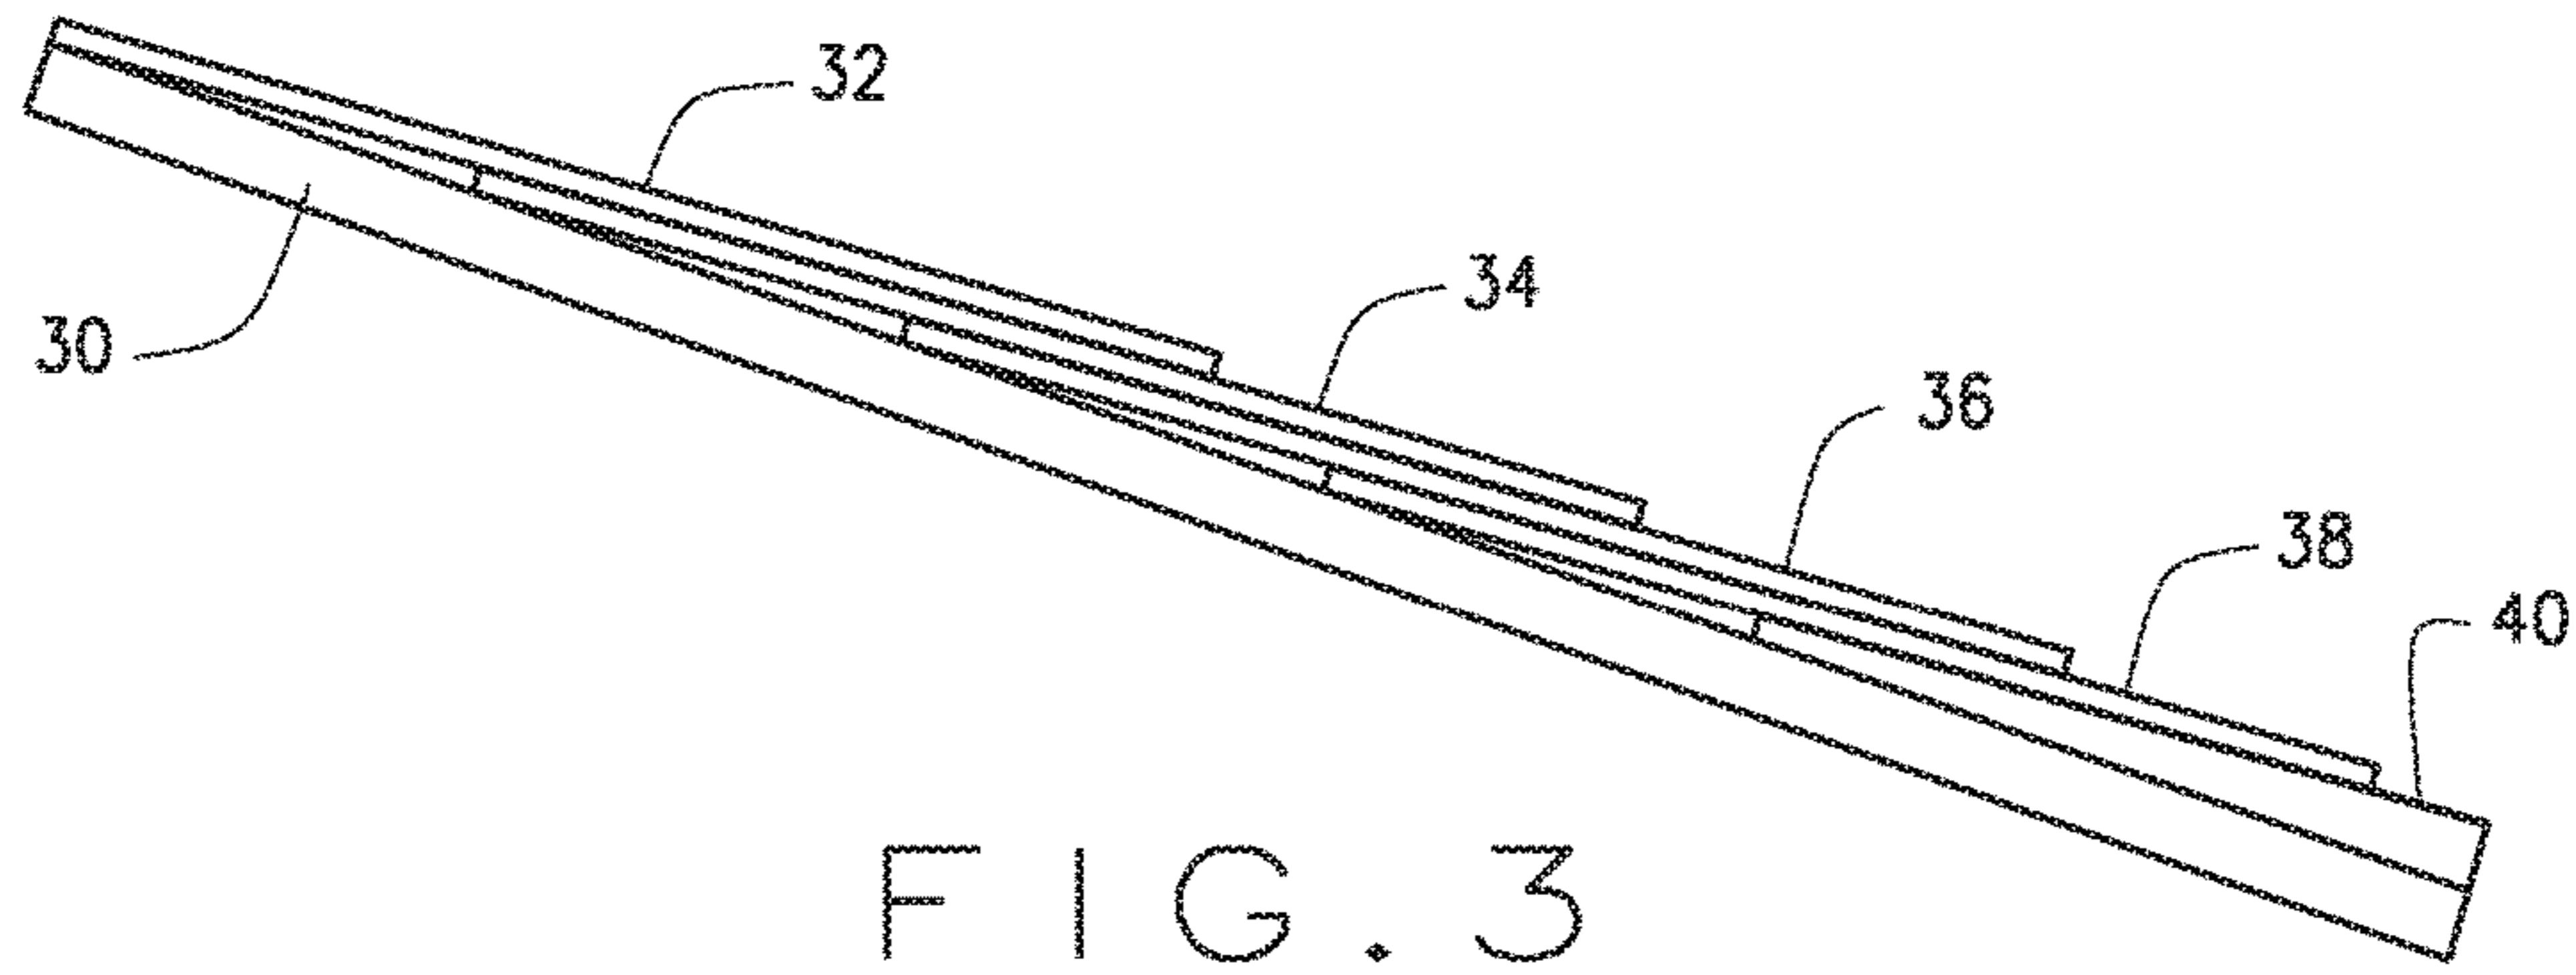
FIG. 3 is a side elevational view of a typical shingled roof showing the overlaying pattern arrangement of shingles before the present shingle patch is applied for repair.

FIG. **3** illustrates a typical asphalt shingled roof wherein the underlying roof structure **30** is typically plywood or some other wood product. Typical asphalt shingles **32**, **34**, **36**, **38** and **40** are overlaid in a typical overlapping pattern as illustrated in FIG. **3**. Assuming that asphalt shingle **36** is damaged by hail or any other weather event, FIGS. **4** and **5** illustrate the method for repairing damaged asphalt shingle **36** using the present shingle patch **10**. Repair will typically begin as illustrated in FIG. **4** where a technician will lift the bottom edge of the shingle that lies immediately above the damaged shingle. As illustrated in FIG. **4**, the bottom edge of shingle **34** lies just one row above the damaged shingle **36**. Lifting of the bottom edge of shingle **34** can be accomplished with known tools in the trade or with the tools illustrated in FIGS. **9** and **10** as will be hereafter further explained. Once the bottom edge of shingle **34** is lifted as illustrated, the technician will remove the release tape **19** and **27** associated with notched portion **14** and the bottom surface **24** of base member **12** respectively and then slide notched portion **14** of base member **12** under the raised portion of shingle **34**. The raised shingle portion of shingle **34** is then lowered onto notched portion **14** and the heat activated or other sealant **18** associated therewith. As stated, prior to inserting notched portion **14** under the raised shingle **34**, the release tape **27** associated with the bottom portion **24** of shingle patch **10** is likewise removed prior to installation.

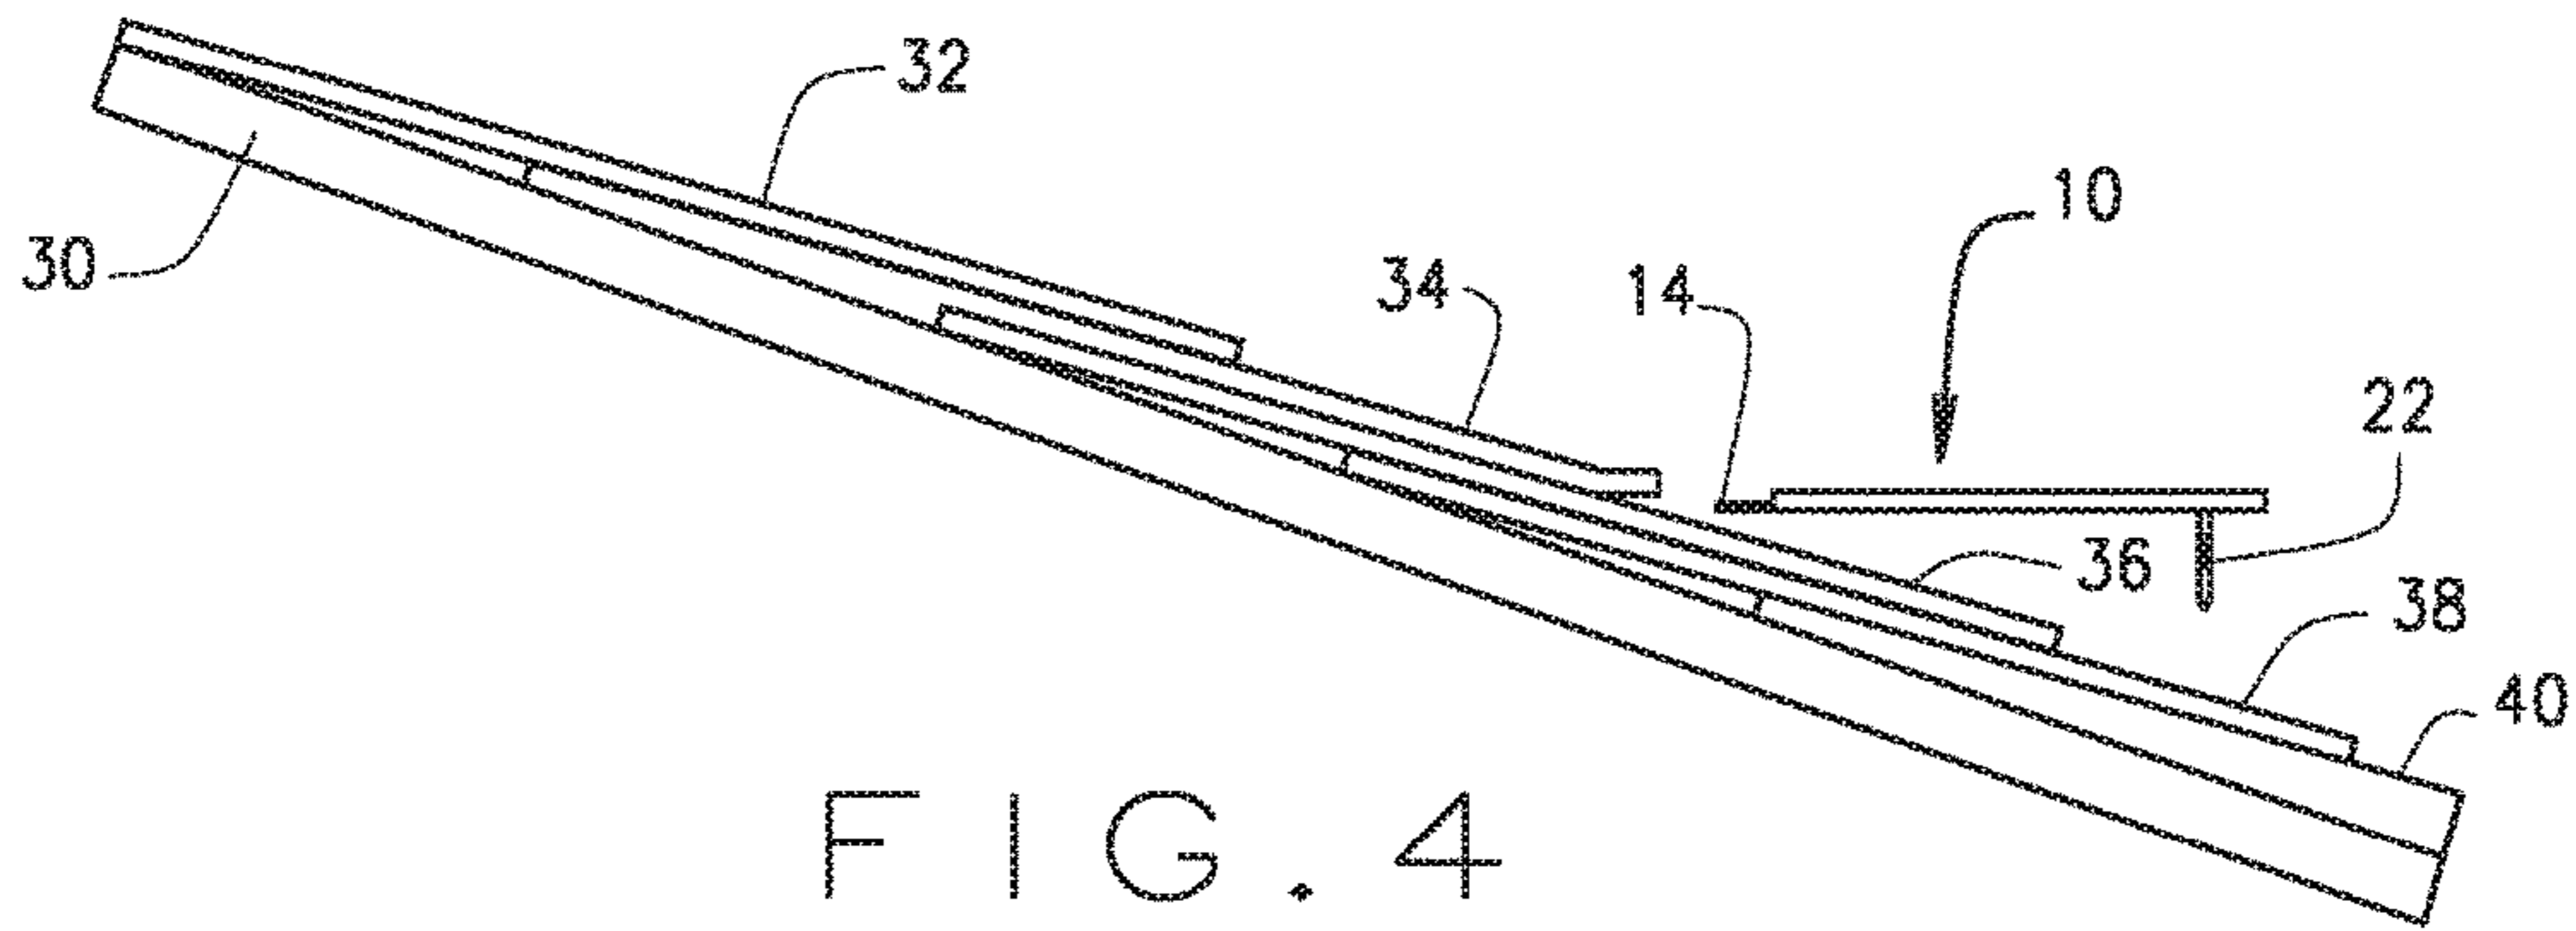
FIG. 4 is a side elevational view similar to FIG. 3 showing the present shingle patch of FIGS. 1 and 2 in exploded view prior to insertion for repair.

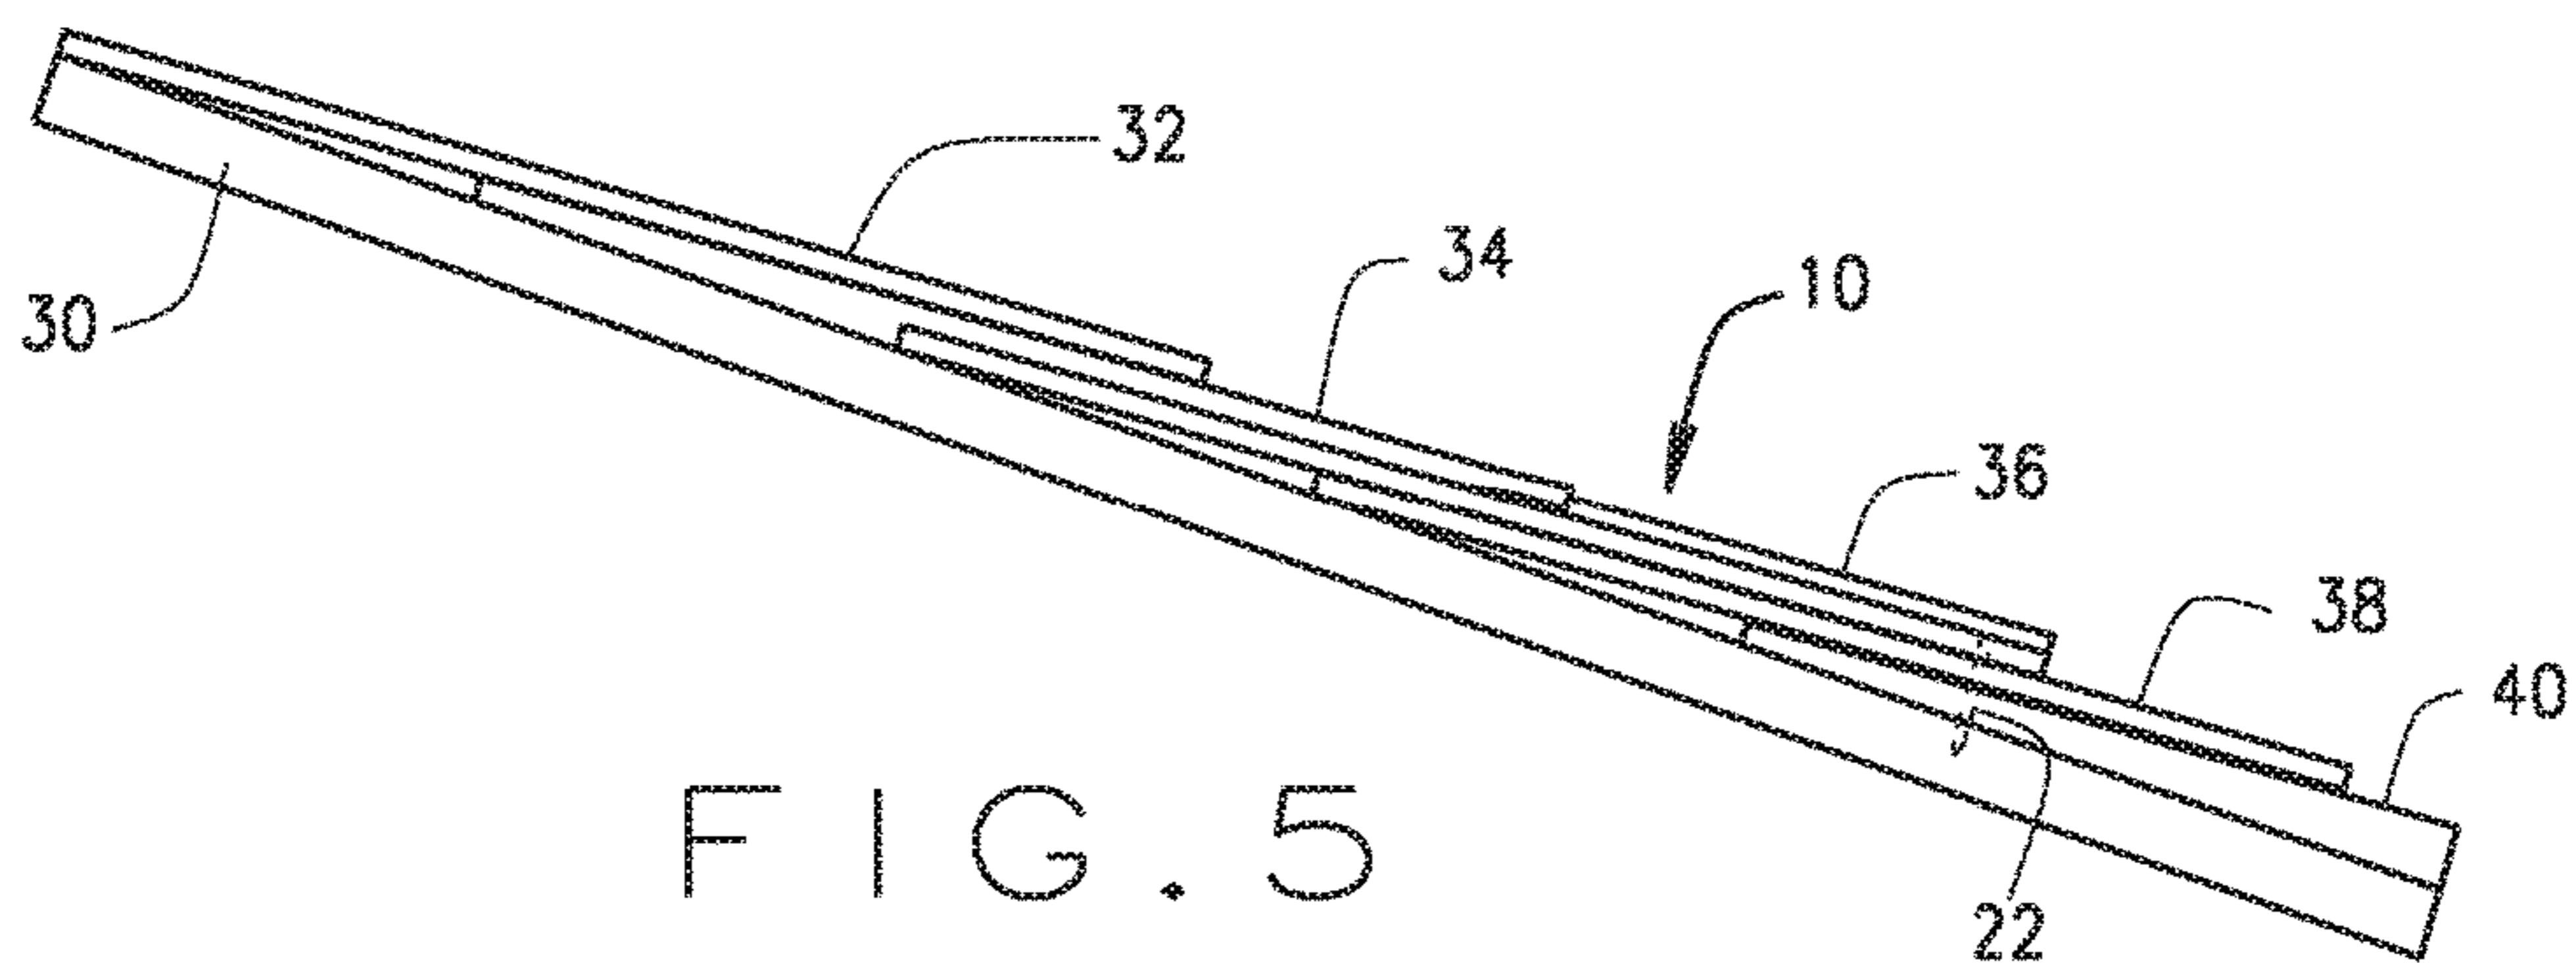
FIG. 5 is a side elevational view similar to FIG. 4 showing the present shingle patch of FIGS. 1 and 2 positioned and attached to the existing roof structure and overlaying the damaged shingle.

Once notched portion **14** is inserted under the existing adjacent shingle **34**, the opposite end portion **20** of base member **12** housing the integrated roofing nail **22** is then nailed to the damaged shingle **36** as best illustrated in FIG. **5**. Once nailed, the undersurface of base member **12** is sealed directly to the damaged shingle **36** via the sealant **26** located across its bottom surface. Once completed, the shingle patch **10** will overlay the damaged shingle **36** as illustrated in FIG. **5** and the colored granules associated with the top surface of base member **12** will match the color scheme of the other shingles **32**, **34**, **36**, **38** and **40** associated with the roof structure. The heat activated sealant **18** and **26** will bind to their respective mating surfaces by the heat generated from the sun if a heat activated sealant is used. Other heat sources can be used to immediately activate the sealant **18** and **26** if so desired. This could include using heat blowers, or using a different type of sealant. Since the damaged shingle **36** remains in place, the present shingle patch **10** provides an extra layer of protection since the damaged shingle **36** still provides some protection to the roof structure. Depending upon the size of the damaged area associated with shingle **36**, shingle patch **10** can be sized and dimensioned so as to adequately overlay the damaged area of shingle **36**. In this regard, shingle patch **10** can merely cover a portion of shingle **36** or, in other embodiments, it can cover substantially all of shingle **36** if so desired. Shingle patch **10** can be made according to any dimensions up to and including covering the entire damaged asphalt shingle.
