(10) **Patent No.:** **US 10,072,418 B2**  
(45) **Date of Patent:** **Sep. 11, 2018**

(54) **INTEGRAL NAIL/DISK STRUCTURE FOR ELIMINATING EXPOSED ROOF NAILS**

(71) Applicant: **Thomas R. Mathieson**, Louisville, CO (US)

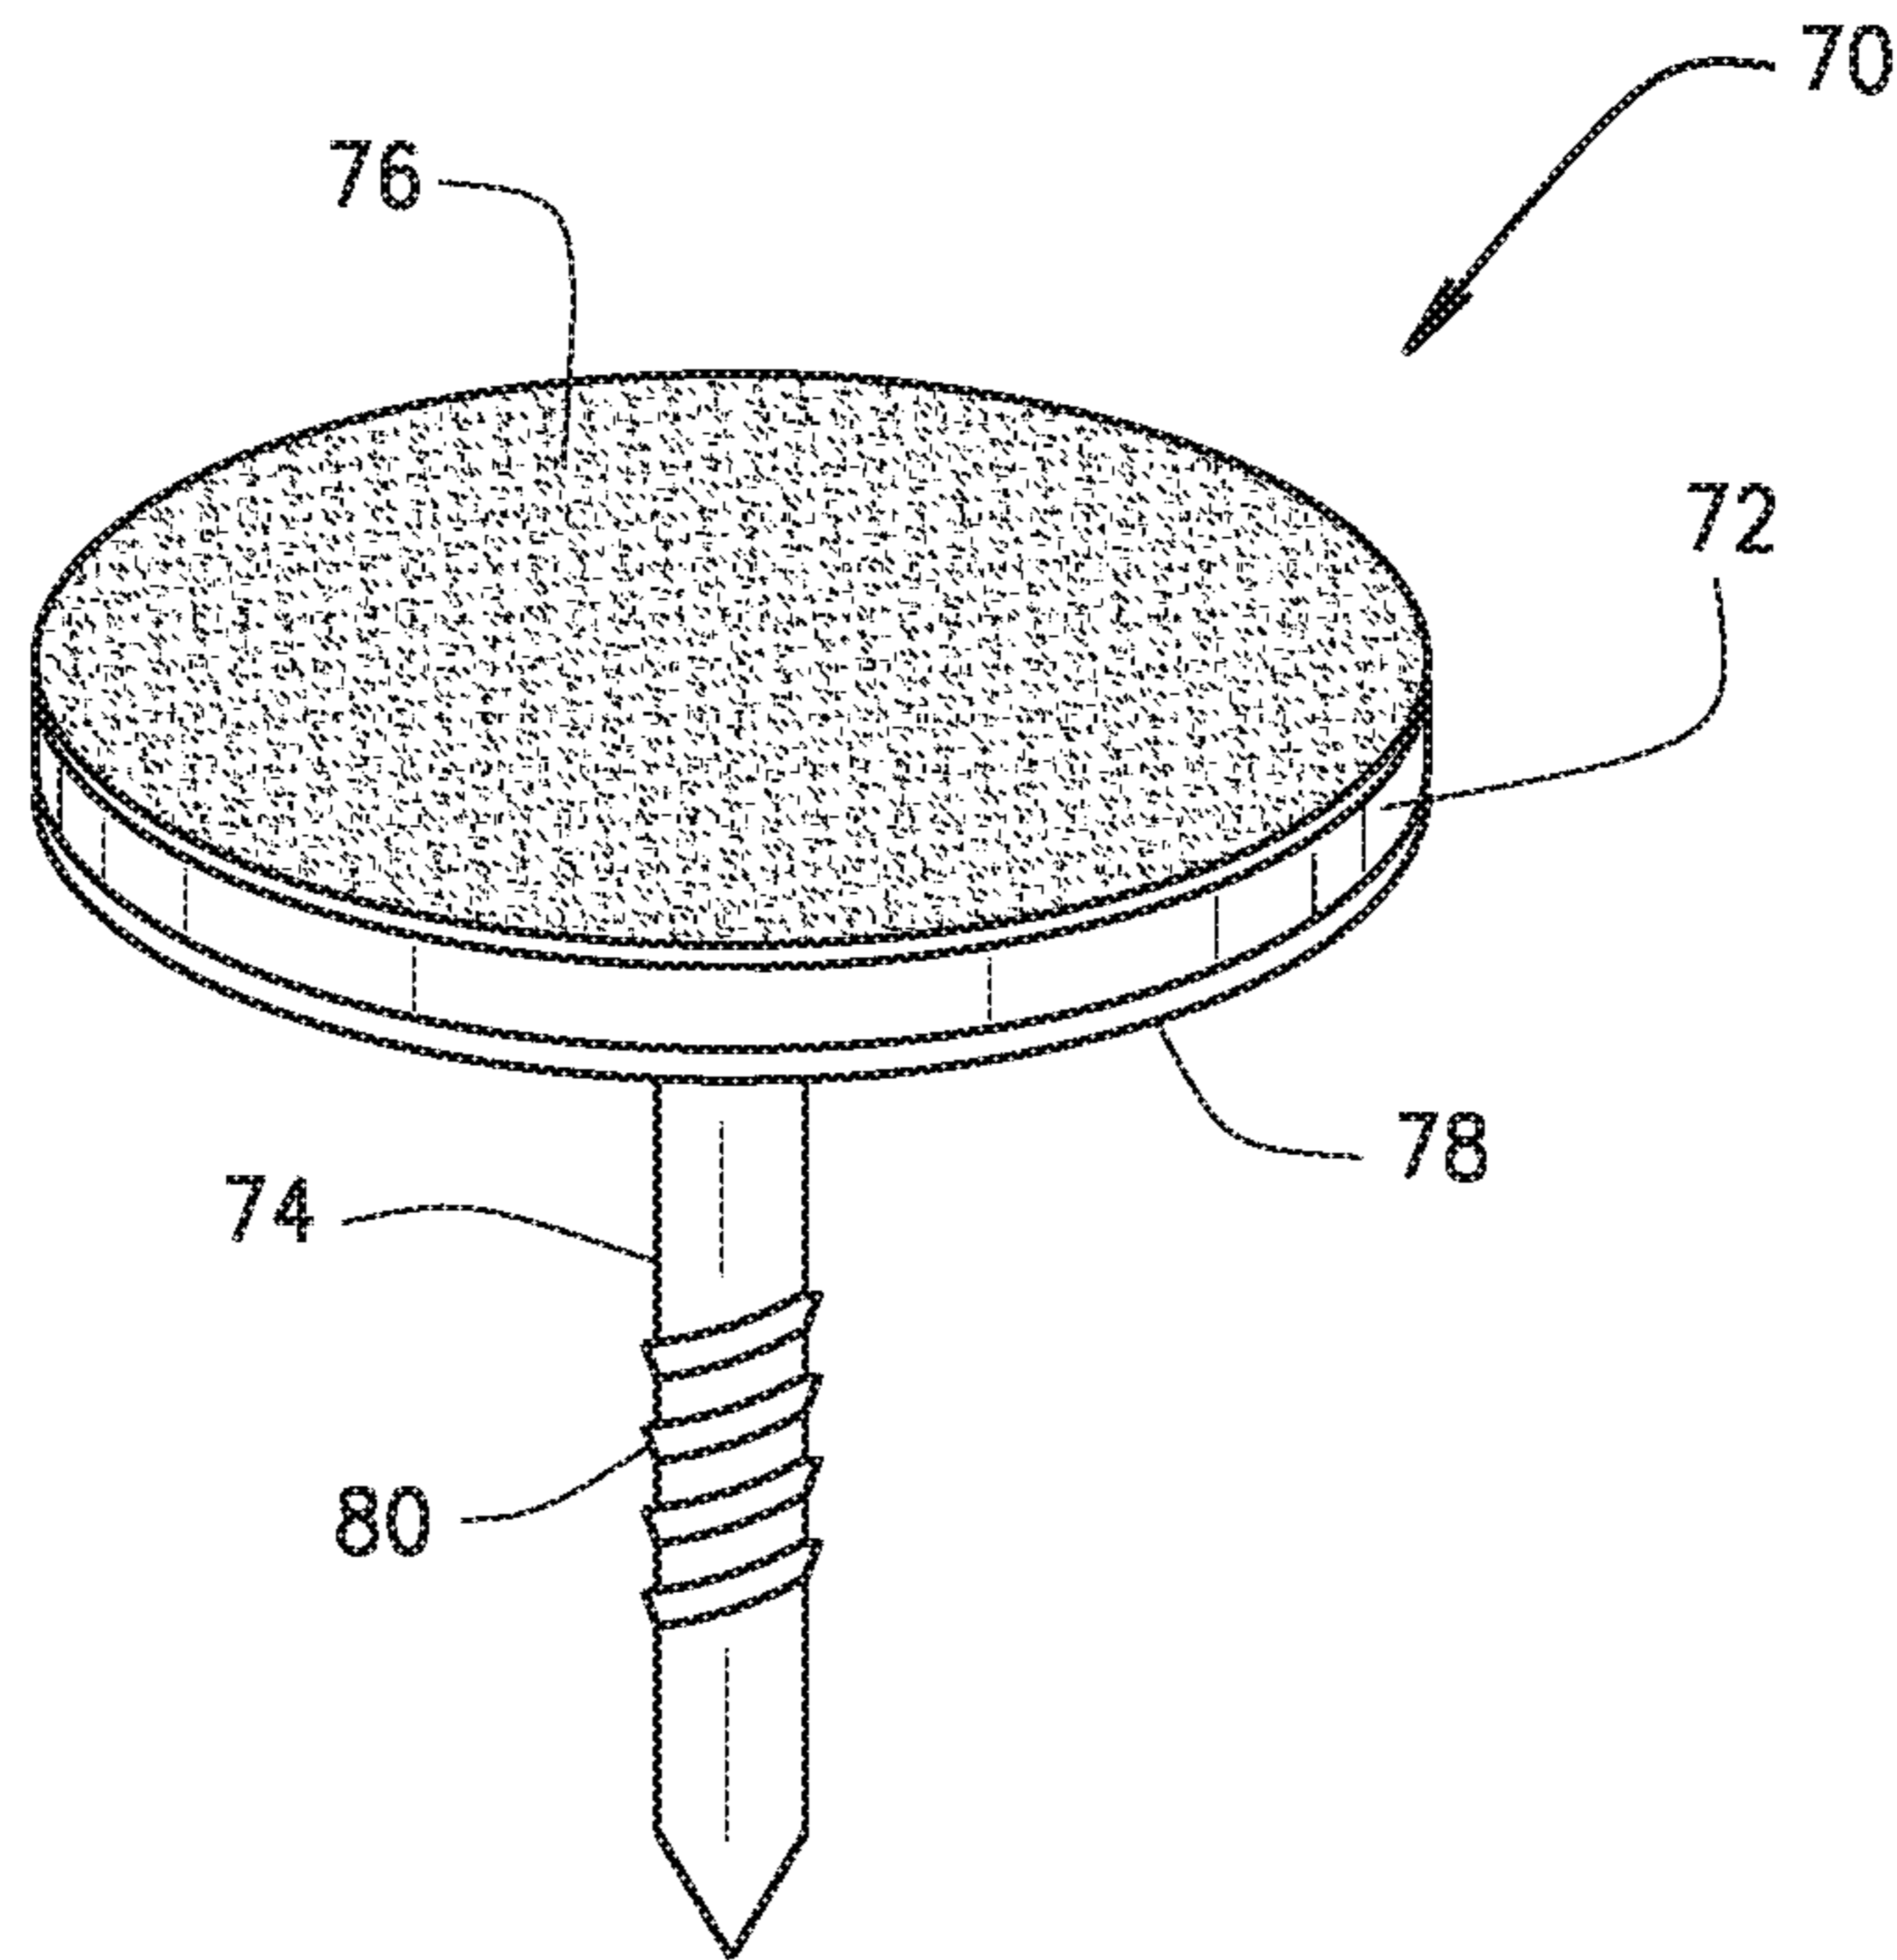
FIG. 7 is a perspective view of another aspect of the present invention illustrating one embodiment of the present nail/disk structure for eliminating exposed nail heads constructed in accordance with the teachings of the present invention.

FIGS. 7 and 7A are perspective views of still another aspect of the present invention illustrating one embodiment 70 of a one-piece nail/disk structure for eliminating exposed nail heads associated with a typical asphalt shingled roof. FIGS. 8 and 8A illustrate side elevational views of the nail/disk structure 70 of FIGS. 7 and 7A and includes a color matching disk or body member 72 which is integrally formed with a roofing nail 74 such that both the disk 72 and the nail 74 are manufactured together. The body of the disk 72 can be made from an asphalt shingle and it can take on any shape including, but not limited to, a round shape, a rectangular shape, or a square shape. The disk 72 can also be made of a hail impact resistant shingle type material which can include a reinforcing layer (not shown), or any other suitable material. The top portion 76 of disk 72 includes colored granules embedded into its top surface so as to match the color scheme of the particular asphalt shingles being used for a particular application. In this regard, the disk 72 can be made from a different material other than asphalt and the color granules 76 can be applied and attached thereto in any conventional manner. In another embodiment, disk 72 and color granules 76 can be one unitary structure formed from a color matching asphalt shingle itself. Either way, the disk portion 72 is color coordinated to the asphalt shingles to which it will be applied.

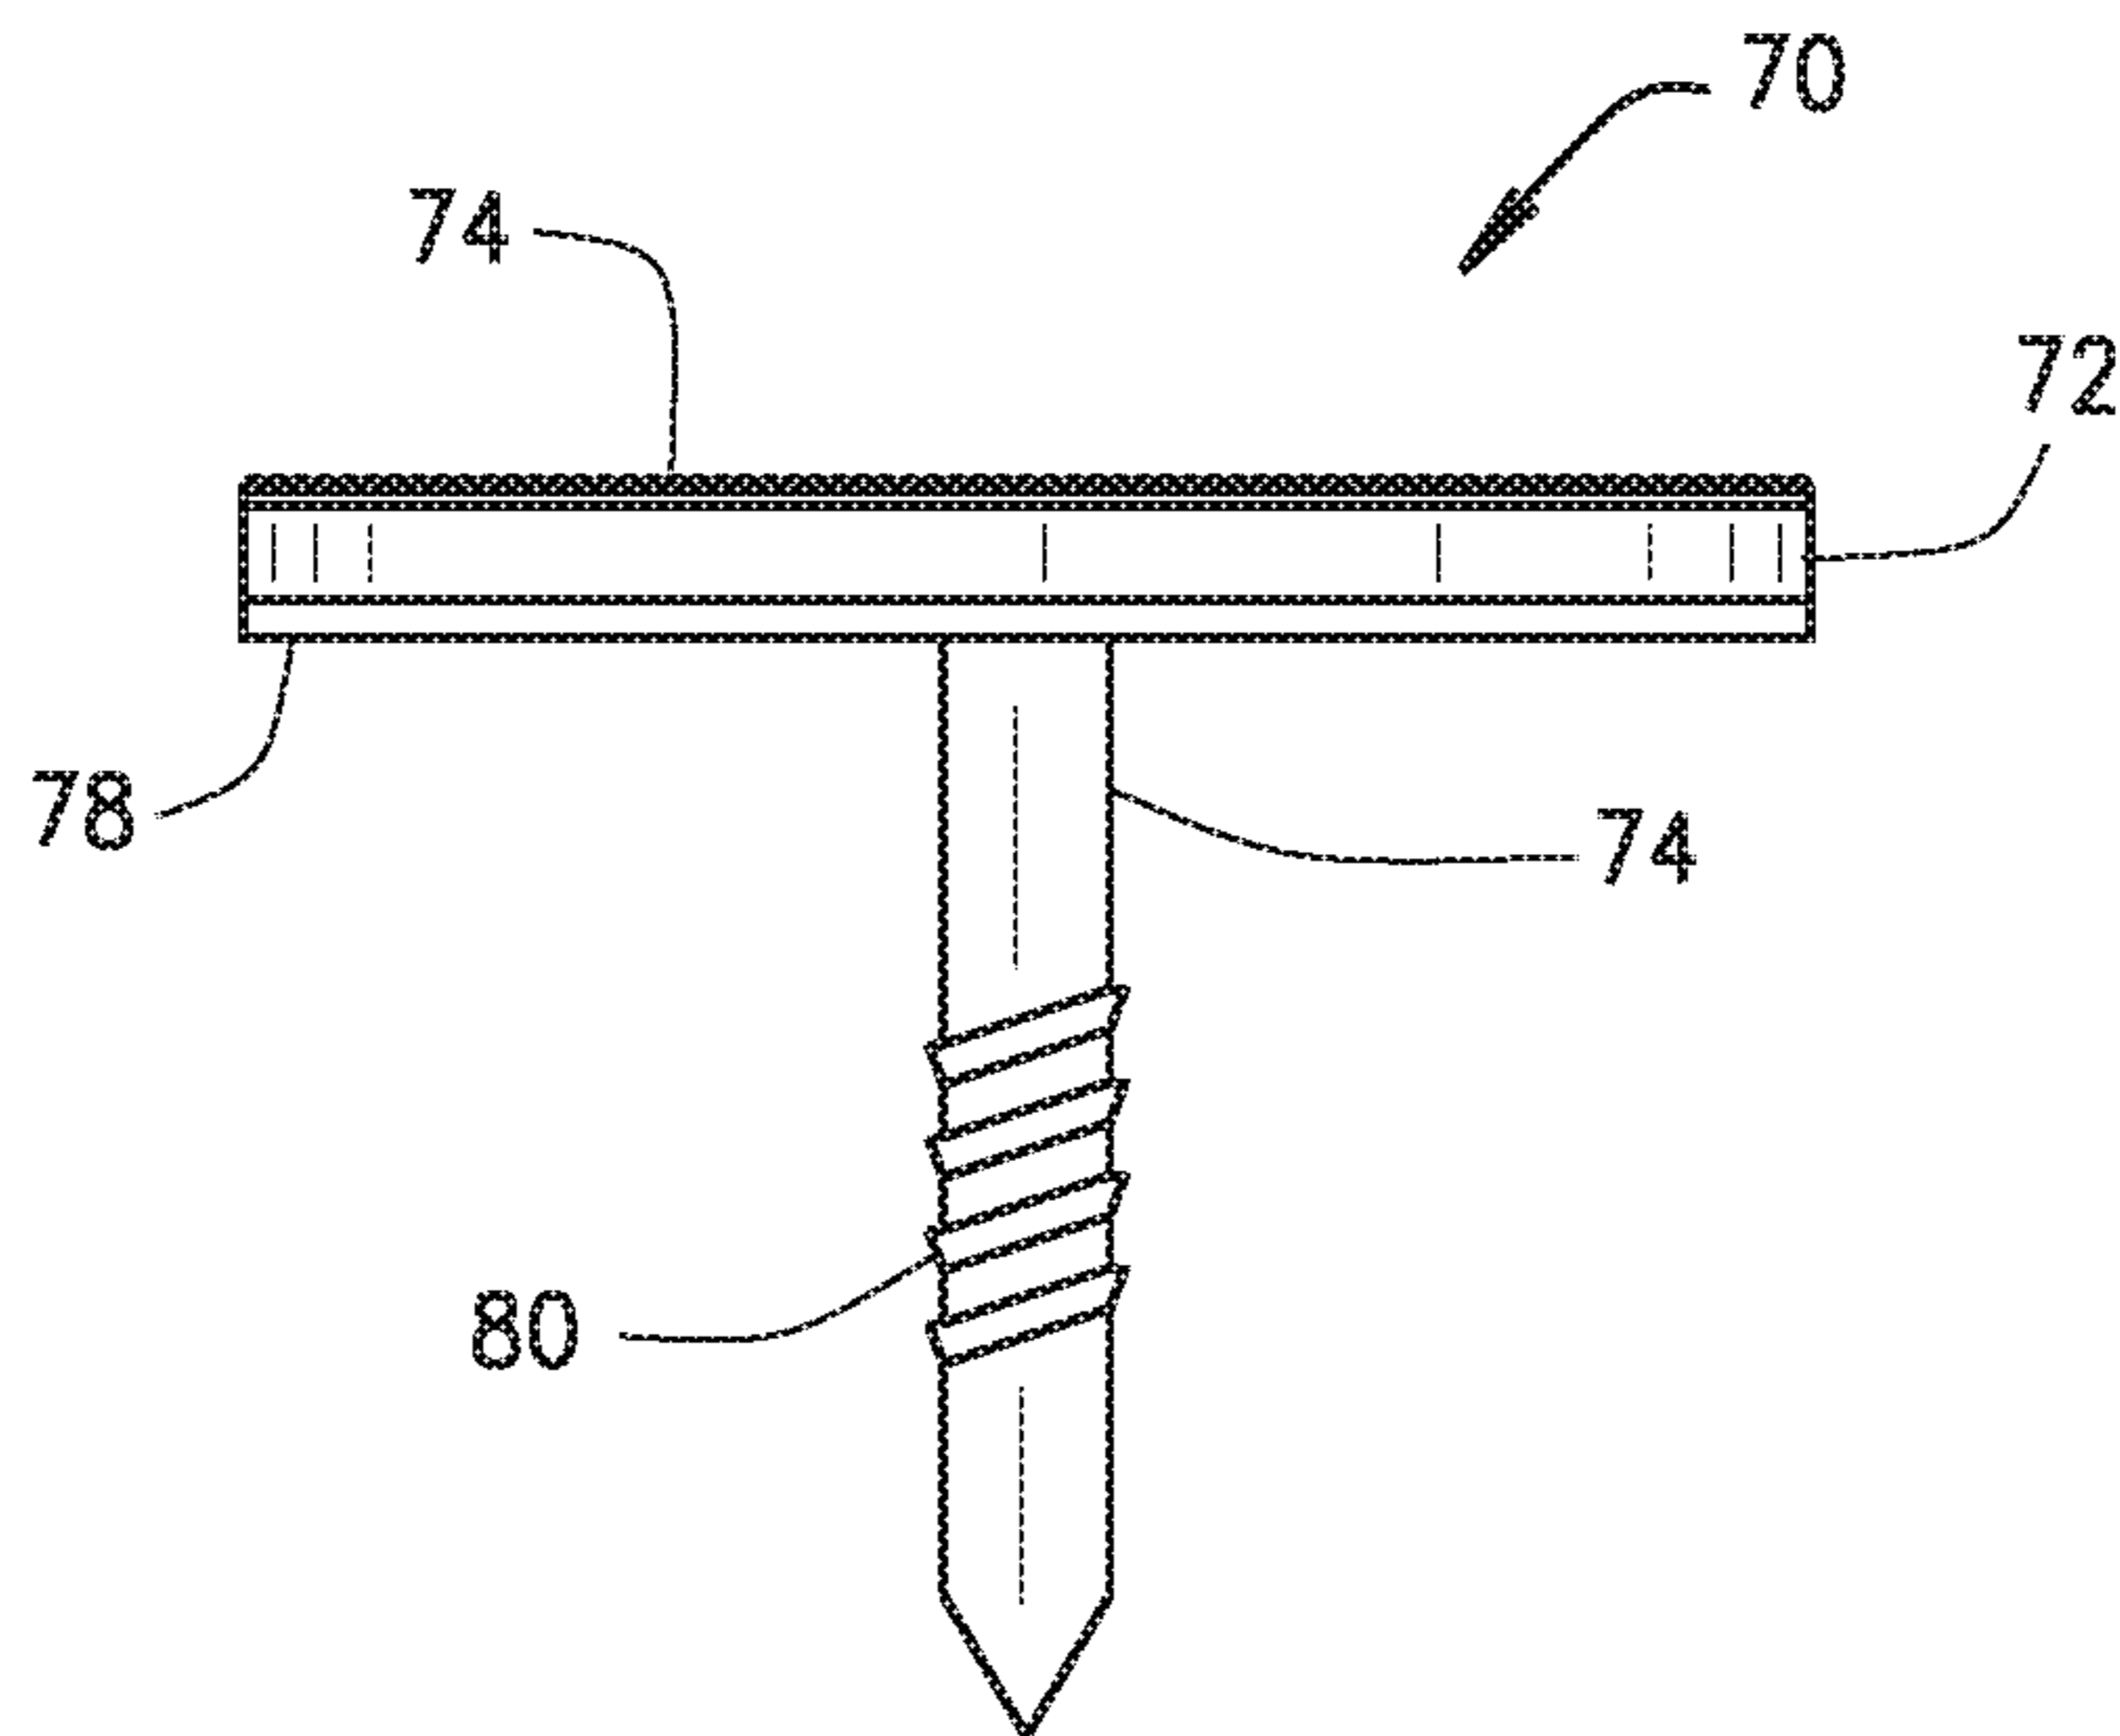
FIG. 8 is a side elevational view of the nail/disk structure illustrated in FIG. 7.

A sealant **78** can optionally cover the underside portion of disk **72** as best illustrated in FIGS. **8** and **8A** thereby allowing the disk to permanently seal to the existing shingle when the present nail/disk structure **70** is nailed into an existing shingle. The sealant can be a heat activated sealant which is preferably activated by the sun although other heat sources can be used to bond the disk **72** to an existing shingle. Other adhesives can likewise be used in place of sealant **78**. Regardless, the sealant **78** or other adhesive helps to prevent water from entering under the disk surface. The nail structure **74** may include a barbed structure **80** to further improve attachment to the existing shingle.

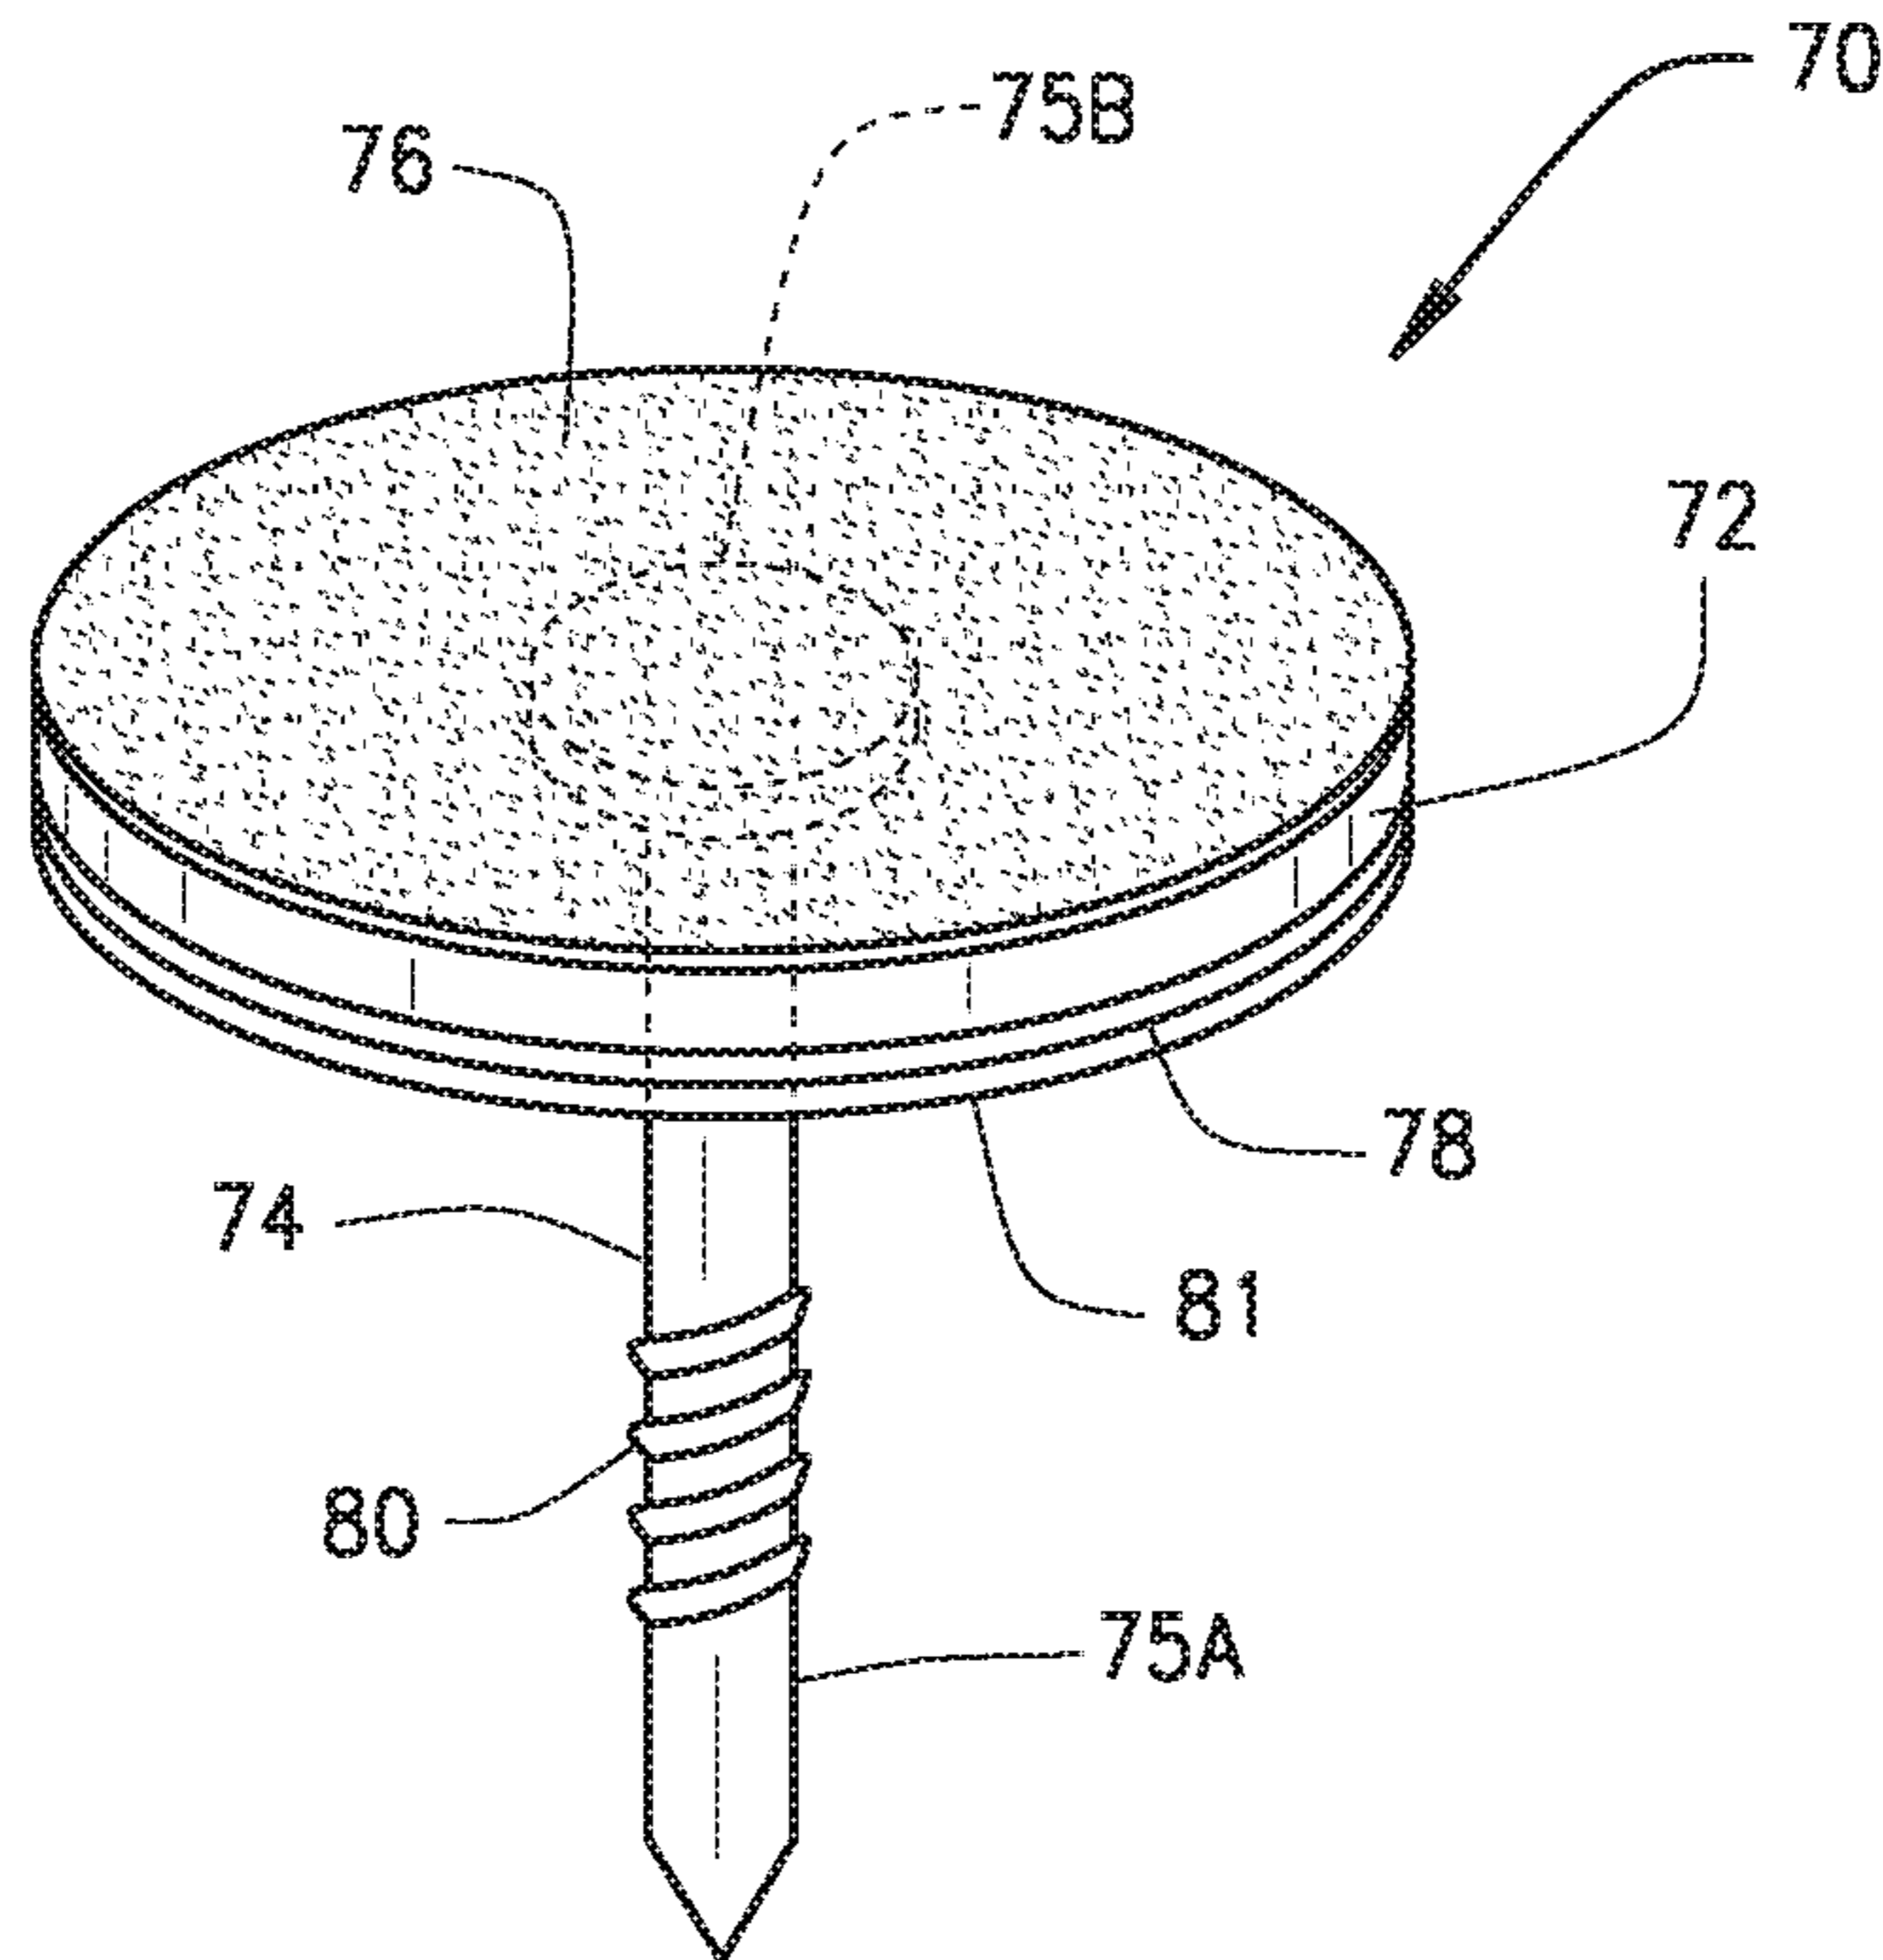
FIG. 7A is a perspective view similar to FIG. 7 showing the nail head incorporated into the body member of the nail/disk structure of FIG. 7.

More particularly, FIGS. 7A and 8A show the one-piece nail/disk structure 70 as well as the nail 74 which is incorporated or encapsulated into the body member 72. As clearly shown in FIGS. 7A and 8A, the nail 74 includes a body or shank portion 75A and a head portion 75B. As clearly illustrated in FIG. 8A, the head portion 75B of nail 74 is completely incorporated into or encapsulated within the body member 72 of the one-piece integral roof nail/disk structure 70 such that the head portion 75B of the nail 74 lies between the top and bottom surfaces of the body member 72. This is clearly shown in FIG. 8A. It is also recognized and anticipated that the nail head 75B can likewise lie equal to or flush with the top surface of the body member 72 such that it again lies within the body member 72 and extends below the top surface of the body member 72 as illustrated in FIG. 8B. In similar fashion, it is recognized and anticipated that the nail head 75B can likewise lie equal to or flush with the bottom surface of the body member 72 such that it again lies within the body member 72 and extends above the bottom surface of the body member 72 as illustrated in FIG. 8C. The nail/disk structure 70 is a one-piece integrally formed structure such that the nail 74 and the disk or body member 72 are one structure. The dotted outline of head portion 75B in FIGS. 7A, 8A, 8B and 8C illustrate the position and location of the nail head within the body member 72 when the nail 74 is incorporated or encapsulated into the disk or body member 72.

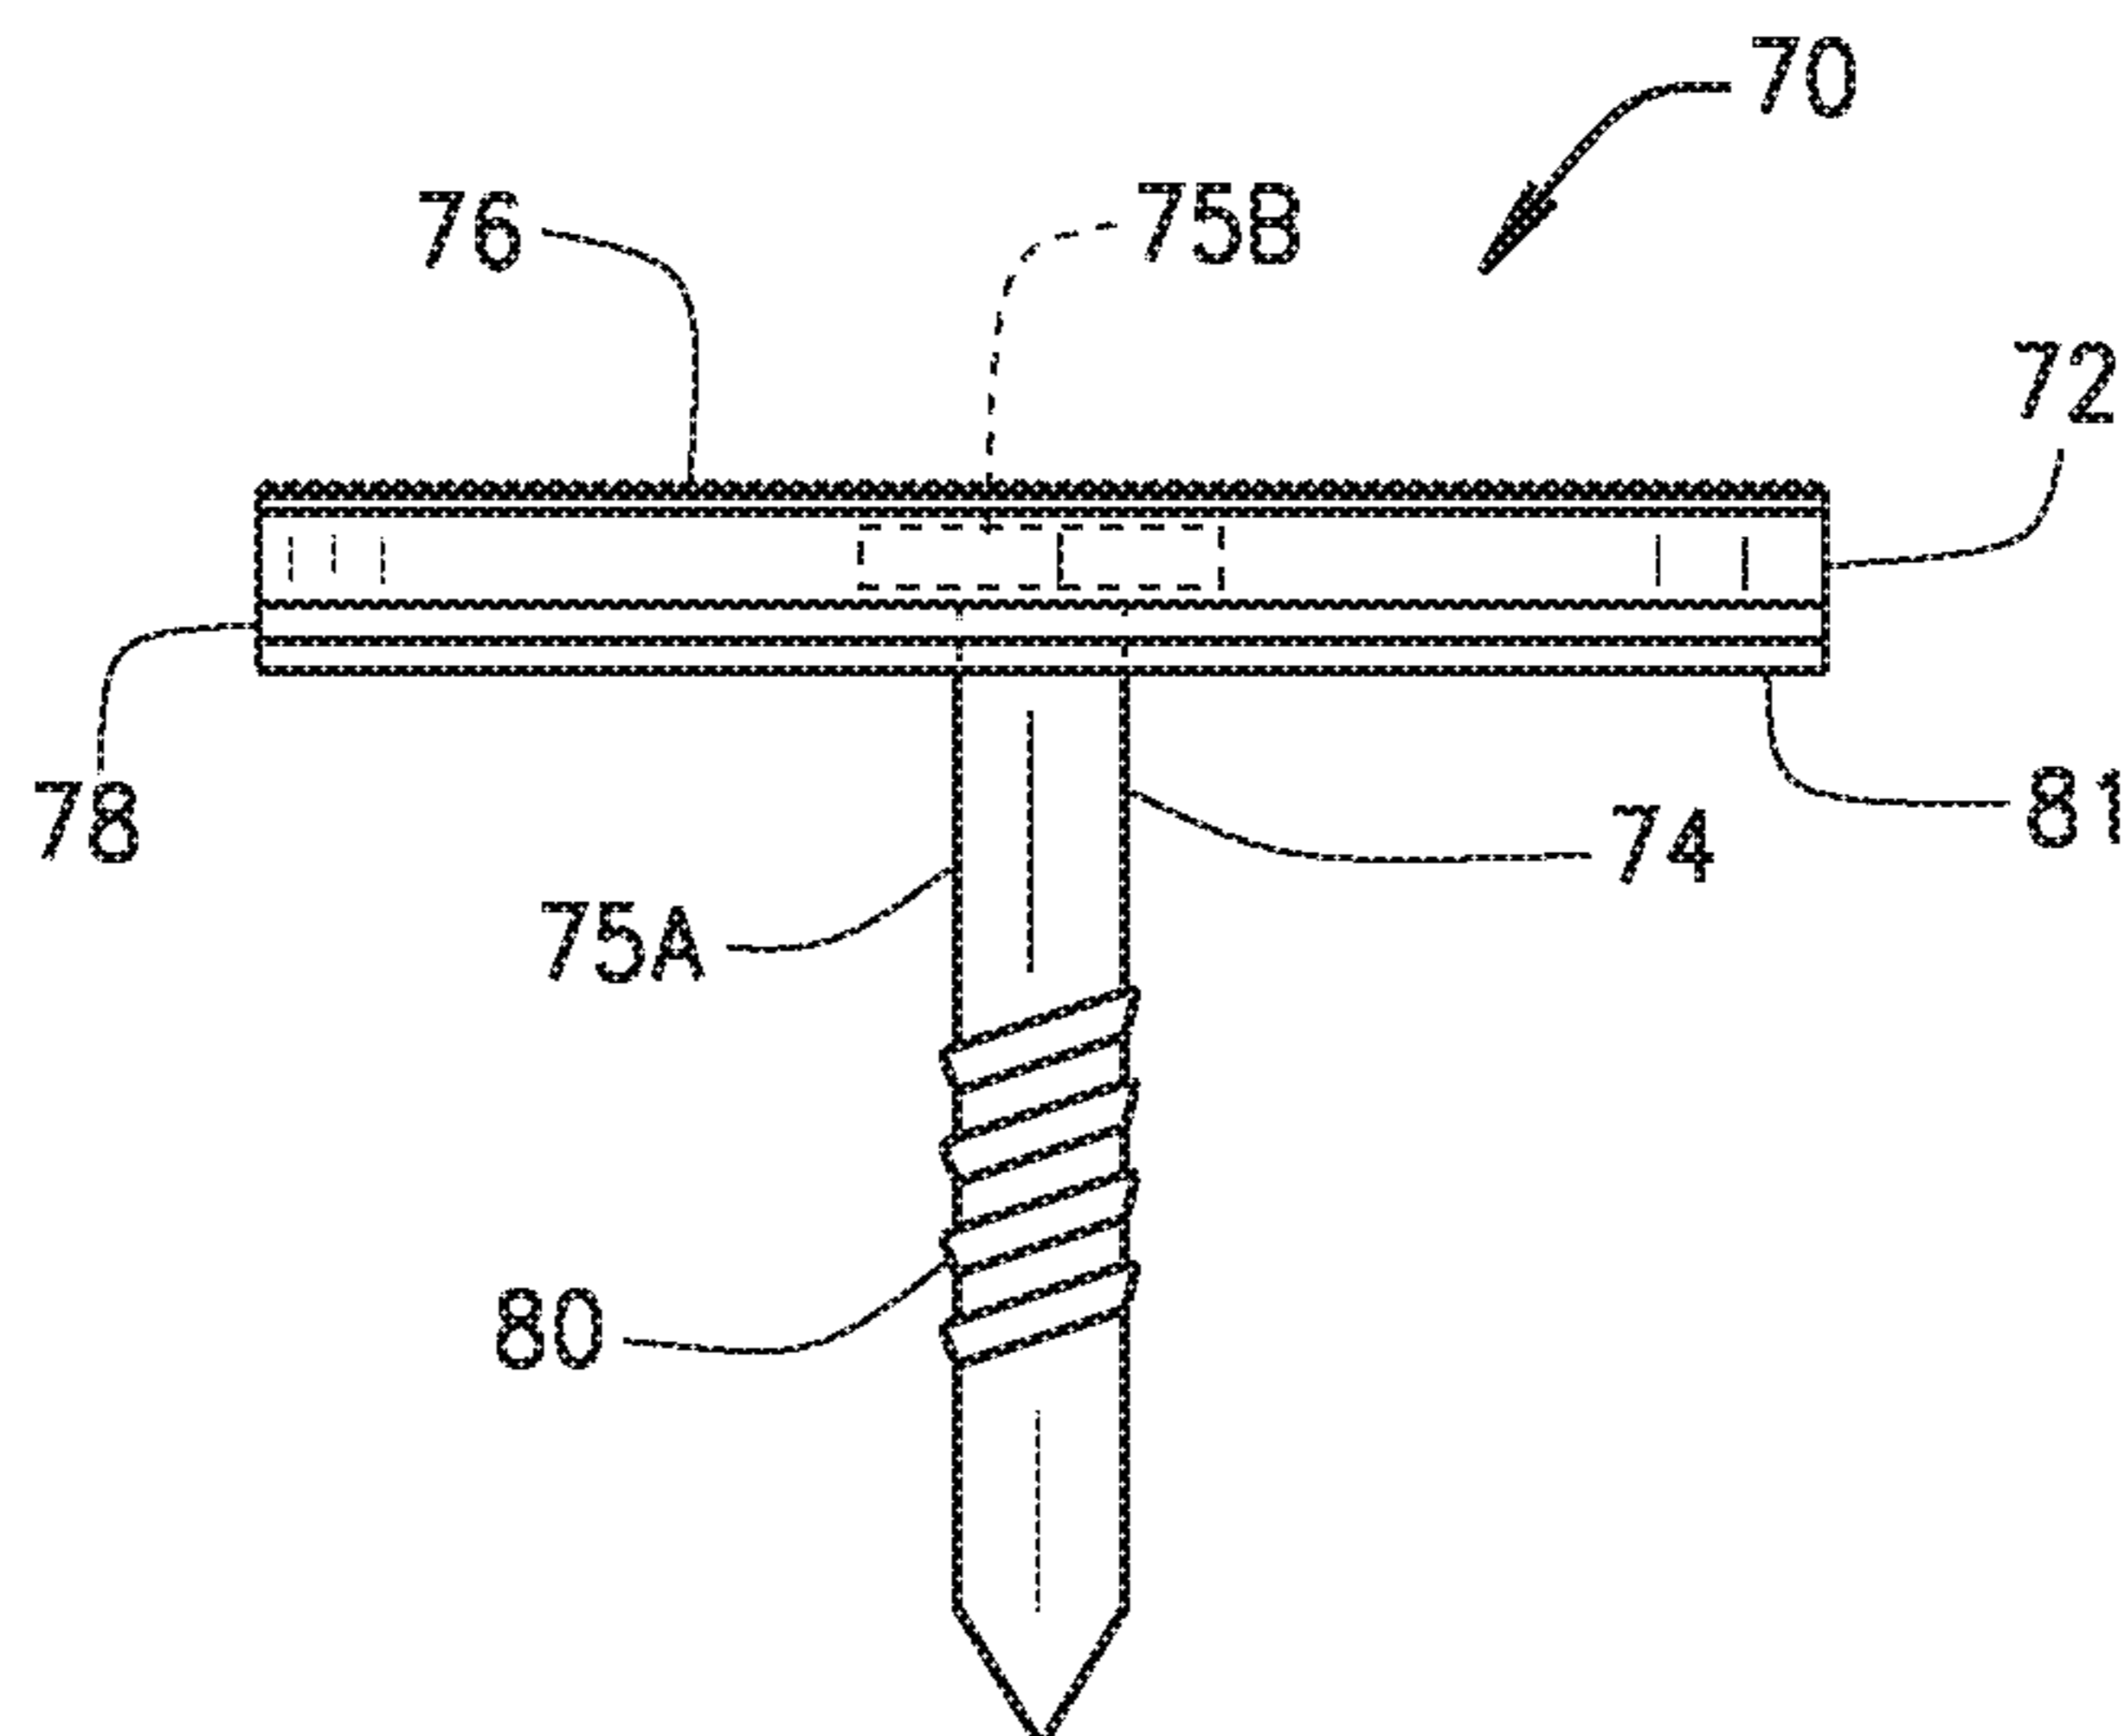
FIG. 8A is a side elevational view similar to FIG. 8 showing the nail head incorporated into the body member of the nail/disk structure of FIG. 8.

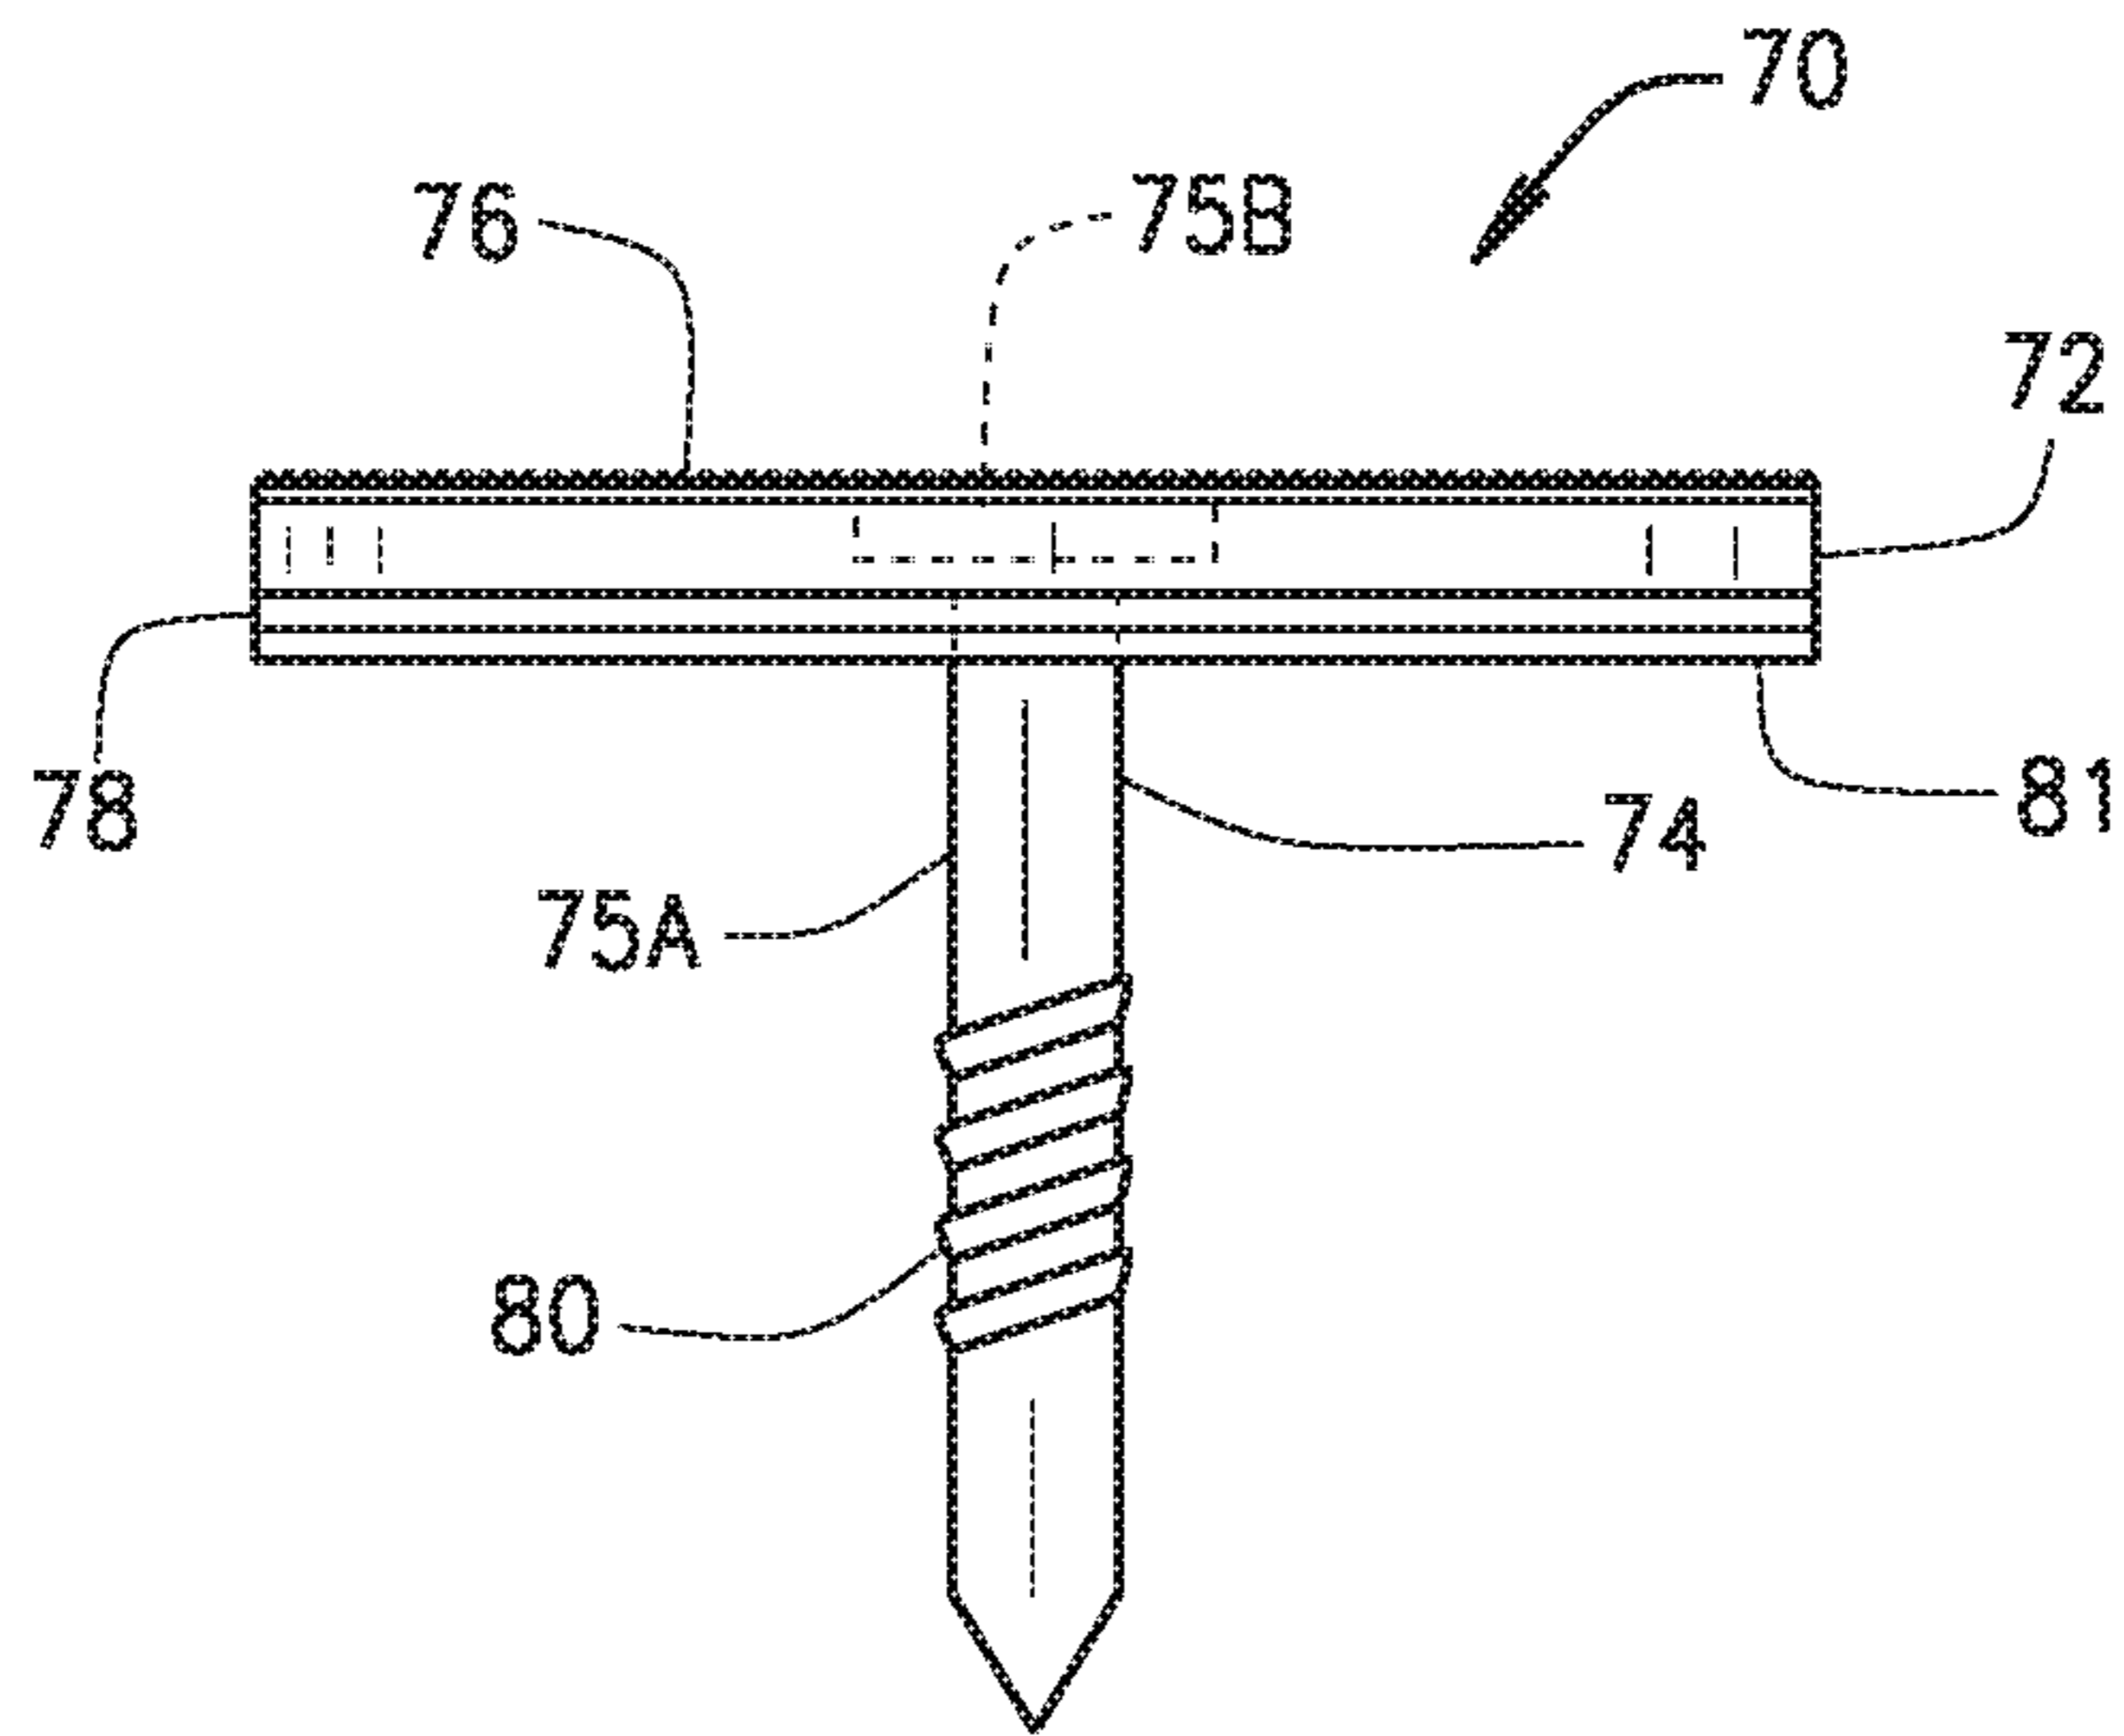
FIG. 8B is a side elevational view similar to FIG. 8A showing another embodiment of the nail head incorporated into the body member of the present nail/disk structure.
