(10) **Patent No.:** **US 10,072,418 B2**  
(45) **Date of Patent:** **Sep. 11, 2018**

(54) **INTEGRAL NAIL/DISK STRUCTURE FOR ELIMINATING EXPOSED ROOF NAILS**

(71) Applicant: **Thomas R. Mathieson**, Louisville, CO (US)

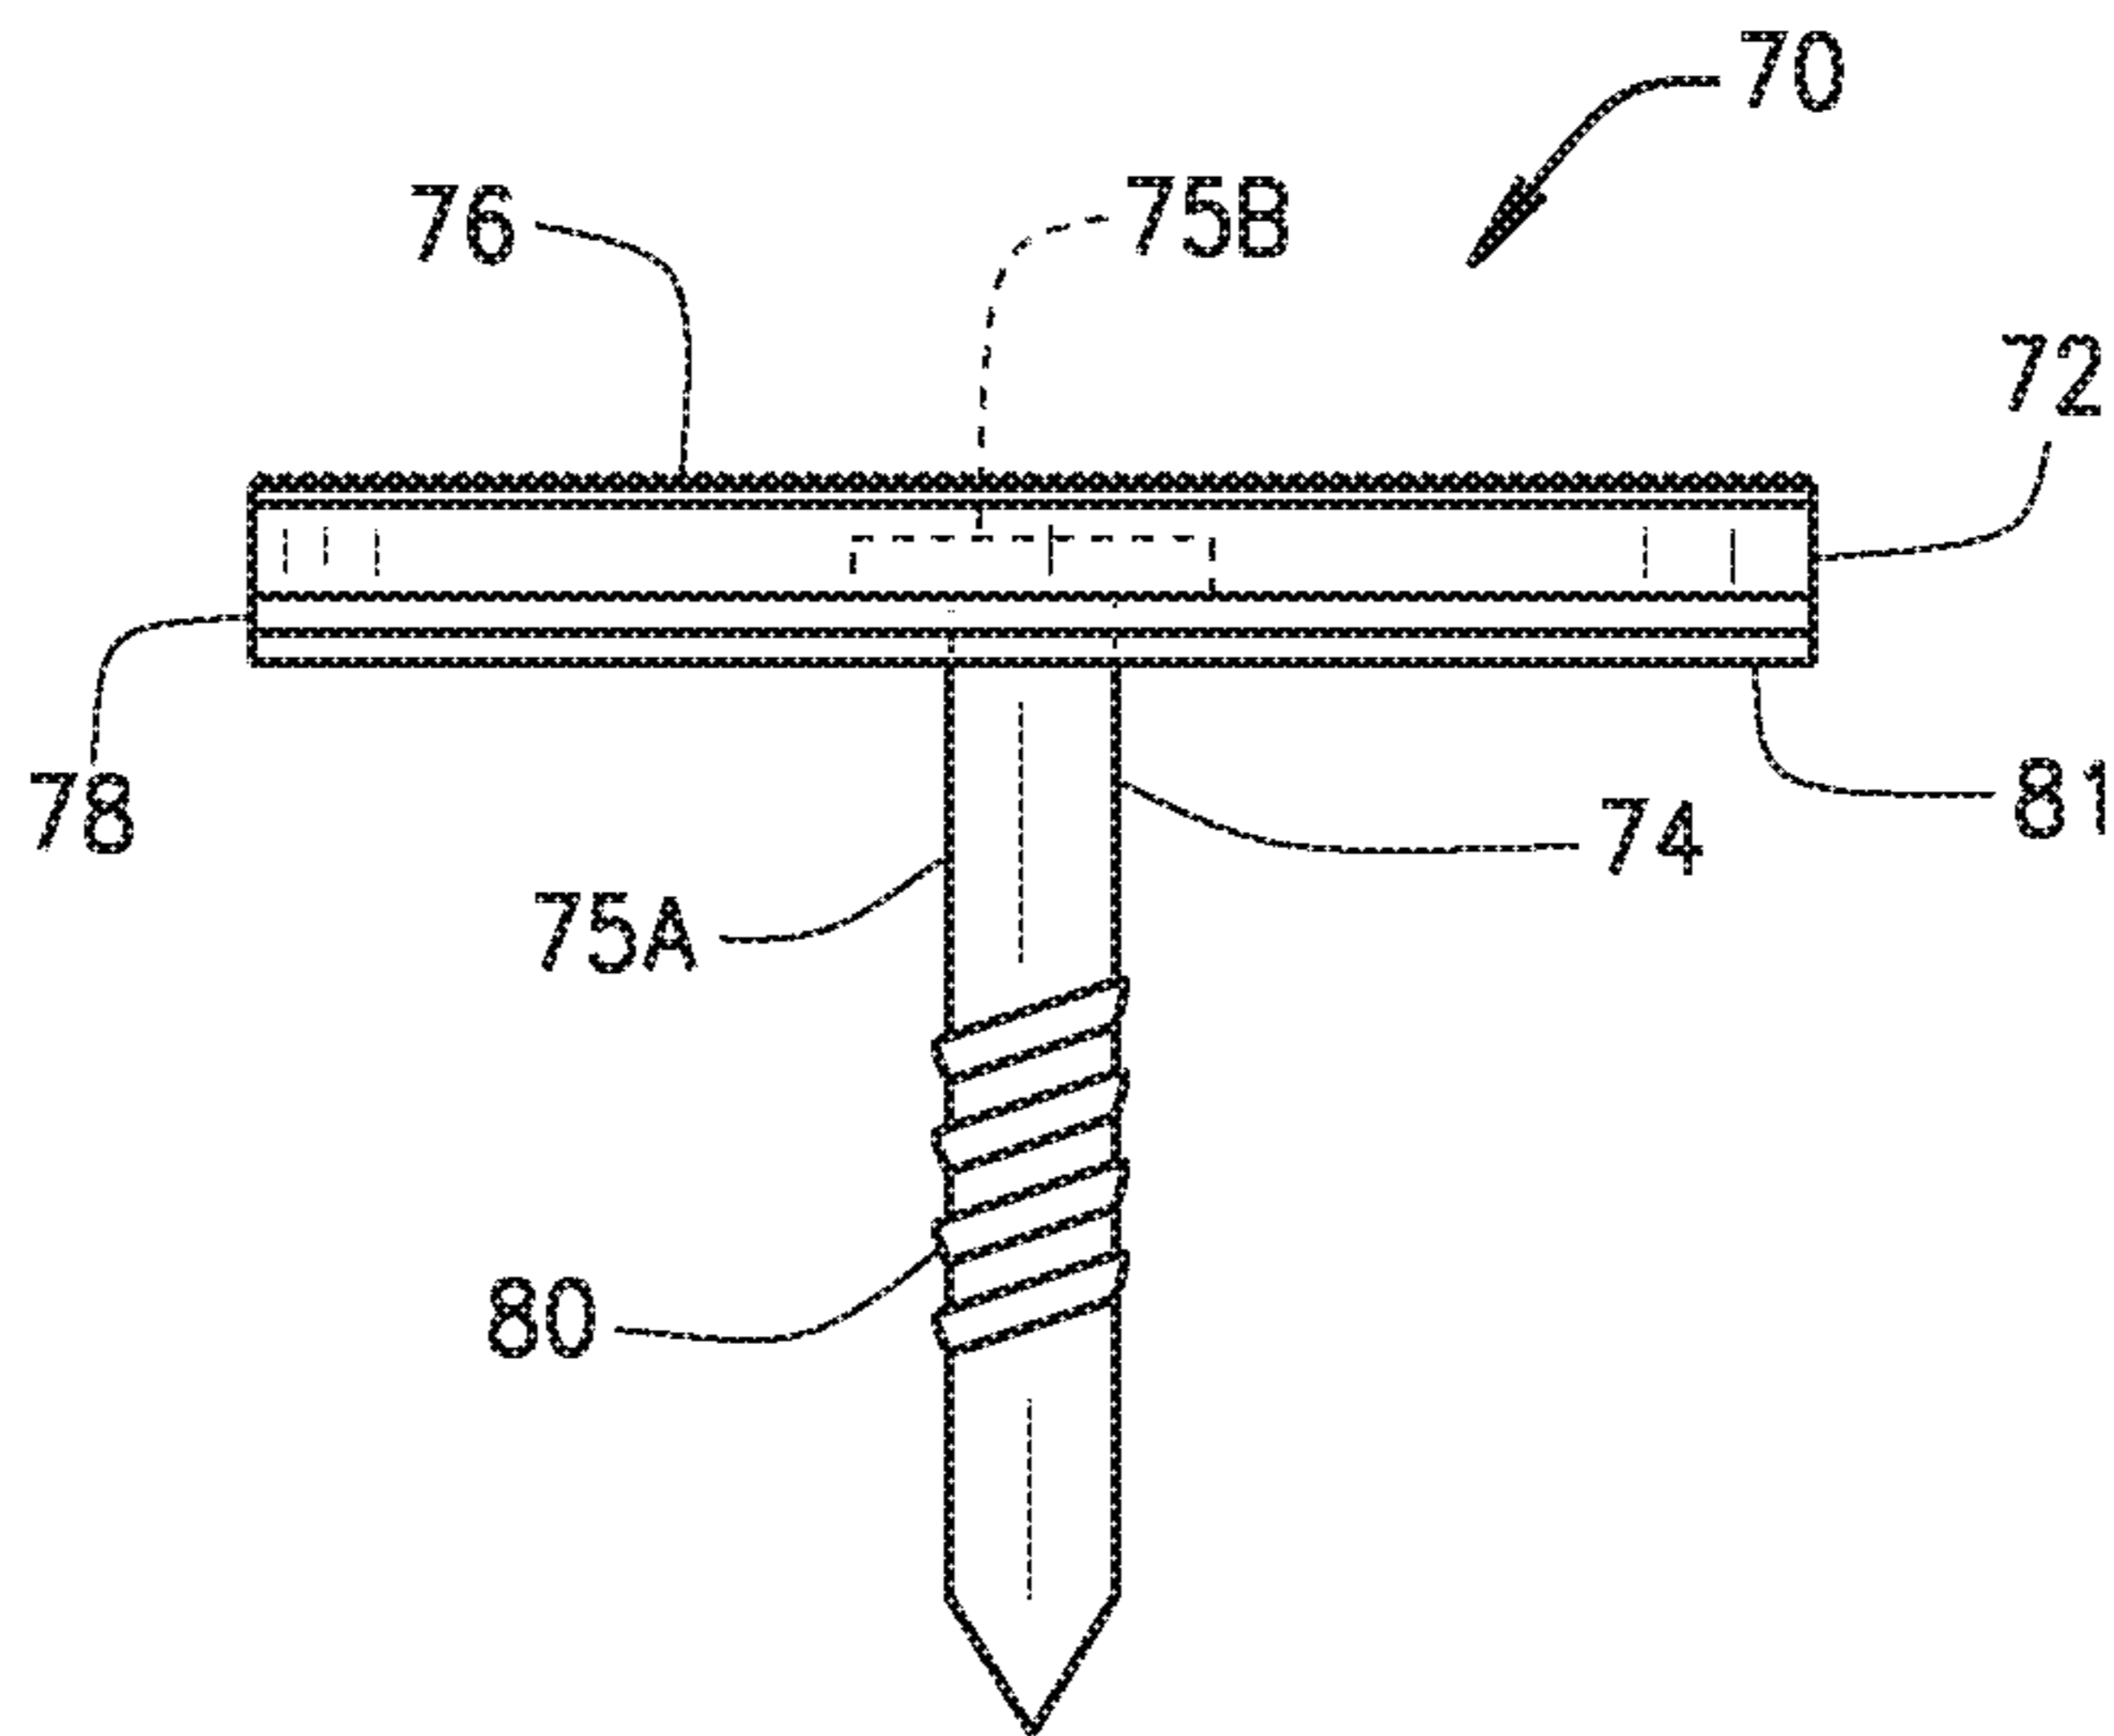
FIG. 8C is a side elevational view similar to FIGS. 8A and 8B showing still another embodiment of the nail head incorporated into the body member of the present nail disk structure.

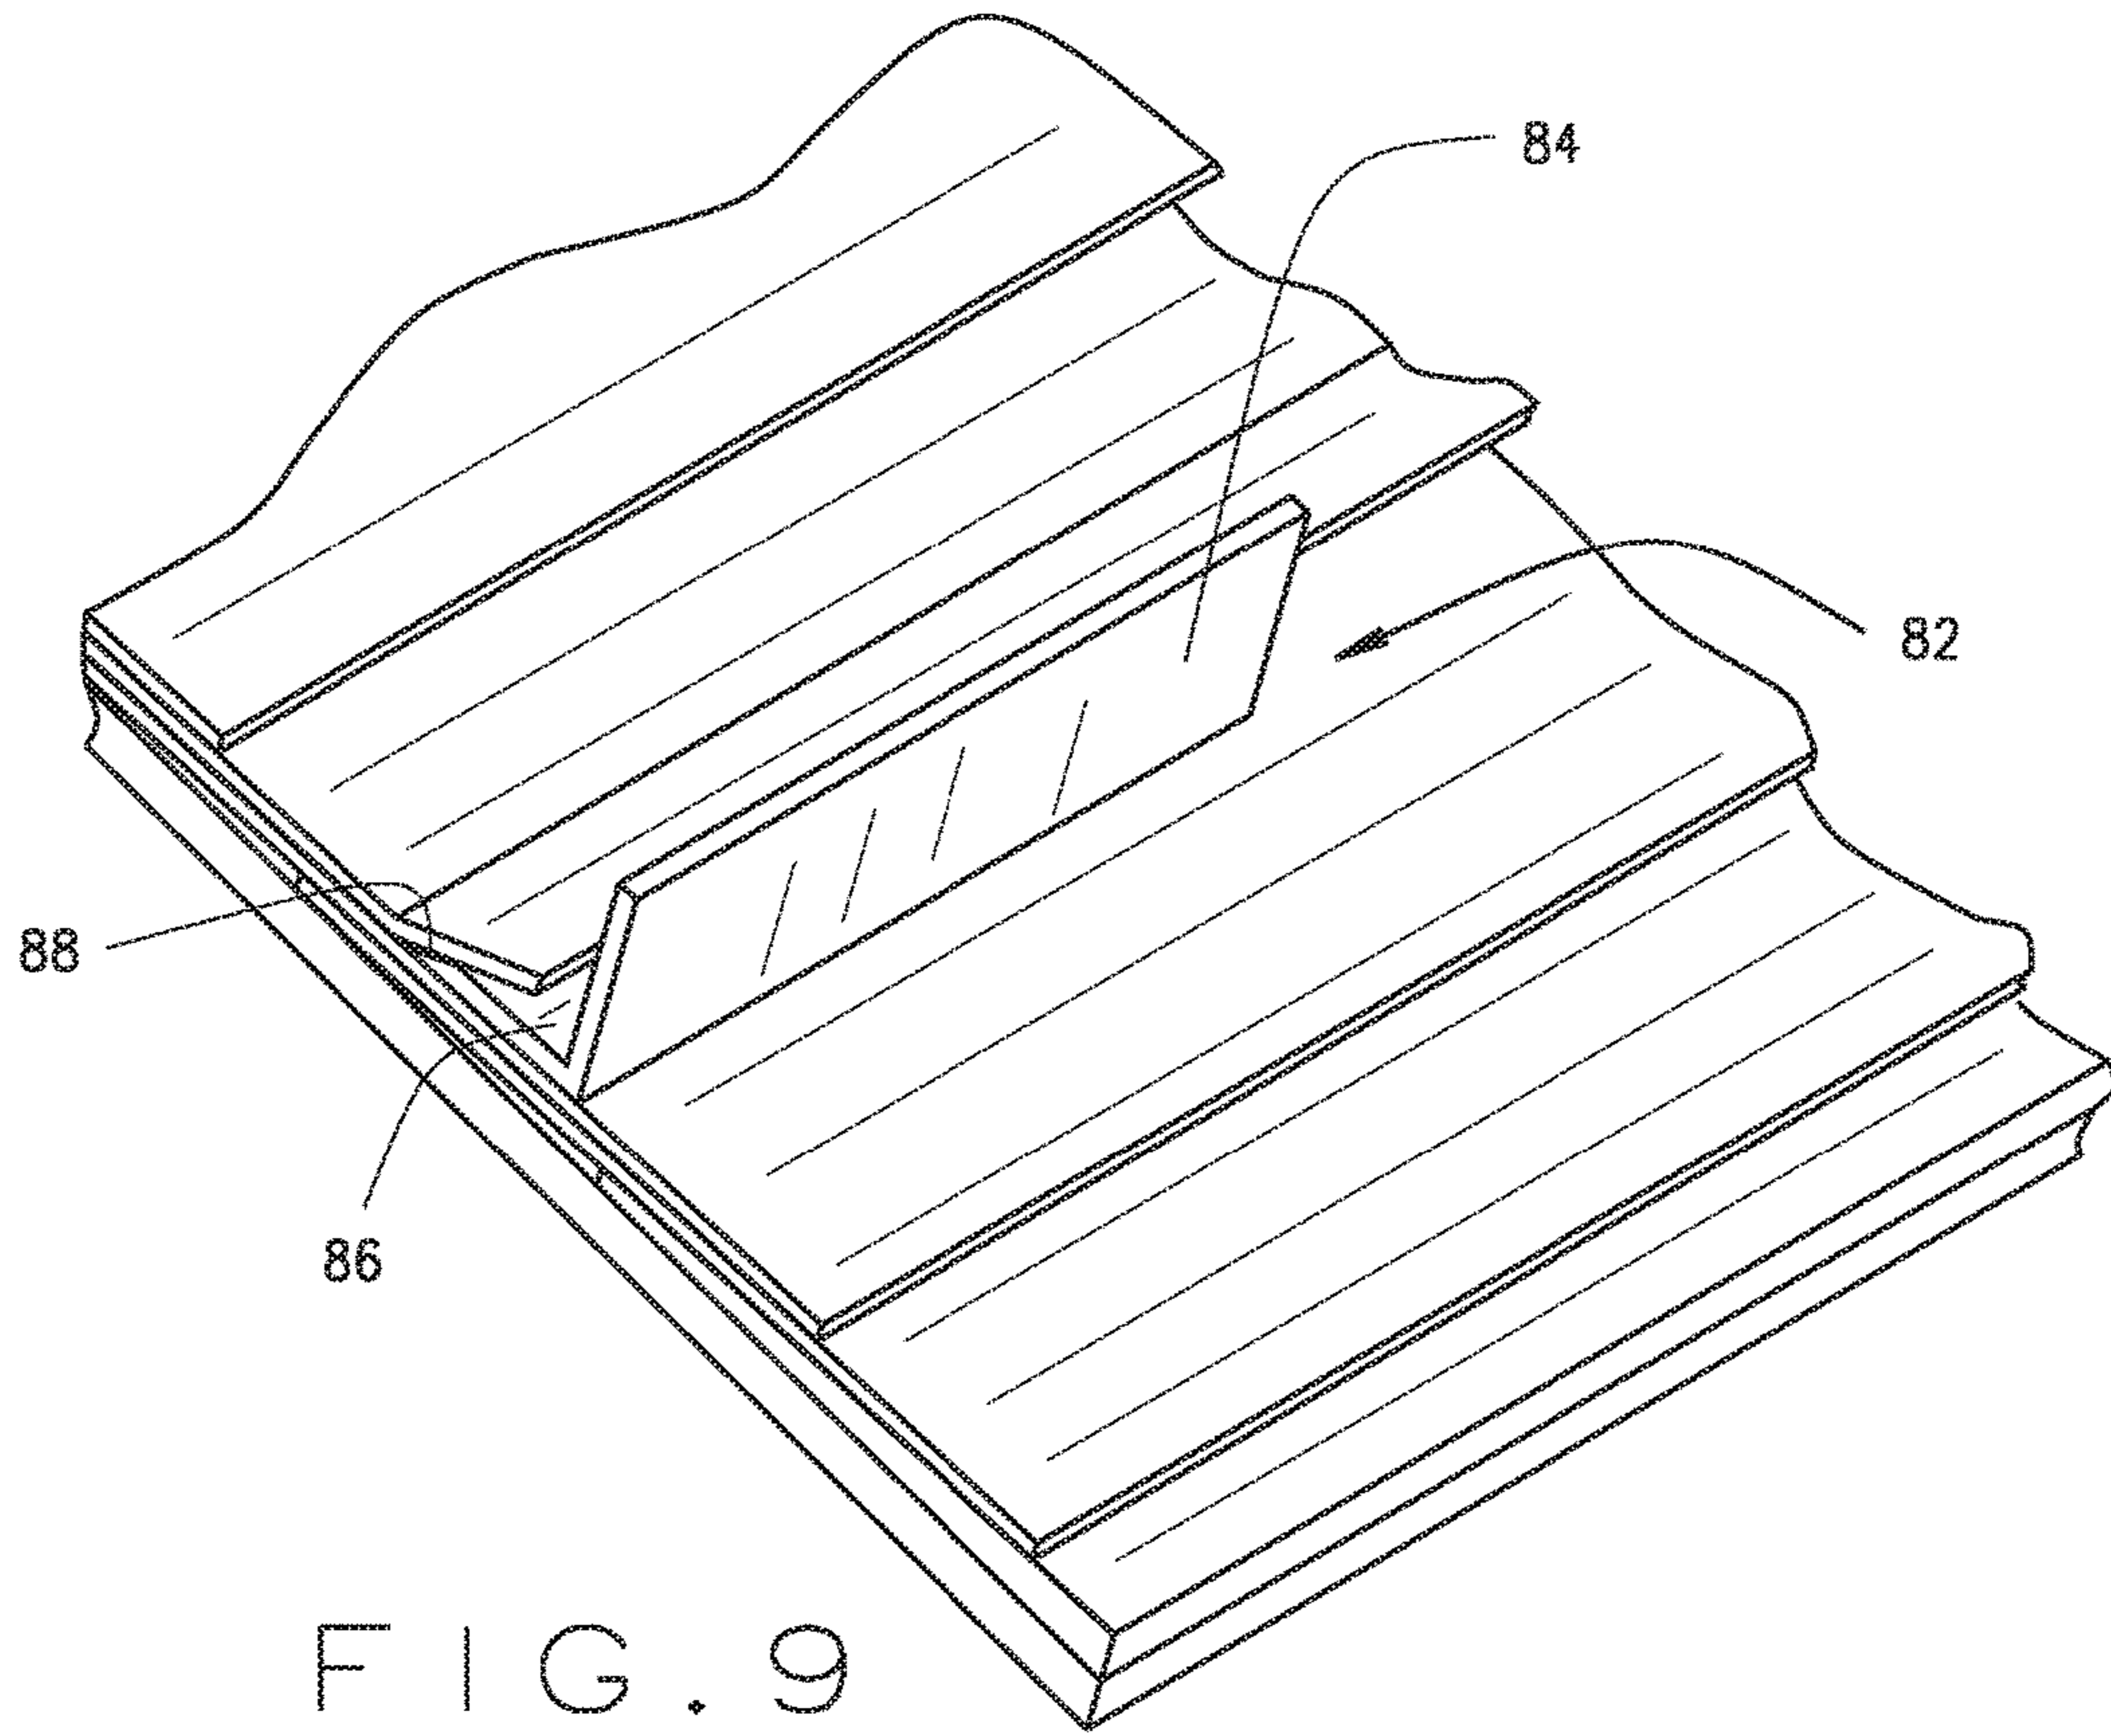
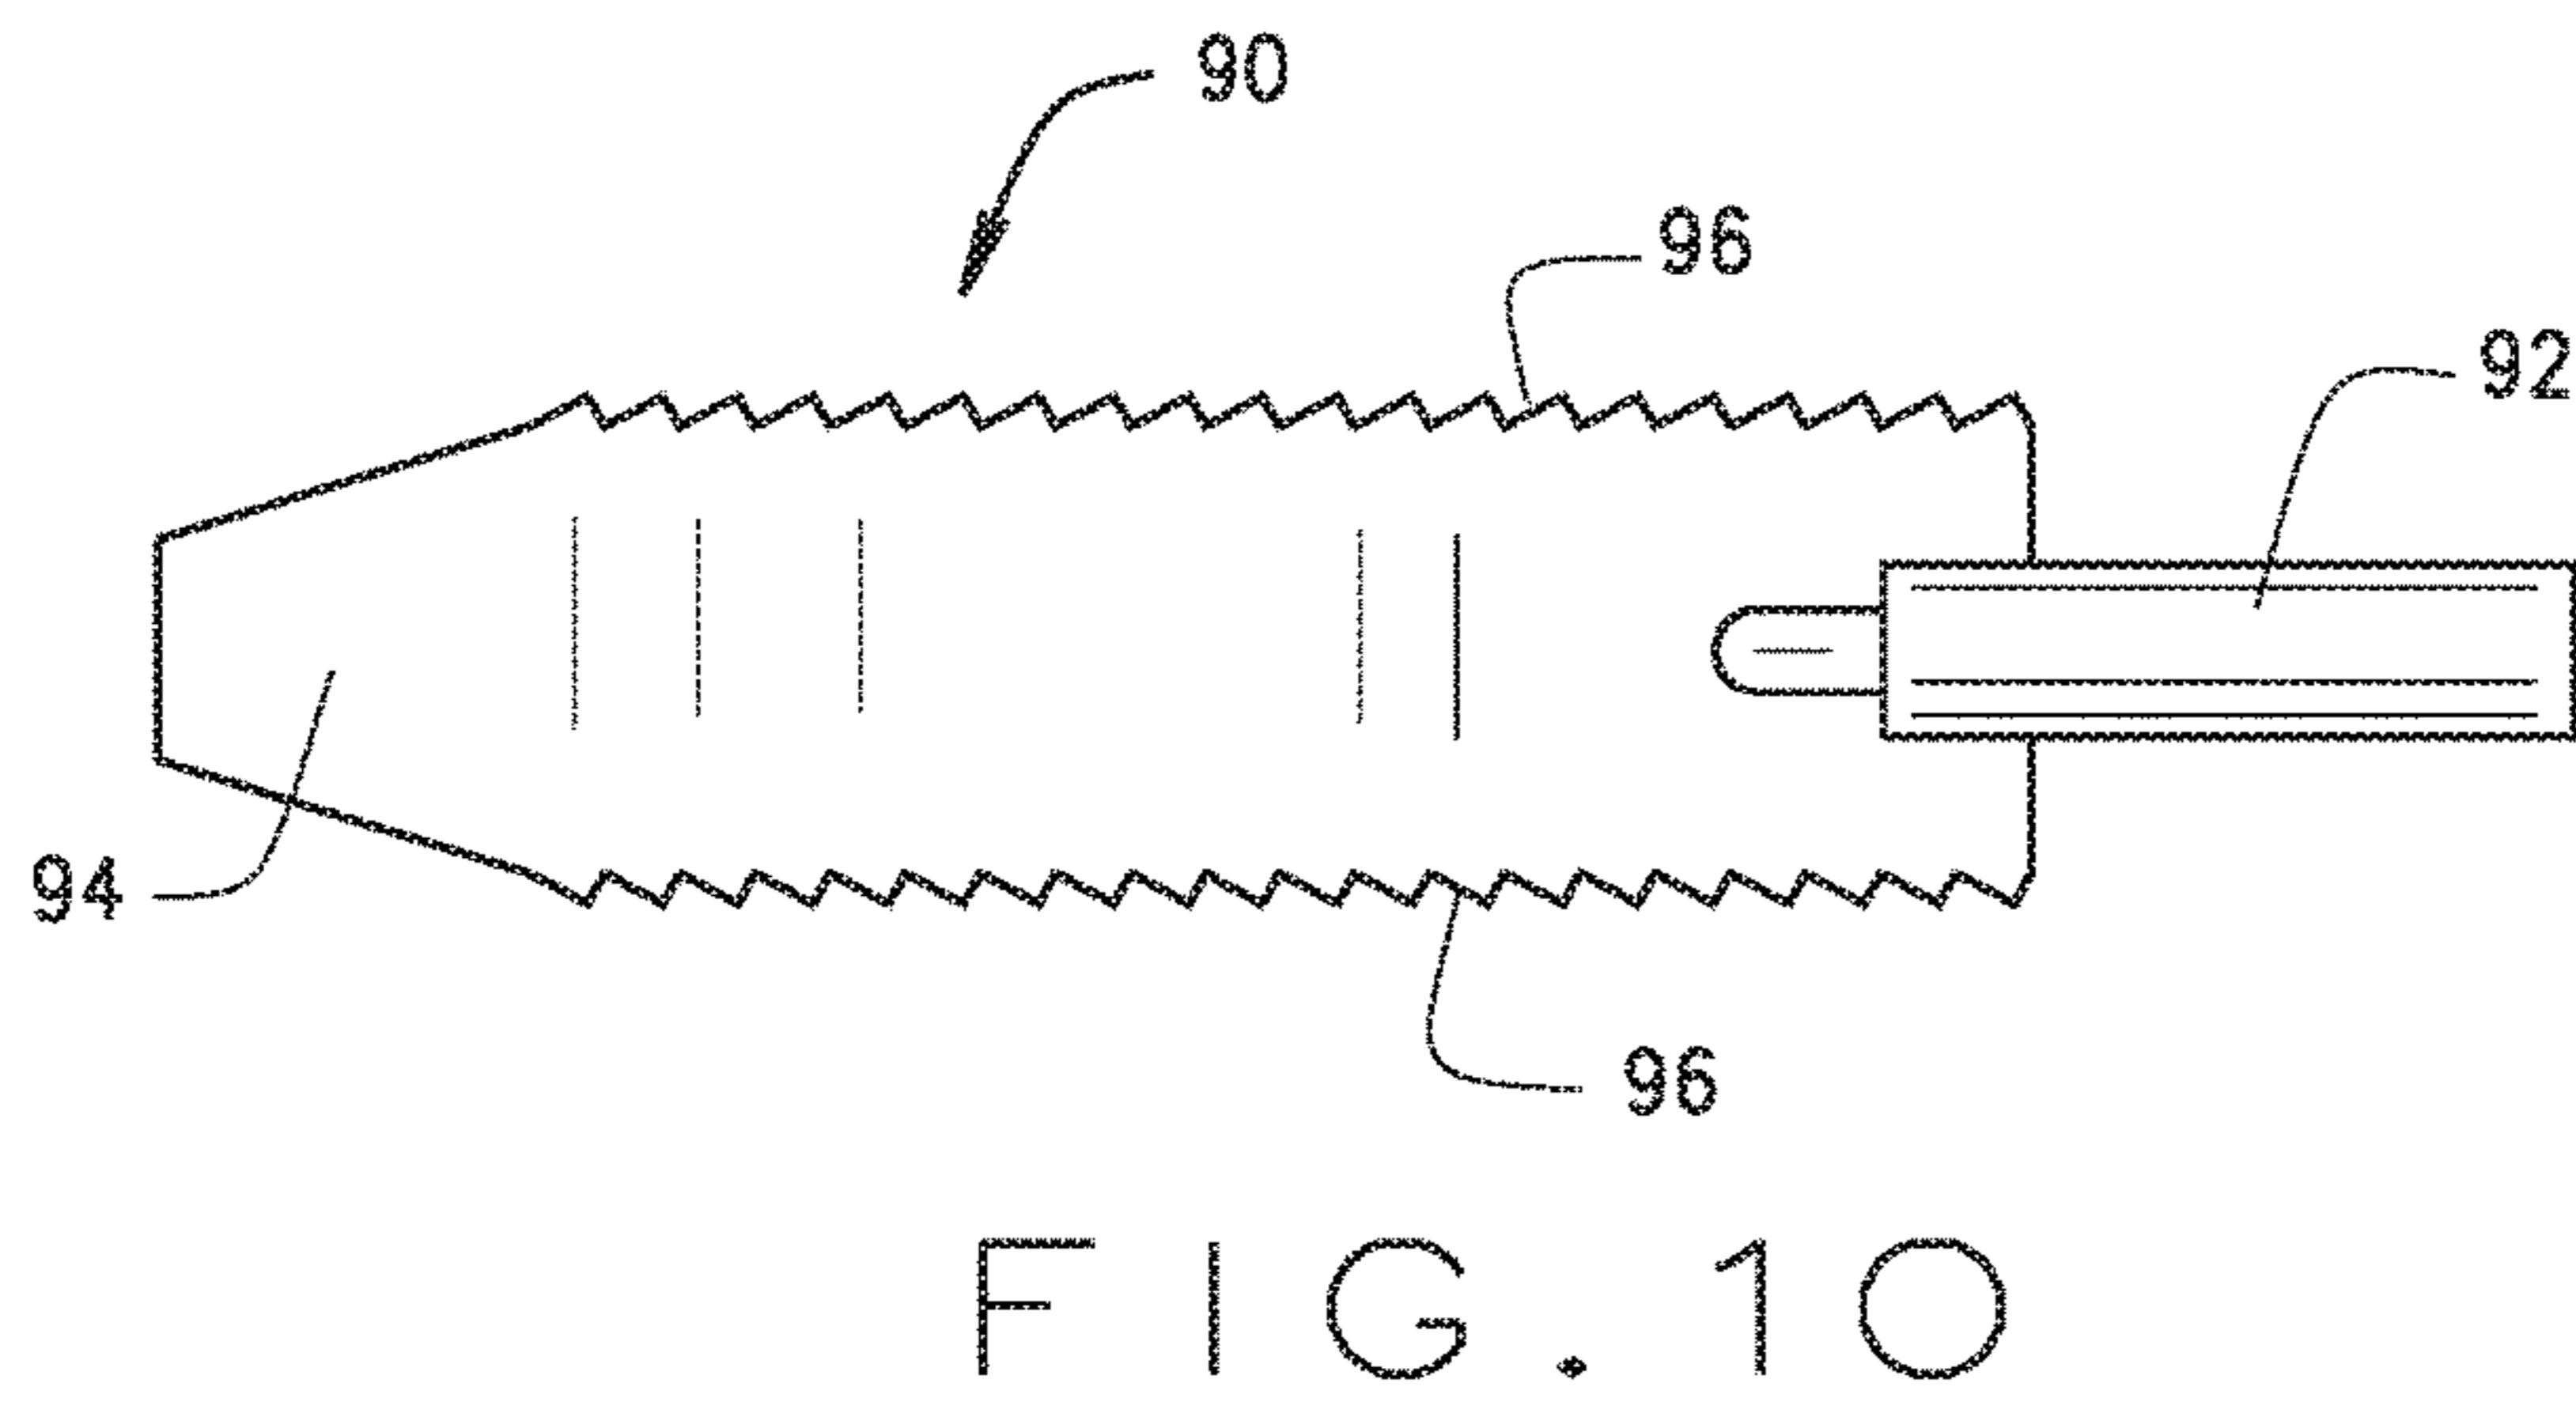
FIG. 9 is a perspective view of one embodiment of a tool that is specifically designed to raise the bottom edge of a shingle to create enough space to slide the present shingle patch thereunder.

FIG. 10 is a top plan view of another embodiment of a tool for breaking the seal of an already installed asphalt shingle without damaging the shingle, the tool likewise functioning to further lift the bottom edge of a shingle to create space for sliding the present shingle patch thereunder.

FIGS. 9 and 10 disclose tools that can be used to easily lift the bottom edge of a shingle for sliding the notched portion 14 or 46 under the lifted shingle edge portion. Tool 82 illustrated in FIG. 9 is L-shaped in configuration and includes tool portions 84 and 86. Tool portion 86 is used as a wedging member for sliding under the bottom edge portion of a shingle and may include a tapered edge portion 88 to facilitate the insertion process. This tool is specifically designed to raise the bottom edge of the shingle to create enough of a space to slide the shingle patch 10 or 42 under the raised shingle. This is accomplished by lining up tool 82 with the bottom of the shingle edge such that tool portion 86 and tapered portion 88 abut the bottom edge of the shingle. A hammer can be used to hit the tool carefully to force the tool portion 86 under the lap of the shingle. The length or depth of tool portion 86 need only be as long as the overall length of the notched portion 14 or 46. Once tool portion 86 is positioned under the shingle edge portion, a prying force can be exerted against tool portion 84 to lift the bottom edge of the shingle.

Tool 90 illustrated in FIG. 10 can be used to break the seal of an already installed asphalt shingle without damaging the shingle. The tool 90 is a trowel shaped tool having a handle 92 and a trowel portion 94. The trowel portion 94 may include saw teeth or a serrated edge portion 96 located along one or both opposed edge portions as illustrated in FIG. 10 to help break up the sealed asphalt as the trowel portion 94 is inserted under the bottom edge of a shingle. In addition, trowel portion 94 may also be heated to further improve and facilitate the break-up of the seal associated with the shingle to be lifted. Heat can be provided to trowel portion 94 in a conventional manner such as the method used in an iron or curling iron. Tool 90 could also be used to lift the bottom edge of a shingle to be raised once the seal has been broken or tool 82 could be used after tool 90, if necessary.

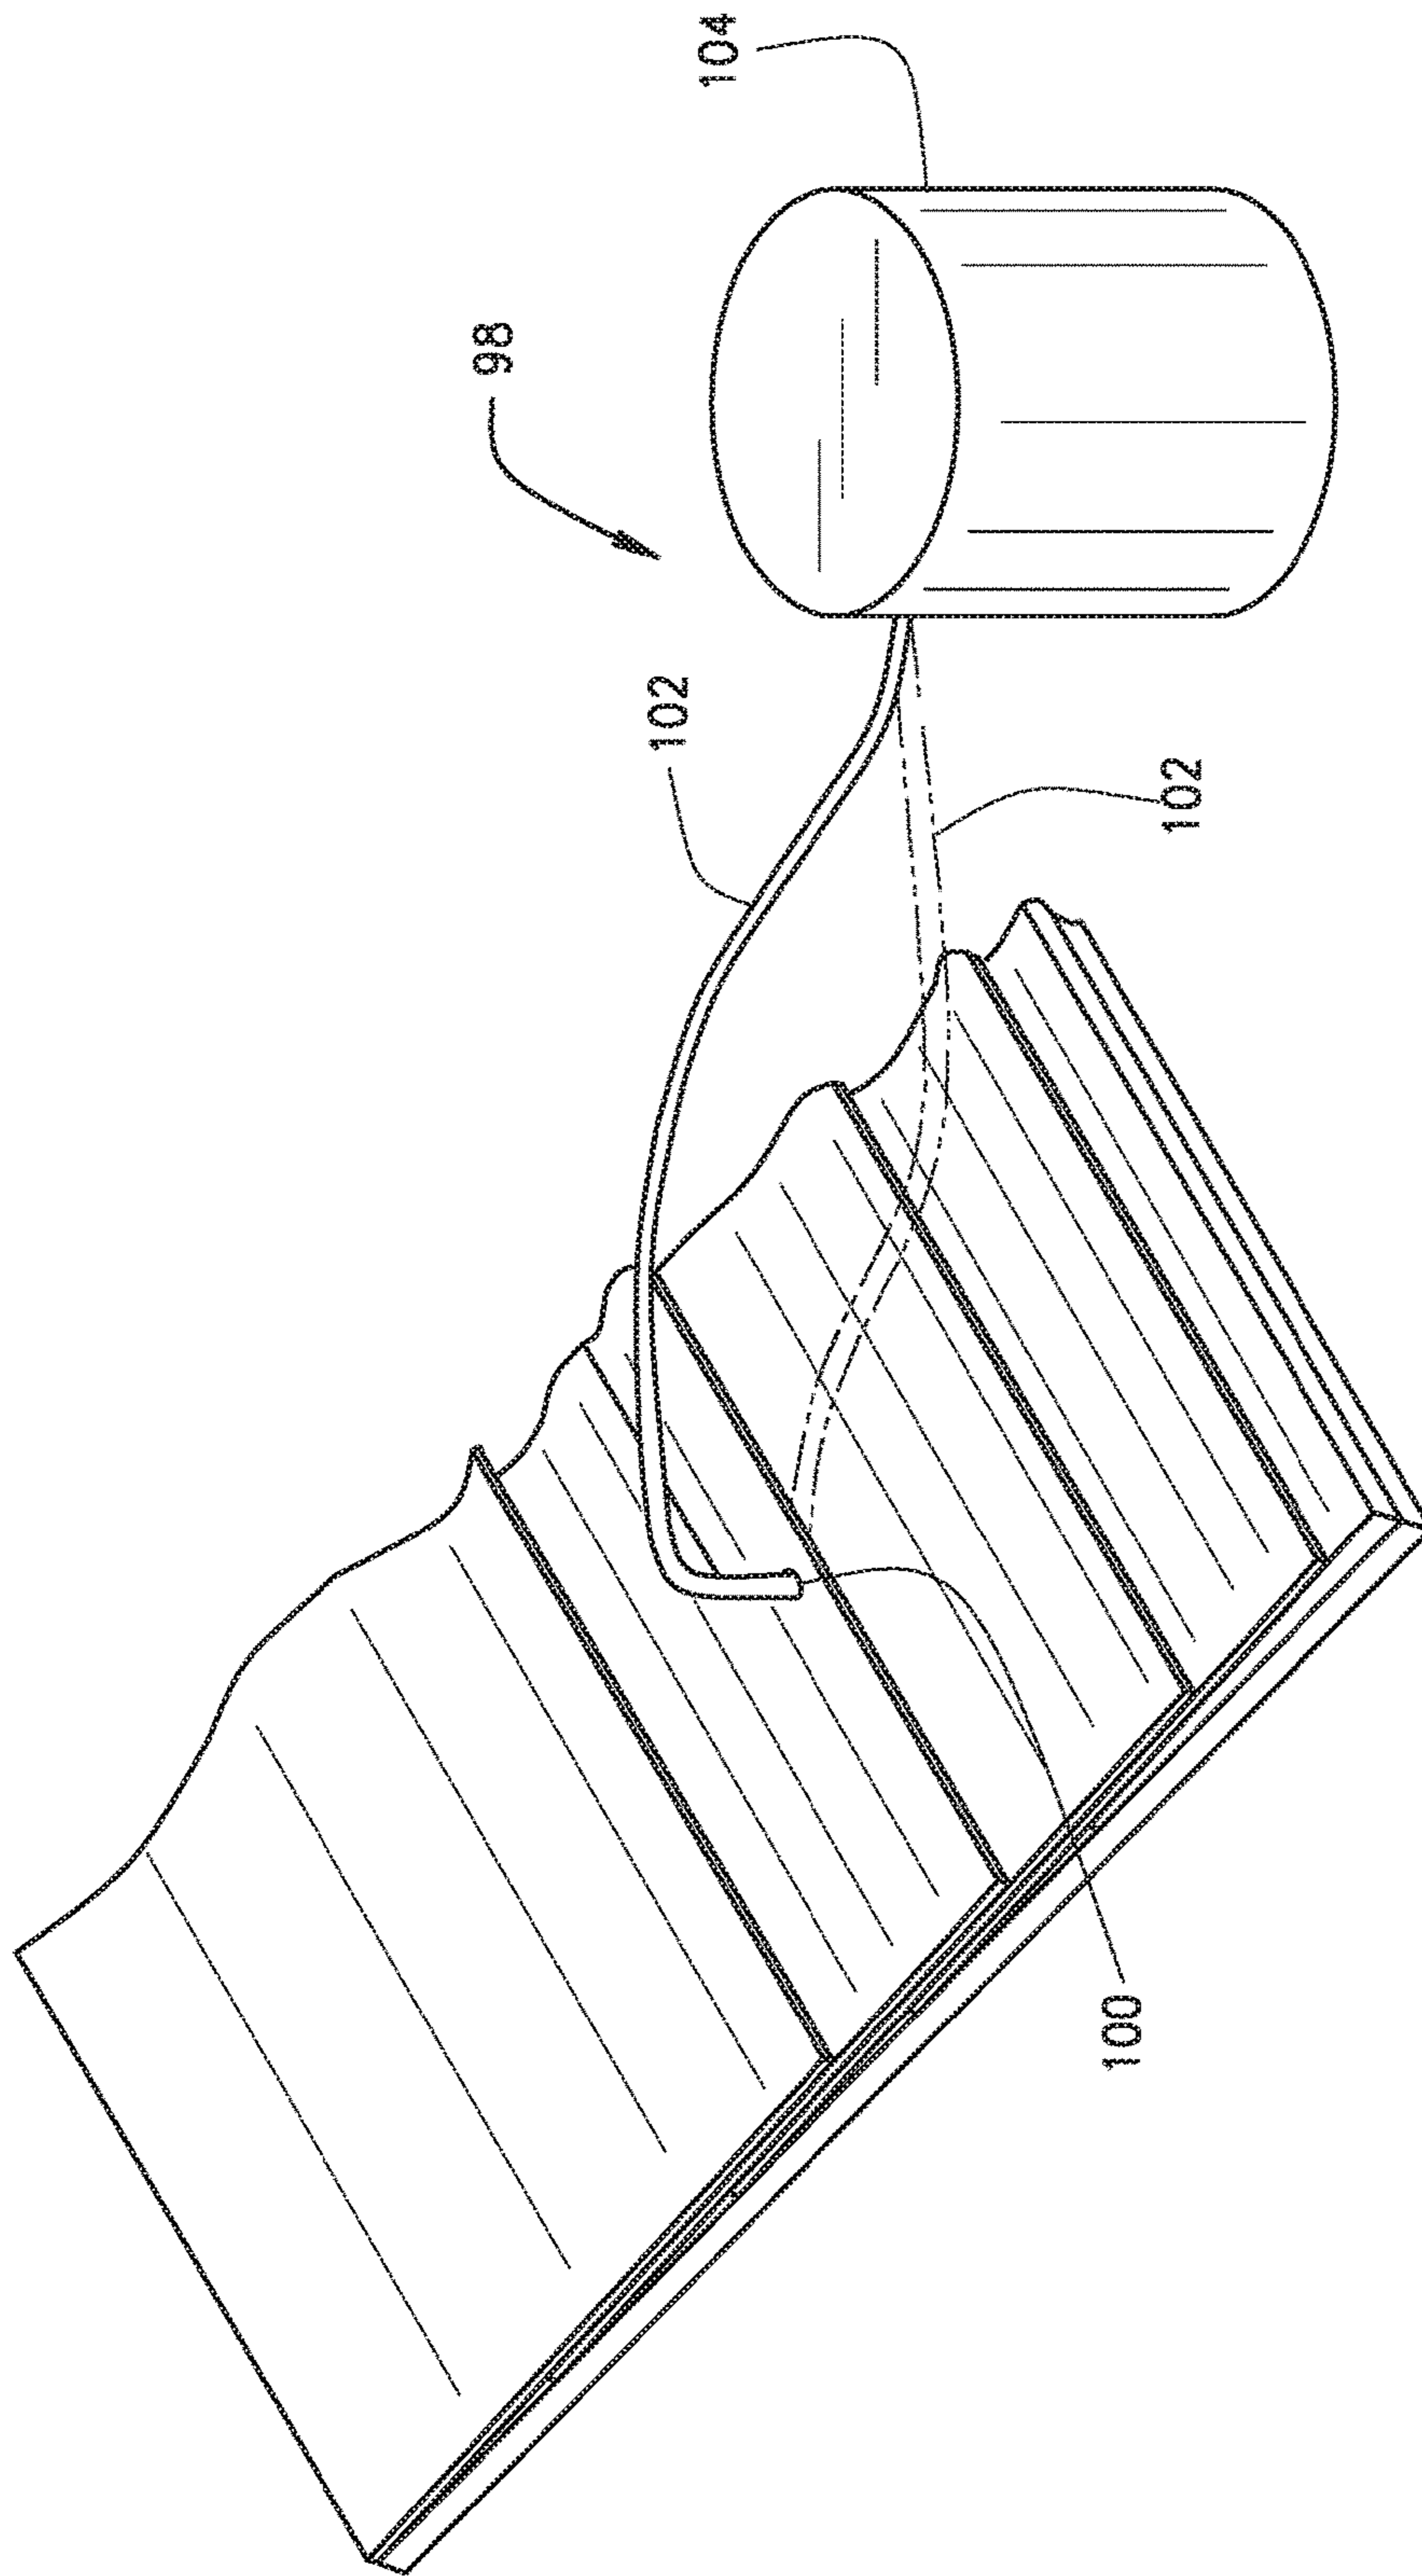
FIG. 11 is a representative schematic view illustrating another method for repairing a damaged shingle.

FIG. 11 illustrates still another method for repairing a damaged shingle, namely, an asphalt emulsion injection system 98. This method includes injecting a sealant or emulsion/adhesive underneath the damaged shingle and then sealing the top damaged surface of the shingle with an emulsion and applying colored granules into the emulsion to match the color of the damaged shingle. In one aspect of the system 98, a small hole is made in the center of the hole impacted or damaged area of the shingle such as hole 100 illustrated in FIG. 11. A sealant is then injected or pumped under the damaged shingle through the use of a tube 102 and an applicator device 104. The applicator device can be any known device capable of pumping, pushing and/or moving a liquid asphalt emulsion/adhesive or any other appropriate sealant from the device 104 through the tube 102 and through the hole 100 made in the damaged shingle to the area located under the damaged shingle. In this regard, the terminal end of the tube 102 is inserted into the hole 100 such that the sealant pumped therethrough will spread underneath shingle around the area where the damage occurred. The sealant then seals and glues the bottom of the damaged shingle to the shingle located therebelow and seals the space therebetween. The hole and upper face of the damaged shingle is then filled with a liquid emulsion to seal the hole and the upper damaged shingle area and colored granules are then placed in the emulsion to match the granules associated with the damaged shingle. The applicator device can be as simple as a caulking gun where the tube 102 would be the nozzle associated with an adhesive, sealant or emulsion container.

In another aspect of the asphalt emulsion ejector system 98, tube 102 can be manipulated under the damaged shingle by using any one of the tools 82, 90 or any other suitable tool and the liquid emulsion can again be pumped or moved under the damaged shingle and around the damaged area to again seal the bottom of the damaged shingle to the shingle located therebelow. In this aspect of system 98, no hole 100 need be made through the damaged shingle. Once a sealant is pumped under the damaged area, the damaged upper face of the shingle is filled with an emulsion to seal the damaged area and colored granules are again placed in the emulsion to match the granules associated with the damaged shingle. Either method of system 98 will adequately seal and repair the damaged shingle.
