US010082375B2

(54) MALFUNCTION TRAINING DEVICE FOR FIREARMS

(57) ABSTRACT

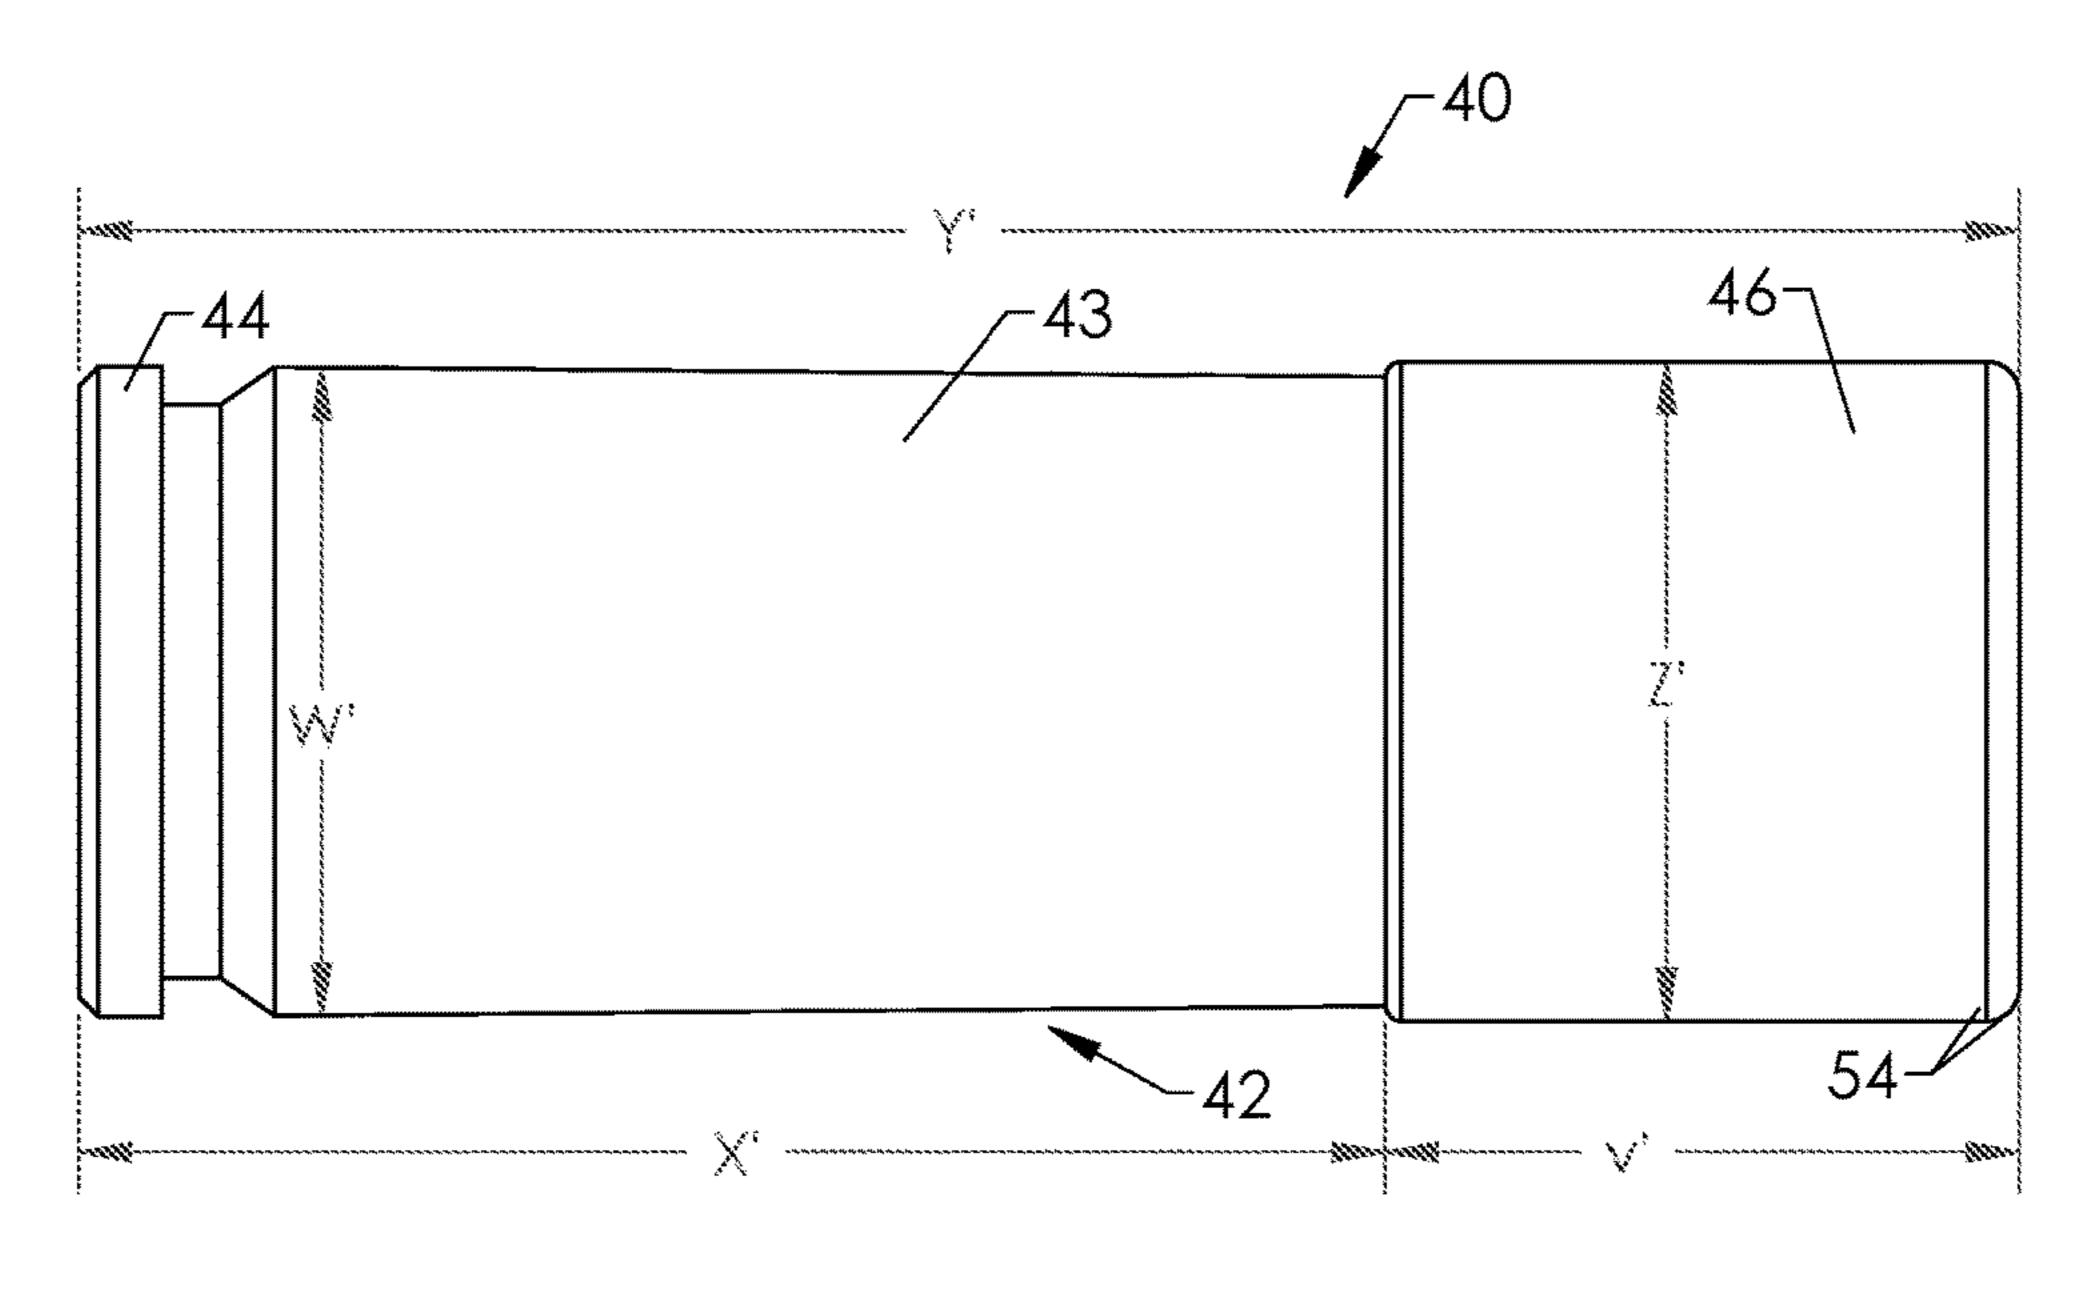
FIG.7B

FIG. 7B is a side view of the malfunction round of FIGS. 2A-5, with dimension variables V', W', X', Y' and Z' indicated, for comparison to the live round of FIG. 7A.

FIG. 7B depicts dimensions V', W', X', Y' and Z' for malfunction round 40 according to certain embodiments of the invention. Dimension W' is the maximum O.D. of central generally cylindrical section 42 including main portion 43 and base/back end 44, which is typically on the main portion 25 43 just distal of the groove 47. Dimension X' is the length of said central generally cylindrical section 42. Dimension Y' is the total length of malfunction round 40. Dimension V' is the length of the front end 46, and dimension Z' is the maximum O.D. of the front end 46 of malfunction round 40.

Therefore, FIG. 7A and FIG. 7B are general representations of live round 10, and a corresponding malfunction round 40, respectively, wherein the dimensions of live round 10 and the dimensions of malfunction round 40 are not embodiments. Dimensions V, W, X, Y, and Z of live round 10 may be different for various calibers, brand names, and grains for the live rounds, and magazine types and breech diameters, for multiple corresponding hand guns. Dimensions V', W', X', Y', and Z' of malfunction round 40 may be 40 adapted so that malfunction round 40 optimally cooperates with said multiple corresponding hand guns of various calibers, brand names, and magazine types and breech diameters. Exemplary adaptations are shown in Tables 1-4 and discussed in the Detailed Description of Provisional 45 Application Ser. No. 62/452,728, filed Jan. 31, 2017, incorporated herein.

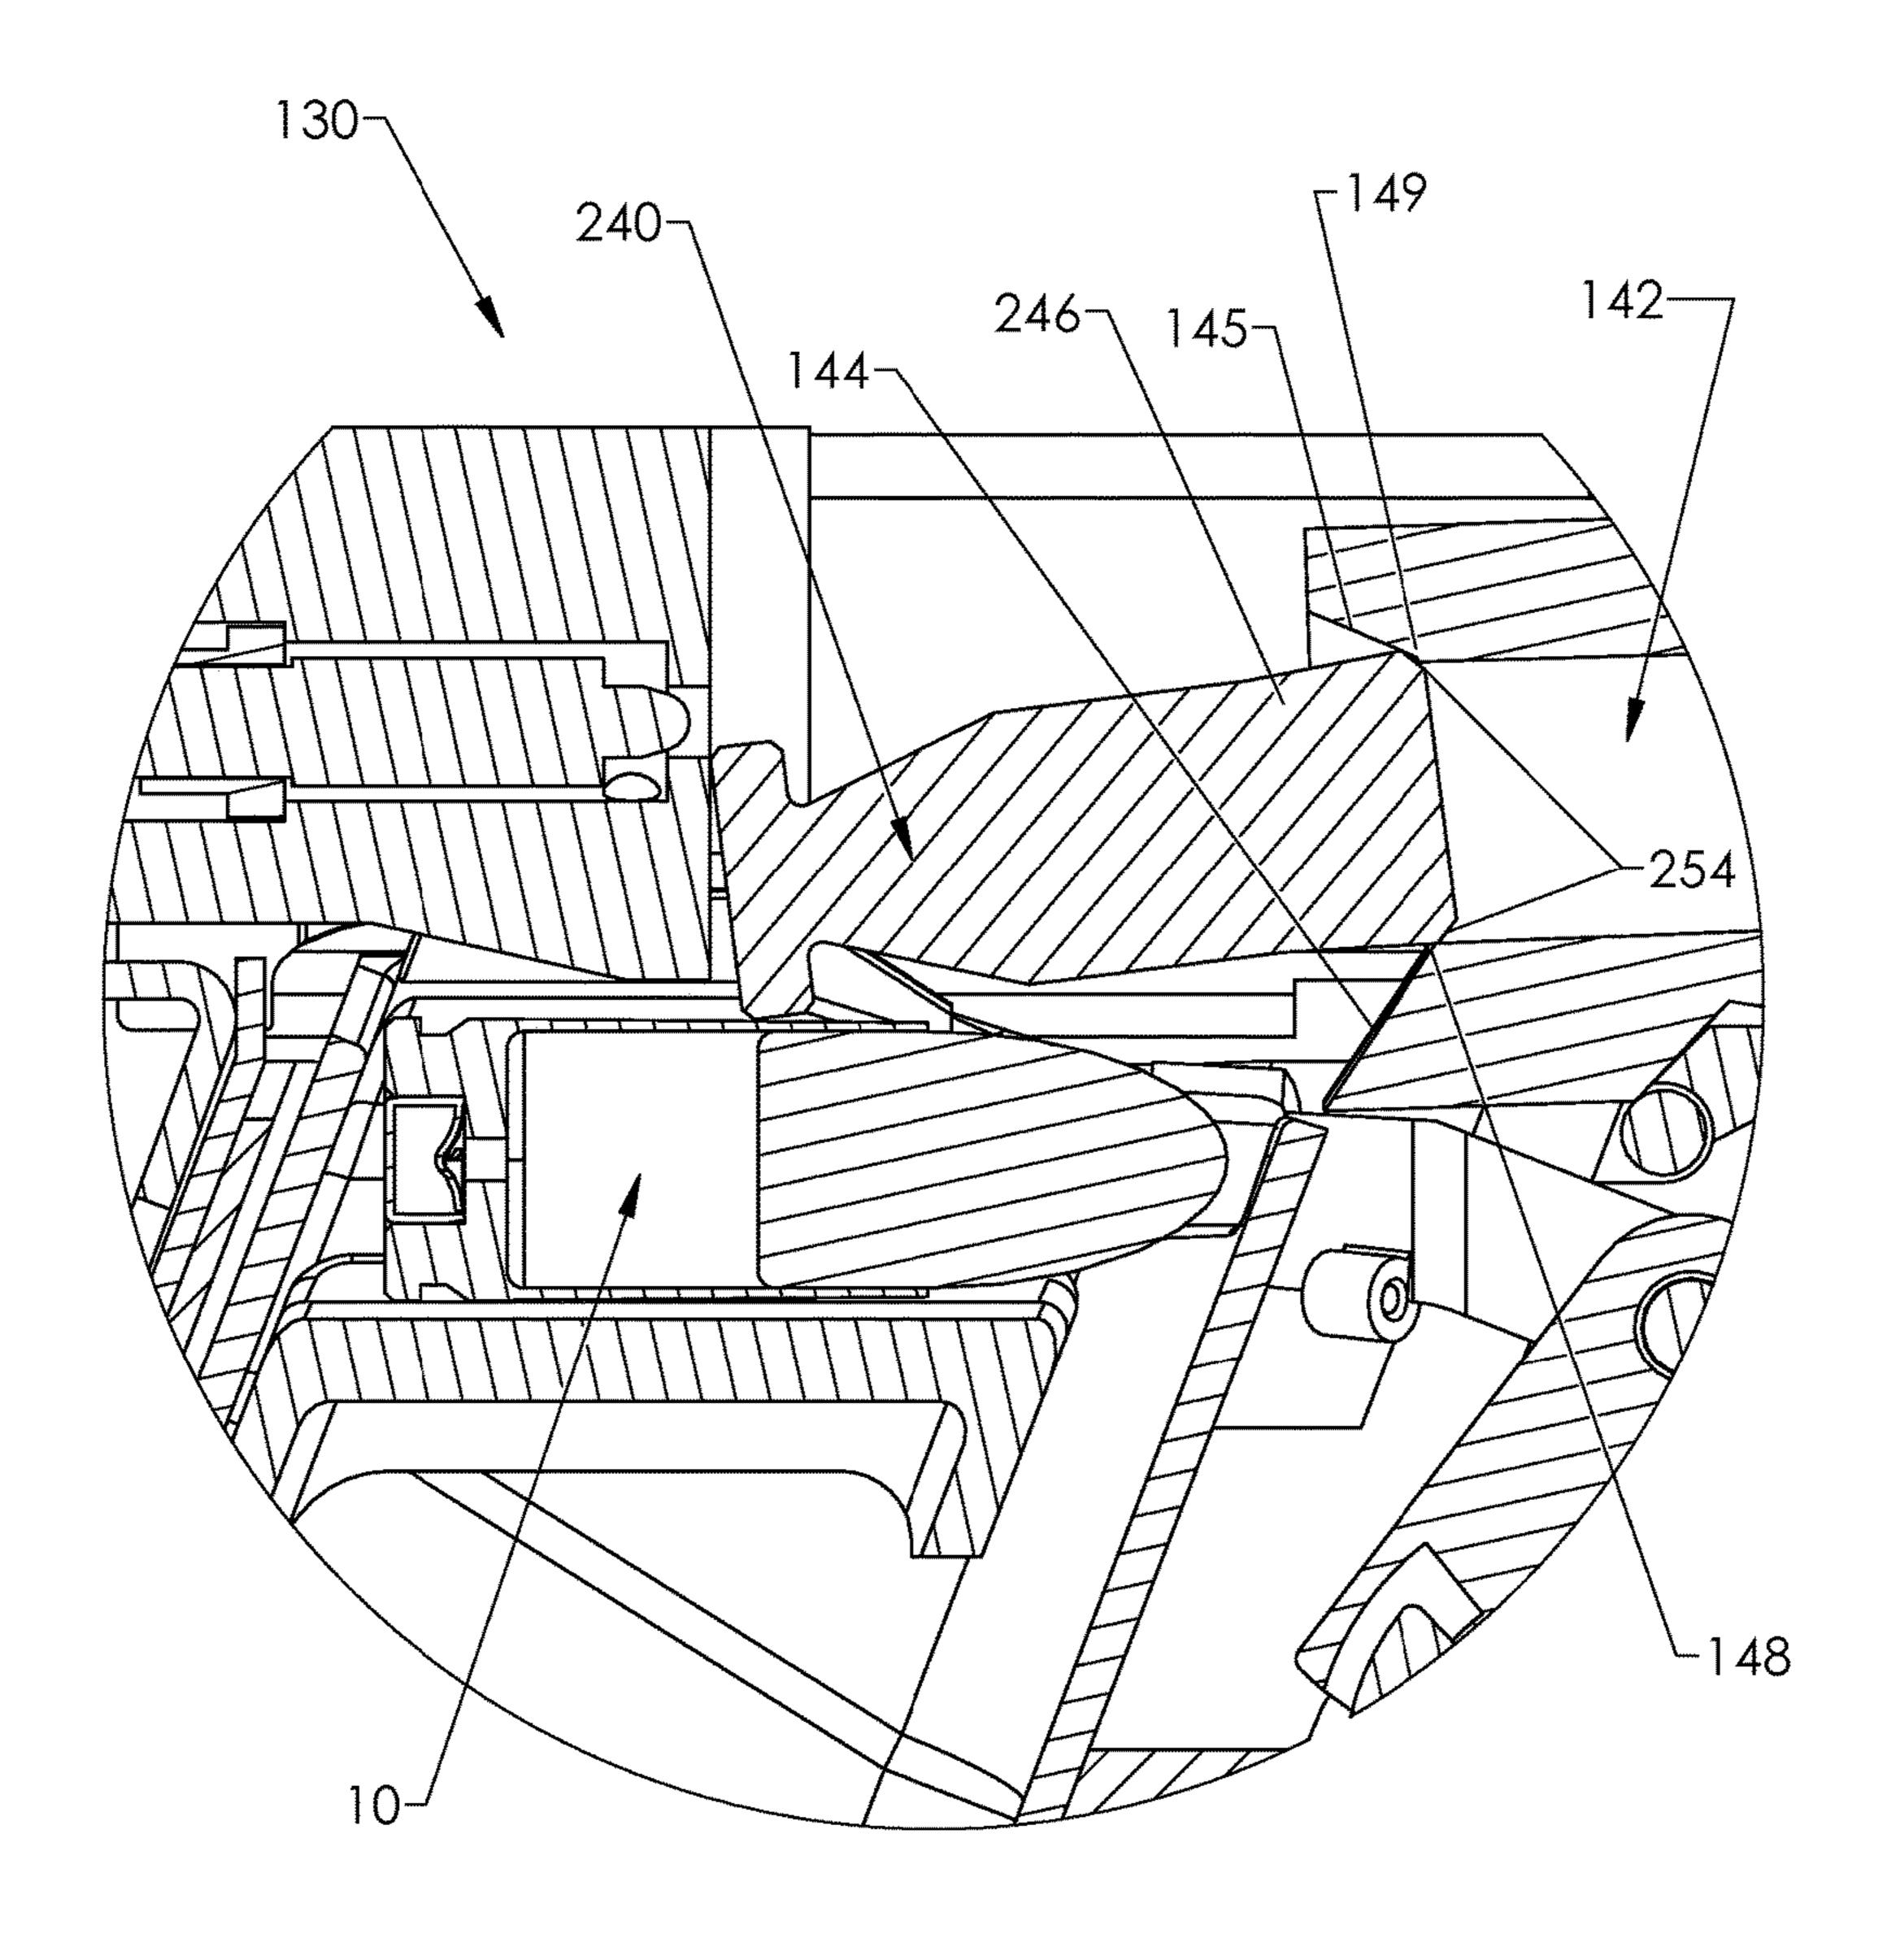
FIG.31

FIG. 31 is a magnified, detail view of the circled portion of FIG. 30.
