US010094242B2

(54) **REPAIR OR REMANUFACTURE OF LINER PANELS FOR A GAS TURBINE ENGINE**

(71) Applicant: **United Technologies Corporation**,
Hartford, CT (US)

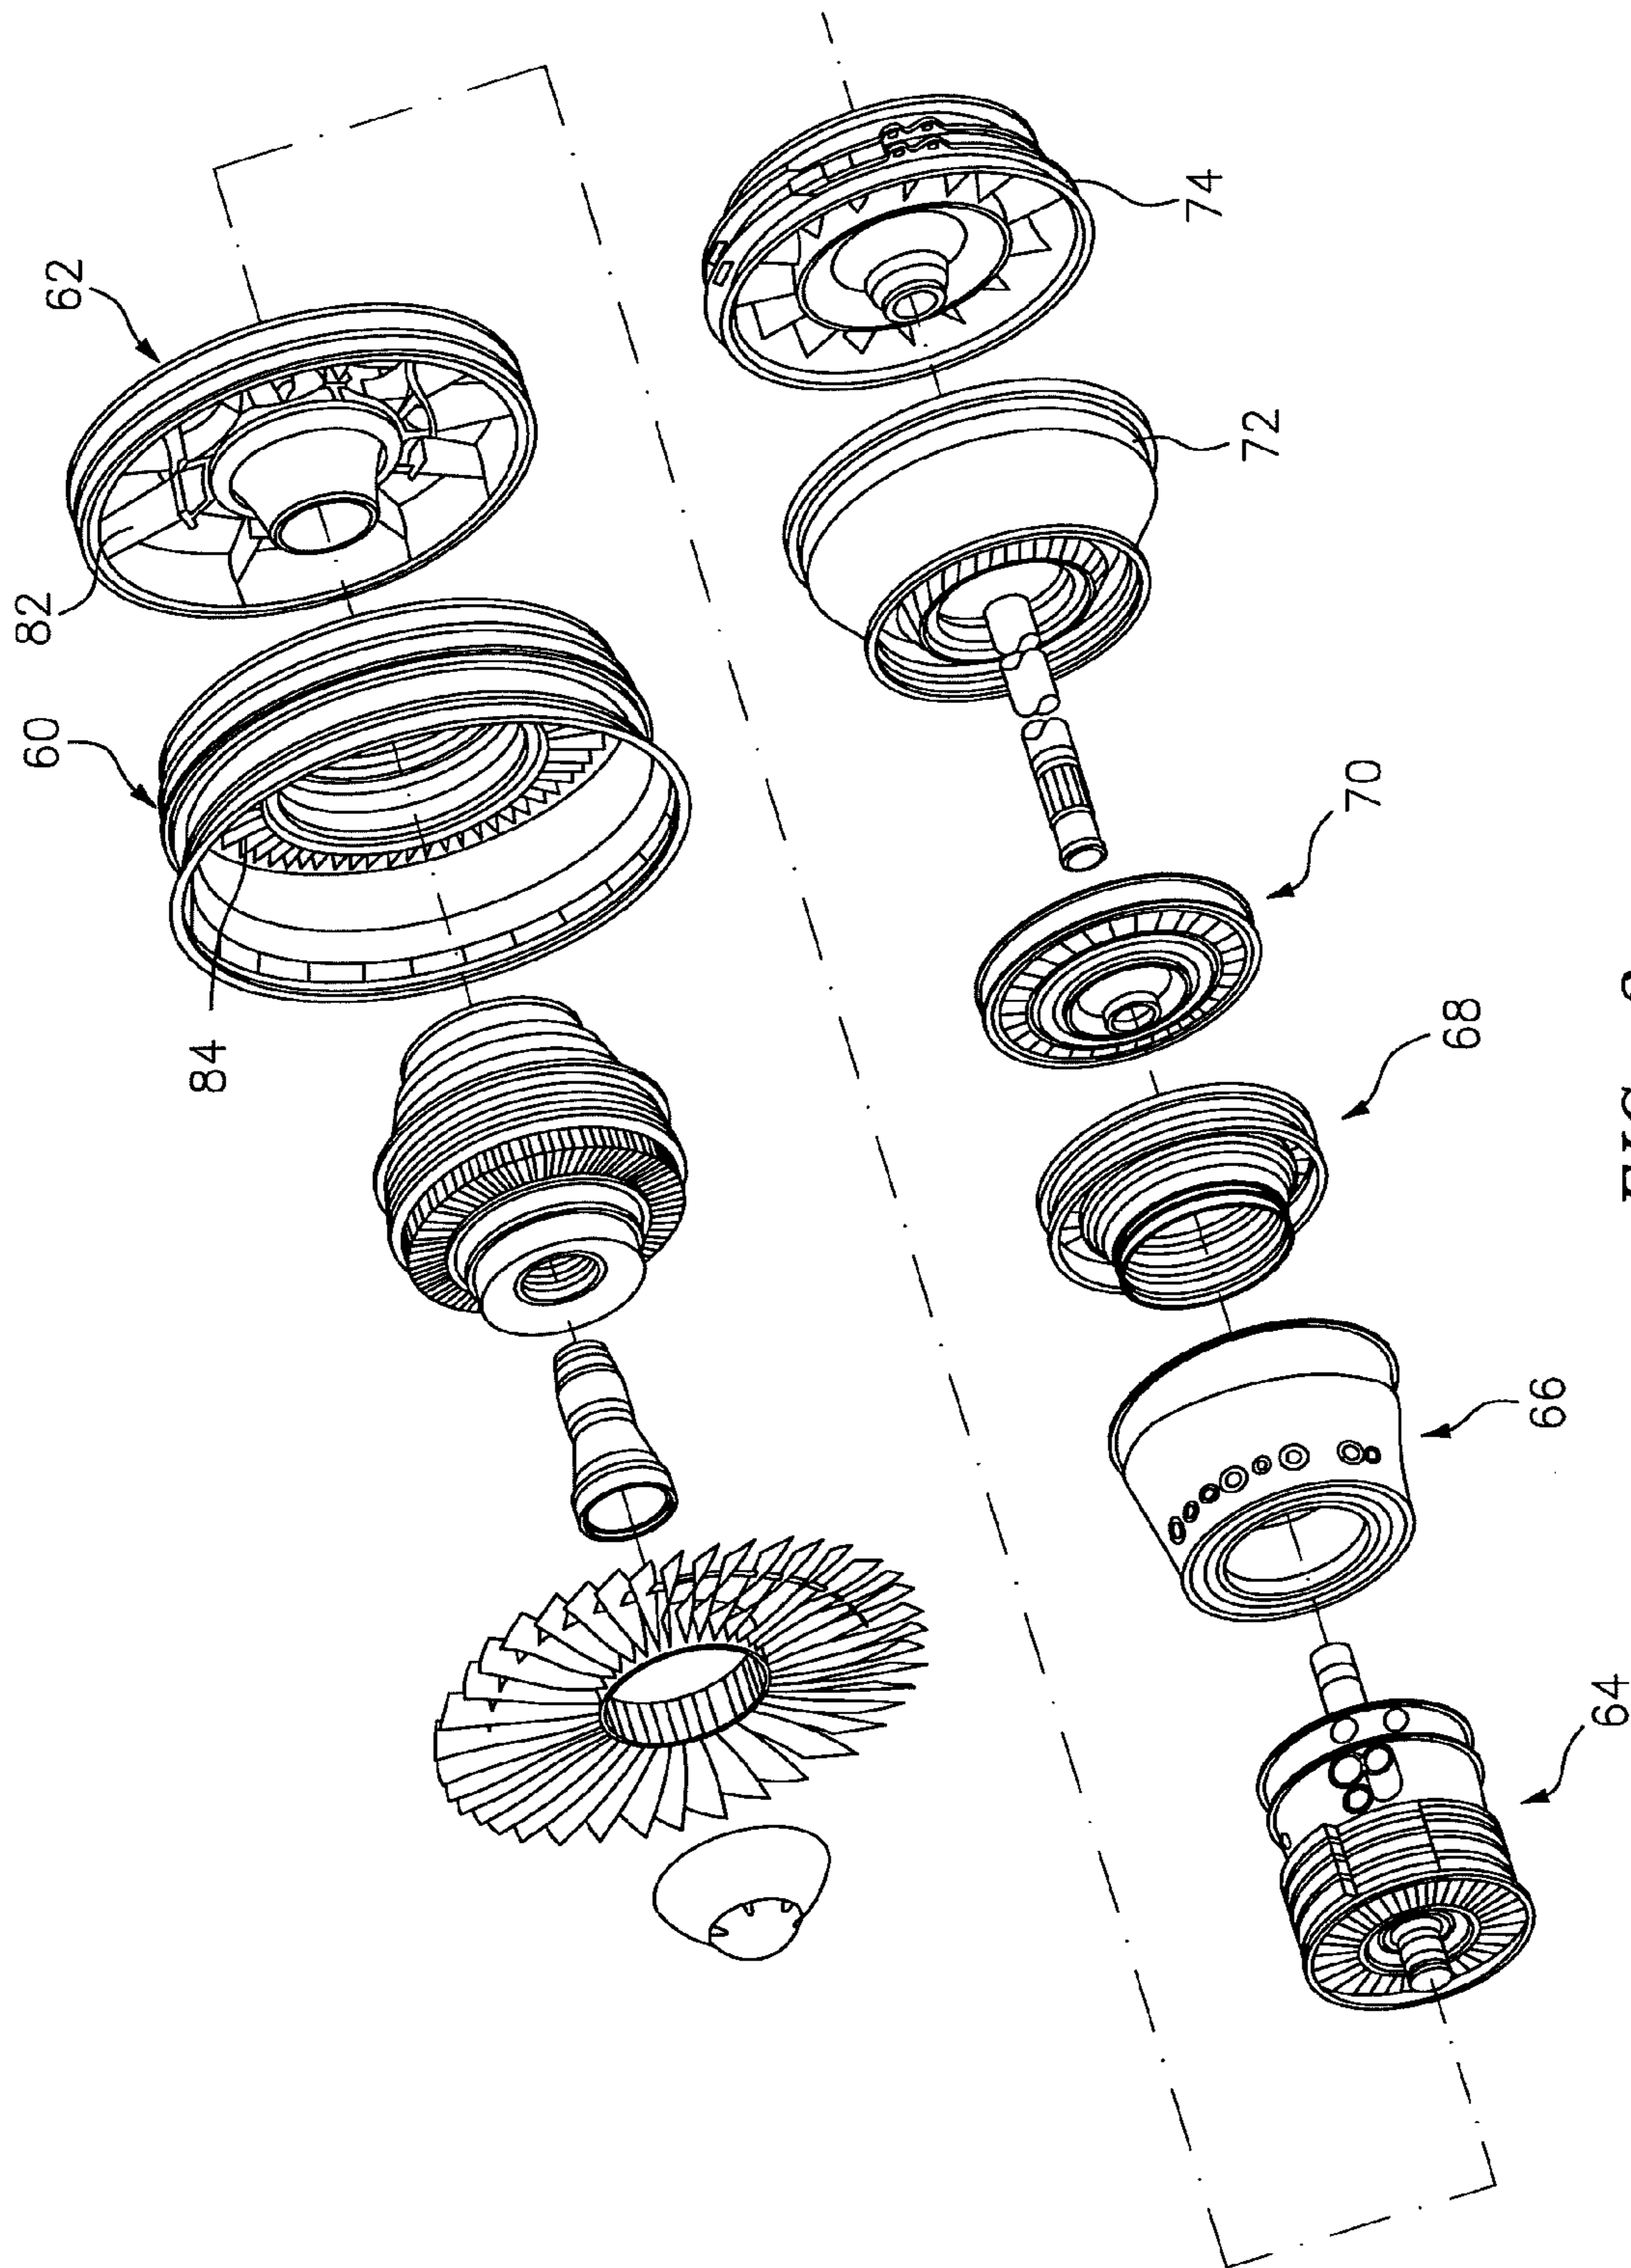
FIG. 2 is an expanded perspective partial schematic view of gas turbine engine illustrating a liner panel assembly location within the fan section;

With reference to FIG. 2, the engine case structure 36 generally includes an assembly of a multiple of cases or modules to include a fan case 60, an intermediate case 62, a HPC case 64, a diffuser case 66, a High Pressure Turbine (HPT) case 68, a mid turbine frame (MTF) case 70, a Low Pressure Turbine (LPT) case 72, and a Turbine Exhaust case (TEC) 74. It should be appreciated that various additional or

alternative cases will also benefit herefrom and the cases 60-74 may be assembled or disassembled for maintenance at any interface.

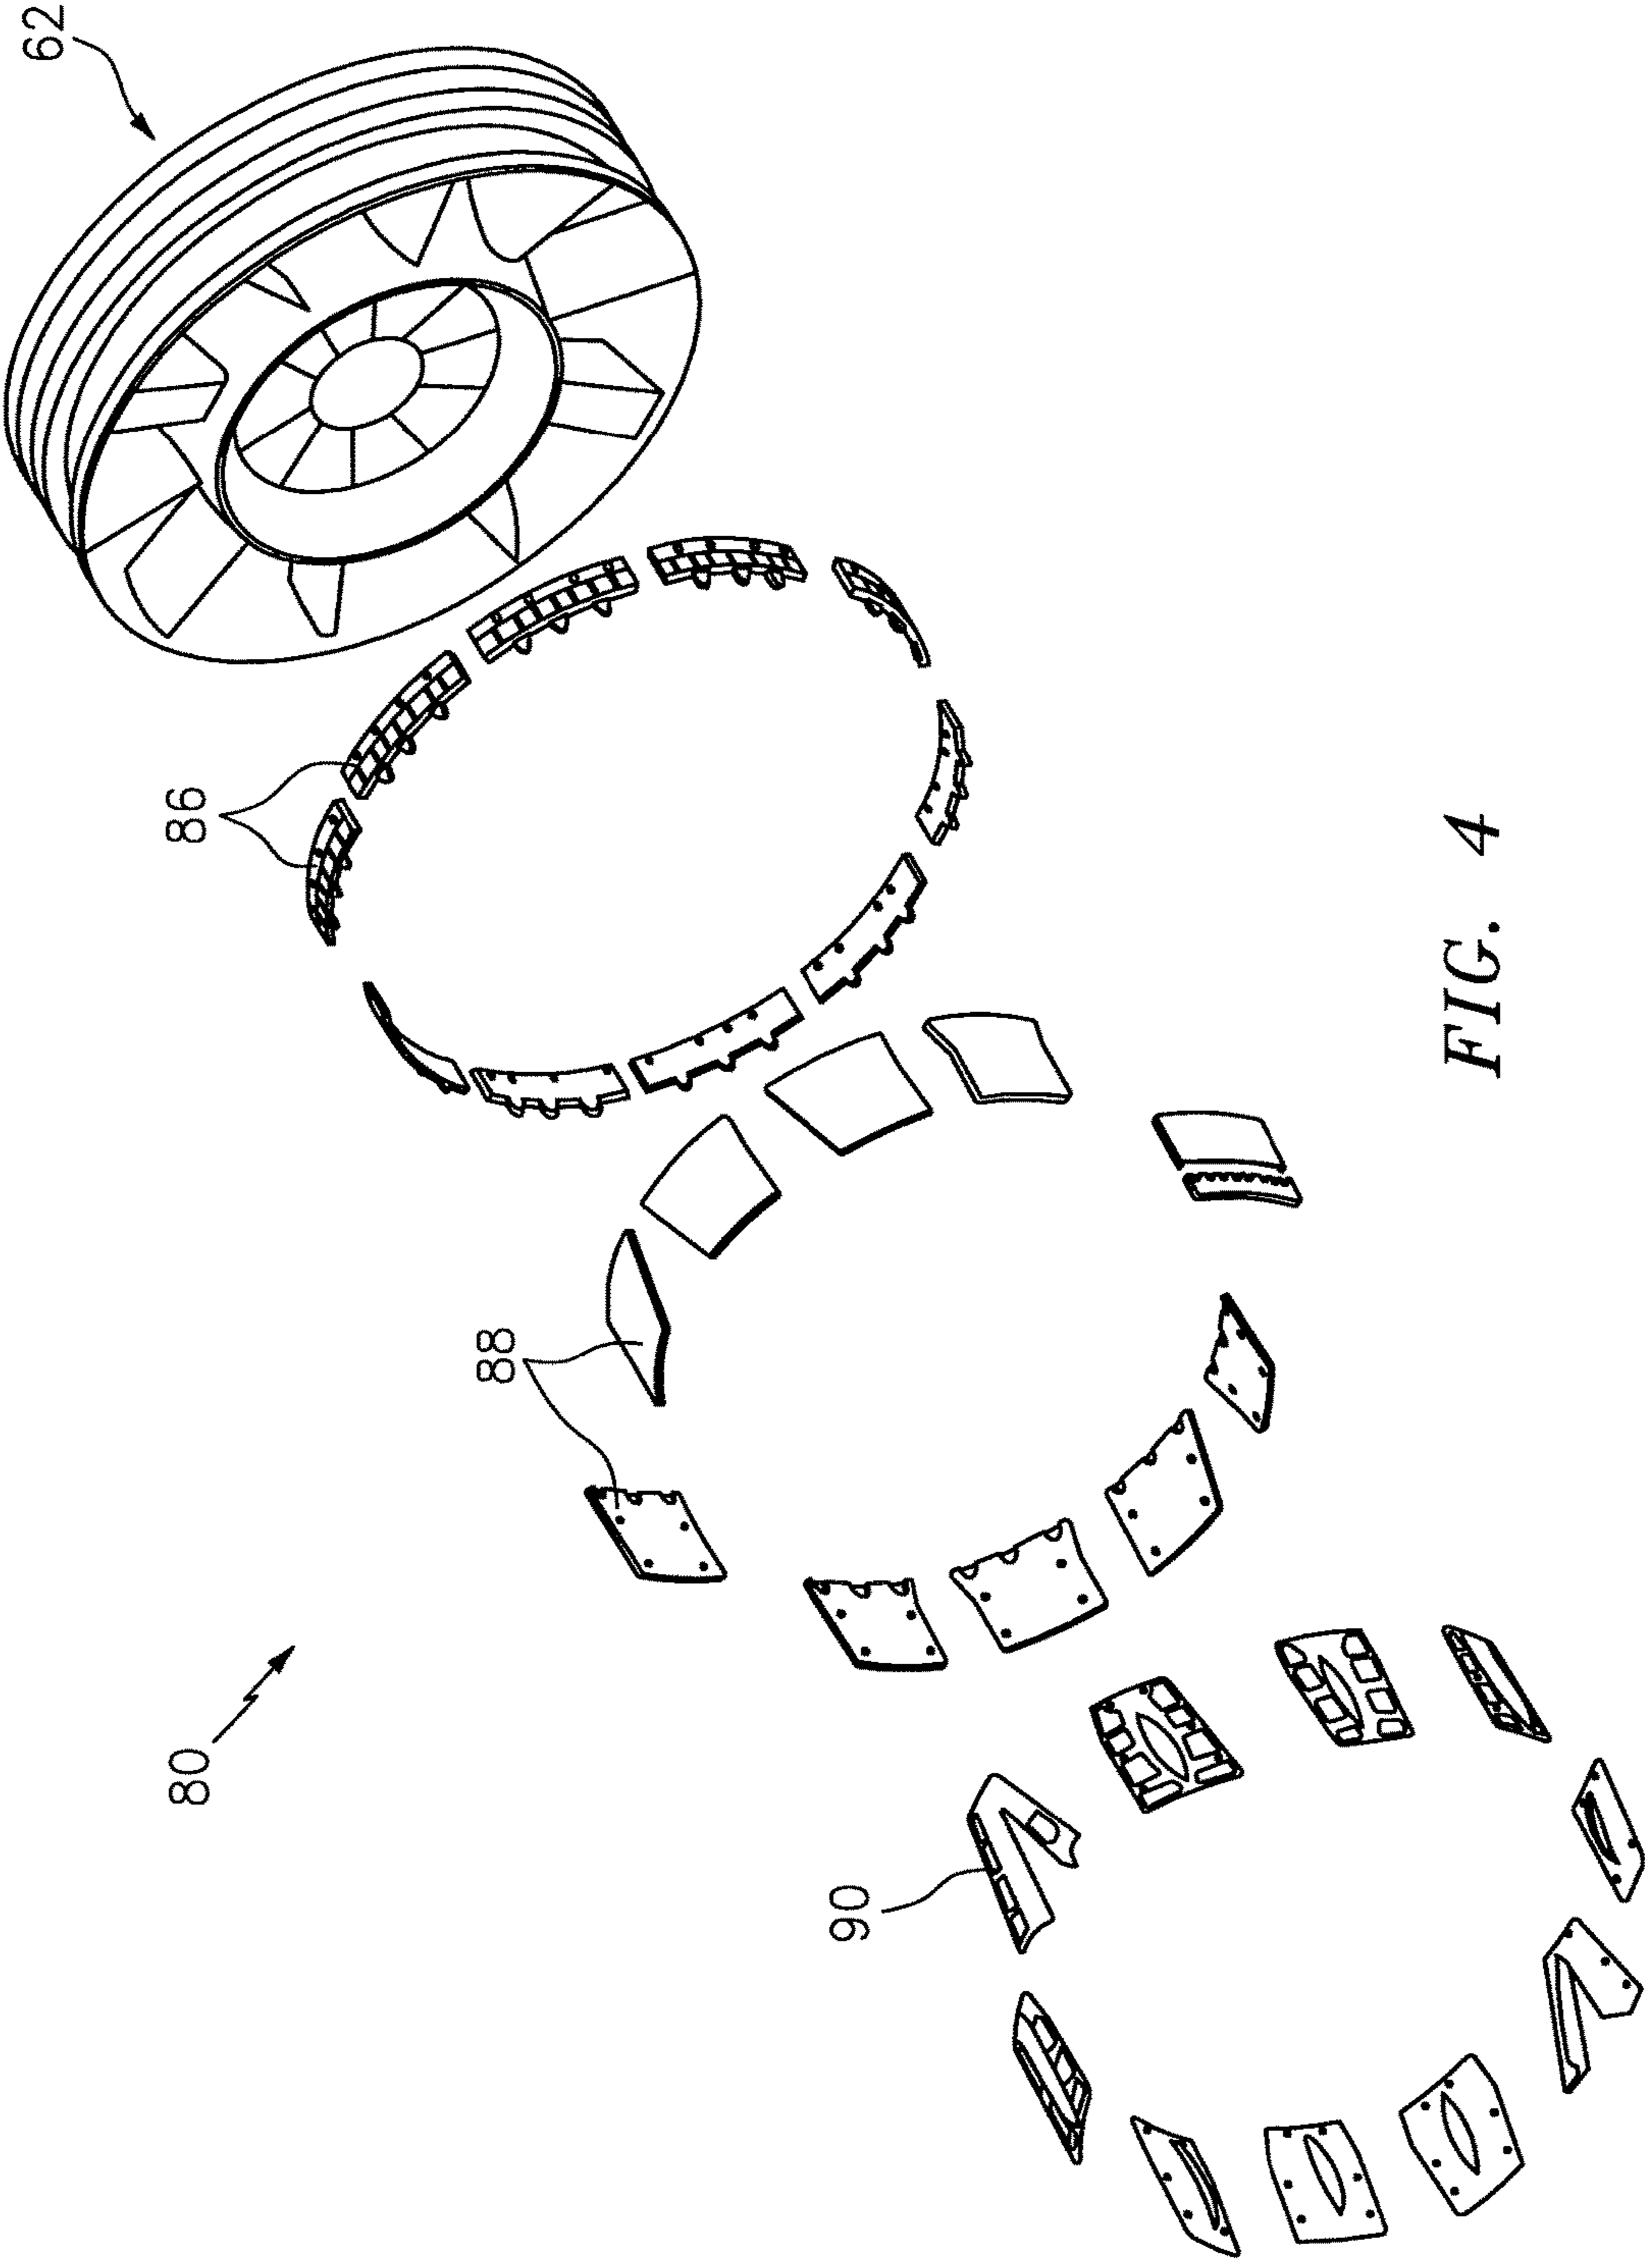
FIG. 4 is an exploded view of the liner panel assembly within the fan section;

With reference to FIG. 3, the fan case 60 and intermediate case 62 are shown by way of example; however, other engine case sections and liner panels will also benefit herefrom. The intermediate case 60 generally includes a liner panel assembly 80 (also shown in FIG. 4) removably mounted to a fan case structure 82 to provide a removable gas path surface that facilitates airflow through the fan case 60 and around a multiple of structural support vanes 82 and a multiple of exit guide vanes 84 forward thereof.

The liner panel assembly 80 shown by way of example includes a multiple of forward fan exit case liner panels 86 (also often known as Ice Panels and A/O Panels), a multiple of aft fan exit case liner panels 88 and a multiple of seal panels 90. Although the forward fan exit case liner panels 86 are utilized hereafter as the example component for a method of repair, remanufacture or original manufacture, it should be appreciated that various panels will also benefit herefrom.

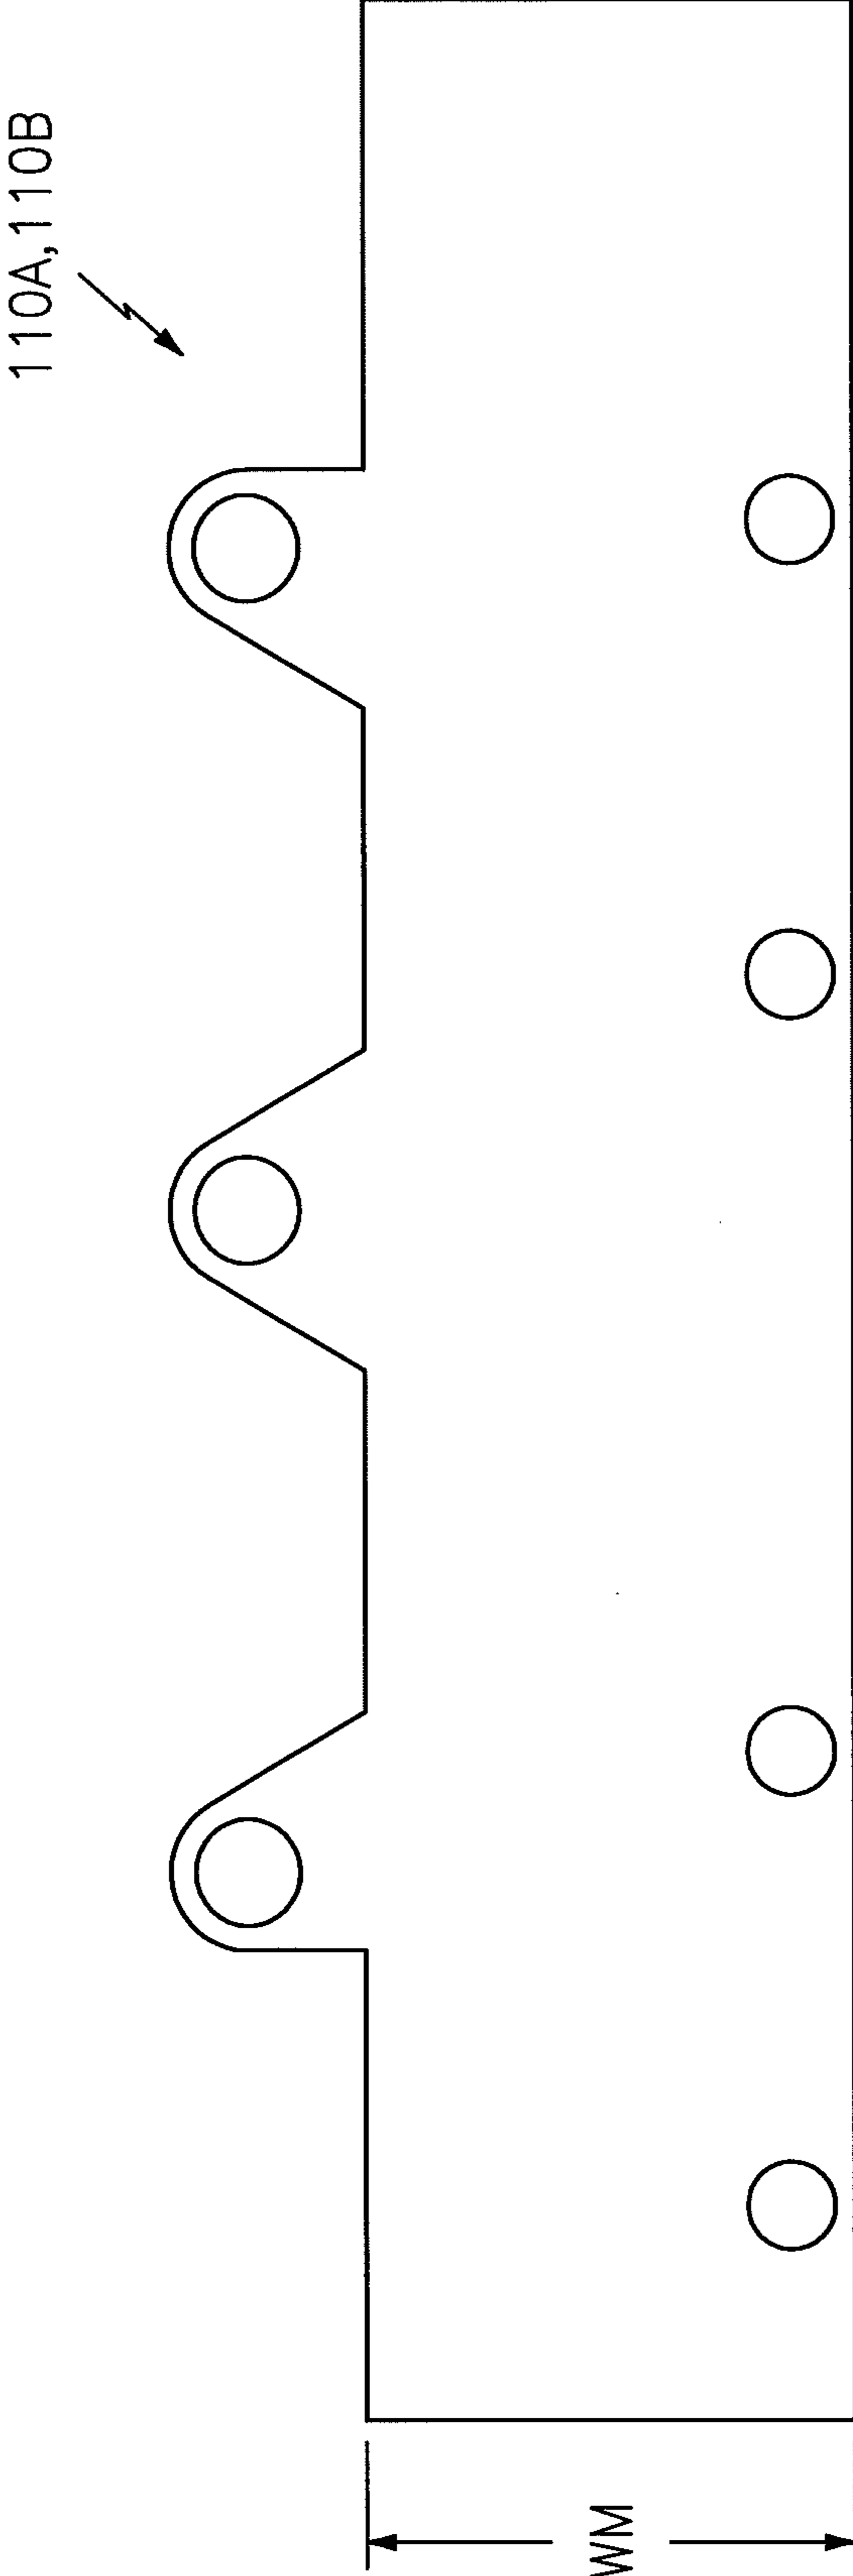
FIG. 9 is a plan view of one layer of the material charge for the liner panel assembly; and

disclosed non-limiting embodiment is a carbon fiber based sheet molding compound material such as Lytex 4149 supplied by Quantum Composites Inc. of Bay City, Mich. USA. Lytex 4149 is a high-performance, 3 K tow carbon fiber (PAN) reinforced epoxy sheet molding compound designed for military and aerospace structural applications with excellent mechanical properties, retention of properties at elevated temperatures, good chemical resistance, and low density.

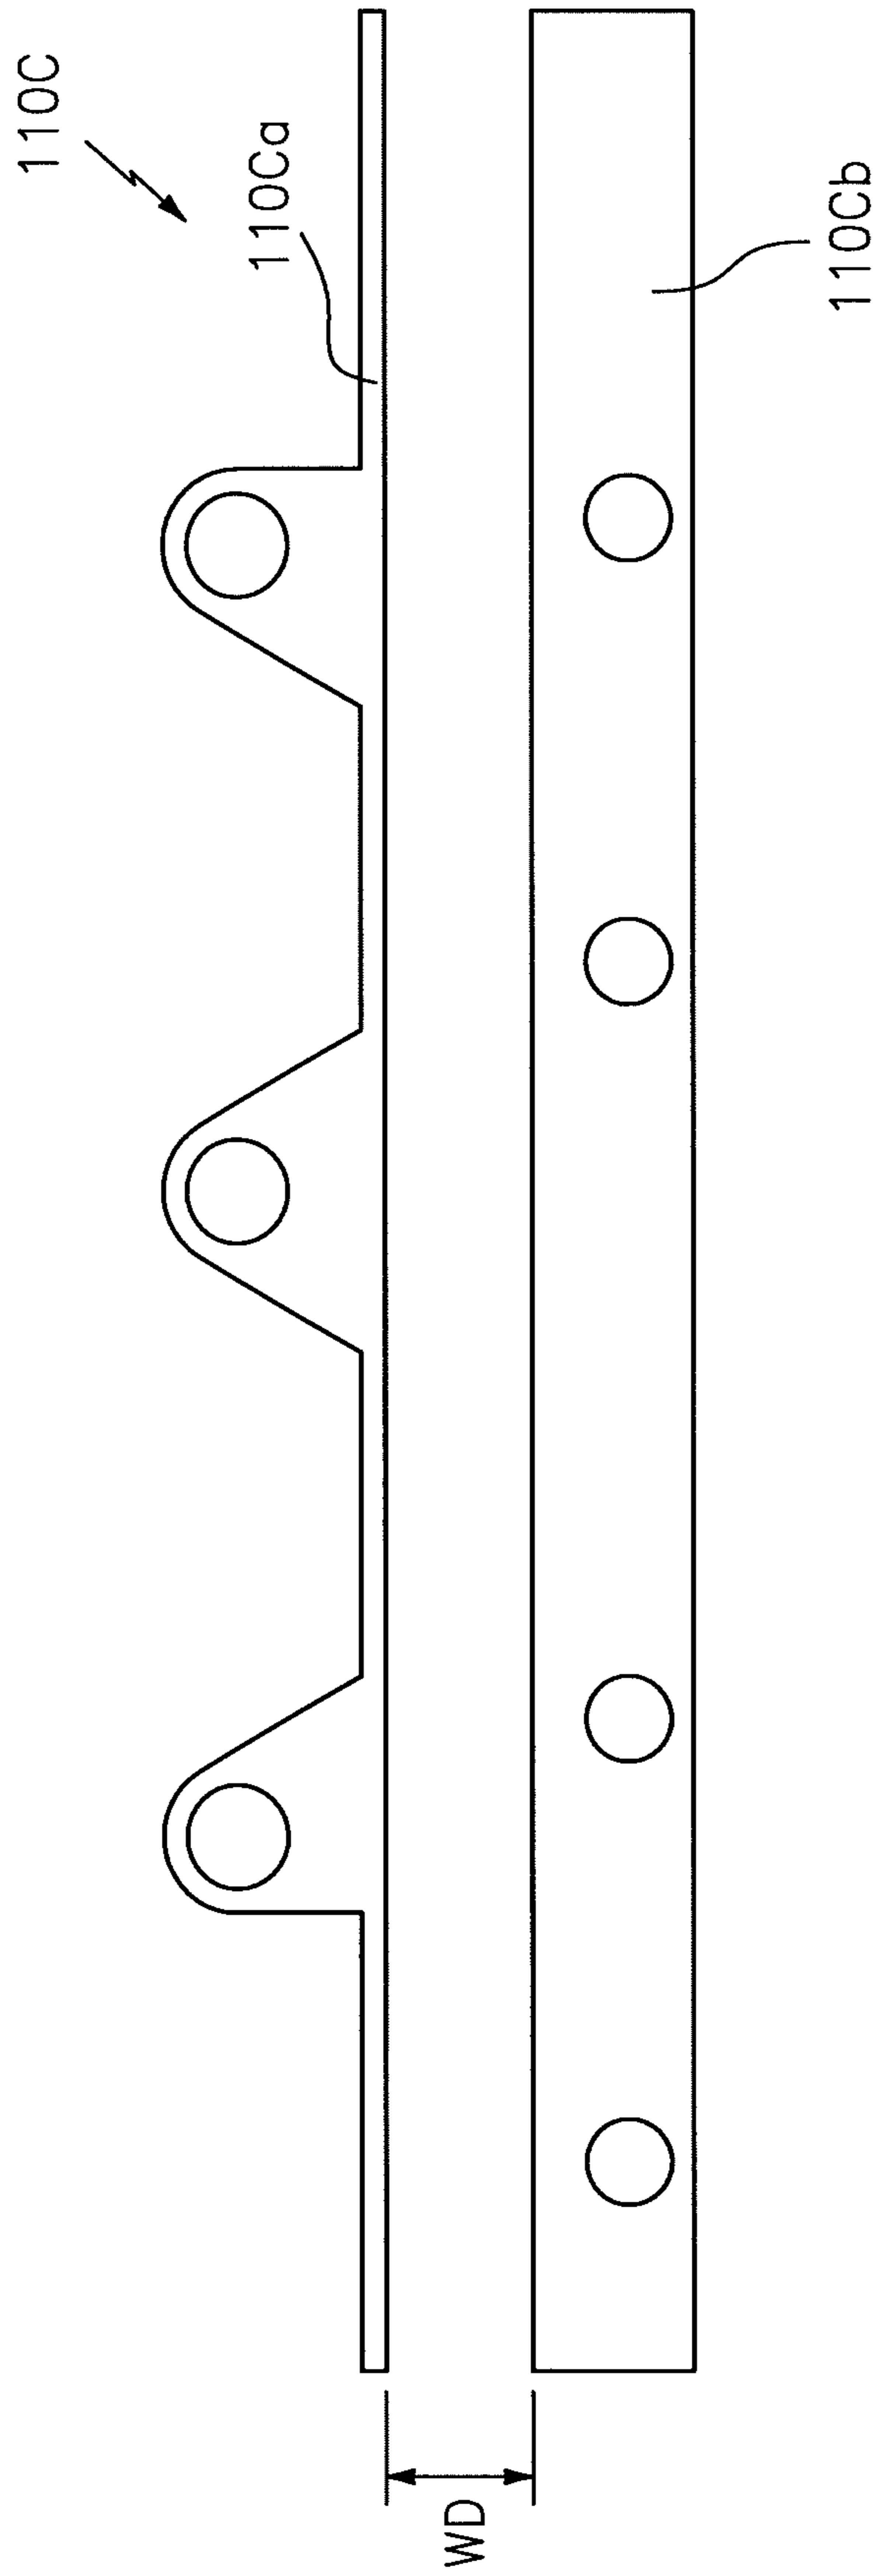
FIG. 10 is a plan view of one layer with a discontinuity of the material charge for the liner panel assembly.

The material charge **102** is then located in the mold **100B** (step **212**). Layer **110A** is positioned along the gas path side and is essentially identical to layer **110B**. Layer **110C** is discontinuous. That is, layer **110C** is actually two portions **110Ca**, **110Cb** with the discontinuity **112** generally along a length thereof. A width WM of the main body of the Layers **110A**, **110B**, and **110C** (FIG. **9**) exclusive of the tabs **108**. A width WD of the discontinuity **112** of the layer **110C** (FIG. **10**). In this disclosed non-limiting dimensional embodiment, a ratio of WD/WM is defined between 0.575-0.66. The disclosed ratios facilitate flow of the sheet molding compound into the circumferential ribs, and raised boss structure of the fabrication mold **100A** and **100B**.

In a further embodiment of any of the foregoing embodiments of the present disclosure, a main body of one of the multiple of layers defines a width WM and the discontinuity of one of the multiple of layers defines a width WD. A ratio WD/WM is defined between 0.575-0.66.

- wherein the material charge includes a multiple of layers, and at least one of the multiple of layers includes a discontinuity; and
 - wherein a main body of one of the multiple of layers defines a width (WM) and the discontinuity of one of the multiple of layers defines a width (WD), and wherein a ratio WD/WM is defined between 0.575-0.66.
