US010094242B2

(54) **REPAIR OR REMANUFACTURE OF LINER PANELS FOR A GAS TURBINE ENGINE**

(71) Applicant: **United Technologies Corporation**,
Hartford, CT (US)

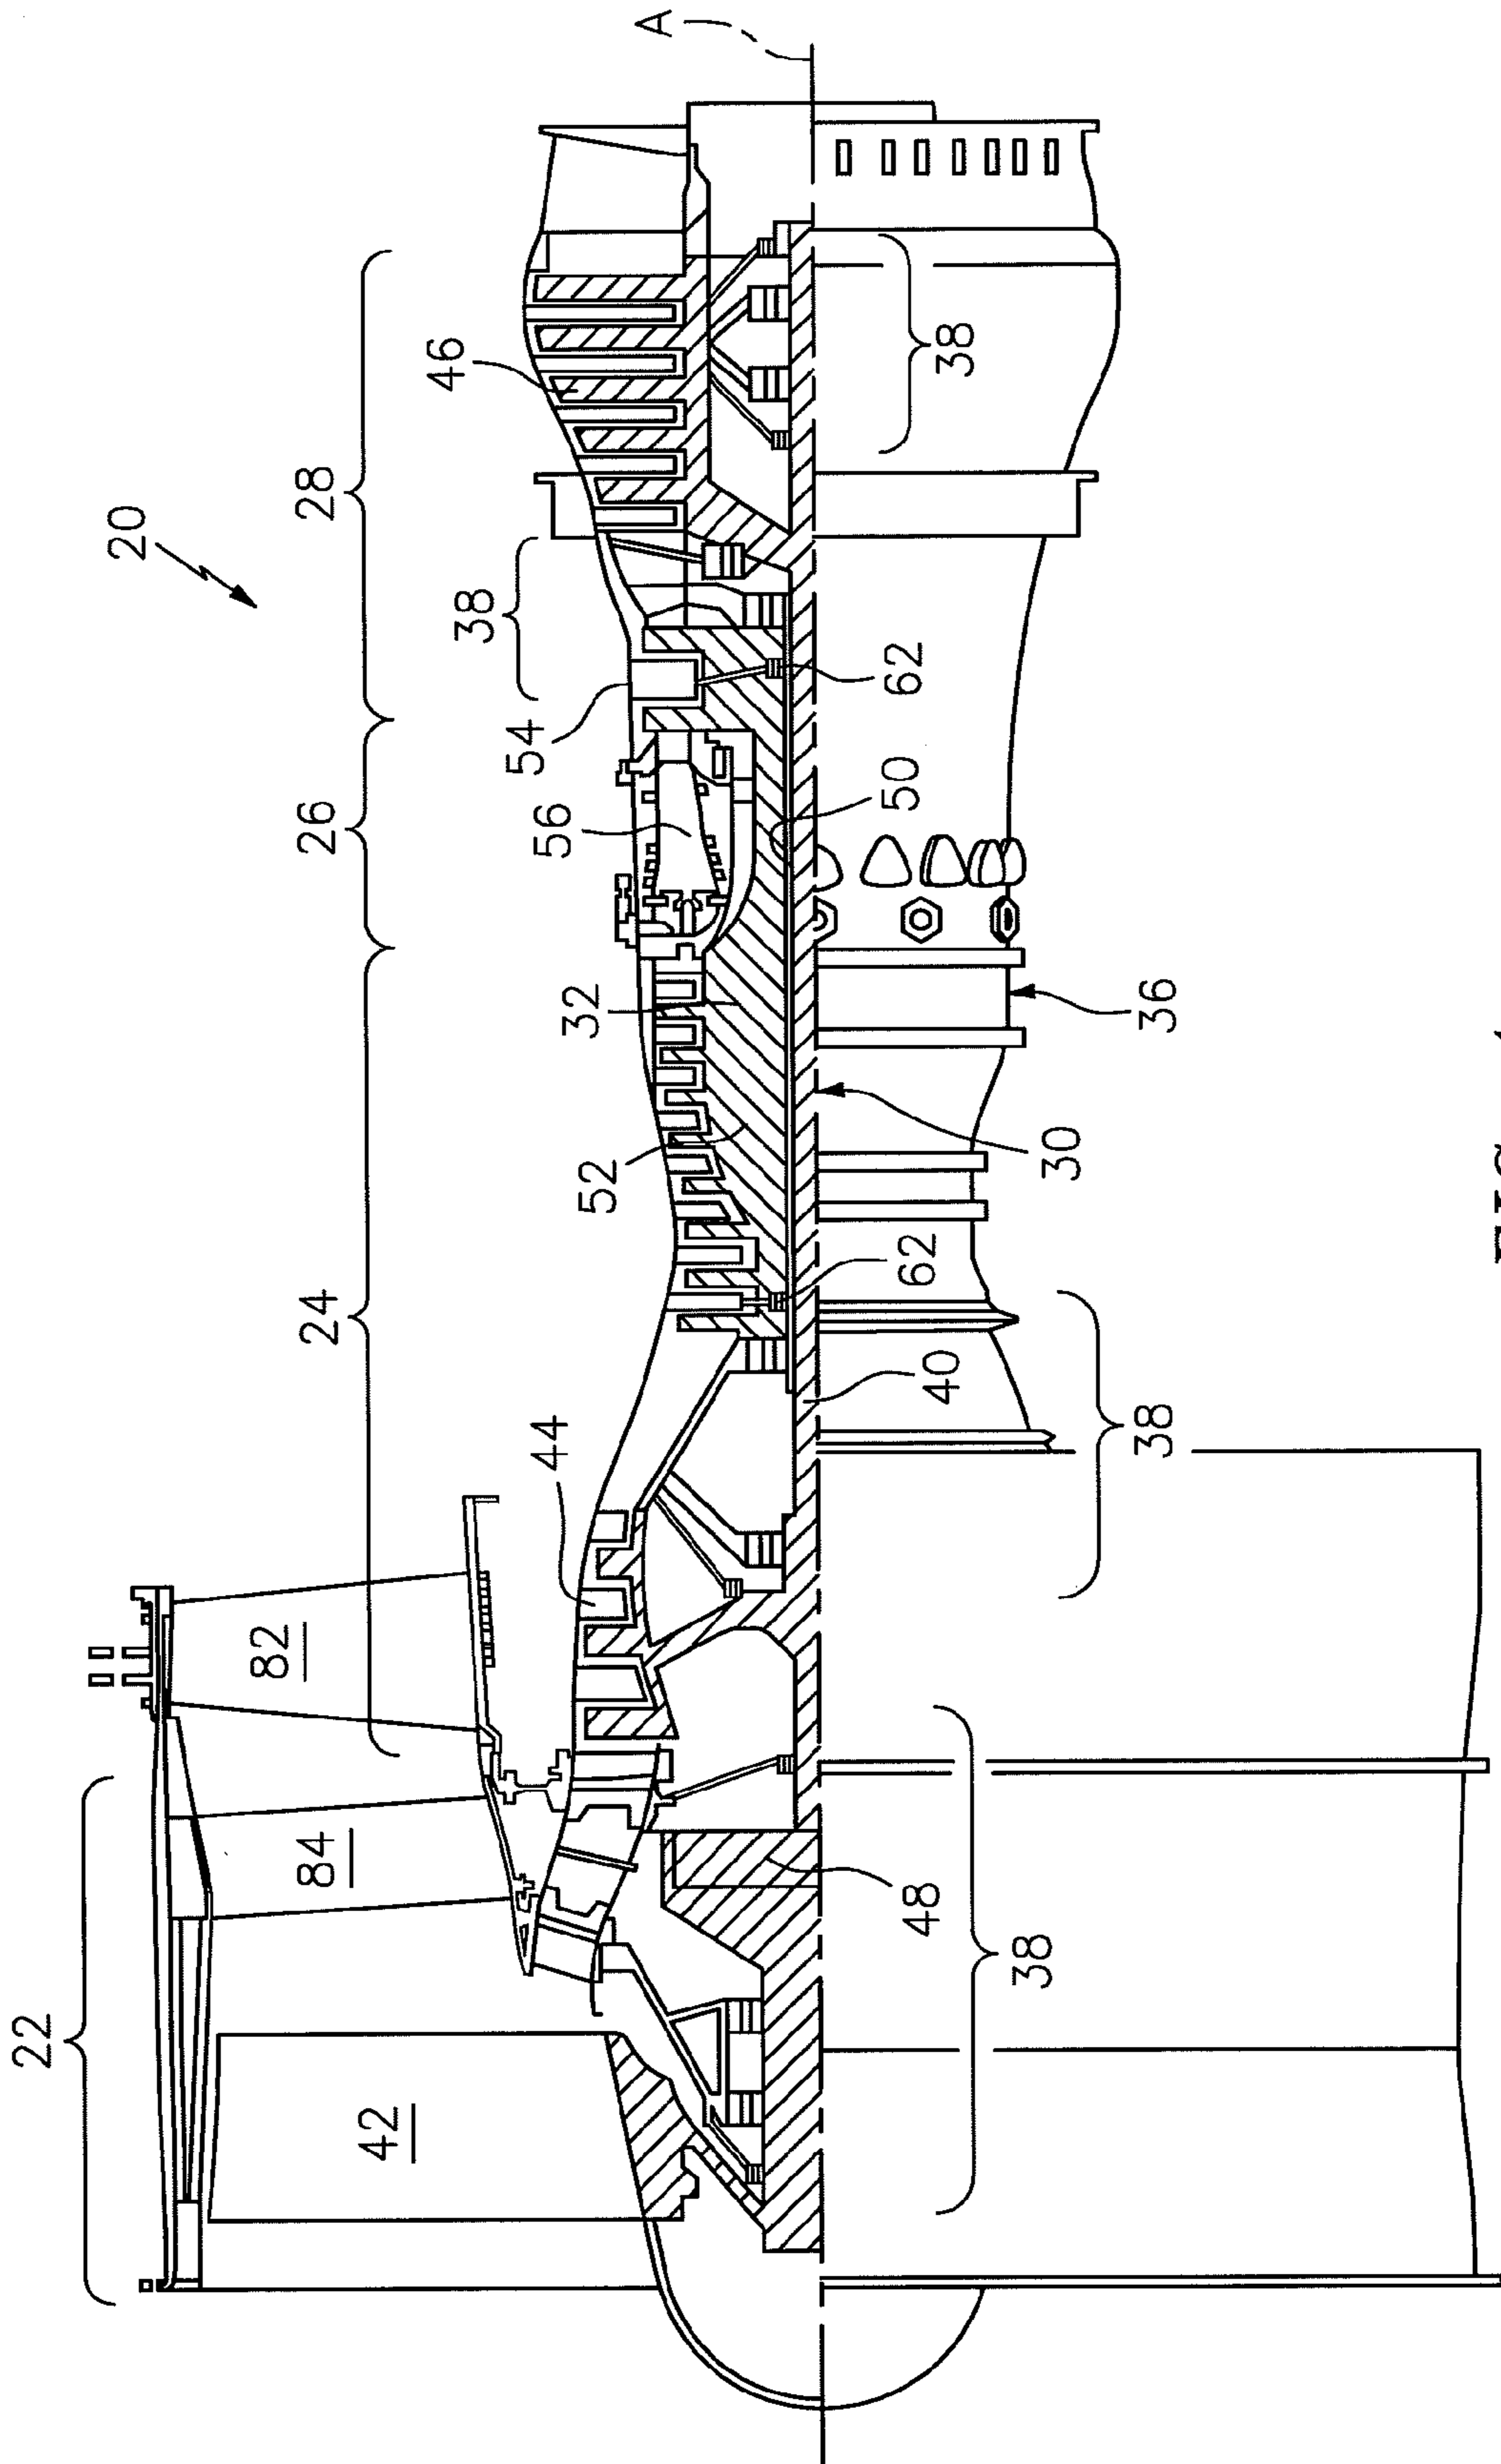
FIG. 1 is a schematic cross-section of an example gas turbine engine;

FIG. 1 schematically illustrates a gas turbine engine 20. The gas turbine engine 20 is disclosed herein as a two-spool turbo fan that generally incorporates a fan section 22, a compressor section 24, a combustor section 26 and a turbine section 28. Alternative engines (not shown) might include an augmentor section among other systems or features. Although depicted as a high-bypass turbofan in the disclosed non-limiting embodiment, it should be appreciated that the concepts described herein are not limited to use only with turbofan architectures as the teachings may be applied to other types of turbine engines such as turbojets, turboshafts, industrial gas turbines, and three-spool (plus fan) turbofans with an intermediate spool.

The engine 20 generally includes a low spool 30 and a high spool 32 mounted for rotation about an engine central longitudinal axis A relative to an engine case structure 36 via several bearing structures 38. The low spool 30 generally includes an inner shaft 40 that interconnects a fan 42, a low pressure compressor (“LPC”) 44 and a low pressure turbine (“LPT”) 46. The inner shaft 40 may drive the fan 42 directly or through a geared architecture 48 to drive the fan 42 at a lower speed than the low spool 30. An exemplary reduction transmission is an epicyclic transmission, namely a planetary or star gear system.

The high spool 32 includes an outer shaft 50 that interconnects a high pressure compressor (“HPC”) 52 and a high pressure turbine (“HPT”) 54. A combustor 56 is arranged between the high pressure compressor 52 and the high pressure turbine 54. The inner shaft 40 and the outer shaft 50 are concentric and rotate about the engine central longitudinal axis A which is collinear with their longitudinal axes.

Core airflow is compressed by the LPC 44 then the HPC 52, mixed with the fuel and burned in the combustor 56, then expanded over the HPT 54 and the LPT 46. The LPT 46 and the HPT 54 rotationally drive the respective low spool 30 and high spool 32 in response to the expansion.

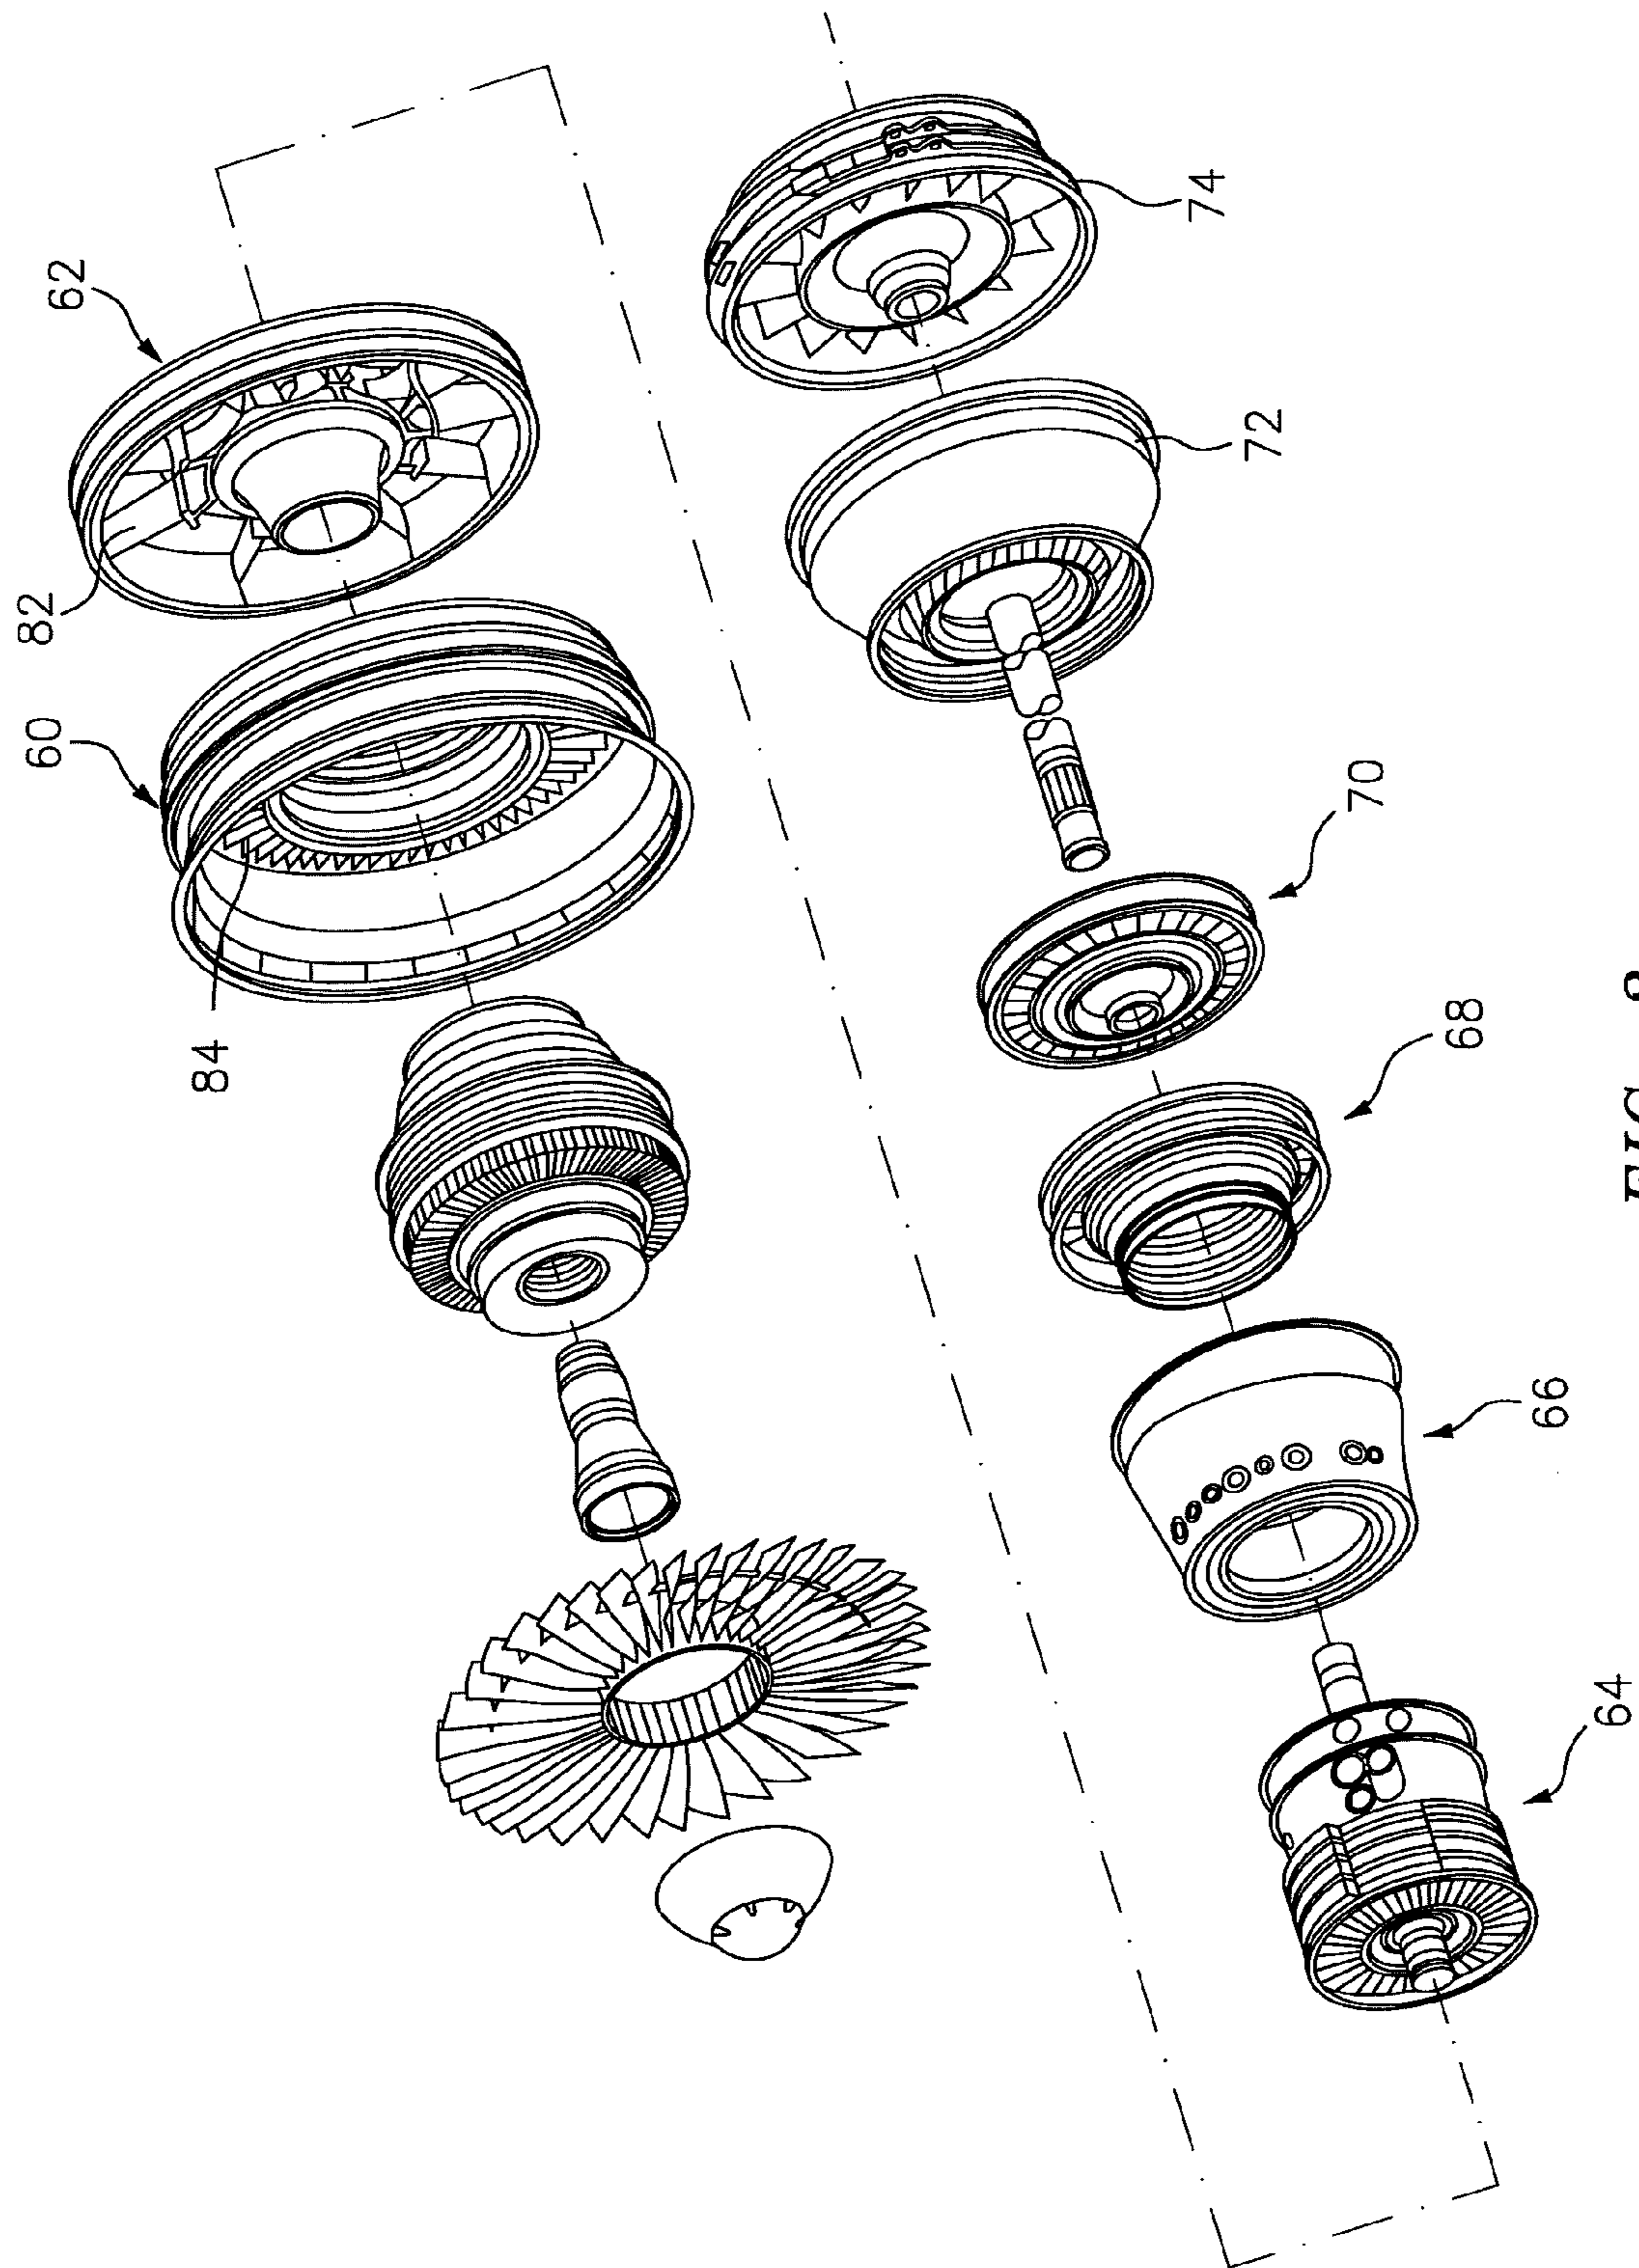
FIG. 2 is an expanded perspective partial schematic view of gas turbine engine illustrating a liner panel assembly location within the fan section;

With reference to FIG. 2, the engine case structure 36 generally includes an assembly of a multiple of cases or modules to include a fan case 60, an intermediate case 62, a HPC case 64, a diffuser case 66, a High Pressure Turbine (HPT) case 68, a mid turbine frame (MTF) case 70, a Low Pressure Turbine (LPT) case 72, and a Turbine Exhaust case (TEC) 74. It should be appreciated that various additional or

alternative cases will also benefit herefrom and the cases 60-74 may be assembled or disassembled for maintenance at any interface.

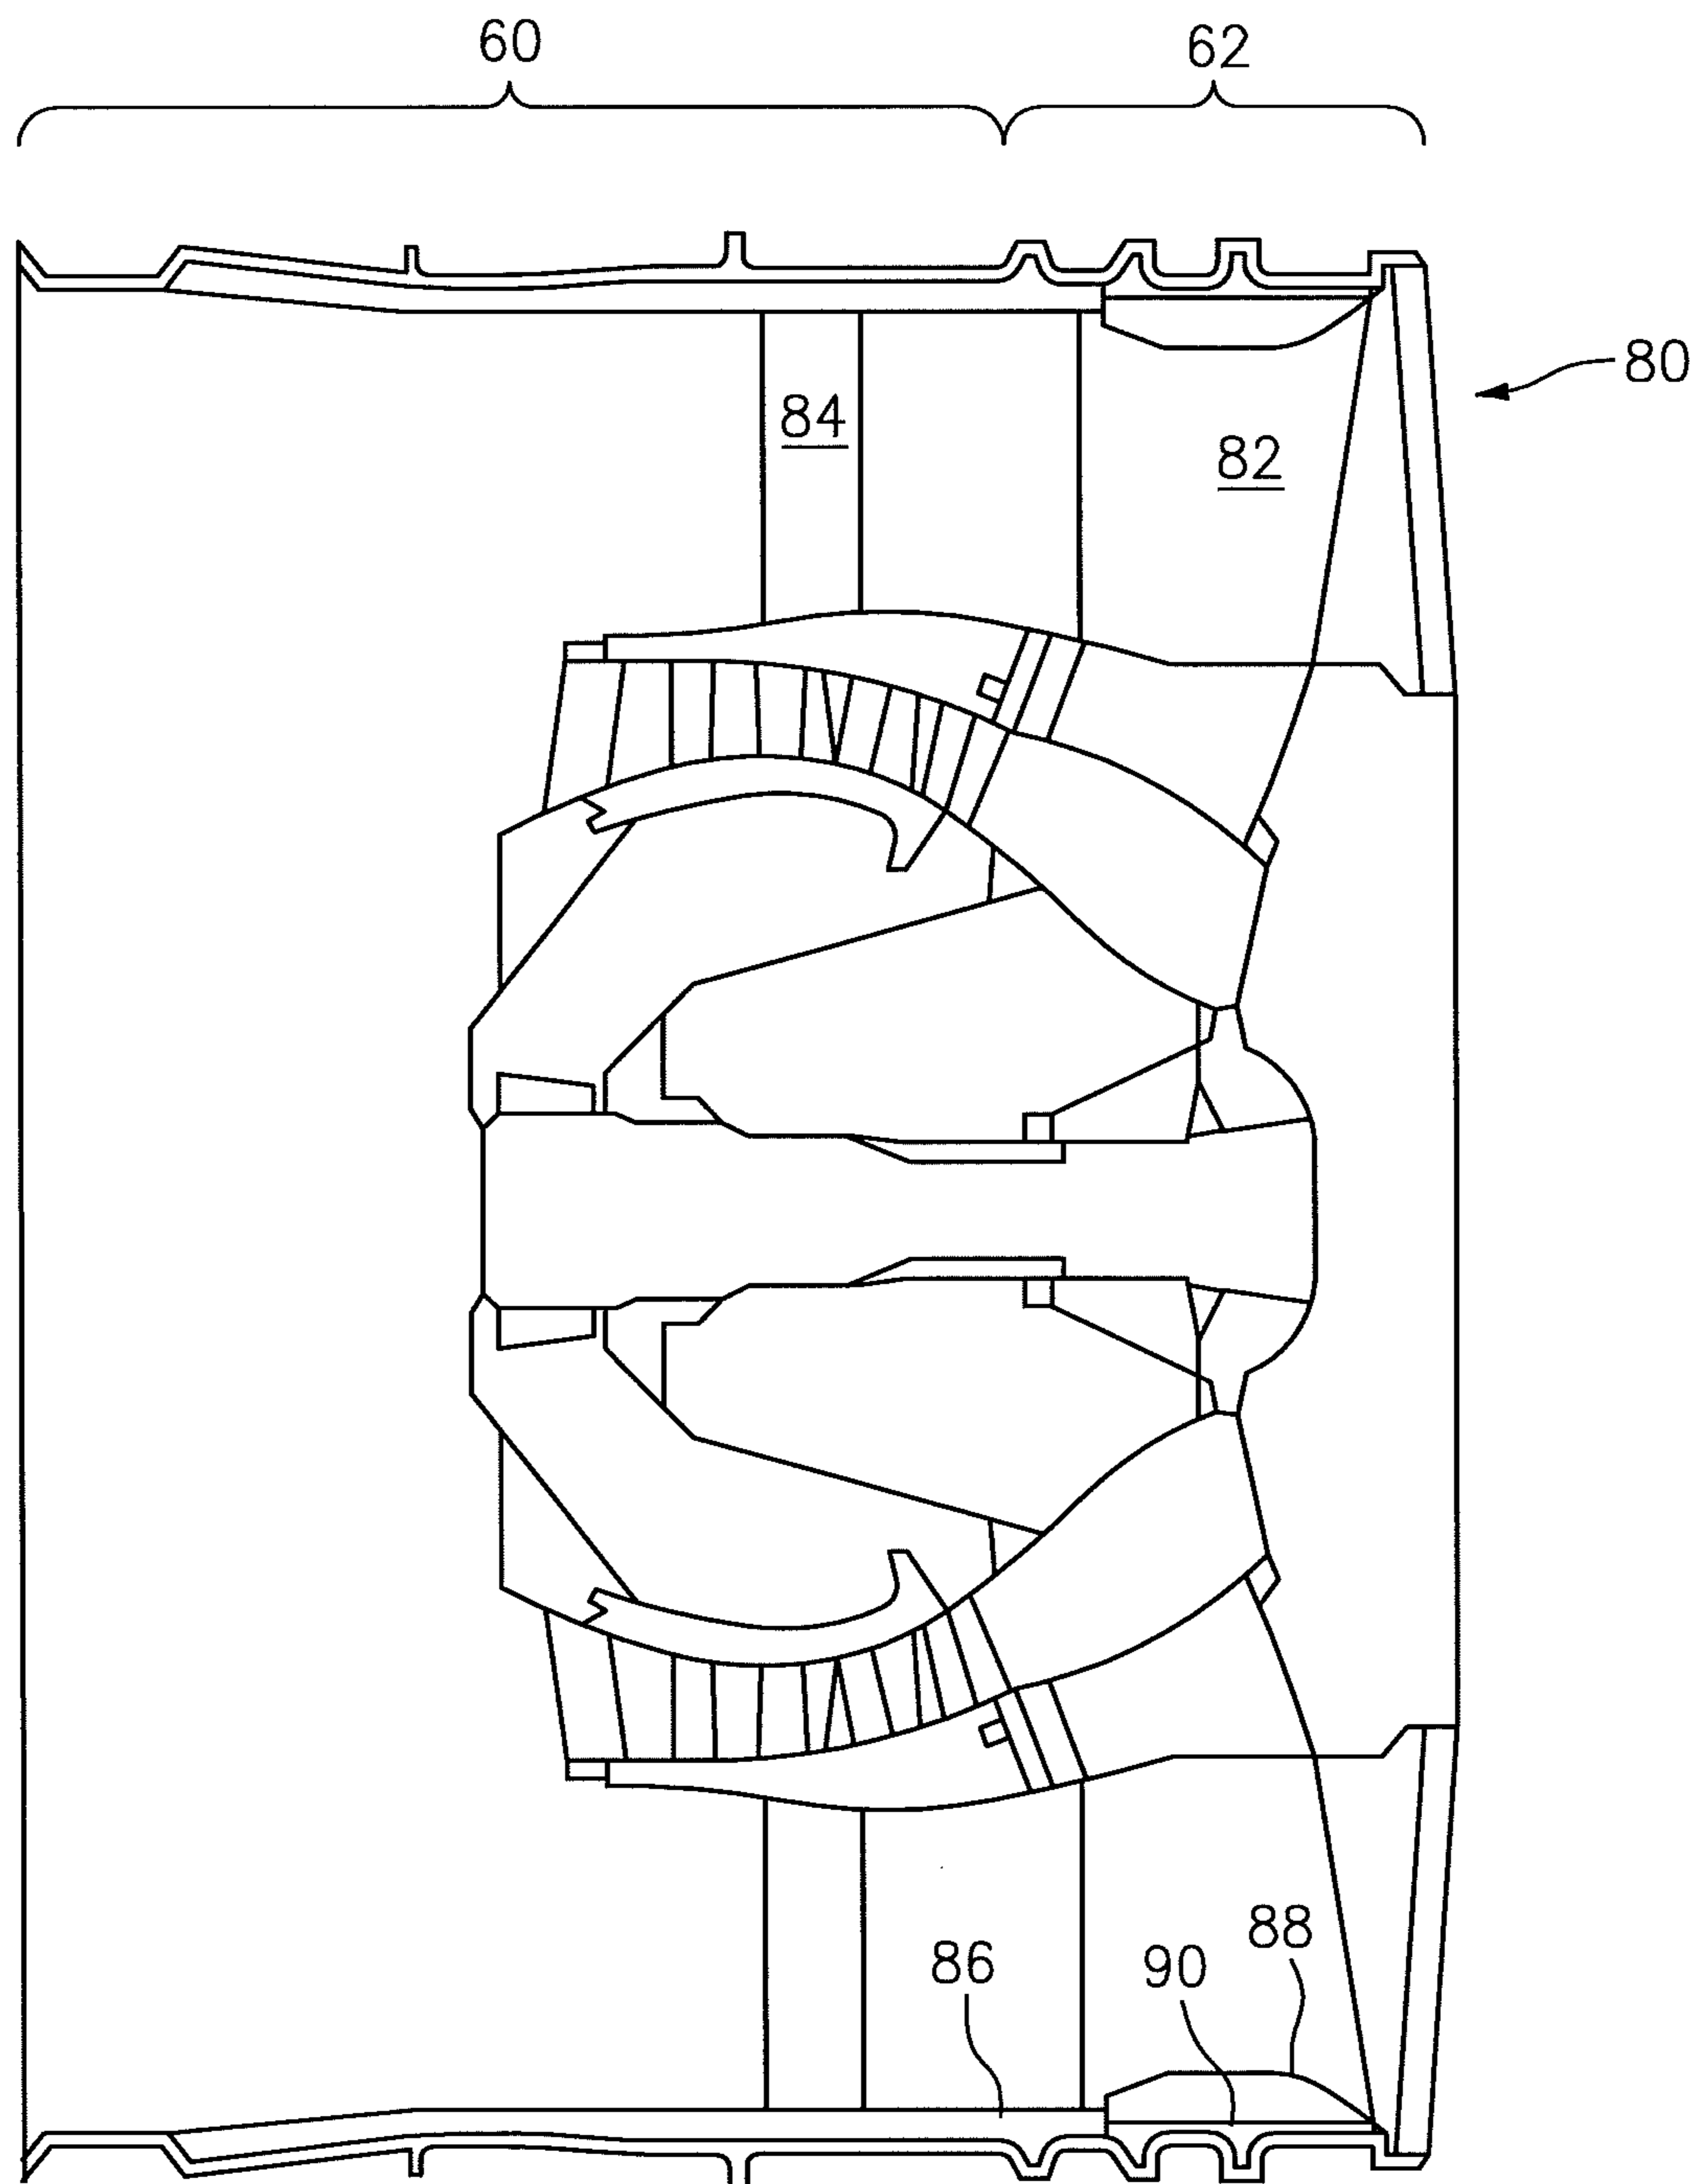
FIG. 3 is a sectional view of the fan section;

With reference to FIG. 3, the fan case 60 and intermediate case 62 are shown by way of example; however, other engine case sections and liner panels will also benefit herefrom. The intermediate case 60 generally includes a liner panel assembly 80 (also shown in FIG. 4) removably mounted to a fan case structure 82 to provide a removable gas path surface that facilitates airflow through the fan case 60 and around a multiple of structural support vanes 82 and a multiple of exit guide vanes 84 forward thereof.

The liner panel assembly 80 shown by way of example includes a multiple of forward fan exit case liner panels 86 (also often known as Ice Panels and A/O Panels), a multiple of aft fan exit case liner panels 88 and a multiple of seal panels 90. Although the forward fan exit case liner panels 86 are utilized hereafter as the example component for a method of repair, remanufacture or original manufacture, it should be appreciated that various panels will also benefit herefrom.

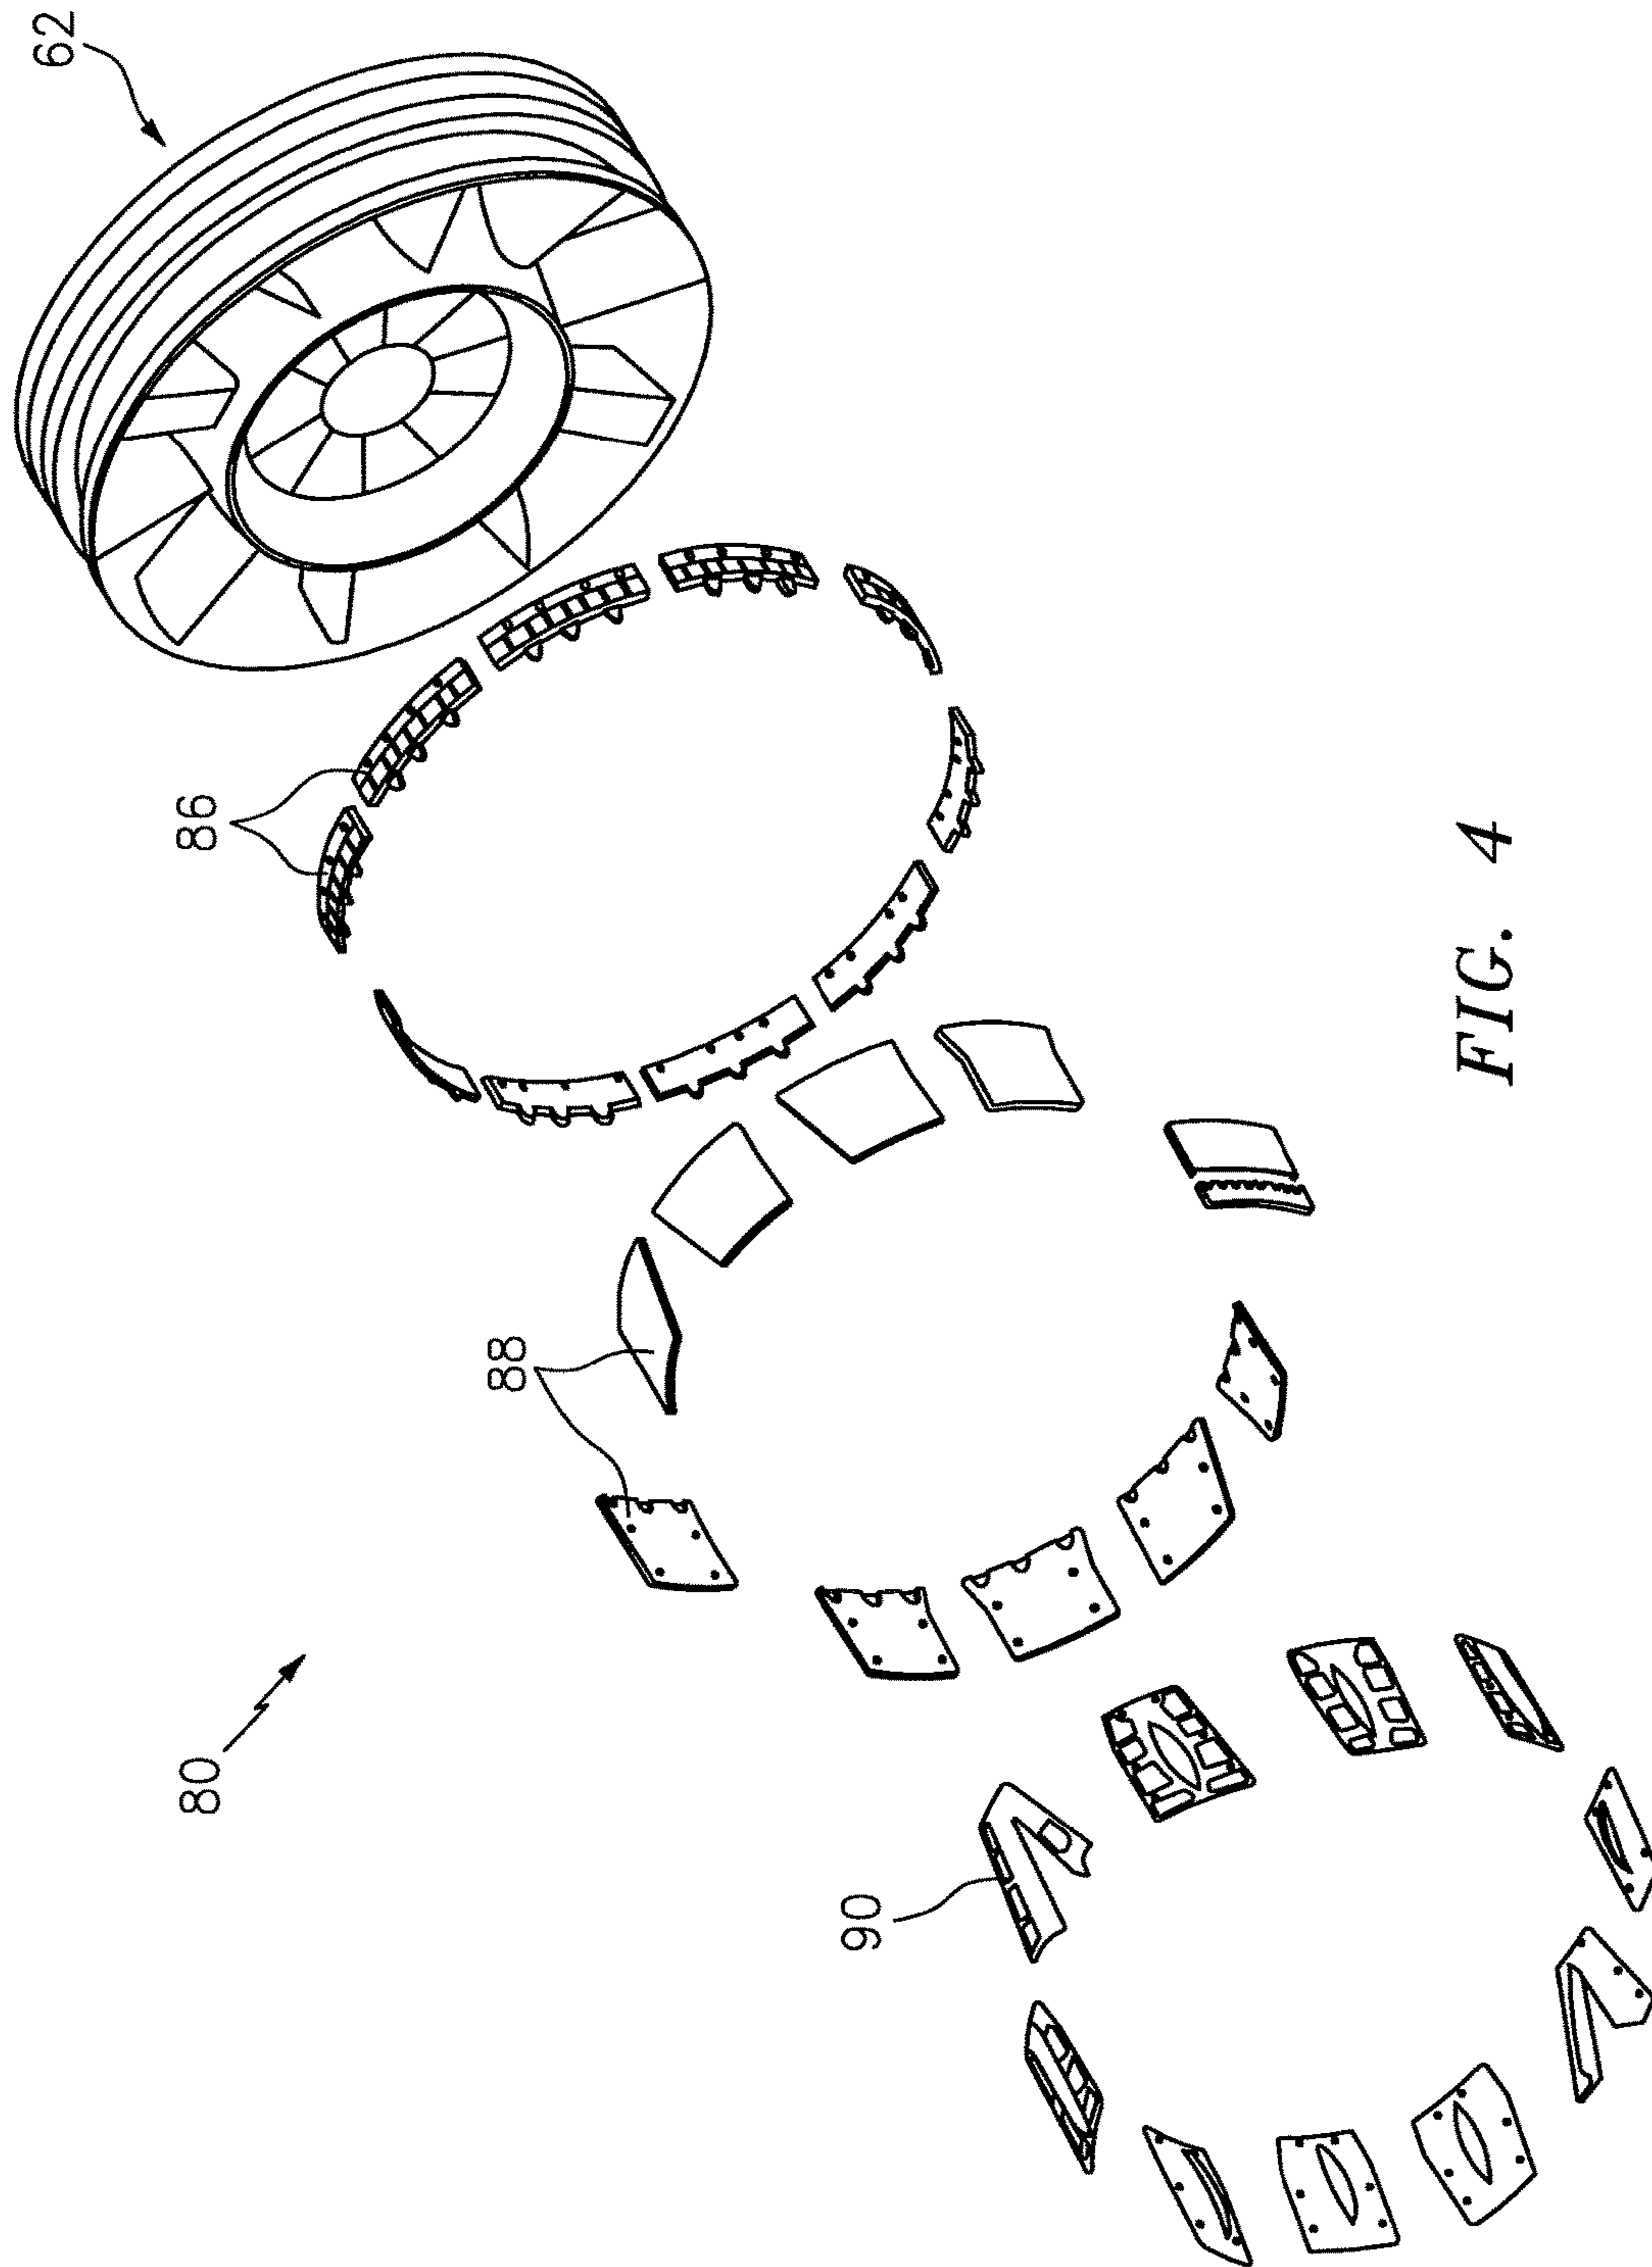
FIG. 4 is an exploded view of the liner panel assembly within the fan section;

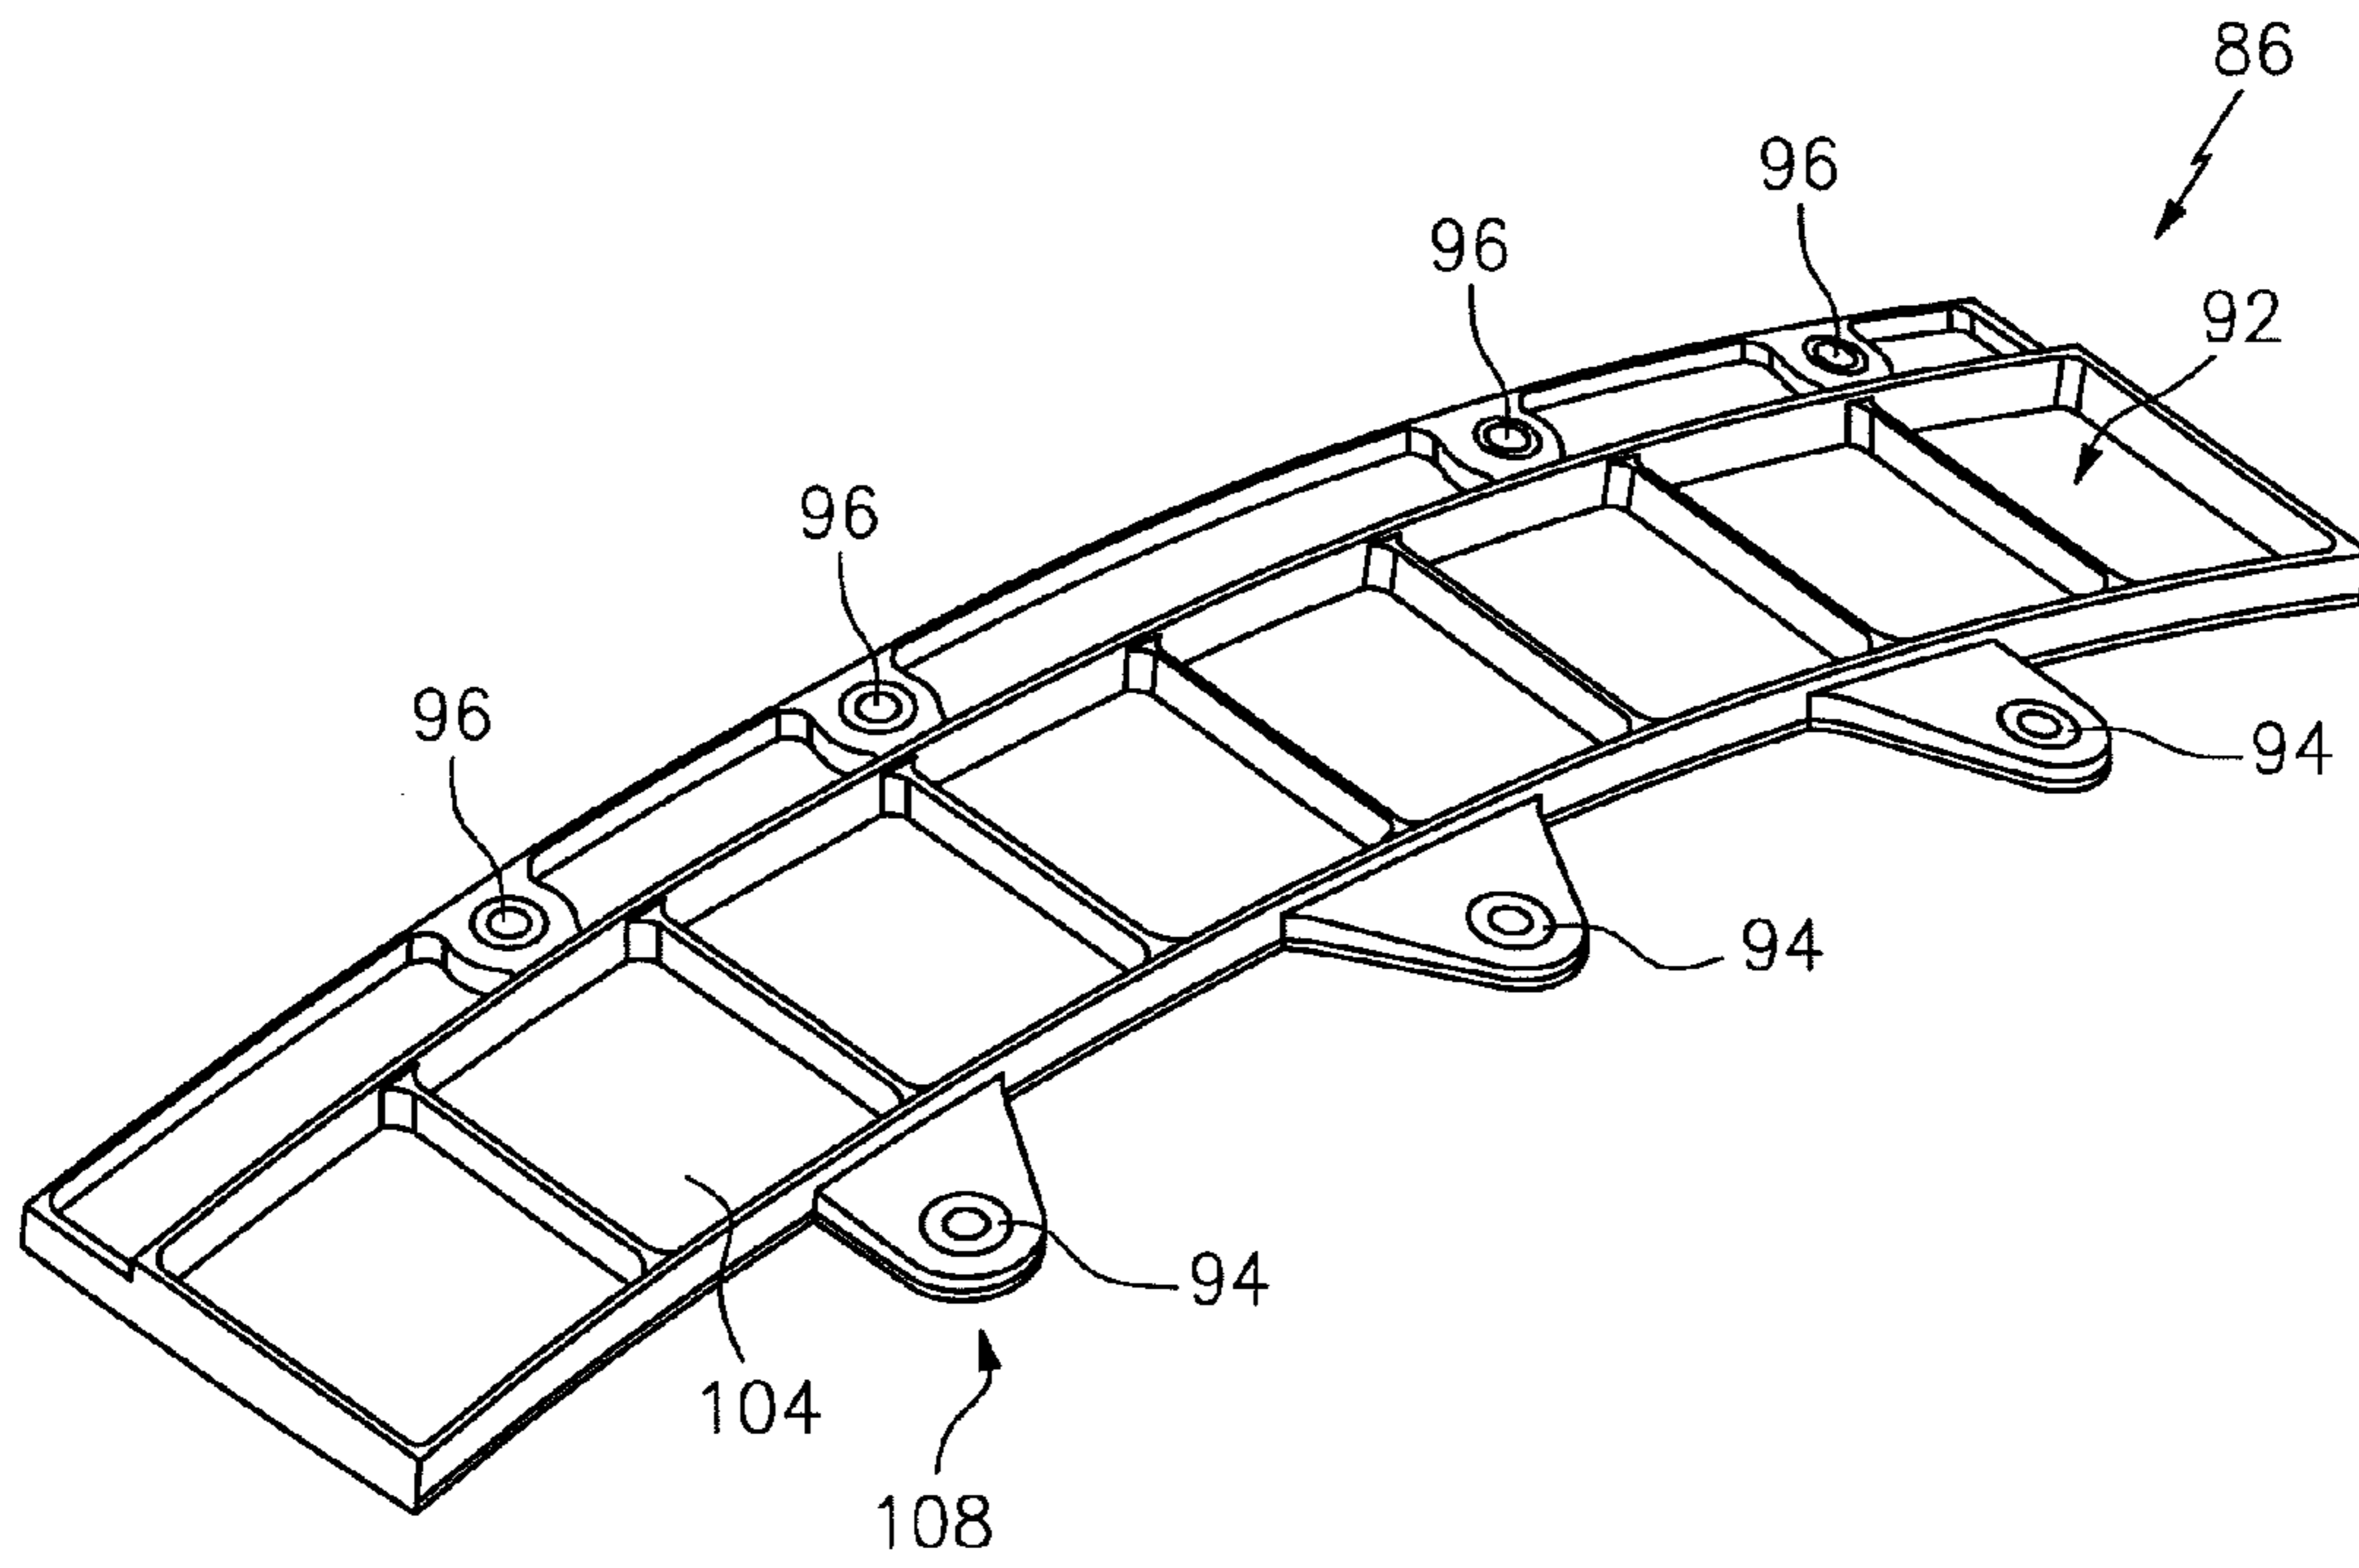
FIG. 5 is a ribbed non-gas path side of an example forward liner panel;

With reference to FIGS. 5 and 6, each of the example forward fan exit case liner panels 86 are formed of a non-metallic material body 92 with a multiple of metallic bushings 94 (three shown) and a multiple of non-metallic bushings 96 (four shown) molded therein. Over time, the non-metallic material body 92 may become worn or damaged because of, for example, vibrations caused by engine operation.
