US010094242B2

(54) **REPAIR OR REMANUFACTURE OF LINER PANELS FOR A GAS TURBINE ENGINE**

(71) Applicant: **United Technologies Corporation**,
Hartford, CT (US)

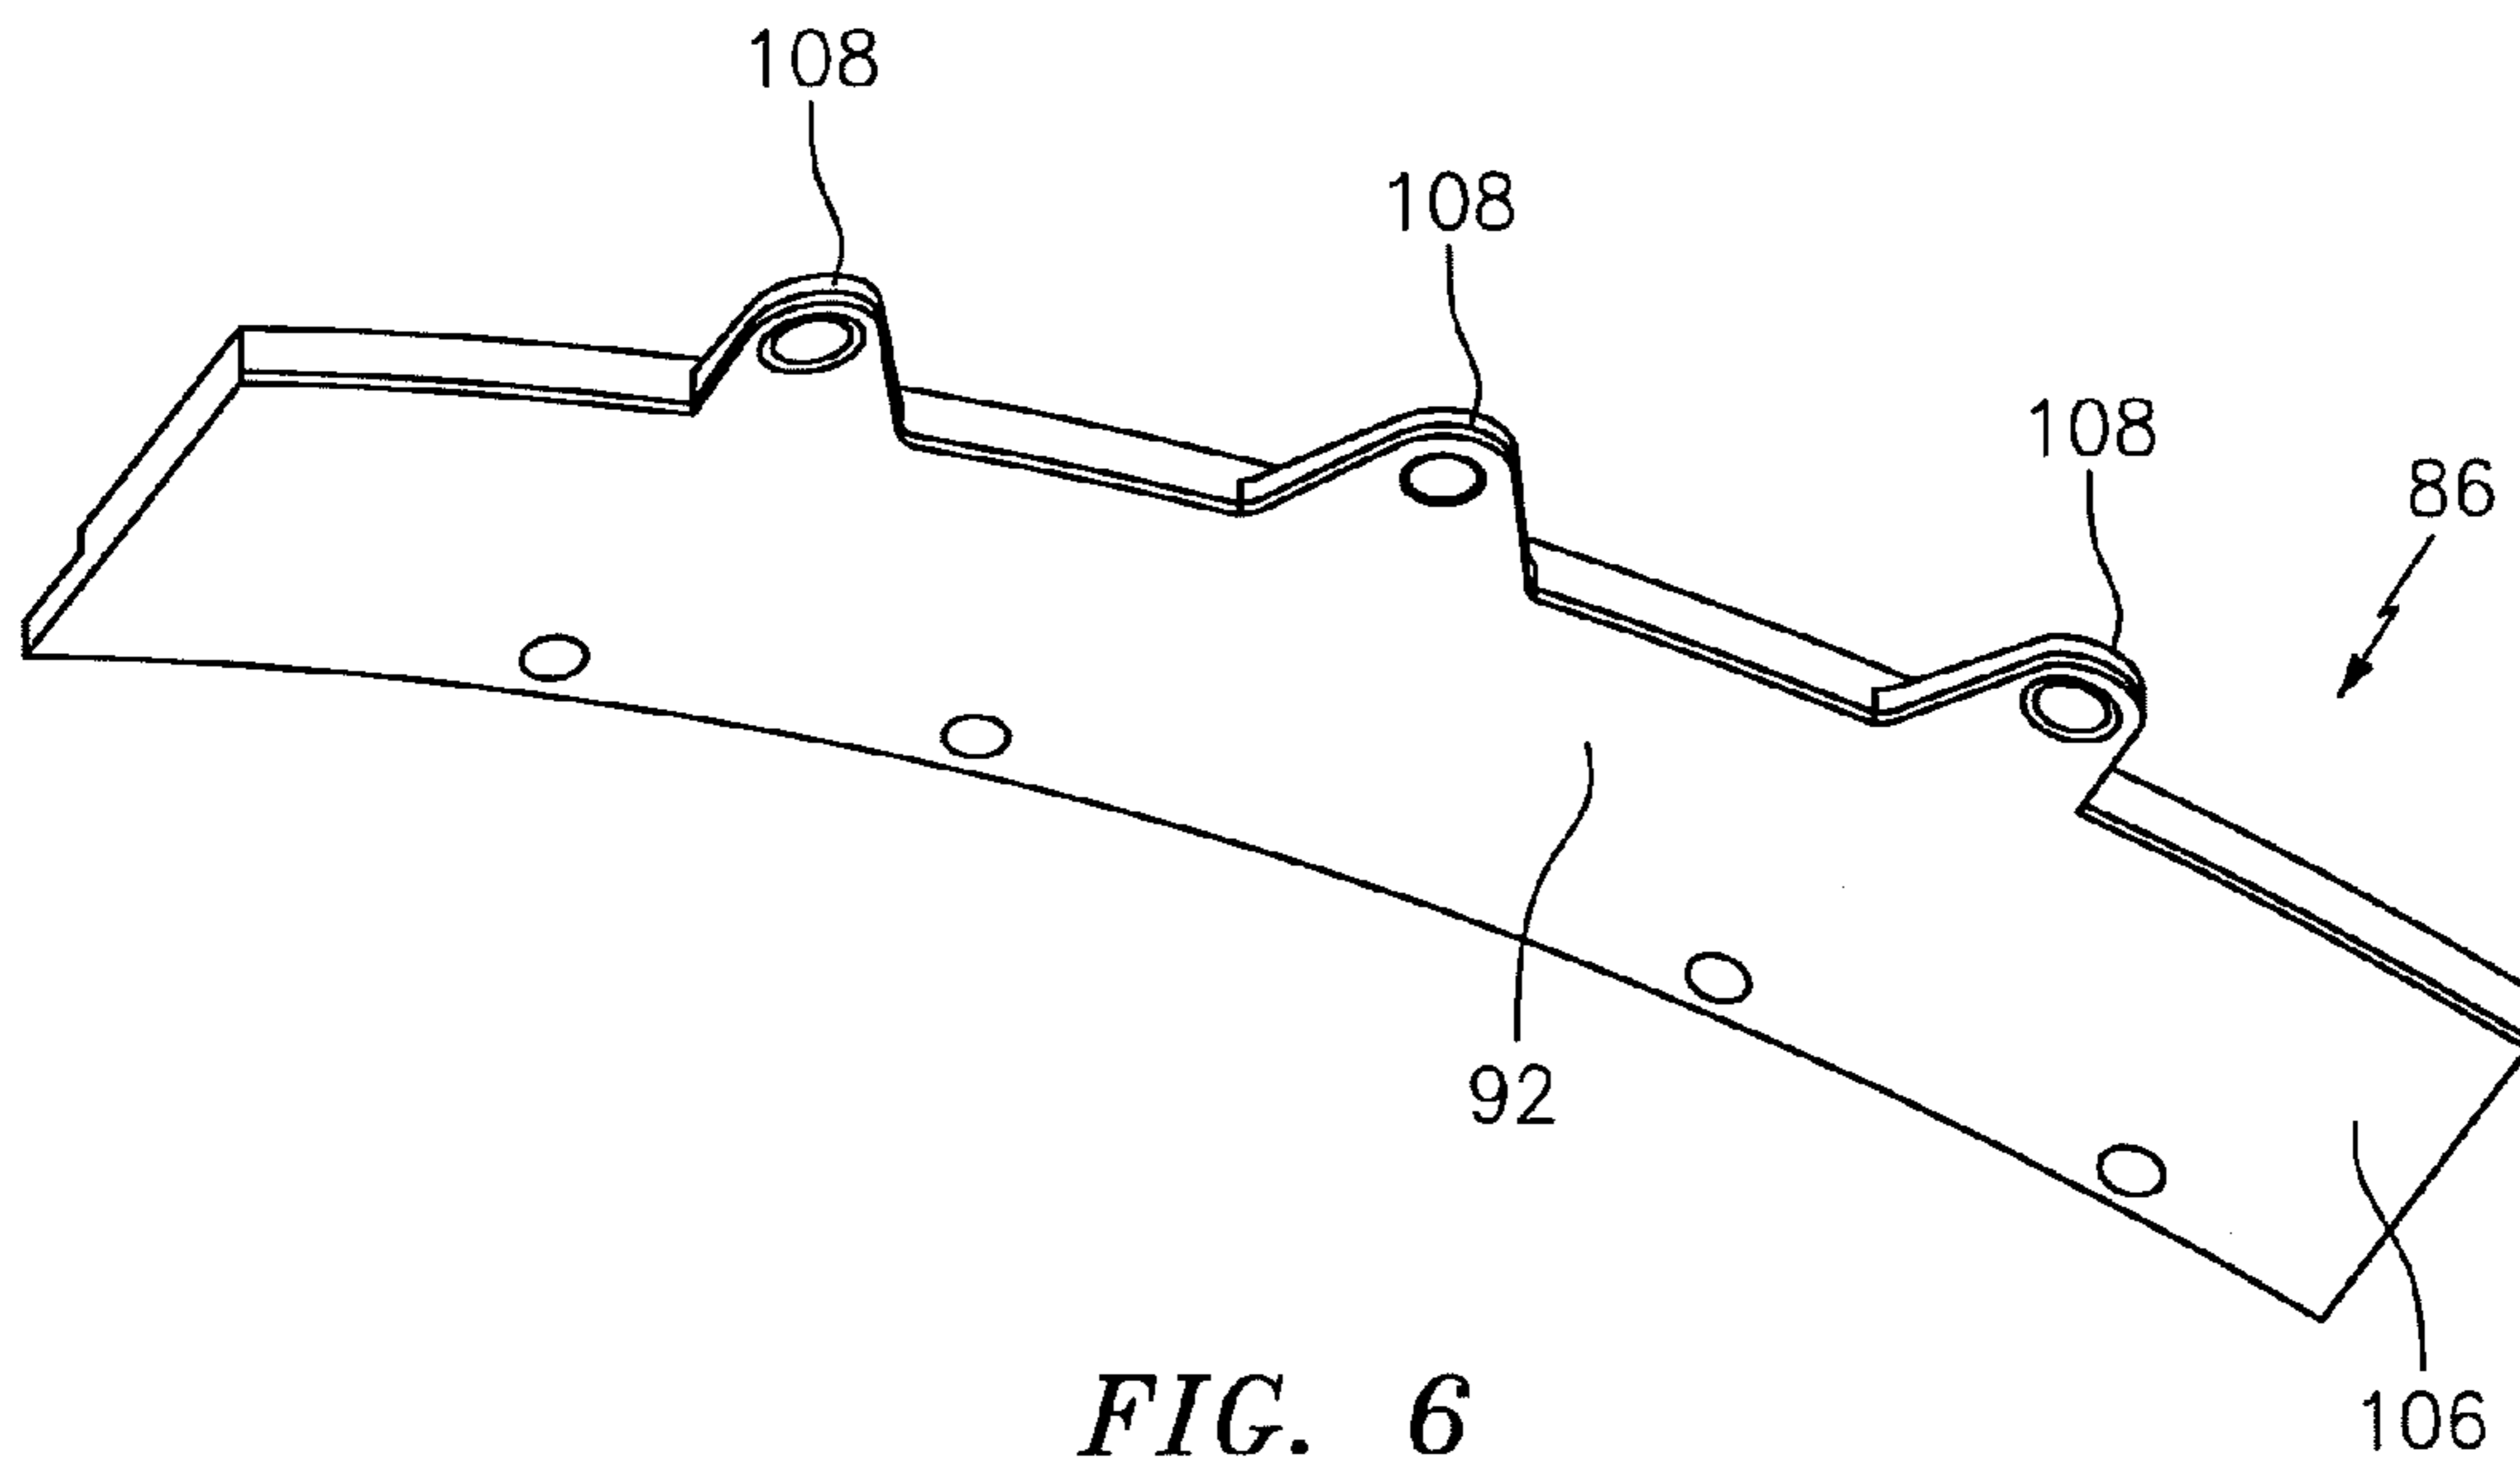
FIG. 6 is a gas path side of the example forward liner panel of FIG. 5;

With reference to FIGS. 5 and 6, each of the example forward fan exit case liner panels 86 are formed of a non-metallic material body 92 with a multiple of metallic bushings 94 (three shown) and a multiple of non-metallic bushings 96 (four shown) molded therein. Over time, the non-metallic material body 92 may become worn or damaged because of, for example, vibrations caused by engine operation.

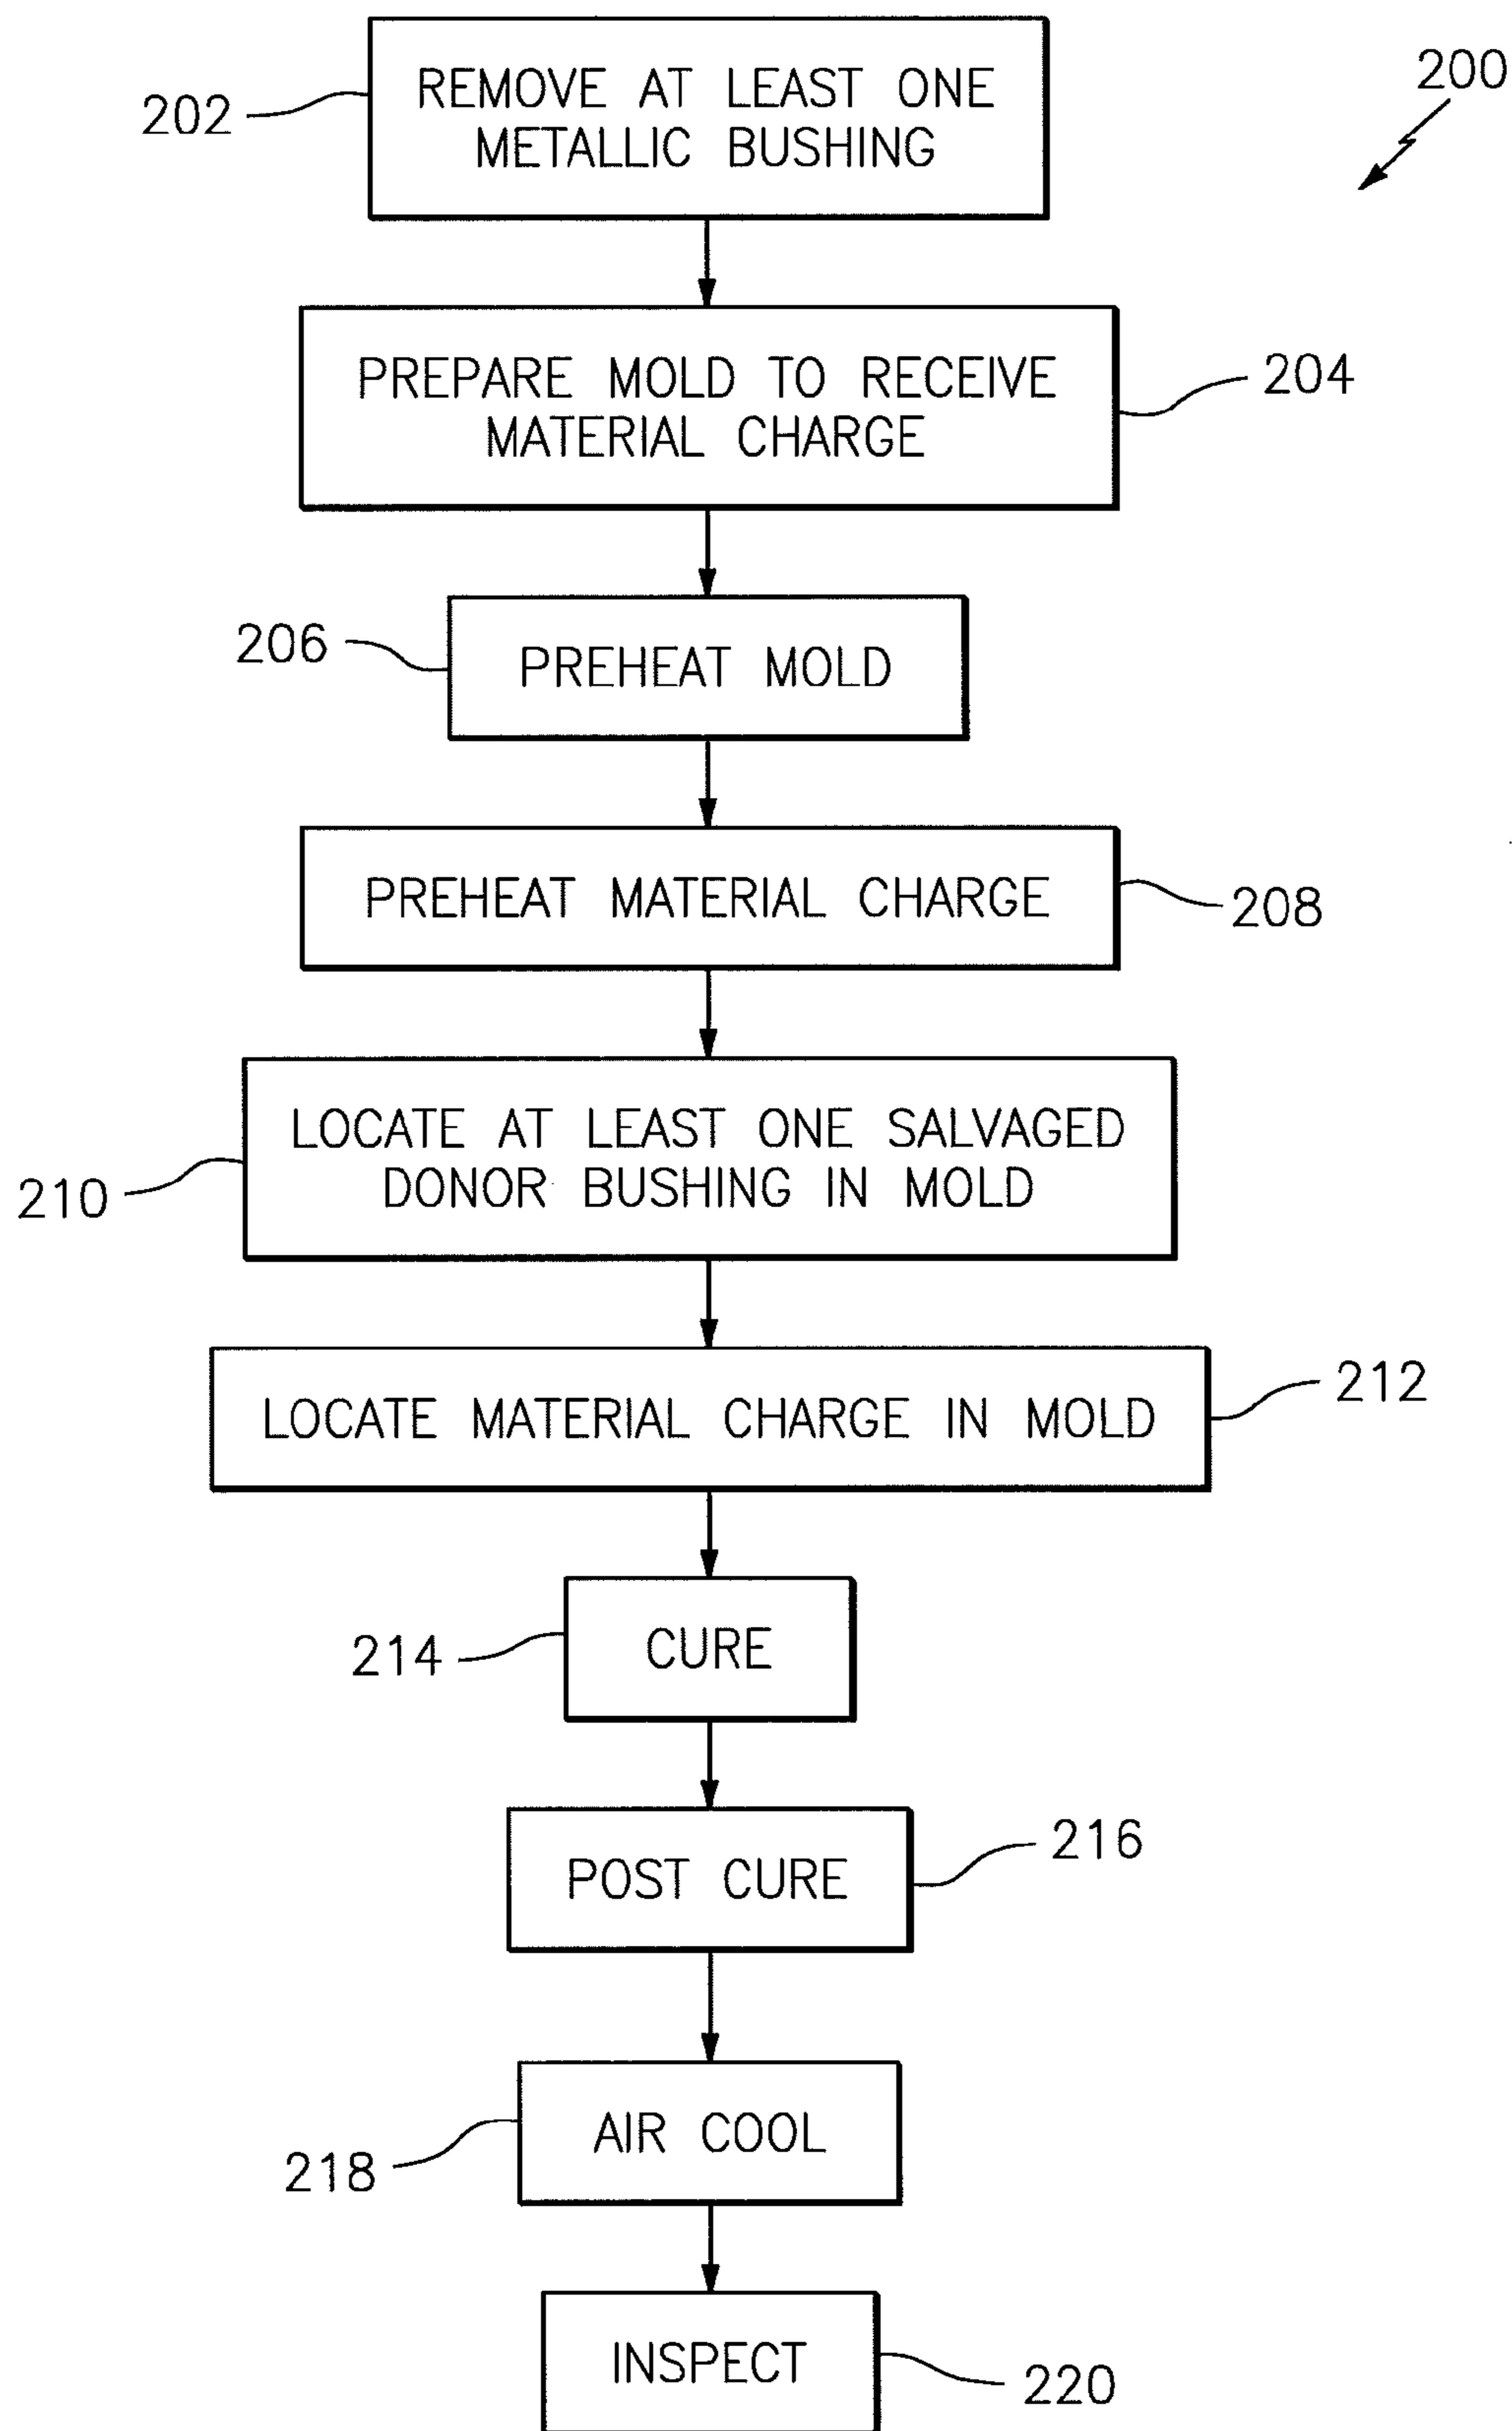
FIG. 7 is a flow chart diagram of a method to repair or remanufacture a liner panel;

With reference to FIG. 7, a method 200 of repair, remanufacture or original manufacture for the example forward fan exit case liner panel 86 (see FIGS. 5 and 6) according to one disclosed non-limiting embodiment initially includes removal of the metallic bushings 94 from a damaged non-metallic material body 92 (step 202). That is, at least one of the metallic bushings 94 is preserved as a donor bushing for remanufacture from a damaged forward fan exit case liner panel 86 that may be non-serviceable. That is, the donor bushing is that which was salvaged. The metallic bushings 94 may be removed by, for example, plastic media blasting at up to 70 psi.

Next, a fabrication mold 100A, 100B (illustrated schematically; see FIG. 8) is prepared to receive a material charge 102 (step 204). The fabrication mold 100 may be preheated to about 315° F. (about 157° C.) maximum (step 206). The material charge 102 may also be preheated at about 200° F. (about 93° C.) maximum for up to twelve (12) minutes maximum (step 208). The fabrication mold 100 is shaped to form the non-metallic material body 92 of the forward fan exit case liner panels 86 that generally includes a ribbed side 104 (see FIG. 5), a smooth gas path side 106 (see FIG. 6), and a multiple of tabs 108 (see FIGS. 5 and 6). It should be appreciated that various components and structures therefor will also benefit herefrom.

The material charge **102** is then located in the mold **100B** (step **212**). Layer **110A** is positioned along the gas path side and is essentially identical to layer **110B**. Layer **110C** is discontinuous. That is, layer **110C** is actually two portions **110Ca**, **110Cb** with the discontinuity **112** generally along a length thereof. A width WM of the main body of the Layers **110A**, **110B**, and **110C** (FIG. **9**) exclusive of the tabs **108**. A width WD of the discontinuity **112** of the layer **110C** (FIG. **10**). In this disclosed non-limiting dimensional embodiment, a ratio of WD/WM is defined between 0.575-0.66. The disclosed ratios facilitate flow of the sheet molding compound into the circumferential ribs, and raised boss structure of the fabrication mold **100A** and **100B**.

The material charge **102** is then cured in the fabrication mold **100A** and **100B** at to form the example forward fan exit case liner panels **86** (step **214**). The forward fan exit case liner panel **86** is then post-cured (step **216**) then air cooled to room temperature (step **218**).

Finally, the forward fan exit case liner panel **86** may be inspected (step **220**).

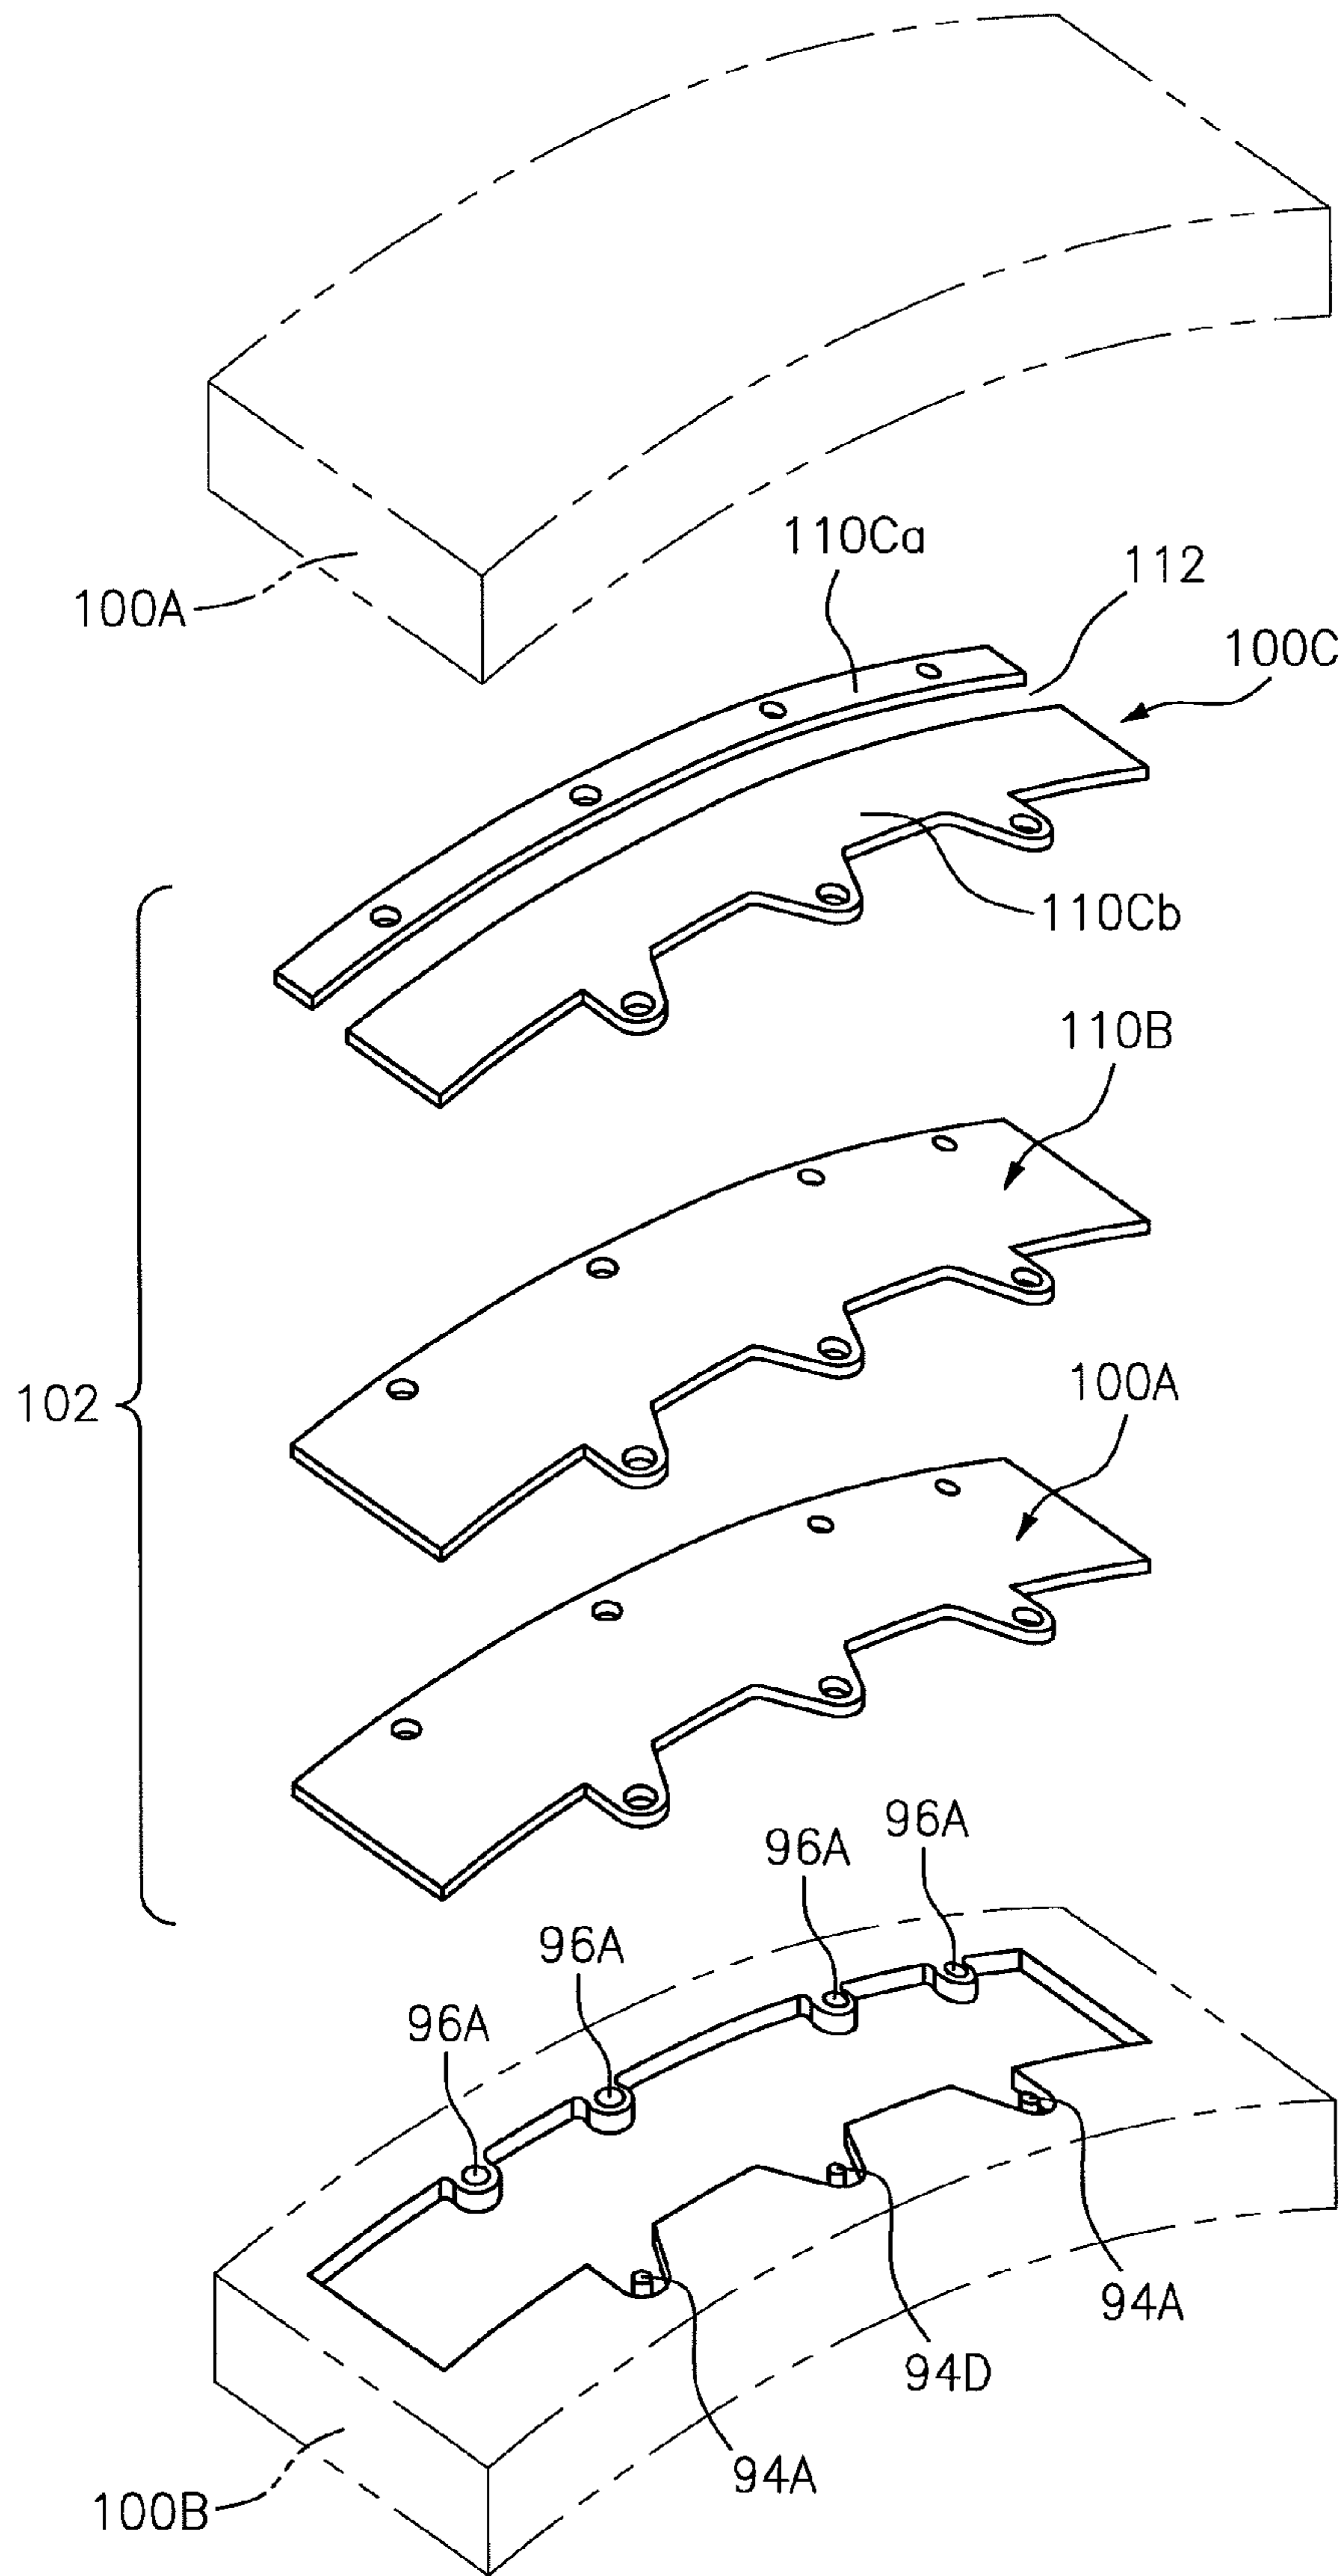
FIG. 8 is an exploded view of a material charge and mold for the liner panel assembly;

Next, at least one salvaged donor metallic bushing 94D as well as new metallic bushings 94A and new non-metallic bushings 96A are positioned—typically on pins—in the fabrication mold 100B (see FIG. 8) that has been prepared to receive the material charge 102 (step 210). Prepared as defined herein includes, at least, that mold release is dried (and cured, if applicable) on fabrication mold 100 before installation of the bushings 94D, 94A, 96A. In another disclosed non-limiting embodiment, all the bushings 94, 96 are new manufacture.

The material charge 102 is prepared from a multiple of layers 110A, 110B, 110C (three shown; see FIG. 8). The material of each of the layers 110A, 110B, 110C in this

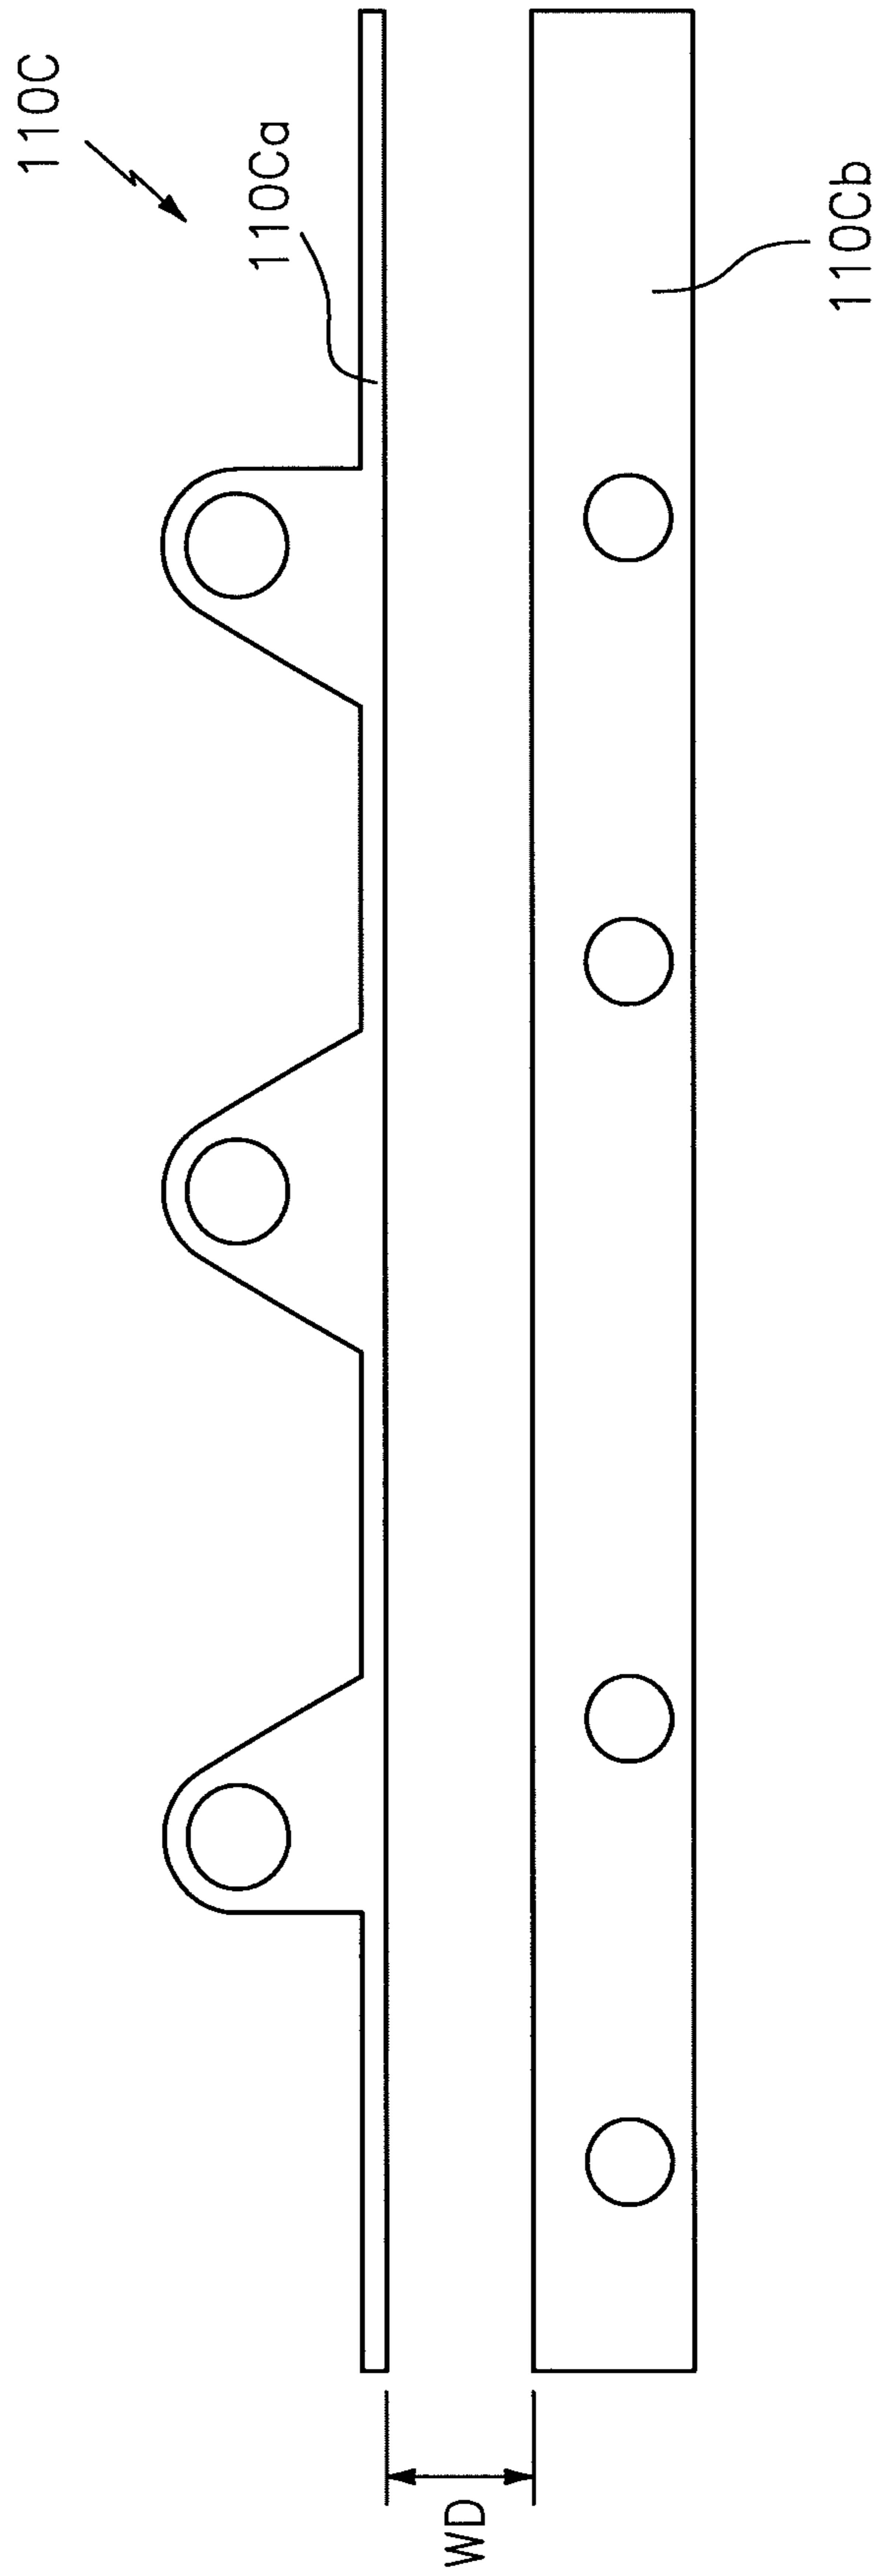
FIG. 10 is a plan view of one layer with a discontinuity of the material charge for the liner panel assembly.

In a further embodiment of any of the foregoing embodiments of the present disclosure, a main body of one of the multiple of layers defines a width WM and the discontinuity of one of the multiple of layers defines a width WD. A ratio WD/WM is defined between 0.575-0.66.
