(12) **United States Patent**
Widener et al.

(10) **Patent No.:** **US 10,099,322 B2**
(45) **Date of Patent:** **Oct. 16, 2018**

(54) **METHODS FOR COLD SPRAY REPAIR**

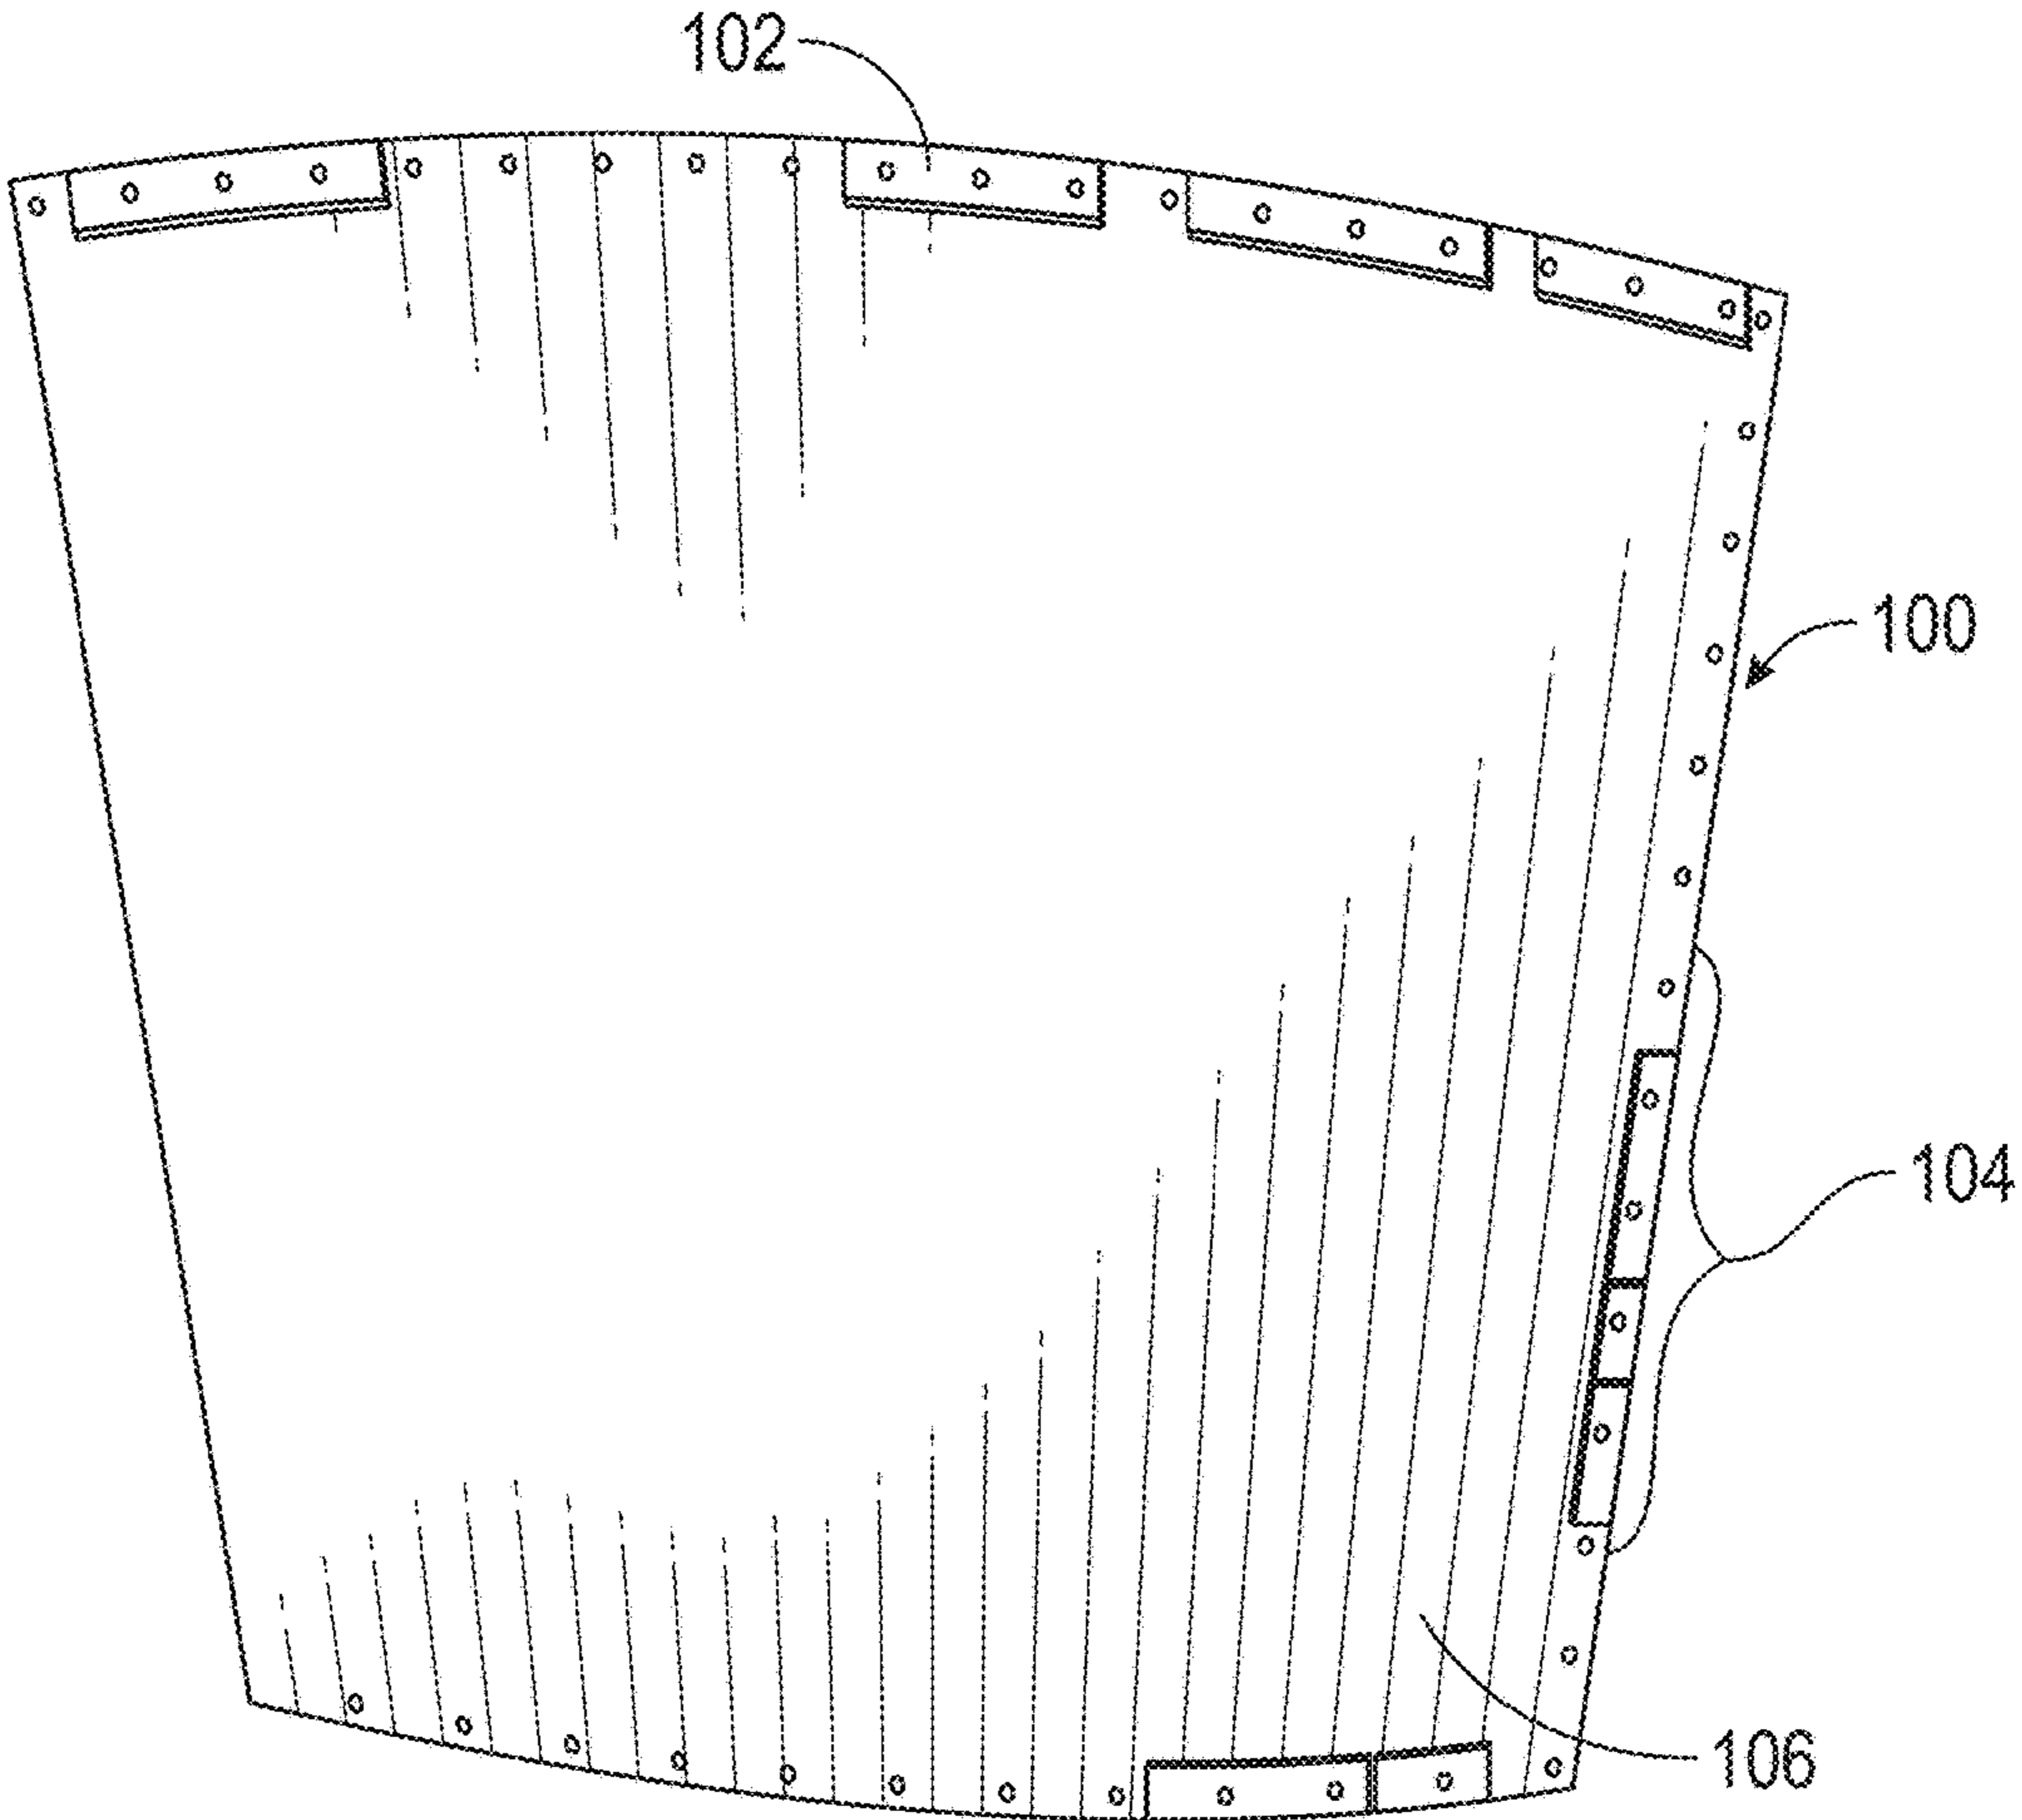
FIG. 1 is a pictorial representation of an aircraft skin panel in need of repair, showing the fastener holes around its perimeter in accordance with an illustrative embodiment;

The illustrative embodiments provide methods for cold spray repair of one or more component parts. Specifically, the illustrative embodiments provide cold spray repair methods for aluminum aircraft skin fastener holes and hydraulic tubing. FIG. 1 provides a pictorial illustration of an aircraft panel, and more specifically an aluminum aircraft external access panel, such as the type that are typically secured to the airframe of an aircraft using steel fasteners, such as Tridair™ fasteners. The aircraft panel 100 is typically fabricated from aluminum (e.g., 2024-T6 aluminum), however other materials may be used where appropriate for use on an aircraft as best shown in FIG. 3. The aircraft panel 100 includes an outer perimeter 102 with a plurality of fastener holes 104. In the case where the aircraft panel 100 is an outer skin or external access panel of an aircraft, the plurality of fastener holes 104 are generally secured to the airframe of the aircraft. The aircraft panel 100 is often removed for gaining access to the aircraft for performing maintenance operations or the like. The aircraft panel 100 includes an outer surface 106 and an inner surface opposite the outer surface (not shown). In the case where the aircraft panel 100 is an integrally stiffened bonded panel, the inner surface (not shown) includes a composite material substrate (not shown). The panel 100 and the composite are fabricated as a single component, thus techniques for repair and reclamation of the aircraft panel 100 must take into consideration the presence of a composite material substrate on the inner surface of the aircraft panel 100.

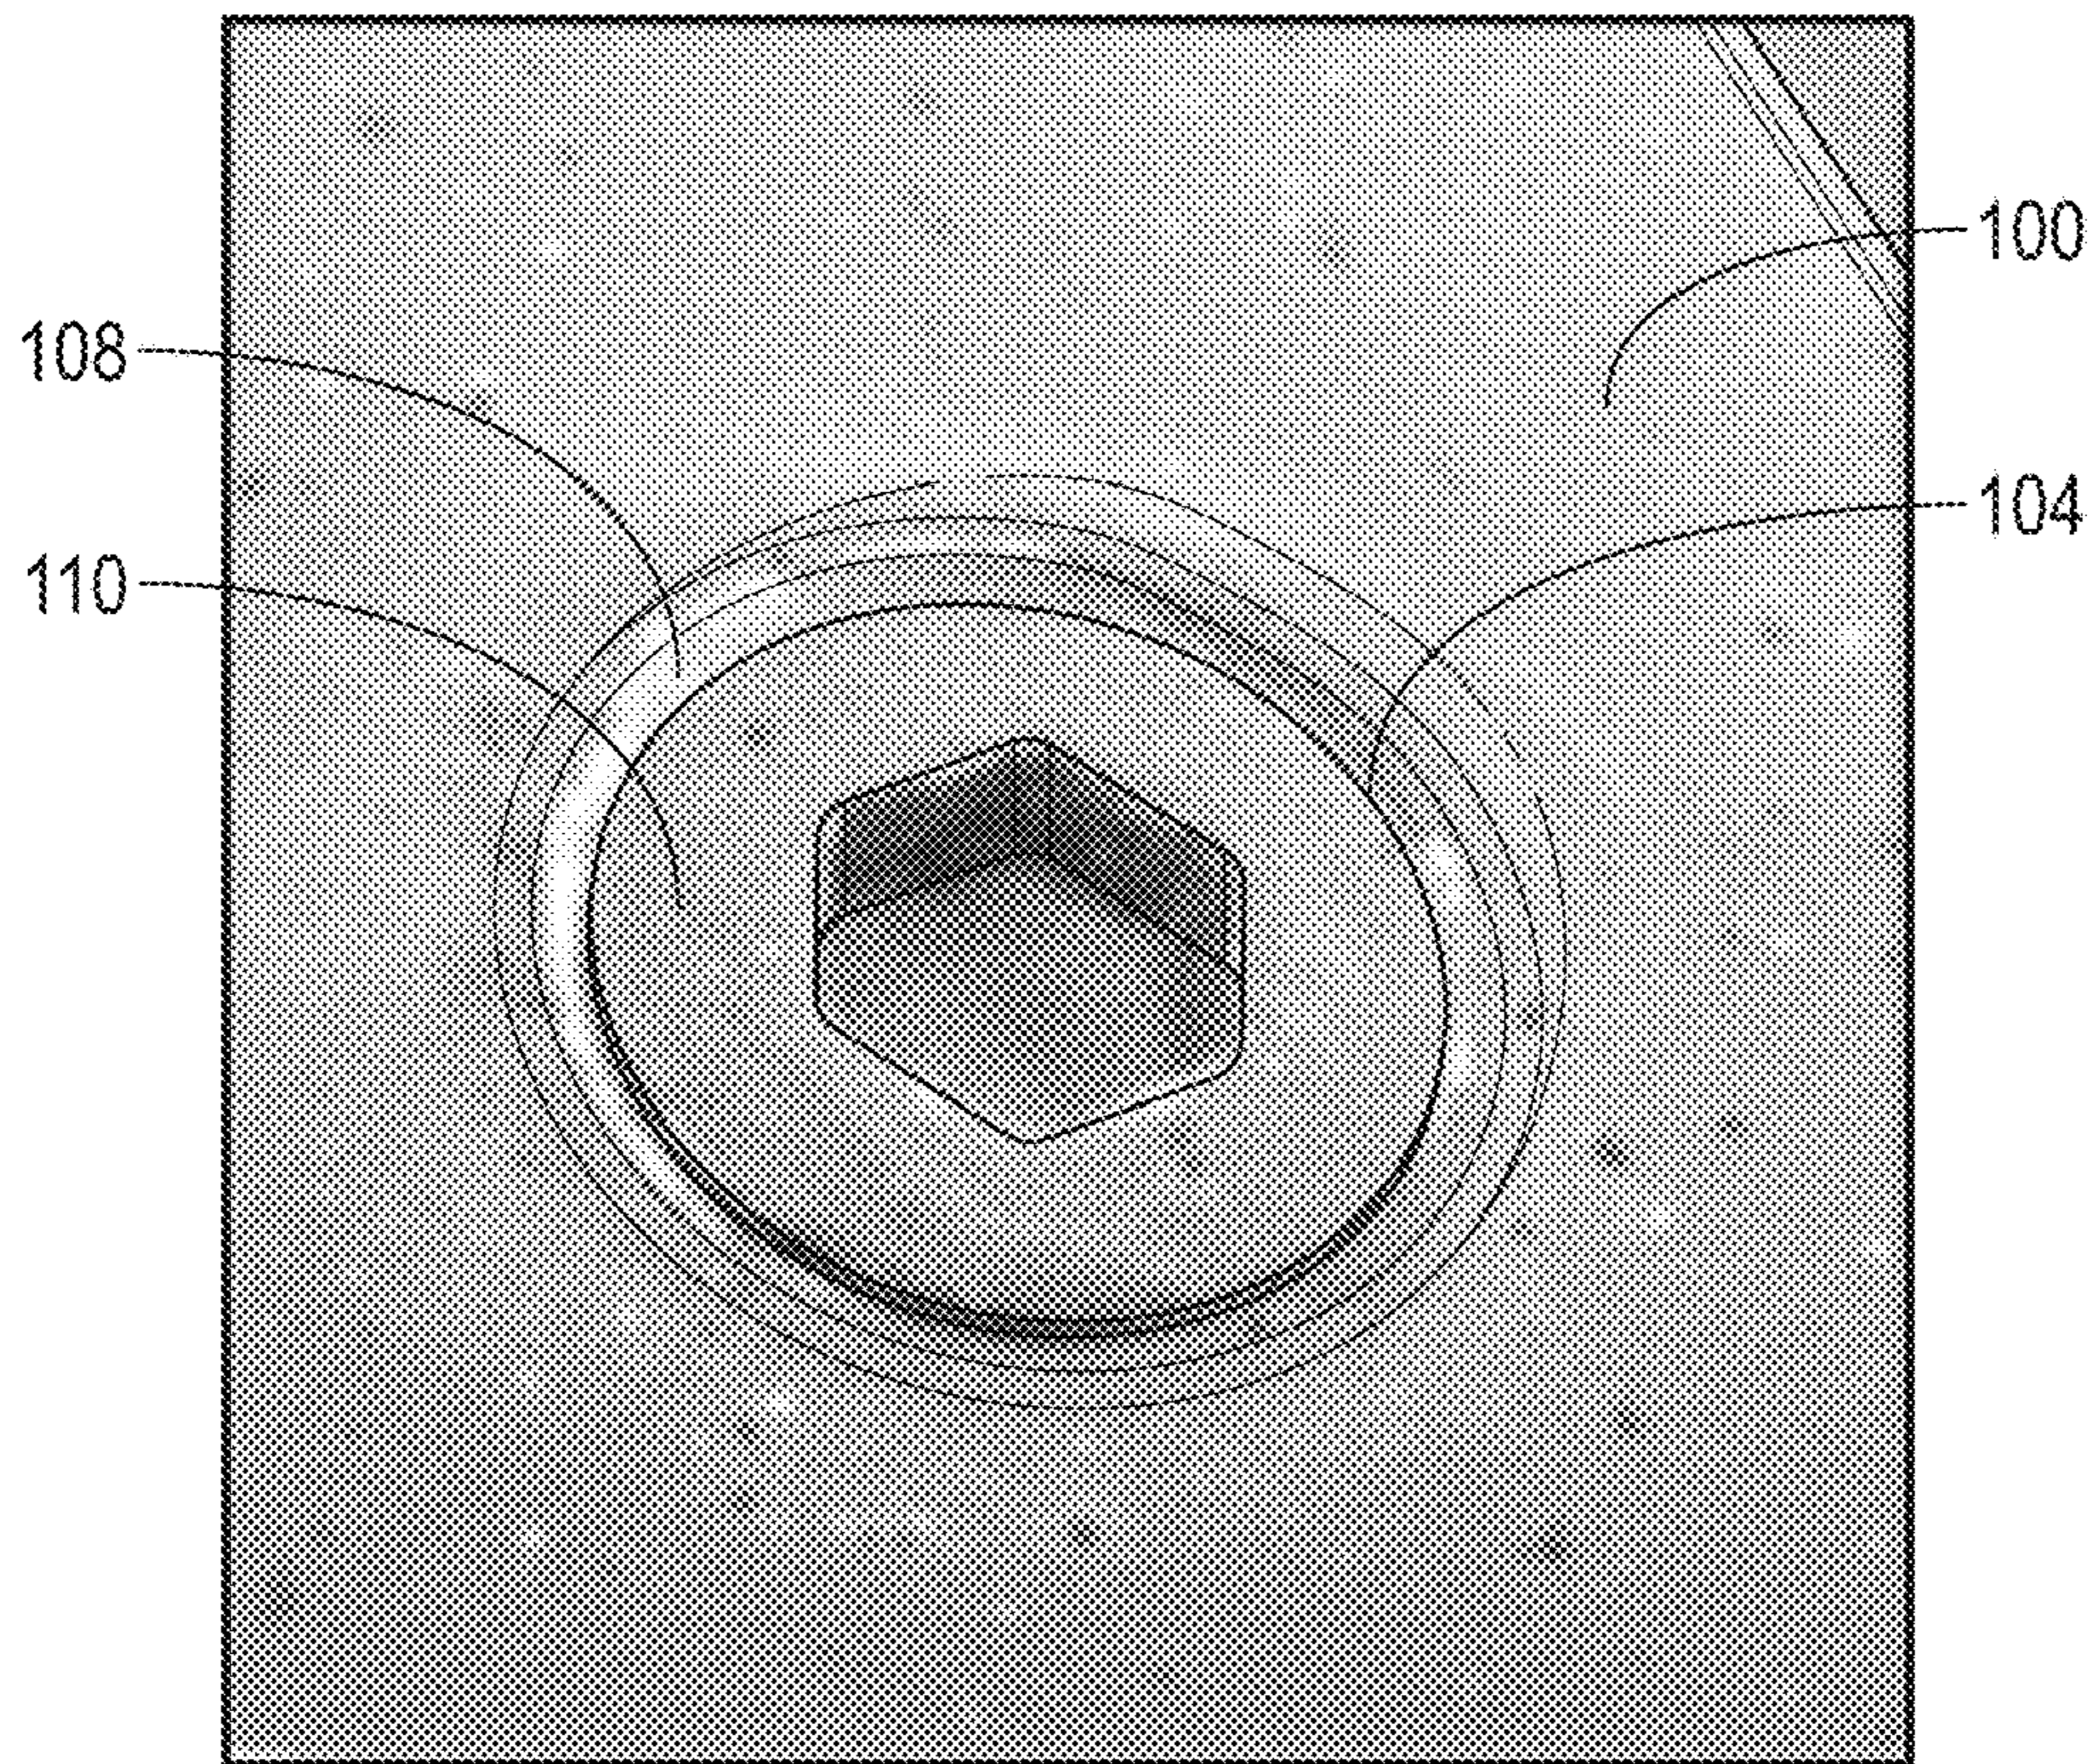
FIG. 2A is a pictorial representation of a fastener in a fastener hole in accordance with an illustrative embodiment;

FIG. 2A provides a pictorial representation of identified wear in a fastener hole 104 in the aircraft panel 100. As illustrated, the fastener hole 104 in the aircraft panel 100 has a chamfer 108 around the fastener hole 104 through which a fastener 110 is received for securing the panel 100 to the airframe of the aircraft. The fastener 110 is designed to sit flush with the panel 100 to enable laminar airflow over the head of the fastener 110. Repeated access to the panel 100 wears and enlarges the fastener hole 104 and the chamfer 108. As wear increases, the fastener 110 sits further and further below the surface of the aircraft panel 100, resulting in turbulent airflow, vibration of the panel 100 and eventually pull through and loss of the fastener in flight.

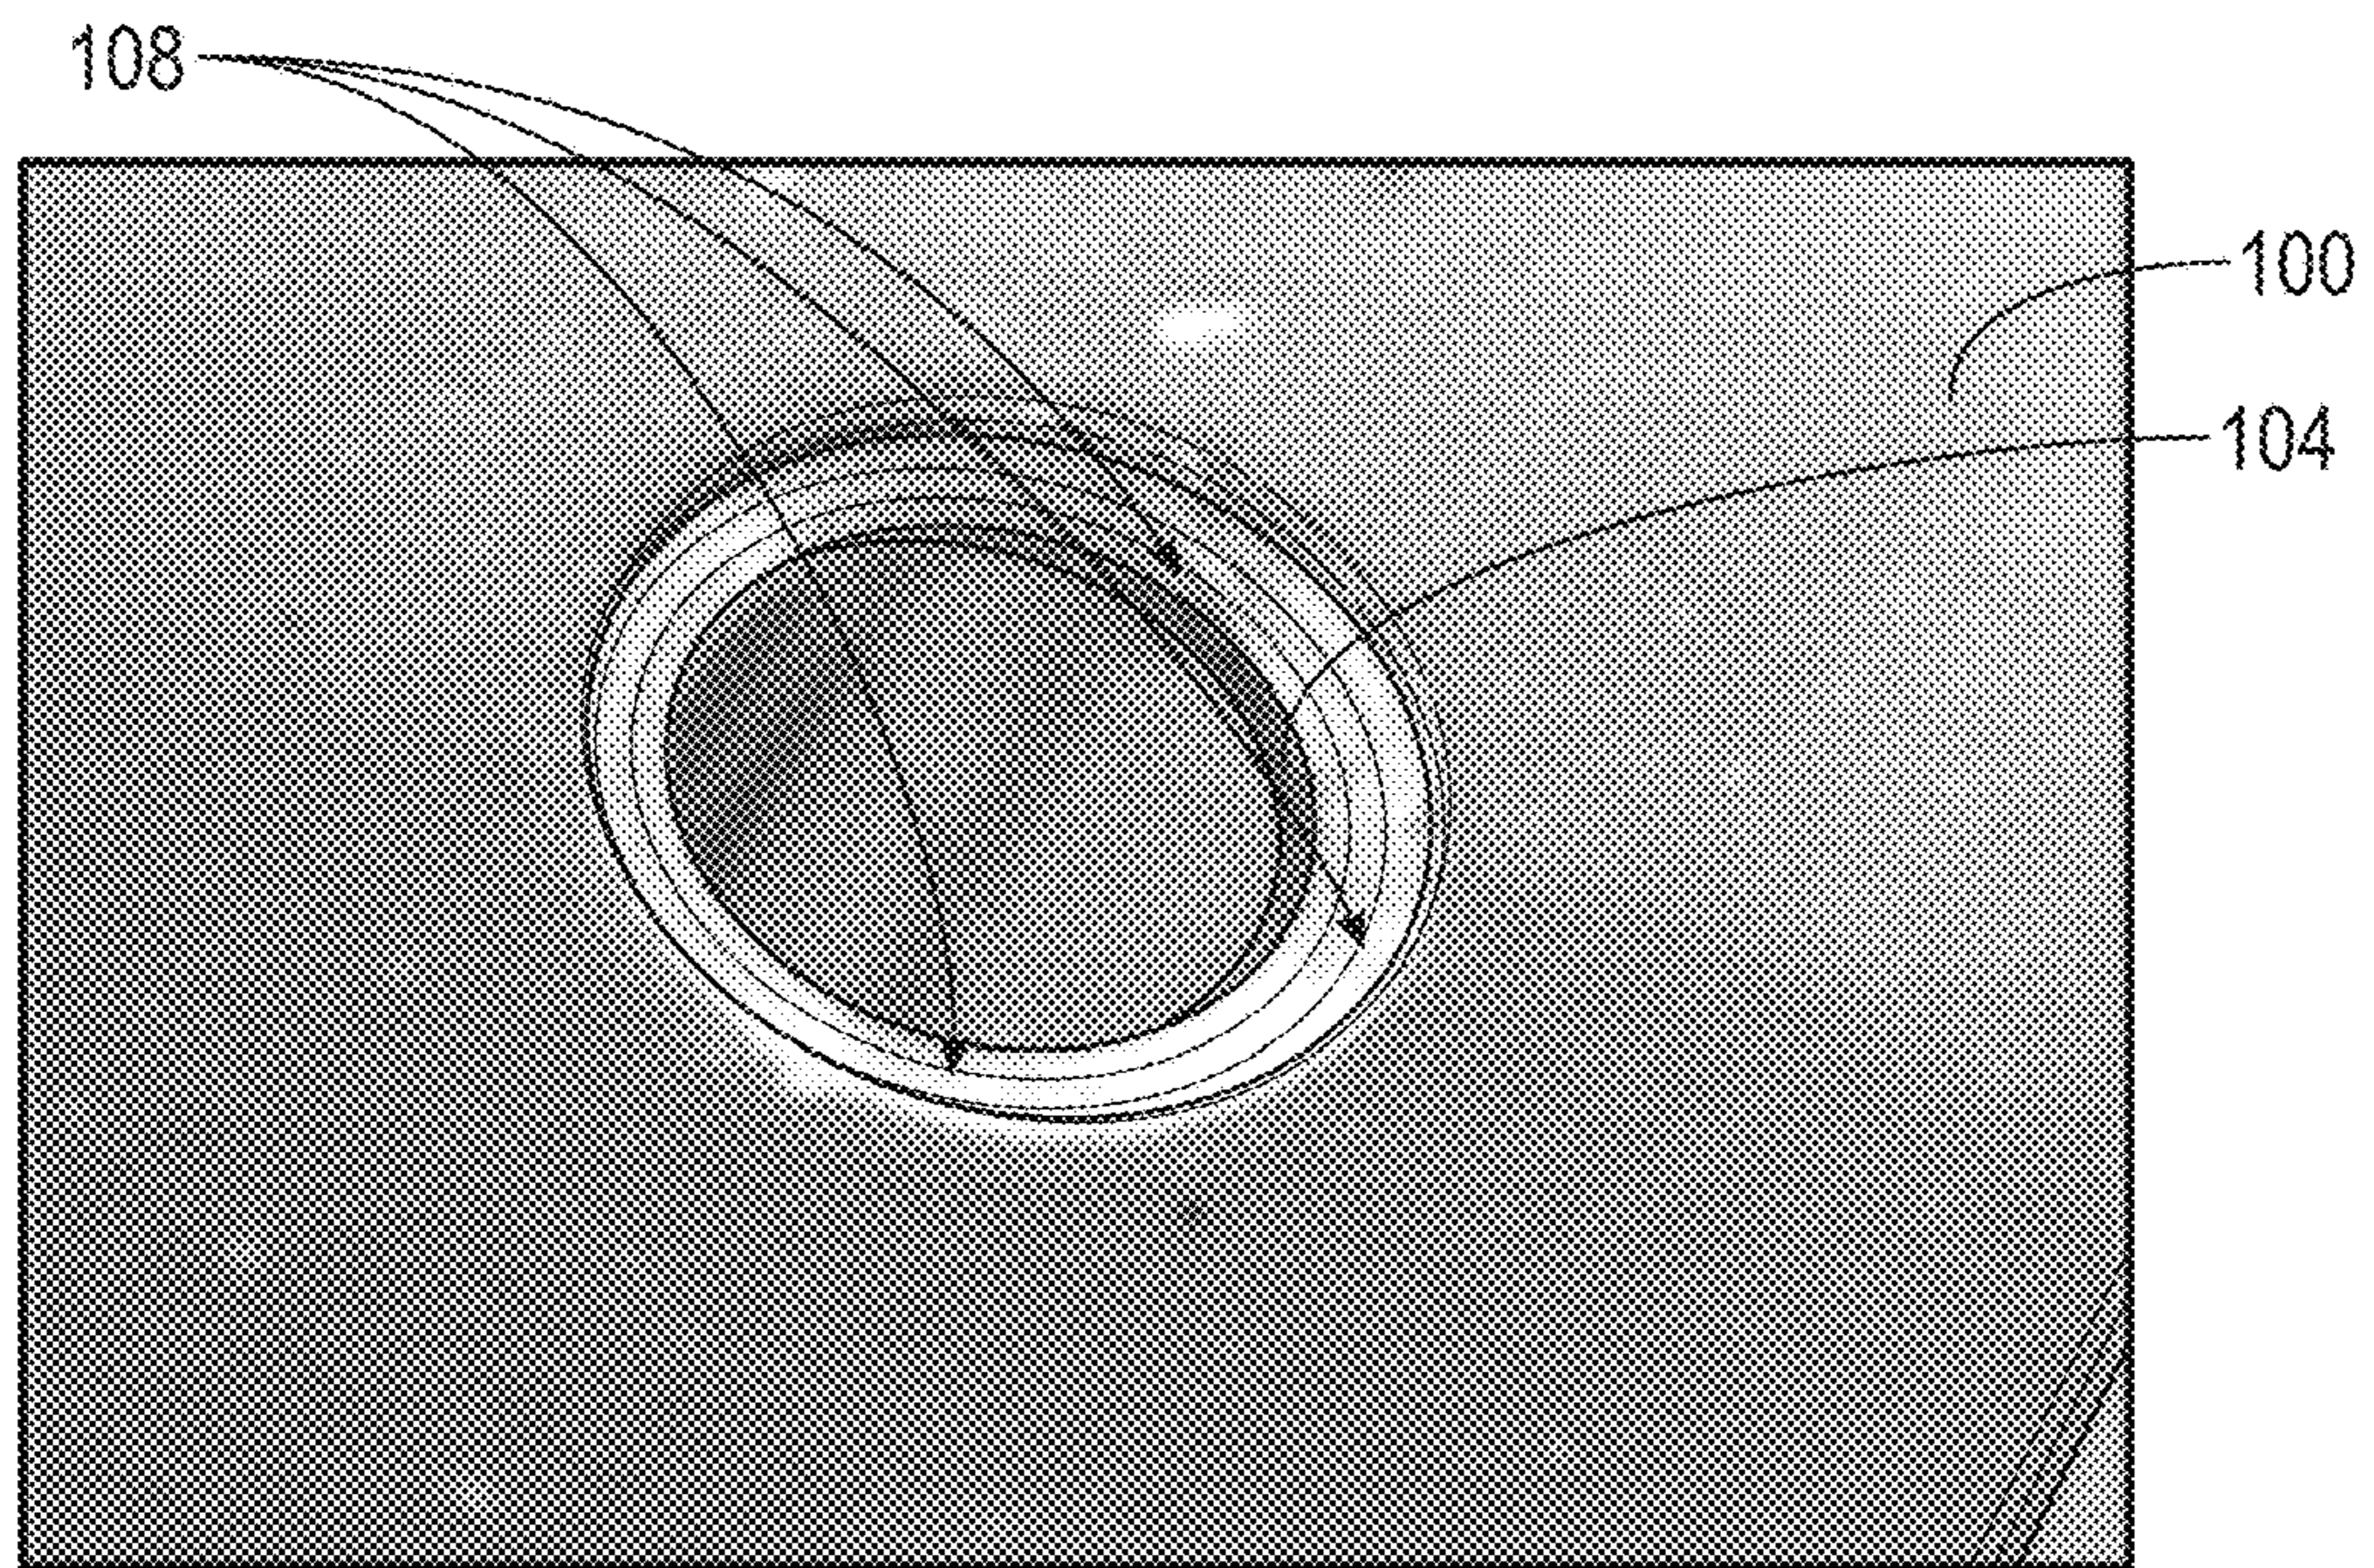
FIG. 2B is a pictorial representation of a worn fastener hole in an aircraft panel according to an illustrative embodiment;

FIG. 2B provides a pictorial representation of the wear occurring at the fastener hole 104 and chamfer 108 on the aircraft panel 100. Note specifically the chaffing wear around the fastener hole 104 in the chamfer 108 portion. The damage to the fastener hole 104 and chamfer 108 caused by chaffing results in many of the aforementioned problems. In the example of an aircraft panel 100, the cost for replacing the panel in the case where such wear is identified can be exorbitant and almost prohibitive to maintain operation of the aircraft. Therefore, a cold spray repair method that

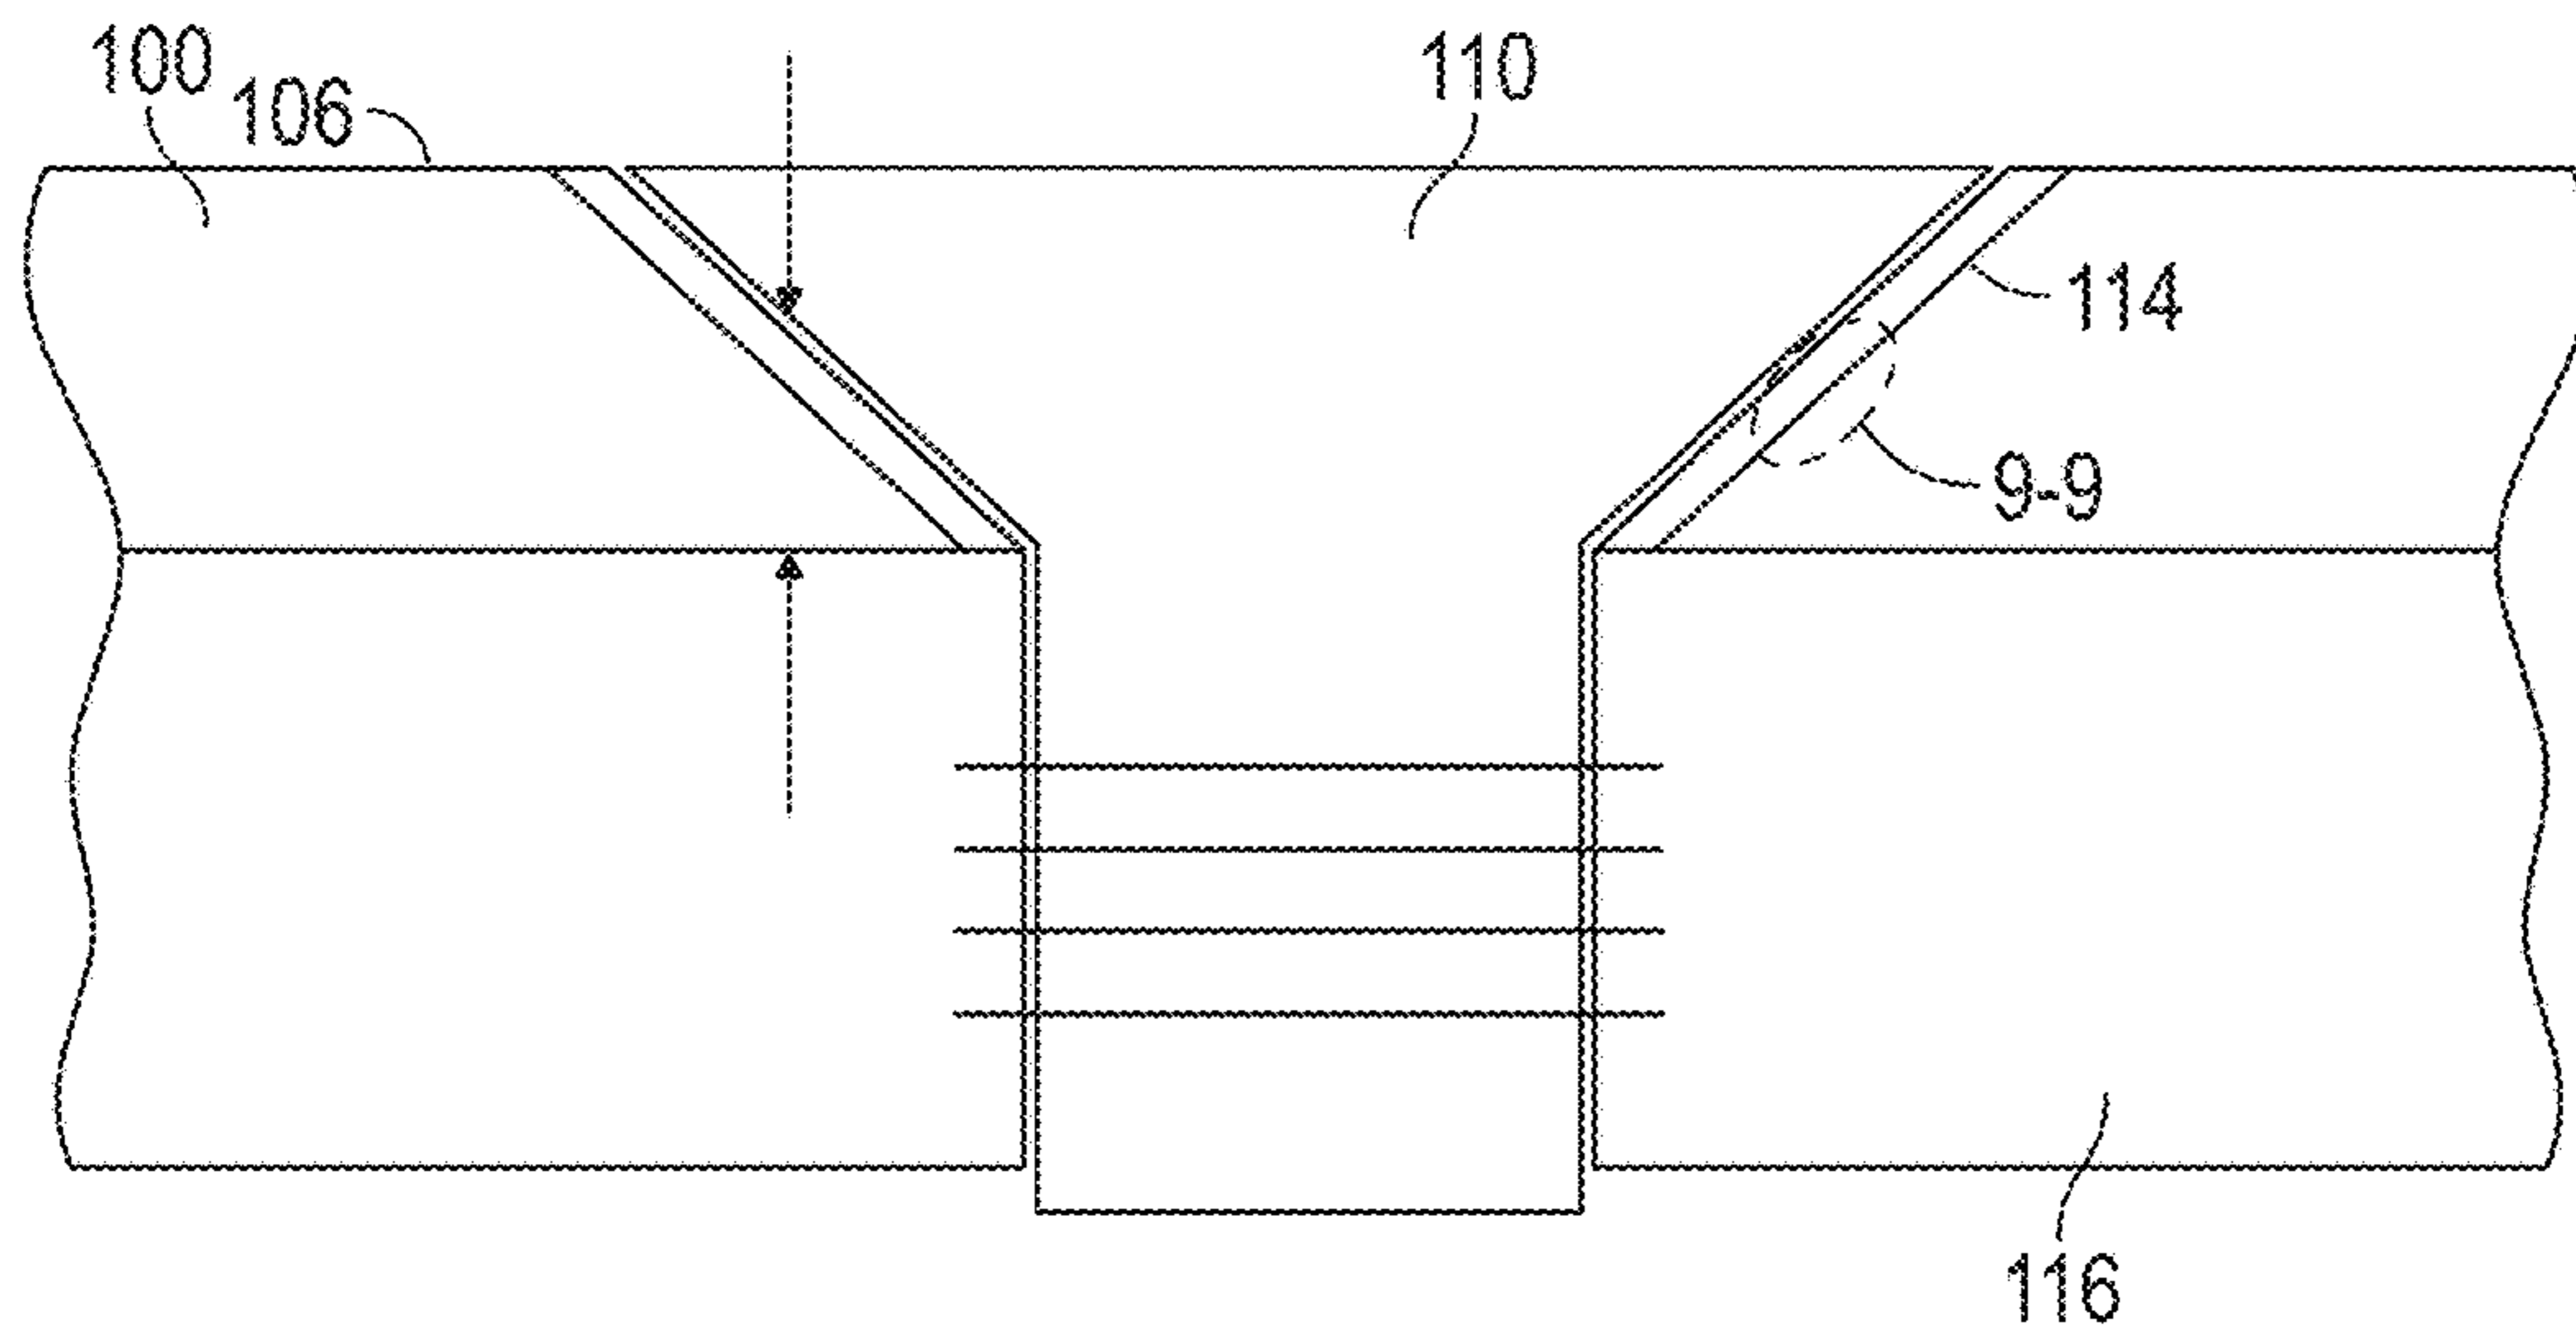
FIG. 3 is a pictorial illustration of a sectional view taken along line 3-3 in FIG. 8 according to an illustrative embodiment;

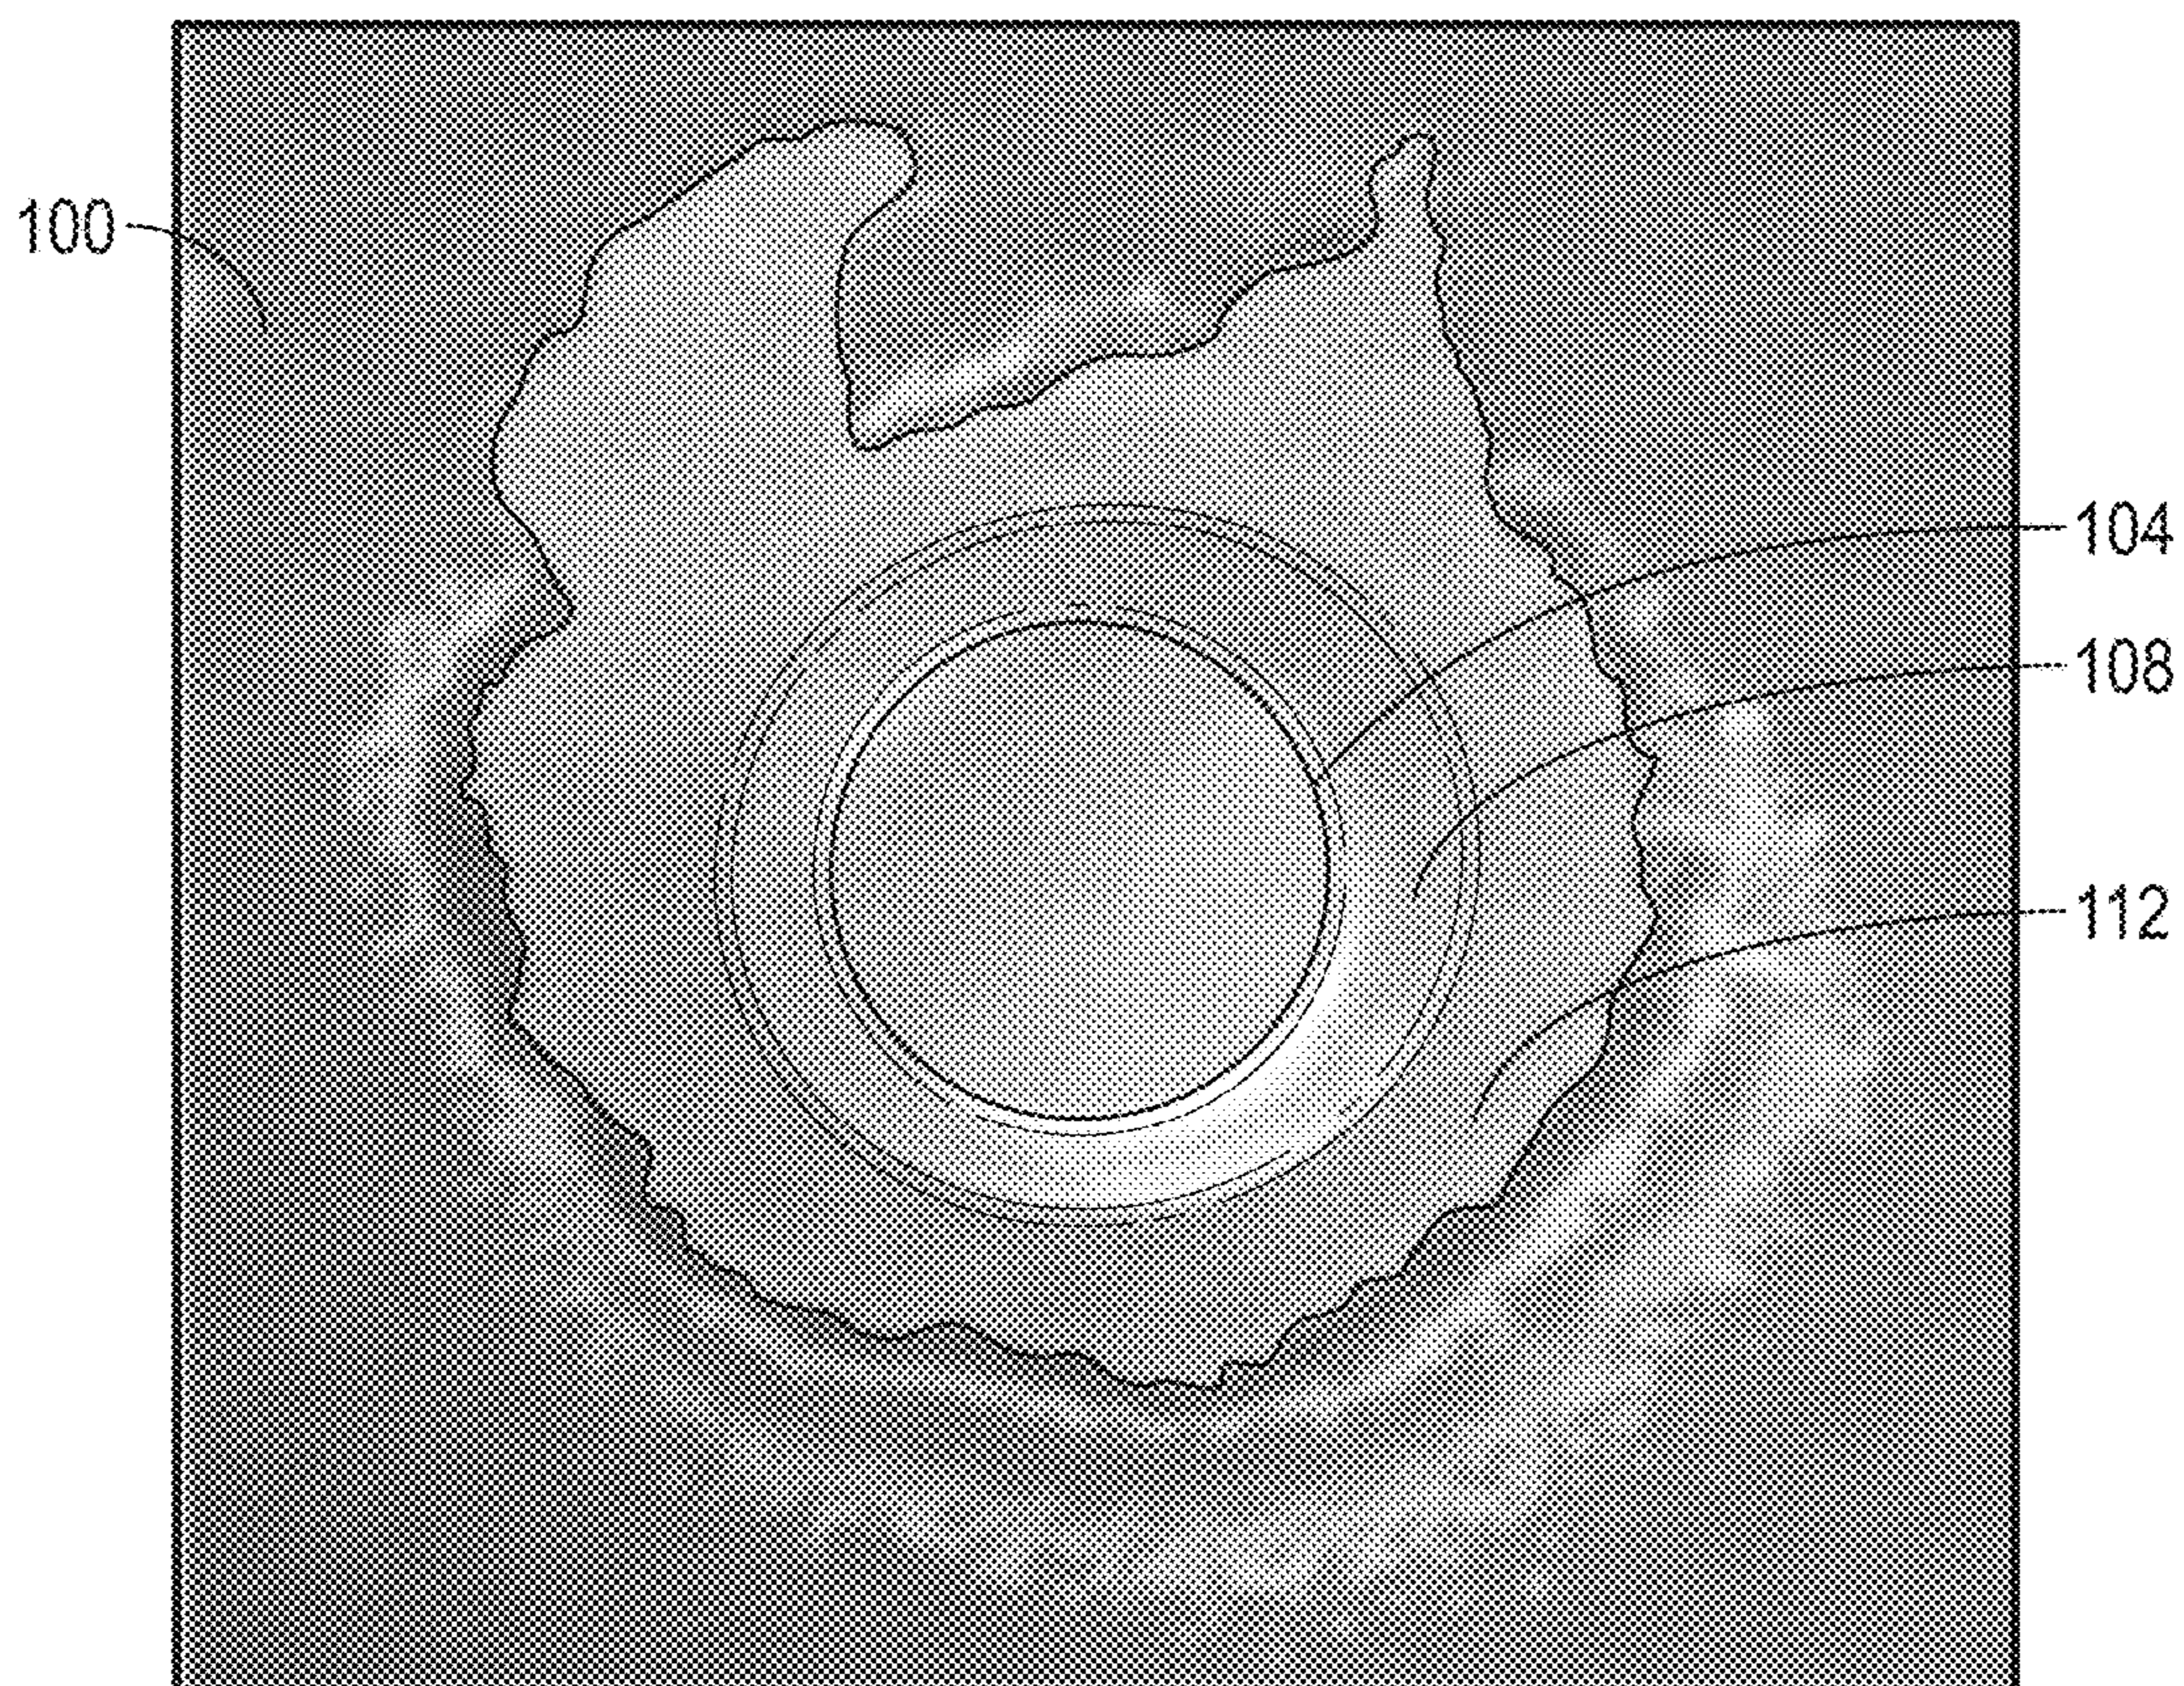
FIG. 4 is a pictorial representation of a fastener hole in an aircraft panel prepped for cold spray application in accordance with an illustrative embodiment;

According to an embodiment of the invention, a fastener hole **104** in need of repair may undergo one or more of the following operations to fully repair and reclaim the fastener hole and aircraft panel using cold spray repair methods of the present invention. FIG. **4** provides a pictorial illustration of an aircraft panel **100** where the fastener hole **104** and chamfer **108** and material of the panel **100** about the chamfer **108** is cleaned and prepped prior to cold spray deposition. One method of cleaning and prepping includes grit blasting the fastener hole **104**, chamfer **108** and surrounding portion **112** to remove paint from the area and to enhance bonding to the surface. According to an exemplary aspect, using grit blasting, paint and other adhesion impediments are removed using AL_2O_3 grit blasting which includes, for example, a combination of grit blast (80 grit AL_2O_3), compressed air, and 6061 aluminum powder. Other methods and materials for prepping, cleaning or otherwise providing optimal surface adhesion properties are contemplated. At some point in the process before cold spray deposition, the plurality of fastener holes **104** or the implicated fastener holes in an aircraft panel **100** may be templated to identify the position and/or centers of each of the fastener holes for subsequent repair and reclamation. Templates, for example, may be created from Mylar to record the position and center location of the fastener holes prior to performing cold spray deposition, repair and reclamation.
