(12) **United States Patent**
Widener et al.

(10) **Patent No.:** **US 10,099,322 B2**
(45) **Date of Patent:** **Oct. 16, 2018**

(54) **METHODS FOR COLD SPRAY REPAIR**

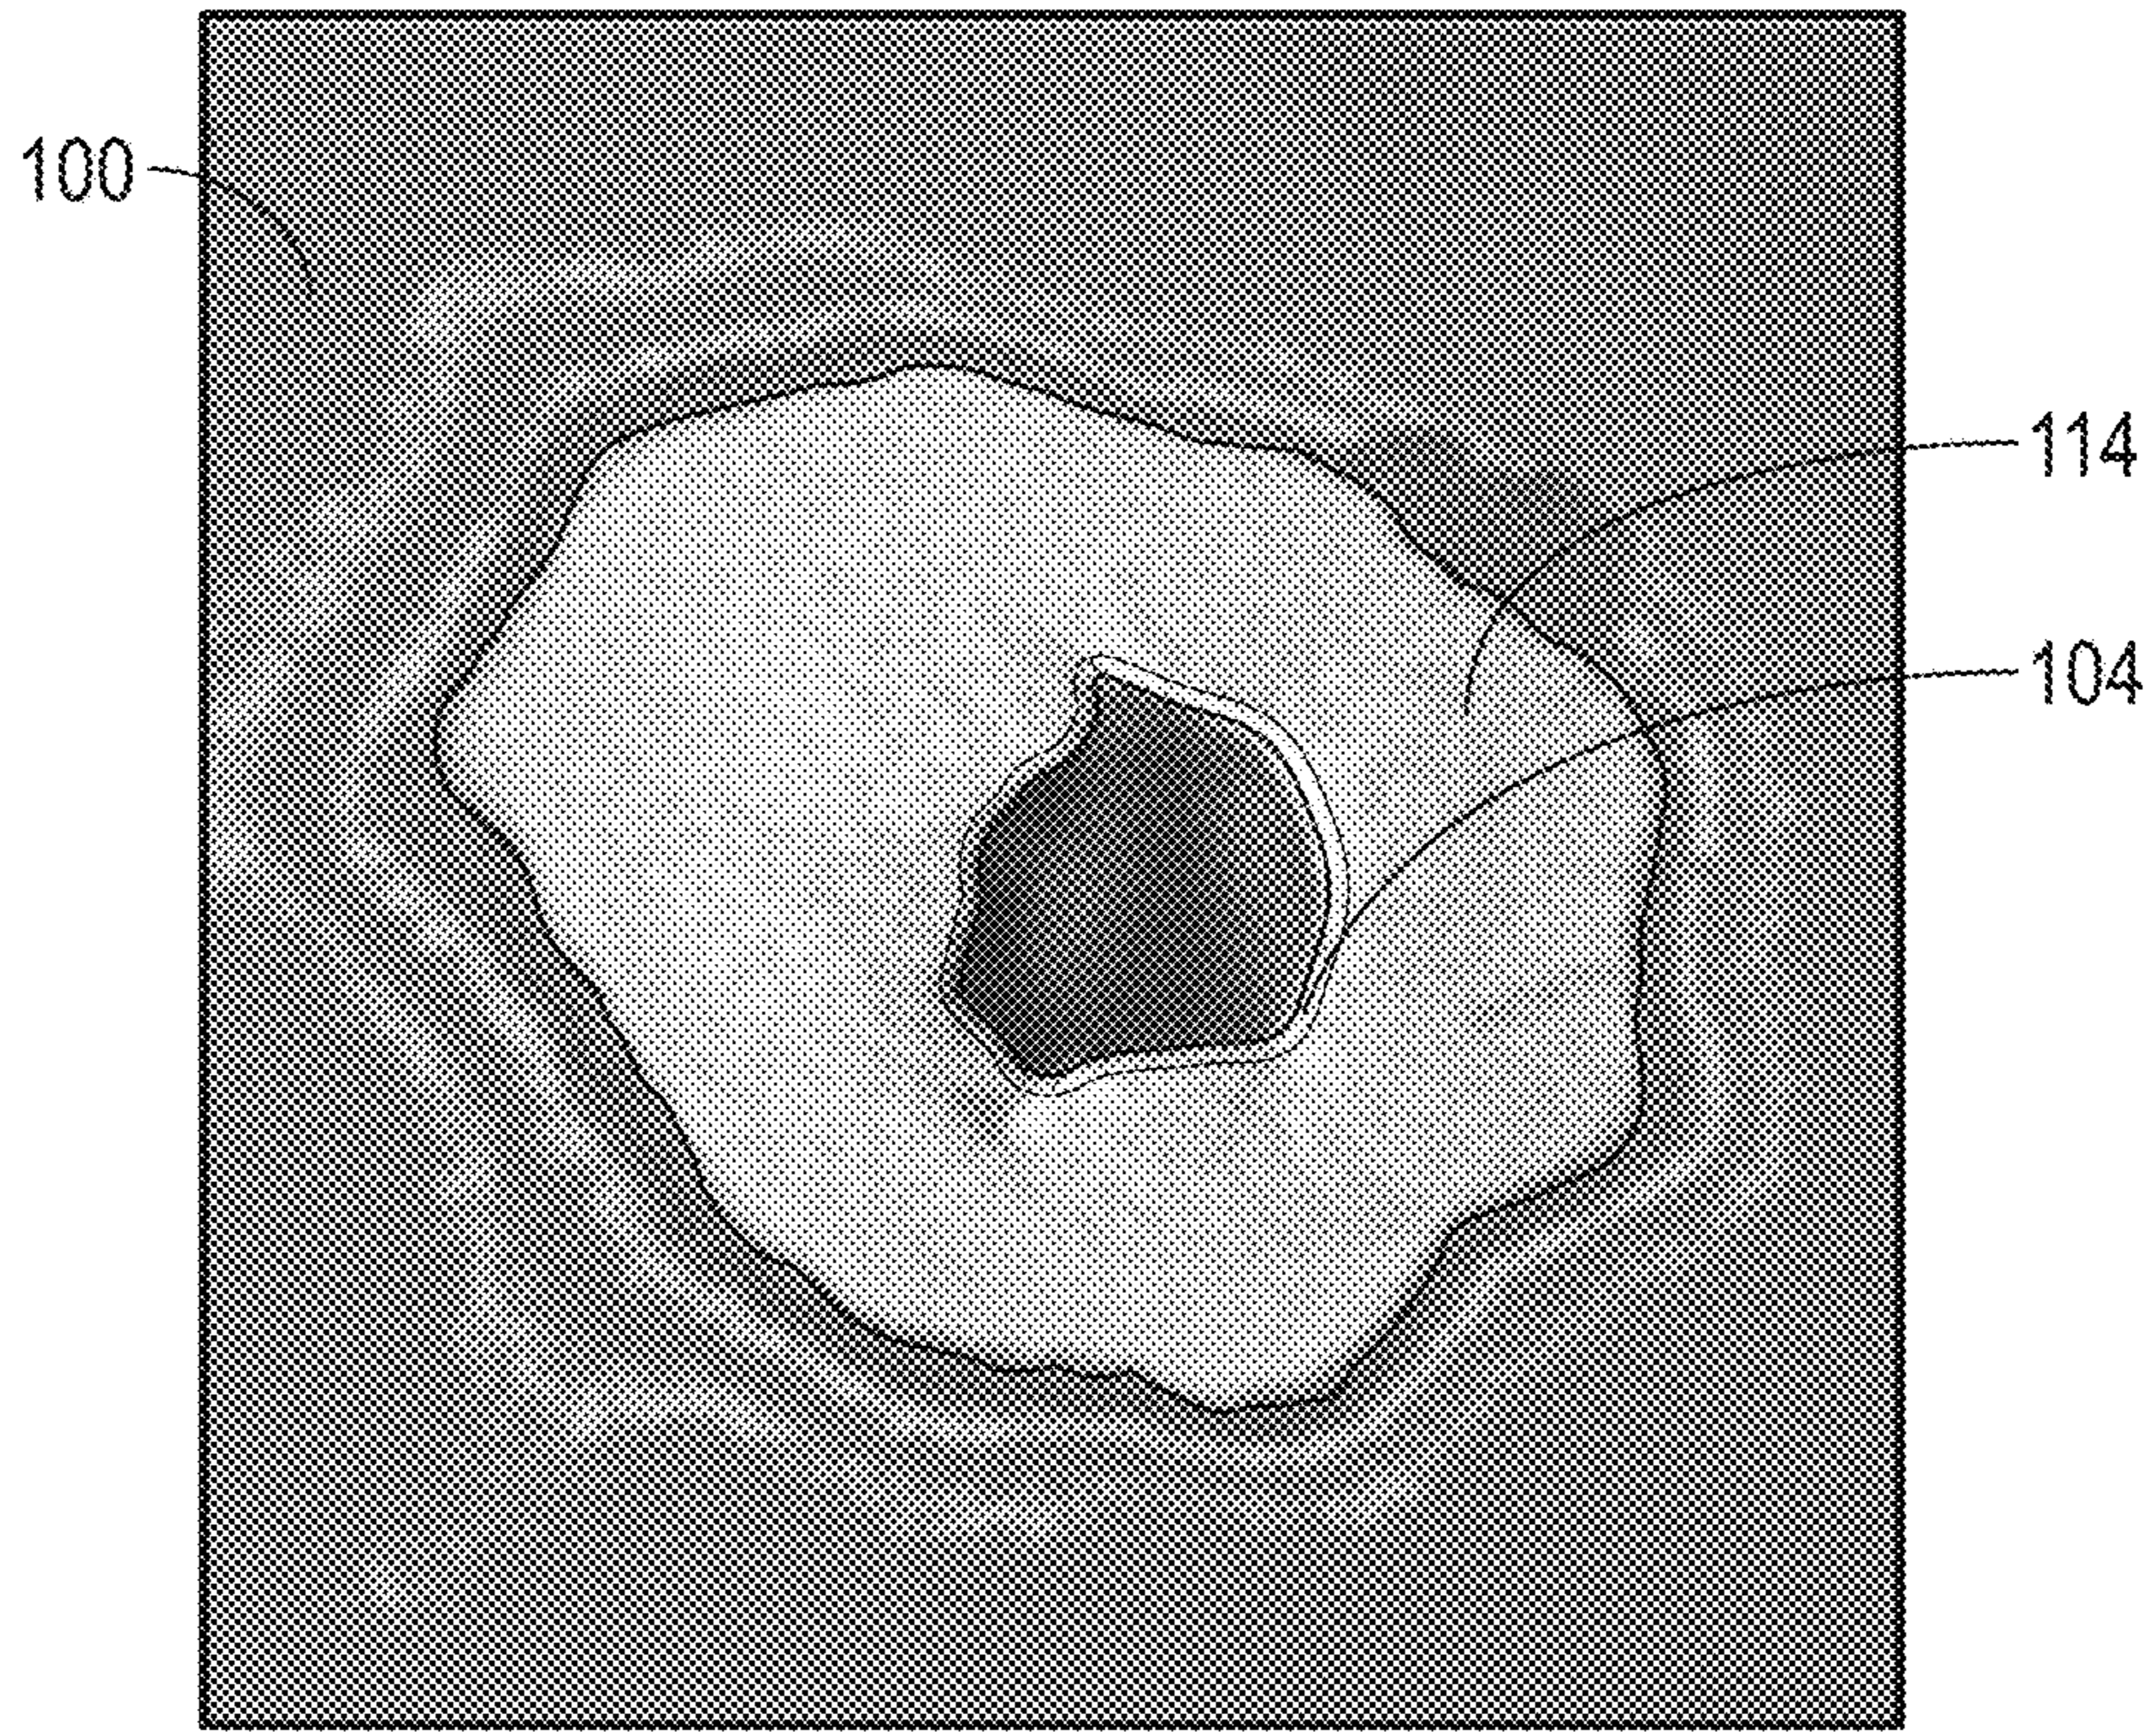
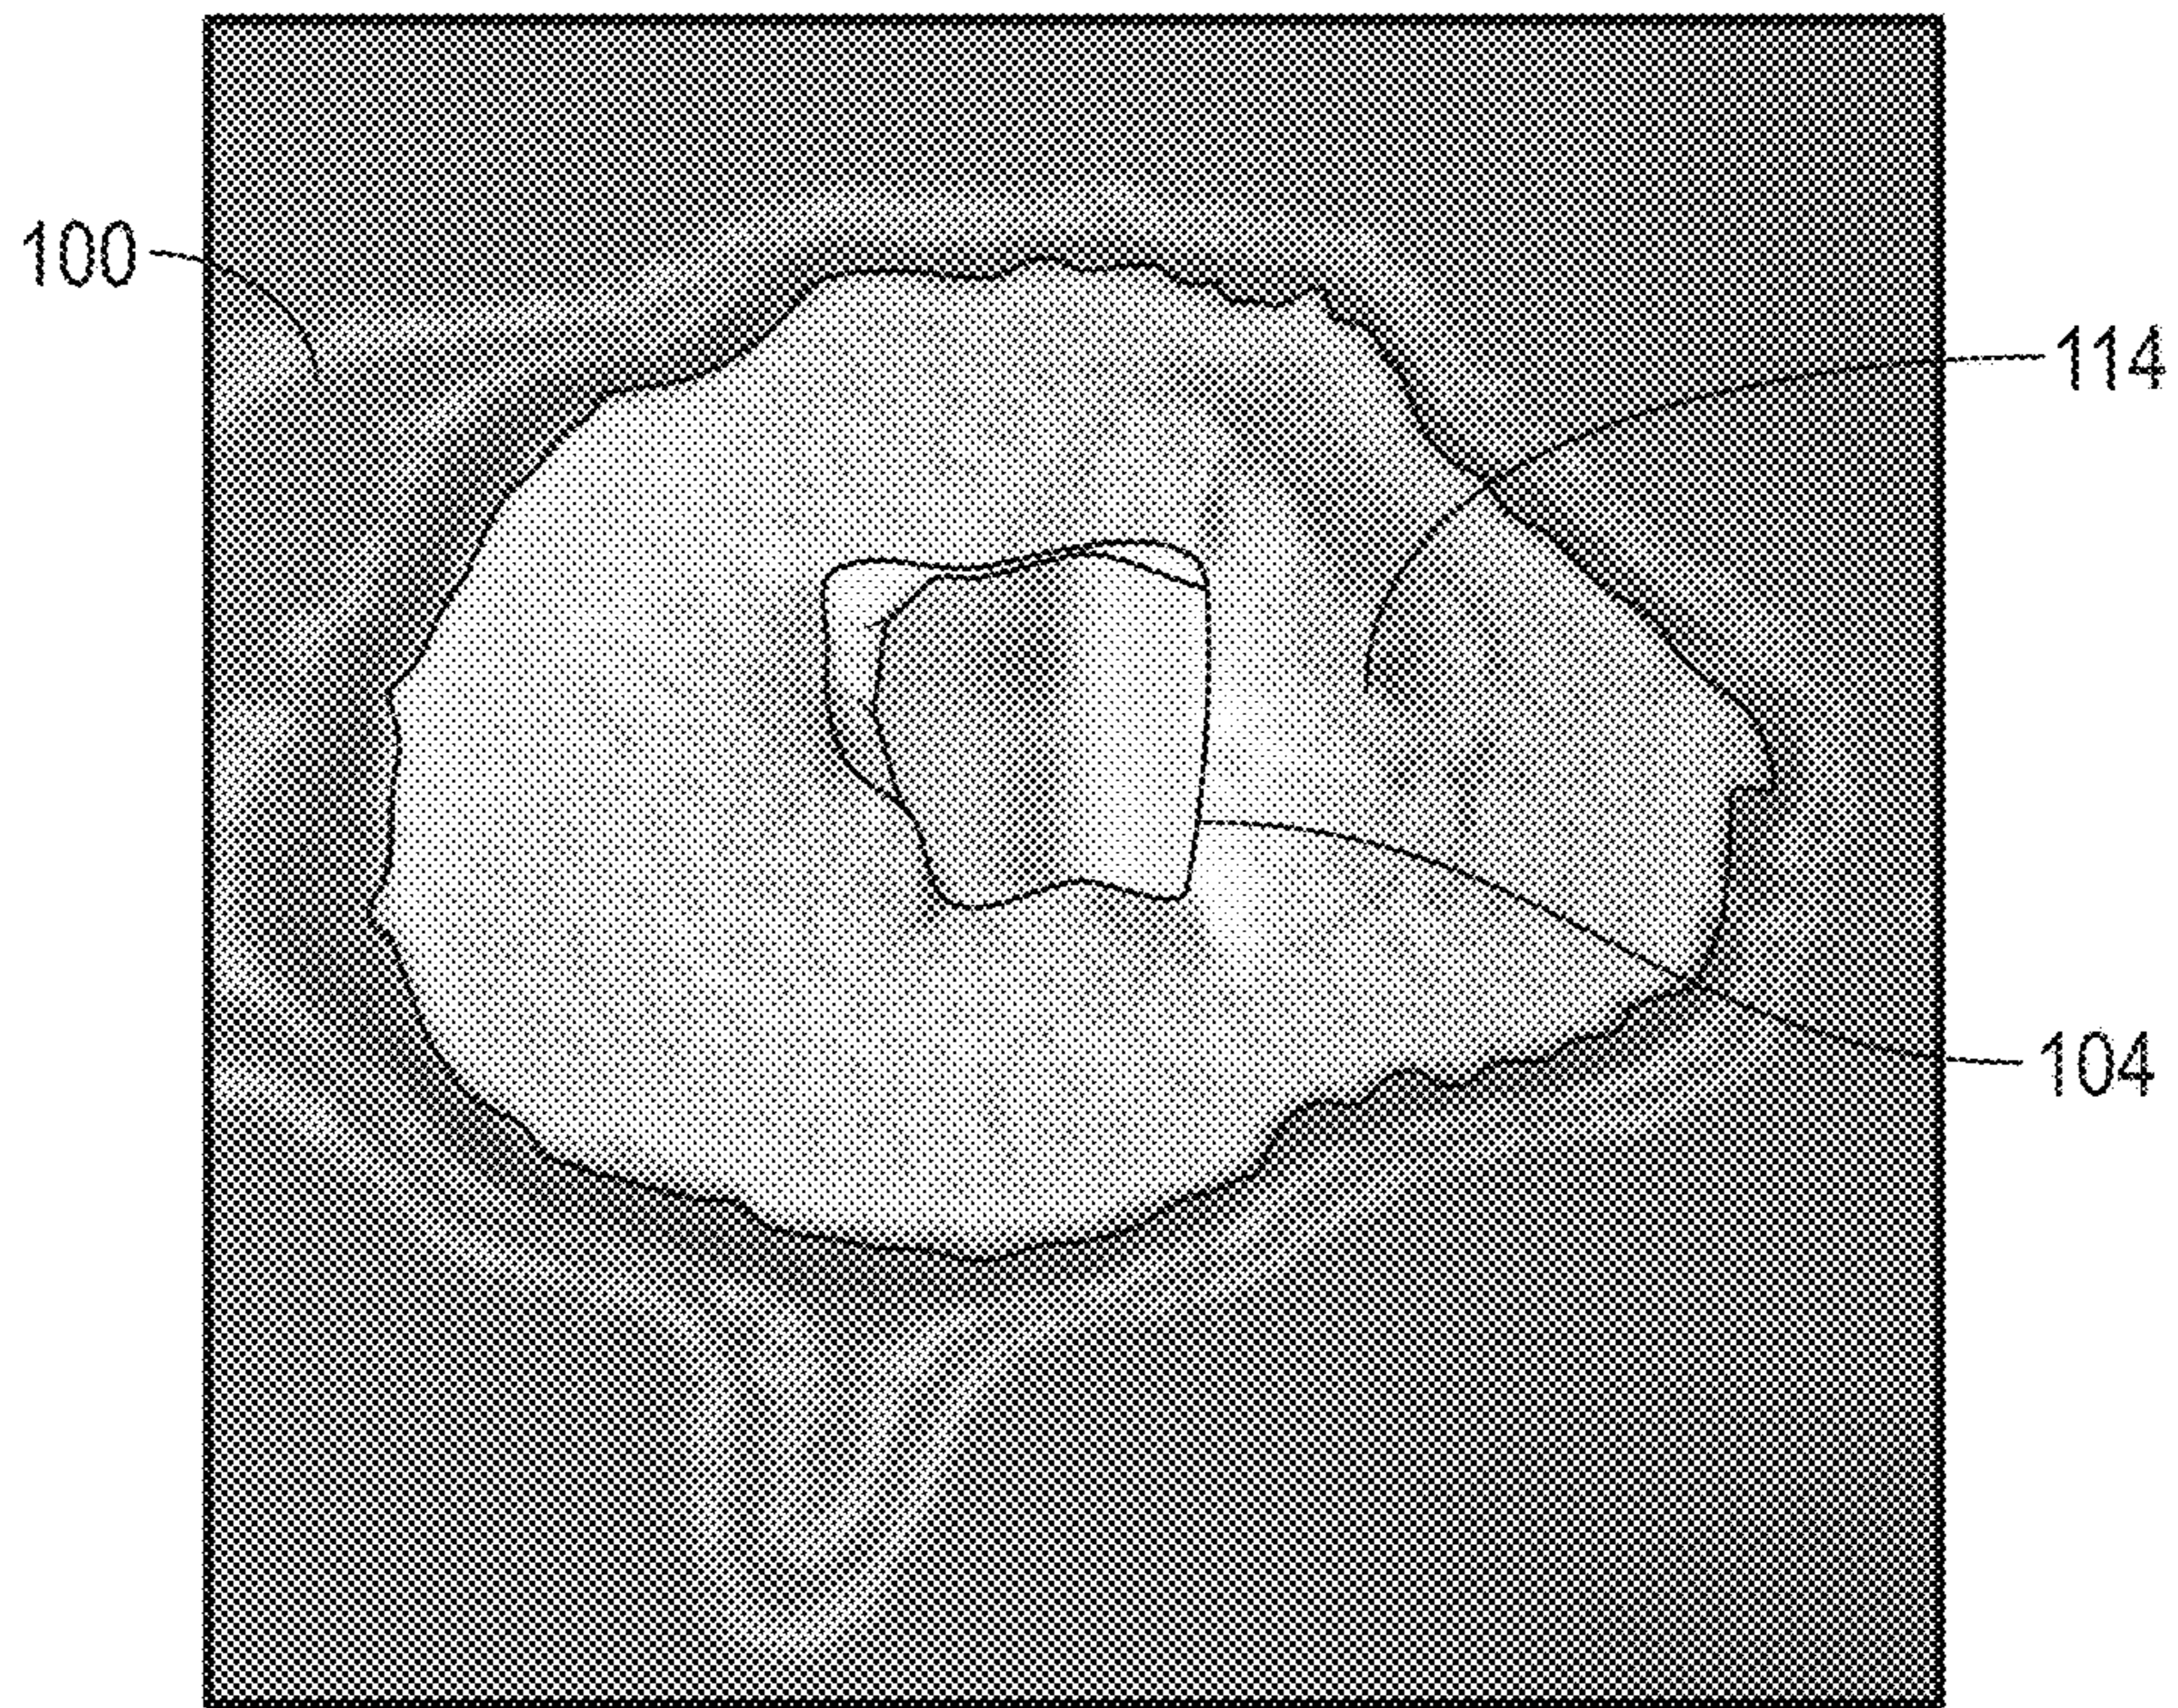
FIG. 5 is a pictorial representation of a pair of fastener holes in an aircraft panel with deposited cold spray materials in accordance with an illustrative embodiment;

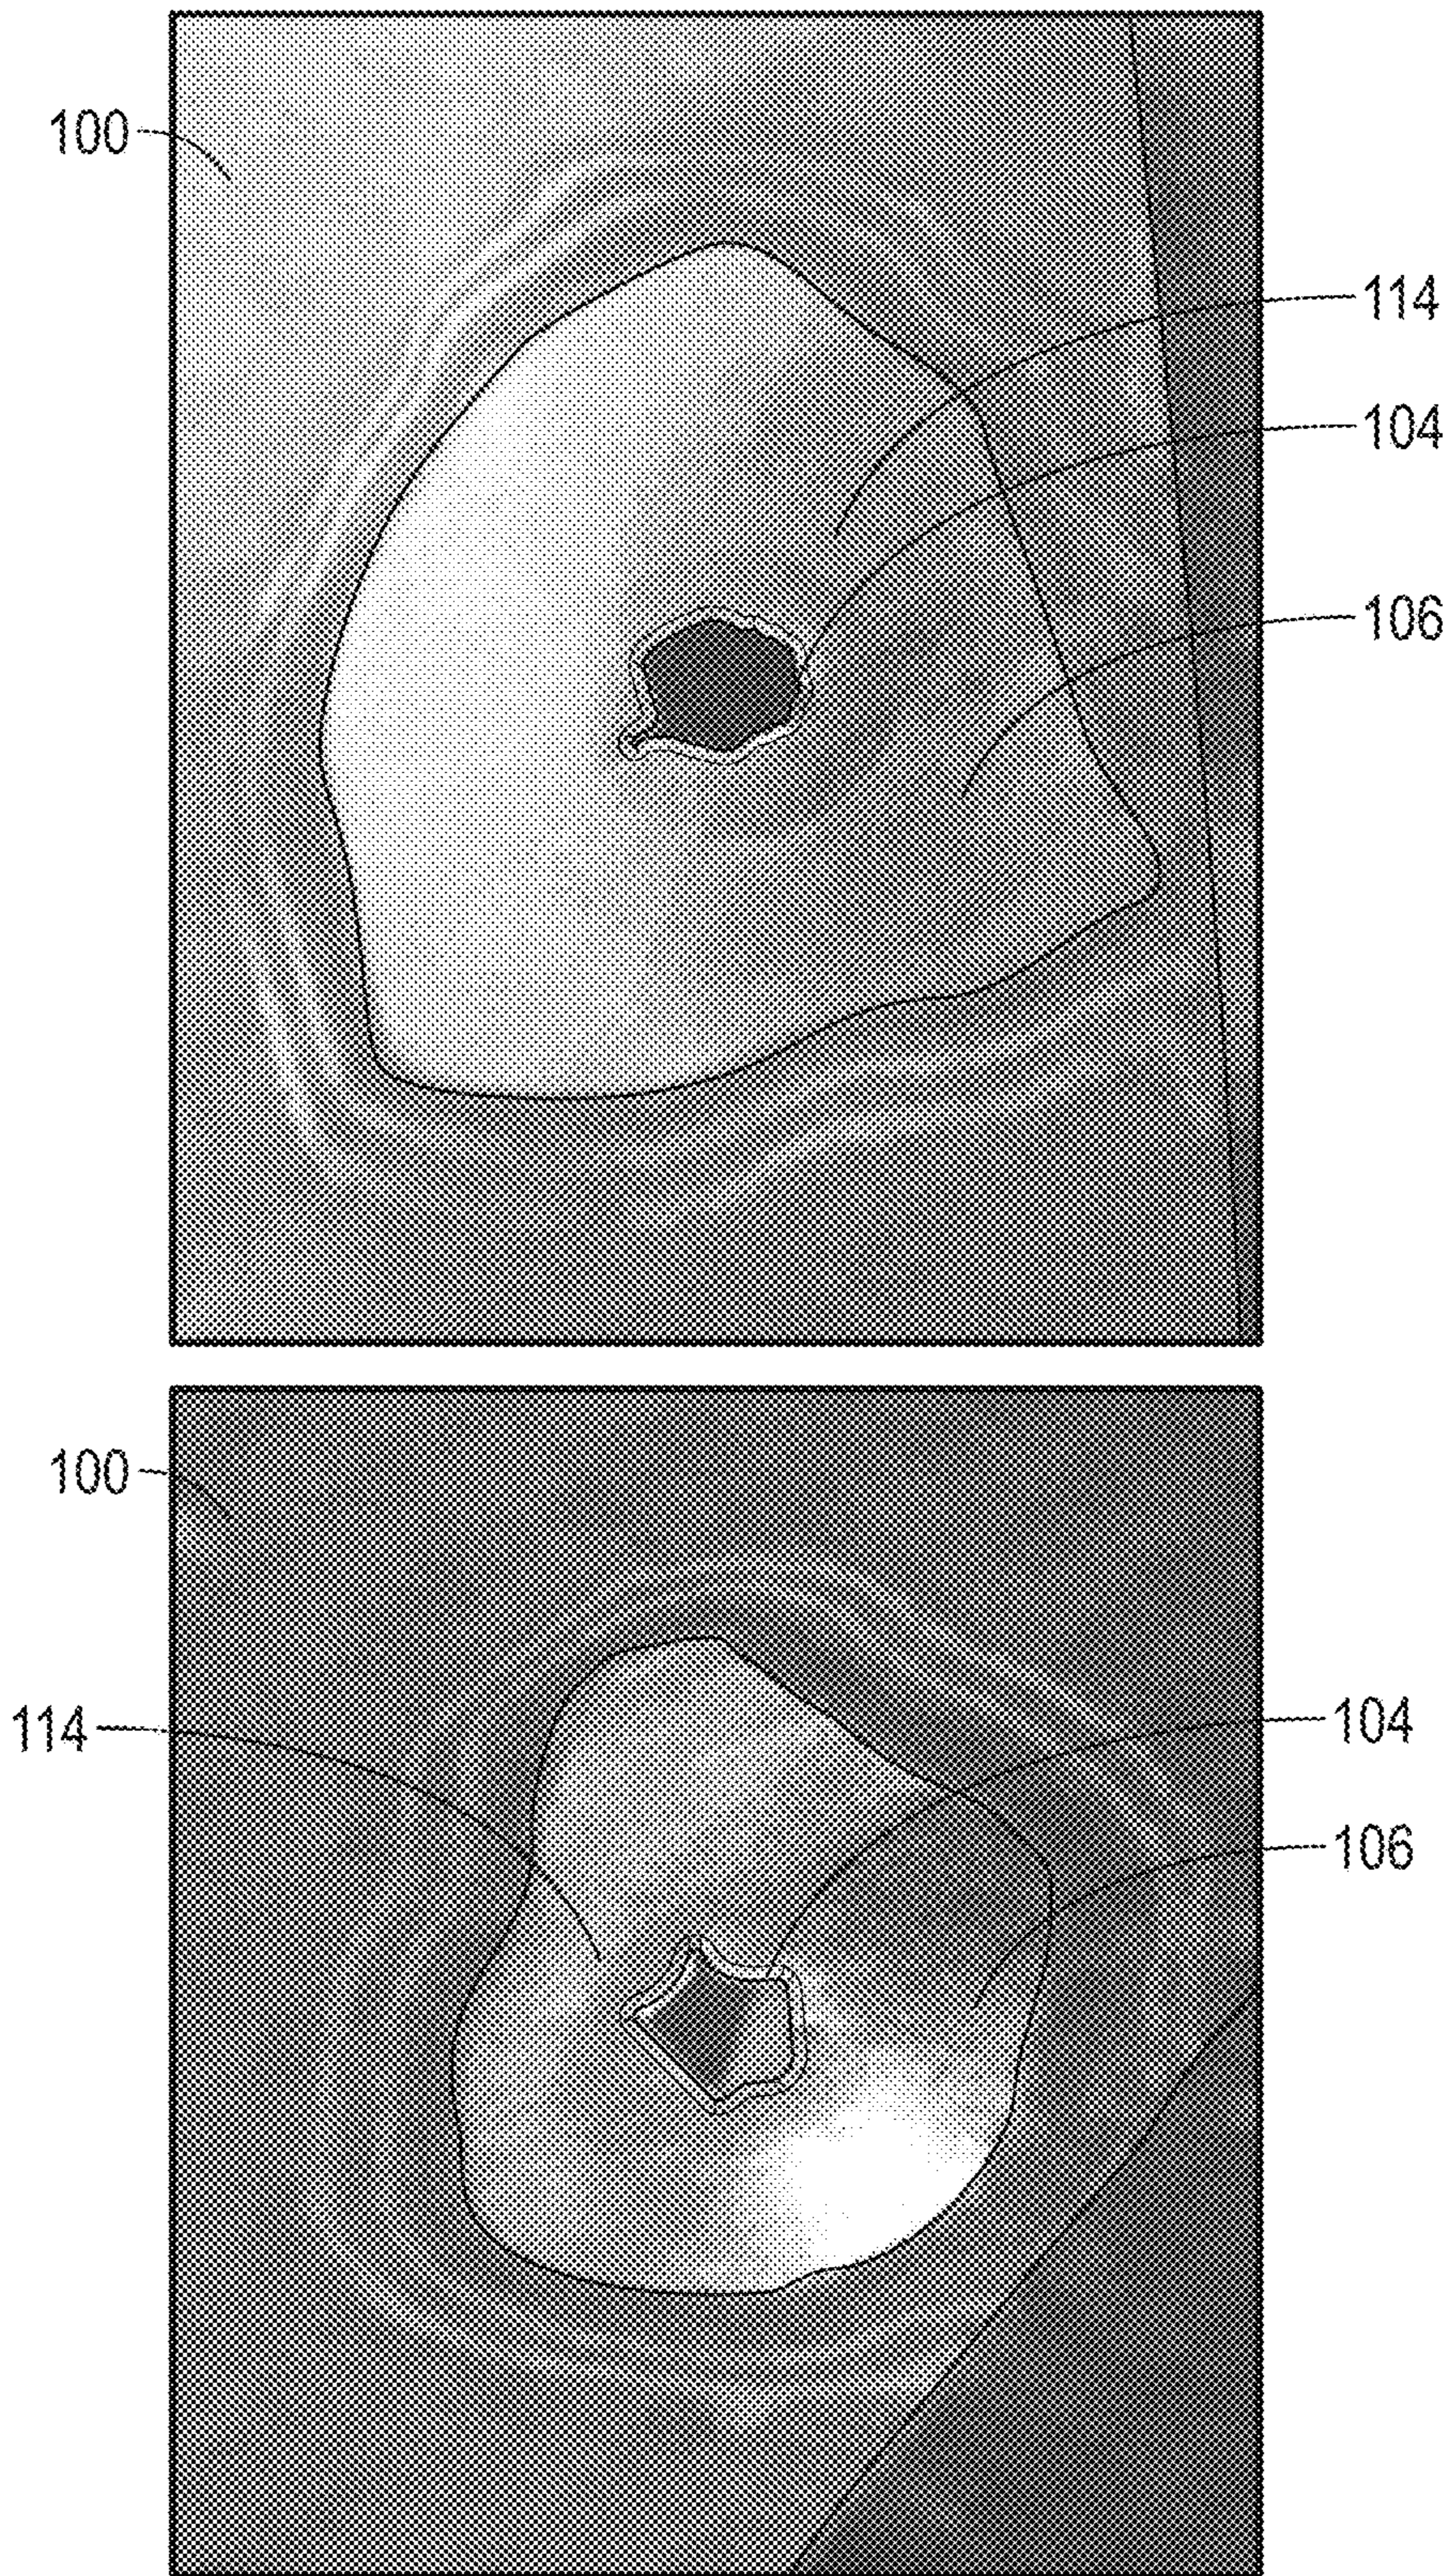
FIG. 6 is a pictorial representation of a pair of fastener holes in an aircraft panel with excess cold spray material removed in accordance with an illustrative embodiment;

FIG. **6** provides pictorial illustrations of a pair of photos for fastener holes **104** after the cold spray material **114** has been removed so as to be flush with the outer surface **106** of the aircraft panel **100**. Removal of excess cold spray material **114** may be accomplished by grinding followed subsequently by polishing. The removal of excess cold spray material **114** provides a flush surface ensuring that the cold spray material is only on the interior of the fastener hole **104**,

and not on the top outer surface **106** of the aircraft panel **100** (i.e., such that it does not increase the thickness of the aircraft panel **100** itself). Exemplary methods for removing cold spray material **114** from the surface of the aircraft panel **100** include, for example, grinding/polishing with a fine Scotch-Brite disk.

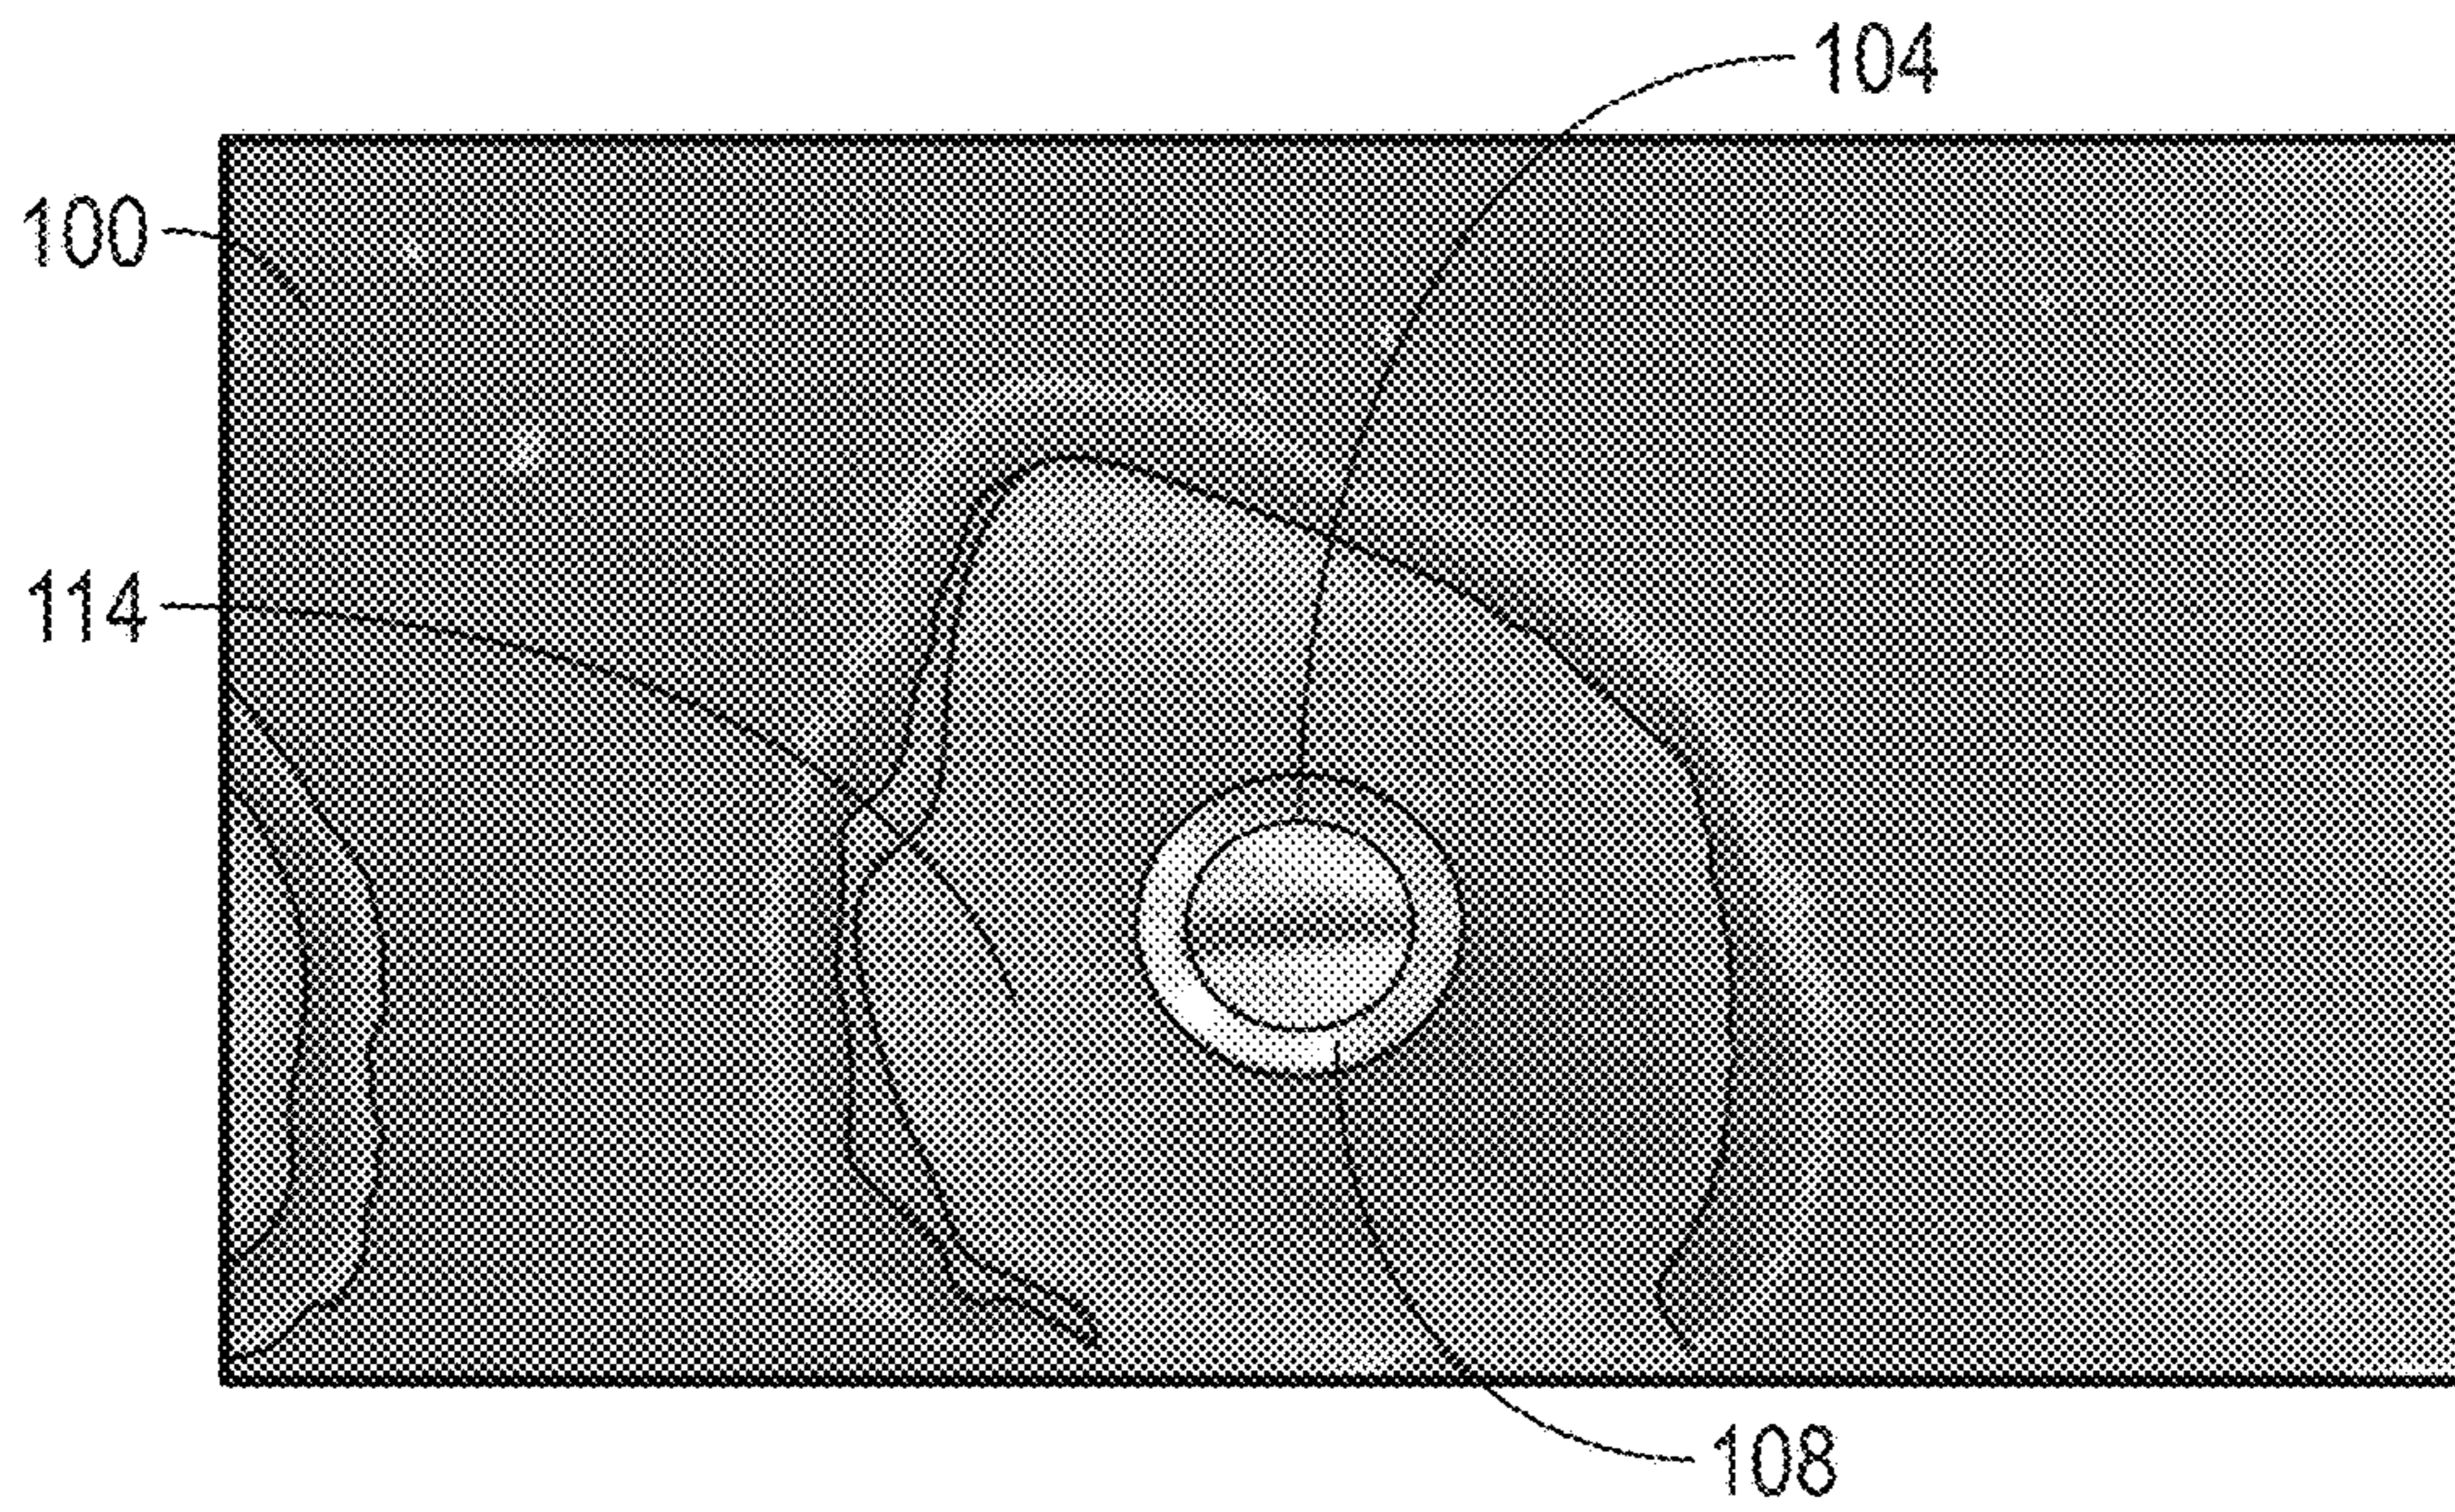
FIG. 7 is a pictorial representation of a fastener hole in an aircraft panel with a chamfer recut in the cold spray deposition in accordance with an illustrative embodiment;

Using, for example, the template created to identify the fastener **104** location and centers, machining may be performed using, for example, a micro-stop tool, to cut the chamfer **108** back into the fastener hole **104**. The chamfer **108** is cut by removing portions of the cold spray material **114** and recreating the desired taper or angle of the chamfer surface **108** relative to the fastener hole **104** and outer surface **106** of the aircraft panel **100**. FIG. **7** provides a pictorial illustration of a machined chamfer **108** about the fastener hole **104** where cold spray material **114** is removed by the machine to create the chamfer **108**. The fastener hole **104** may be located, positioned and centered using one or more of the aforementioned templates or described methods. Specifically, the chamfer **108** is designed to mirror the taper on the head of a fastener, such as a Tridair™ fastener.

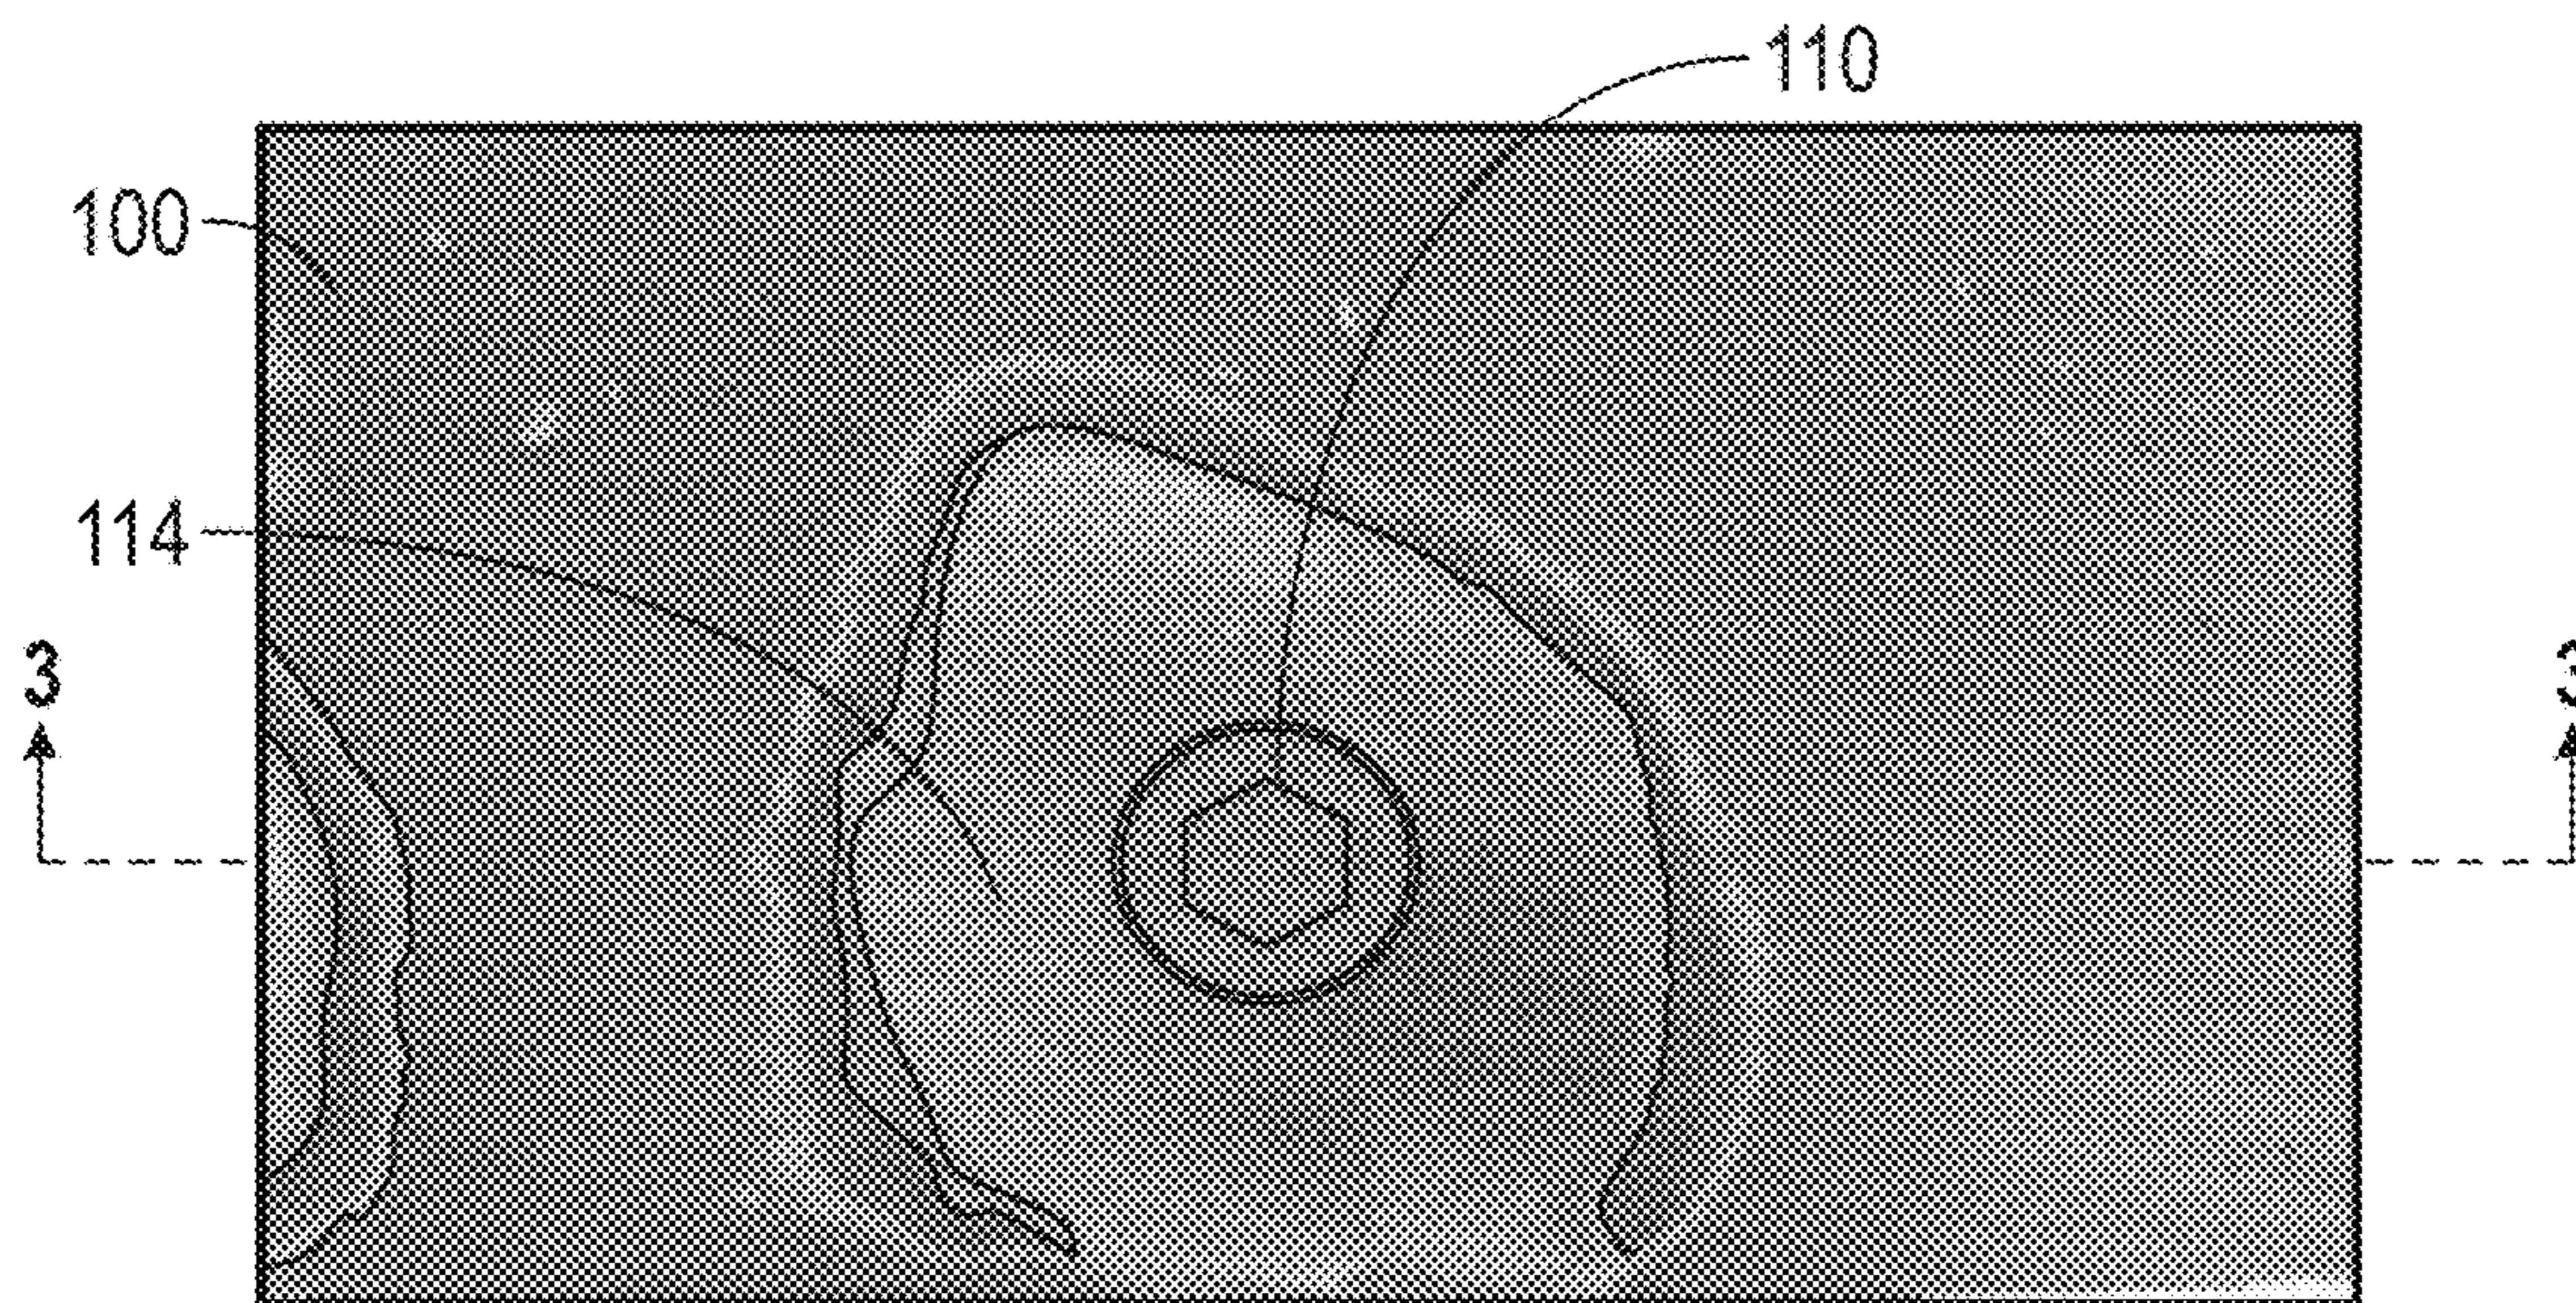
FIG. 8 is a pictorial representation of the fastener hole illustrated in FIG. 7 with a new fastener inserted there-through in accordance with an illustrative embodiment;

FIG. **8** provides a pictorial illustration of a new fastener **110** inserted into the fastener hole **104** of the aircraft panel **100**. Thus, after the chamfer **108** has been prepared as illustrated in FIG. **7** and new fastener **110** (e.g., a new Tridium™ rivet or Tridair™ fastener) may be inserted therethrough as illustrated in FIG. **8**. FIG. **3** provides a pictorial illustration of a sectional view taken along line 3-3 in FIG. **8**. As can be seen in FIG. **3**, the top of the fastener **110** now sits flush with the outer surface **106** of the aircraft panel **100** to enable laminar airflow over the fastener head in the aircraft panel. The cold spray material **114** creates the chamfer **108** in contact with the head of the fastener **110**. The cold spray material **114** within the chamfered region is generally under compression (as shown by the two opposing arrows). Thus, it will transfer the panel loads to the fastener just as effective as was previously done (when the panel was new) without the cold spray layer or if a new OEM aircraft panel were purchased and used. FIG. **3** also illustrates how the aircraft panel **100** is secured to the aircraft frame **116** using fastener **110**.

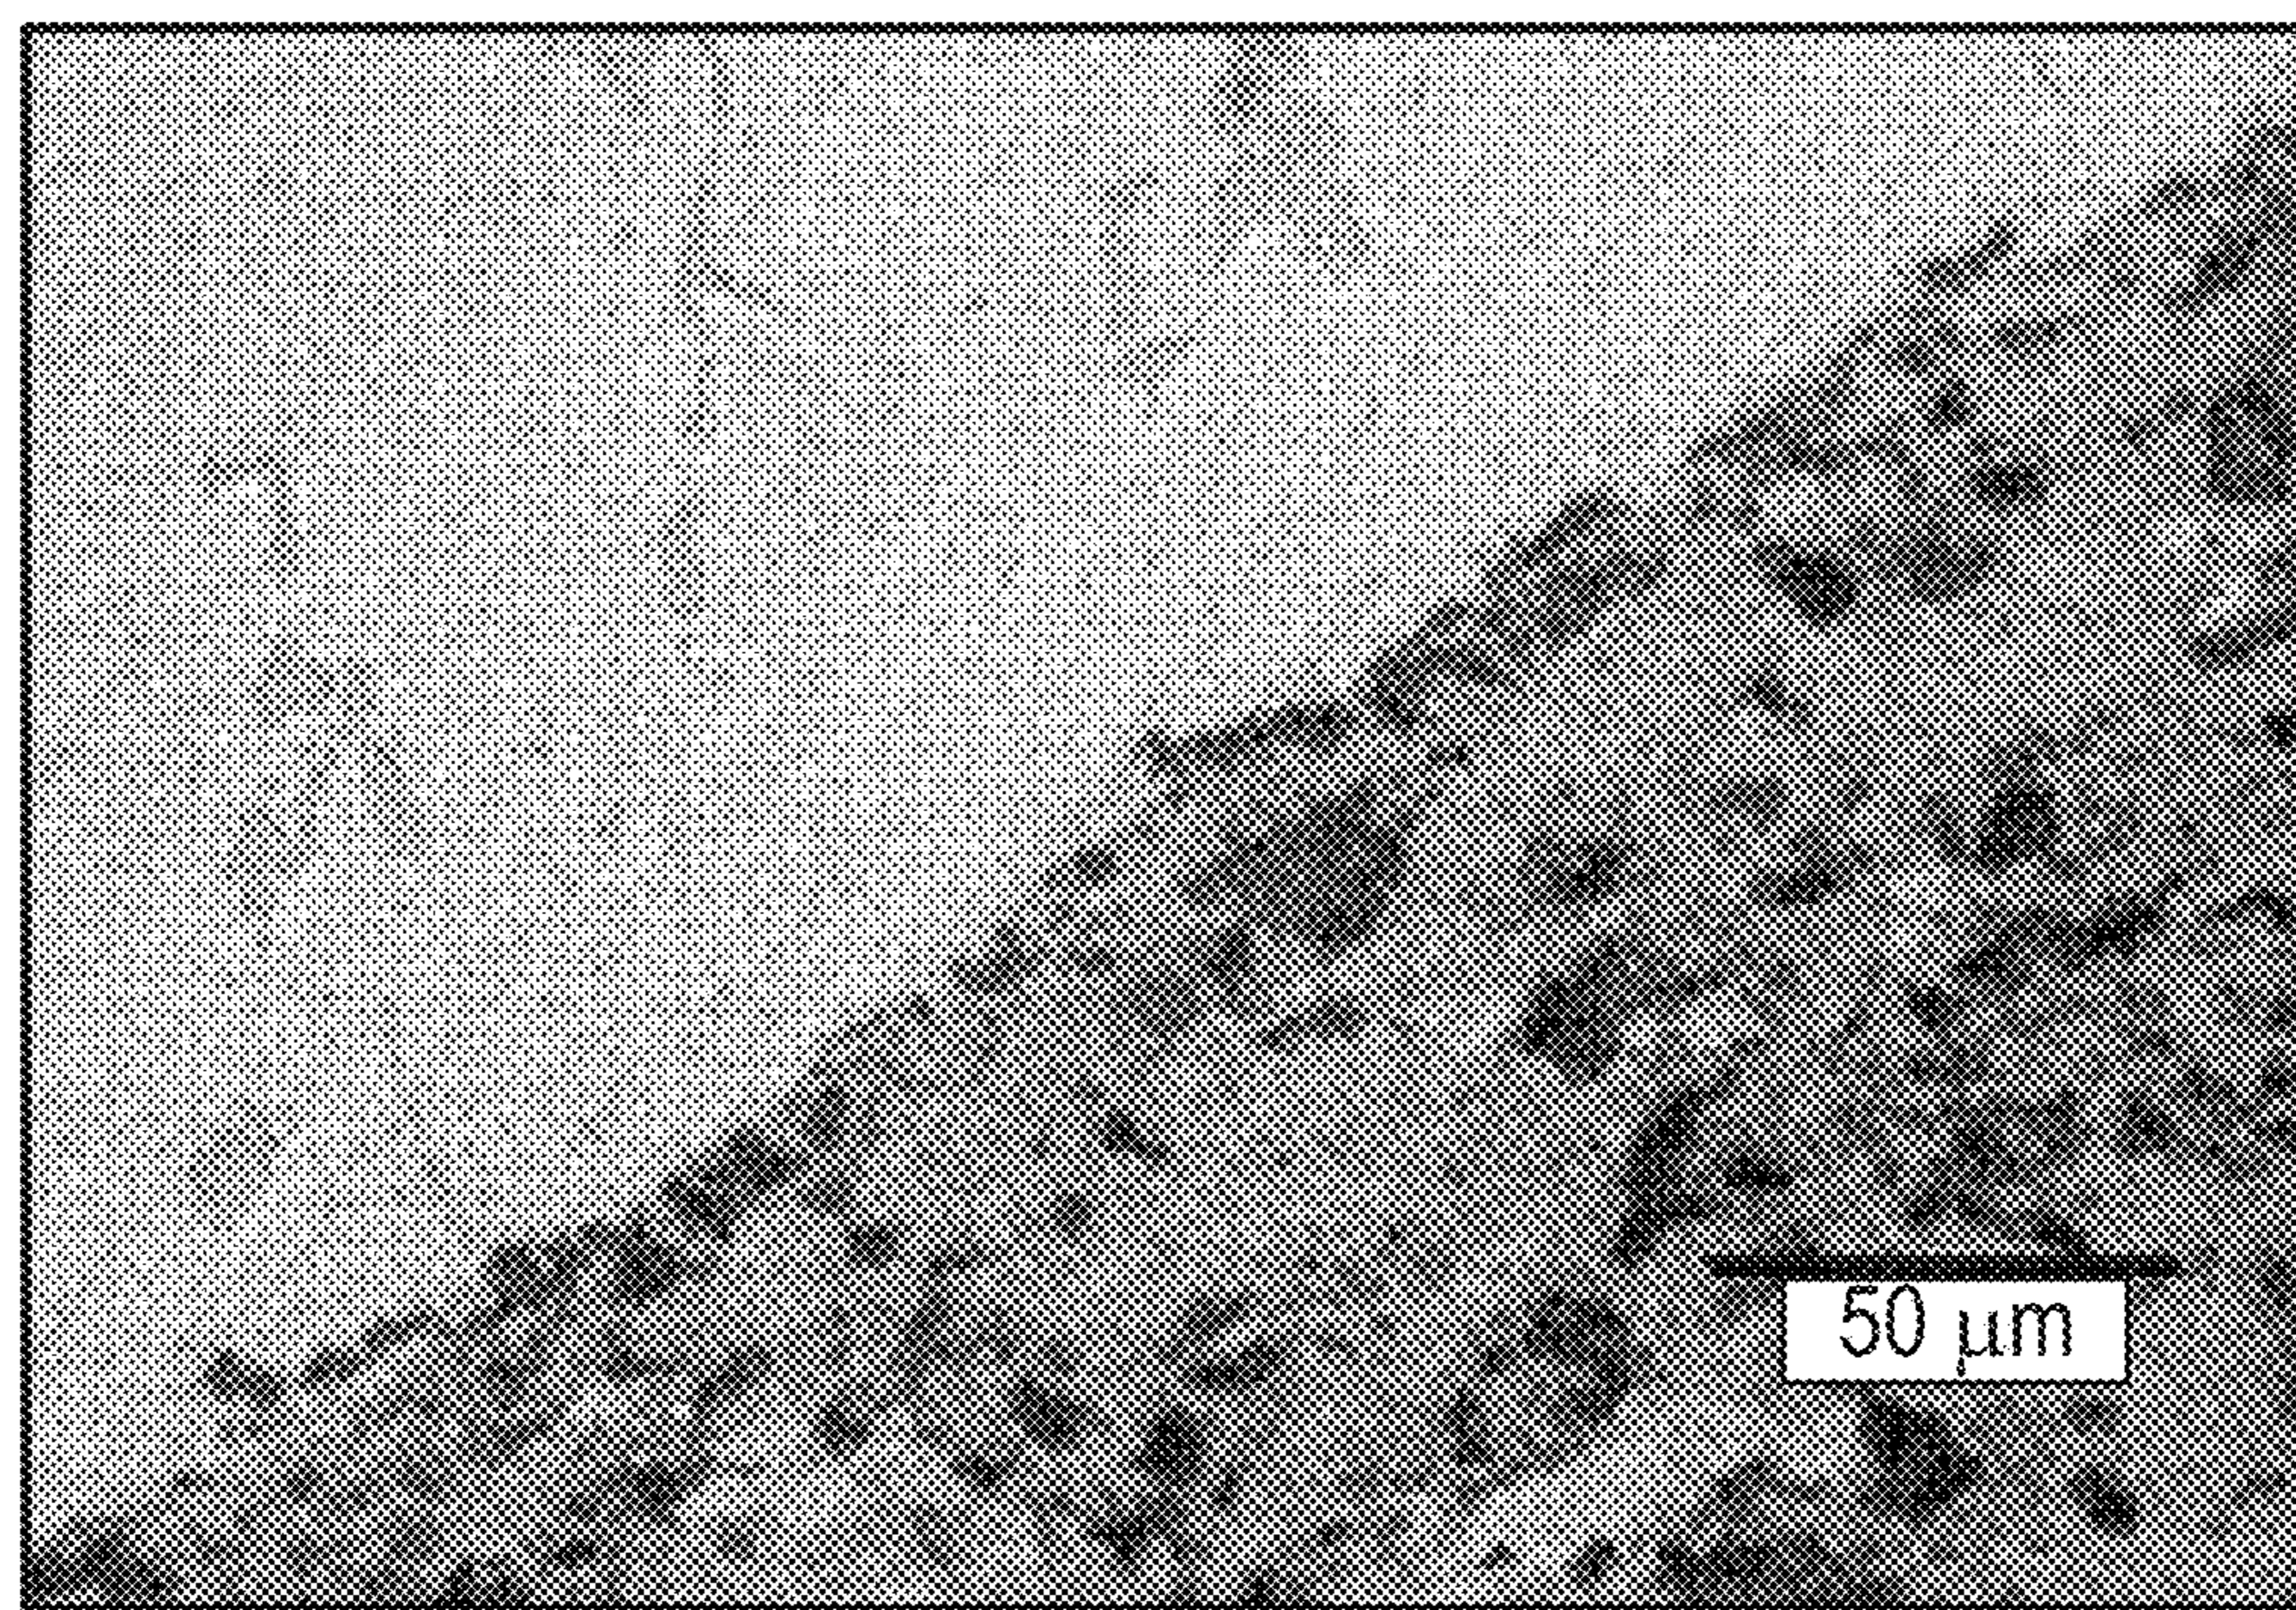
FIG. 9 provides a pictorial illustration of a photo of the interface between the cold spray material and the aircraft panel taken along line 9-9 in FIG. 3;

FIG. **9** is a pictorial illustration of a cold spray interface metallography taken along line 9-9 in FIG. **3**.
