(12) **United States Patent**
Widener et al.

(10) **Patent No.:** **US 10,099,322 B2**
(45) **Date of Patent:** **Oct. 16, 2018**

(54) **METHODS FOR COLD SPRAY REPAIR**

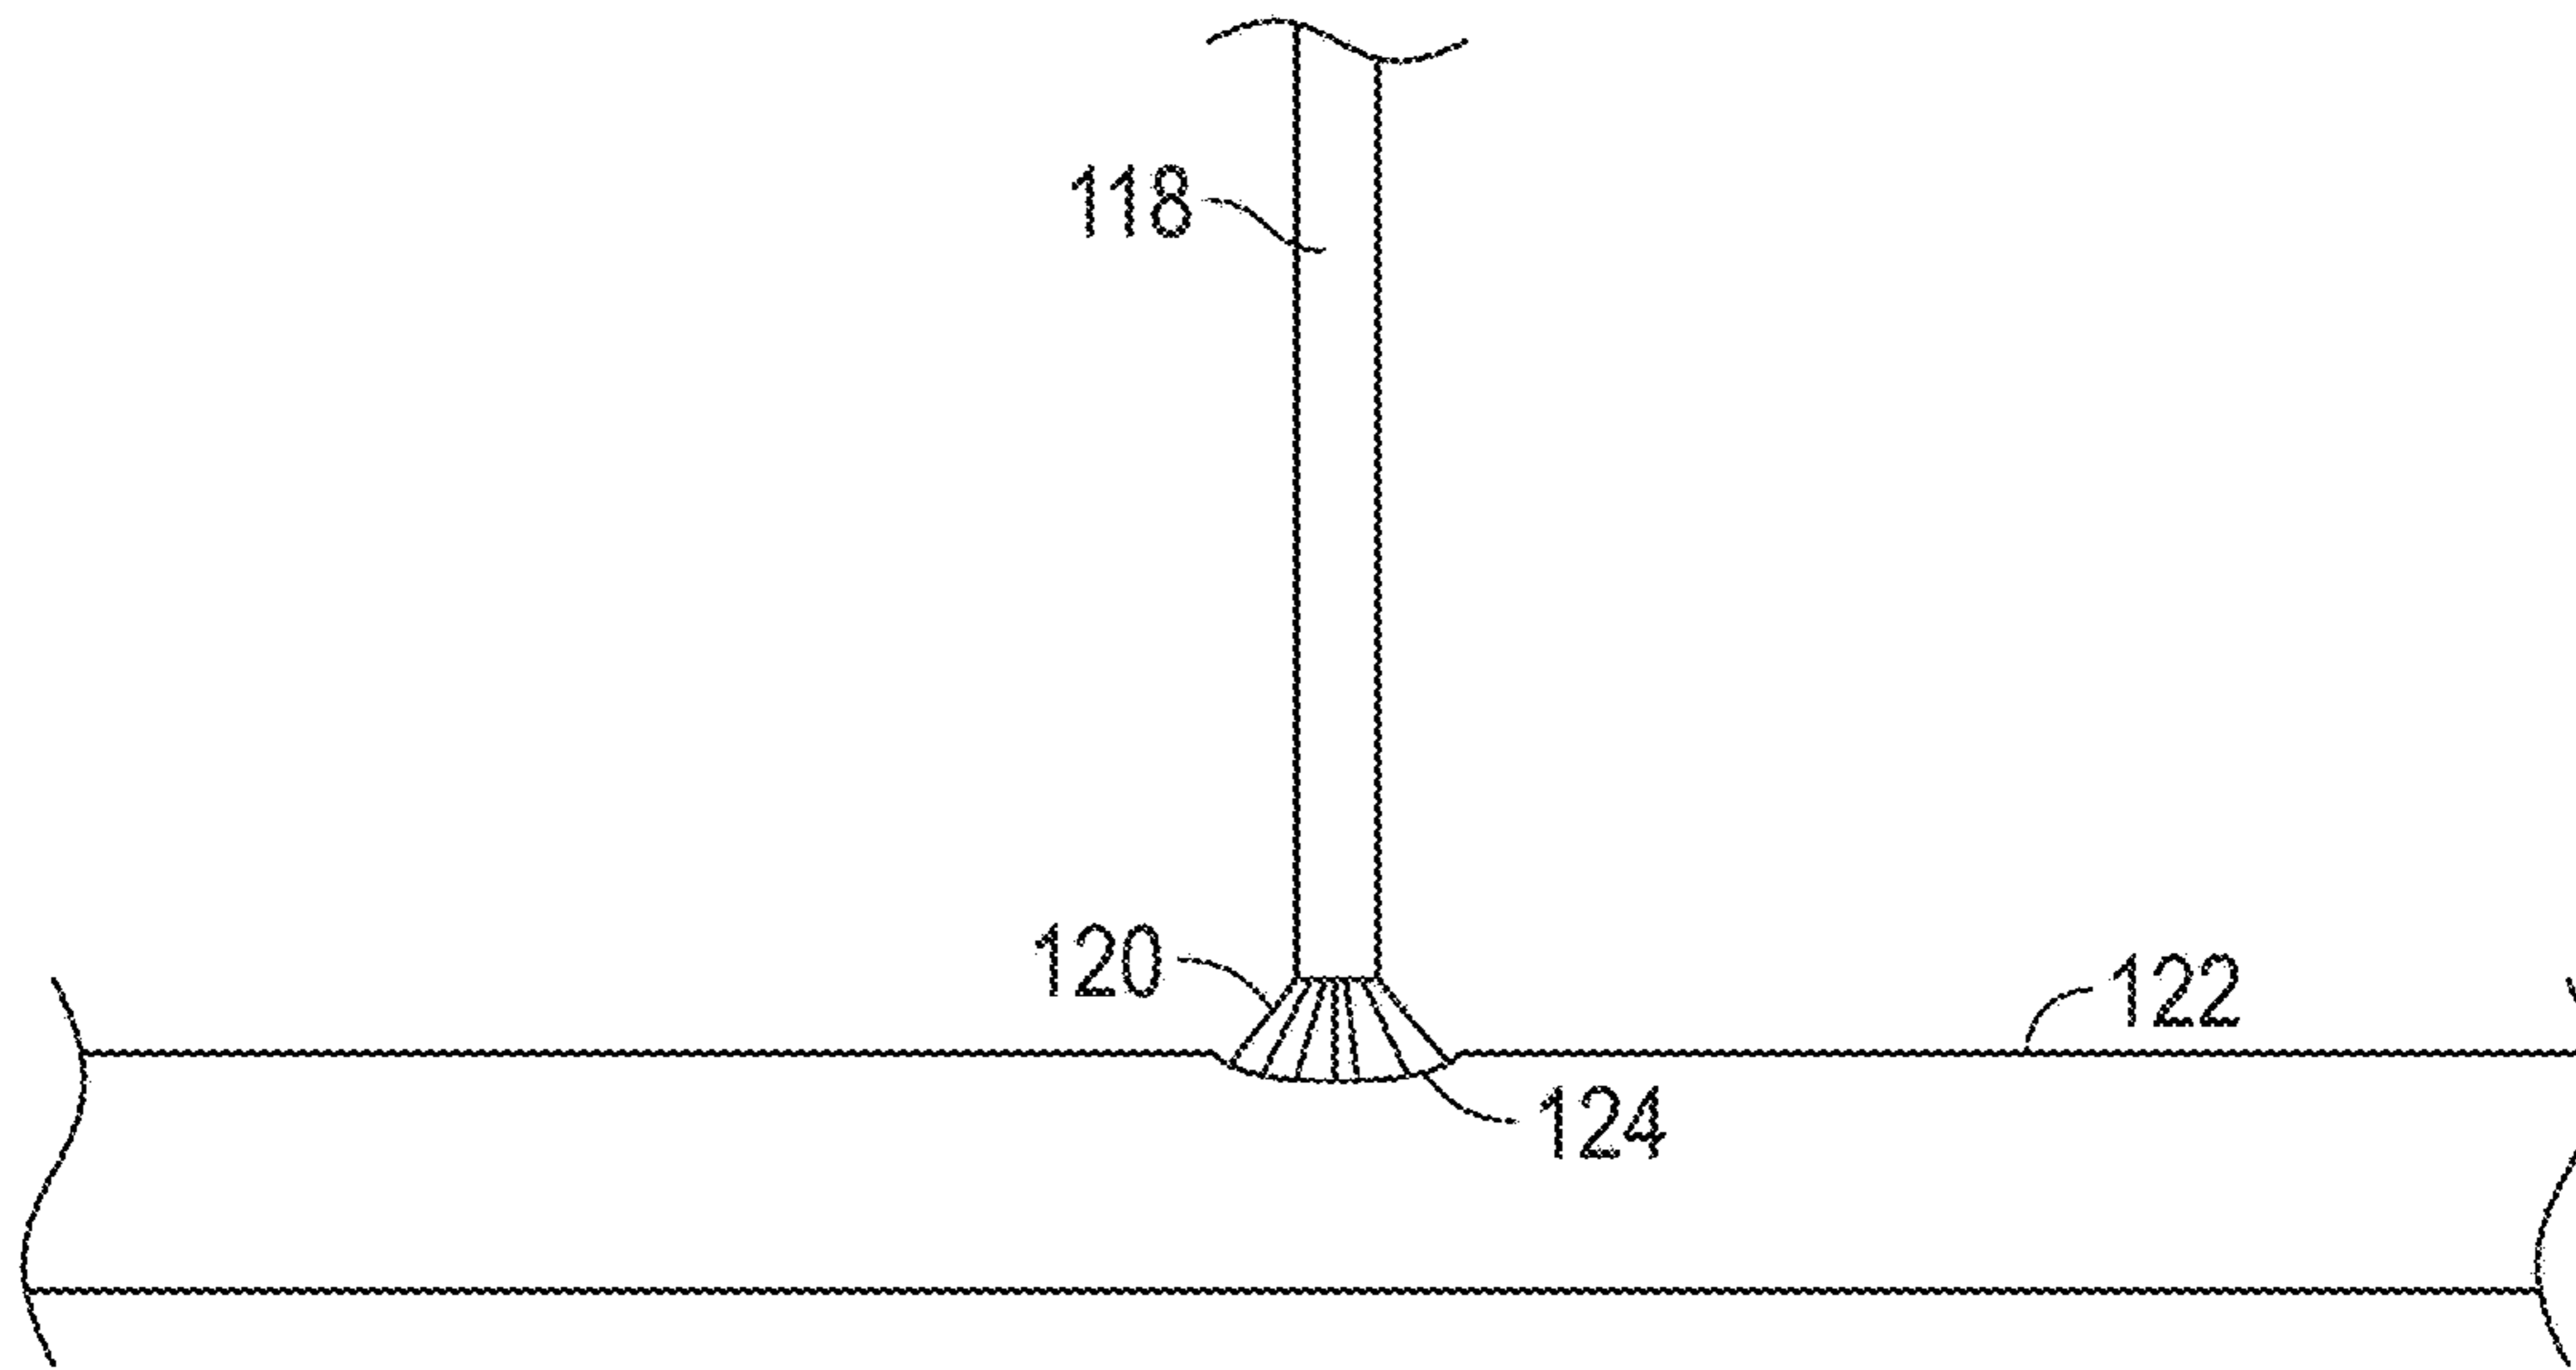
FIG. 10A is a pictorial representation of a cold spray method for a hydraulic line in accordance with an illustrative embodiment;

FIGS. 10A-10B provide pictorial illustrations for repair and reclamation of the hydraulic line 122, such as those illustrated in FIGS. 11-12. Using cold spray methods provided, for example, in FIGS. 14A-14B, a cold spray material 120 is applied to a chaff point 124 on a hydraulic line 122 by discharging the cold spray material 120 from a cold spray nozzle 118. This repair and reclamation of the hydraulic line 122 may be performed in situ (i.e., where the hydraulic line 122 remains connected within the aircraft and is not removed) or on the hydraulic line after it is removed from service. In either case, the speed at which the repair can be made does not require the aircraft to be out of service for any significant amount of time. Given that the cold spray methods shown and illustrated in FIGS. 14A-14B are highly maneuverable and compact, the cold spray nozzle 118 can be positioned relative to the chaff point 124 at generally any

location aboard an aircraft to repair and reclaim the hydraulic line. This high degree of mobility, maneuverability and positionability of the cold spray nozzle **118** allows the cold spray repair and reclamation process to be used in situation where other techniques simply could not be performed due to space, position and location constraints. FIG. **10B** provides a pictorial illustration of a completed repair and reclamation of a hydraulic line **122**. The removed or shaped material at the chaffing point **124** is replaced with cold spray material **120** which provides a protective layer or coating over the chaff point that forms a strong mechanical and metallurgical bond with the substrate material (i.e., the hydraulic line **122**). FIG. **13** provides pictorial illustrations of a set of exemplary metallographs taken along line **13-13** in FIG. **10B**, which illustrate the strong mechanical and metallurgical bond that occurs between the interface of the hydraulic line and the cold spray material.

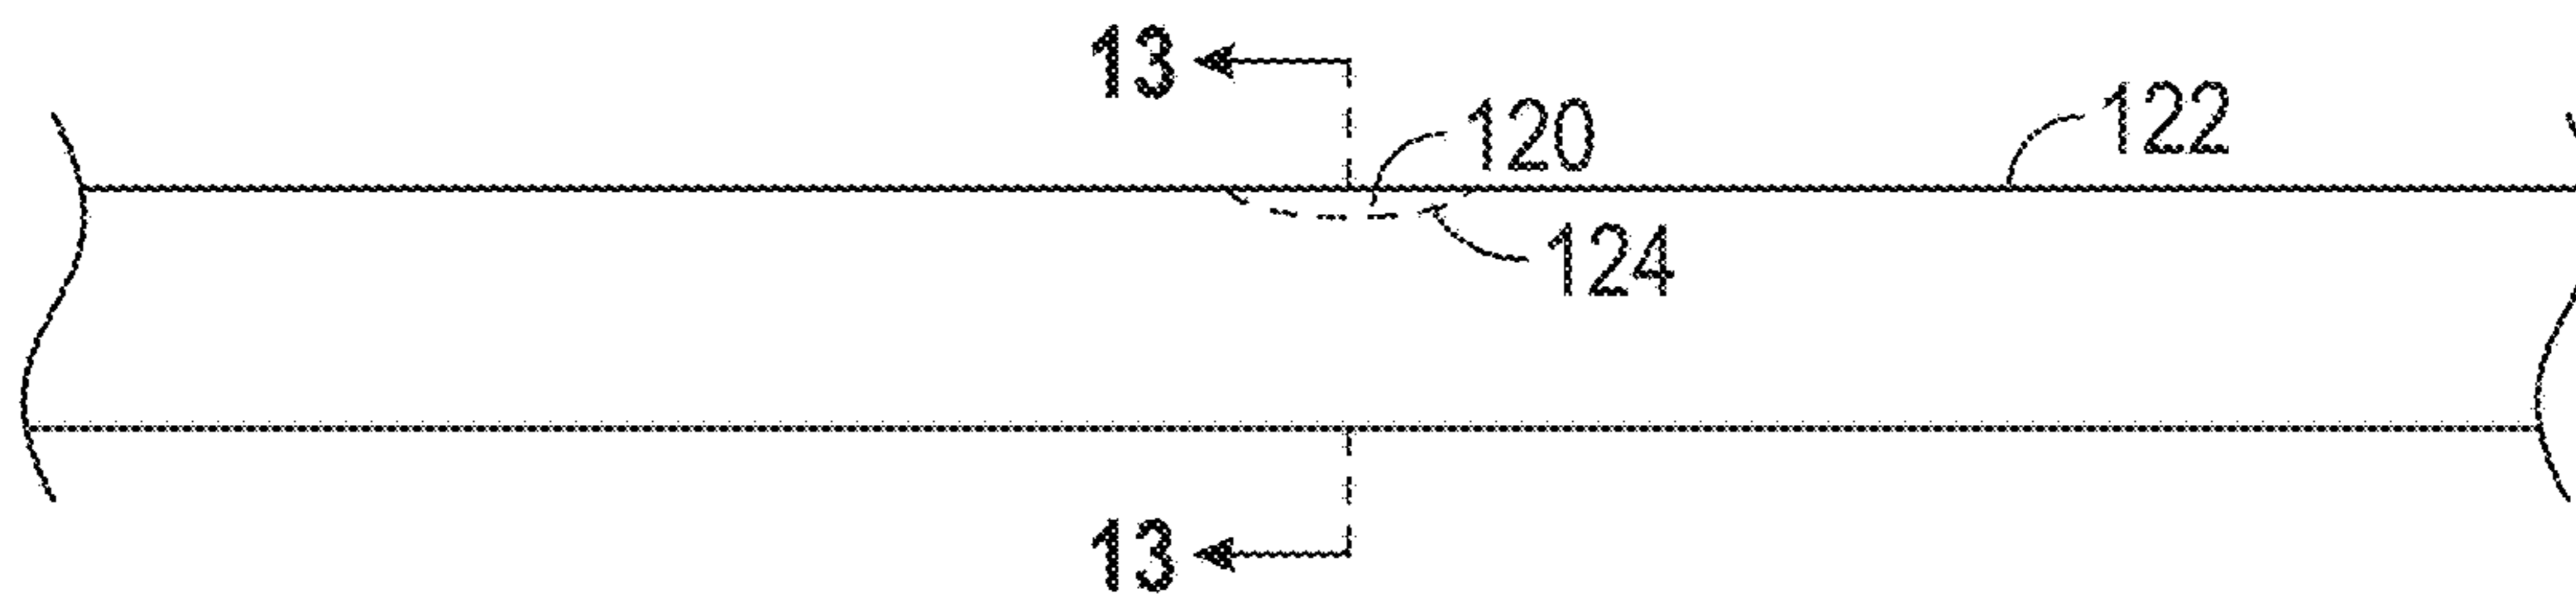
FIG. 10B is a pictorial representation of a sectional view of the hydraulic line shown in FIG. 10A in accordance with an illustrative embodiment;

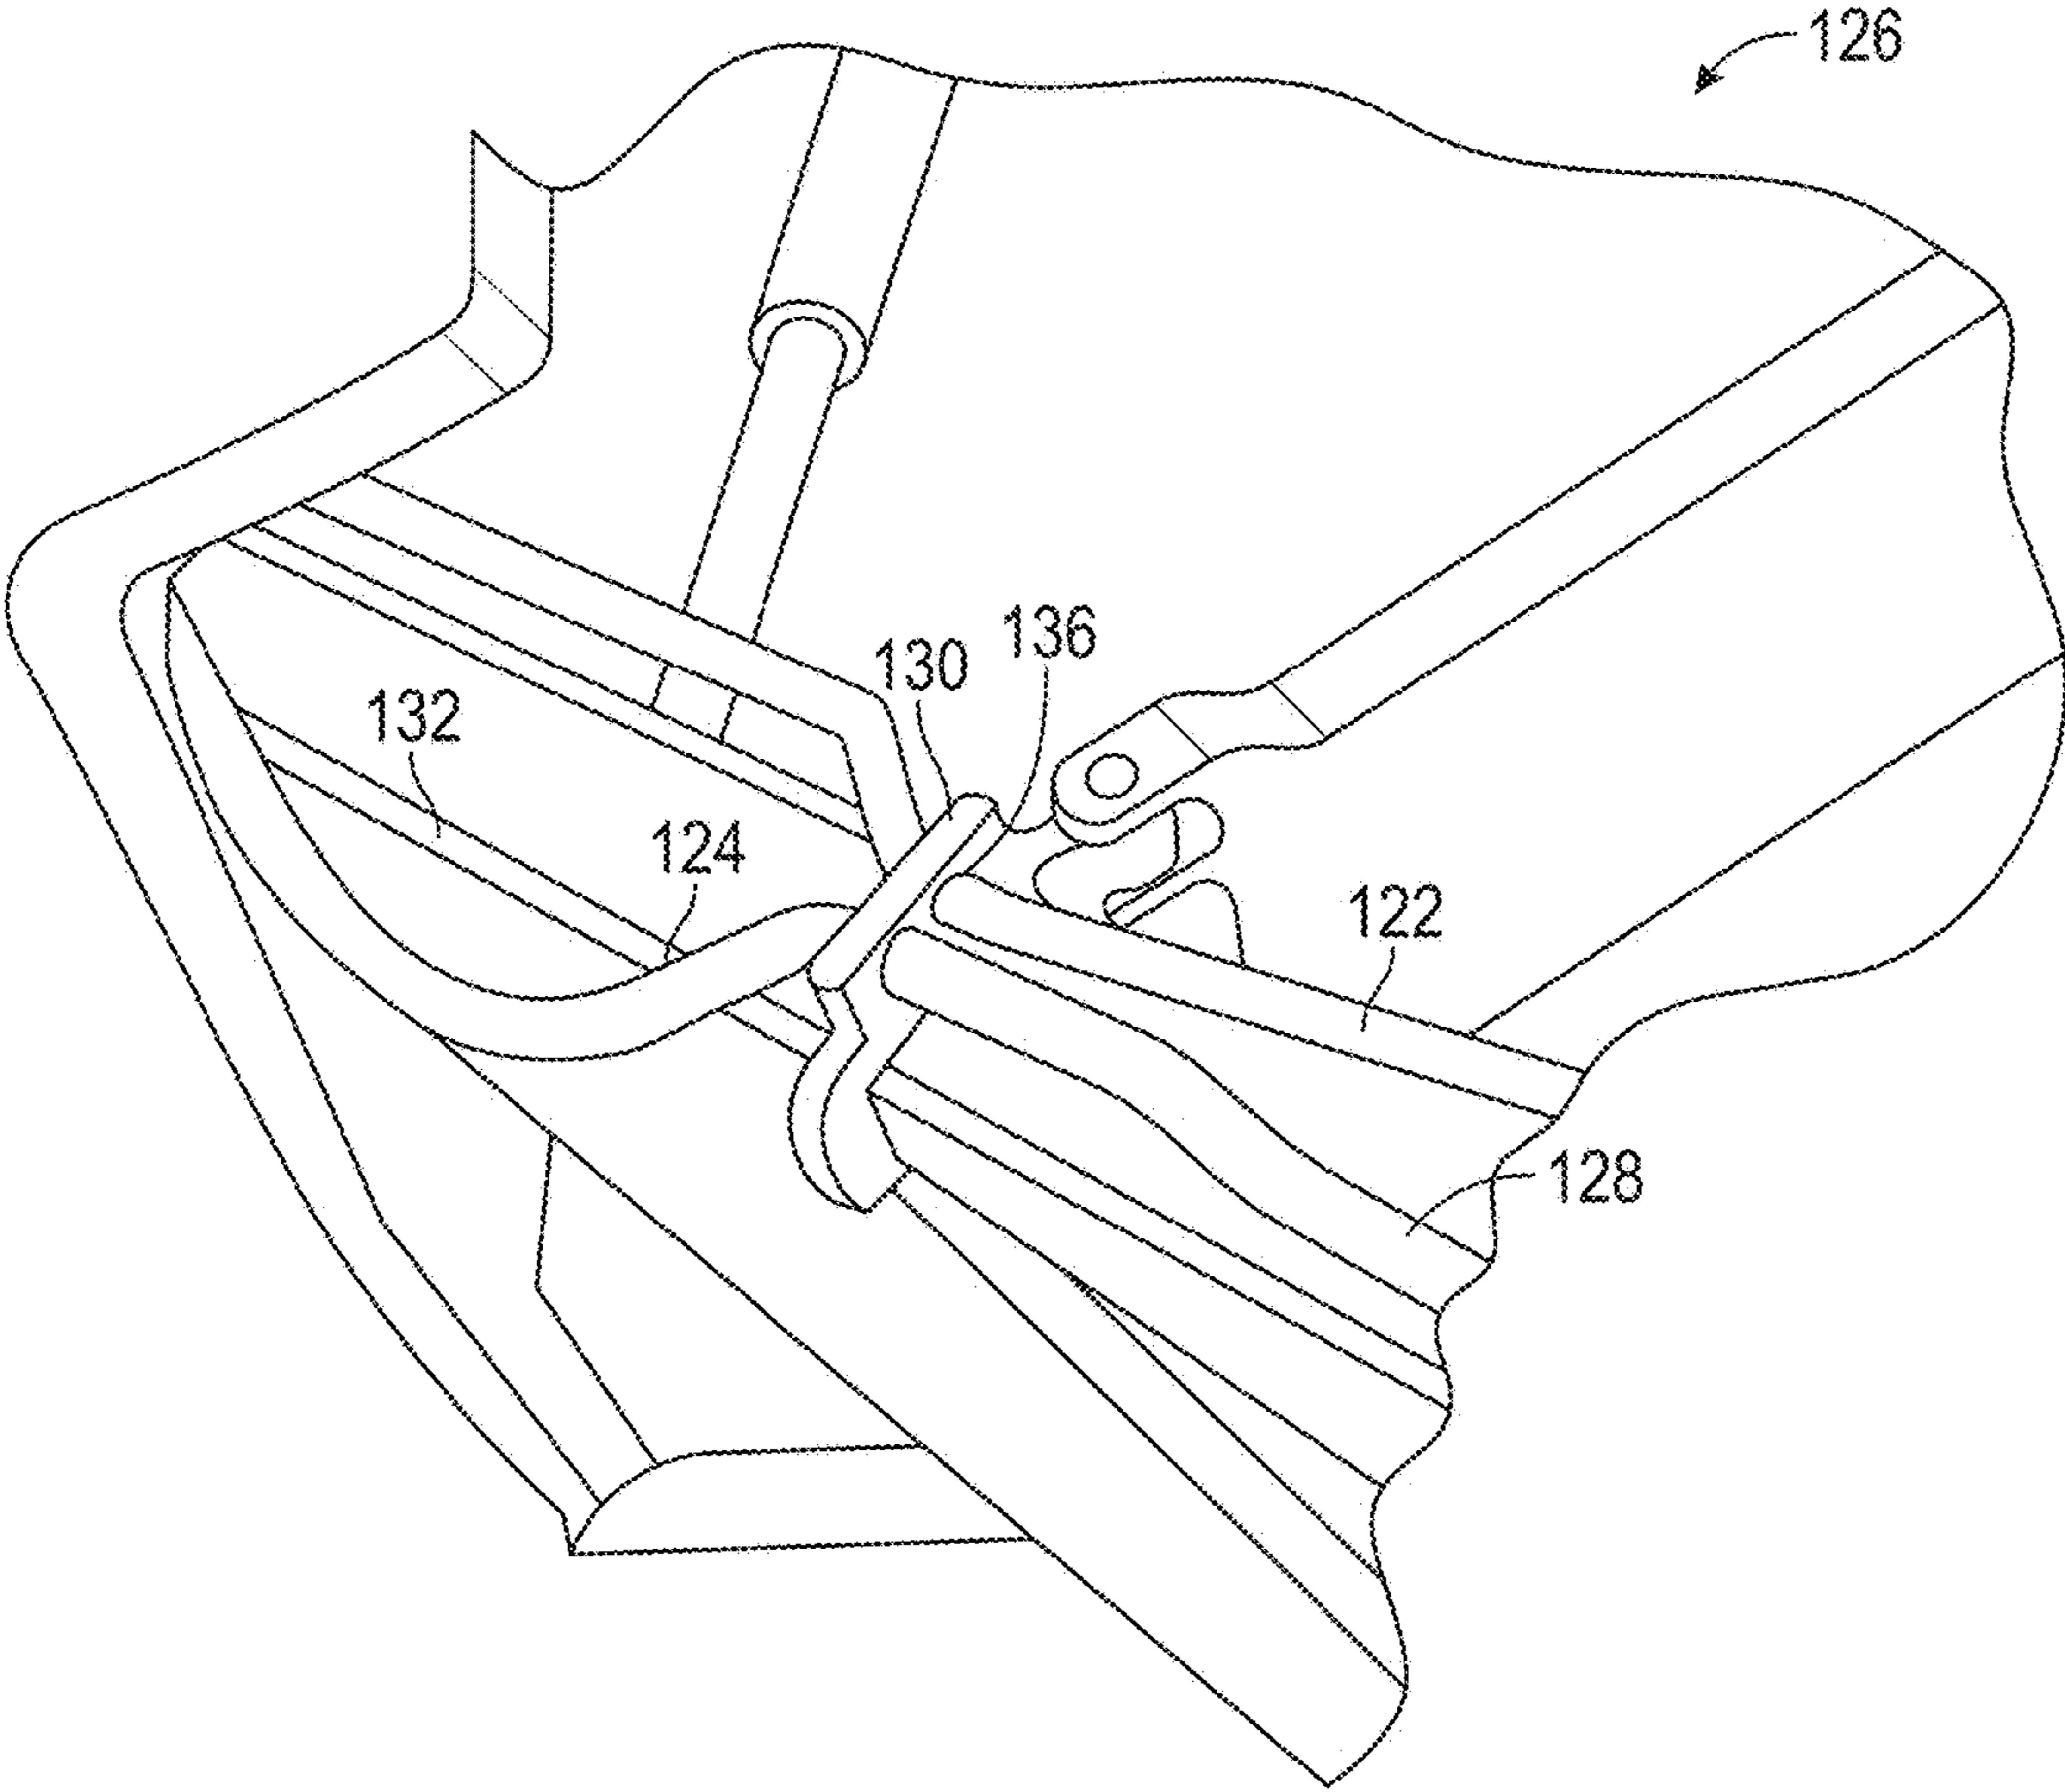
FIG. 11 is a pictorial representation of a hydraulic line and chaff points or locations in a USAF B-1 landing gear assembly in accordance with an illustrative embodiment;

FIGS. 11-12 provide pictorial illustrations of specific locations aboard an aircraft where hydraulic line is located and prone or subject to chaffing, wear or other like degradation effects. Specifically, FIG. 11 provides a pictorial illustration of hydraulic line 122 and 128 housed within landing gear assembly 126, such as landing gear assembly of a USAF B-1 bomber. FIG. 12 provides a pictorial illustration of hydraulic tubing 122 housed within a spoiler assembly 134, such as a spoiler assembly in a USAF B-1 bomber. In each instance, the hydraulic lines are exposed to, prone to, or otherwise subject to rubbing, chaffing or like degradation effects. In the landing gear assembly 126 shown in FIG. 11, hydraulic line 122 and 128 passes through a bracket 130 and overtop the surface 132 of a member of the landing gear assembly 126. A chaffing point 124, 136 results as the hydraulic tubing 122, 128 passes through, adjacent to, by, over top of, around, or otherwise in contact with another surface, such as surface 132. For example, hydraulic line 122, 128 passes through bracket 130. Where the hydraulic line touches the bracket 130, a chaffing point 136 exists. Similarly, where hydraulic line 128 passes over the surface 132 of a component of the landing gear assembly 126, a chaffing point 124 exists. Chaffing points may exist along a hydraulic line at any location where the hydraulic line touches another surface. Vibration, movement and interaction between the surface and other degradative elements cause the hydraulic line to wear over time. An inordinate amount of wear occurs specifically at these chaff points, such as chaff points 124, 136 illustrated in FIG. 11. FIG. 12 provides another pictorial illustration for an assembly aboard an aircraft, such as a spoiler assembly 134 in a USAF B-1 bomber. As with the landing gear assembly 126, the spoiler assembly 134 includes a hydraulic line 122 that passes through the spoiler assembly 134. The hydraulic line 122 comes into contact with surfaces in the spoiler assembly 134, for example surface 138 where a chaffing point 124 exists. The hydraulic line 122 may also come into contact with other surfaces, such as surface 132 where another chaff point 136 exists. These are exhibited only for the purpose of illustration, and to provide examples of where hydraulic lines within an aircraft are exposed to possible chaffing points. In this instance, the hydraulic line 122 experiences wear at the chaff points 124, 136.

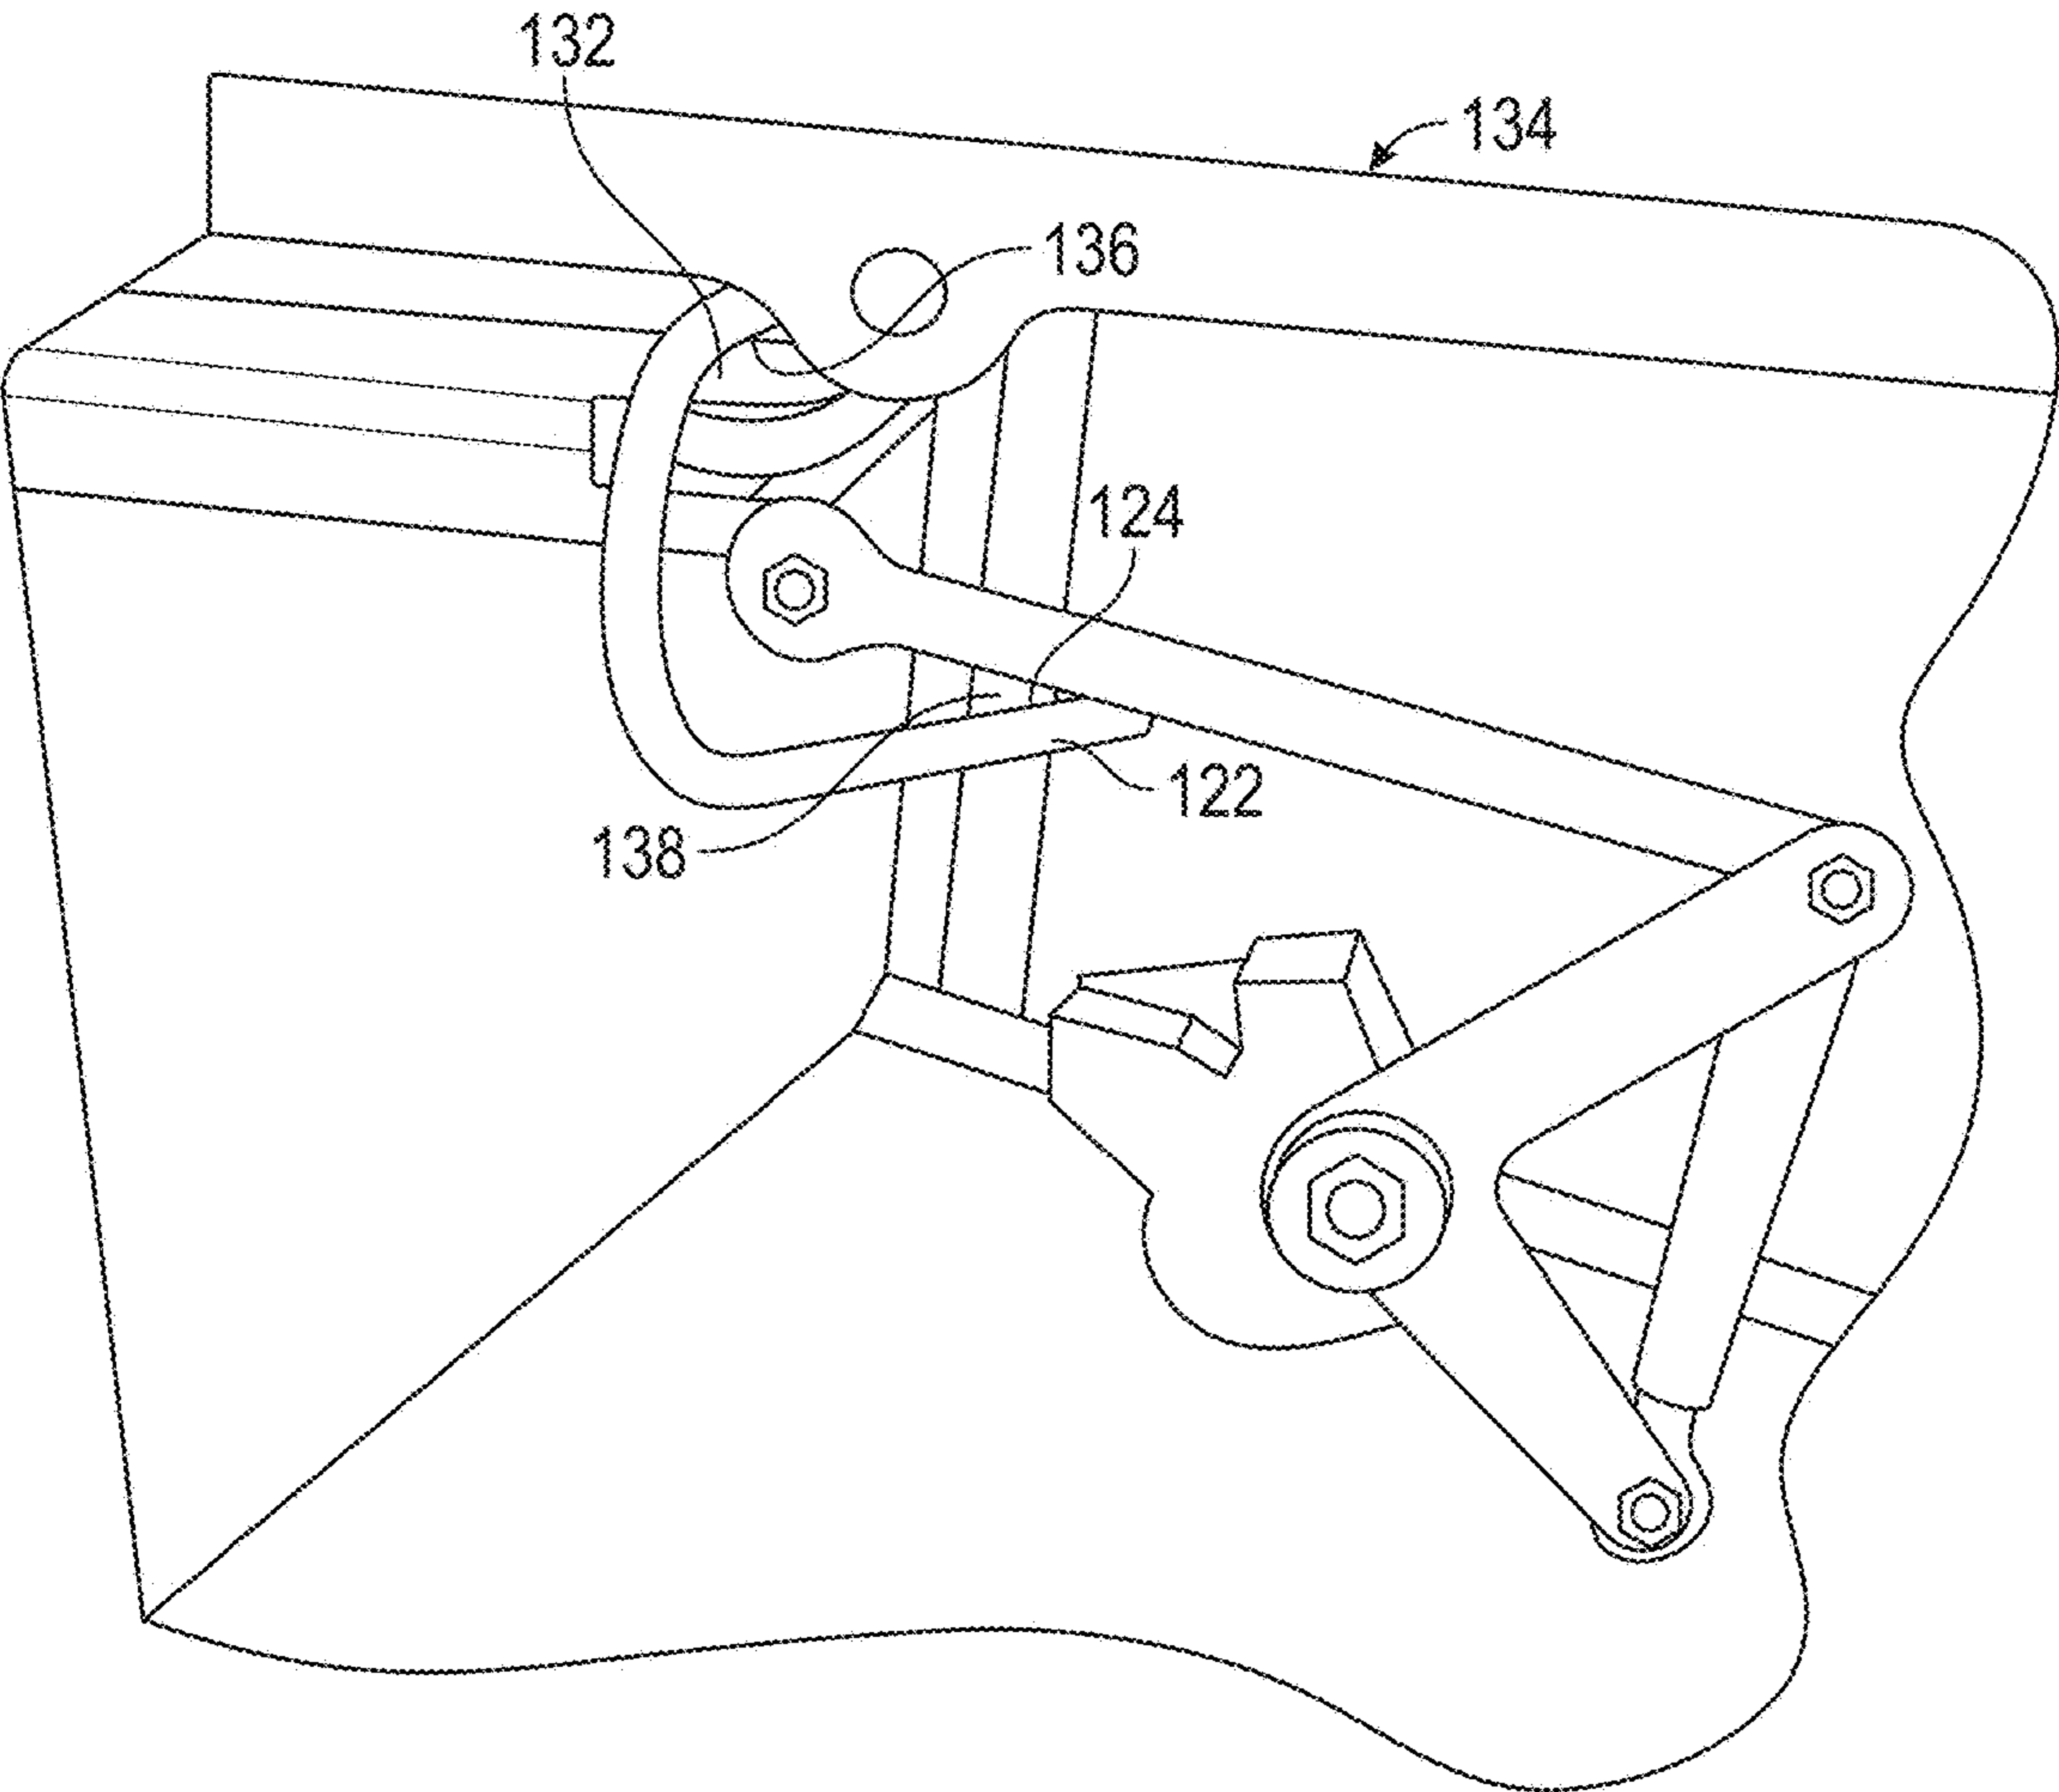
FIG. 12 is a pictorial representation of a hydraulic line showing chaff points in a USAF B-1 spoiler hydraulic assembly in accordance with an illustrative embodiment;

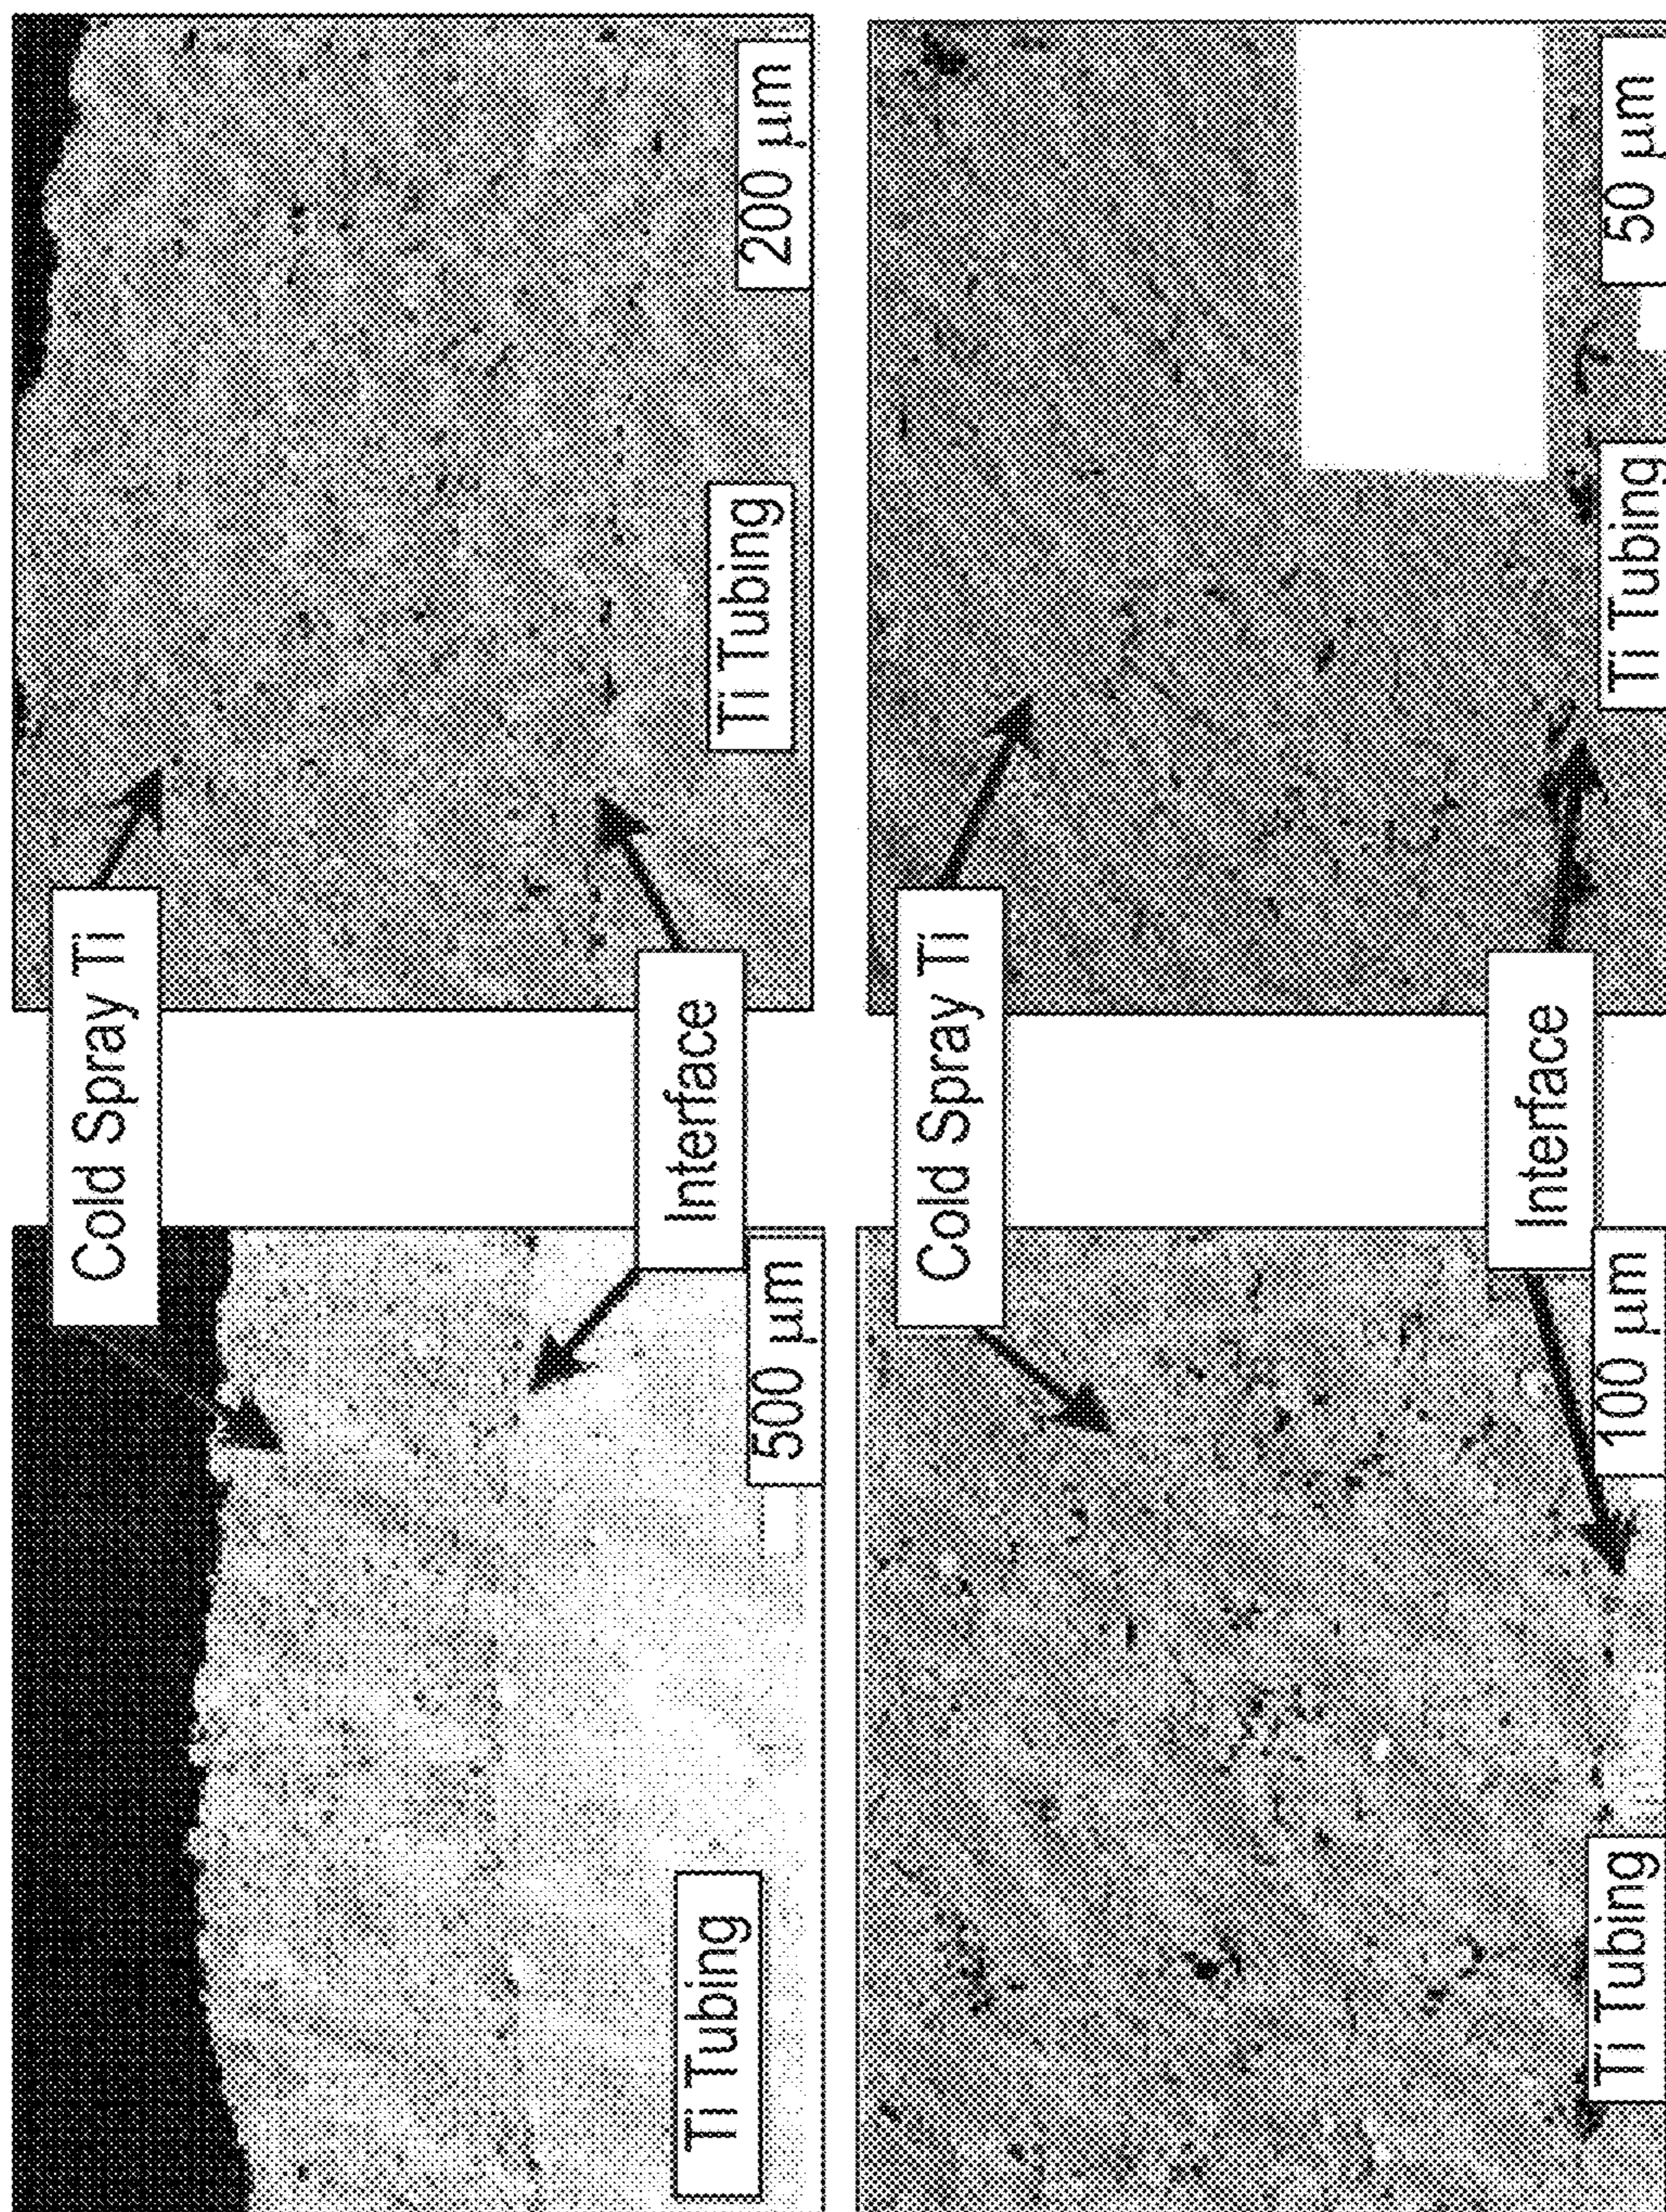
FIG. 13 is a pictorial representation of exemplary metallographs showing cold spray application on the tubing in accordance with an illustrative embodiment;

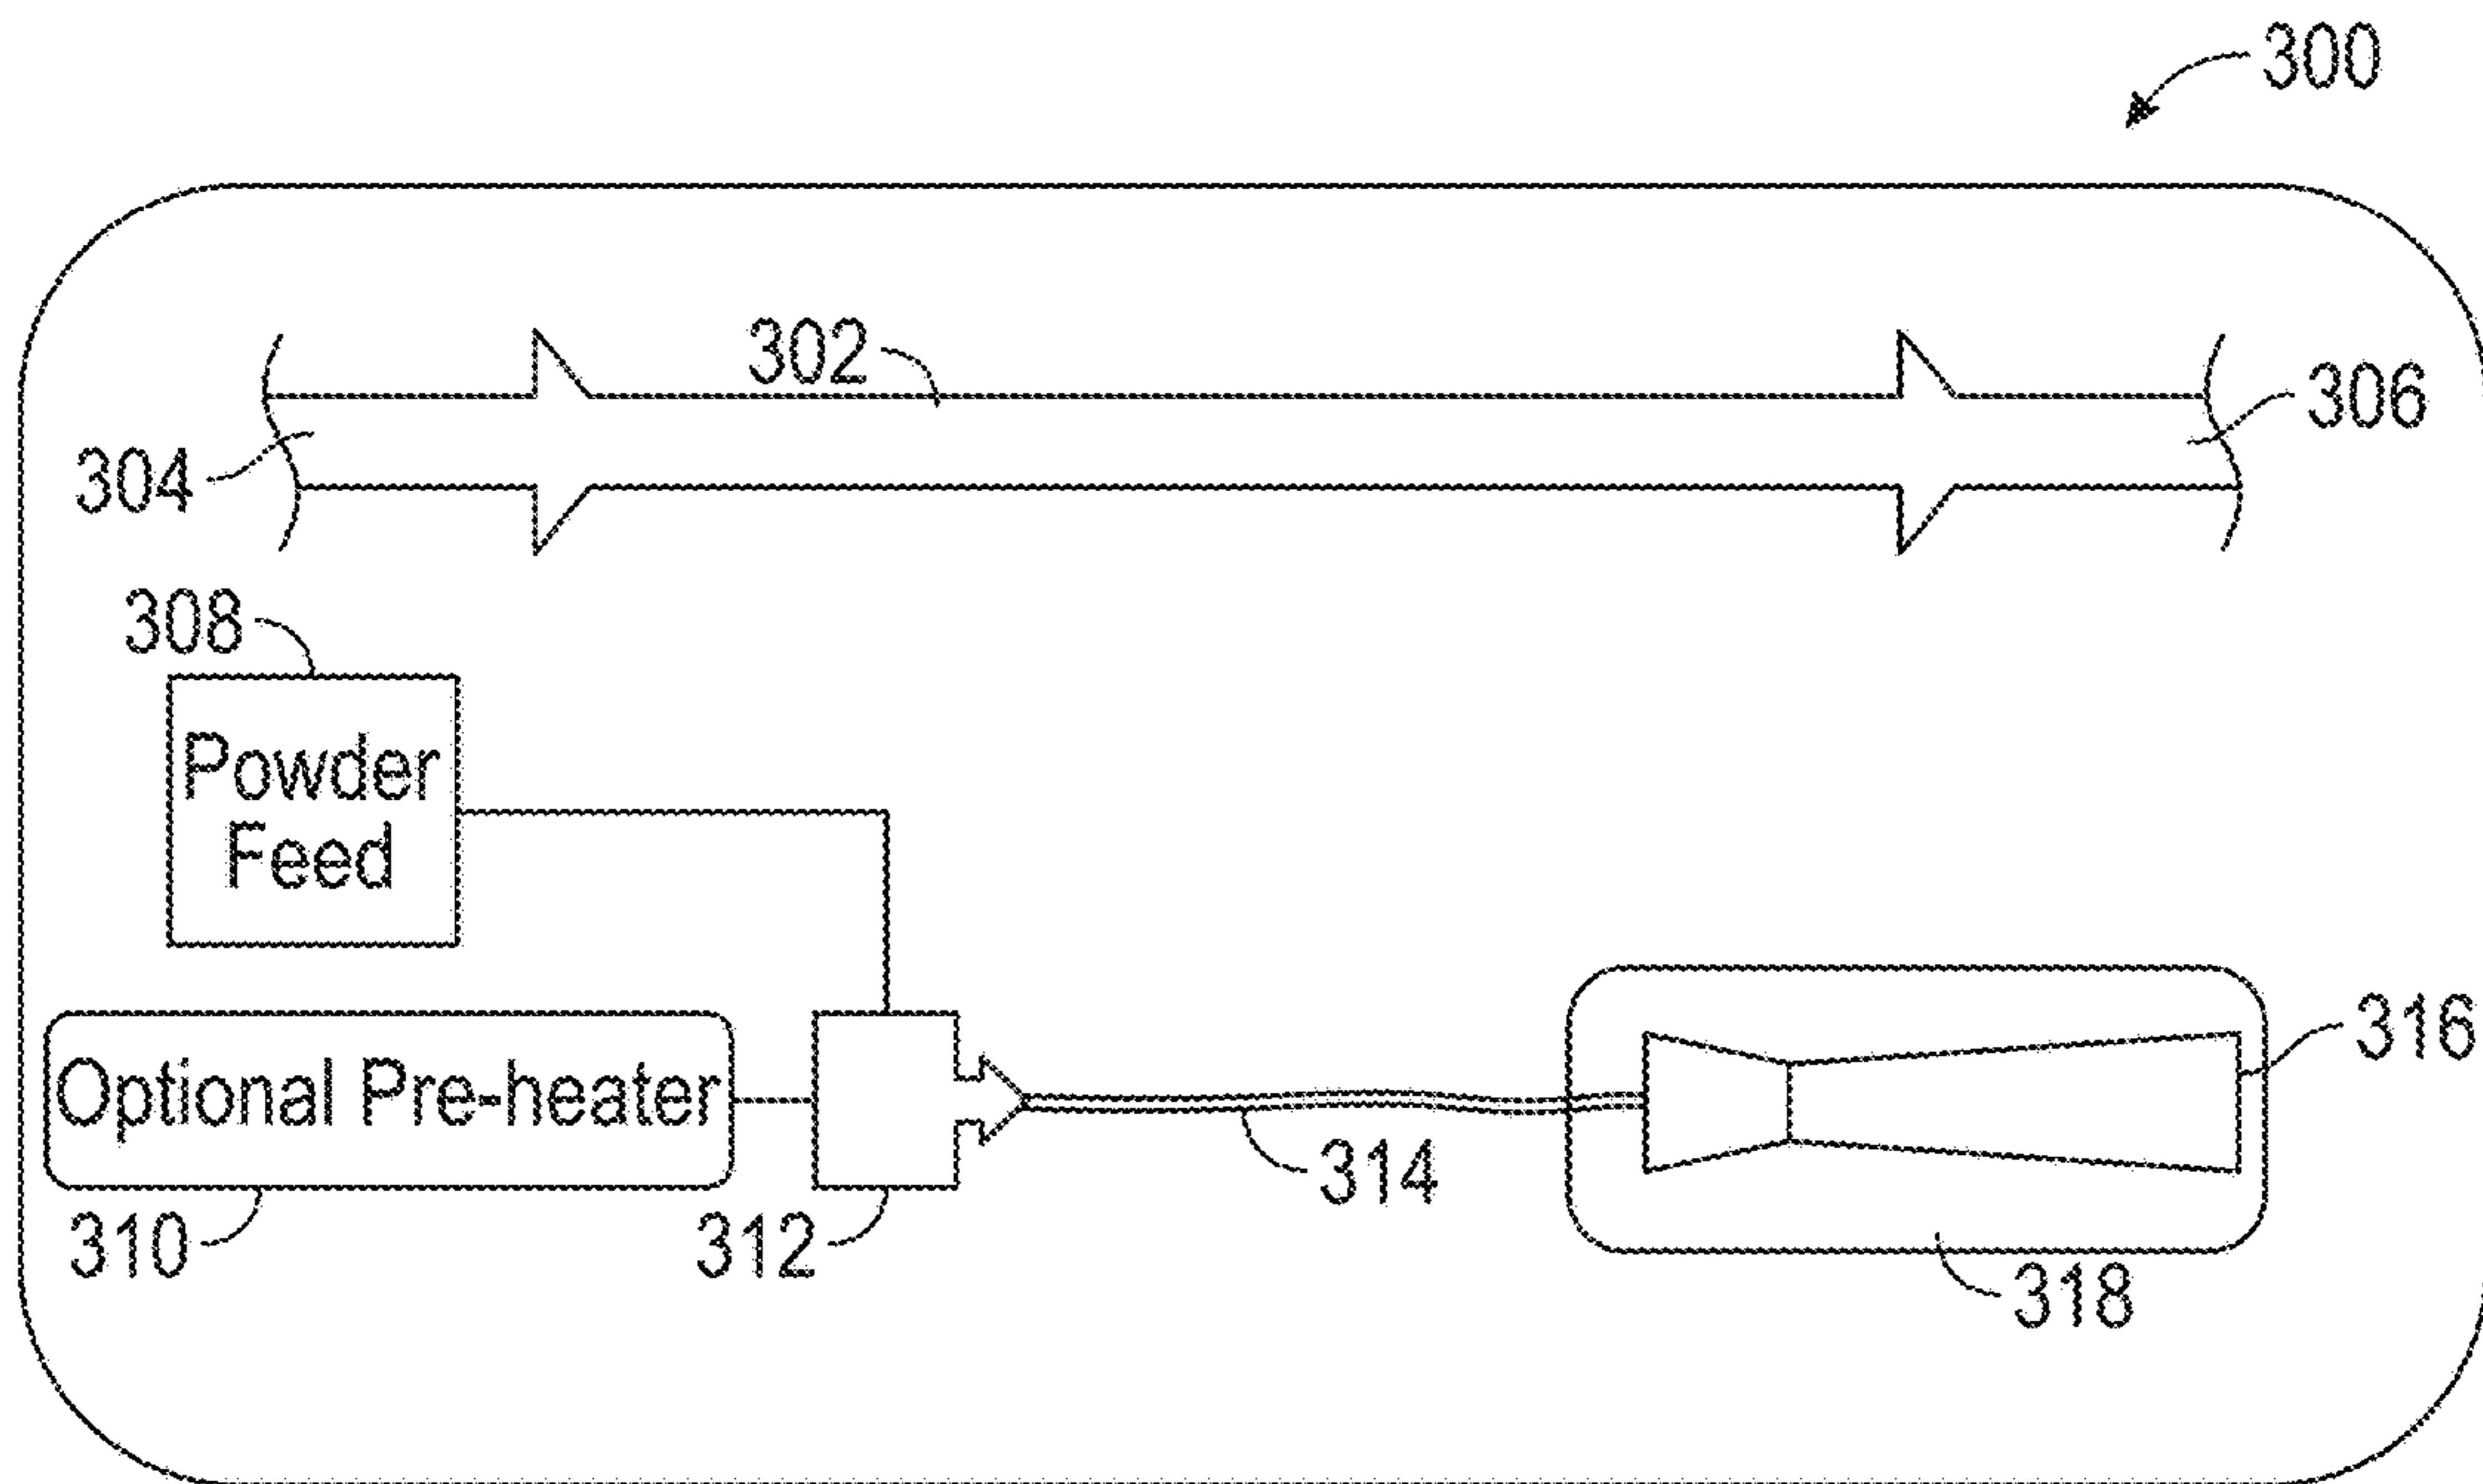
FIG. 14A is a pictorial representation of a cold spray repair method in accordance with an illustrative embodiment; and

Methods for cold spray repair may use any one of the cold spray methods illustrated in FIGS. **14A** and **14B**, as described in application Ser. No. 14/066,346 entitled, "COLD SPRAY DEVICE AND SYSTEM", filed on the same date as the present application, and incorporated herein in its entirety by reference. The methods pictorially represented in FIGS. **14A-14B** describe cold spray methods that are advantageously applied by a highly mobile, highly maneuverable, cold spray nozzle that mixes a gas-powder mixture upstream of the nozzle for providing cold spray deposition. Using the methods illustrated in FIGS. **14A-14B**, a cold spray repair and reclamation of the fastener hole **104** illustrated in the pair of photos shown in FIG. **5** is accomplished. Specifically, cold spray material **114** is applied about the fastener hole **104** to the aircraft panel **100** as shown and illustrated. Cold spray material **114** can be applied by hand or by automation using the methods shown and illustrated in FIGS. **14A-14B**. For example, in the case where the aircraft panel **100** is 2024-T6 aluminum, cold spray material **114** may comprise A0027 powder and compressed nitrogen at 350 PSI and 350° C. The cold spray material **114** may be applied using the methods shown and illustrated in FIGS. **14A-14B** using, for example, a tungsten carbide nozzle on the spray nozzle assembly. Embodiments of the invention contemplate performing the repair and reclamation of a fastener hole in an aircraft panel in situ or with the panel removed from operation for a short window of time.

In a cold spray method shown in FIGS. 14A-14B, described in application Ser. No. 14/066,346 entitled "COLD SPRAY DEVICE AND SYSTEM", filed on the same date as the present application, and incorporated herein in its entirety by reference, provide specially engineered methods whereby sub-micron and micron size solid state particles are accelerated to supersonic speeds through a convergent-divergent nozzle using, such accelerants as helium, nitrogen or compressed air. When the particles impact the surface, the particles form a strong mechanical and metallurgical bond.
