(12) **United States Patent**
Widener et al.

(10) **Patent No.:** **US 10,099,322 B2**
(45) **Date of Patent:** **Oct. 16, 2018**

(54) **METHODS FOR COLD SPRAY REPAIR**

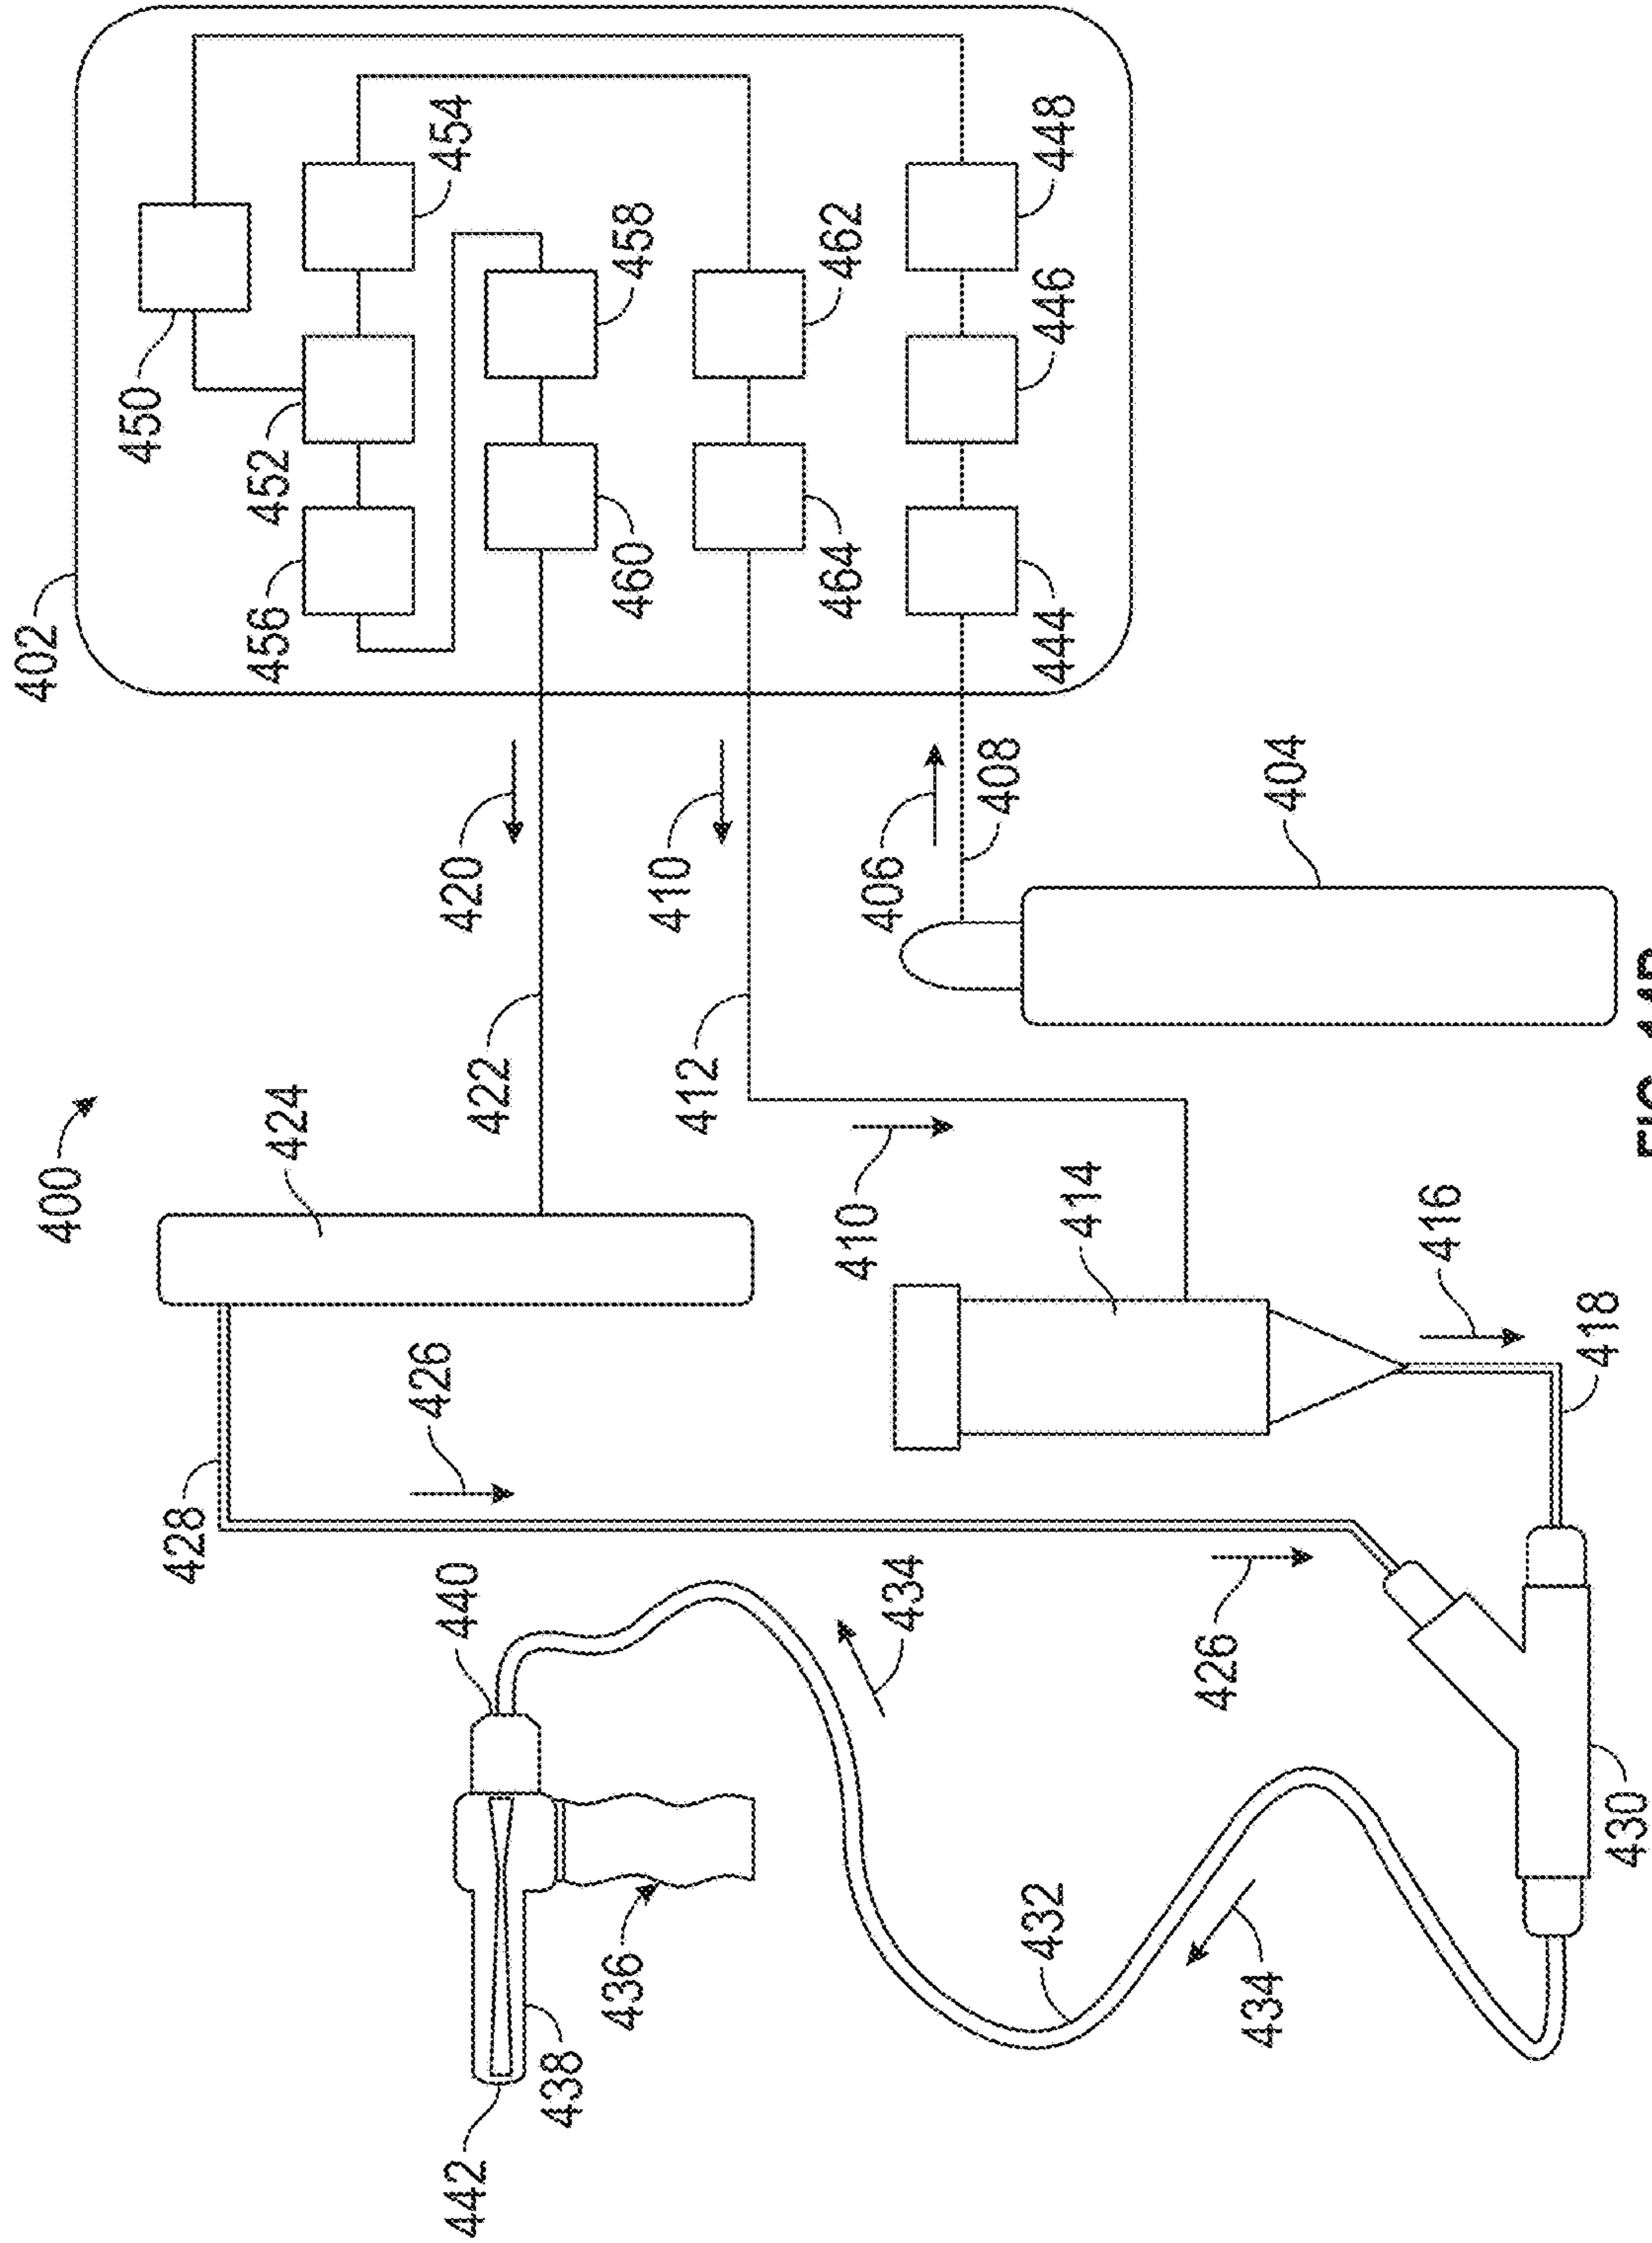
FIG. 14B is another pictorial representation of a cold spray repair method in accordance with an illustrative embodiment.

In a cold spray method shown in FIGS. 14A-14B, described in application Ser. No. 14/066,346 entitled "COLD SPRAY DEVICE AND SYSTEM", filed on the same date as the present application, and incorporated herein in its entirety by reference, provide specially engineered methods whereby sub-micron and micron size solid state particles are accelerated to supersonic speeds through a convergent-divergent nozzle using, such accelerants as helium, nitrogen or compressed air. When the particles impact the surface, the particles form a strong mechanical and metallurgical bond.

Embodiments of the present invention leverage cold spray methods illustrated in FIGS. 14A-14B to extend the life of hydraulic lines for aircraft and locations where chaffing is known to occur. Thus, cold spray repair and reclamation can be an important part of a preventative maintenance program for aircraft hydraulic lines. In one aspect, cold spray materials applied as an additional layer of material (e.g., titanium material) to the region of the hydraulic line that is prone to chaffing. By applying the additional layer, the chaffing occurs first in the cold spray material, and not in the structural wall of the hydraulic line. As a result, the time that it takes to chaff into the hydraulic line is greatly extended, thereby extending the life the hydraulic tubing. Thus, this reduces the maintenance hours required to maintain the aircraft in serviceable condition. As a result, these hydraulic lines need only be replaced during scheduled maintenance and do not require the parts to be taken out of service and thus the aircraft out of service. The repair also returns the draft point and line back to its fully fit, form and function.
