US010329719B1

(12) **United States Patent**
Giles

(54) **COMPOSITION AND METHOD FOR SURFACE REPAIR**

(57) **ABSTRACT**

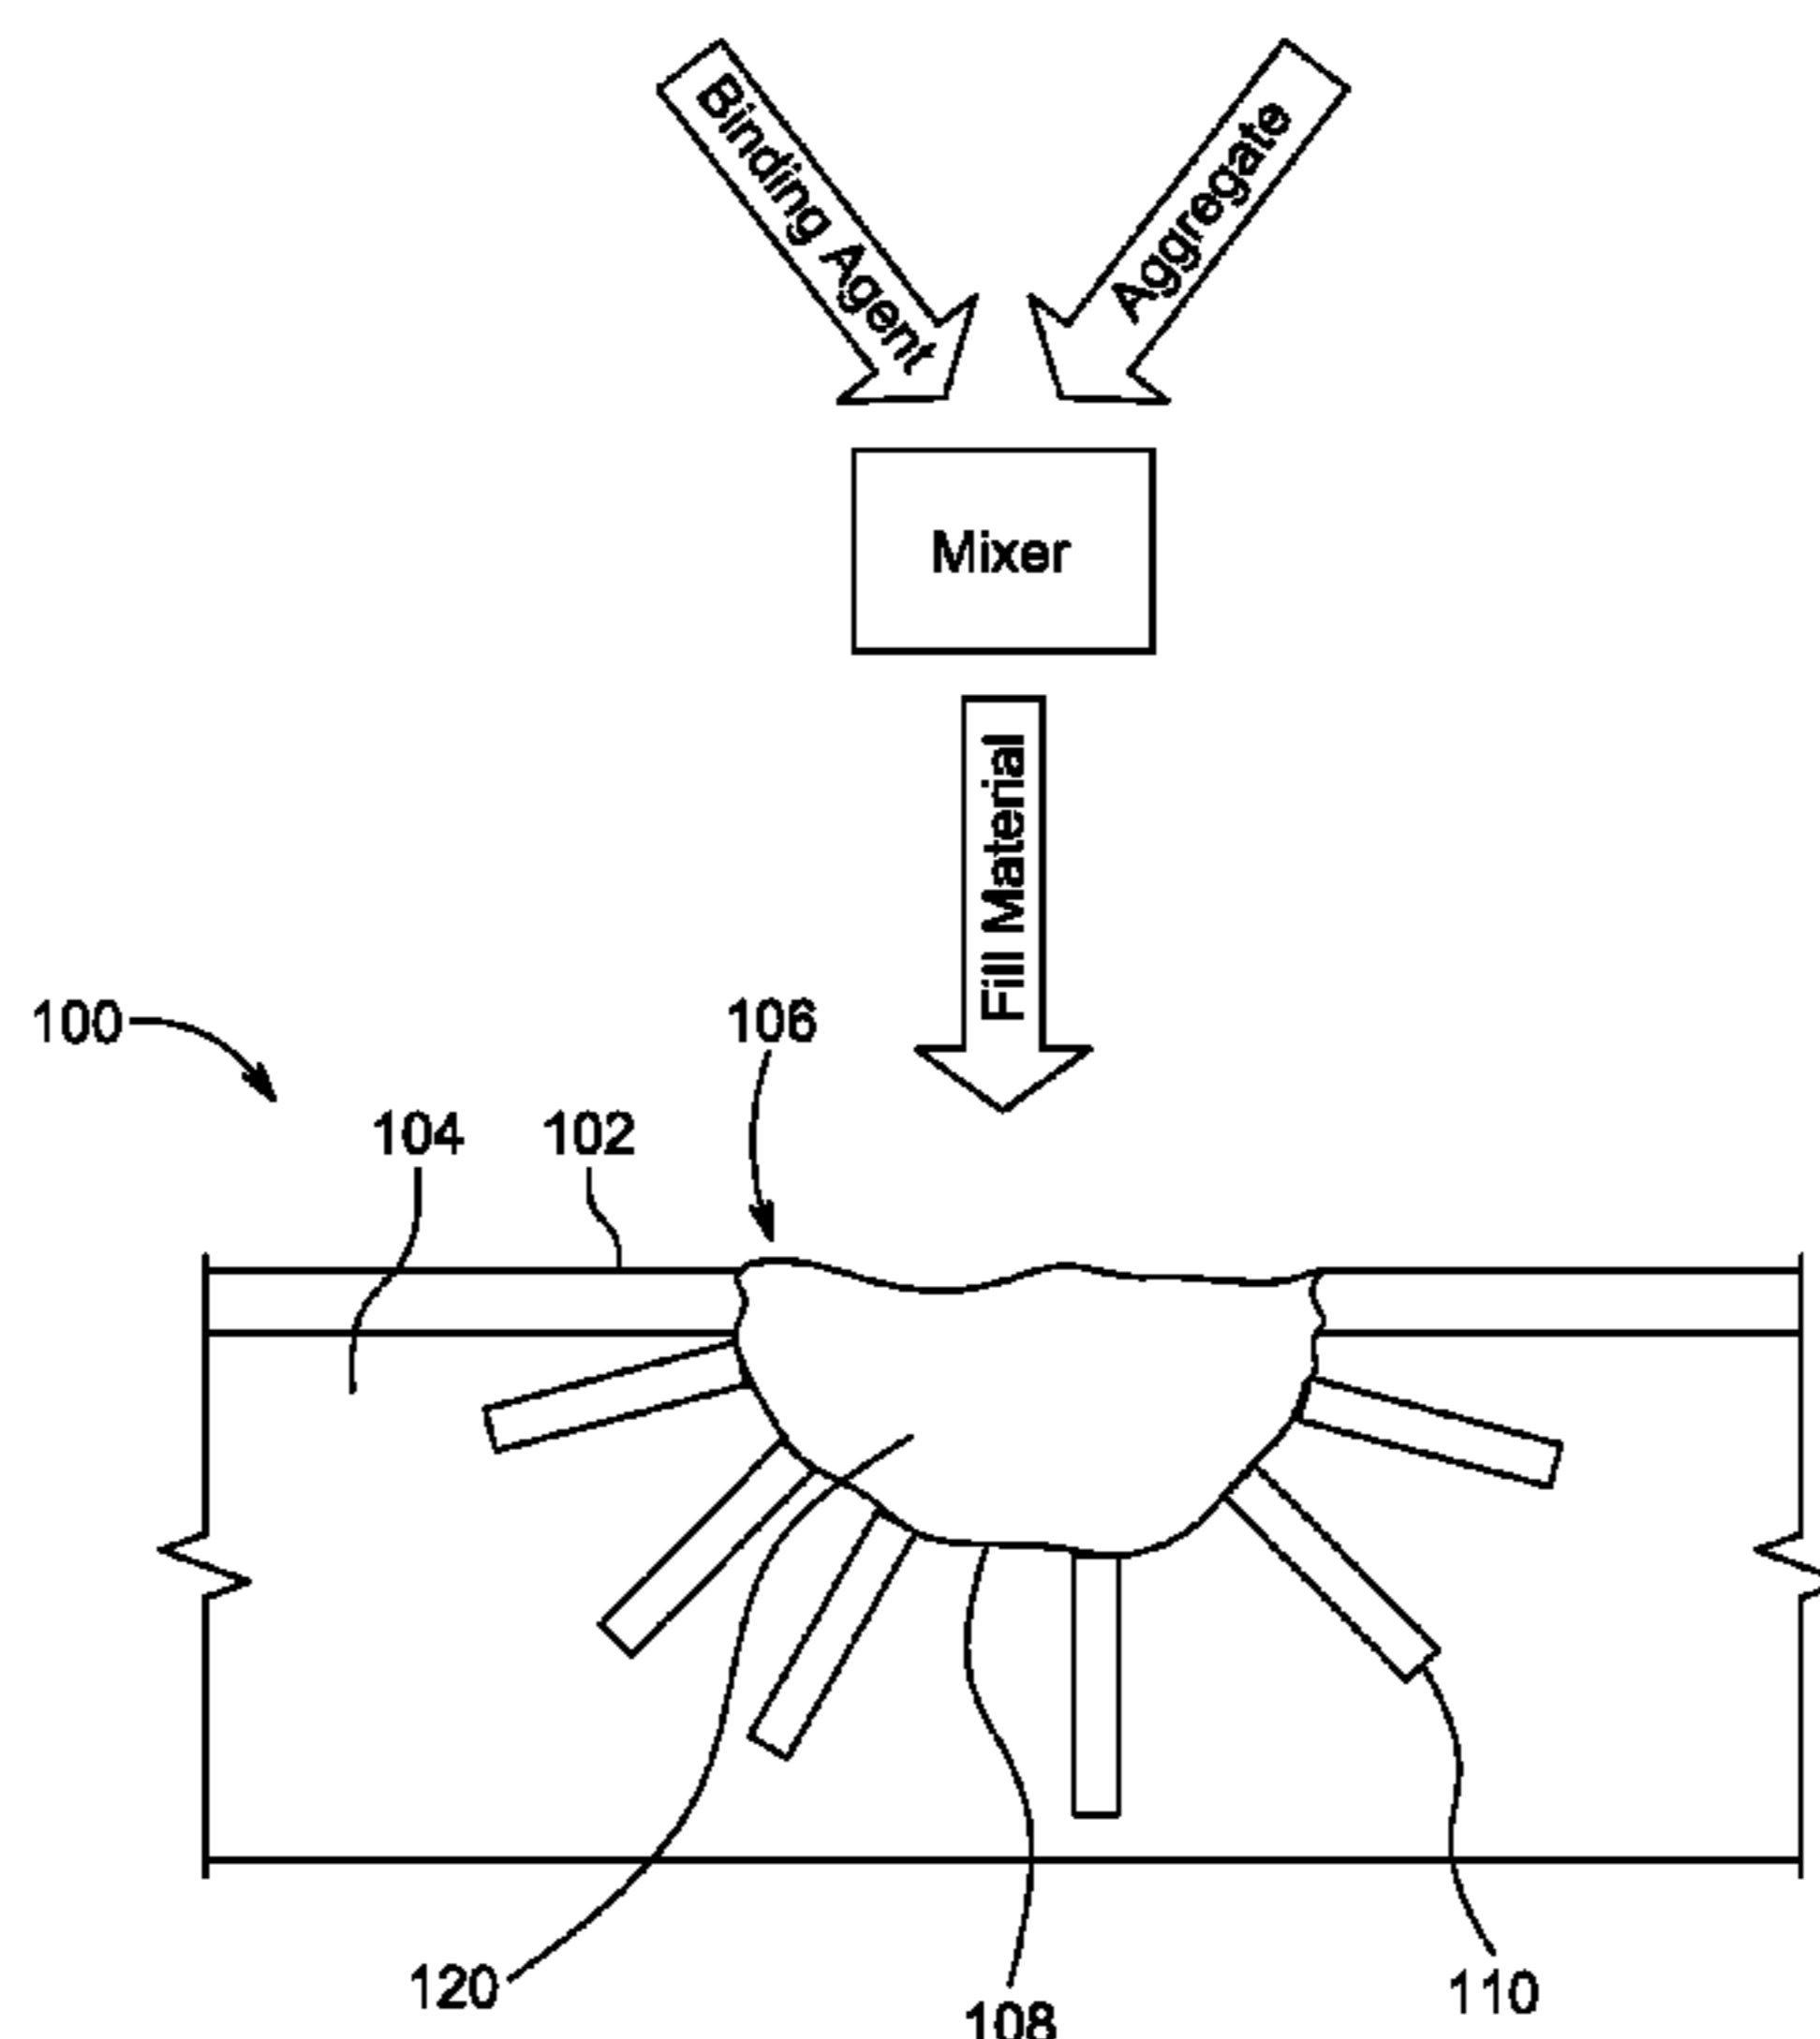
A composition and method of repairing damaged concrete and asphalt surfaces includes a two-part polymer resin mixture. To effectuate a repair, the damaged portion is cleaned of debris and loose pieces. The two-part polymer resin mixture is mixed onsite and is applied as a protective overlay over the damaged portion. Once cured, the mixture provides a protective layer over the damaged area.

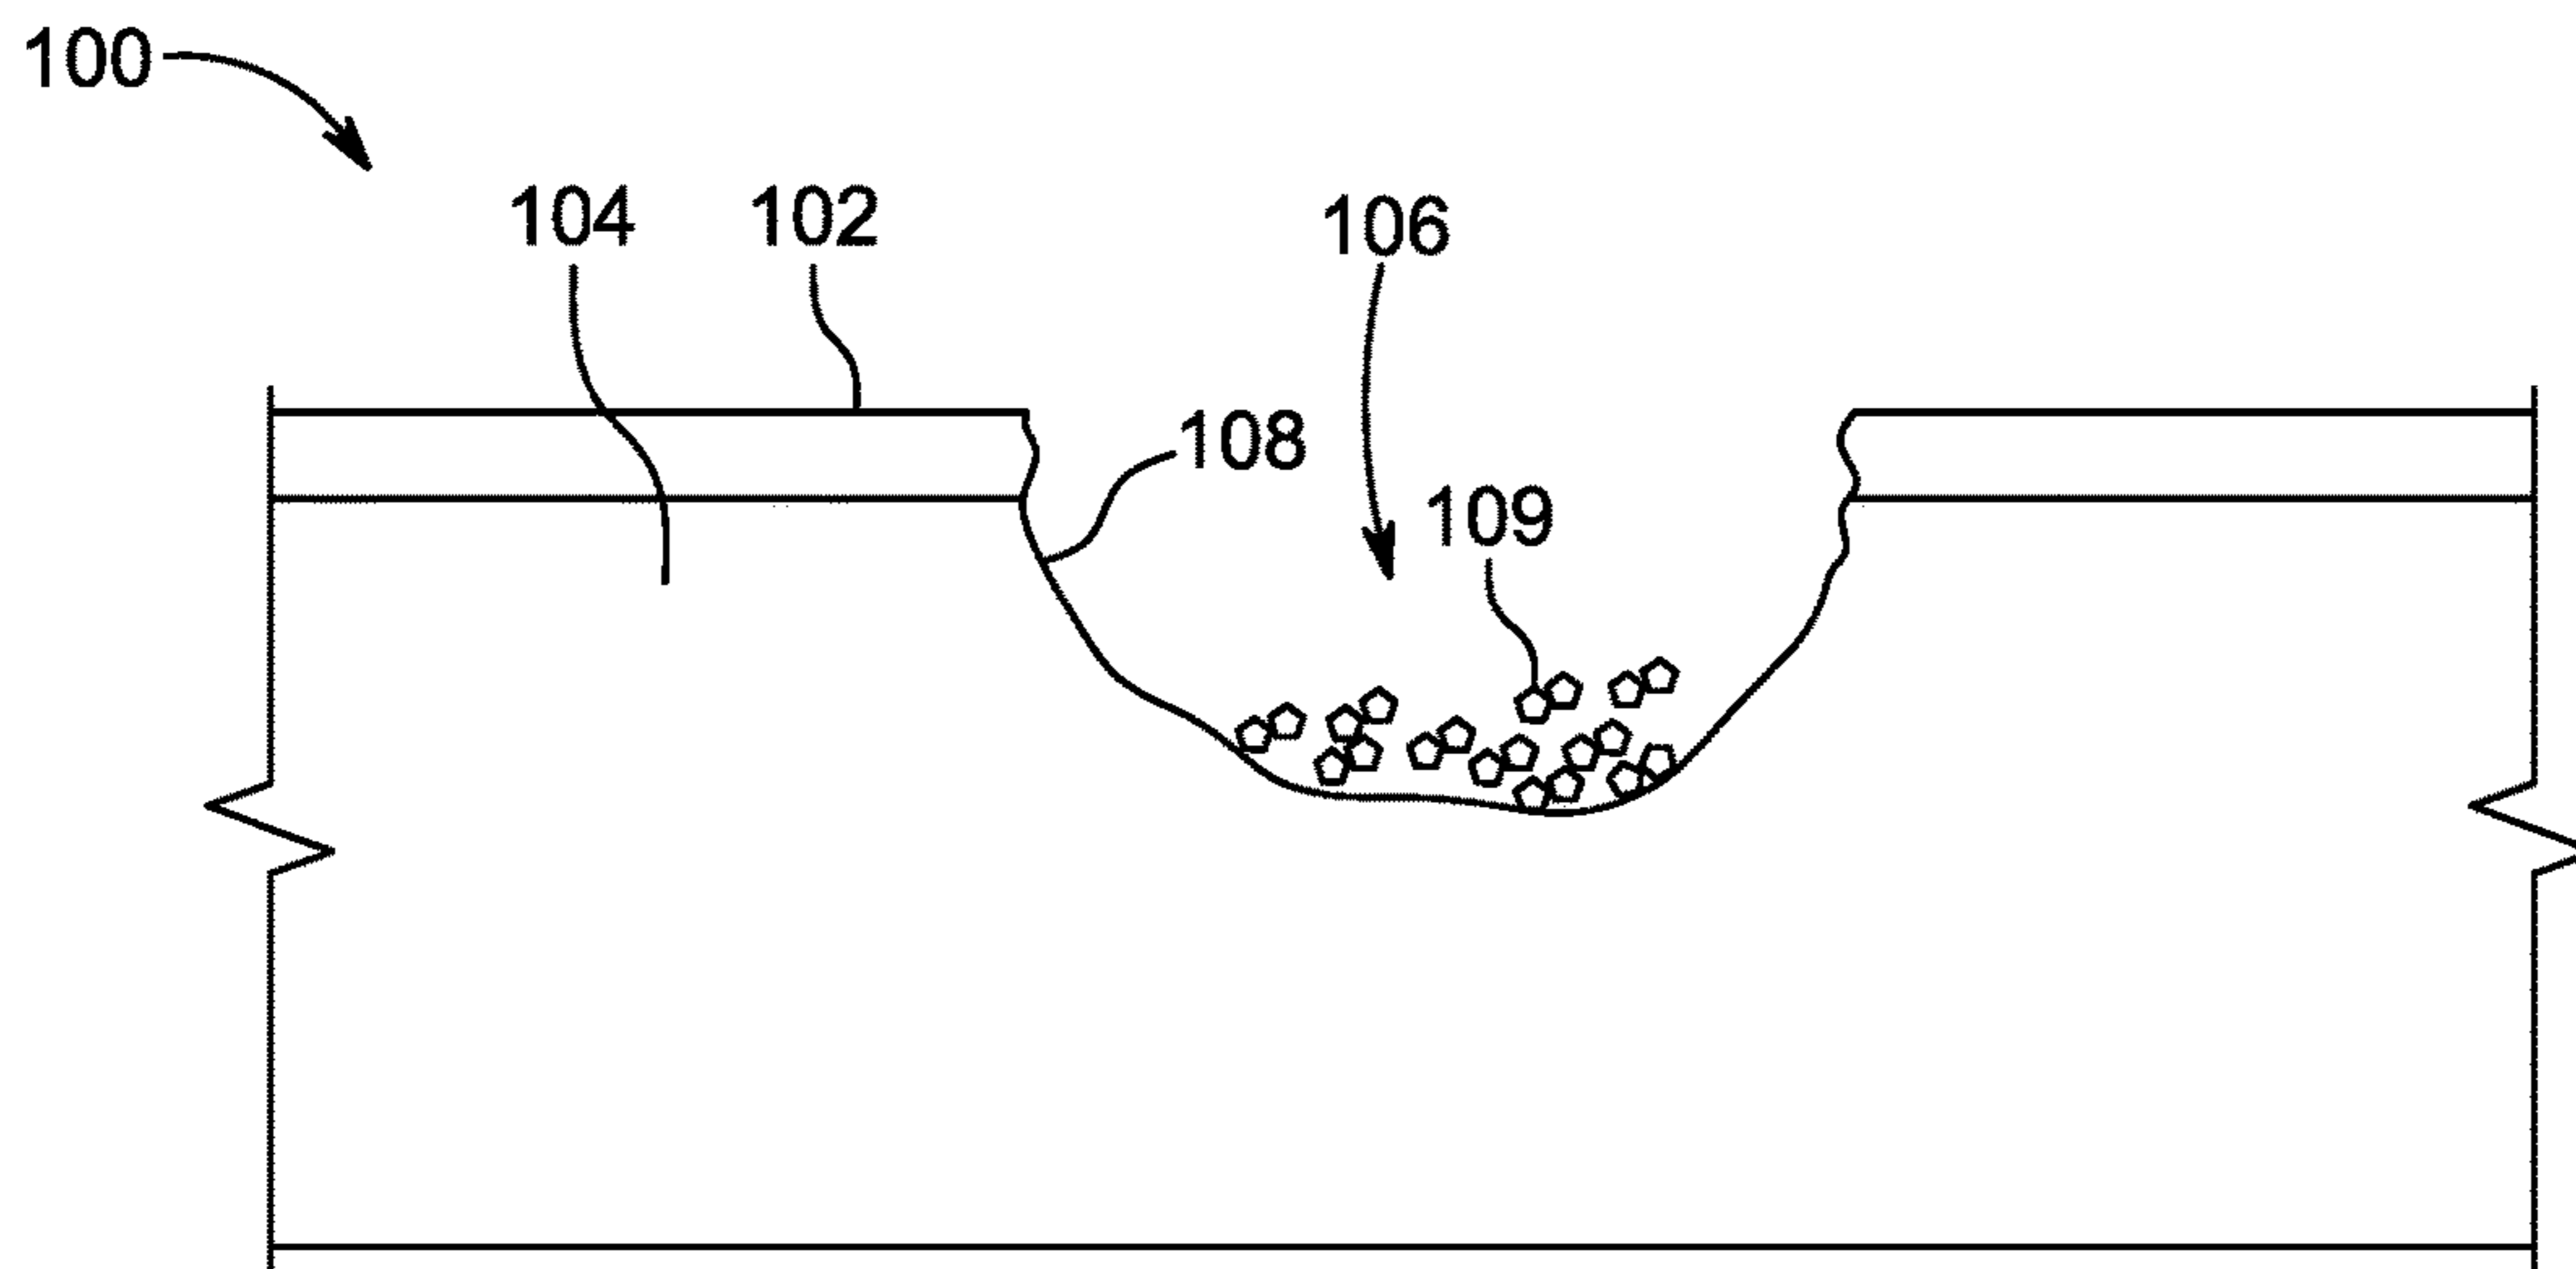
FIG. 1 depicts a pothole in a roadway identified for repair according to an embodiment of the present disclosure;

Referring now to FIG. 1, there is depicted a roadway **100** according to an embodiment of the present disclosure. The roadway **100** may be formed of any suitable material. The roadway **100** may include a surface layer **102** formed on a base material **104** as is known to those of ordinary skill. The surface layer **102** may be formed of any suitable material, including, but not limited to, asphalt or concrete. The base material **104** may be formed of aggregate or some other crushed material, such as crushed stone.

A damaged portion **106** may be formed in the roadway **100**. The damaged portion **106** may be caused by several factors, including the wear and tear of traffic as well as seasonal freeze-thaw cycles. The damaged portion **106** may take any shape or form, including cracks or other types of damage in the roadway **100**. The damaged portion **106** may have an interior surface **108** that defines a cavity or void that extends below the surface layer **102** and into the base material **104**. Loose debris **109** may be present in the bottom of the damaged portion **106**. The loose debris **109** may include fragmented pieces of the surface layer **102**.

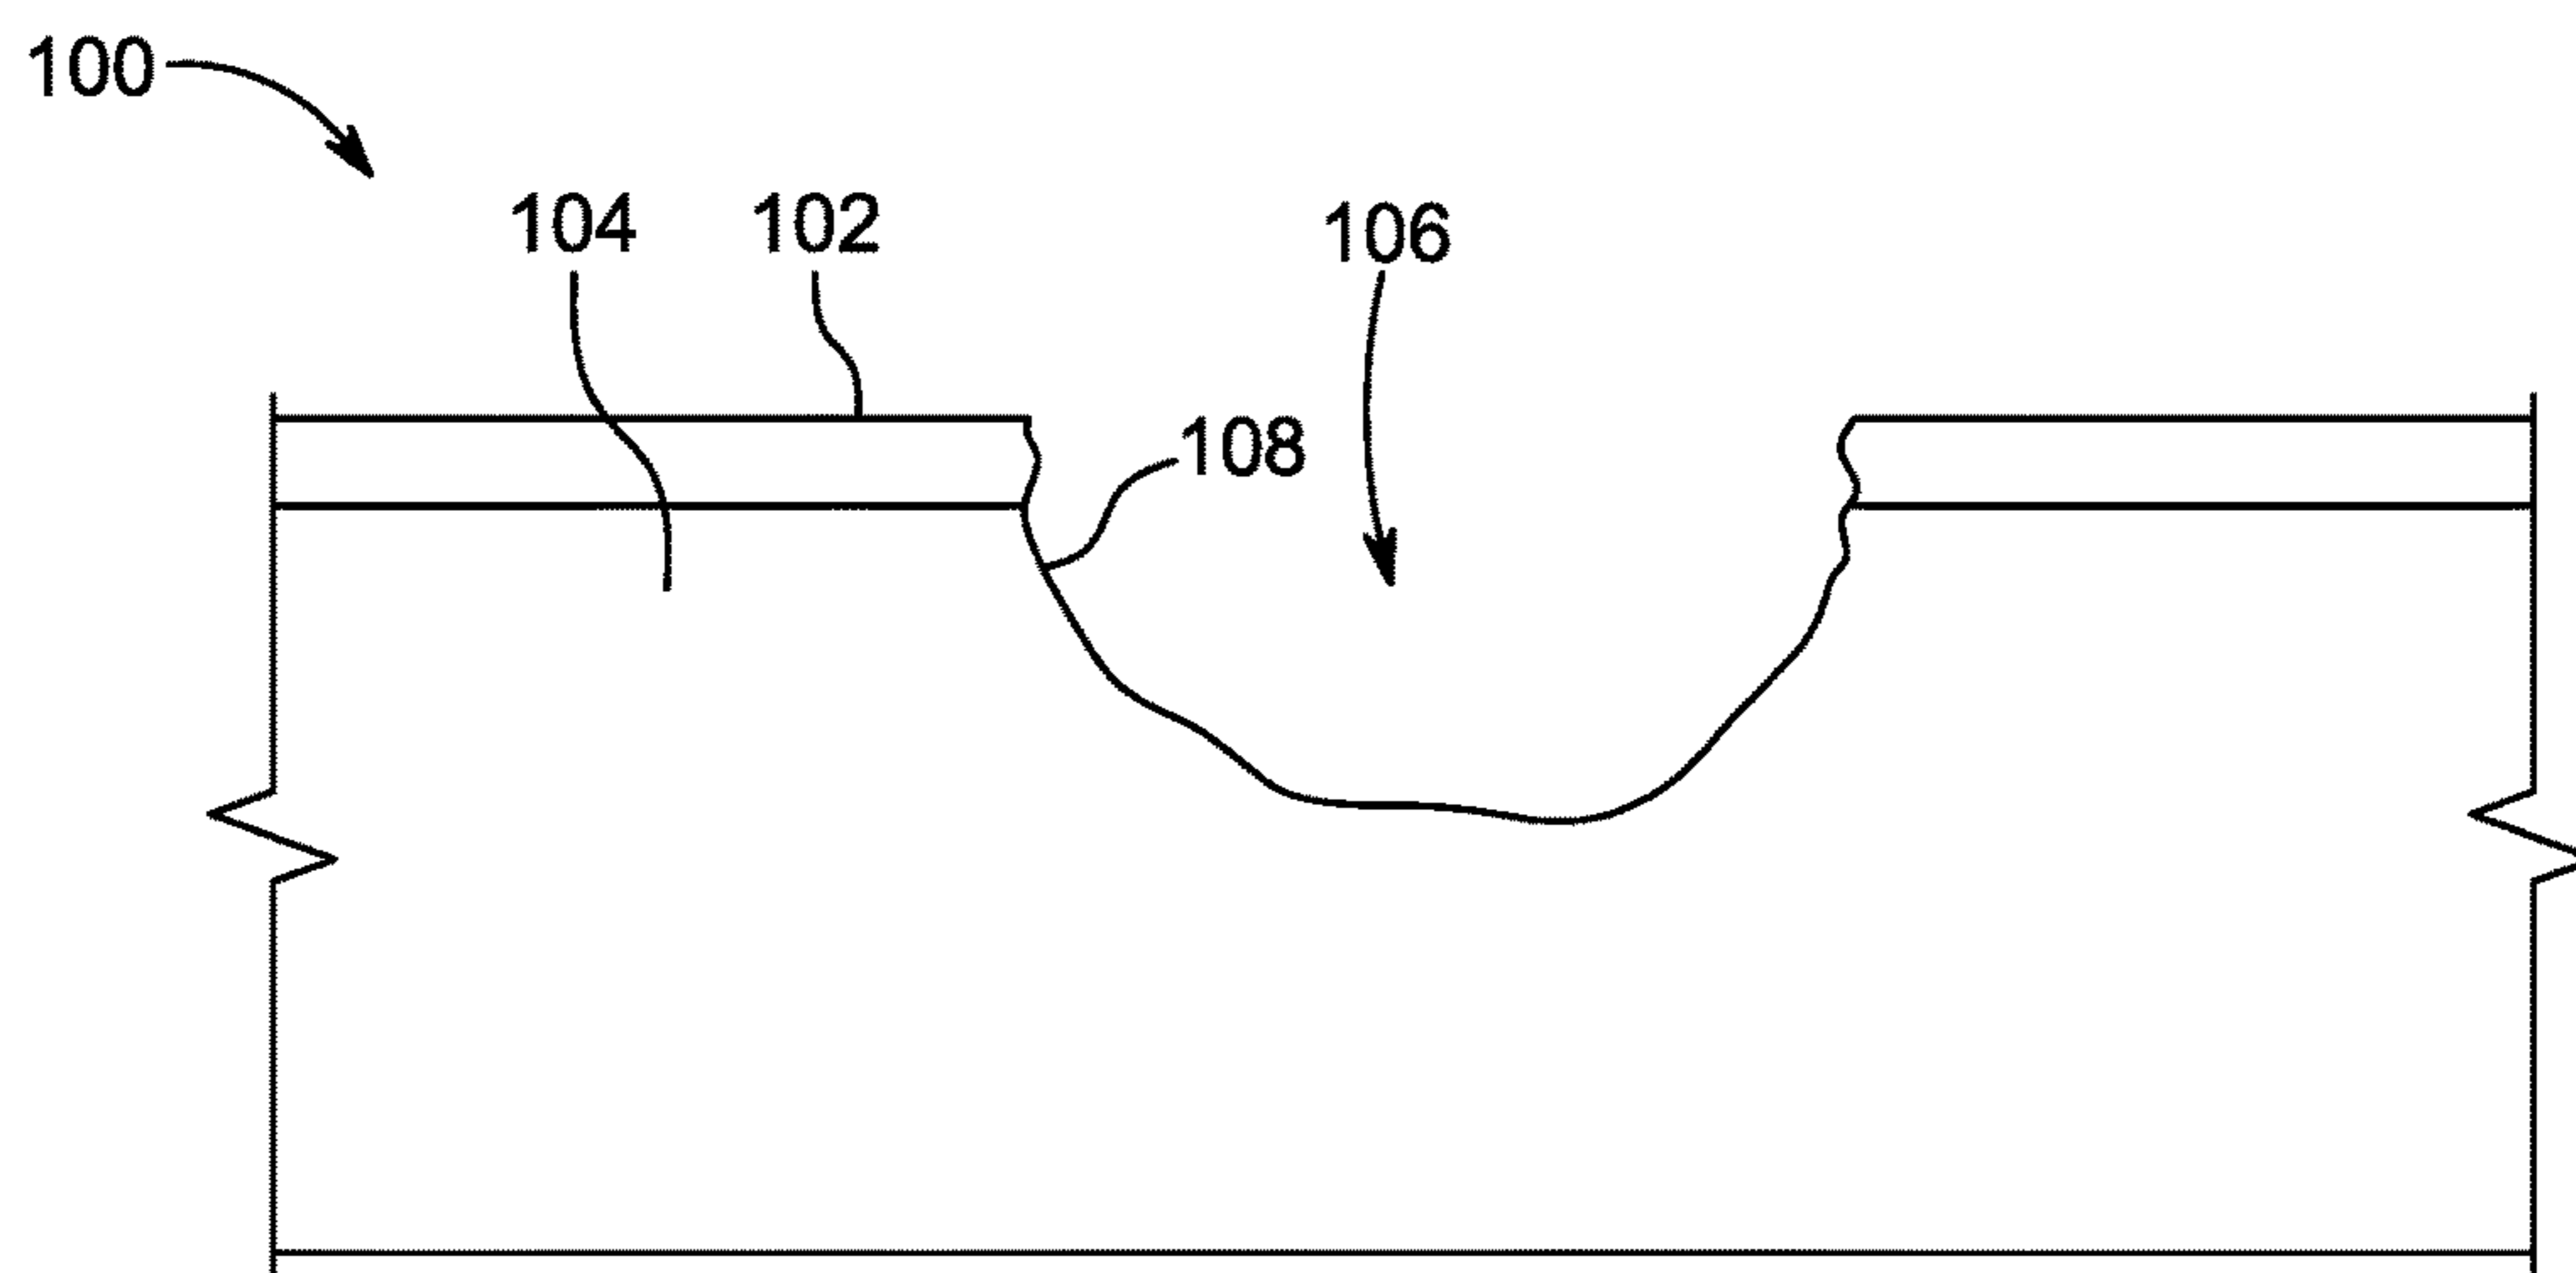
FIG. 2 depicts the pothole in FIG. 1 with the debris removed;

As shown in FIG. 2, where like reference numerals depict like components, the first step in patching the damaged portion **106** is to remove the loose debris to expose the interior surface **108**. This may be done using handheld or powered tools, including shovels.

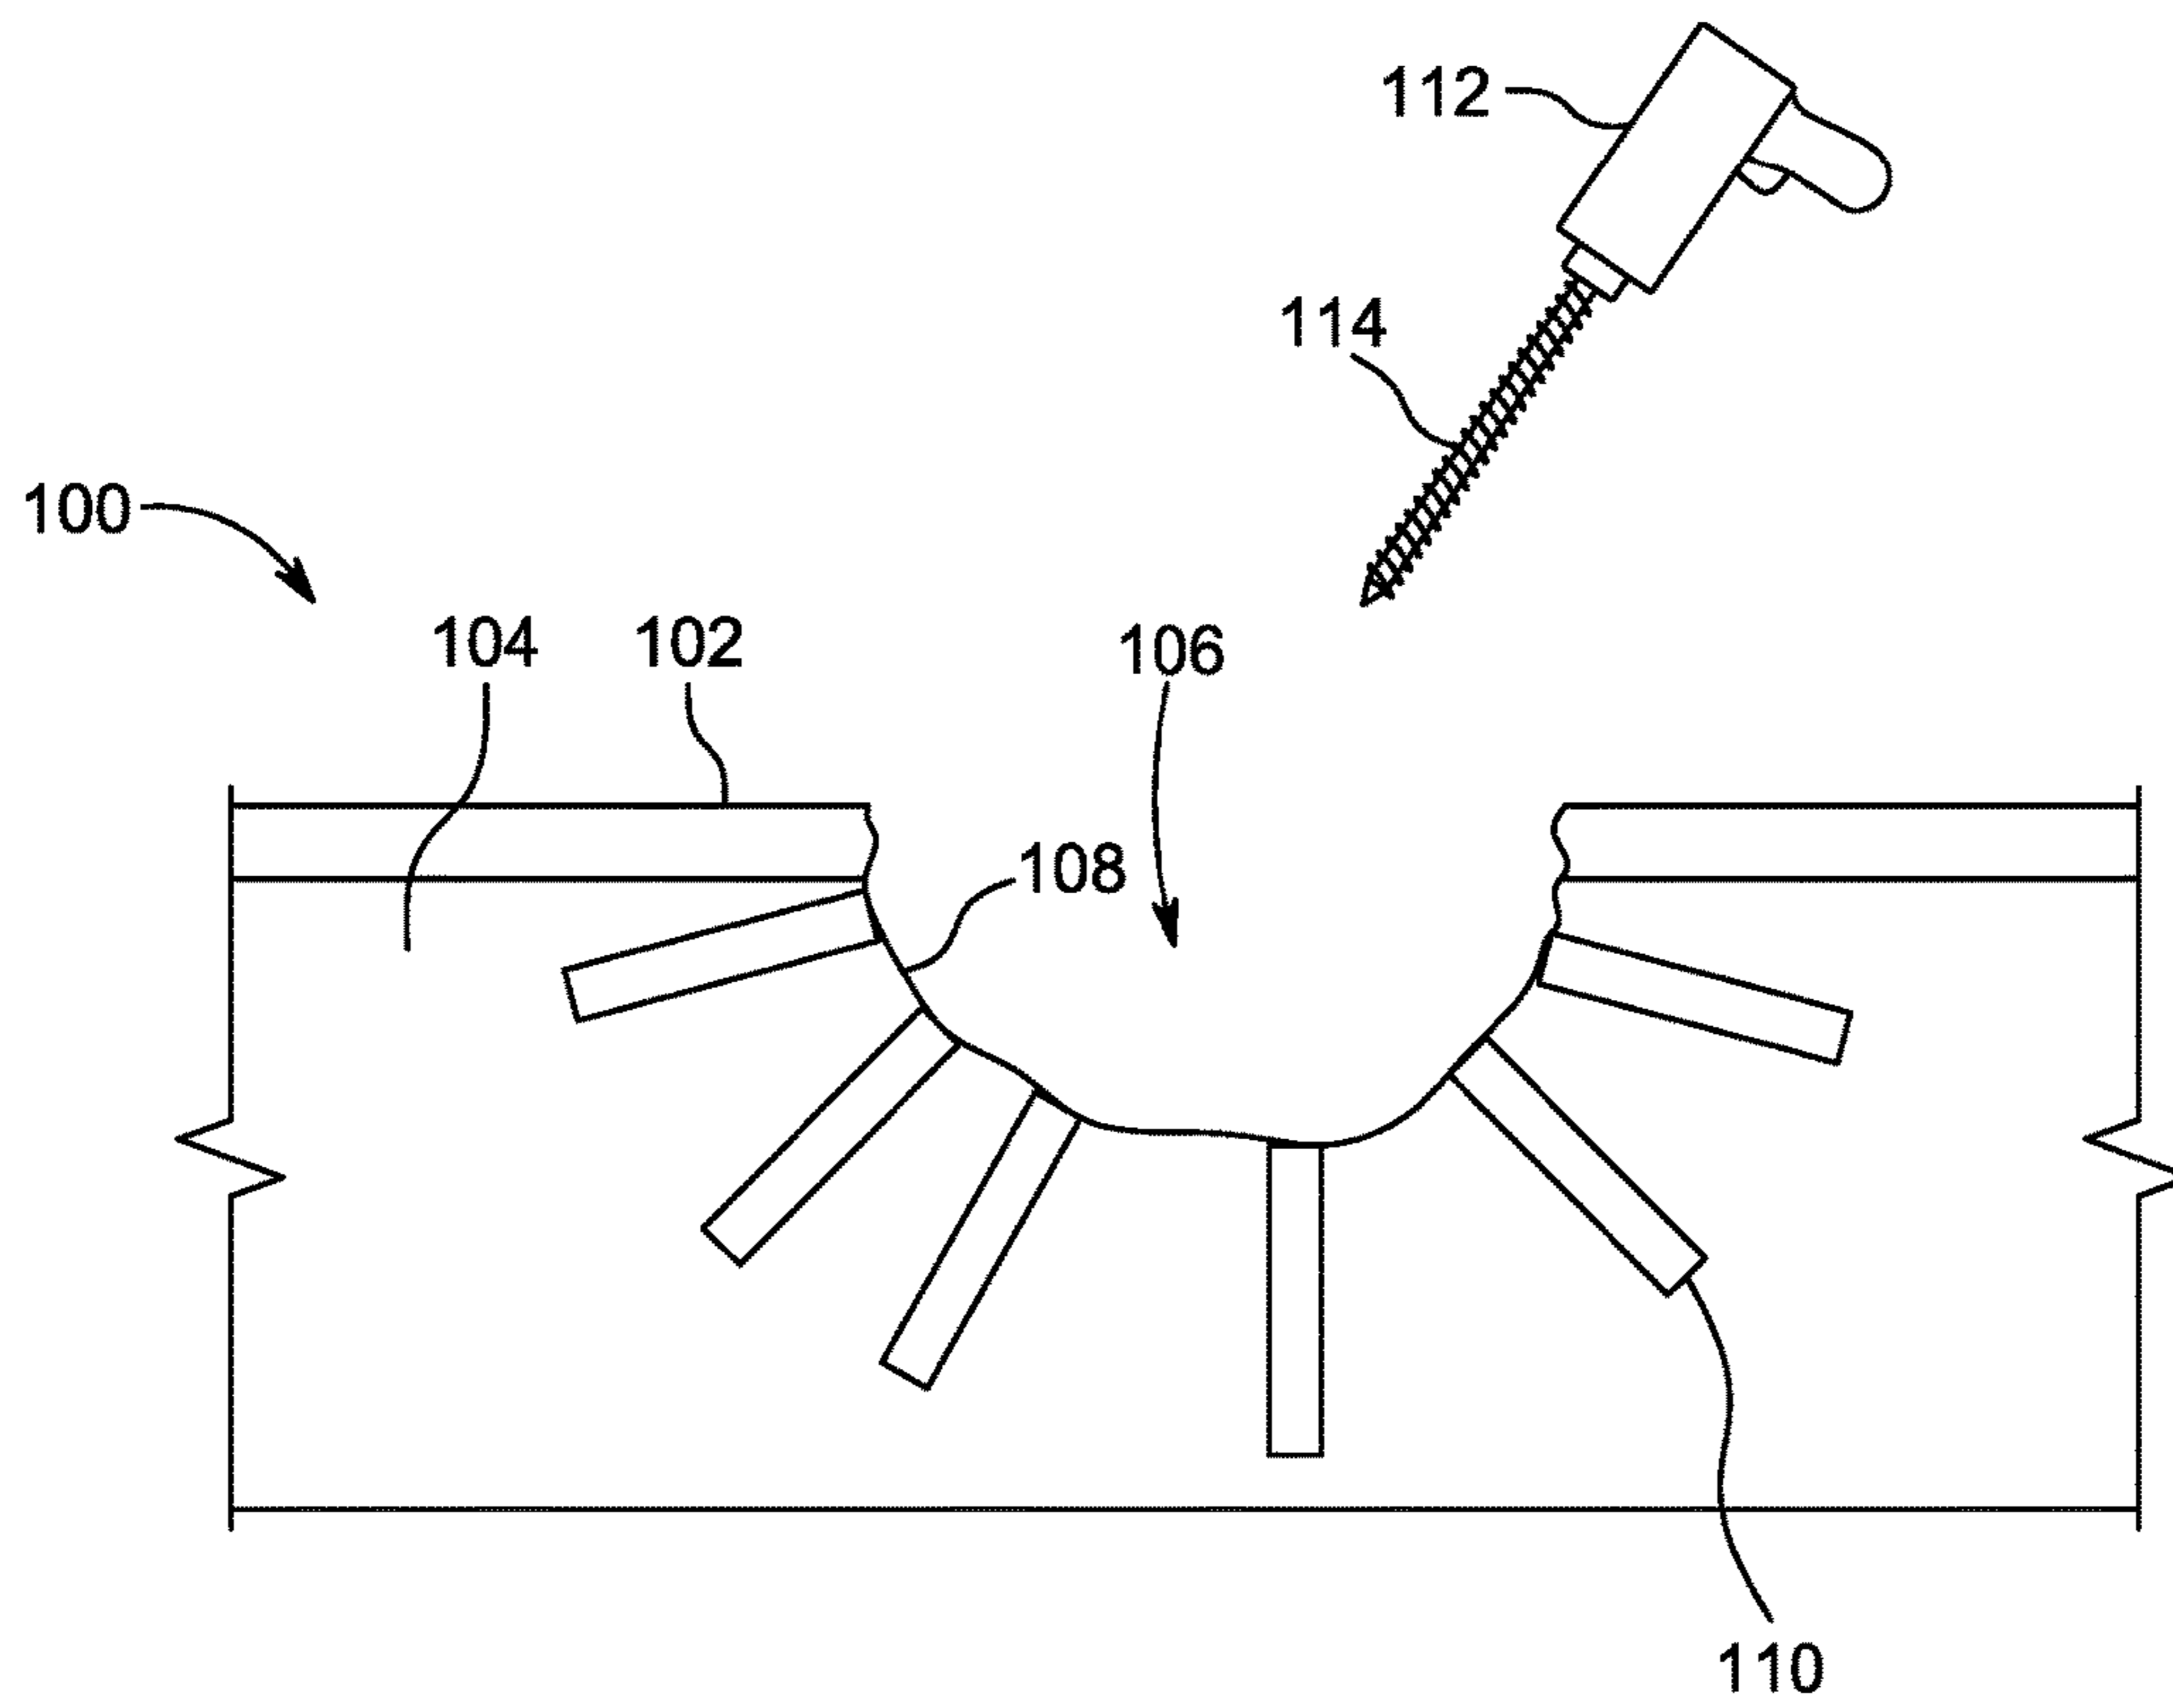
FIG. 3 depicts the pothole in FIG. 1 with the boreholes formed in the interior surface;

As shown in FIG. 3, where like reference numerals depict like components, the next step in patching the damaged portion **106** is to form at least one borehole **110** in the interior surface **108**. In an embodiment, the at least one borehole **110** may be formed using a powered tool, such as a drill **112** having a bit **114**. In an embodiment, the drill **112** may be one of electric and hydraulic. In an embodiment, the drill **112** may be handheld or mounted to an arm of a machine.

In an embodiment, the diameter of the bit **114** is between one-half inch and three inches. In an embodiment, the diameter of the bit **114** is about one inch. In an embodiment, a length of the cutting surface of the bit **114** is between six inches to three feet. In an embodiment, a length of the cutting surface of the bit **114** may be about one foot, or between ten inches and fourteen inches. In an embodiment, a length of the cutting surface of the bit **114** may be about two feet.

The at least one borehole **110** may have a diameter between one-half inch and three inches. In an embodiment, the diameter of the at least one borehole **110** is one inch. A depth of the at least one borehole **110** may range from about six inches to three feet. In an embodiment, the depth of the at least one borehole **110** may be about one foot, or between ten inches and fourteen inches. In an embodiment, the depth of the at least one borehole **110** may be about two feet.

The number of boreholes **110** formed in the damaged portion **106** may depend on the size void formed by the damaged portion **106**. In an embodiment, the number of boreholes **110** may range from about one to twenty, or two boreholes. In an embodiment, some of the at least one borehole **110** may undercut the surface layer **102**. In an embodiment, the boreholes **110** may extend into the base material **104**.

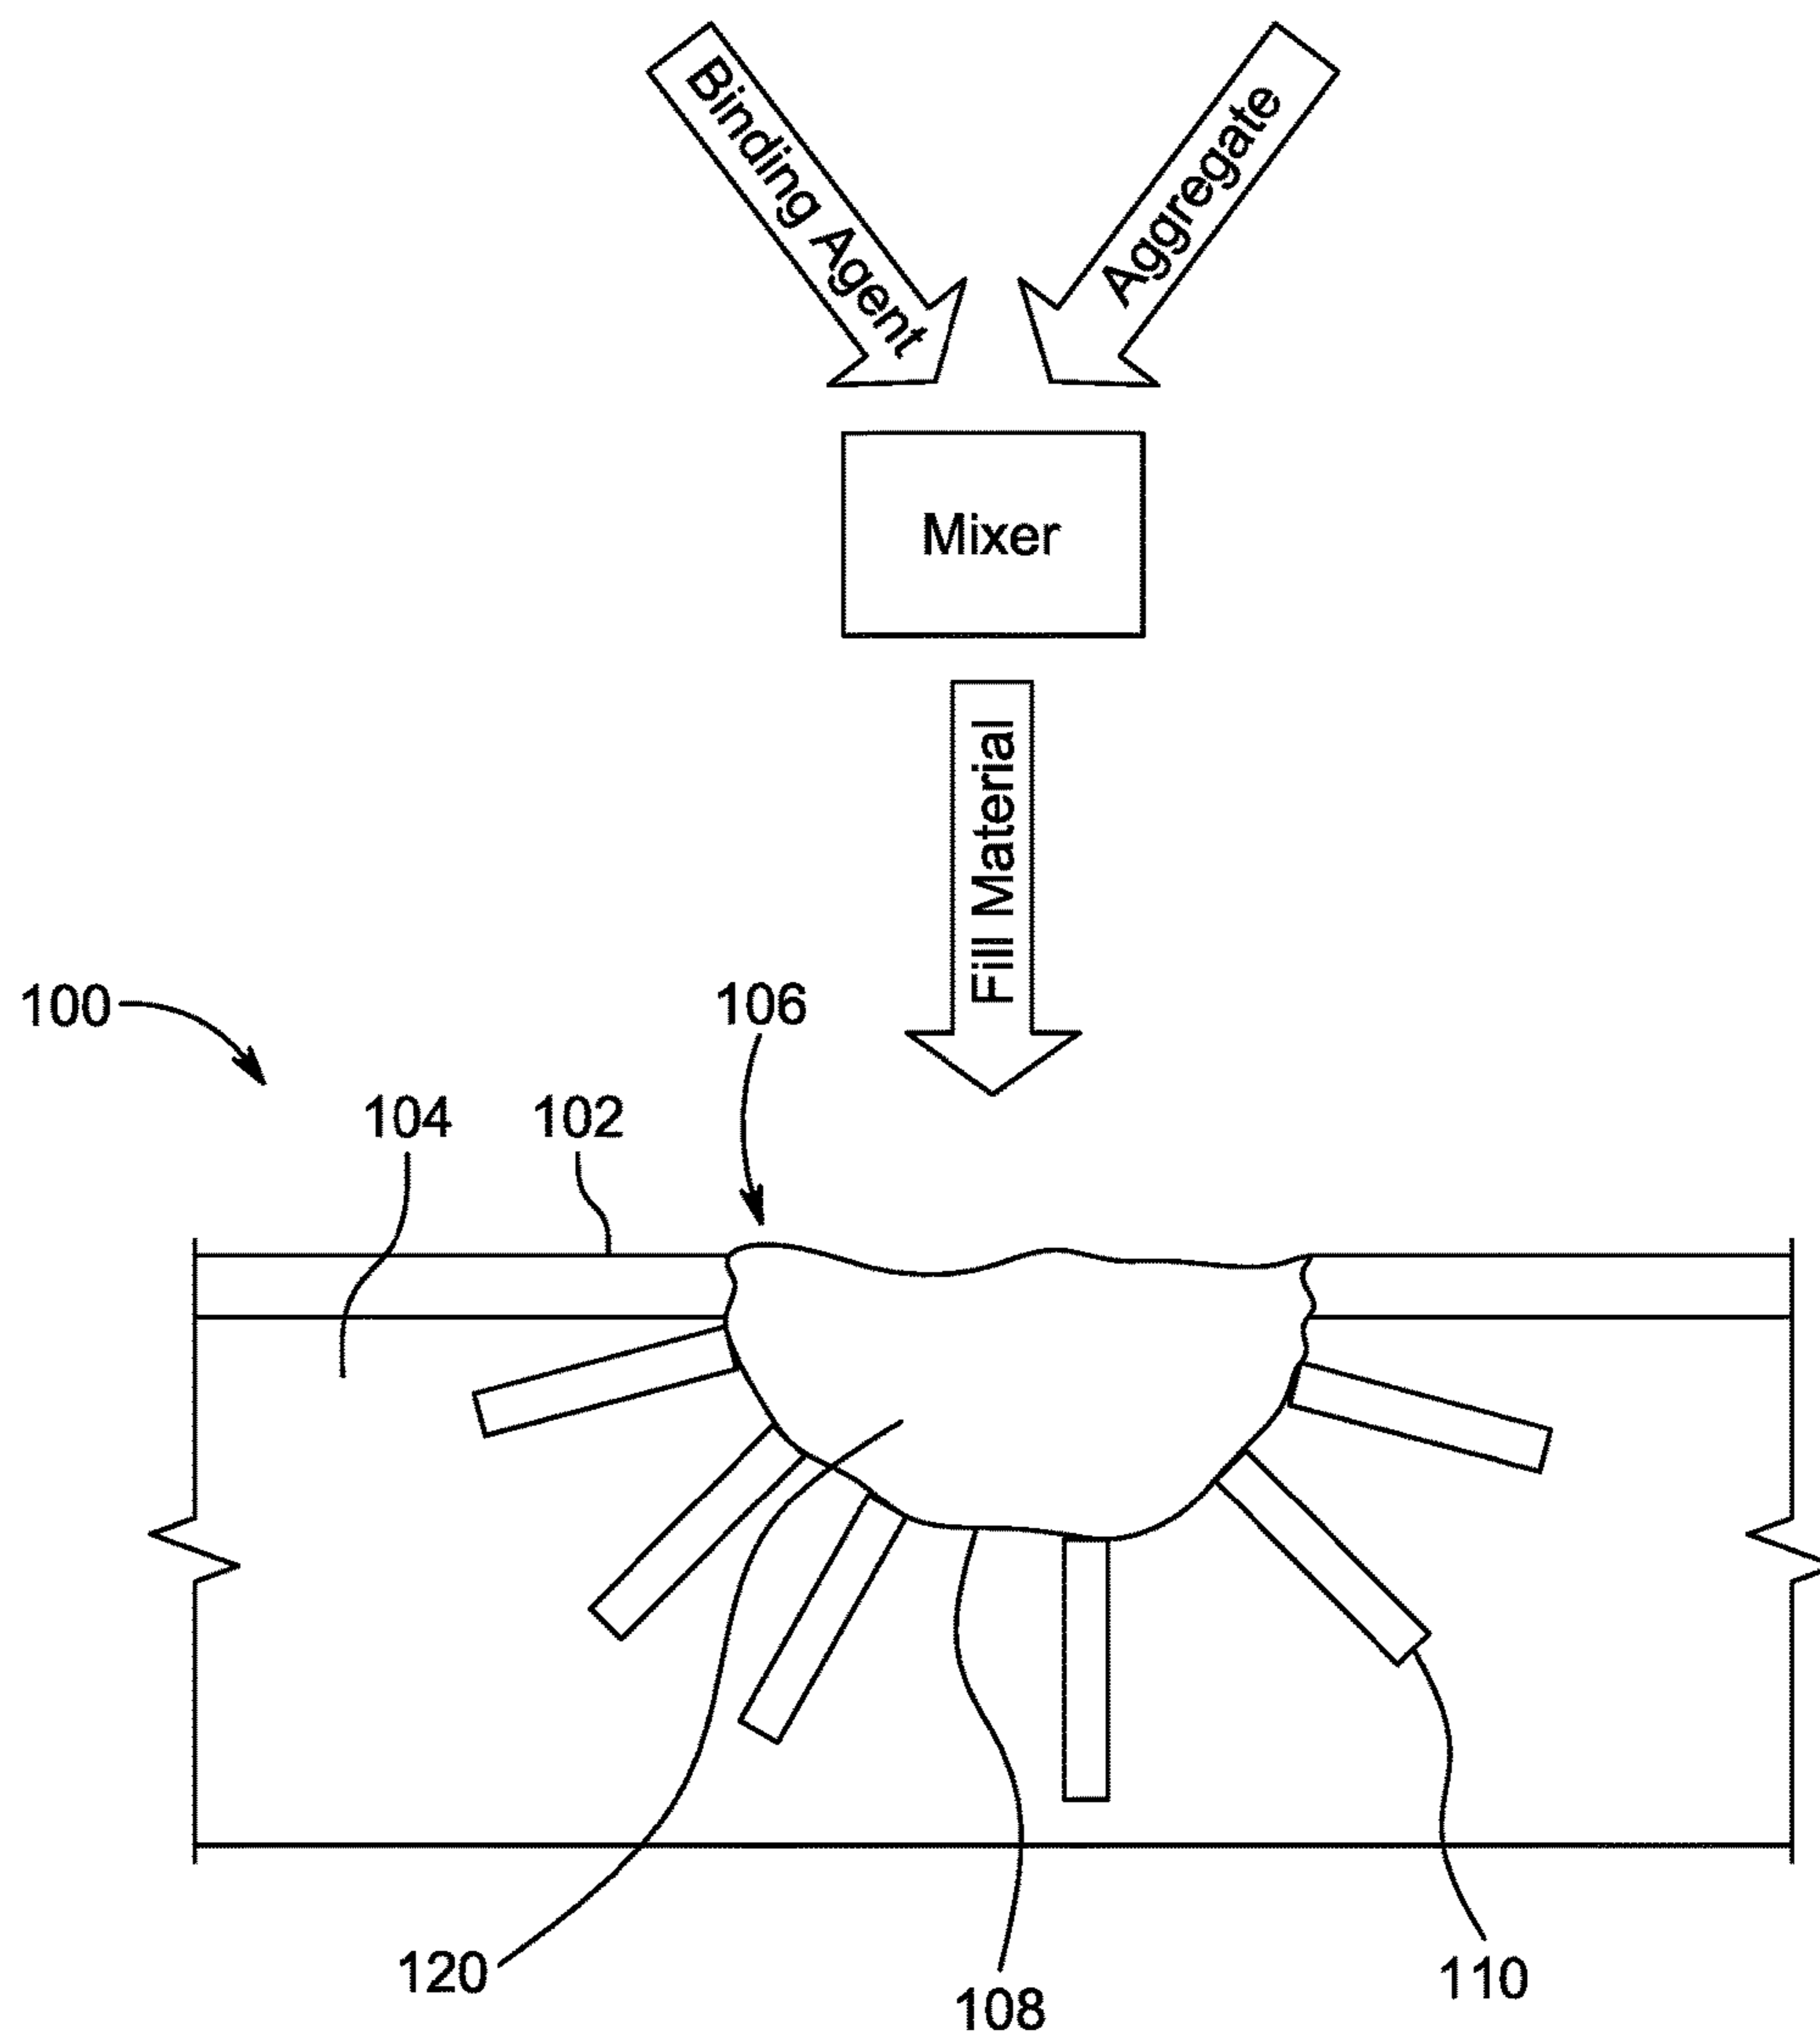
FIG. 4 depicts the pothole in FIG. 1 with the boreholes and pothole filled with a fill material;

As shown in FIG. 4, the next step for patching the damaged portion **106** is to install a fill material **120**. The fill material **120** may have a consistency such that it flows into the at least one borehole **110**. The fill material **120** may comprise a mixture of a binding agent and an aggregate. In

As shown in FIG. 4, the fill material **120** is placed into the damaged portion **106** until it is about even with the top of the surface layer **102**. As shown in FIG. 5, a friction enhancing material **122** may be placed or sprinkled onto the top of the fill material **120**. The friction enhancing material **122** may comprise a crushed material, such as crushed stone.

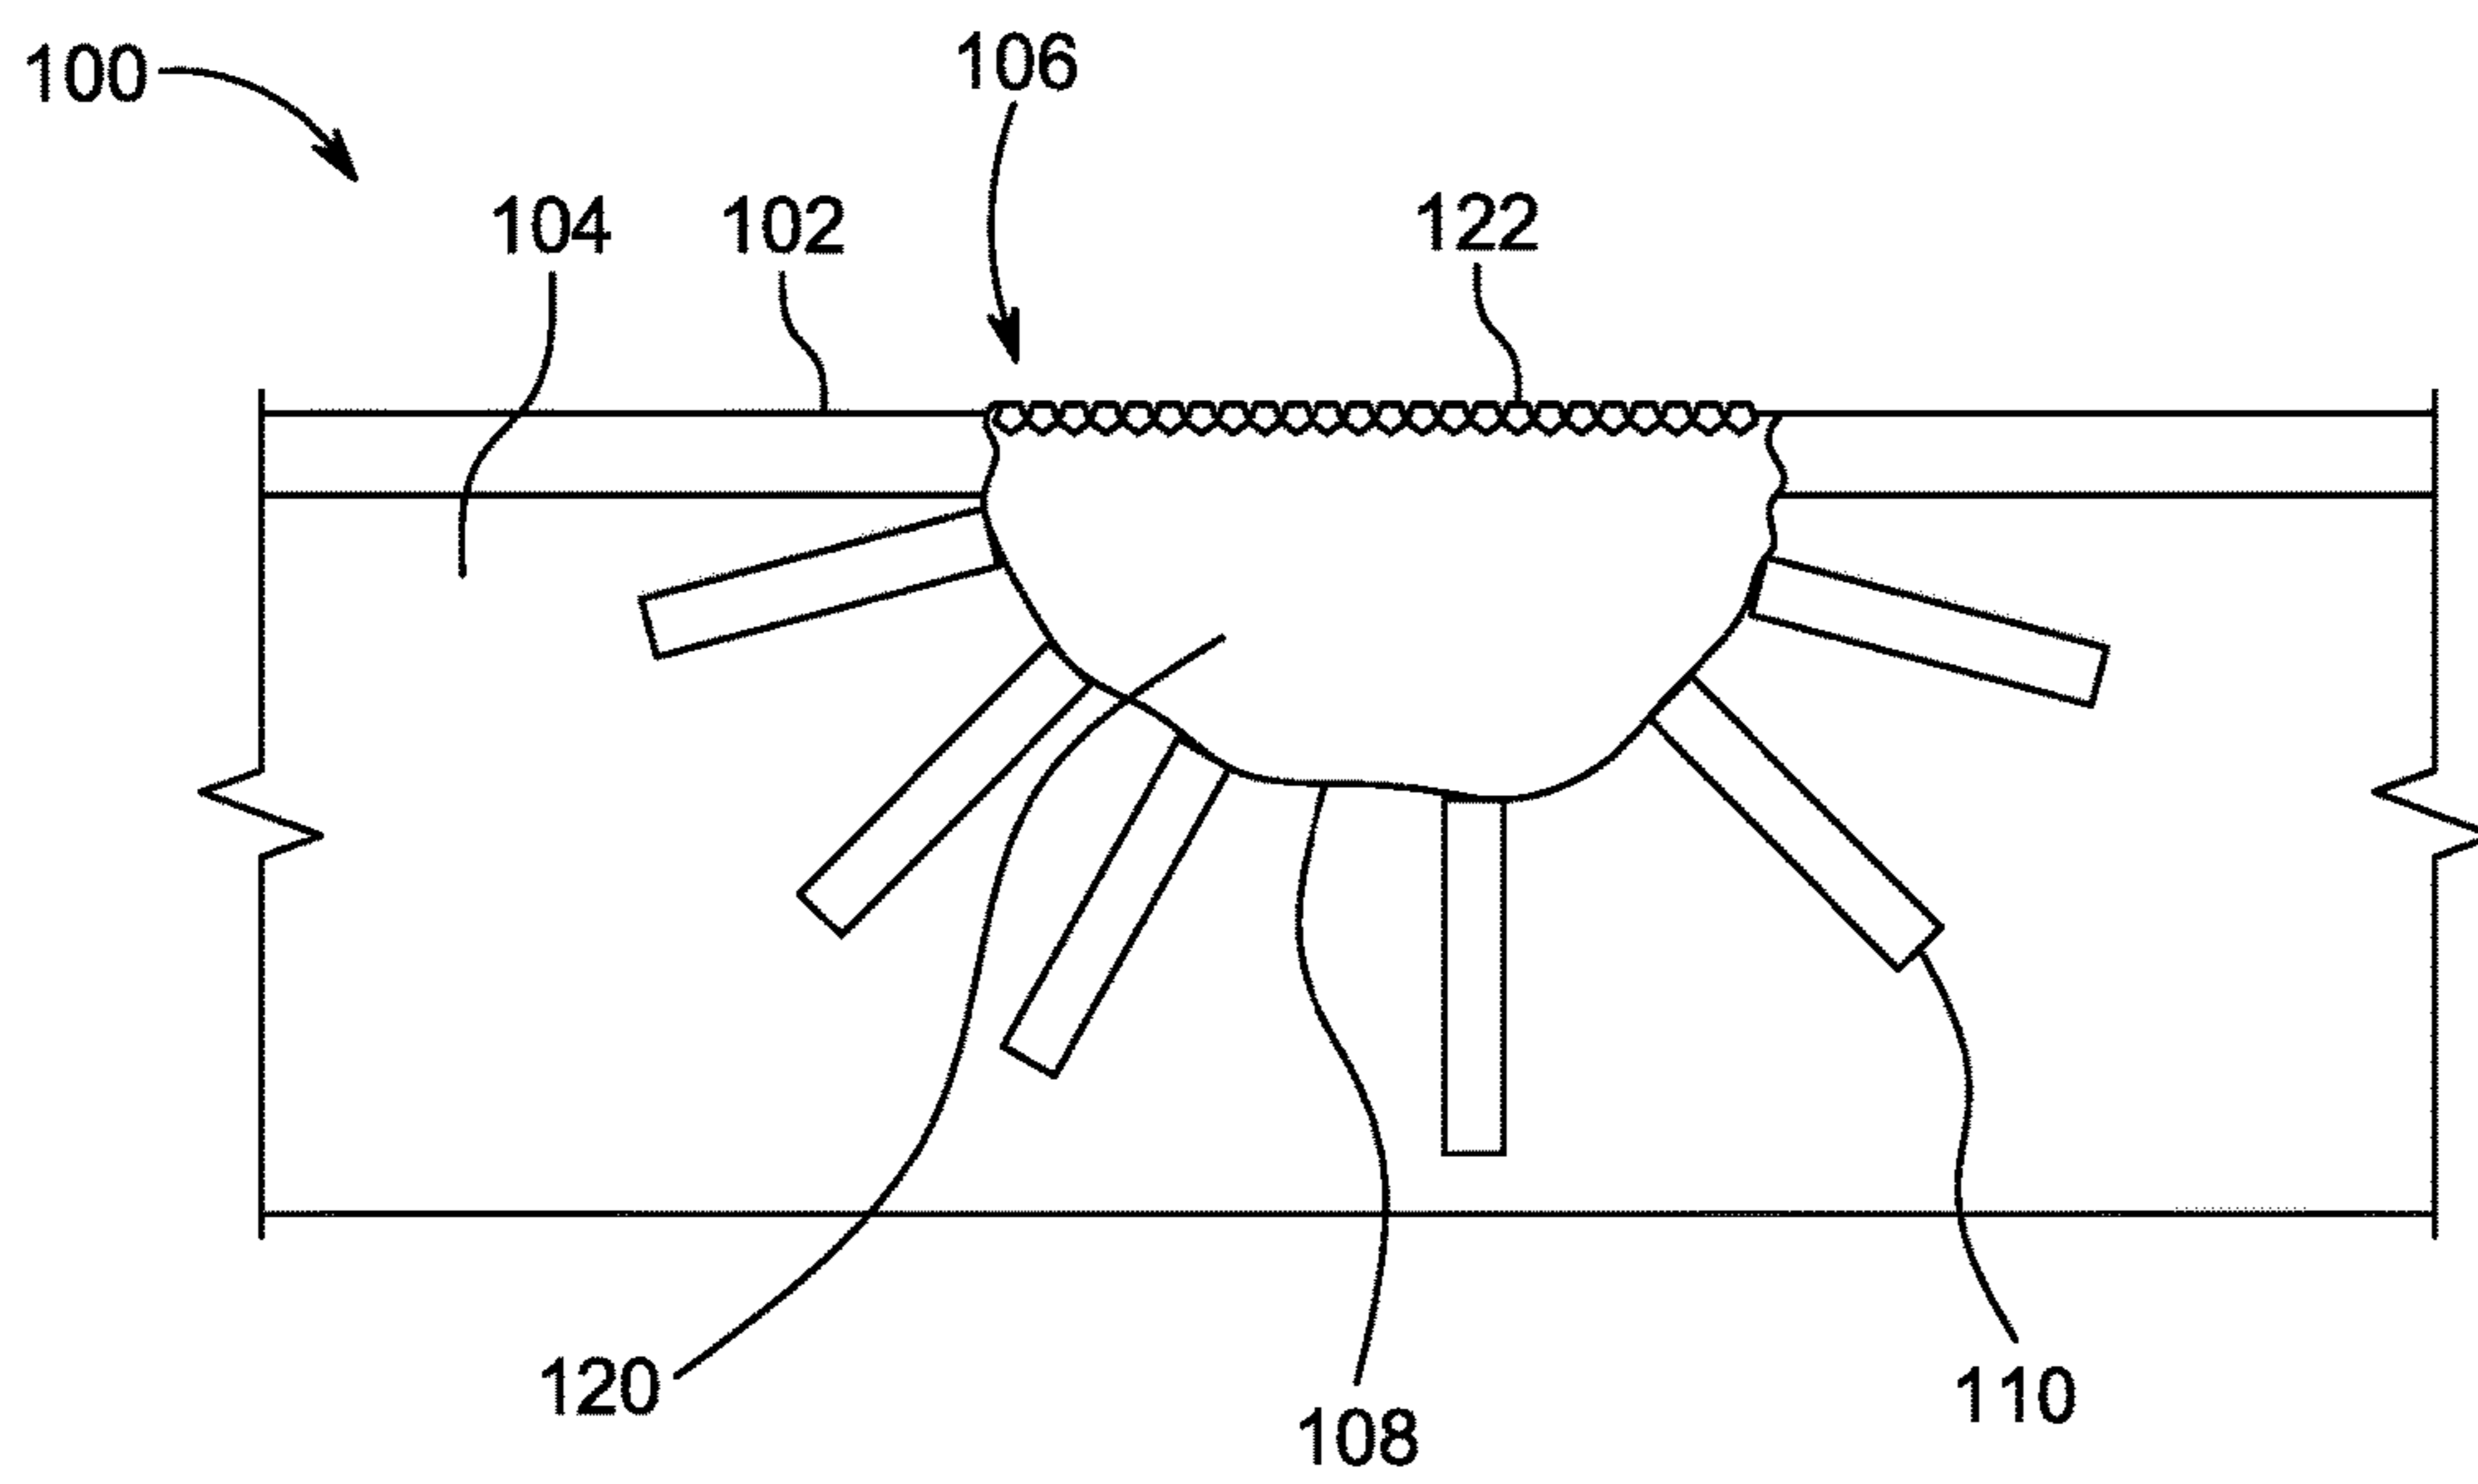
FIG. 5 depicts the pothole in FIG. 1 with the fill material and a friction enhancing material;
