US010329719B1

(12) **United States Patent**
Giles

(54) **COMPOSITION AND METHOD FOR SURFACE REPAIR**

(57) **ABSTRACT**

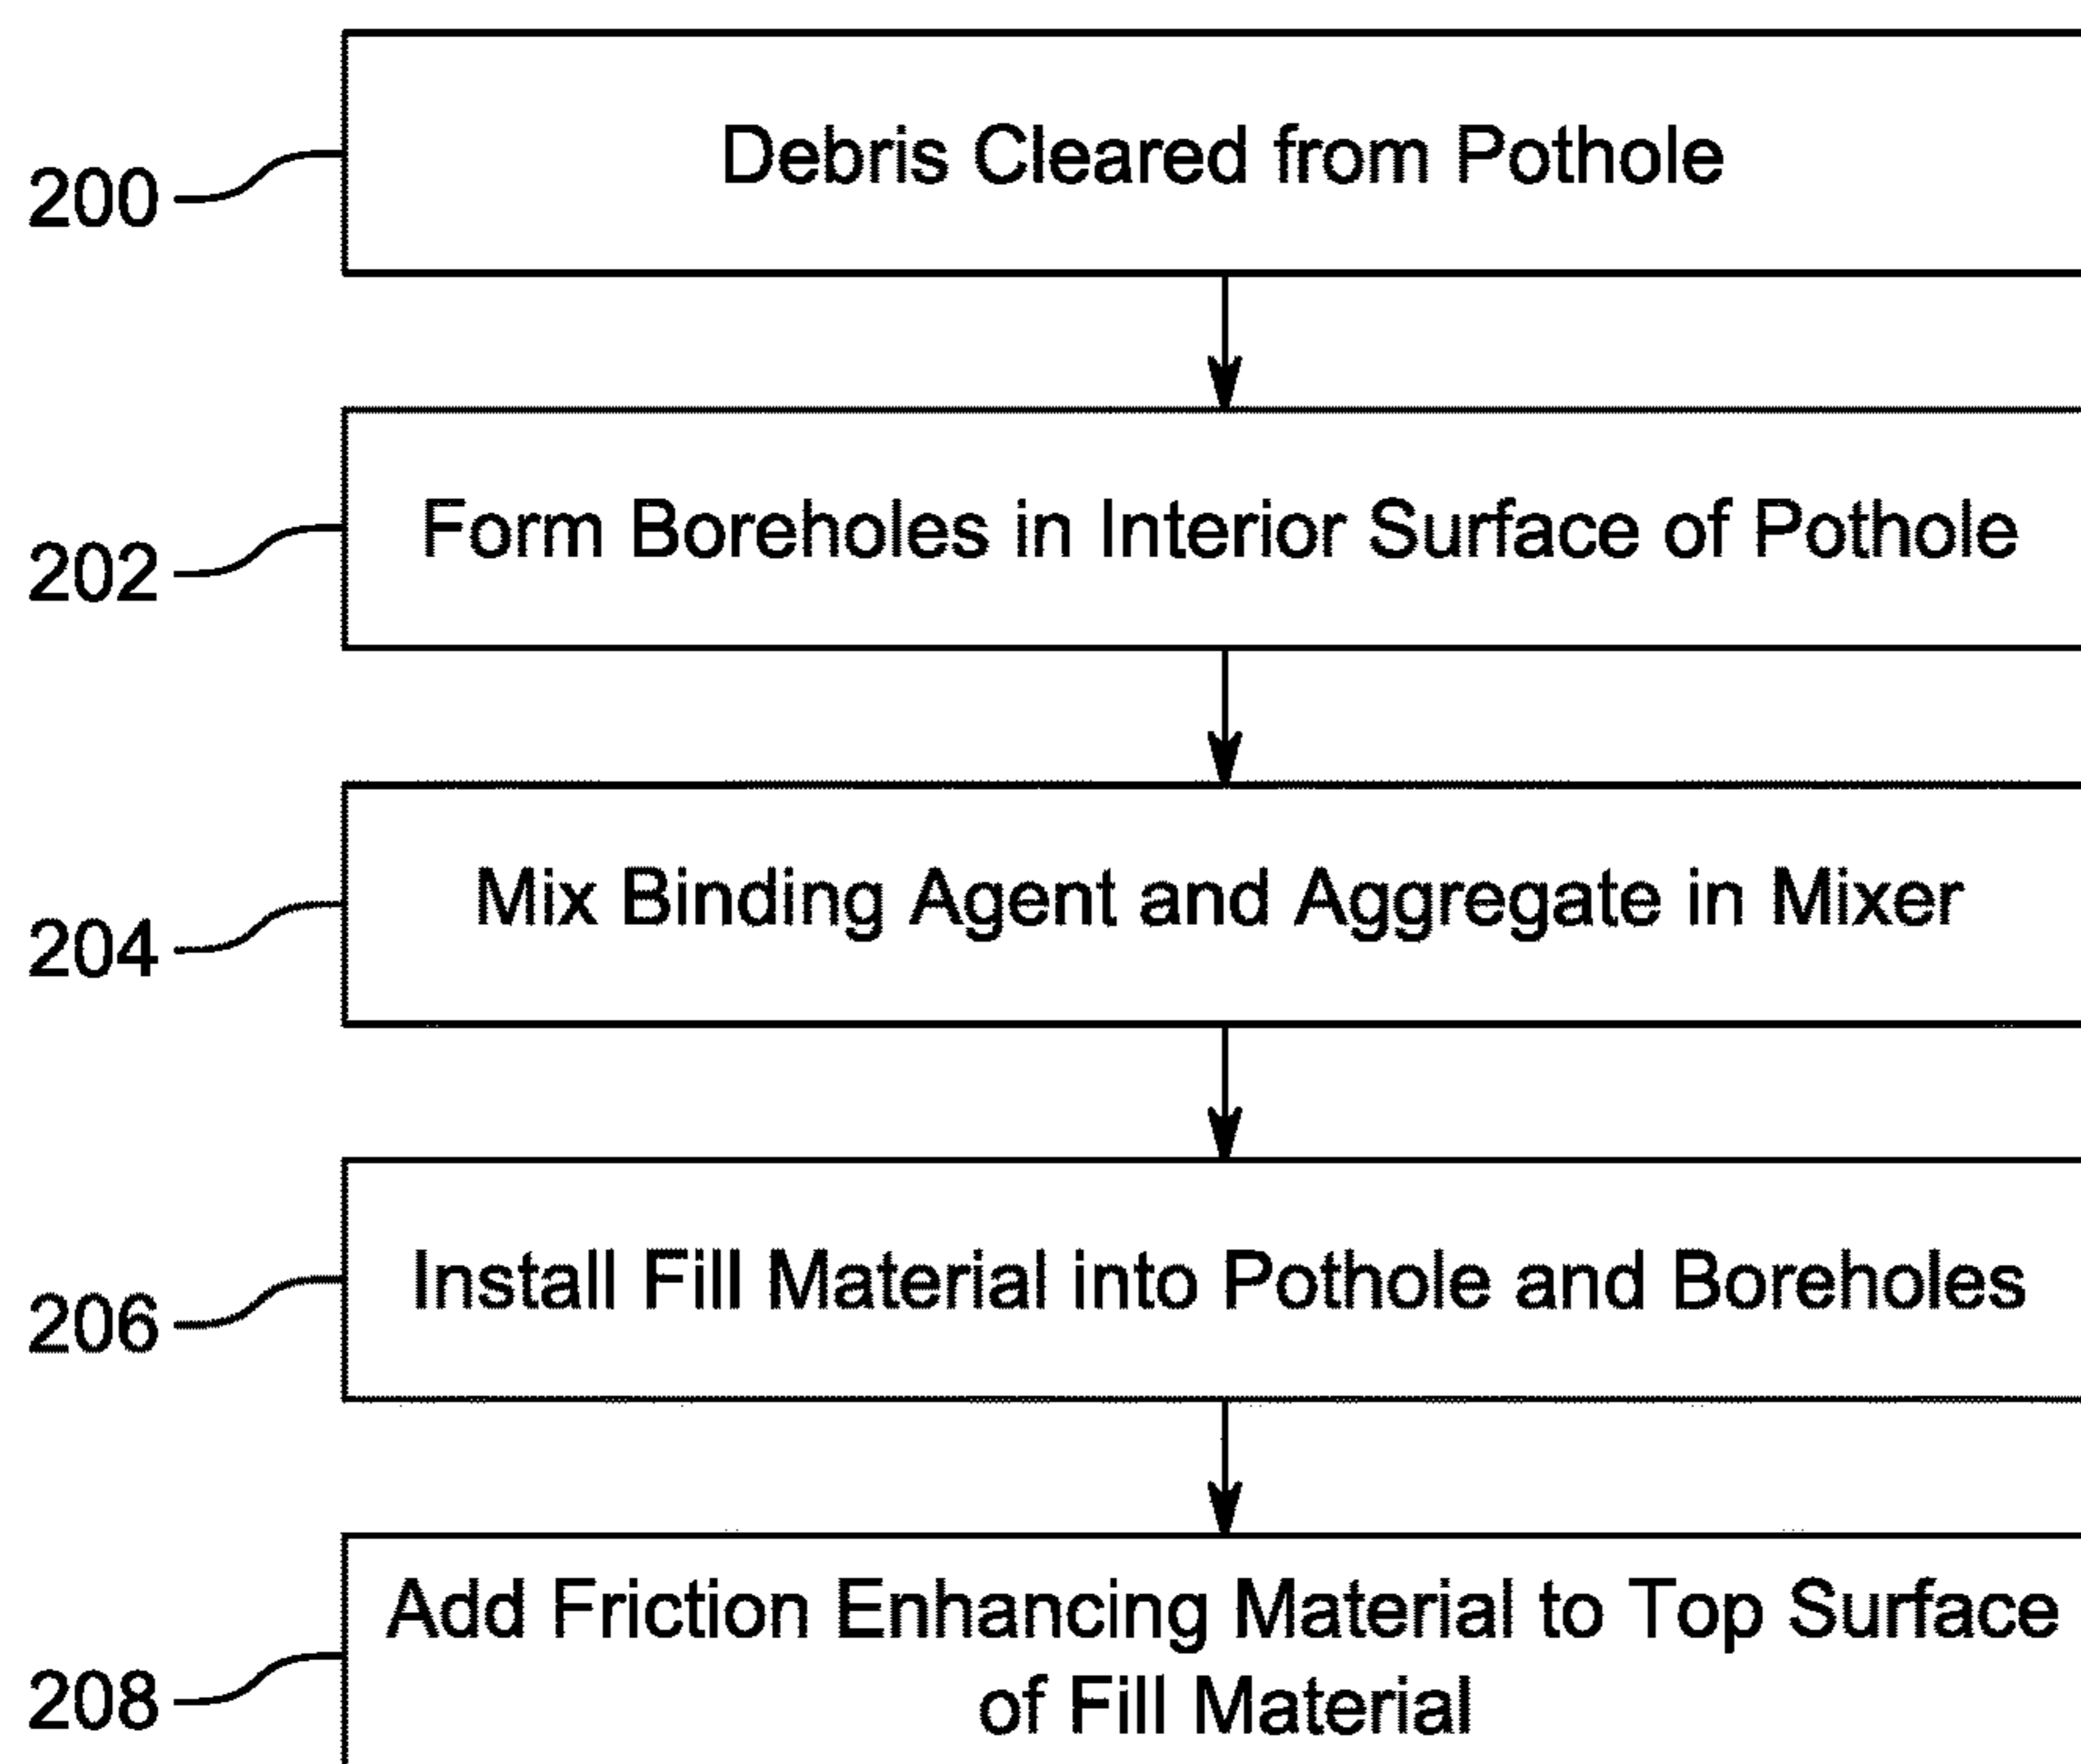
FIG. 6 is a flow chart of a process for repairing a pothole in a roadway according to an embodiment of the present disclosure;

Referring now to FIG. 6, a method of repairing a damaged portion is disclosed. At step **200**, debris is cleared from the damaged portion in order to expose an interior surface of the damaged portion. At step **202**, at least one borehole is formed in the interior surface of the damaged portion. The at least one borehole may have a diameter between about one half inch and three inches. In an embodiment, the at least one borehole may have a diameter of about one inch. It will be appreciated that the at least one borehole may have any diameter. The at least one borehole may be formed by a bit mounted on a drill. In an embodiment, the depth of the at least one borehole may be about two feet. It will be appreciated that at least one borehole may have any depth.

At step **204**, a binding agent and an aggregate are added to a mixer. The binding agent and aggregate are mixed together to form a fill material. In an embodiment, the fill material comprises a binding agent and an aggregate mixture that are combined in the mixing container on site. In an embodiment, the binding agent and the aggregate mixture are pre-mixed offsite and transported to the site of the damaged portion.

At step **206**, the fill material is installed into the damaged portion and the at least one borehole. In an embodiment, the fill material may be poured or pumped from the mixer. A top surface of the fill material may be about even with the top of the roadway. At step **208**, a friction enhancing material is placed onto the top surface of the fill material. It will be appreciated that the friction enhancing material may include a granular material, such as crushed stone, sand, or any other substance.

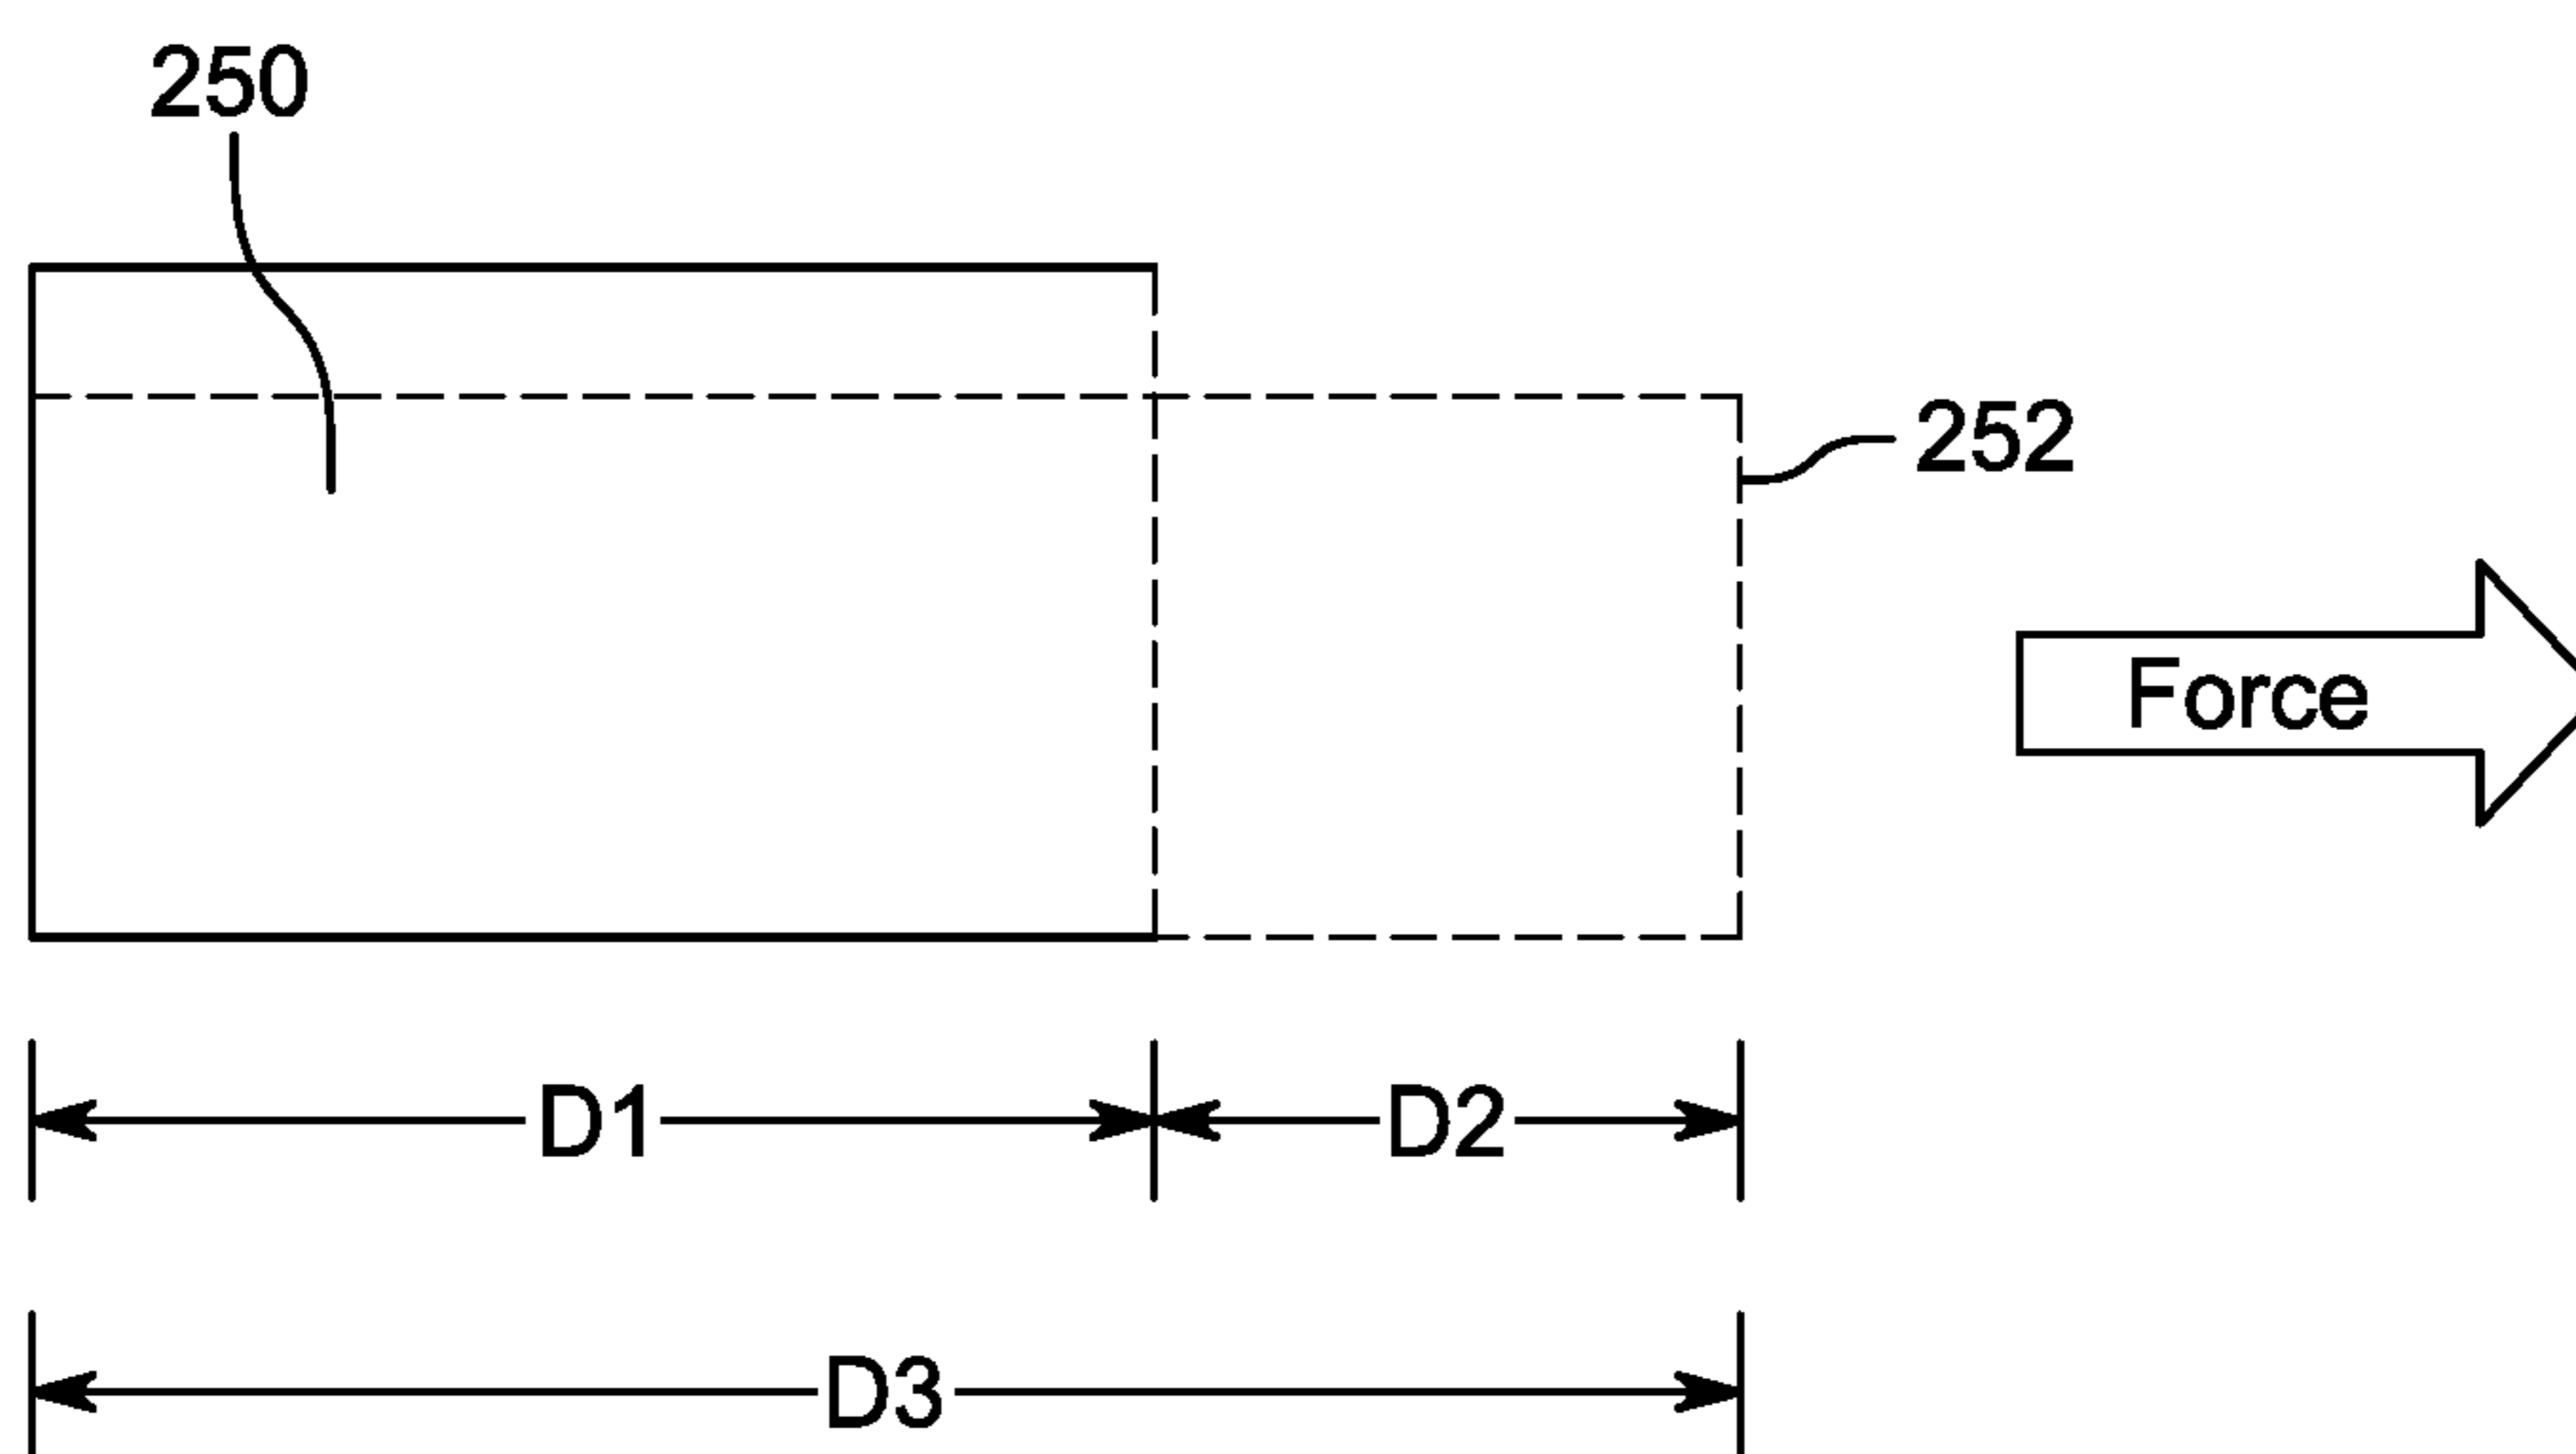
FIG. 7 depicts the deformability of the binding agent used in roadway repairs according to an embodiment of the present disclosure;

Referring now to FIG. 7, according to an embodiment of the present disclosure, a cured binding agent **250** suitable for use in the repair as described above may be deformable under tension, either plastically or elastically. It will be appreciated that the deformability of the cured binding agent **250** improves the life of the repair, especially when subject to the impact forces of vehicle traffic. The binding agent **250** may be deformed by a tension force to a new shape shown by the dashed line **252**. As shown, length **D1** represents the original length of the binding agent **250**, length **D3** represents the stretched length of the binding agent **250**, and **D2** is the difference between **D3** and **D1**. When the tension force is removed, the binding agent **250** may or may not return to its original shape due to its elasticity. In some cases, the stretched binding agent will not return to its original shape as it is plastically deformable. In an embodiment, the binding agent **250** is deformable under tension to a percentage of its original length.

In an embodiment, a “percentage of deformability” is a property of the cured binding agent **250** and is defined by Equation 1, below:

Where **D1** is an original length of the cured binding agent and **D3** is a stretched length of the cured binding agent. The percentage of deformability defined by Equation 1 represents the amount of deformation under which the binding agent **250** undergoes without failing. As used herein, the term “failure” may mean the cured binding agent **250** breaks into two pieces. For example, if the binding agent **250** is deformable under a tension force from an original length of 4 units (**D1**) to a length of 6 units (**D3**) without failure, the percentage of deformability is at least 50%. By way of another example, if the binding agent **250** is deformable under a tension force from an original length of 4 units (**D1**) to a length of 5 units (**D3**) without failure, the percentage of deformability is at least 25%.

In an embodiment, the percentage of deformability of the binding agent **250** suitable for roadway repair as described herein is at least 15%. In an embodiment, the percentage of deformability of the binding agent **250** suitable for roadway repair as described herein is at least 20%. In an embodiment, the percentage of deformability of the binding agent **250** suitable for roadway repair as described herein is at least 25%. In an embodiment, the percentage of deformability of the binding agent **250** suitable for roadway repair as described herein is at least 30%. In an embodiment, the percentage of deformability of the binding agent **250** suit-

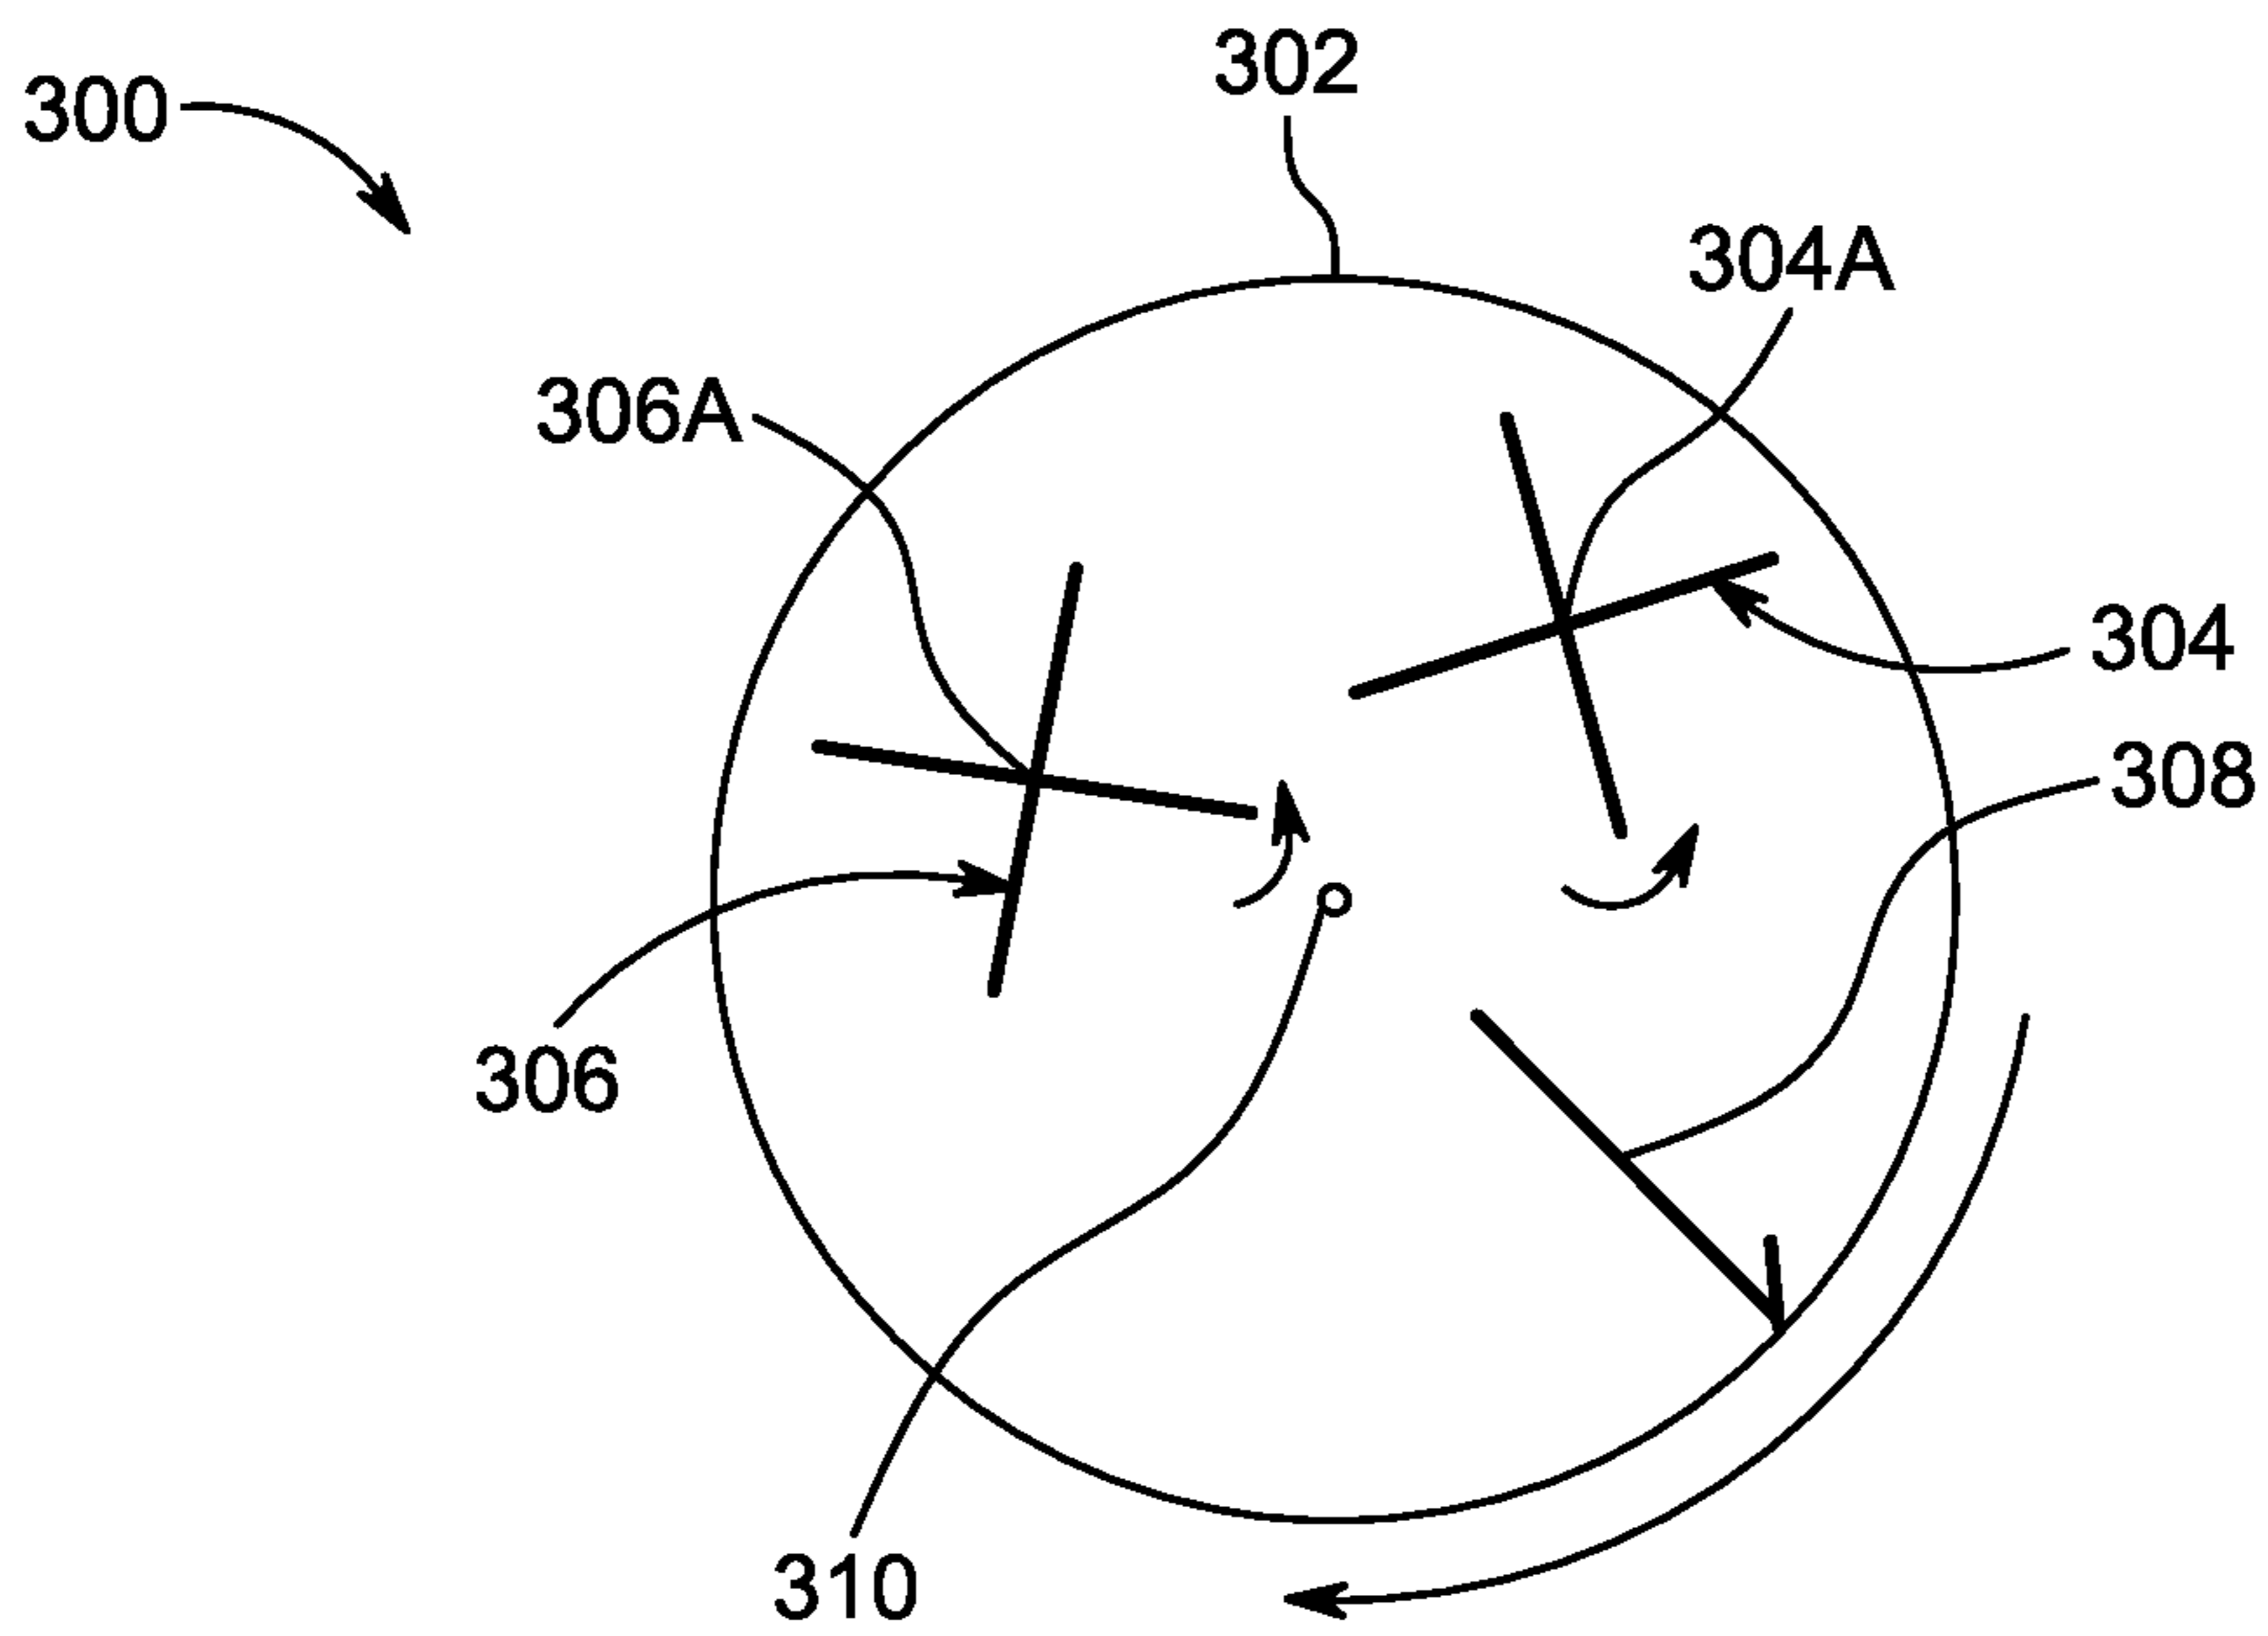
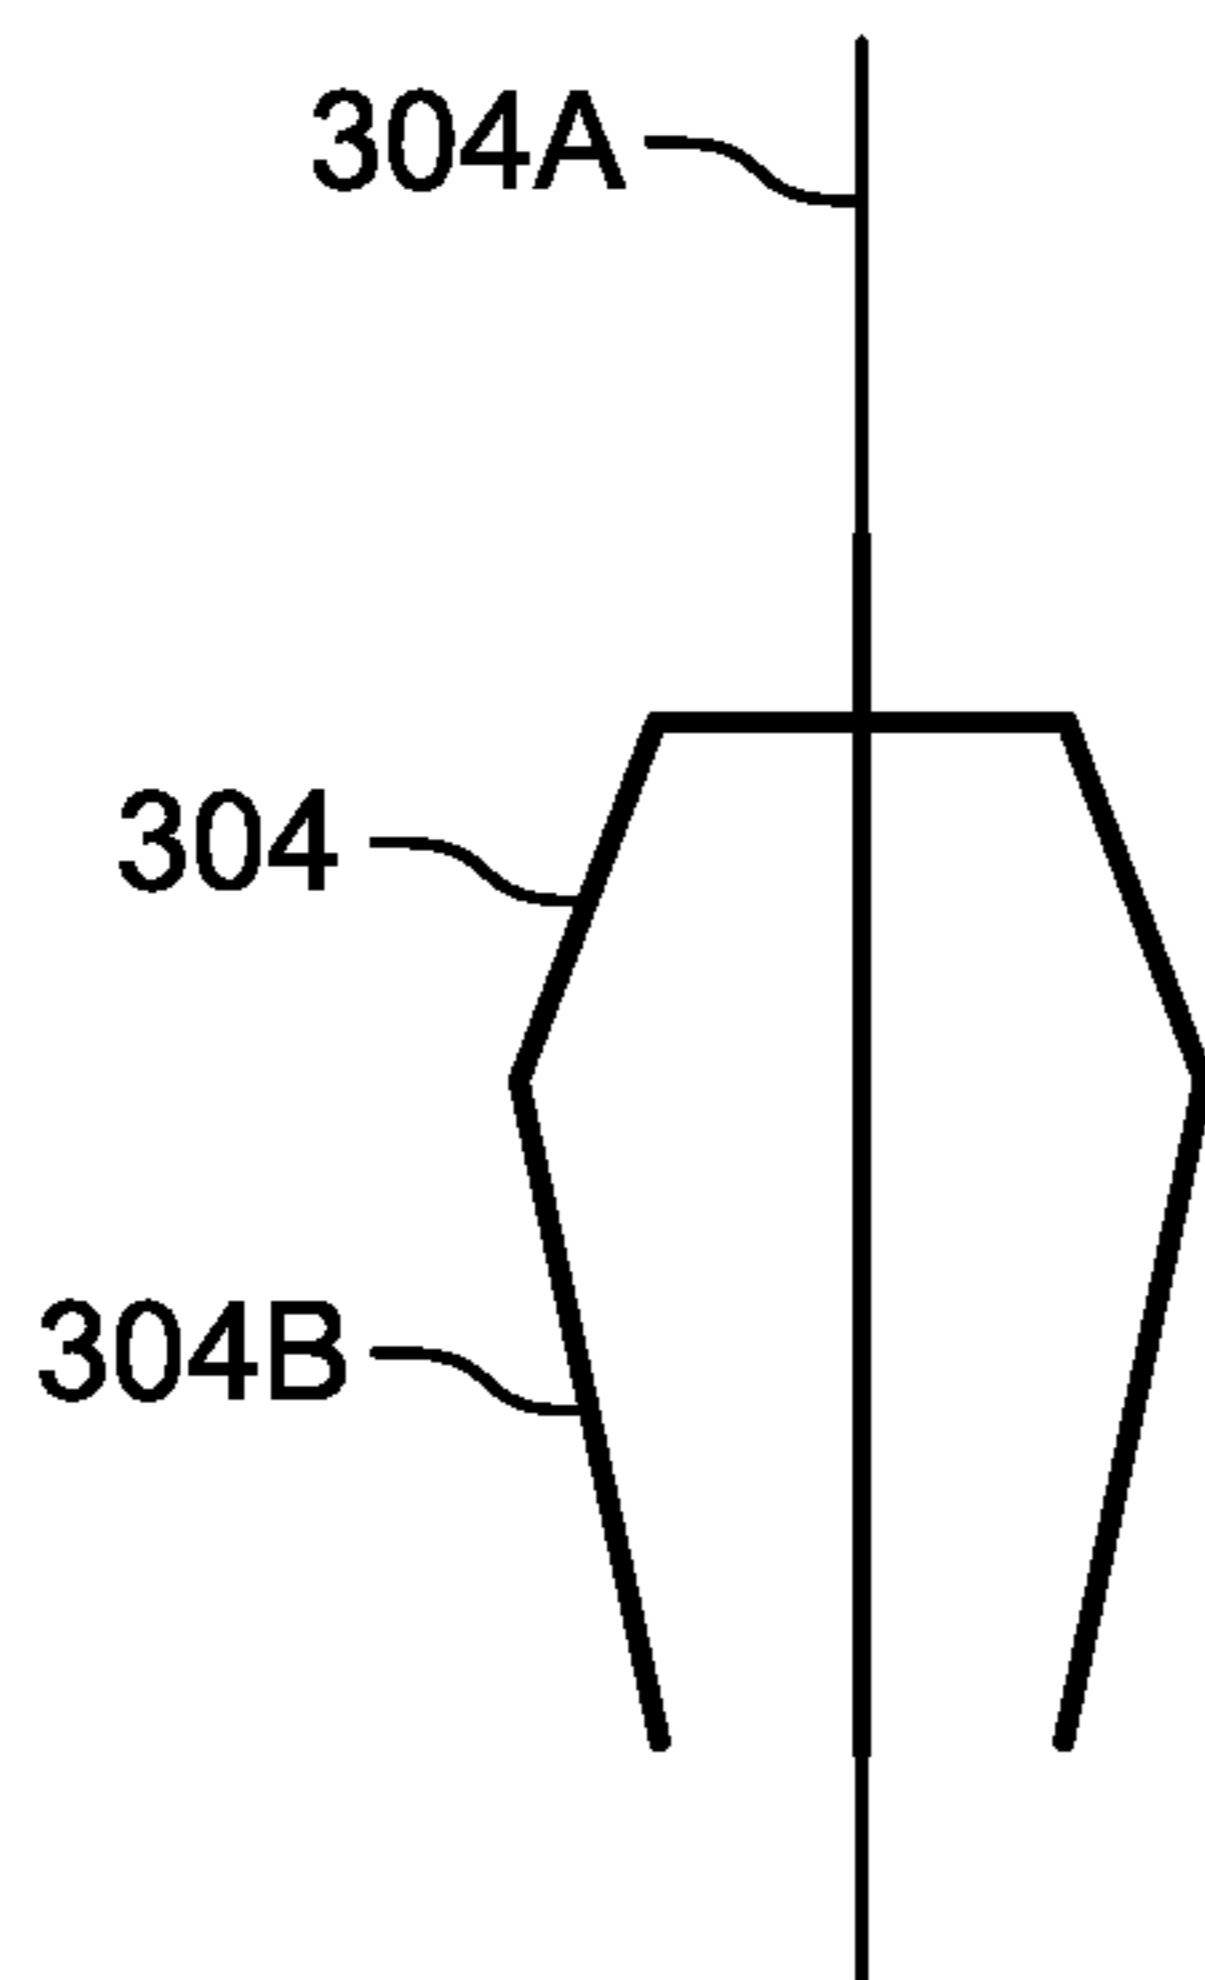
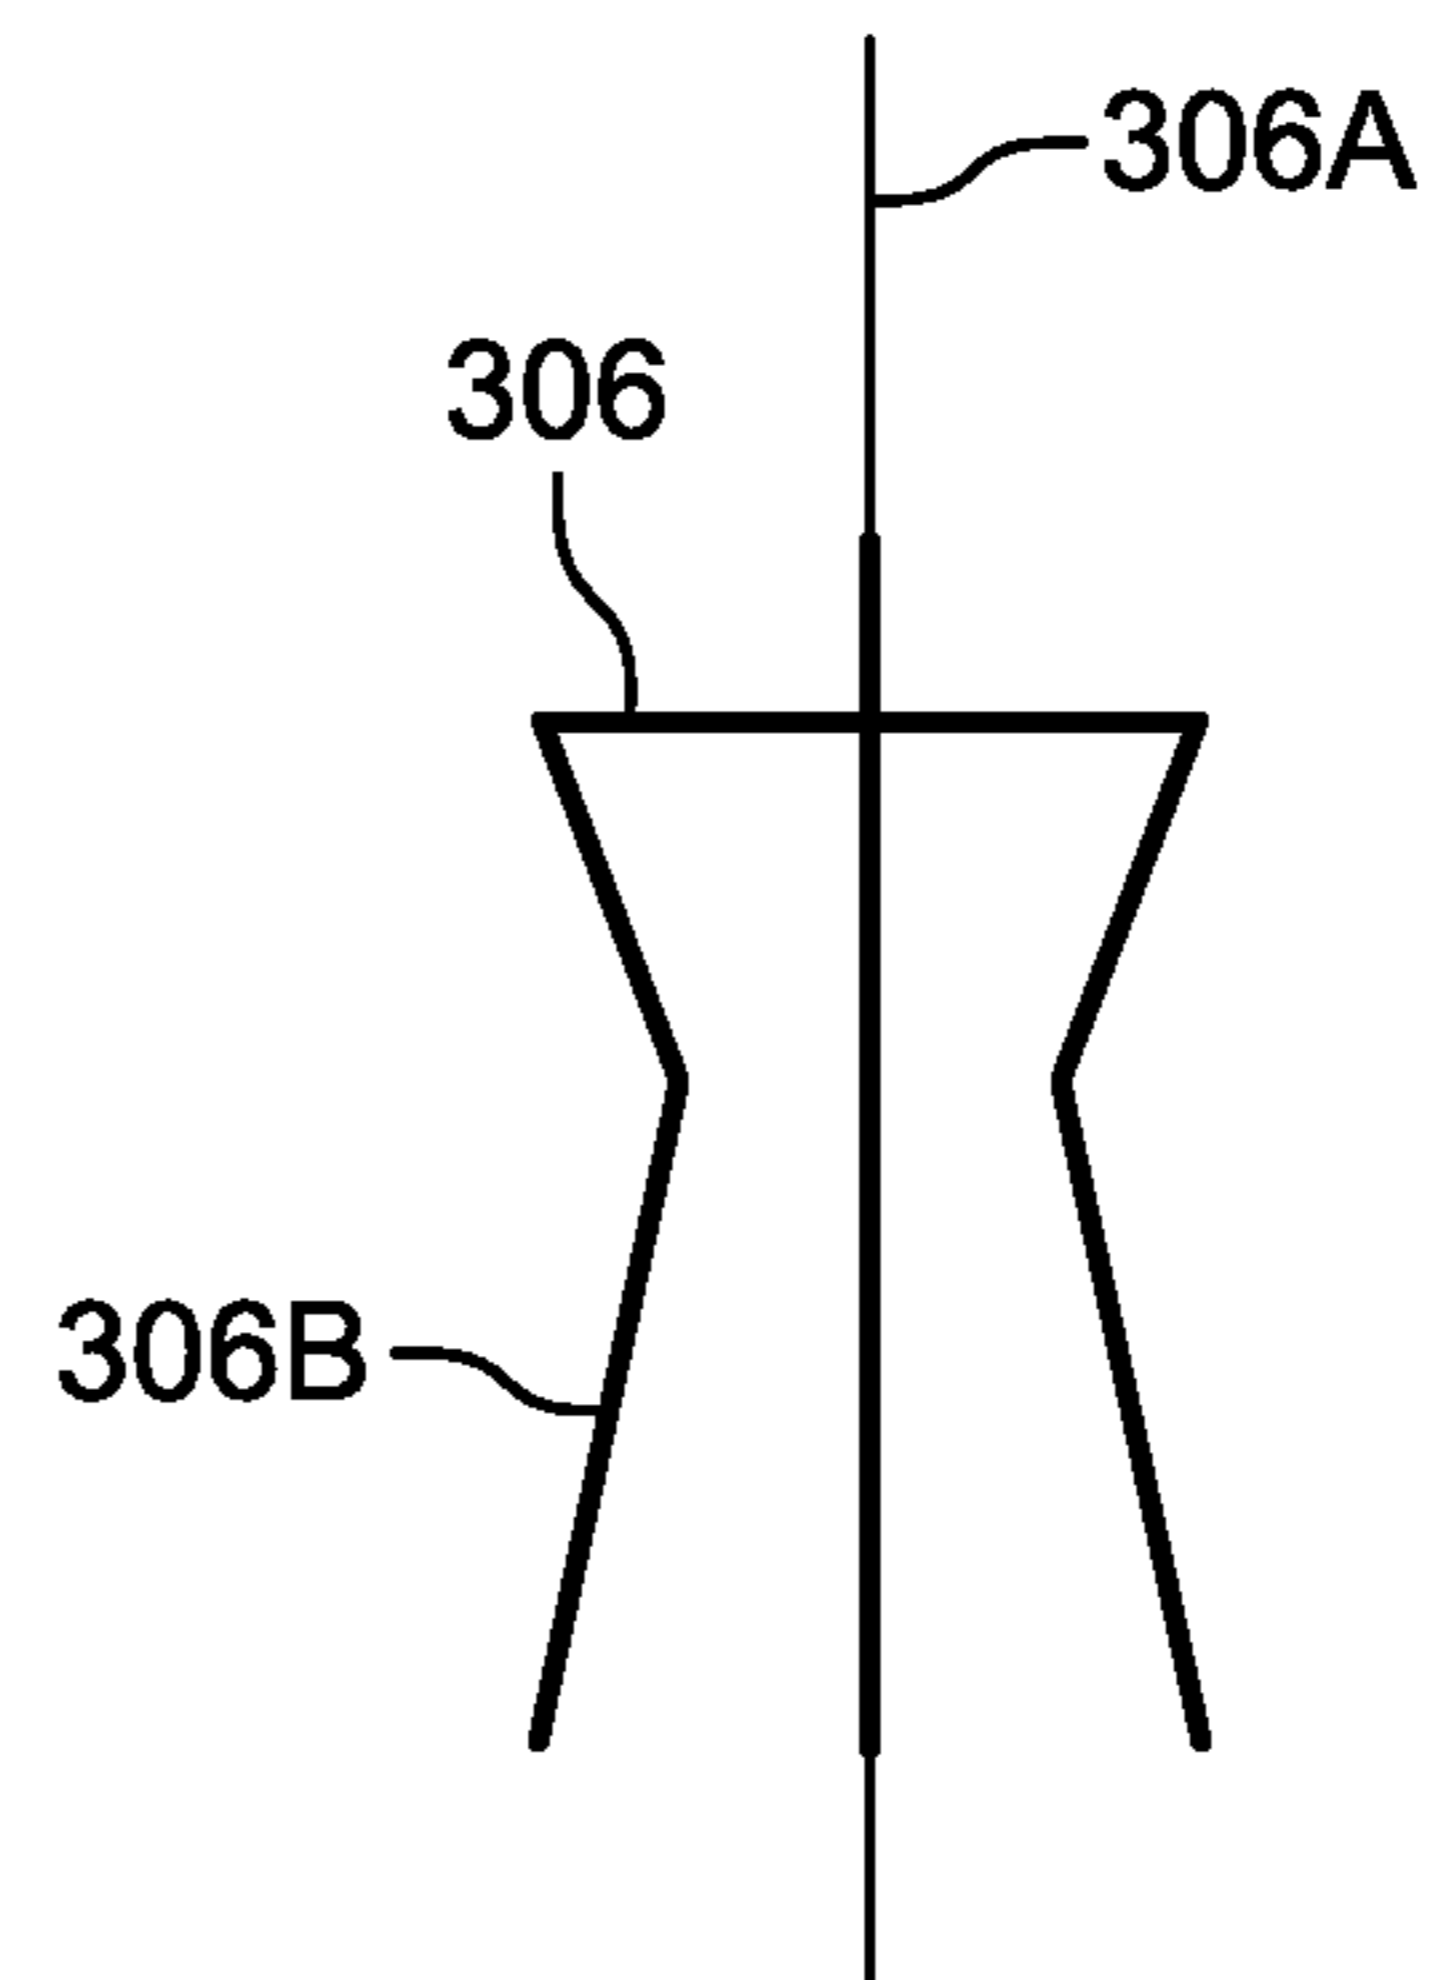
FIGS. 8A-8C depict a mixer for a binding agent and an aggregate according to an embodiment of the present disclosure;

Referring now to FIGS. **8A**, **8B** and **8C**, there is depicted an exemplary embodiment of a mixer **300** suitable for use with the present disclosure. The mixer **300** may be utilized to mix a binding agent and aggregate as disclosed herein. The mixer **300** may include a mixing tub **302**. The mixer **300** may further include a first mixing blade assembly **304** and a second mixing blade assembly **306**. The mixer **300** may further include a scraper **308**.

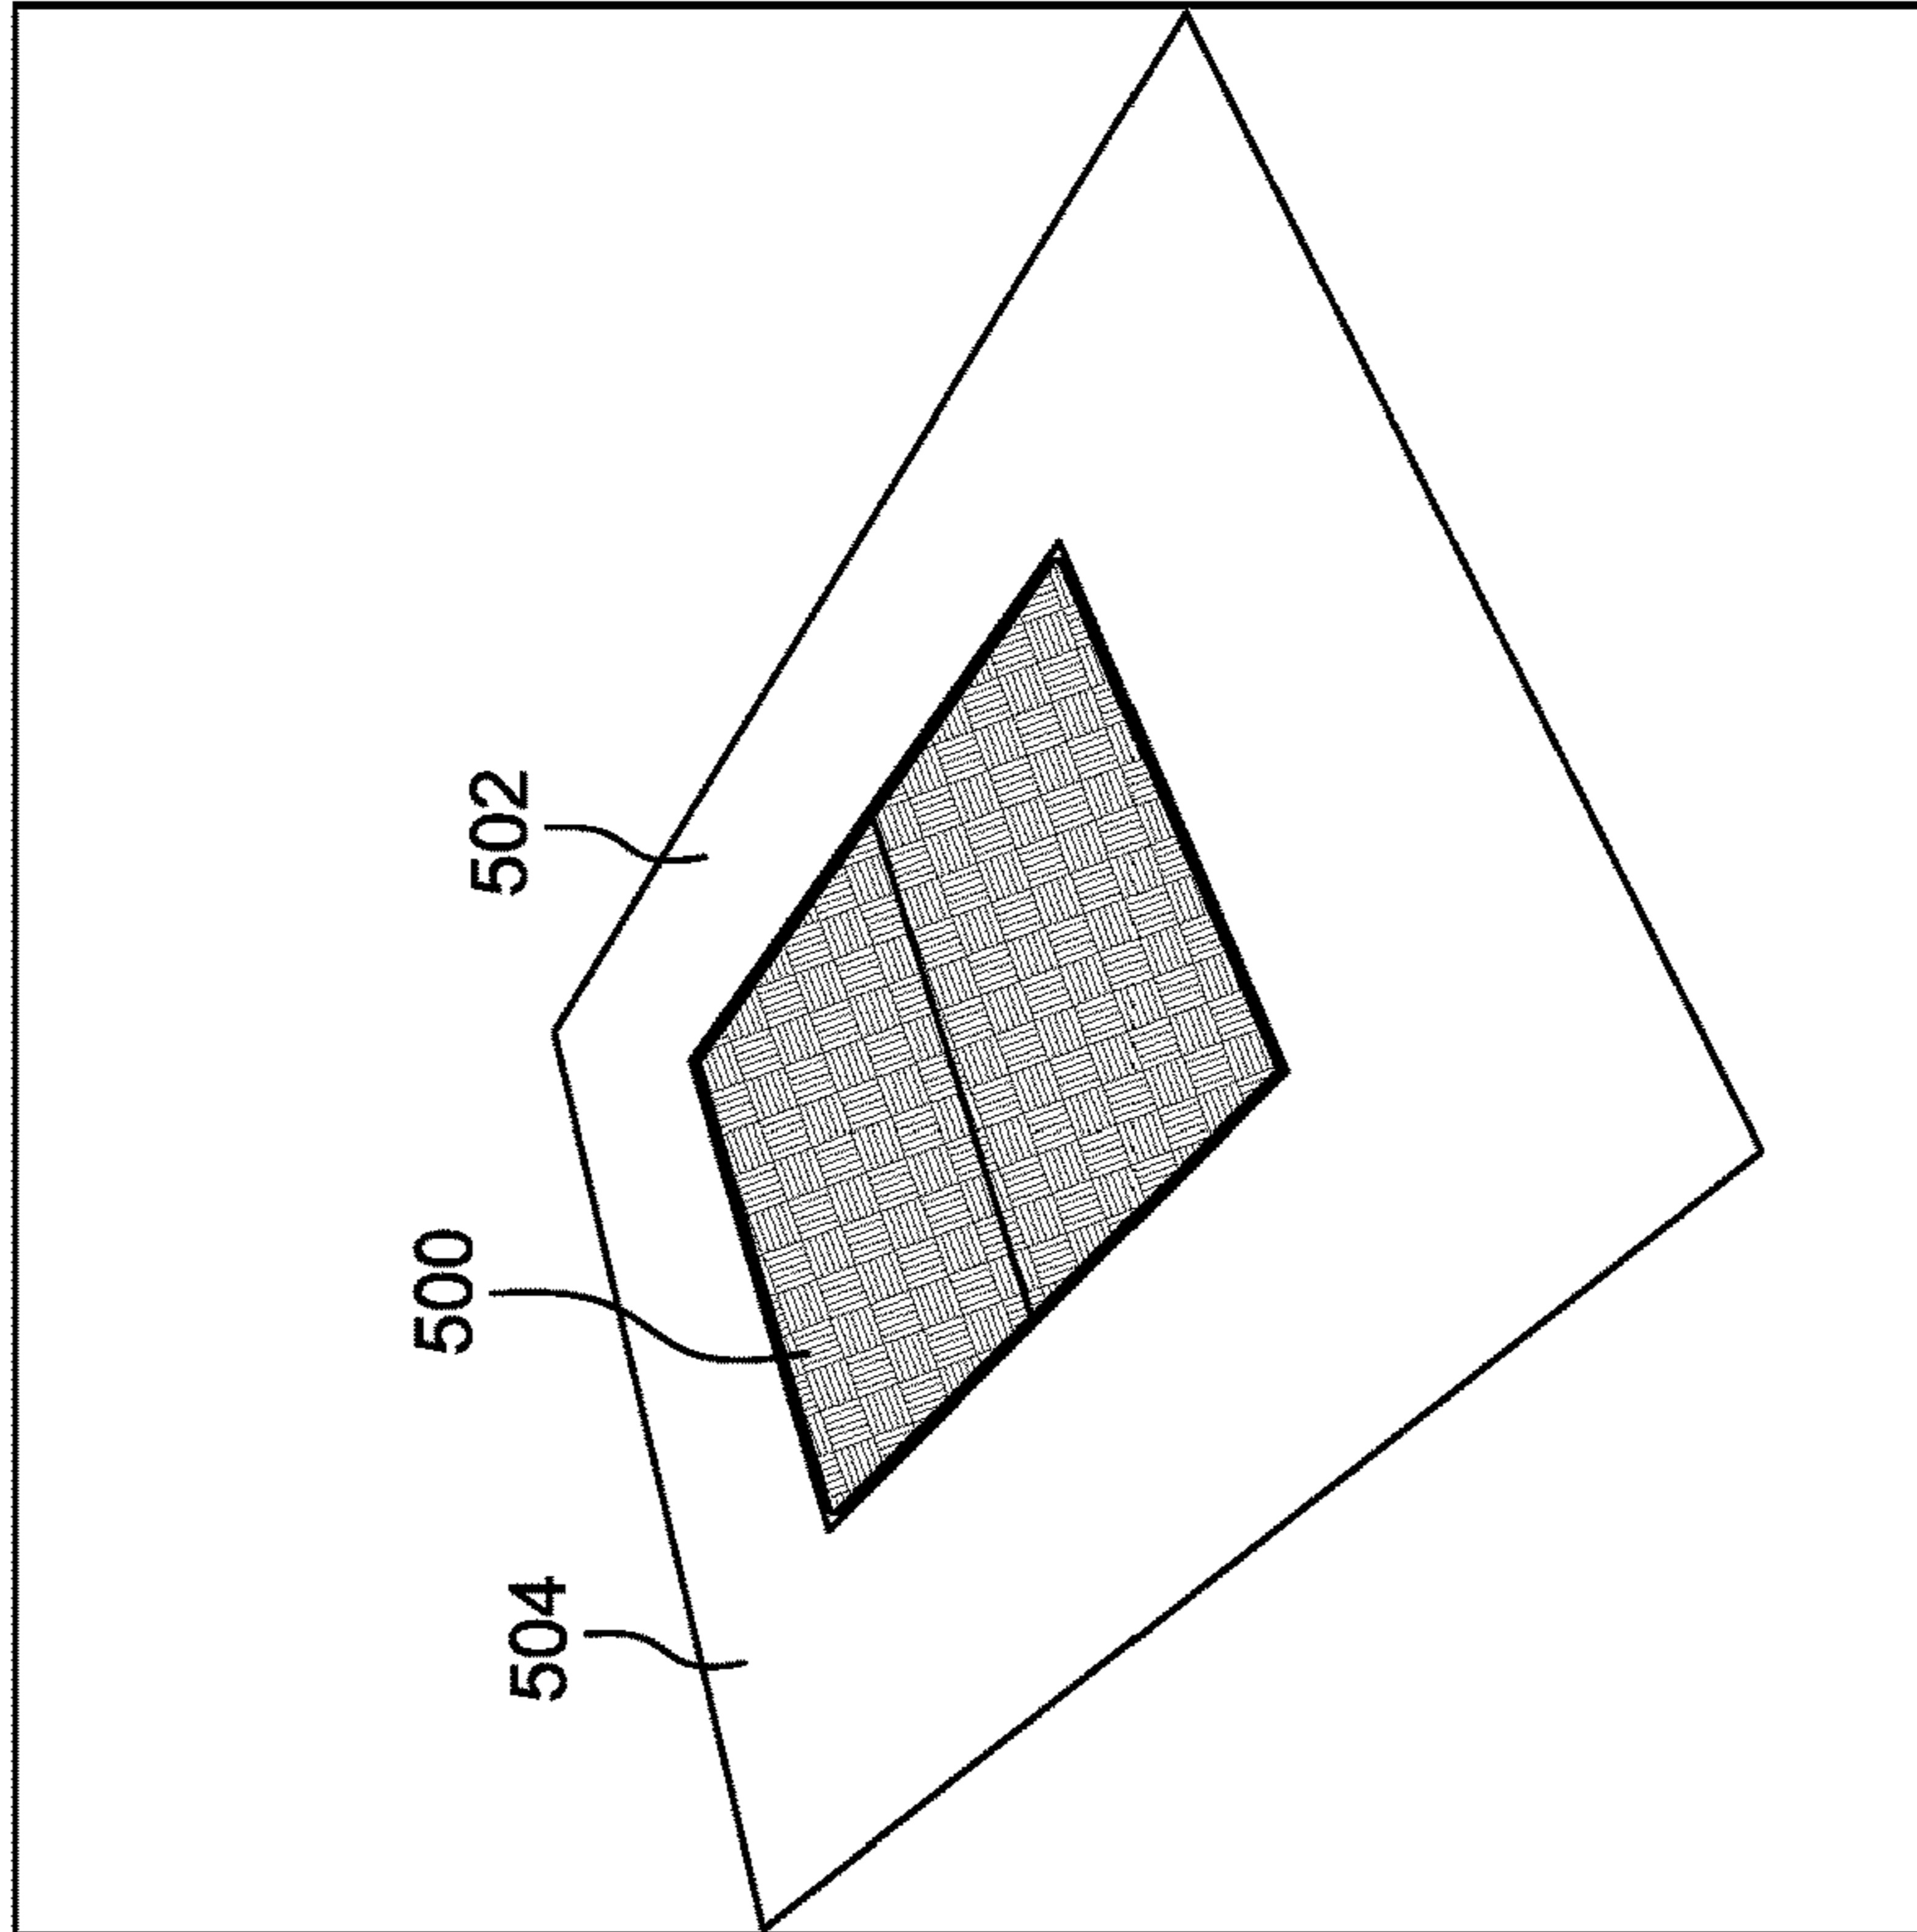
FIG. 9 shows a metal cover installed over an access tunnel and having a damaged concrete apron;

Referring now to FIG. **9**, there is depicted a metal cover **500** installed over a utility access tunnel. Surrounding the cover **500** is a concrete apron **502**. As can be seen, the apron **502** is damaged and includes cracks, pits and voids. A process of repairing the apron **502** is as follows. First, the apron **502** is cleared of debris. Next, as shown in FIG. **21**, a grinder is used to remove rough edges and loose edges on the apron **502**. Next, a protective overlay and composite material **504** is installed onto the apron **502** to effectuate the repair. In an embodiment, the protective overlay material **504** is mixed in a mixer as shown in FIG. **22** and then placed onto the damaged surface of the apron **502**. The material **504** is then finished by using a hand trowel as shown in FIG. **23**. The repaired apron **502** is shown in FIG. **10**.
