US010329719B1

(12) **United States Patent**
Giles

(54) **COMPOSITION AND METHOD FOR SURFACE REPAIR**

(57) **ABSTRACT**

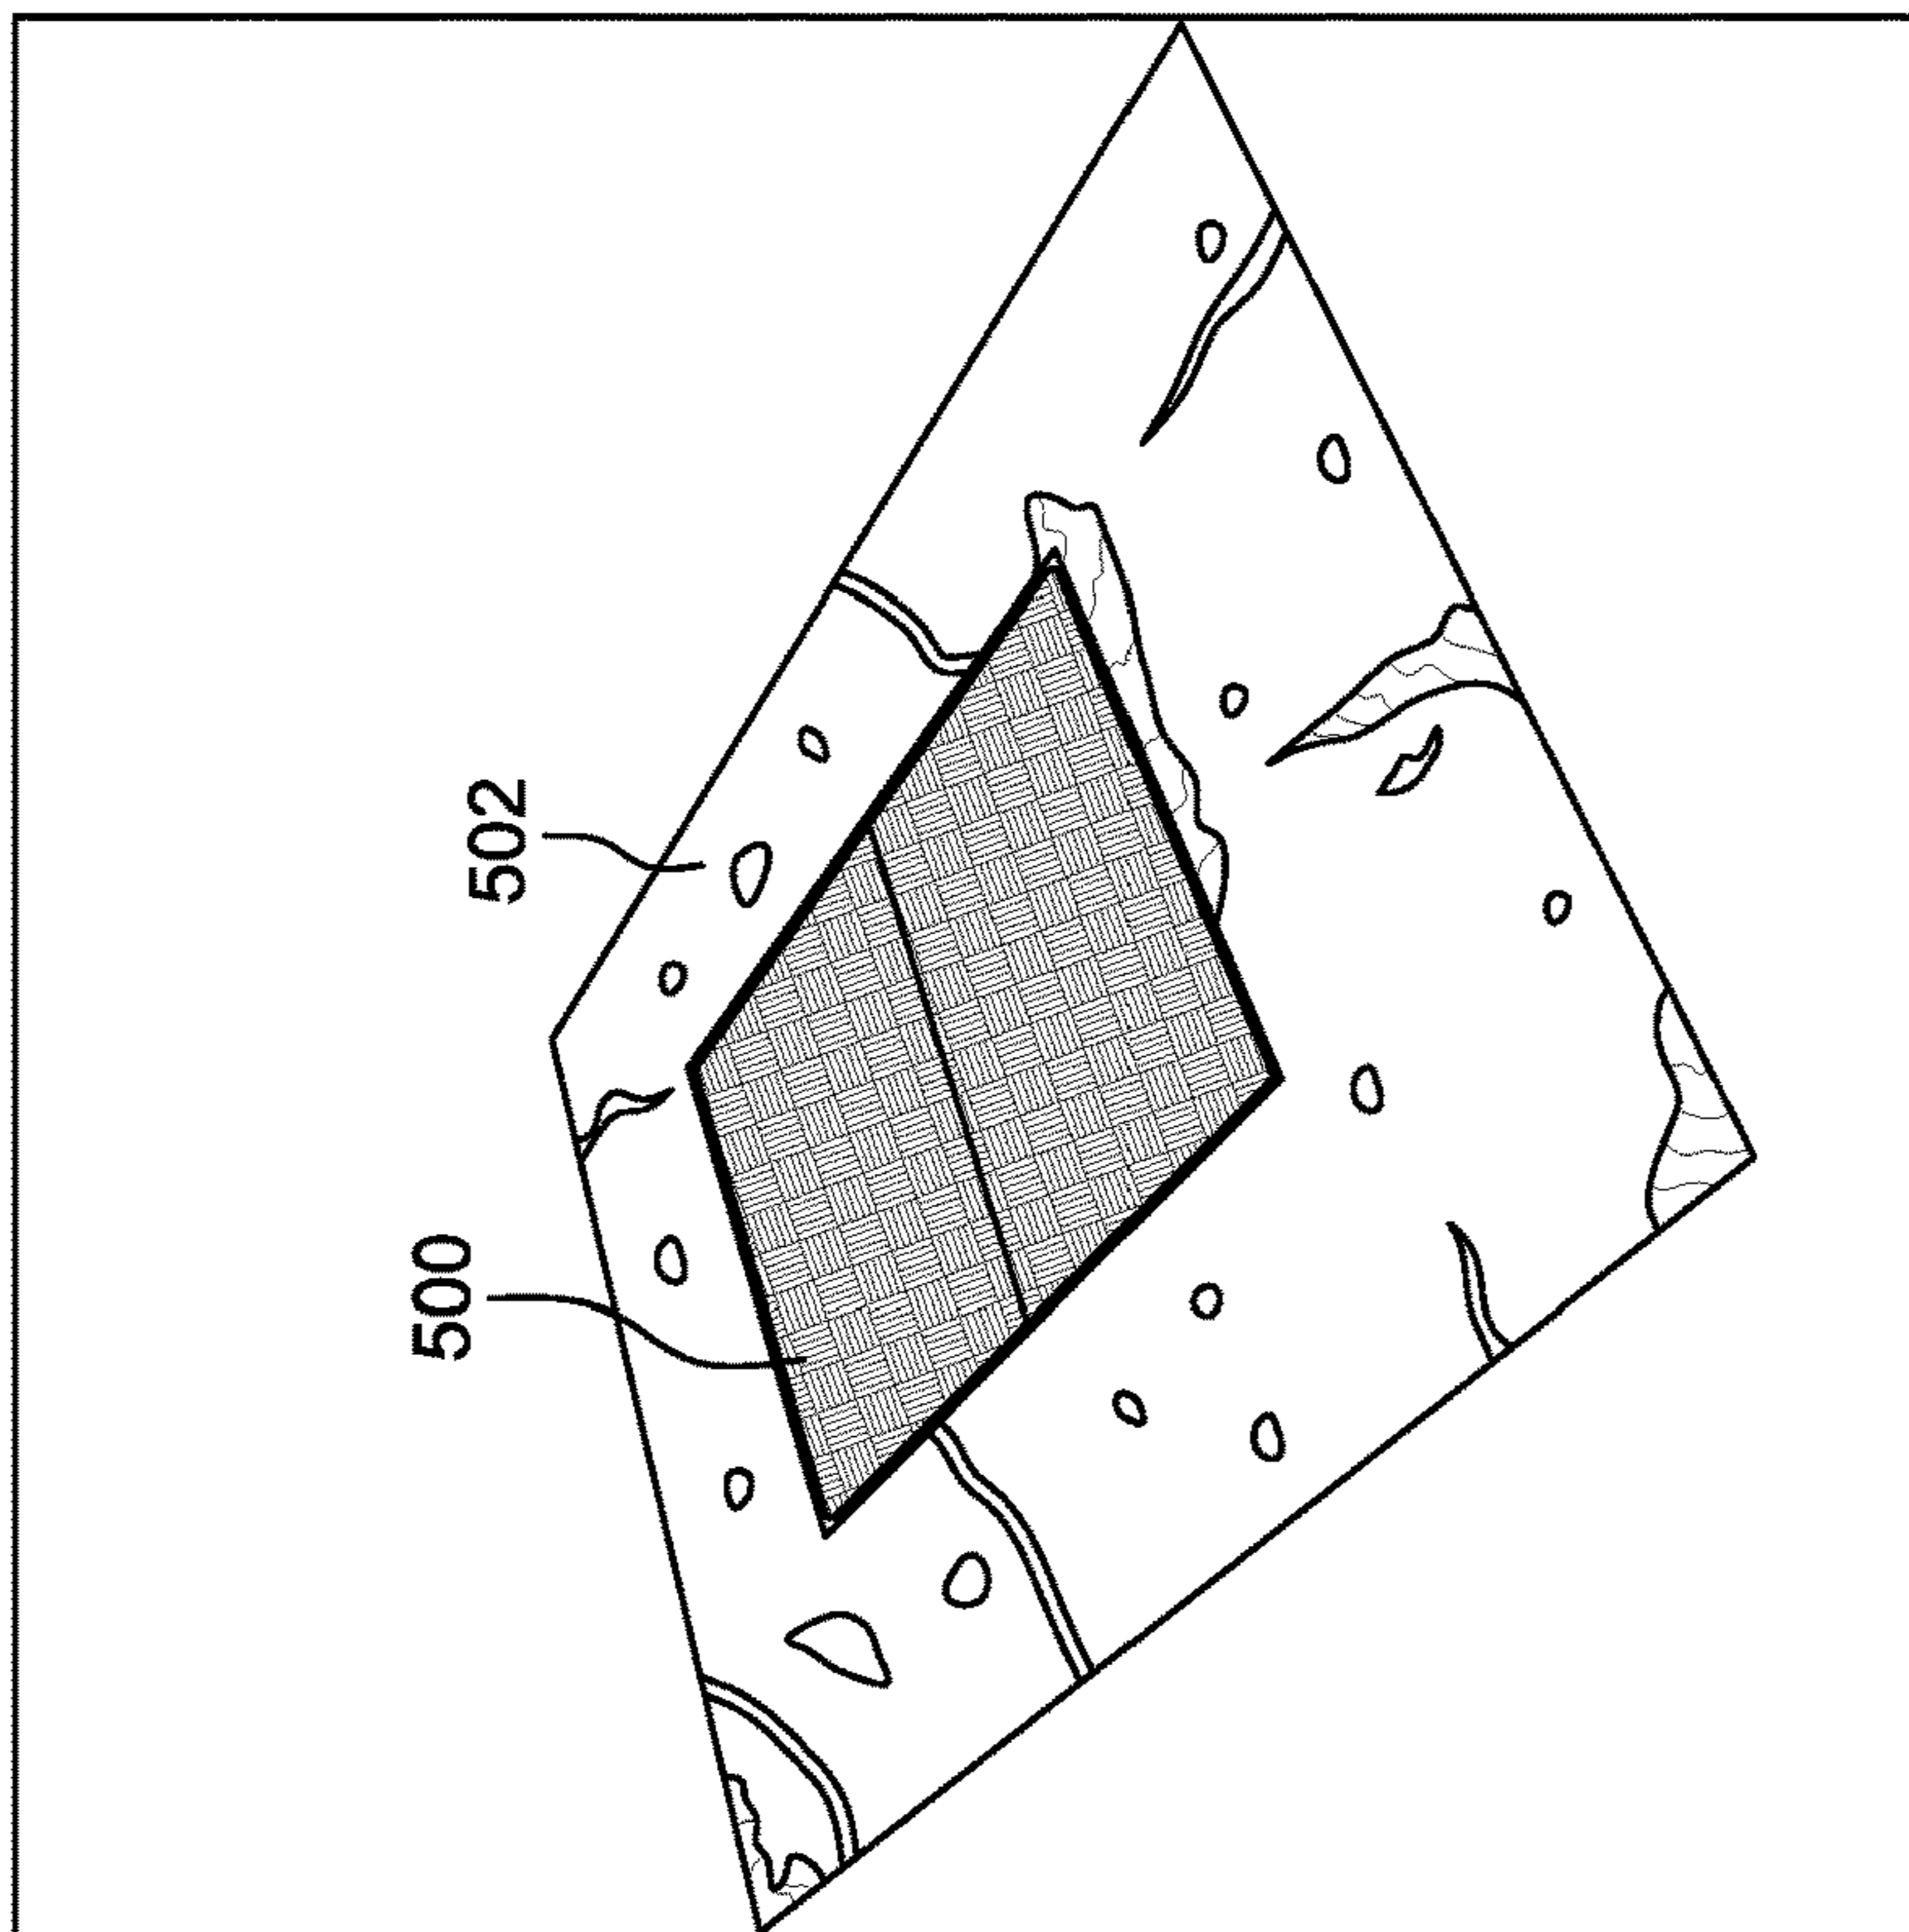
FIG. 10 shows the concrete apron in FIG. 9 after repairs according to an embodiment of the present disclosure;

Referring now to FIG. **9**, there is depicted a metal cover **500** installed over a utility access tunnel. Surrounding the cover **500** is a concrete apron **502**. As can be seen, the apron **502** is damaged and includes cracks, pits and voids. A process of repairing the apron **502** is as follows. First, the apron **502** is cleared of debris. Next, as shown in FIG. **21**, a grinder is used to remove rough edges and loose edges on the apron **502**. Next, a protective overlay and composite material **504** is installed onto the apron **502** to effectuate the repair. In an embodiment, the protective overlay material **504** is mixed in a mixer as shown in FIG. **22** and then placed onto the damaged surface of the apron **502**. The material **504** is then finished by using a hand trowel as shown in FIG. **23**. The repaired apron **502** is shown in FIG. **10**.

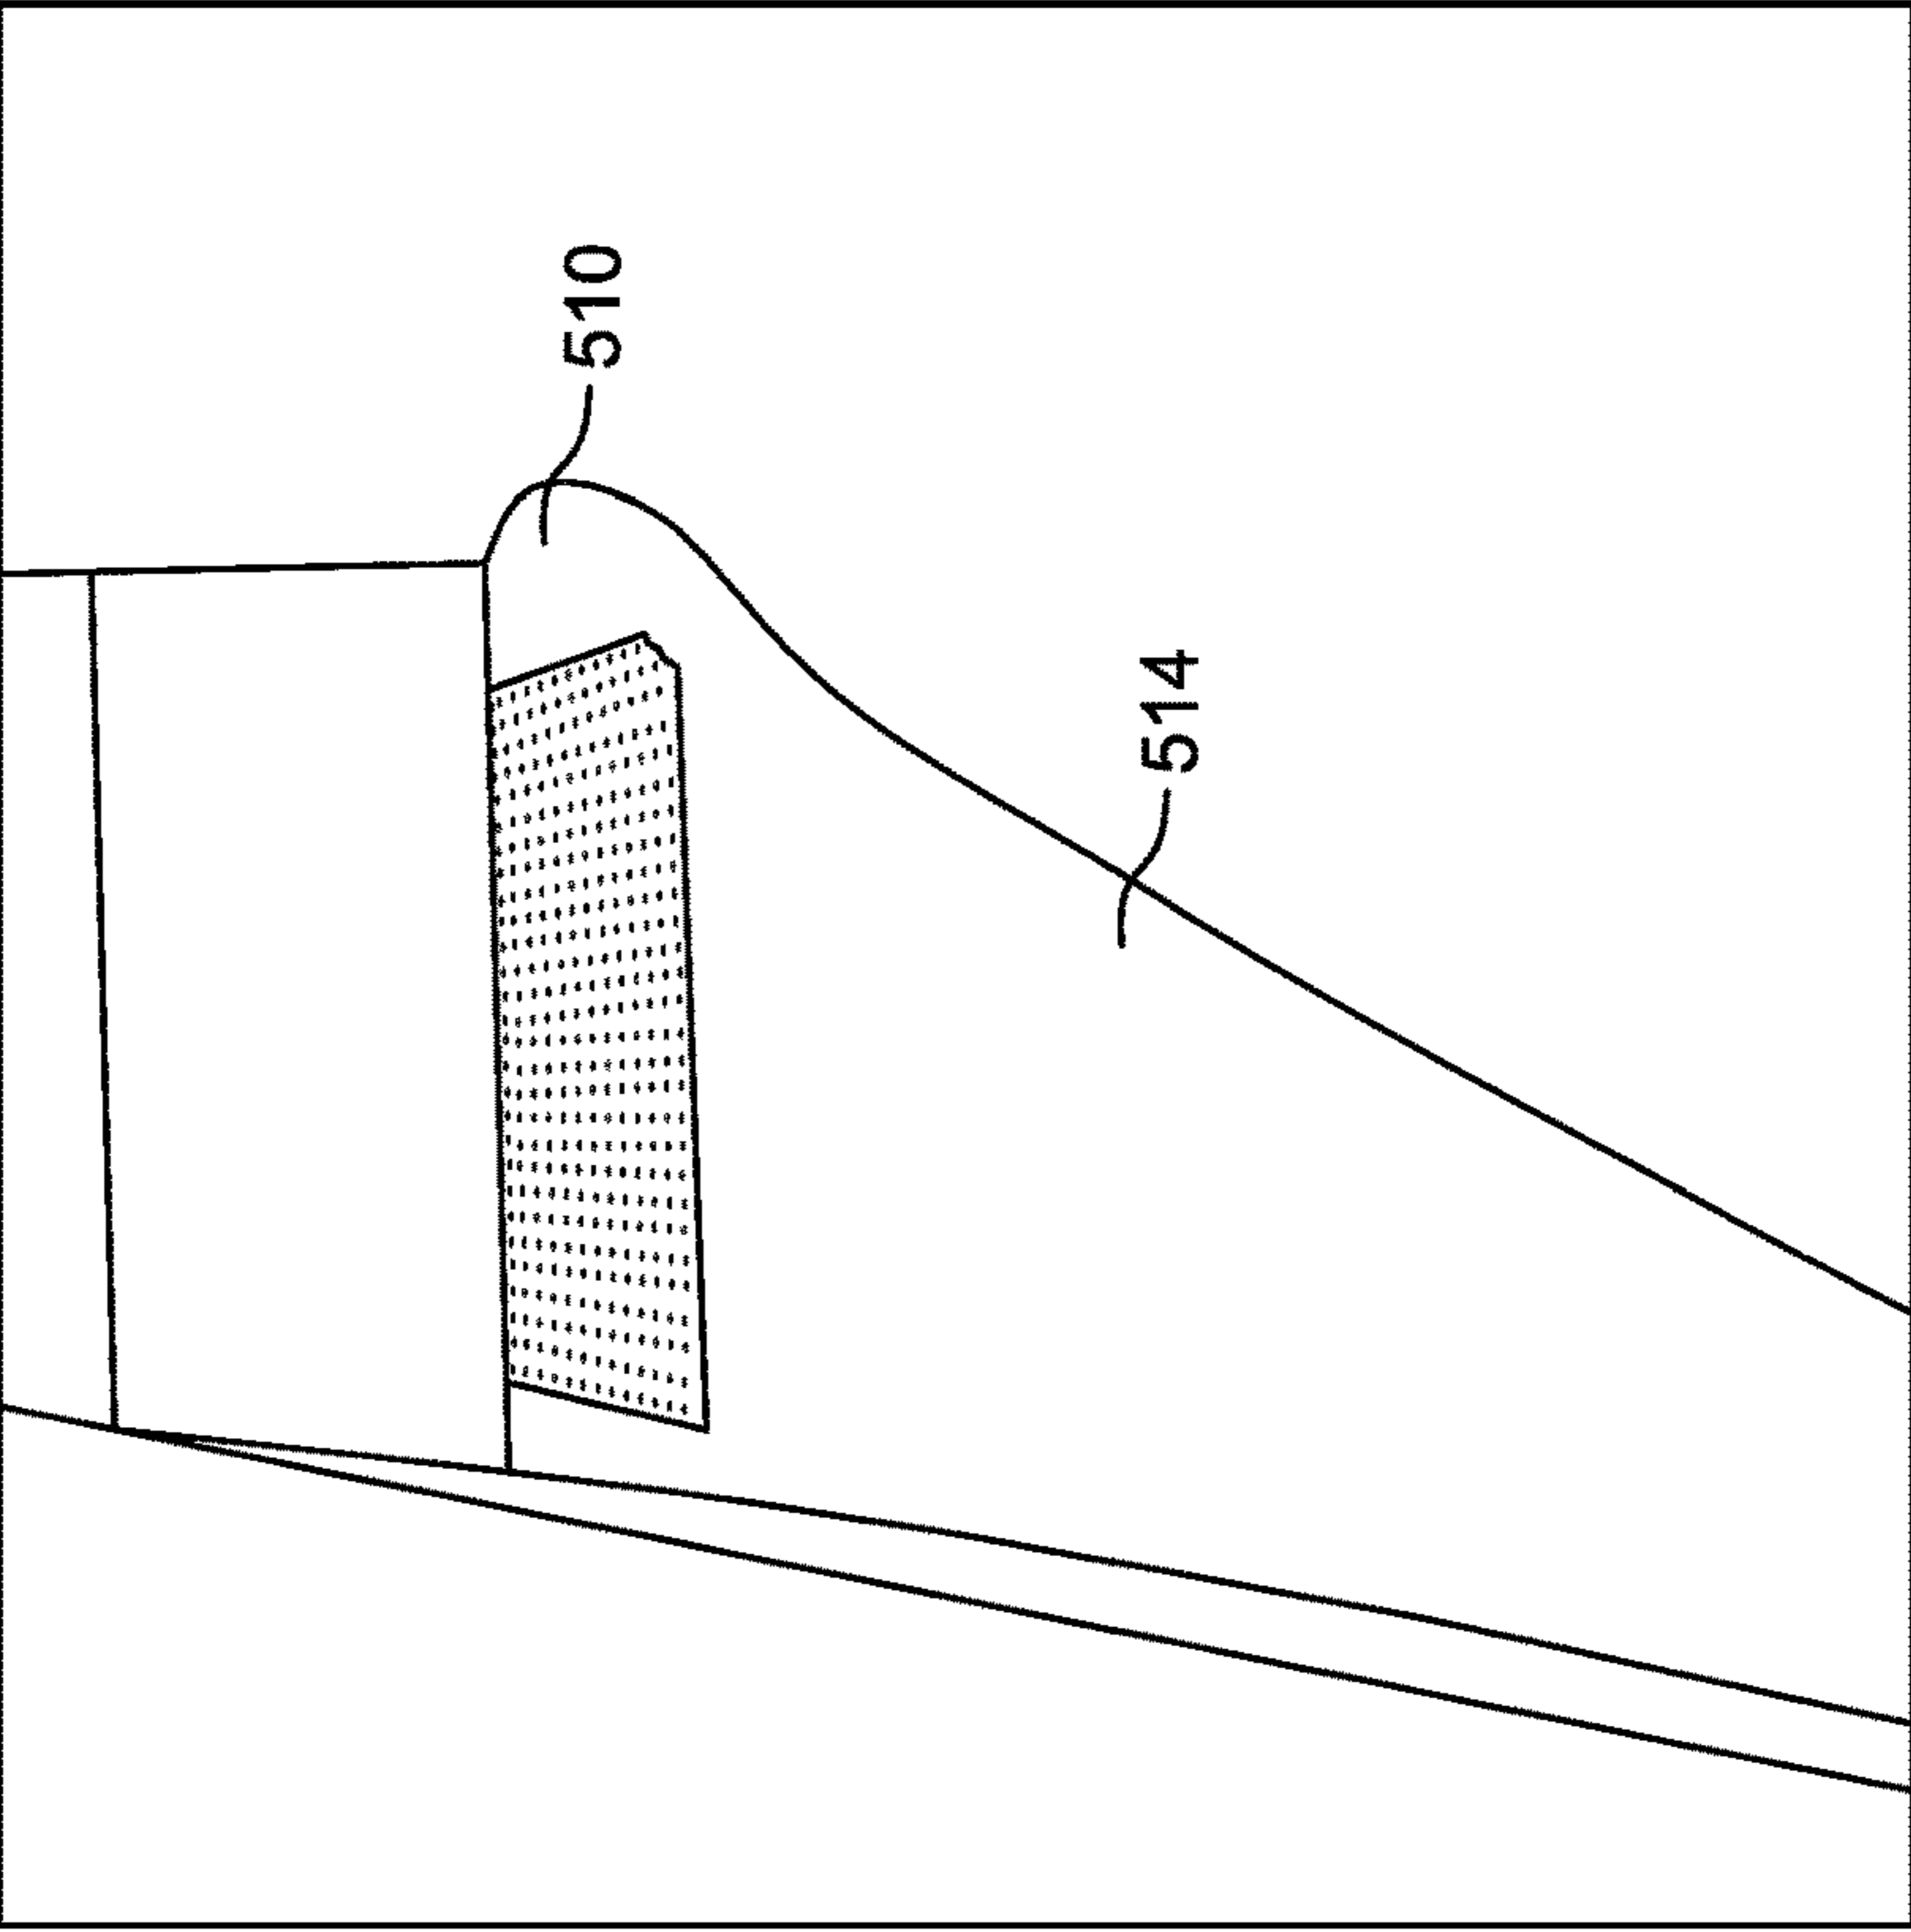
FIG. 11 shows a damaged pedestrian ramp;

Referring now to FIG. **11**, there is depicted a concrete pedestrian ramp **510** having a damaged surface **512**. The damage to the surface **512** includes cracks, pits and voids. A process of repairing the surface **512** is as follows. First, the surface **512** is cleared of debris. Next, as shown in FIG. **21**, a grinder is used to remove rough edges and loose edges on the surface **512**. Next, a protective overlay and composite material **514** is installed onto the surface **512** to effectuate the repair. In an embodiment, the protective overlay material **514** is mixed in a mixer as shown in FIG. **22** and then placed onto the damaged surface of the surface **512**. The material

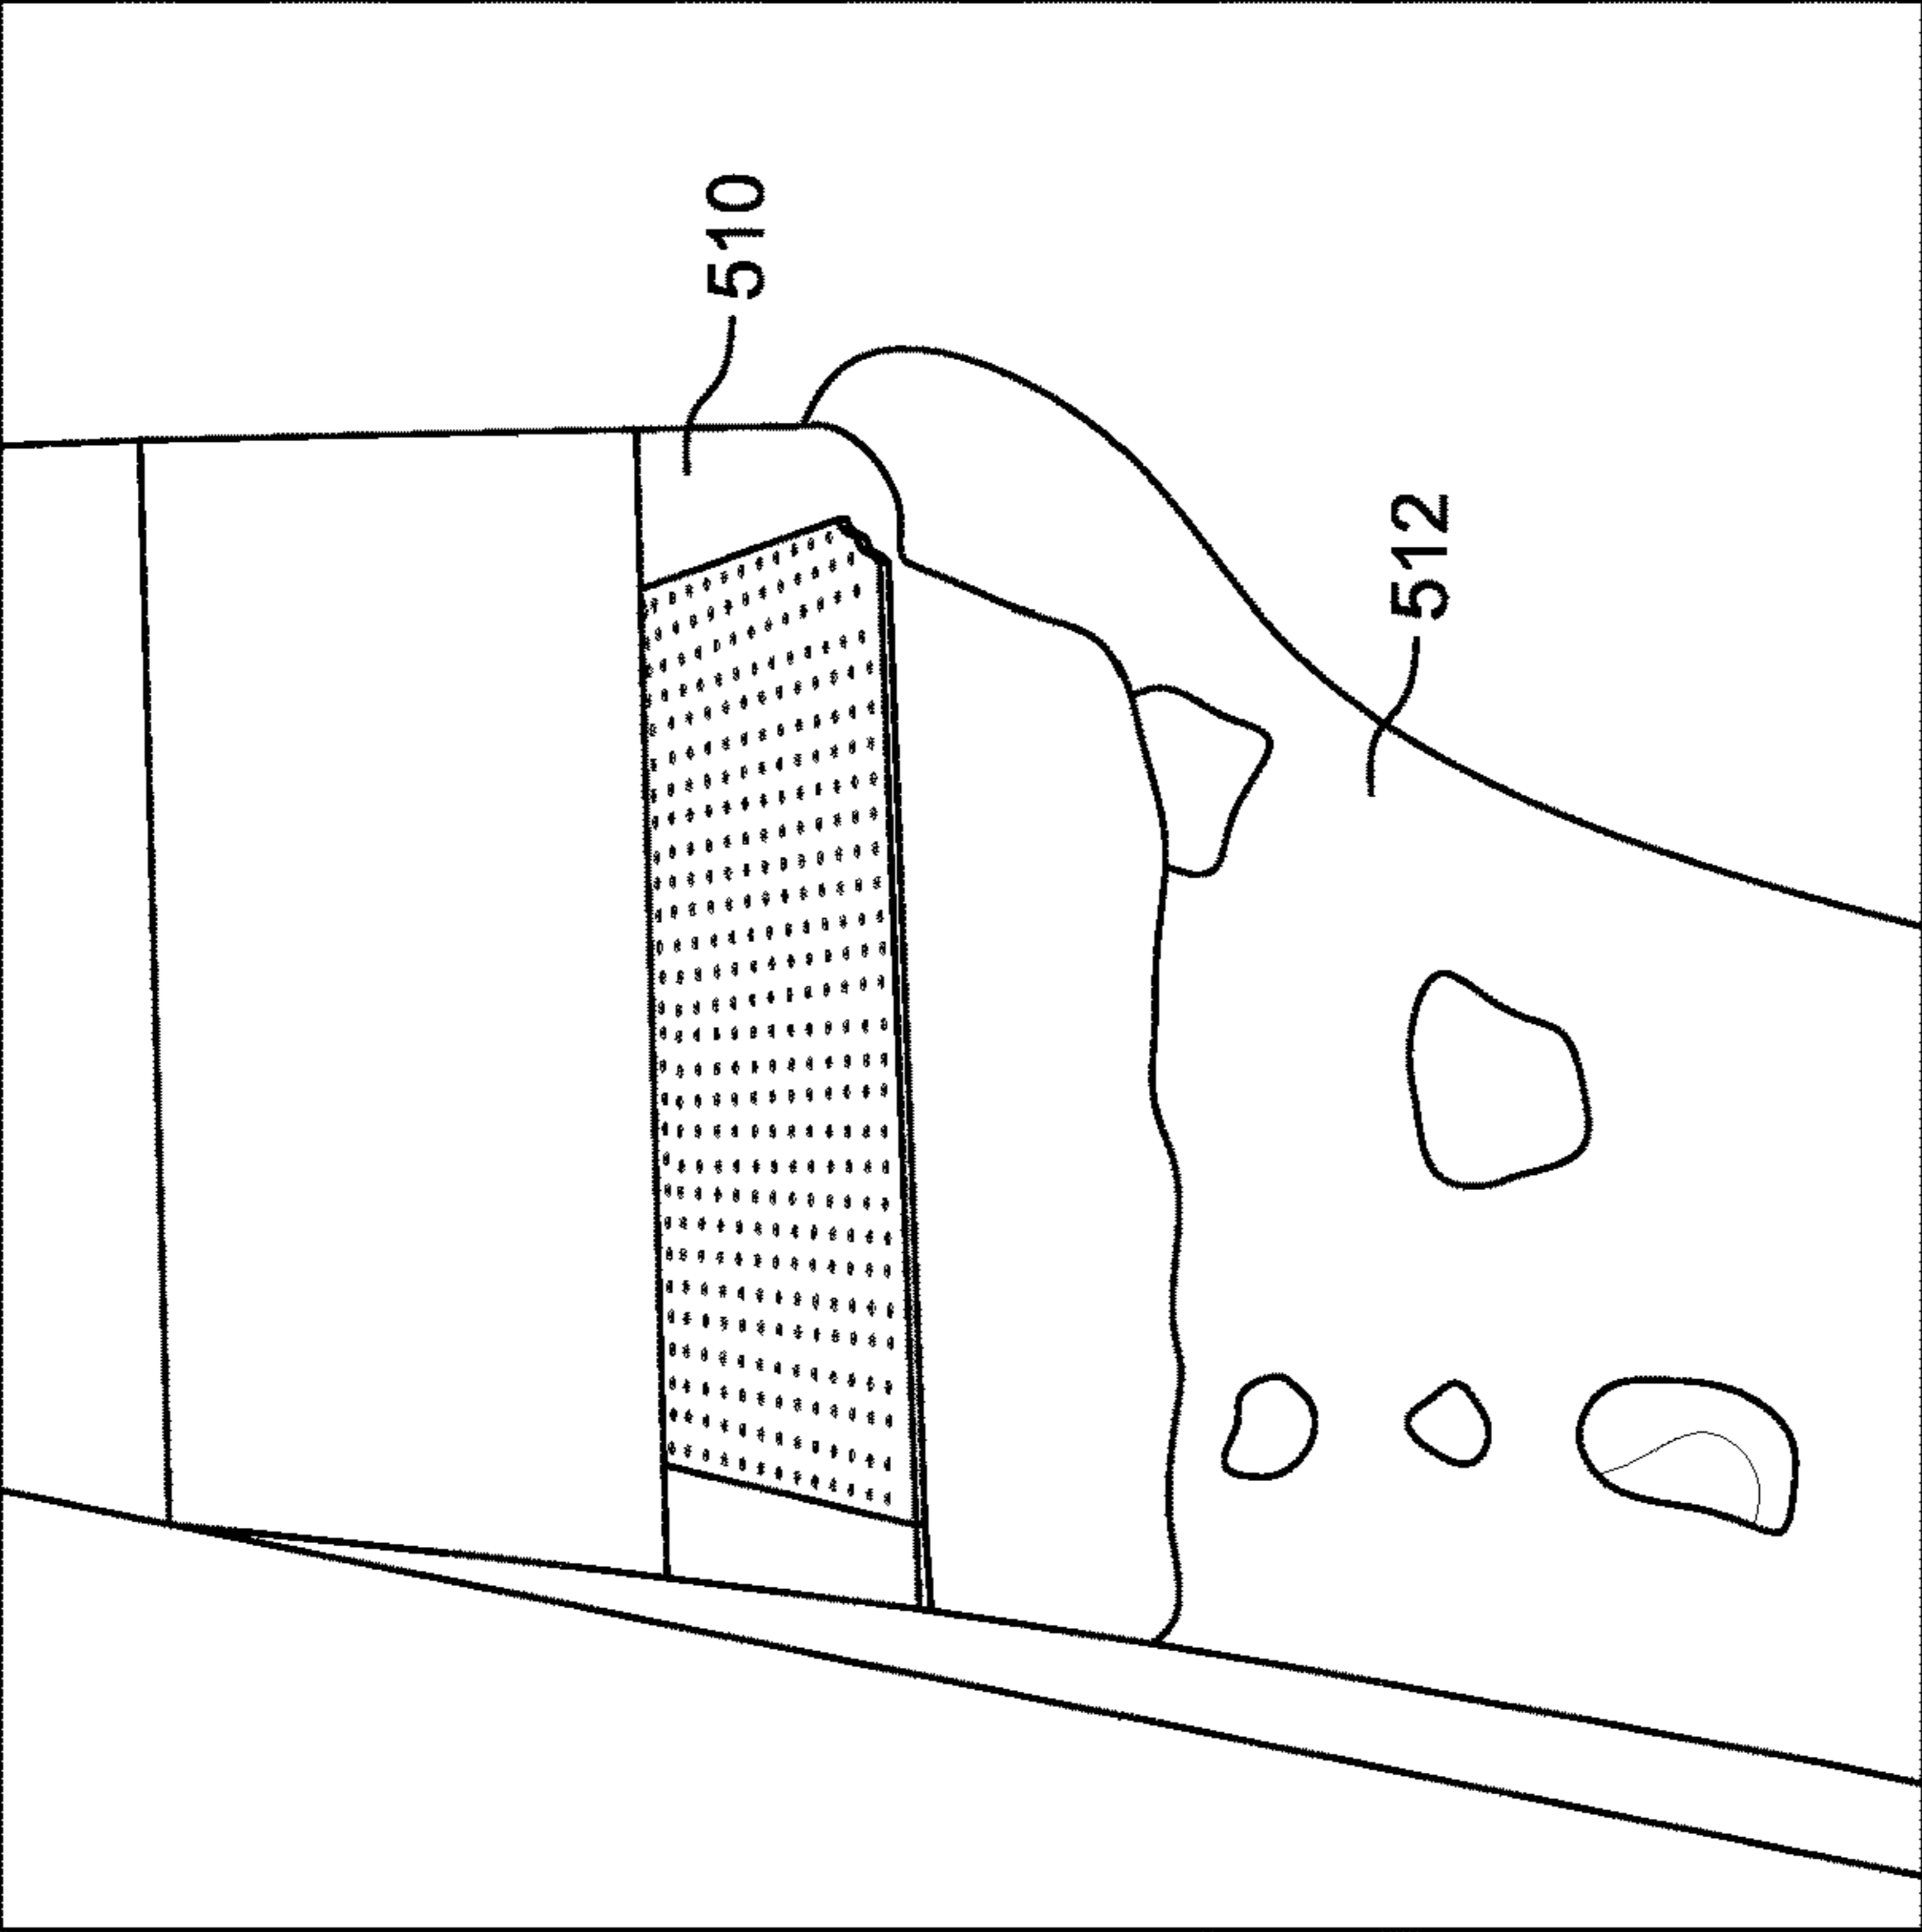
FIG. 12 shows the pedestrian ramp in FIG. 11 after repairs according to an embodiment of the present disclosure;

514 is then finished by using a hand trowel as shown in FIG. 23. The repaired ramp 510 is shown in FIG. 12.

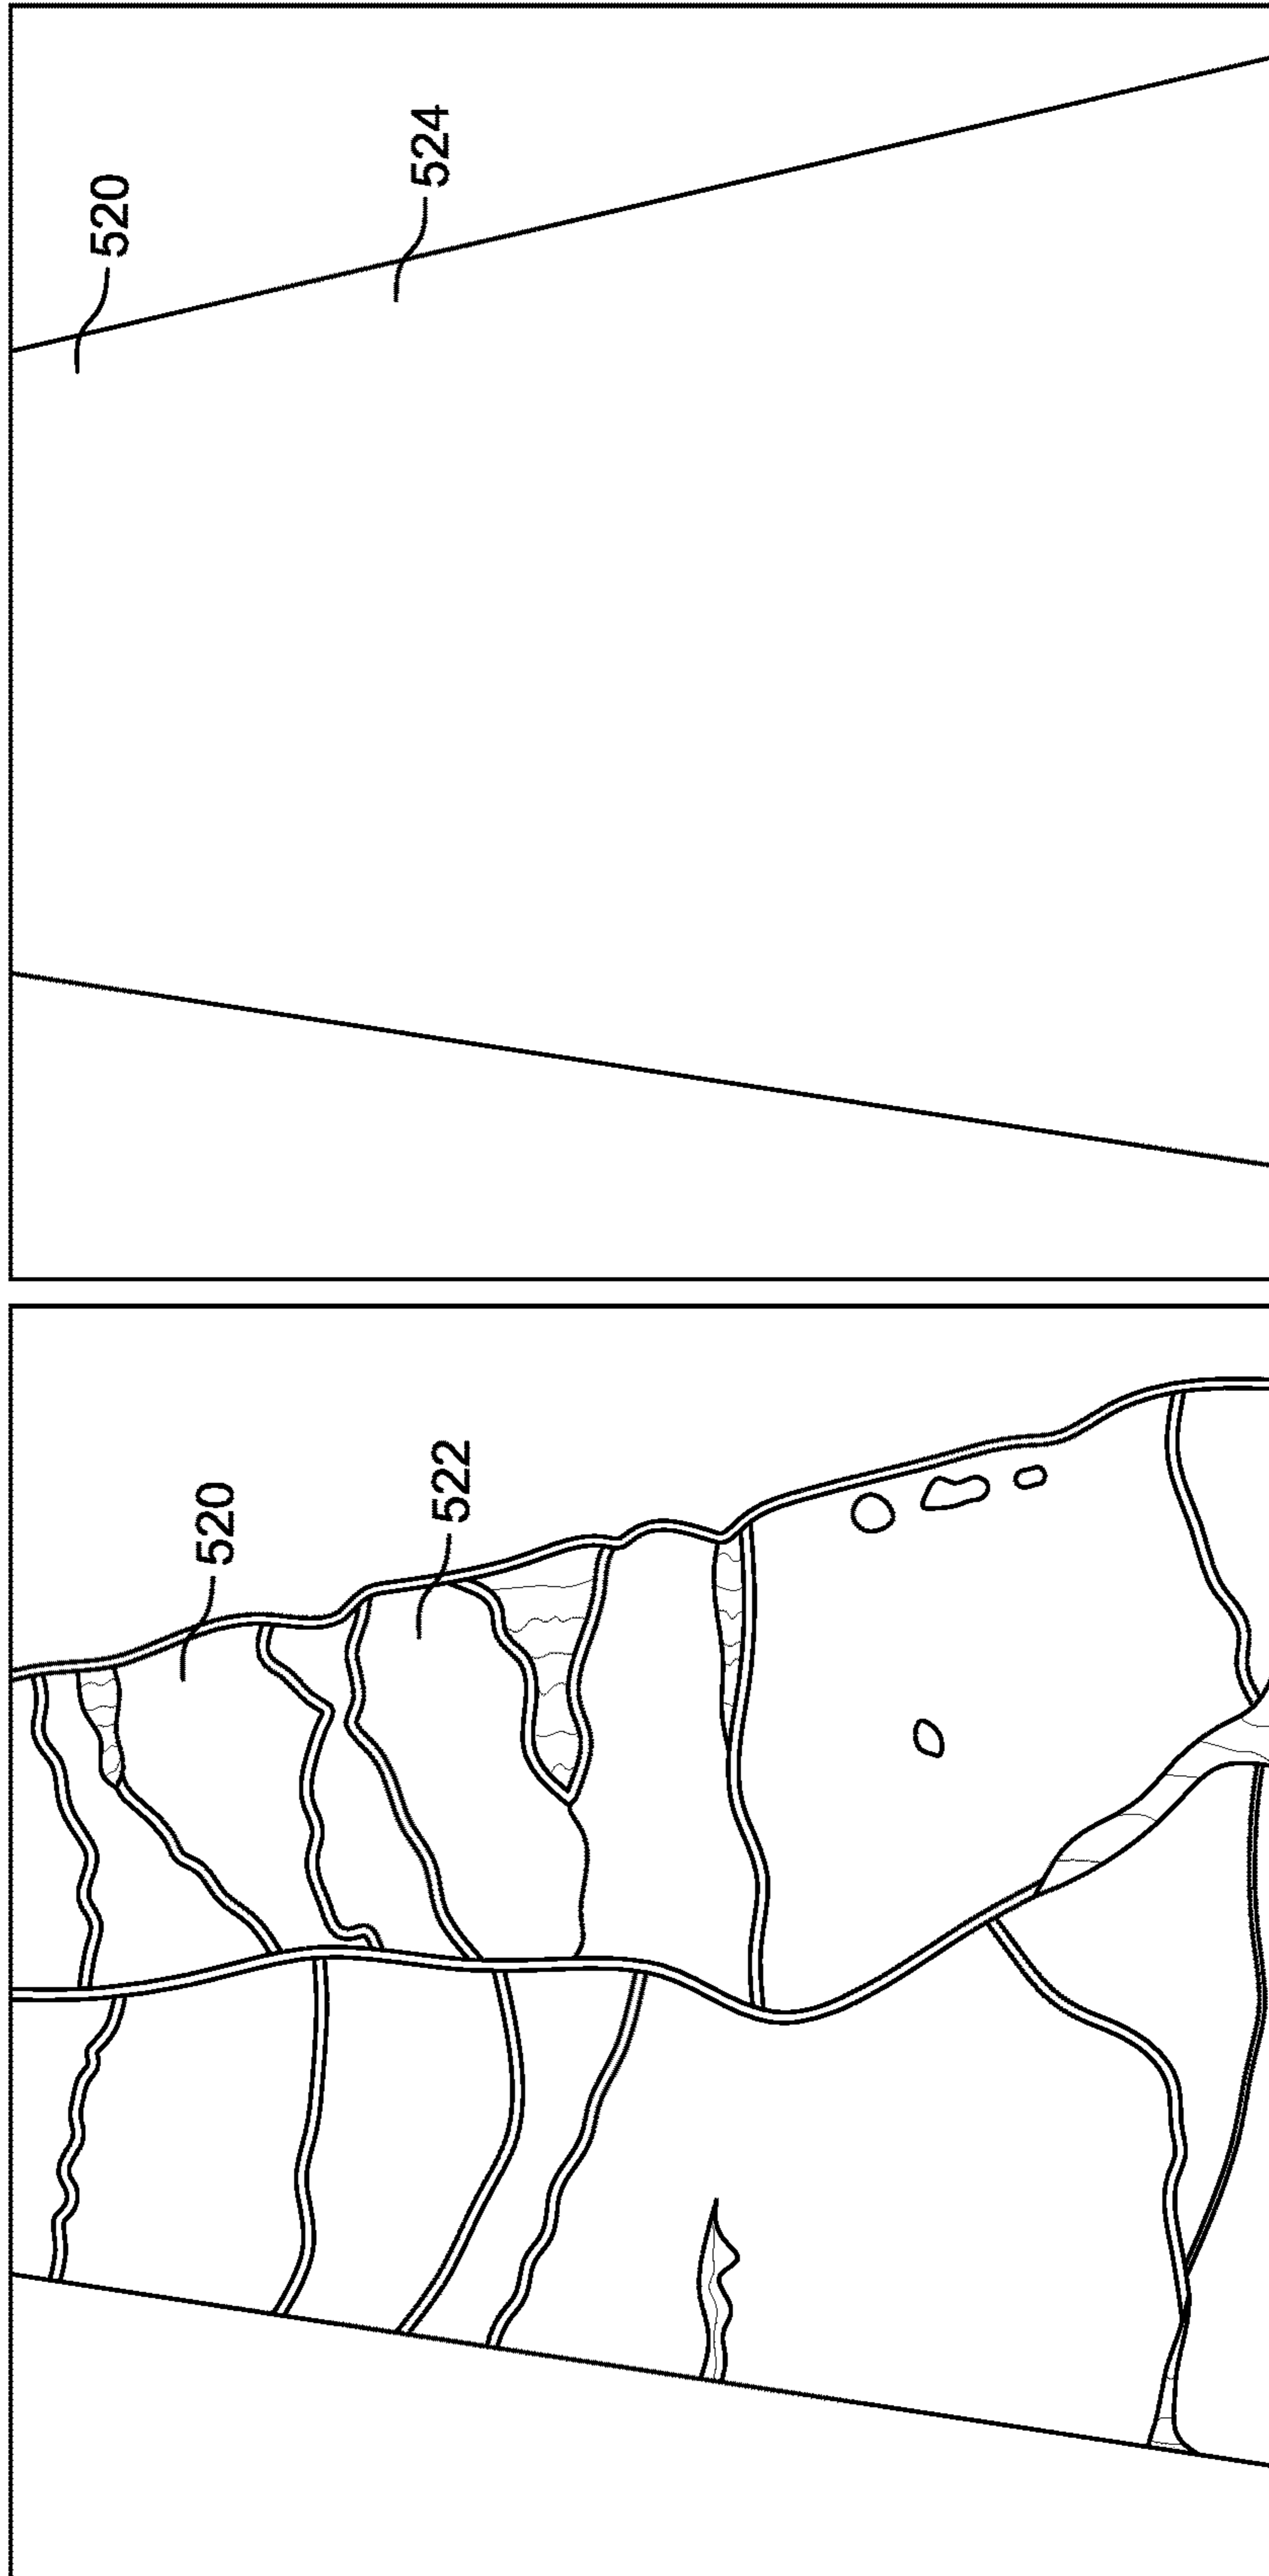
FIG. 13 depicts a damaged concrete water trough formed in a roadway;

FIG. 14 depicts the concrete water trough in FIG. 13 after repairs according to an embodiment of the present disclosure;

Referring now to FIG. 13, there is depicted a concrete trough 520 having a damaged surface 522. The damage to the surface 522 includes cracks, pits and voids. A process of repairing the surface 522 is as follows. First, the surface 522 is cleared of debris. Next, as shown in FIG. 21, a grinder is used to remove rough edges and loose edges on the surface 522. Next, a protective overlay and composite material 524 is installed onto the surface 522 to effectuate the repair. In an embodiment, the protective overlay material 524 is mixed in a mixer as shown in FIG. 22 and then placed onto the damaged surface of the surface 522. The material 524 is then finished by using a hand trowel as shown in FIG. 23. The repaired trough 520 is shown in FIG. 14.

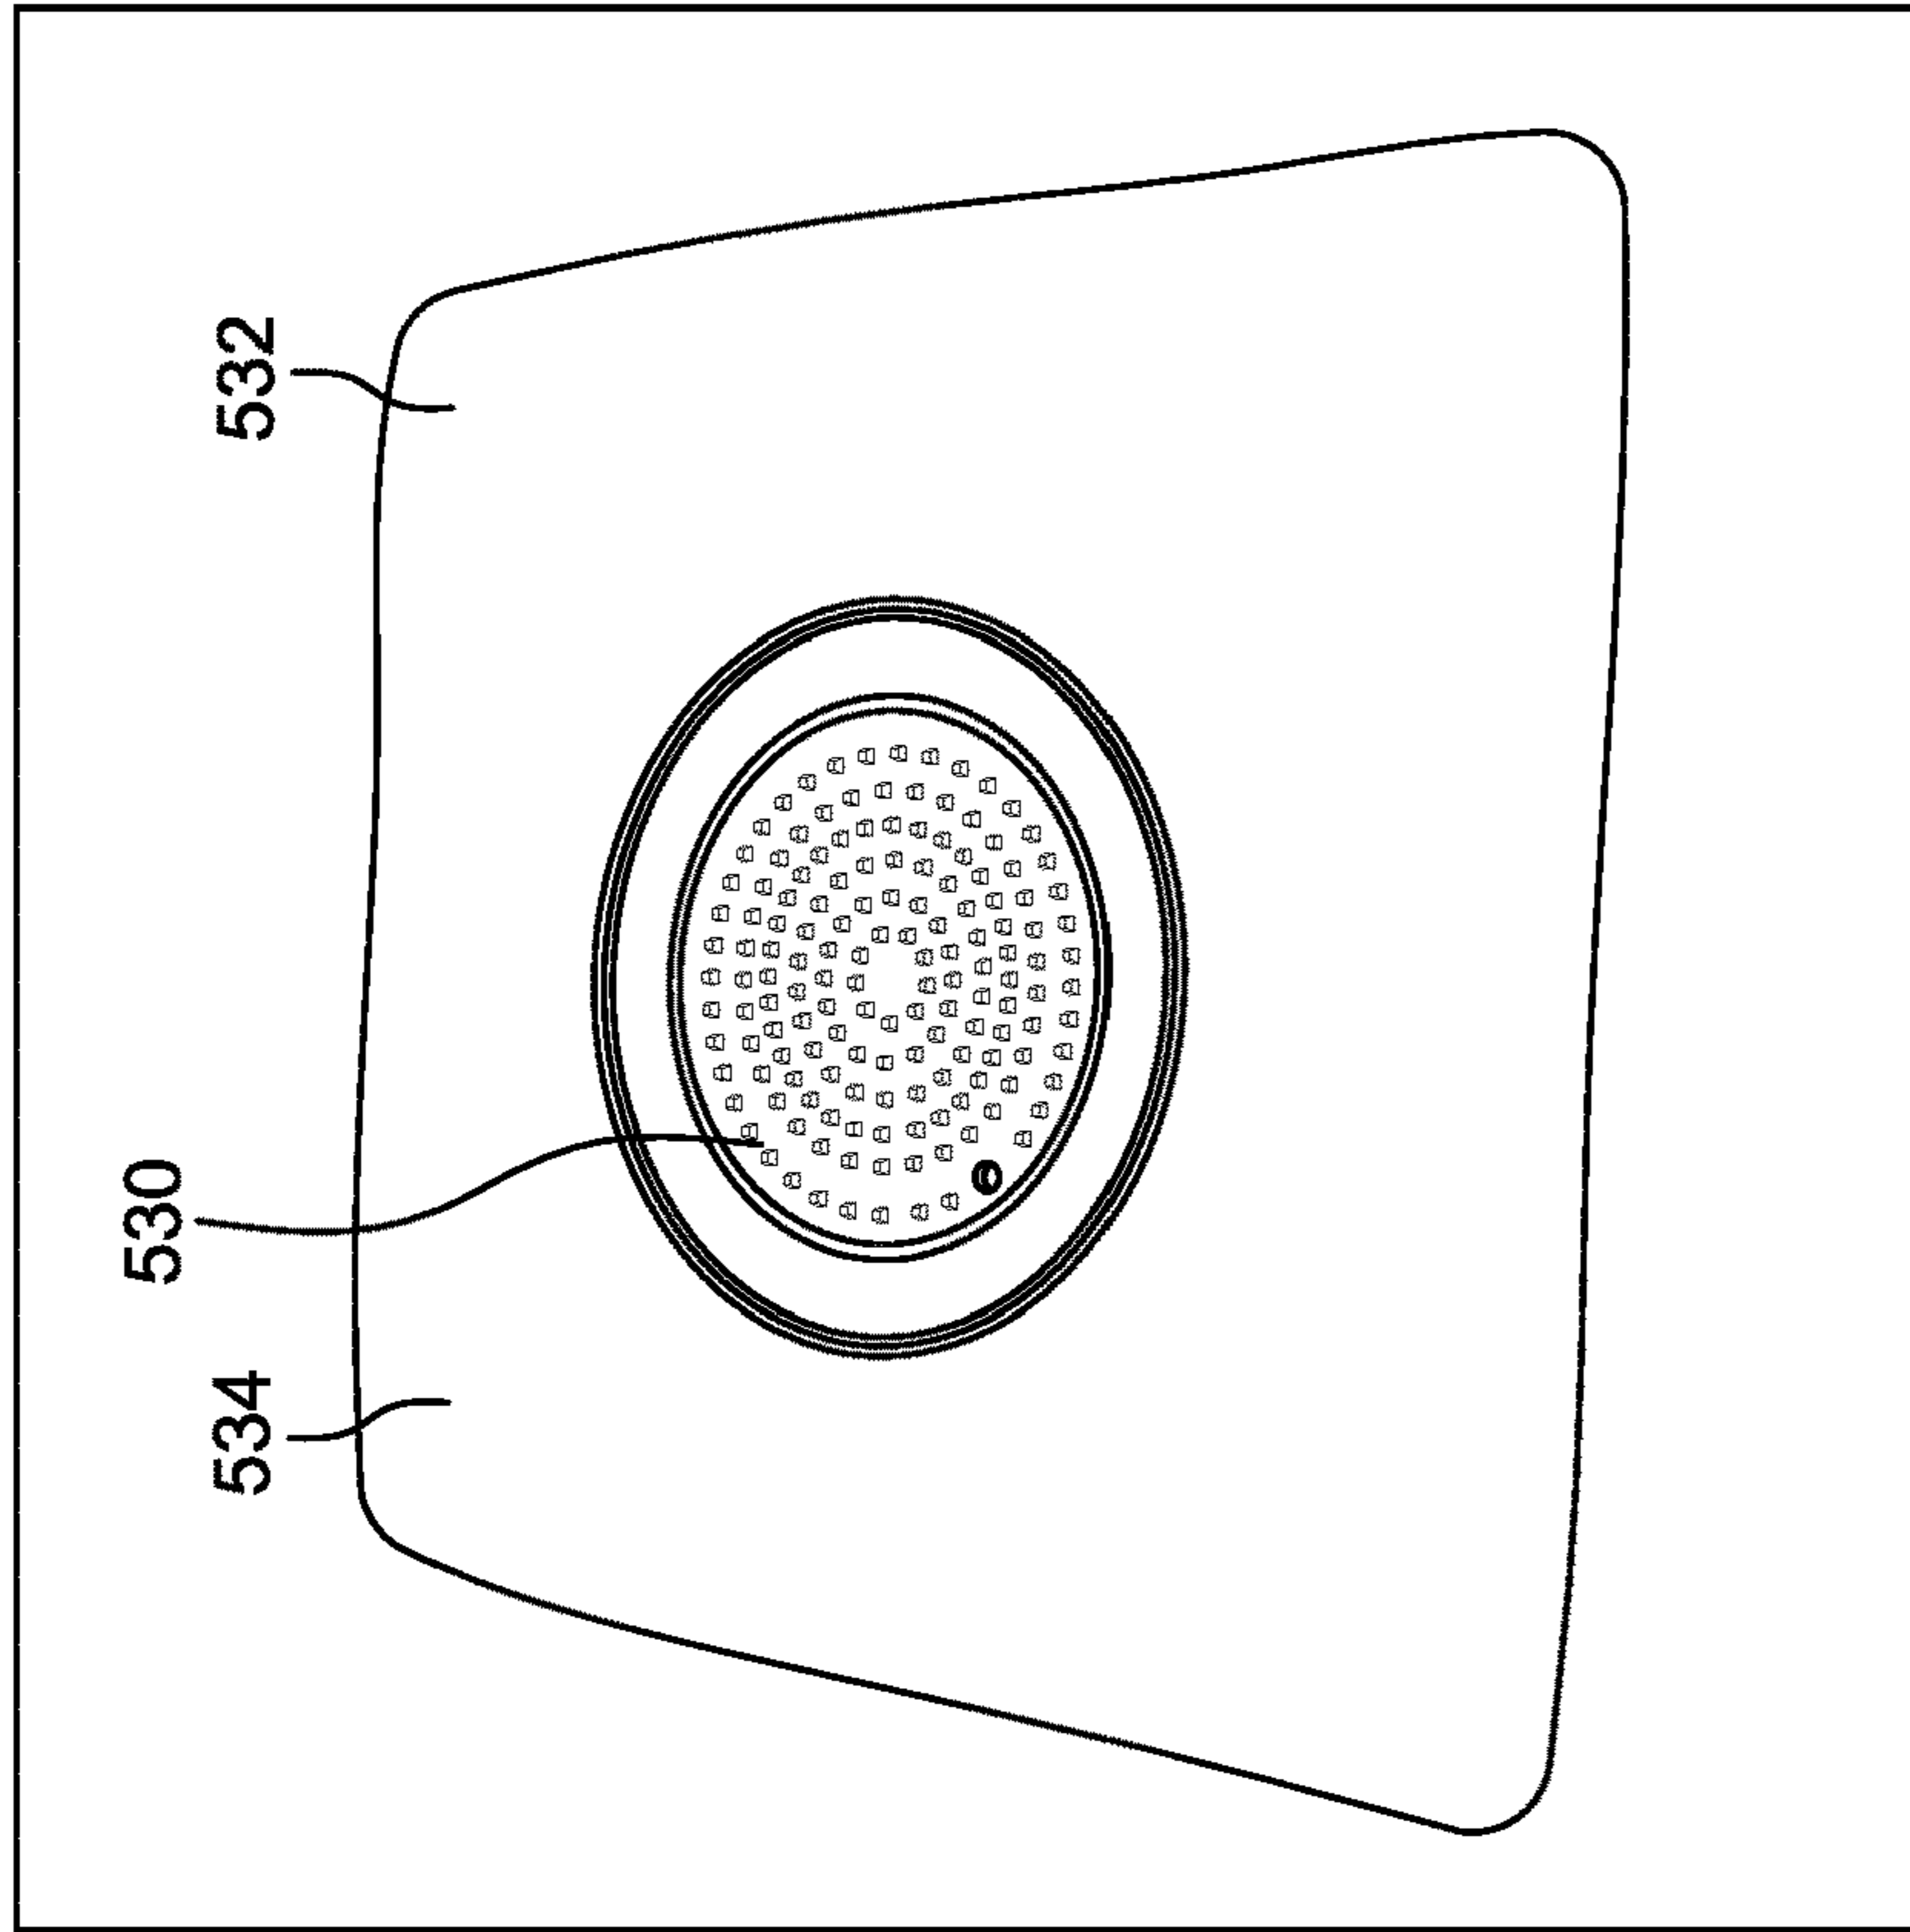
FIG. 15 shows a metal cover manhole cover installed over an access tunnel and having a damaged concrete apron;

Referring now to FIG. 15, there is depicted a manhole cover 530 installed over a utility access tunnel. Surrounding the cover 530 is a concrete apron 532. As can be seen, the apron 532 is damaged and includes cracks, pits and voids. A process of repairing the apron 532 is as follows. First, the apron 532 is cleared of debris. Next, as shown in FIG. 21, a grinder is used to remove rough edges and loose edges on the apron 532. Next, a protective overlay and composite material 534 is installed onto the apron 532 to effectuate the repair. In an embodiment, the protective overlay material 534 is mixed in a mixer as shown in FIG. 22 and then placed onto the damaged surface of the apron 532. The material 534 is then finished by using a hand trowel as shown in FIG. 23. The repaired apron 532 is shown in FIG. 16.
