US010329719B1

(12) **United States Patent**
Giles

(54) **COMPOSITION AND METHOD FOR SURFACE REPAIR**

(57) **ABSTRACT**

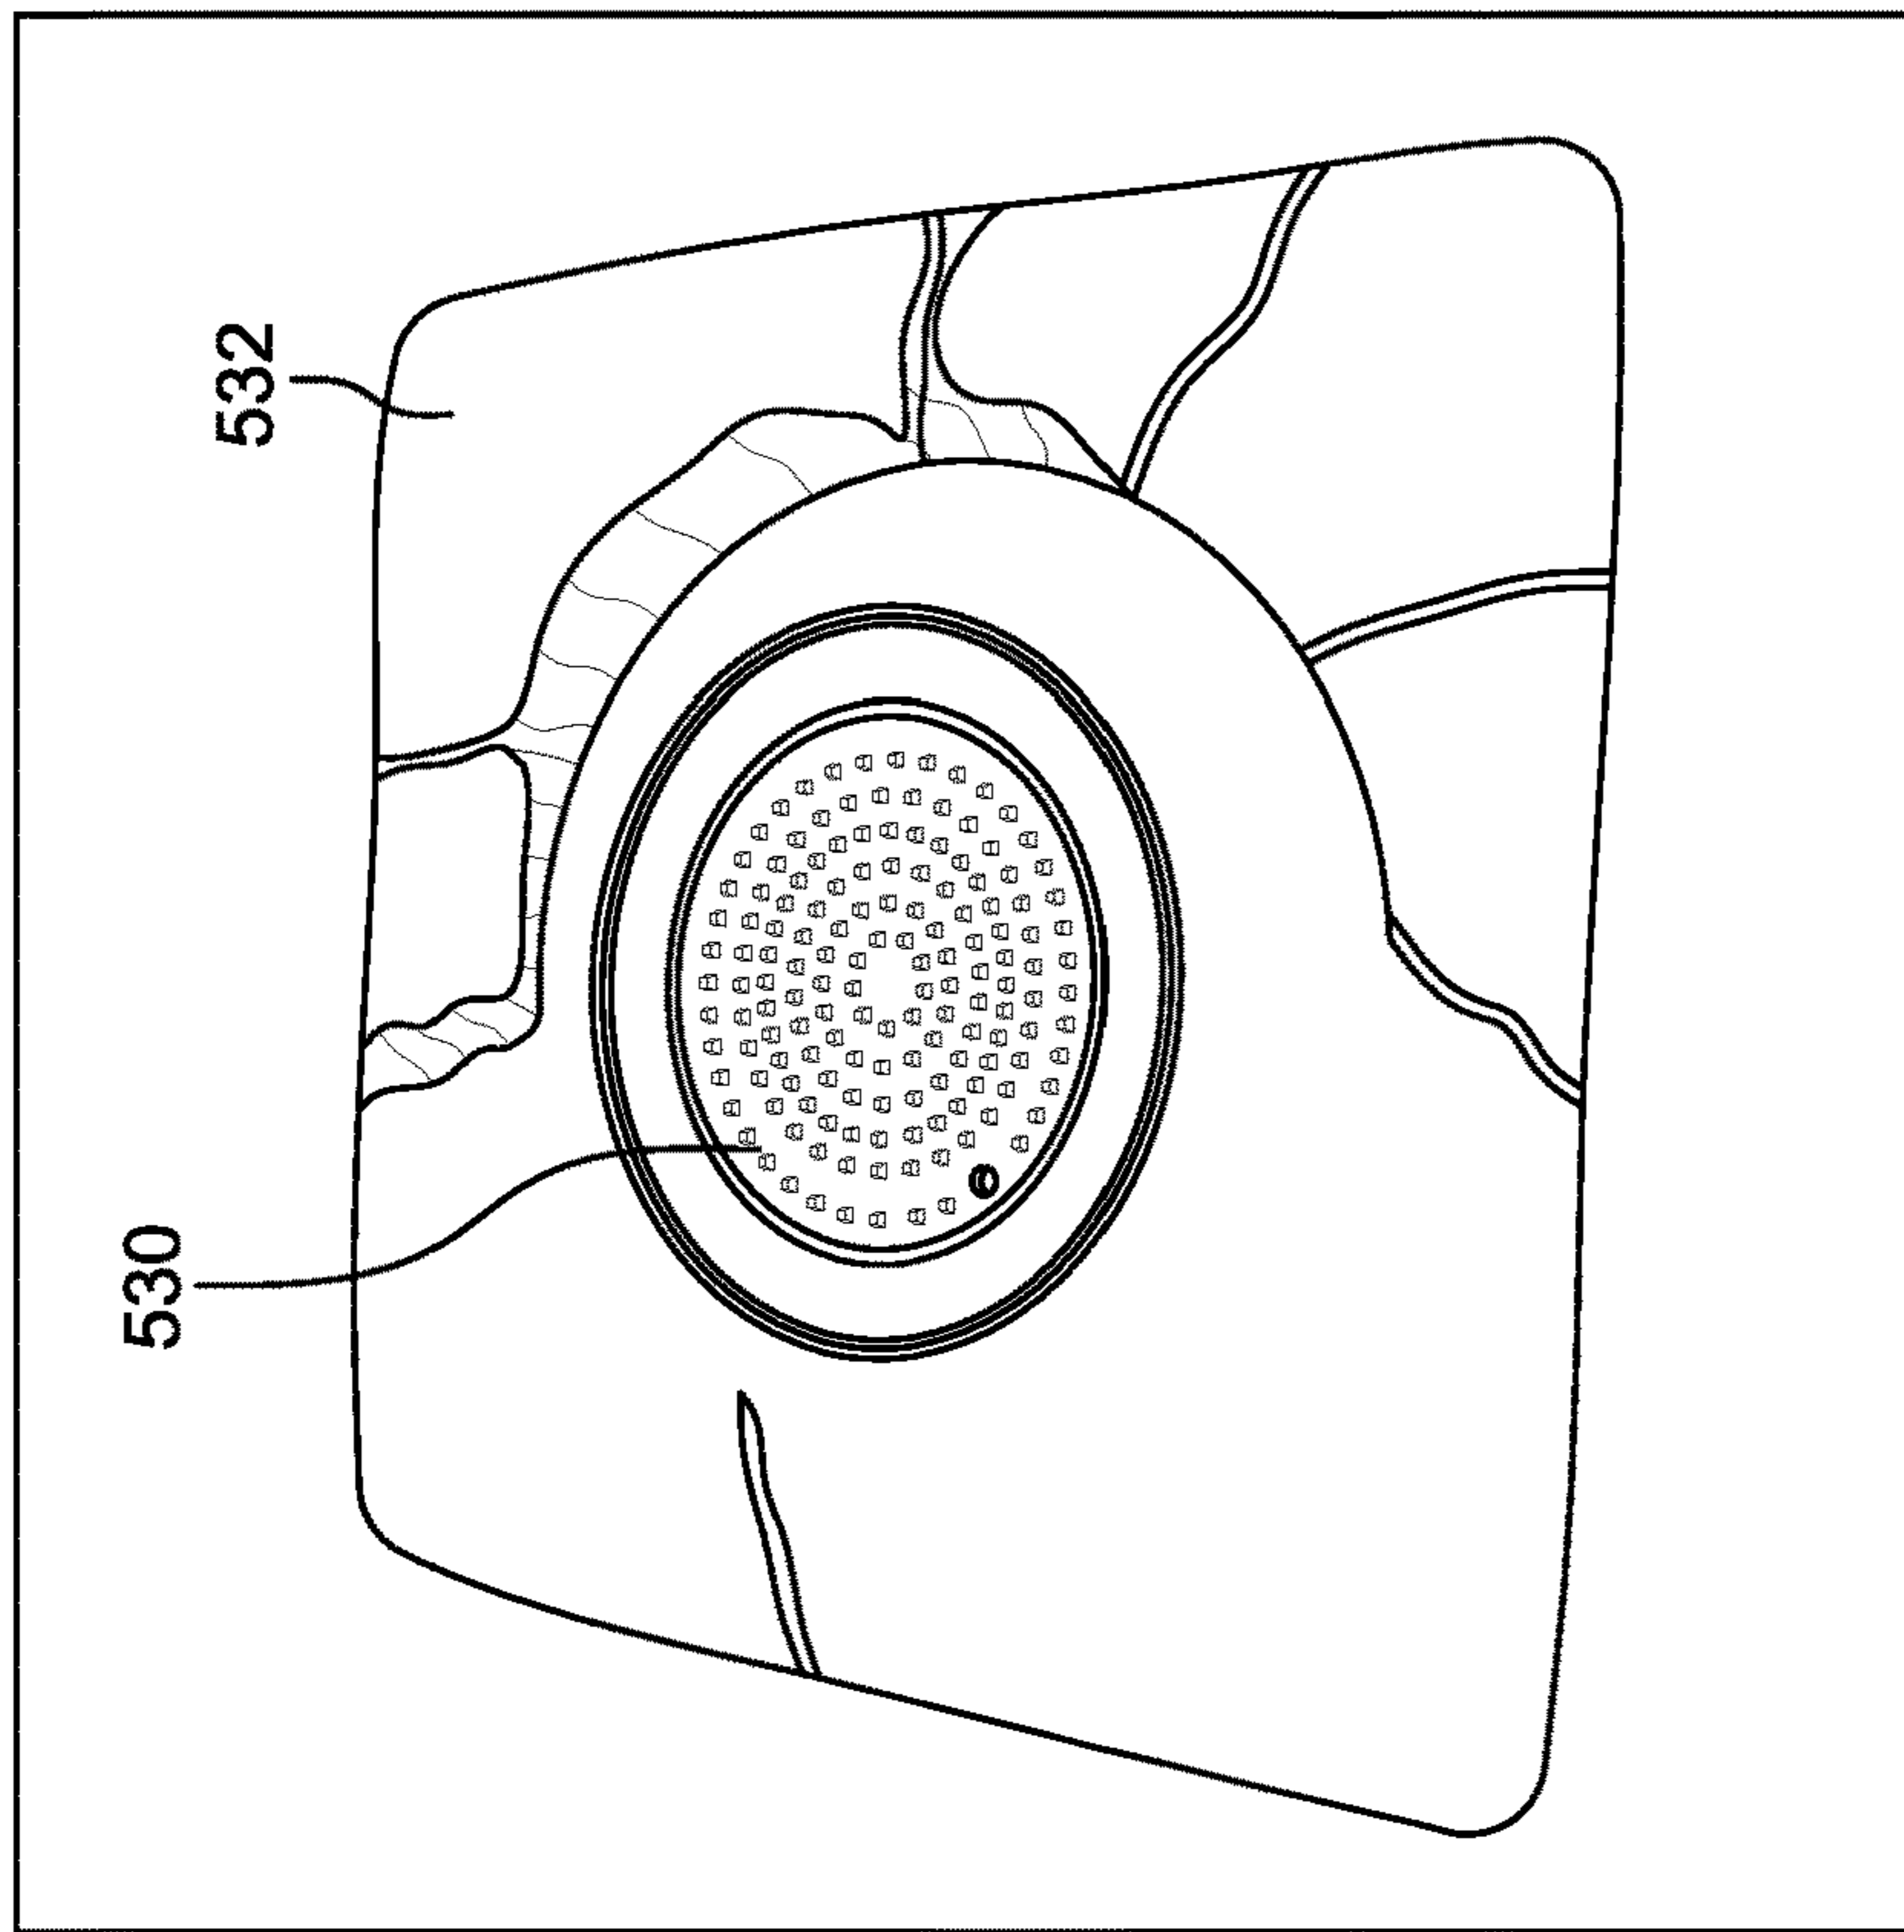
FIG. 16 shows the concrete apron in FIG. 15 after repairs according to an embodiment of the present disclosure;

Referring now to FIG. 15, there is depicted a manhole cover 530 installed over a utility access tunnel. Surrounding the cover 530 is a concrete apron 532. As can be seen, the apron 532 is damaged and includes cracks, pits and voids. A process of repairing the apron 532 is as follows. First, the apron 532 is cleared of debris. Next, as shown in FIG. 21, a grinder is used to remove rough edges and loose edges on the apron 532. Next, a protective overlay and composite material 534 is installed onto the apron 532 to effectuate the repair. In an embodiment, the protective overlay material 534 is mixed in a mixer as shown in FIG. 22 and then placed onto the damaged surface of the apron 532. The material 534 is then finished by using a hand trowel as shown in FIG. 23. The repaired apron 532 is shown in FIG. 16.

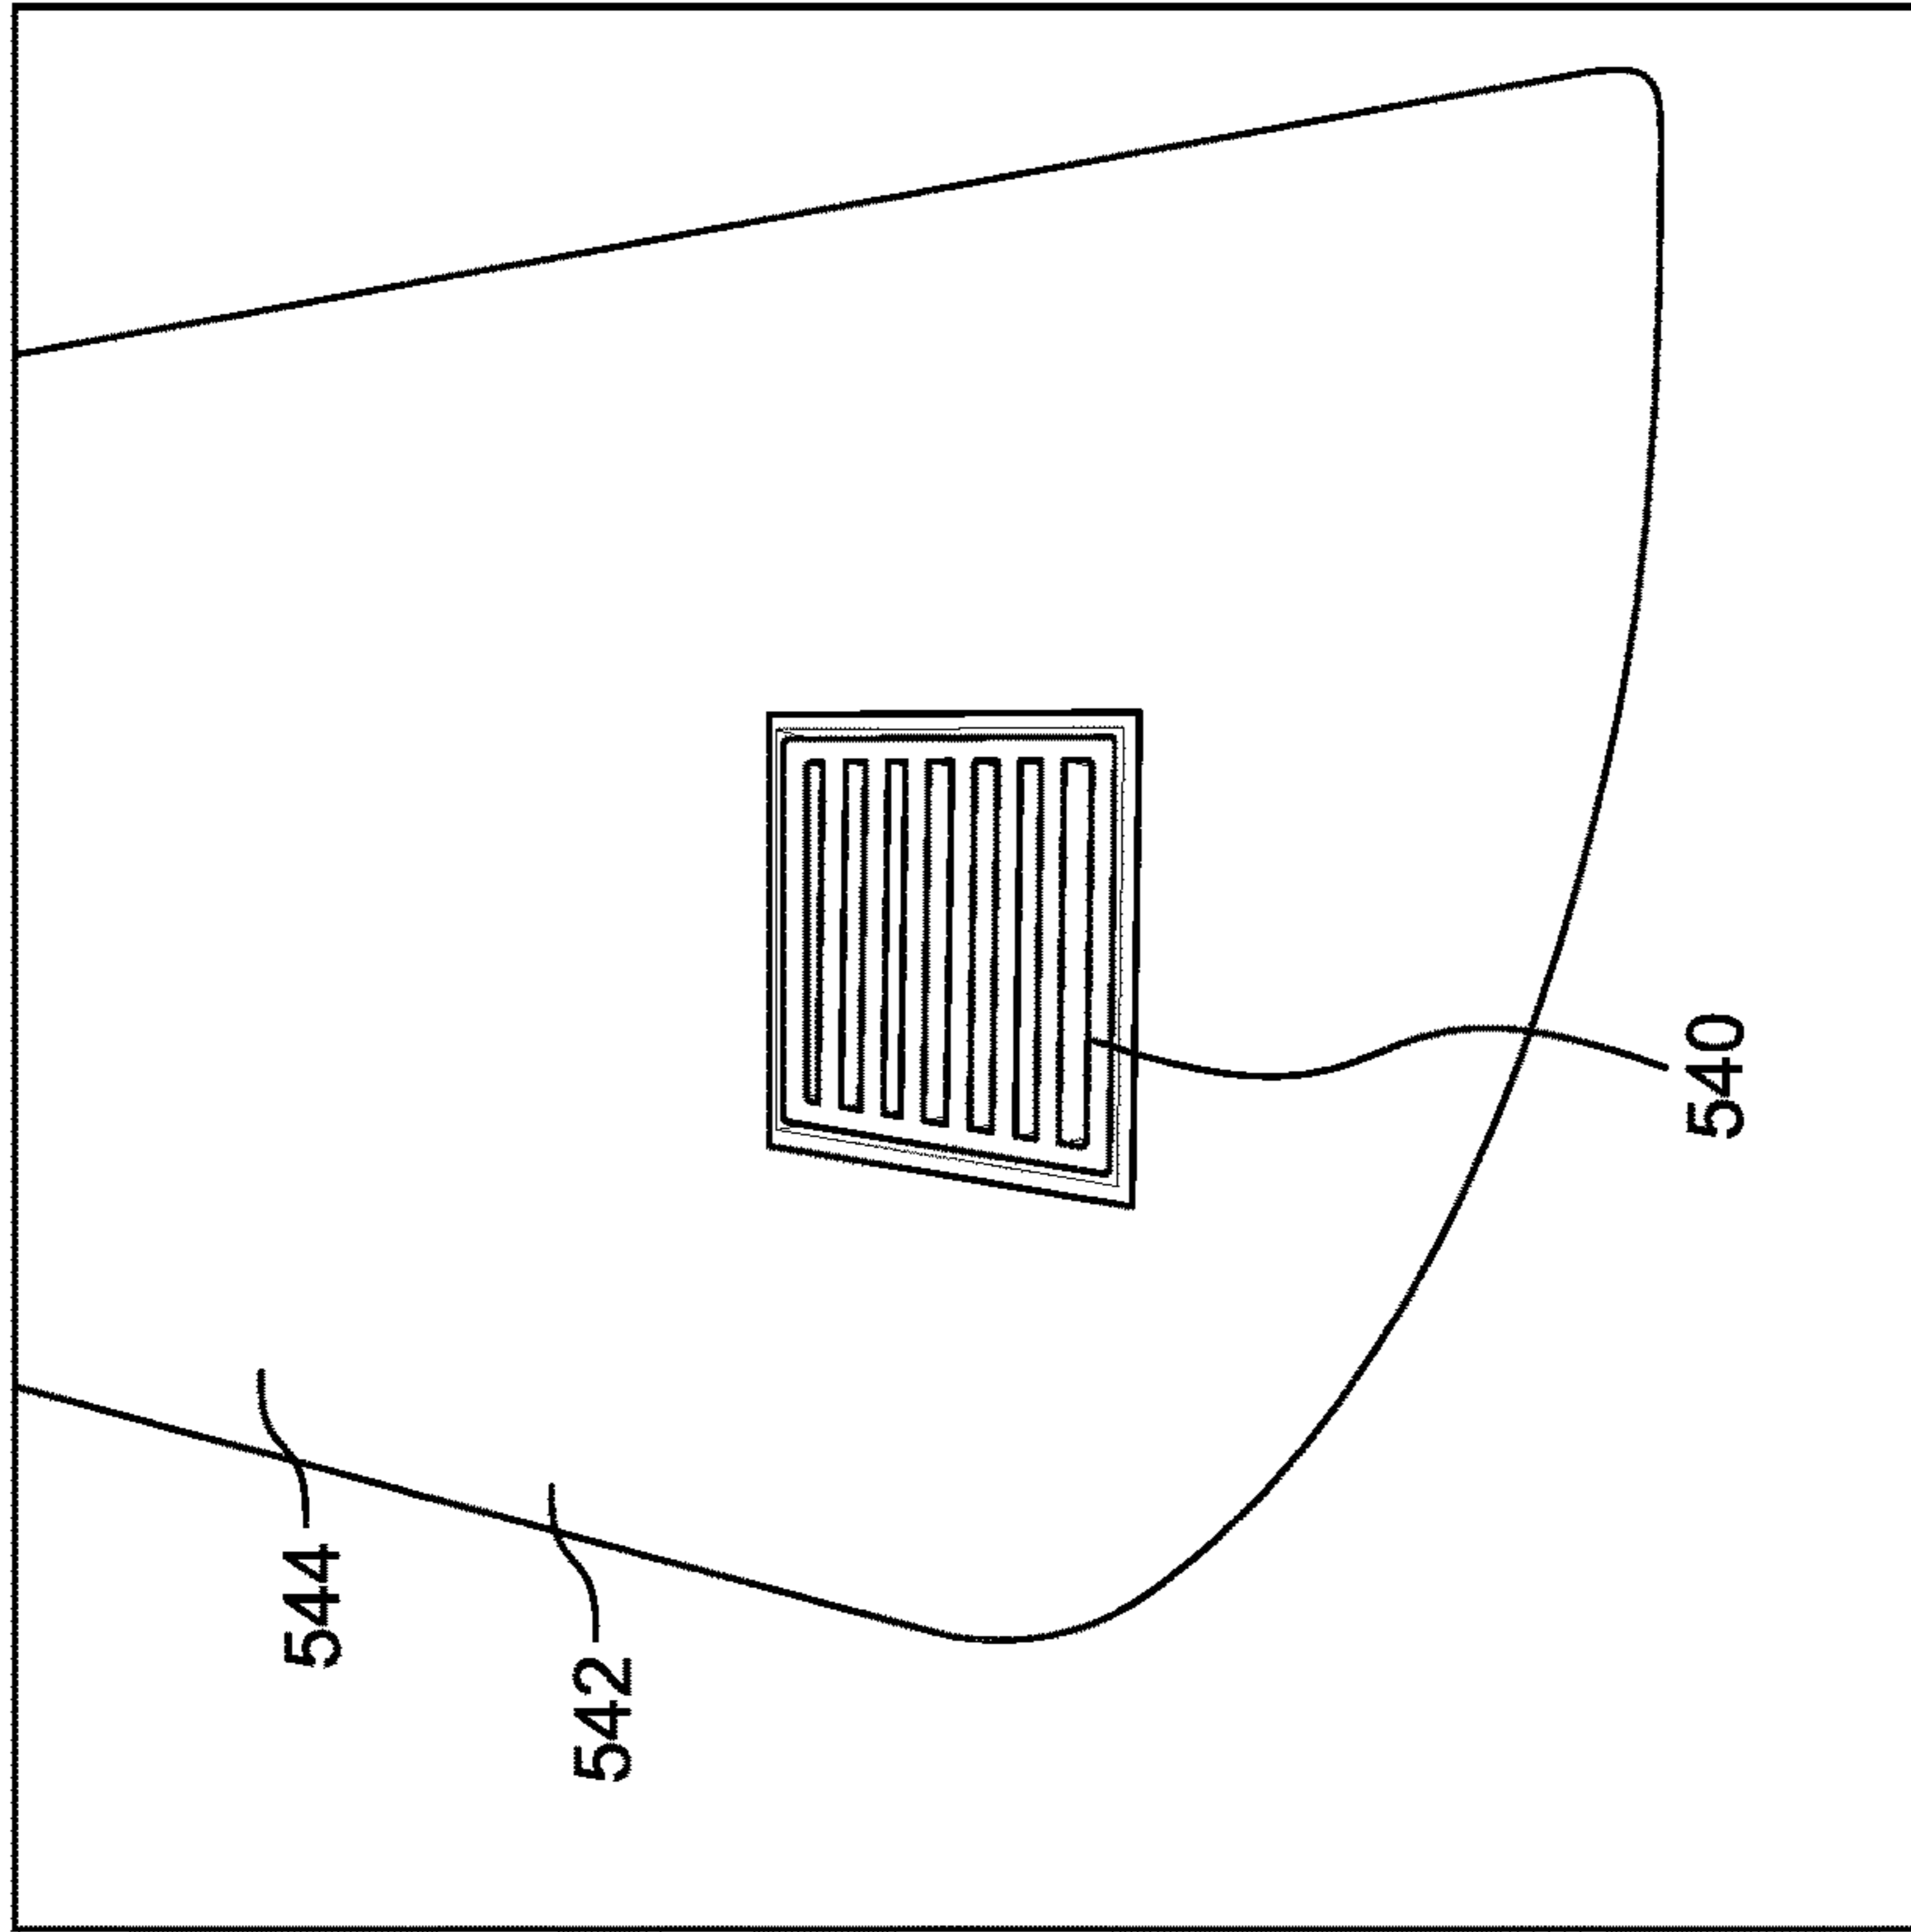
FIG. 17 depicts a metal grate in a roadway having a damaged concrete apron;

Referring now to FIG. 17, there is depicted a metal grate 540 installed over a drain pipe. Surrounding the grate 540 is a concrete trough 542. As can be seen, the trough 542 is damaged and includes cracks, pits and voids. A process of repairing the trough 542 is as follows. First, the trough 542 is cleared of debris. Next, as shown in FIG. 21, a grinder is used to remove rough edges and loose edges on the trough 542. Next, a protective overlay material 544 is installed onto the trough 542 to effectuate the repair. In an embodiment, the protective overlay material 544 is mixed in a mixer as shown in FIG. 22 and then placed onto the damaged surface of the trough 542. The material 544 is then finished by using a hand trowel as shown in FIG. 23. The repaired trough 542 is shown in FIG. 18.

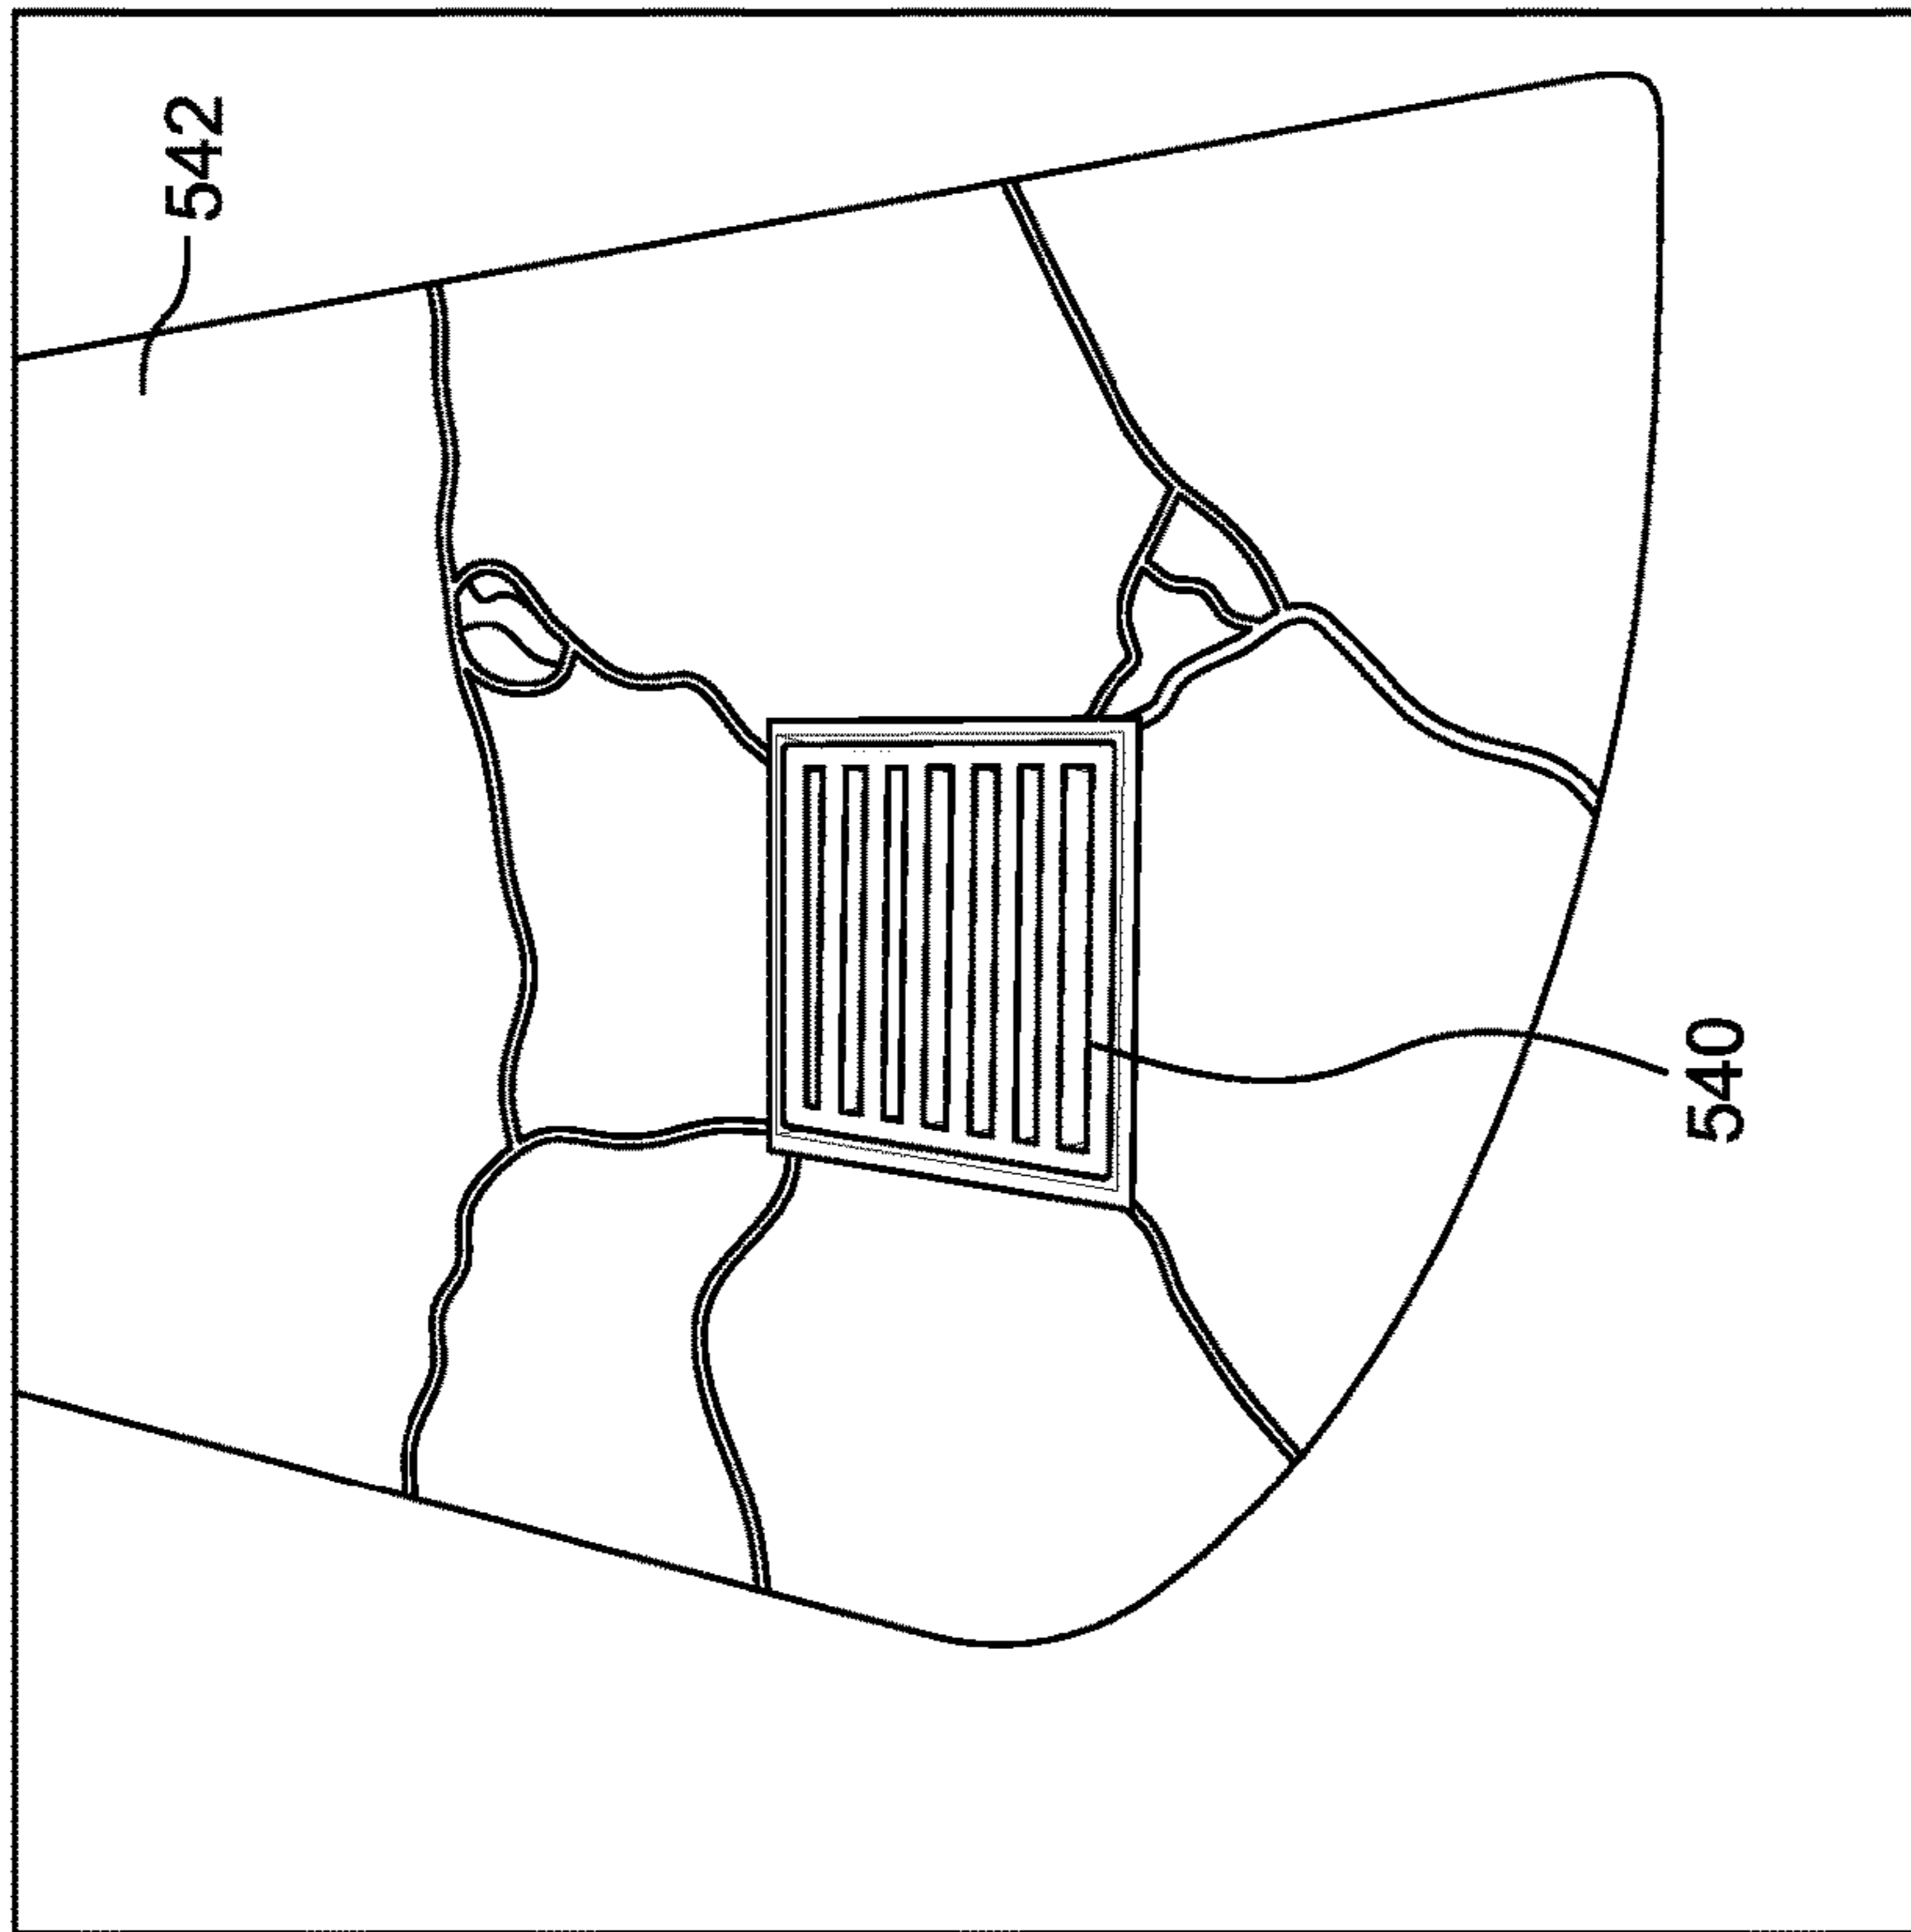
FIG. 18 shows the concrete apron in FIG. 17 after repairs according to an embodiment of the present disclosure;

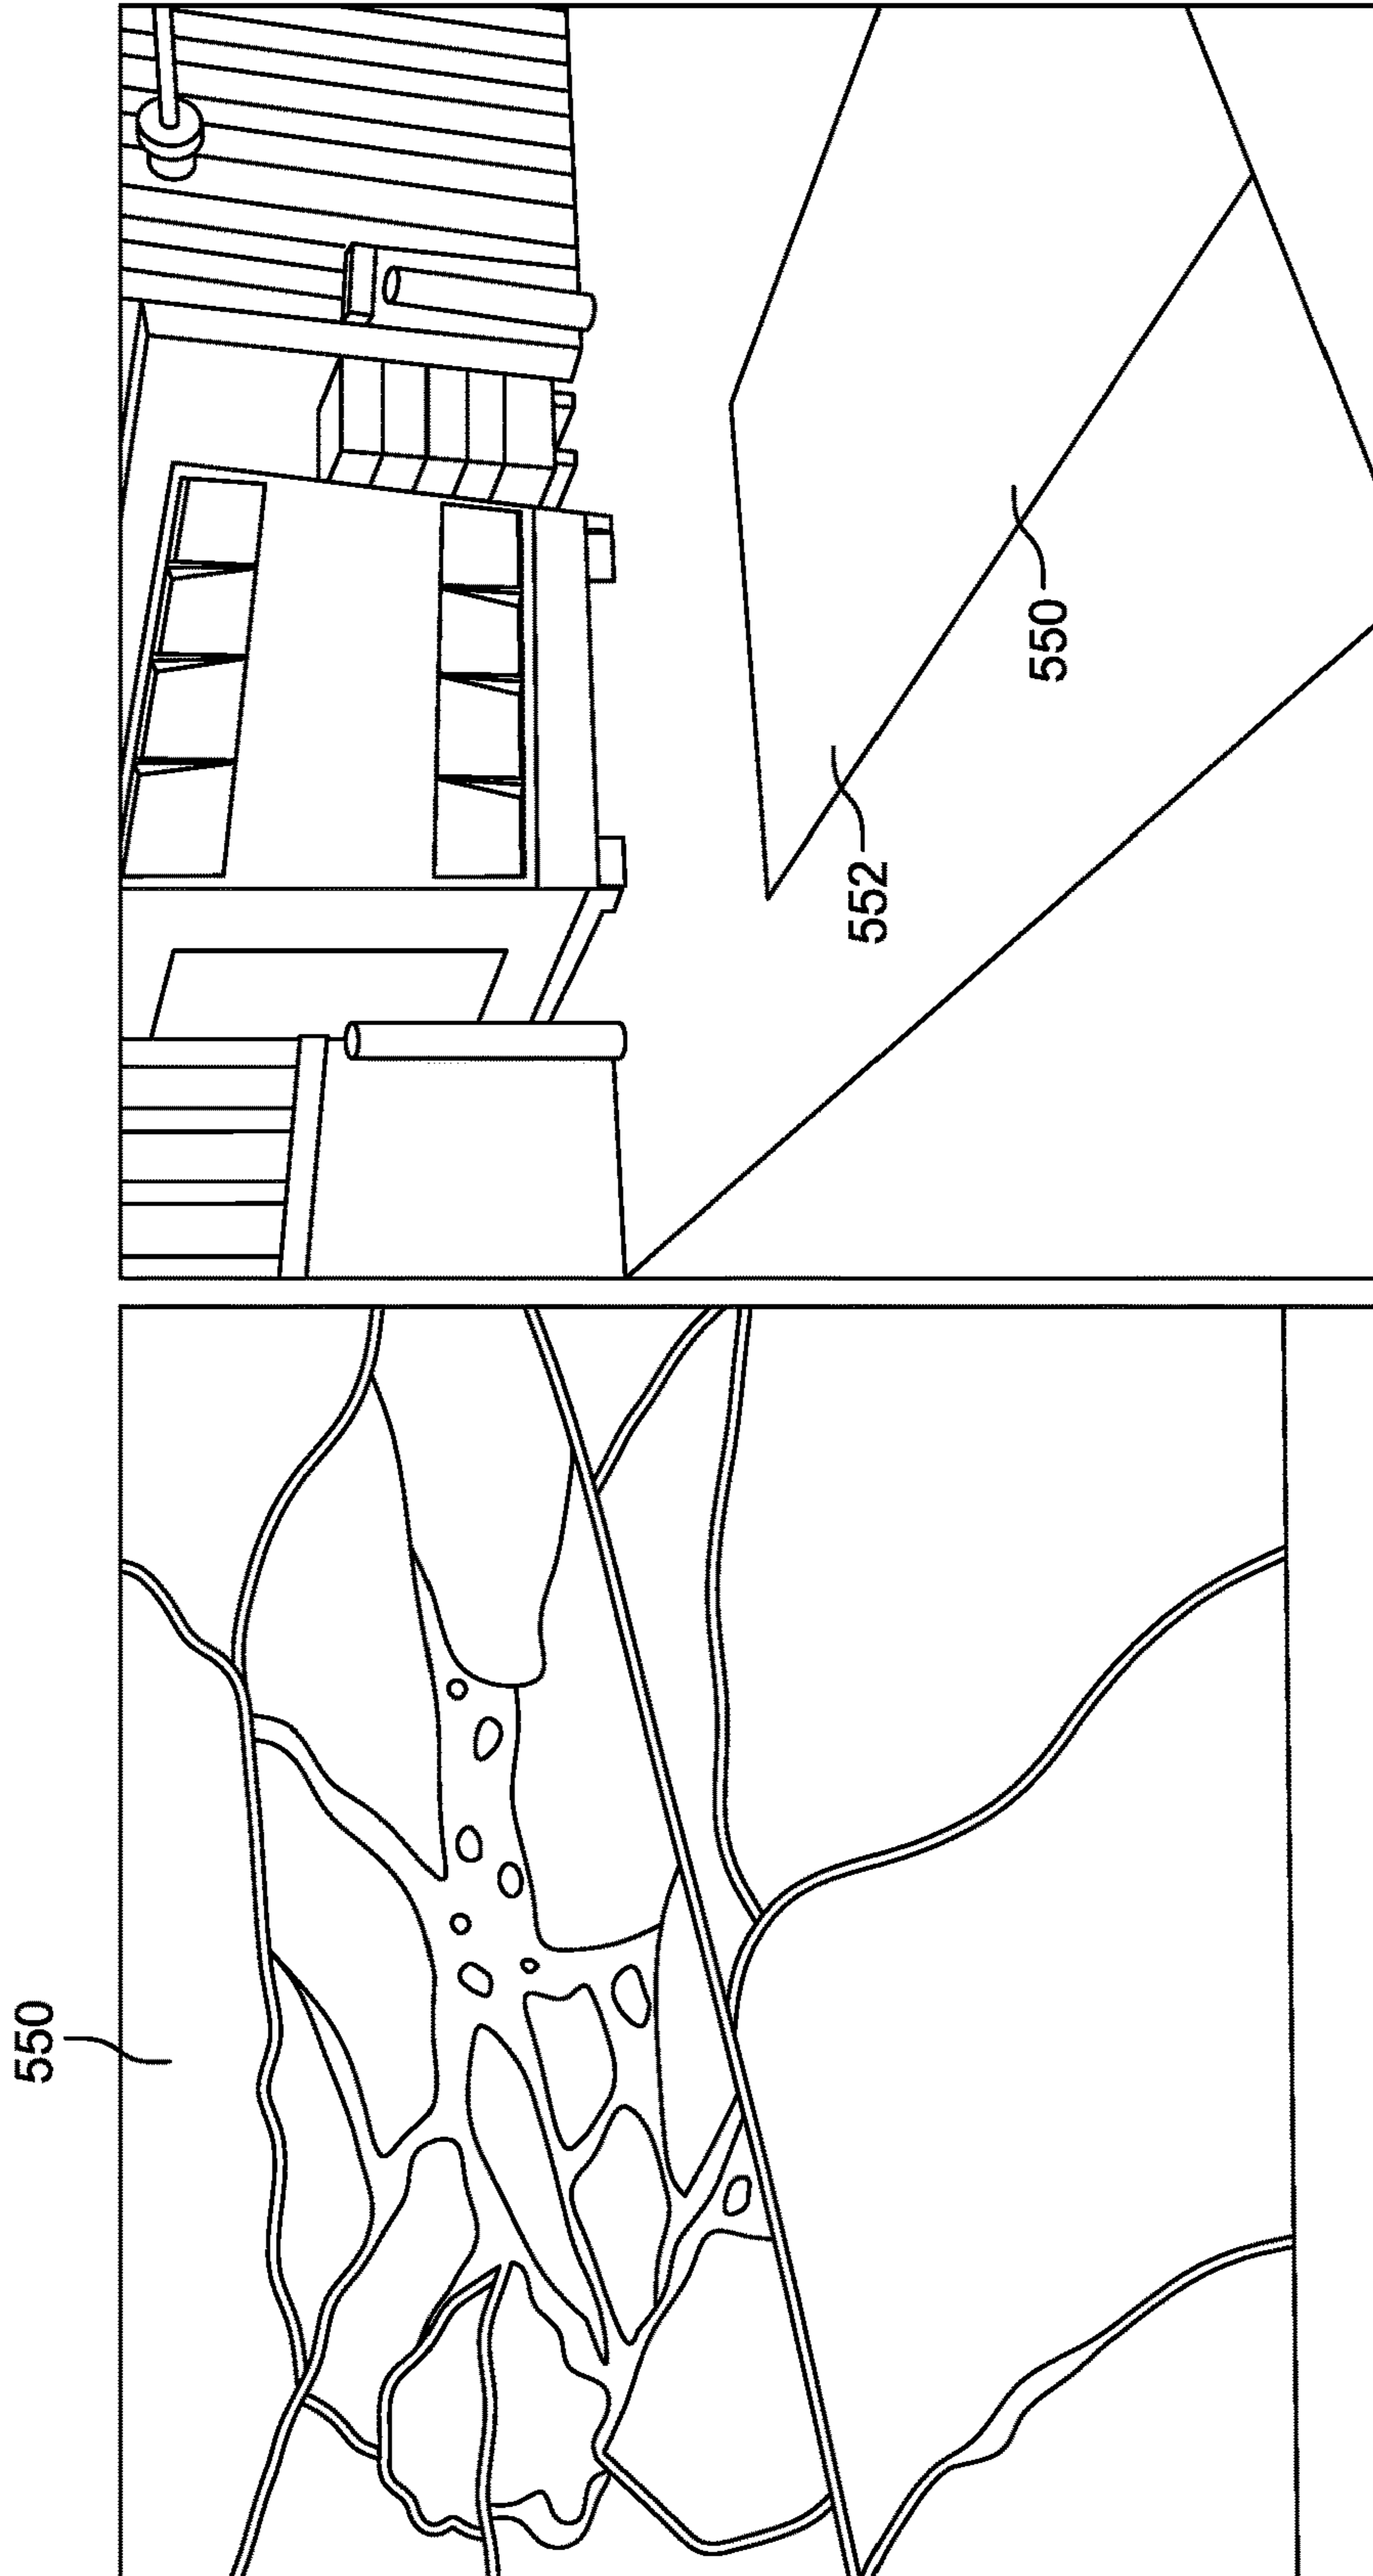
FIG. 19 depicts a damaged surface;

FIG. 20 depicts the surface in FIG. 19 after repairs according to an embodiment of the present disclosure;

Referring now to FIG. 19, there is depicted a concrete pad 550. As can be seen, the pad 550 is damaged and includes cracks, pits and voids. A process of repairing the pad 550 is as follows. First, the pad 550 is cleared of debris. Next, as shown in FIG. 21, a grinder is used to remove rough edges and loose edges on the pad 550. Next, a protective overlay and composite material 552 is installed onto the pad 550 to effectuate the repair. In an embodiment, the protective overlay material 552 is mixed in a mixer as shown in FIG. 22 and then placed onto the damaged surface of the pad 550. The material 552 is then finished by using a hand trowel as shown in FIG. 23. The repaired pad 550 is shown in FIG. 20.

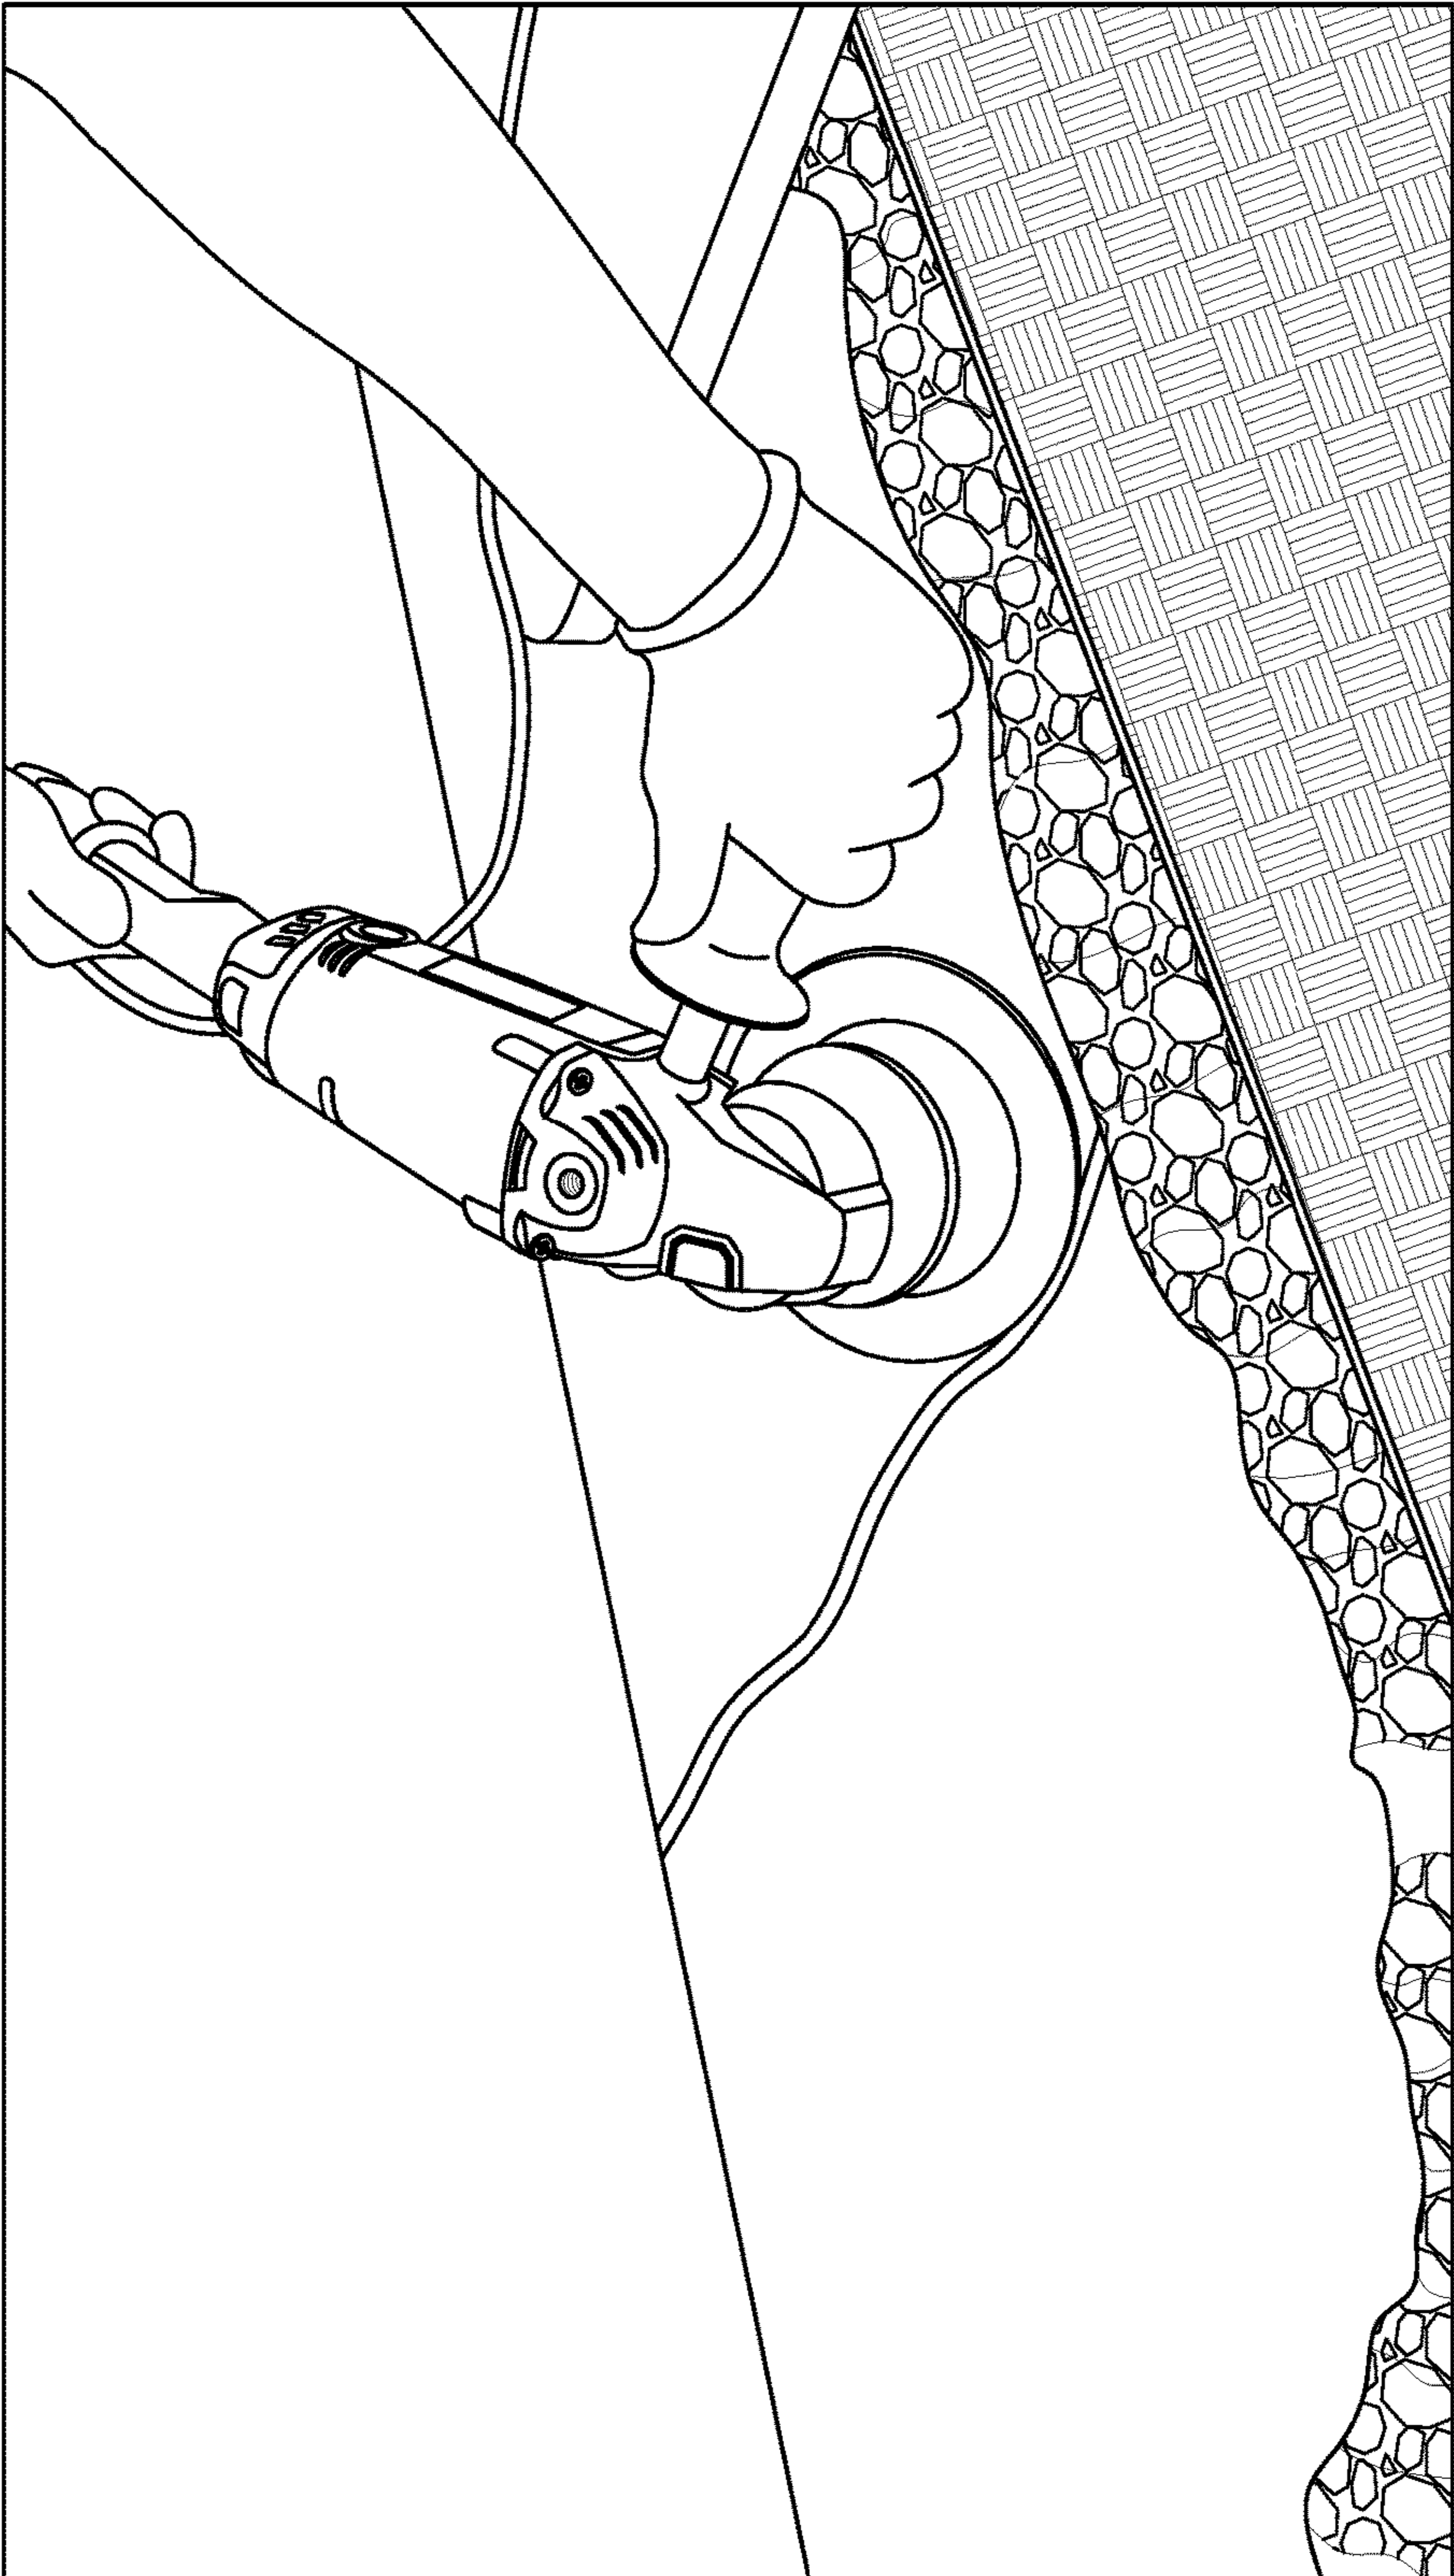
FIG. 21 depicts a process for preparing a damaged surface for repair according to an embodiment of the present disclosure;

A process of repairing the inner surface 612 of the base member 608 is as follows. First, the inner surface 612 is cleared of debris. Next, as illustratively shown in FIG. 21, a grinder is used to remove rough edges and loose edges on the inner surface 612. Next, a protective overlay and composite material 614 is installed onto the inner surface 612 to effectuate the repair. In an embodiment, the protective overlay material 614 is mixed in a mixer as shown in FIG. 22 and then placed onto the inner surface 612. The material 614 is then finished by using a hand trowel as illustratively shown in FIG. 23. The repaired inner surface of the base member 608 is shown in FIG. 25.

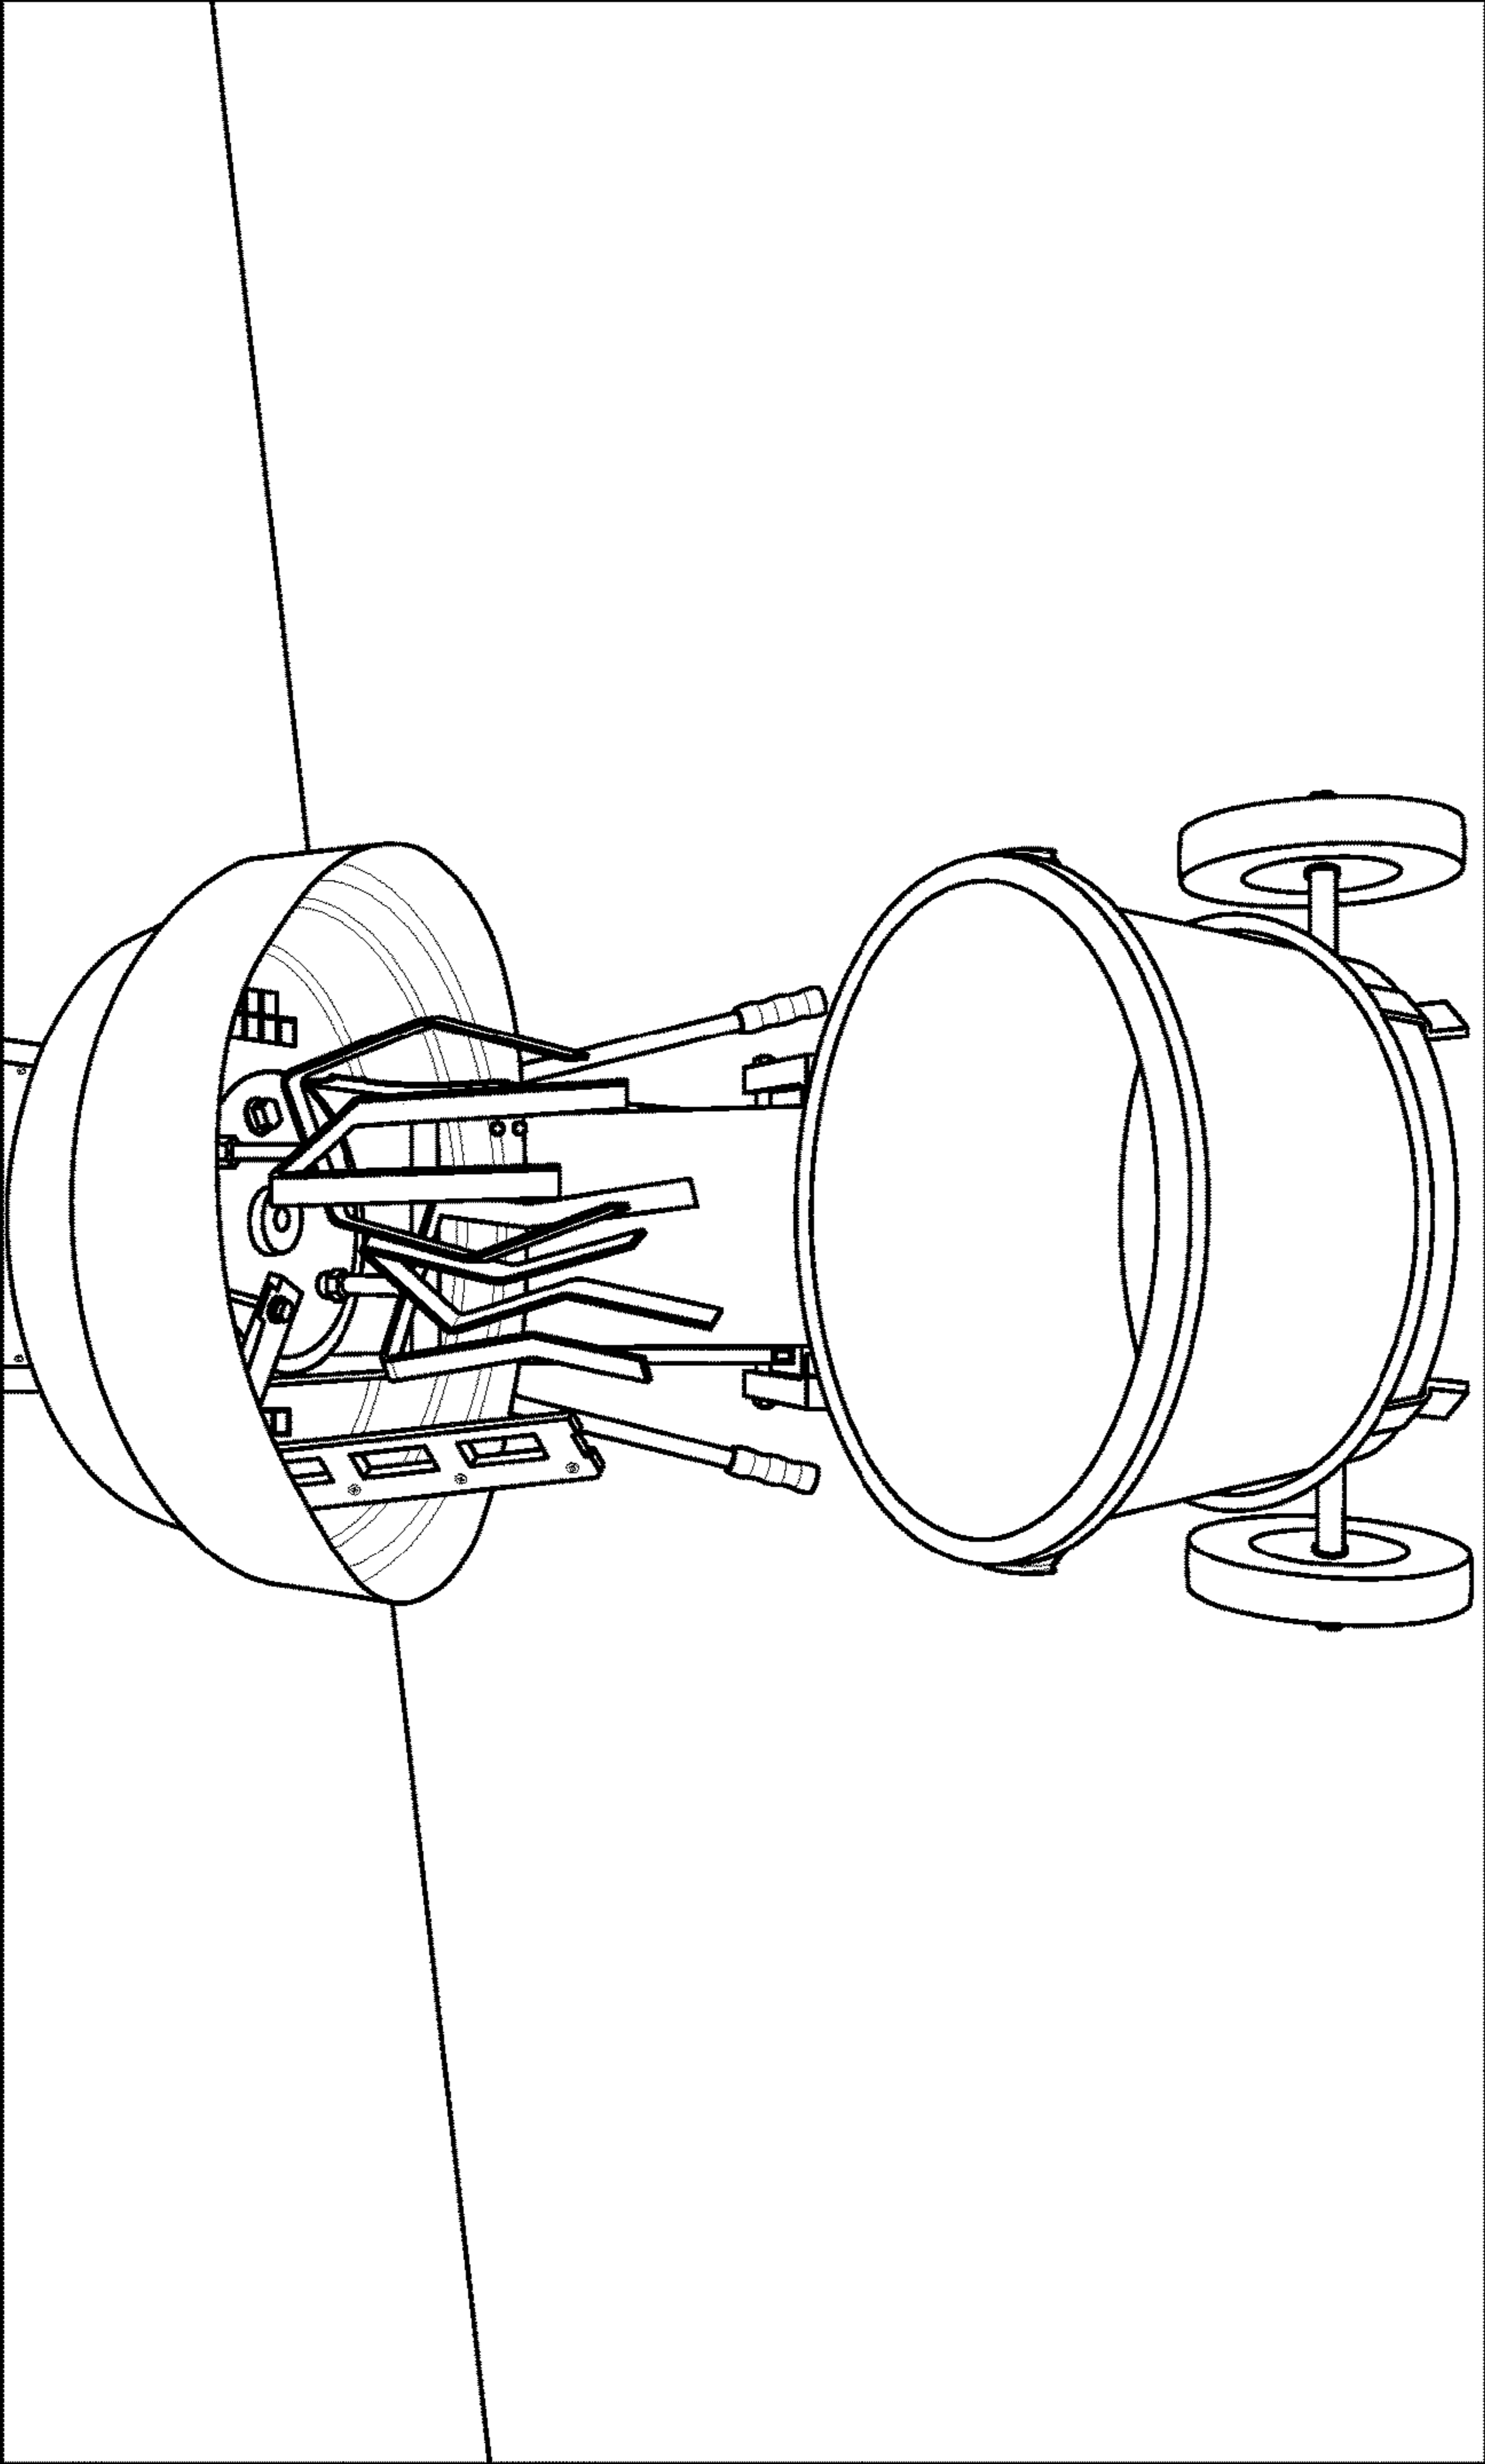
FIG. 22 depicts a mixer for use in mixing resin and aggregate utilized in surface repair according to an embodiment of the present disclosure;
