US010329719B1

(12) **United States Patent**
Giles

(54) **COMPOSITION AND METHOD FOR SURFACE REPAIR**

(57) **ABSTRACT**

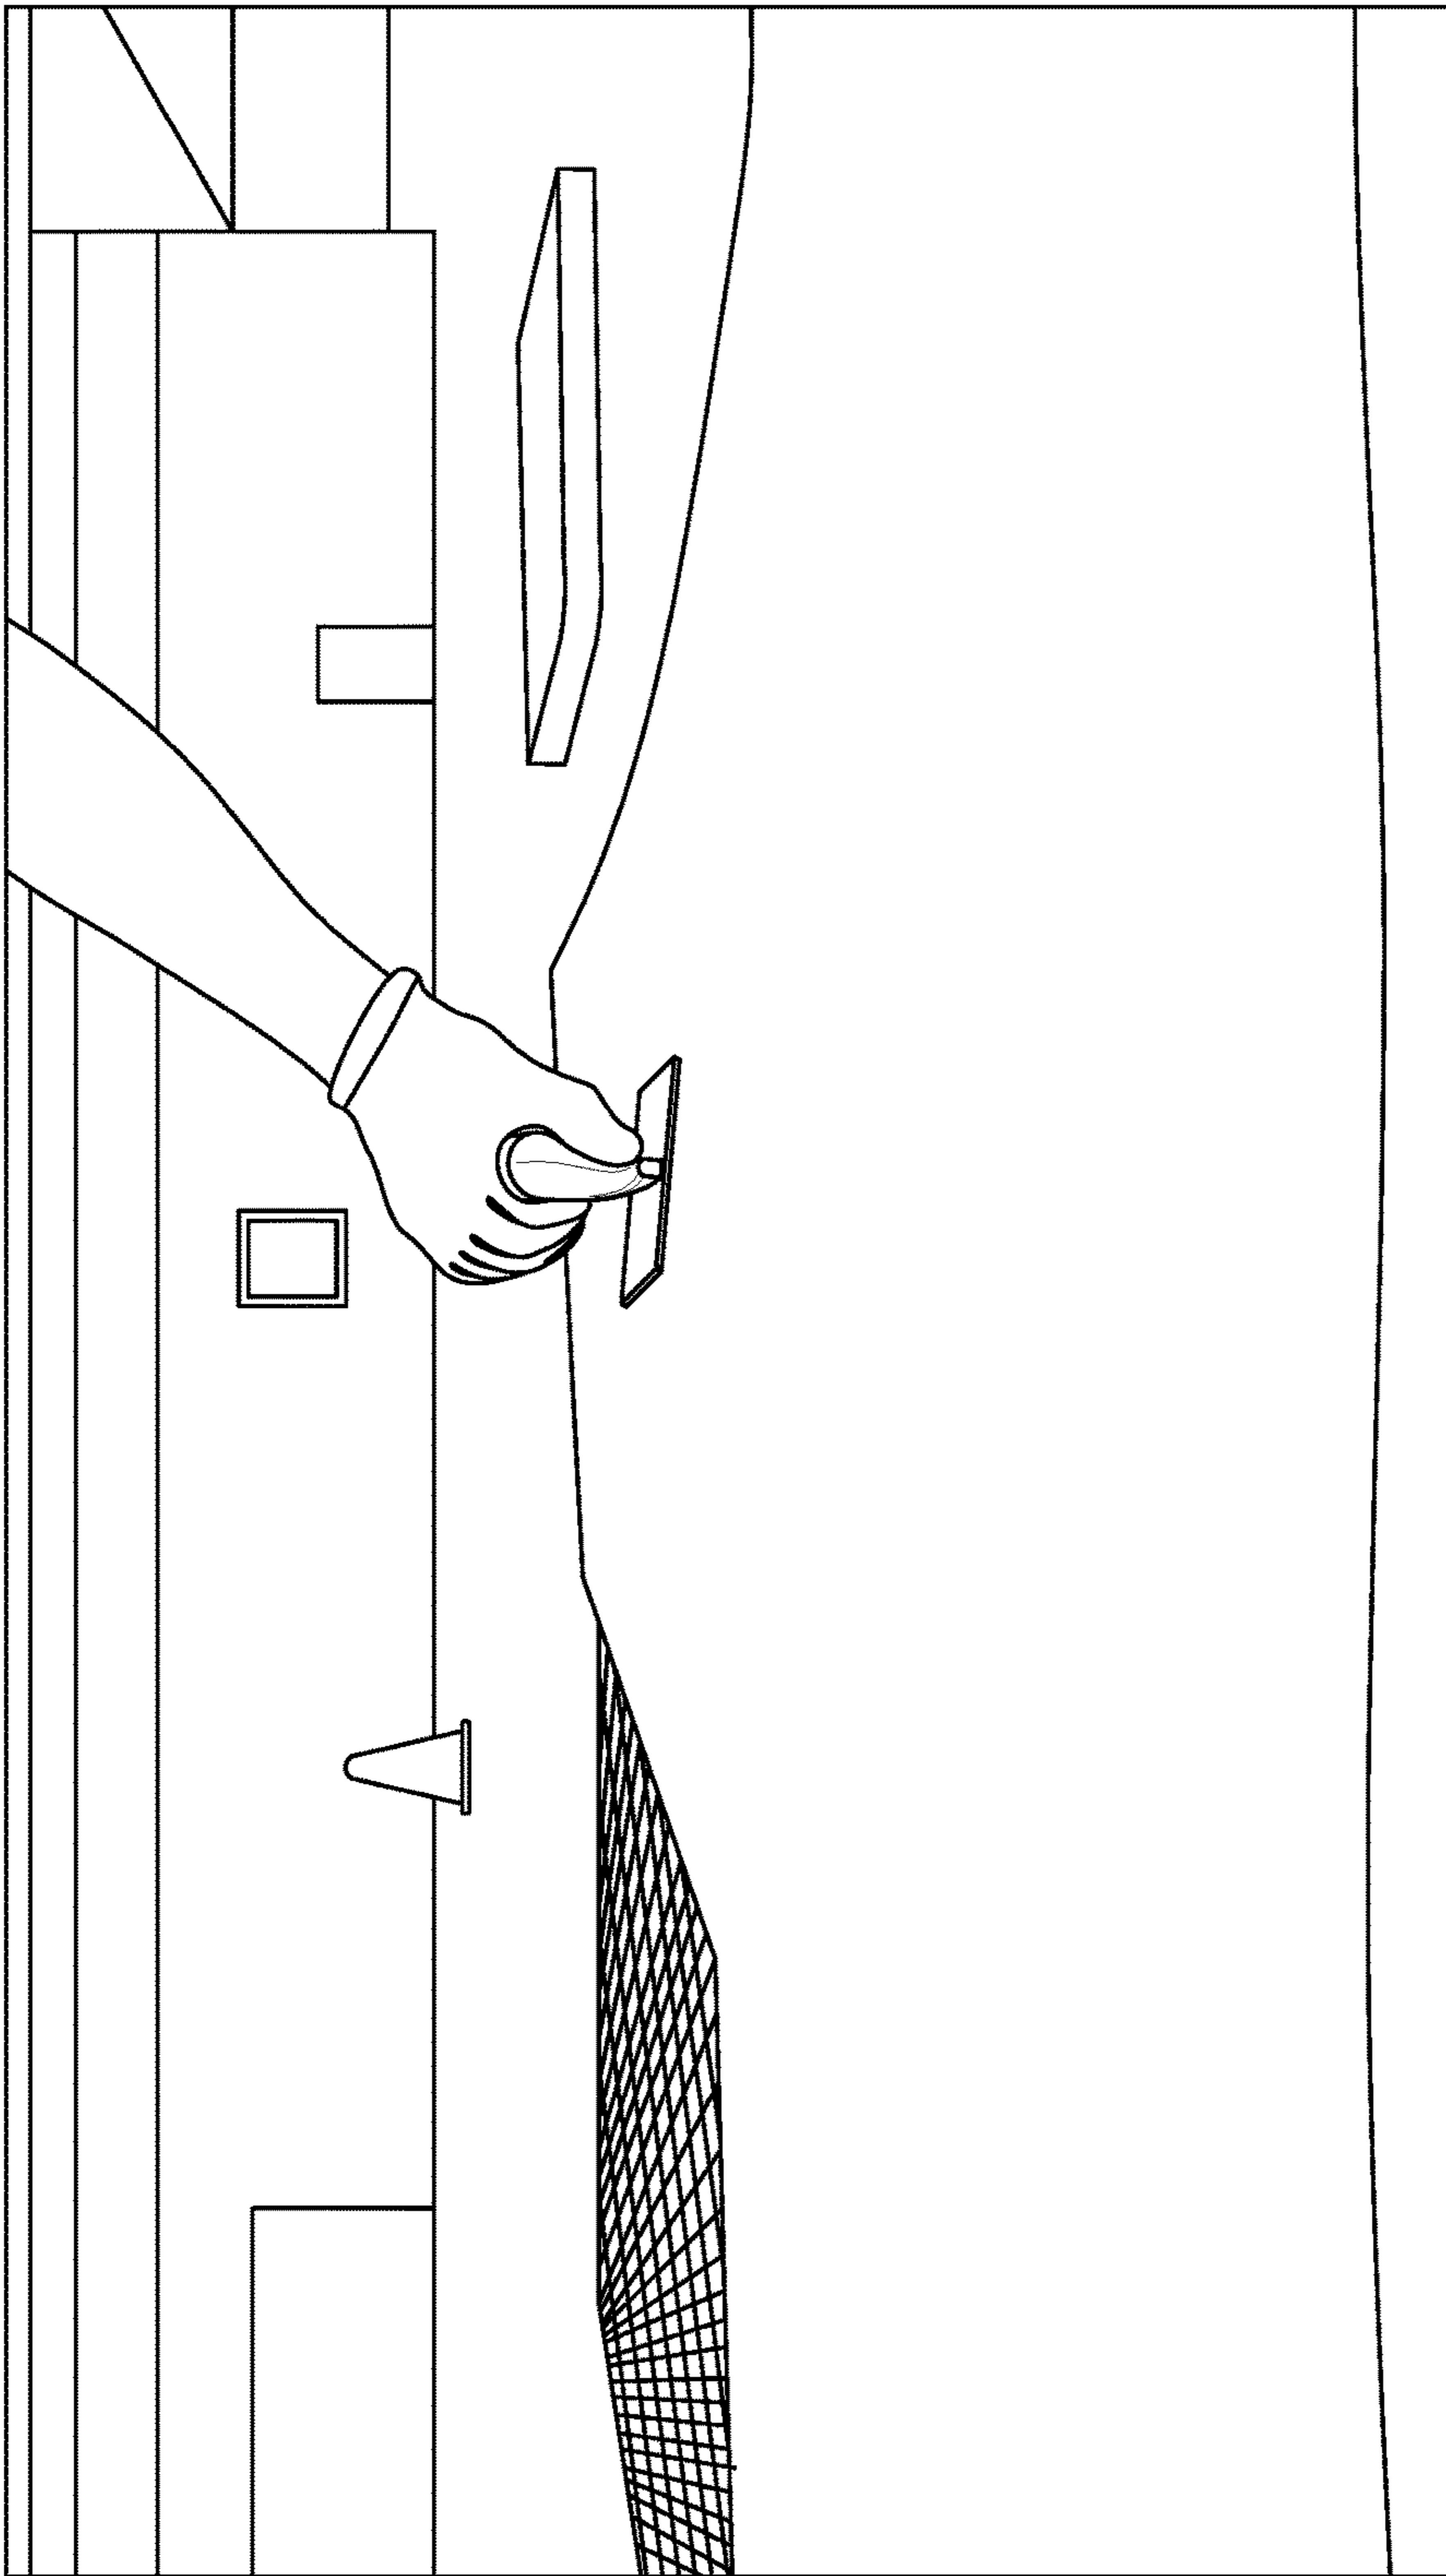
FIG. 23 depicts a process for finishing a repair to a damaged surface according to an embodiment of the present disclosure;

Referring now to FIG. **9**, there is depicted a metal cover **500** installed over a utility access tunnel. Surrounding the cover **500** is a concrete apron **502**. As can be seen, the apron **502** is damaged and includes cracks, pits and voids. A process of repairing the apron **502** is as follows. First, the apron **502** is cleared of debris. Next, as shown in FIG. **21**, a grinder is used to remove rough edges and loose edges on the apron **502**. Next, a protective overlay and composite material **504** is installed onto the apron **502** to effectuate the repair. In an embodiment, the protective overlay material **504** is mixed in a mixer as shown in FIG. **22** and then placed onto the damaged surface of the apron **502**. The material **504** is then finished by using a hand trowel as shown in FIG. **23**. The repaired apron **502** is shown in FIG. **10**.

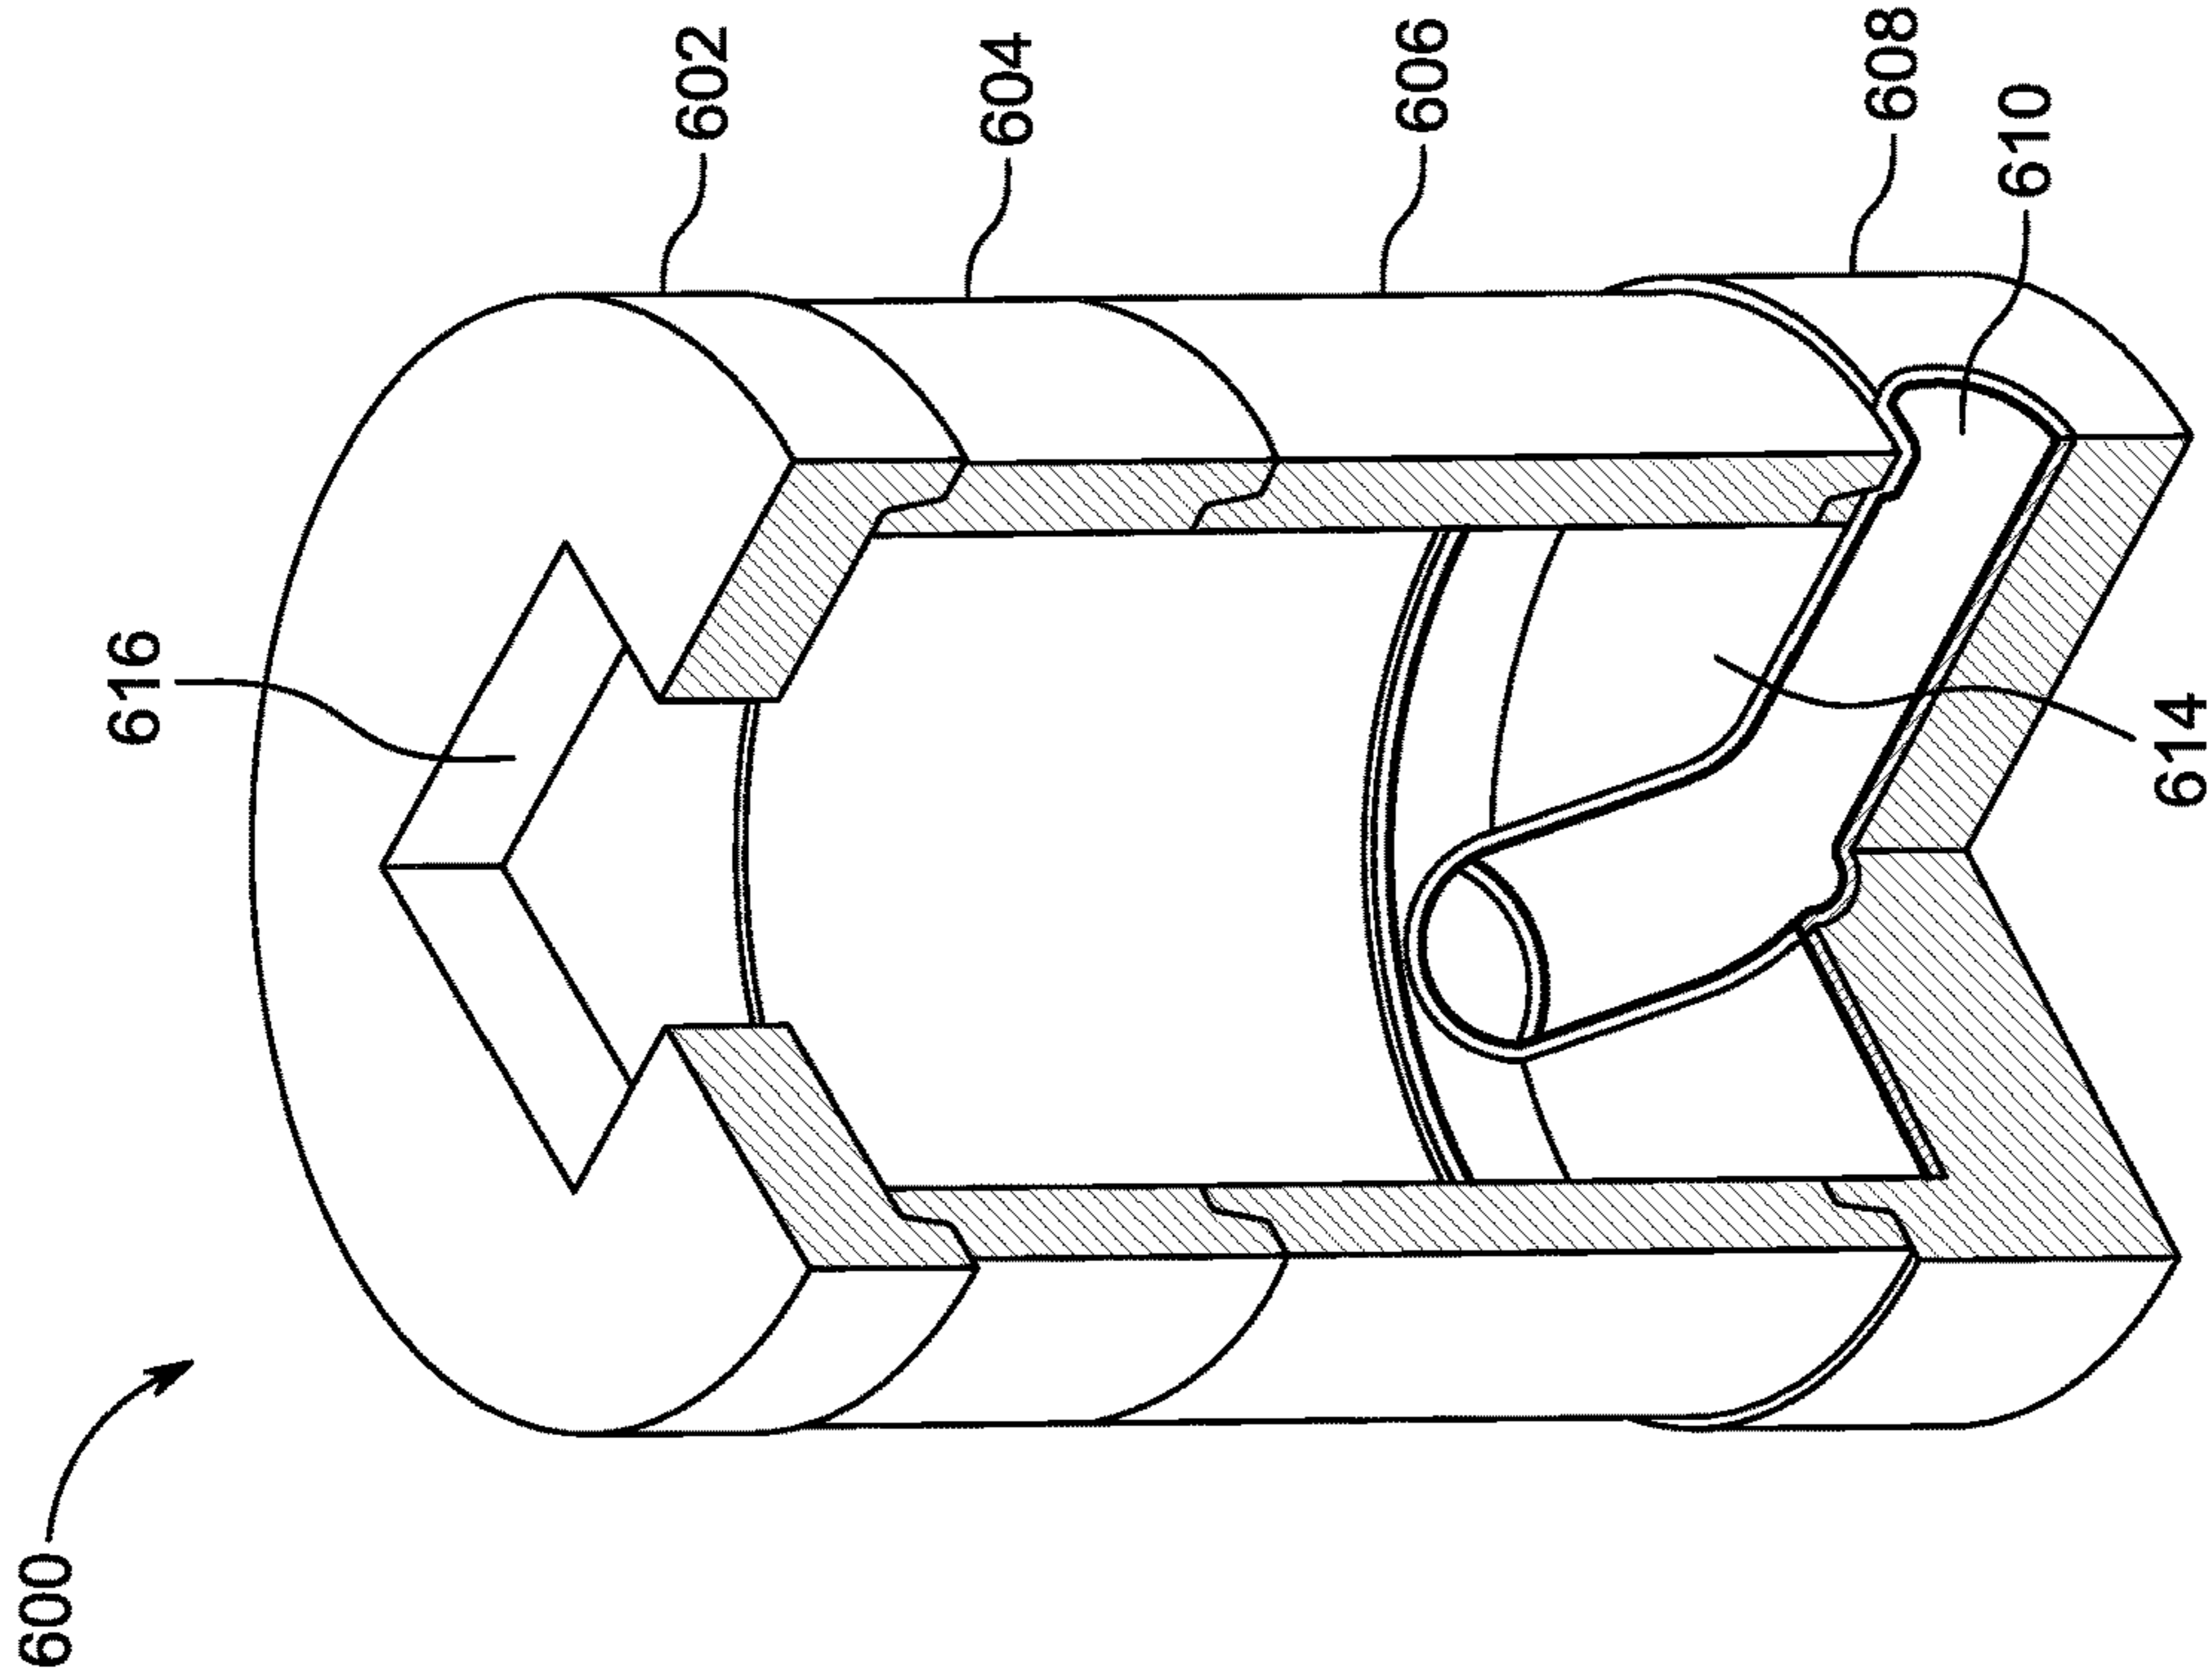
FIG. 24 depicts a manhole assembly having a damaged inner surface; and

Referring now to FIG. 24, there is depicted a manhole vault assembly 600. The assembly 600 comprises a cap 602, mid-risers 604 and 606, and a base member 608. In an embodiment, the manhole vault assembly 600 is formed of concrete. The assembly 600 may be buried underground and provide access to a sewage system through an opening formed in the cap 602. In particular, the base member 608 may include a trough 610 for directing sewage as is known to one having ordinary skill in the art. As can be observed, an inner surface 612 of the base member 608 may include damaged portions in the nature of pitting and corrosion caused by the toxic sewer gases.

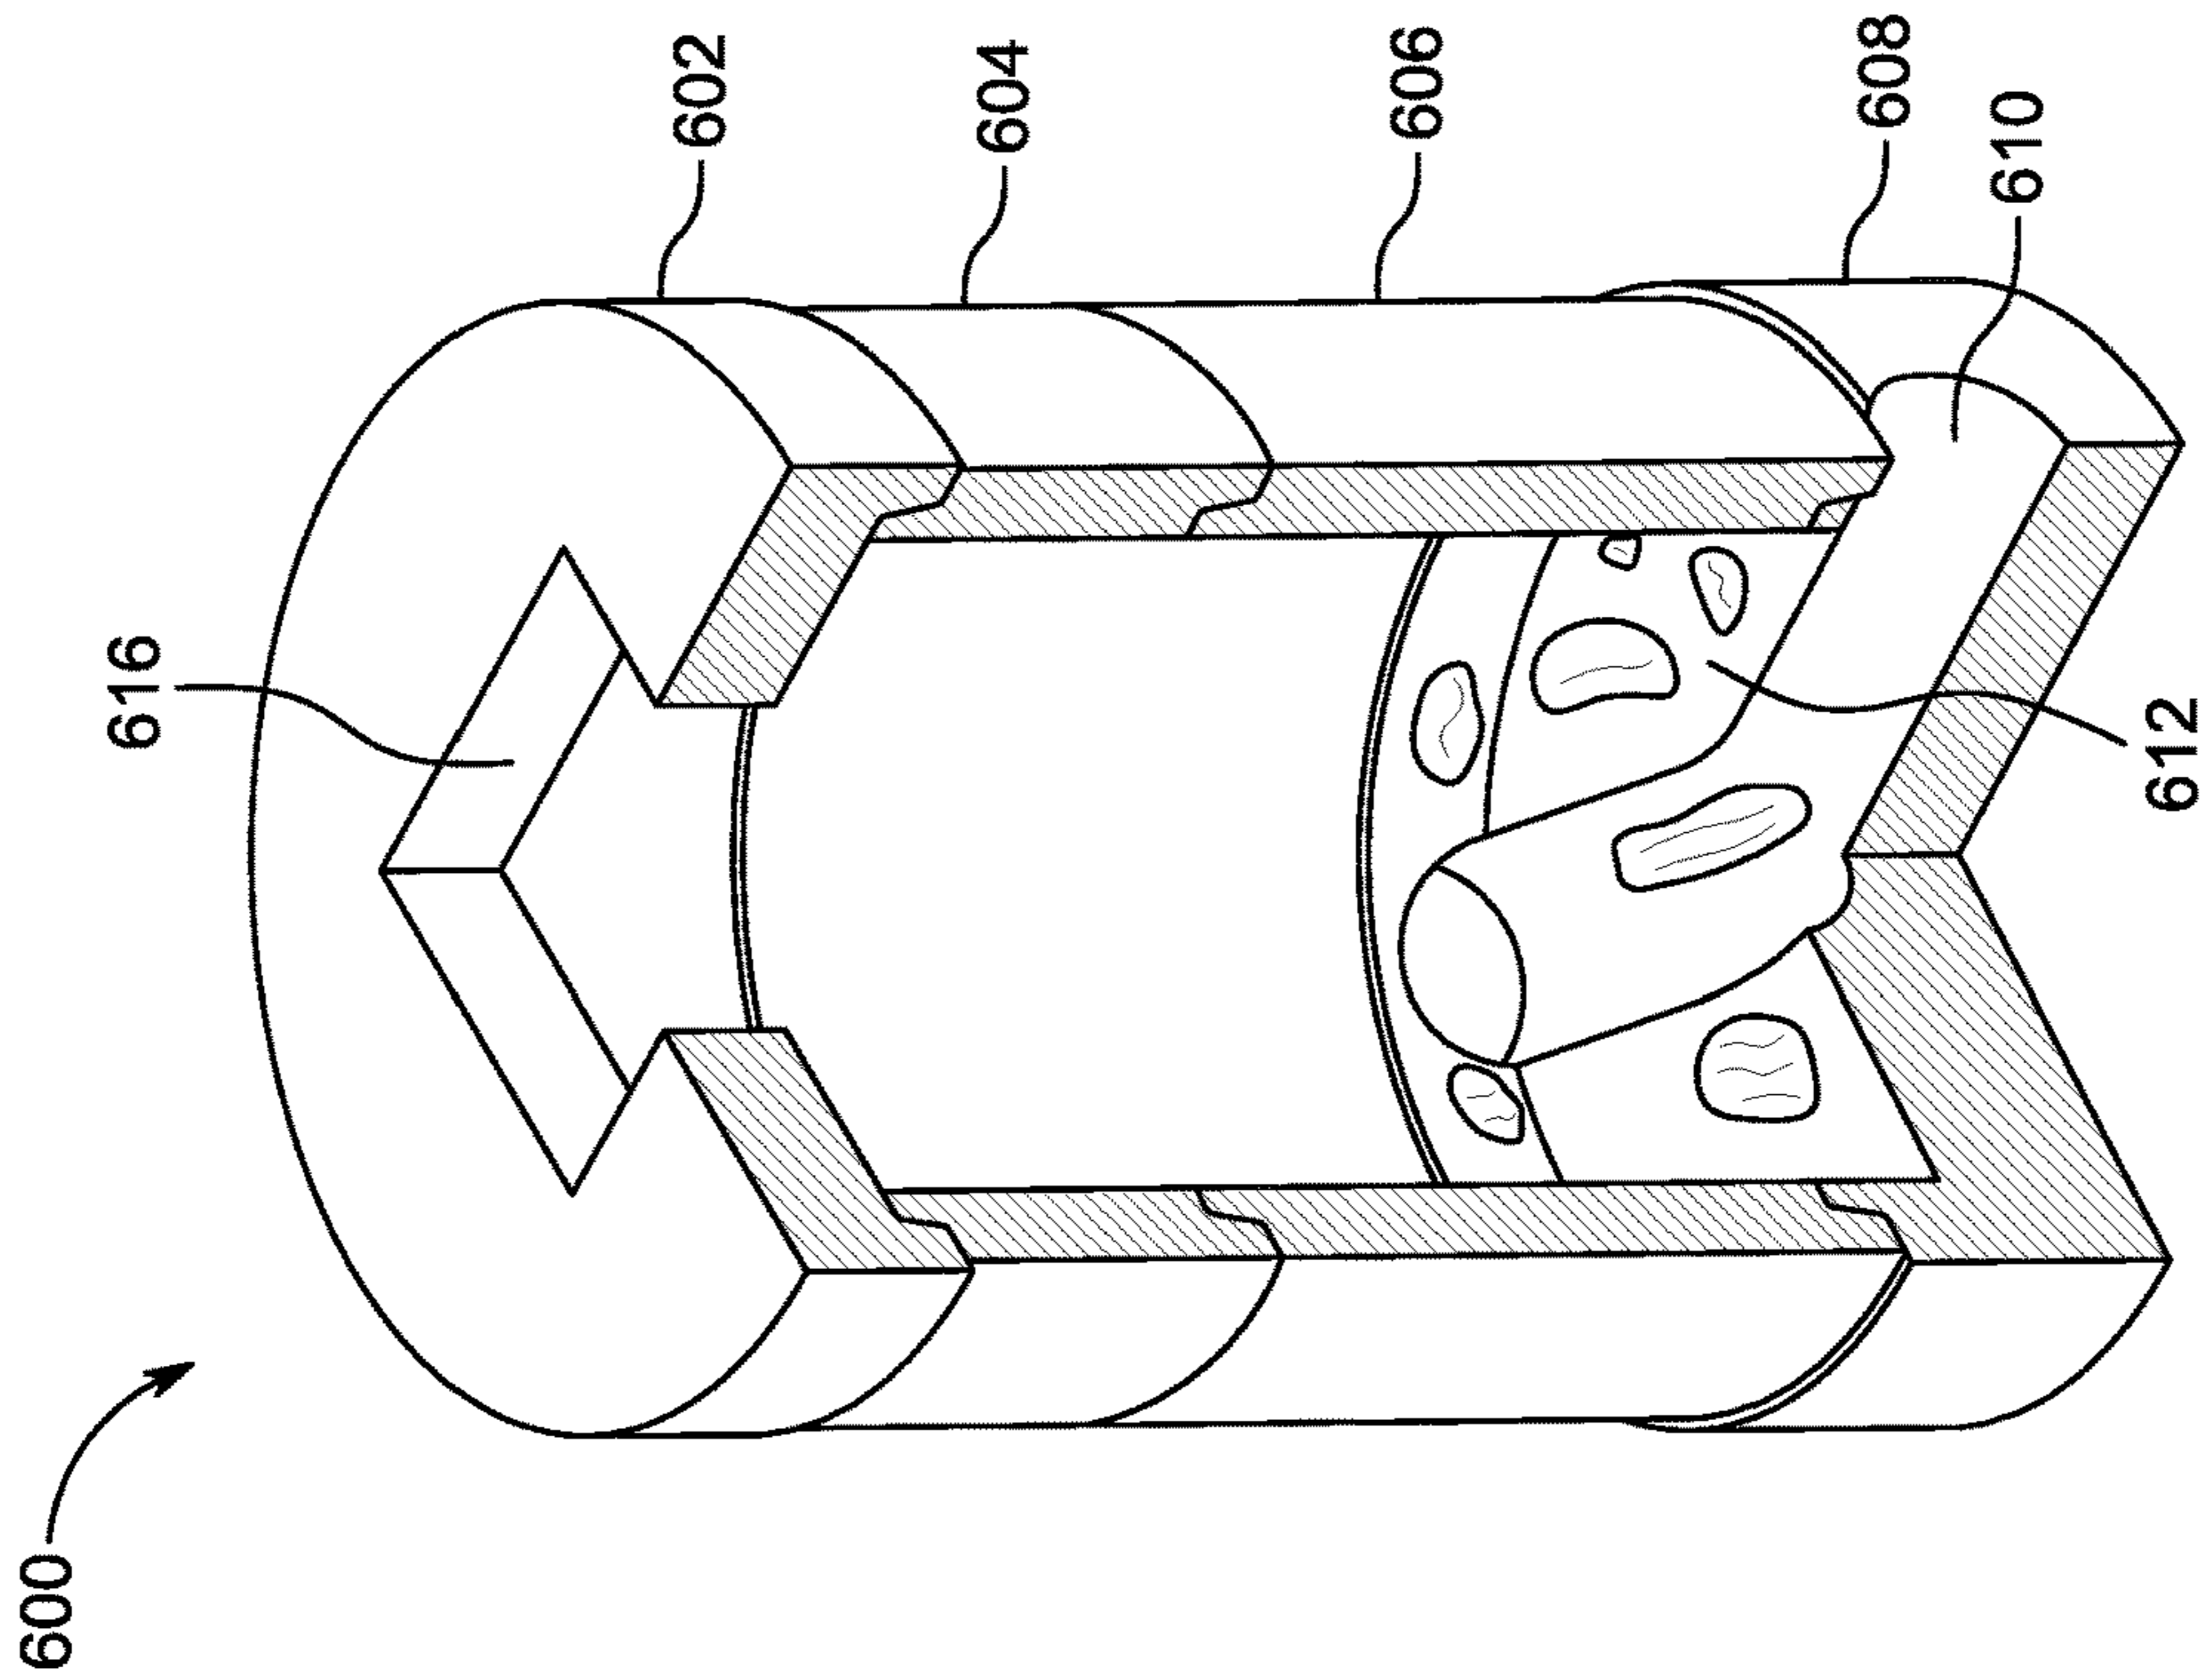
FIG. 25 depicts the manhole assembly of FIG. 24 after repairs according to an embodiment of the present disclosure.

A process of repairing the inner surface 612 of the base member 608 is as follows. First, the inner surface 612 is cleared of debris. Next, as illustratively shown in FIG. 21, a grinder is used to remove rough edges and loose edges on the inner surface 612. Next, a protective overlay and composite material 614 is installed onto the inner surface 612 to effectuate the repair. In an embodiment, the protective overlay material 614 is mixed in a mixer as shown in FIG. 22 and then placed onto the inner surface 612. The material 614 is then finished by using a hand trowel as illustratively shown in FIG. 23. The repaired inner surface of the base member 608 is shown in FIG. 25.
