(10) **Patent No.:** **US 10,402,957 B2**
(45) **Date of Patent:** **Sep. 3, 2019**

- (54) **EXAMINING DEFECTS**
- (71) Applicant: **PRE-CHASM RESEARCH LIMITED**, Hale Cheshire (GB)
- (72) Inventor: **Anthony Rhoades**, Cheshire (GB)
- (73) Assignee: **Pre-Chasm Research Limited**, Cheshire (GB)
- (*) Notice: Subject to any disclaimer, the term of this patent is extended or adjusted under 35 U.S.C. 154(b) by 164 days.
- (21) Appl. No.: **15/311,394**
- (22) PCT Filed: **May 18, 2015**
- (86) PCT No.: **PCT/GB2015/051454**
§ 371 (c)(1),
(2) Date: **Nov. 15, 2016**
- (87) PCT Pub. No.: **WO2015/173594**
PCT Pub. Date: **Nov. 19, 2015**
- (65) **Prior Publication Data**
US 2017/0084015 A1 Mar. 23, 2017
- (30) **Foreign Application Priority Data**
May 16, 2014 (GB) 1408757.1
- (51) **Int. Cl.**
G06T 7/00 (2017.01)
H04N 1/00 (2006.01)
- (52) **U.S. Cl.**
CPC **G06T 7/0002** (2013.01); **H04N 1/00307** (2013.01); **G06K 2209/19** (2013.01); **G06T 2207/10004** (2013.01)

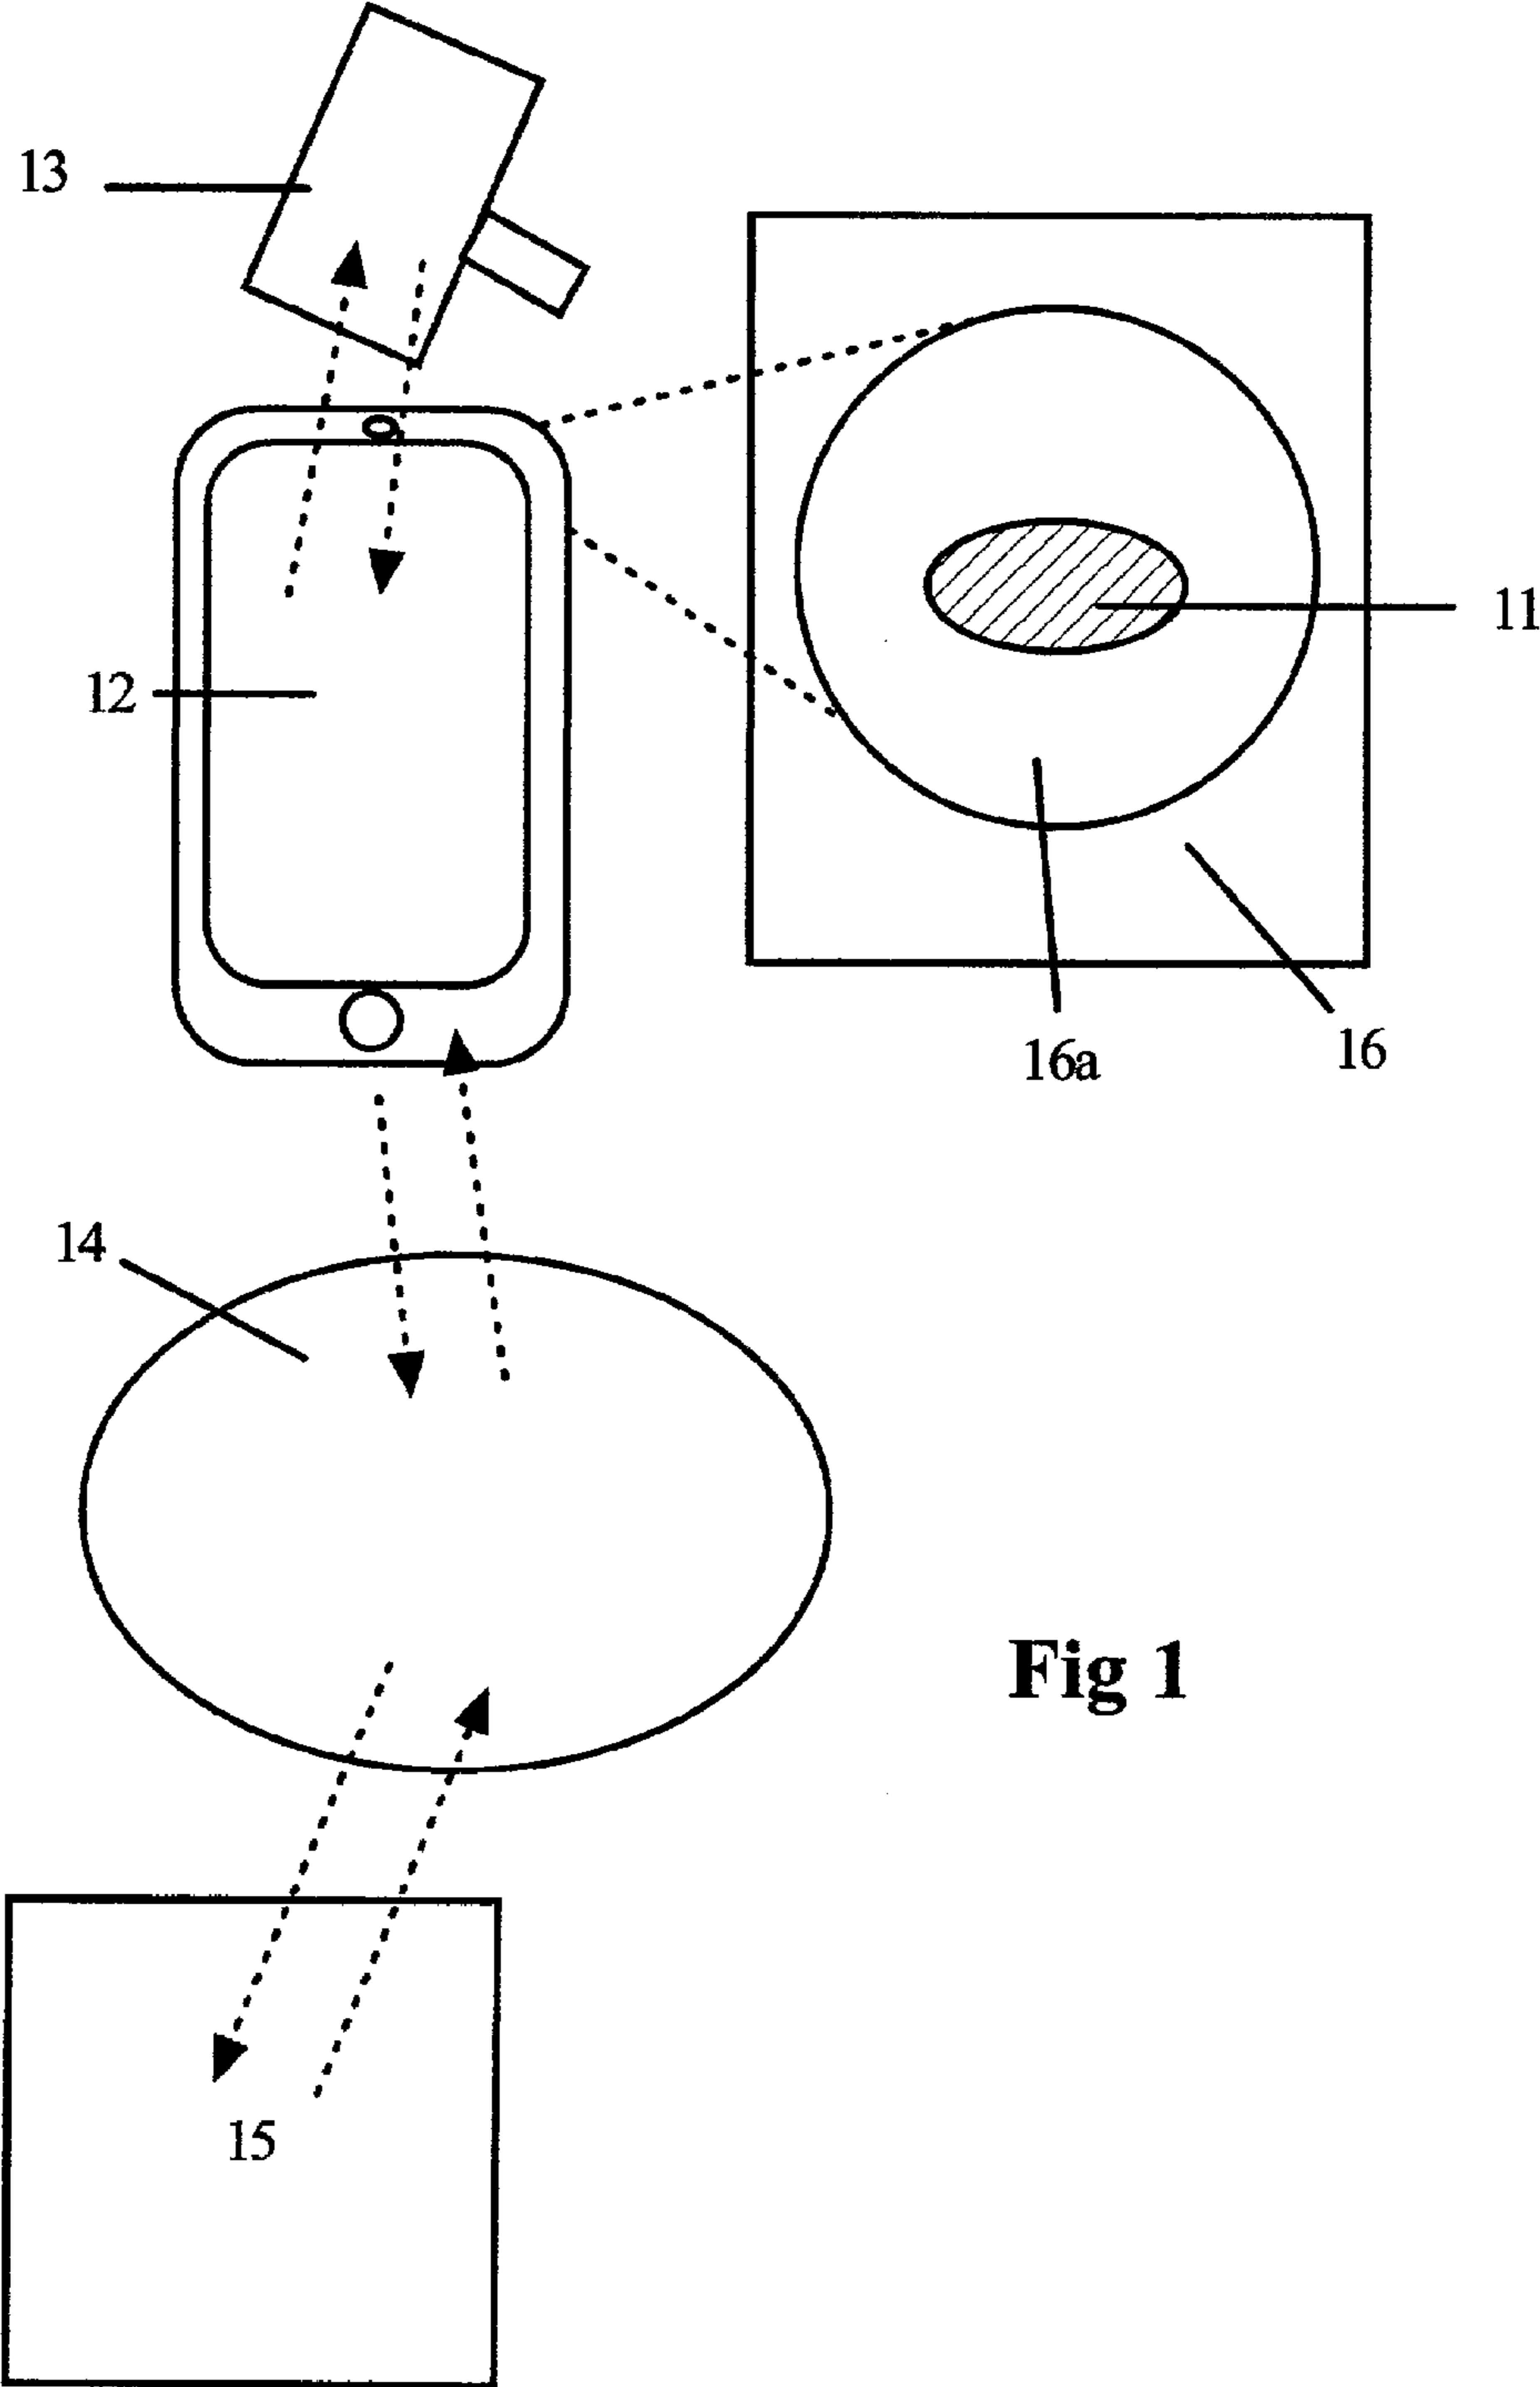
Fig 1

FIG. 1 is a diagrammatic representation of apparatus used in the analysis;

The drawings illustrate apparatus used in a method of imaging and analysing a vehicle windscreen defect **11** comprising analysing a digital image of the defect **11** on a portable device **12** using software contained in the device **12** by virtue of a downloaded app.

The device **12** comprises a smartphone, which already has all the imaging, storage and processing power needed, and has the advantage that many people, and particularly many drivers and vehicle owners already possess one and need not purchase specialised equipment.

The smartphone **12** is used to form the image using a built-in camera, of which there are usually two, or may be used in conjunction with a near field communication equipped digital camera **13**, which can form the image and transfer it to the smartphone **12**.

The smartphone **12** comprises data processing facility, by virtue of an app that carries out the analysis, but it may have just rudimentary functionality in capturing the image, trans-

ferring the image via the internet **14** to an external processor **15** for analysis and recording, and such external processor **15** will copy the result of such analysis to the smartphone **11**.

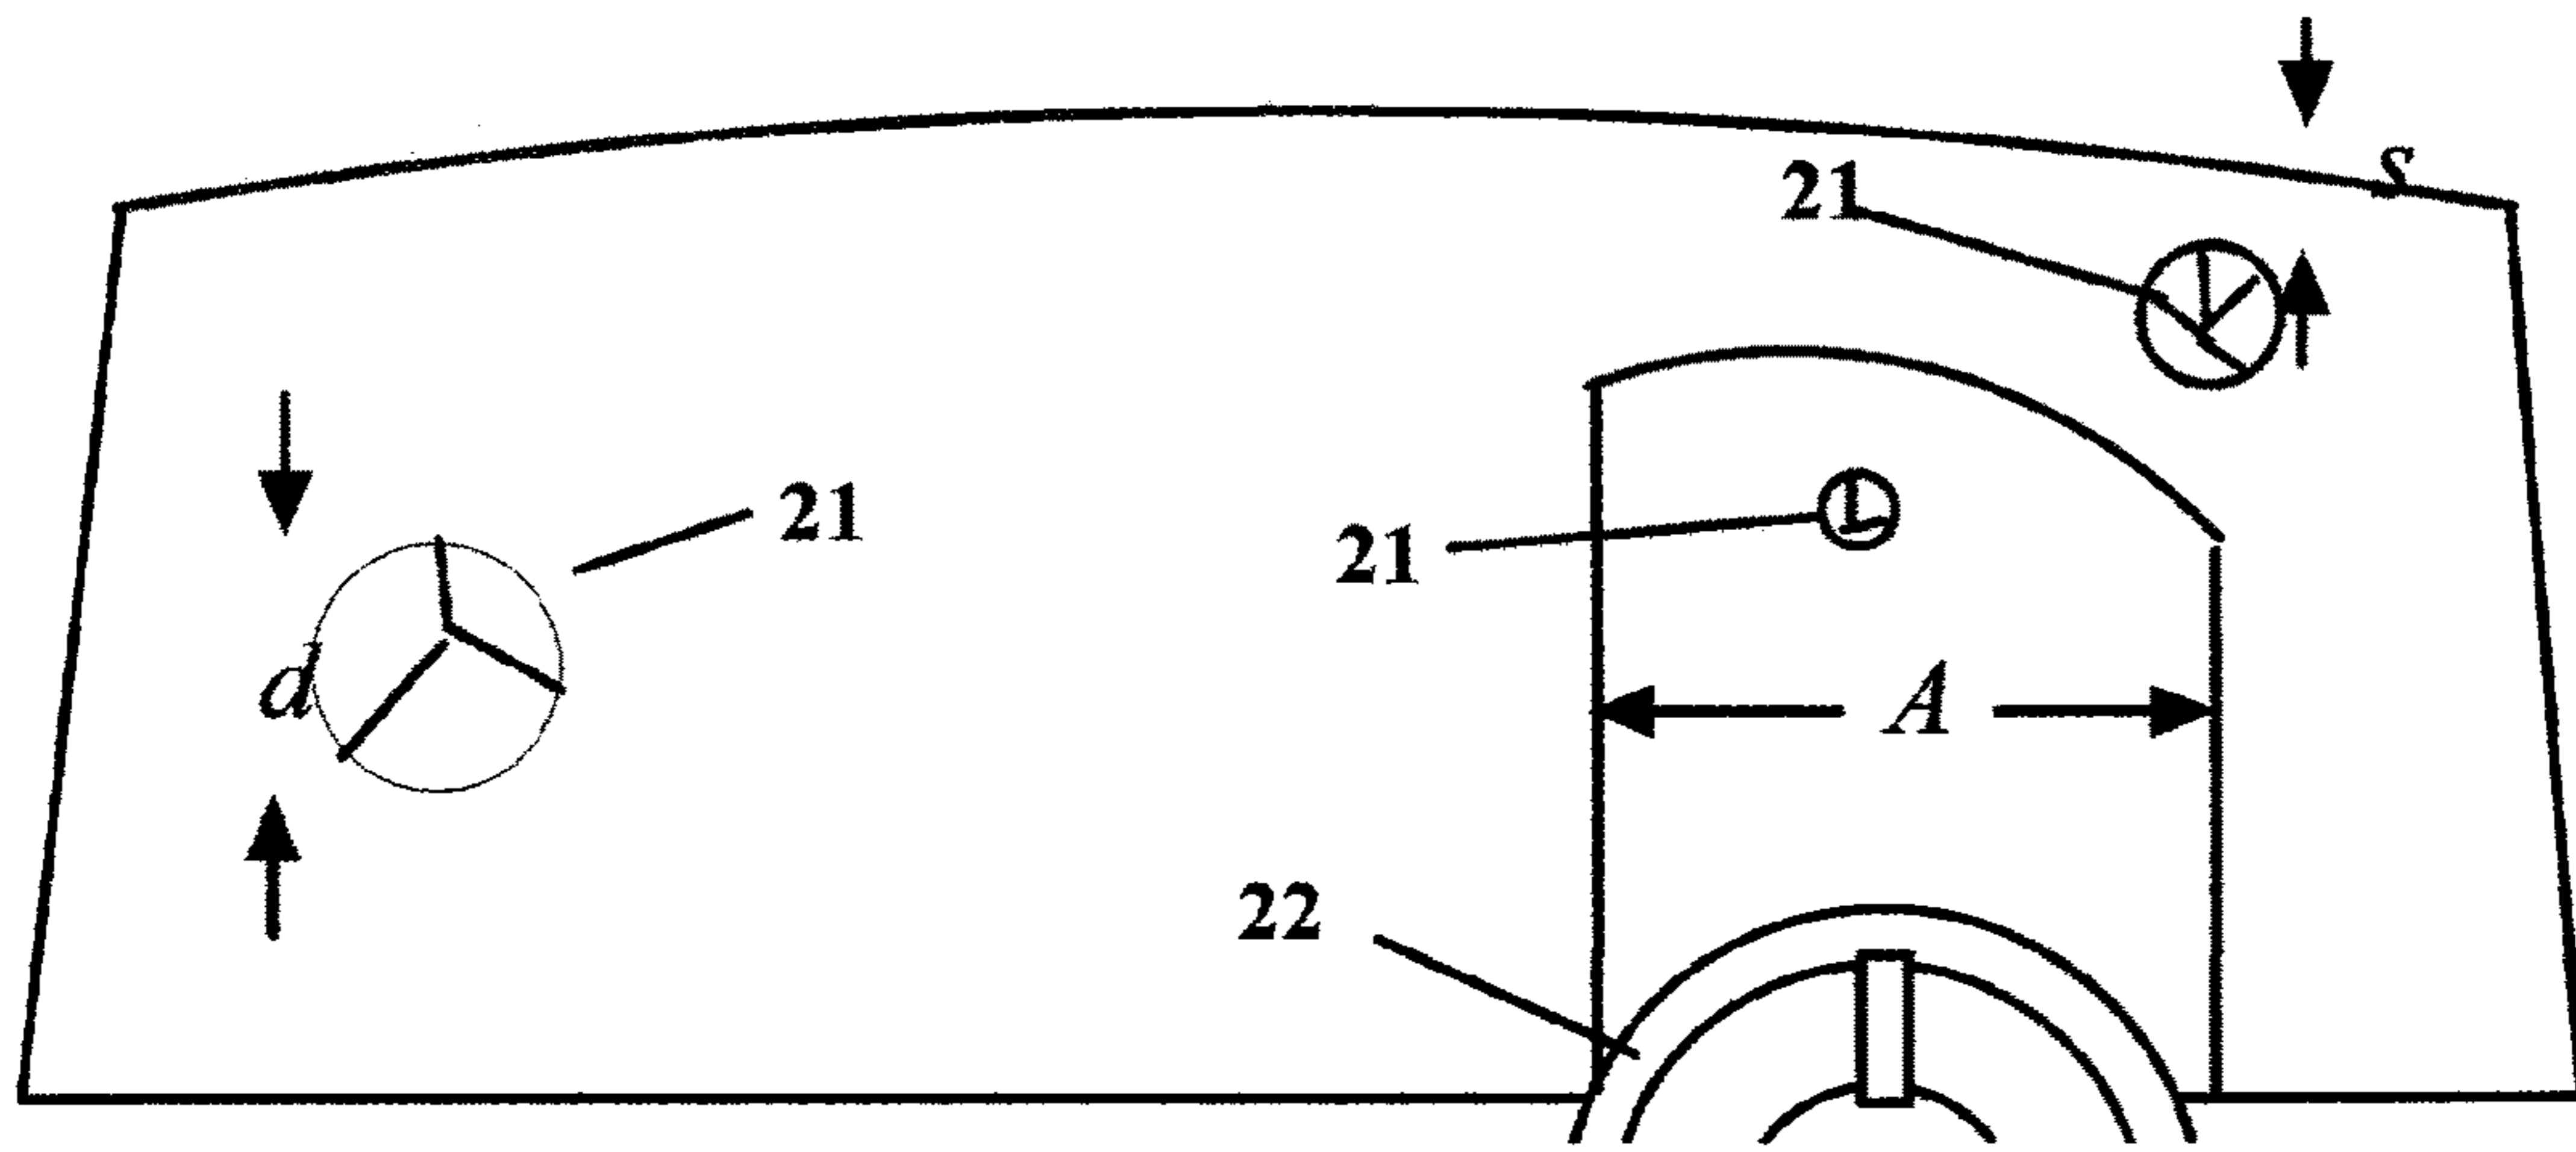
Fig 2

FIG. 2 is a view of a vehicle windscreen with chip defects;

The image analysis will, in the case of a chip **21** (FIG. 2), first determine the diameter d of the smallest circle that can be placed around the chip to completely contain it. If d is larger than 28 mm, the software will decide that the chip cannot be repaired. If d is 28 mm or less, the image analysis will measure the distance between the circle and the edge of the screen. If this distance is less than 30 mm, the software will decide that the chip cannot be repaired.

Finally, the image analysis will determine if the chip **21** is within an area A 300 mm wide extending up the screen centred on the steering wheel **22**. This may require a second image including the steering wheel **22**. If it is, it will then be decided if the circle containing the chip **21** is more than 10 mm in diameter. If it is, the software will decide that the chip cannot be repaired.

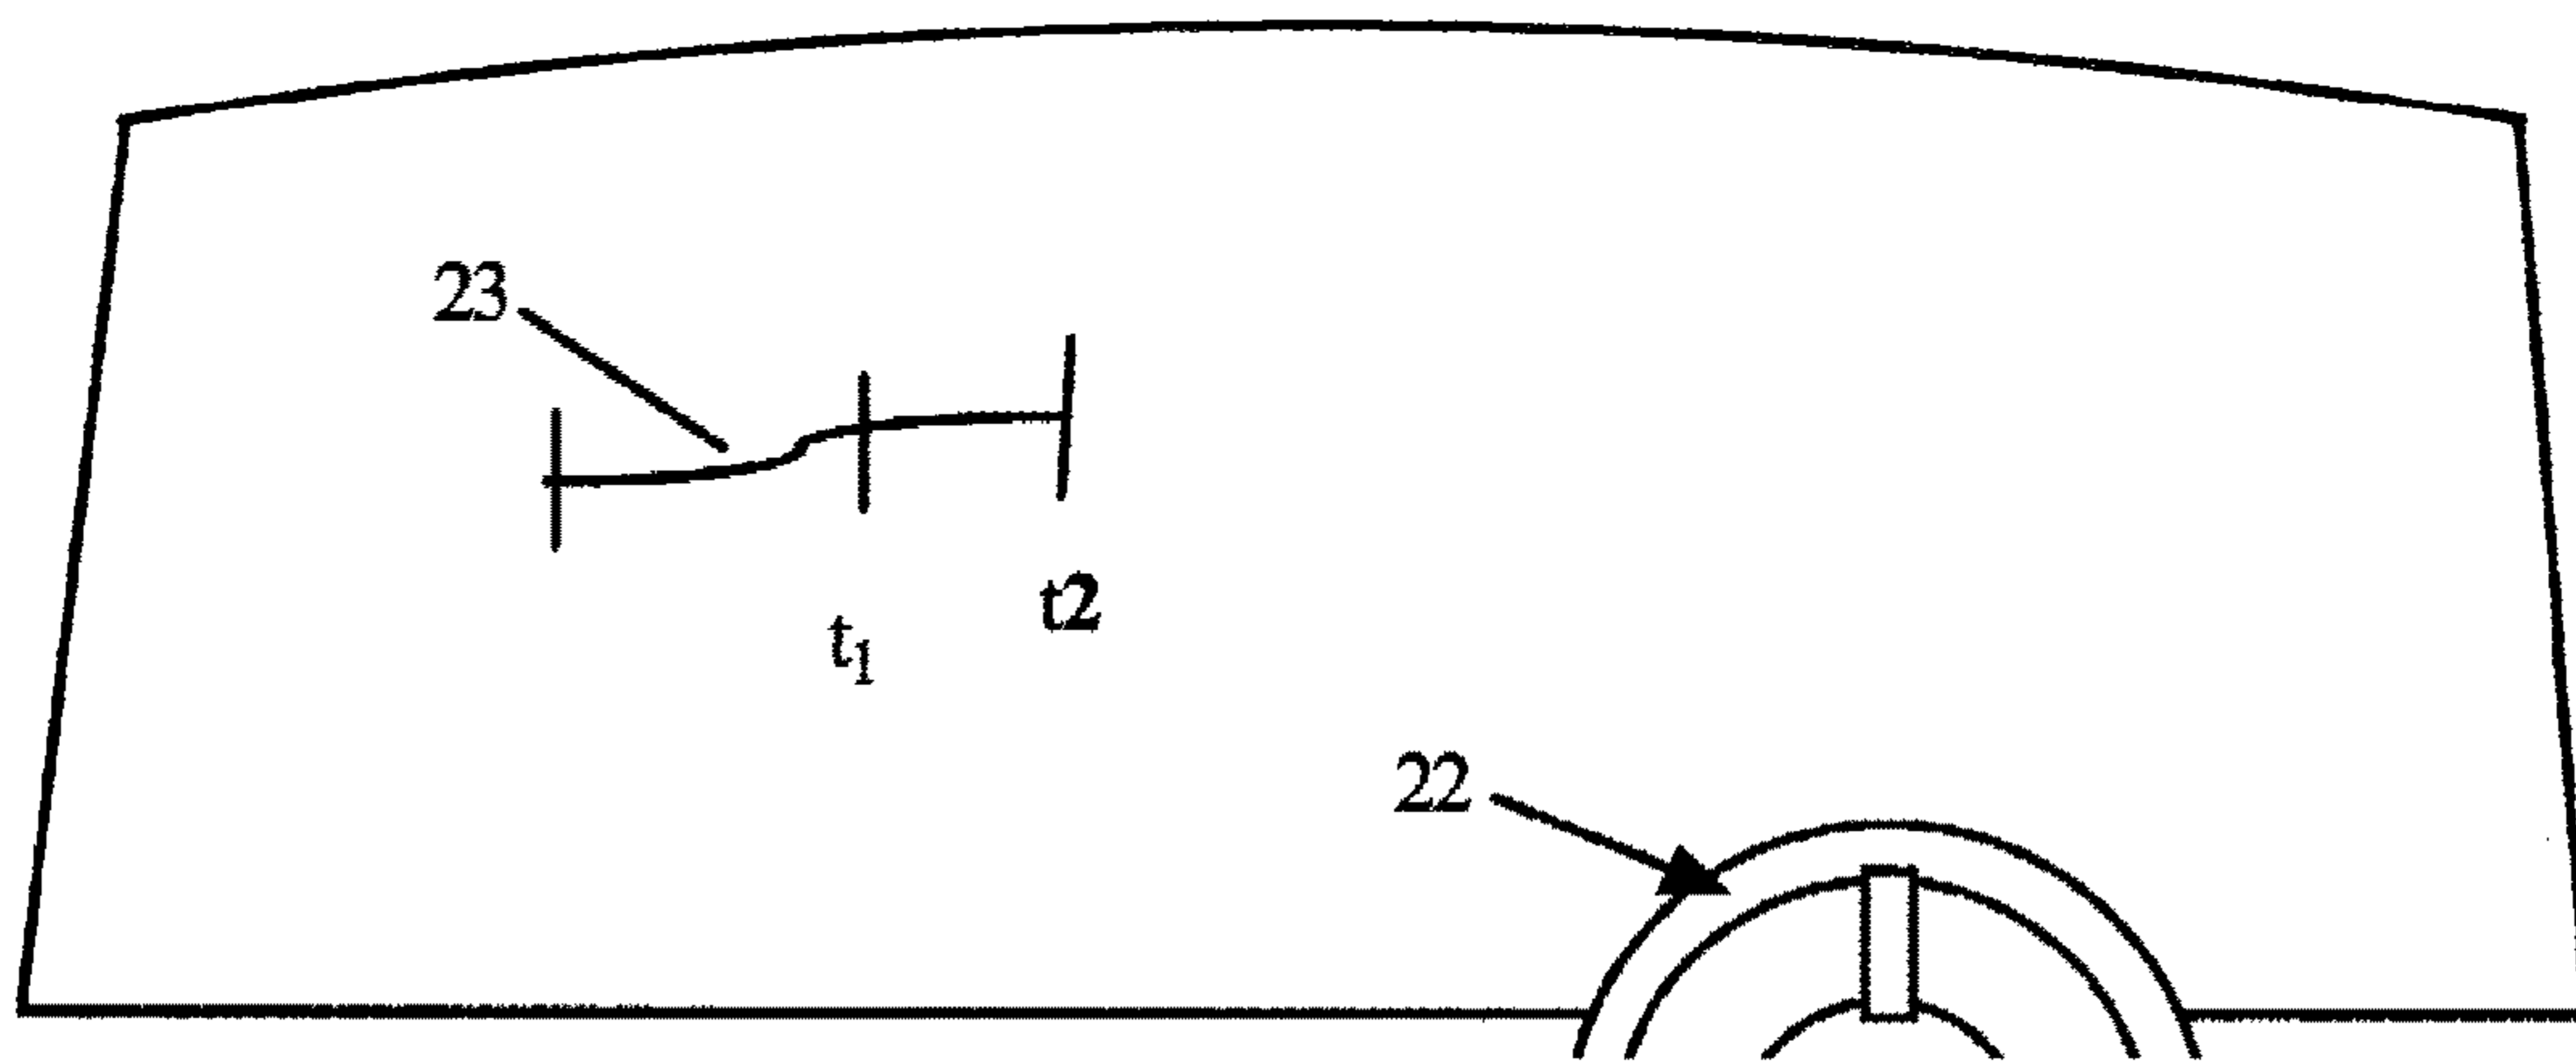
Fig 3

FIG. 3 is a view of a windscreen with a growing crack;

If the defect is a crack **23** (FIG. 3), rather than a chip, the image analysis may automatically switch to 'crack' mode, or the driver can select 'crack' from a crack or chip menu, and image the crack at a point t_1 in time. A second, later image, at time t_2 , can then be compared with the first and the rate of crack propagation determined, which may give a time-before-failure indication.

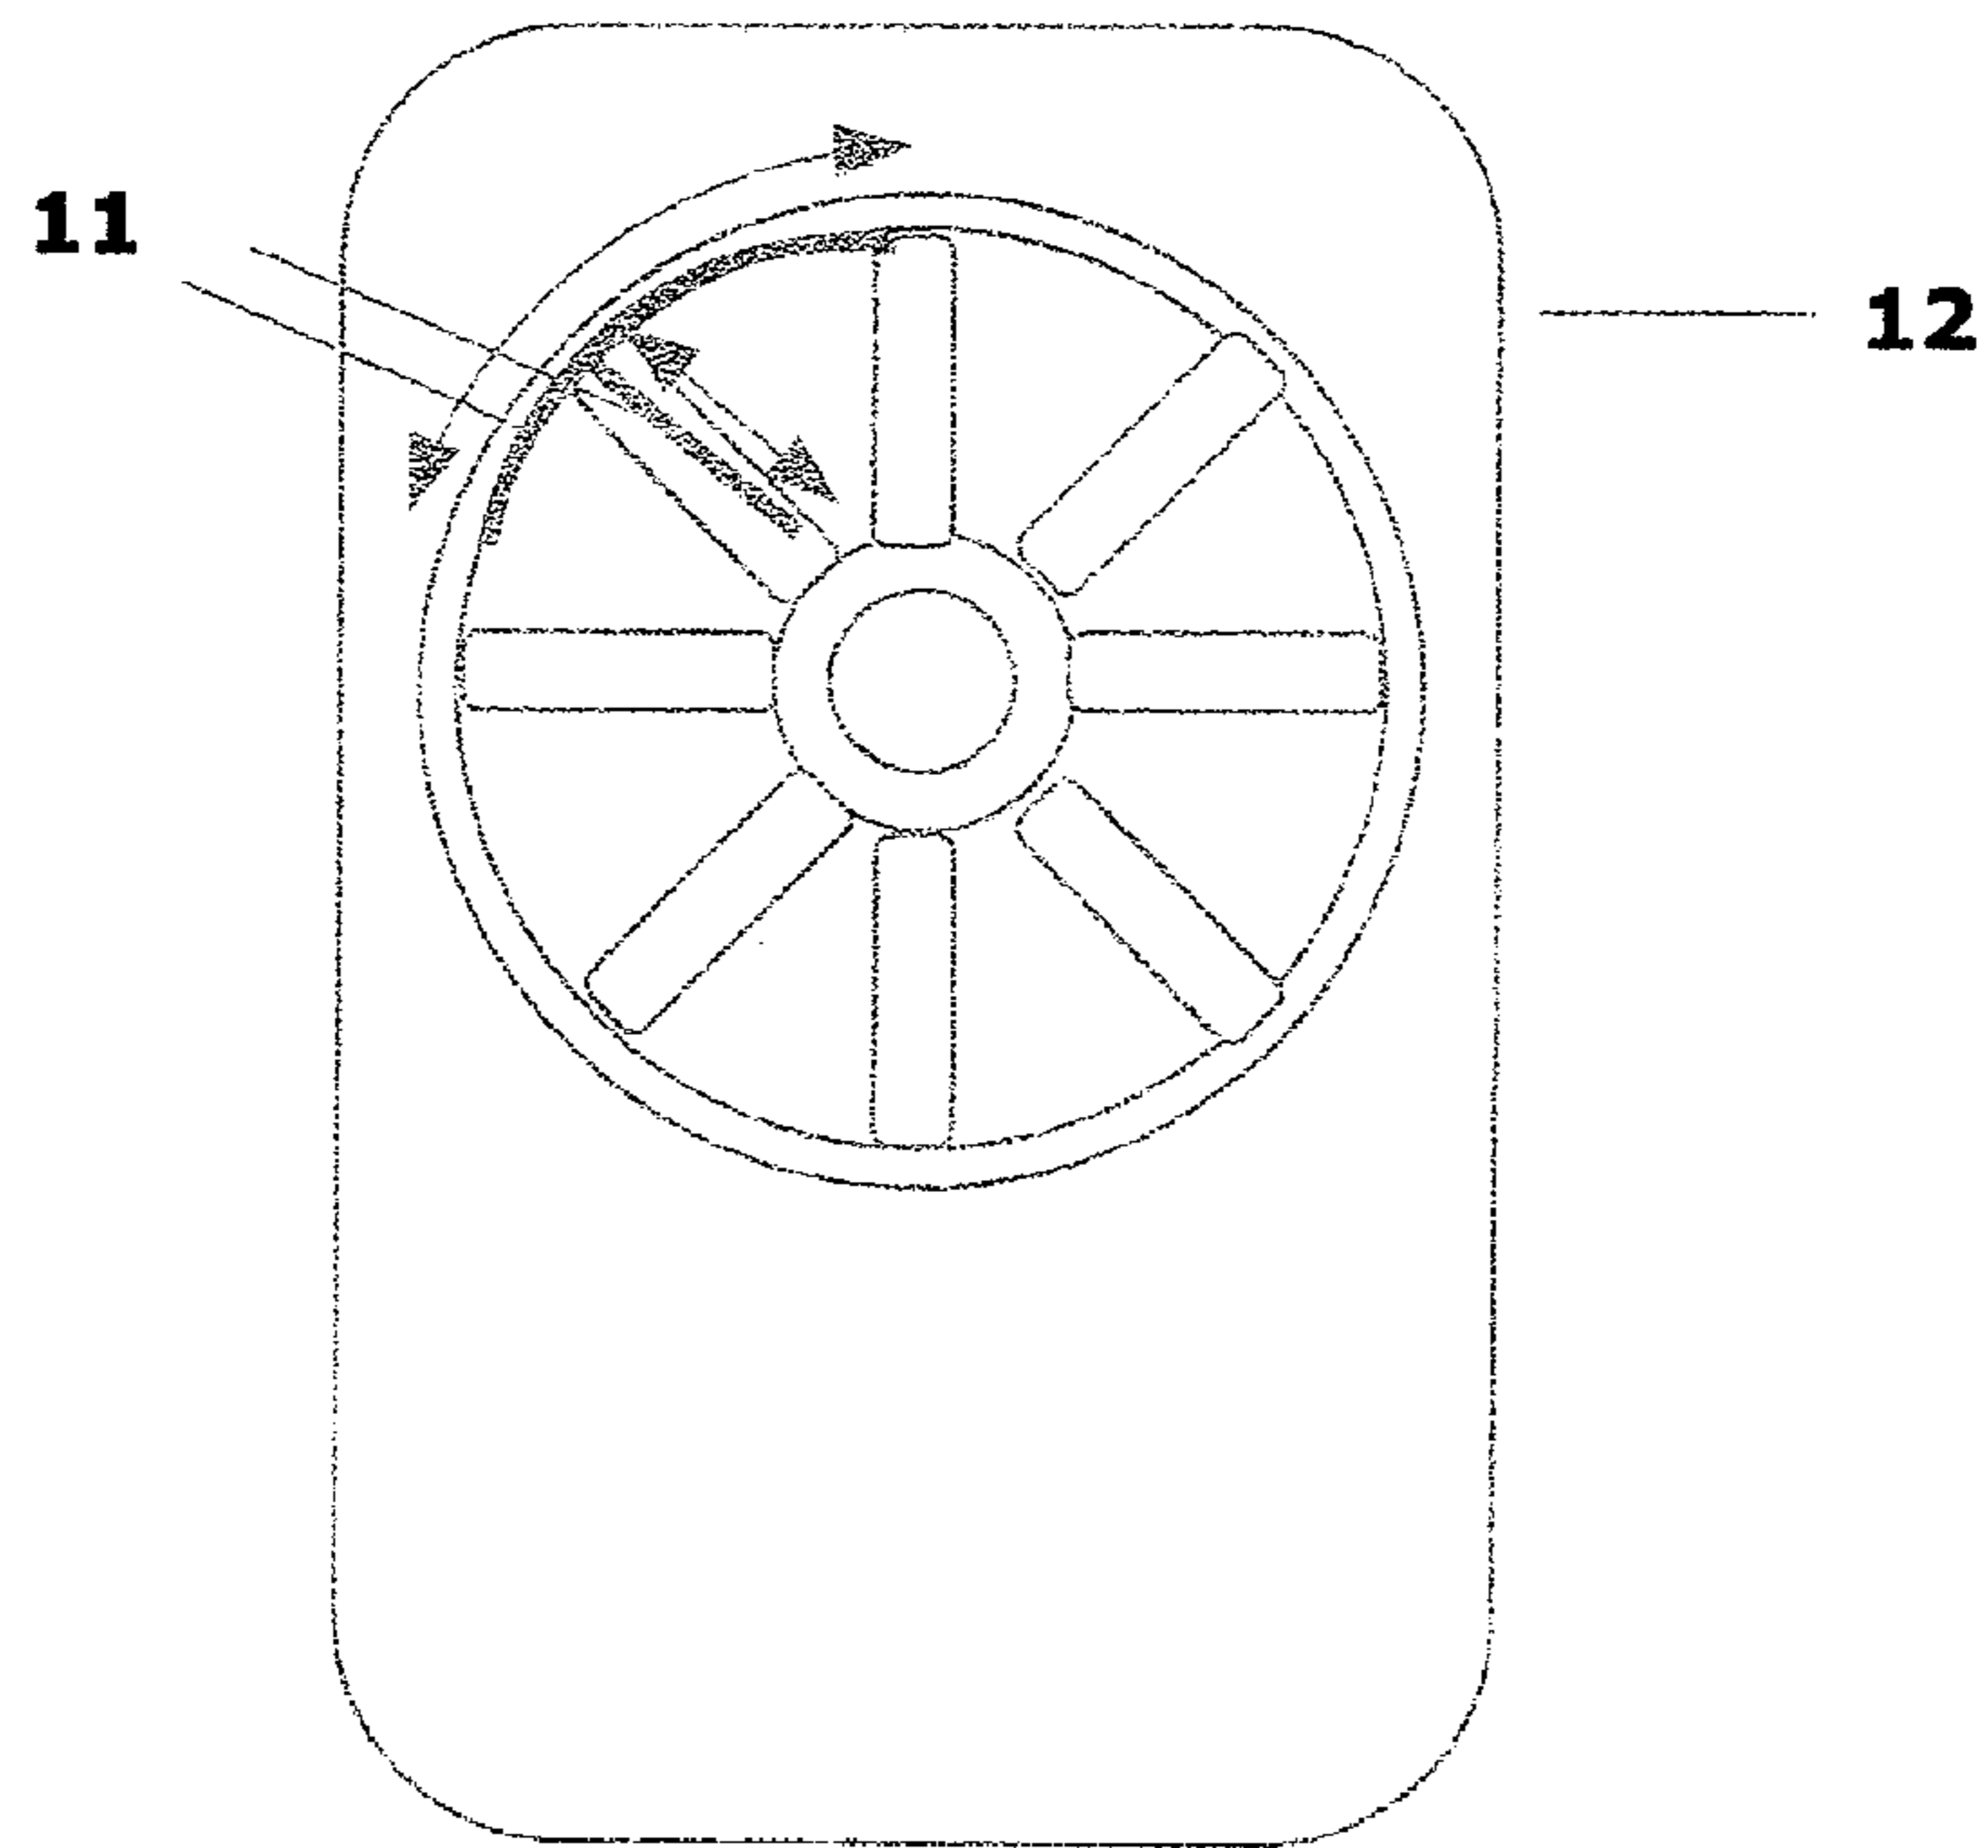
Fig 4

FIG. 4 is a view of a smartphone screen used in assessing an alloy wheel scuff.

To facilitate sizing the defect, the smartphone may first image an object of known size, such as a coin, placed next to the defect. For sizing an alloy wheel, as seen in FIG. 4, the user will position the camera so that the wheel image just fits in a guide circle drawn on the screen by the app, and the user will then be prompted to enter, via on-screen keyboard or keypad, the tyre size, from which the app software can scale the wheel image.

FIG. 4 illustrates a simple way of determining defect size. Instead of image analysis software calculating defect dimensions, the user is invited to trace the defect **11** image on the smartphone touch screen using a finger or a tracer stylus, as indicated by the arrows. Software can readily determine the on-screen length over which the finger or stylus travels and scale that up.
