US010408615B2

(54) **METHOD OF INSPECTING A DEGRADED AREA OF A METAL STRUCTURE COVERED BY A COMPOSITE REPAIR AND METHOD OF MEASURING A REMAINING WALL THICKNESS OF A COMPOSITE STRUCTURE**

(71) Applicant: **INVERSA SYSTEMS LTD.**,
Fredericton (CA)

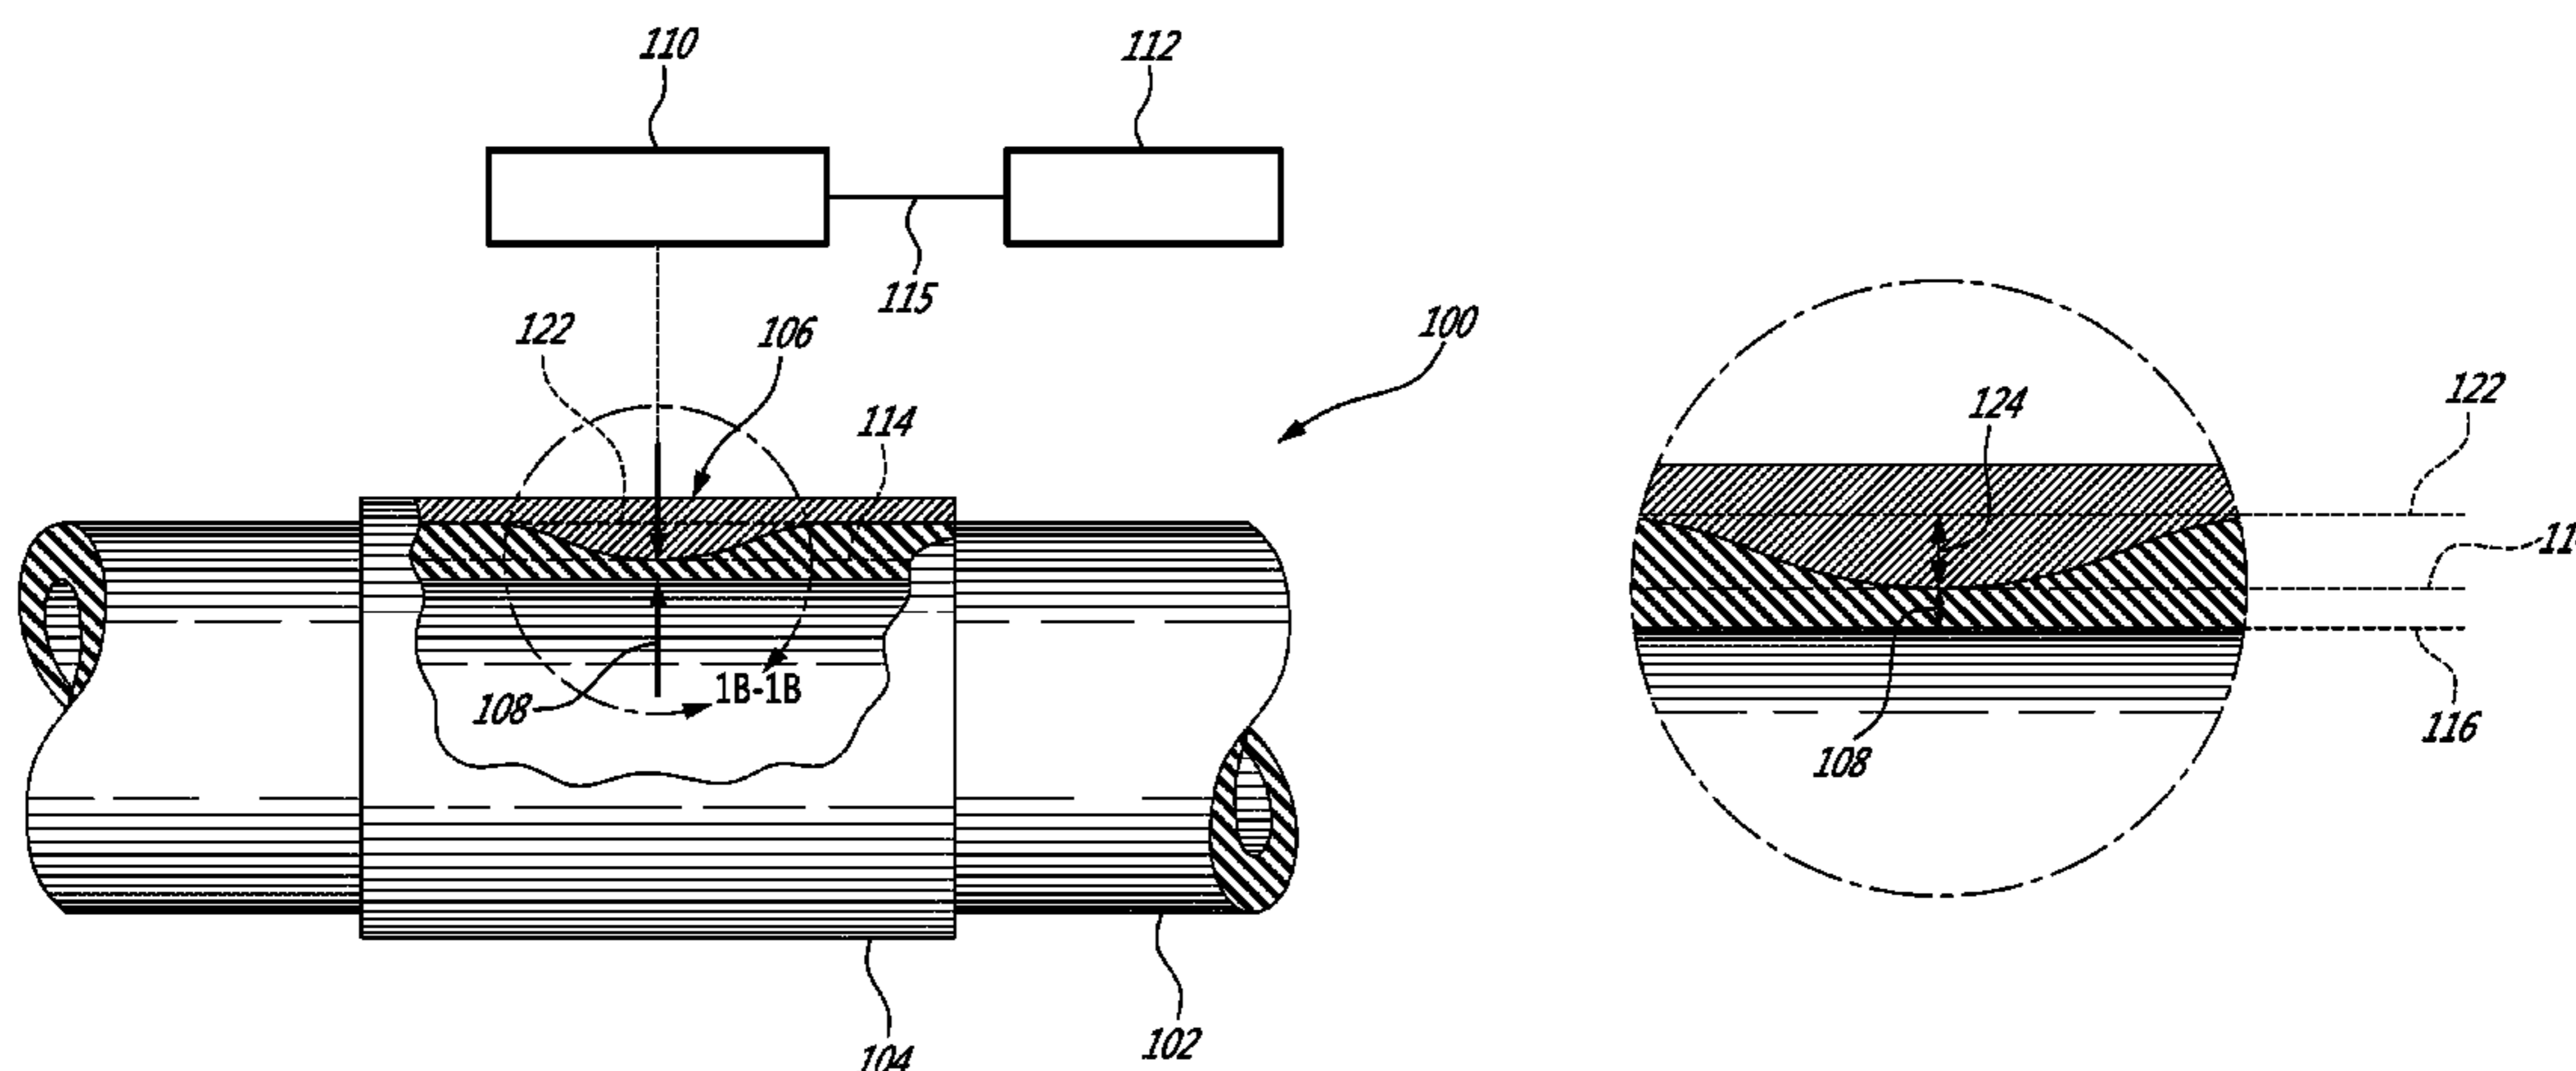
The method of inspecting a degraded area of a metal structure covered by a composite repair generally comprises operating a Compton scattering inspection device onto the degraded area, including emitting a beam of radiation particles directed towards and across the composite repair, detecting at least some backscattered photons scattered back from the metal structure, and acquiring Compton scattering data from the detected backscattered photons, the Compton scattering data being indicative of remaining wall thickness of the degraded area.

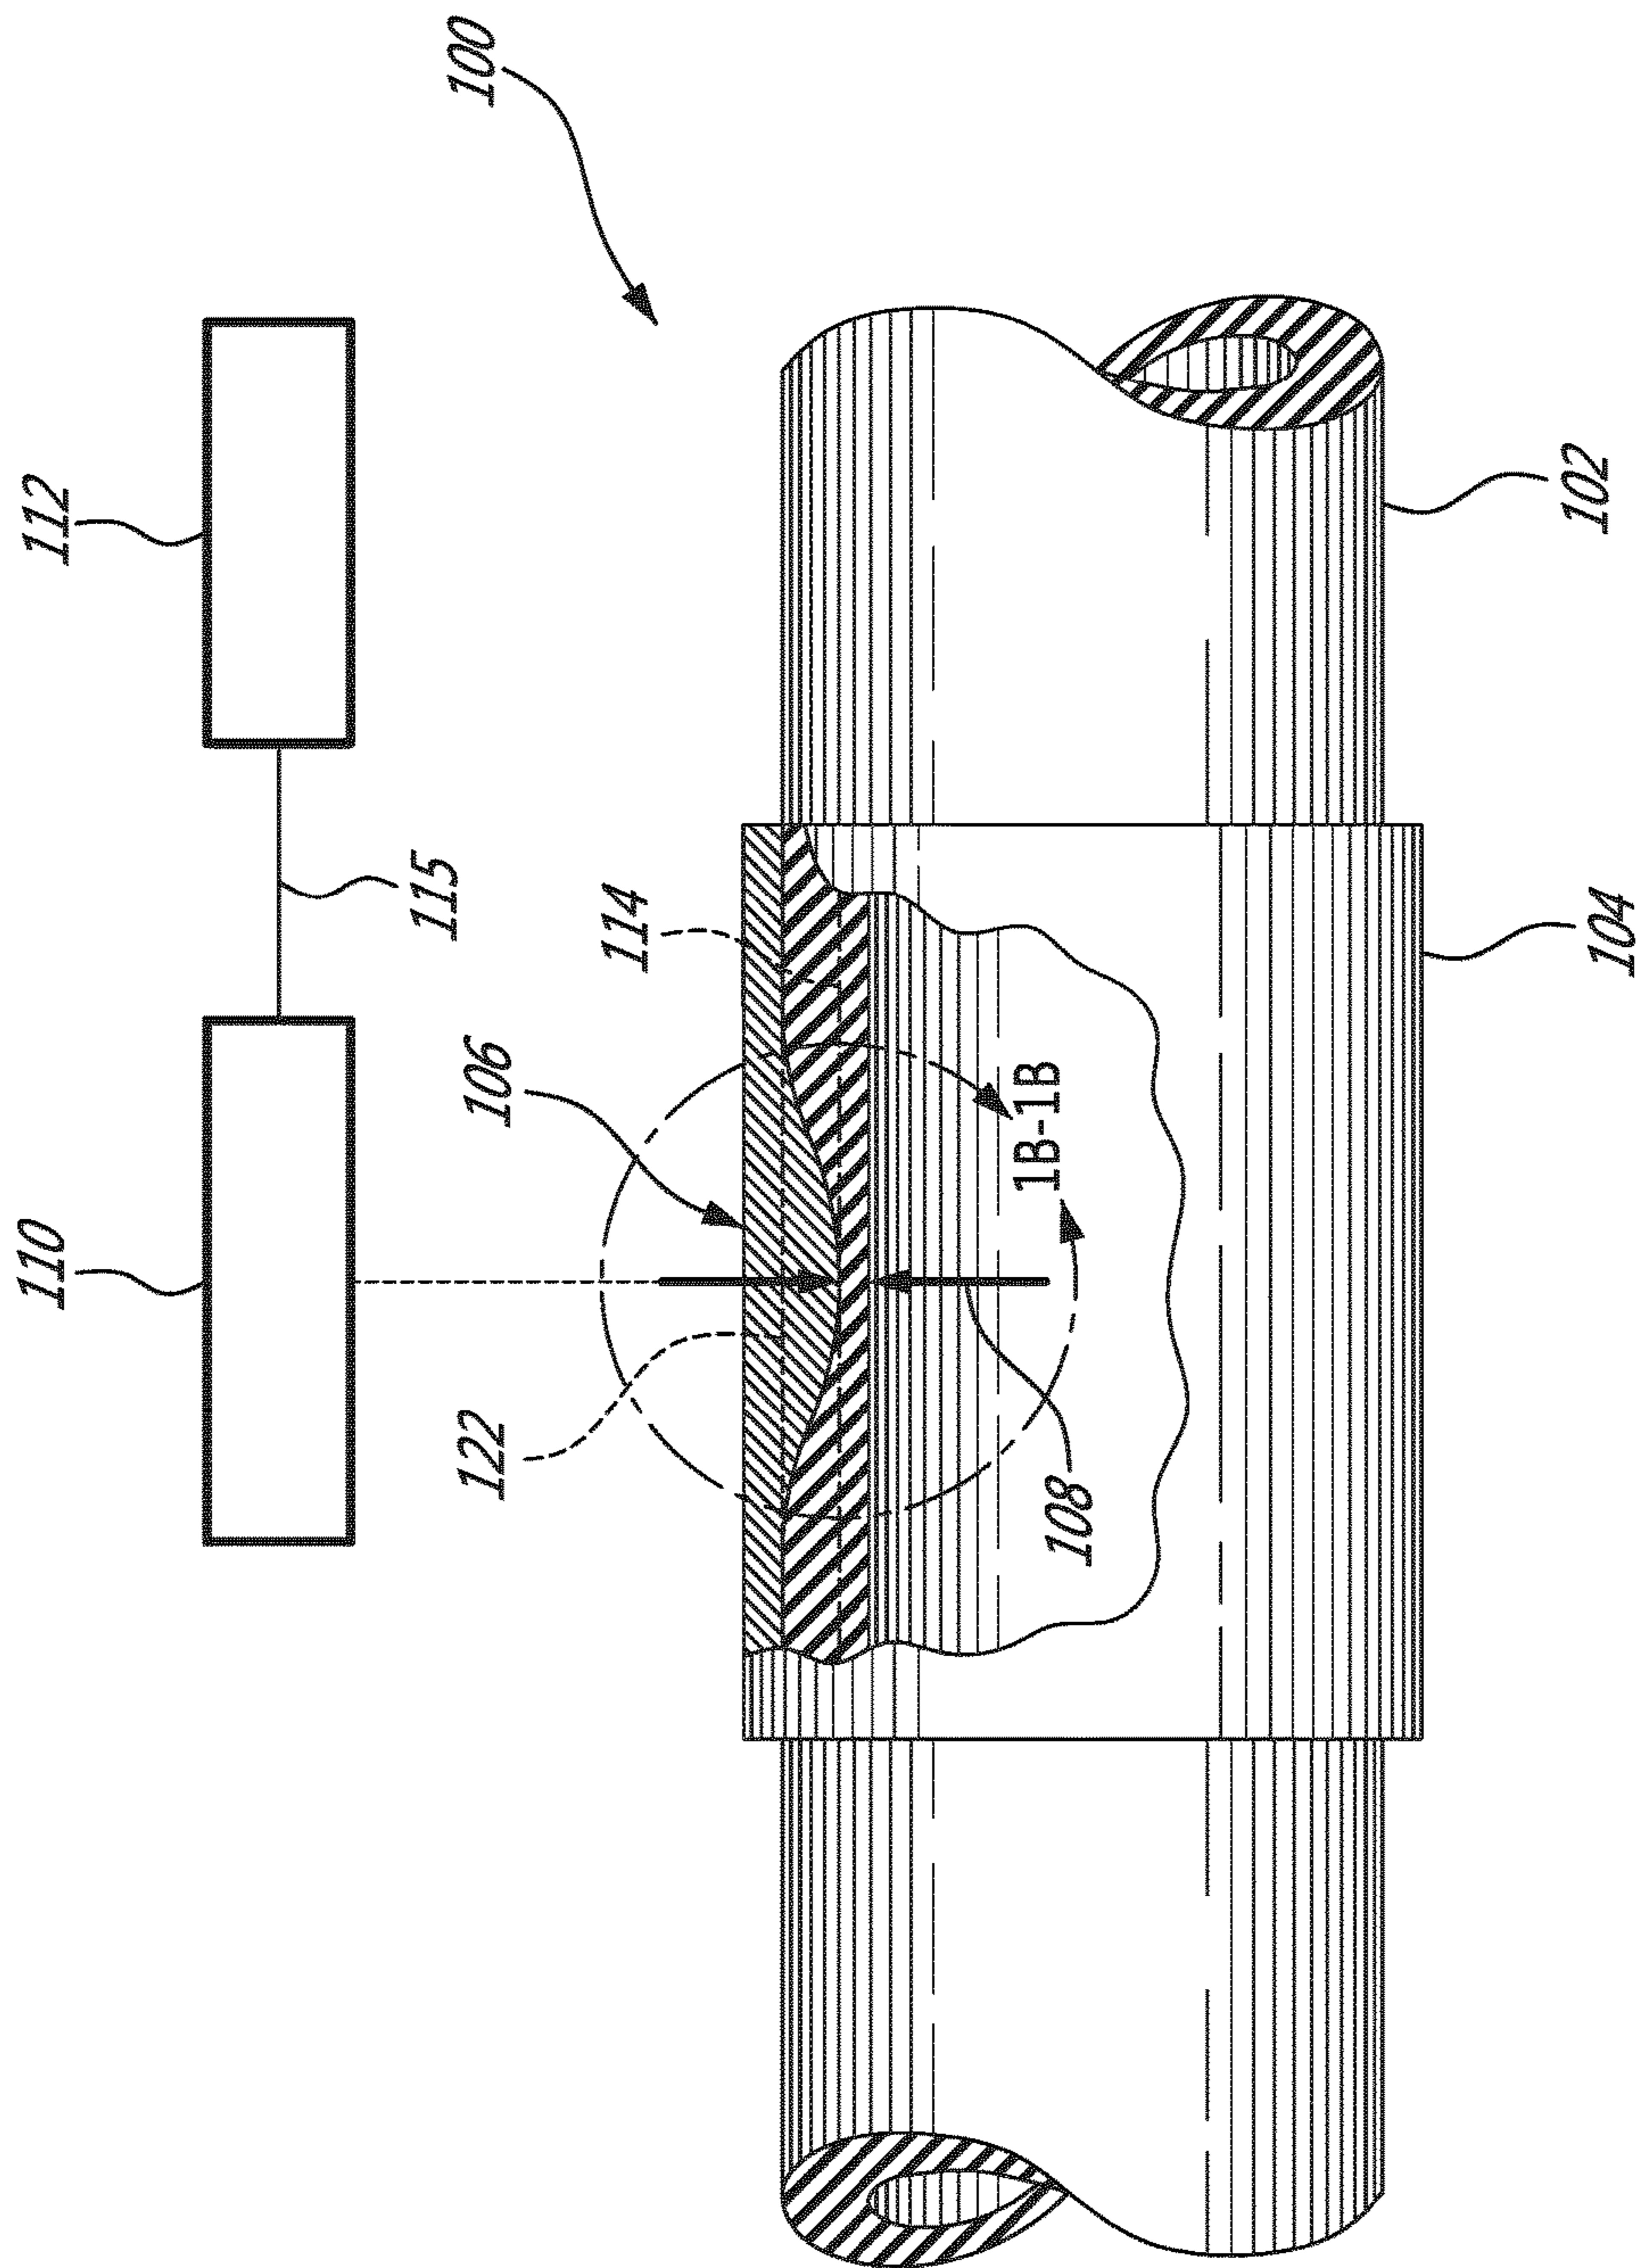
FIG. 1A is a schematic view of an example of a Compton scattering inspection device in position to measure a remaining wall thickness of a portion of a metal pipe shown in a partial and fragmented view, in accordance with an embodiment;

FIG. 1A shows an example of a composite structure 100, in accordance with an embodiment. The illustrated composite structure 100 is a metal pipe 102 covered by a composite wrap repair 104. The composite wrap repair 104 is shown to cover an area of severe degradation 106 of the metal pipe 102. As shown, the surface of the metal pipe 102 is damaged and has a wall having a reduced wall thickness. FIG. 1B shows an enlarged view of the area of severe degradation 106 and a remaining wall thickness 108. In the embodiment shown in FIGS. 1A-B, the area of severe degradation 106 has a defect which is embodied in the form of an expanding portion of the composite wrap repair 104 which compensates for the defect of the metal pipe 102 and which allows the defect to go relatively unnoticed from the outside. In another embodiment, such as the one shown in FIG. 3, the area of severe degradation 106 has a defect which creates a void space between the composite wrap repair 104 and the metal pipe 102. The area of severe degradation can include other types of defects.

Referring back to FIG. 1A, there is shown a Compton scattering inspection device 110 and a computer 112 configured to communicate data with one another. In this embodiment, during use, the Compton scattering inspection device 110 is configured to be received against the metal pipe 102 so that the Compton scattering inspection device

110 projects a beam of radiation particles (i.e. radiation that behaves as a particle), such as gamma-rays, x-rays and neutrons, towards and across the composite wrap repair 104 of the metal pipe 102. Backscattered photons, typically referred to as Compton scattering radiation, are then detected in order to generate the Compton scattering data. The number of backscattered photons detected is determined so as to obtain a statistically meaningful number of photons while maintaining a practical size, weight and speed for portable use with industrial facilities. The beam can be a pencil beam, a cone beam, and any suitable beam. In this embodiment, the computer 112 is shown to be connected to the Compton scattering inspection device 110 via a wireless or a wired connection 115. The computer 112 typically has a processor, a memory, a communication port and other components deemed suitable to process, store and/or communicate data during use. In another embodiment, the computer 112 and the Compton scattering inspection device 110 are provided in the form of a single device.

Depending on the circumstances, the Compton scattering inspection device 110 can be operable to acquire an actual inner wall position data 116. In the embodiment shown in FIGS. 1A-B, the remaining wall thickness 108 is measured by performing a difference between the actual inner wall position data 116 and the actual outer wall position data 114. For instance, if the actual inner and outer wall position data 116 and 114 are distances from the Compton scattering inspection device 110, the remaining wall thickness 108 corresponds to the actual inner wall position data 116 minus the actual outer wall position data 114.

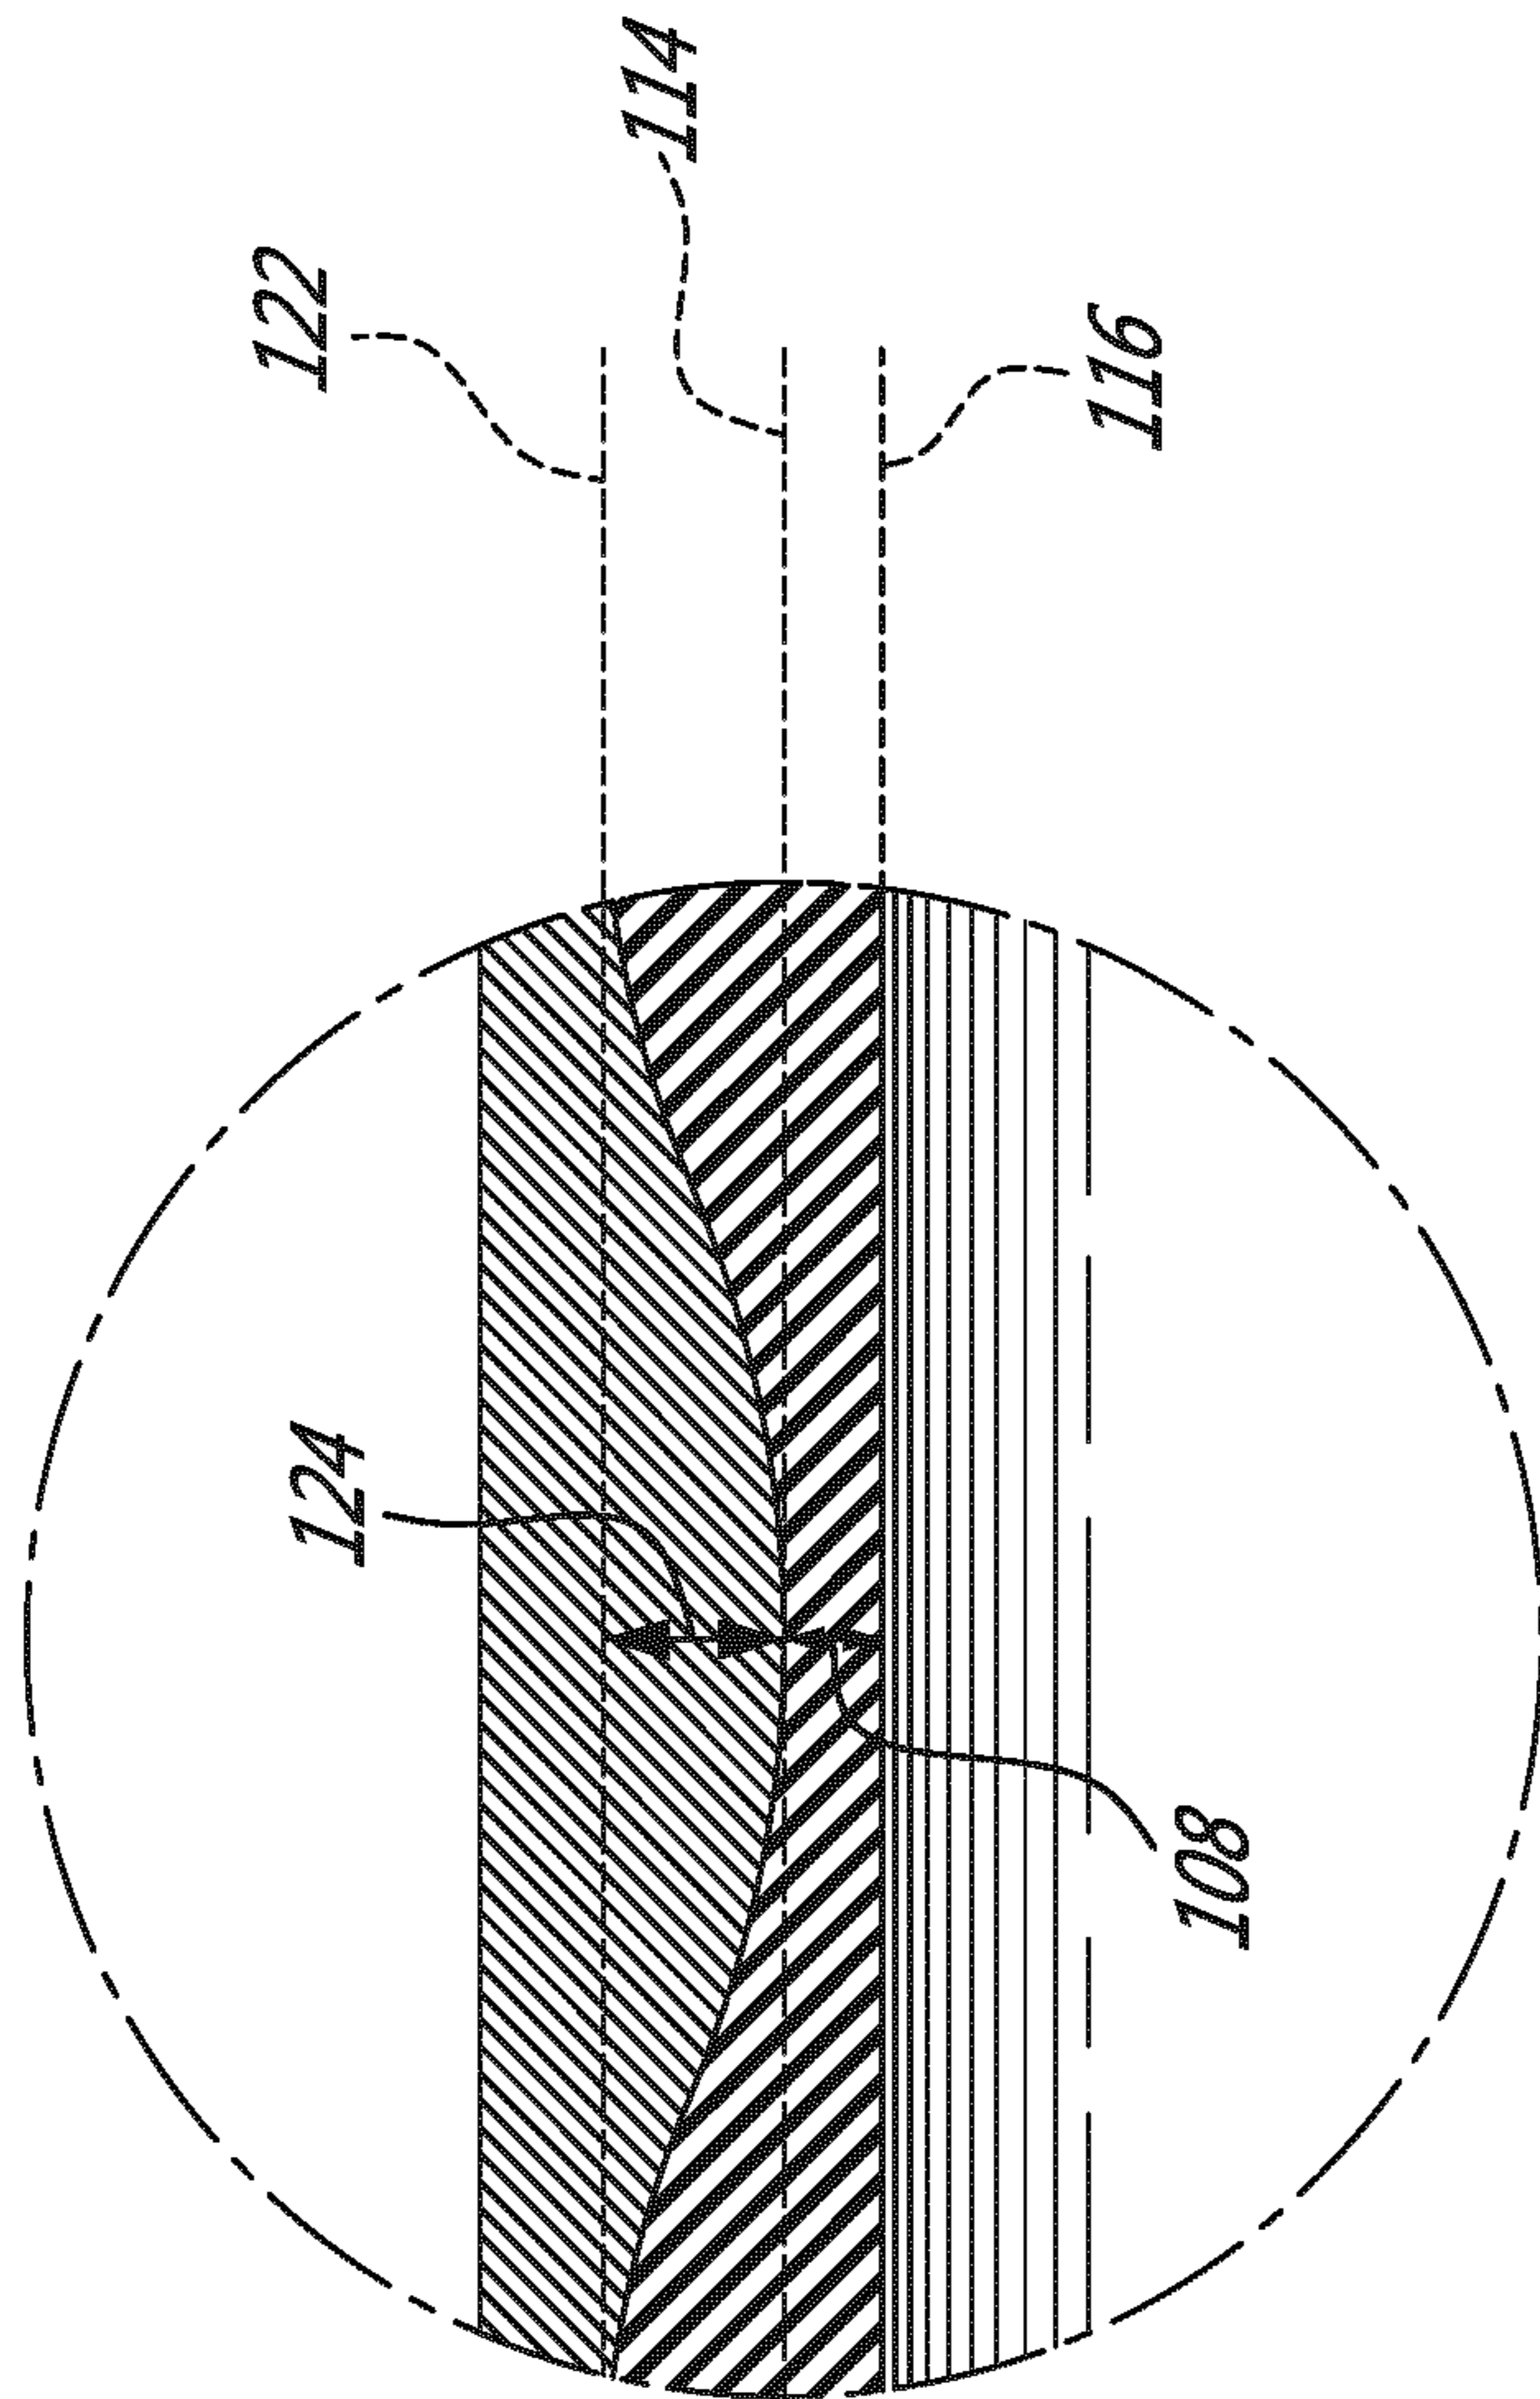
FIG. 1B is an enlarged cross-sectional view of an area of severe degradation of the metal pipe shown in FIG. 1A;

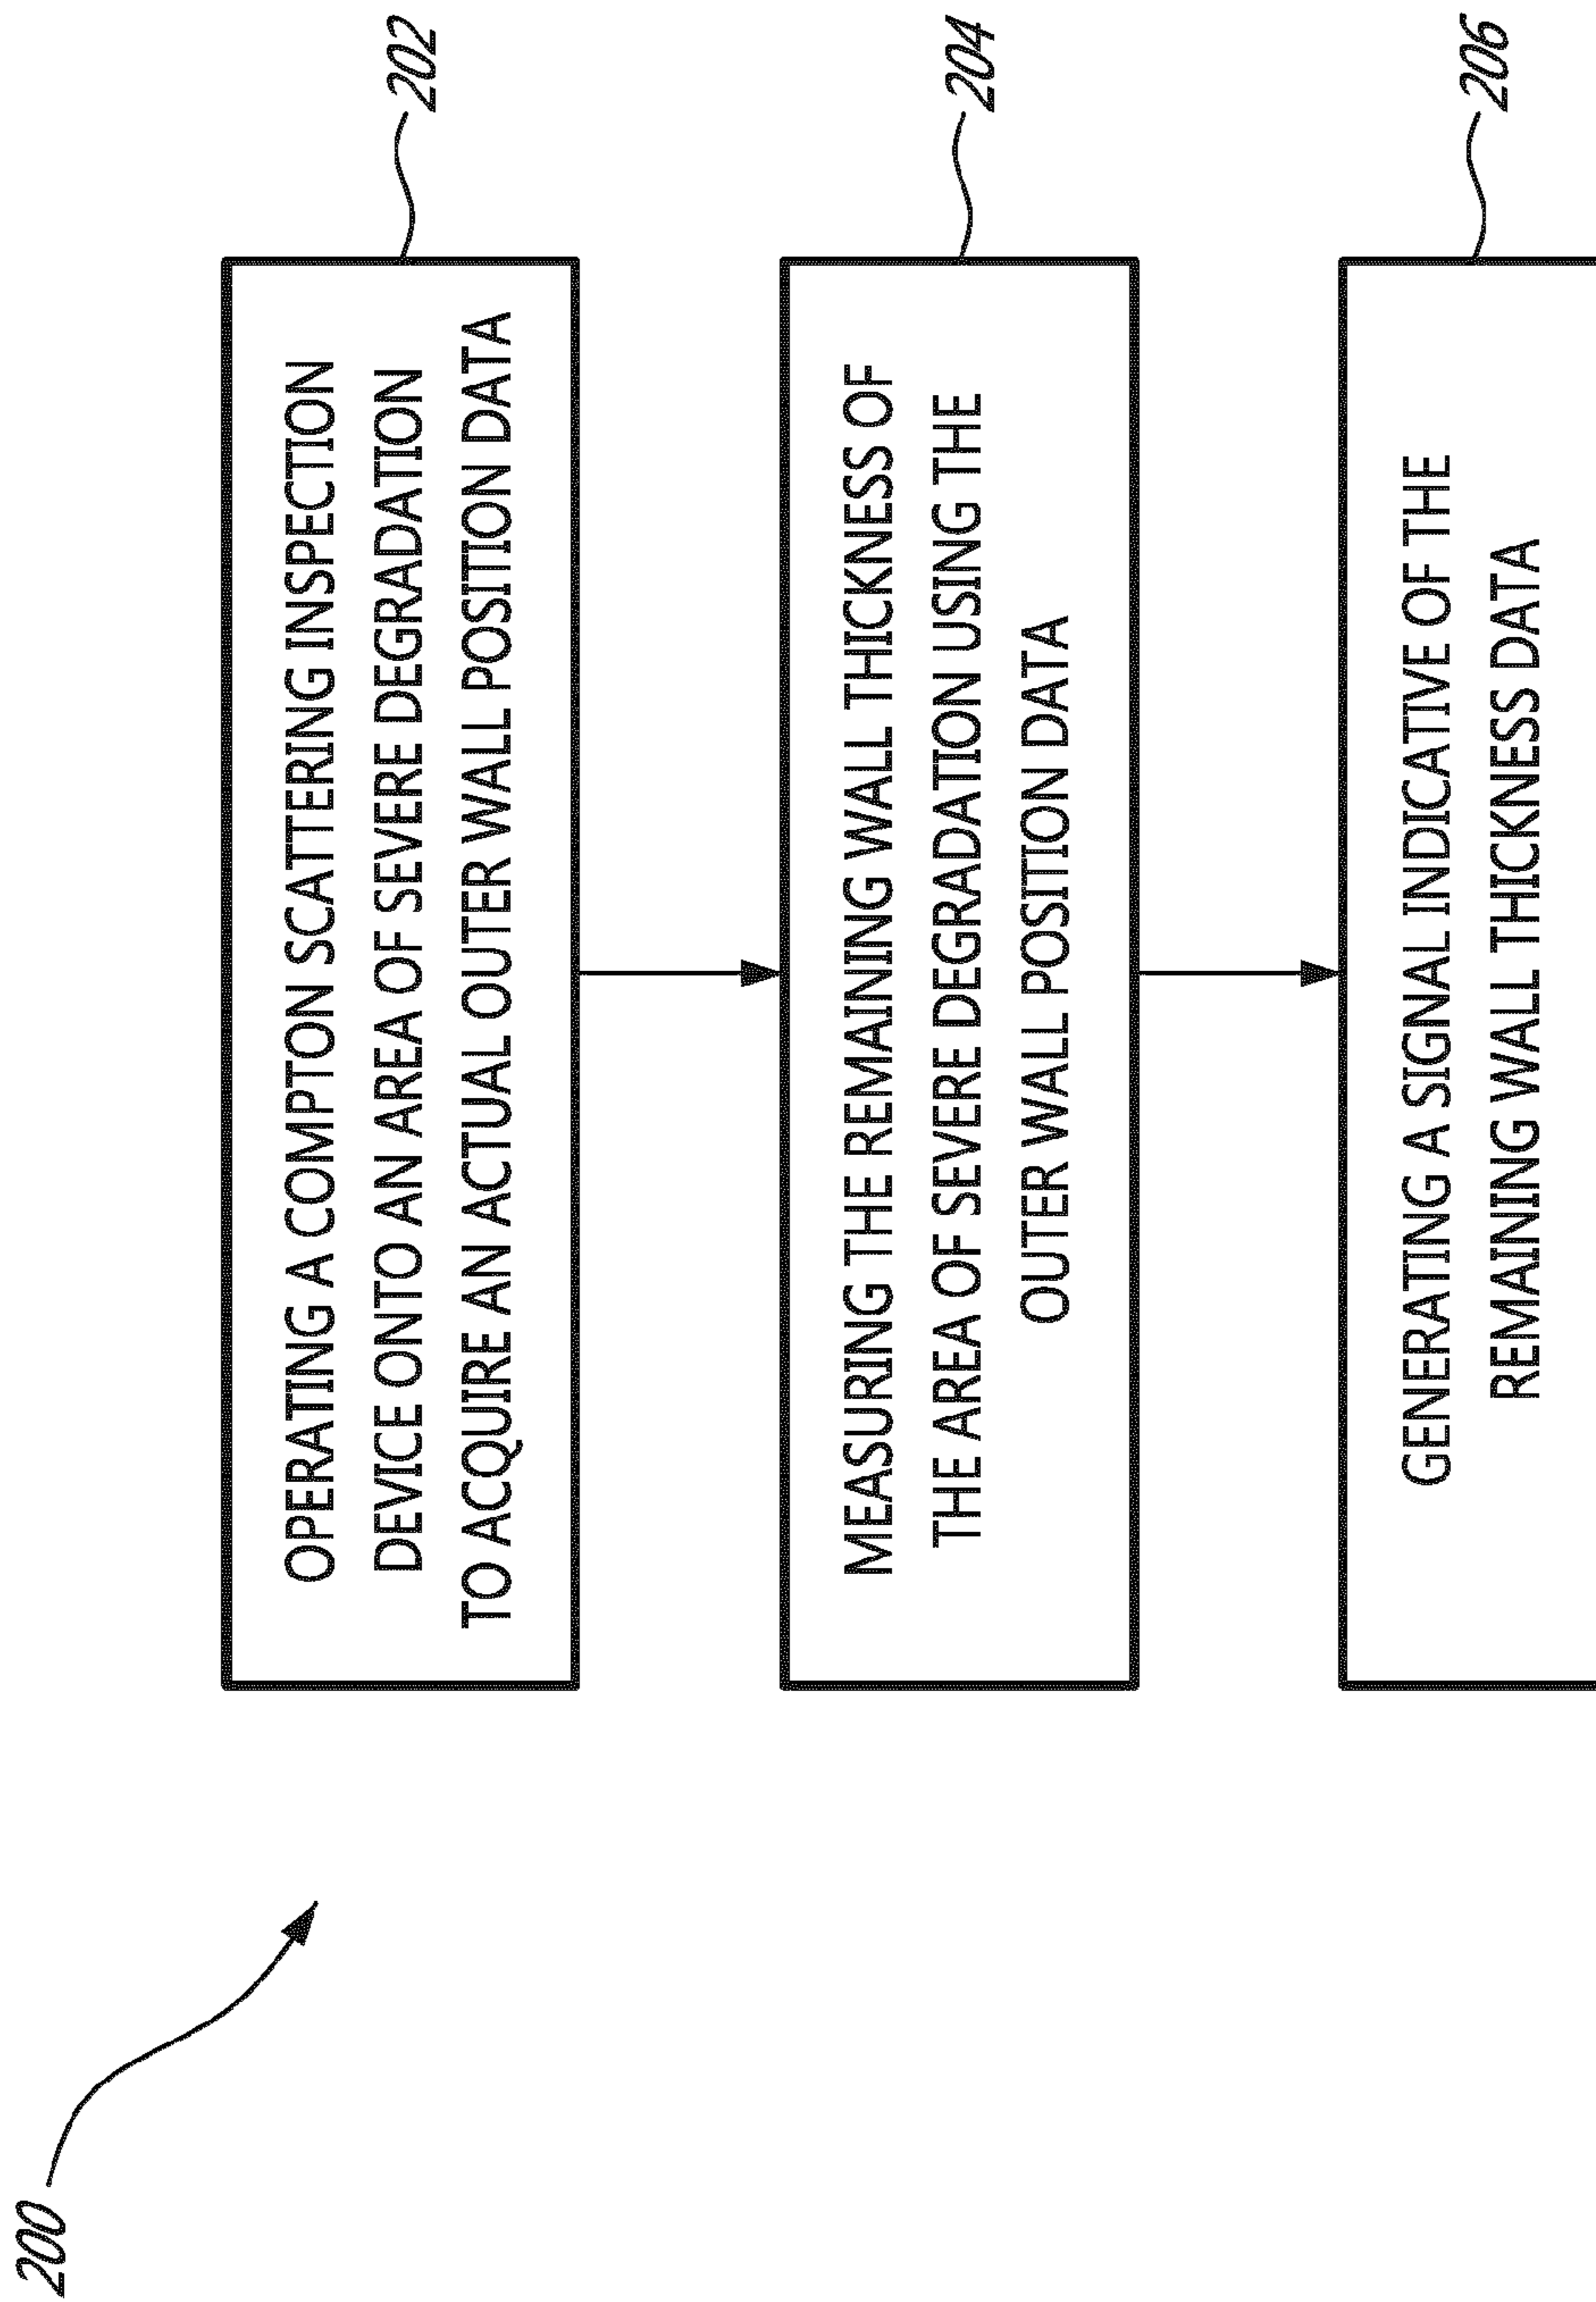
FIG. 2 is a flow chart of an example of a method for measuring a remaining wall thickness, in accordance with an embodiment; and

Referring now to FIG. 2, the Compton scattering inspection device 110 and the computer 112 can be used to measure the remaining wall thickness 108 of the area of severe degradation 106 in accordance with the method shown at 200. More specifically, the method 200 has a step 202 of operating the Compton scattering inspection device 110 onto the area of severe degradation 106, across the composite wrap repair 104, in a manner to acquire an actual outer wall position data 114, which is best seen in FIG. 1B. The method 200 has a step of measuring, by using the computer 112, the remaining wall thickness 108 of the area of severe degradation 106 using at least the outer wall position data 114. The method 200 then has a step of generating, by using the computer 112, a signal indicative of the remaining wall thickness 108. Once measured, the remaining wall thickness 108 can be used to determine the integrity of the composite structure 100 as a whole, and especially the integrity of the area of severe degradation 106. In envisaged embodiment, the composite wrap repair 104 can be used as long as the remaining wall thickness 108 is deemed to be safe, thus prolonging the use of the composite wrap repair 104. Performing maintenance of the composite structure 100 can thus be more efficient and less costly.

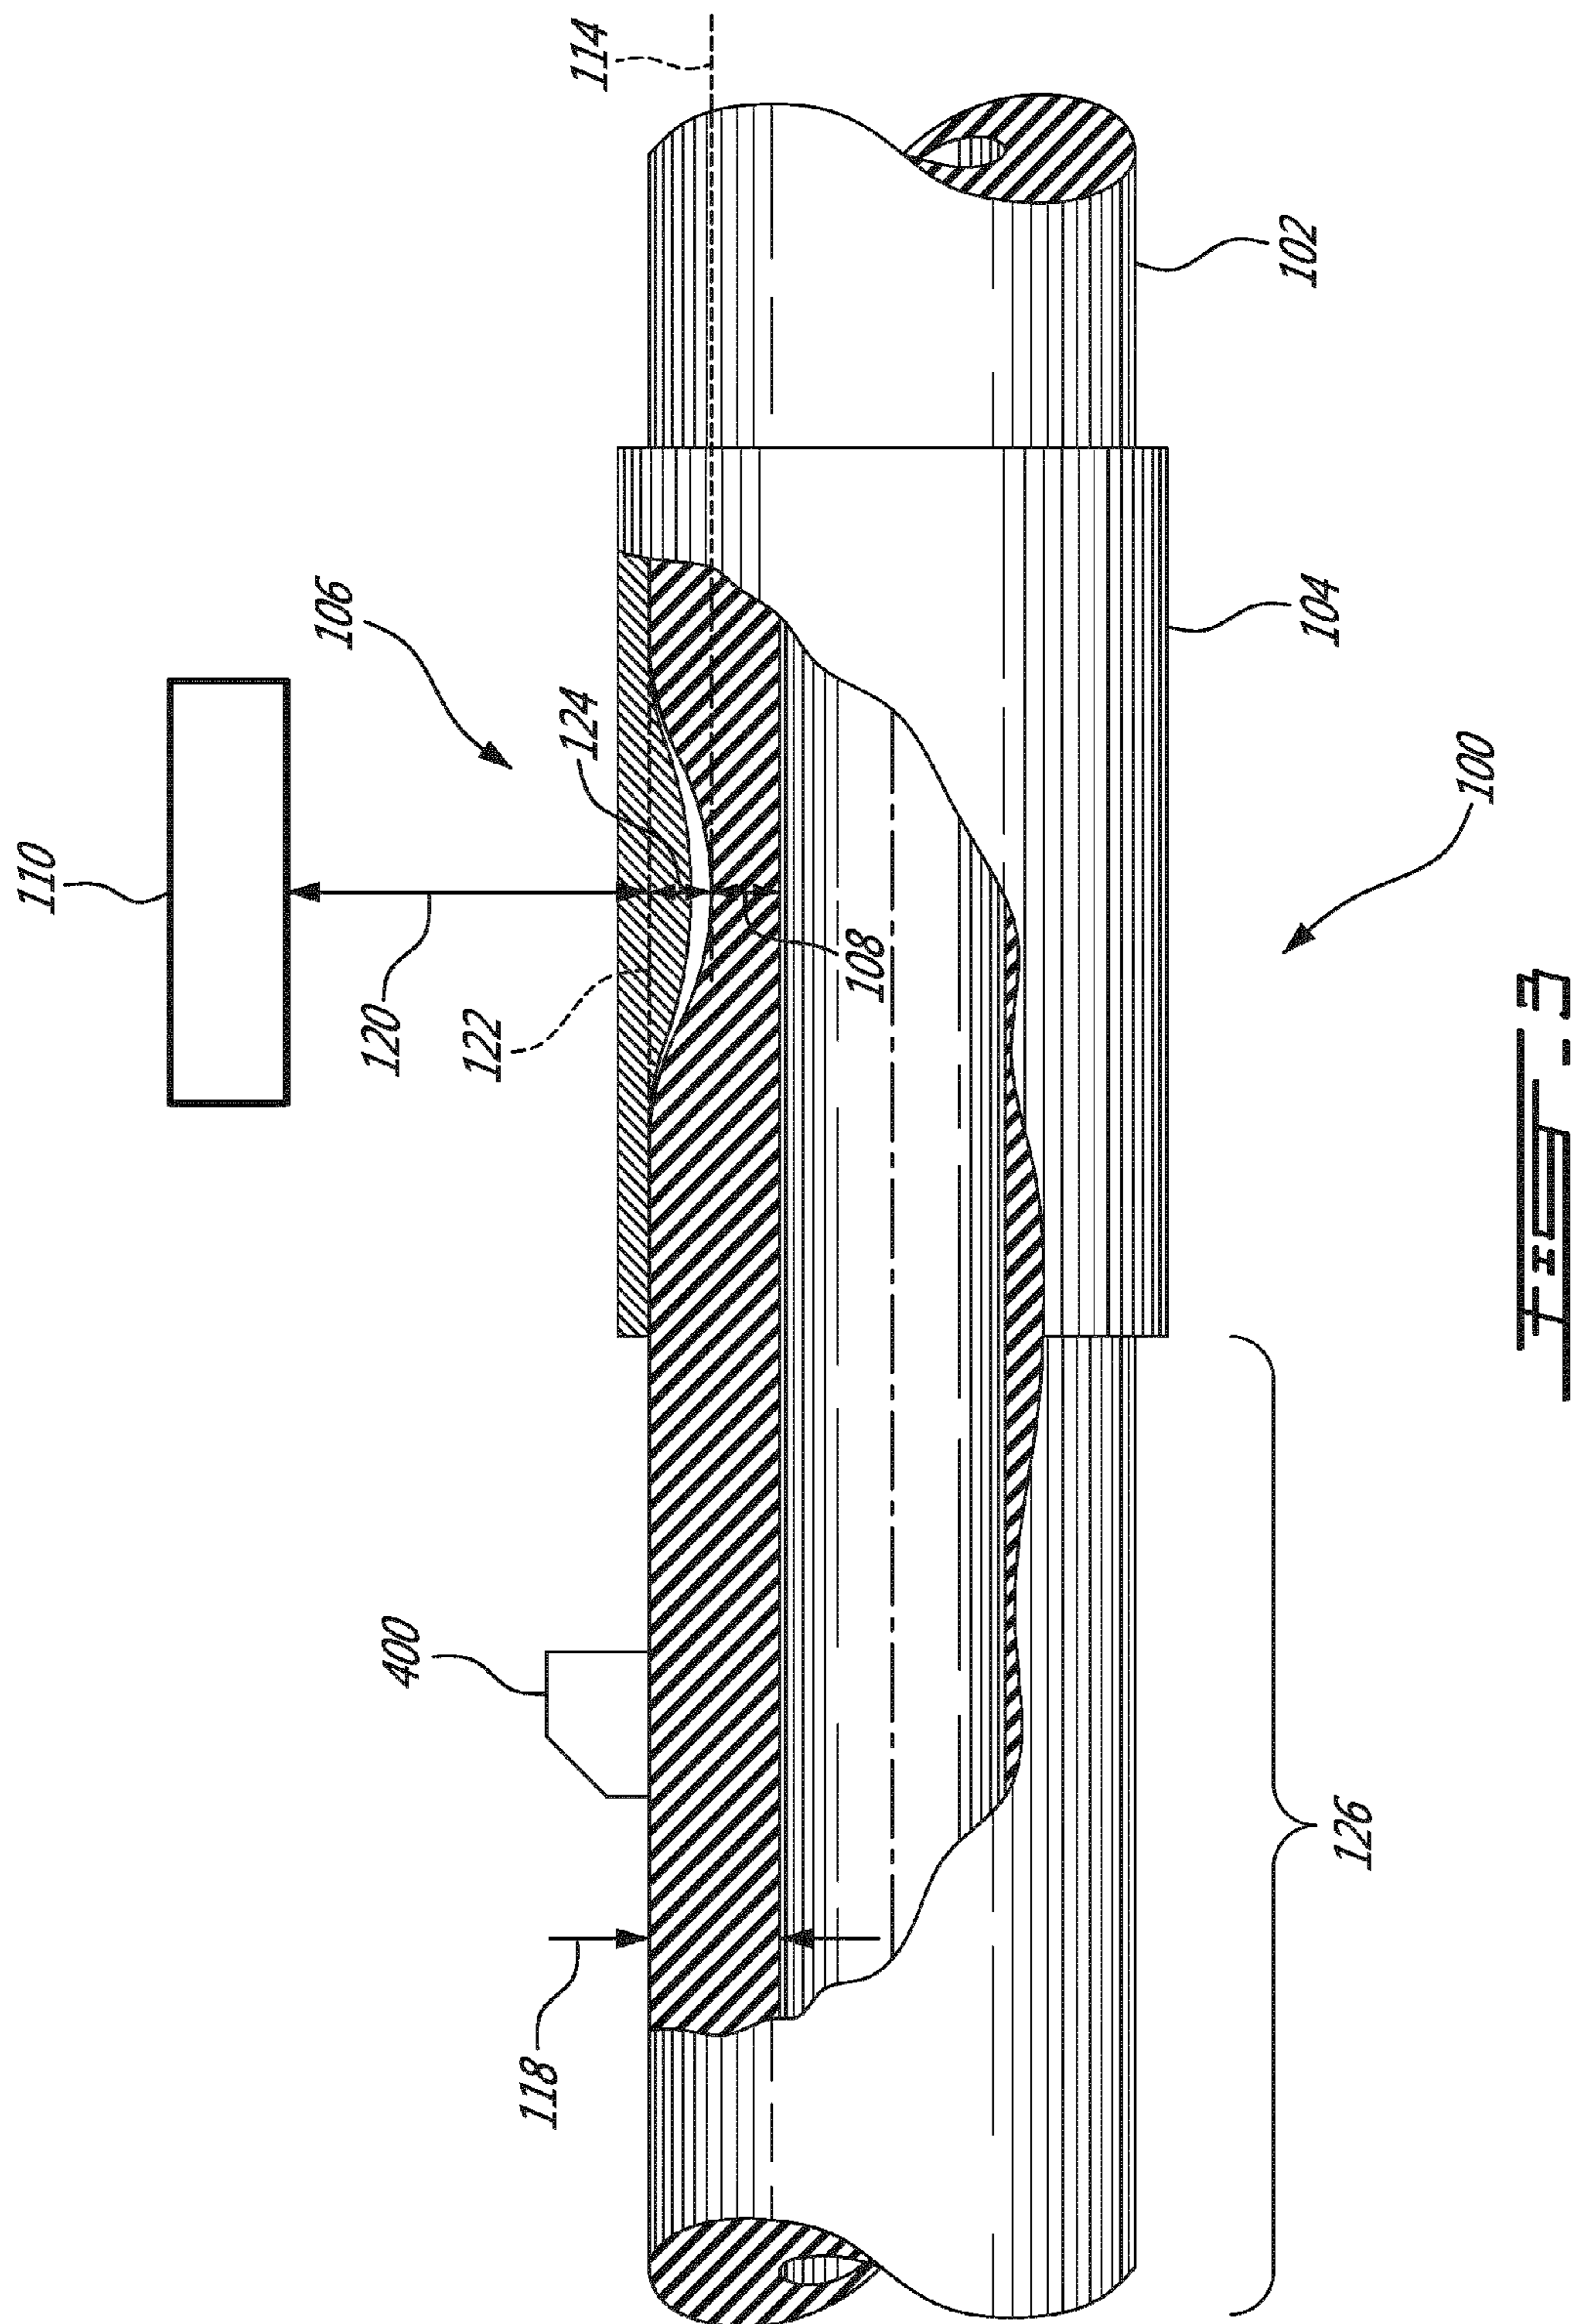
FIG. 3 is a schematic view of an example of a Compton scattering inspection device in a position to measure a

remaining wall thickness of an area of severe degradation of the metal pipe, in accordance with another embodiment.

For some composite structures, as illustrated in FIG. 3, the Compton scattering inspection device 110 may not be able to acquire the actual inner wall position data, allowing only to acquire the actual outer position data 114. This can occur when the wall is too thick. In this case, the remaining wall thickness 108 can be measured using a nominal wall thickness 118 of the metal pipe 102. In an embodiment, the nominal wall thickness 118 is known a priori from a construction specification of the metal pipe 102 and used directly in the calculations. In another embodiment, the nominal wall thickness 118 is measured using either the Compton scattering inspection device 110 or an NDT device 400. An example of the NDT device 400 is an ultrasonic testing (UT) device. Such UT device provides satisfactory

In the embodiment shown in FIG. 3, measuring the remaining wall thickness **108** is performed by operating the Compton scattering inspection device **110** at a known distance **120** relative to a virtual unaltered outer wall position data **112**, represented by the dashed line. It will be understood that the unaltered outer wall position data **112** corresponds to the actual outer wall position data **114** when the Compton scattering inspection device **110** is operated towards an unaltered area **126** of the metal pipe **102** from the known distance **120**. In this embodiment, the Compton scattering inspection device **110** is maintained at the known distance **120**, for instance at position P, using support such as a jig. Other ways of maintaining the Compton scattering inspection device **110** can also be used. By having the known distance **120**, a pit depth **124** is measured using the computer **112** by performing a difference of the actual outer wall position **114** and the virtual unaltered outer wall position **122**. Then, measuring the remaining wall thickness **108** is possible by subtracting the pit depth **124** from the nominal wall thickness **118**. In another embodiment, measuring the remaining wall thickness **108** is performed by the computer **112** using a BCT image of the metal pipe **102**. The BCT image typically results from the operation of the Compton scattering inspection device **110** along a linear section of the metal pipe **102** which includes successively an unaltered area **126**, an area of severe degradation **106** and another unaltered area **126**. For instance, in the case of the area of severe degradation **106** shown in FIG. 3, operating the Compton scattering device **110** along the linear section which is delimited by opposite edges of the composite wrap repair **104** is sufficient. Once the BCT image of the linear section is obtained, the computer **112** can draw a digital line in the BCT image which starts from the unaltered outer wall of the unaltered area **126** and ends to the unaltered outer wall of the other unaltered area **126**, across the area of severe degradation **106**. The measurement of the pit depth **124** can then be performed by measuring the distance between a depth associated with a deepest flawed region and the digital line, perpendicularly therefrom. The linear displacement path of the Compton scattering device does not need to be perfectly parallel to the length of the metal pipe **102**. For instance, publication WO 2014/124,522 discloses a Compton scattering device which has means to be displaced linearly along a frame which can be positioned immobile relative to the metal pipe **102**. Even if the frame slightly slopes relative to the metal pipe **102**, the displacement path is linear and the measurement can be made.
