US010408615B2

(54) **METHOD OF INSPECTING A DEGRADED AREA OF A METAL STRUCTURE COVERED BY A COMPOSITE REPAIR AND METHOD OF MEASURING A REMAINING WALL THICKNESS OF A COMPOSITE STRUCTURE**

(71) Applicant: **INVERSA SYSTEMS LTD.**,
Fredericton (CA)

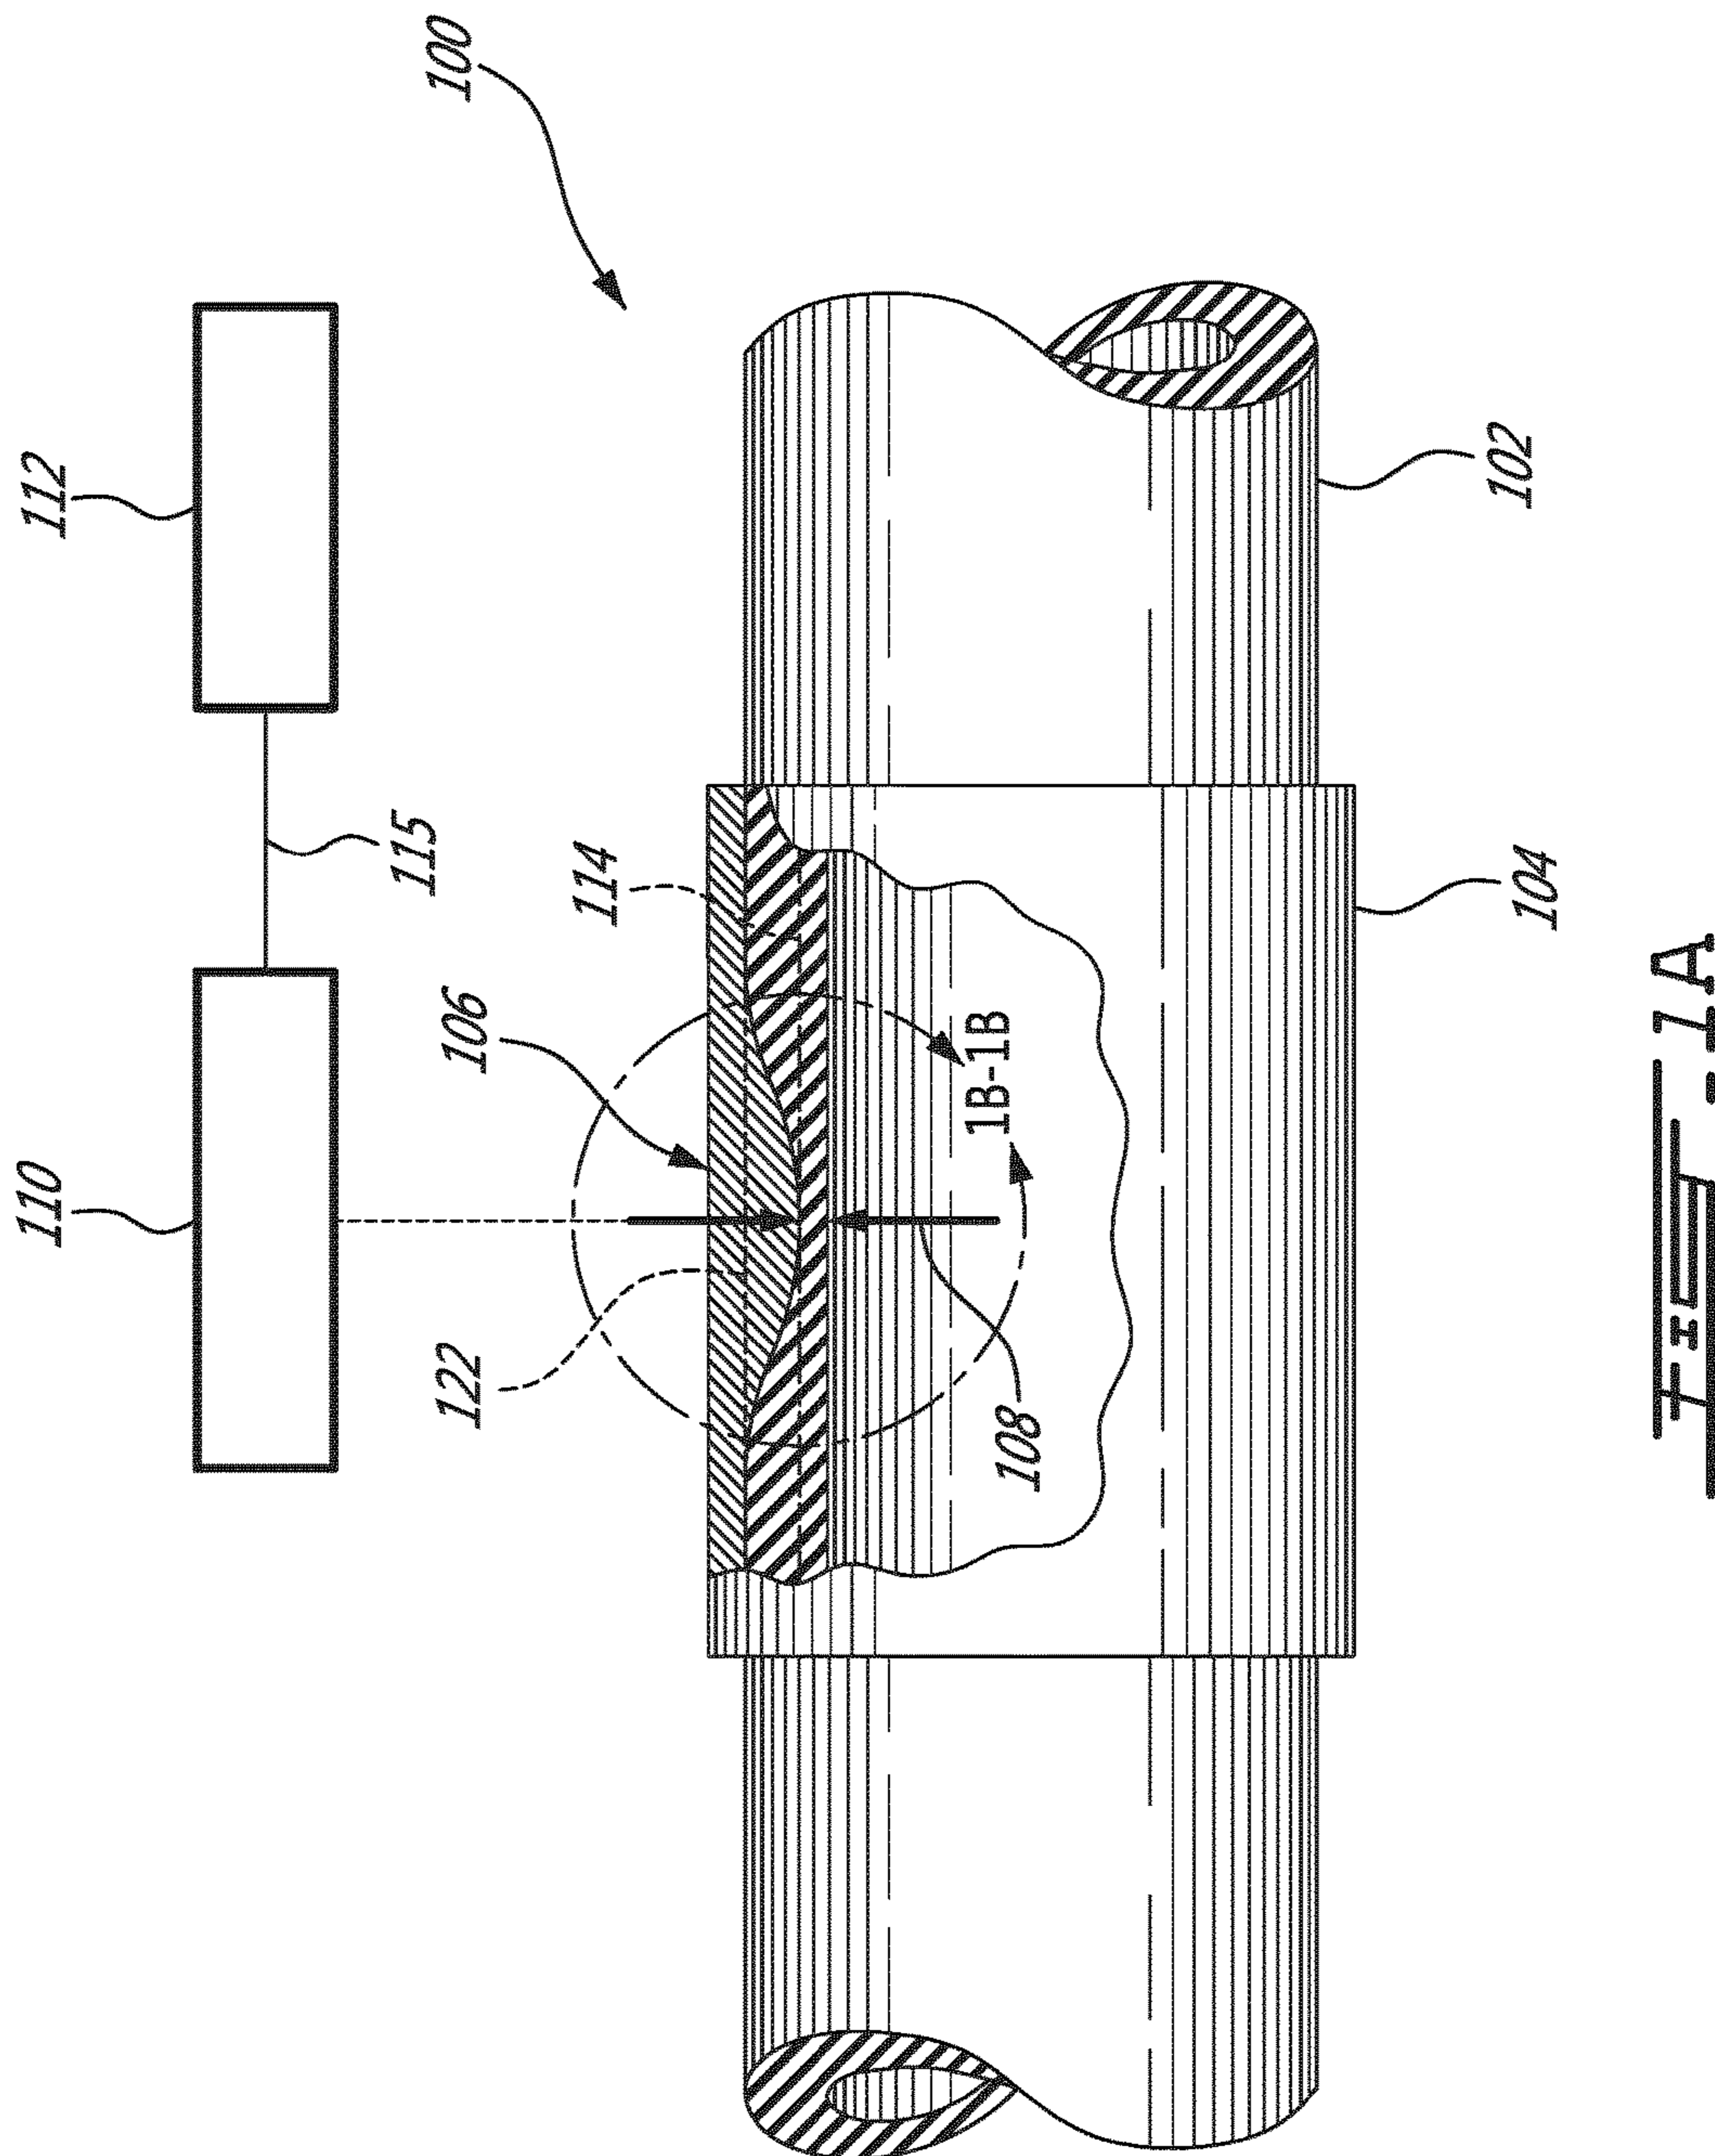
FIG. 1A is a schematic view of an example of a Compton scattering inspection device in position to measure a remaining wall thickness of a portion of a metal pipe shown in a partial and fragmented view, in accordance with an embodiment;

FIG. 1A shows an example of a composite structure 100, in accordance with an embodiment. The illustrated composite structure 100 is a metal pipe 102 covered by a composite wrap repair 104. The composite wrap repair 104 is shown to cover an area of severe degradation 106 of the metal pipe 102. As shown, the surface of the metal pipe 102 is damaged and has a wall having a reduced wall thickness. FIG. 1B shows an enlarged view of the area of severe degradation 106 and a remaining wall thickness 108. In the embodiment shown in FIGS. 1A-B, the area of severe degradation 106 has a defect which is embodied in the form of an expanding portion of the composite wrap repair 104 which compensates for the defect of the metal pipe 102 and which allows the defect to go relatively unnoticed from the outside. In another embodiment, such as the one shown in FIG. 3, the area of severe degradation 106 has a defect which creates a void space between the composite wrap repair 104 and the metal pipe 102. The area of severe degradation can include other types of defects.

Referring back to FIG. 1A, there is shown a Compton scattering inspection device 110 and a computer 112 configured to communicate data with one another. In this embodiment, during use, the Compton scattering inspection device 110 is configured to be received against the metal pipe 102 so that the Compton scattering inspection device

110 projects a beam of radiation particles (i.e. radiation that behaves as a particle), such as gamma-rays, x-rays and neutrons, towards and across the composite wrap repair 104 of the metal pipe 102. Backscattered photons, typically referred to as Compton scattering radiation, are then detected in order to generate the Compton scattering data. The number of backscattered photons detected is determined so as to obtain a statistically meaningful number of photons while maintaining a practical size, weight and speed for portable use with industrial facilities. The beam can be a pencil beam, a cone beam, and any suitable beam. In this embodiment, the computer 112 is shown to be connected to the Compton scattering inspection device 110 via a wireless or a wired connection 115. The computer 112 typically has a processor, a memory, a communication port and other components deemed suitable to process, store and/or communicate data during use. In another embodiment, the computer 112 and the Compton scattering inspection device 110 are provided in the form of a single device.

Depending on the circumstances, the Compton scattering inspection device 110 can be operable to acquire an actual inner wall position data 116. In the embodiment shown in FIGS. 1A-B, the remaining wall thickness 108 is measured by performing a difference between the actual inner wall position data 116 and the actual outer wall position data 114. For instance, if the actual inner and outer wall position data 116 and 114 are distances from the Compton scattering inspection device 110, the remaining wall thickness 108 corresponds to the actual inner wall position data 116 minus the actual outer wall position data 114.

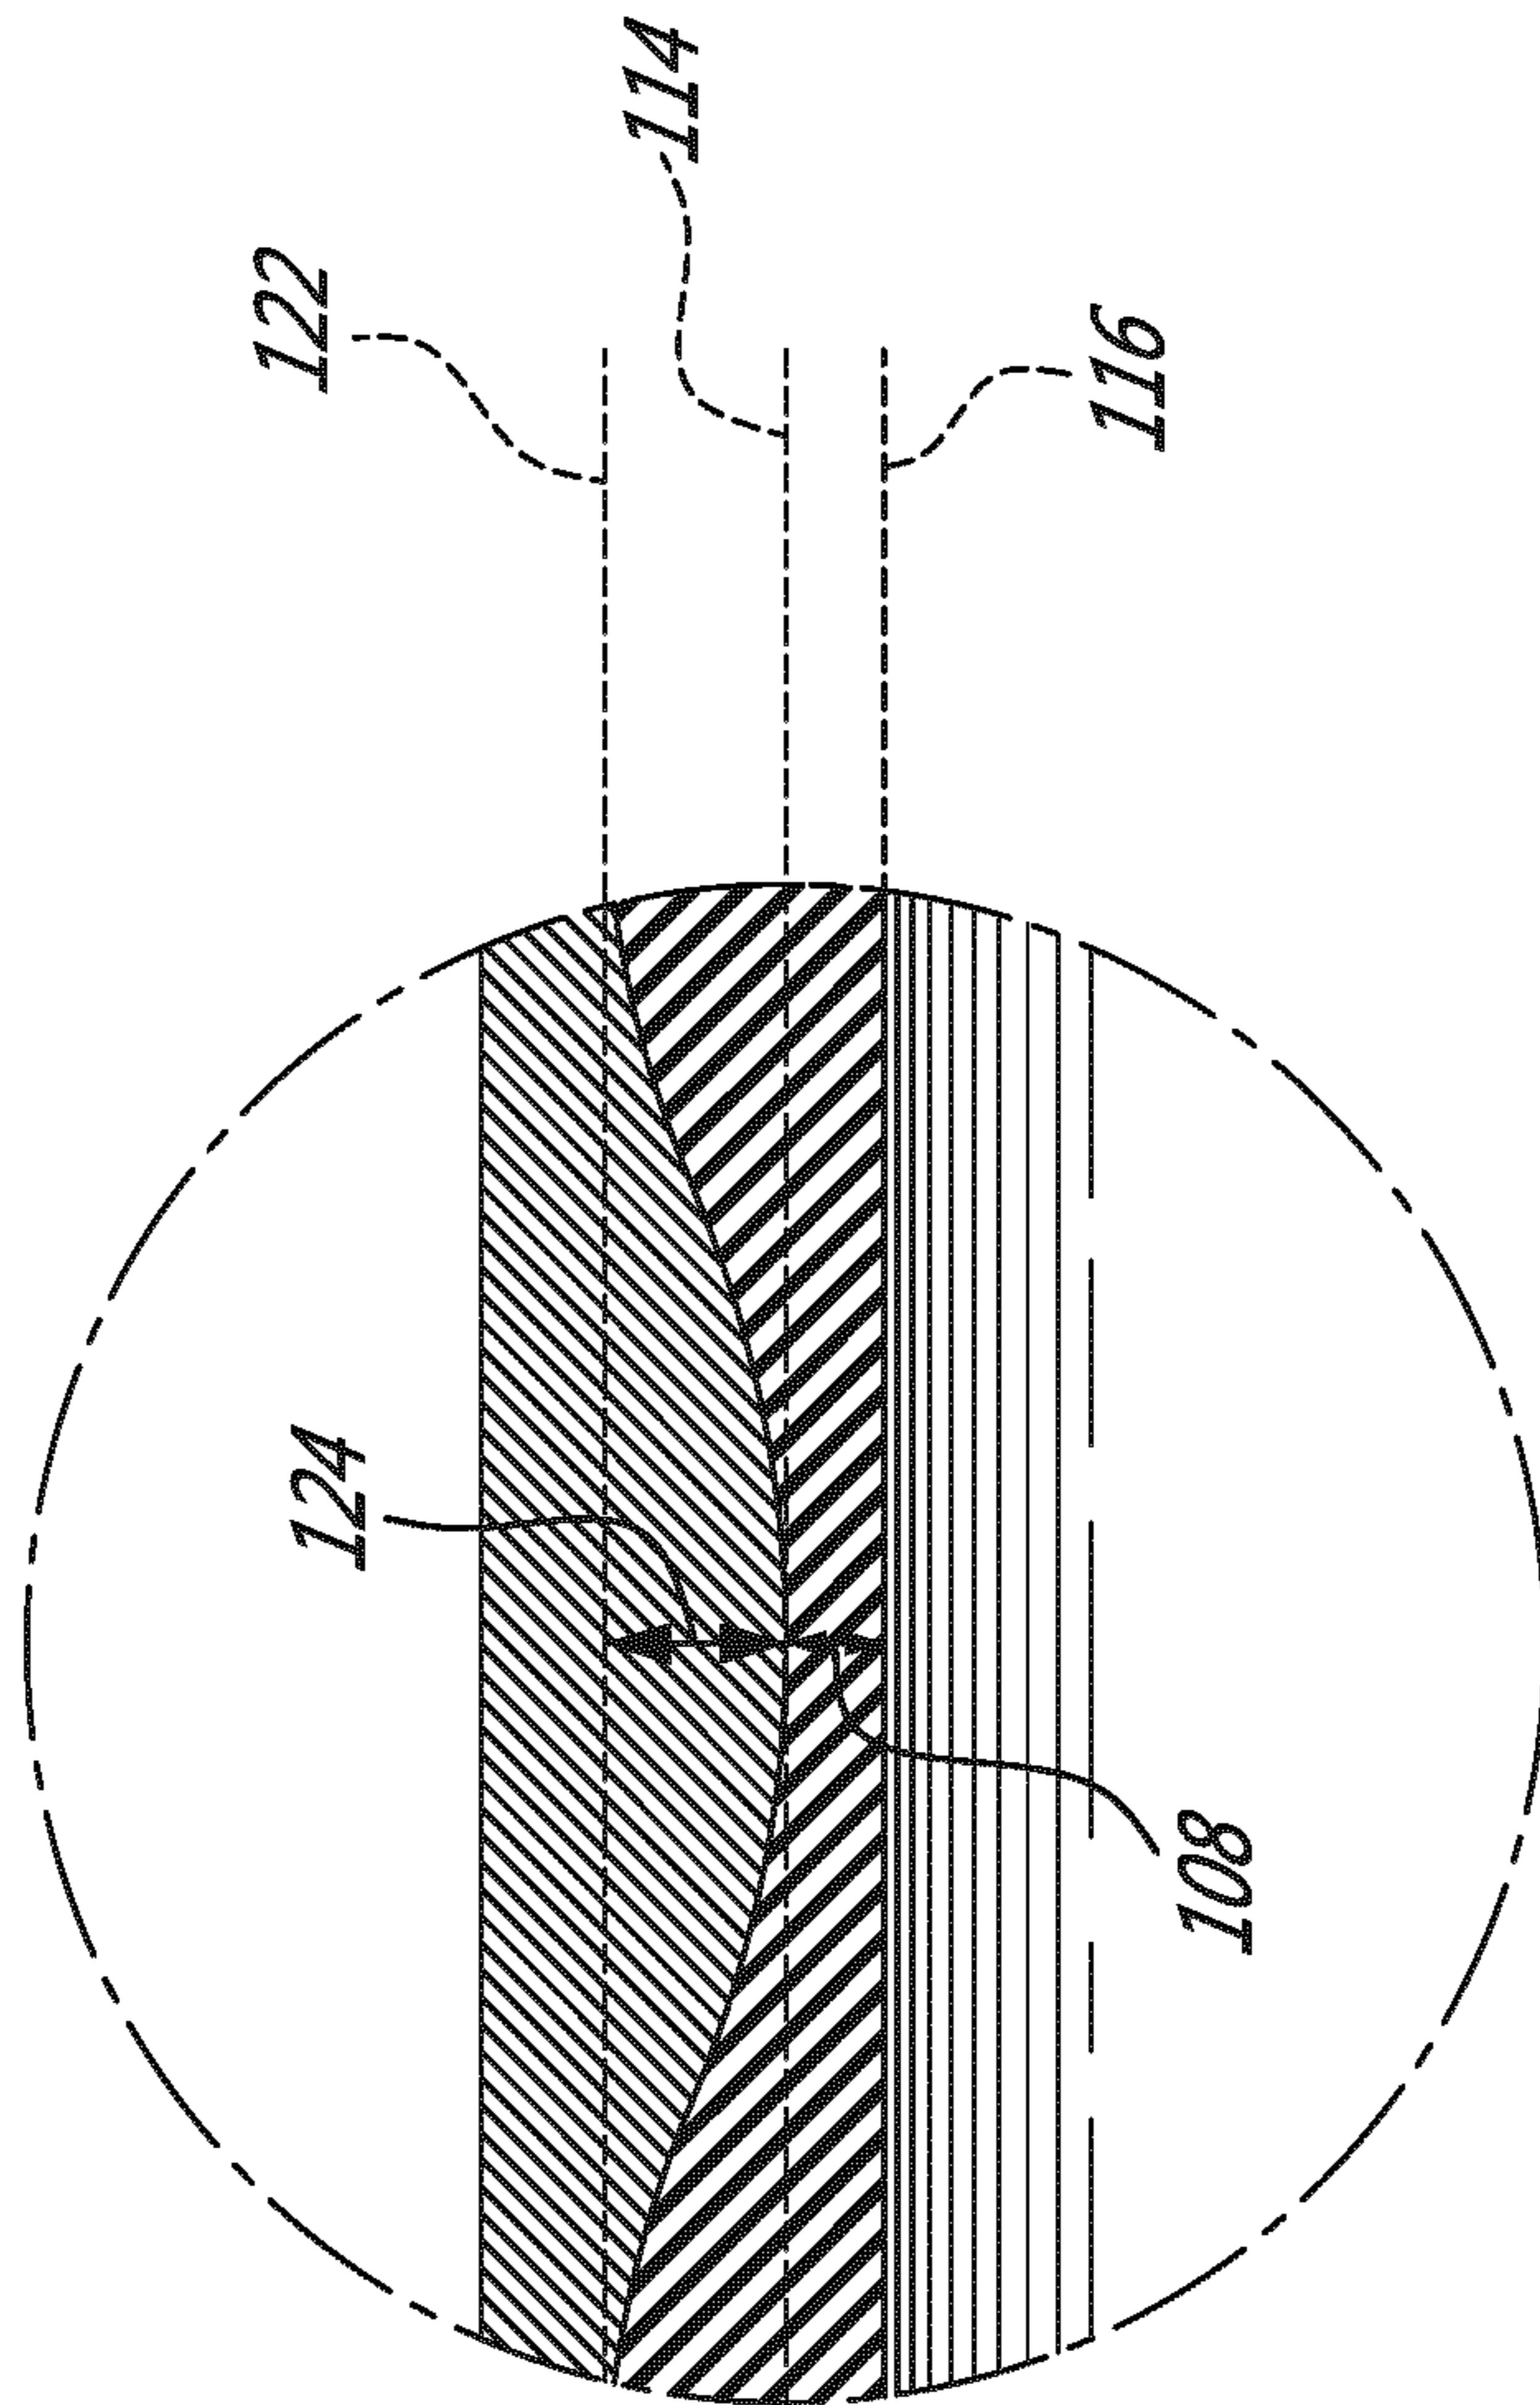
FIG. 1B is an enlarged cross-sectional view of an area of severe degradation of the metal pipe shown in FIG. 1A;
