US010458776B2

(54) **ABRASION INSPECTION APPARATUS,
ABRASION INSPECTION METHOD, AND
PROGRAM**

(71) Applicant: **mitsubishi heavy industries,
LTD.**, Tokyo (JP)

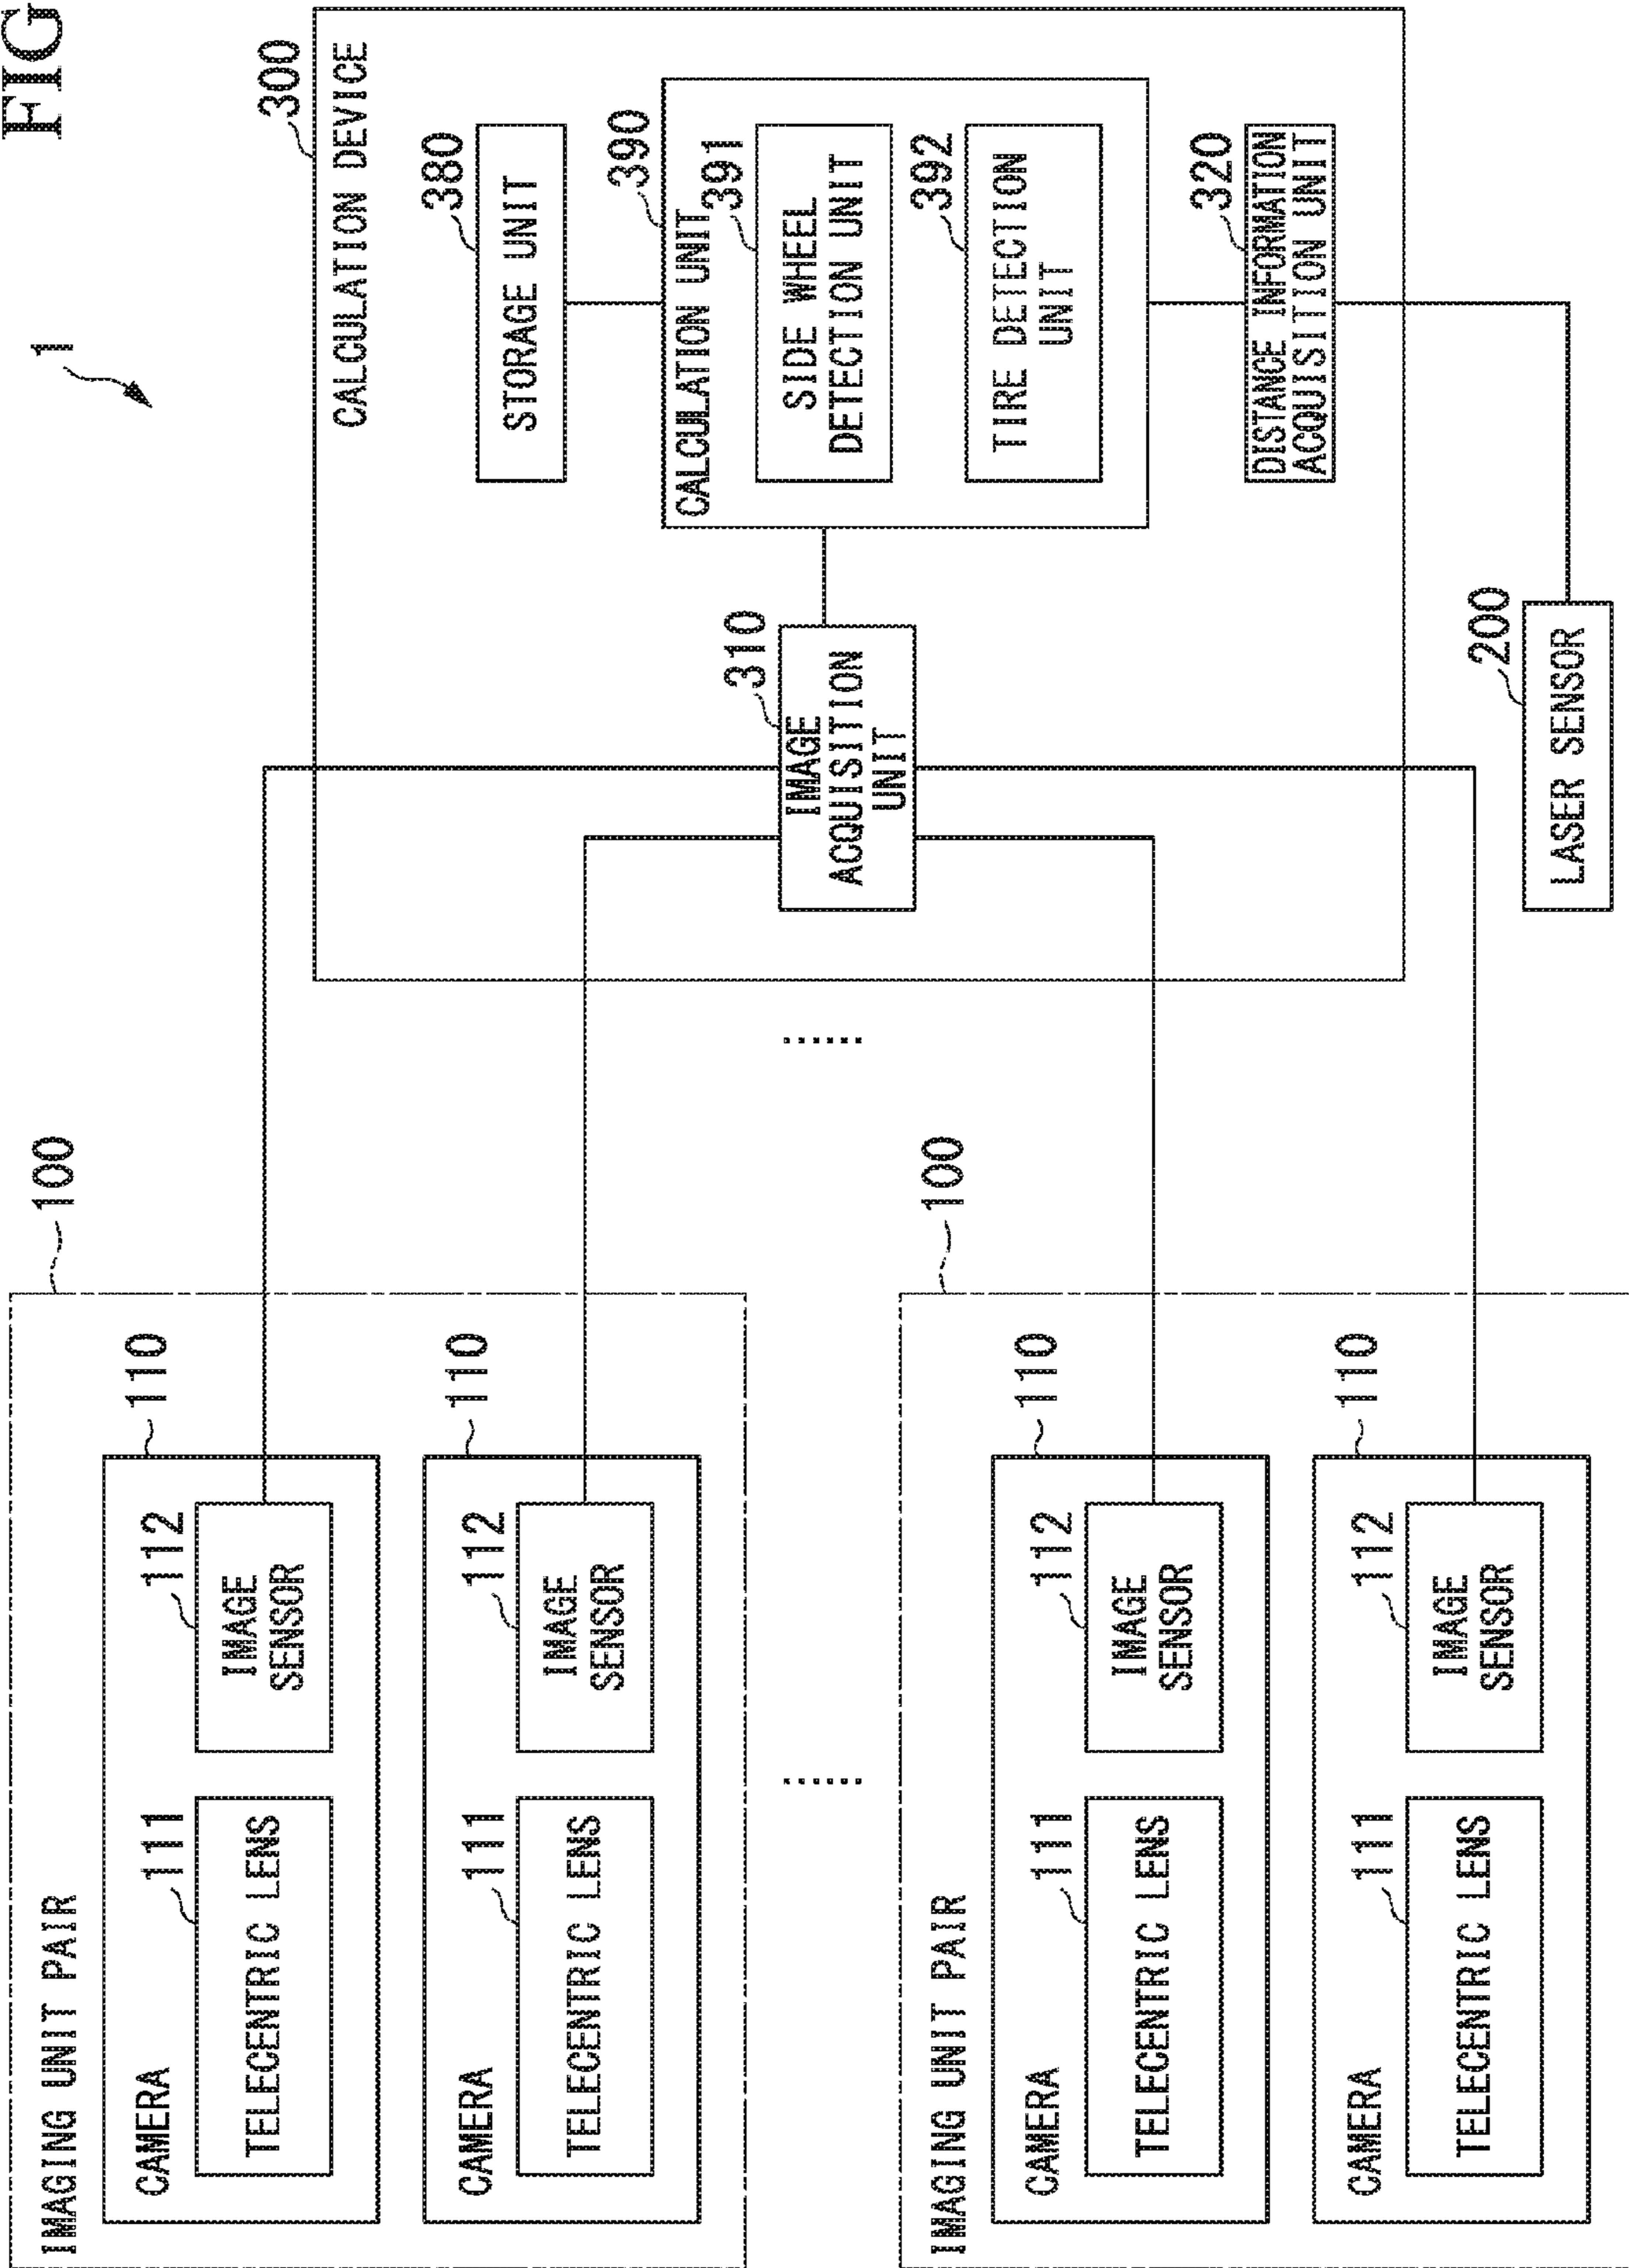
FIG. 1 is a schematic block diagram showing a functional configuration of an abrasion inspection apparatus according to an embodiment of the invention.

FIG. 1 is a schematic block diagram showing a functional configuration of an abrasion inspection apparatus according to an embodiment of the invention. In FIG. 1, an abrasion inspection apparatus 1 includes cameras 110, a laser sensor 200, and a calculation device 300. The camera 110 includes a telecentric lens 111 and an image sensor 112. The calculation device 300 includes an image acquisition unit 310, a distance information acquisition unit 320, a storage unit 380, and a calculation unit 390. The calculation unit 390 includes a guide wheel and branching wheel abrasion situation detection unit (hereinafter referred to as a side wheel detection unit) 391 and a tire abrasion situation detection unit (hereinafter referred to as a tire detection unit) 392.

Two cameras 110 are paired to configure an imaging unit pair 100. The number of imaging unit pairs 100 included in the abrasion inspection apparatus 1 may be 1 or more.

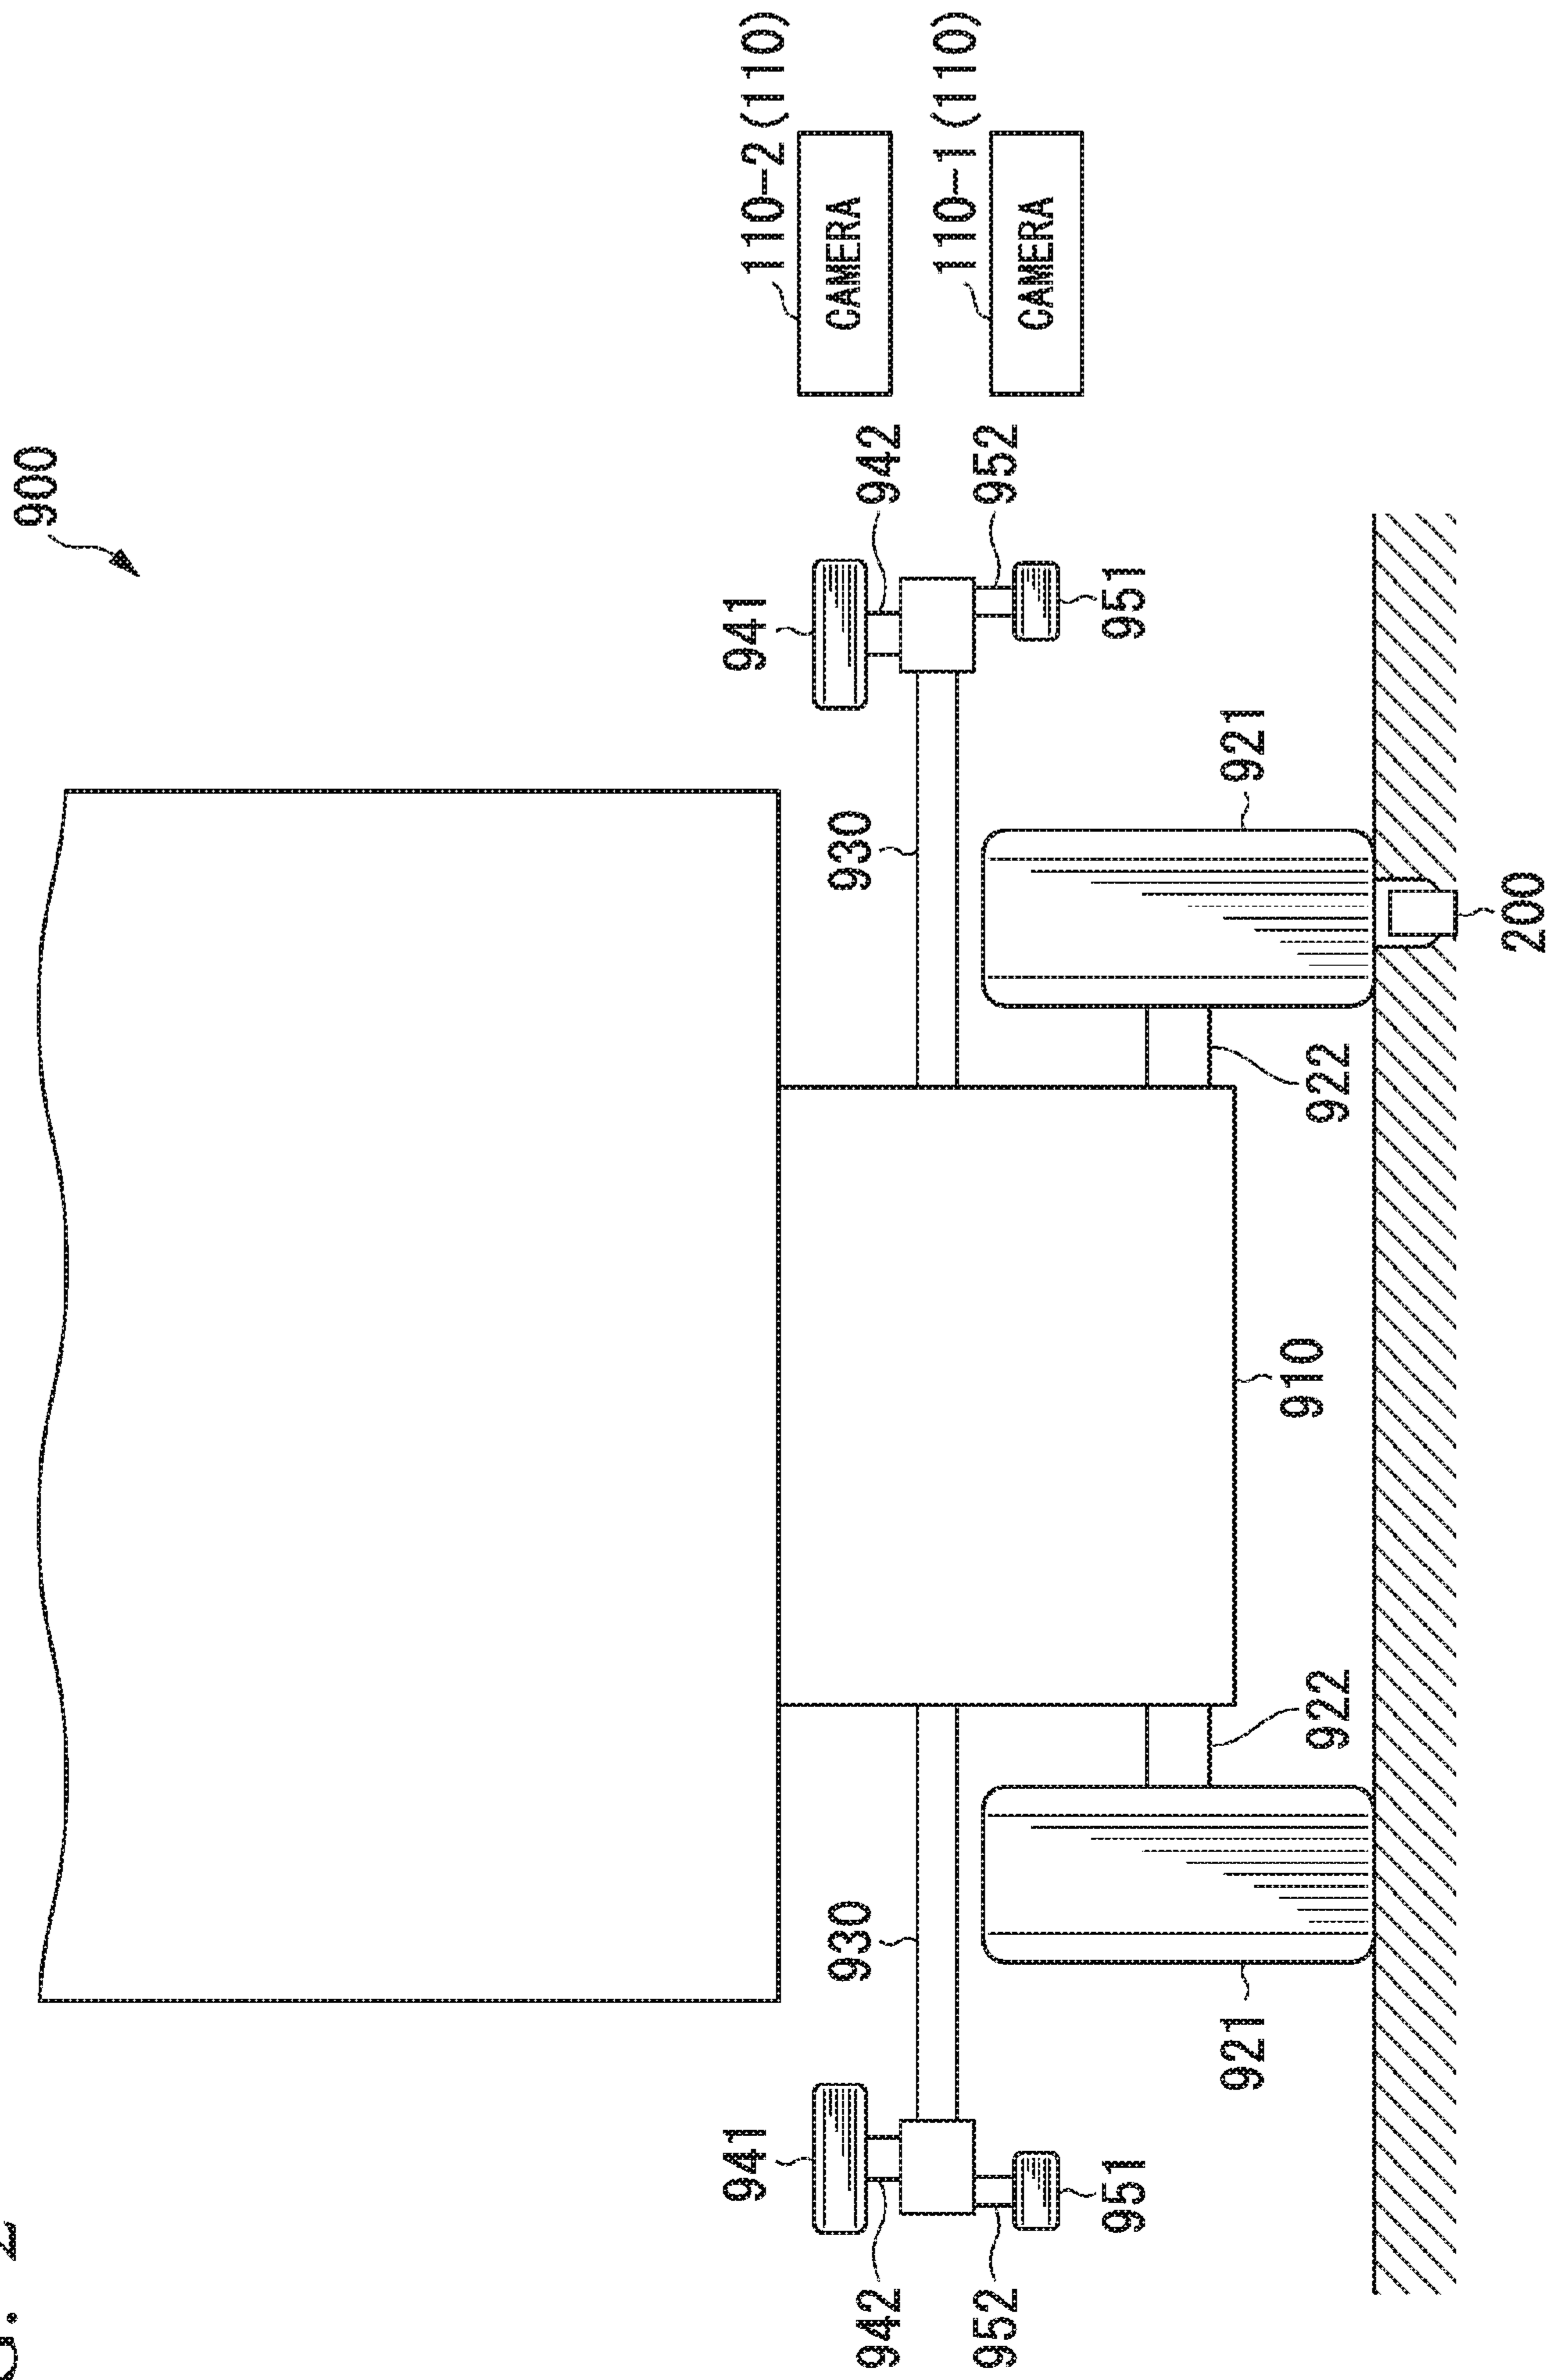
FIG. 2 is an exterior diagram showing a schematic exterior of a lower portion of a vehicle when viewed from the front side according to the embodiment.

FIG. 2 is an exterior diagram showing a schematic exterior of a lower portion of the vehicle when viewed from the front side. In a vehicle 900 shown in FIG. 2, traveling tires 921 are installed on the right and left of a vehicle body 910 via shafts 922 and are in contact with a road surface. Supports 930 are installed on the right and left of the vehicle body 910. In the supports 930, guide wheels 941 are

installed via shafts 942. In the supports 930, branching wheels 951 are installed via shafts 952.

The traveling tires 921 rotate about the shafts 922 so that the vehicle 900 travels. The guide wheels 941 come into contact with guide rails installed on the sides of a track along which the vehicle 900 travels and limit a traveling direction of the vehicle 900 so that the vehicle 900 can travel along the track. The branching wheels 951 come into contact with guide rails installed on the sides of the track and limit the traveling direction of the vehicle 900 at a branching point of the track to control the traveling direction of the vehicle 900 at the branching point.

FIG. 2 shows a disposition example of the cameras 110 and the laser sensor 200. As the cameras 110, cameras 110-1 and 110-2 are installed on the side of the track to image the inside of the track. The camera 110-1 is installed at a height at which the guide wheel 941 is imaged in the horizontal direction. An image captured by the camera 110-1 is used for the side wheel detection unit 391 to determine an abrasion situation of the guide wheel 941.

The camera 110-2 is installed at a height at which the branching wheel 951 is imaged in the horizontal direction. An image captured by the camera 110-2 is used for the side wheel detection unit 391 to determine an abrasion situation of the branching wheel 951.

The laser sensor 200 is installed in a hole formed on the road surface. As will be described below, the laser sensor 200 is installed in a direction which has an inclination in the traveling direction of the vehicle 900 with respect to the vertical direction.

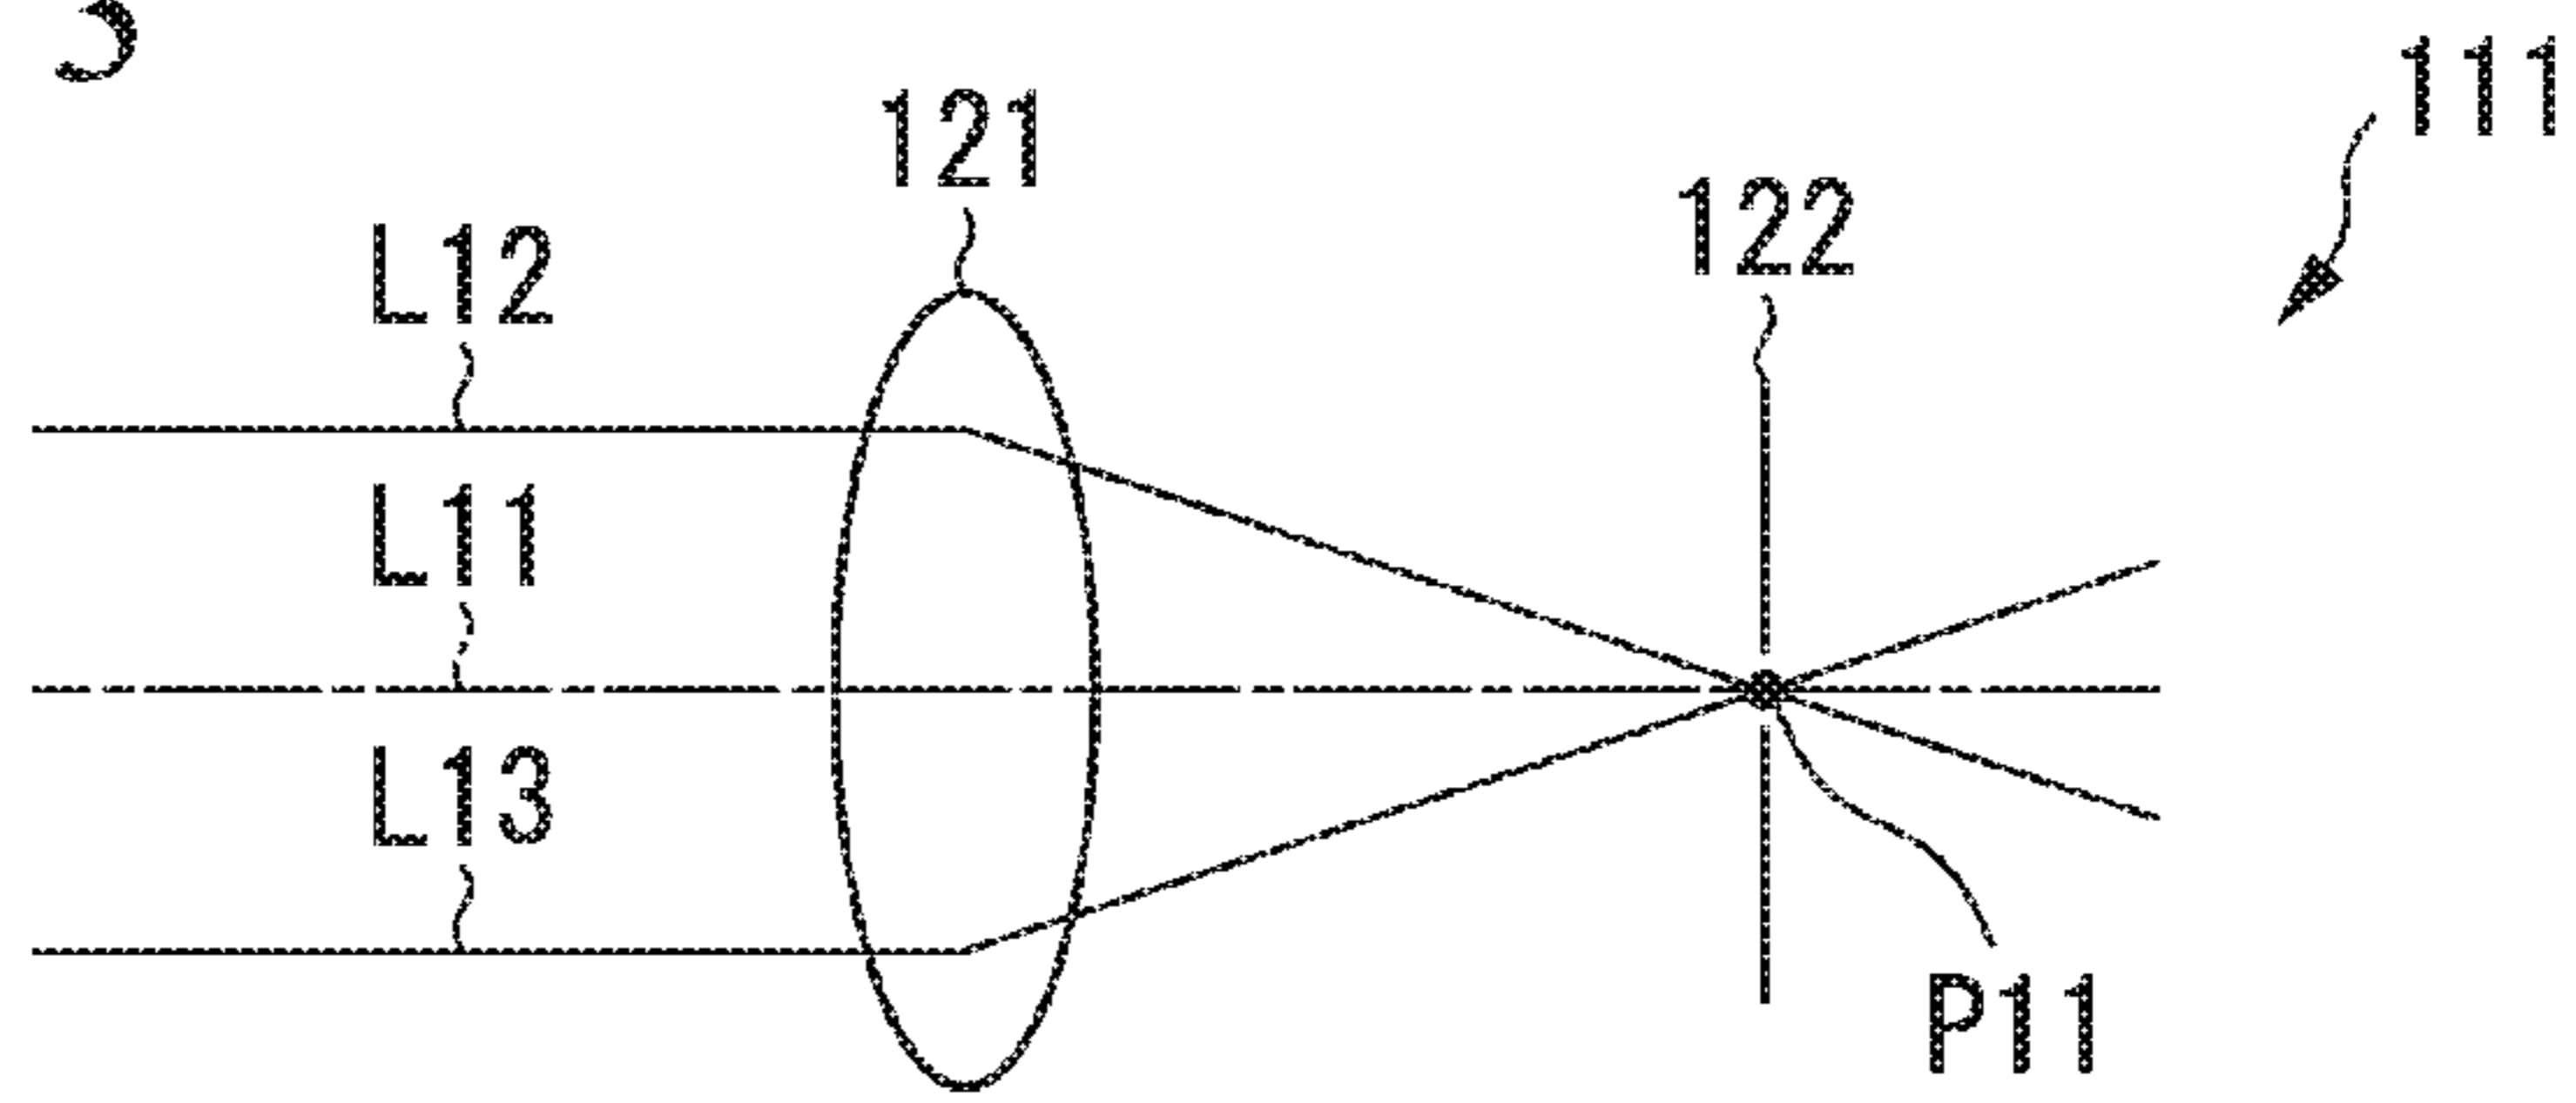
FIG. 3 is an explanatory diagram showing an example of a principal ray in a telecentric lens according to the embodiment.

FIG. 3 is an explanatory diagram showing an example of a principal ray in the telecentric lens 111. In FIG. 3, the telecentric lens 111 includes a lens body 121 and a diaphragm 122. The diaphragm 122 is installed at a position of a focal point P11 of the lens body 121, and thus a principal ray is telecentric on an object side parallel to a lens optical axis. In FIG. 3, a ray L11 indicates the lens optical axis and an example in which both rays L12 and L13 are principal rays is shown.

Both of the rays L12 and L13 indicating the principal rays are parallel to the ray L11 indicating the lens optical axis on the object side (a subject side).

The camera 110 includes the telecentric lens 111. Thus, even when the position of a subject is changed in a depth direction of the camera 110, the position of an image of the subject in a captured image is not changed.

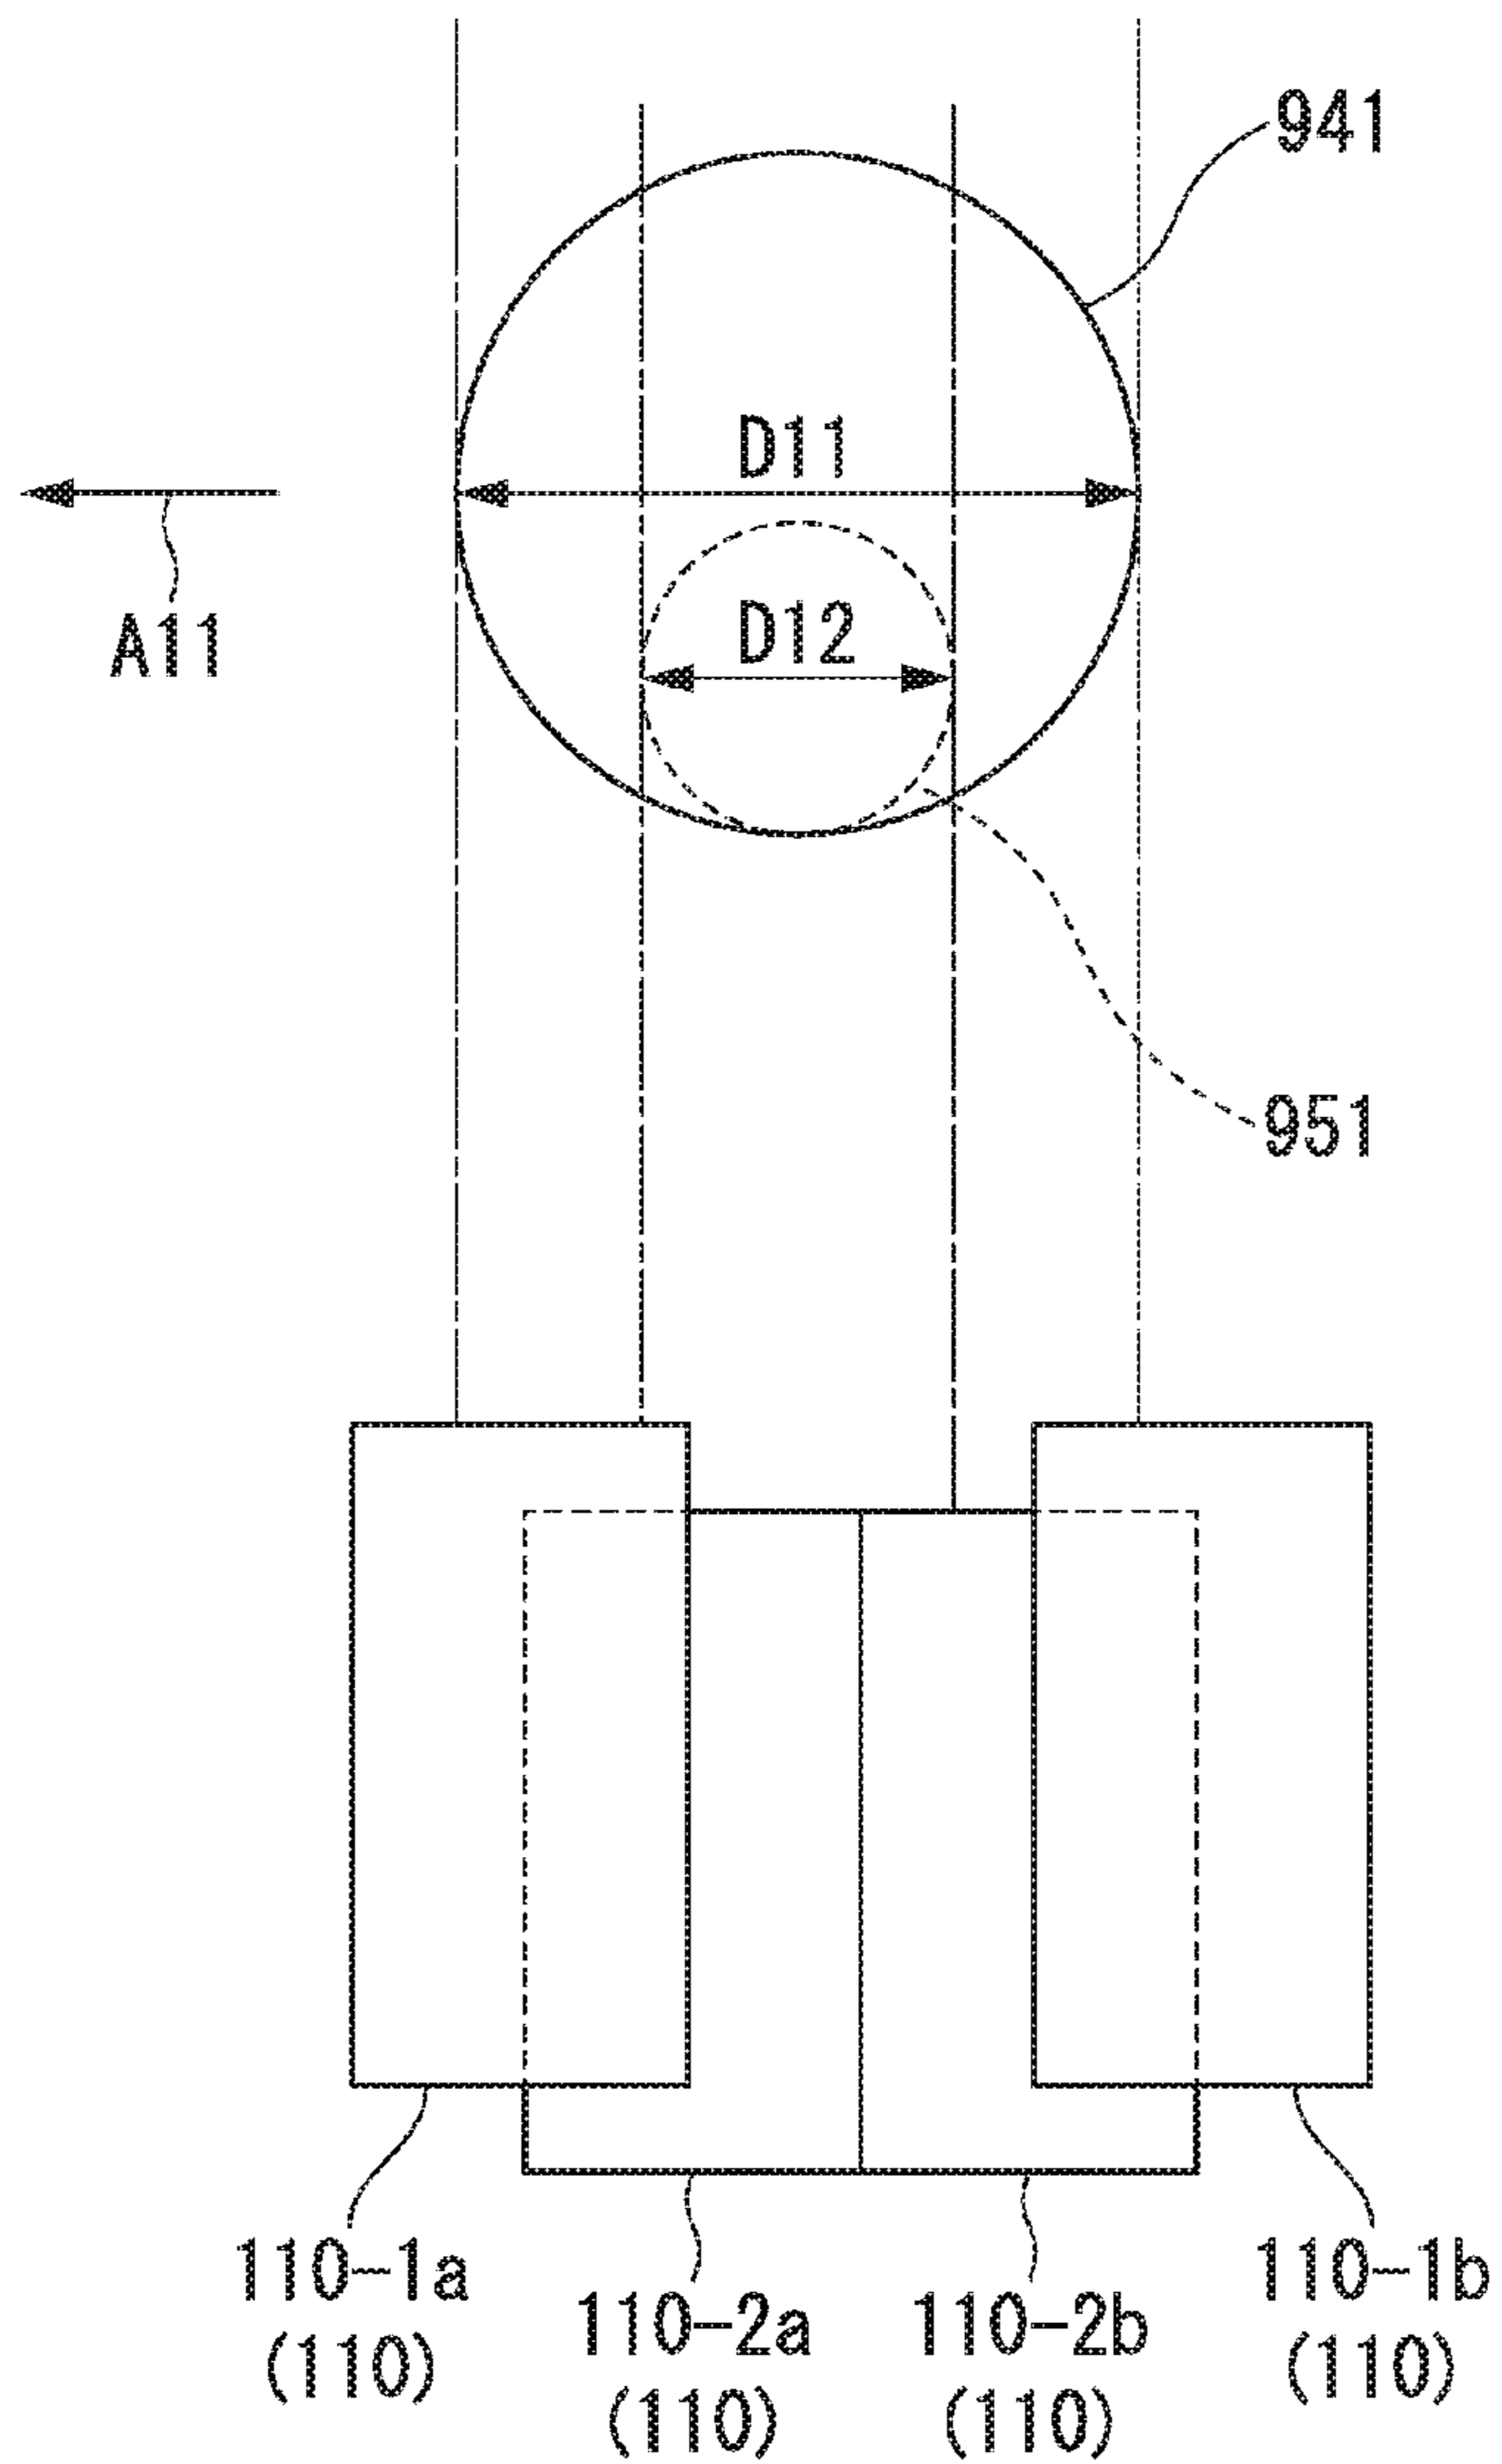
FIG. 4 is an explanatory diagram showing an example of imaged spots of a guide wheel and a branching wheel by a camera according to the embodiment.

FIG. 4 is an explanatory diagram showing an example of imaged spots of the guide wheel 941 and the branching wheel 951 by the camera 110. Cameras 110-1a and 110-1b image the guide wheel 941. Cameras 110-2a and 110-2b image the branching wheel 951. An arrow A11 indicates a traveling direction of the vehicle 900.

Any one of the cameras 110-1a and 110-1b corresponds to a first imaging unit and captures an image which is an image of a boundary of the guide wheel 941 and is an image of a boundary on a first direction side in a vehicle traveling direction. The other of the camera 110-1a and 110-1b corresponds to a second imaging unit and captures an image which is an image of the boundary of the guide wheel 941 and is an image of the boundary on an opposite side to the first direction side. Specifically, the camera 110-1a captures an image of a boundary of the front side in the vehicle traveling direction of the guide wheel 941 and the camera 110-1b captures an image of a boundary of the rear side in the vehicle traveling direction of the guide wheel 941. The camera 110-1a is installed to be separated from the camera 110-1b in the vehicle traveling direction. The cameras 110-1a and 110-1b perform imaging at the same time. However, the imaging timing of the camera 110-1a and the imaging timing of the camera 110-1b is not necessarily precisely simultaneous, but may be substantially simultaneous.

A distance D11 between boundaries of both sides of the side wheel detection unit 391 can be calculated from an image captured by the camera 110-1a and an image captured by the camera 110-1b. Specifically, the side wheel detection unit 391 detects images of the boundaries of the guide wheel 941 from the image captured by the camera 110-1a and the image captured by the camera 110-1b. The side wheel detection unit 391 calculates the distance D11 according to a positional relation of the cameras 110-1a and 110-1b (in particular, the distance between the cameras 110-1a and 110-1b) and the position of the detected image of the boundary in the image which is known at the magnification (the scaling ratio) of the image.

The cameras 110-2a and 110-2b capture images which are images of a boundary of the branching wheel 951 and are images of a boundary on the first direction side in the vehicle traveling direction and capture images which are images of a boundary of the branching wheel 951 and are images of a boundary on the opposite side to the first direction side. Specifically, the camera 110-2a captures an image of a boundary on the front side in the vehicle traveling direction of the branching wheel 951 and the camera 110-2b captures an image of a boundary on the rear side in the vehicle traveling direction of the branching wheel 951. The camera 110-2a is installed in the vehicle traveling direction with respect to the camera 110-2b.

A distance D12 between the boundaries of both sides of the branching wheel 951 can be calculated from an image captured by the camera 110-2a and an image captured by the camera 110-2b. Specifically, the side wheel detection unit 391 detects images of the boundaries of the branching wheel 951 from the image captured by the camera 110-2a and the image captured by the camera 110-2b. The side wheel detection unit 391 calculates the distance D12 according to a positional relation of the cameras 110-2a and 110-2b (in particular, the distance between the cameras 110-2a and 110-2b) and the position of the detected image of the boundary in the image which is known at the magnification (the scaling ratio) of the image.

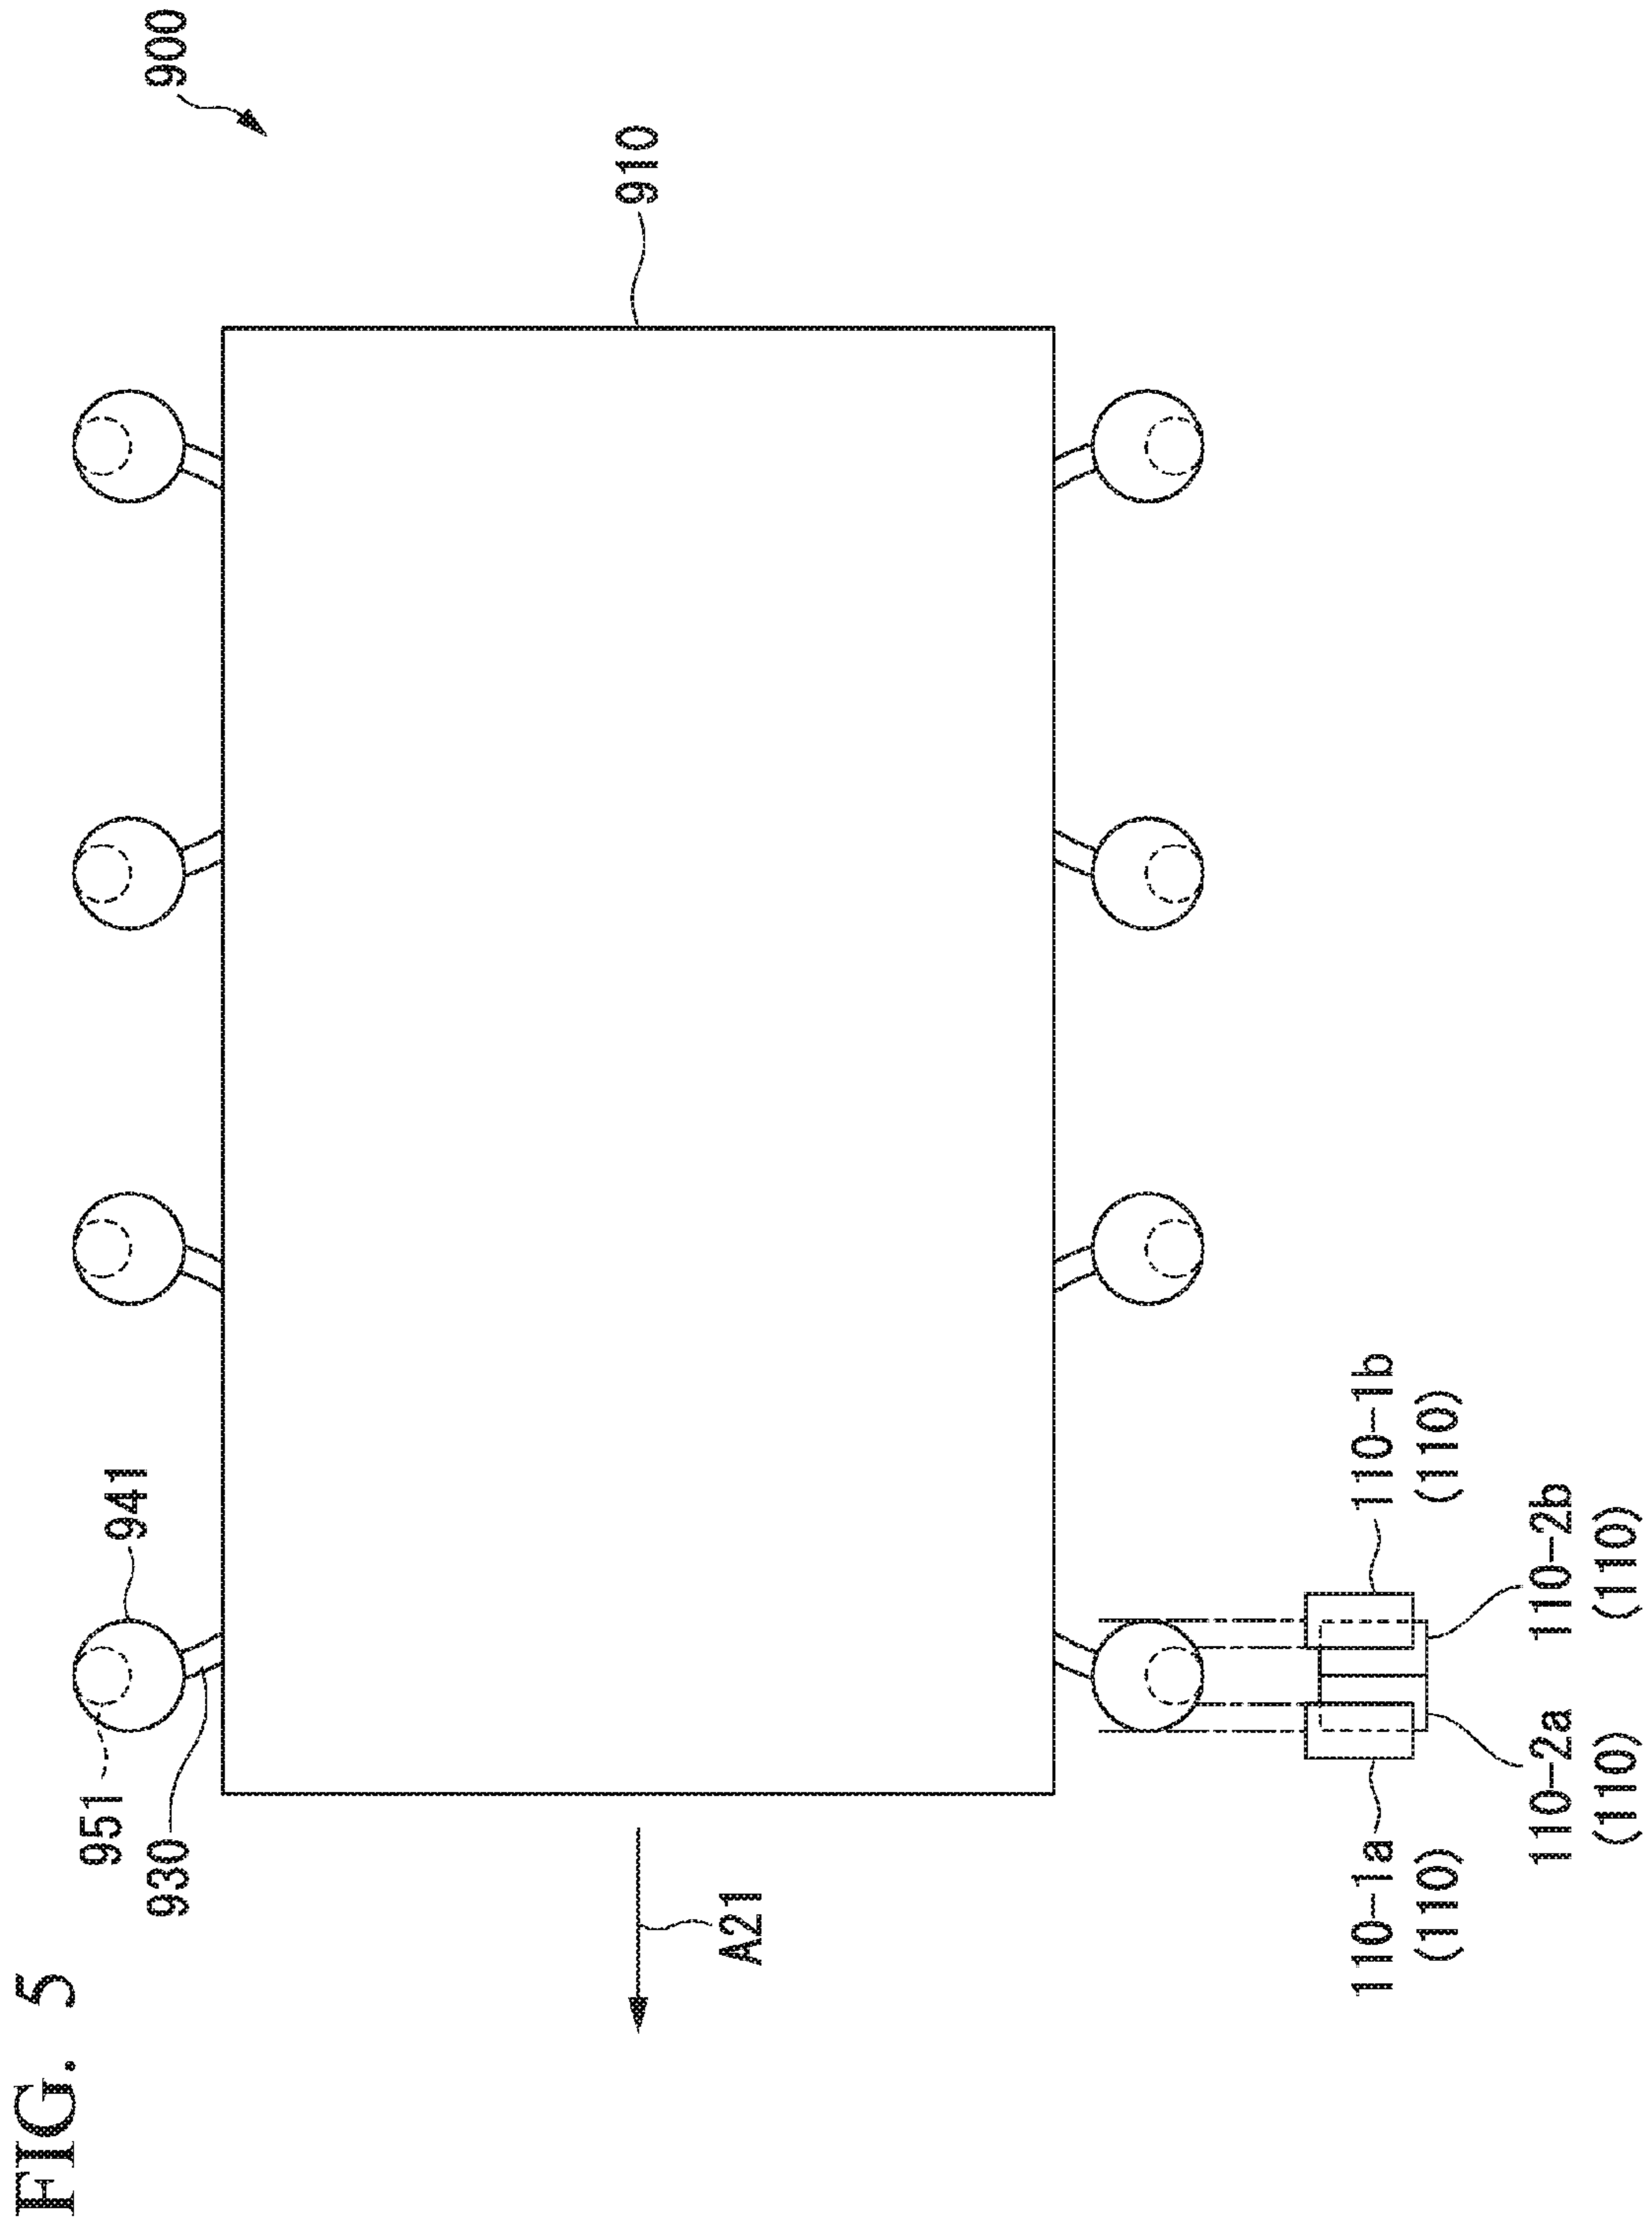
FIG. 5 is an exterior diagram showing a schematic exterior of the vehicle when viewed from the upper side according to the embodiment.

FIG. 5 is an exterior diagram showing a schematic exterior of the vehicle 900 when viewed from the upper side. As described with reference to FIG. 2, the supports 930 are installed to the right and left of the vehicle body 910. The guide wheels 941 and the branching wheels 951 are installed in the supports 930.

As the cameras 110, the cameras 110-1a, 110-1b, 110-2a, and 110-2b are installed on the sides of the track to image the inside of the track. As described with reference to FIG. 4, the cameras 110-1a and 110-1b image the guide wheels 941. The cameras 110-2a and 110-2b image the branching wheels 951. An arrow A21 indicates a traveling direction of the vehicle 900.

The plurality of guide wheels 941 and the plurality of branching wheels 951 are installed on each of the sides of the vehicle body 910. For example, the cameras 110-1a and 110-1b may capture images of the boundary whenever the boundary of the guide wheel 941 is located in front of the cameras 110. For example, the cameras 110-1a and 110-1b continuously perform imaging. Thus, the side wheel detection unit 391 can determine abrasion situations of the plurality of guide wheels 941. For example, the cameras 110-2a and 110-2b may capture images of the boundary whenever the boundary of the branching wheel 951 is located in front of the cameras 110. For example, the cameras 110-2a and 110-2b continuously perform imaging. Thus, the side wheel detection unit 391 can determine the abrasion situations of the plurality of branching wheels 951.

FIG. 5 shows an example of a case in which the cameras 110 are installed only on one of the sides of the track, but the cameras 110 may be installed on both sides of the track.
