US010458776B2

(54) **ABRASION INSPECTION APPARATUS,
ABRASION INSPECTION METHOD, AND
PROGRAM**

(71) Applicant: **mitsubishi heavy industries,
LTD.**, Tokyo (JP)

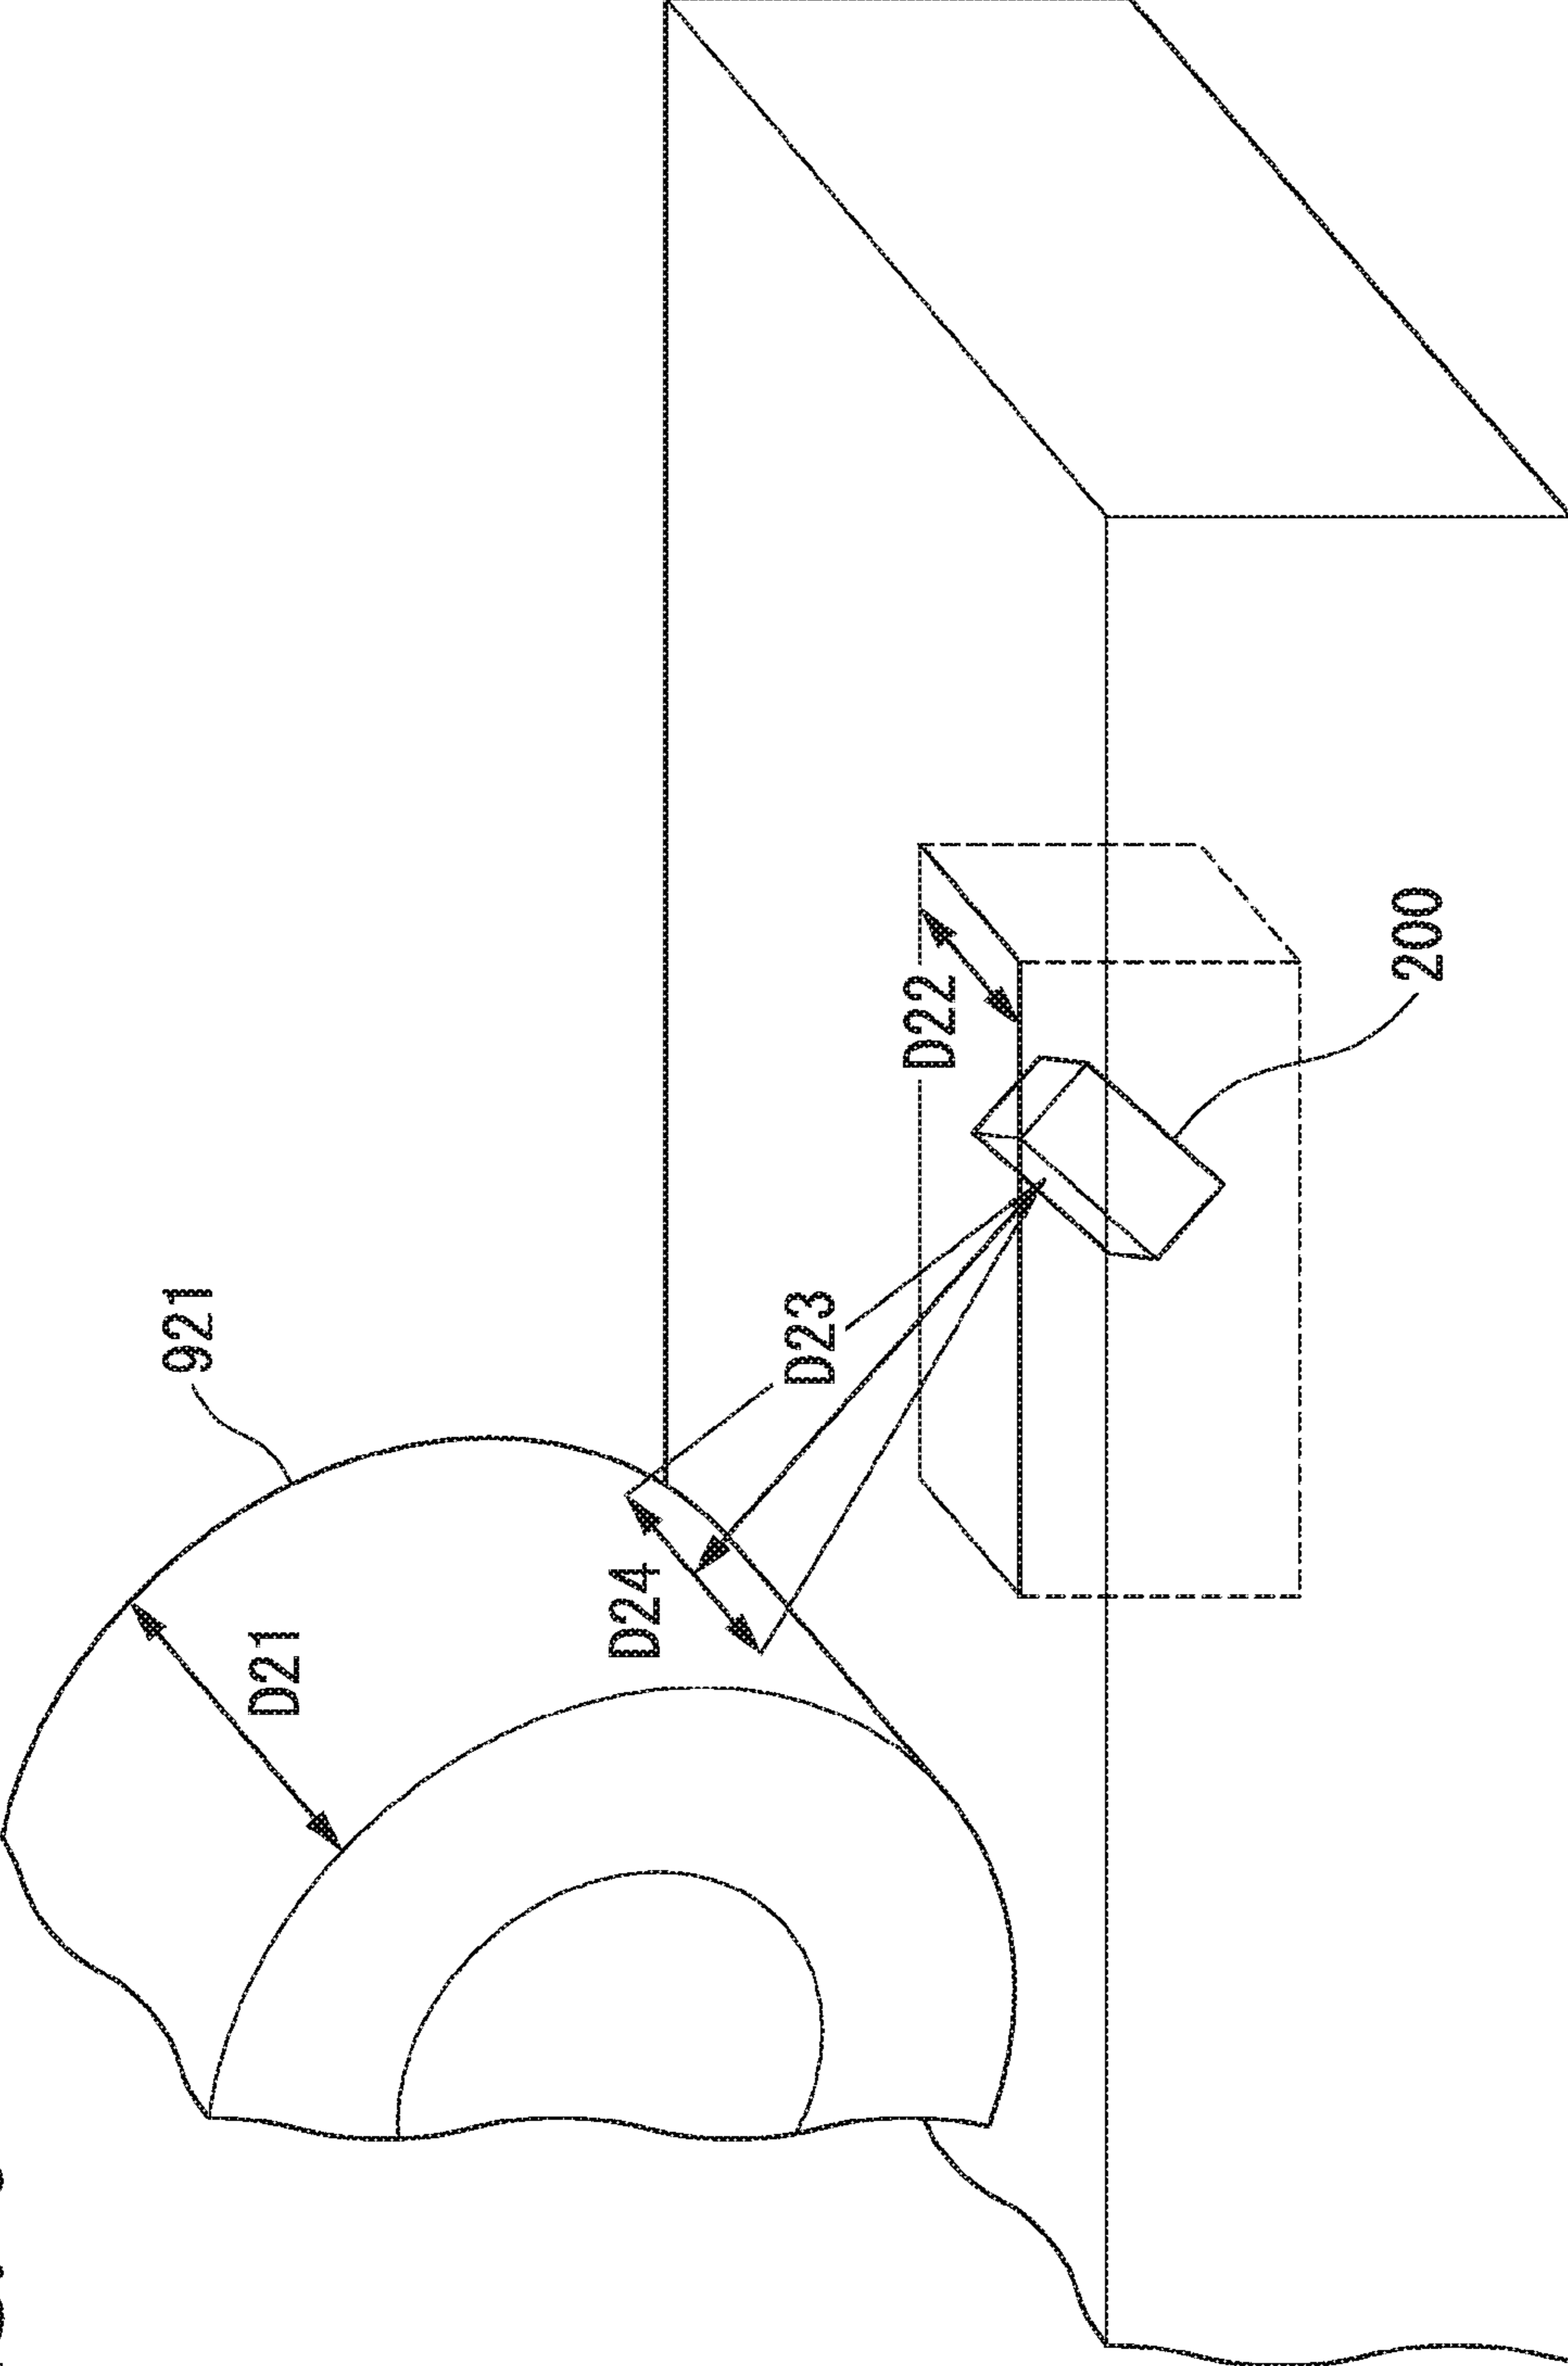
FIG. 6 is an explanatory diagram showing an installation example of a laser sensor according to the embodiment.

FIG. 6 is an explanatory diagram showing an installation example of the laser sensor 200. In FIG. 6, a hole with a width D22 narrower than a width D21 of the traveling tire 921 is installed at a position at which the traveling tire 921 travels on the road surface and the laser sensor 200 is installed in the hole. The laser sensor 200 radiates a laser beam with a width D24 that expands on the traveling tire 921

to measure a distance between the laser sensor 200 and each portion. Accordingly, the laser sensor 200 measures a distance between the laser sensor 200 and each portion in a line form in the width direction of the traveling tire 921.

For example, the width D21 of the traveling tire 921 is about 300 millimeters (mm) and the width D22 of the hole is about 50 millimeters. The laser sensor 200 measures a distance to each portion with the width D24 of about 250 millimeters at the position of the traveling tire 921 from which a radiation distance of the laser beam is about 450 millimeters.

As shown in FIG. 6, the laser sensor 200 is installed on a lower side of the track and is installed to measure a distance to the traveling tire 921 located on an upper side which has an inclination in the vehicle traveling direction with respect to the vertical direction. In this way, the laser sensor 200 measures a distance to the traveling tire 921 located in a direction which has an inclination in the vehicle traveling direction with respect to the vertical direction. As a result, the laser sensor 200 can perform the measurement in a state in which the traveling tire 921 is not in contact with the ground, and accordingly, in a state in which the traveling tire 921 is weightless.

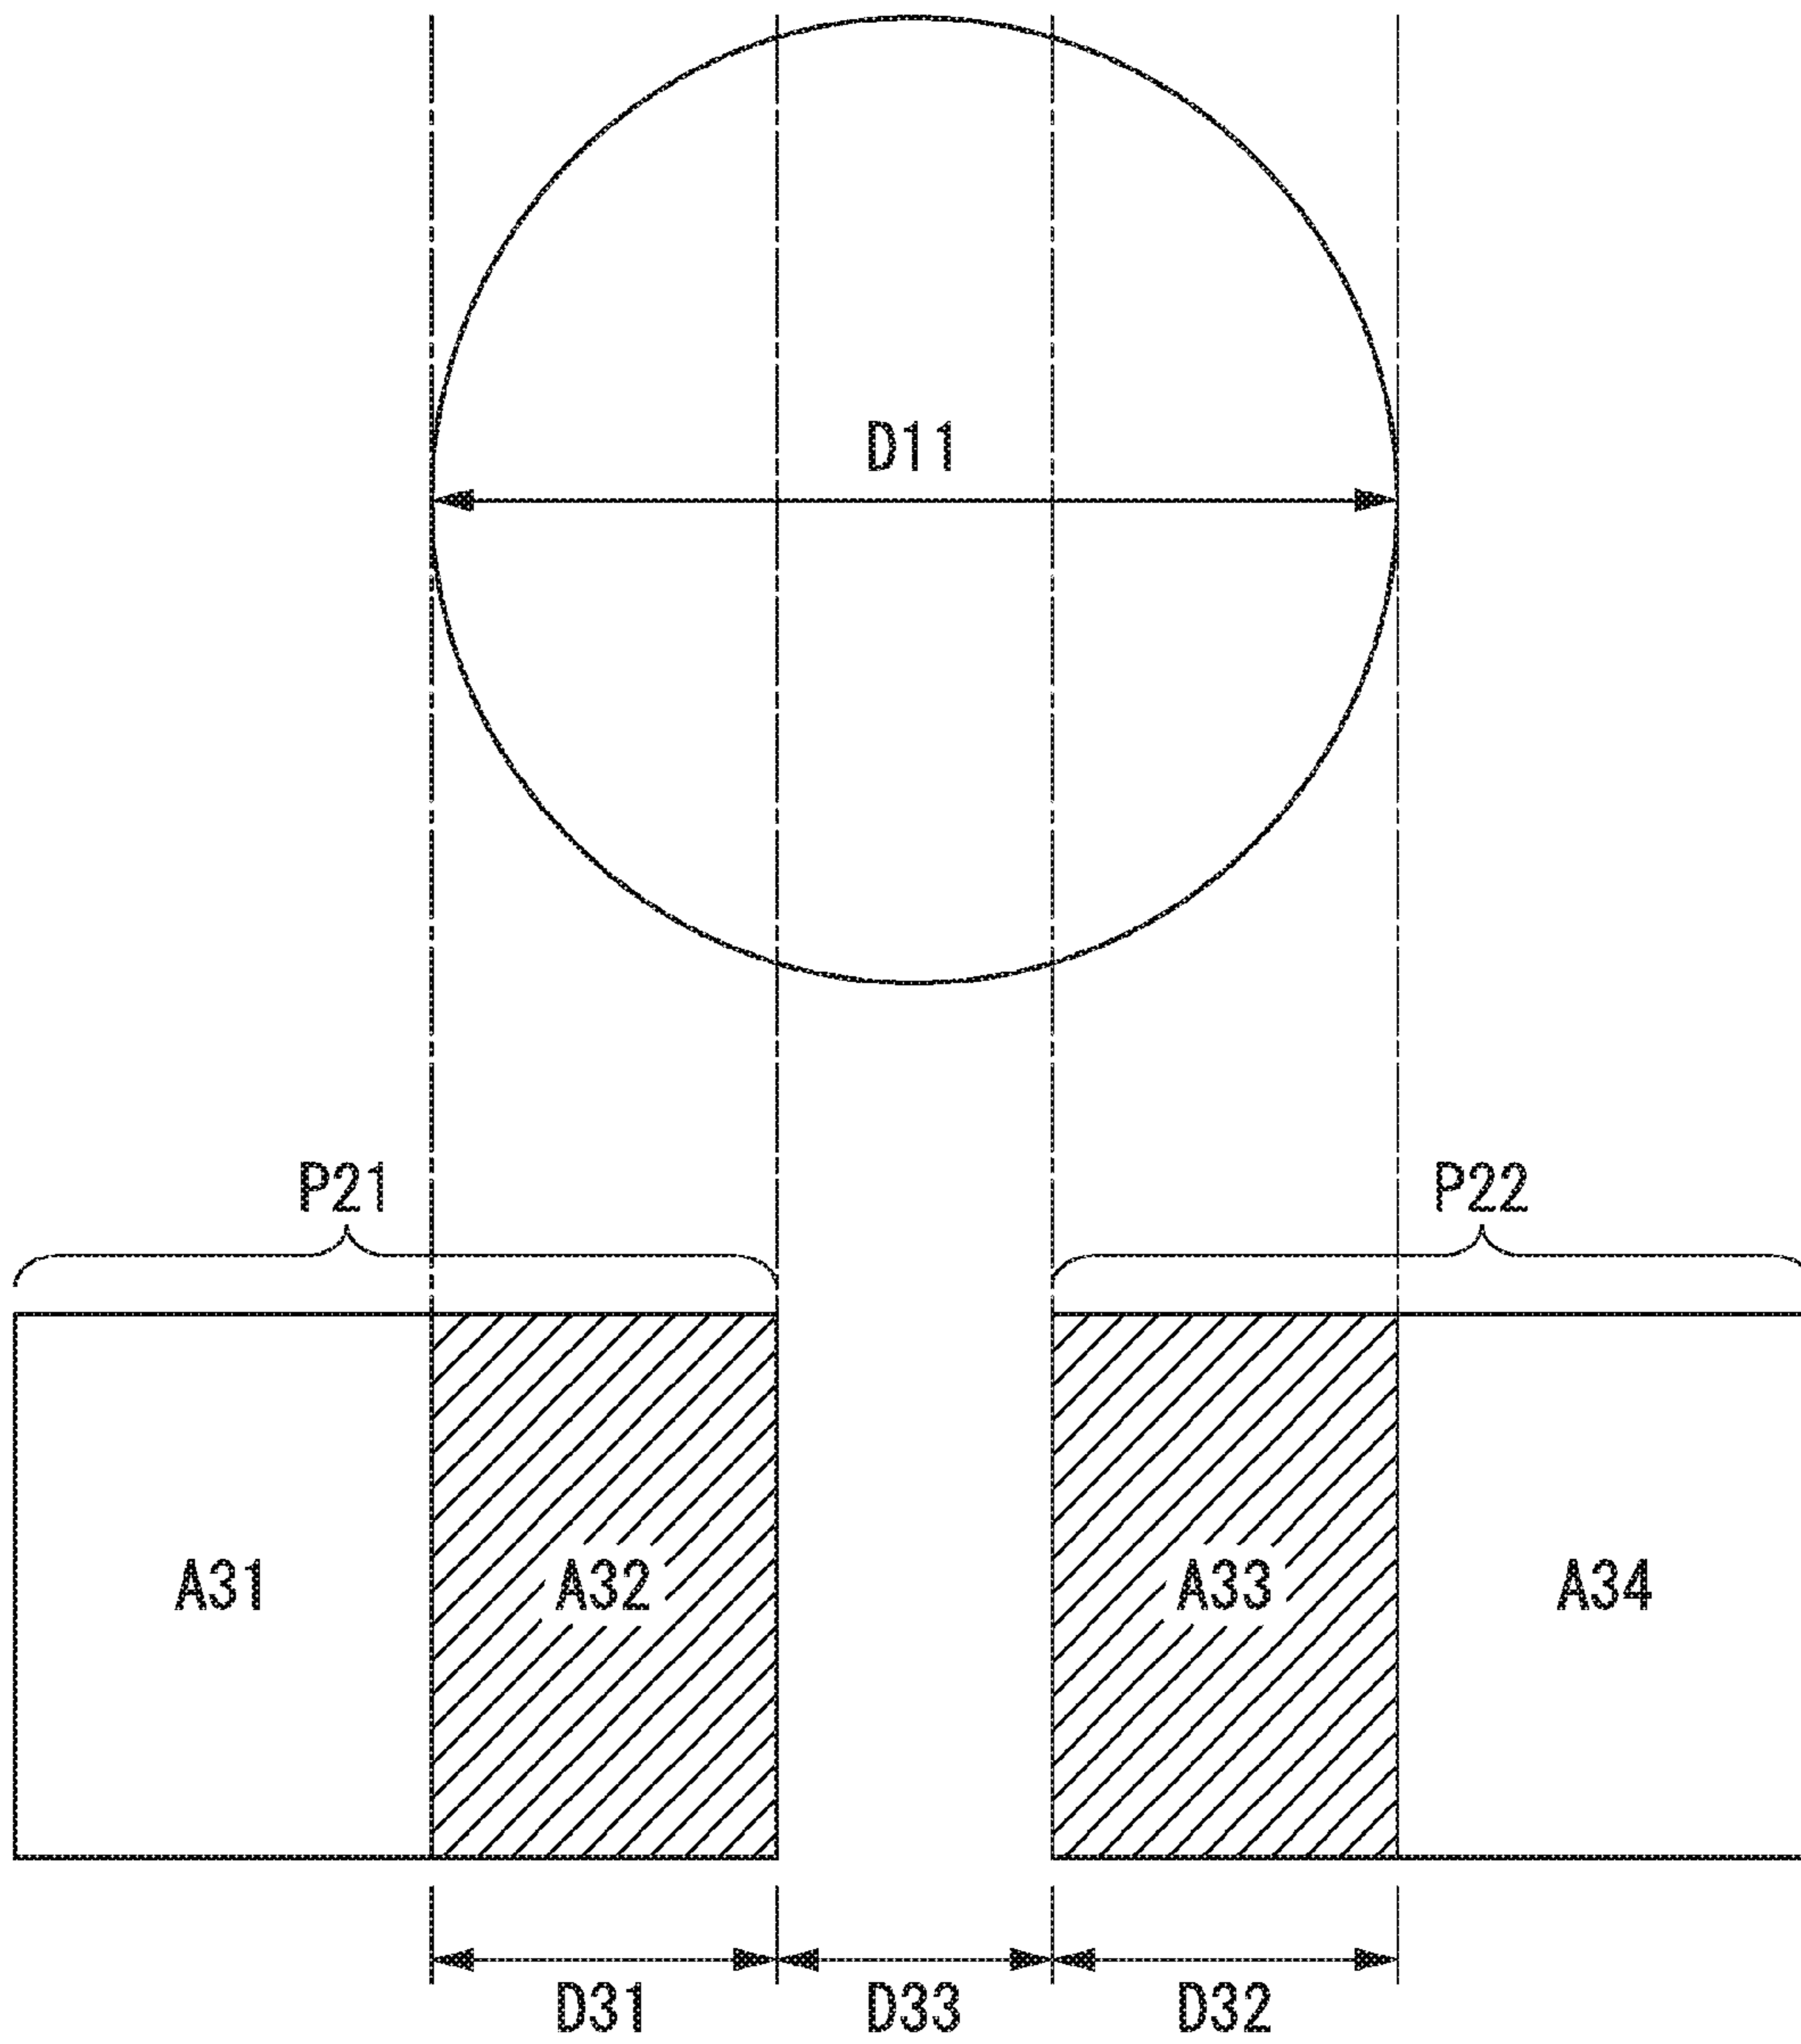
FIG. 7 is an explanatory diagram showing an example of a correspondence relation between an image captured by the camera and the guide wheel according to the embodiment.

FIG. 7 is an explanatory diagram showing an example of a correspondence relation between an image captured by the camera **110** and the guide wheel **941**. In FIG. 7, an image **P21** is an example of an image which is an image of the boundary of the guide wheel **941** captured by the camera **110** (for example, the camera **110-1a** in FIG. 4) and is an image of the boundary on the first direction side in the vehicle traveling direction. In the image **P21**, a region **A31** is a region other than an image of the guide wheel **941** and a region **A32** is a region of the image of the guide wheel **941**. A distance **D31** indicates an actual width of a portion equivalent to the region **A32** in the guide wheel **941**. The side wheel detection unit **391** stores a magnification (a scaling ratio) of an image captured by the camera **110** in advance, detects the width of the region **A32** in the image **P21**, and calculates the distance **D31** by dividing the obtained width by the magnification.

An image **P22** is an example of an image which is an image of the boundary on the other side of the vehicle traveling direction in the guide wheel **941** captured by the camera **110** (for example, the camera **110-1b** in FIG. 4). In the image **P22**, a region **A33** is a region of the image of the guide wheel **941** and a region **A34** is a region other than an image of the guide wheel **941**. A distance **D32** indicates an actual width of a portion equivalent to the region **A33** in the guide wheel **941**. The side wheel detection unit **391** detects the width of the region **A33** in the image **P22** and calculates the distance **D32** by dividing the obtained width by the magnification of the image **P22**.

A distance **D33** is a distance equivalent to a gap between the images **P21** and **P22**. The distance **D33** is a fixed distance corresponding to a distance at which two cameras **110** are installed away from each other. For example, a user of the abrasion inspection apparatus **1** registers the distance **D33** and the storage unit **380** stores the distance **D33** in advance.

The side wheel detection unit **391** calculates the width (the distance **D11**) between the boundaries of the guide wheel **941** by calculating the distances **D31** and **D32**, reading the distance **D33** from the storage unit **380**, and calculating a sum of the distances **D31**, **D32**, and **D33**. The distance **D11** is equivalent to the diameter of the guide wheel **941**.

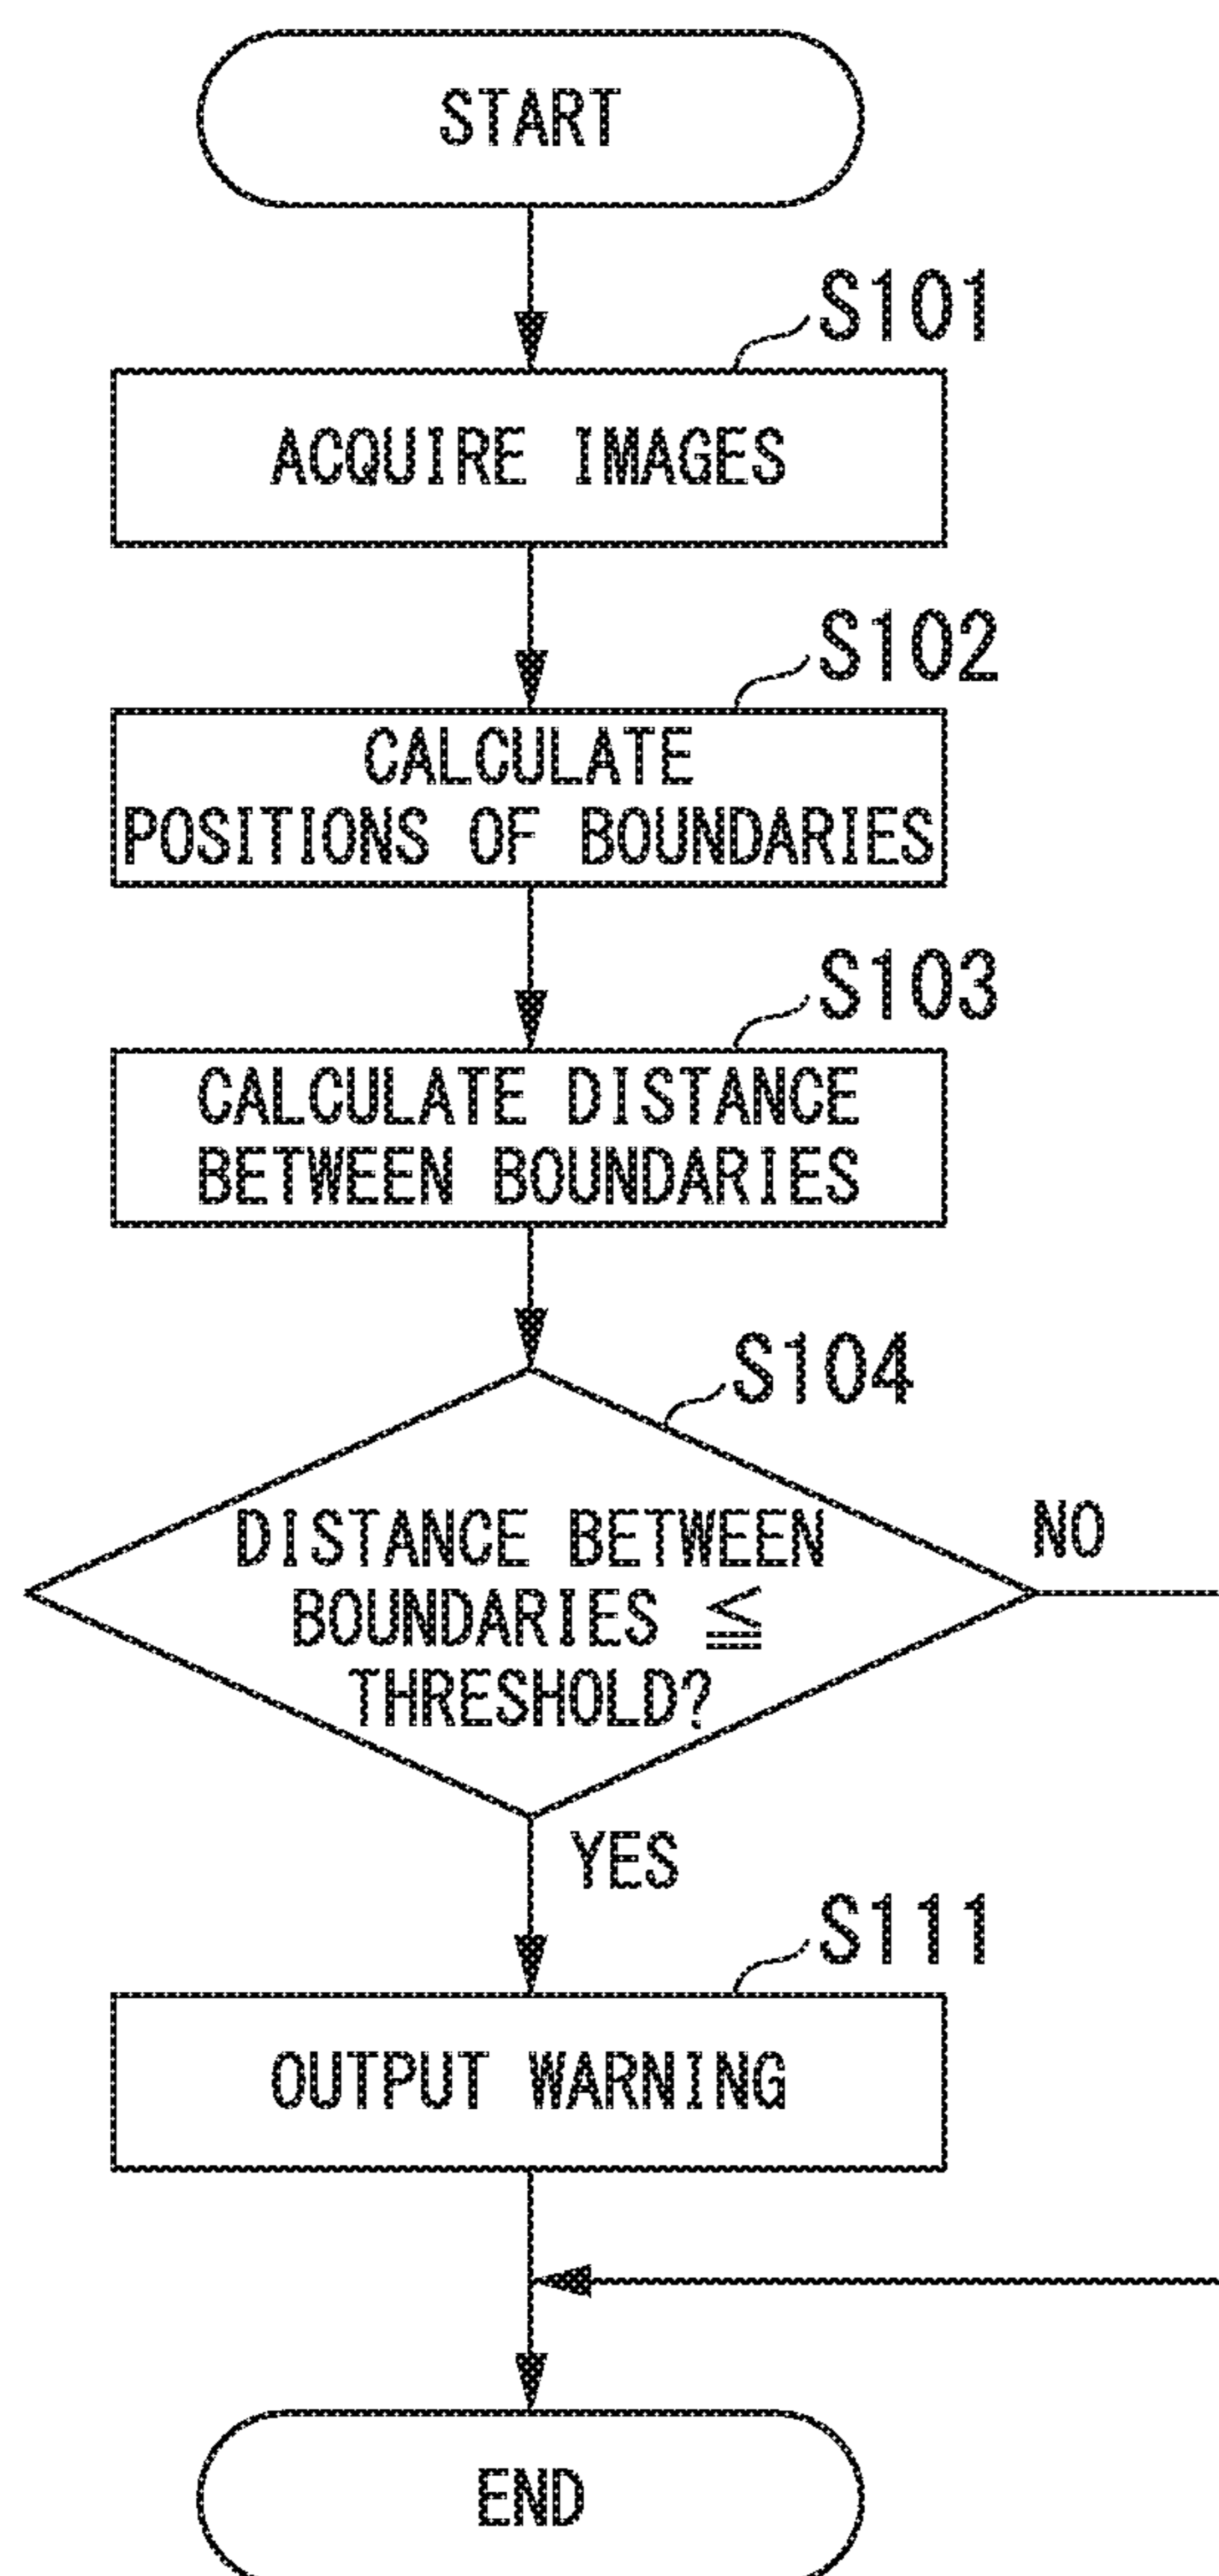
FIG. 8 is a flowchart showing an example of a process procedure in which a calculation device detects the abrasion situation of the guide wheel according to the embodiment.

After step **S111**, the process of FIG. **8** ends.

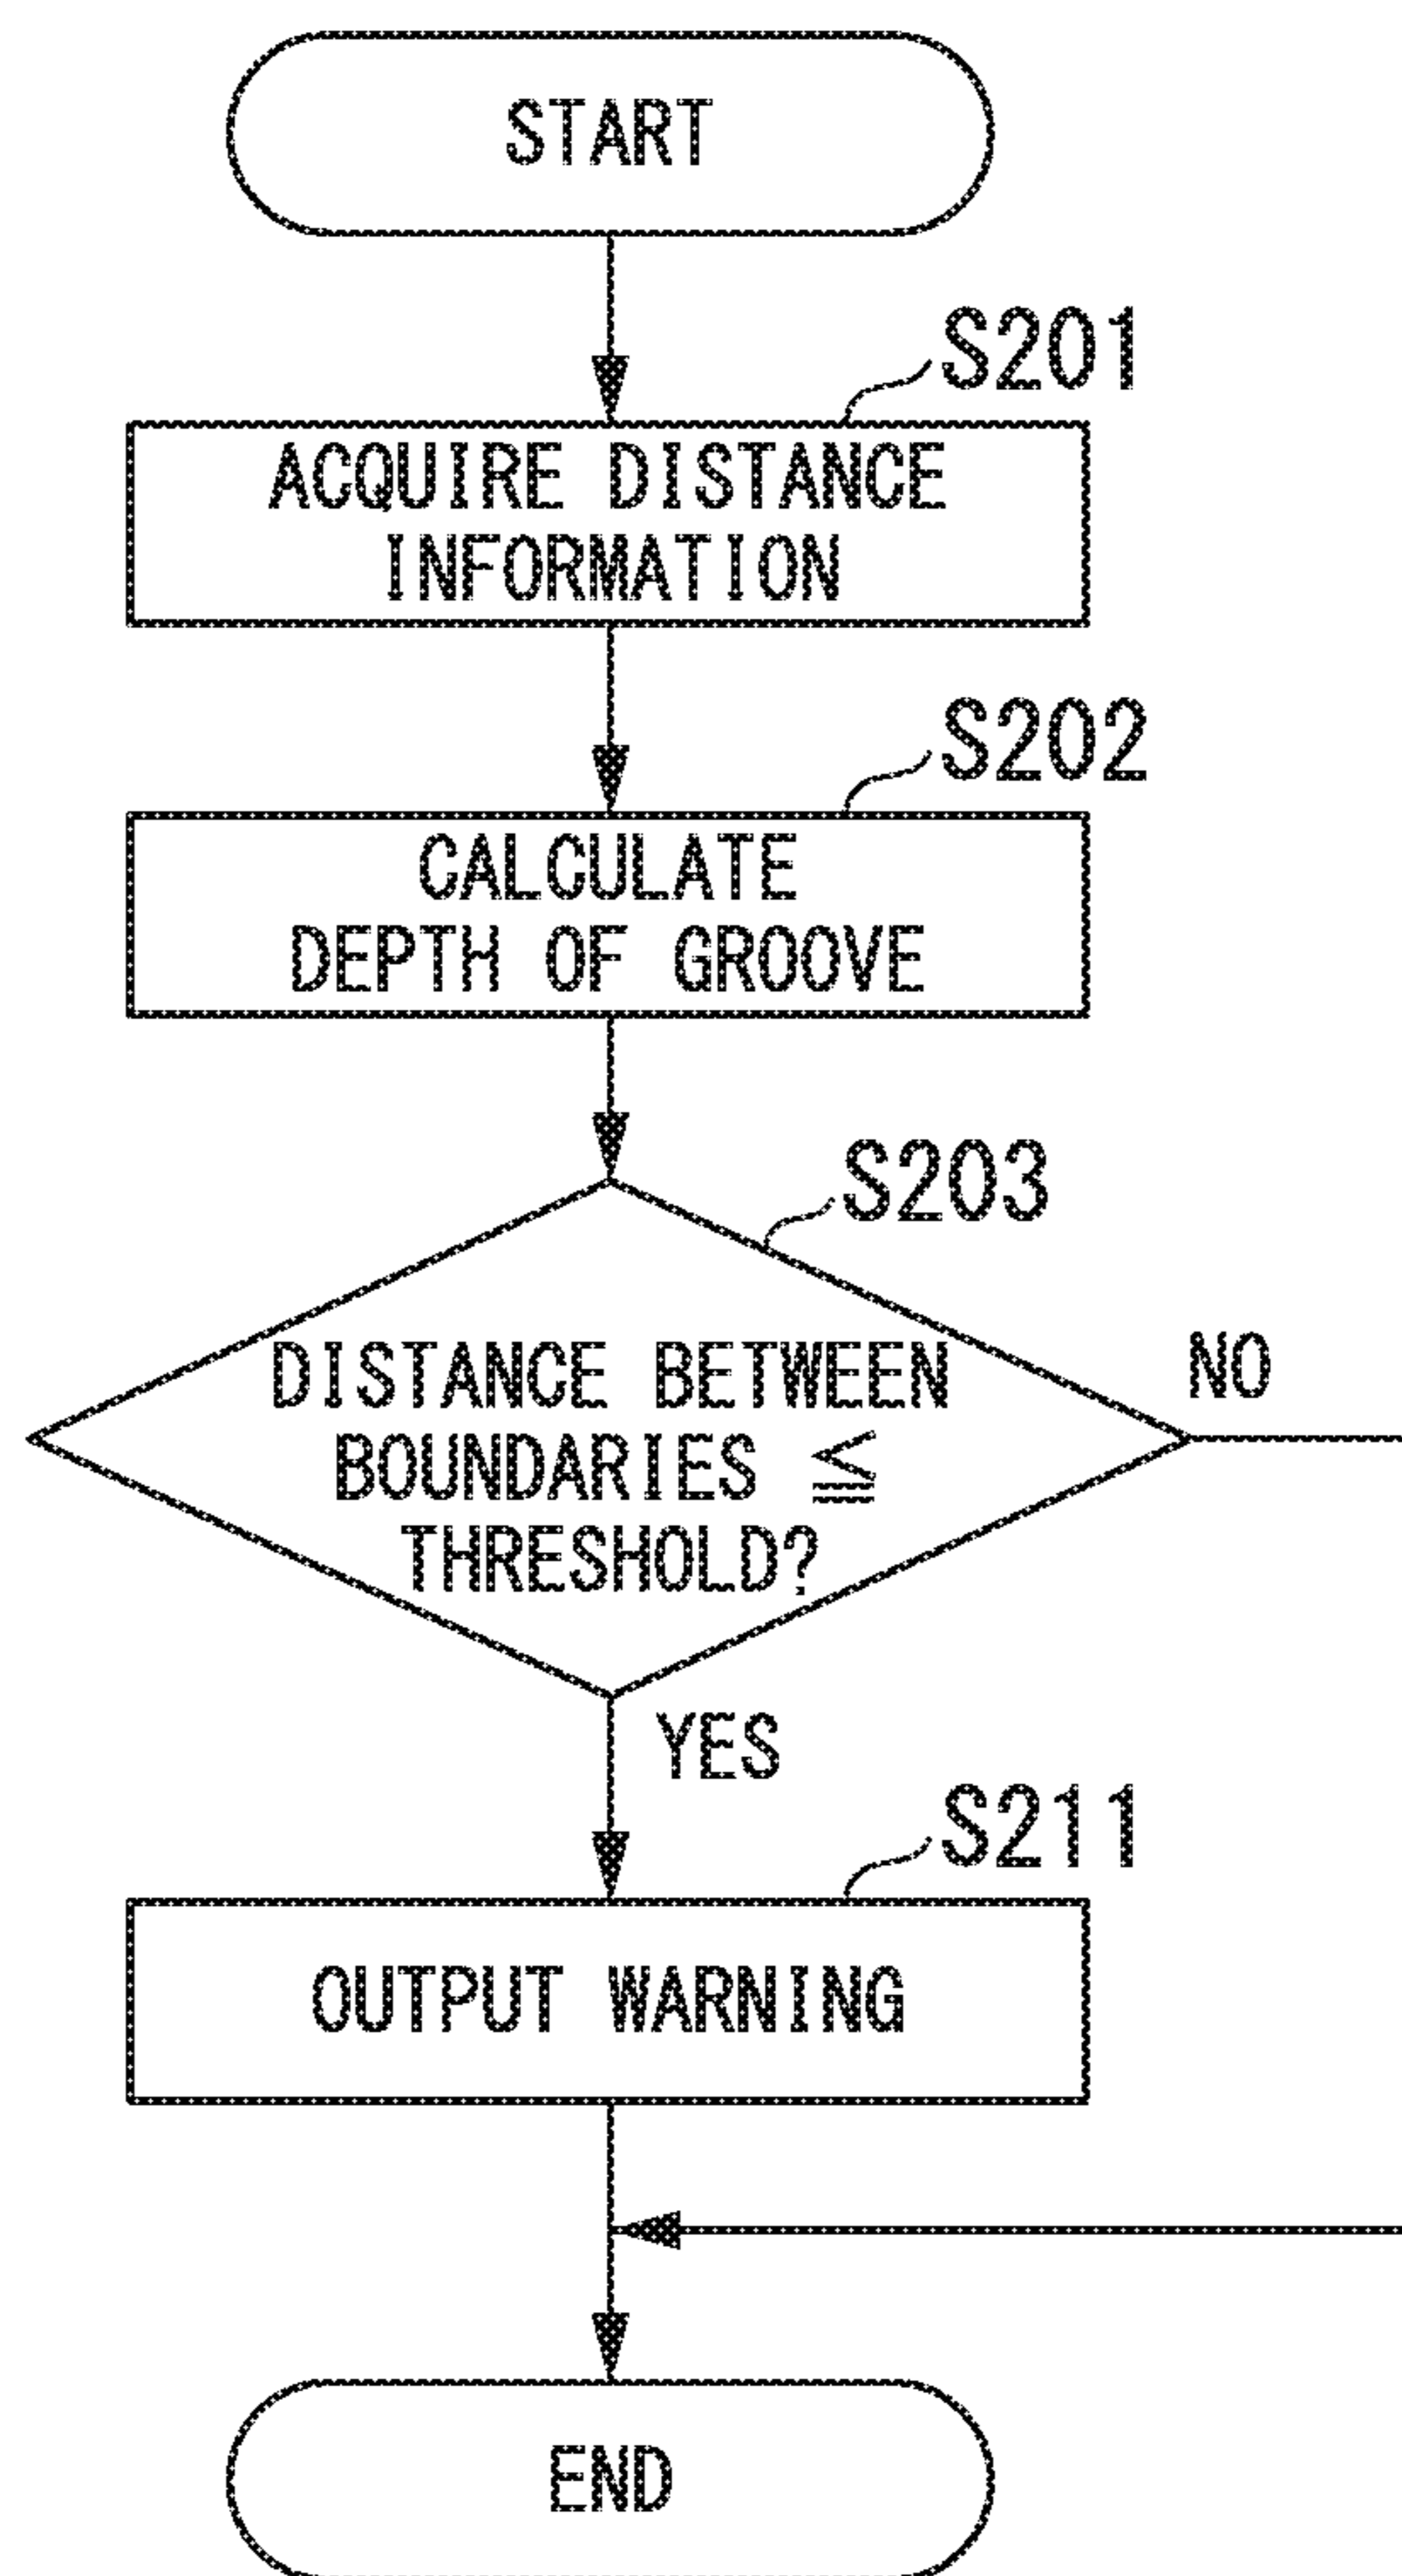
FIG. 9 is a flowchart showing an example of a process procedure in which the calculation device detects the abrasion situation of a traveling tire according to the embodiment.

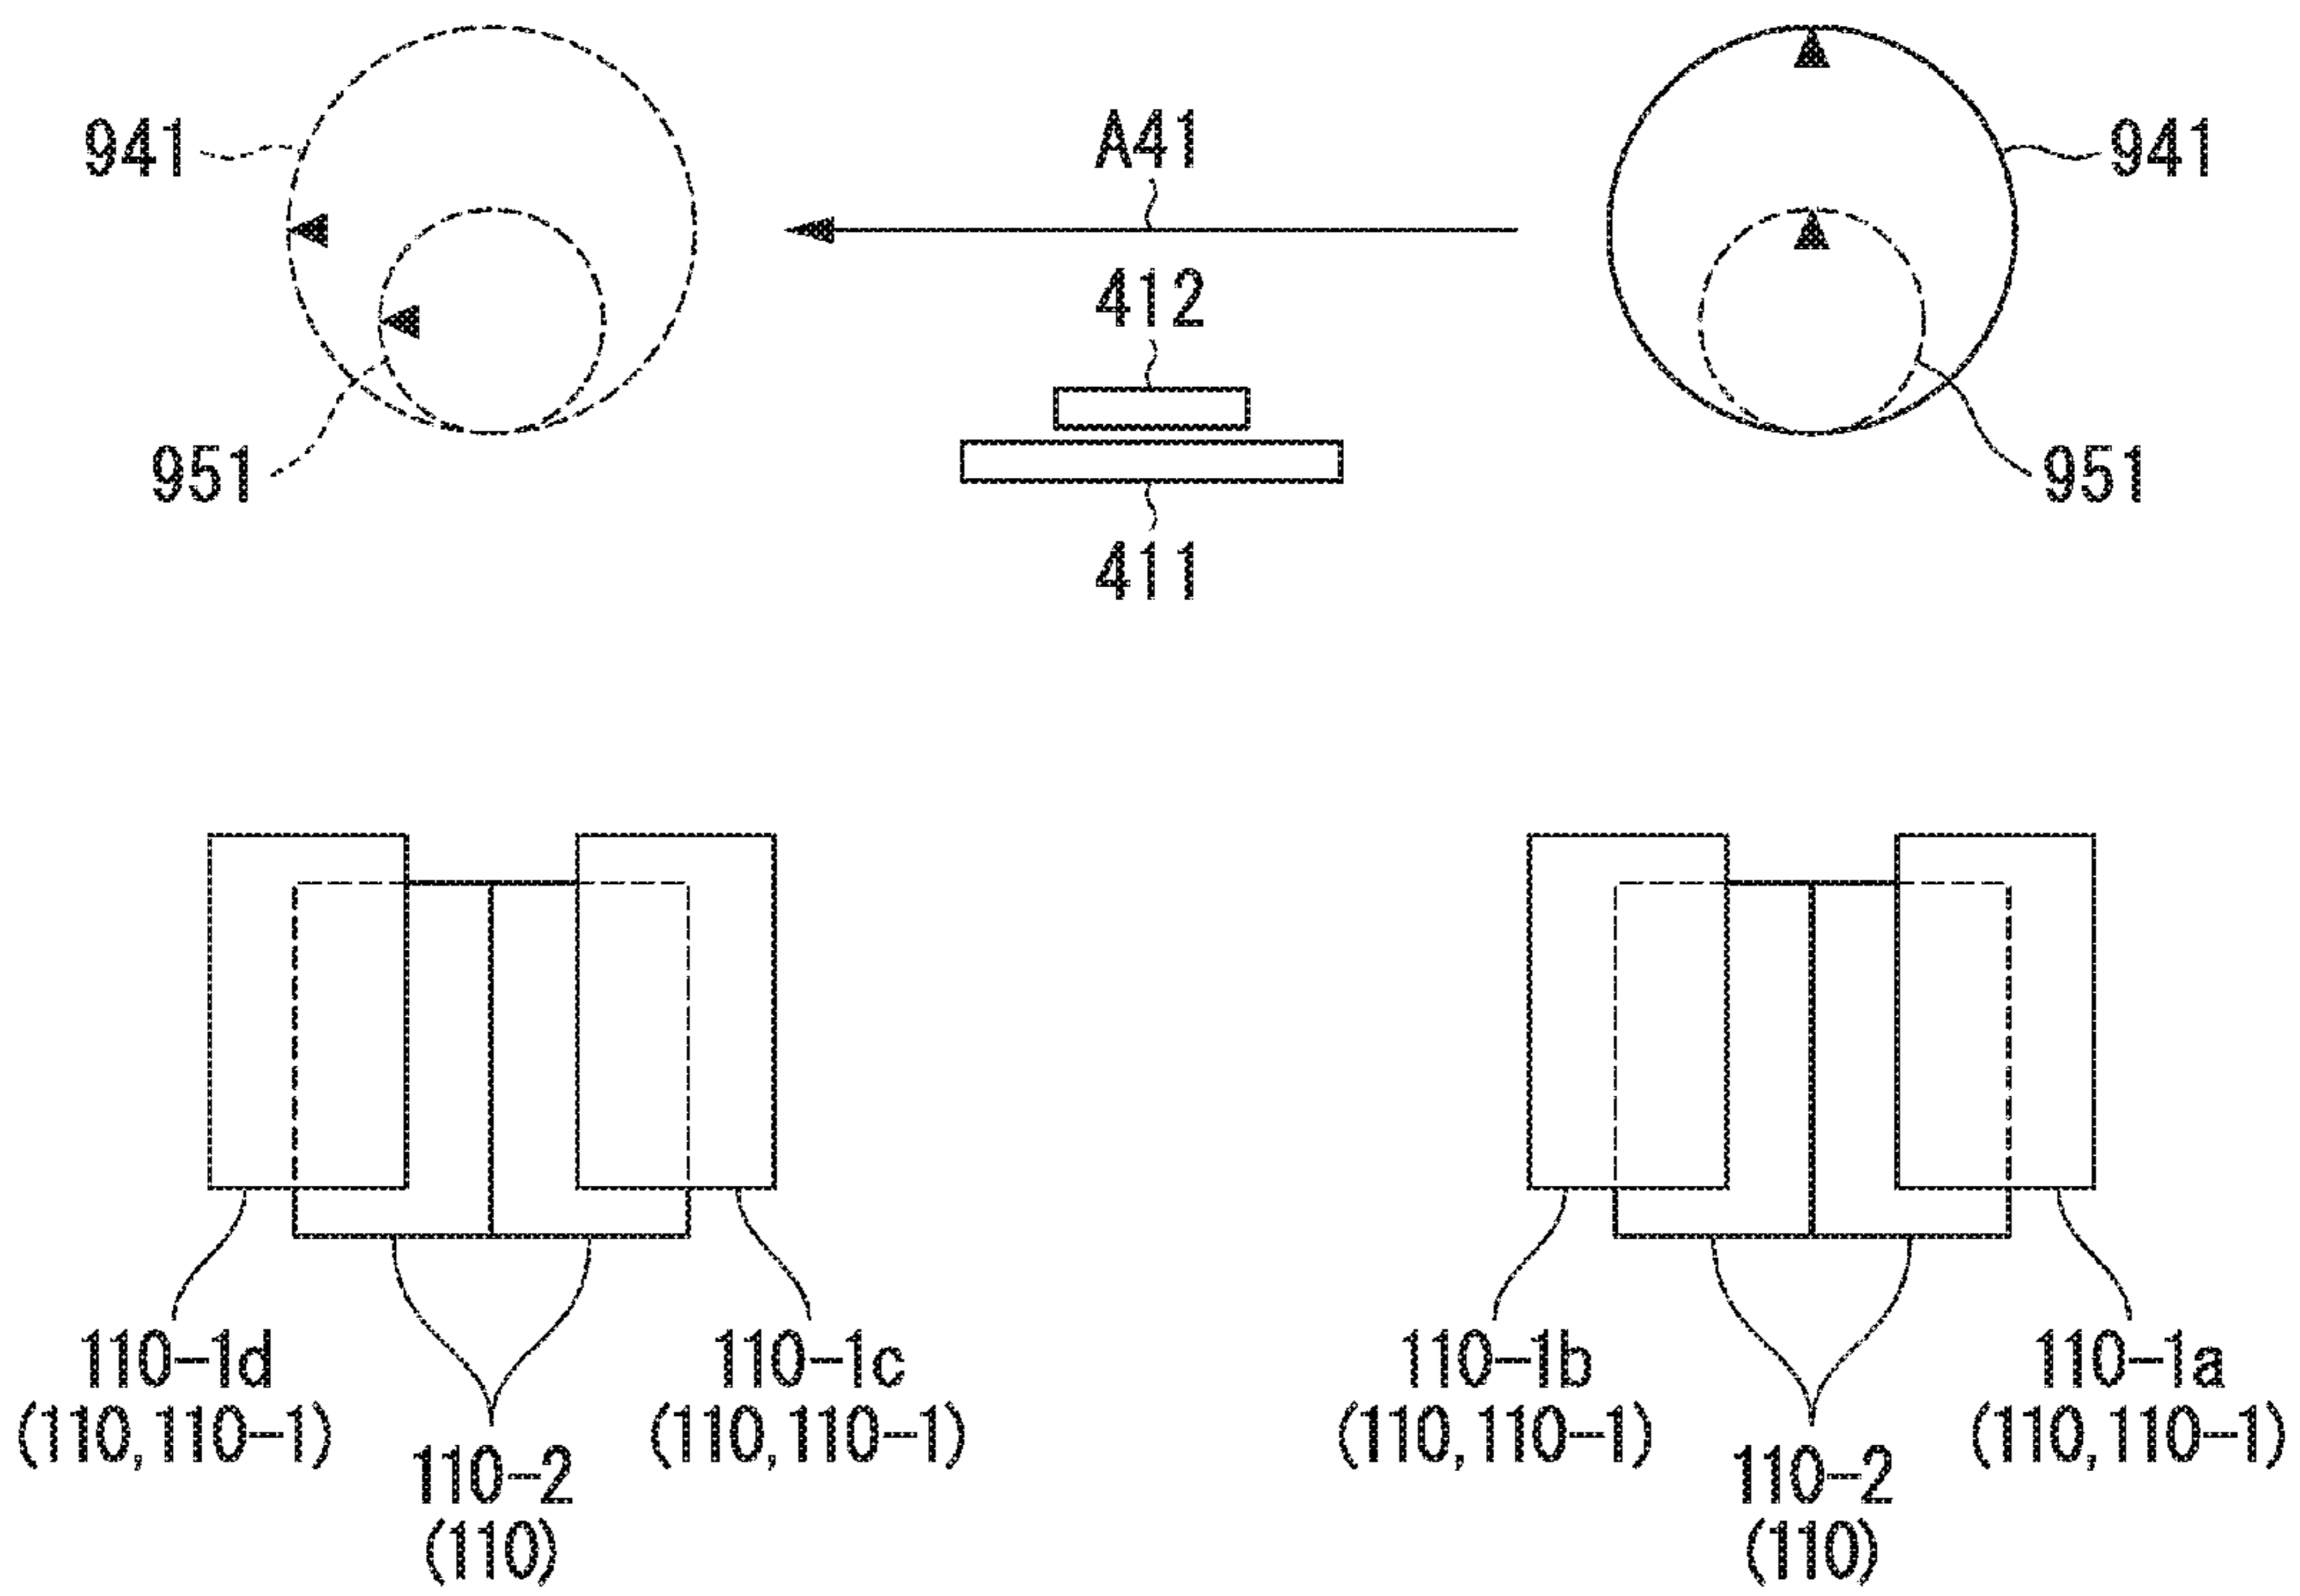
FIG. 10 is an explanatory diagram showing an example of a change in the direction of the guide wheel according to the embodiment.

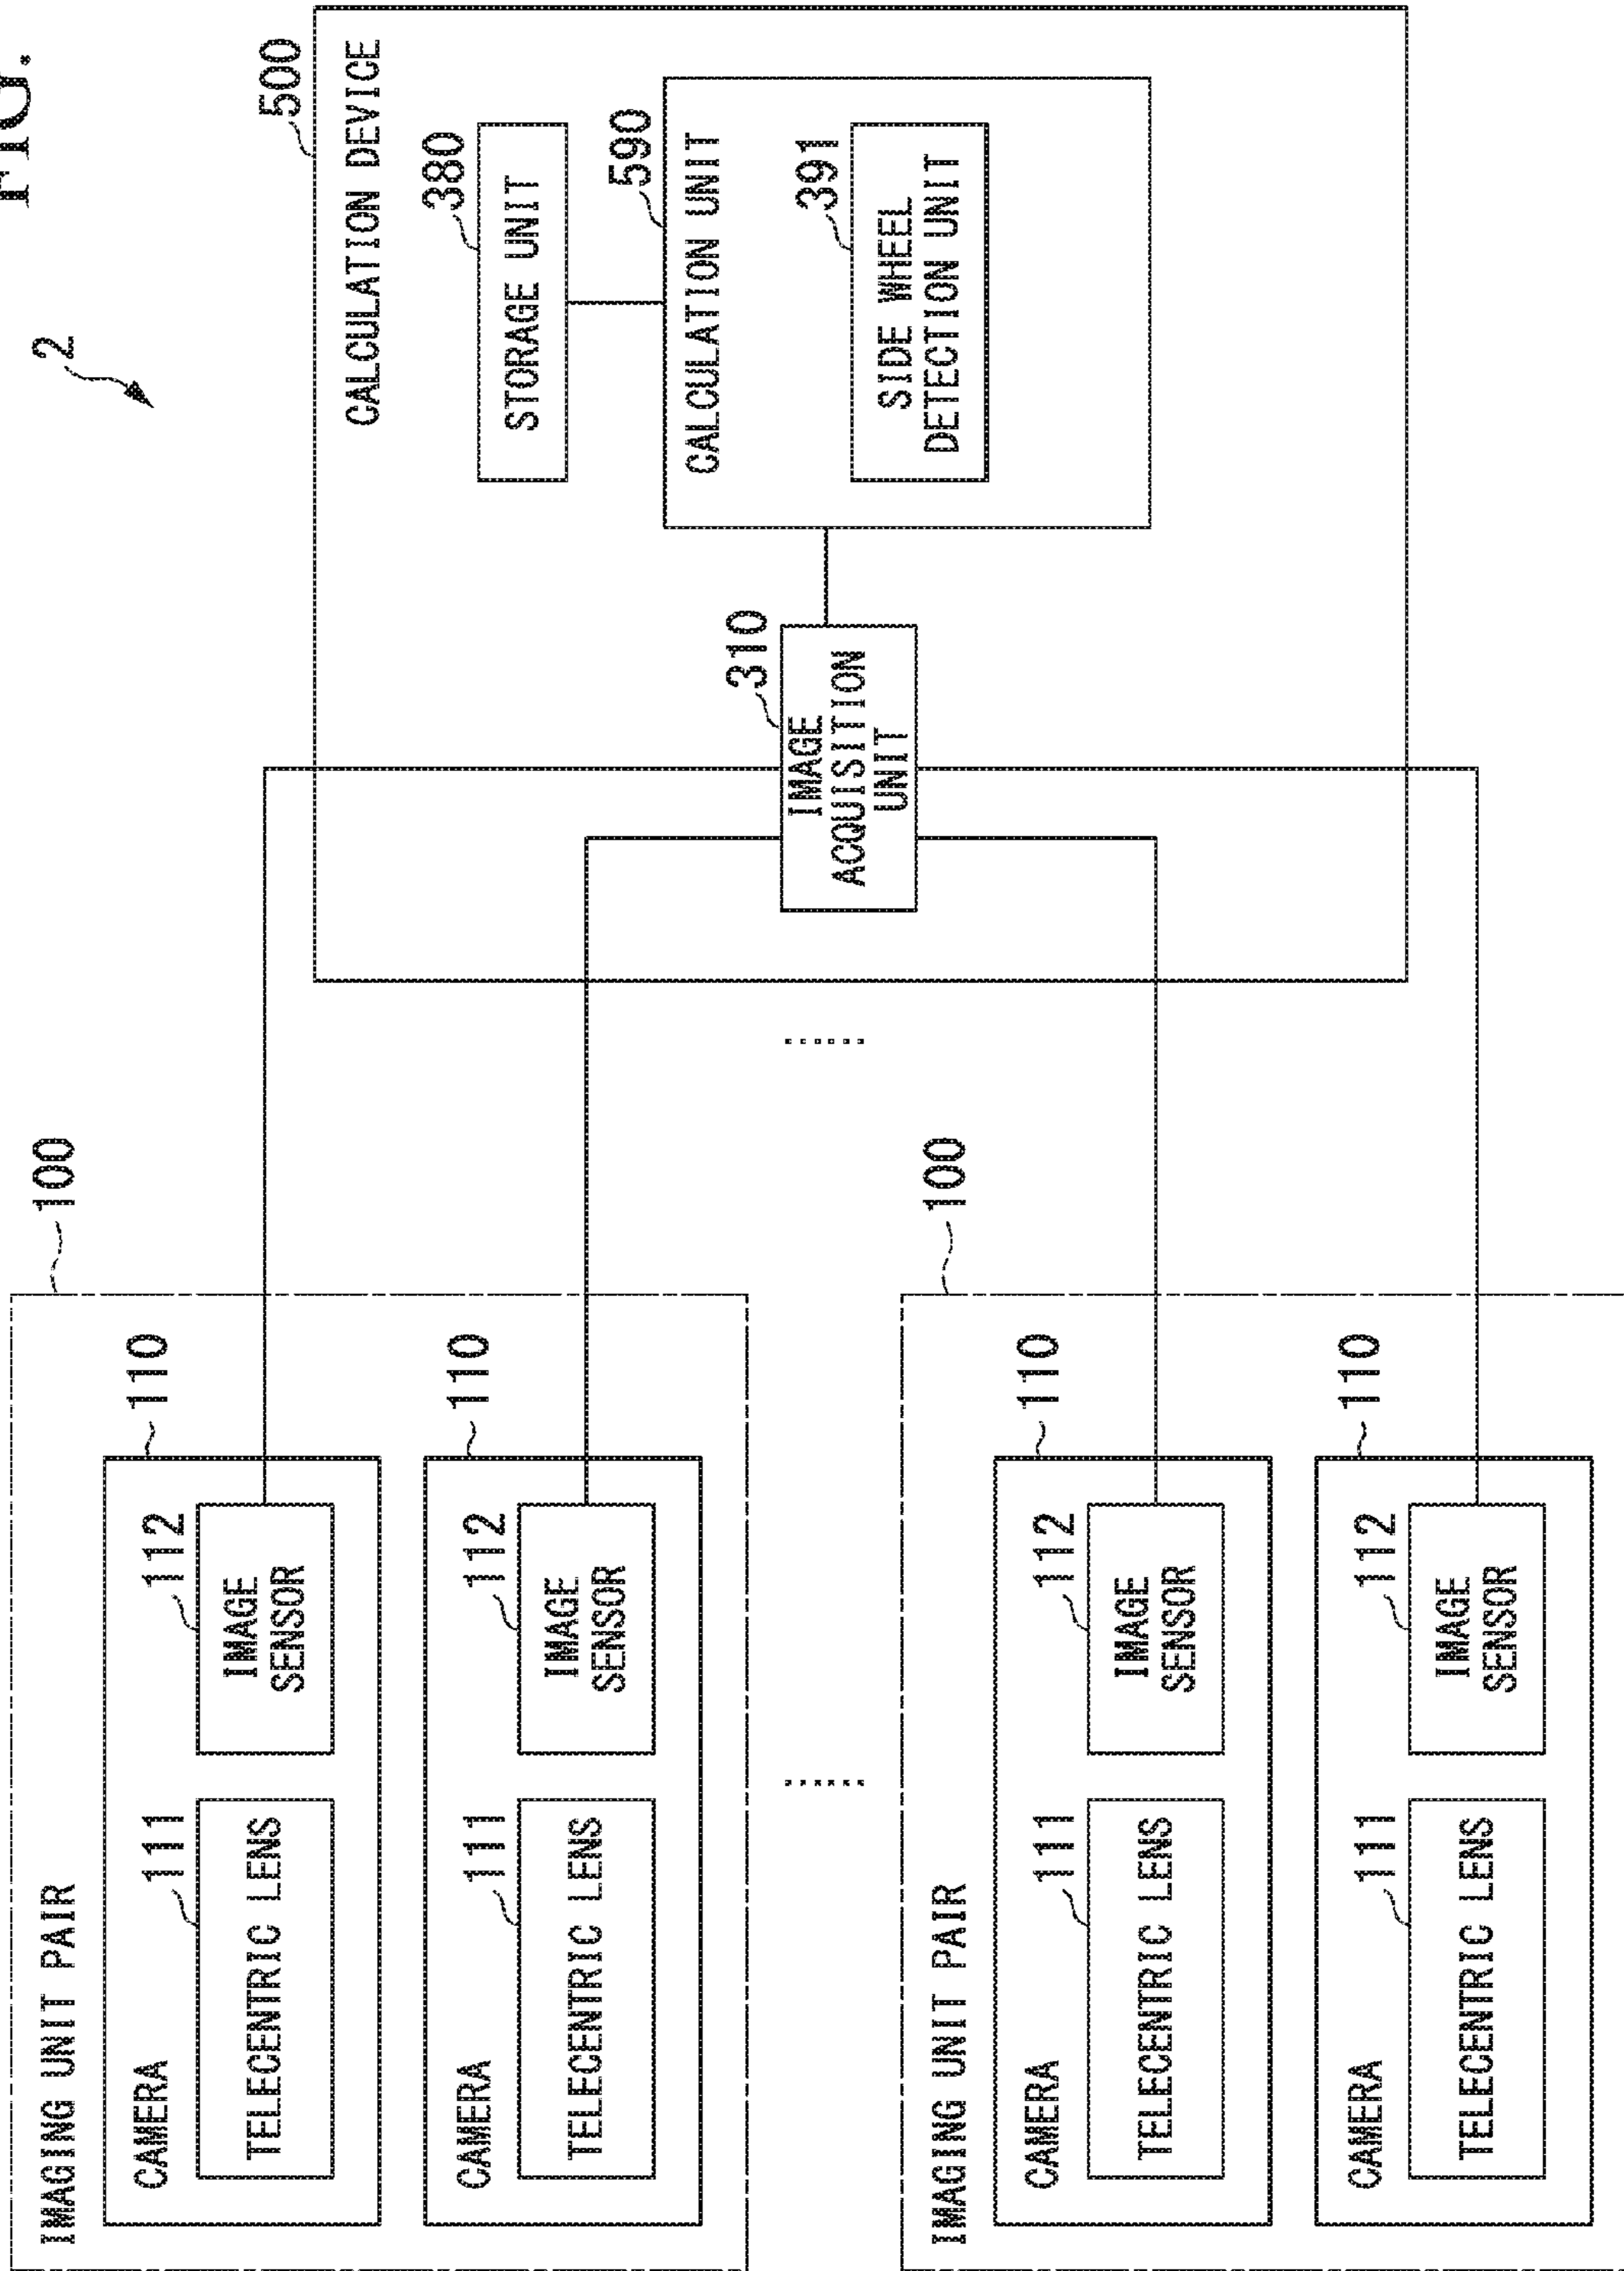
FIG. 11 is a schematic block diagram showing a functional configuration of a first modification example of an abrasion inspection apparatus according the embodiment.
