US010458776B2

(54) **ABRASION INSPECTION APPARATUS,
ABRASION INSPECTION METHOD, AND
PROGRAM**

(71) Applicant: **mitsubishi heavy industries,
LTD.**, Tokyo (JP)

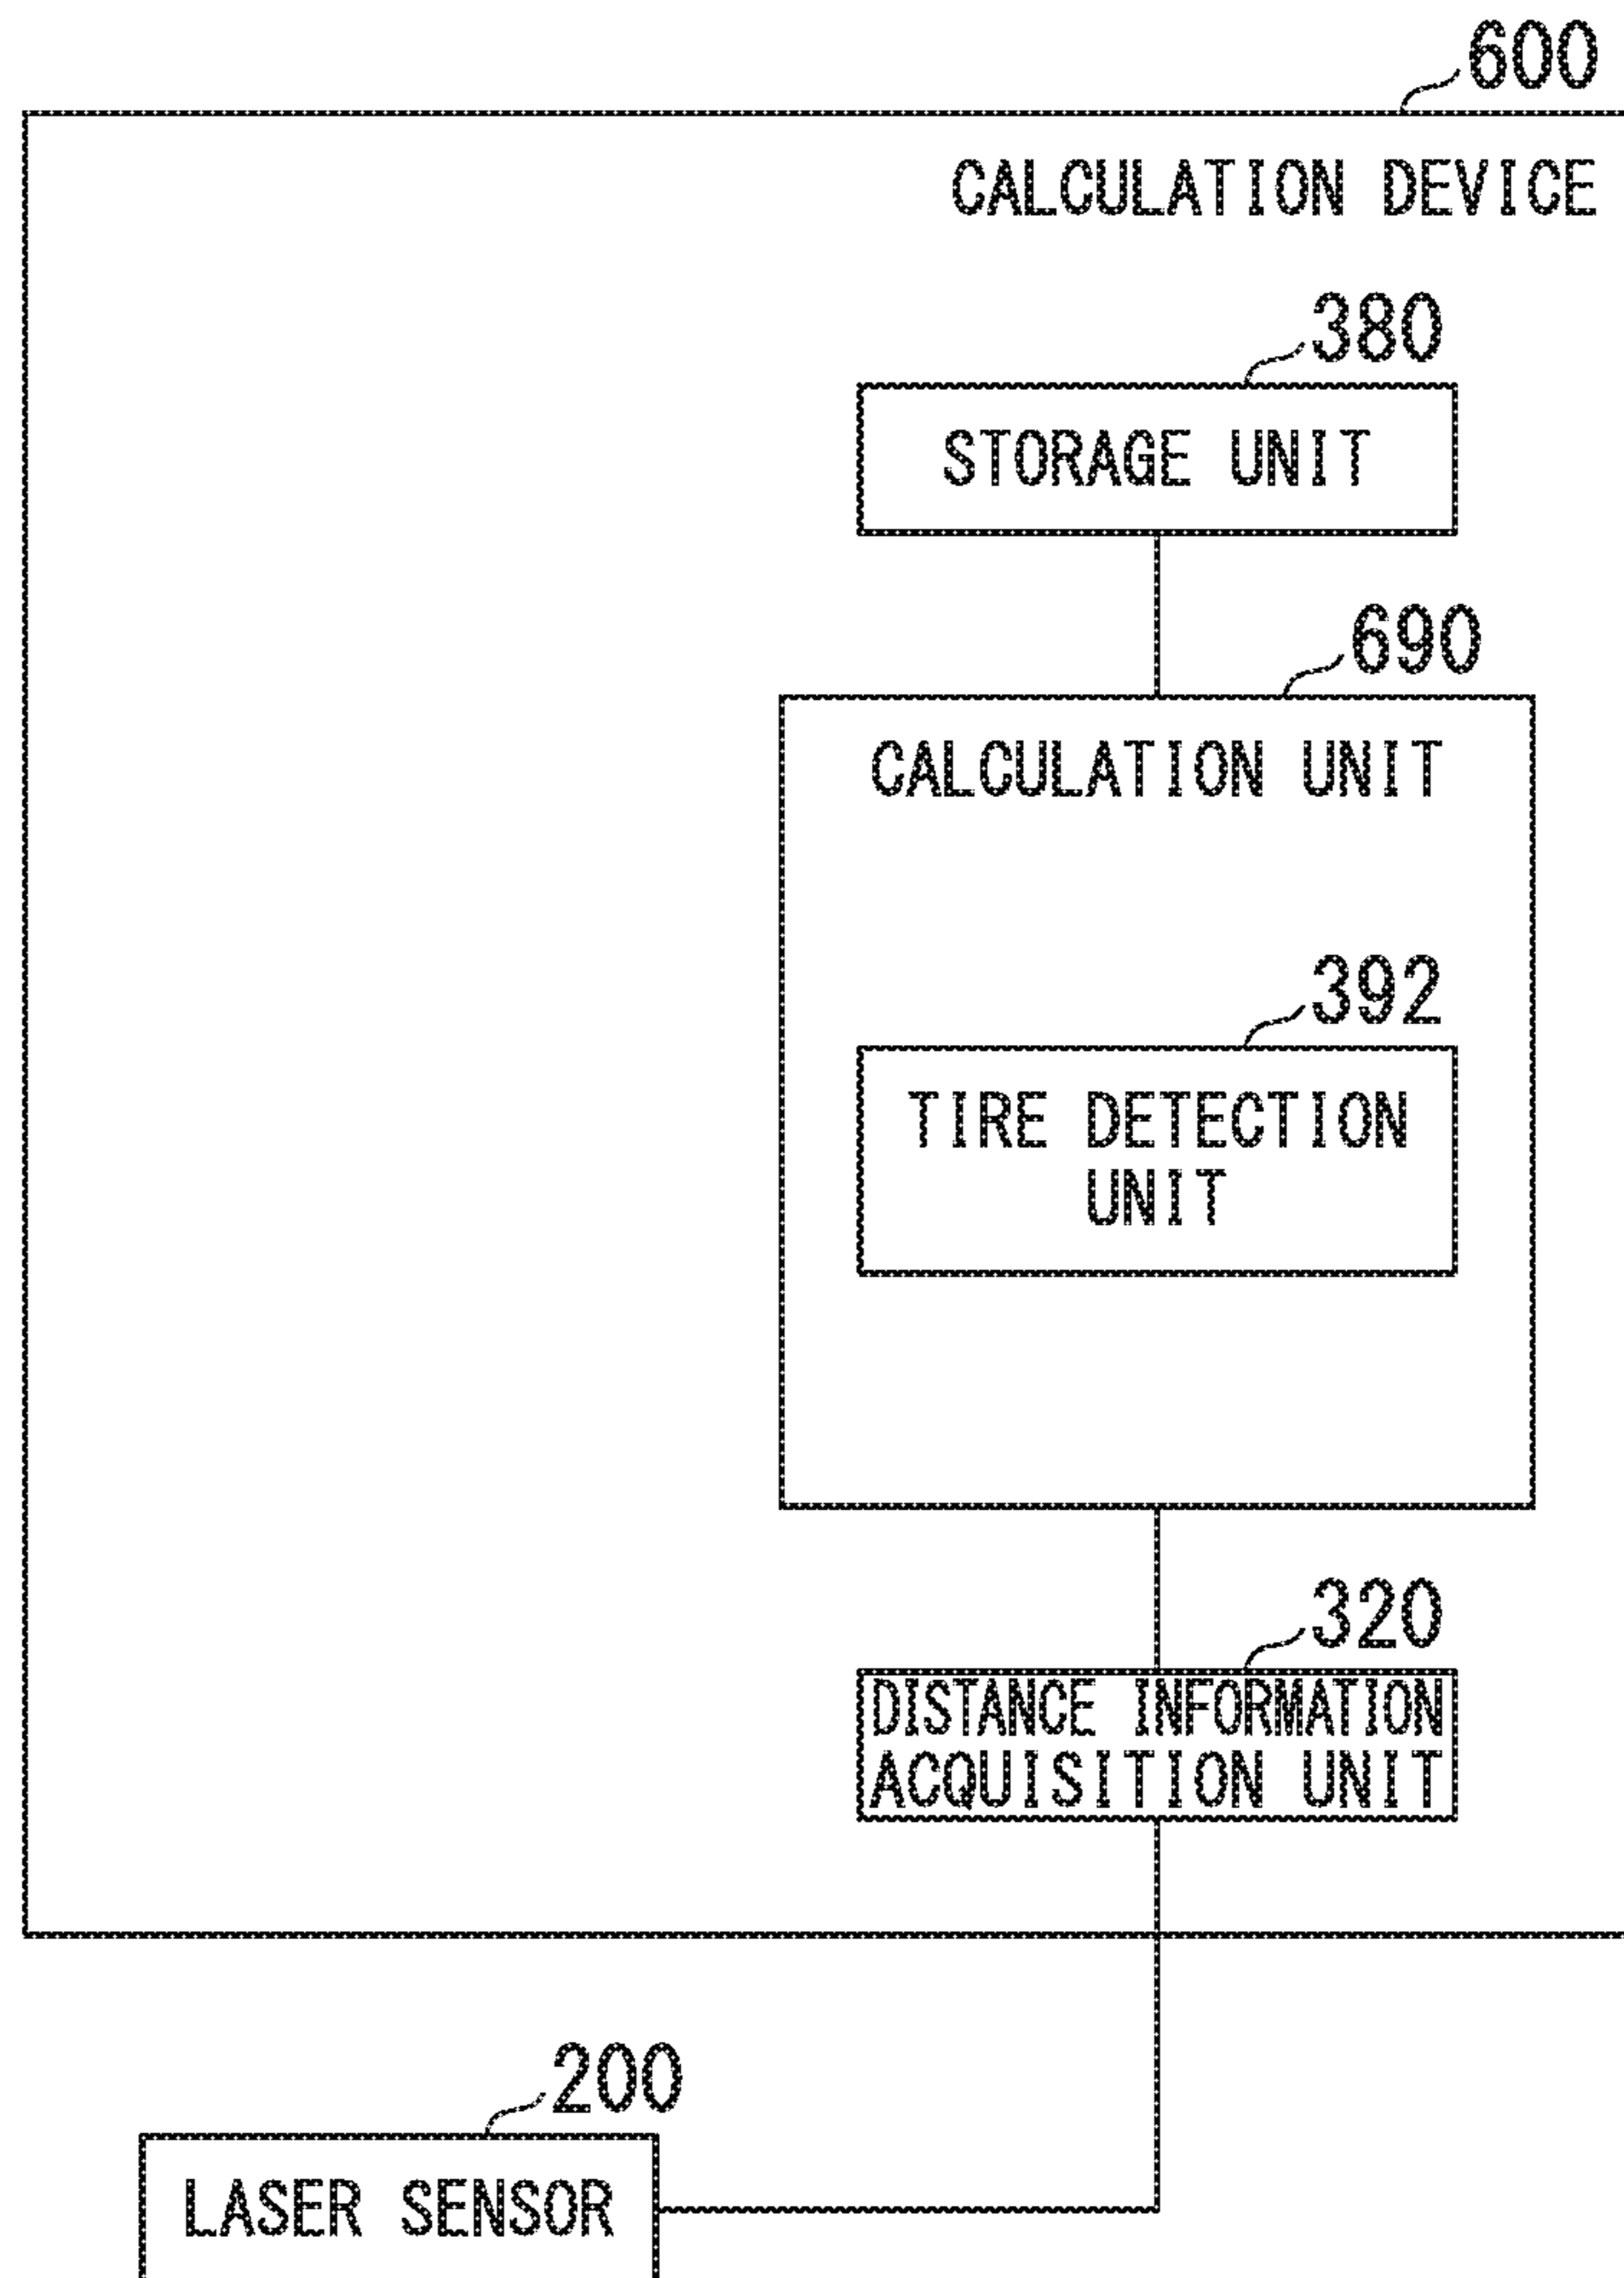
FIG. 12 is a schematic block diagram showing a functional configuration of a second modification example of an abrasion inspection apparatus according the embodiment.
