US010578240B2

(54) **EXPANDABLE PIPE INCLUDING A LINER FOR RESTORING A CONDUIT**

An expandable pipe for restoring a damaged pipe is provided. The expandable pipe includes a liner formed of thermoplastic polyurethane, and grout material applied to the exterior surface of the liner. The exterior surface includes a plurality of flared tips and grooves, and each groove is located between adjacent flared tips. The grout material is disposed on the flared tips and in the grooves of the liner. The method used to restore the damaged pipe includes clamping the liner with the grout material on a puller-sealer fixture having a U-shaped cross-section to prevent debris from entering the interior of the liner, and pulling the puller-sealer fixture and liner through the damaged pipe. The grout material expands in volume upon exposure to moisture, ultra violet radiation, heat, and/or ultrasonics, and fills cracks or other imperfections and voids along the interior surface of the conduit, caused by corrosion, erosion, or other circumstances.

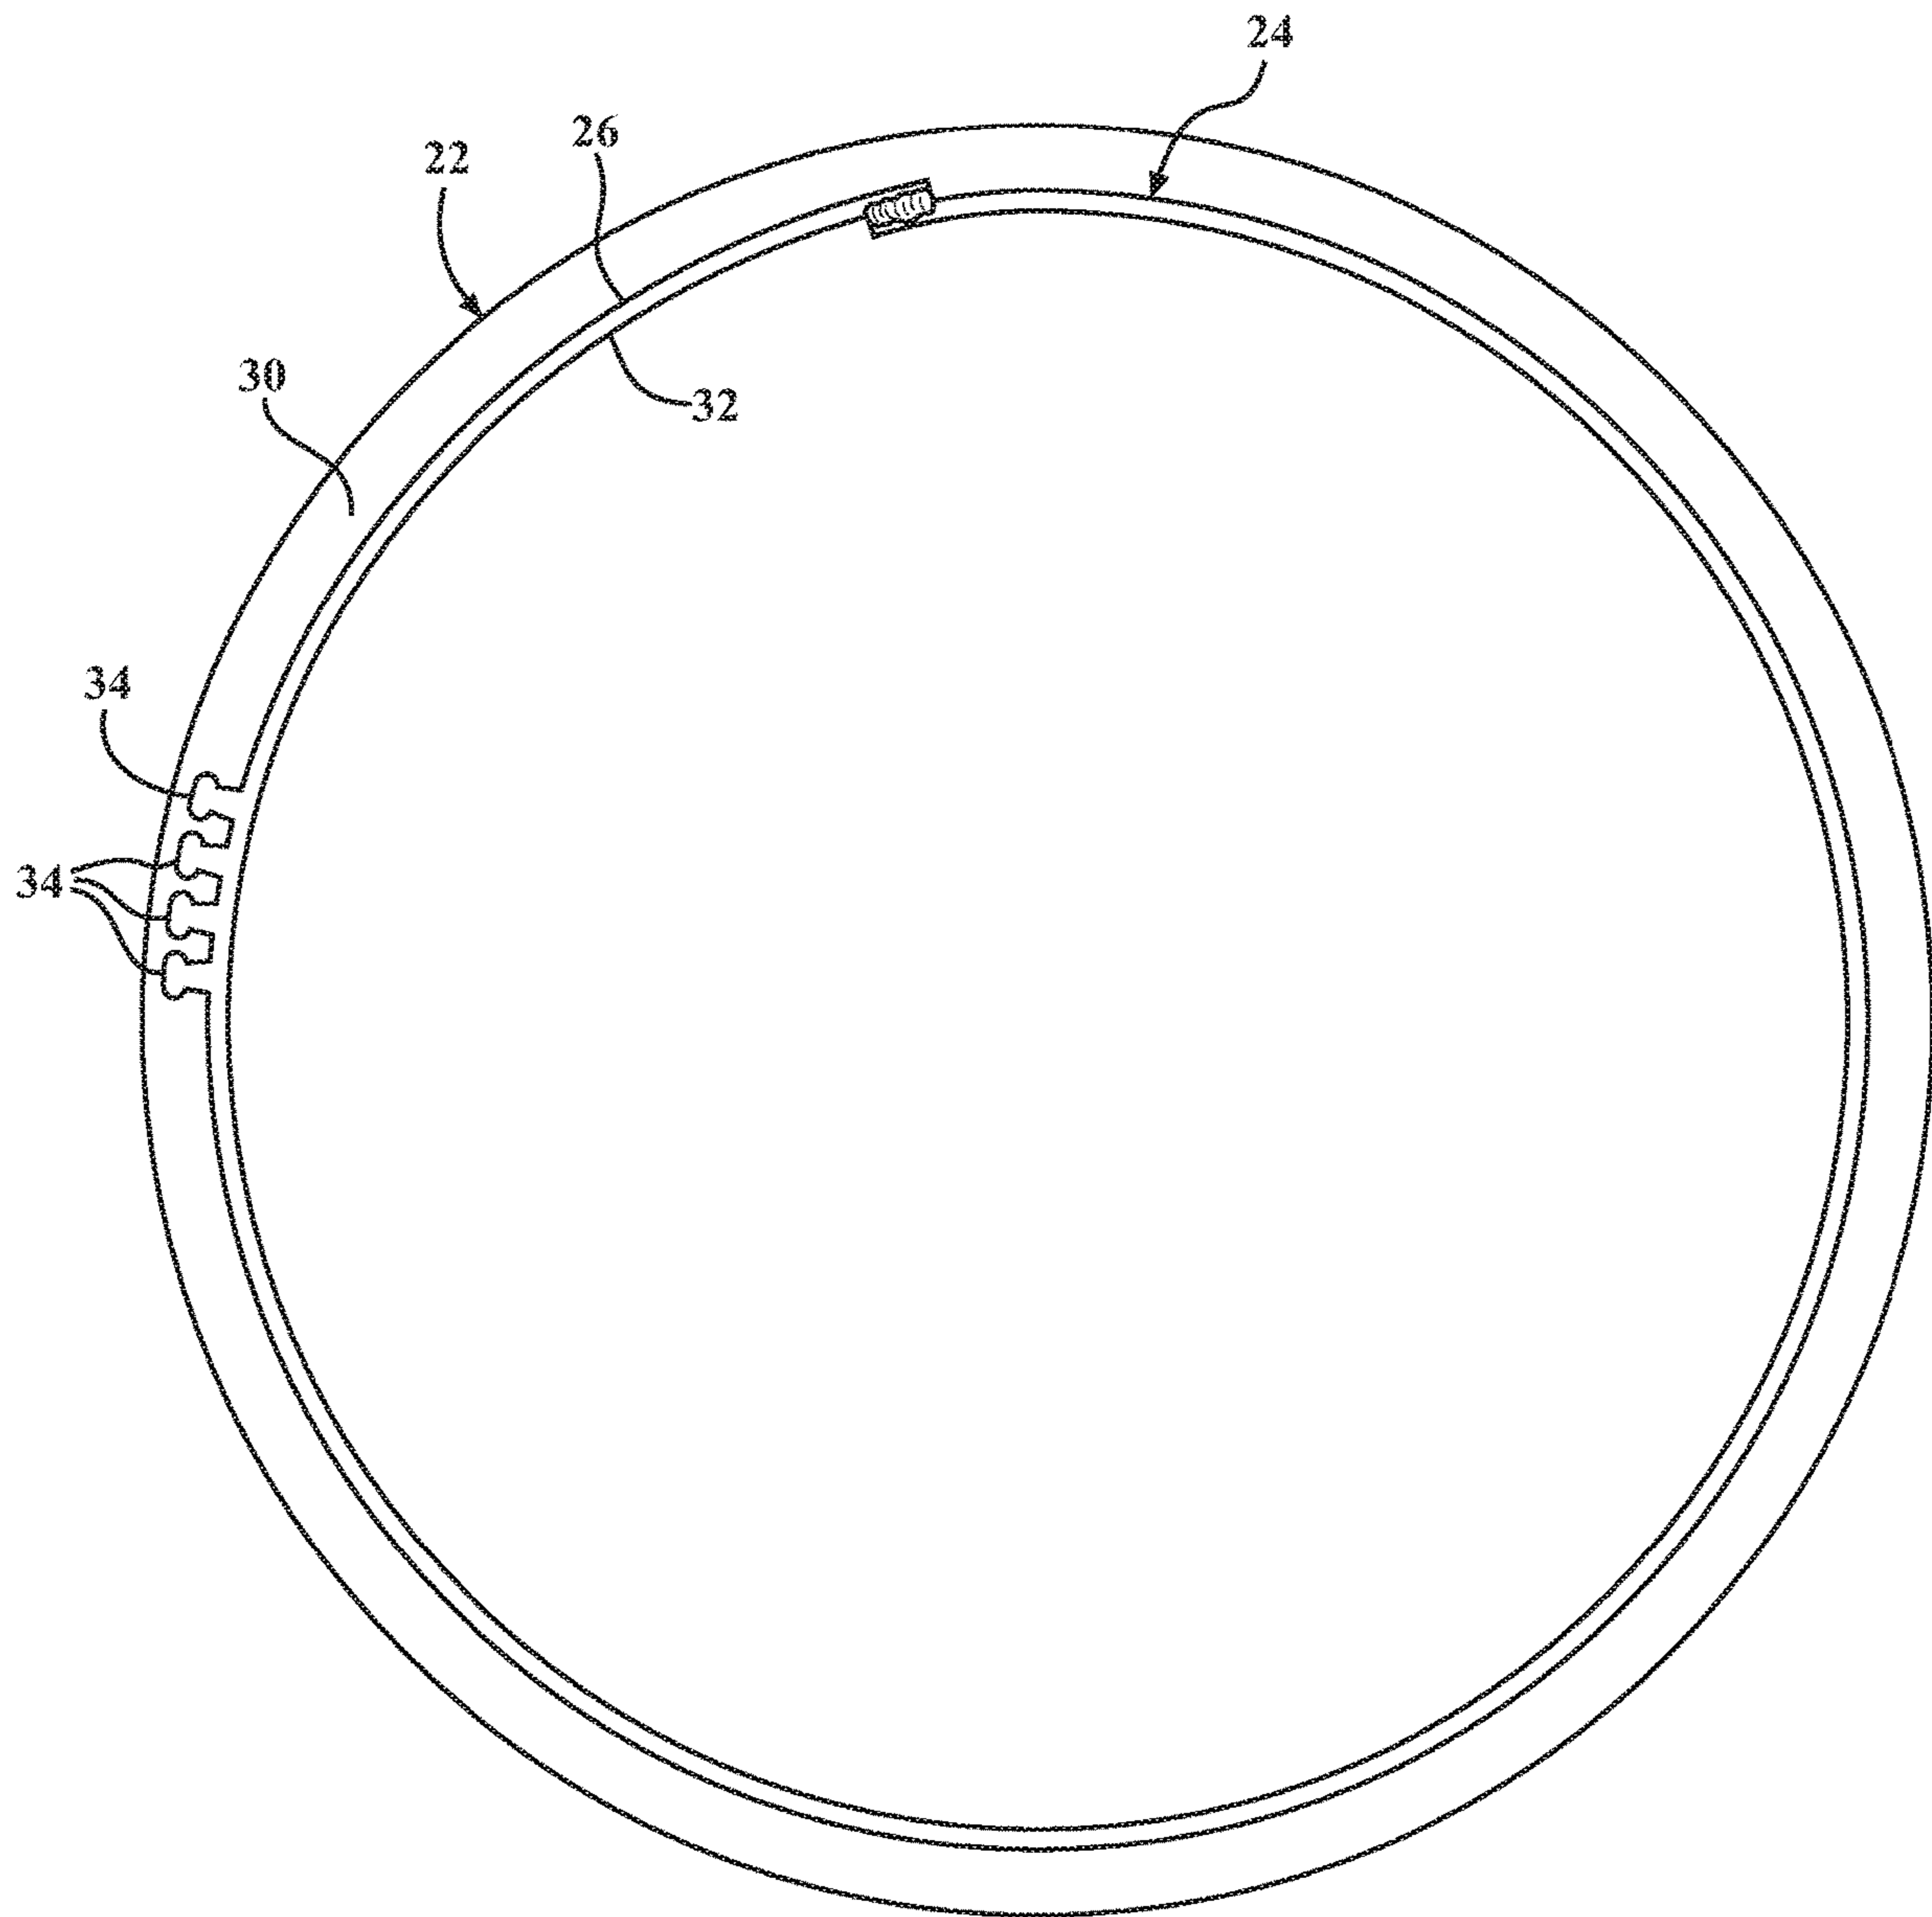
FIG. 2 is a cross-sectional view of the entire liner disposed inside of a host pipe according to the example embodiment of the invention;

According to a preferred embodiment, the grooves 28 of the liner 24 are achieved by a profile on an exterior surface 26, also referred to as an outer diameter surface, of the liner 24, as shown in FIGS. 1 and 2. In the embodiment of FIGS. 1 and 2, the profile of the exterior surface 26 of the liner 24 includes flared tips 34 which act as a mechanical lock for the grout material 30 applied to the exterior surface 26 of the liner 24. FIG. 1 only shows the flared tips 34 along a portion of the exterior surface 26 of the liner 24, but the flared tips 34 are preferably located along the entire exterior surface 26 of the liner 24, and continuously around the outer circumference of the liner 24. In the example of FIGS. 1 and 2, each groove 28 is formed between two adjacent flared tips 34, and the grout material 30 is contained in those grooves 28. The flared tips 34 include a stem 36 extending perpendicular to the base of the liner 24, and an enlarged top 38 which flares outwardly relative to the stem 36. The diameter or width of the enlarged top 38 is greater than the diameter or width of the stem 36. The flared tips 34 shown in FIGS. 1 and 2 are only an example, as the shape and dimensions of the flared tips 34 can vary. Alternatively, other profiled shapes and dimensions can be used to achieve the grooves 28 in the liner 24. However, the flared tips 34 or other mechanical locking features are not required if a sufficient bond between the liner 24 and the grout material 30 is achieved.

The liner 24 can be formed by extrusion, preferably in a flat extrusion die to produce a flat product, such as a sheet of the TPU or another thermoplastic material. The flat extruded product is then welded into a circular pipe shape to produce the liner 24 and so as to reside inside the host pipe 22, as shown in FIG. 2. In other words, the flat product is welded it at a circumference that matches the required diameter for the liner 24. The diameter of the liner 24 should be less than the inner diameter of the host pipe 22 when the liner 24 is inflated. For example, the liner 24 of the example embodiment has a 7.5 inch inner diameter when inflated, and the host pipe 22 has an 8 inch inner diameter. The liner 24 could be extruded to size, as a circular tube, however certain raw materials are difficult to extrude into circular geometries due to a lack of melt strength. The other advantage of extruding flat and welding is the ability to obtain any diameter with limited tooling.

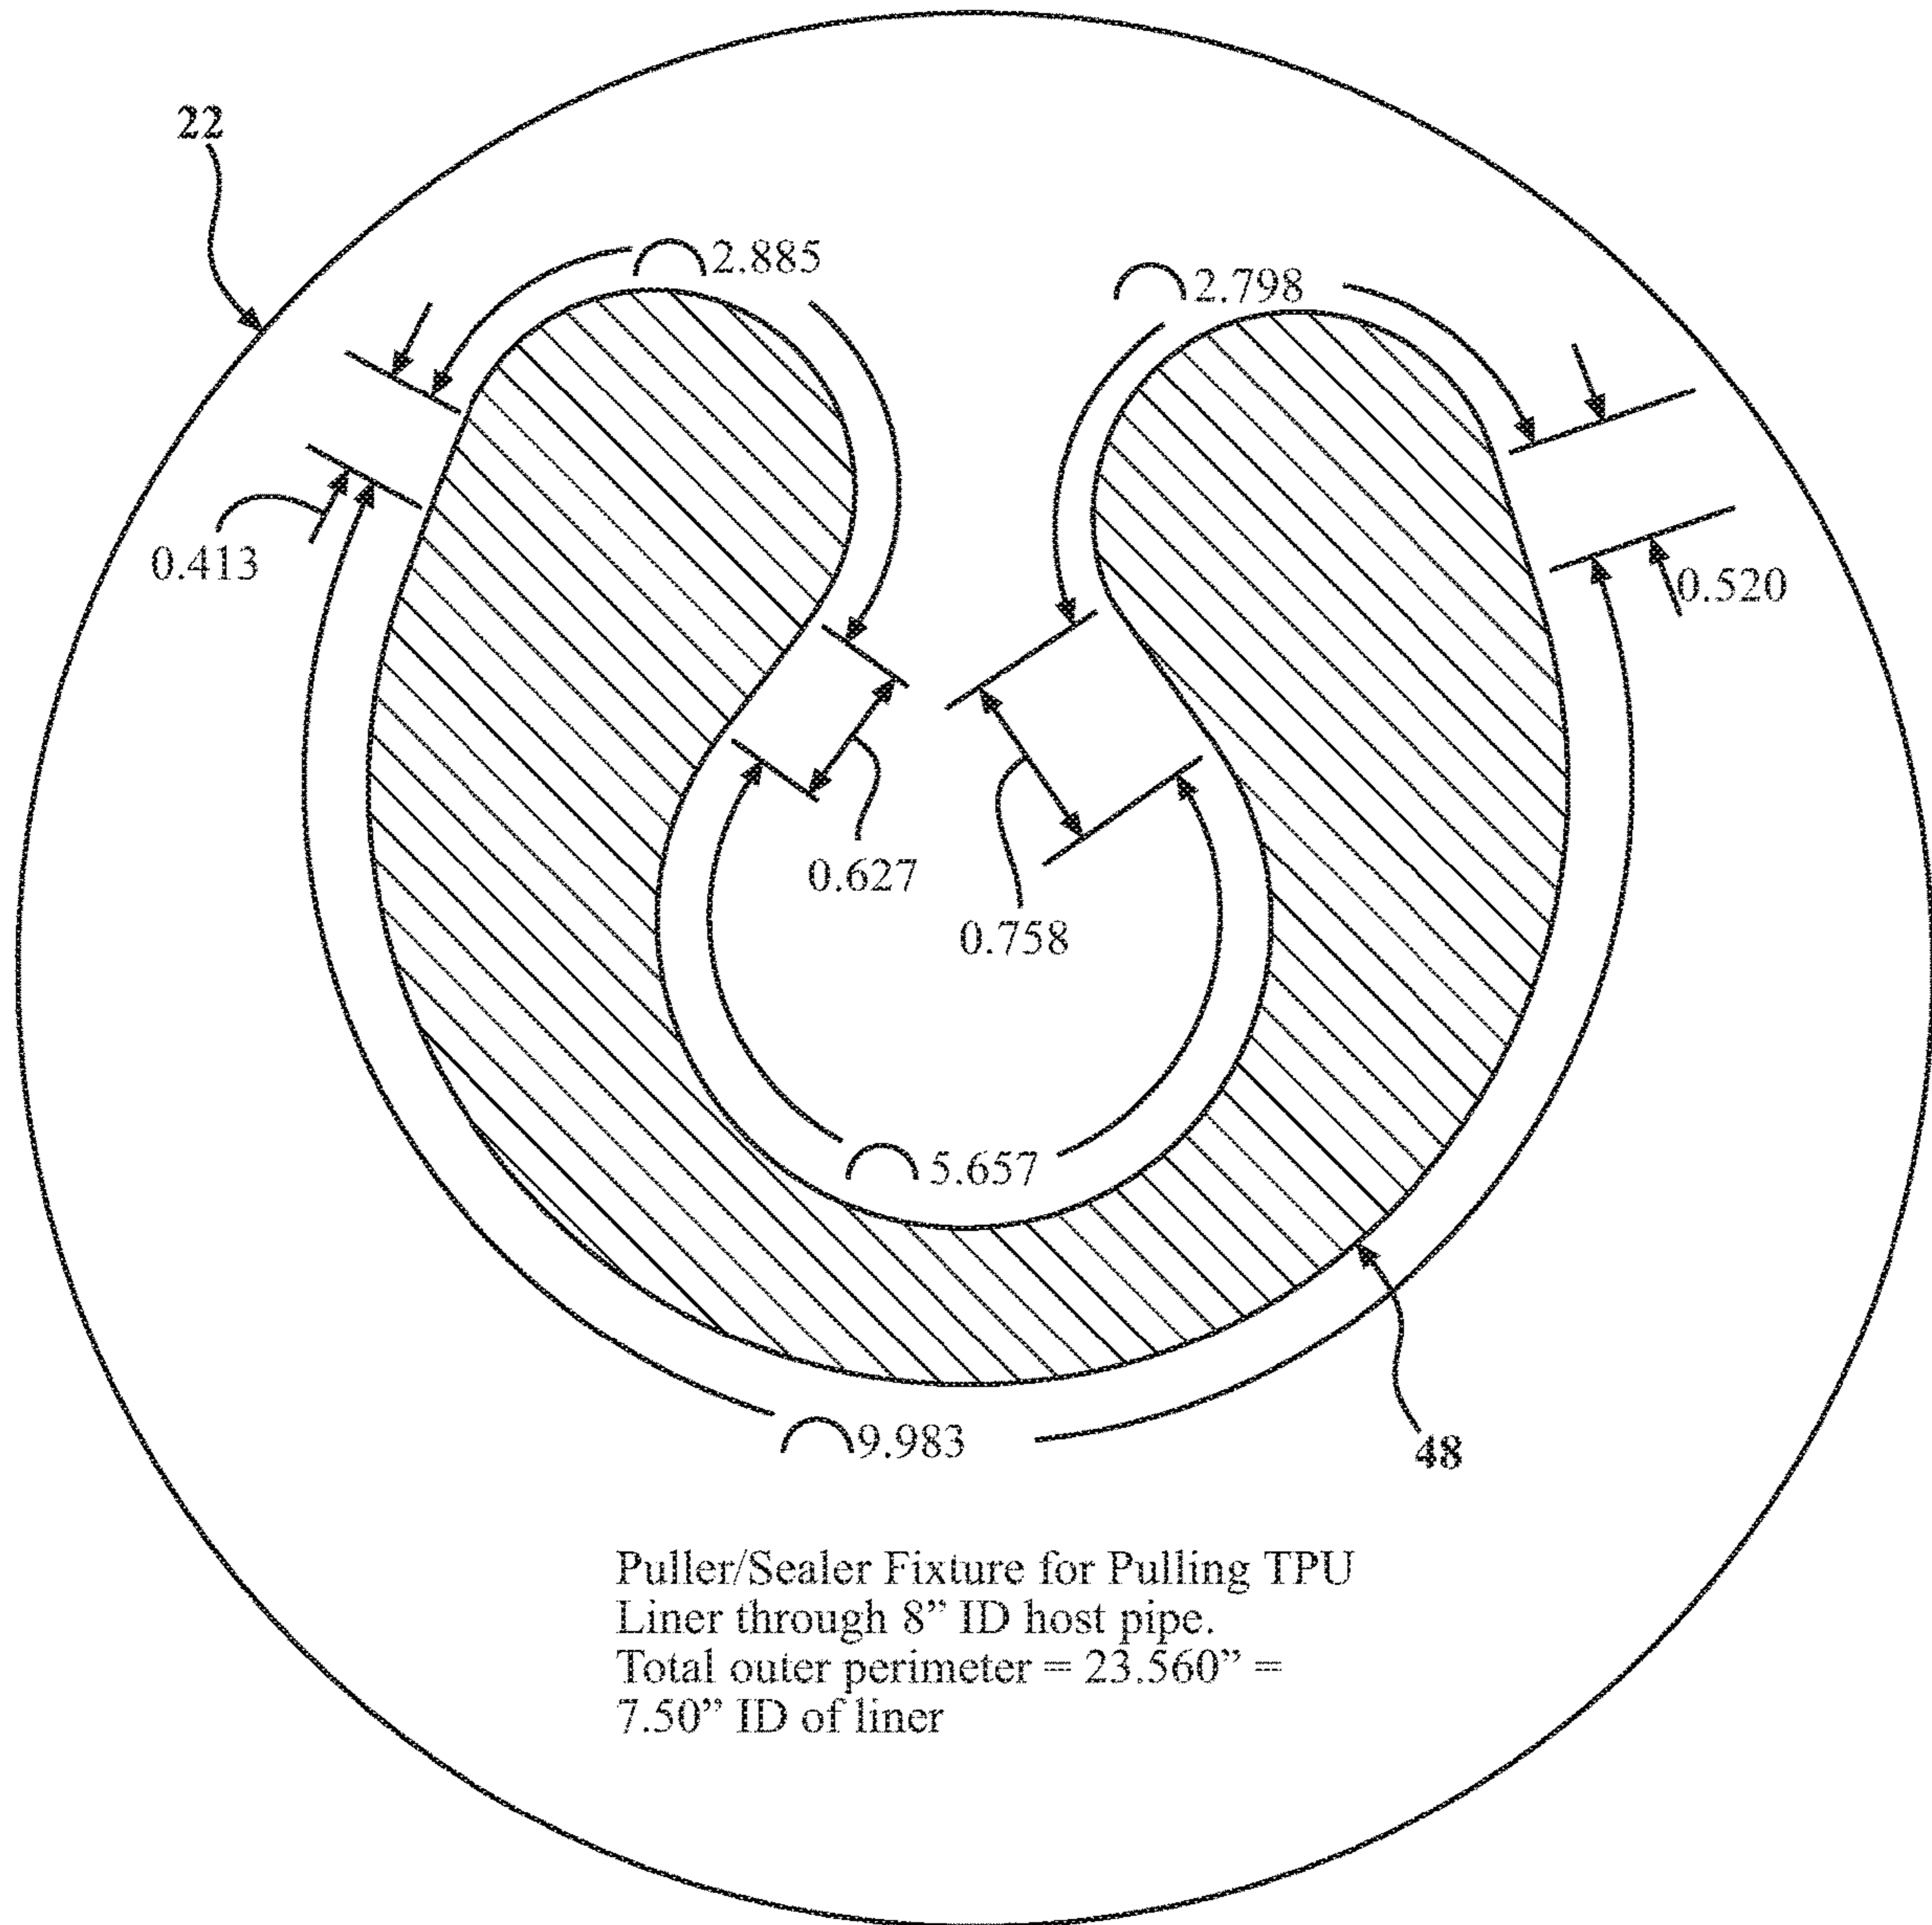
FIG. 3 is a cross-sectional view of a puller/sealer fixture disposed inside of the host pipe which configures the liner for passage through the host pipe with minimal interference

with the inner diameter of the host pipe and which seals an inner diameter of the liner from water, debris, and grout material;

The TPU liner 24, with its exterior surface 26 soaked in the urethane grout, is directed down into an opening of the host pipe 22. The TPU liner 24 is there attached to a spraying fixture 46 via the puller/sealer fixture 48, as shown in FIGS. 3 and 4. The puller/sealer fixture 48 is a solid piece of material which serves as a mounting fixture which configures the liner 24 for optimal passage through the host pipe 22, with minimal interference with the inner diameter surface of the host pipe 22. In the example embodiment, the puller/sealer fixture 48 has a U-shaped cross-section with no sharp edges. The puller/sealer fixture 48 maintains the liner 24 in an appropriate position, without any sharp edges along the liner 24. In the example embodiment, the puller/sealer fixture 48 has an outer perimeter of 23.560 inches, which is

equal to the length of the 7.5 inch inner diameter of the liner 24. Jigs or clamps 50 can be used to secure the liner 24 to the puller/sealer fixture 48. The puller/sealer fixture 48 also prevents debris, moisture, and/or the grout material 30 from entering the interior of the liner 24. For example, the clamps 50 can secure the liner 24 tightly against the puller/sealer fixture 48 to prevent the debris, moisture, and/or the grout material 30 from entering the interior of the liner 24. During installation, the puller/sealer fixture 48 is attached to the rolling dolly 42 and pulled by the cable 40 through the host pipe 22.

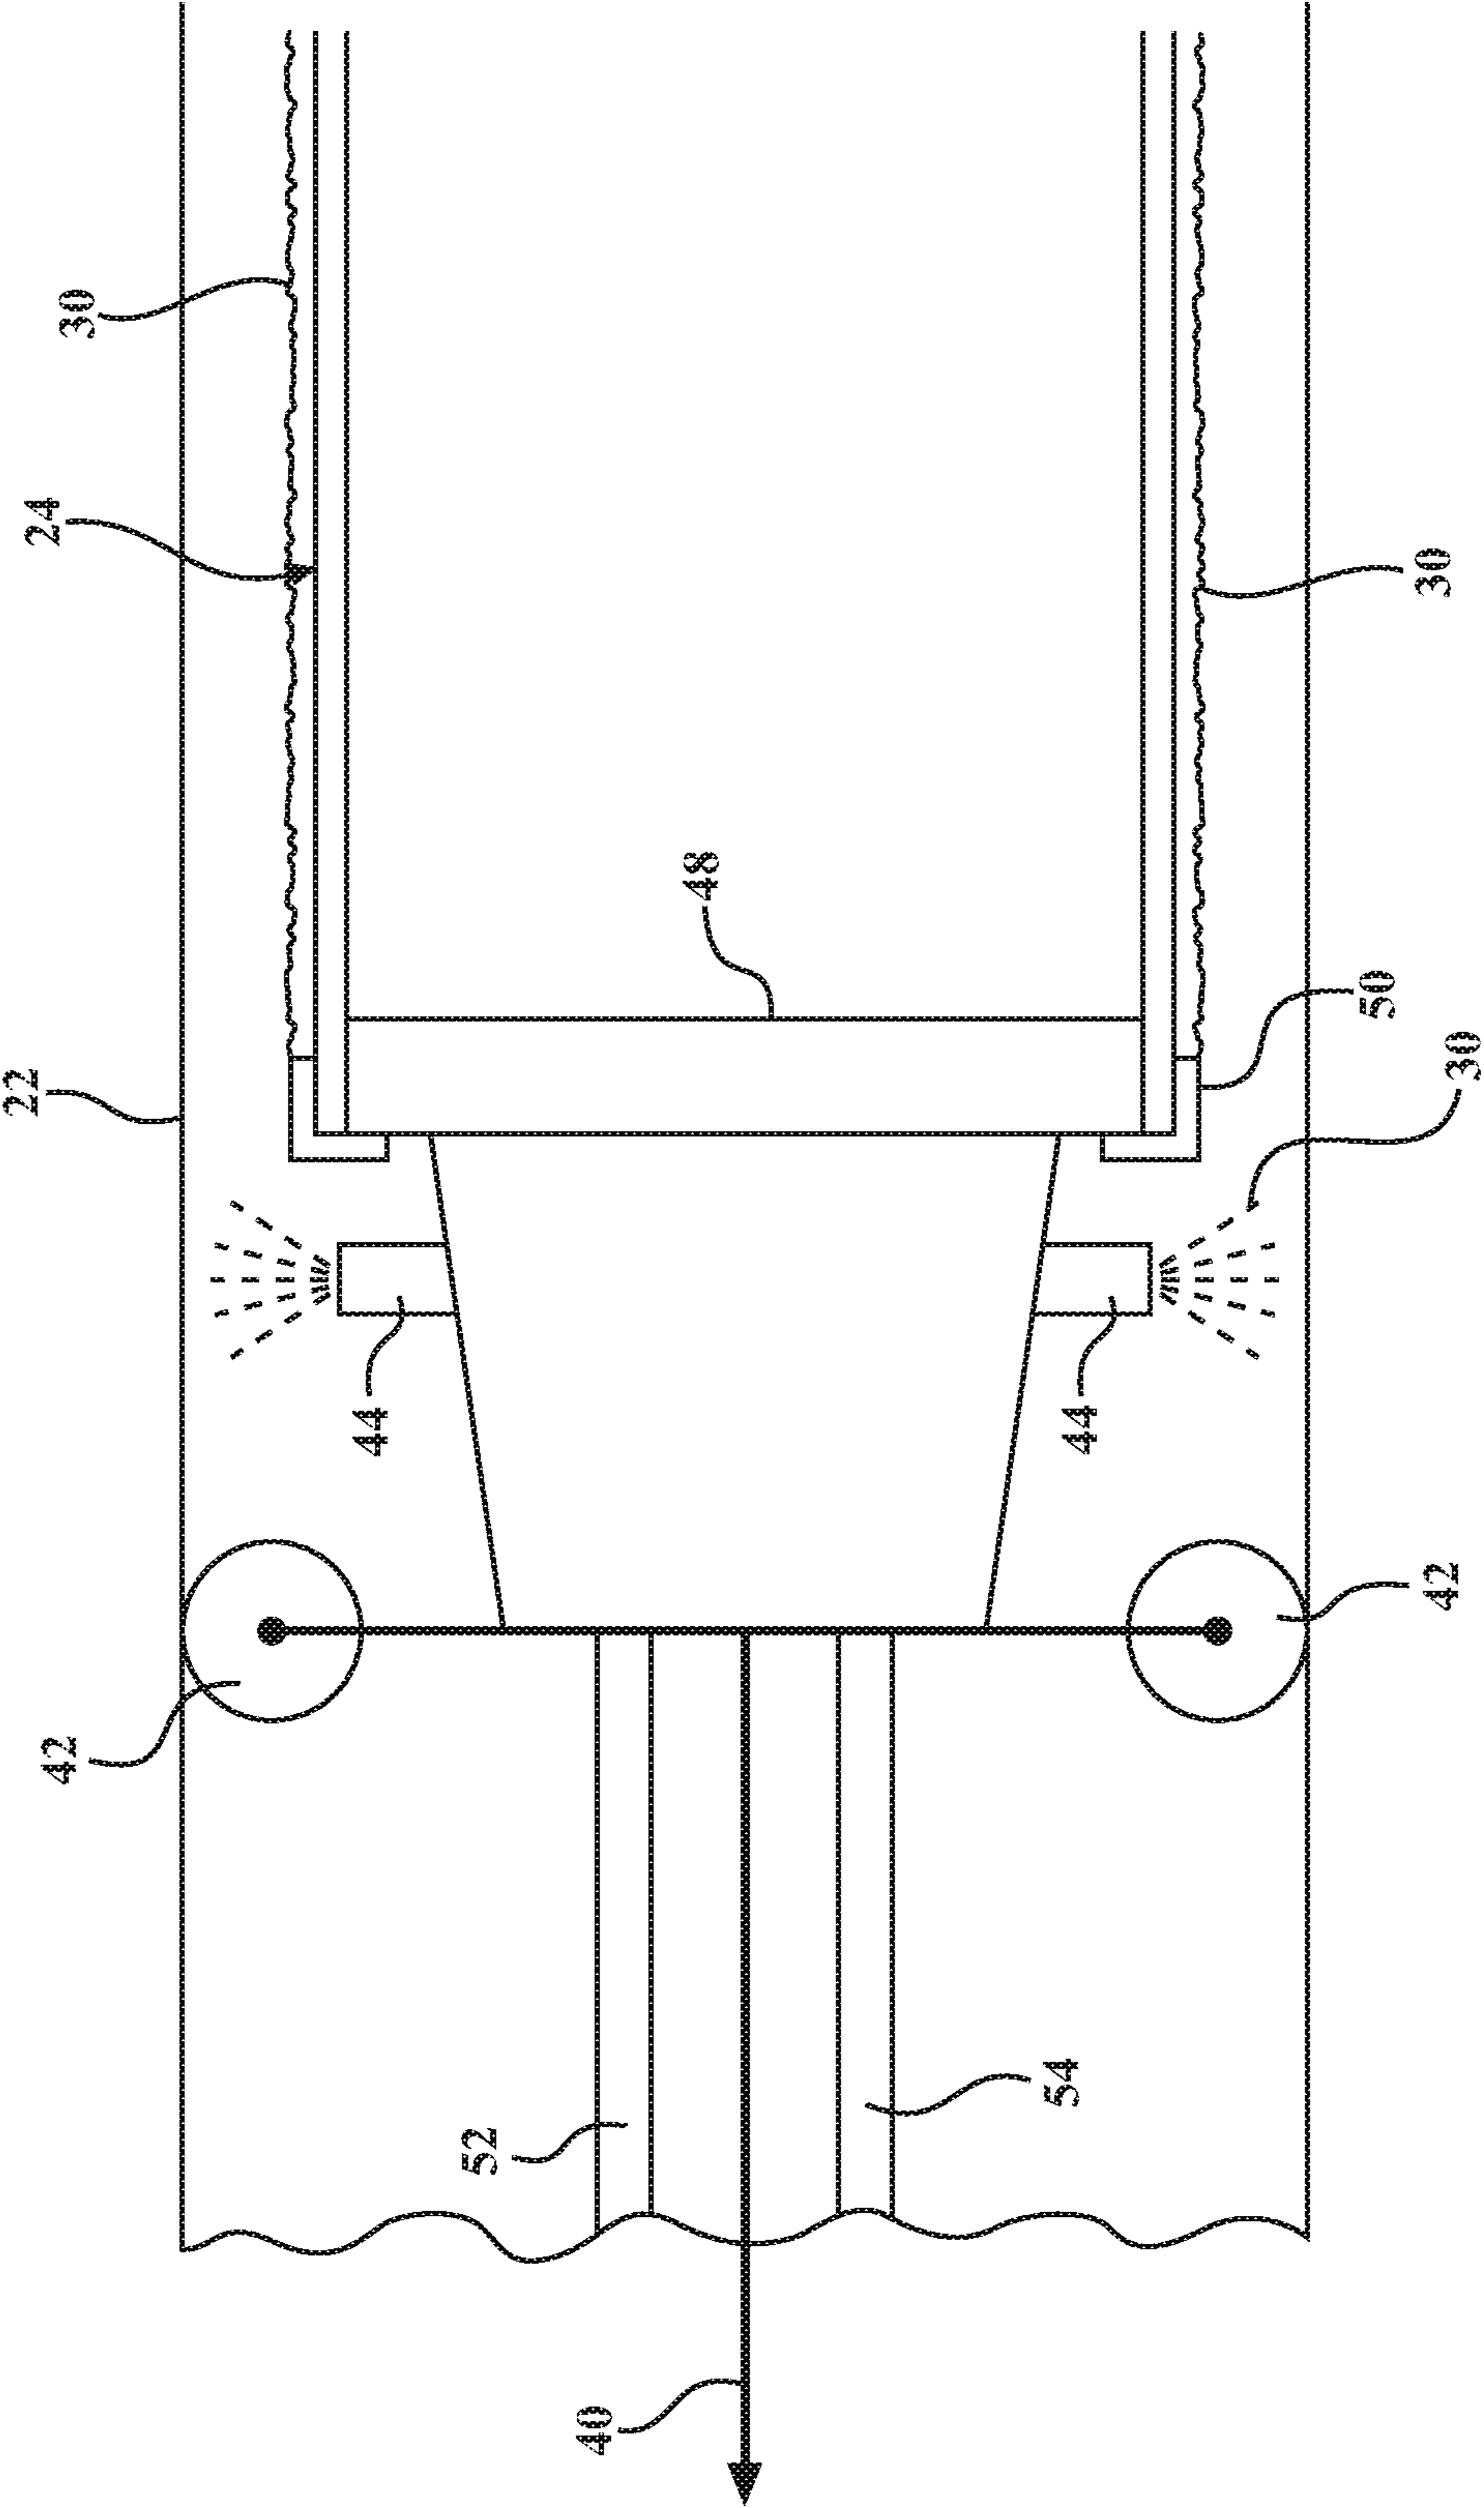
FIG. 4 illustrates the puller/sealer fixture attached to a spraying fixture and rolling dolly used to install the liner in the host pipe;

The method of installing the liner 24 in the host pipe 22 according to example embodiments will now be described in more detail with reference to FIGS. 3 and 4. When the TPU liner 24 is ready for installation, it is coiled, laying flat like a fire hose, onto reels. At the jobsite where the host pipe 22 is located, the liner 24 is routed through a dip (or soaking) tank assembly 56 containing the 1-part moisture-curing urethane grout. FIG. 5 illustrates the liner 24 being routed through the dip tank assembly 56 according an example embodiment. The dip tank assembly 56 is capable of uniformly coating the liner 24 with the 1-part moisture-curing urethane grout, for example an unactivated liquid polyurethane. The dip tank assembly 56 is also able to apply the 1-part moisture-curing urethane grout to liners 24 varying from 2 inches to 20 feet in diameter, for example 6 inches to 12 inches in diameter. The dip tank assembly 56 is robust in construction, easy to maintain and service, and is portable in nature. As shown in FIG. 5, the dip tank assembly 56 includes a coating tank 58 which guides the liner 24 through the liquid polyurethane using a series of vertical and horizontal rollers 60. Guide rollers G are used to guide the liner 24 from a supply into the coating tank 58, and guide rollers G are again used to guide the coated liner 24 from the coating tank 58 to a manhole where the liner 24 will be used to repair the damaged pipe 22. The coating tank 58 is typically formed of aluminum and includes a removable top 62 and a drain 64. However, the design and the material used to form the coating tank 58 can vary. The rollers 60 are typically formed of ultra-high density polyurethane. However, the dip tank assembly 56 could include a different array of rollers 60, and/or the rollers 60 could be formed of different materials. The dip tank assembly 56 also includes a mixing tank 66 acting as a reservoir to supply additional liquid polyurethane to the coating tank 58 on demand to maintain the liquid level in the coating tank 58. The mixing tank 66 can also be formed of aluminum, or another material. Example specifications of the coating tank 58 and the mixing tank 66 are provided in FIG. 6. These specifications are general in nature and can be adjusted as required prior to fabrication of the dip tank assembly 56.

A set of the mixing/spraying heads 44 is also attached to the dolly 42 and are pulled through the host pipe 22 during installation. The mixing/spraying heads 44 receive two urethane grout feed lines 52, 54 routed from the pulling side, such as along the cable, that will mix the 2-part grout before spraying the mixture onto the inner diameter surface of the host pipe 22. One feed line 52 includes the urethane and a second feed line 54 includes a curing agent. The rate of flow into the mixing/spraying heads 44 will be controlled automatically as a function of the velocity of the dolly 42 and the entire assembly through the host pipe 22 so as to assure a consistent coating of the host pipe 22 throughout. Thus, the area between the liner 24 and the host pipe 22 is filled with both the 1-part and 2-part urethane grout. Once the full length of the TPU liner 24 has been pulled through the host pipe 22, the ends of the liner 24 are capped, and the liner 24 is inflated to a specific pressure. The grout material 30 is exposed to moisture, ultra violet radiation, heat, and/or ultrasonics and thus cures and expands to adhere to the liner 24 and the inner diameter surface of the damaged pipe 22. The grout material 30 is typically in the form of a foam and bonds to the extruded liner 24, forming an adhesive and preferably cohesive bond, such that the plurality of flared tips 34 are not required for the liner 24 and grout material to maintain contact. After an appropriate curing period, pressure is released from the interior of the liner 24. Ends of the liner 24, as well as access points for laterals (service lines), can then be trimmed.

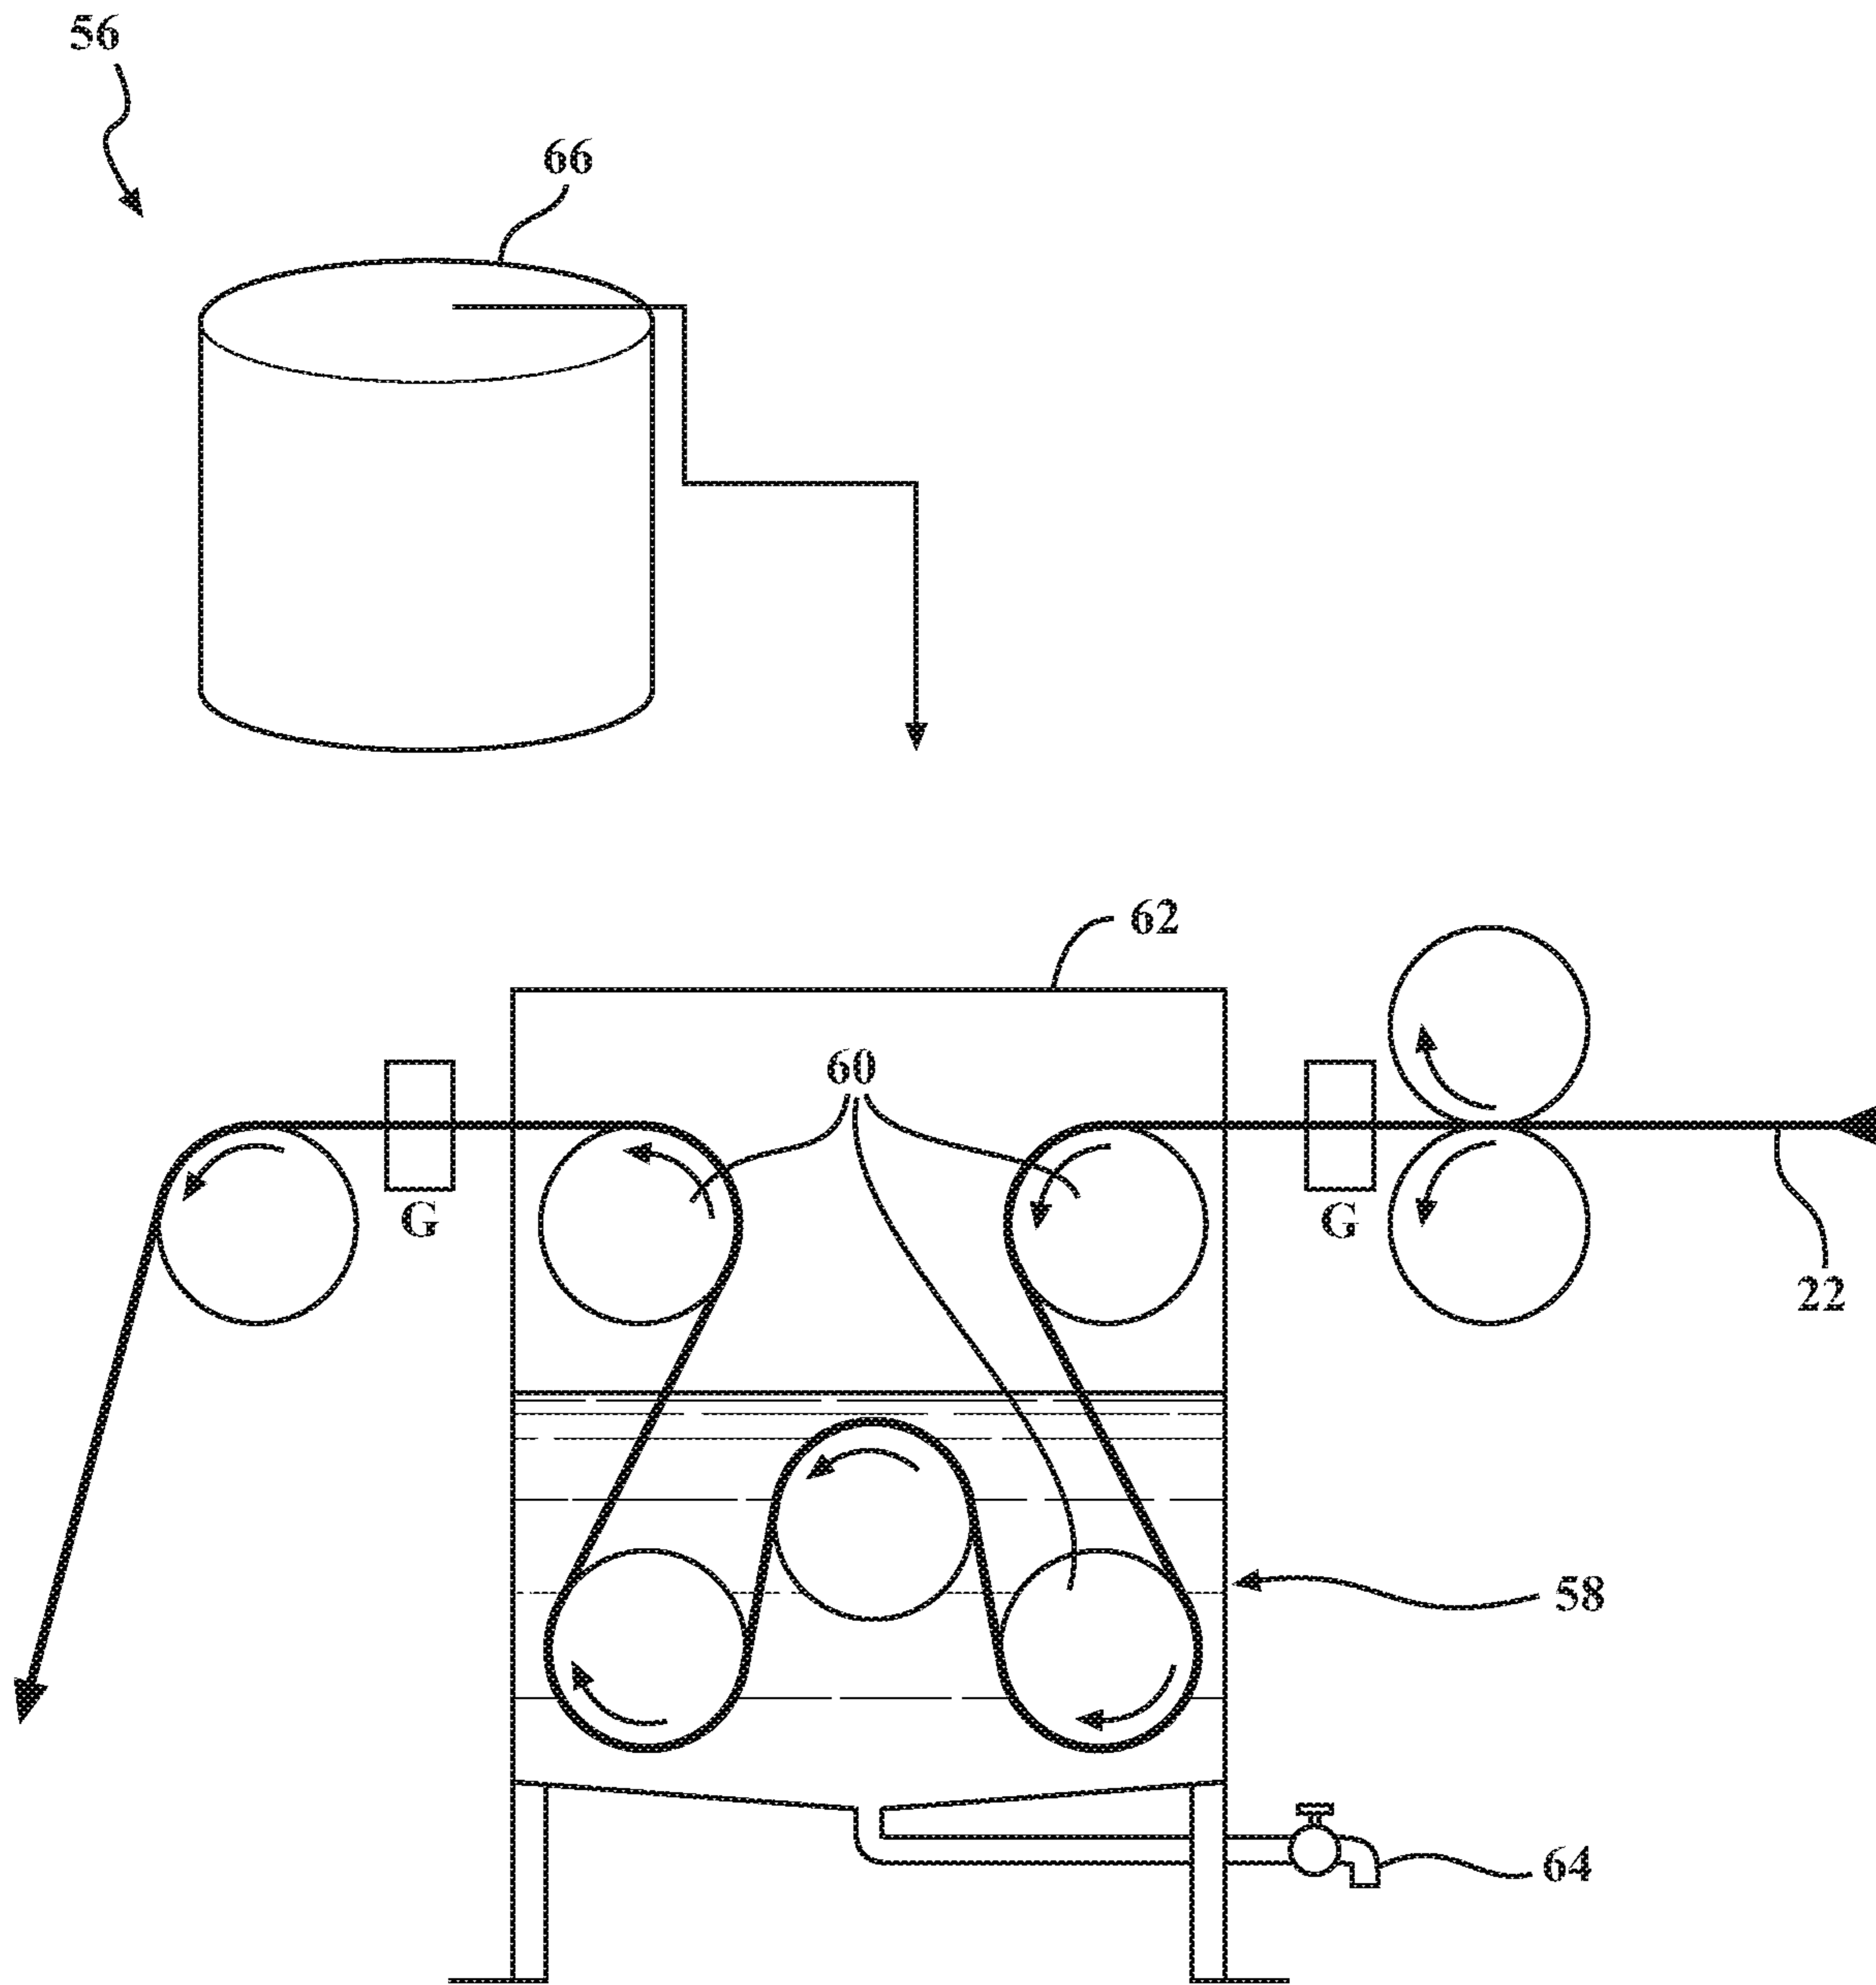
FIG. 5 illustrates an example of a dip tank assembly for coating the liner with a 1-part moisture-curing urethane grout according to an example embodiment; and
