US010665048B1

(10) **Patent No.:** **US 10,665,048 B1**
(45) **Date of Patent:** ***May 26, 2020**

(54) **APPARATUS AND METHOD FOR A BALCONY ACCESS STATUS ALERT SYSTEM**

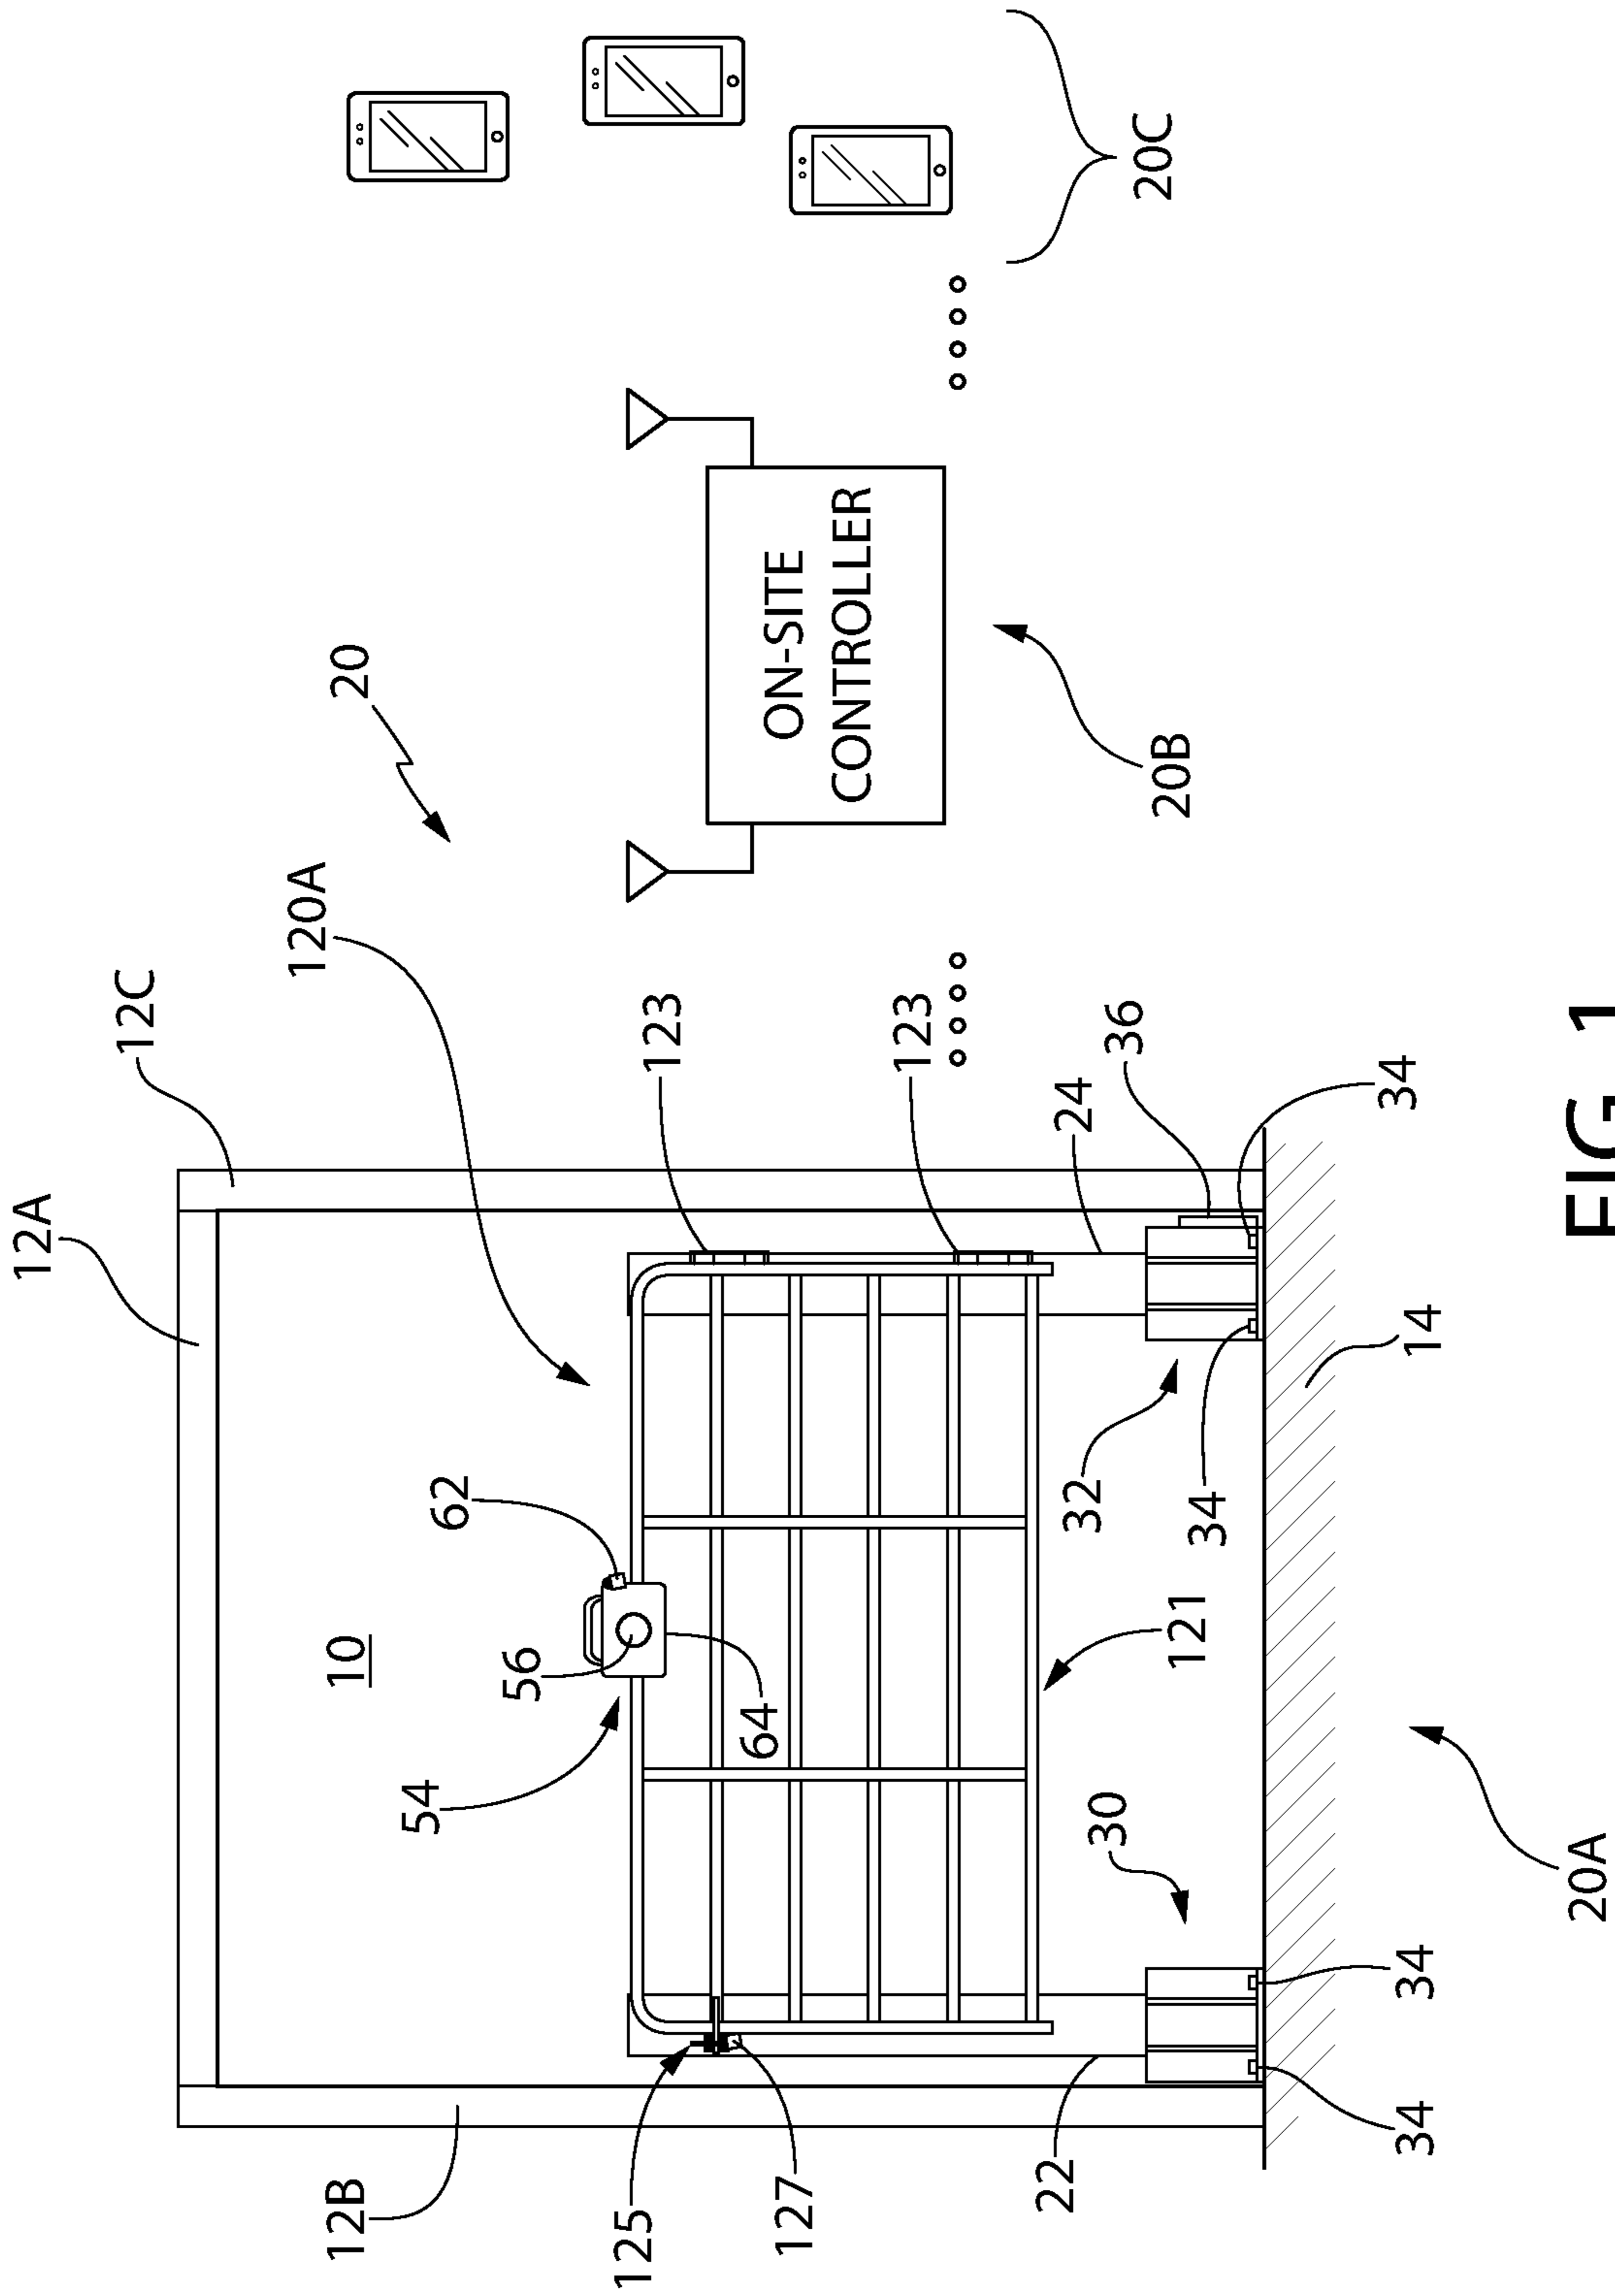
FIG. 1 is a diagram of the system of the balcony access status alert system (BASAS) showing the gate installed in front of the balcony, the onsite controller and the wireless devices of the authorized personnel;

As shown in FIG. 1, the system and method 20 of the present invention (also referred to as the “balcony access status alert system, BASAS”) comprises a gate 120A installed in front of the ingress/egress 10 (hereinafter, “opening 10”) to a balcony (or other elevated platform), an on-site controller 20B (e.g., a DMP-XTLC-Wireless Control Panel, etc.) and at least one wireless communication device 20C (e.g., a cellphone, a smartphone, computer tablet, etc.). As will be discussed in detail later, if the gate 120A is ever opened, or removed from its location in front of the balcony opening 10, a wireless signal is transmitted from the gate 120A to the on-site controller 20B which in turn transmits warnings (e.g., text alerts, etc.) to at least one wireless device 20C of at least one authorized person (e.g., an on-site safety manager, superintendent, etc.) to take the appropriate action to close the gate 120A or restore the gate 120A or otherwise coordinate actions to secure the balcony opening 10.

It should be understood that the term “on-site controller” 20B is a device that is located on a site where construction is on-going but that the controller 20B itself may be located remotely from the actual gate(s) 120A/opening(s) 10, as indicated by the “dots” in FIGS. 1 and 5A-5B. Similarly, “on-site personnel” may be located at the site where construction may be occurring but they also may be remote from the actual gate(s) 120A/opening(s) 10. Thus, by way of example only, construction work may be occurring at particular units in a residential housing facility (“site”) that is already occupied; as a result, certain authorized personnel can be present anywhere at the site but remote from any of the gate(s) 120A/opening(s) 10 and thus are unaware of the particular status of the gates 120A. The BASAS 20 provides the requisite status automatically to these authorized personnel, as is discussed below.

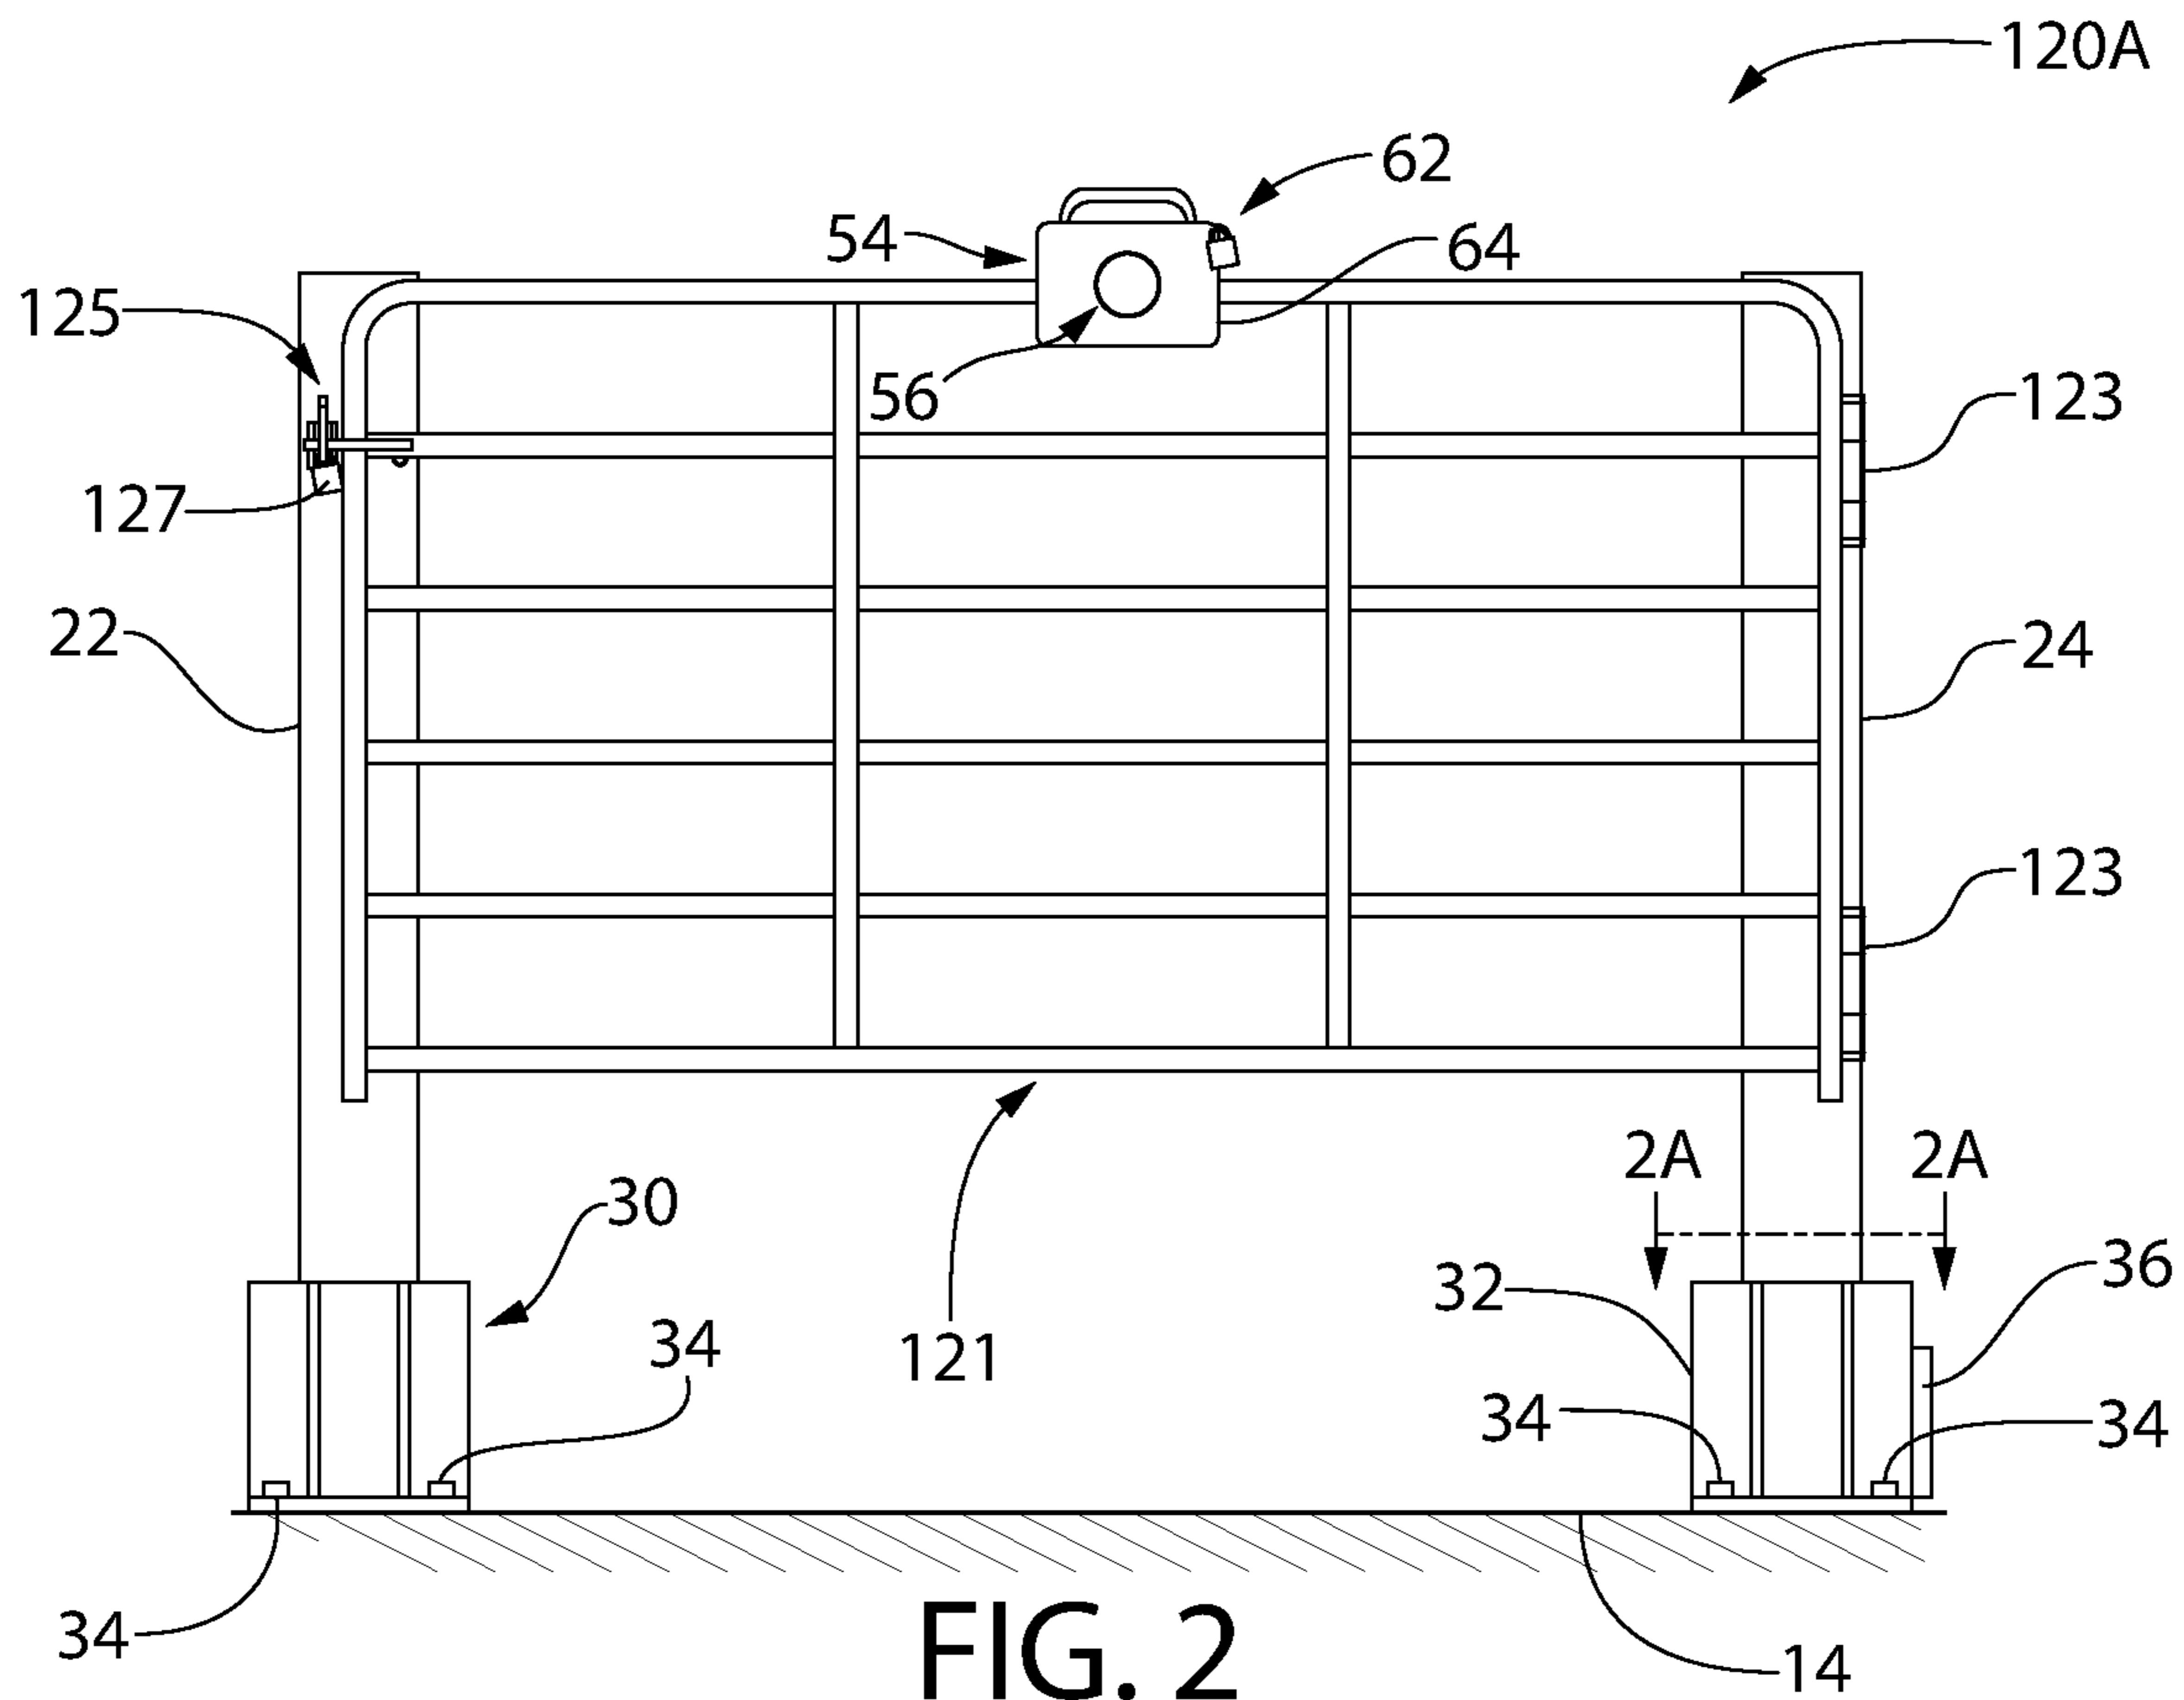
FIG. 2 is a plan view of the gate portion of the BASAS positioned in its receptacles and with the gate portion shown closed;

A balcony opening 10 is typically formed by a frame, e.g., studs 12A-12C and the floor 14. As shown most clearly in FIG. 2, the gate 120A comprises a gate structure 121 (e.g., a “cow gate” such as the Tarter 6 Bar Economy Tube Gate, 6EBL12, by Tractor Supply Co., etc.) of metal bars/struts and wherein one side of the gate 120A is pivotally-coupled (e.g., via hinges 123) to one vertical post 24 (e.g., wood posts, metal posts, etc.) and the other side of the gate 120A can be releasably secured (e.g., using a latch 125 and padlock 127, etc.) to another vertical post 22 (e.g., wood posts, metal posts, etc.) to close the gate 120A. By way of example only, the latch 125 may comprise a self-locking gate latch assembly (e.g., Self-locking gate latch-post mount automatic gravity lever wood fence gate latches by Nidaye, or by Zoro Select or National Hardware N184-861 Universal Automatic Gate Latch, etc.) which can then be locked with the padlock 127. Moreover, where wooden posts are used for the vertical posts 22/24, tamper-proof fasteners (e.g., Lobe pan head screws (“star-shaped” socket)), etc.) are preferred to deter others from easily disengaging the gate structure 121 (e.g., attempting to disengage the hinges 123, or the latch assembly 125, etc.) from the vertical posts 22/24 to enter the balcony opening 10. The bottom of each vertical post 22/24 is received in a respective receptacle 30 and 32 (e.g., an Occupational Safety and Health Act (OSHA) safety boot SB001) and each of which are fixedly secured to the

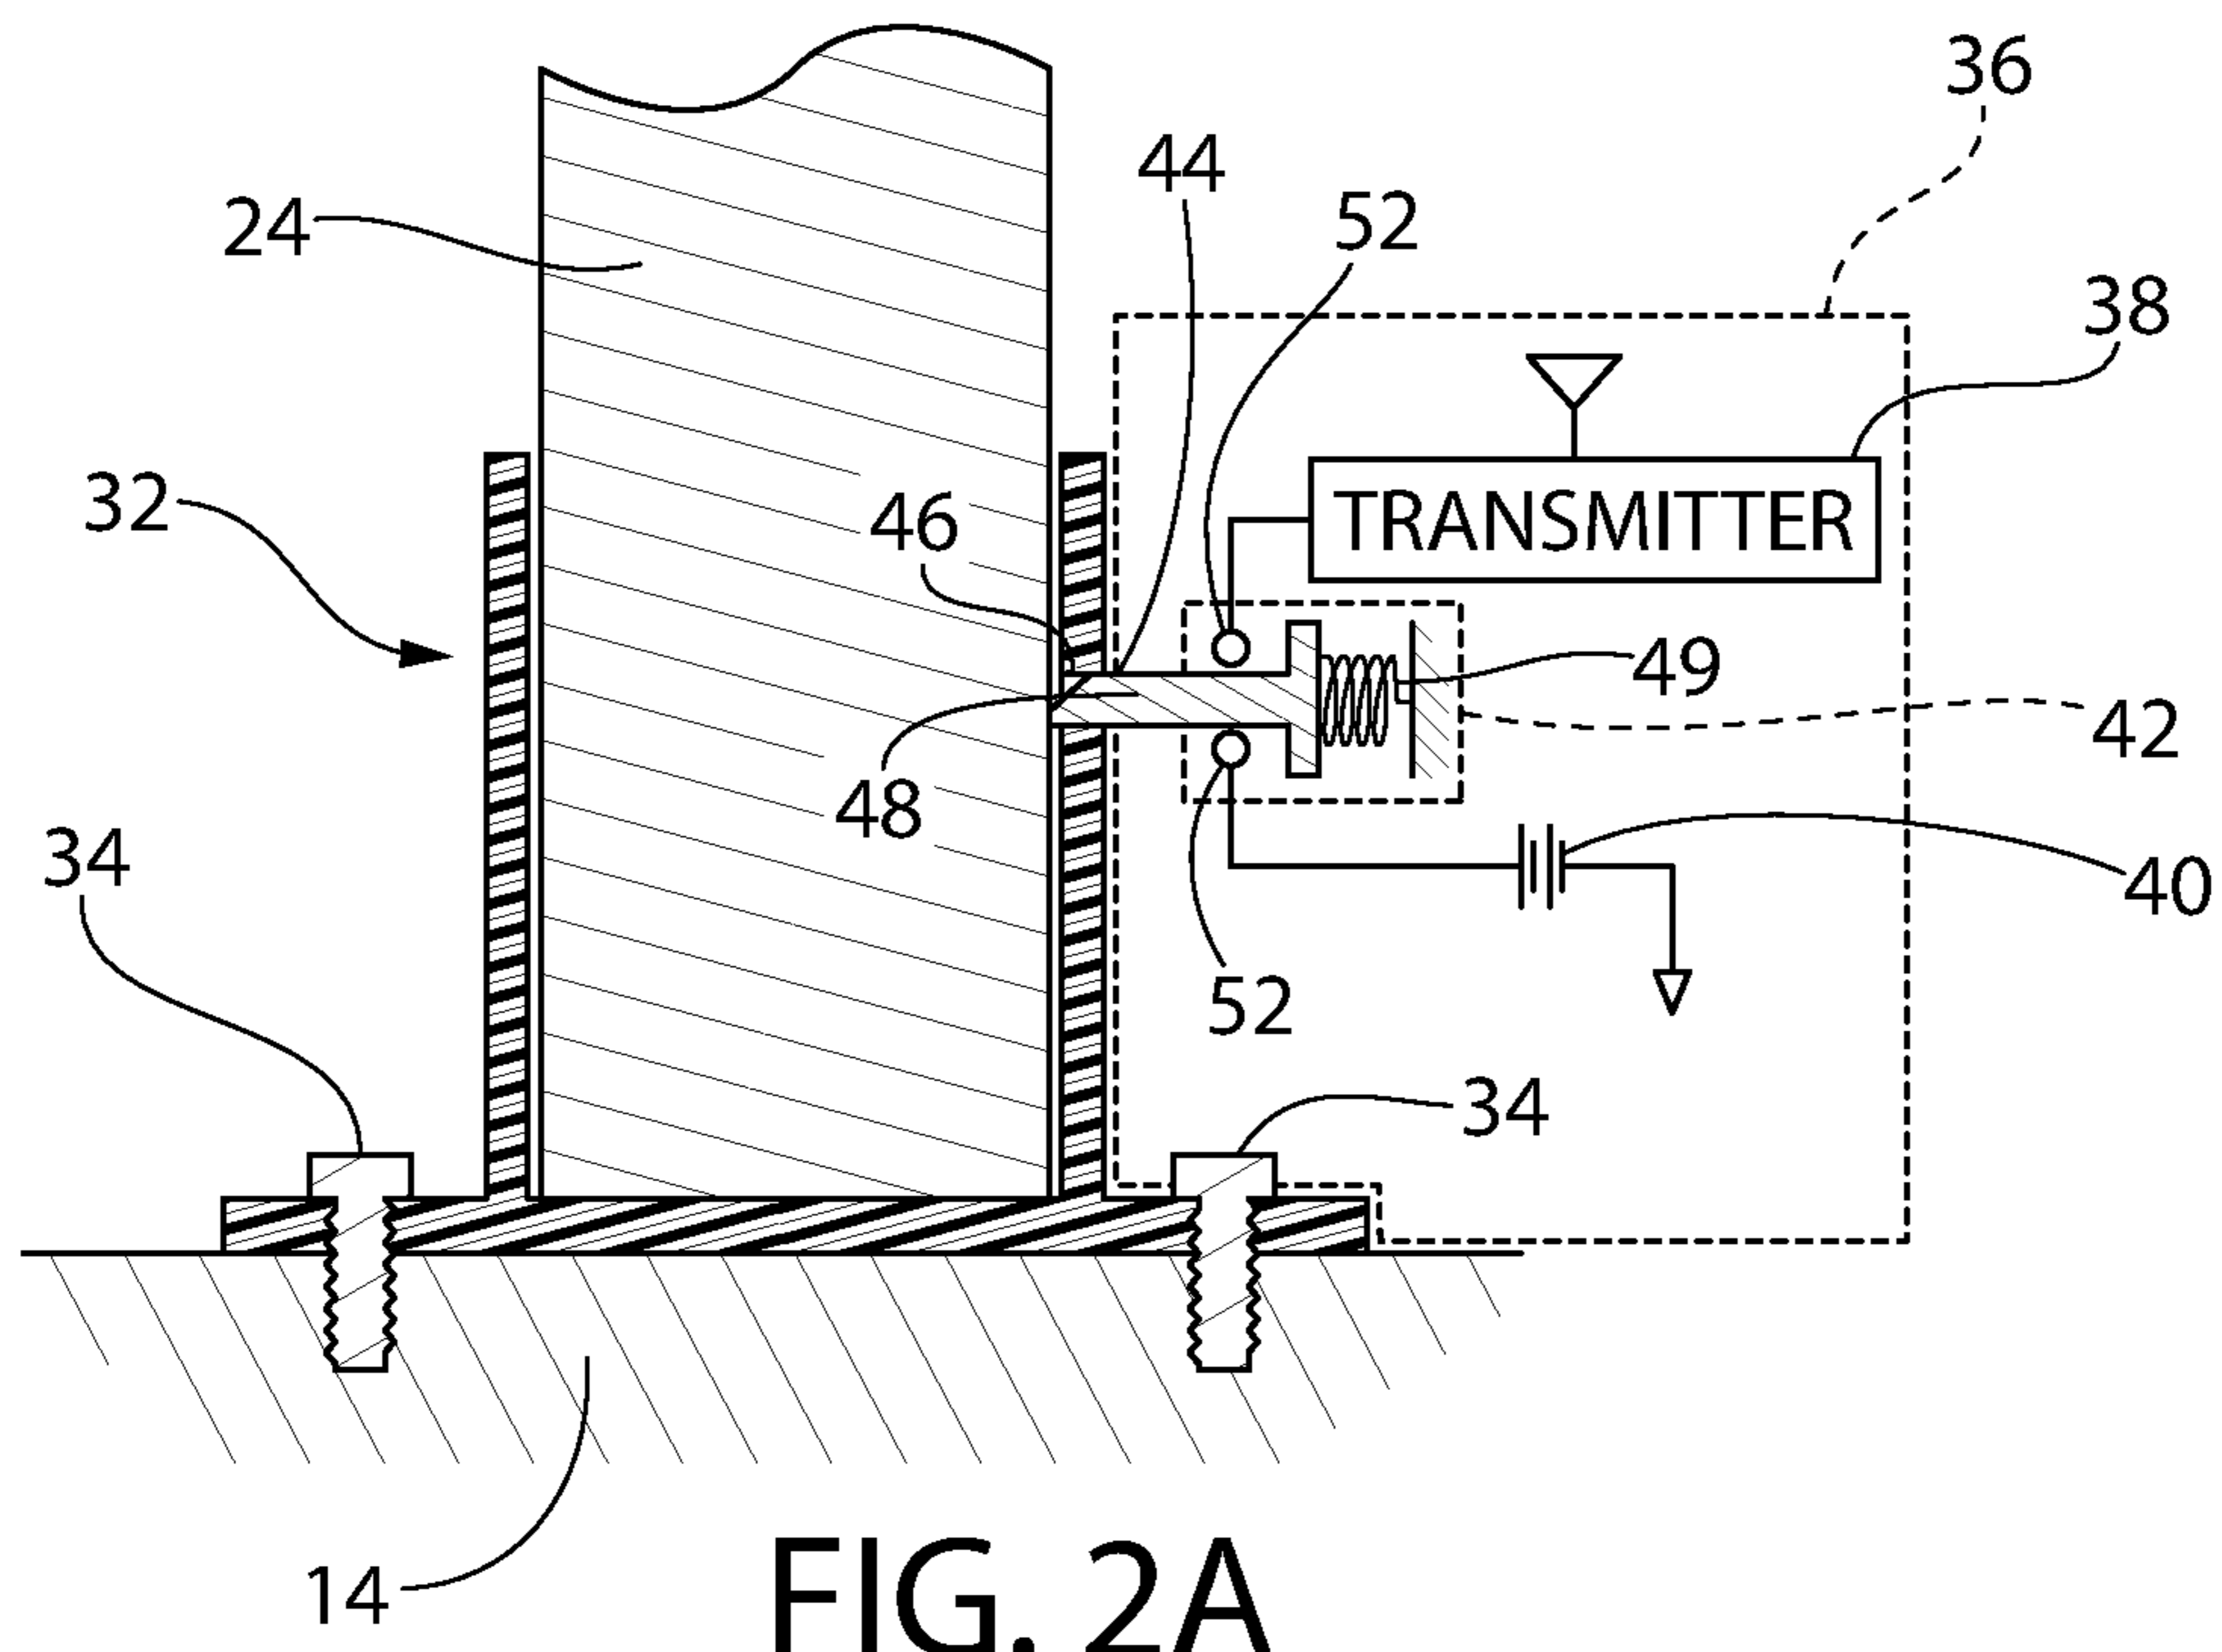
FIG. 2A is a functional diagram showing how the presence of the gate post, shown partially, in the corresponding boot maintains the first transmitter inactive;

By way of example only, a housing 36 is provided in the receptacle 32, it being understood that this housing 36 can just as easily be provided in the receptacle 30. As shown most clearly in FIG. 2A, the housing 36 comprises a transmitter 38 (e.g., DMP-1101 or DMP 1106 wireless input transmitter, etc.), a battery 40 (e.g., 3 VDC lithium battery) and a switch 42 electrically connected between the transmitter 38 and the battery 40. The housing 36 comprises an aperture 44 which aligns with an aperture 46 in the receptacle 32 through which projects a conductive switch element 48 that is biased (via a spring 49) to close contacts 52 when the bottom of the post 24 is removed from the receptacle (see FIG. 3A) and to activate the transmitter 38 to transmit a wireless signal 66 (FIGS. 3A-4). As shown in FIG. 2A, with the bottom of the post 24 inserted within the receptacle 32, the conductive switch element 48 is displaced away from contacts 52 and the transmitter 38 is thus de-energized. As such, the transmitter 38/switch 42 form a detector which determines when the gate 120A has been removed or restored. With that said, it should be understood that it is within the broadest scope of the present invention 20 to include various types of detection schemes (e.g., proximity switches, magnetic coupling, electrical field disturbance, photoelectric detection, etc.) for detecting the removal/restoration of the gate 120A and that the transmitter 38/switch 42 configuration disclosed herein is by way of example only.

Just as the removal and restoration of the gate 120A is monitored by a detector (see FIG. 2A), so too is the opening and closing of the gate 120A monitored by a second detector (see FIG. 4A). It should be noted, as stated earlier, that these detectors are by way of example only, and that it is within the broadest scope of the present invention 20 to include various types of detection schemes (e.g., proximity switches, magnetic coupling, electrical field disturbance, photoelectric detection, etc.) for detecting not only the removal/restoration of the gate 120A but also the opening/closing of the gate 120A. Thus, the detector of FIG. 2A is referred to hereinafter as the “first detector” and the detector of FIG. 4A is referred to hereinafter as the “second detector.”

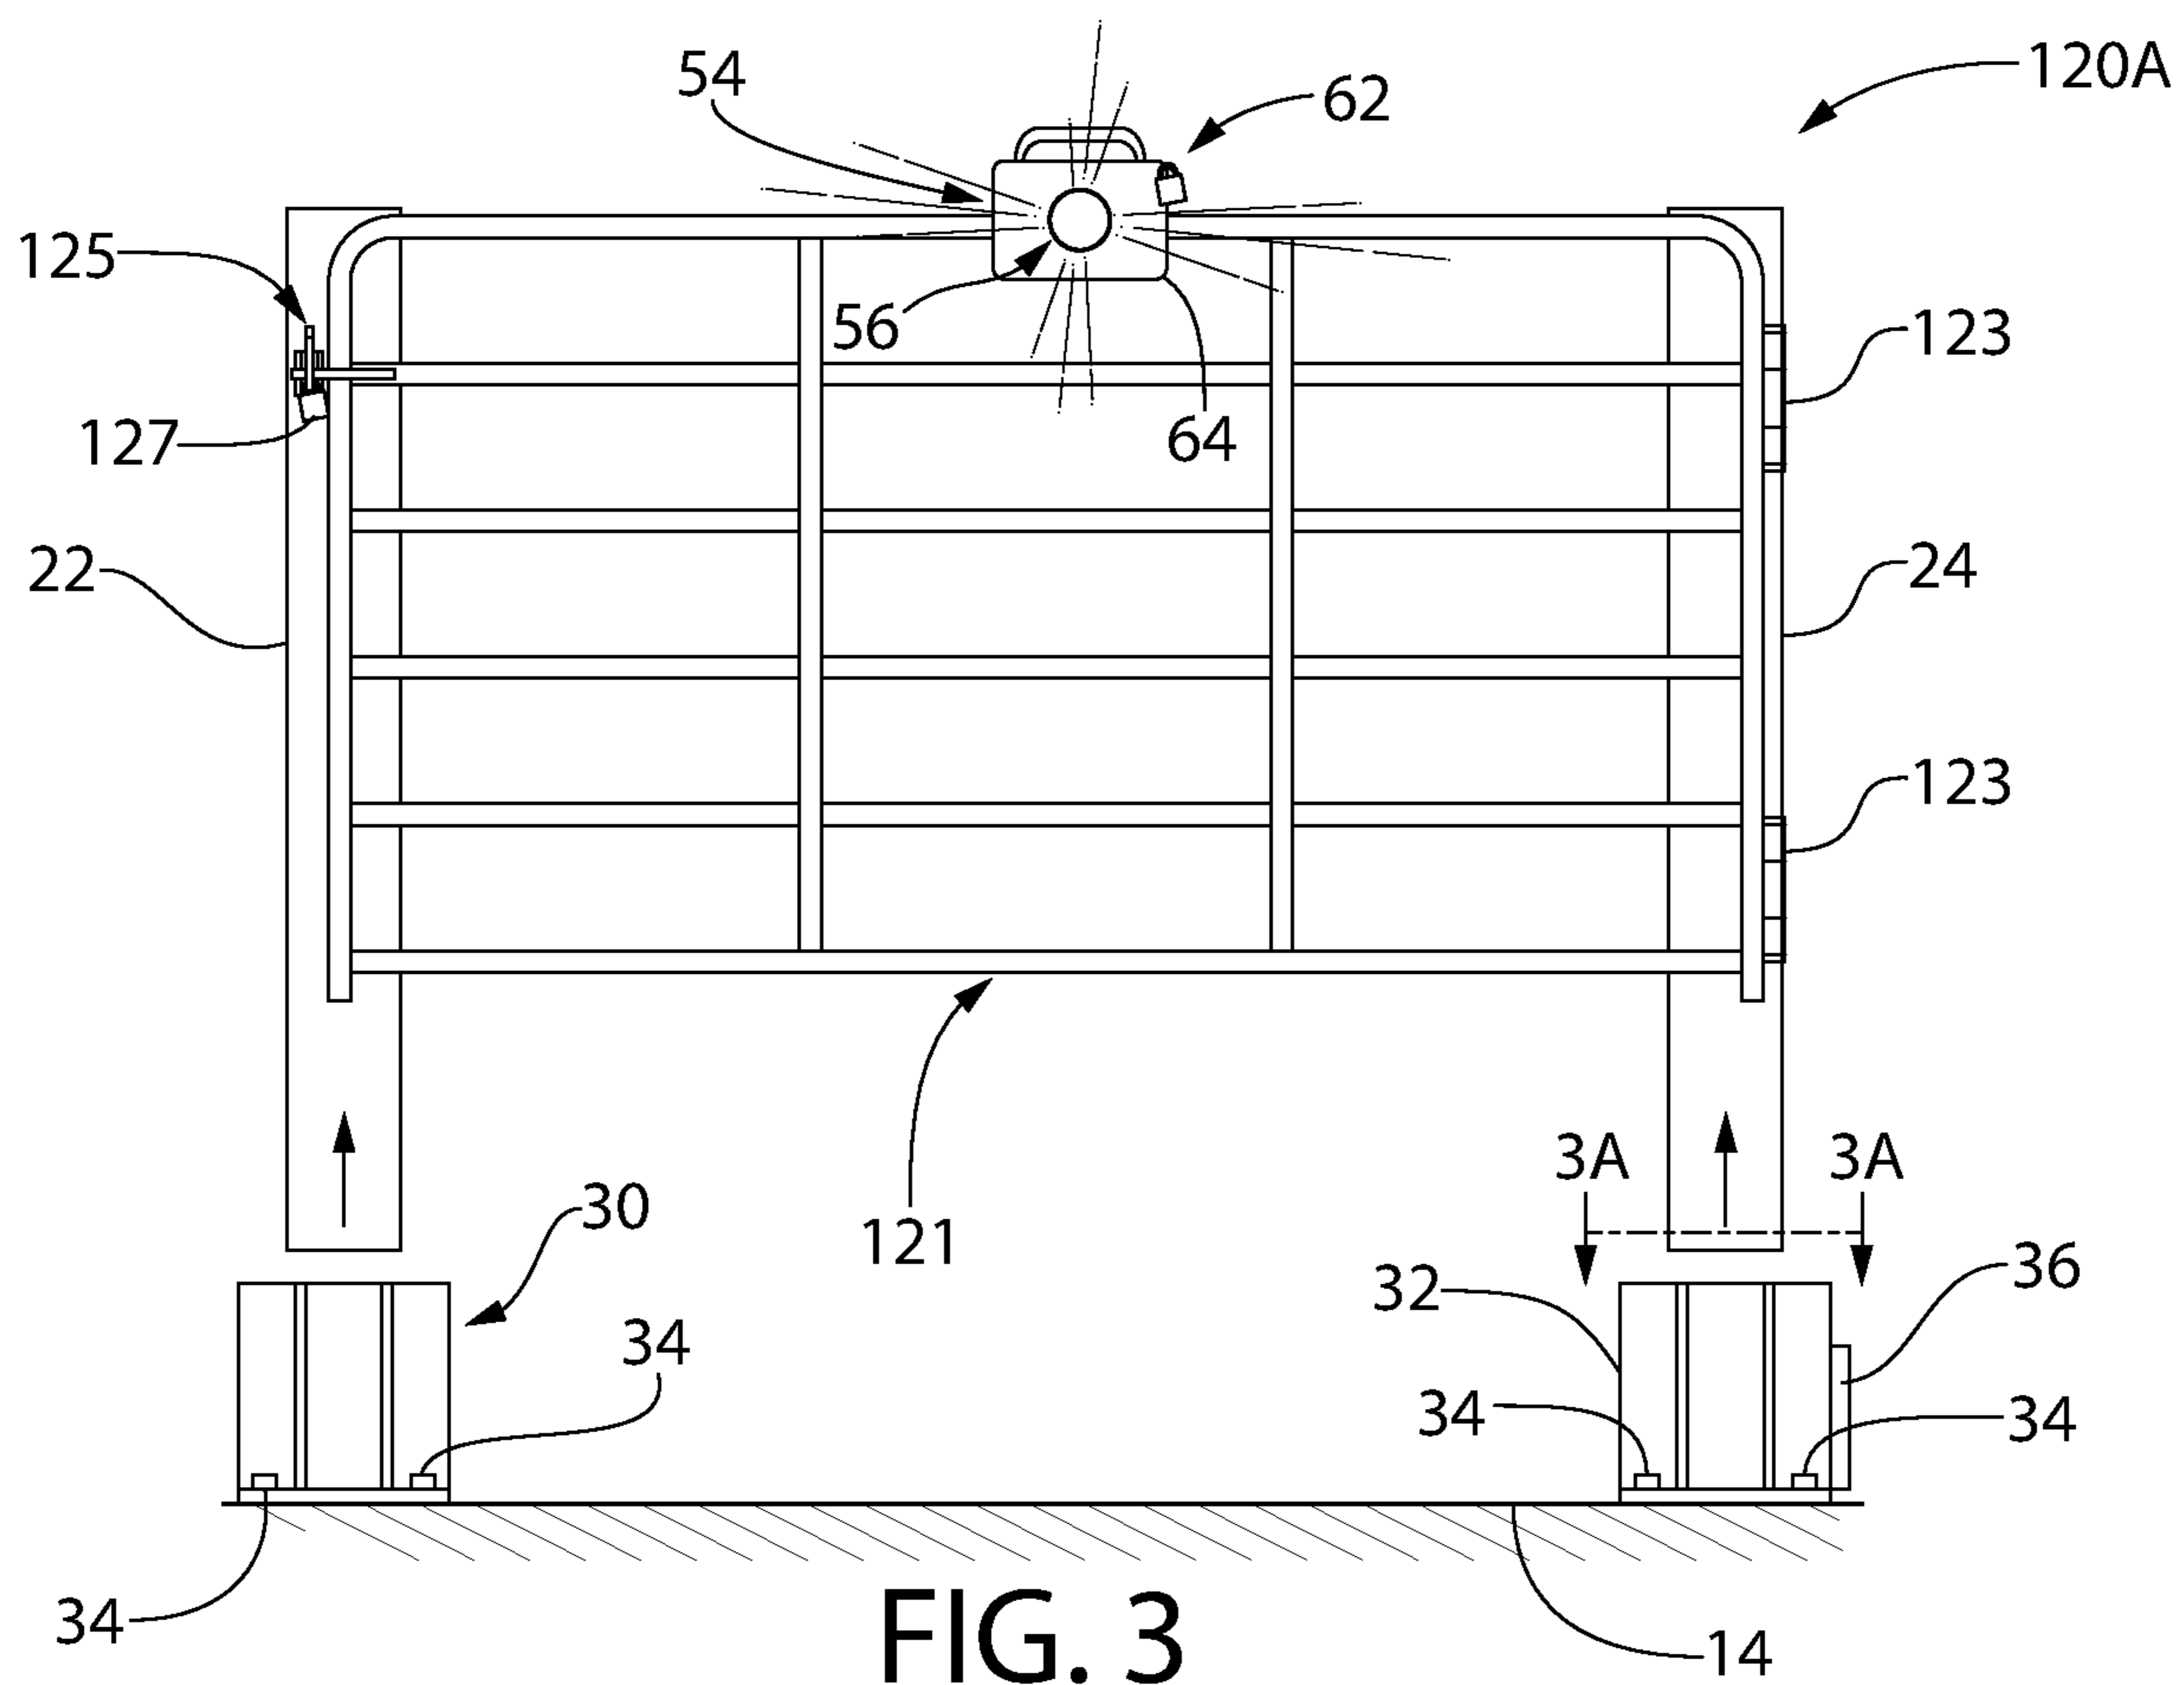
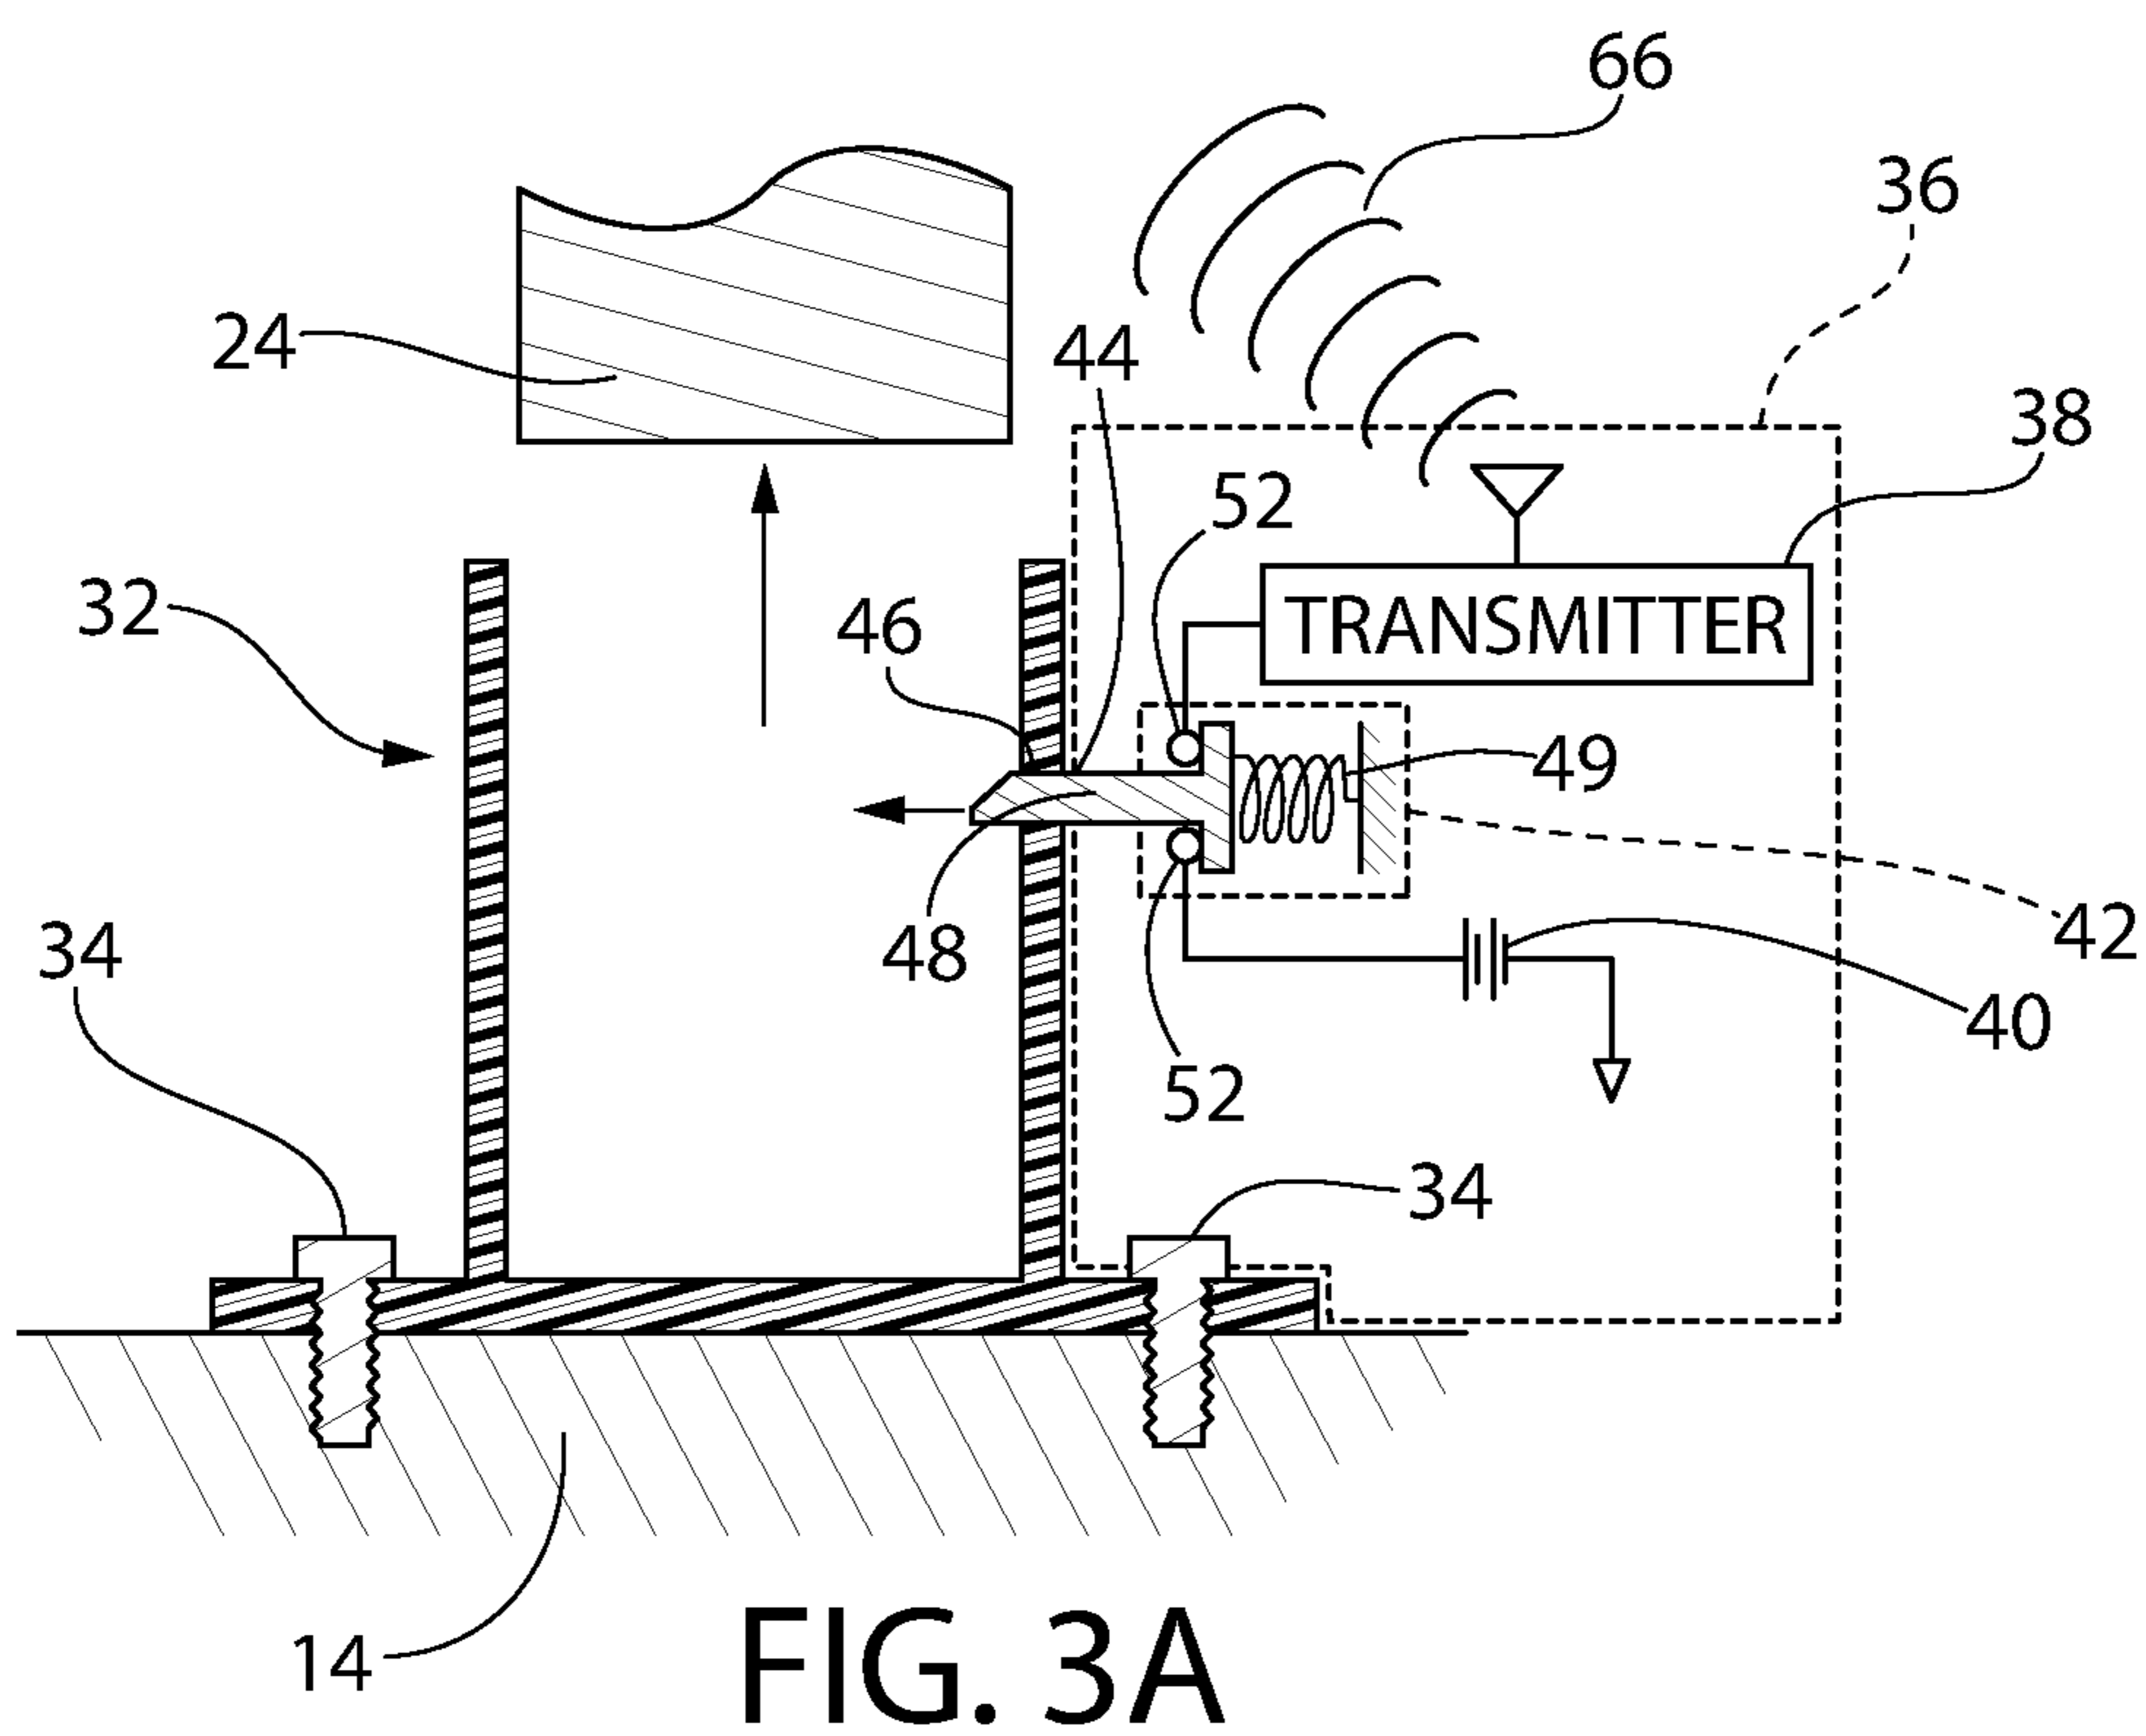
FIG. 3 shows the gate portion of the system being removed from the respective boots;

FIG. 3A is a functional diagram showing how the removal of the gate post, shown partially, from the corresponding boot activates the first transmitter;

As will be discussed in detail later, there are two actions that are detected by the system and method 20 of the BASAS. The first action is the removal of the gate 120A from the receptacles 30 and/or 32 (FIG. 3). The second action is the opening of the gate 120A, e.g., by unlatching it from the vertical post 22 and then swinging it open (FIG. 4B). Either of these actions will cause the BASAS to send the alerts as discussed in detail below. Removal of the gate 120A as opposed to simply opening the gate 120A may be necessary when large equipment or other needs require a wider pathway onto or from the balcony 15 (FIG. 11).
