US010665048B1

(10) **Patent No.:** **US 10,665,048 B1**
(45) **Date of Patent:** ***May 26, 2020**

(54) **APPARATUS AND METHOD FOR A BALCONY ACCESS STATUS ALERT SYSTEM**

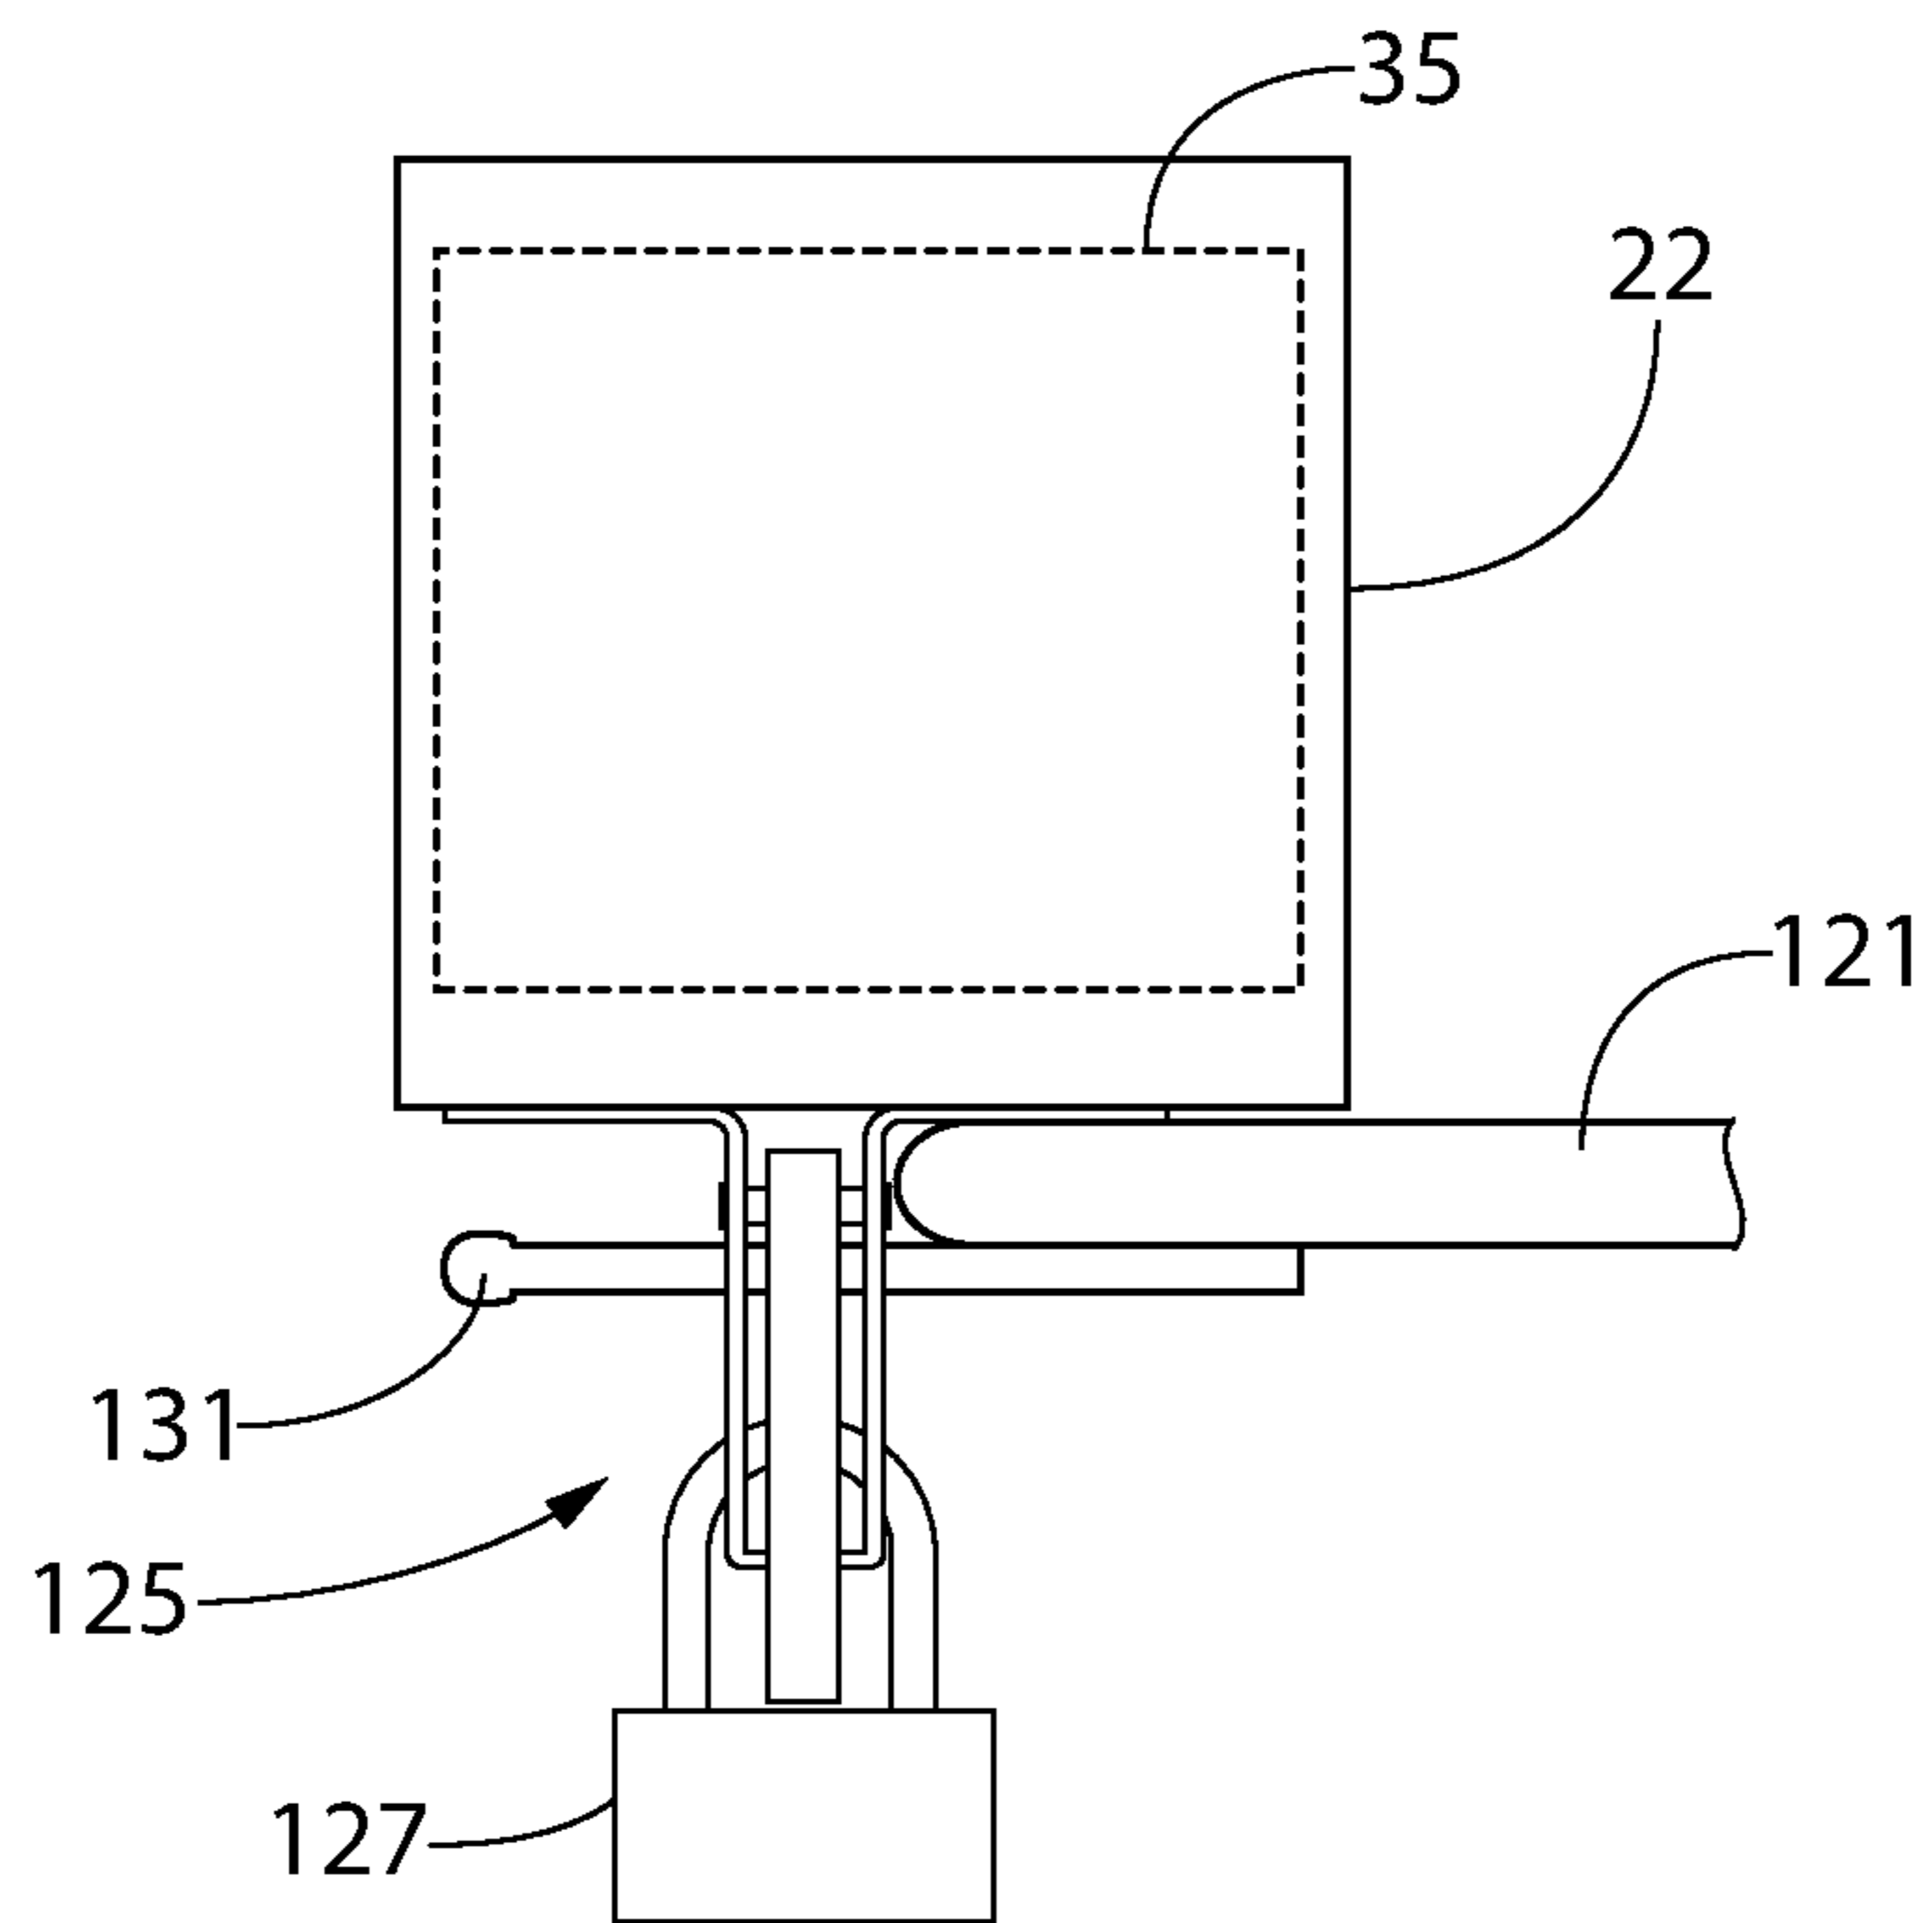
FIG. 4 is partial top view of the gate and vertical post and showing an exemplary latch device for releasably securing the gate in a closed position;

numbers in the first detector without the letter “A”. By way of example only, the second detector is contained within a housing 36A (FIGS. 4A and 4C) that can be positioned within a cavity 35 (FIG. 4) at the top of the vertical post 22. As shown most clearly in FIG. 4A, the housing 36A comprises the second transmitter 38A (e.g., DMP-1101 or DMP 1106 wireless input transmitter, etc.), a battery 40A (e.g., 3 VDC lithium battery) and a switch 42A electrically connected between the second transmitter 38A and the battery 40A. The housing 36A also comprises a guide 45 through which projects a conductive switch element 48A that is biased (via a spring 49A) to close contacts 52A when the gate structure 121 is moved away from the vertical post 22 to open the gate 120A and thereby to activate the transmitter 38A to transmit the wireless signal 66 (FIGS. 4B-4C). If someone were to open the gate 120A by unlatching it, as shown in FIG. 4B, the second transmitter 38A will transmit a wireless signal 66, as shown in FIG. 4C, and the transceiver 58 (in the housing 56) will receive the wireless signal 66. At that time, the transceiver 58 will activate (see FIG. 4B) the visual indicator 56 (and/or the audible alarm 56A) to provide a “local” alert to those in the near vicinity that the gate 120A has been opened. Simultaneously, the transceiver 58 will transmit its own wireless signal 68 (FIG. 5A) to the on-site controller 20B (which is also always listening), which, in turn, will transmit alert warnings 70 (e.g., text messages, etc.; see FIG. 10) that a particular gate 120A (e.g., gate “McB4”) has been opened to wireless devices 20C of authorized personnel that are on the site and even off the site (if the power range permits). These warning signals 70 may be transmitted continuously, periodically or in any manner that the system operators wish to establish. FIG. 7B depicts a flow diagram of the second transmitter 38A operation while FIG. 8 depicts the transceiver 58 operation. FIG. 9 depicts the on-site controller processor 16 (FIG. 6) operation.

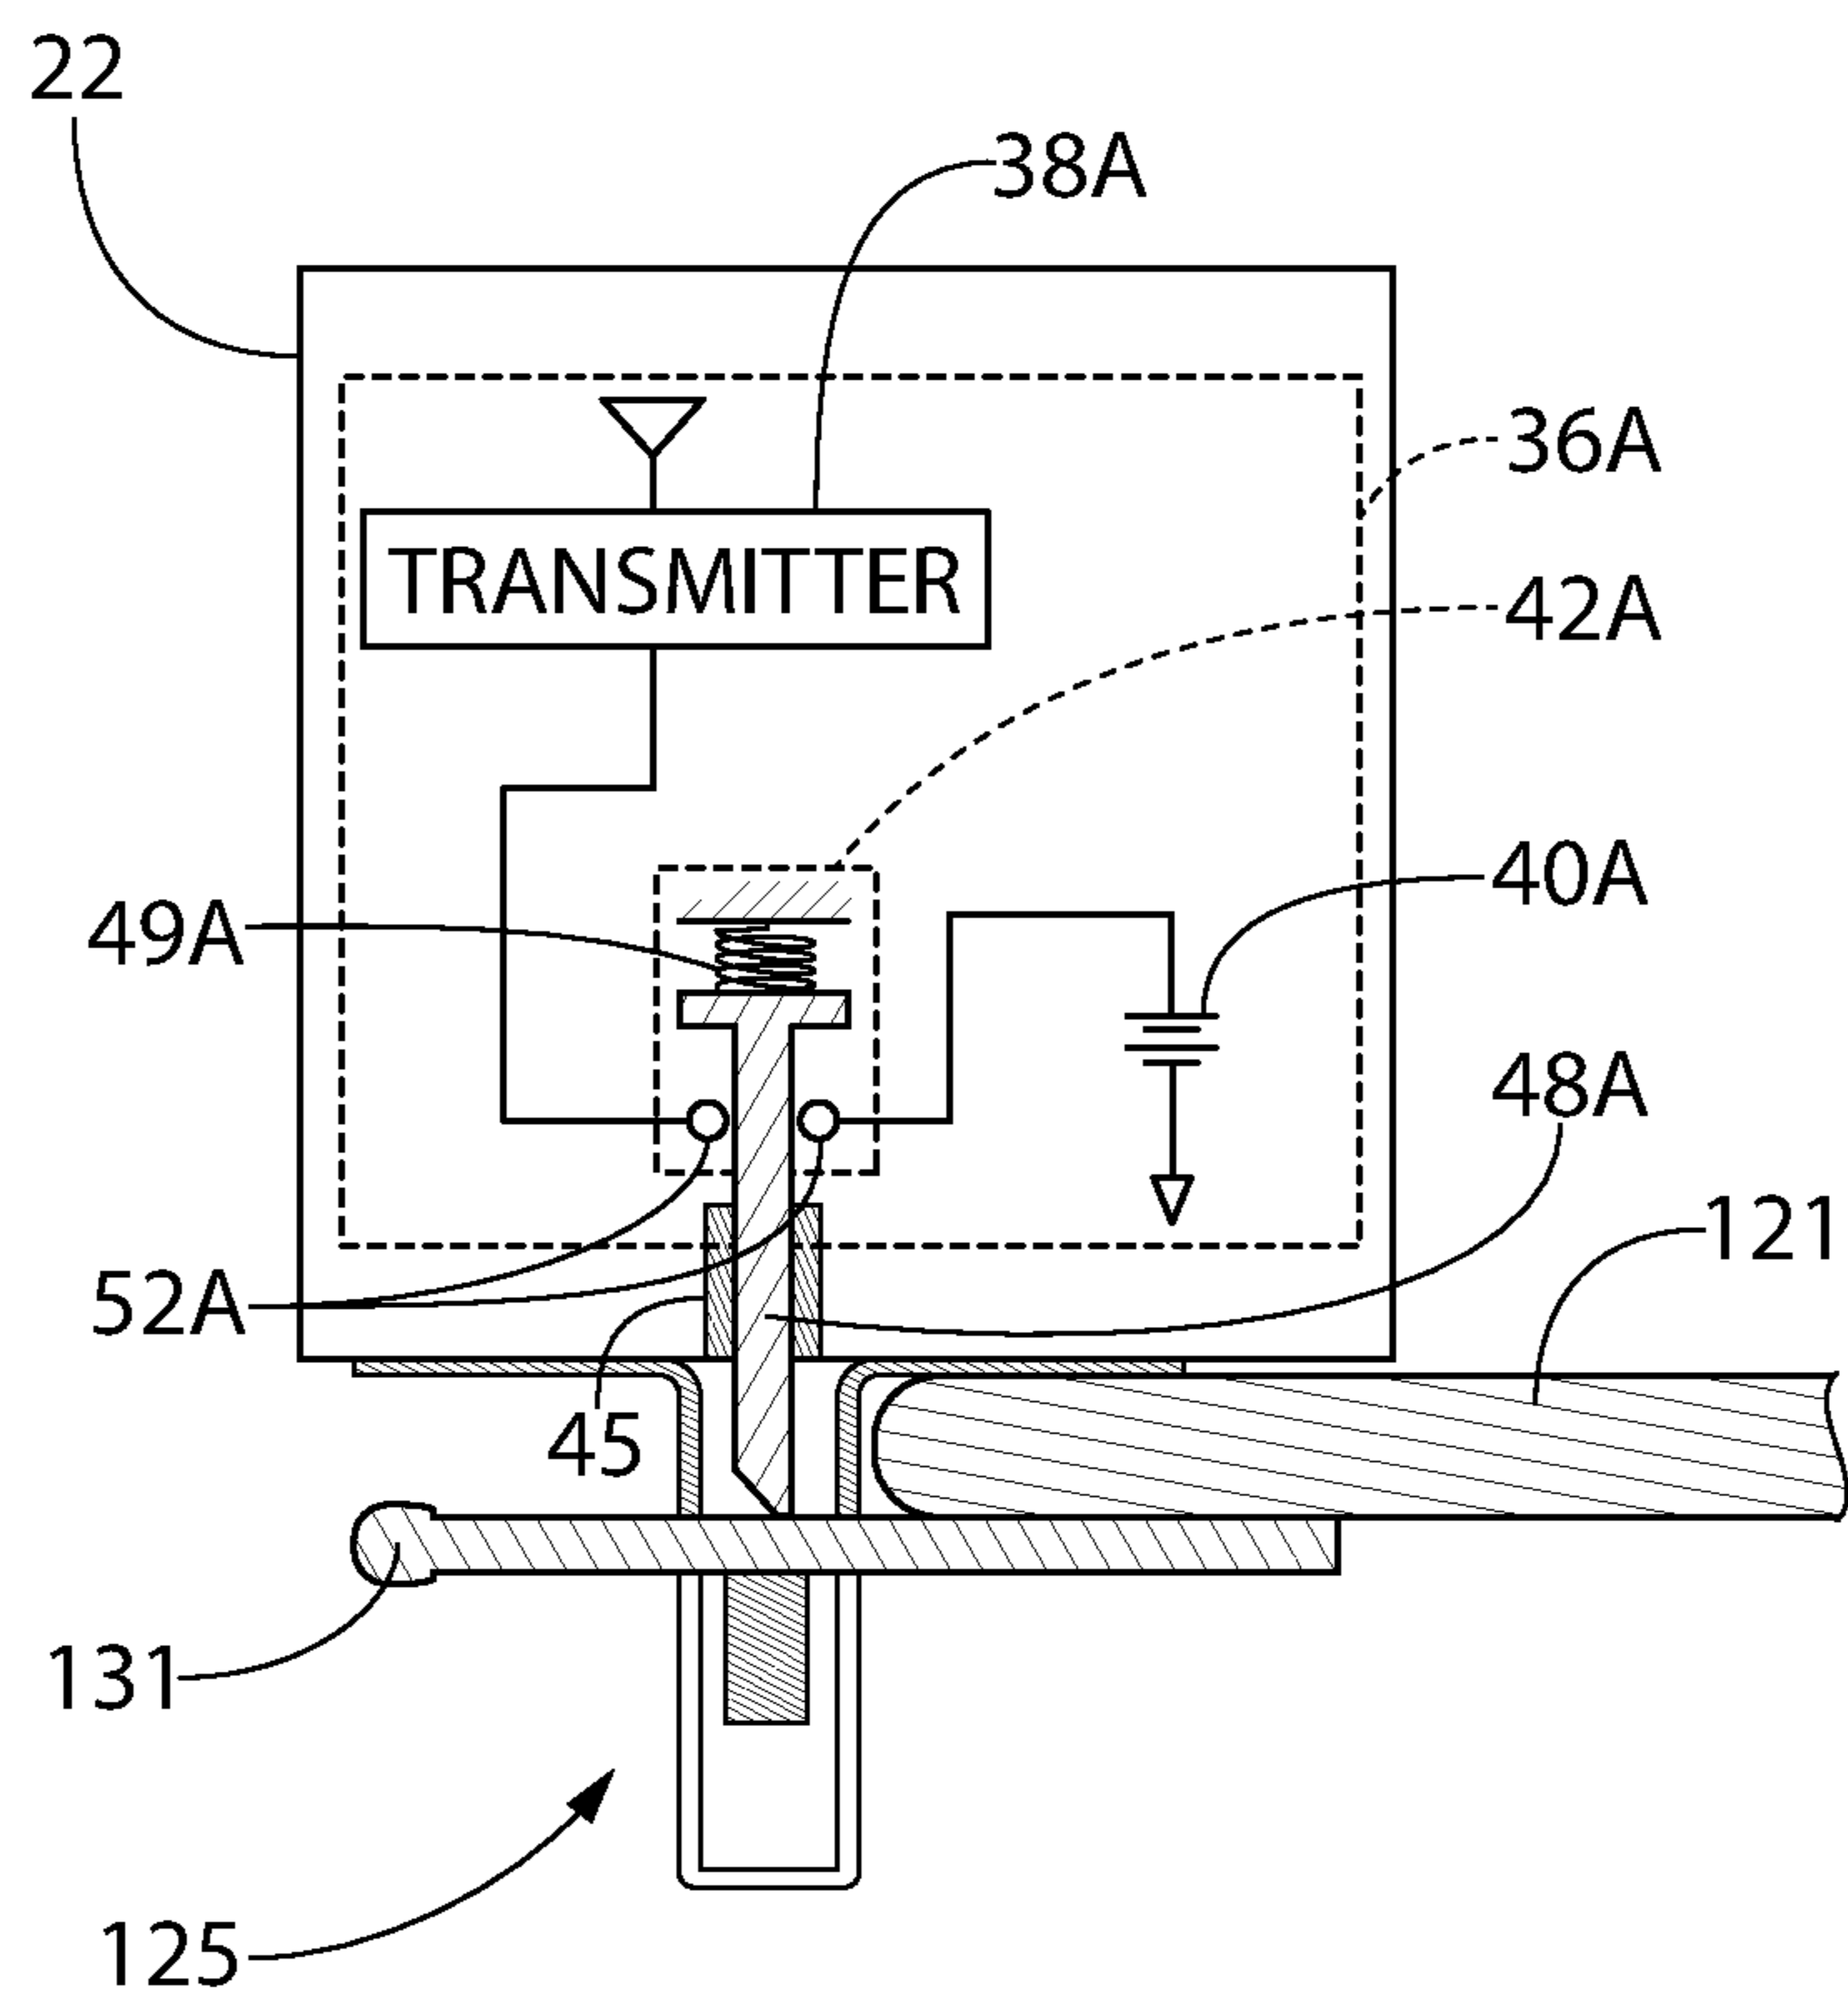
FIG. 4A is a functional diagram showing how the gate, shown partially, in a closed condition maintains the second transmitter inactive;

As such, the second detector shown in FIG. 4A is also exemplary and operates in a manner similar to the first detector. In particular, when the gate 120A is opened, the second detector activates a second transmitter 38A to transmit the signal 66 to the transceiver 58 (FIG. 5A) and when the gate 120A is closed, the second detector no longer transmits the signal 66, as shown in FIG. 5B. Since both detectors use respective transmitters (viz., transmitter 38 for the first detector and transmitter 38A for the second detector), the term “first transmitter” corresponds to transmitter 38 and the term “second transmitter” corresponds to transmitter 38A. Moreover, the components in both detectors are identical and the reference numbers using the letter “A” in the second detector correspond numerically to the reference

Conversely, as shown in FIG. 4A, with the gate structure 121 closed against the vertical post 22, the conductive switch element 48A is displaced away from contacts 52A and the second transmitter 38A is thus de-energized and the system status is shown in FIG. 5B.

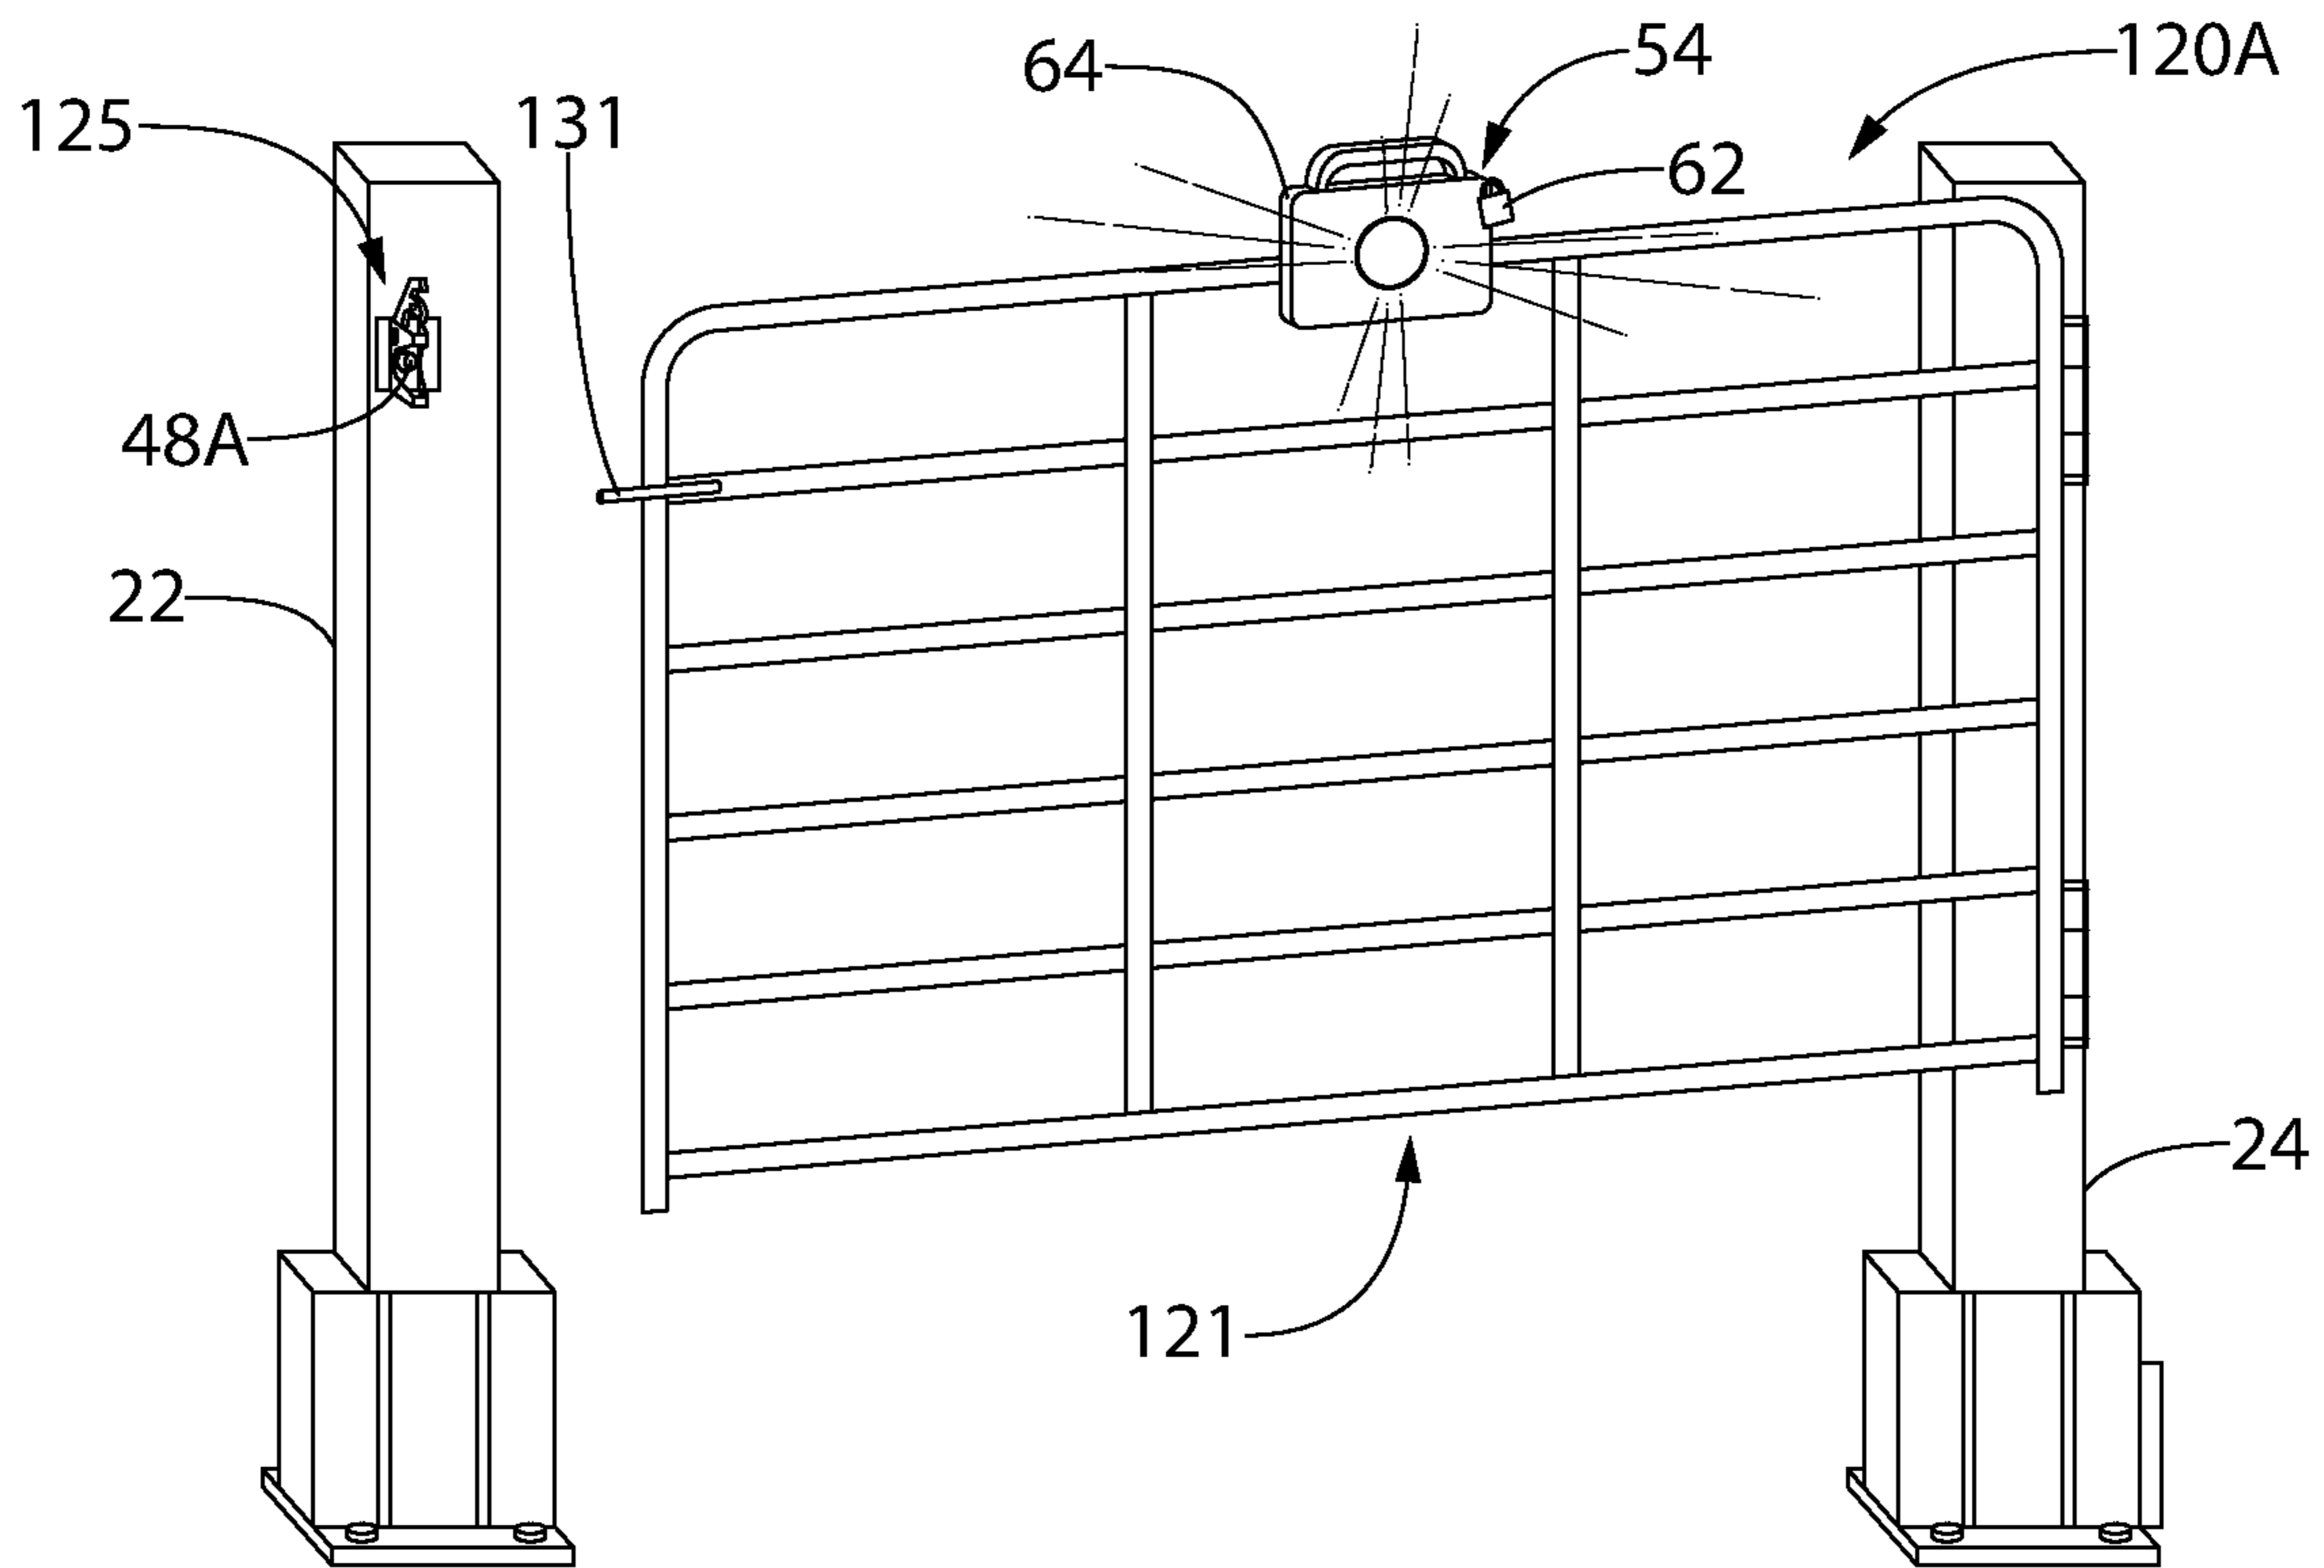
FIG. 4B shows the gate portion of the system in an open condition;

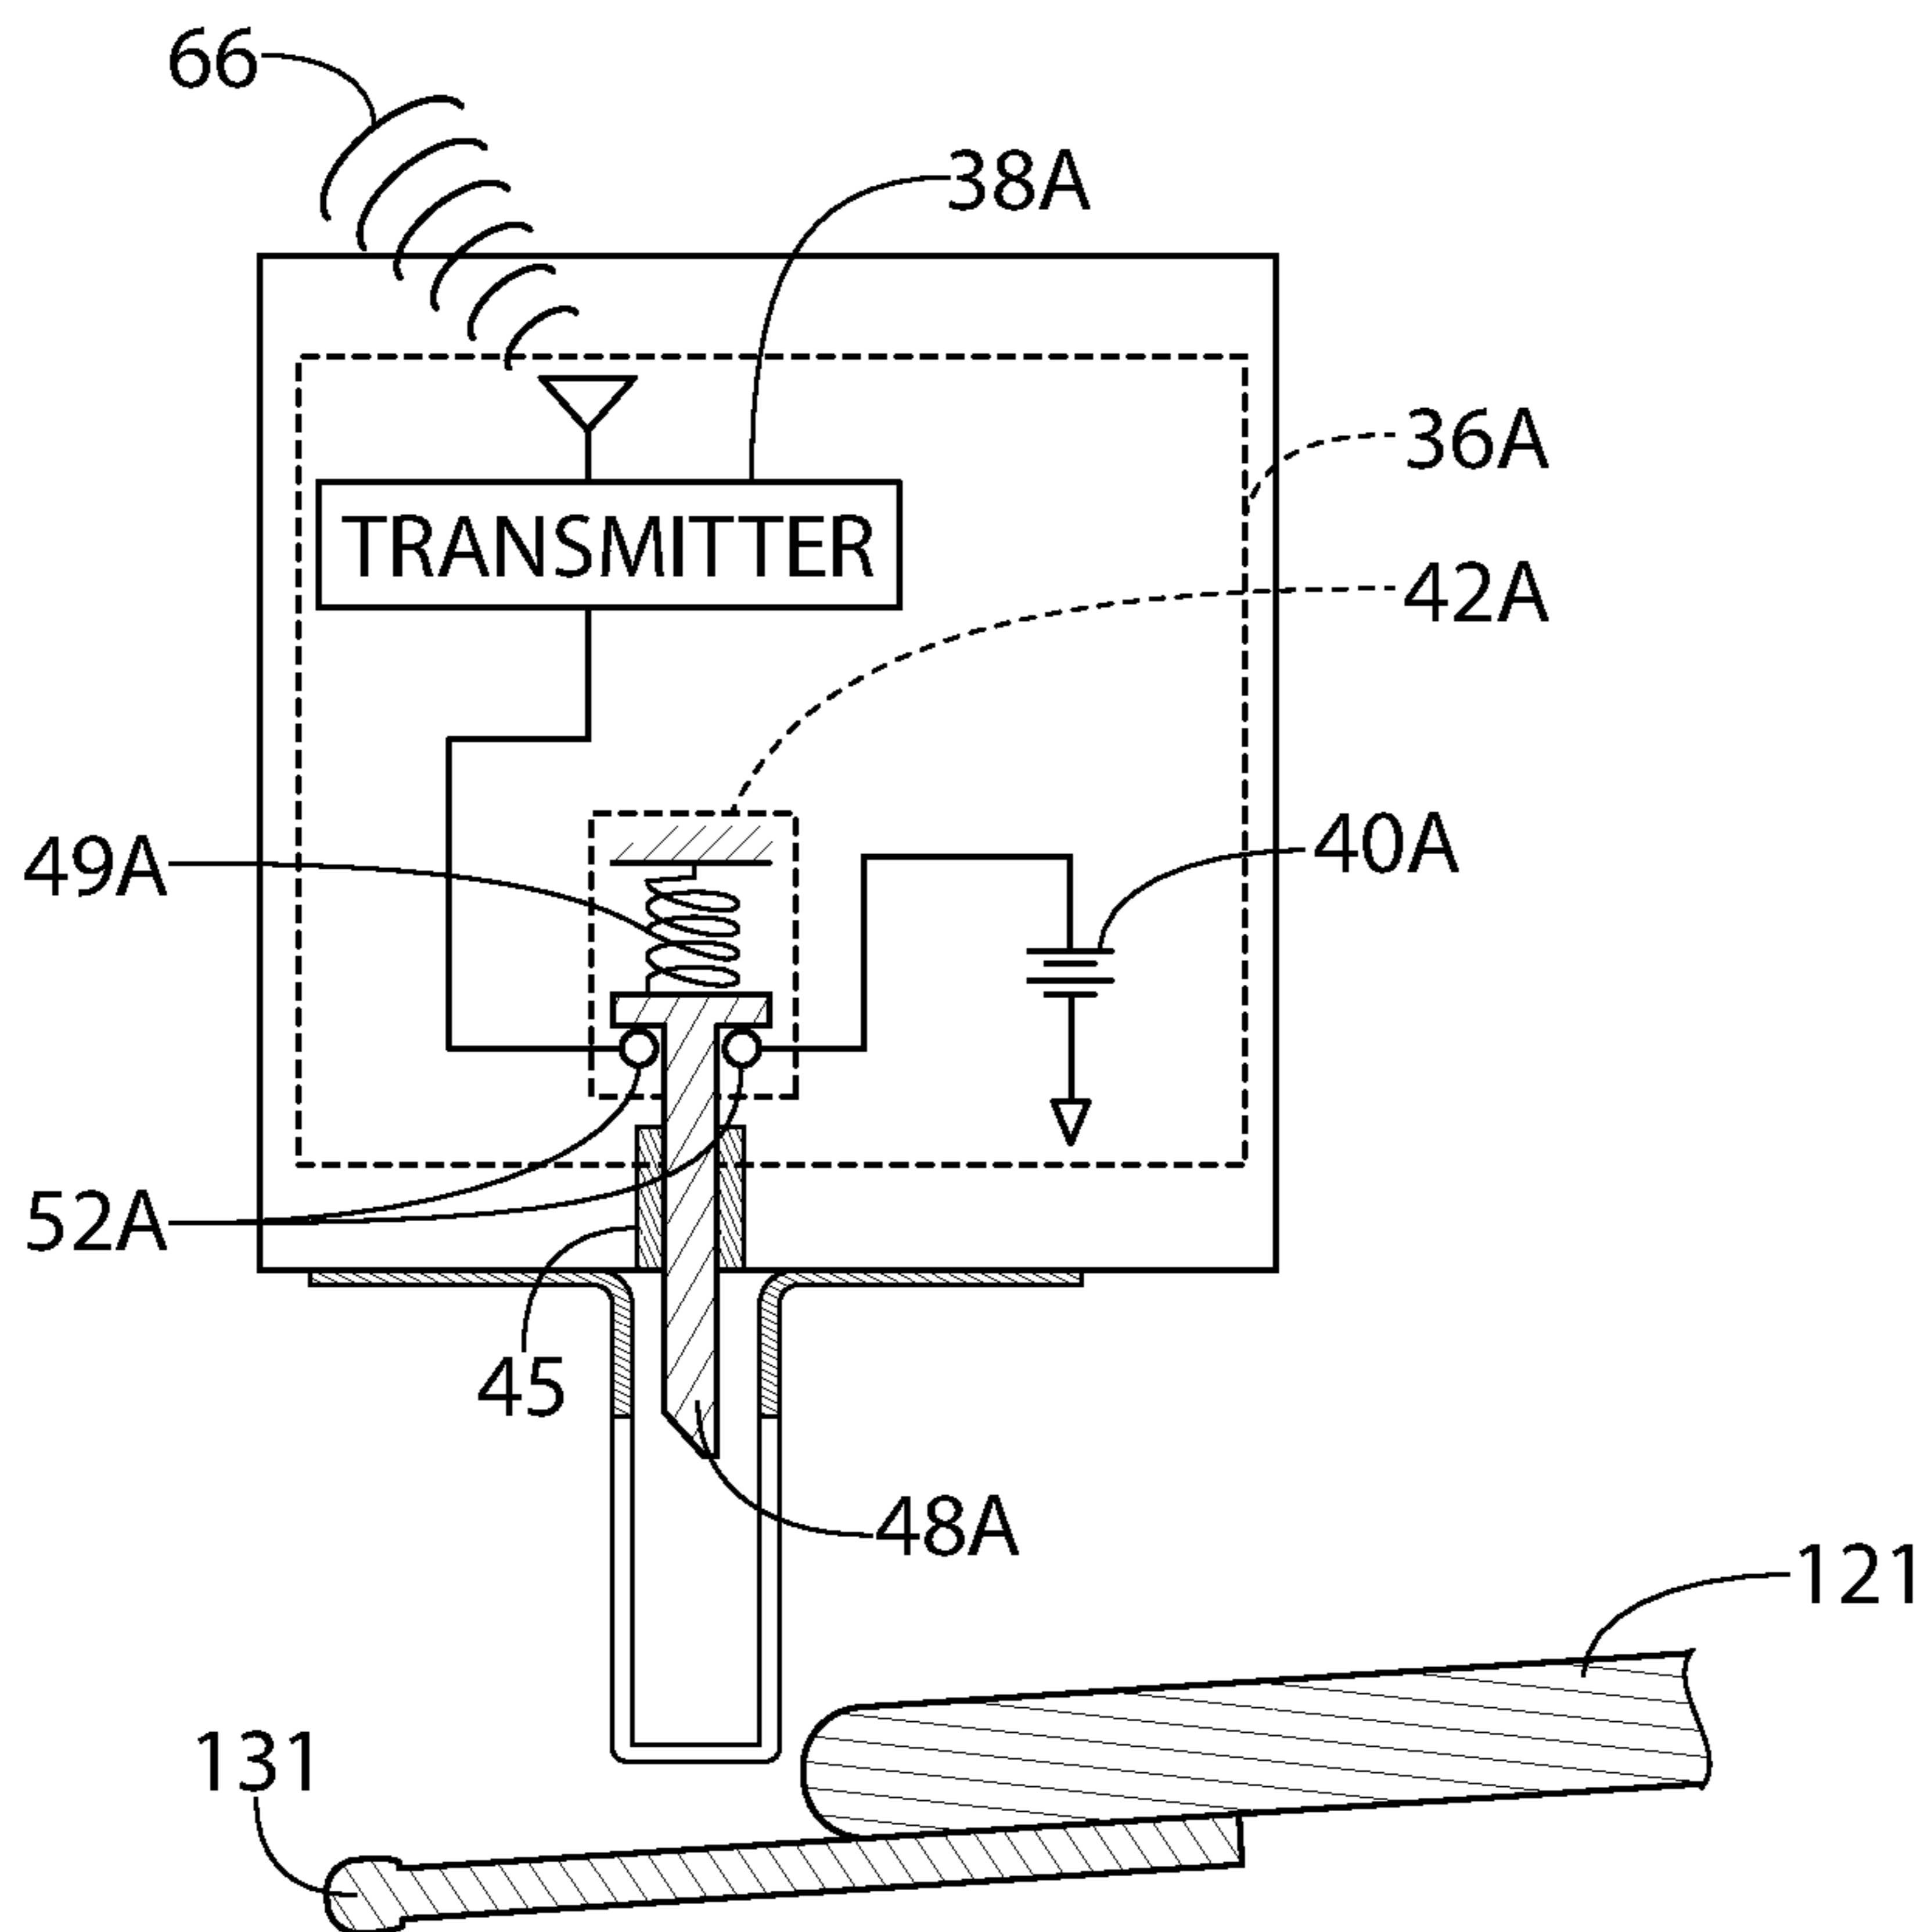
FIG. 4C is a functional diagram showing how the opening of the gate, shown partially, activates the second transmitter;

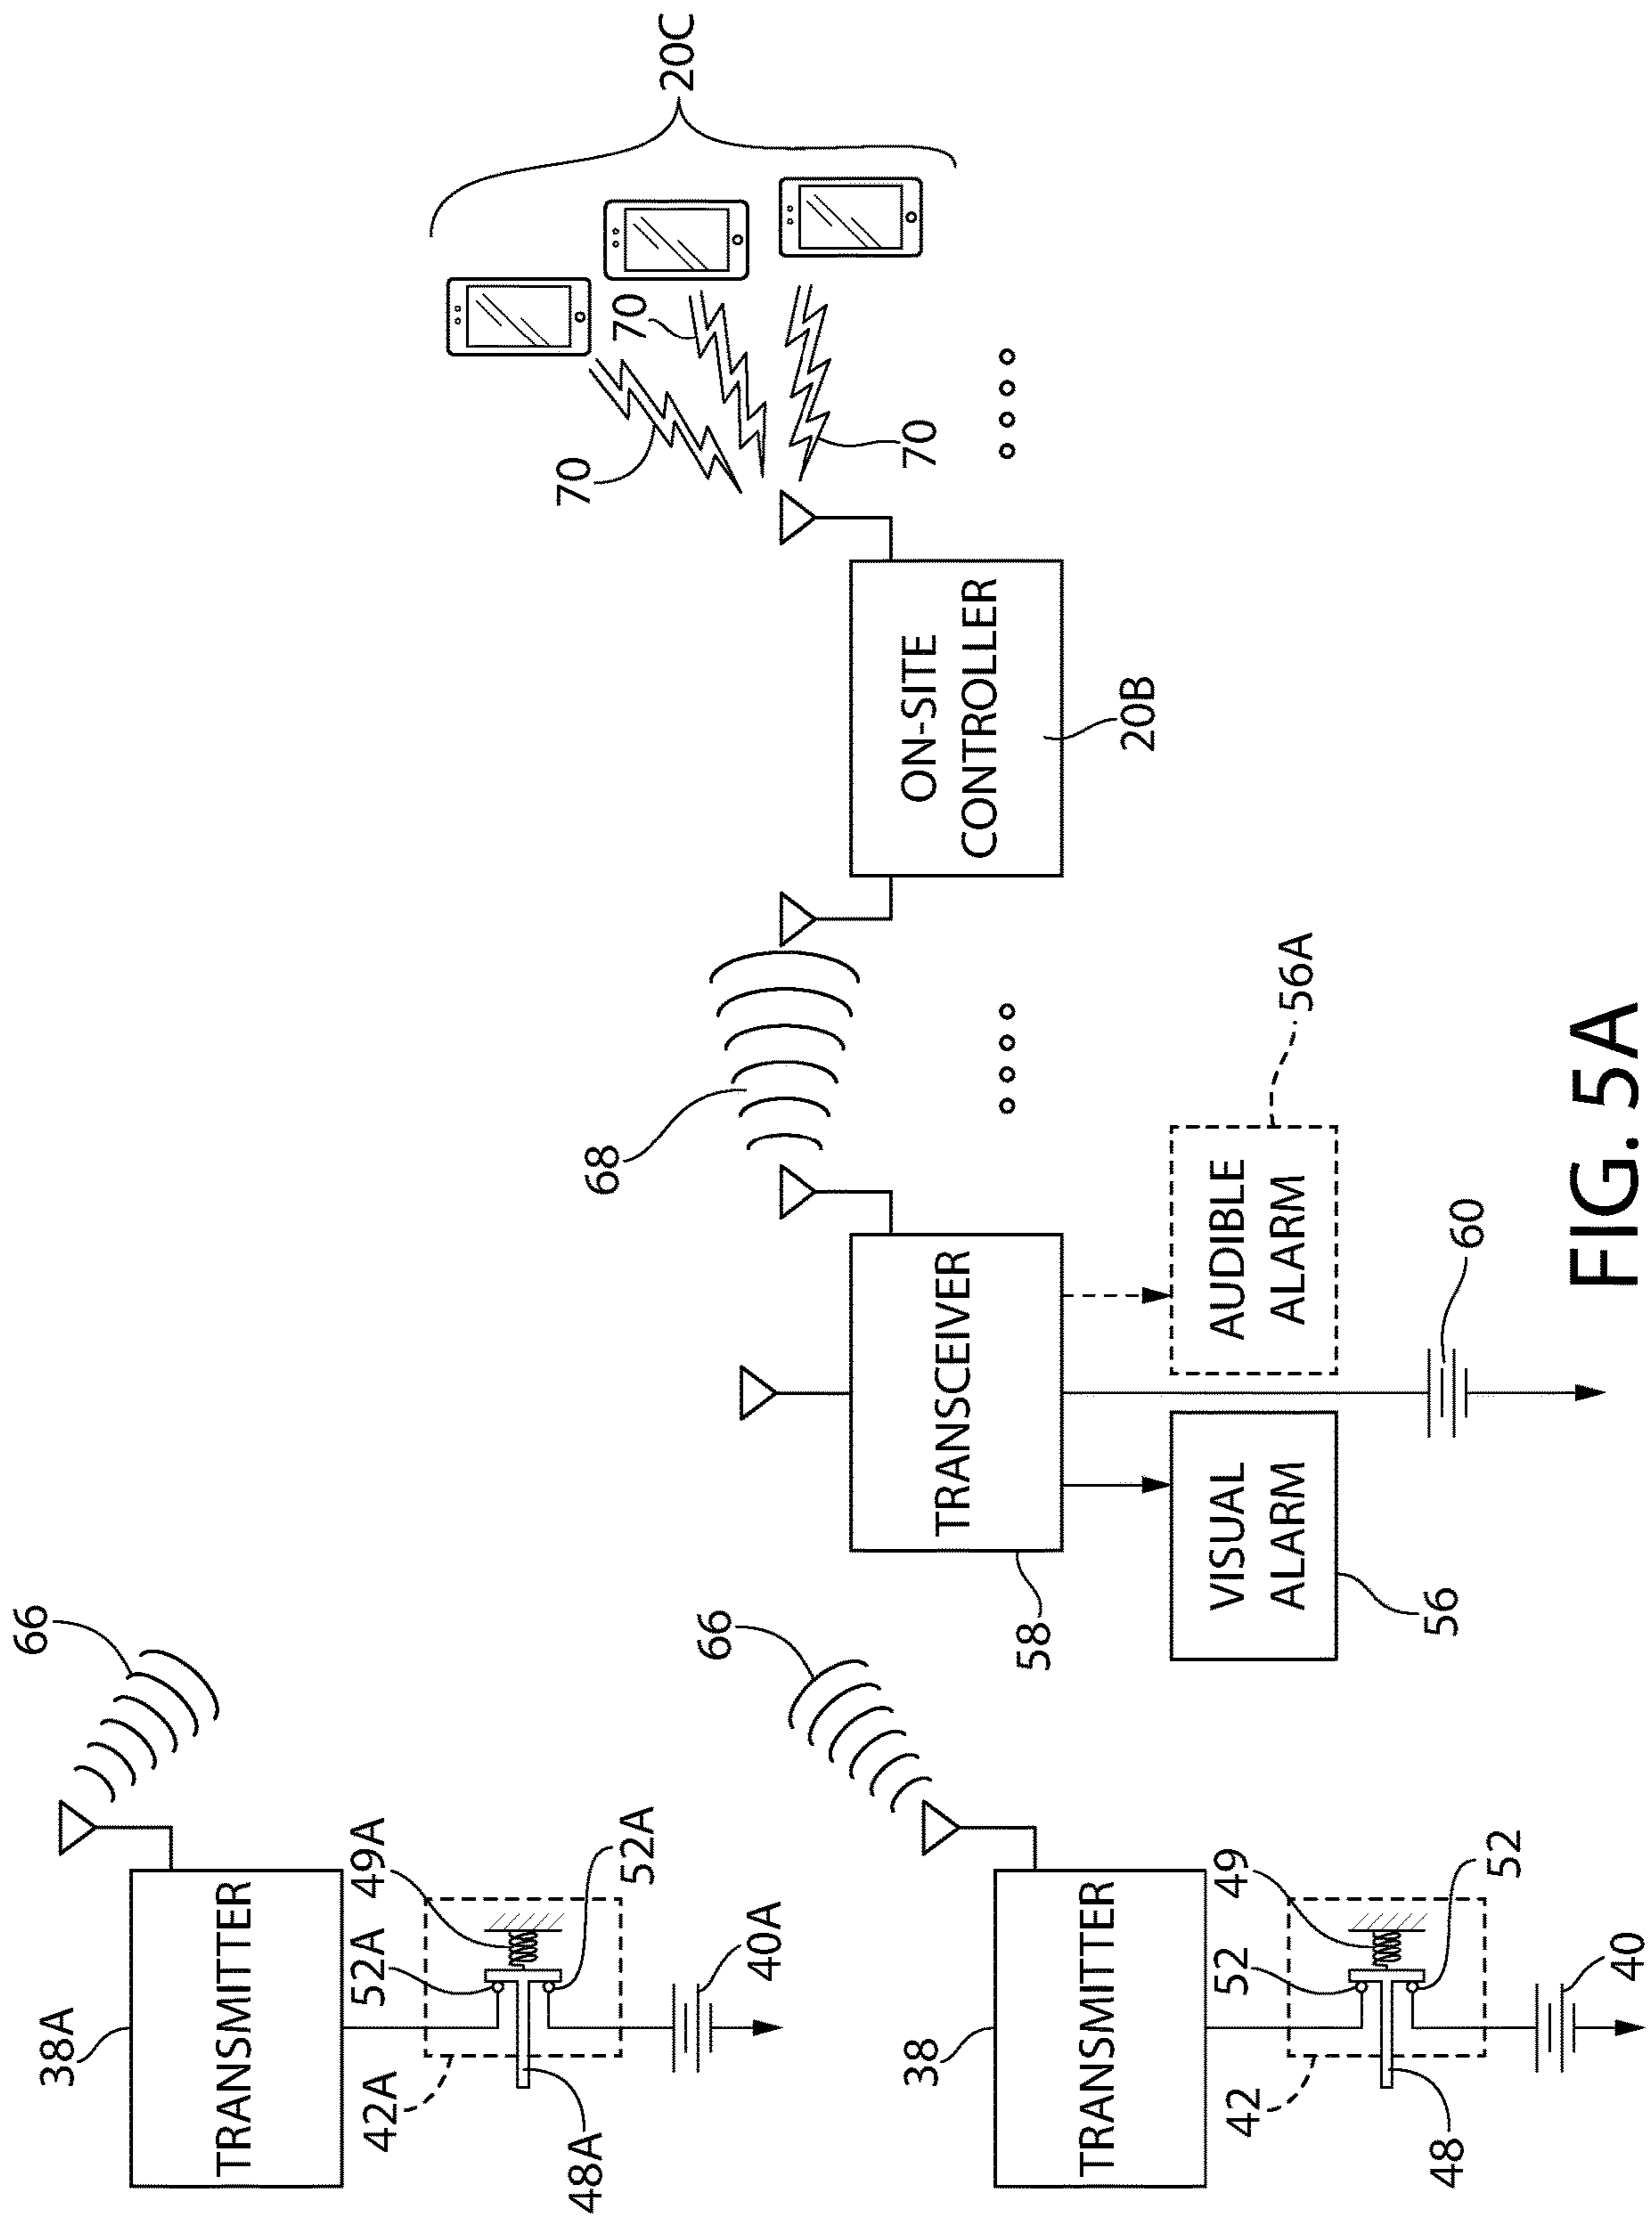
FIG. 5A is a block diagram of the wireless portion of the system of the present invention depicting its operation when the gate posts are removed from their respective boots or the gate is opened;

It should be understood that the term “on-site controller” 20B is a device that is located on a site where construction is on-going but that the controller 20B itself may be located remotely from the actual gate(s) 120A/opening(s) 10, as indicated by the “dots” in FIGS. 1 and 5A-5B. Similarly, “on-site personnel” may be located at the site where construction may be occurring but they also may be remote from the actual gate(s) 120A/opening(s) 10. Thus, by way of example only, construction work may be occurring at particular units in a residential housing facility (“site”) that is already occupied; as a result, certain authorized personnel can be present anywhere at the site but remote from any of the gate(s) 120A/opening(s) 10 and thus are unaware of the particular status of the gates 120A. The BASAS 20 provides the requisite status automatically to these authorized personnel, as is discussed below.
