US010665048B1

(10) **Patent No.:** **US 10,665,048 B1**
(45) **Date of Patent:** ***May 26, 2020**

(54) **APPARATUS AND METHOD FOR A BALCONY ACCESS STATUS ALERT SYSTEM**

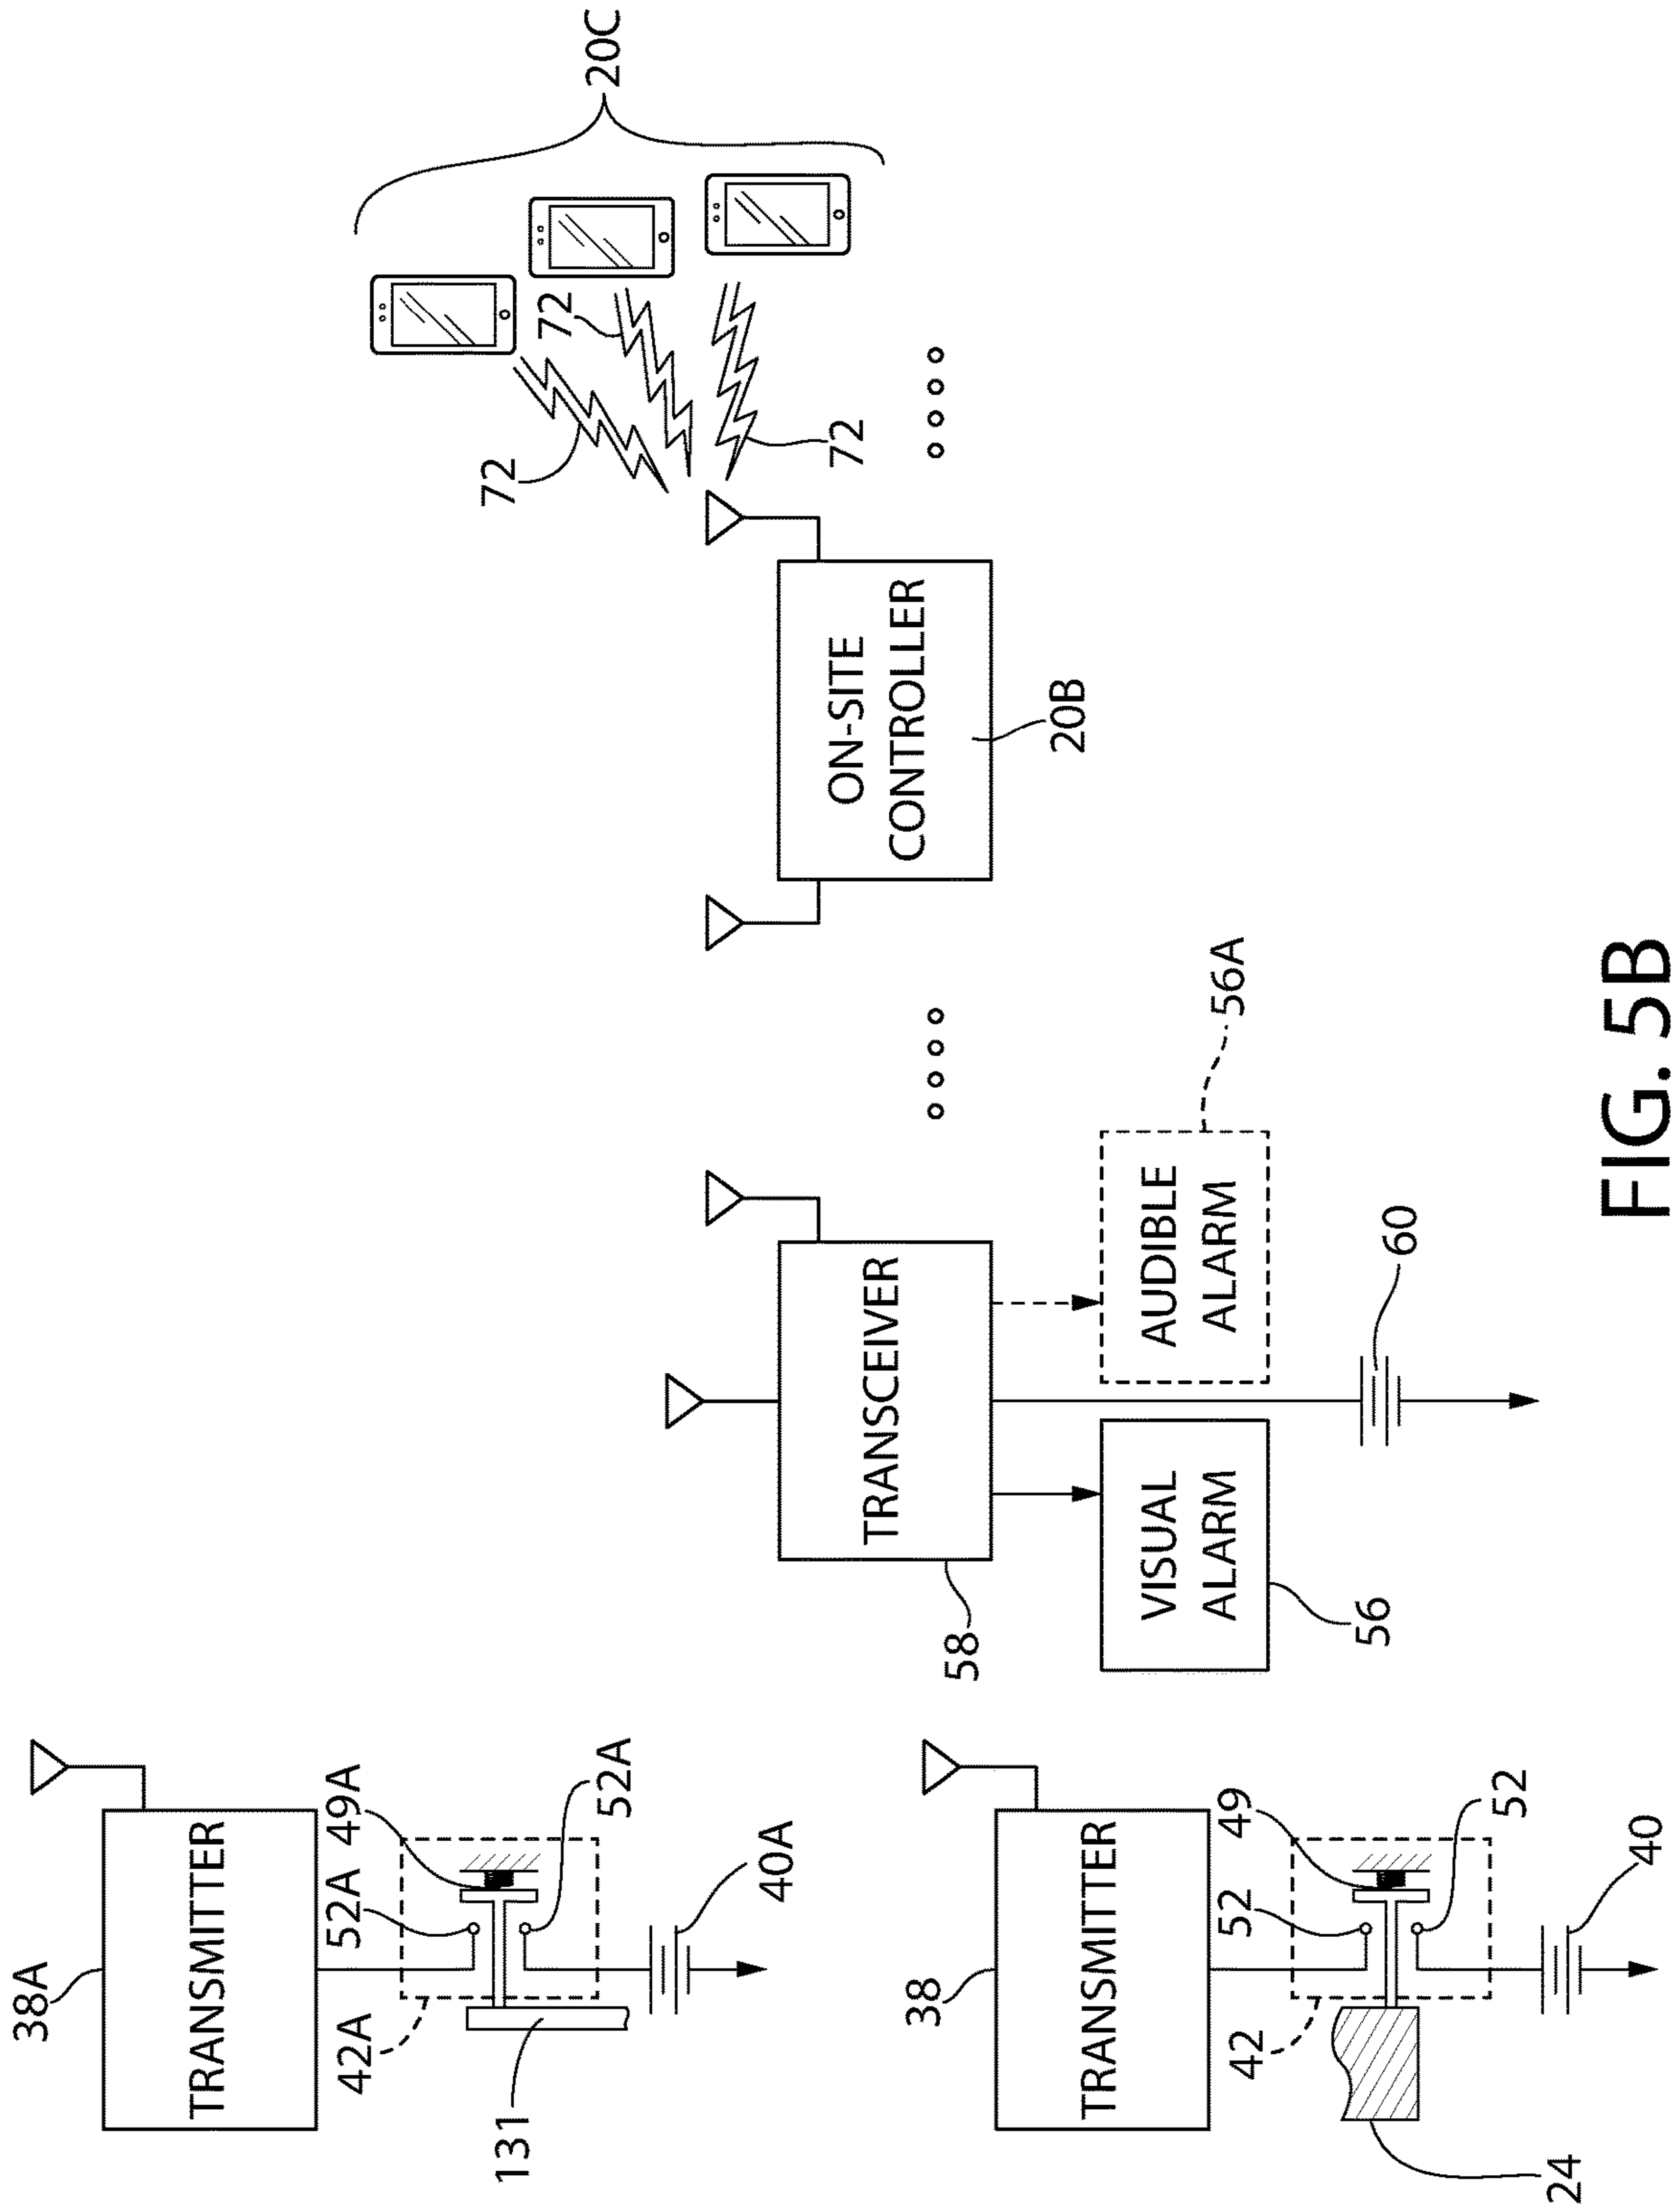
FIG. 5B is a block diagram of the wireless portion of the system of the present invention depicting its operation when the gate posts are restored to their respective boots or the gate is closed;

Conversely, as shown in FIG. 4A, with the gate structure 121 closed against the vertical post 22, the conductive switch element 48A is displaced away from contacts 52A and the second transmitter 38A is thus de-energized and the system status is shown in FIG. 5B.

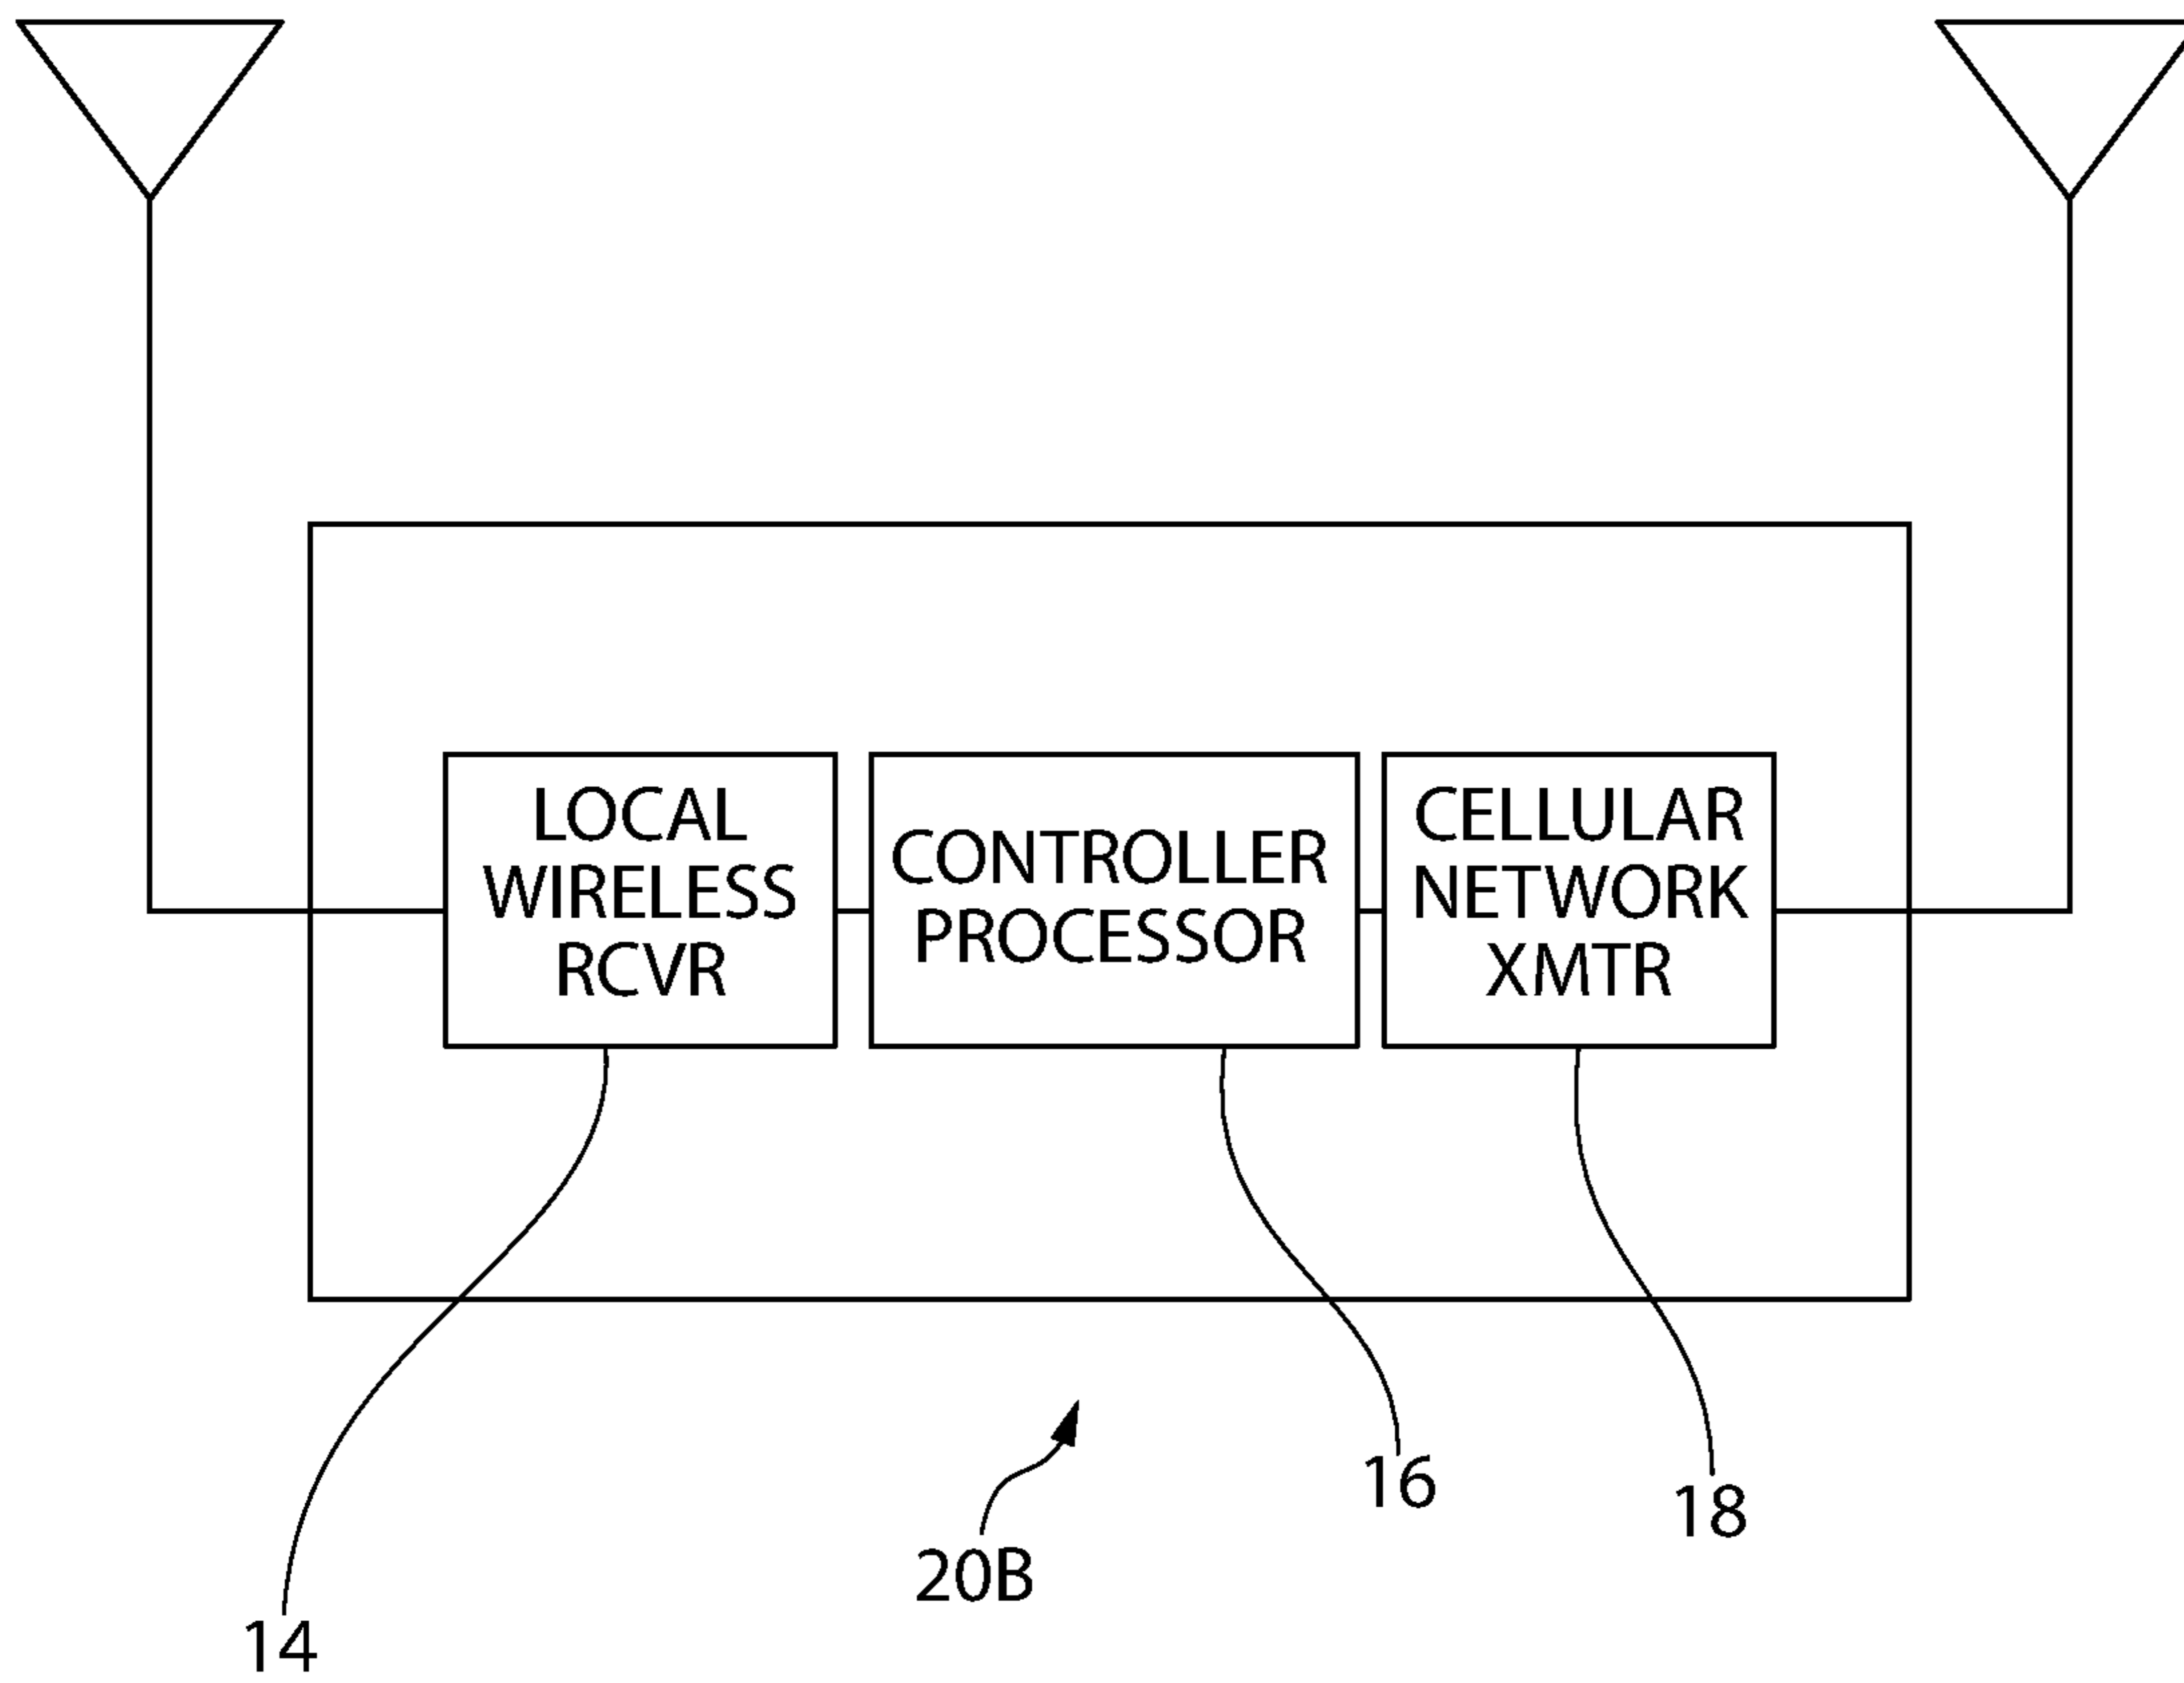
FIG. 6 is a block diagram of the on-site controller of the present invention;

As mentioned previously, the on-site controller 20B may comprise a DMP-XTLC-Wireless Control Panel, by way of example only. As shown in FIG. 5, the DMP-XTLC-Wireless Control Panel comprises a local wireless receiver 14, a controller processor 16 and a cellular network transmitter 18 (e.g., CDMA cellular compatible configuration and frequency band(s)) the latter of which permits messaging features (e.g., the messages 70 and 72) with the wireless communication devices 20C (e.g., cell phone), as well as the capability (e.g., a keypad/display, not shown) for authorized system operators to control the frequency of messages 70 and 72, as described previously. The on-site controller 20B is housed in a rugged casing (not shown).

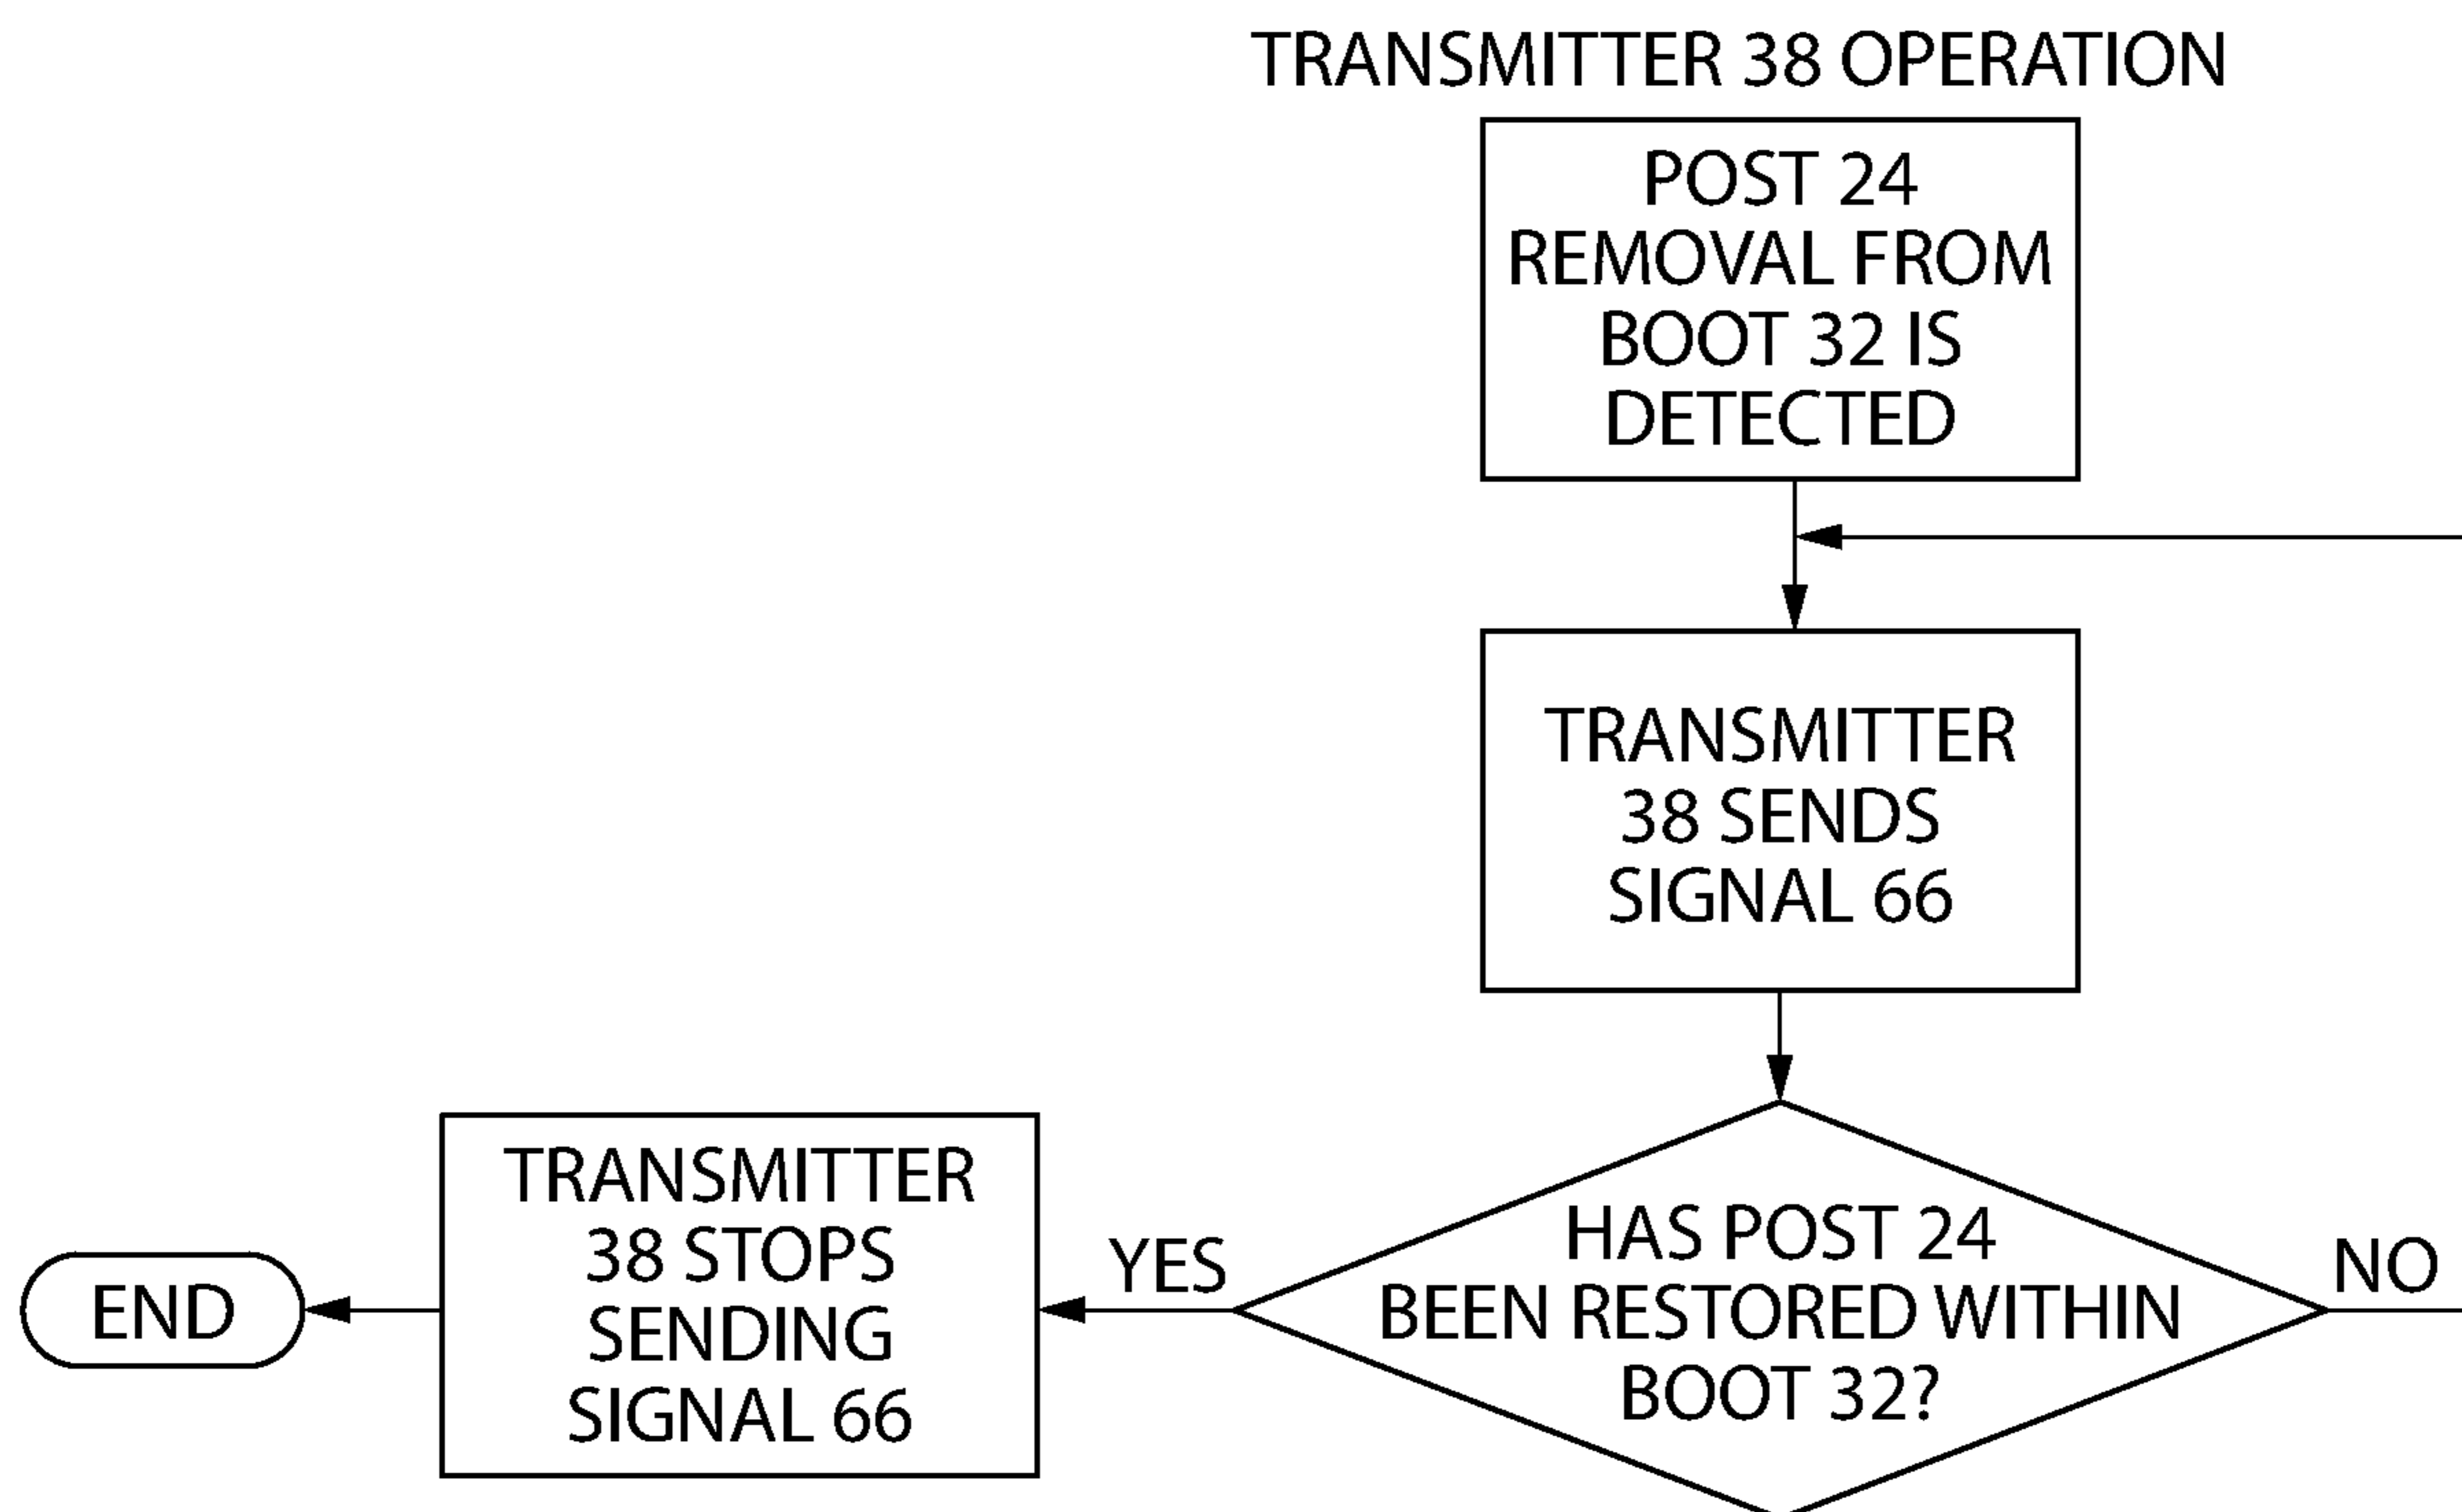
FIG. 7A is a flow diagram of the operation of the first transmitter of the present invention;

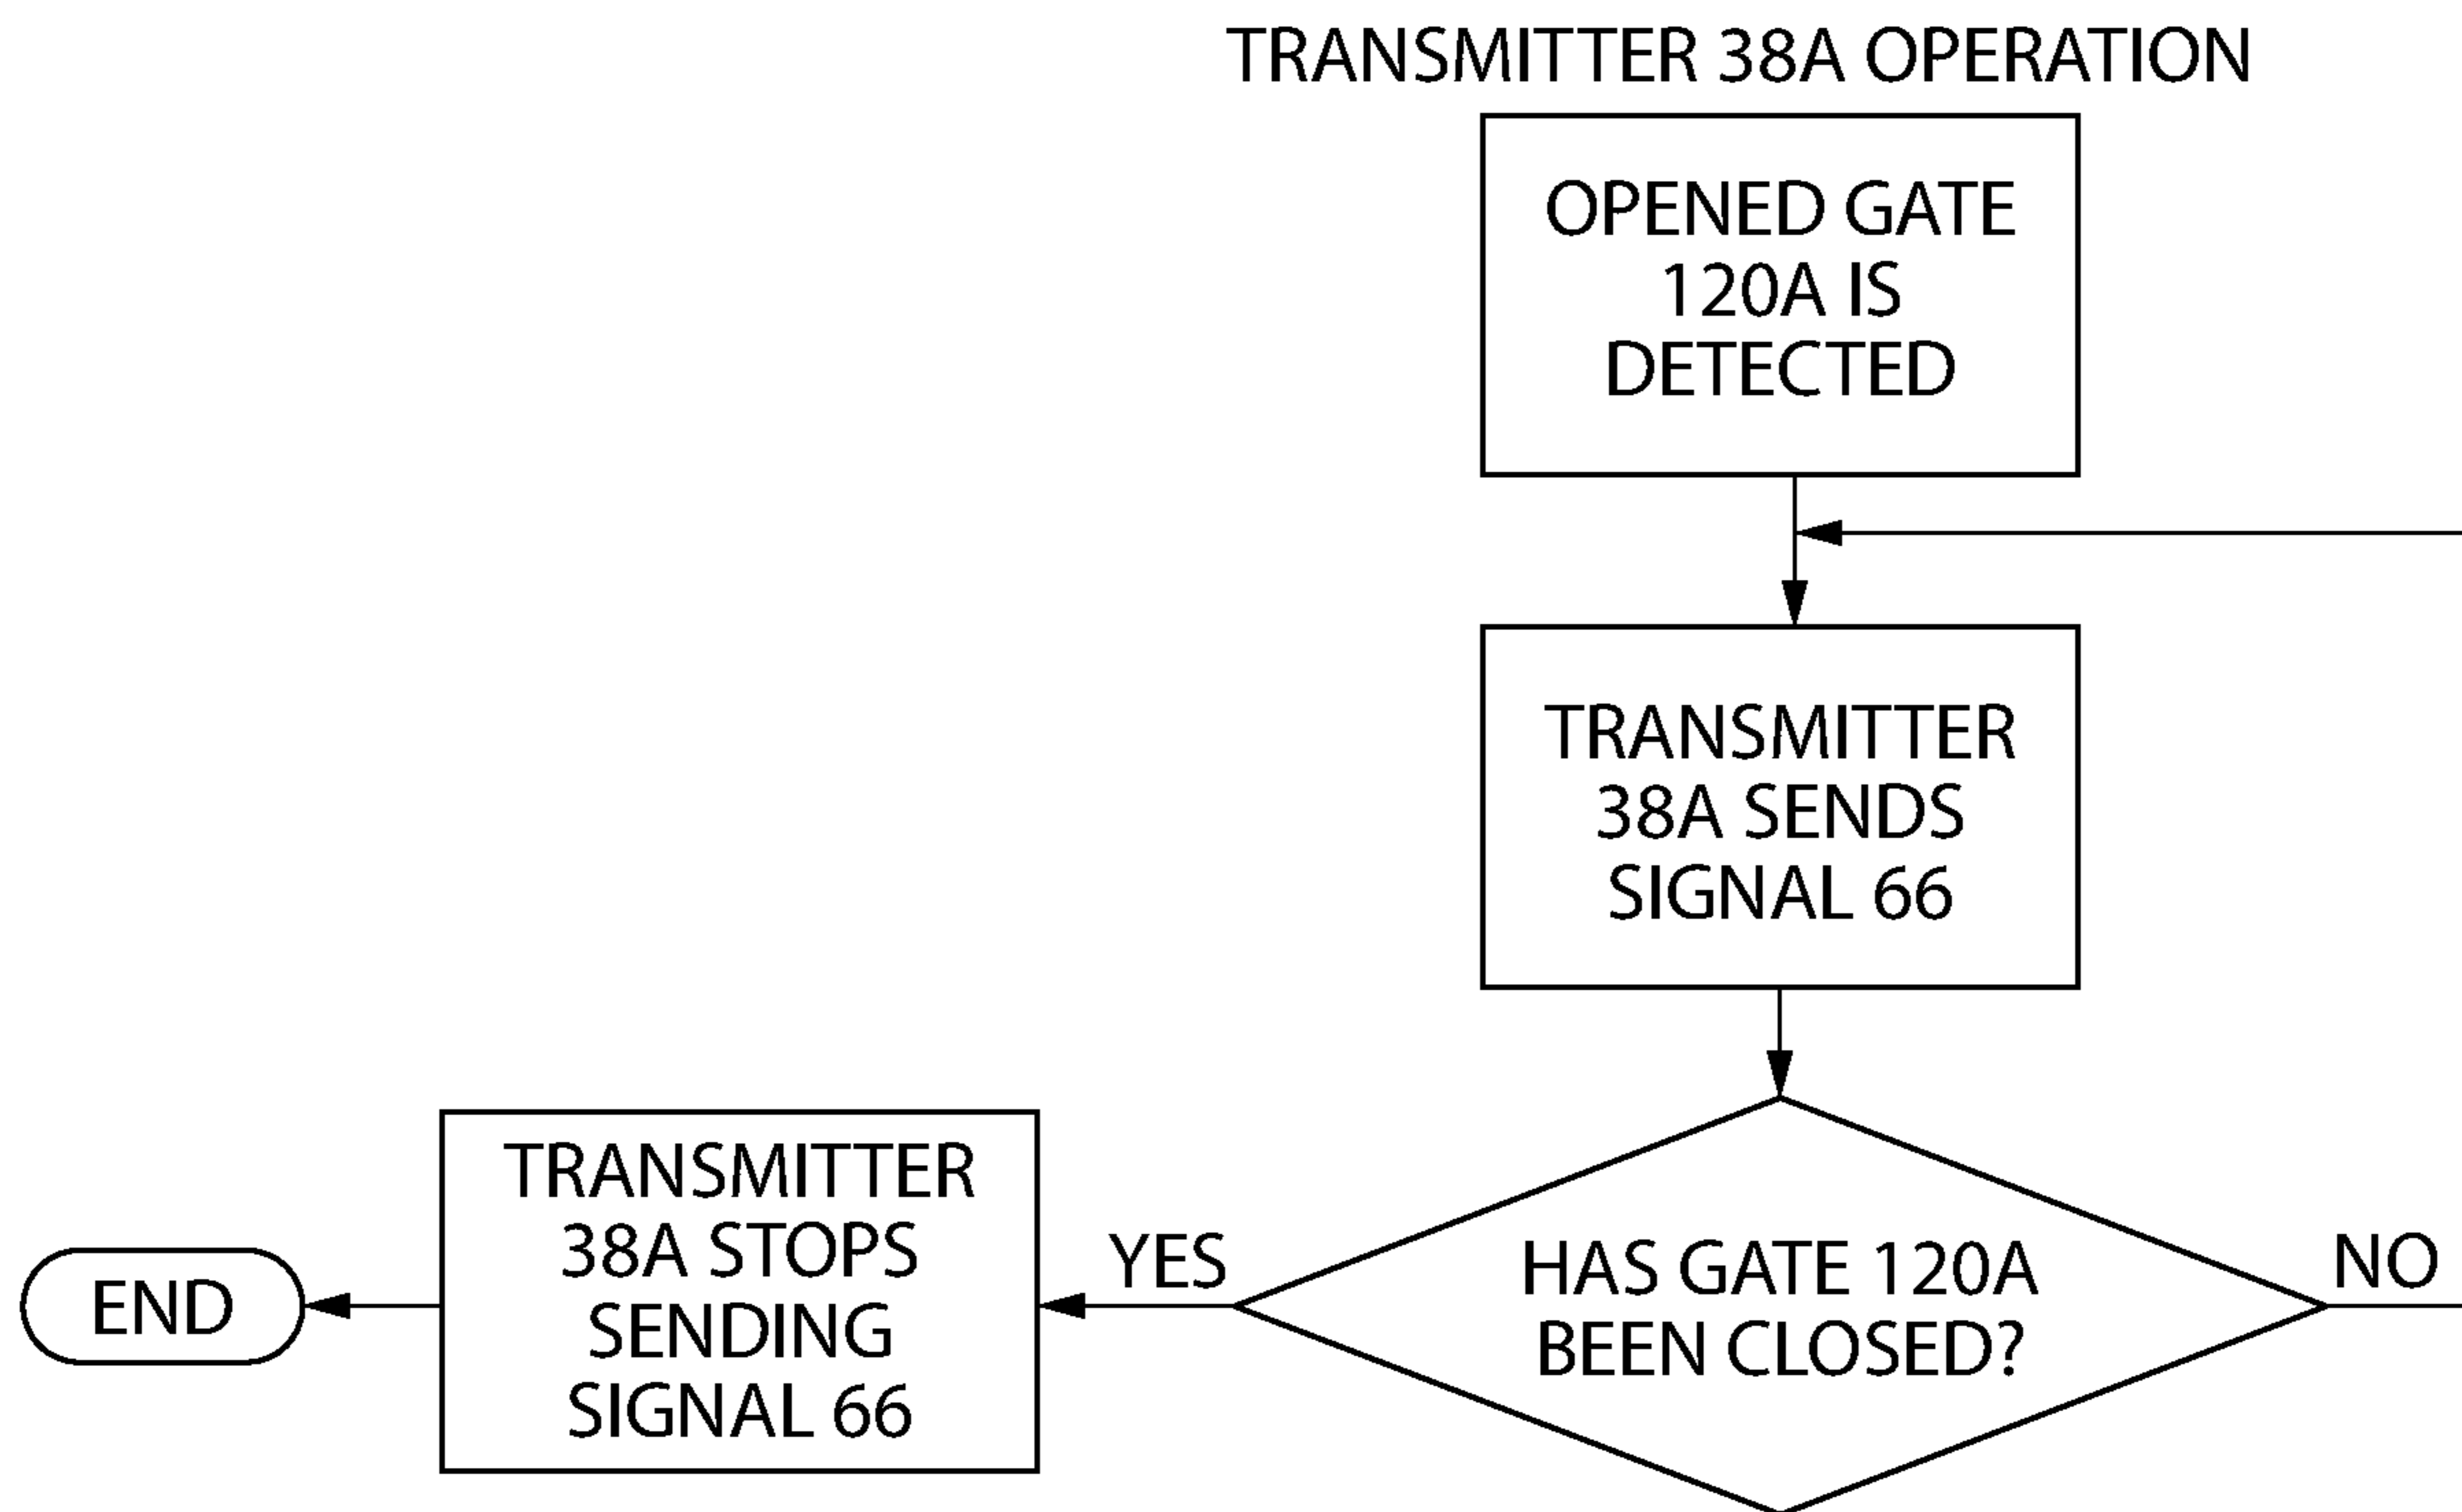
FIG. 7B is a flow diagram of the operation of the second transmitter of the present invention;

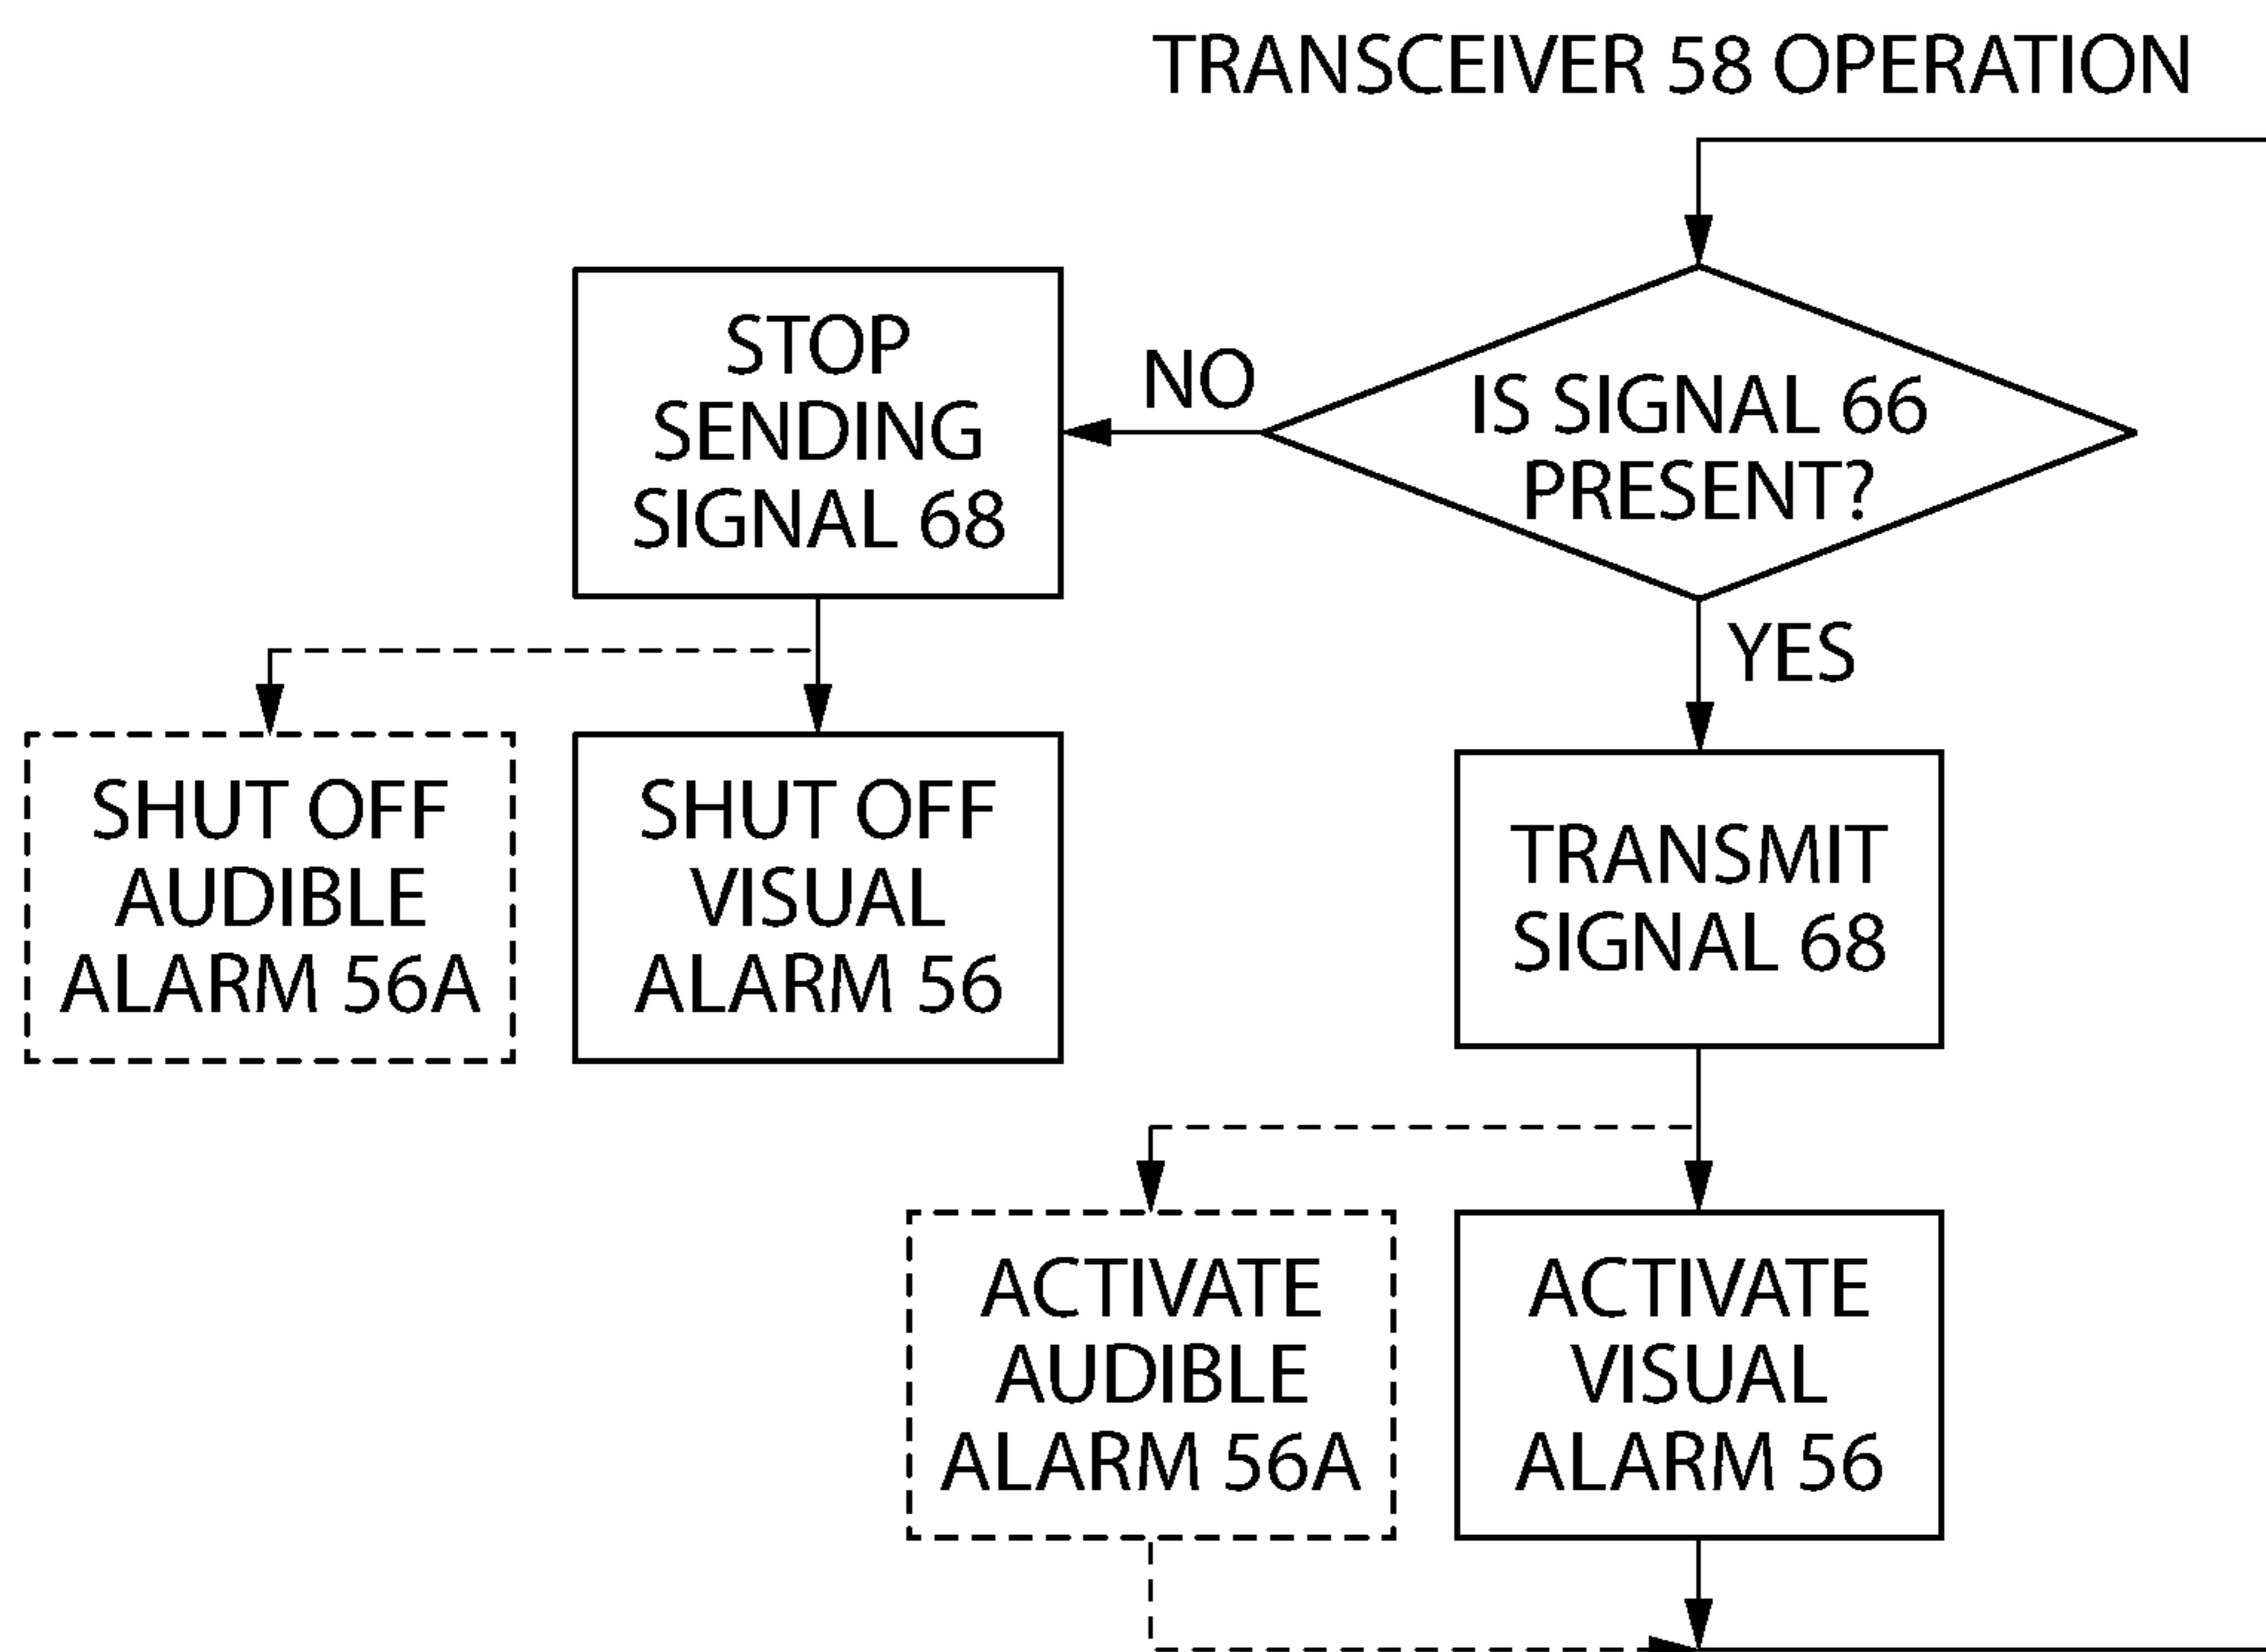
FIG. 8 is a flow diagram of the operation of the transceiver of the present invention;

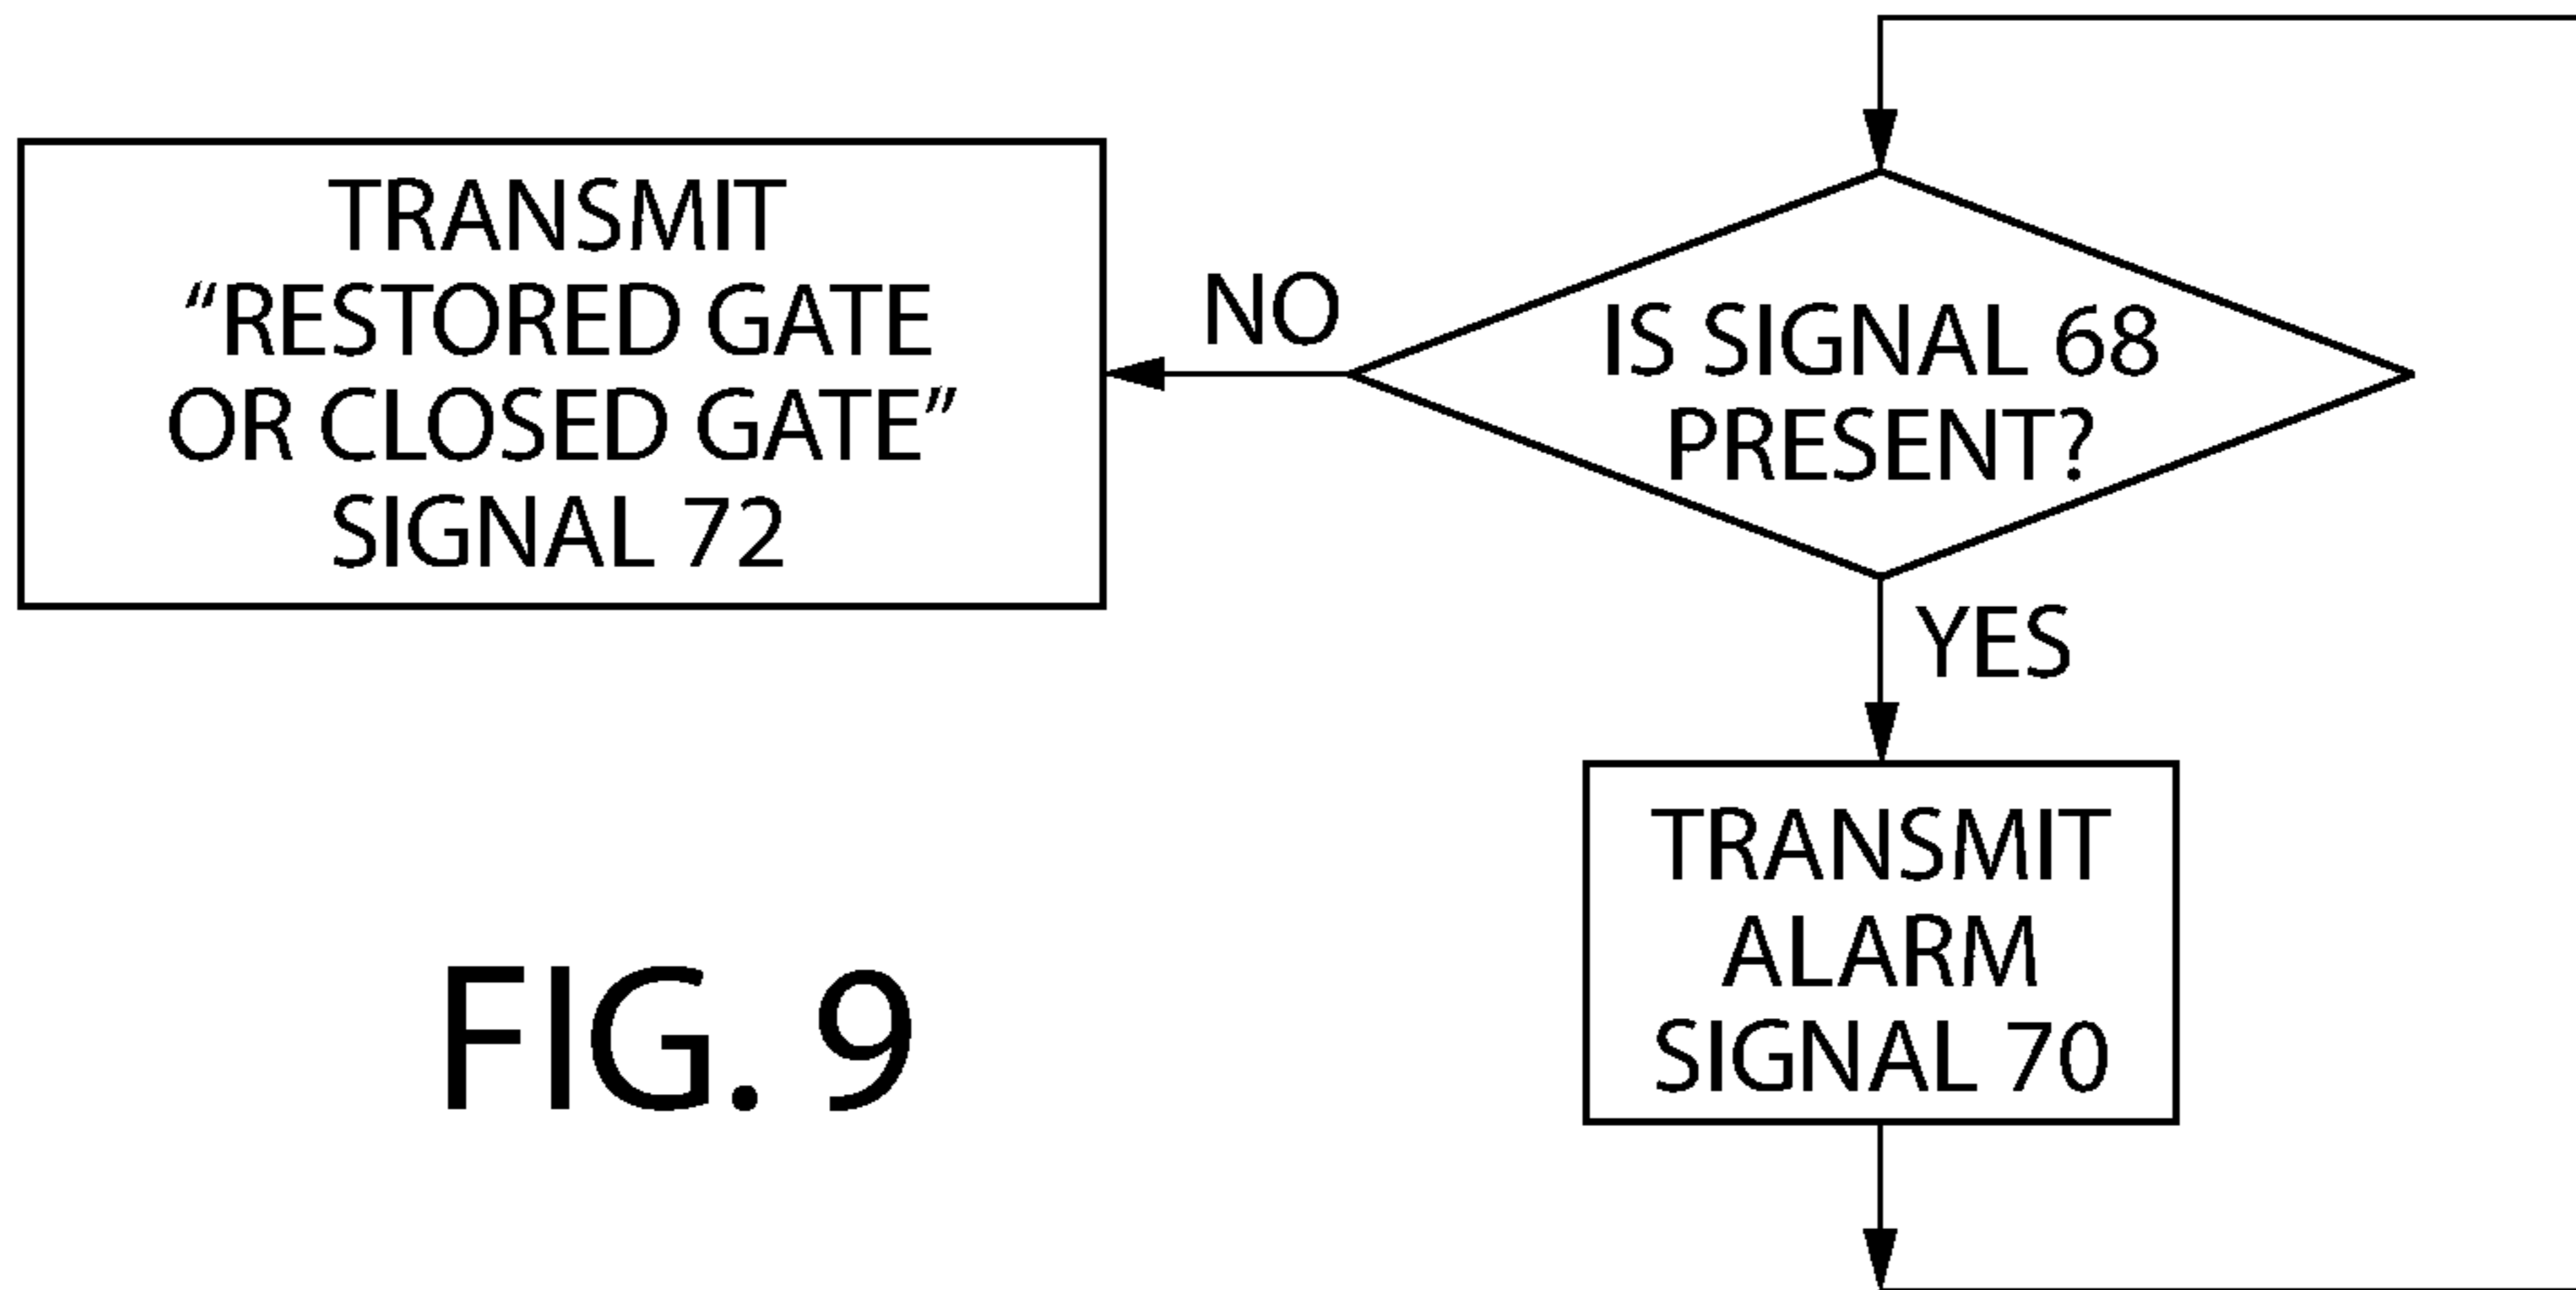
FIG. 9 is a flow diagram of the operation of the on-site controller of the present invention;
