US010665048B1

(10) **Patent No.:** **US 10,665,048 B1**
(45) **Date of Patent:** ***May 26, 2020**

(54) **APPARATUS AND METHOD FOR A BALCONY ACCESS STATUS ALERT SYSTEM**

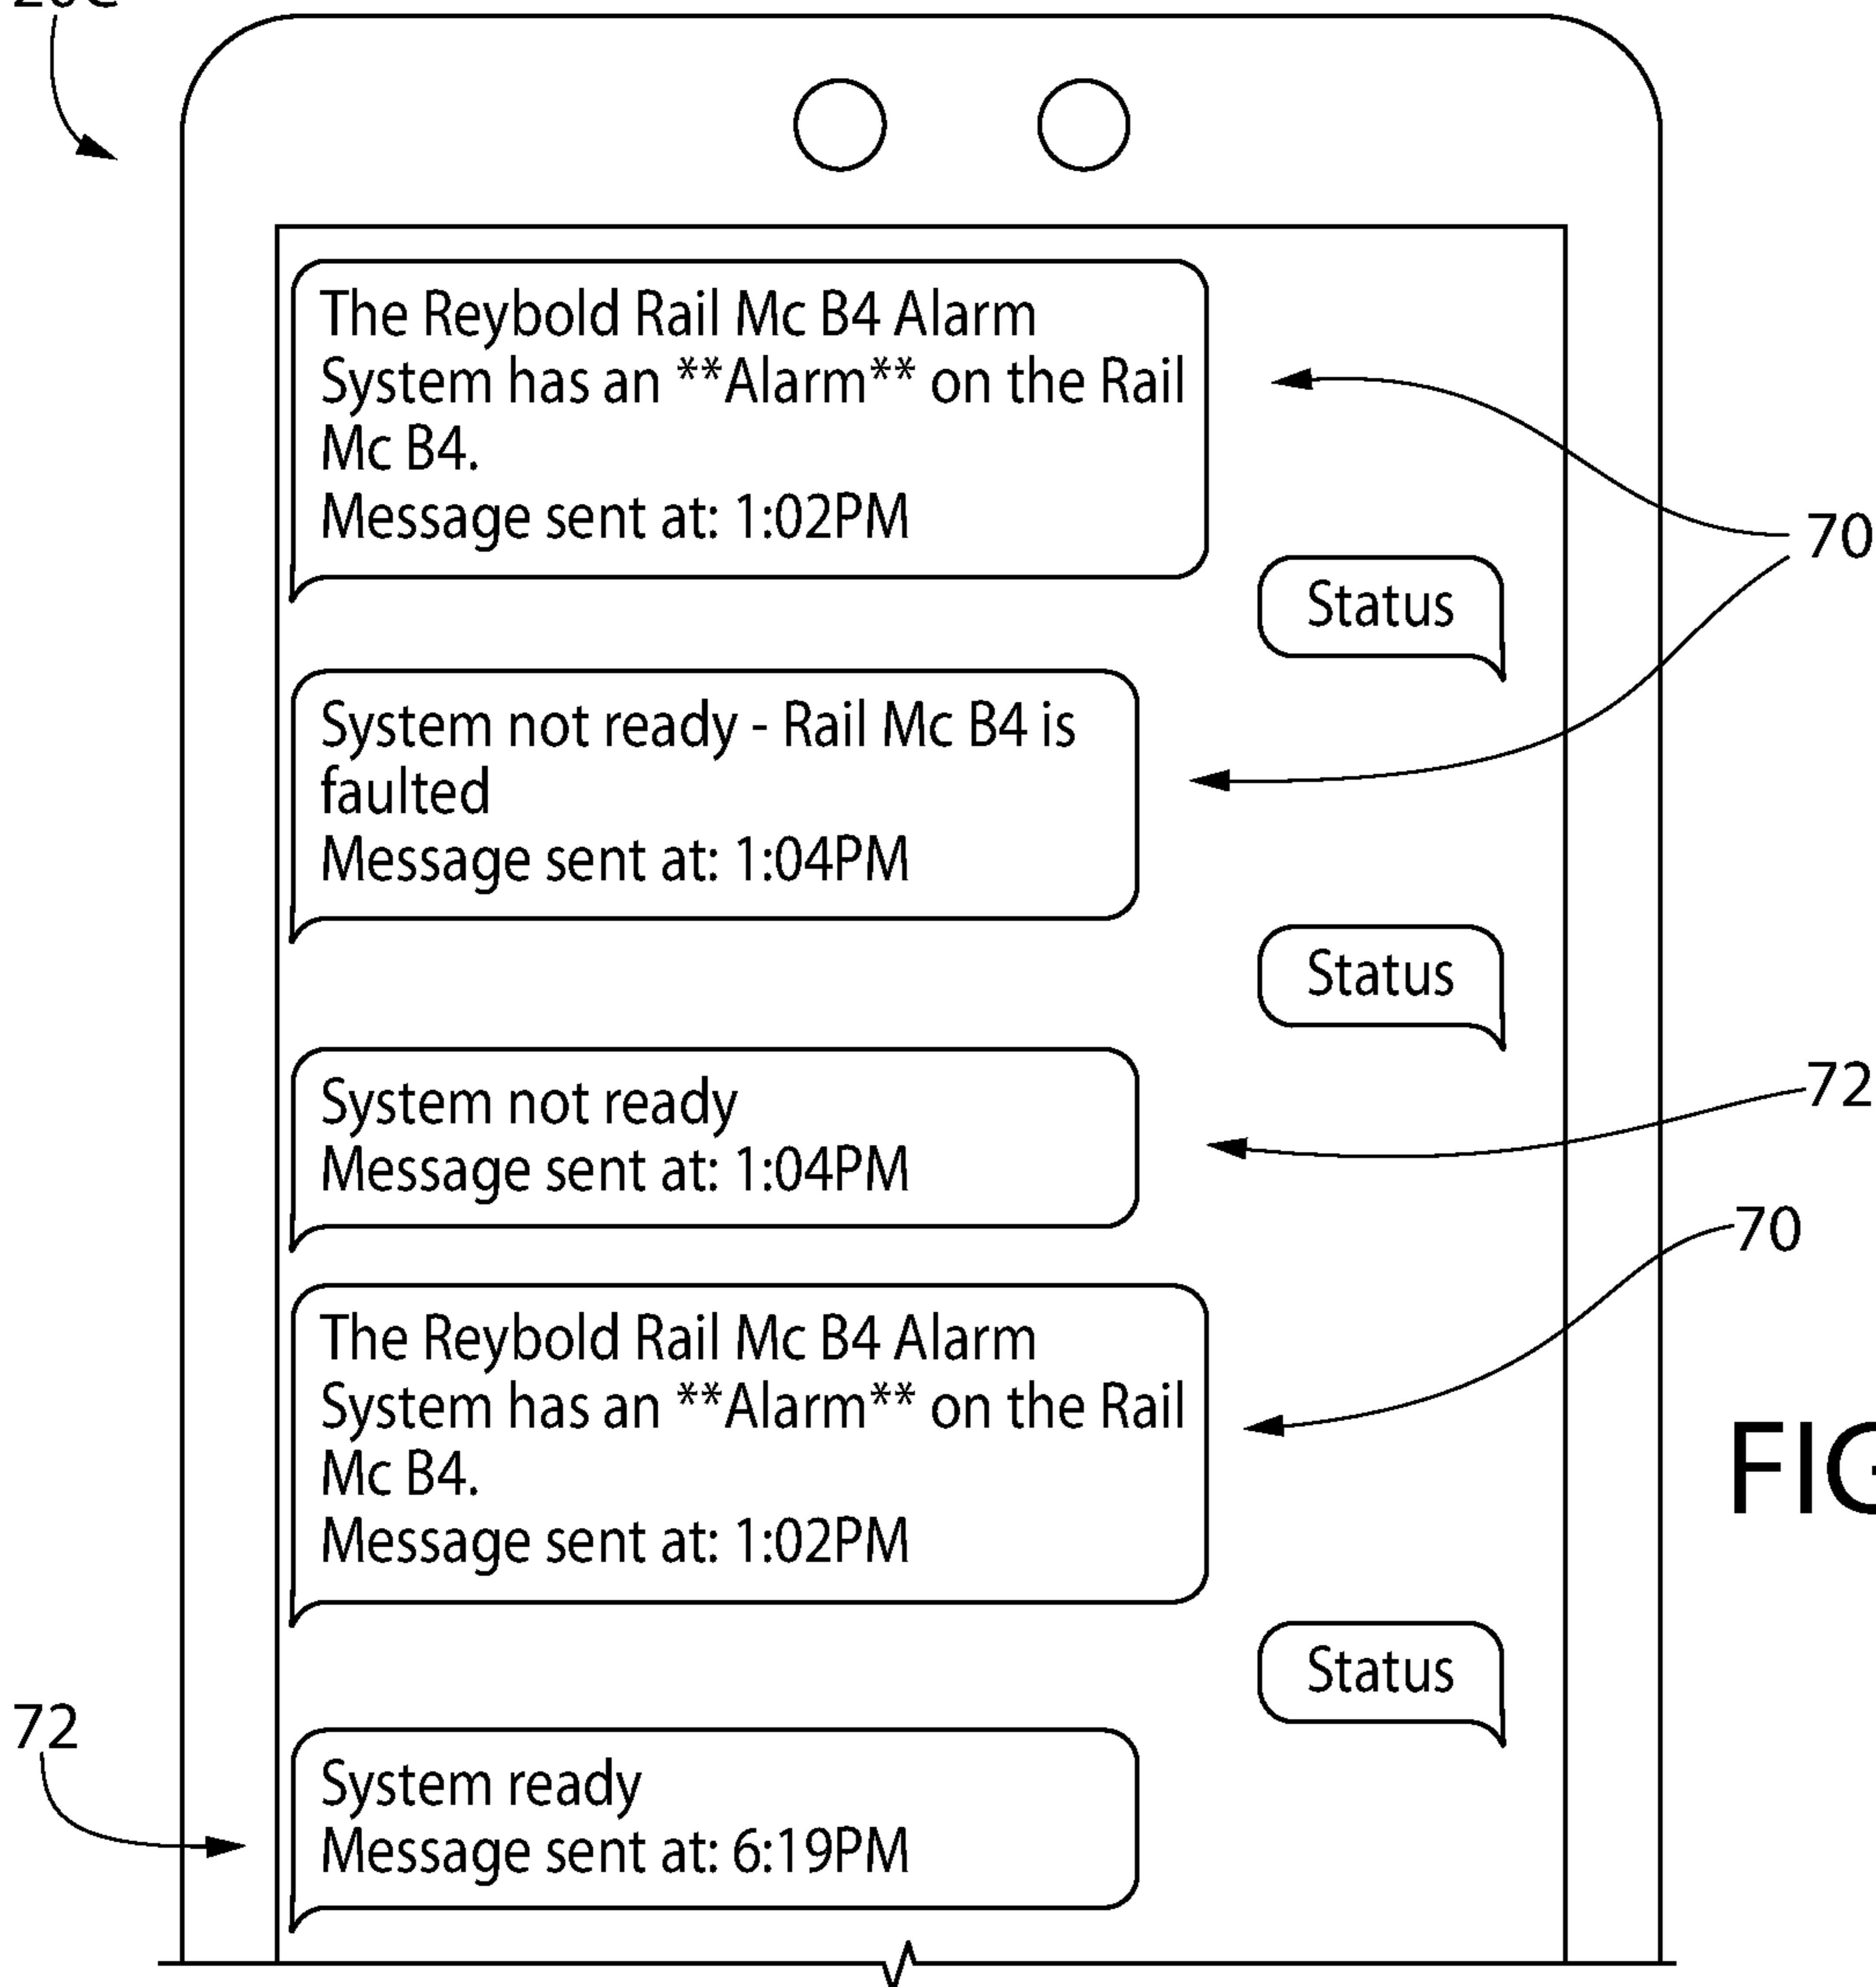
FIG. 10 is a partial view of a display screen view of a wireless device showing the alert signal message and the restored signal message; and

FIG. 10 depicts an exemplary wireless device 20C screen display of a typical BASAS 20 operation. As shown, a particular gate 120A (identified as “McB4”) has been removed from its boots 30/32, thereby alerting the wireless device 20C of this authorized person that the gate 120A was removed at 1:02 pm. Two minutes later (by way of example only) another alert message 70 indicates that the gate 120A system ready message 72 is sent, indicating that the gate 120A (viz., “McB4”) has been restored or the gate 120A has

been closed. As mentioned previously, it is up to the system operator to determine how often the alert signal 70 and/or the system ready signal 72 are sent to the authorized personnel. In this example, at 1:34 pm the gate 120A (“McB4”) is again removed or opened and the authorized personnel wireless devices 20C are alerted. A “system ready” signal 72 is sent at 6:19 pm to the wireless devices 20C. Again, because the system operator can set the frequency of warning signals 70 and system ready signals 72, this can allow the system operators to avoid nuisance warnings if, for example, the removed gate 120A or opened gate 120A is clearly in everyone’s sight and the need to “warn” the authorized personnel of the removed gate 120A or opened gate 120A is not as critical.

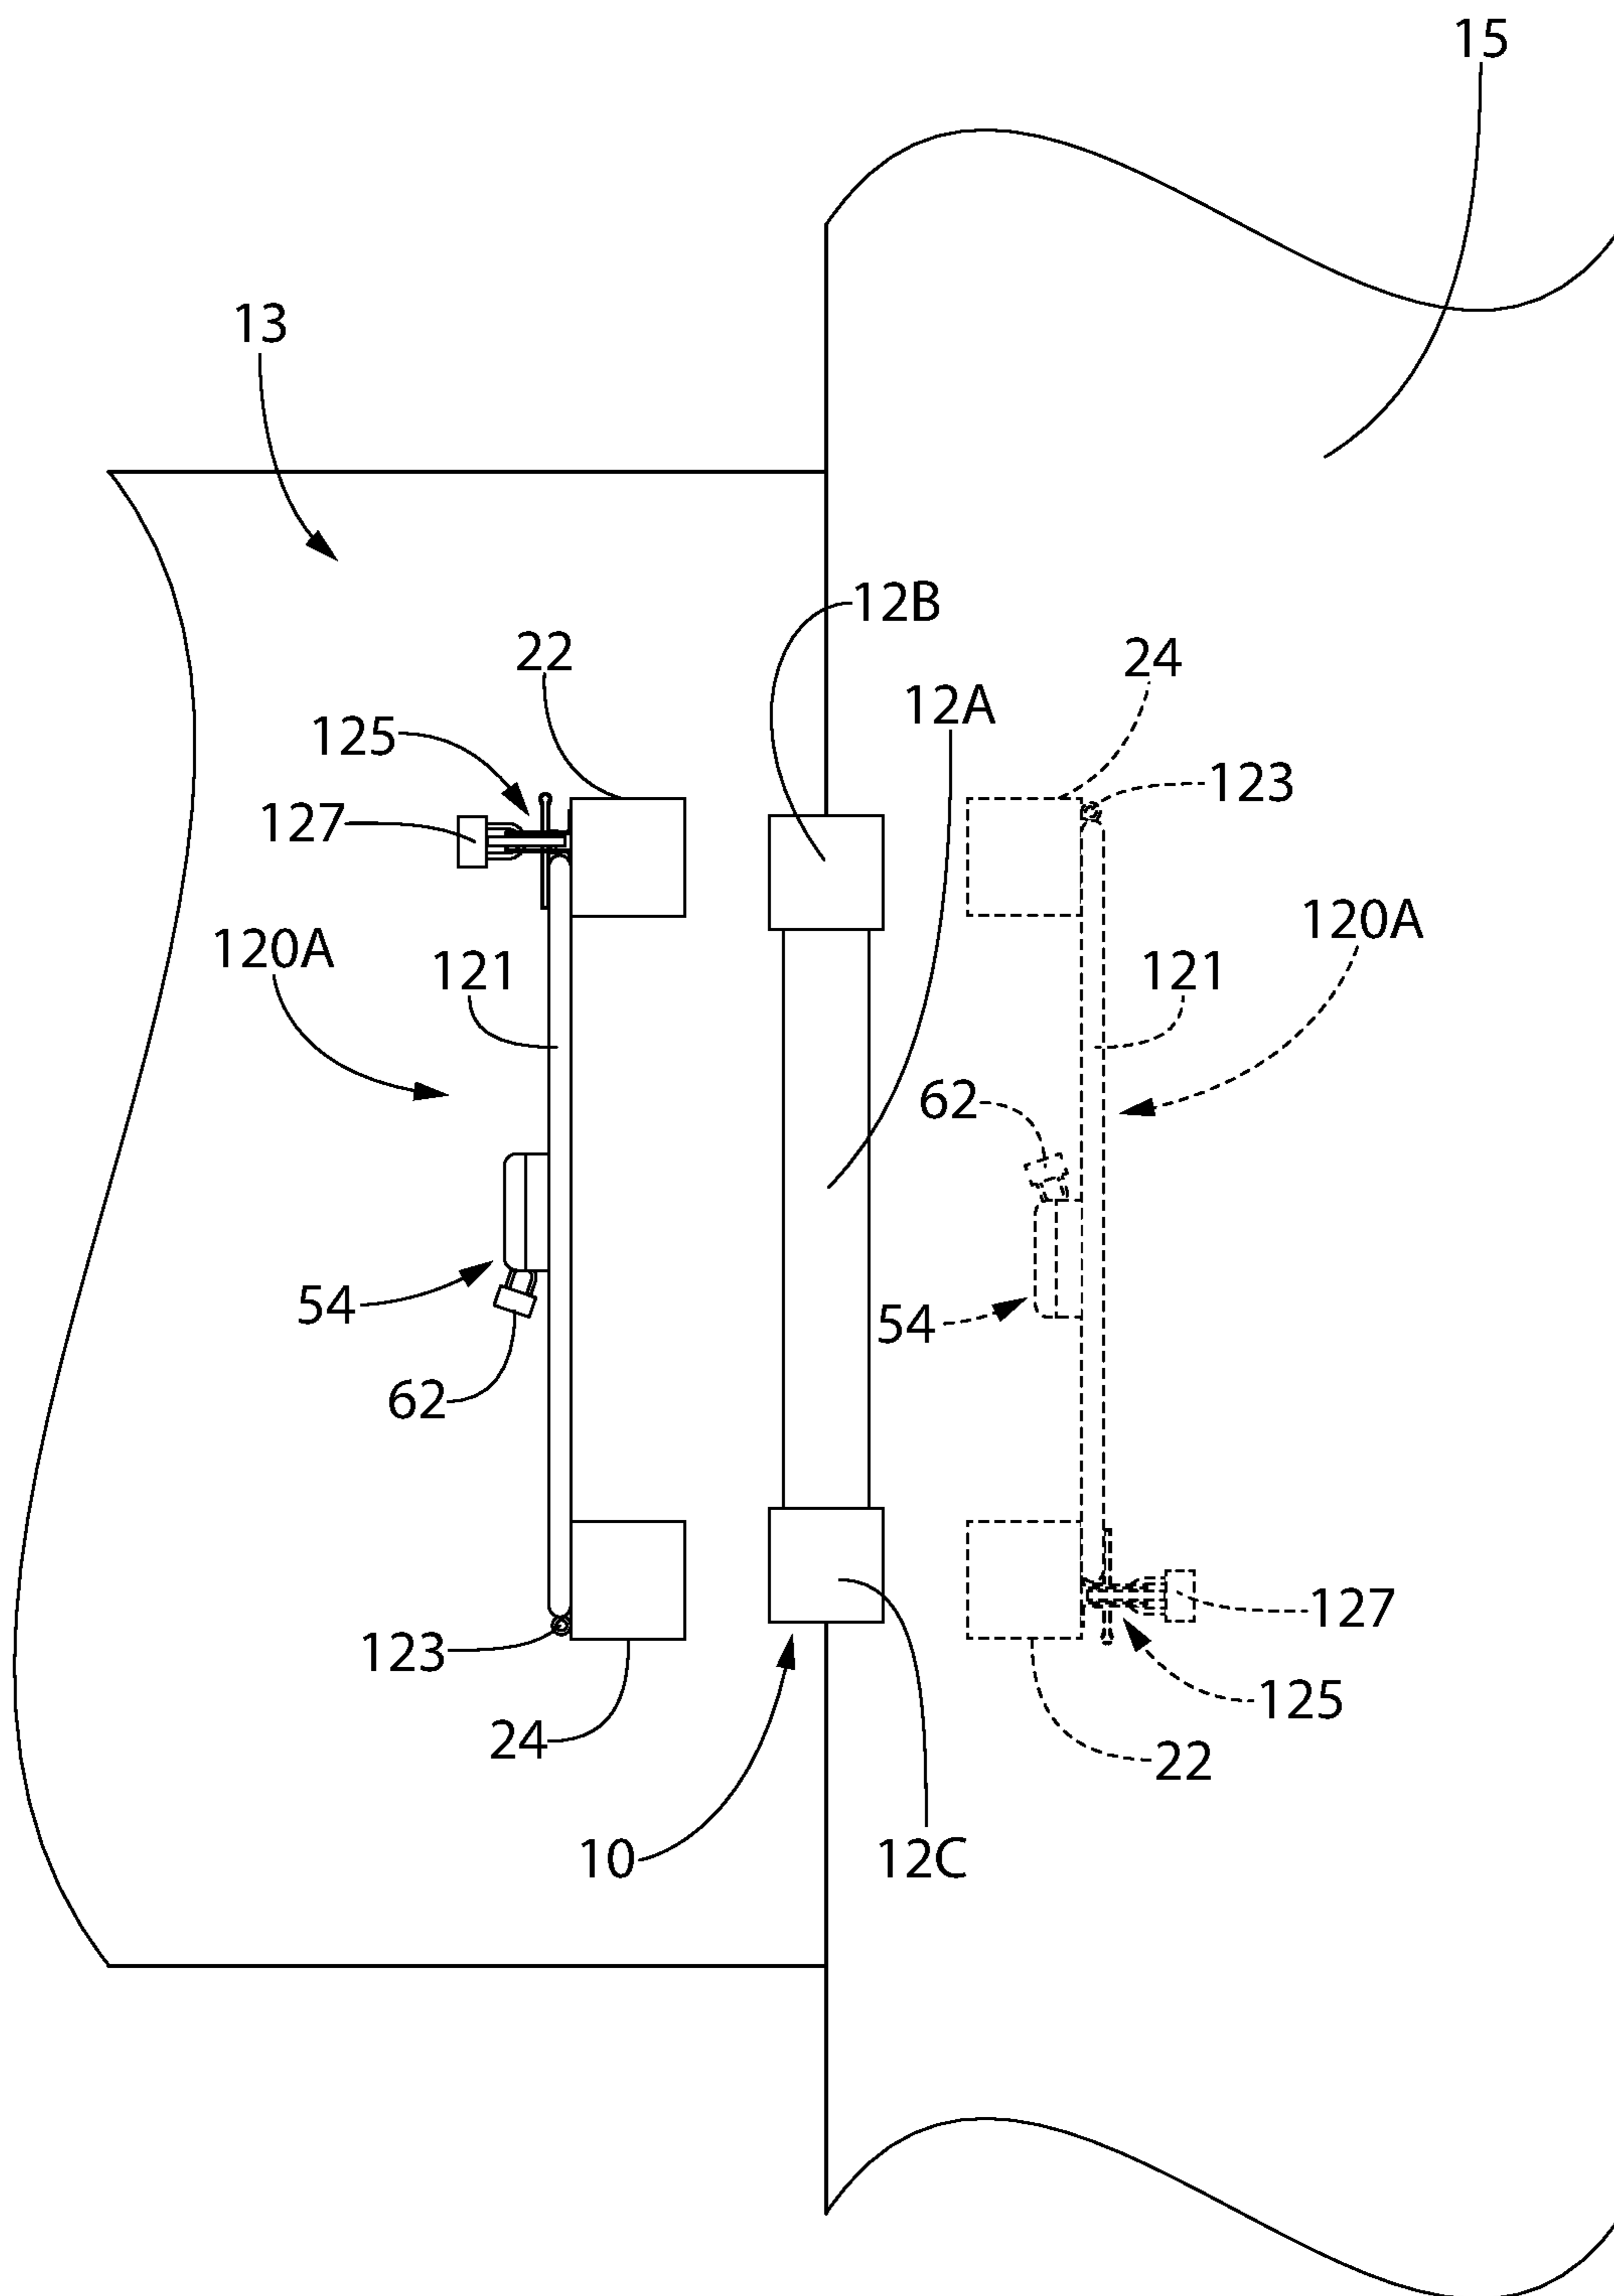
FIG. 11 is a top view functional diagram showing alternative positions of the gate portion of the present invention.

FIG. 11 shows alternative positions of the gate 120A. In particular, the gate 120A is positioned inside the upper level structure 13 (e.g., an upper level room, etc.) at the balcony opening 10, adjacent the frame. Alternatively, the gate 120A can also be positioned outside the upper level structure, on the balcony 15 itself, adjacent the frame, as shown in phantom. As such, the floor 14 (FIG. 1) represents the floor 14 in the upper level structure or the floor of the balcony 15.

If the gate 120A is installed on the balcony 15 (see phantom gate 120A in FIG. 11) rather than on the upper level structure 13, it is preferable that the housing 54 containing the visual indicator 56 be mounted on the inside of the gate 120A to provide a local warning to personnel inside the upper level structure 13.
