(10) **Patent No.:** **US 10,677,340 B2**
(45) **Date of Patent:** **Jun. 9, 2020**

(54) **DAMAGE MITIGATION FOR GEARBOX**

(71) Applicant: **SIKORSKY AIRCRAFT CORPORATION**, Stratford, CT (US)

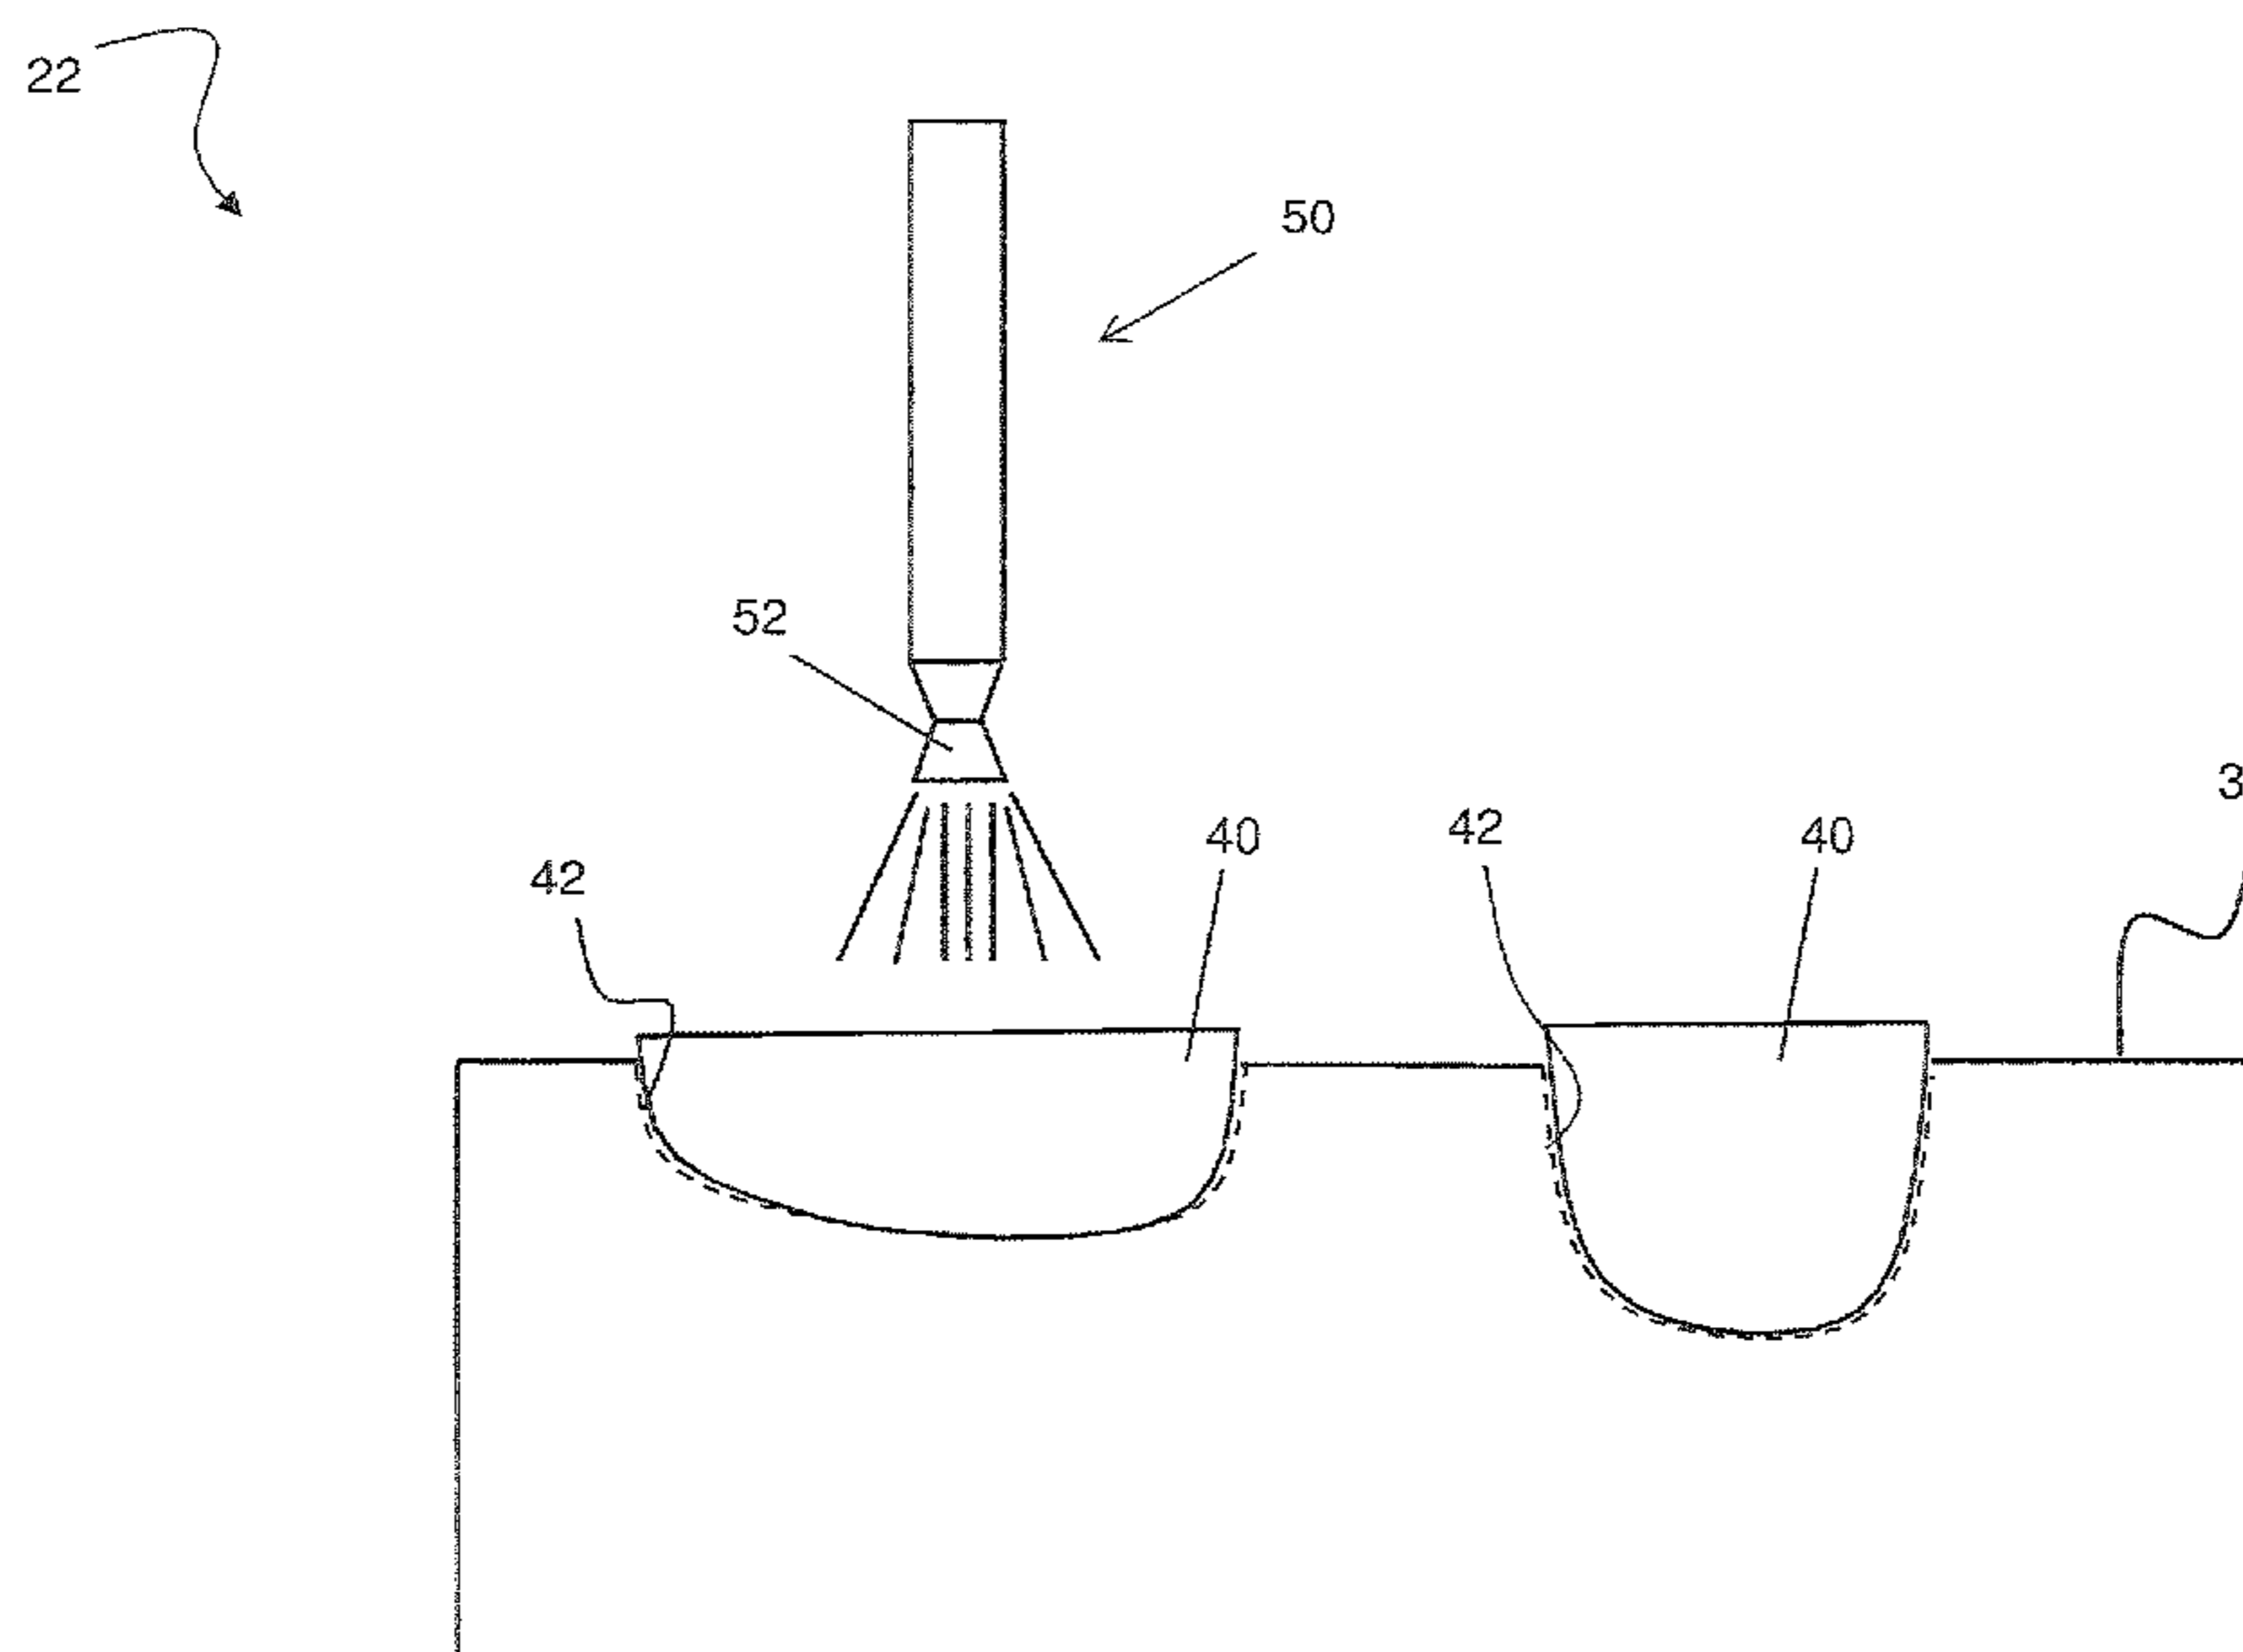
FIG. 7 is a method for preemptively forming a structural deposit in a surface of a gearbox housing according to an embodiment of the invention.

A method **200** of preemptively forming a structural deposit **40** in a surface **30** of a housing **22** is illustrated in FIG. **7**. The surface **30** may be any of the surfaces **30a**, **30b**, **30c** previously described. The method **200** may begin in block **202** by removing some material from the surface **30** of an unused gearbox housing **22**, at a position where localized corrosion and pitting is most likely to occur, to form an area **42**. Material may be removed from the surface **30** either mechanically or chemically, for example using grinding, machining, etching, or other applicable techniques. In embodiments where a structural deposit **40** is being added to the existing surface of the housing **22**, the step illustrated in block **202** may be skipped. In block **204**, the portion of the surface **30** configured to receive the structural deposit **40**, such as area **42** for example, is prepared and masked, as previously discussed. In block **206**, at least one layer of powdered material is applied using a cold spray deposition process to form a structural deposit **40**. The structural deposit **40** bonded to the surface **30** may extend beyond a desired dimension, such as the original dimension of the surface **30** of the gearbox housing **22** for example. In such instances, excess material is removed after formation of the structural deposit **40**, as shown in block **208**. The excess material **40** may be removed so that the structural deposit **40** is generally flush with the remainder of the surface **30** of the gearbox housing **22** so that the dimension of the gearbox housing **22** including the structural deposit **40** is substantially equal to the original dimension thereof.

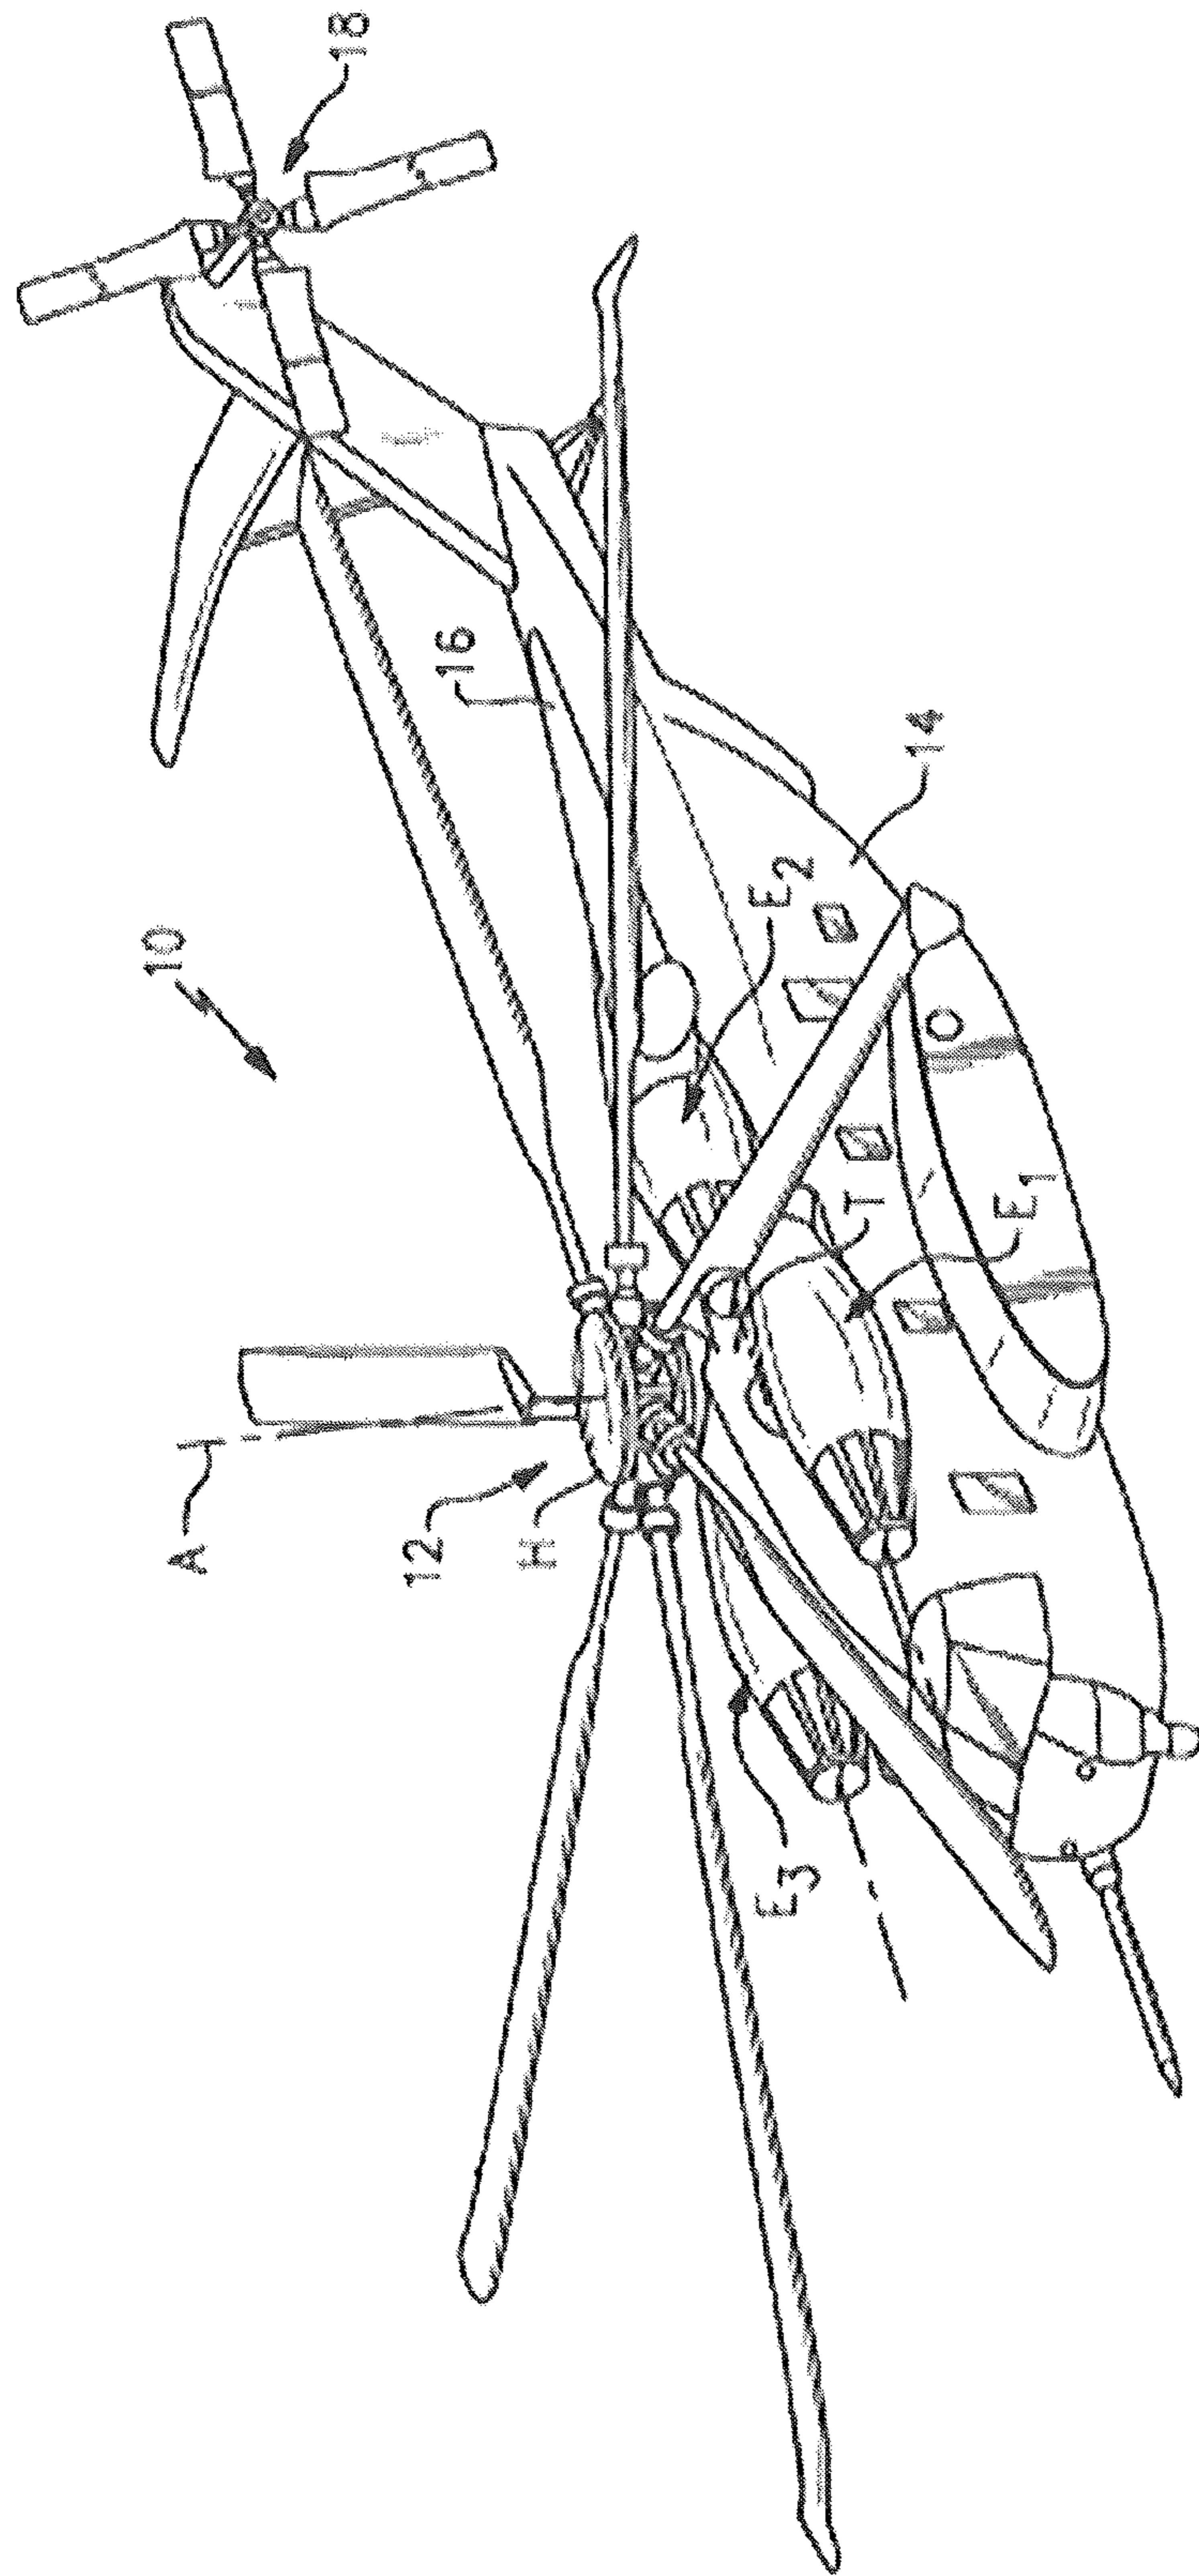
FIG.1

FIG. 1 is a perspective view of an exemplary rotary wing aircraft;

FIG. 1 schematically illustrates a rotary-wing aircraft 10 having a main rotor system 12. The aircraft 10 includes an airframe 14 having an extending tail 16 which mounts a tail rotor system 18, such as an anti-torque system, a translational thrust system, a pusher propeller, or a rotor propulsion system for example. Power is transferred from one or more engines E to a power transmission gearbox 20 (see FIGS. 2a and 2b), to drive the main rotor system 12 about a respective axis of rotation A. Although a particular rotary wing aircraft configuration is illustrated and described in the disclosed embodiment, other configurations and/or machines, such as a high speed compound rotary wing aircraft with supplemental translational thrust systems, a dual contra-rotating, coaxial rotor system aircraft, and a turbo-prop, tilt-rotor or tilt-wing aircraft for example, will also benefit from the present invention.

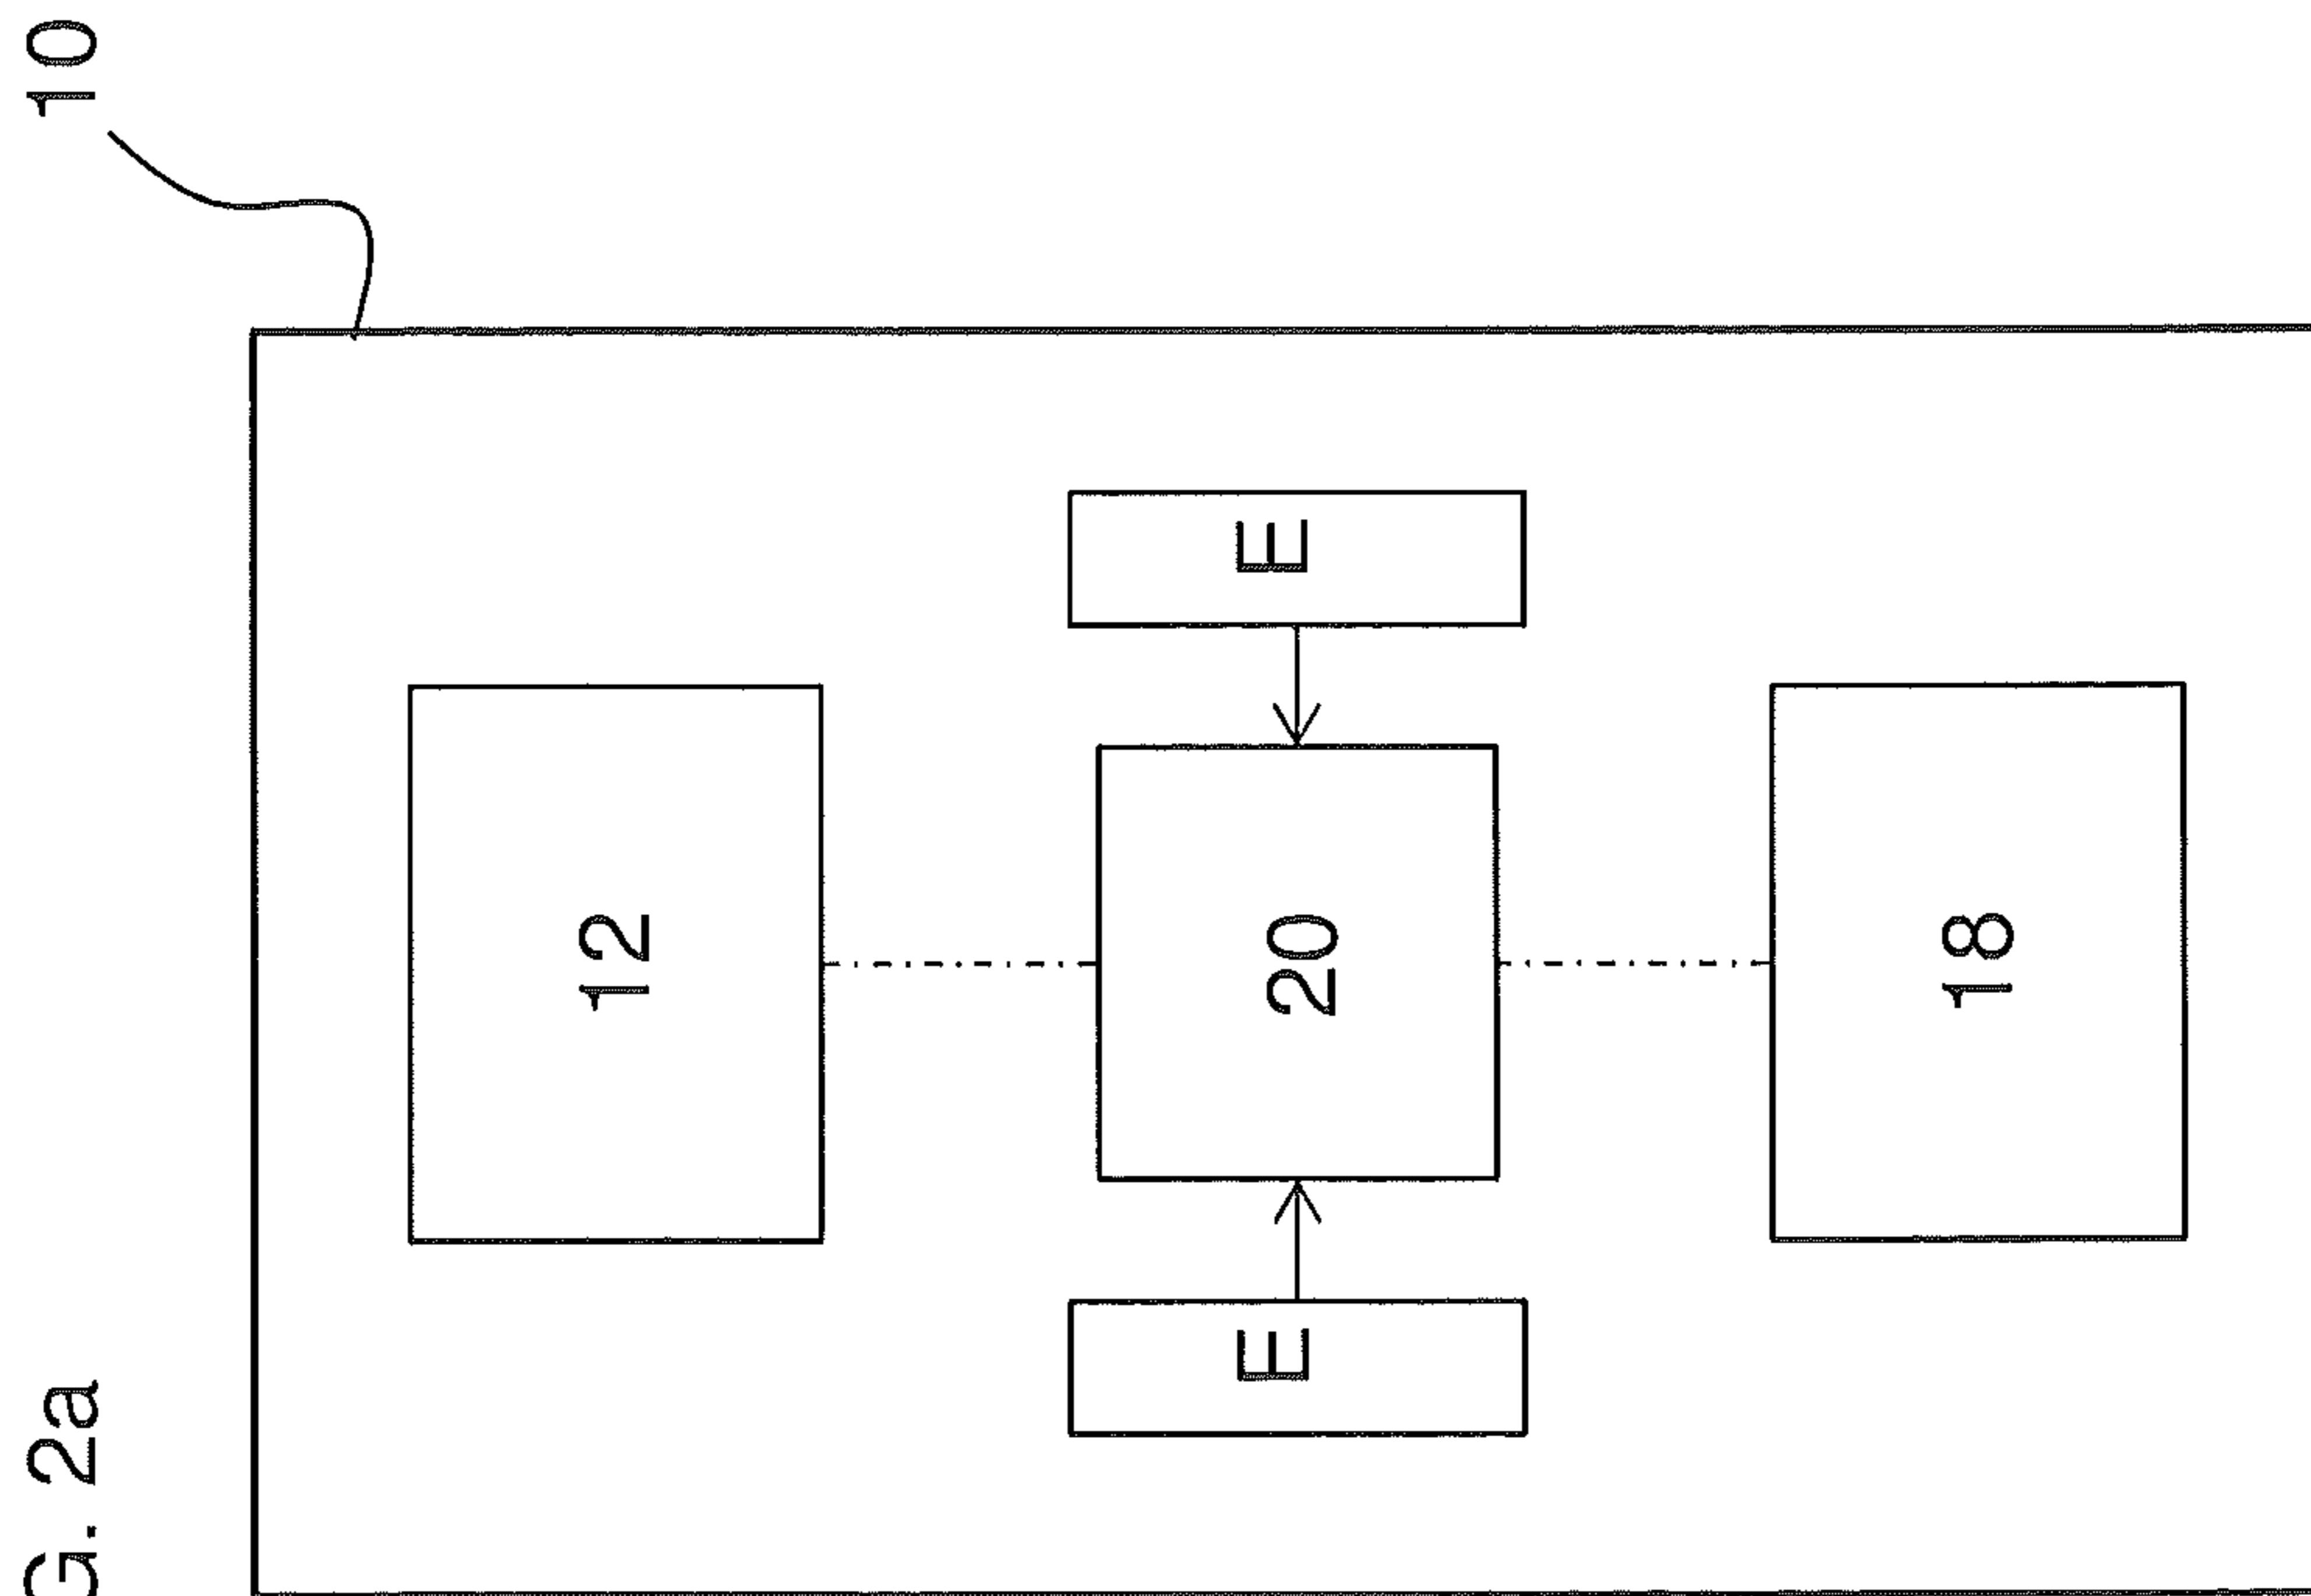
FIG. 2a

FIGS. 2a and 2b are exemplary schematic diagrams of the main rotor system and the tail rotor system of the aircraft of FIG. 1;

Referring now to FIG. 2a, a schematic diagram of the main rotor system 12 and the tail rotor system 18 of the

aircraft 10 of FIG. 1 is provided in more detail. In the illustrated non-limiting embodiment, the power transmission gearbox 20 is interposed between one or more engines E, the main rotor system 12 and the tail rotor system 18. The gearbox 20 may be mechanically connected to and configured to operate both the main rotor system 12 and to the tail rotor system 18. In another embodiment, shown in FIG. 2b, the rotary wing aircraft 10 includes a first power transmission gearbox 20 mechanically coupled to and configured to operate the main rotor system 12. Similarly, the second power transmission gearbox 21 is mechanically connected to and configured to operate the tail rotor system 18. Each of the power transmission gearboxes 20, 21 receives power from at least one engine E of the aircraft 10.

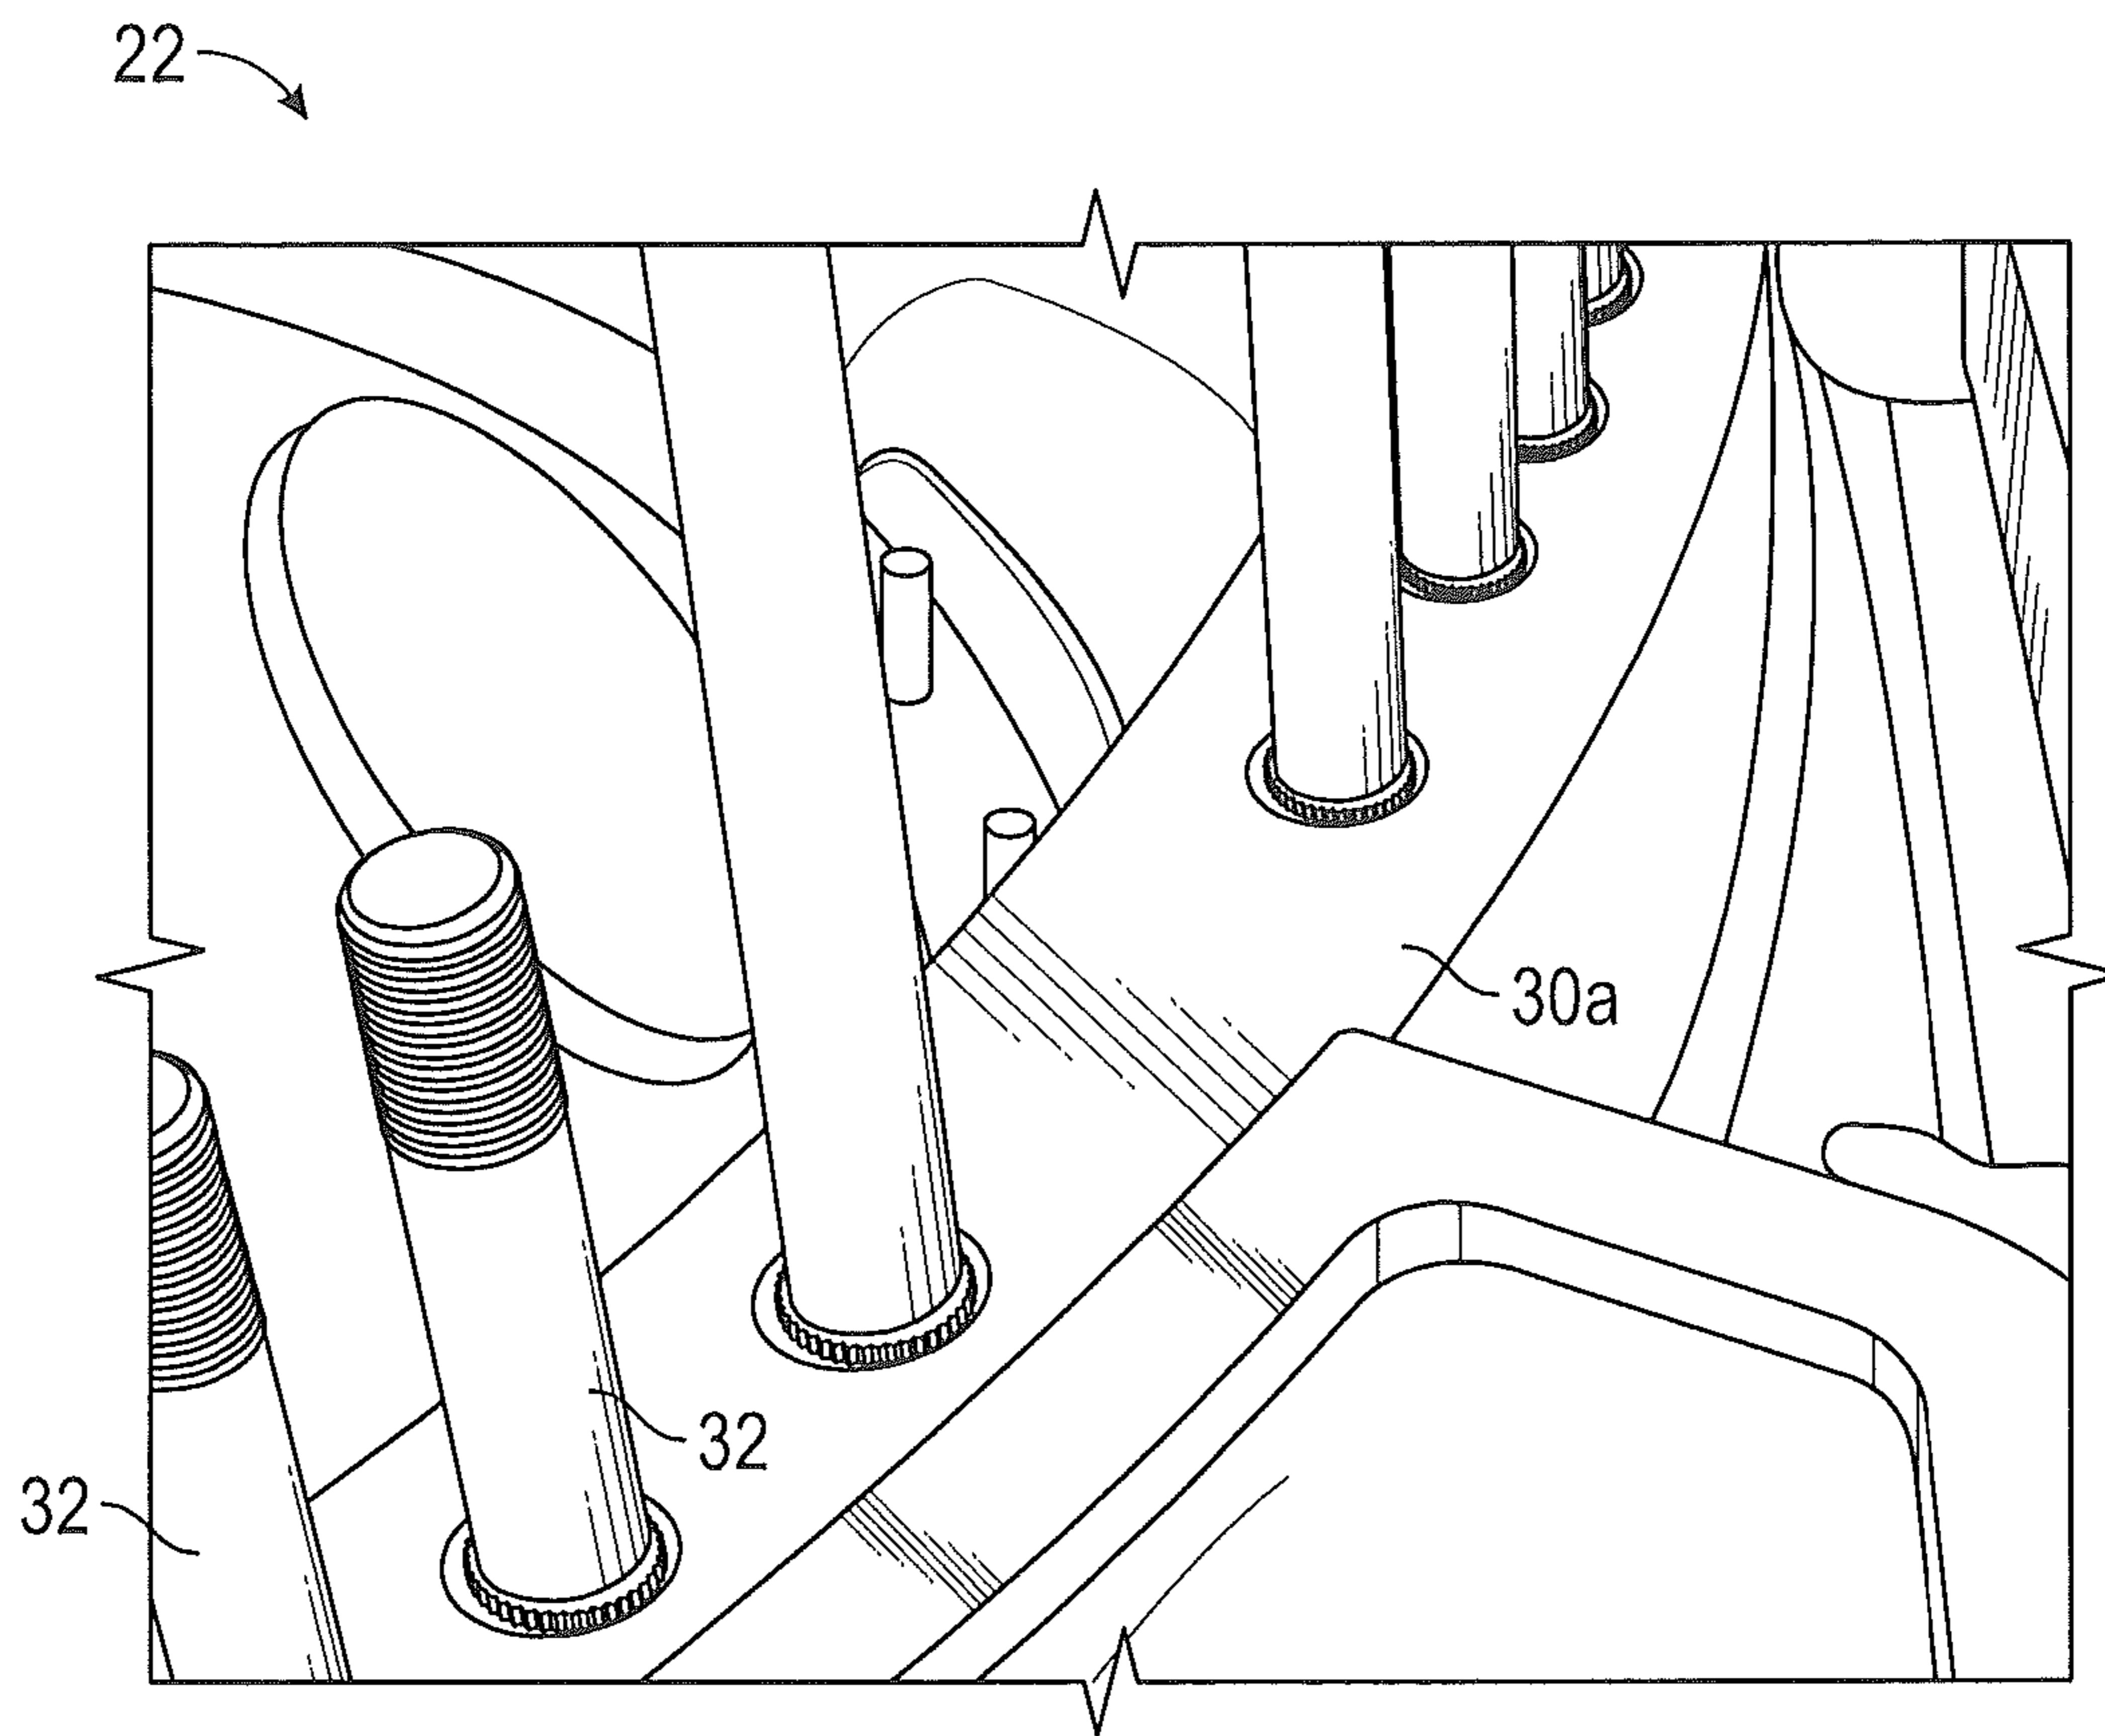
FIG. 3 is a perspective view of a gearbox housing of a rotary wing aircraft according to an embodiment of the invention;

The power transmission gearbox 20, 21 is generally mounted within a housing 22 configured to support the gear-train therein. In one embodiment, the housing includes either an aluminum or a magnesium material. The non-limiting embodiment of a housing 22 illustrated in FIG. 3 generally includes a plurality of first openings 24 configured to provide a plurality of passageways for a lubricant to various portions of the gearbox 20. The housing 22 may also include a plurality of second openings 26 configured to at least partially support an input module attachment (not shown), such as the rotor shaft (not shown) of the main rotor system 12 or the tail rotor system 18 for example. In addition, the housing 22 may include a plurality of mounting feet 28 arranged about the periphery thereof near a first end 23. Although a particular gearbox housing 22 configuration is illustrated and described in the disclosed non-limiting embodiment, other configurations are within the scope of the invention.

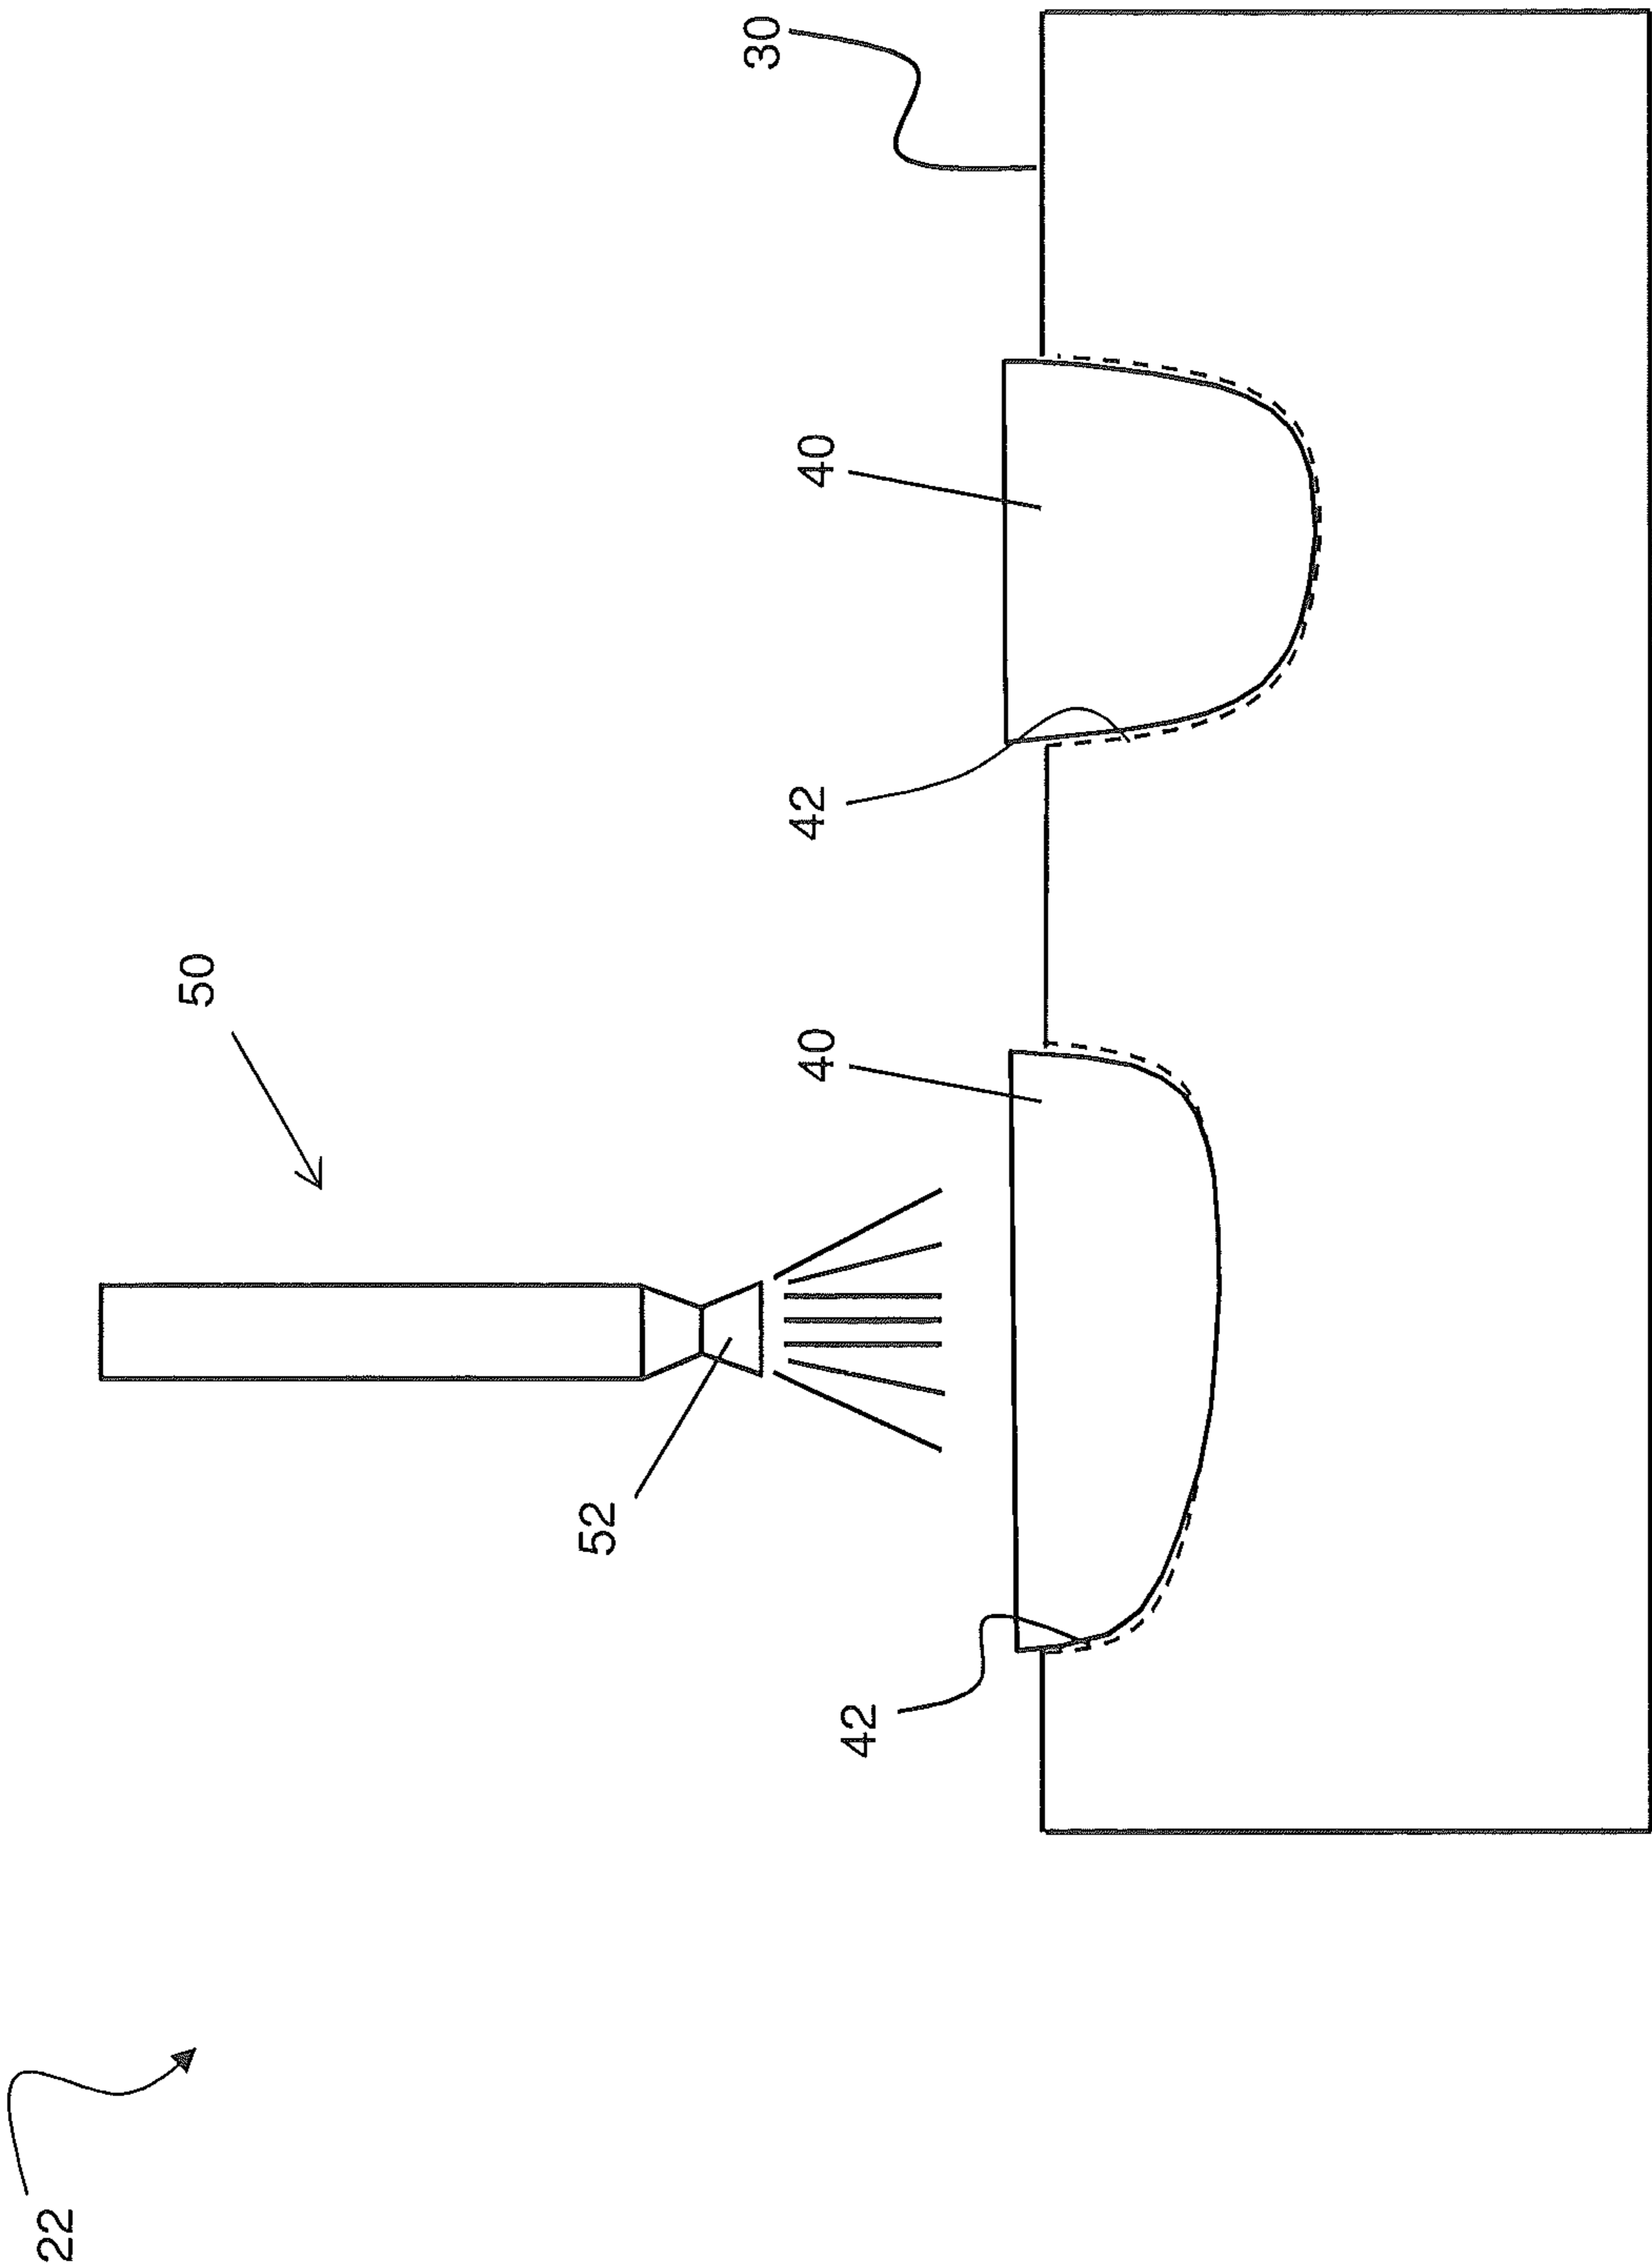
FIG. 4 is a perspective view of a mating surface of a gearbox housing of a rotary wing aircraft according to an embodiment of the invention;

The portions of the housing 22 that are most susceptible to damage, as well as corrosion and pitting are generally the surfaces 30 configured to contact or engage another component and/or a material distinguishable from the material of the housing 22. Exemplary surfaces 30 include, but are not limited to, end mating surface 30a, flight control surfaces 30b, and bottom surfaces 30c for example. The end mating surface 30a is located at the first end 23 of the housing 22 and is configured to engage a portion of the airframe 10 or another component of the aircraft 10. As illustrated in FIG. 4, at least one fastener 32 may extend generally perpendicularly from the end mating surface 30a, the at least one fastener 32 being configured to connect the first end 23 of the housing 22 to another portion of the aircraft 10. Each flight control surface 30b is configured to couple to a flight control or another component (not shown) of the aircraft 10. A plurality of flight control surfaces 30b may be disposed about the exterior of the housing 22 and may be arranged at any angle relative to the end mating surface 30a. Similarly, the bottom surfaces 30c are the portion of the mounting feet 28, such as the underside for example, configured to contact another component of the aircraft 10 or a portion of the airframe 14.
