(10) **Patent No.:** **US 10,677,340 B2**
(45) **Date of Patent:** **Jun. 9, 2020**

(54) **DAMAGE MITIGATION FOR GEARBOX**

(71) Applicant: **SIKORSKY AIRCRAFT CORPORATION**, Stratford, CT (US)

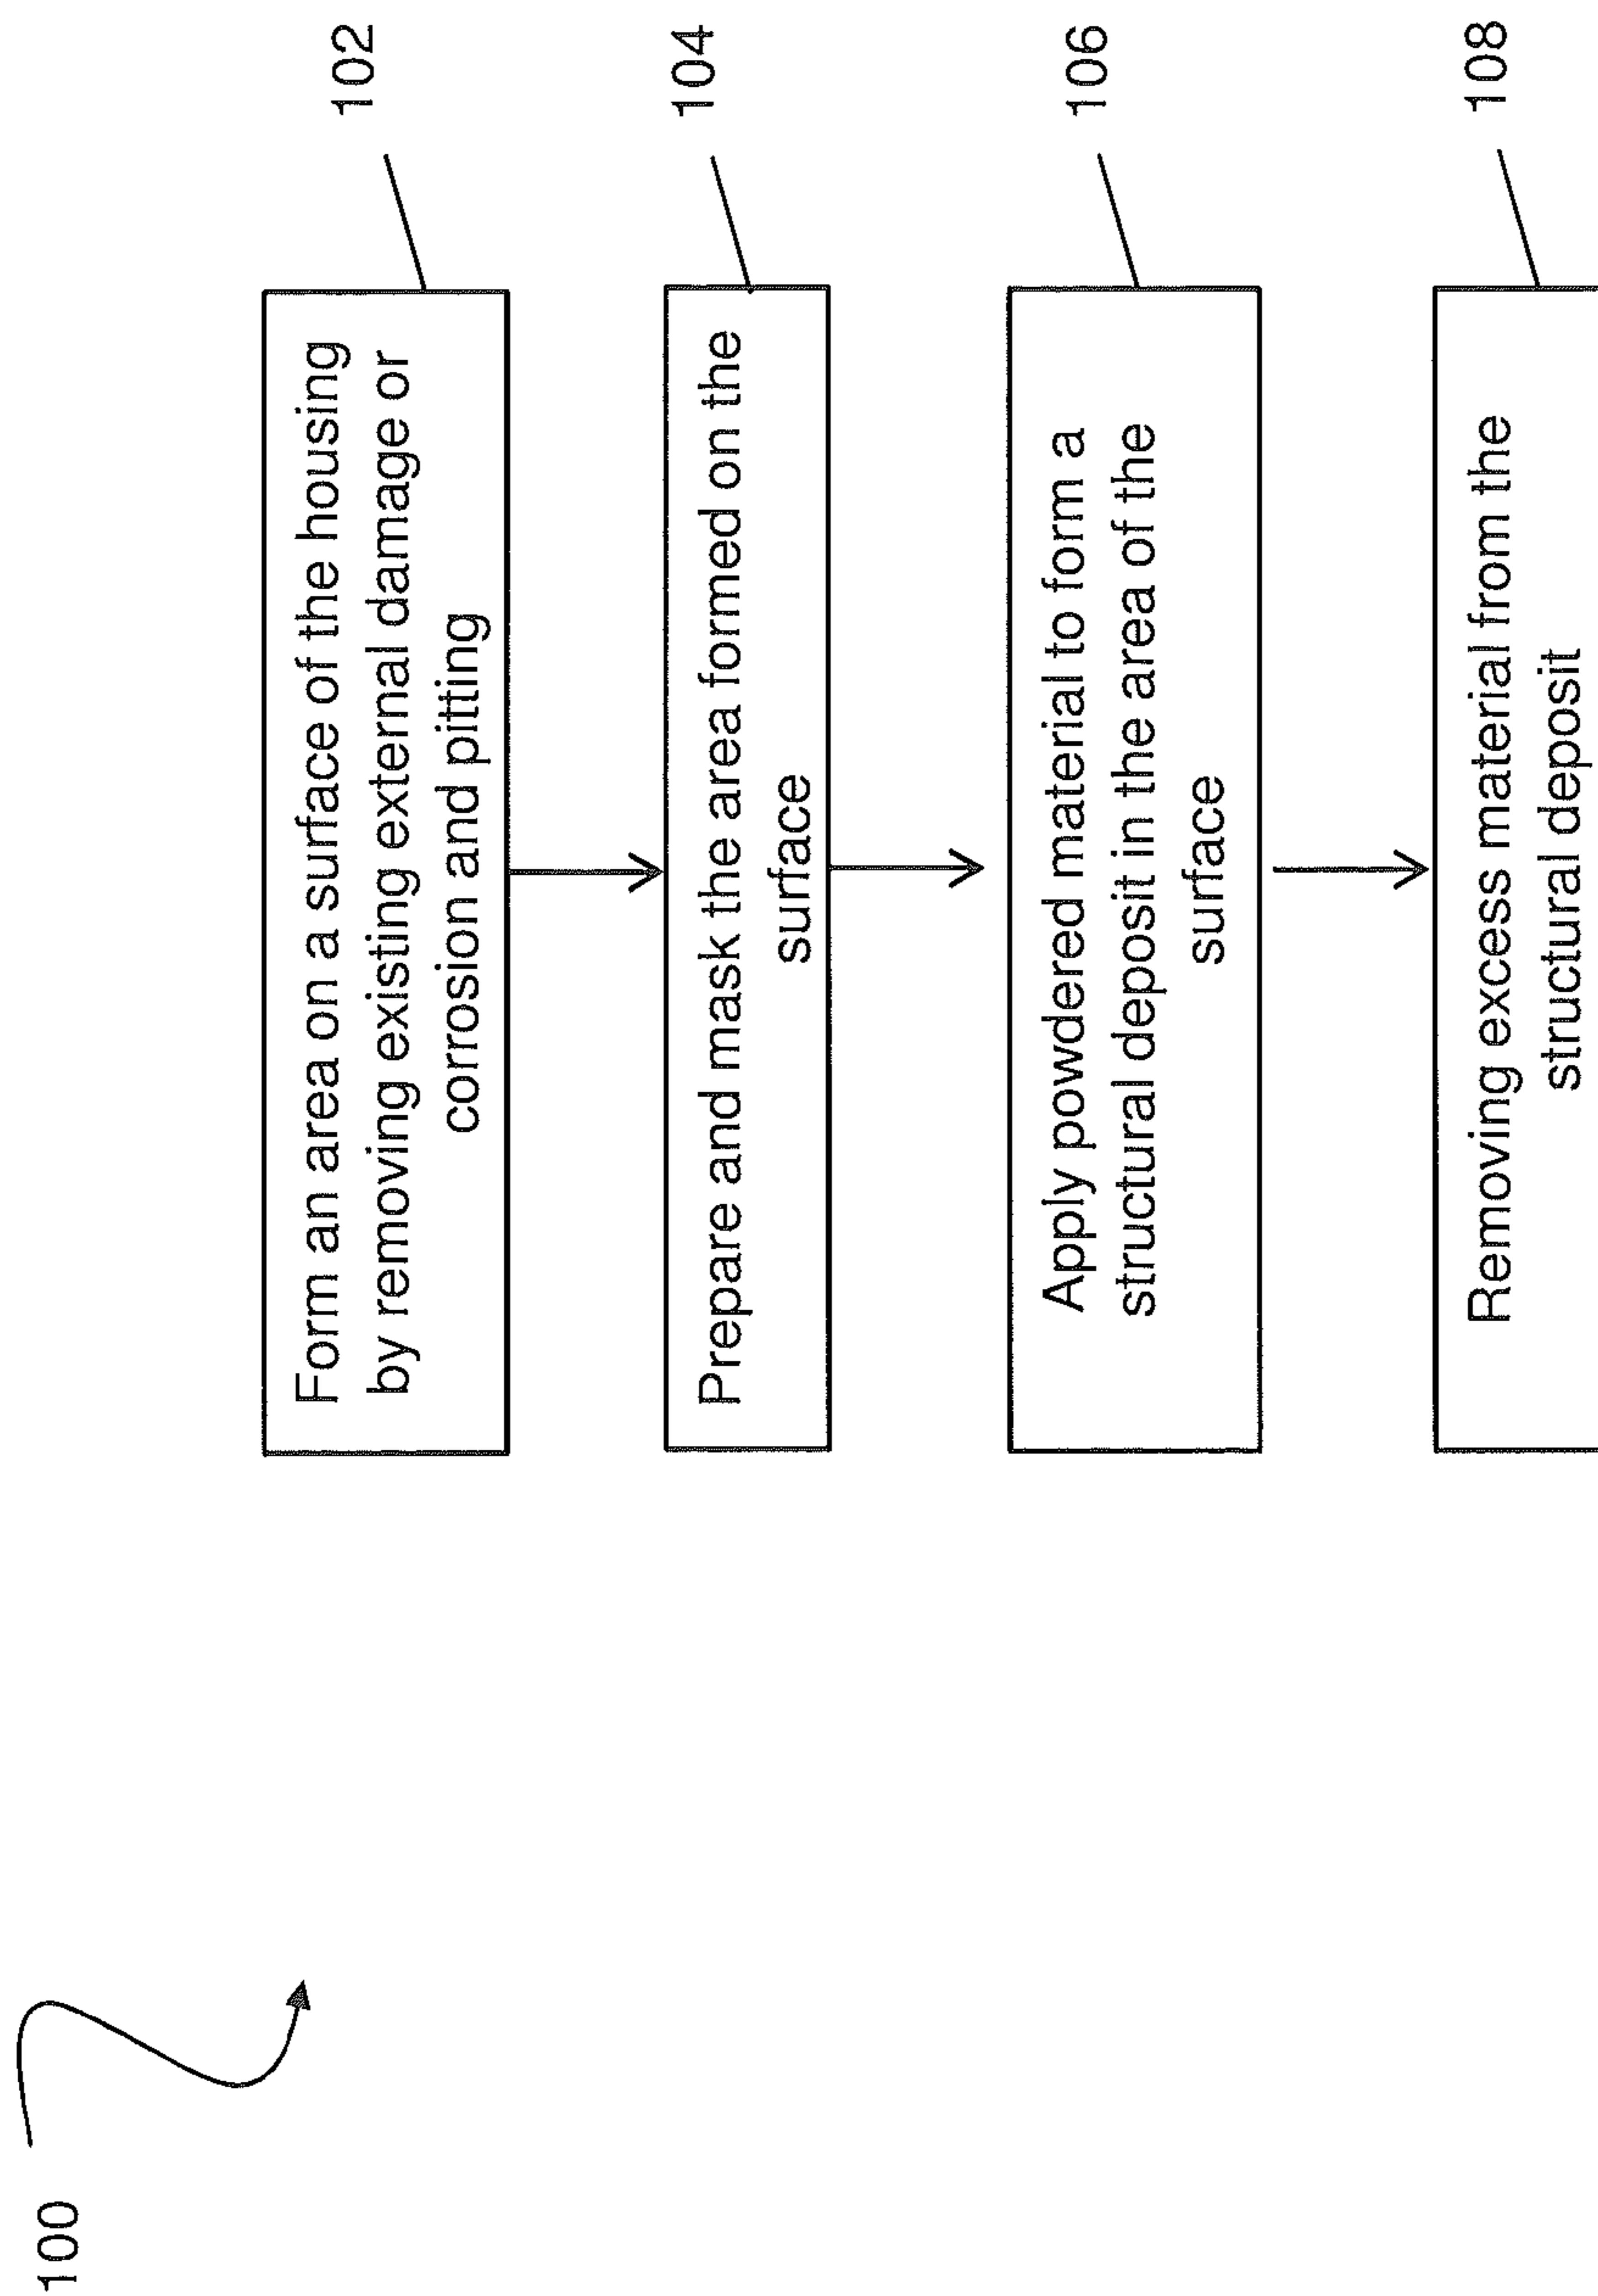
FIG 5

FIG. 5 is a cross-sectional view of a portion of a gearbox housing having an integrally formed structural deposit according to an embodiment of the invention;

Referring now to FIG. 5, a structural deposit 40 configured to support a load applied to the housing 22 is formed on at least a portion of a surface 30 of the gearbox housing 22 susceptible to corrosion and pitting. The structural deposit 40 may be formed from any suitable powdered material known in the art, such as aluminum or aluminum alloy for example. In one embodiment, the structural deposit 40 is formed as a means of repairing the housing 22 after either external damage (i.e. nicks, dings or gouges) or corrosion and/or pitting has already occurred. In another embodiment, the structural deposit 40 is formed as a “pre-

A structural deposit **40** is formed by applying one or more layers of powdered material to an area **42** of the surface **30**. In embodiments where the structural deposit **40** is applied after corrosion has occurred, each area **42** is created by removing as little of the material of the surface **30** as necessary to completely eliminate all of the localized corrosion and pitting. Some of the adjacent non-compromised material of the surface **30** may additionally be removed along with the localized corrosion and pitting to ensure that the remaining material of the housing **22** has not been compromised. In embodiments where the structural deposit **40** is applied “preemptively,” each area **42** is created either by removing material from the surface **30** where corrosion and pitting are most likely to occur, or by depositing one or more layers of powdered material used to form a structural deposit **40** on top of the as-processed (or as-cast) surface. In either embodiment, the one or more areas **42** formed in the surface **30** are generally, but not limited to, concave grooves.

The one or more layers of powdered material used to form the structural deposit **40** are more substantial than a coating and are configured to share a load applied over the surface **30**. As a result, the strength of a housing **22** having one or more structural deposits **40** integrally formed with the surfaces **30** where corrosion and pitting has/is likely to occur is near, substantially equal to, or in excess of the original strength of the housing **22**. The structural deposit **40** formed from one or more layers of powdered material may have a thickness in the range of about 0.010 inches and 2.00 inches. In one embodiment, the structural deposit **40** has a thickness greater than or equal to 0.025 inches, depending on part geometry and other factors, to properly share the load applied to the component.

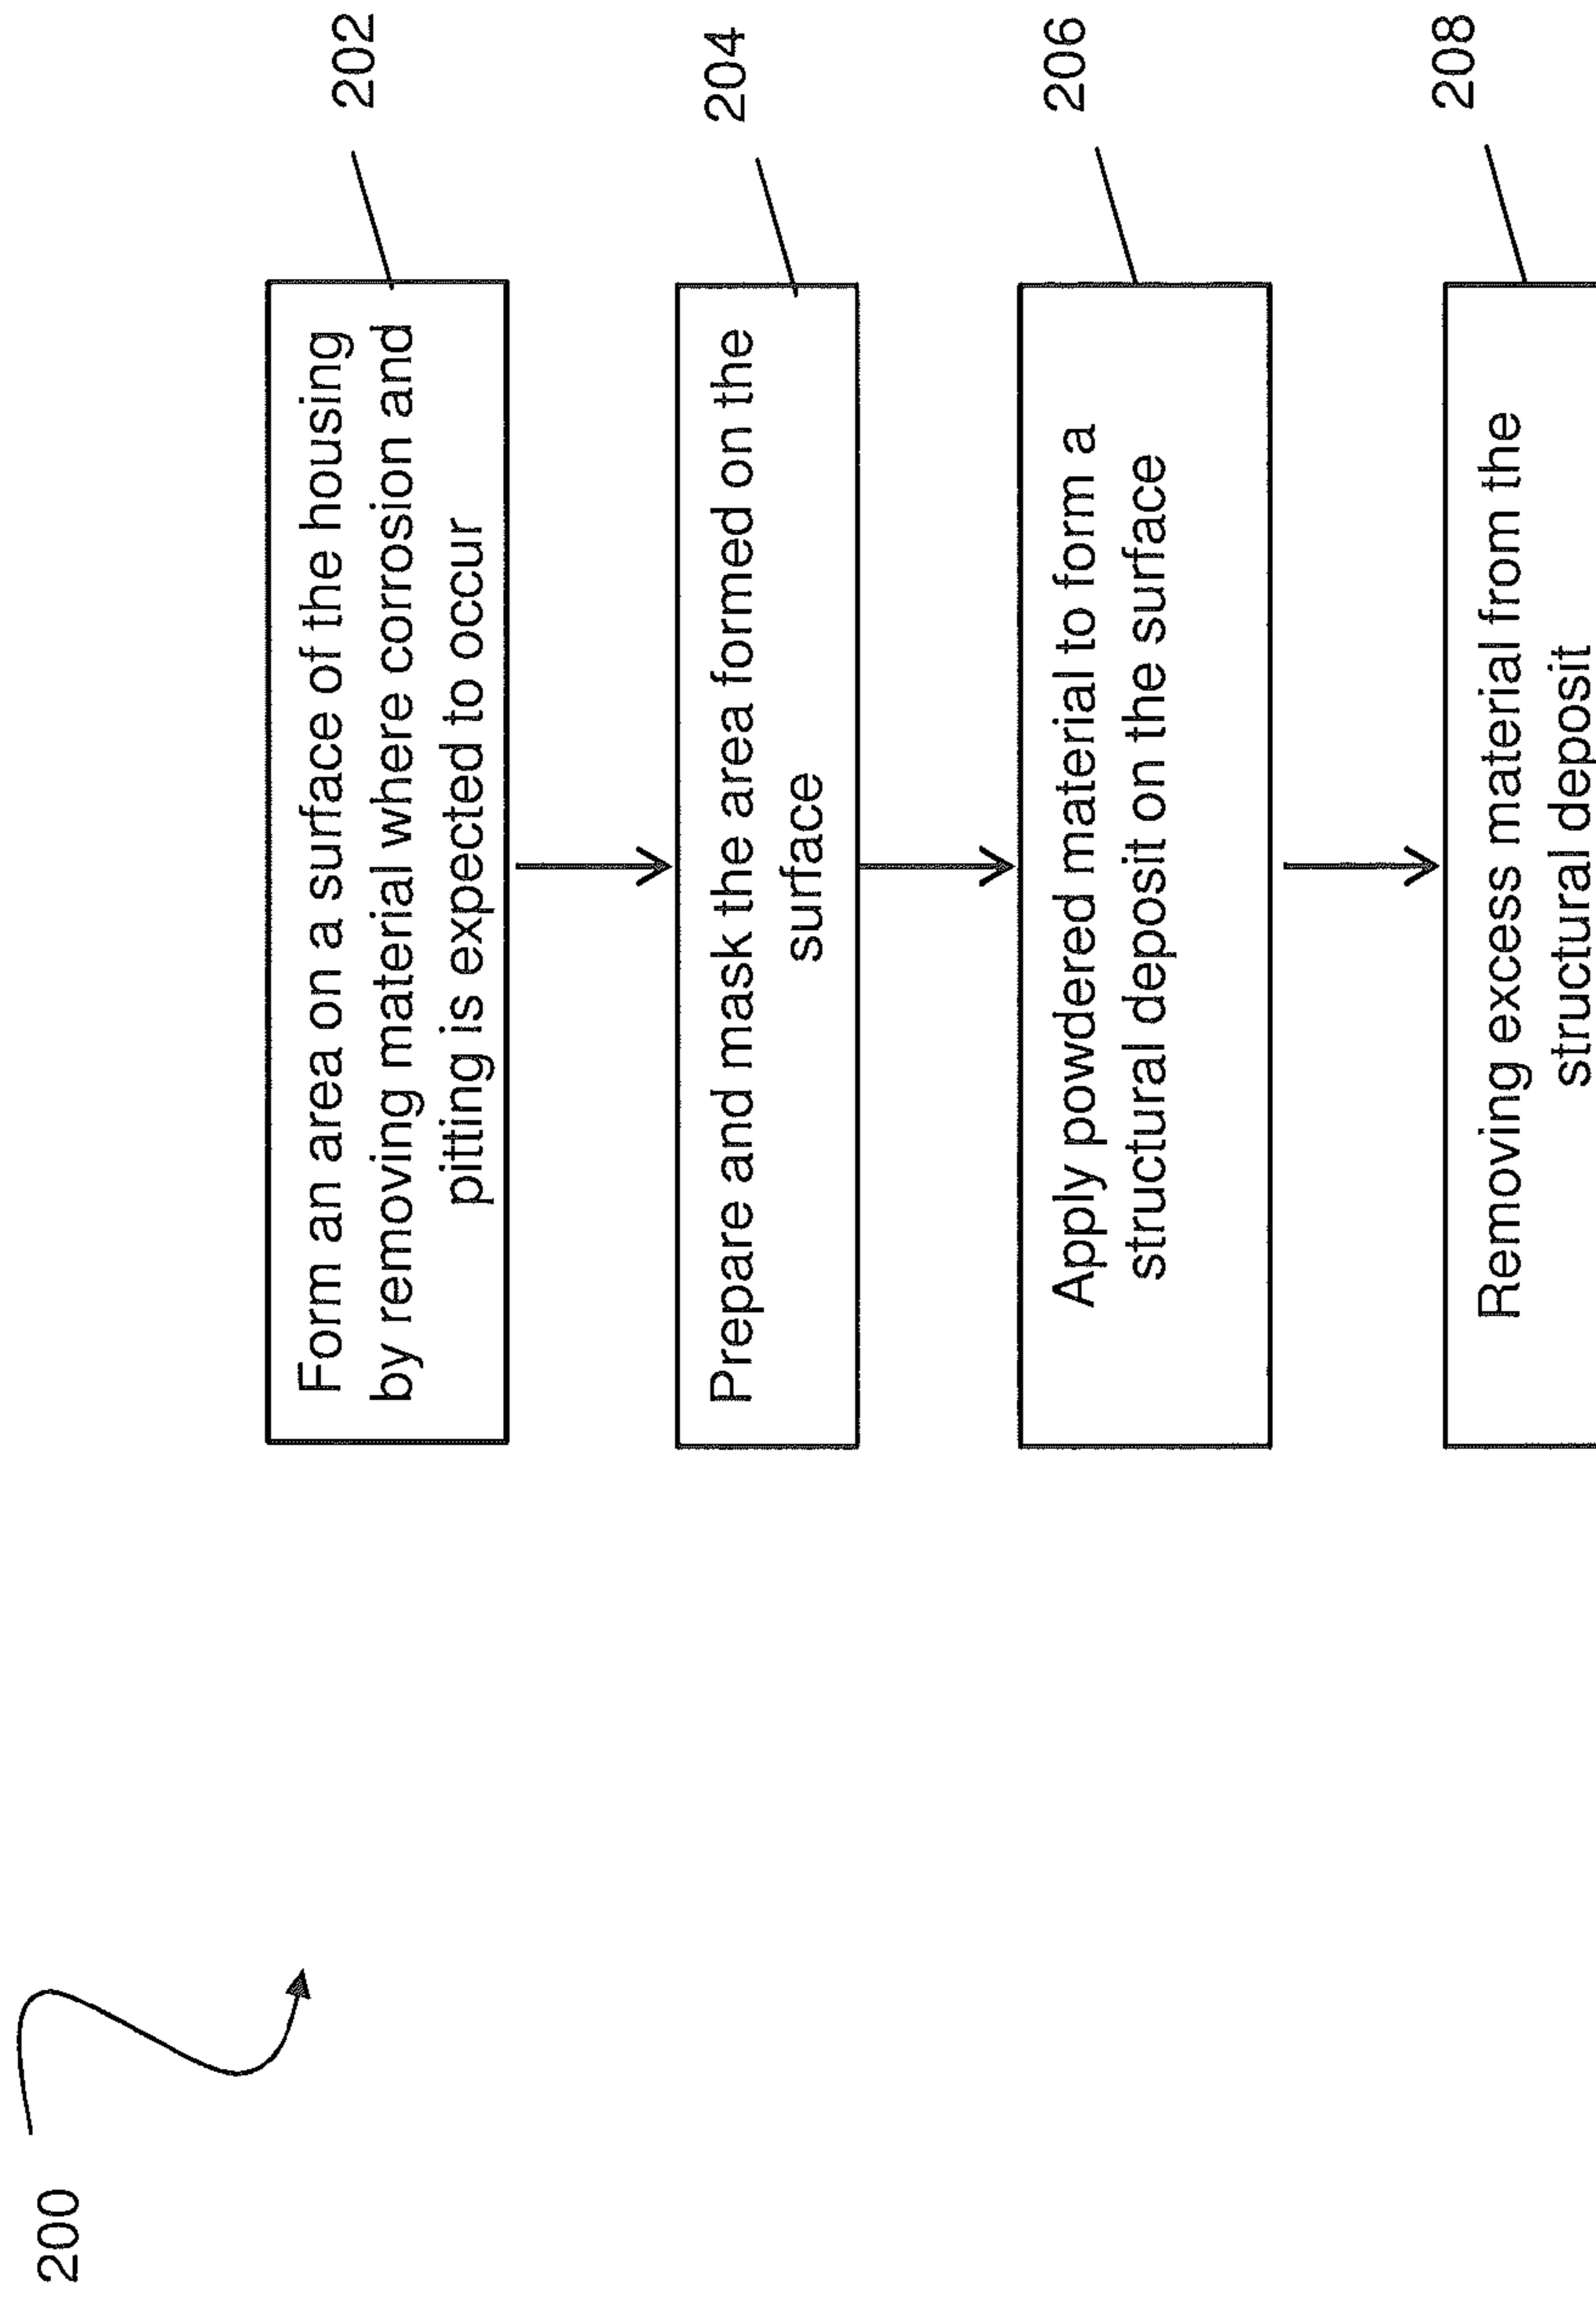
FIG. 6 is a method for rebuilding a portion of a surface of a gearbox housing according to an embodiment of the invention; and

A method **100** for rebuilding a damaged or corroded portion of a surface **30** of a gearbox housing **22** is illustrated in FIG. **6**. The surface **30** may be any of the surfaces **30a**, **30b**, **30c** previously described. The method begins in block **102** by removing all of the localized damage or corrosion from a portion of surface **30** to form an area **42** (see FIG. **5**). The corrosion and pitting may be removed either mechani-

cally or chemically, for example using grinding, machining, etching, or other applicable techniques. After the localized corrosion is removed, as shown in block **104**, the surface **30** is prepared and masked as is known in the art. In one embodiment, preparation and masking of the surface **30** involves the use of an abrasive grit blast. An additional material may be used to eliminate any blast residue as a course of contamination. In block **106**, at least one layer of powdered material is applied to the area **42** using a cold spray deposition process to create a structural deposit **40** integrally formed with the material of the housing **22**. The structural deposit **40** bonded to the area **42** may extend beyond the original dimension of the surface **30** of the gearbox housing **22**. After formation of the structural deposit **40**, excess material is removed, as shown in block **108**. As a result, the structural deposit **40** is generally flush with the remainder of the surface **30** of the gearbox housing **22** and/or the dimension of the gearbox housing **22** including the structural deposit **40** is substantially equal to the original dimension thereof.
