US010686029B1

(10) **Patent No.:** **US 10,686,029 B1**  
(45) **Date of Patent:** **Jun. 16, 2020**

(54) **METHOD FOR REPAIRING  
DISCONNECTING SIGNAL LINE OF THIN  
FILM TRANSISTOR (TFT) ARRAY  
SUBSTRATE**

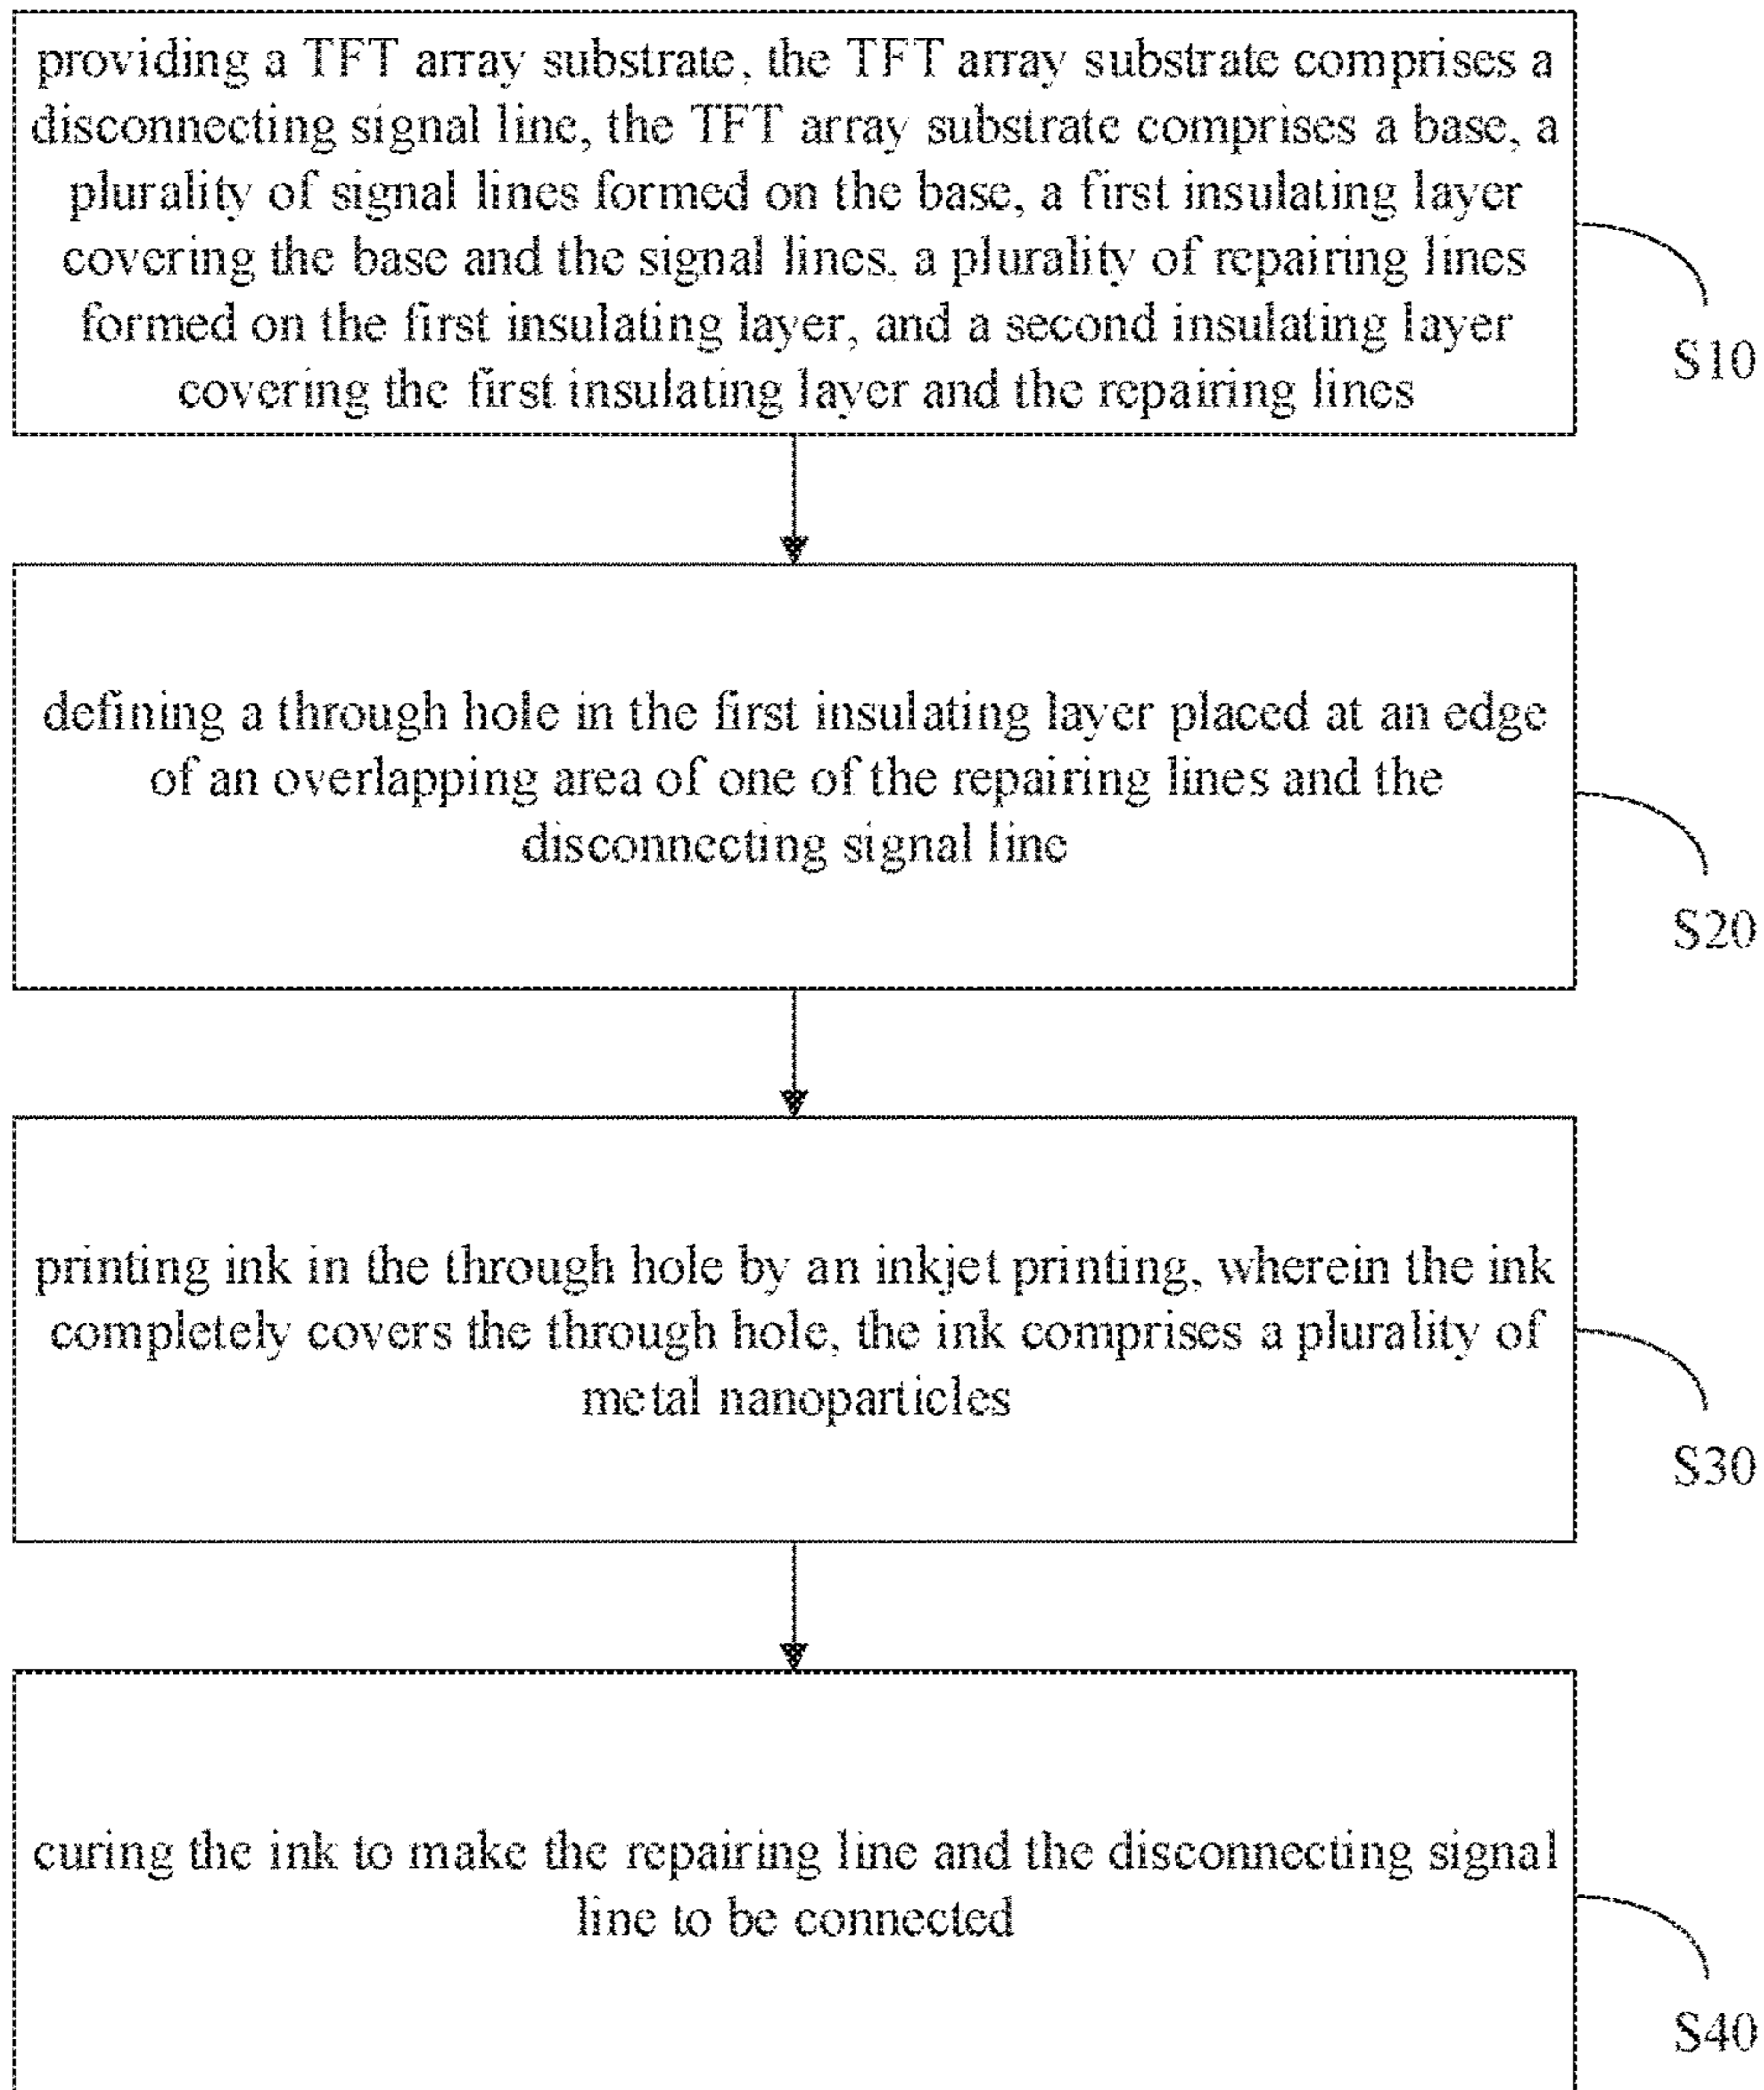
FIG. 1 is a flow chart of a method for repairing a disconnecting signal line of a TFT array substrate of the present disclosure.

Referring to FIG. 1, a method for repairing a disconnecting signal line of a TFT array substrate is provided, the method including:

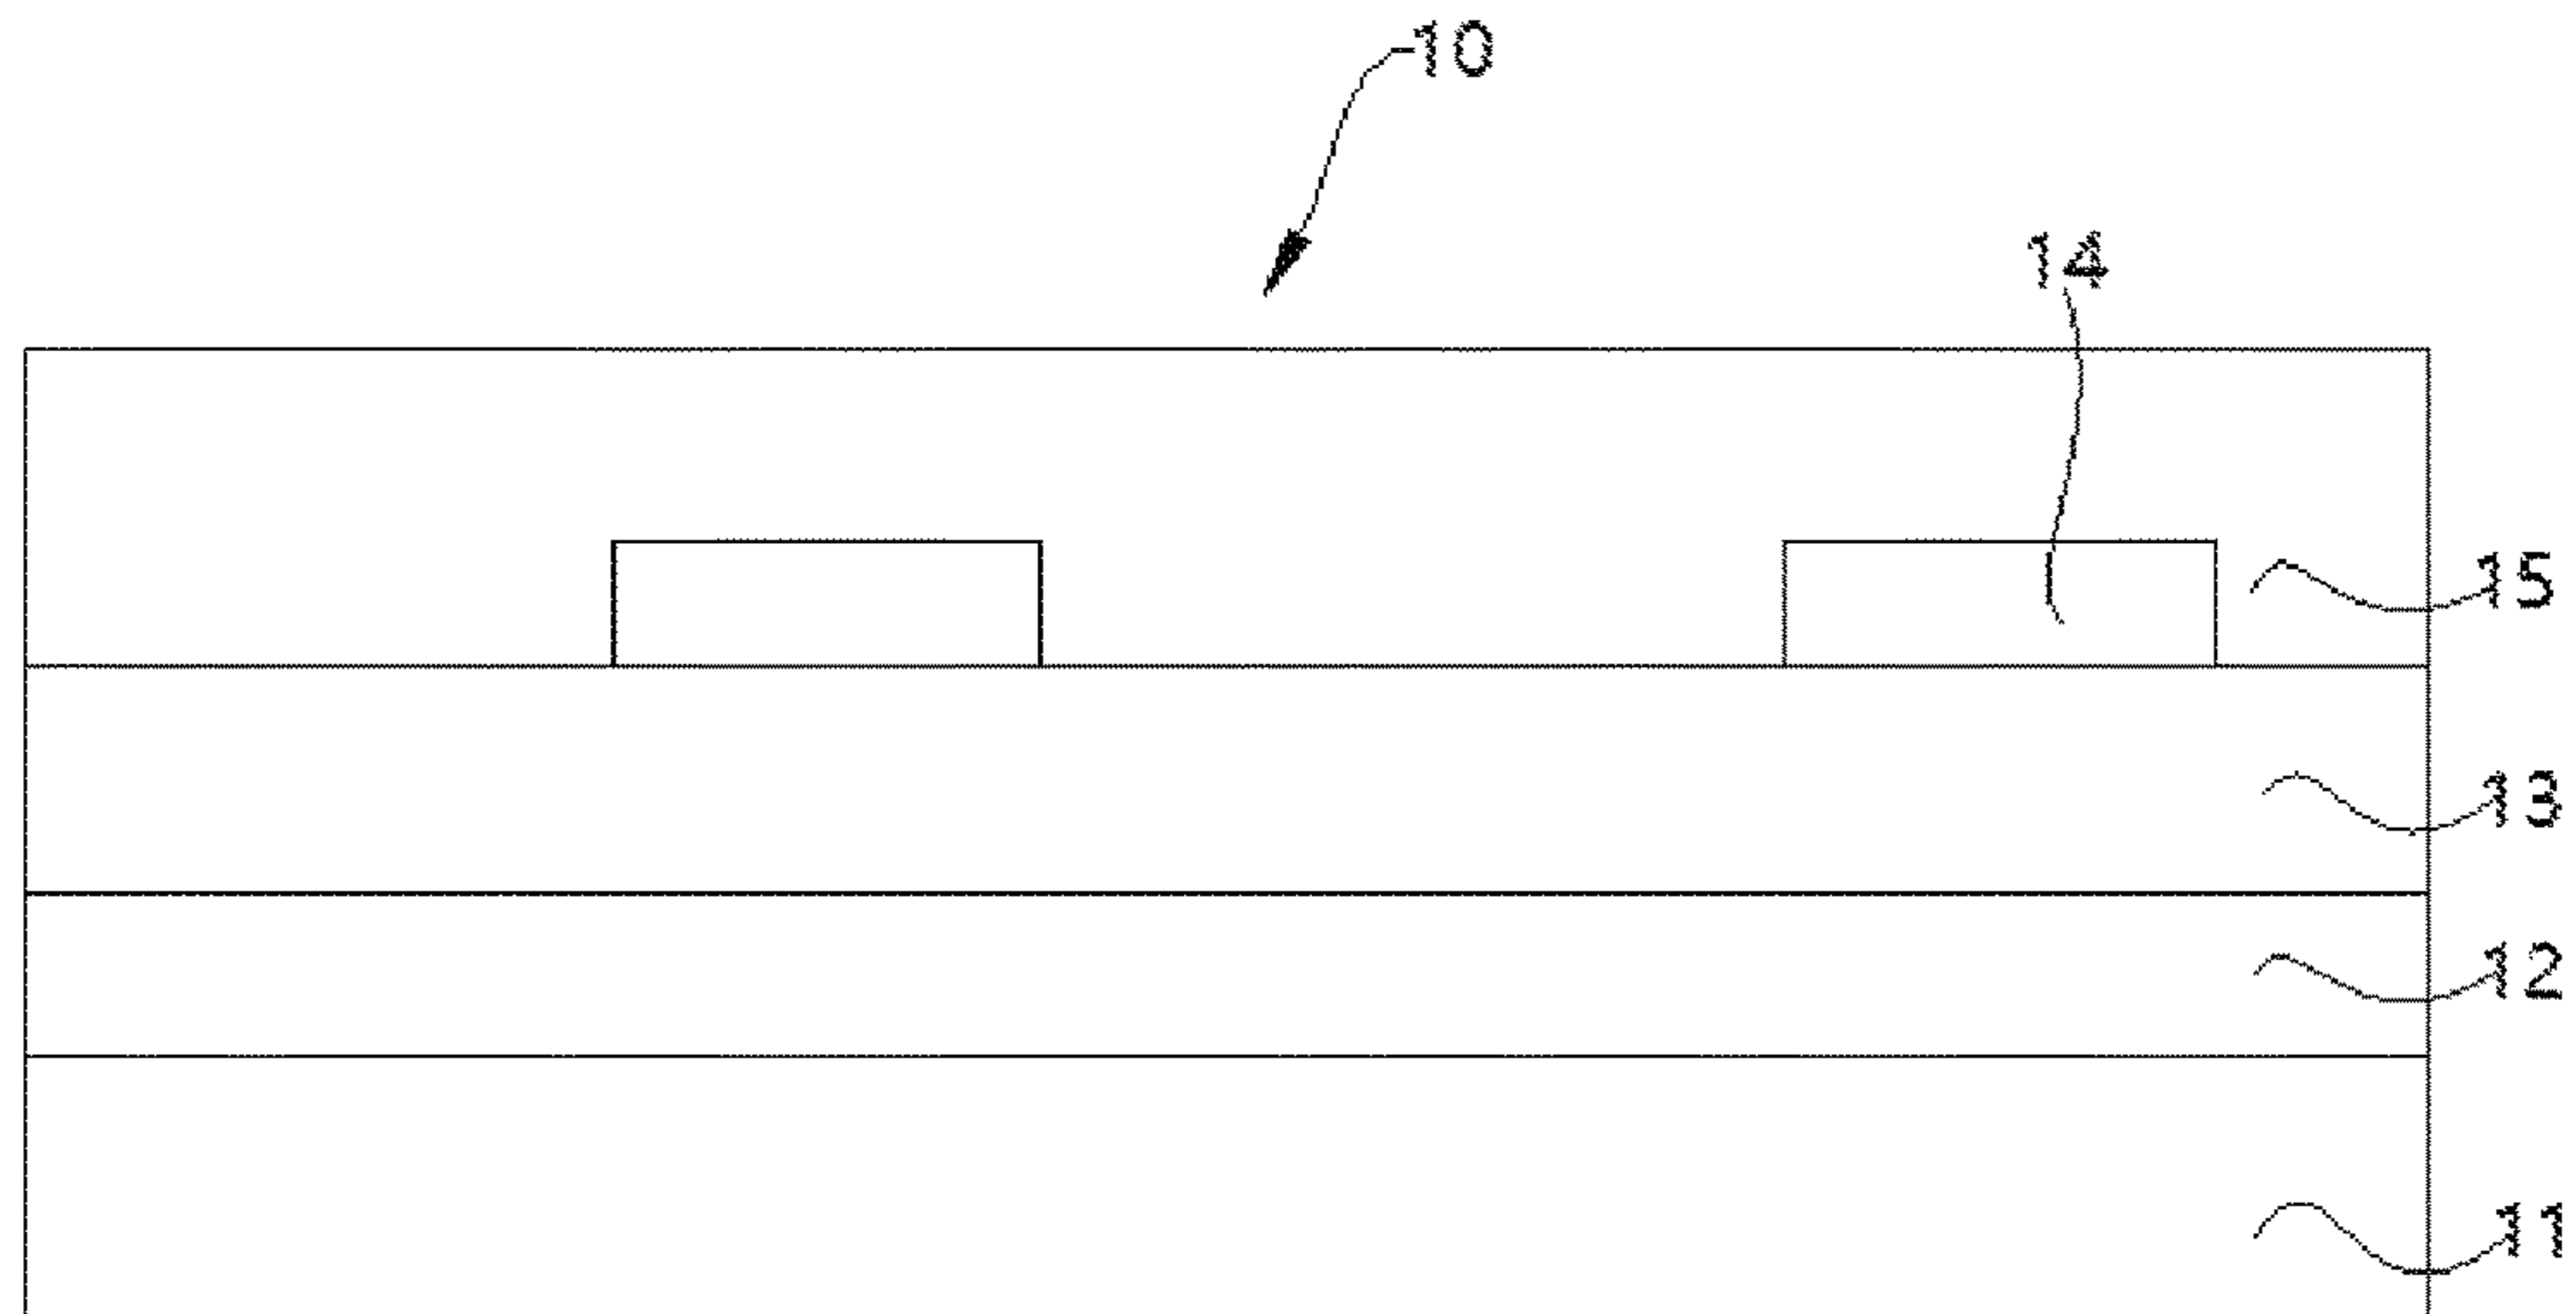
FIG. 2A

FIGS. 2A, 2B, 2C and 2D are schematic views of the method for repairing the disconnecting signal line of the TFT array substrate of FIG. 1 of the present disclosure.

S10, Referring to FIG. 2A, a TFT array substrate 10 is provided. The TFT array substrate 10 includes a disconnecting signal line 12. The TFT array substrate 10 includes a base 11, a plurality of signal lines 12 formed on the base 11,

a first insulating layer 13 covering the base 11 and the signal lines 12, a plurality of repairing lines 14 formed on the first insulating layer 13, and a second insulating layer 15 covering the first insulating layer 13 and the repairing line 14.

Secondly, a first insulating layer 12 is formed on and covers the base 11 and the signal lines 12. The first insulating layer 13 is made of one or a combination of silicon oxide or silicon nitride. Then, the repairing lines 14 are formed on a surface of the first insulating layer 13. The repairing lines 14 are made of tungsten or molybdenum. Finally, a second insulating layer 15 is formed on and covers the first insulating layer 13 and the repairing layer 14. The second insulating layer 15 and the first insulating layer 13 are made by a same material. A thickness of the second insulating layer 15 is greater than a thickness of the first insulating layer 13, shown as FIG. 2A.
