(10) **Patent No.:** **US 10,793,292 B2**  
(45) **Date of Patent:** **Oct. 6, 2020**

(54) **METHODS OF REPAIRING AN ACOUSTIC SANDWICH PANEL AND ACOUSTIC SANDWICH PANEL REPAIR KITS THEREFOR**

(71) Applicant: **The Boeing Company**, Chicago, IL (US)

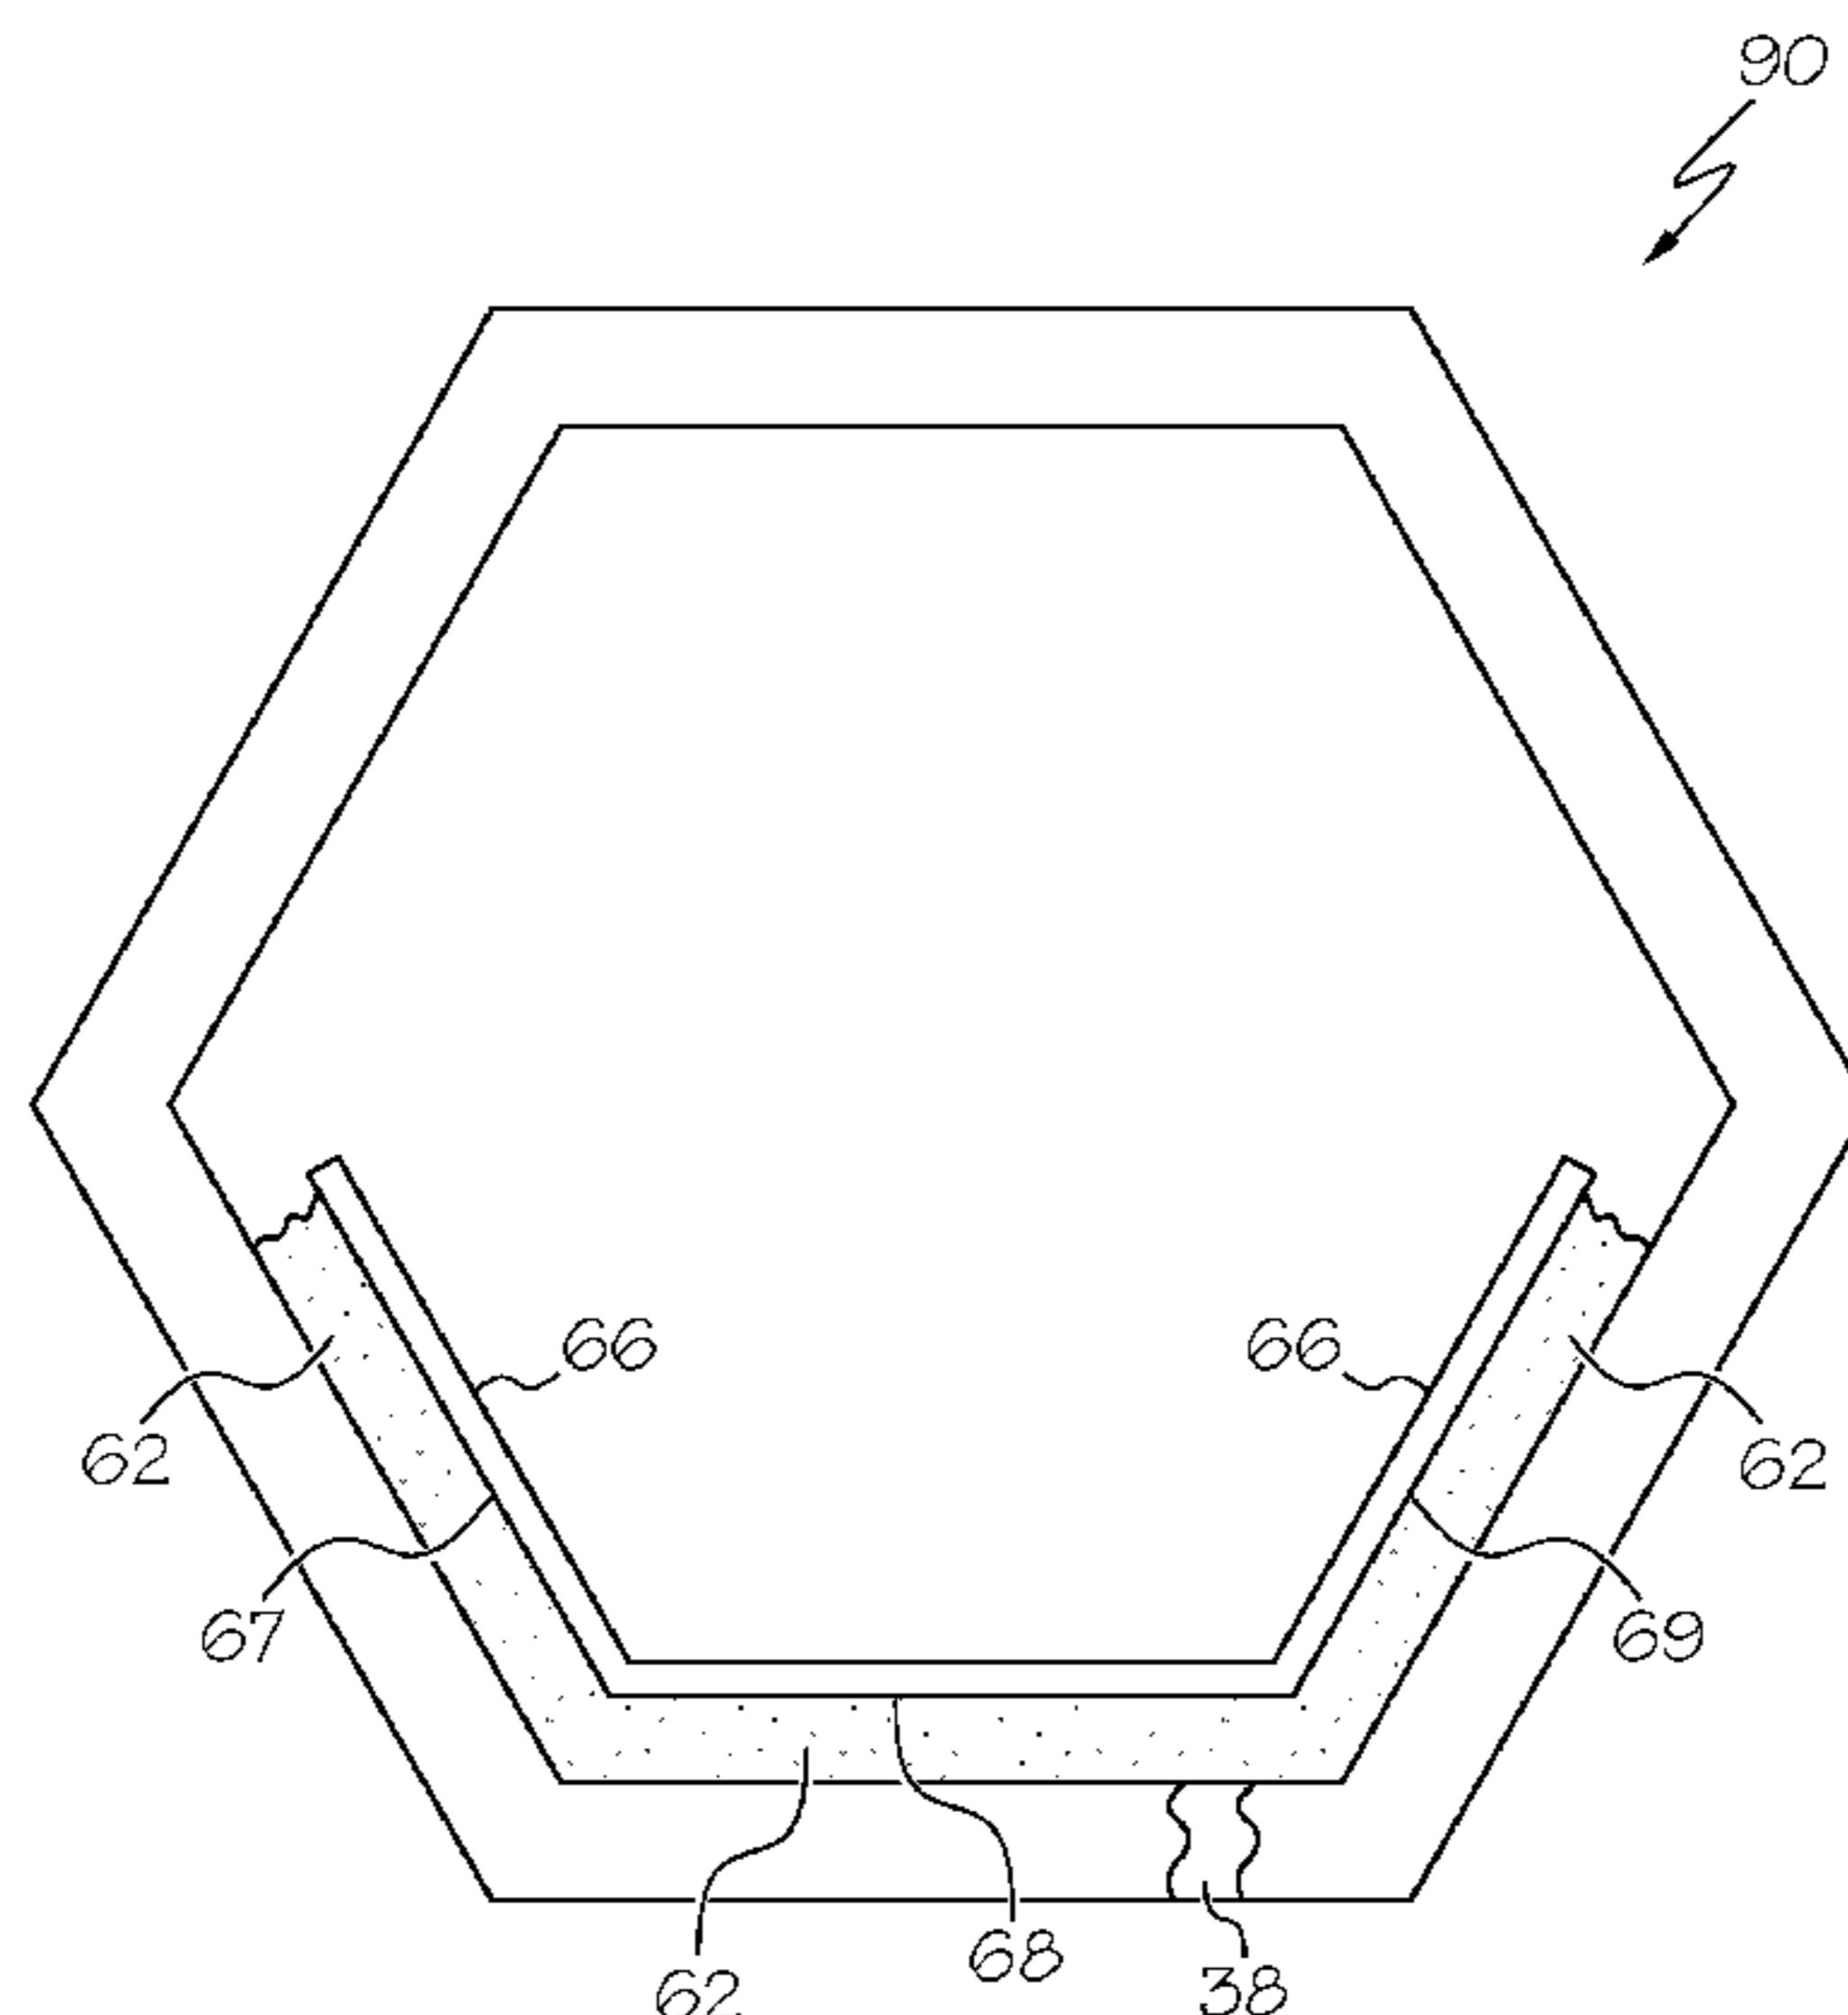
A method of repairing an acoustic core cell of an acoustic sandwich panel is provided. The method comprises inserting a core repair splice adjacent to a number of damaged walls of the acoustic core cell of the acoustic sandwich panel, nesting the core repair splice onto the number of damaged walls, and bonding the core repair splice to the number of damaged walls and thereby to repair the acoustic core cell of the acoustic sandwich panel.

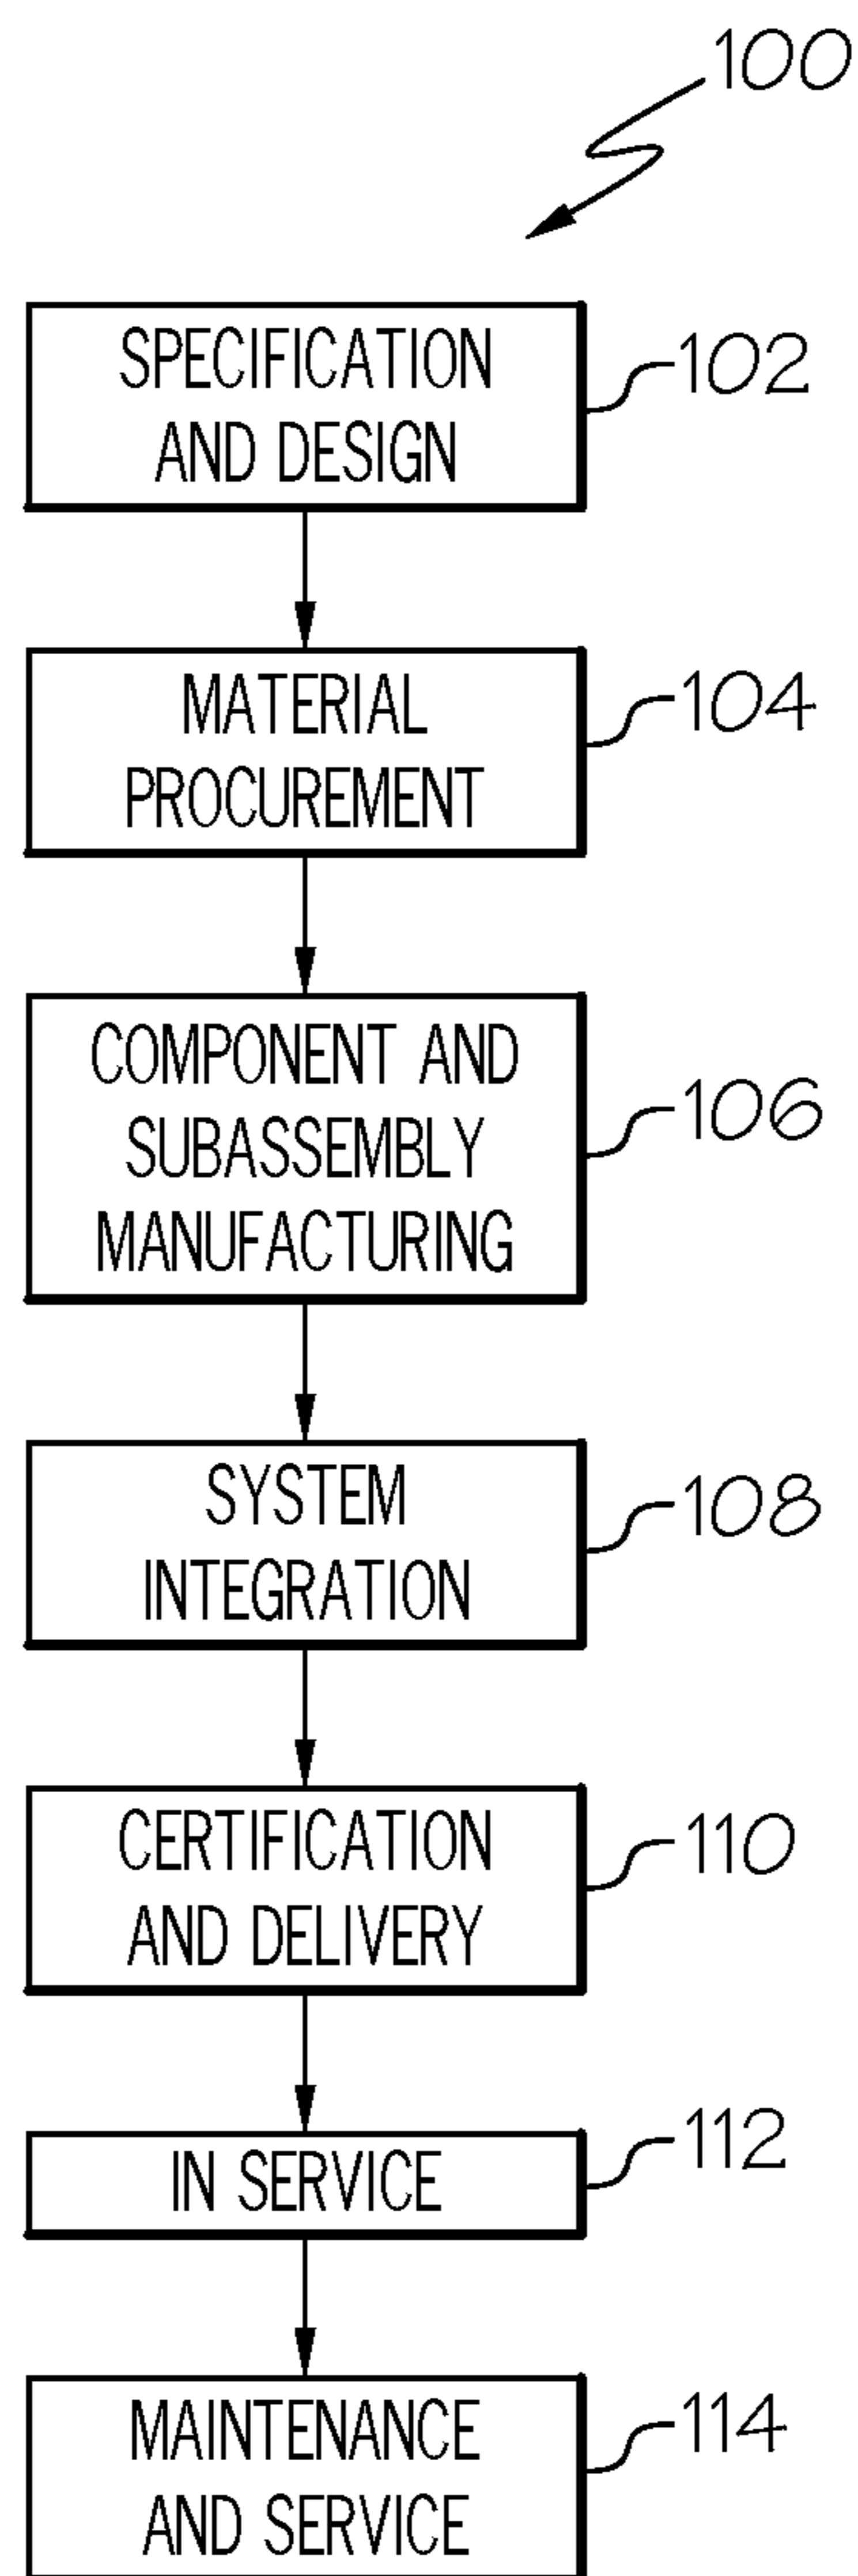
FIG. 1 is a flow diagram of an aircraft manufacturing and service methodology.

Examples of the present disclosure may be described in the context of an aircraft manufacturing and service method **100** as shown in FIG. **1** and an aircraft **200** as shown in FIG. **2**. During pre-production, the illustrative method **100** may include specification and design, as shown at block **102**, of the aircraft **200** and material procurement, as shown at block **104**. During production, component and subassembly manufacturing, as shown at block **106**, and system integration, as shown at block **108**, of the aircraft **200** may take place. Thereafter, the aircraft **200** may go through certification and delivery, as shown block **110**, to be placed in service, as shown at block **112**. While in service, the aircraft **200** may be scheduled for routine maintenance and service, as shown at block **114**. Routine maintenance and service may include modification, reconfiguration, refurbishment, etc. of one or more systems of the aircraft **200**.

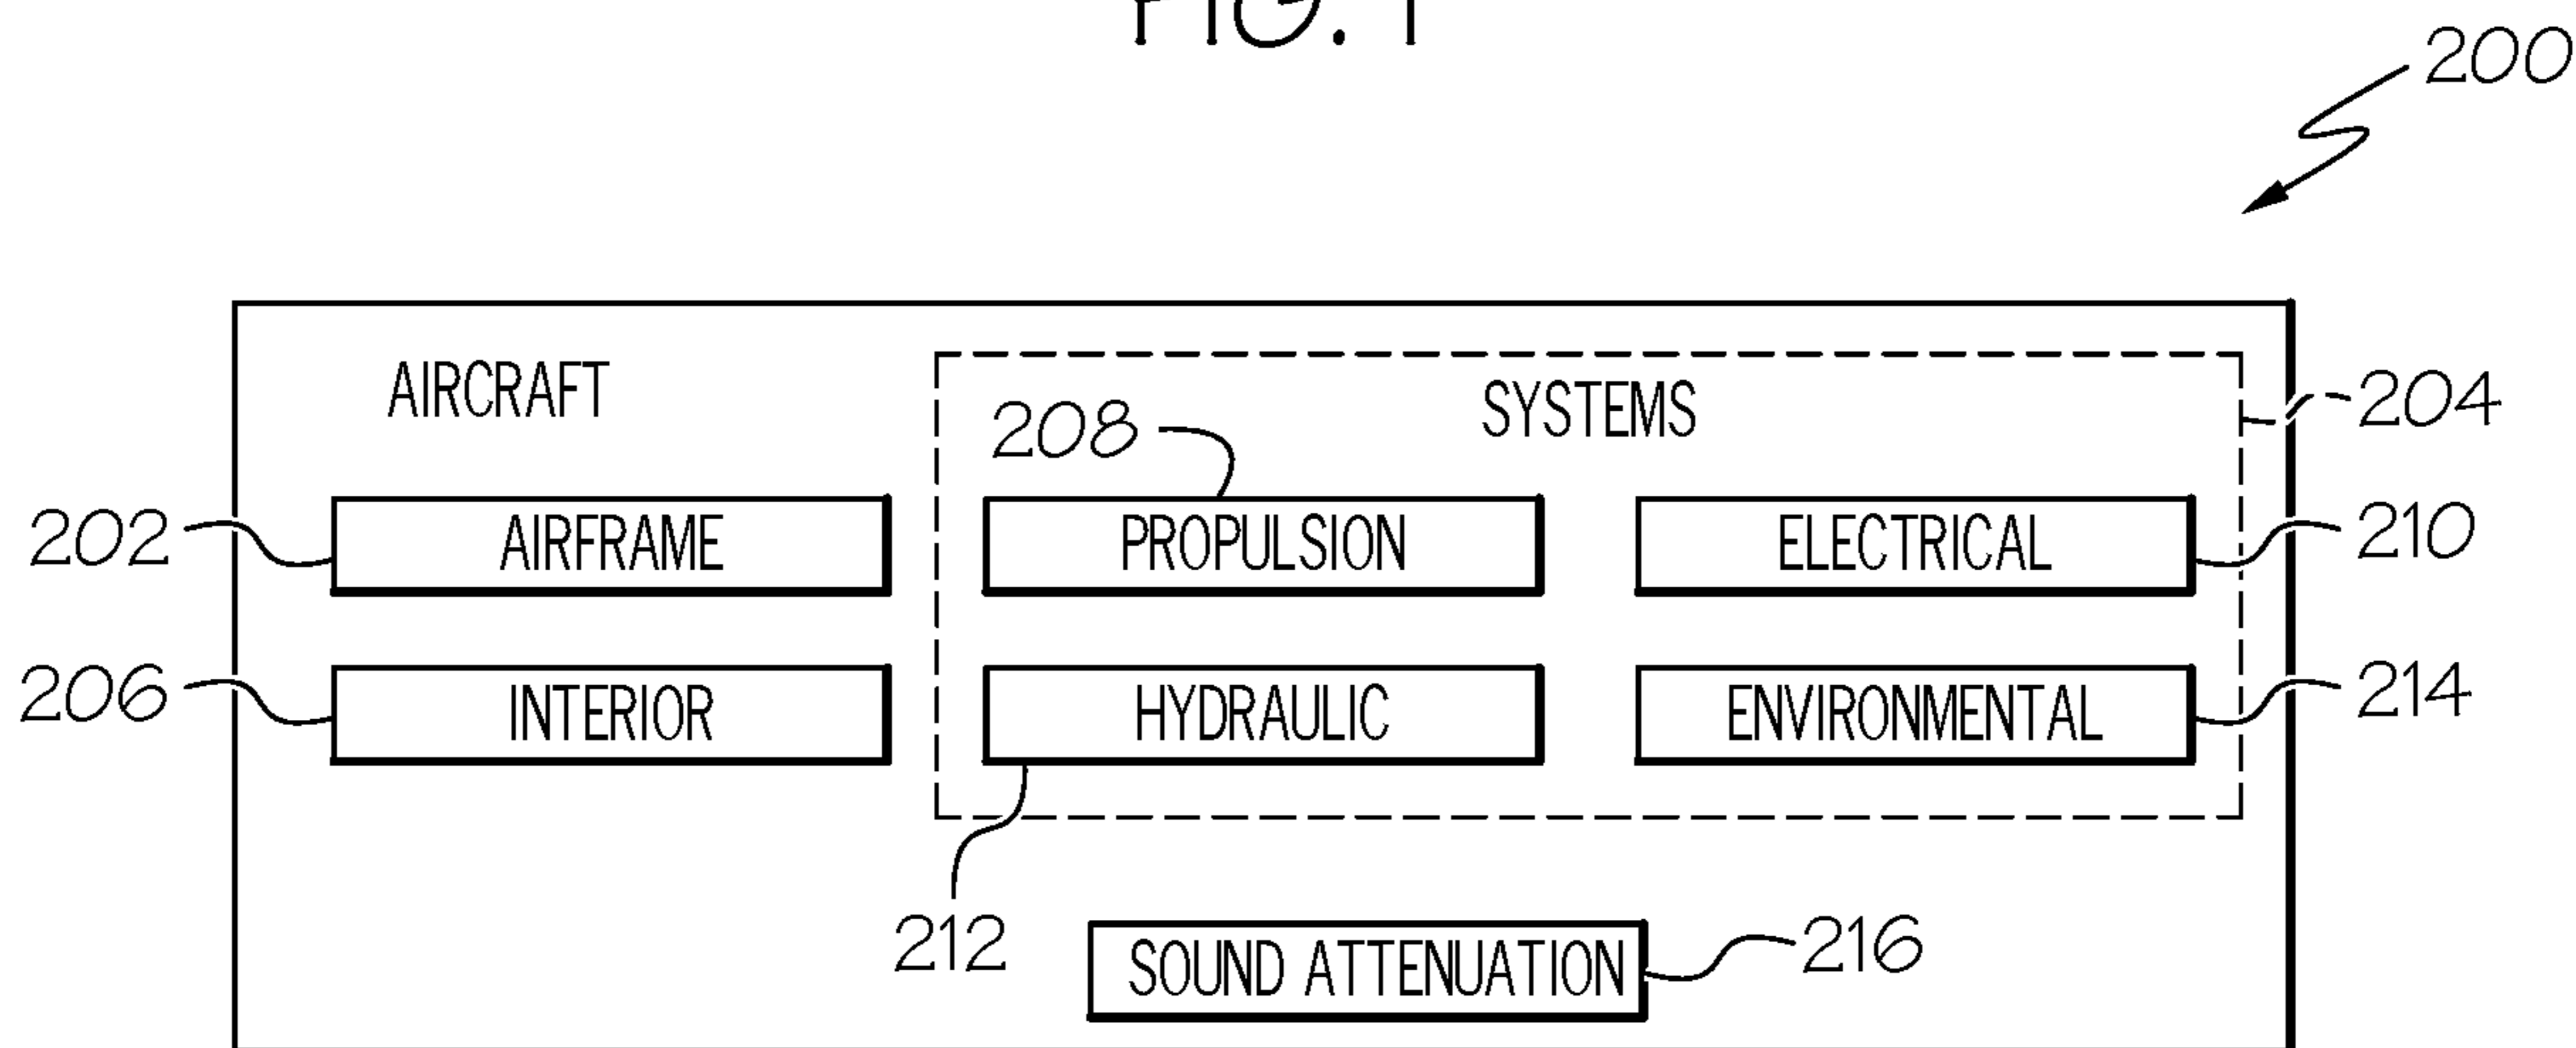
FIG. 2 is a block diagram of an aircraft.

As shown in FIG. **2**, the aircraft **200** produced by illustrative method **100** (FIG. **1**) may include an airframe **202** with a plurality of high-level systems **204** and an interior **206**. Examples of high-level systems **204** may include one or more of propulsion system **208**, electrical system **210**, hydraulic system **212**, environmental system **214**, and sound attenuation system **216**. Any number of other systems may be included. Although an aerospace example is shown, the principles disclosed herein may be applied to other industries, such as the automotive and marine industries. Accordingly, in addition to the aircraft **200**, the principles disclosed herein may apply to other vehicles (e.g., land vehicles, marine vehicles, space vehicles, etc.).

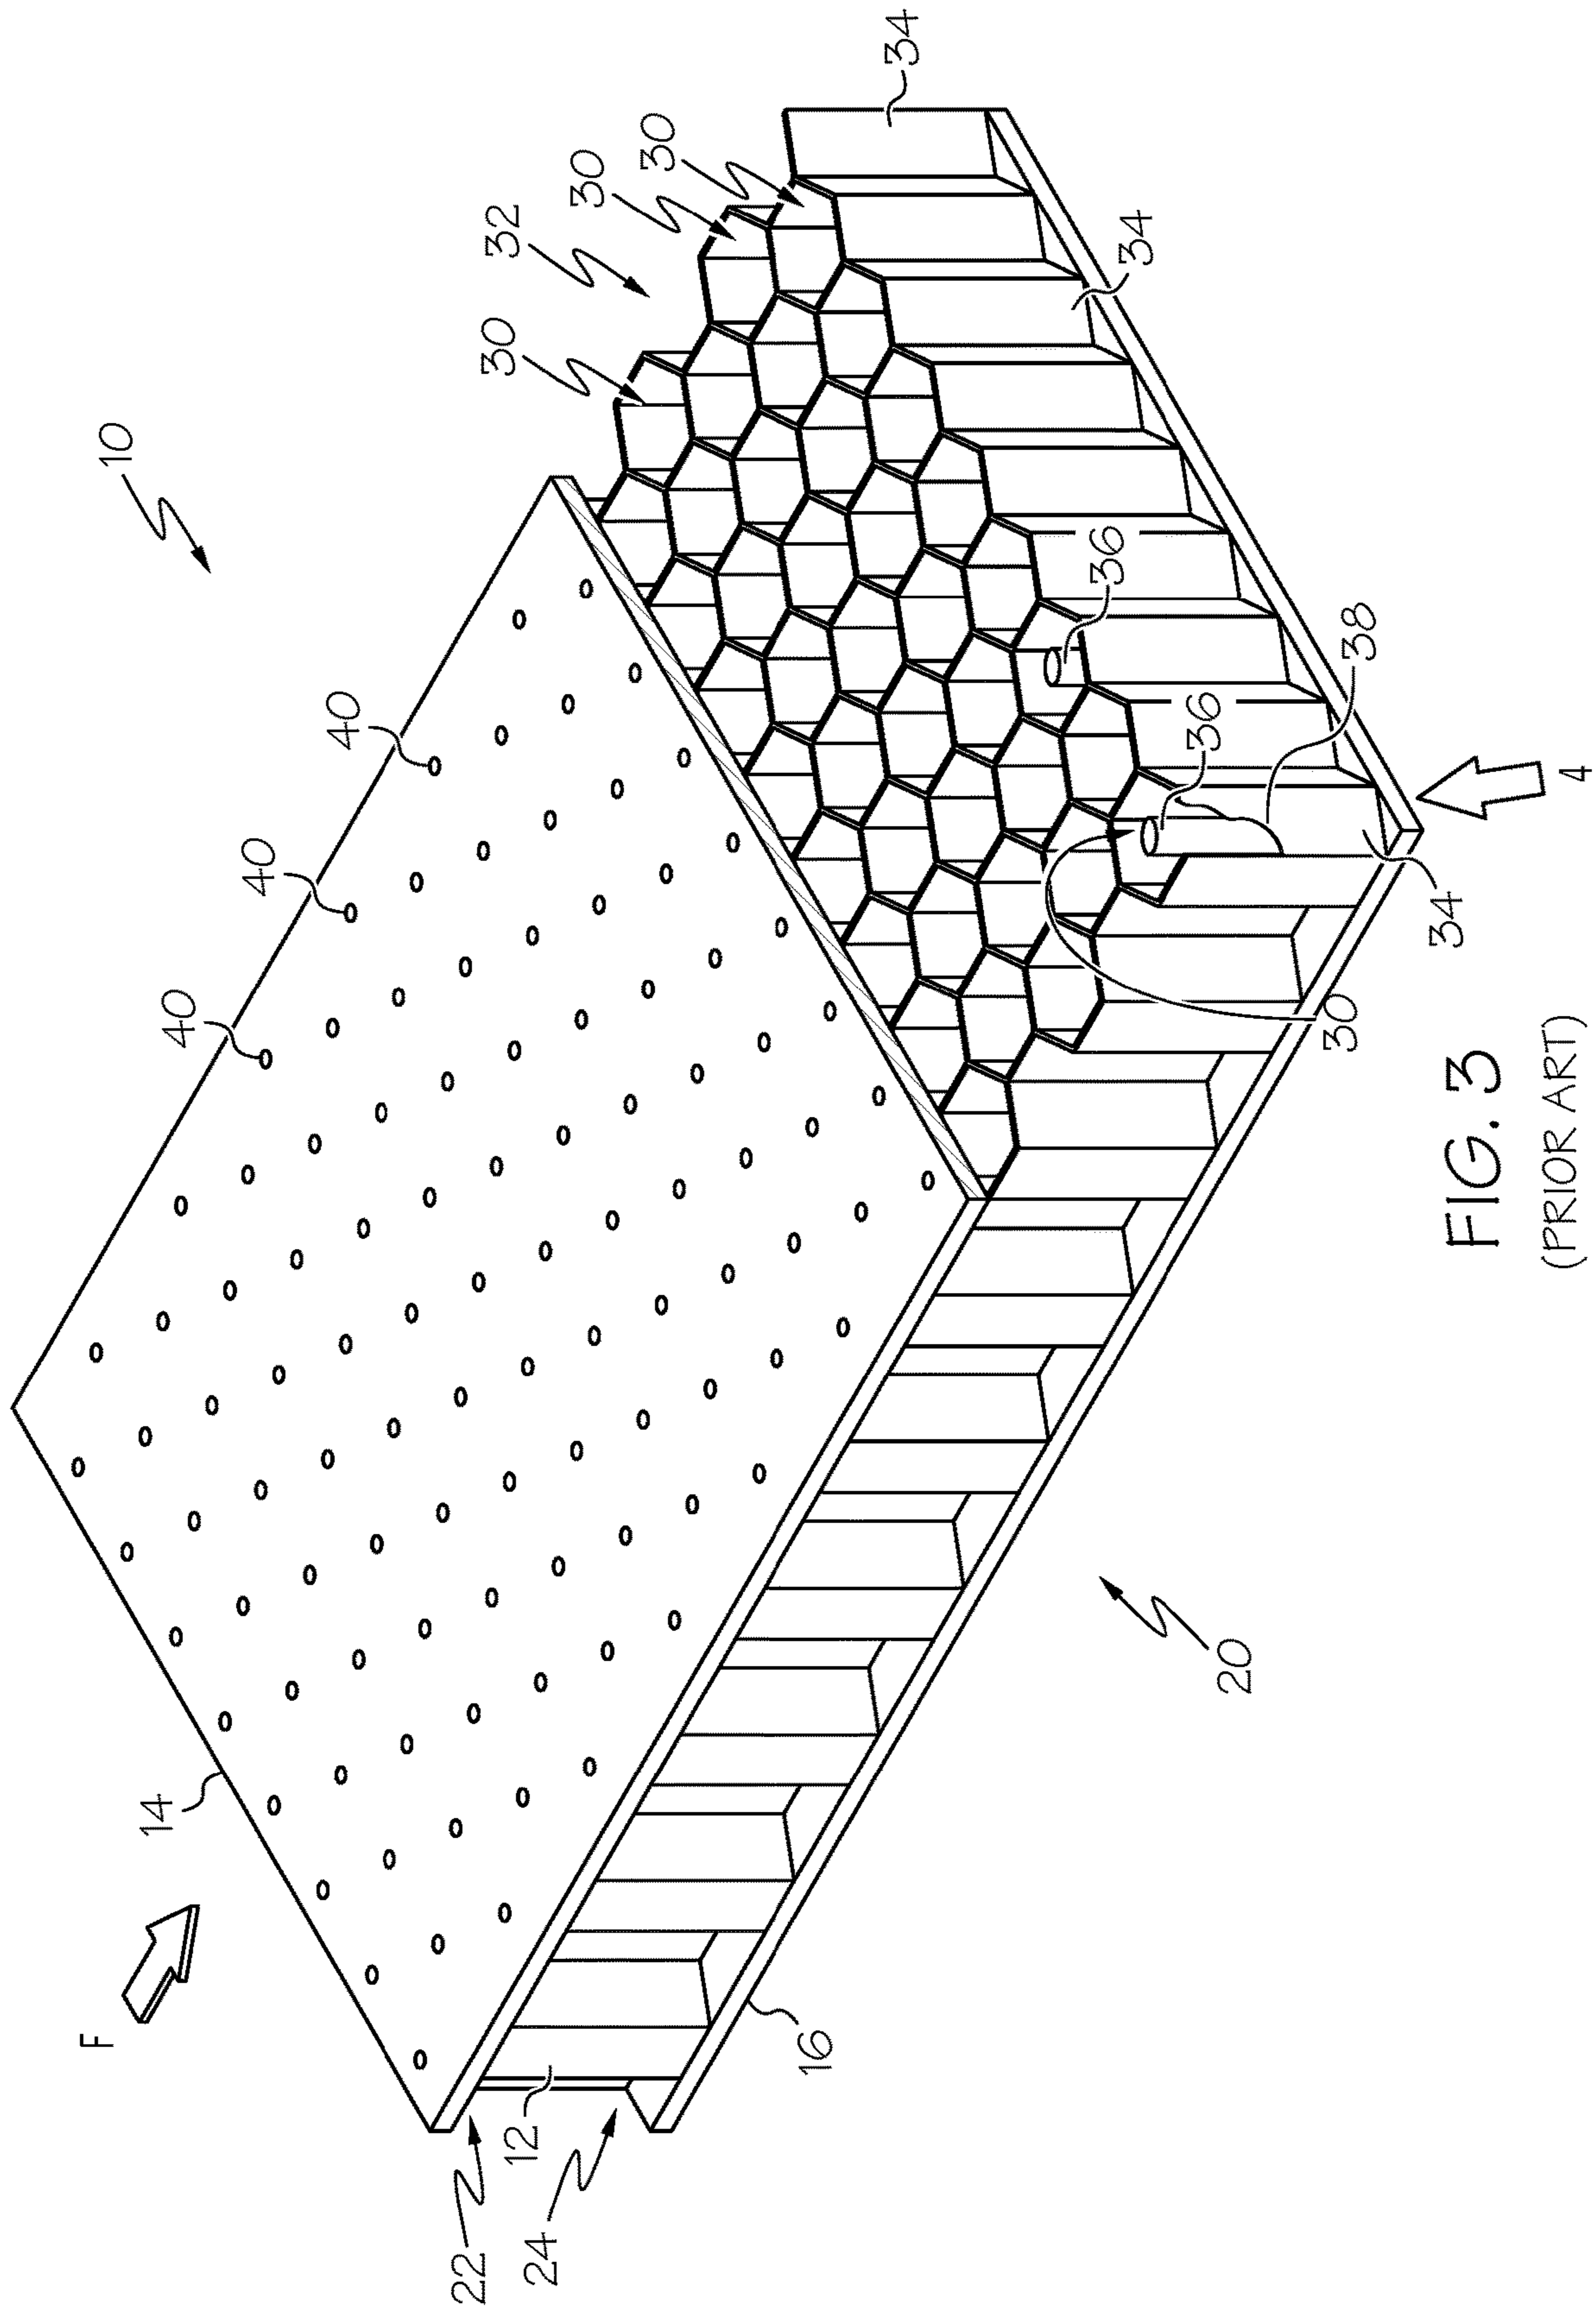
FIG. 3  
(PRIOR ART)

FIG. 3 is a perspective view of a known acoustic sandwich panel including an acoustic core cell that has a damaged core cell wall in need of repair.

Referring to FIG. **3**, a known acoustic sandwich panel, generally designated **10**, may include a core **12**, a first liner

sheet **14**, a second liner sheet **16** and a plurality of inserts **36**. The core **12**, the first liner sheet **14** and the second liner sheet **16** form a layered structure **20**, and the inserts **36** are positioned and housed within the core **12** of the layered structure **20**. For simplicity and clarity of discussion, only two inserts **36** are shown in FIG. **3**.

For purposes of discussion, one of the acoustic core cells **34** (i.e., the core cell **34** located in the lower left corner of the perspective view of FIG. 3) of the acoustic sandwich panel **10** is shown with an example damaged core cell wall **38**. Various embodiments of repair methods and repair kits for repairing damaged walls, such as the damaged core cell wall **38** of the acoustic core cell **34** of the acoustic sandwich panel **10** shown in FIG. 3, are disclosed herein.

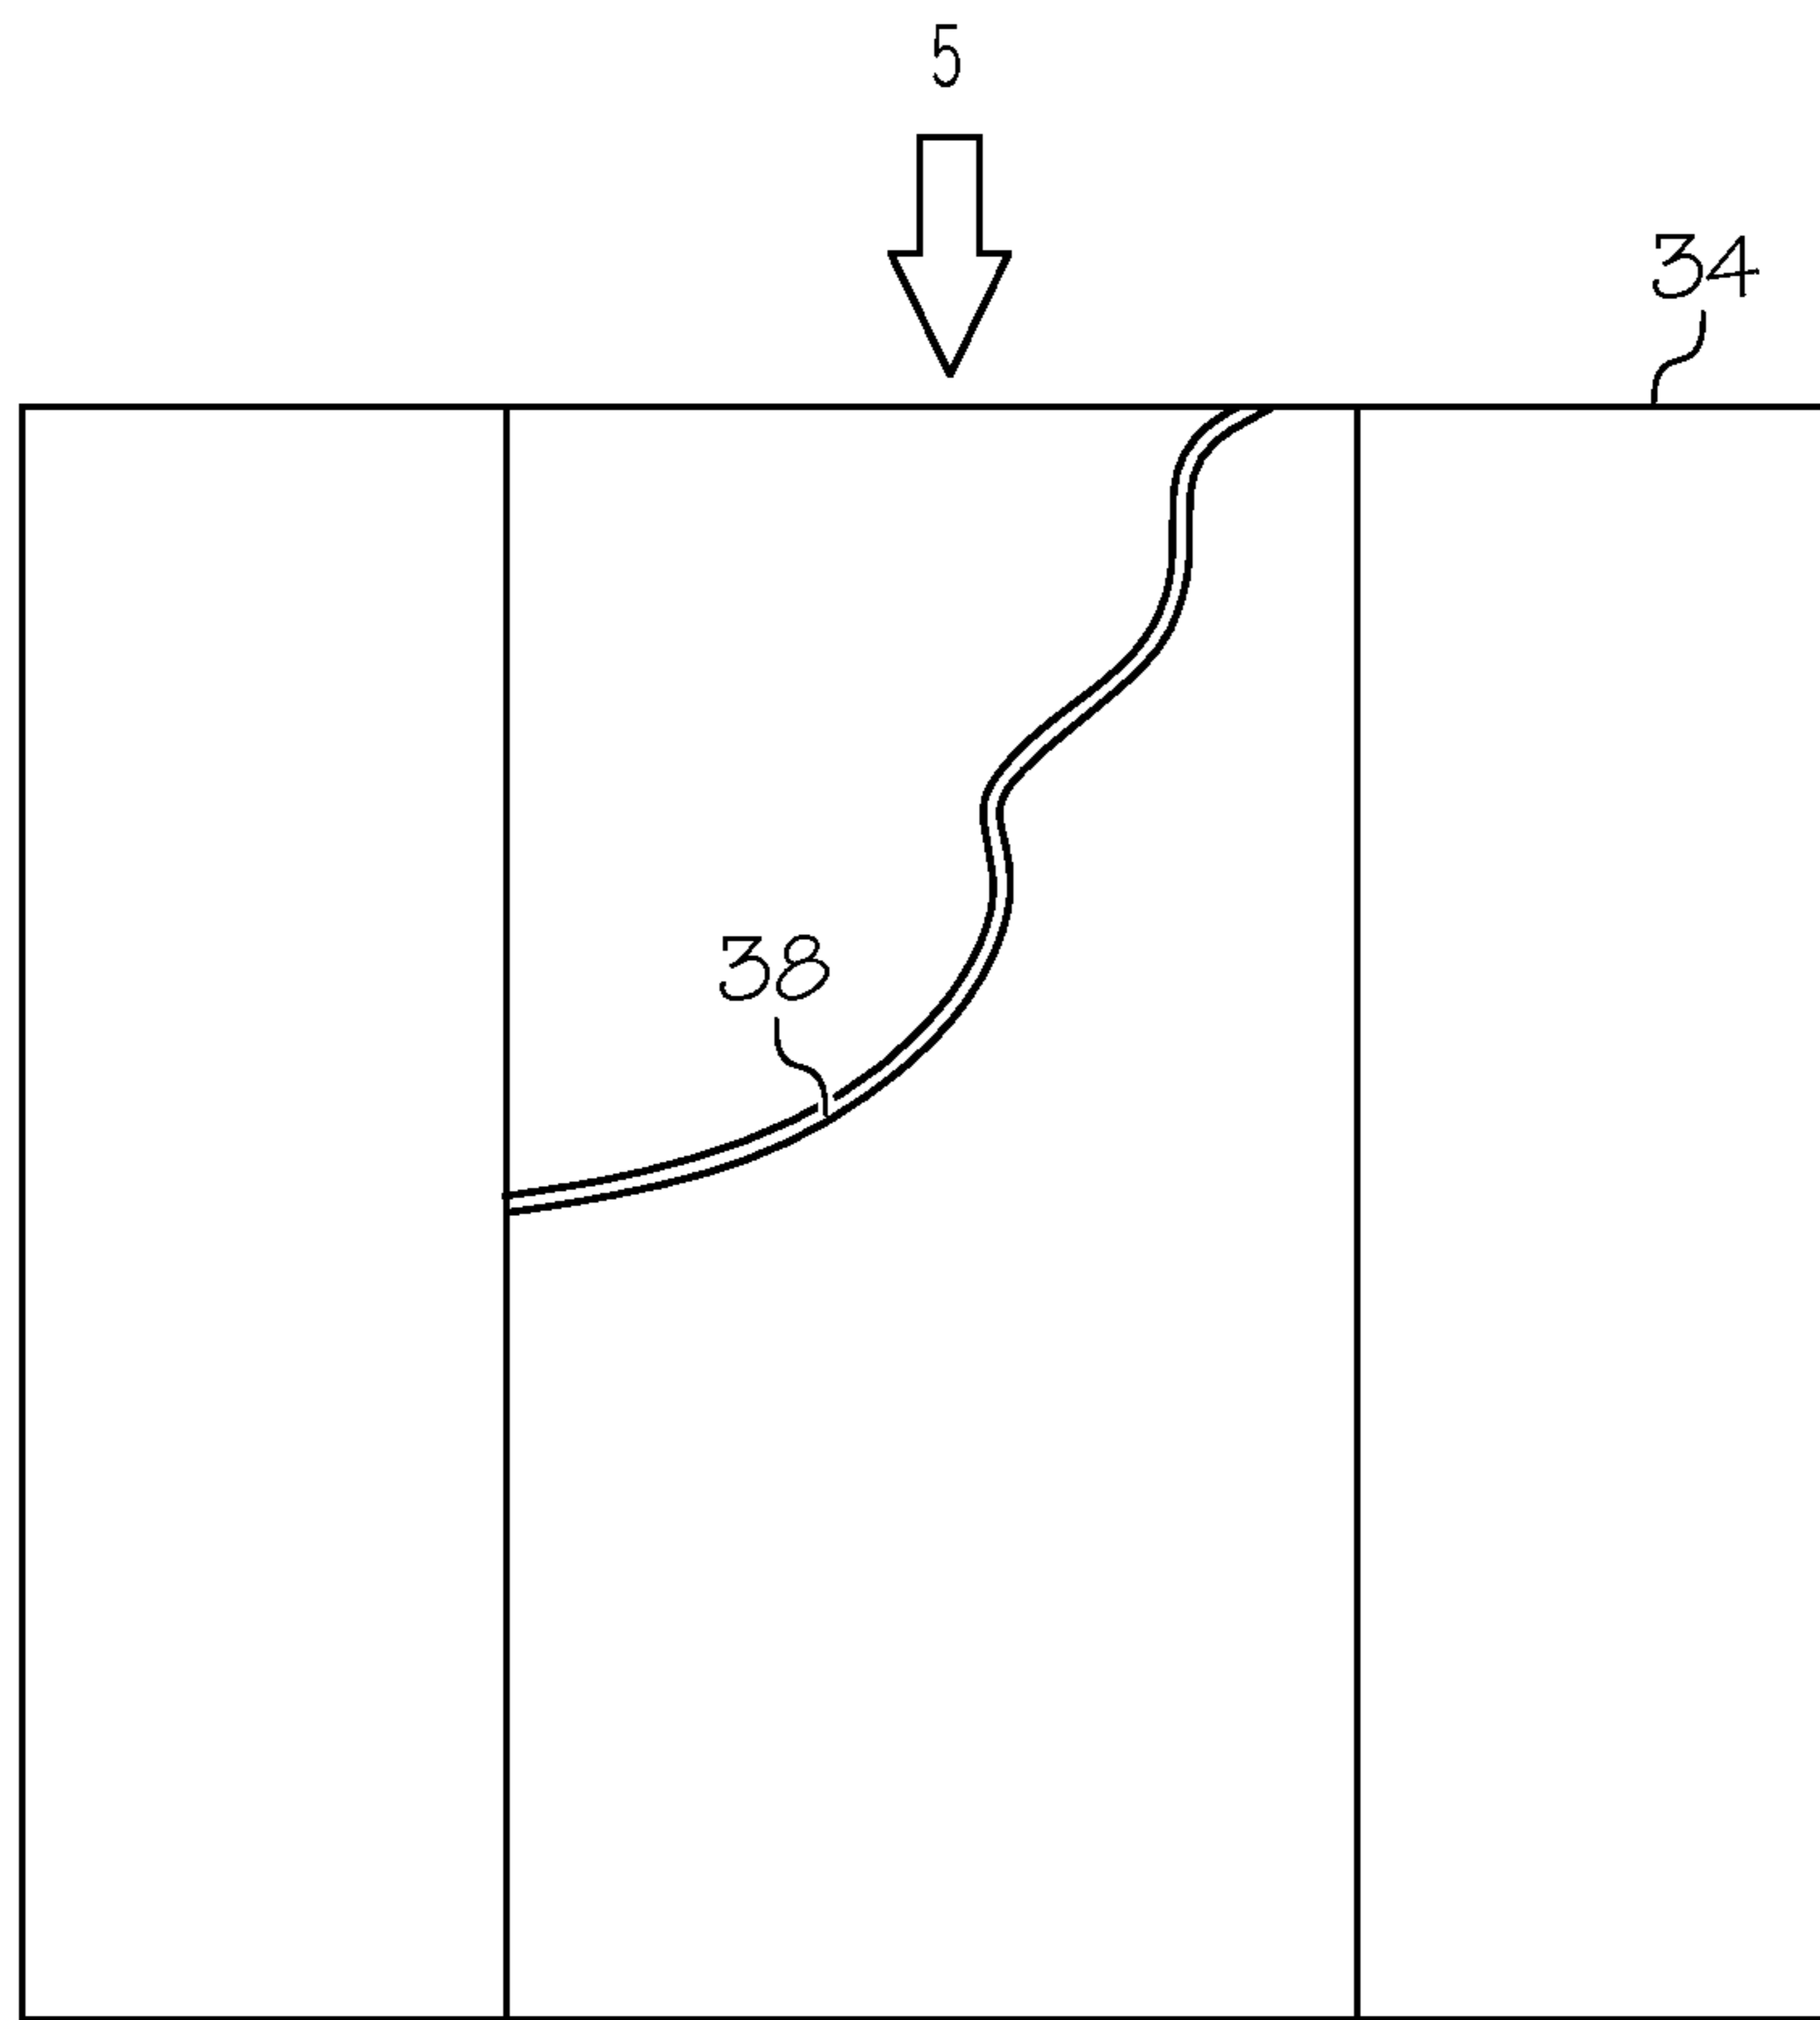
FIG. 4  
(PRIOR ART)

FIG. 4 is a cross-sectional view, looking approximately in the direction of arrow 4 shown in FIG. 3, of the damaged core cell wall of FIG. 3.

Referring to FIG. 4, a cross-sectional view, looking approximately in the direction of arrow **4** shown in FIG. 3, of the damaged core cell wall **38** of FIG. 3 is shown. For clarity of discussion herein, the insert **36** in the cavity **30** of the acoustic core cell **34** shown in FIG. 3 is omitted from FIG. 4. Referring to FIG. 5, a top plan view, looking approximately in the direction of arrow **5** shown in FIG. 4, of the damaged core cell wall **38** of FIG. 4 is shown. As best shown in FIG. 4, the example damaged core cell wall **38** of the core cell **34** is in the form of a crack. This crack has the negative effect of reducing the effectiveness of the cavity **30** of the core cell **34** to function as a Helmholtz resonator and thereby reducing the sound attenuation capacity of the core cell **34**. Accordingly, it would be desirable to repair the damaged core cell wall **38** to restore the sound attenuation capacity of the core cell **34** and thereby restore the sound attenuation capacity of the acoustic sandwich panel **10** (FIG. 1).

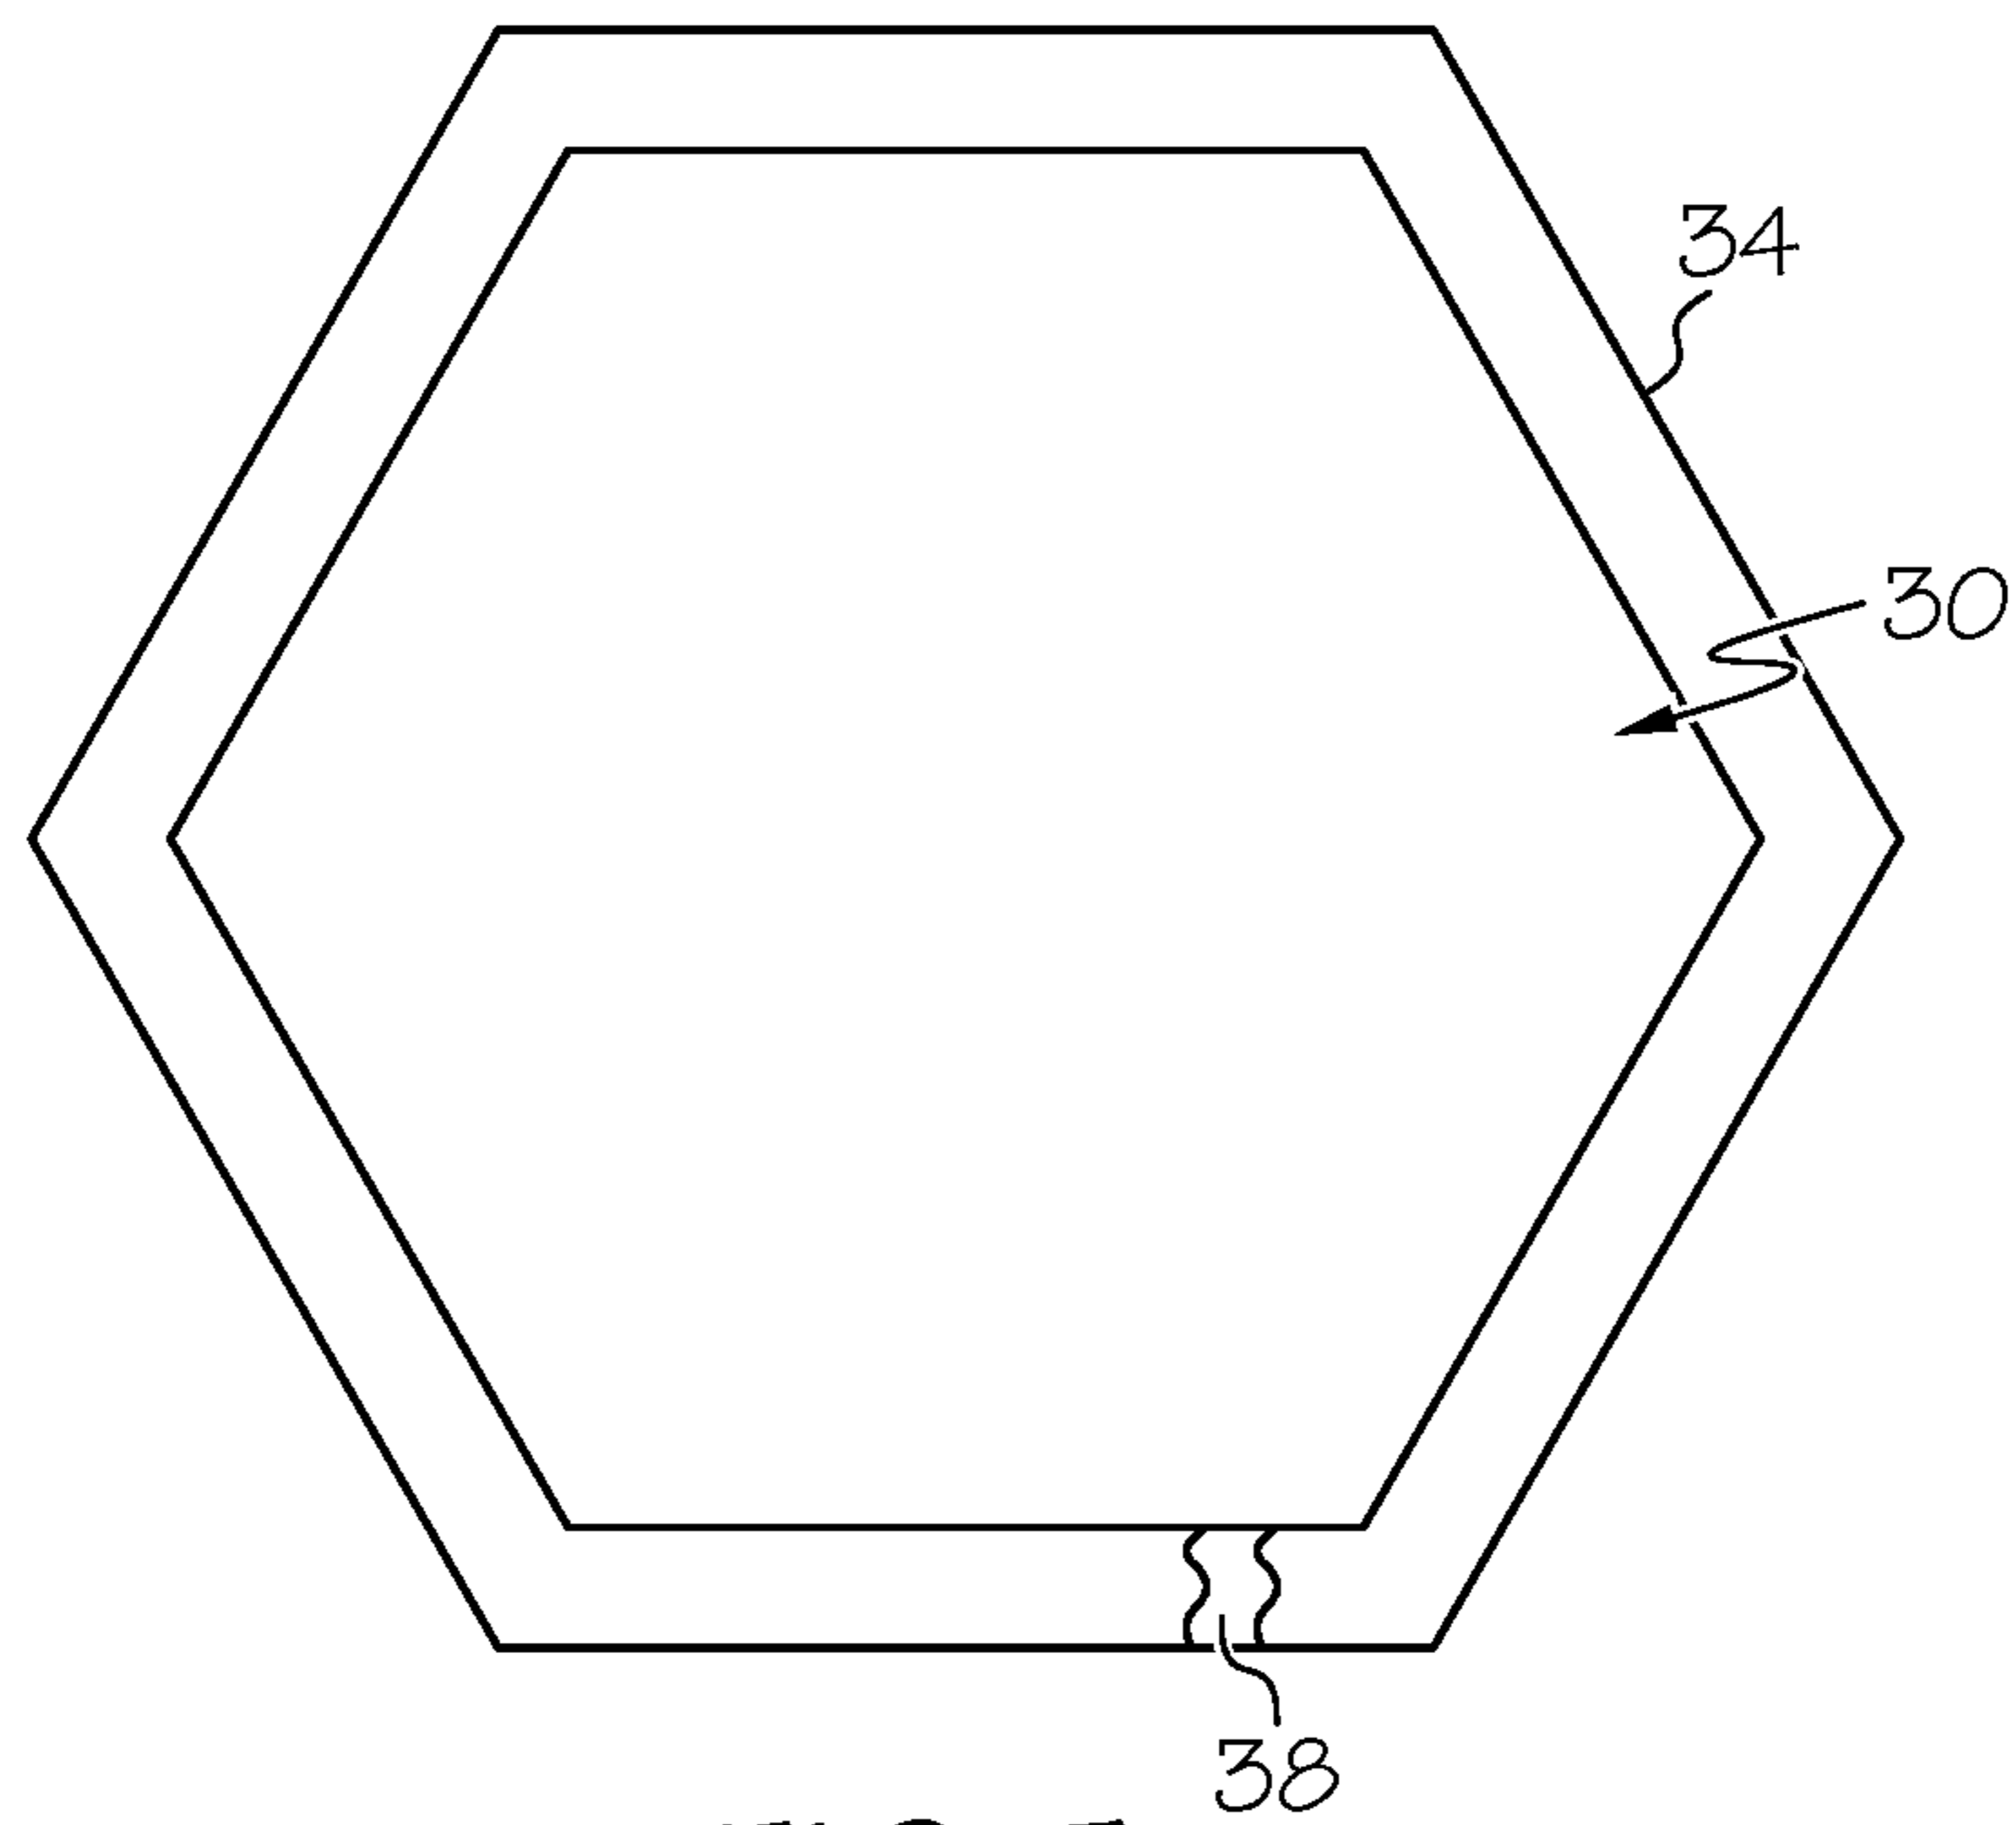
FIG. 5  
(PRIOR ART)

FIG. 5 is a top plan view, looking approximately in the direction of arrow 5 shown in FIG. 4, of the damaged core cell wall of FIG. 4.
