(10) **Patent No.:** **US 10,793,292 B2**  
(45) **Date of Patent:** **Oct. 6, 2020**

(54) **METHODS OF REPAIRING AN ACOUSTIC SANDWICH PANEL AND ACOUSTIC SANDWICH PANEL REPAIR KITS THEREFOR**

(71) Applicant: **The Boeing Company**, Chicago, IL (US)

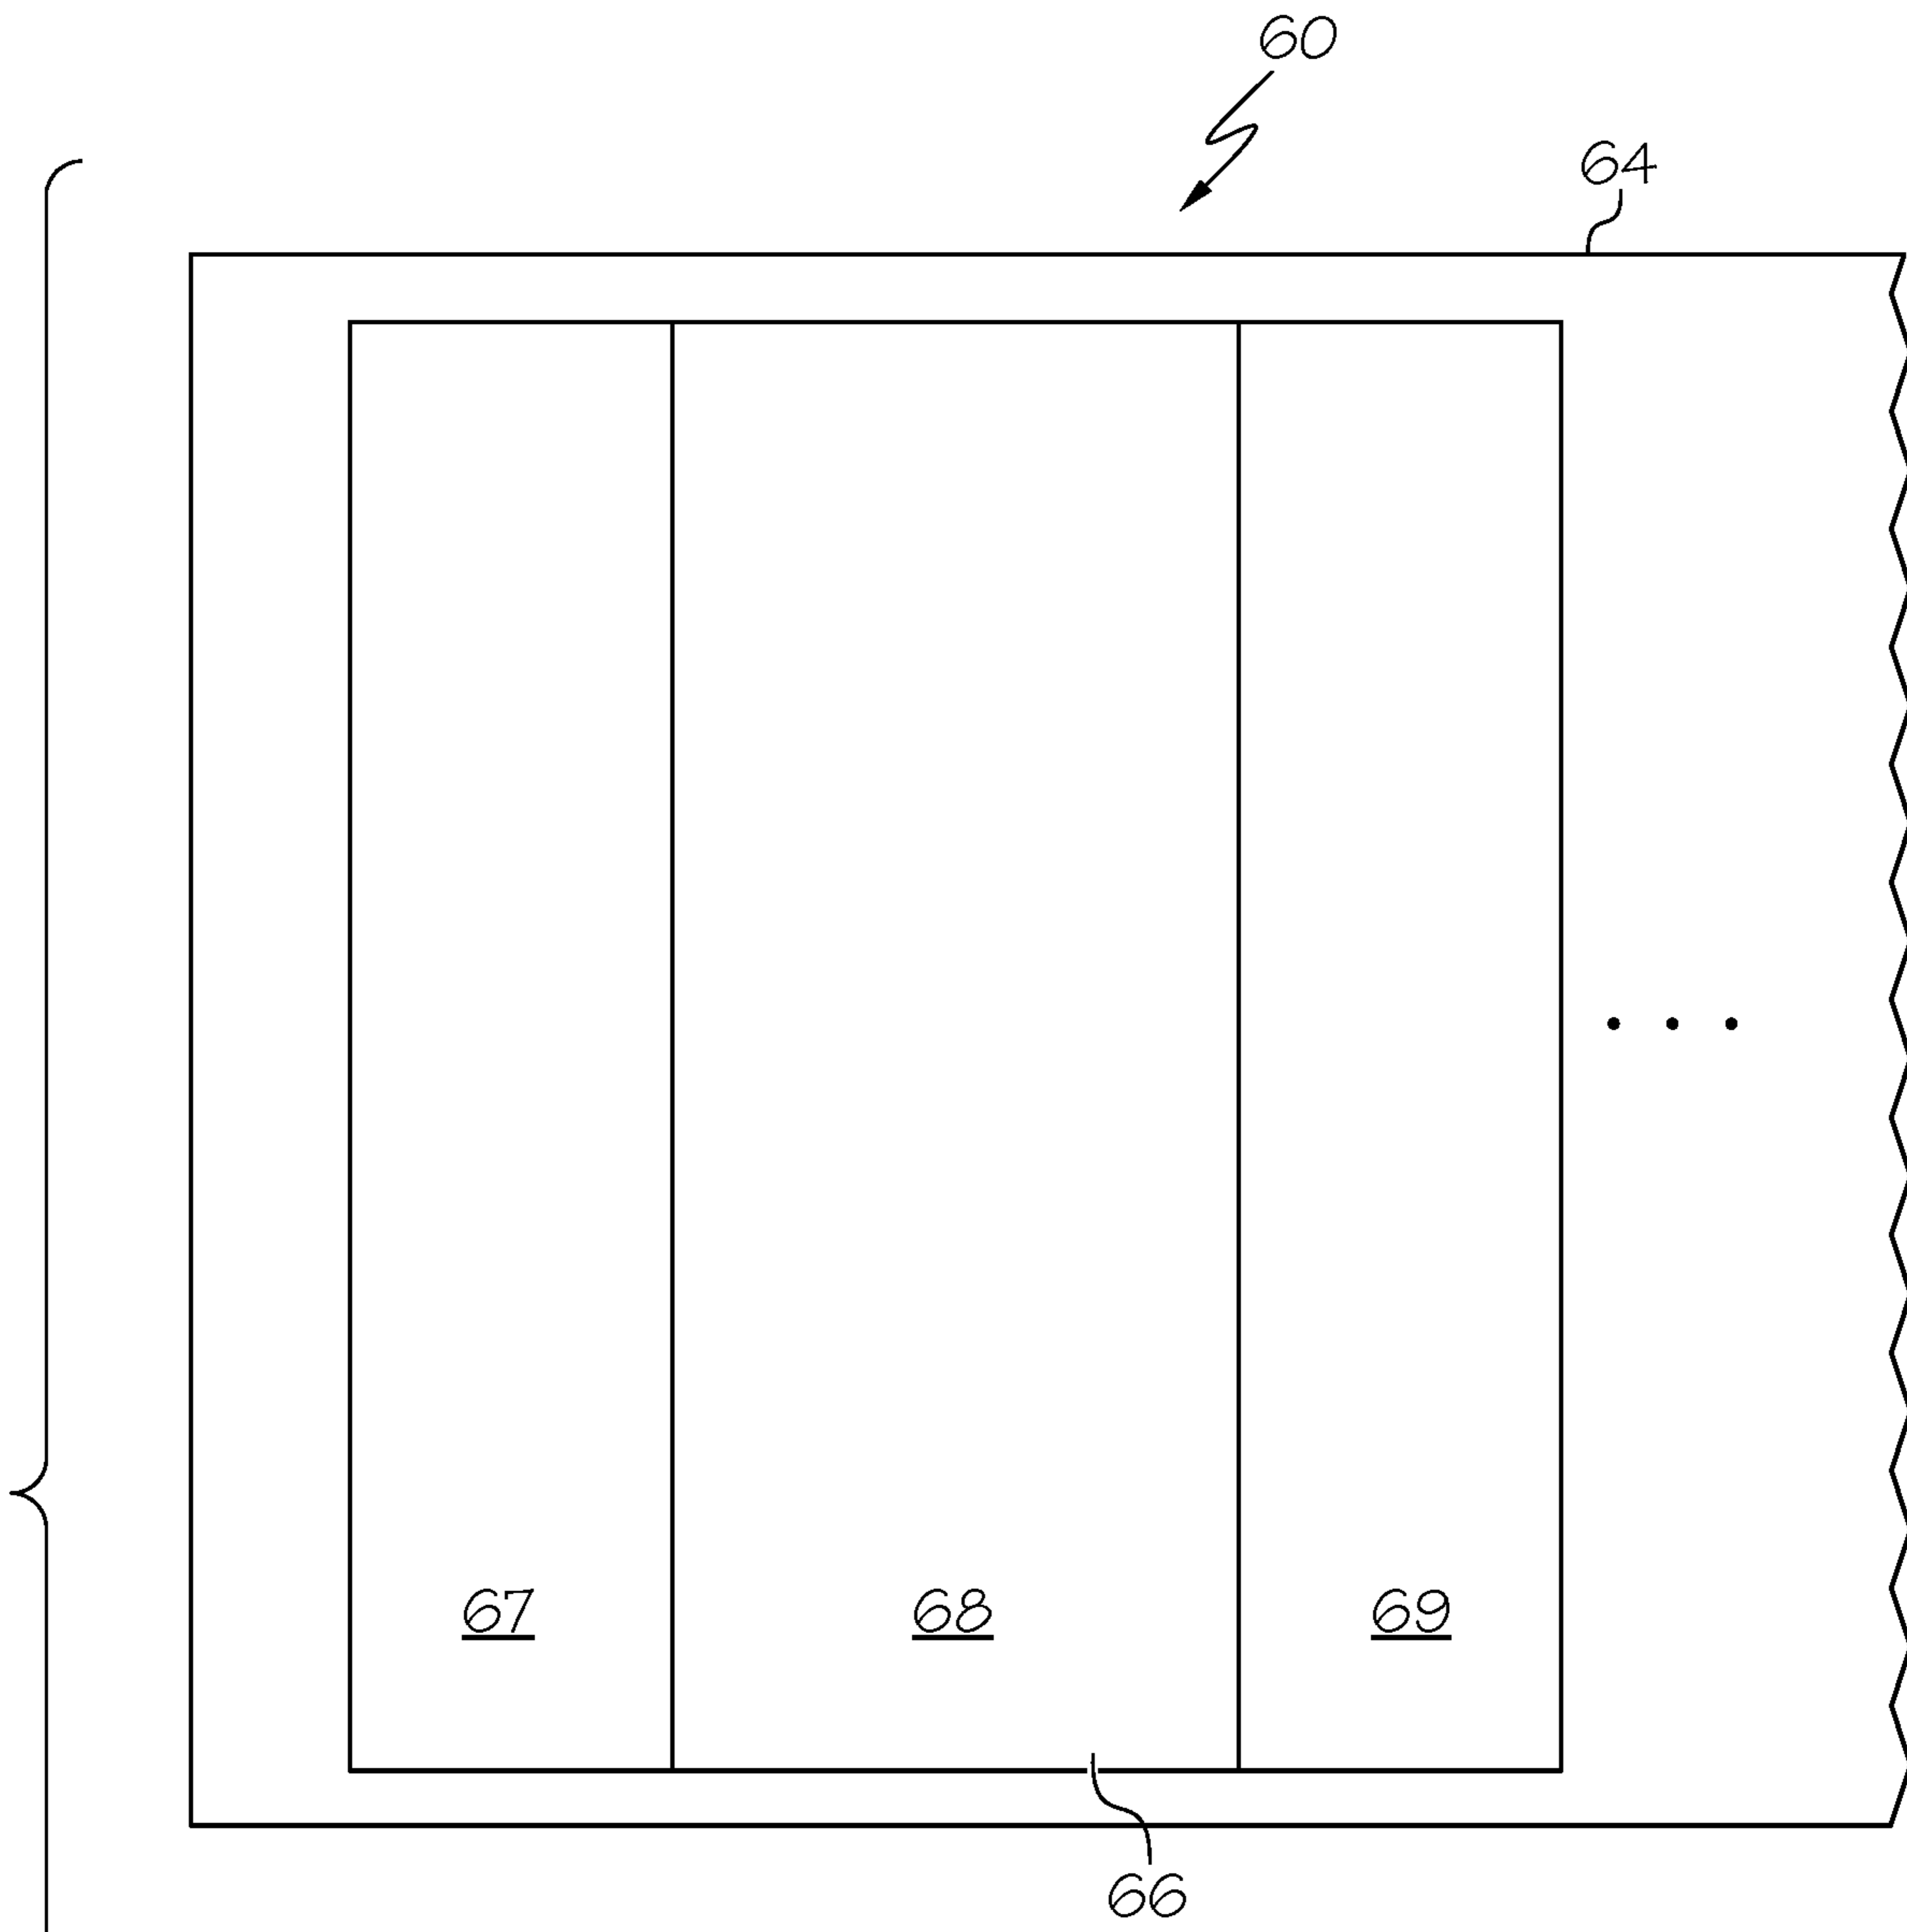
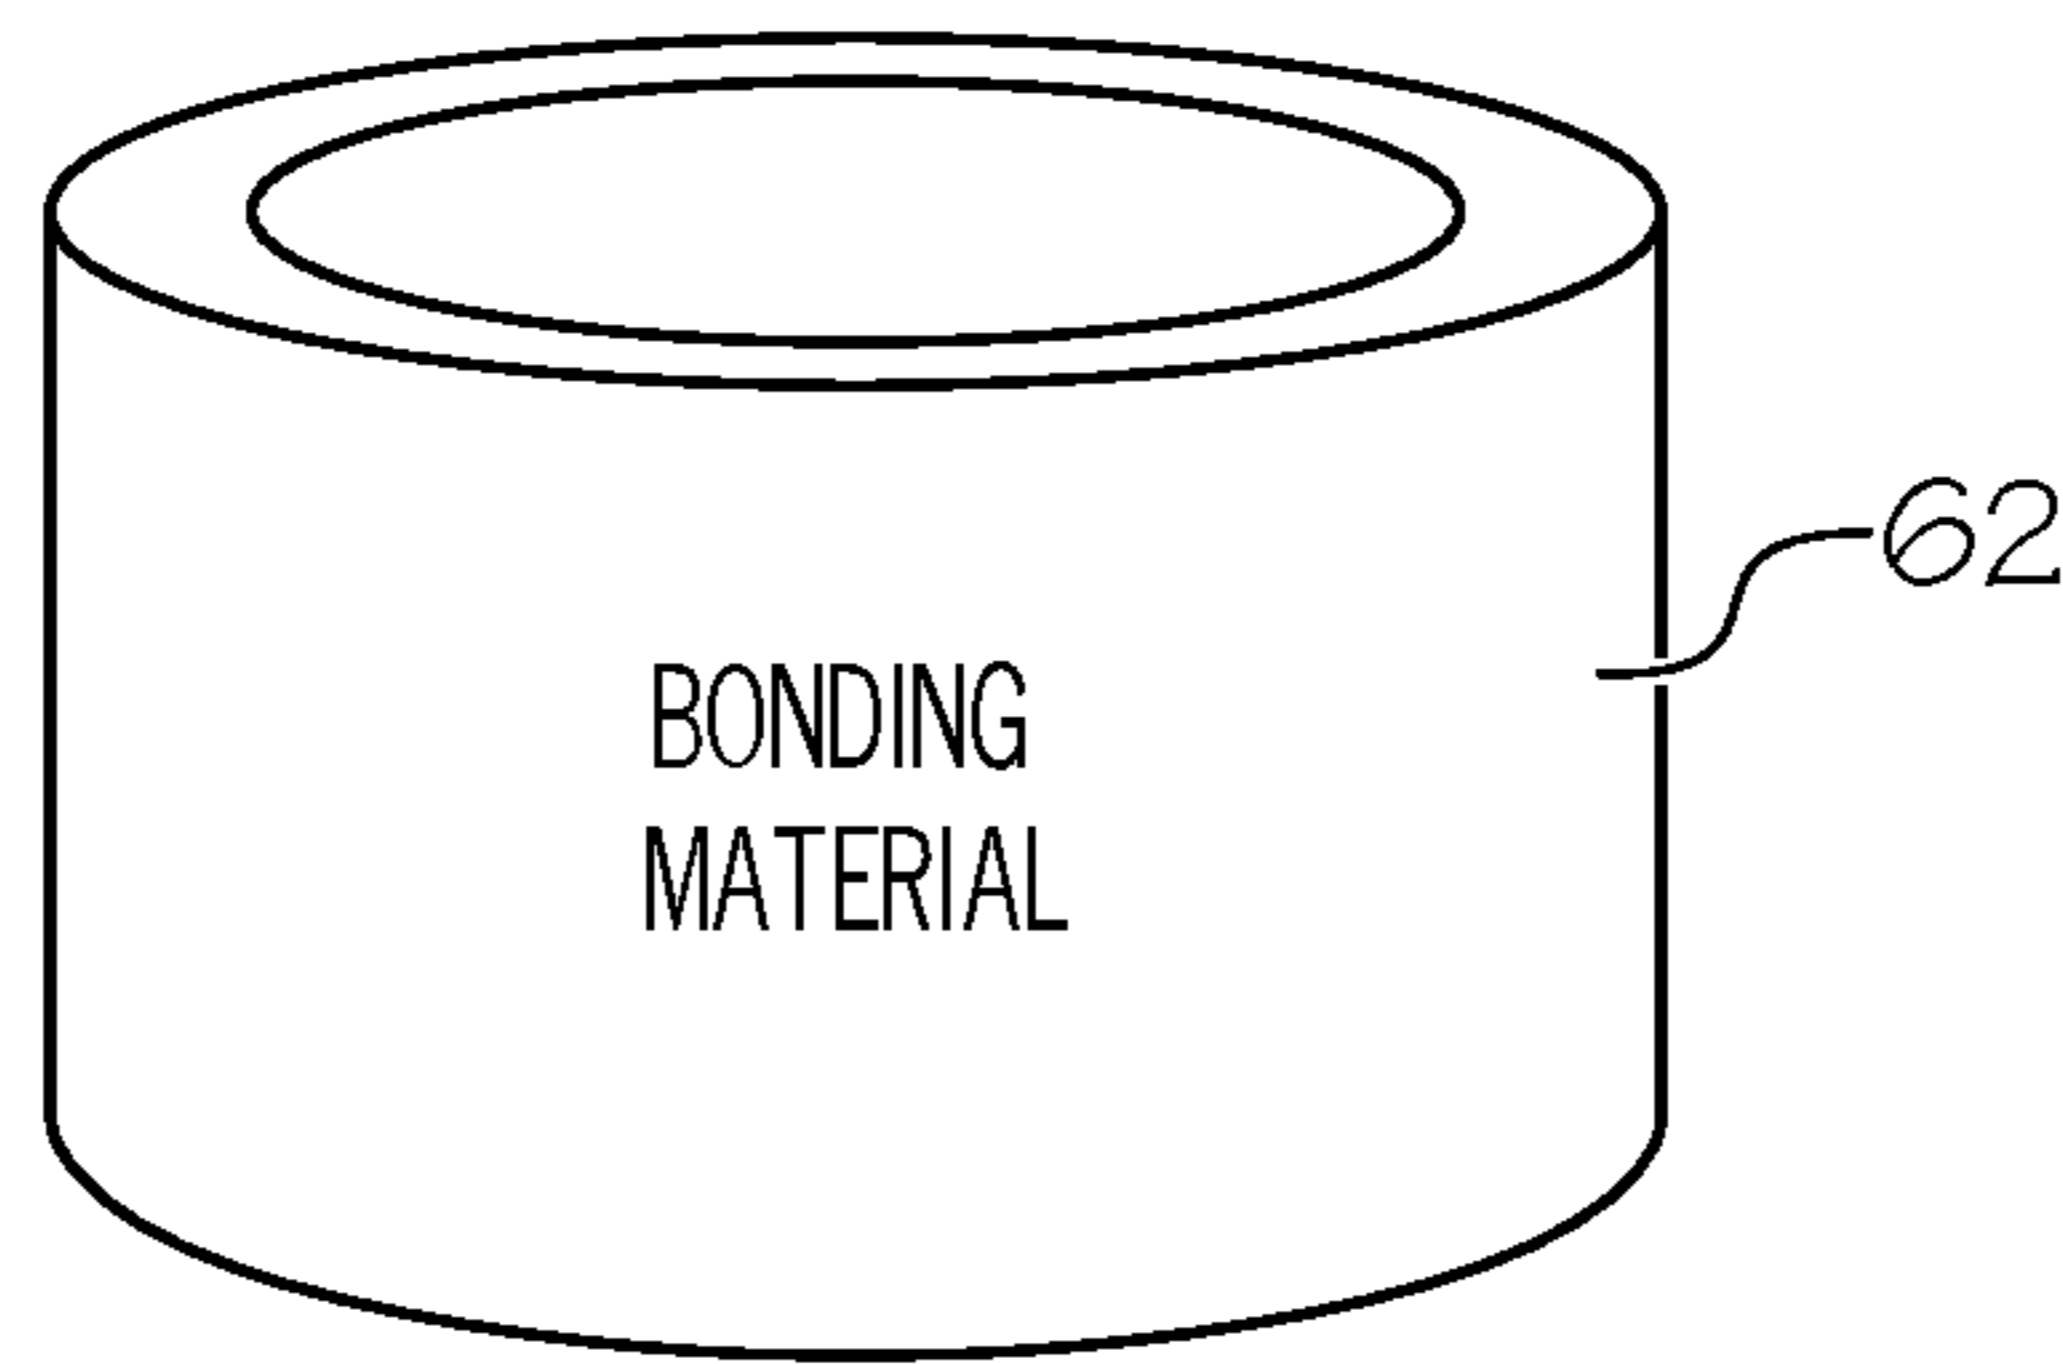
FIG. 6 is a perspective view of an acoustic sandwich panel repair kit constructed in accordance with an embodiment, which contains a bonding material and a ribbon of core repair splices for repairing the damaged core cell wall of FIGS. 3-5.

Referring to FIG. 6, a perspective view of an acoustic sandwich panel repair kit **60** constructed in accordance with an embodiment is shown. The acoustic sandwich panel repair kit **60** includes a container of bonding material **62** and a ribbon **64** of core repair splices **66** for repairing damaged walls, such as the damaged core cell wall **38** shown in FIGS.

The ribbon **64** includes a plurality of core repair splices **66**, only one of which is shown in FIG. 6. The ellipsis shown in FIG. 6 designates other one or more of core repair splices on the ribbon **64**. For simplicity and clarity of discussion, only the core repair splice **66** shown in FIG. 6 is described herein. The core repair splice **66** includes a plurality of surfaces shaped to conform to a number of damaged walls. More specifically, the plurality of surfaces includes a first flat surface **68**, a second flat surface **67** that is oblique to the first flat surface **68** at one edge of the first flat surface **68**, and a third flat surface **69** that is oblique to the first flat surface **68** at an opposite end edge of the first flat surface **68**.

Each of the panels **67**, **68**, **69** has a length or height (as viewed looking at FIG. 6) that is greater than the distance between the first liner sheet **14** and the second liner **16** (FIG. 1), for example. Each of the panels **67**, **68**, **69** has a width that is about the width of a core cell wall of a core cell, such as the width of the damaged core cell wall **38** of the core cell **34** shown in FIGS. 3-5. The core repair splice **66** comprises material that is substantially the same or similar to the material of the damaged core cell wall **38**.

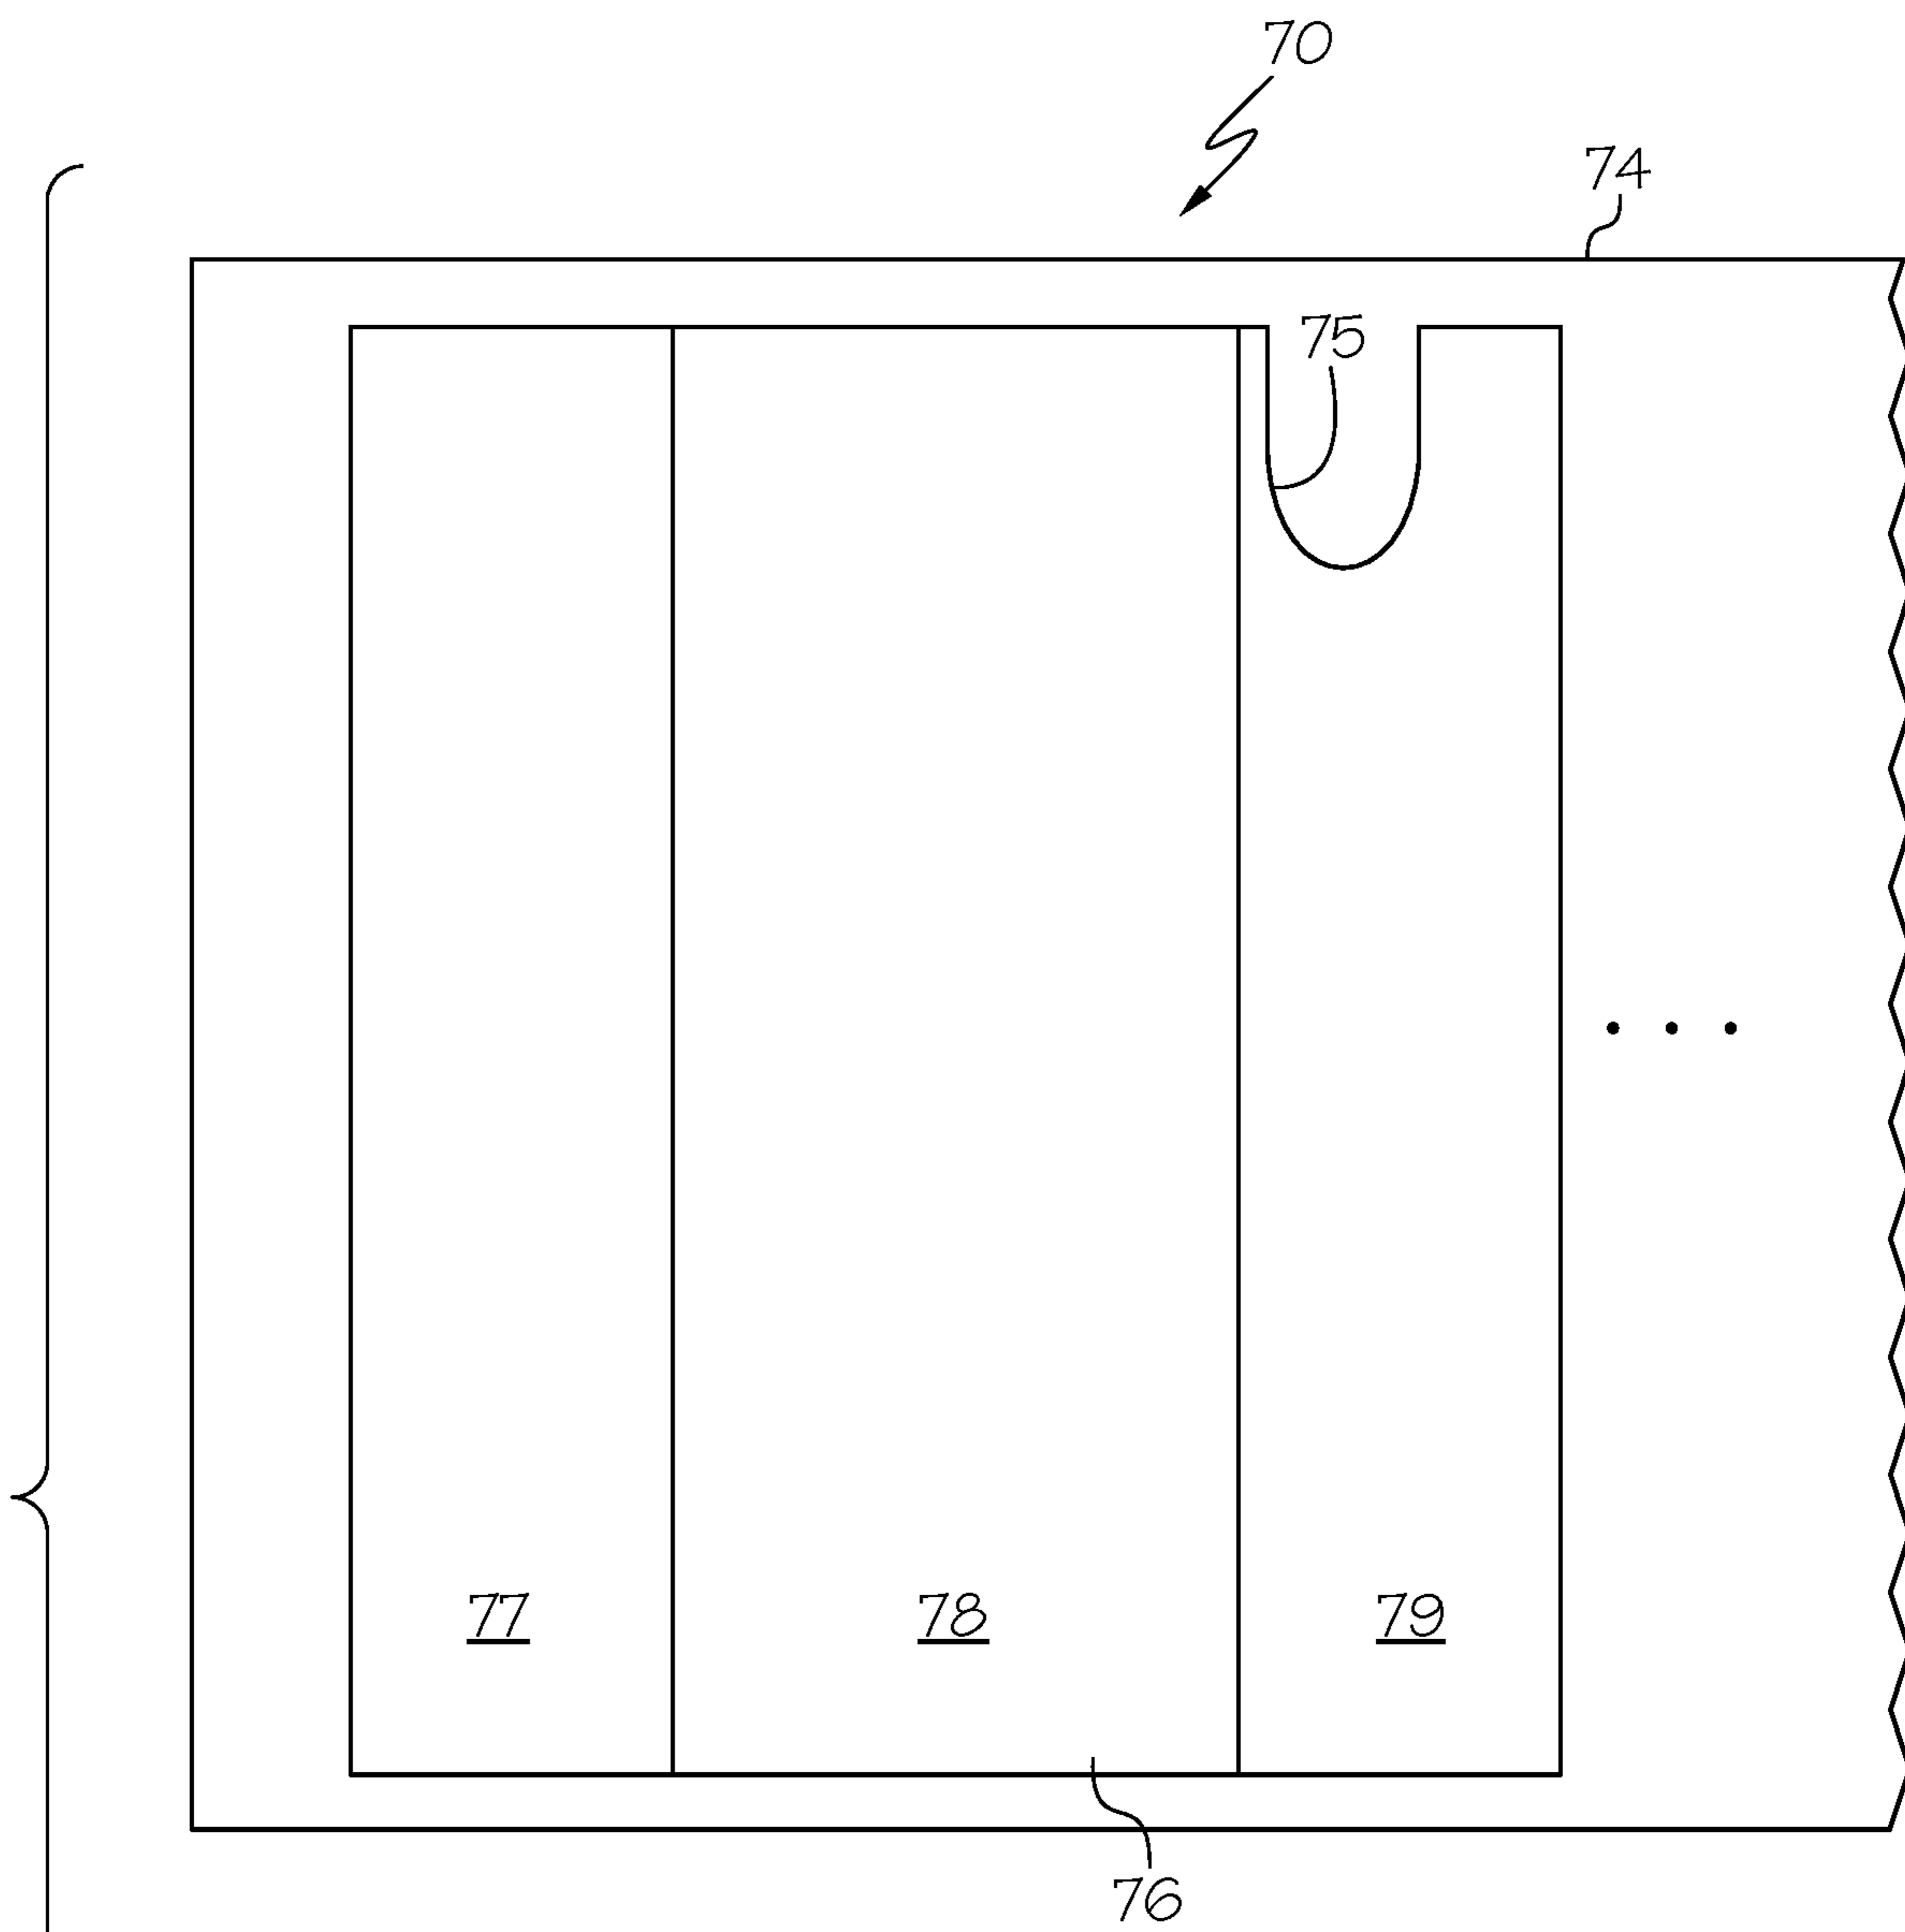
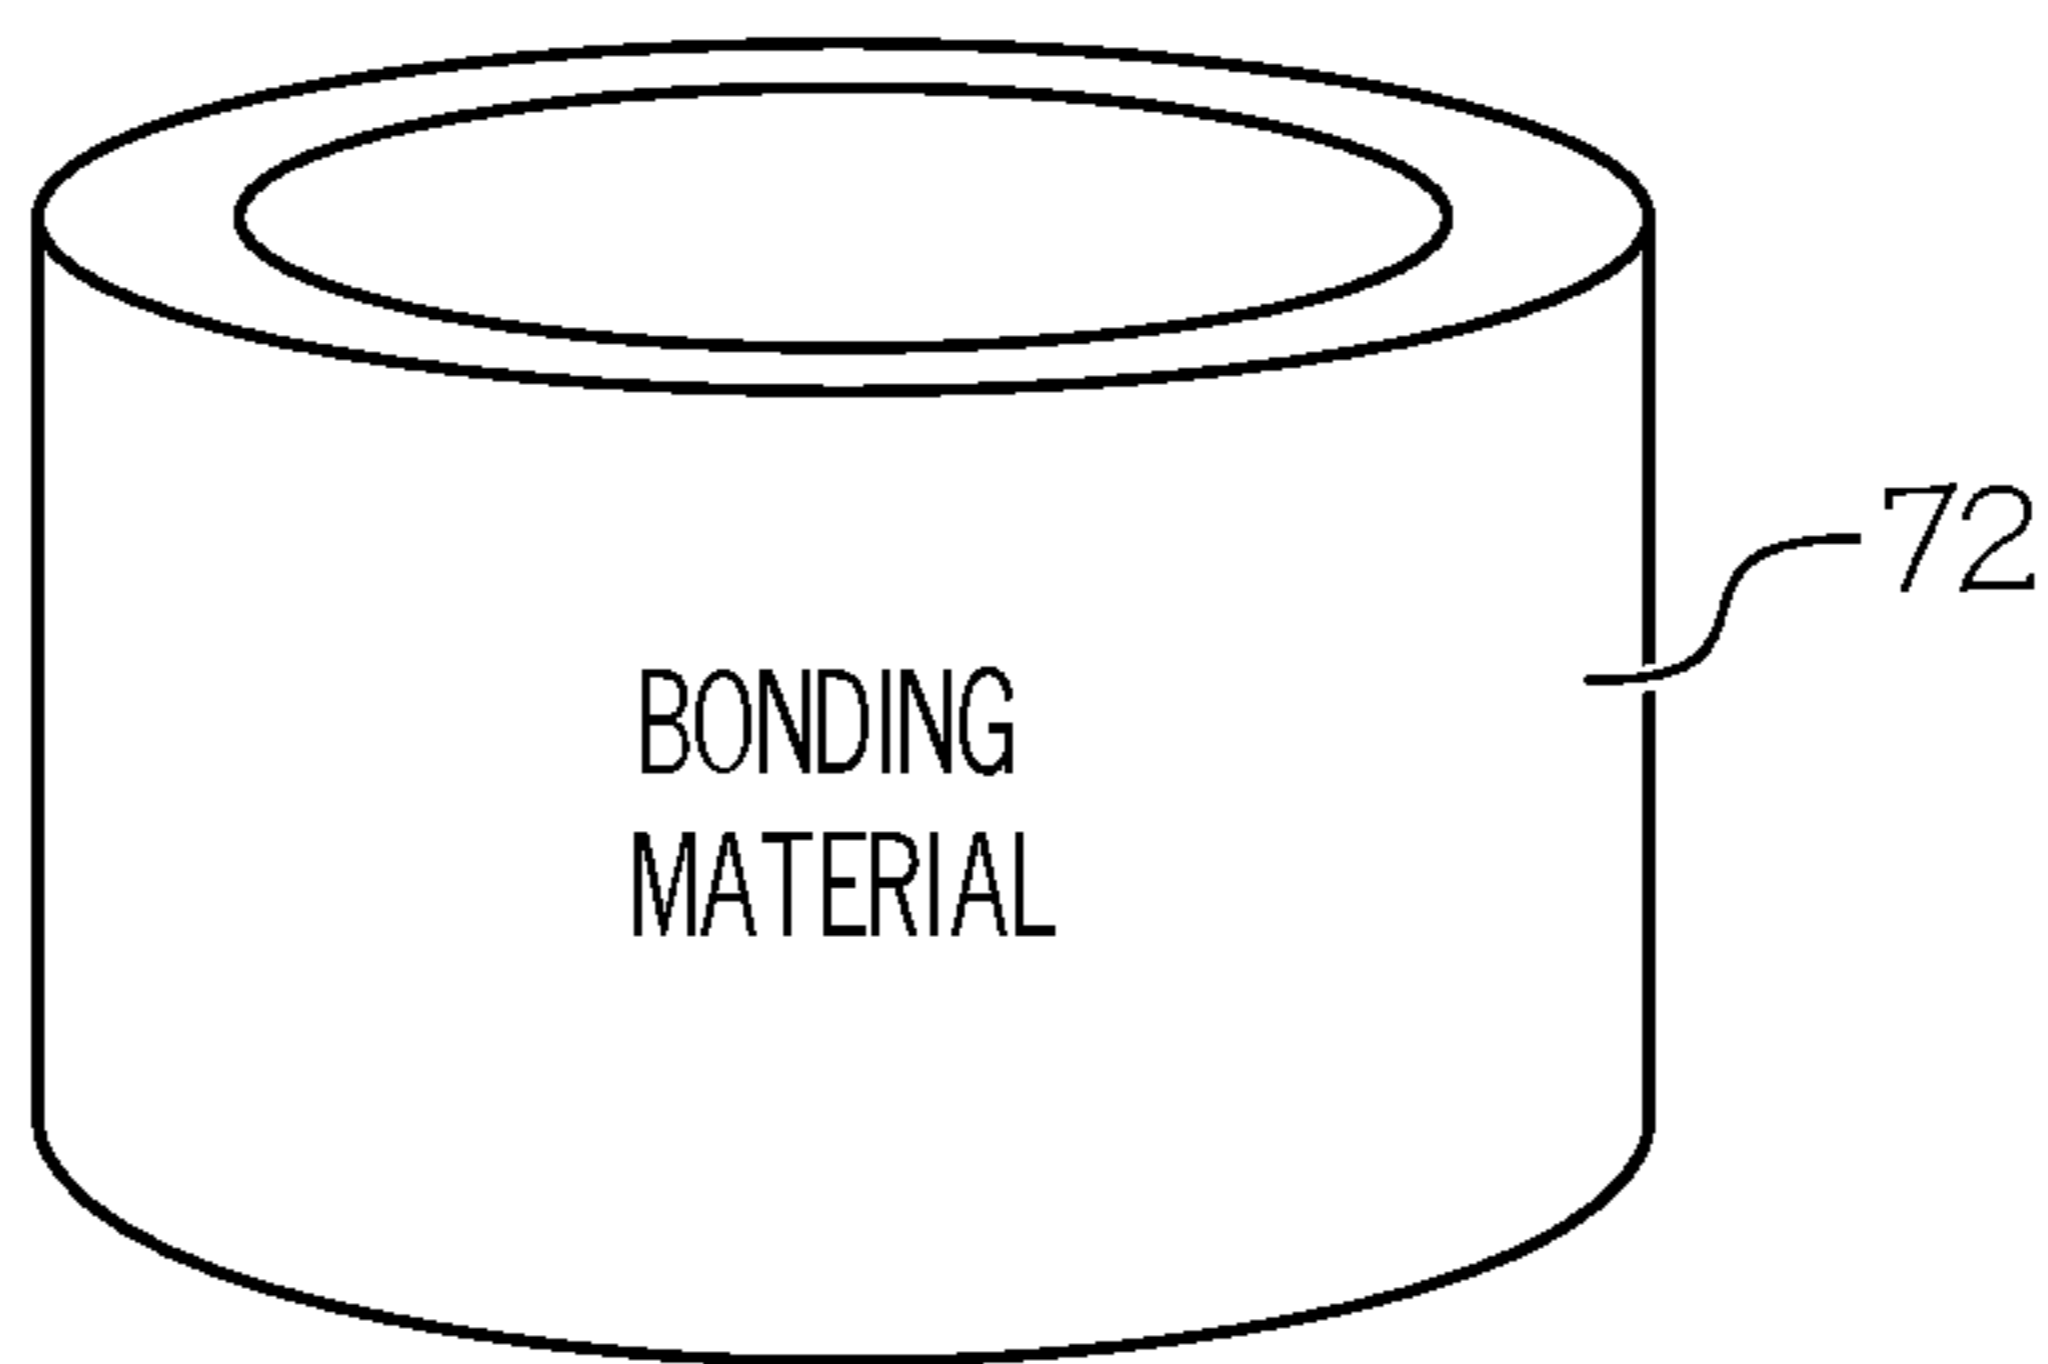
FIG. 7 is a perspective view similar to the perspective view of FIG. 6, and showing an acoustic sandwich panel repair kit constructed in accordance with another embodiment.

Referring to FIG. 7, a perspective view similar to the perspective view of FIG. 6 is shown. FIG. 7 shows an acoustic sandwich panel repair kit **70** constructed in accordance with another embodiment. The acoustic sandwich panel repair kit **70** includes a container of bonding material **72** and a ribbon **74** of core repair splices **76** for repairing damaged walls. The bonding material **72** may comprise an adhesive. In one implementation, an epoxy paste adhesive is used. An example epoxy paste adhesive is LOCTITE® EA 9394 AERO™ available from Henkel Corporation Aerospace located in Bay Point, Calif., U.S.A. In another implementation, a high viscosity adhesive is used. Other implementations of bonding material **72** are possible.

The ribbon **74** includes a plurality of core repair splices **76**, only one of which is shown in FIG. 7. The ellipsis shown in FIG. 7 designates other one or more of core repair splices on the ribbon **74**. For simplicity and clarity of discussion, only the core repair splice **76** shown in FIG. 7 is described herein. The core repair splice **76** includes a plurality of surfaces shaped to conform to a number of damaged walls. More specifically, the plurality of surfaces includes a first flat surface **78**, a second flat surface **77** that is oblique to the first flat surface **78** at one edge of the first flat surface **78**, and a third flat surface **79** that is oblique to the first flat surface **78** at an opposite end edge of the first flat surface **78**. Further, one or more of the three panels **77**, **78**, **79** may have one or more slots formed therein depending upon the need of the particular repair application. As shown in the example implementation of FIG. 7, the panel **79** has one slot **75** formed at one end of the panel **79**. The slot **75** is provided for the purpose of water drainage.

Each of the panels **77**, **78**, **79** also has a length or height (as viewed looking at FIG. 7) that is greater than the distance between liner sheets of the particular acoustic sandwich panel that is being repaired. Also, each of the panels **77**, **78**, **79** has a width that is about the width of a damaged core cell wall of an acoustic core cell of the acoustic sandwich panel that is being repaired. The core repair splice **76** comprises material that is substantially the same or similar to the

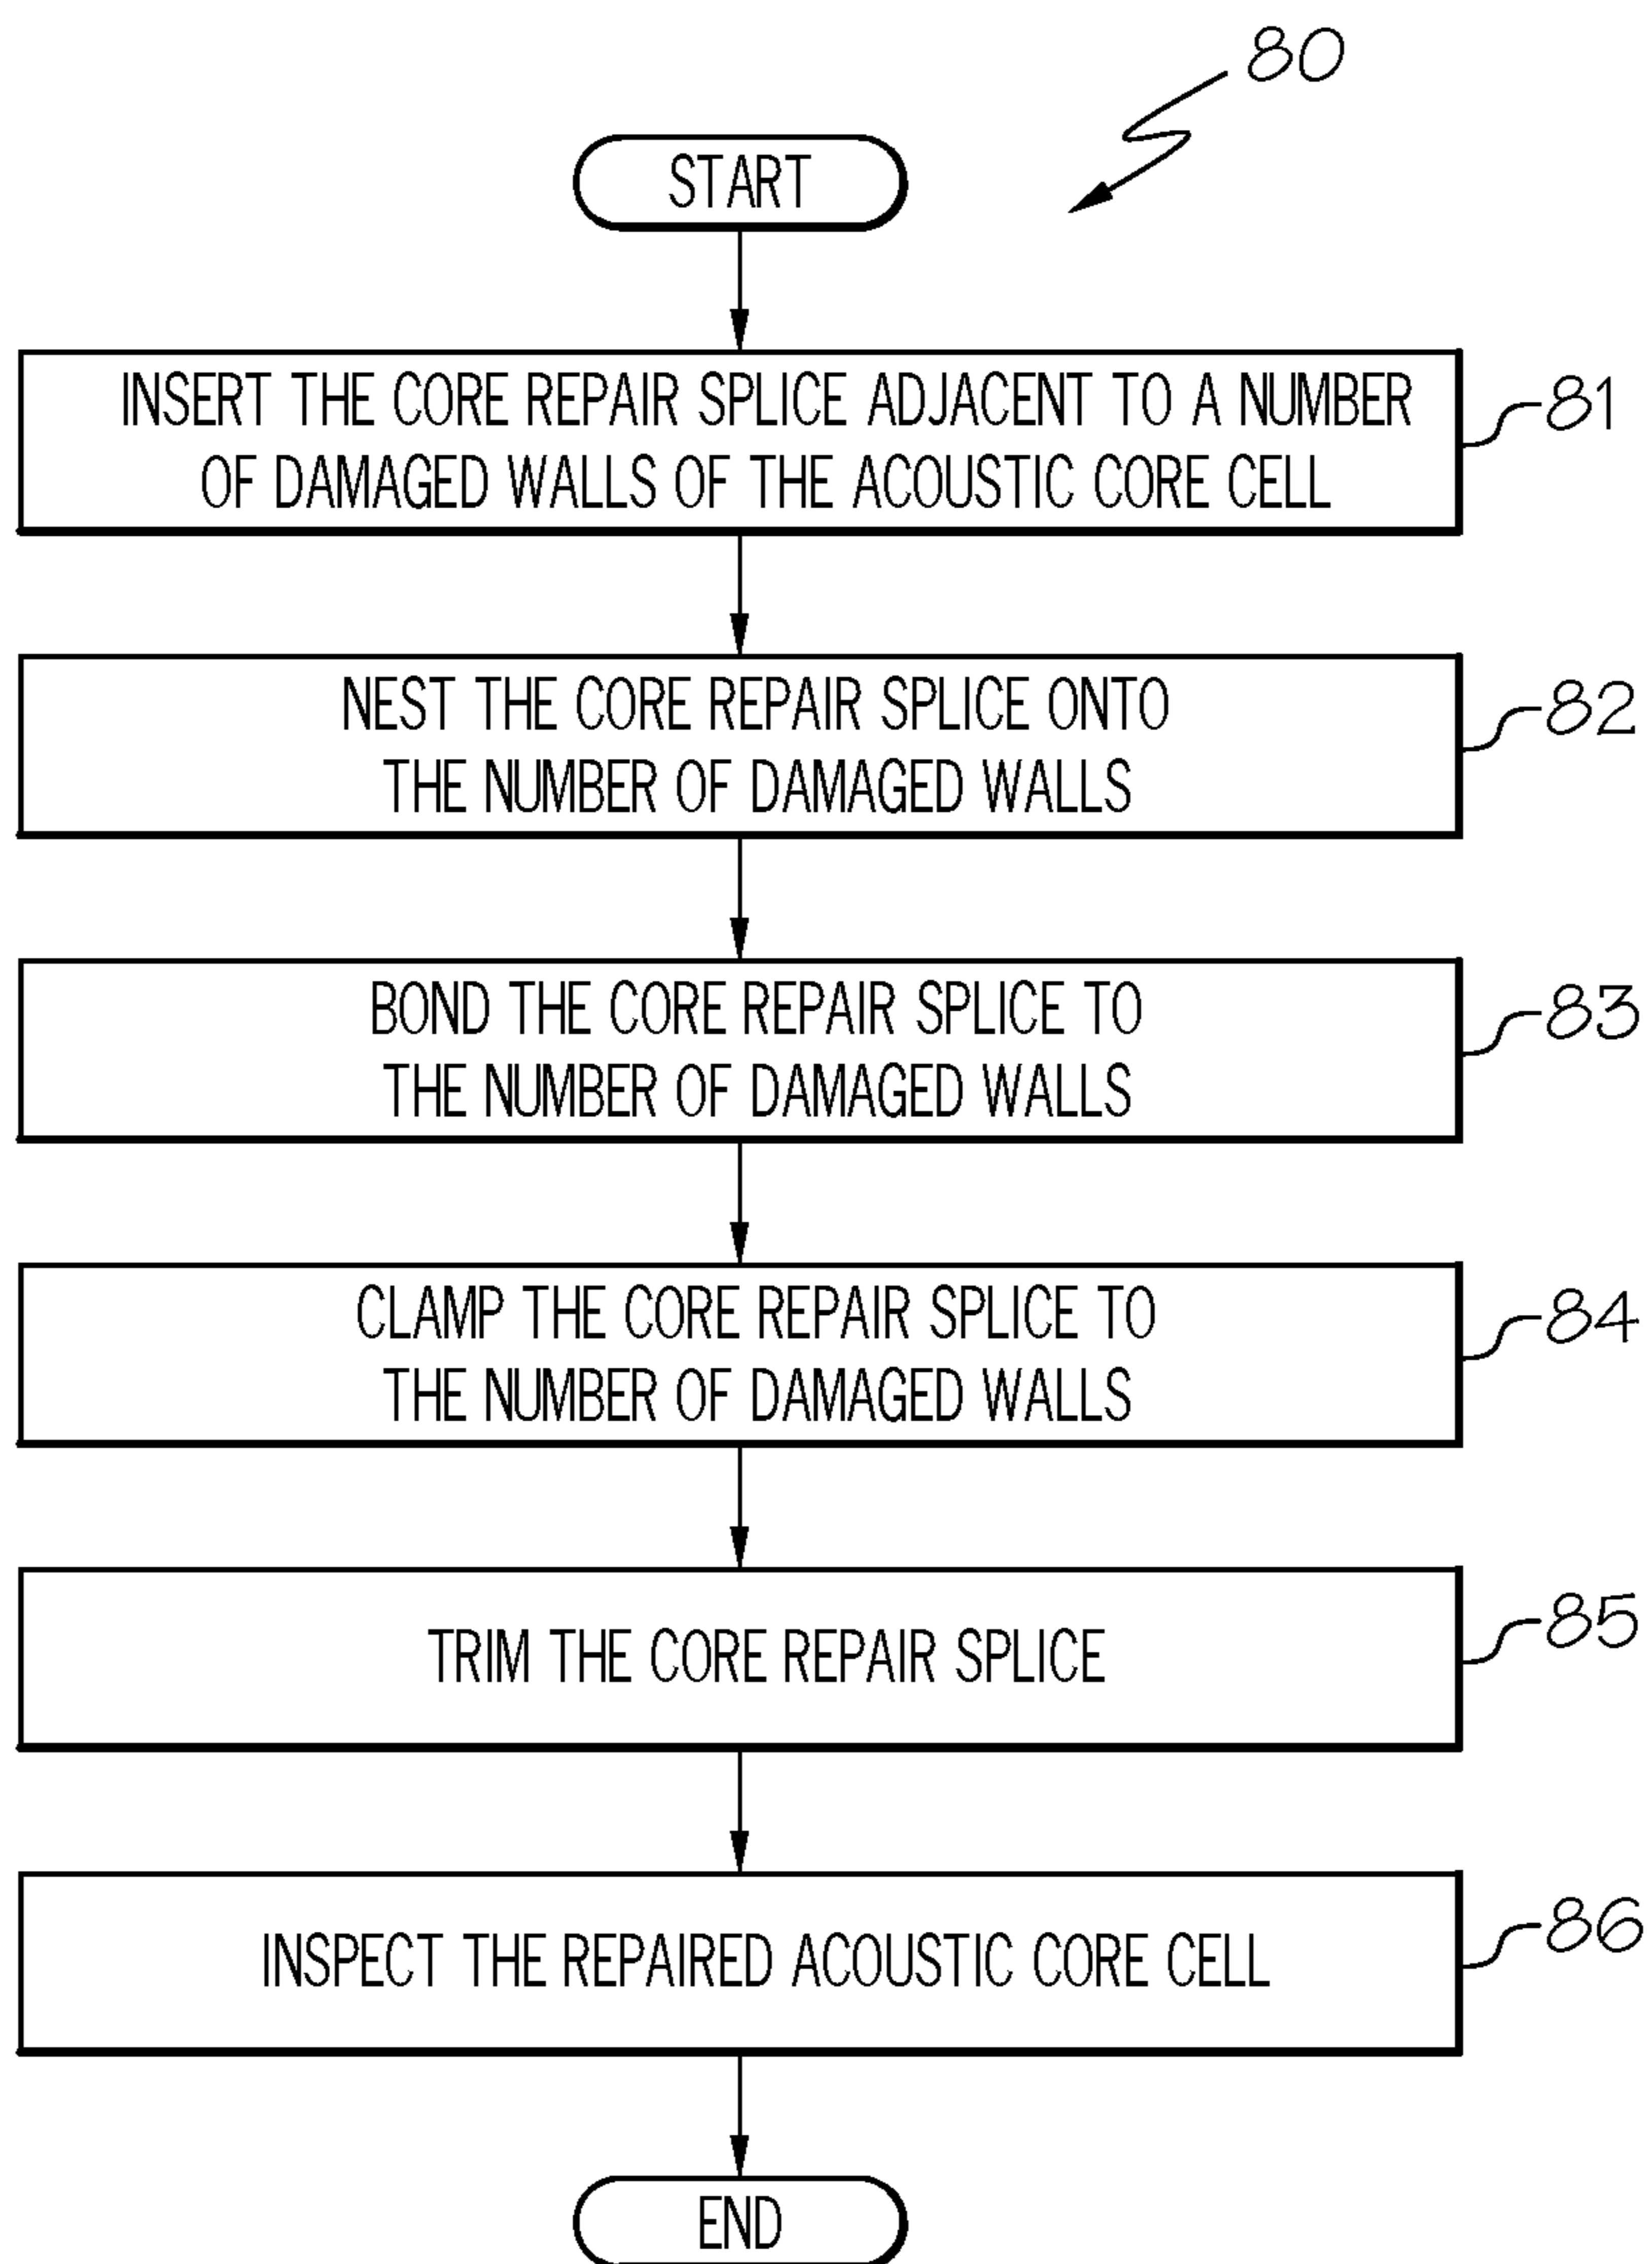
FIG. 8 is a flow diagram illustrating a method of repairing the damaged core cell wall of FIGS. 3-5 in accordance with an embodiment.

Referring to FIG. 8, a flow diagram **80** is shown illustrating a method of repairing the damaged core cell wall **38** of FIGS. 3-5 using a core repair splice **66** of FIG. 6 in accordance with an embodiment. Referring to FIG. 9, a top plan view similar to the top plan view of FIG. 5 is shown. More specifically, FIG. 9 shows the damaged core cell wall **38** of FIGS. 3-5 repaired with the bonding material **62** and a core repair splice **66** of the repair kit **60** of FIG. 6. The repaired acoustic core cell is designated with reference numeral “**90**” in FIG. 9. The acoustic sandwich panel repair method **80** and acoustic sandwich panel repair kits **60**, **70** disclosed herein may be employed according to FAA regulations. Specifications of FAA regulations for repairing acoustic sandwich panels are known and, therefore, will not be described.

In the flow diagram **80** of FIG. 8, the core repair splice **66** is inserted adjacent to a number of damaged walls of the acoustic core cell **34** (block **81**). The core repair splice **66** is nested onto the number of damaged walls (block **82**). In the example implementation shown in FIG. 9, the panel **68** of the core repair splice **66** is nested onto the damaged core cell wall **38**, and the other two panels **67**, **69** are nested onto walls adjacent to the damaged core cell wall **38**.

After the core repair splice **66** is bonded to the number of damaged walls, the core repair splice **66** is clamped to the number of damaged walls (block **84**). In one example implementation, one or more hair clips can be inserted into the cavity **30** to clamp the core repair splice **66** to the damaged core cell wall **38** when the bonding material **62** cures. In another implementation, one or more foam ear plugs can be inserted into the cavity **30** to clamp the core repair splice **66** to the damaged core cell wall **38** when the bonding material **62** cures. After the bonding material **62** cures and the one or more foam ear plugs or hair clips are removed.

After block **84**, the core repair splice **66** is trimmed (block **85**). In one implementation, the core repair splice **66** is trimmed such that the core repair splice **66** extends flush with a core surface of the acoustic core cell **34** when the trimmed core repair splice is bonded to the number of damaged walls. In another implementation, the core repair splice **66** is trimmed such that the core repair splice **66** extends beyond a core surface of the acoustic core cell when the trimmed core repair splice is bonded to the number of damaged walls. While the above description described the core repair splice **66** being trimmed after the core repair splice **66** is bonded to the number of damaged walls, it is conceivable that the core repair splice **66** be trimmed before the core repair splice **66** is inserted adjacent to the number

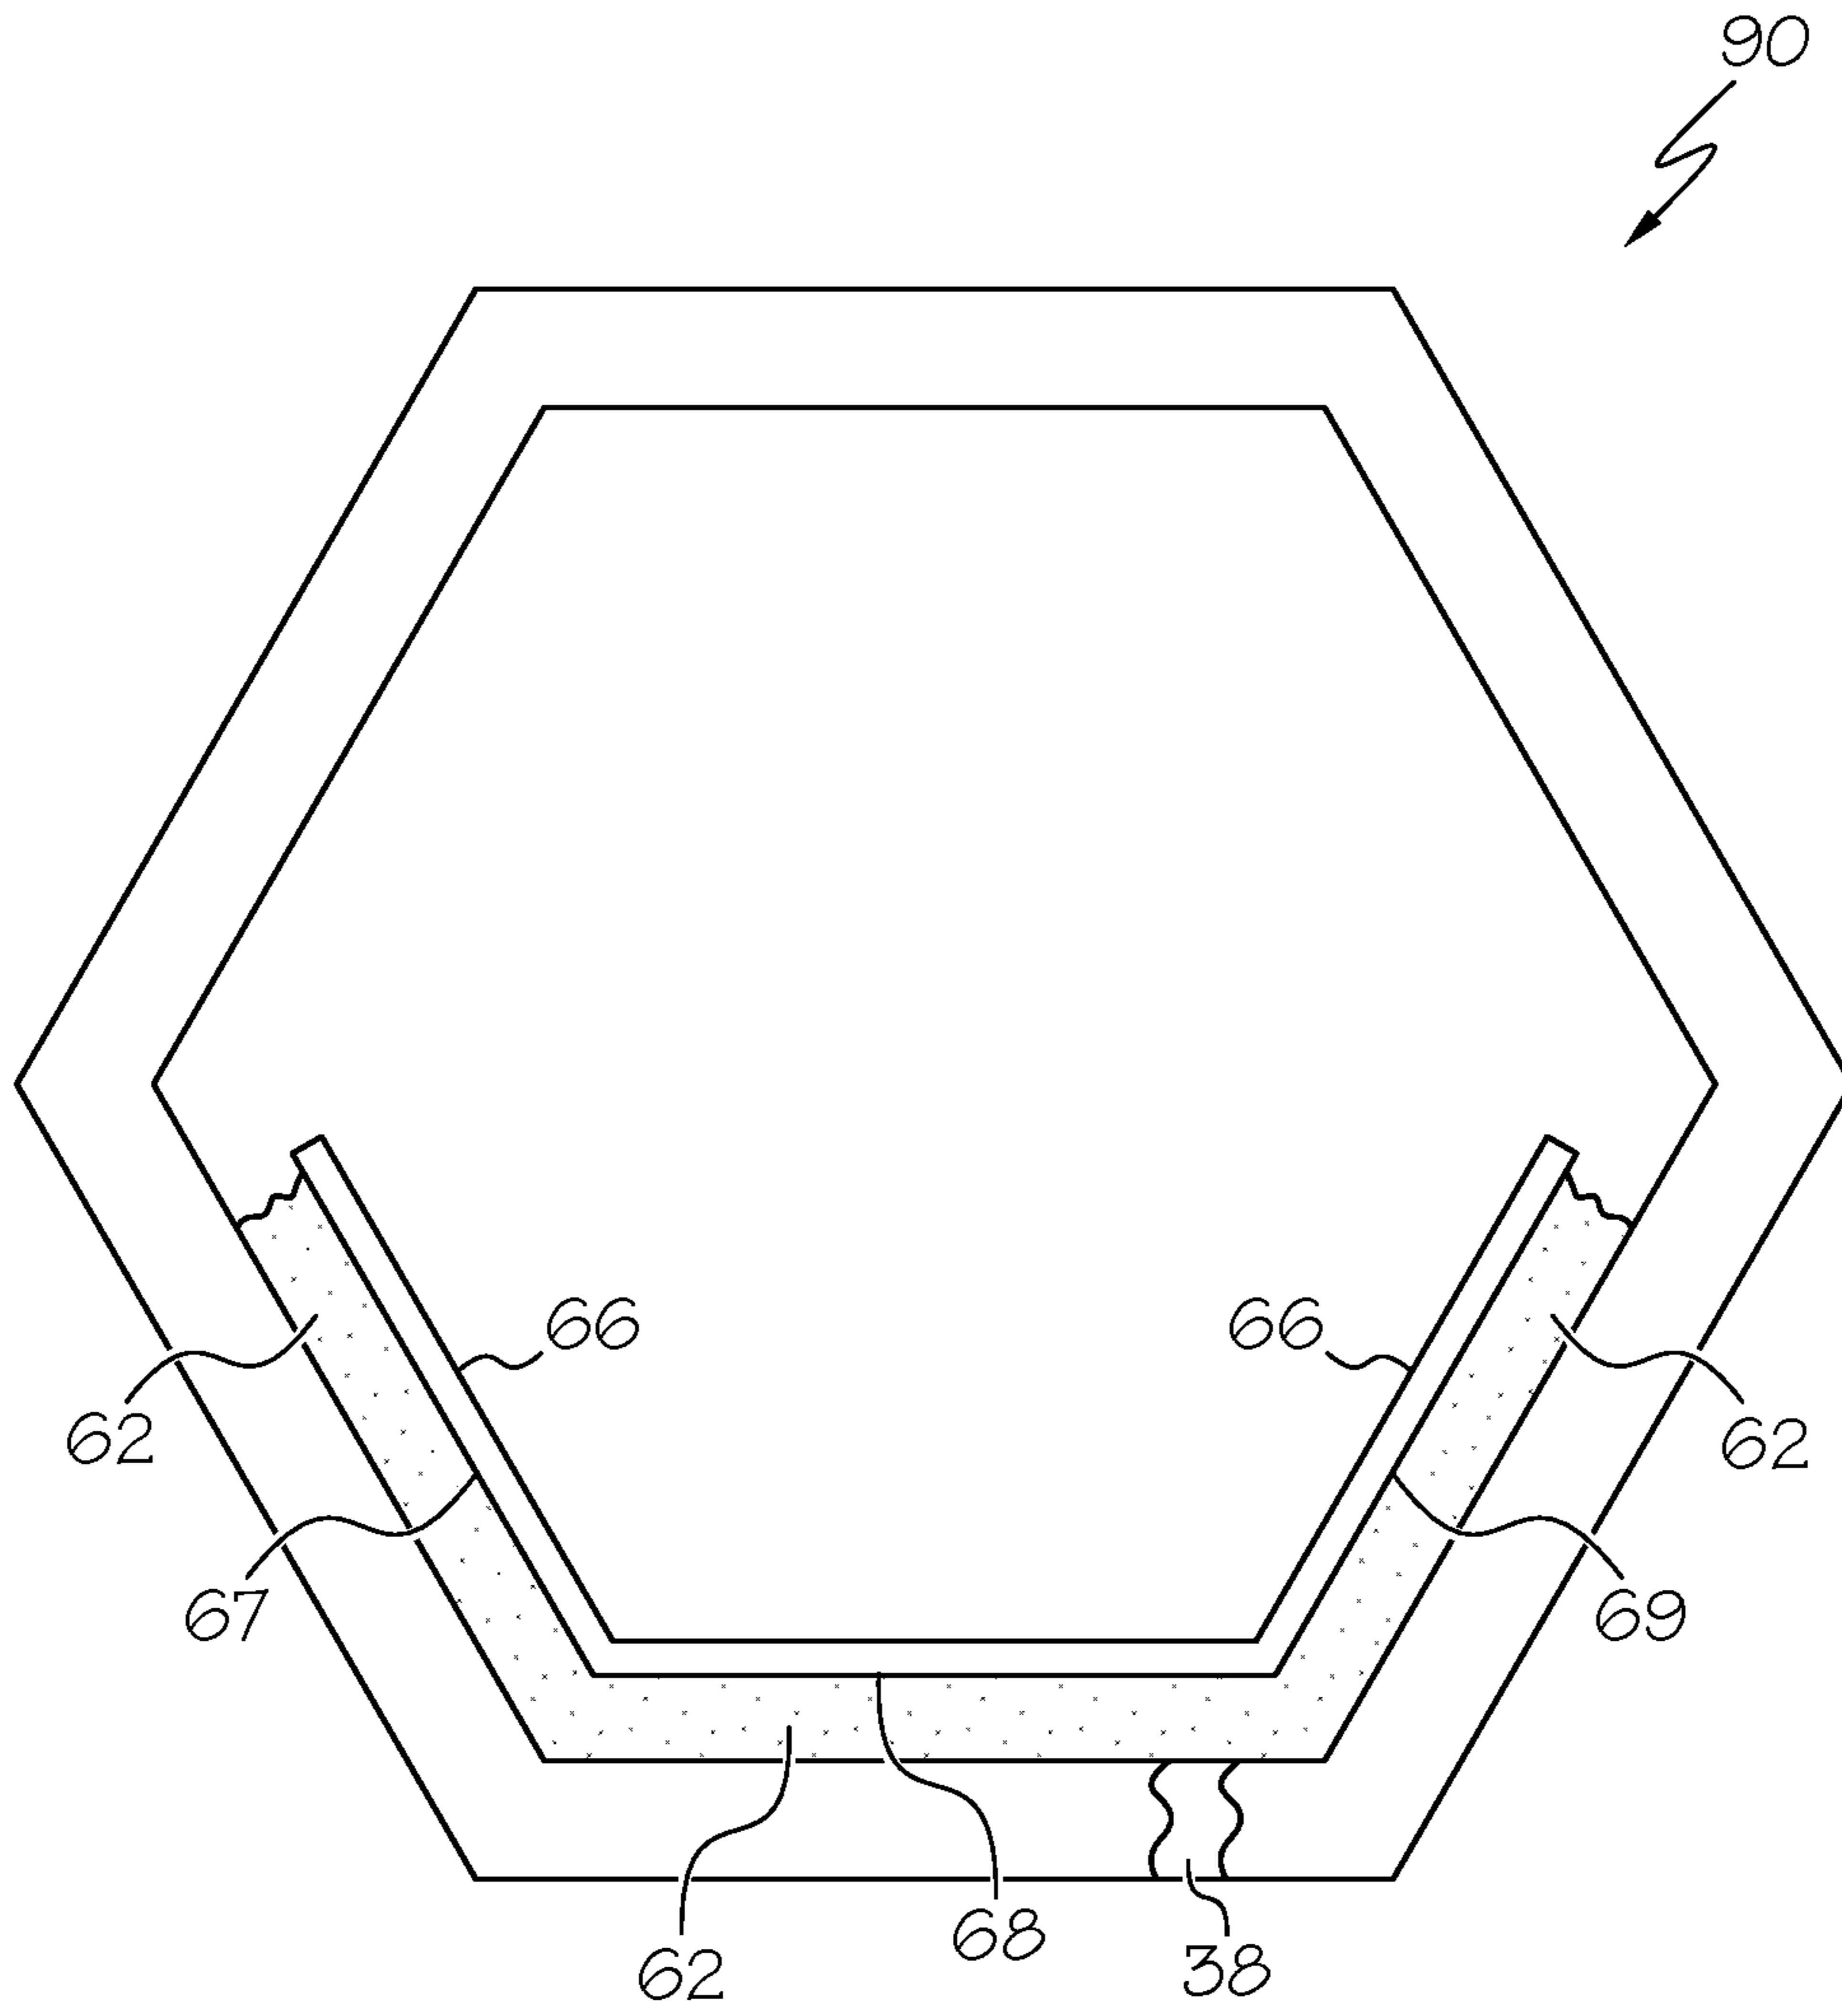
FIG. 9 is a top plan view similar to the top view of FIG. 5, and showing the damaged core cell wall of the acoustic core cell of FIGS. 3-5 repaired with the bonding material and a core repair splice of the repair kit of FIG. 6.

The core repair splice **66** is then bonded to the number of damaged walls to repair the acoustic core cell **34** to provide the repaired acoustic core cell **90** (block **83**). As shown in FIG. 9, the panels **67**, **68**, **69** are bonded with bonding material **62** to core cell walls including the damaged core cell wall **38**. It should be noted that the thickness of the bonding material **62** between the core repair splice **66** and the core cell walls including the damaged core cell wall **38** is shown exaggerated for purposes of illustration.

of damaged walls. As a result, the repaired acoustic core cell **90** shown in FIG. **9** is provided and subsequently inspected to ensure quality of the repair (block **86**).
