(10) **Patent No.:** **US 10,793,292 B2**  
(45) **Date of Patent:** **Oct. 6, 2020**

(54) **METHODS OF REPAIRING AN ACOUSTIC SANDWICH PANEL AND ACOUSTIC SANDWICH PANEL REPAIR KITS THEREFOR**

(71) Applicant: **The Boeing Company**, Chicago, IL (US)

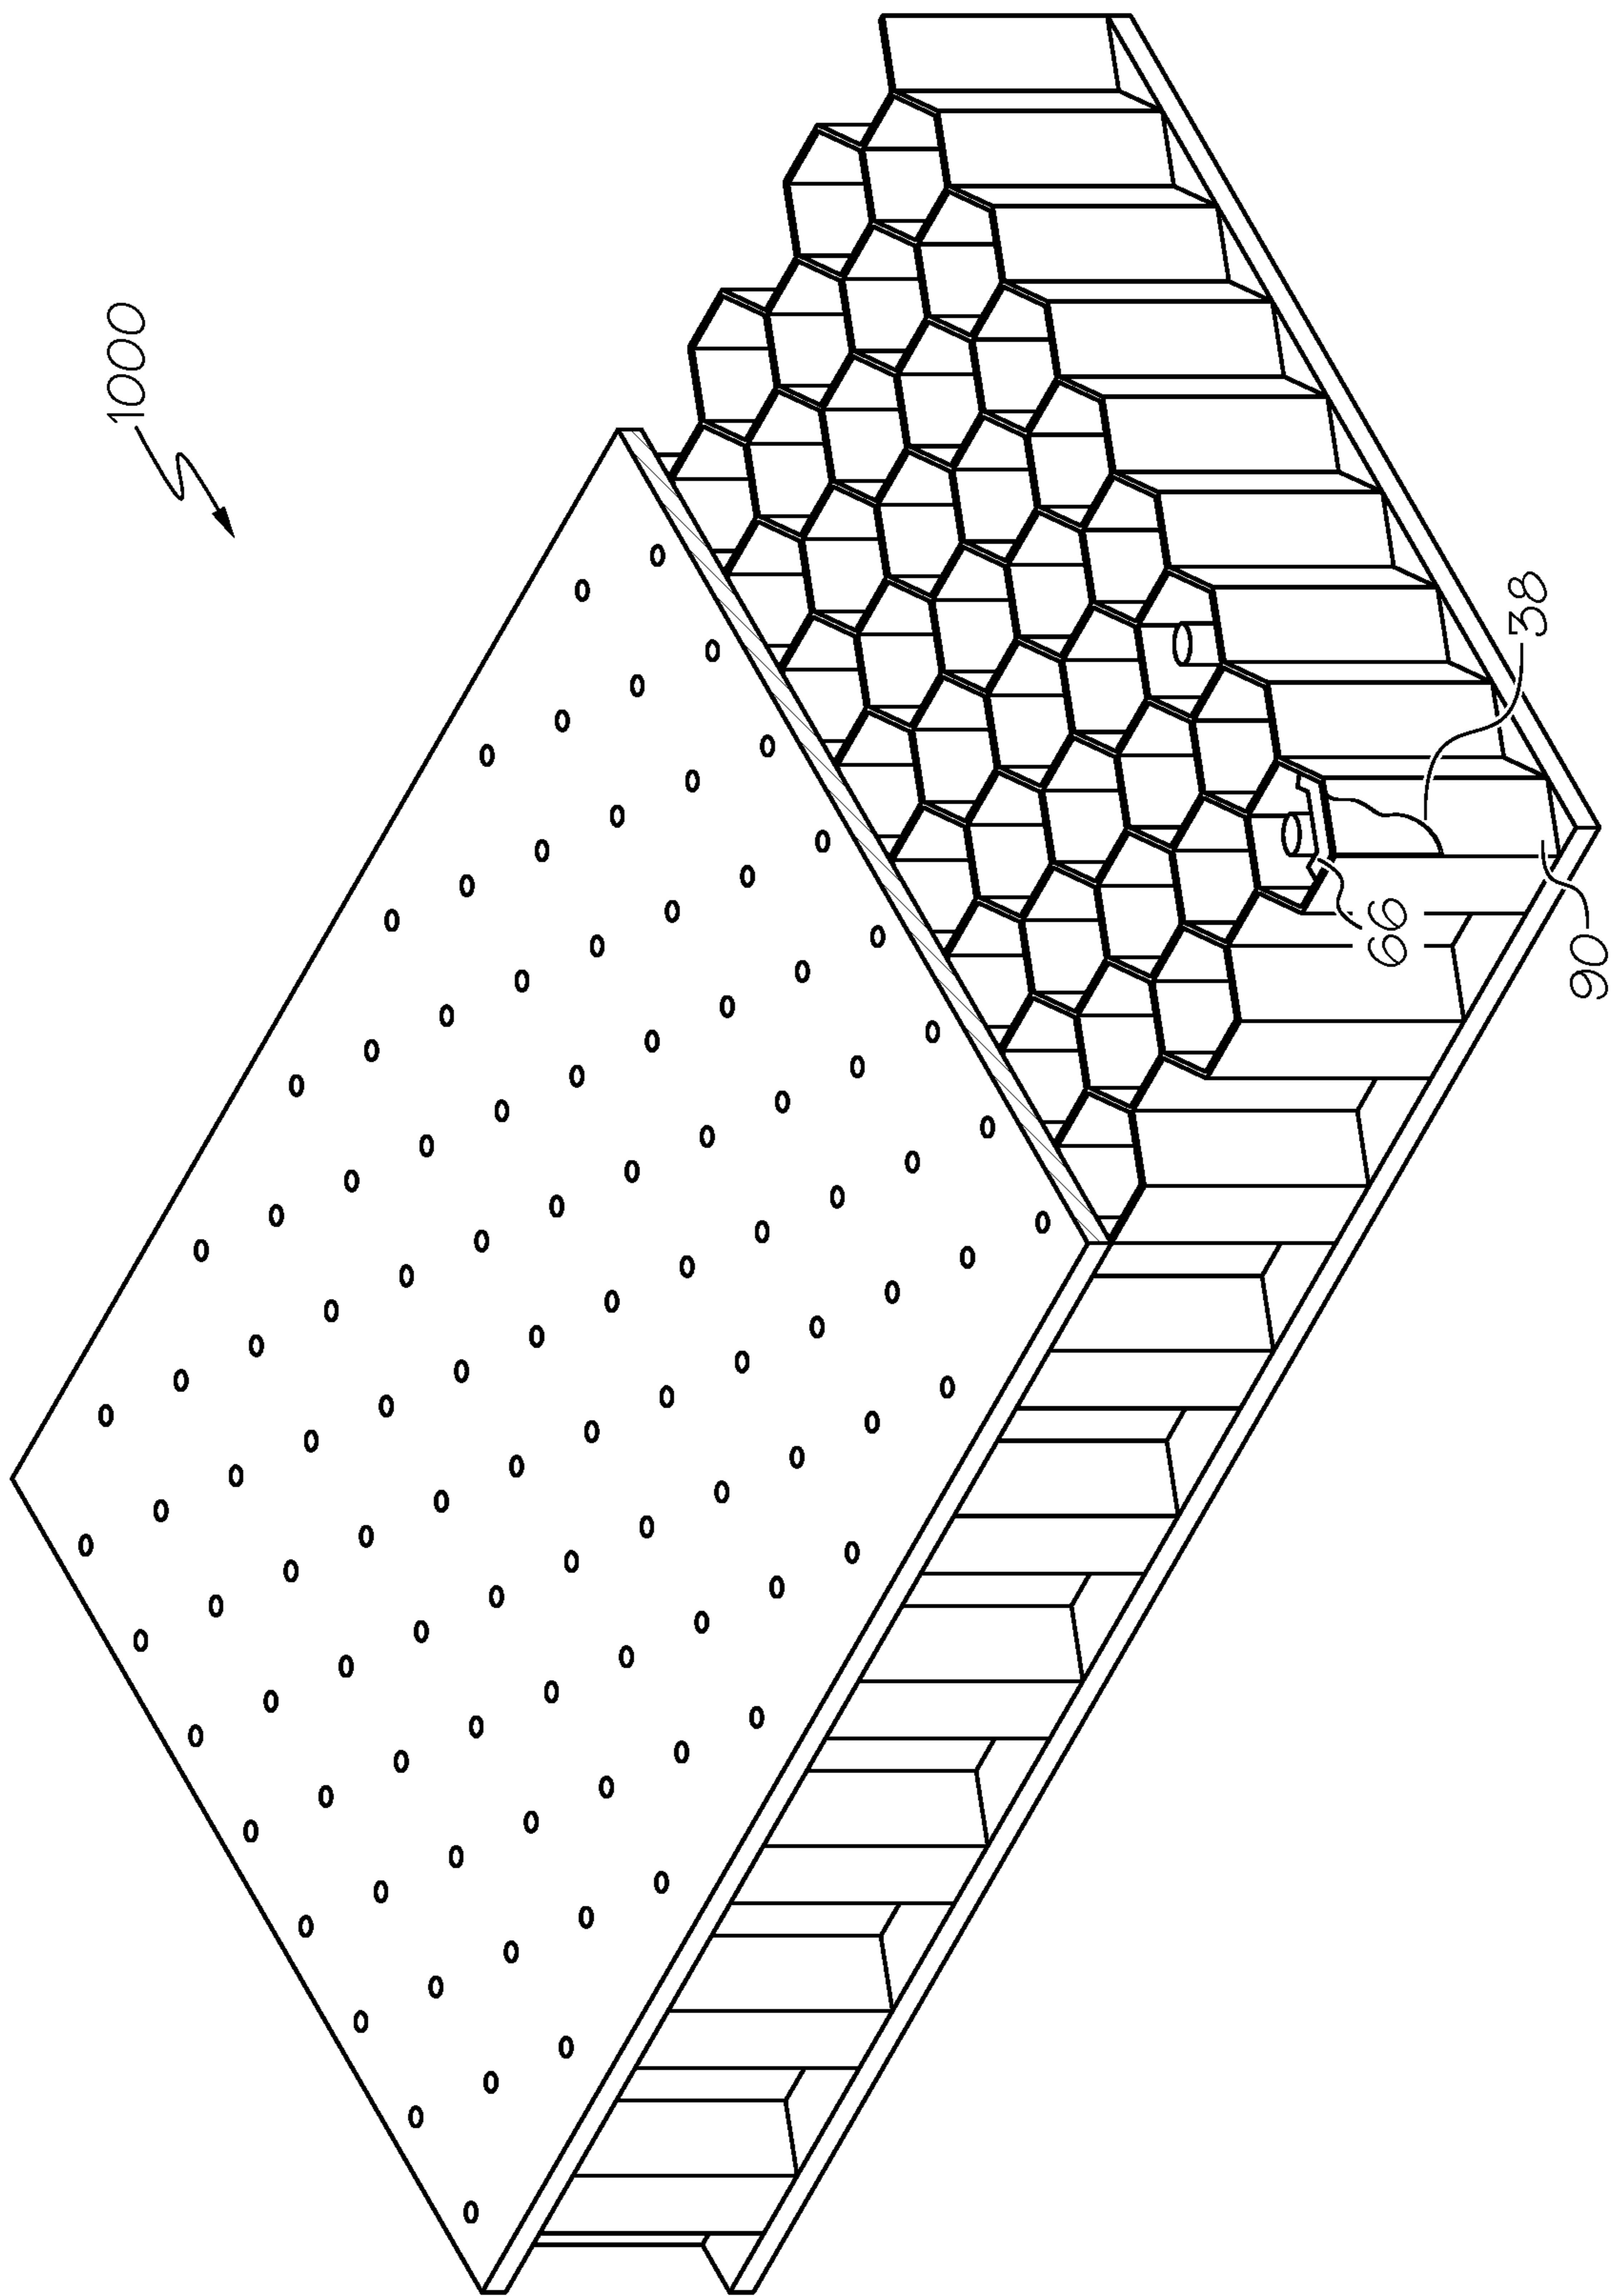
FIG. 10 is a perspective view similar to the perspective view of FIG. 3, and showing the repaired core cell wall of the acoustic core cell of FIG. 9 as part of repaired acoustic sandwich panel.

The core repair splice **66** and the bonding adhesive **62** disposed on the panels **67, 68, 69** of the core repair splice **66** provide structural support and reinforcement for the damaged core cell wall **38** to thereby provide repaired acoustic core cell **90** (FIG. **9**) that is part of repaired acoustic sandwich panel **1000** shown in FIG. **10**.
