(10) **Patent No.:** **US 10,919,180 B2**
(45) **Date of Patent:** **Feb. 16, 2021**

(54) **REPAIR PROCESS USING NETWORKED CERAMIC NANOFIBERS**

(71) Applicant: **United Technologies Corporation**,
Farmington, CT (US)

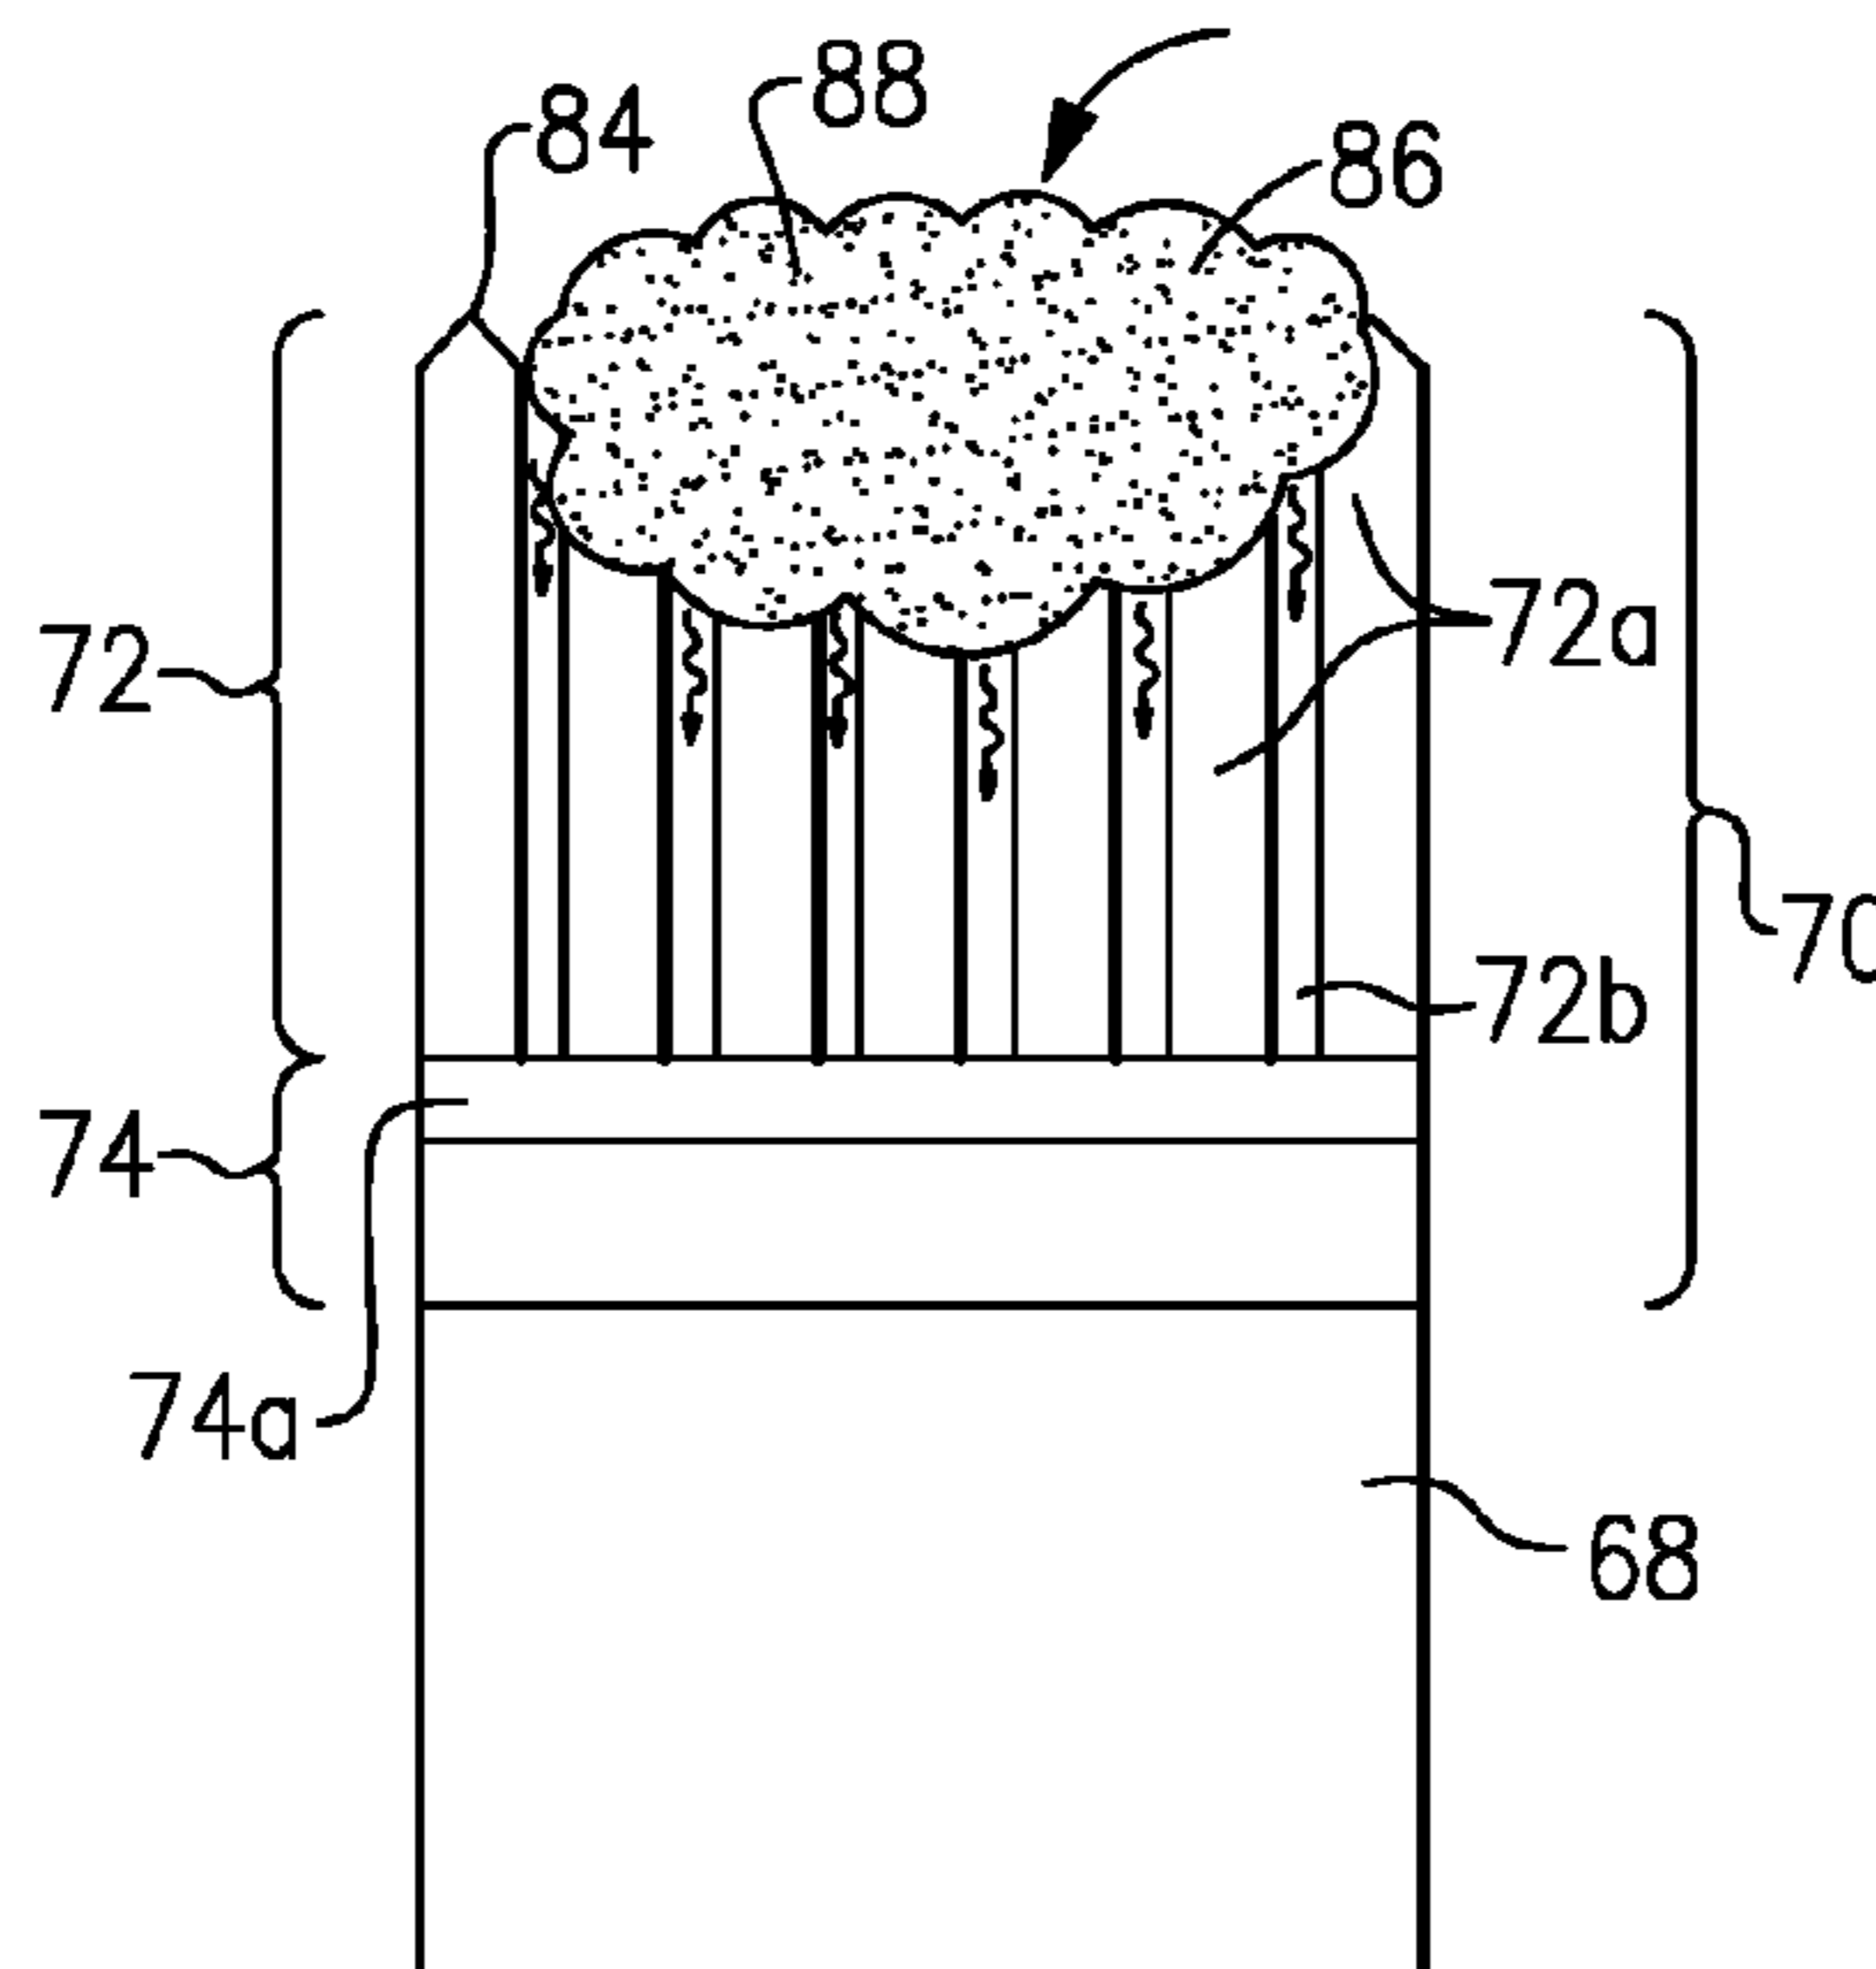
A repair process for an article such as an airfoil includes providing an article that has a substrate and a ceramic barrier coating disposed on the substrate, where the ceramic barrier coating has a damaged region, abrading the damaged region to provide dimple in the ceramic barrier coating, wherein a remaining region of the ceramic barrier coating adjacent the dimple remains intact, and depositing a patch of networked ceramic nanofibers in the dimple.

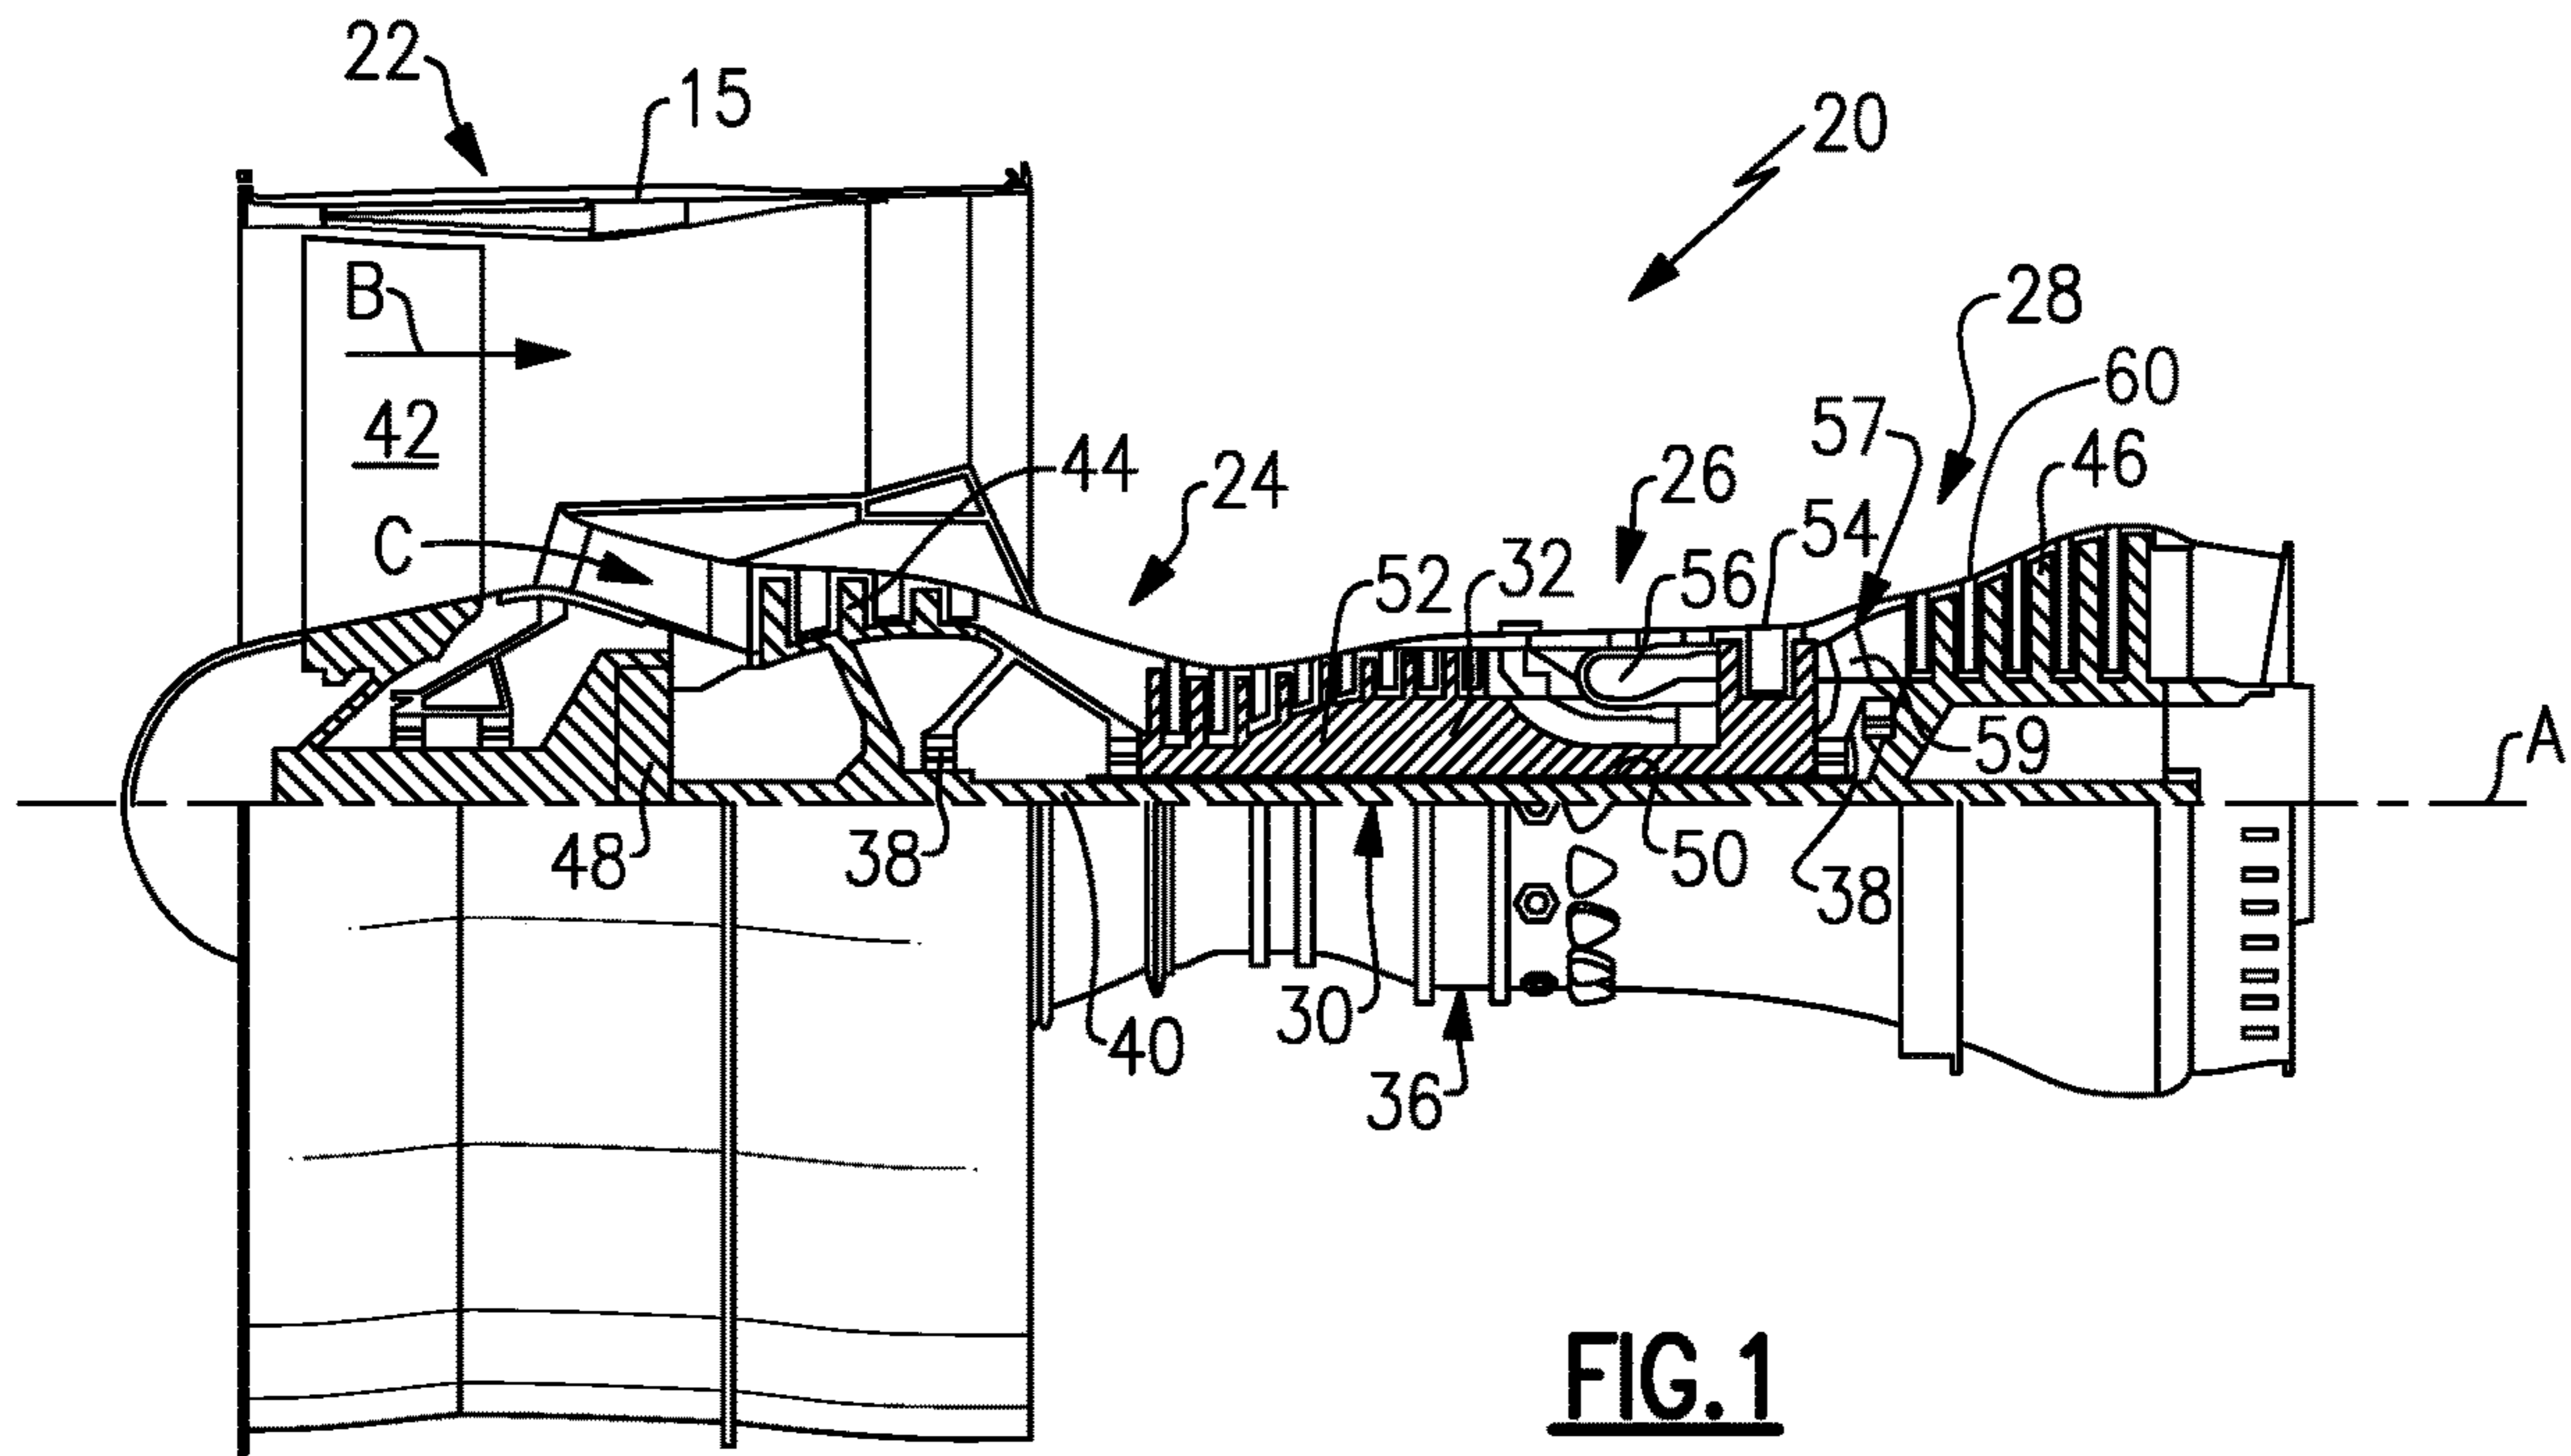
FIG. 1 illustrates an example gas turbine engine.

FIG. 1 schematically illustrates a gas turbine engine **20**. The gas turbine engine **20** is disclosed herein as a two-spool turbofan that generally incorporates a fan section **22**, a compressor section **24**, a combustor section **26** and a turbine section **28**. The fan section **22** drives air along a bypass flow path B in a bypass duct defined within a nacelle **15**, and also drives air along a core flow path C for compression and communication into the combustor section **26** then expansion through the turbine section **28**. Although depicted as a two-spool turbofan gas turbine engine in the disclosed non-limiting embodiment, it should be understood that the concepts described herein are not limited to use with two-spool turbofans as the teachings may be applied to other types of turbine engines including three-spool architectures.

The exemplary engine 20 generally includes a low speed spool 30 and a high speed spool 32 mounted for rotation about an engine central longitudinal axis A relative to an engine static structure 36 via several bearing systems 38. It should be understood that various bearing systems 38 at various locations may alternatively or additionally be provided, and the location of bearing systems 38 may be varied as appropriate to the application.

The low speed spool 30 generally includes an inner shaft 40 that interconnects, a first (or low) pressure compressor 44 and a first (or low) pressure turbine 46. The inner shaft 40 is connected to the fan 42 through a speed change mechanism, which in exemplary gas turbine engine 20 is illustrated as a geared architecture 48 to drive a fan 42 at a lower speed than the low speed spool 30. The high speed spool 32 includes an outer shaft 50 that interconnects a second (or high) pressure compressor 52 and a second (or high) pressure turbine 54. A combustor 56 is arranged in exemplary gas turbine 20 between the high pressure compressor 52 and the high pressure turbine 54. A mid-turbine frame 57 of the engine static structure 36 may be arranged generally between the high pressure turbine 54 and the low pressure turbine 46. The mid-turbine frame 57 further supports bearing systems 38 in the turbine section 28. The inner shaft 40 and the outer shaft 50 are concentric and rotate via bearing systems 38 about the engine central longitudinal axis A which is collinear with their longitudinal axes.

The core airflow is compressed by the low pressure compressor 44 then the high pressure compressor 52, mixed and burned with fuel in the combustor 56, then expanded over the high pressure turbine 54 and low pressure turbine 46. The mid-turbine frame 57 includes airfoils 59 which are in the core airflow path C. The turbines 46, 54 rotationally drive the respective low speed spool 30 and high speed spool 32 in response to the expansion. It will be appreciated that each of the positions of the fan section 22, compressor section 24, combustor section 26, turbine section 28, and fan drive gear system 48 may be varied. For example, gear system 48 may be located aft of the low pressure compressor, or aft of the combustor section 26 or even aft of turbine section 28, and fan 42 may be positioned forward or aft of the location of gear system 48.

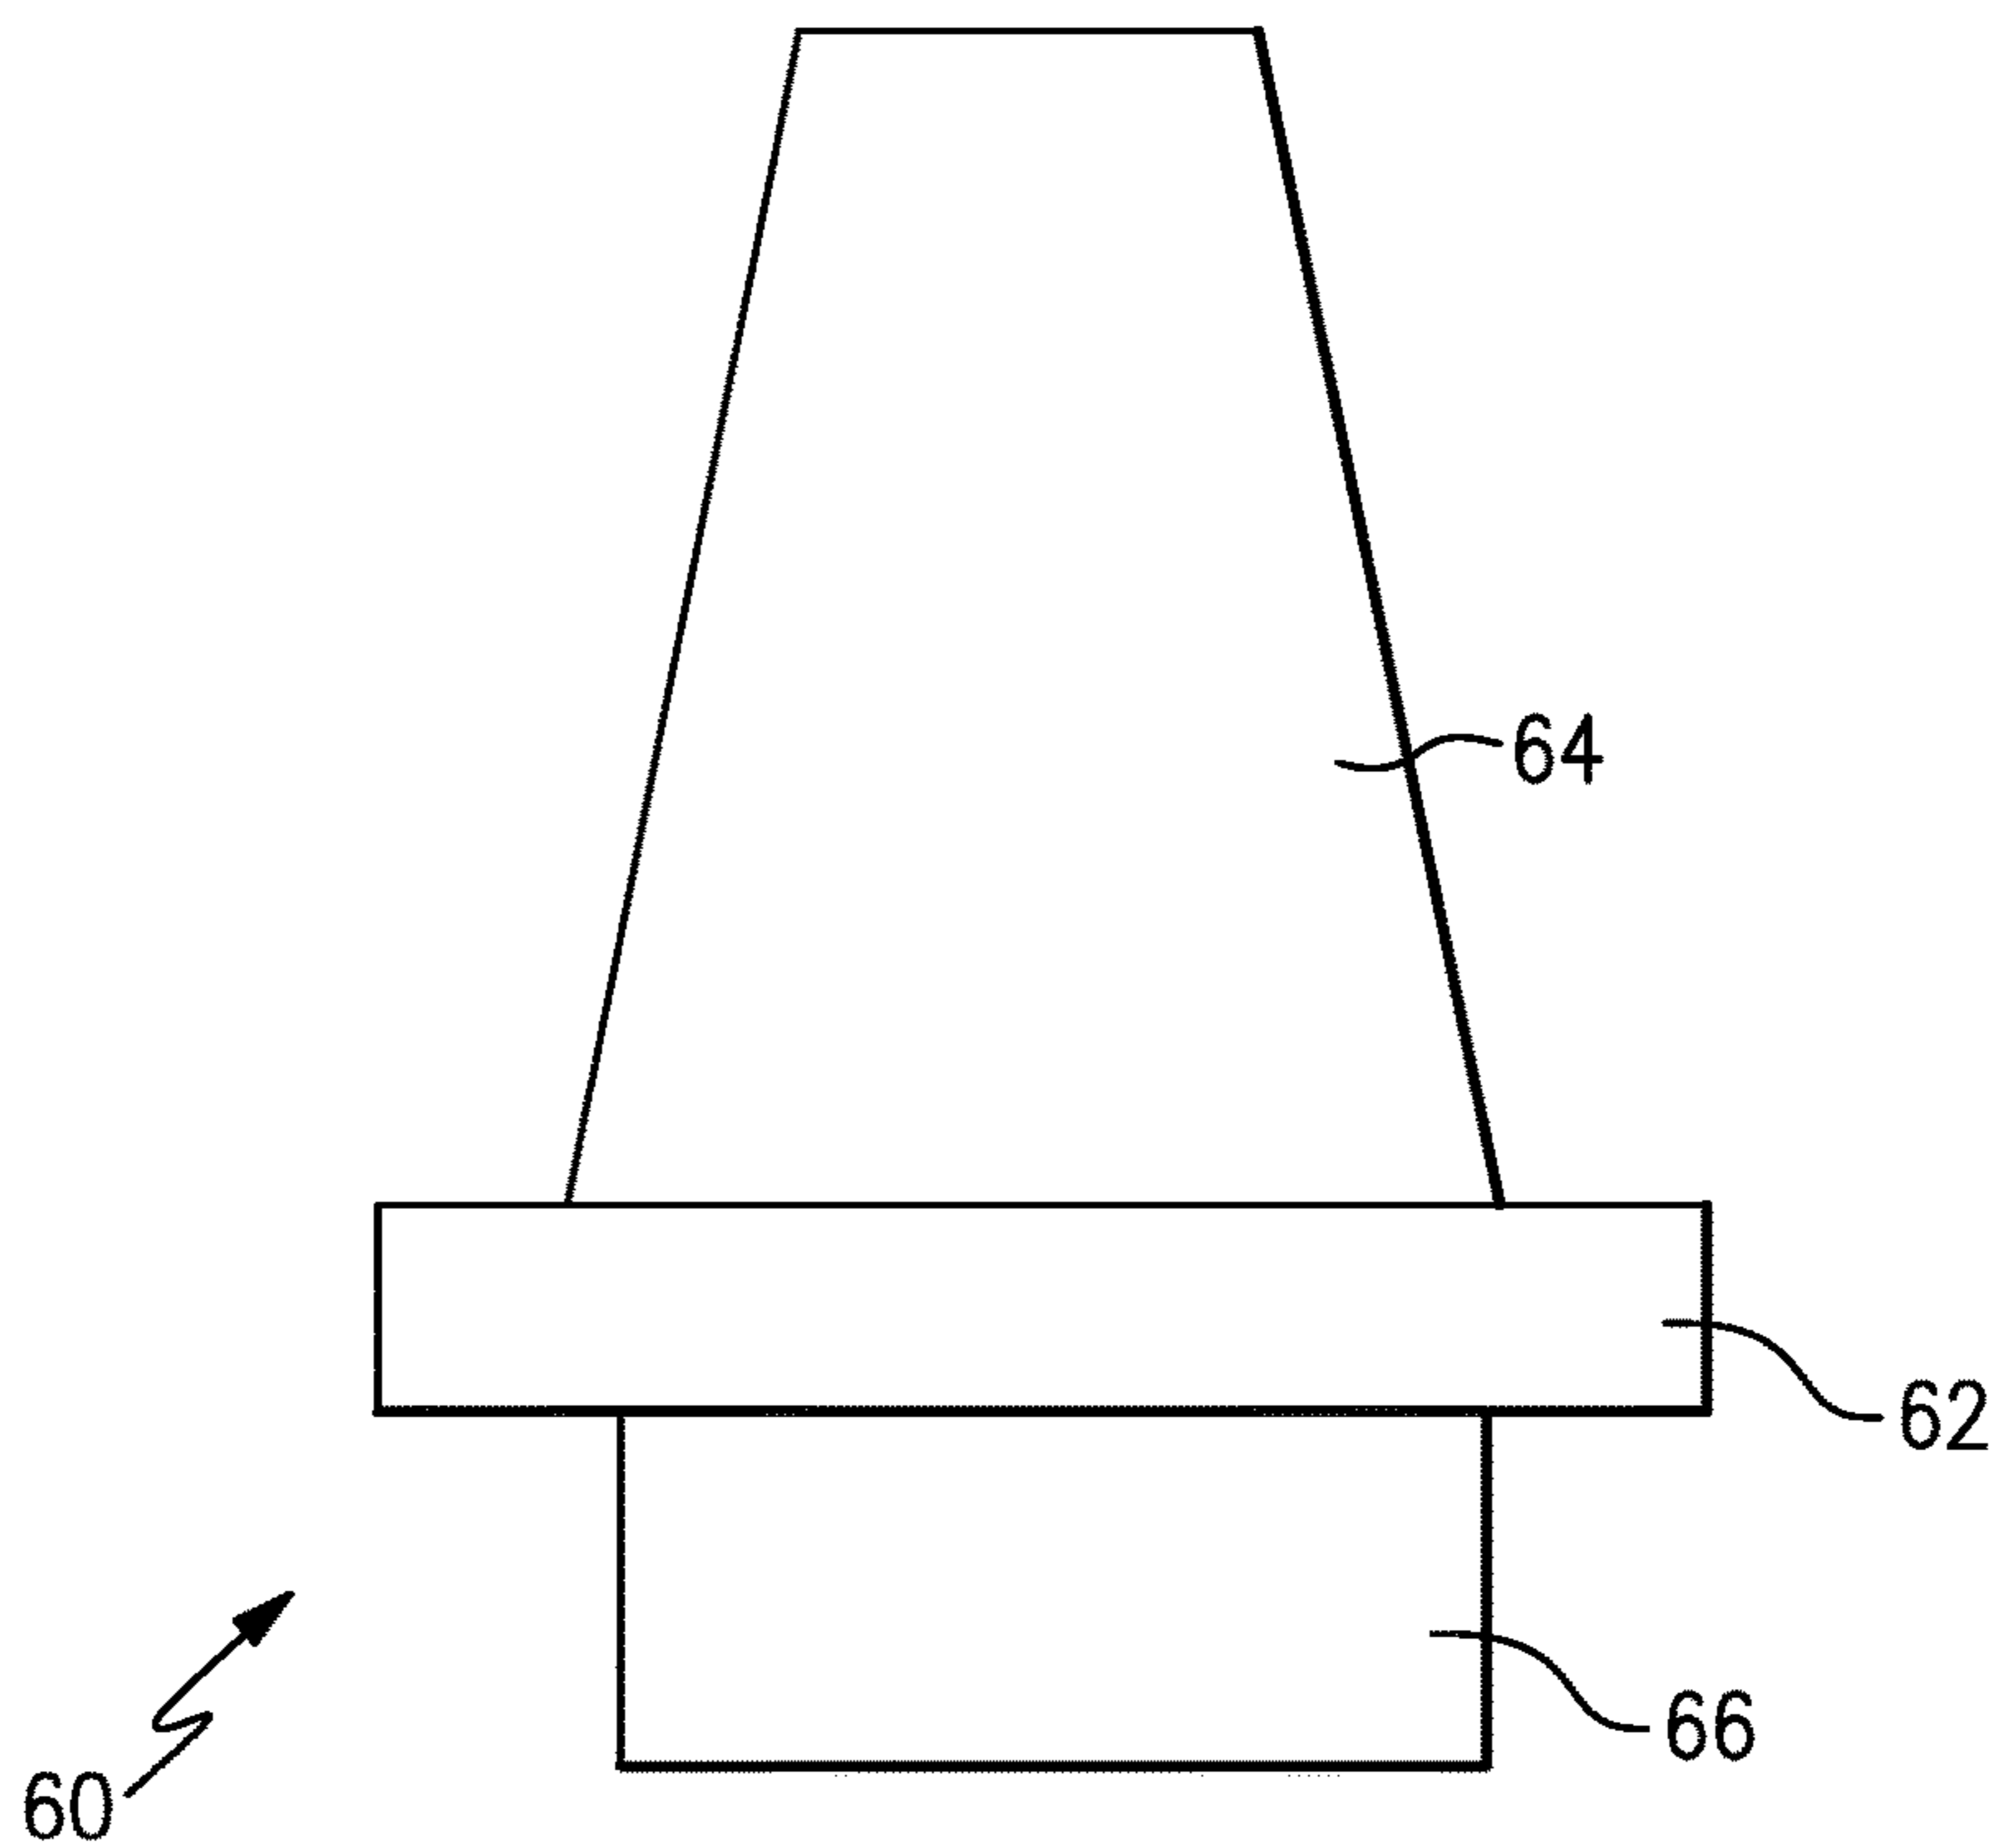
FIG. 2 illustrates an example article subject to repair.

FIG. 2 illustrates an example article 60. In this example, the article 60 is a rotatable turbine blade of the engine 20 (see also FIG. 1). It is to be understood that, although the examples herein may be described with reference to the turbine blade, this disclosure is also applicable to static turbine vanes, other types of airfoils, seals, combustors, or other gas turbine engine components.

The turbine blade generally includes a platform 62, an airfoil section 64 that extends from the platform 62, and a root 66. The article 60 is subjected during use to extreme temperatures in the engine 20. The article 60 includes a coating system to protect against the high temperatures and environmental effects that might otherwise damage the article 60. The coating system may include a ceramic barrier coating. Such ceramic barrier coatings can be subject to damage during use, such as damage from spalling, erosion, or wear. From time to time and inasmuch as feasible, such articles are repaired in order to extend use.

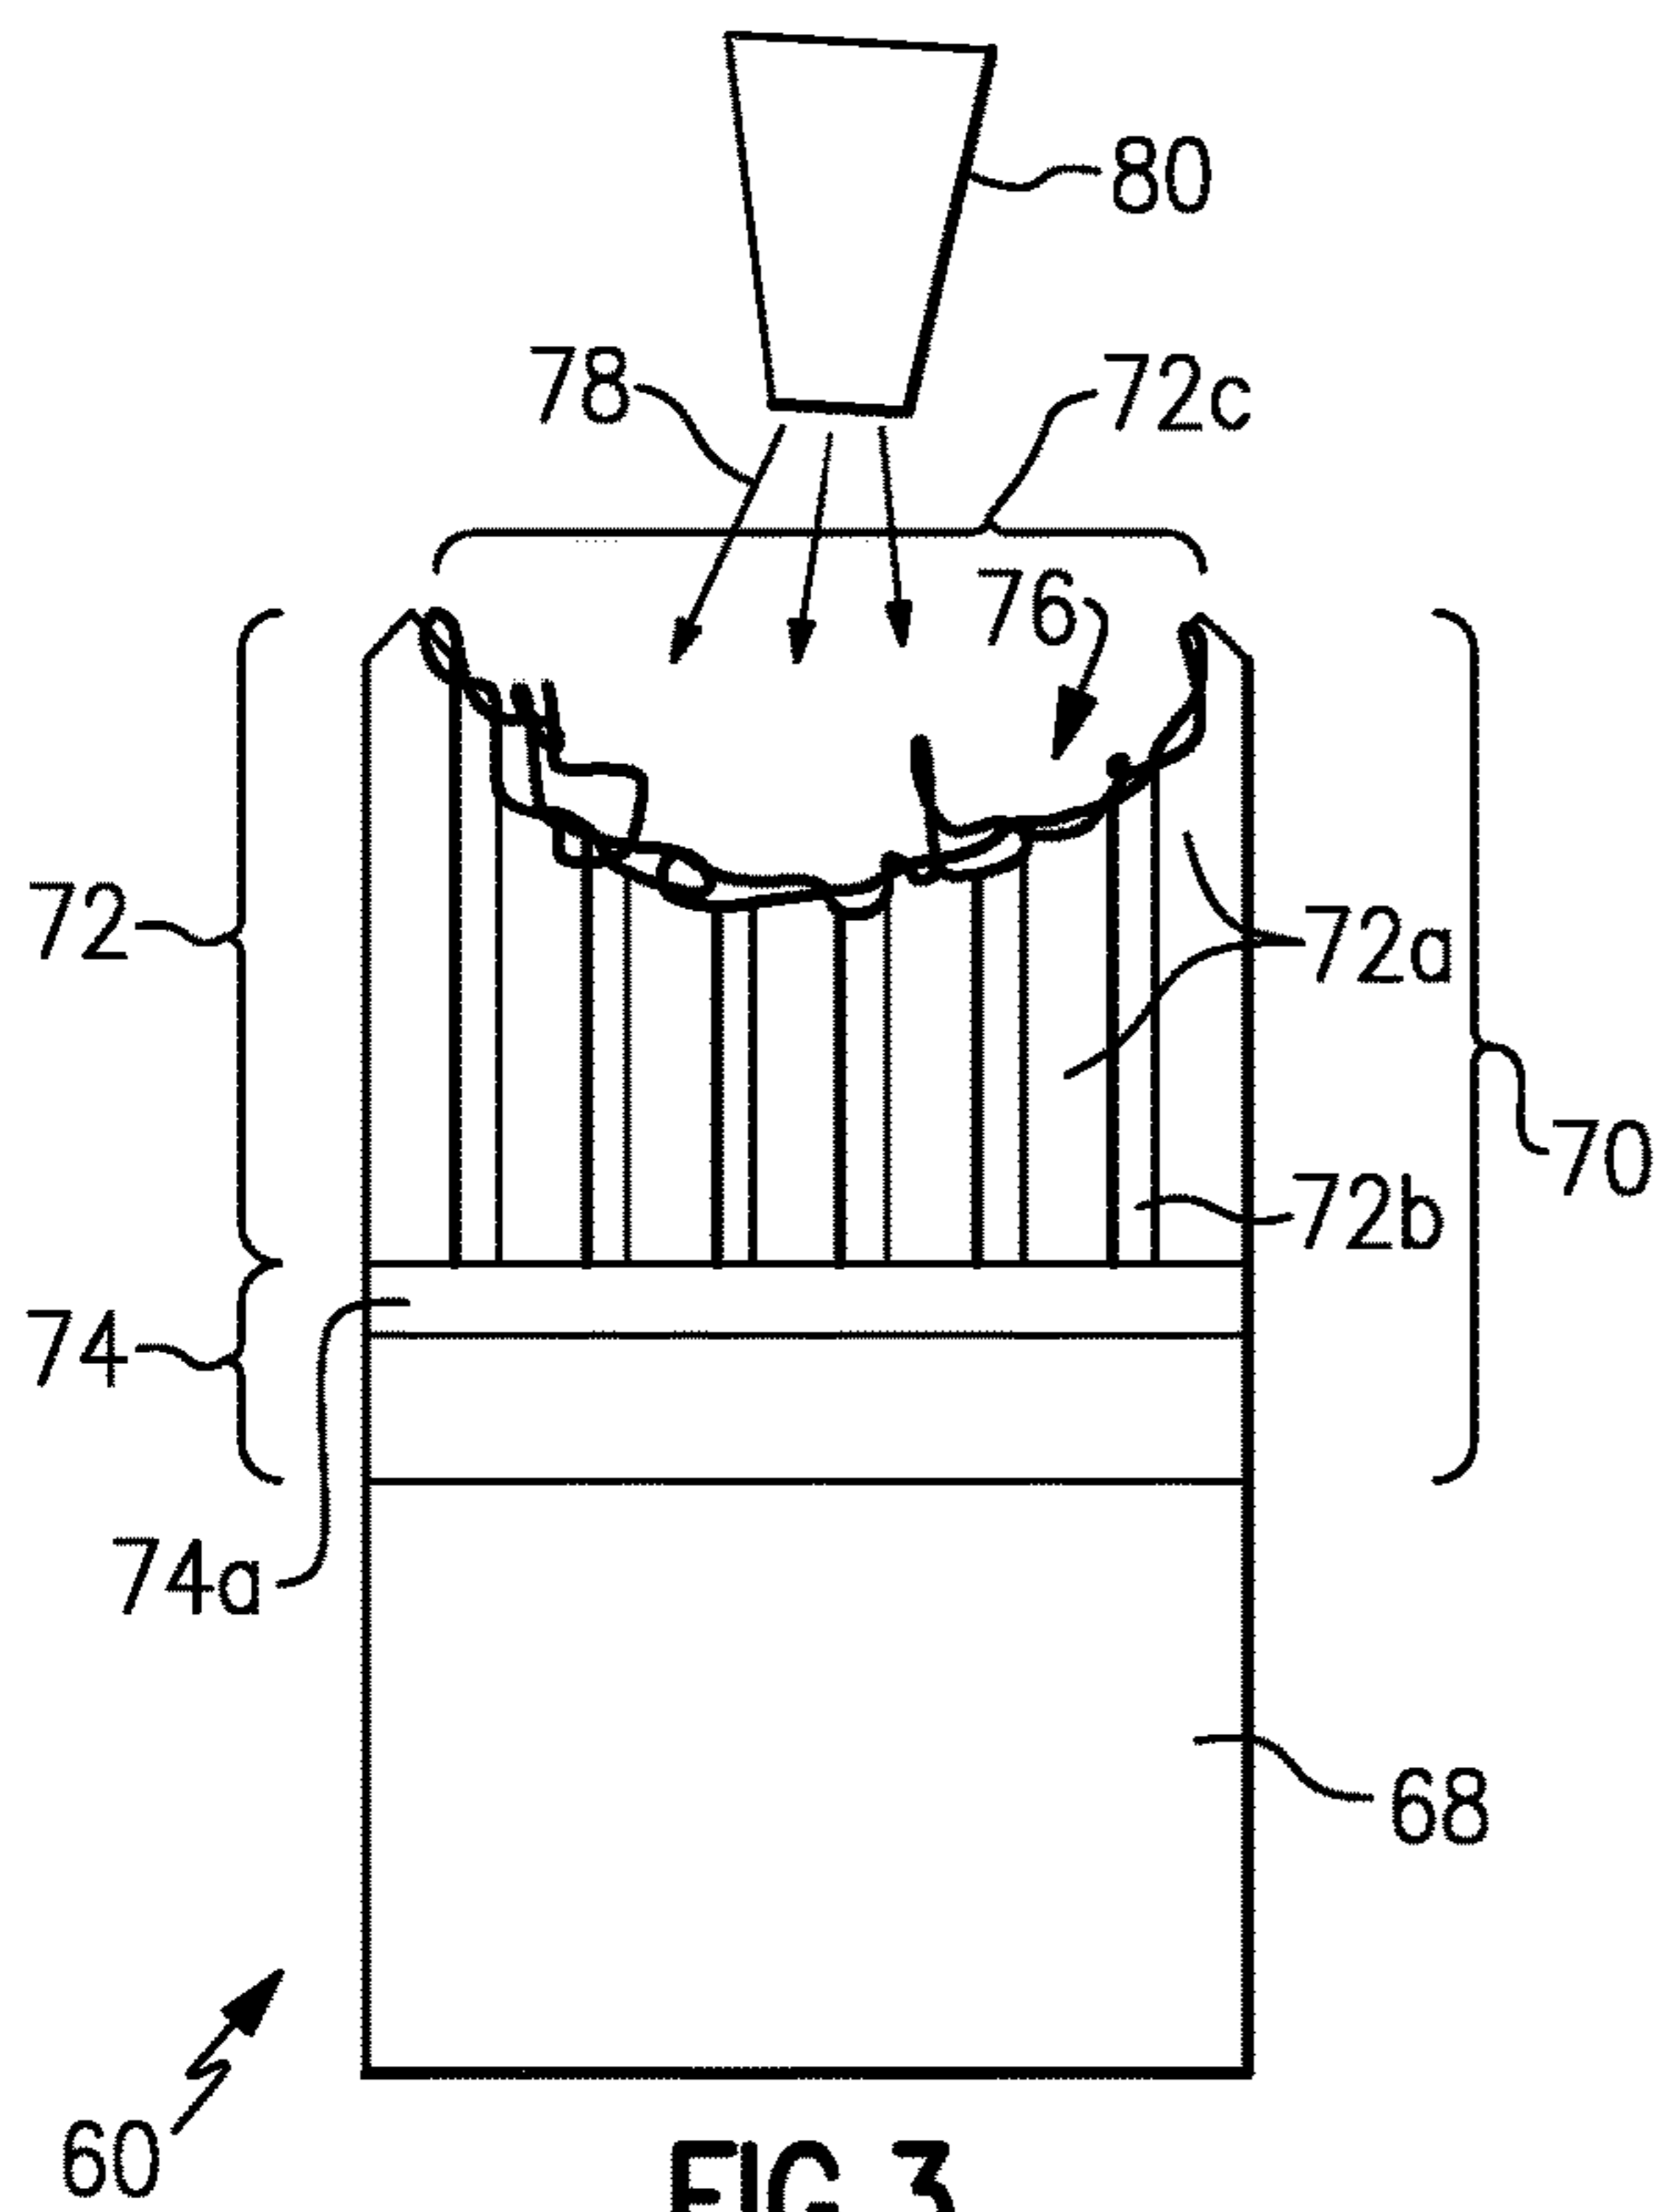
FIG. 3 illustrates a view of a representative portion of the article of FIG. 2 during a repair process involving abrading the article.

The next step in the repair process includes abrading the damaged region **72c**. The depression **76** may contain debris or other undesirable substances which could be detrimental to the ceramic barrier coating **72** or hinder the remainder of the repair process. In this respect, the abrading facilitates removal of much or all of the debris, as well as possibly small portions of the ceramic barrier coating **72** in the vicinity of the damaged region **72c**. The abrading thereby produces a fresh, clean surface in the ceramic barrier coating **72**.

As an example, the abrading may include spraying an abrasive media **78** from a spray nozzle **80** onto the damaged region **72c**. For instance, the abrasive media **78** may be carried in a pressurized process gas. The abrasive media **78** strikes the damaged region **72c** and thereby removes the debris and possibly portion of the ceramic barrier coating **72**. The pressure of the process gas may be controlled in order to control removal of the debris and ceramic barrier coating **72**. In one example, the abrasive media **78** includes particles of dry ice, which is solid carbon dioxide. The dry ice facilitates clean removal because it is substantially non-reactive at normal pressure and temperature (NTP) with the ceramic barrier coating **72** and thus does not leave residue or stains. Additionally, the dry ice rapidly evaporates and thus does not leave a mess.

FIGS. 3, 4, and 5 depict an example repair process for a representative portion of the article 60. For a turbine blade, the portion may be on the platform 62, airfoil section 64, or root 66. As will also be appreciated, the article 60 may have numerous portions which are repaired in a similar manner as described below.

The article 60 is formed of a substrate 68 and a coating system 70. Most typically, the substrate 68 will be formed of a superalloy, such as a nickel- or cobalt-based alloy. Alternatively, the substrate 68 may be formed of a ceramic or ceramic composite material.

The coating system 70 includes a ceramic barrier coating 72 disposed on the substrate 68. An optional bond coat 74 that has a thermally grown oxide region 74a is disposed between the ceramic barrier coating 72 and the substrate 68. The bond coat 74 may be MCrAlY, where M is nickel, iron or cobalt, Cr is chromium, Al is aluminum, and Y is yttrium. A portion of the bond coat 74 may oxidize to form the thermally grown oxide region 74a, which facilitates bonding of the ceramic barrier coating 72.

As an example, the ceramic barrier coating 72 is formed primarily of zirconium oxide. For instance, the zirconium oxide may be a stabilized or partially stabilized zirconia, such as yttrium stabilized zirconia or gadolinia stabilized zirconia, or a zirconate that is doped with a rare earth stabilizer, such as yttria or gadolinia. The ceramic barrier coating 72 may, for example, be deposited by plasma spray or physical vapor deposition, which generally result in a porous structure.

In the illustrated example, the ceramic barrier coating 72 has a columnar microstructure, represented schematically by

microstructural columns **72a**. Such a columnar microstructure is a result of fabrication by electron beam physical vapor deposition. The columns **72a** are substantially perpendicular to the bond coat **74** and substrate **68**. There are pores **72b** defined by the gaps between the columns **72a**. Such a columnar microstructure facilitates coating durability.

The repair process begins with the providing of the article **60** for repair, where the ceramic barrier coating **72** has a damaged region **72c**. The “providing” may include identifying that the article **60** is in need of repair. In this regard, known inspection techniques may be used to detect and assess damage. More typically however, the article for repair will have already been identified and the “providing” may refer to the selection of the article to begin the repair process.

The damaged region **72c** may be a region of the ceramic barrier coating **72** which has a physical deformity or imperfection, especially to a point that is unacceptable for the given article **60**. Most typically, the damaged region **72c** will be the result of physical phenomena that are incurred during use of the article **60** in its intended operating environment. As an example, the phenomena may be related to thermal-mechanical stresses that cause spallation, impact events that cause erosion, rubbing events that cause wear, or combinations of these. In these regards, the physical deformity may be a spalled, eroded, and/or worn portion of the ceramic barrier coating **72**. Alternatively, damage may be incurred prior to use or outside of use, such as during handling and transport of the article **60**. In the illustrated example, the physical deformity is a depression **76** in the ceramic barrier coating **72**. In another alternative, the physical deformity may be an imperfection, such as a crack or void, that results from original fabrication of the ceramic barrier coating **72**. For instance, a fabrication imperfection that renders the article **60** unacceptable for its intended use may be repaired using the disclosed repair process to render the article acceptable for its intended use.

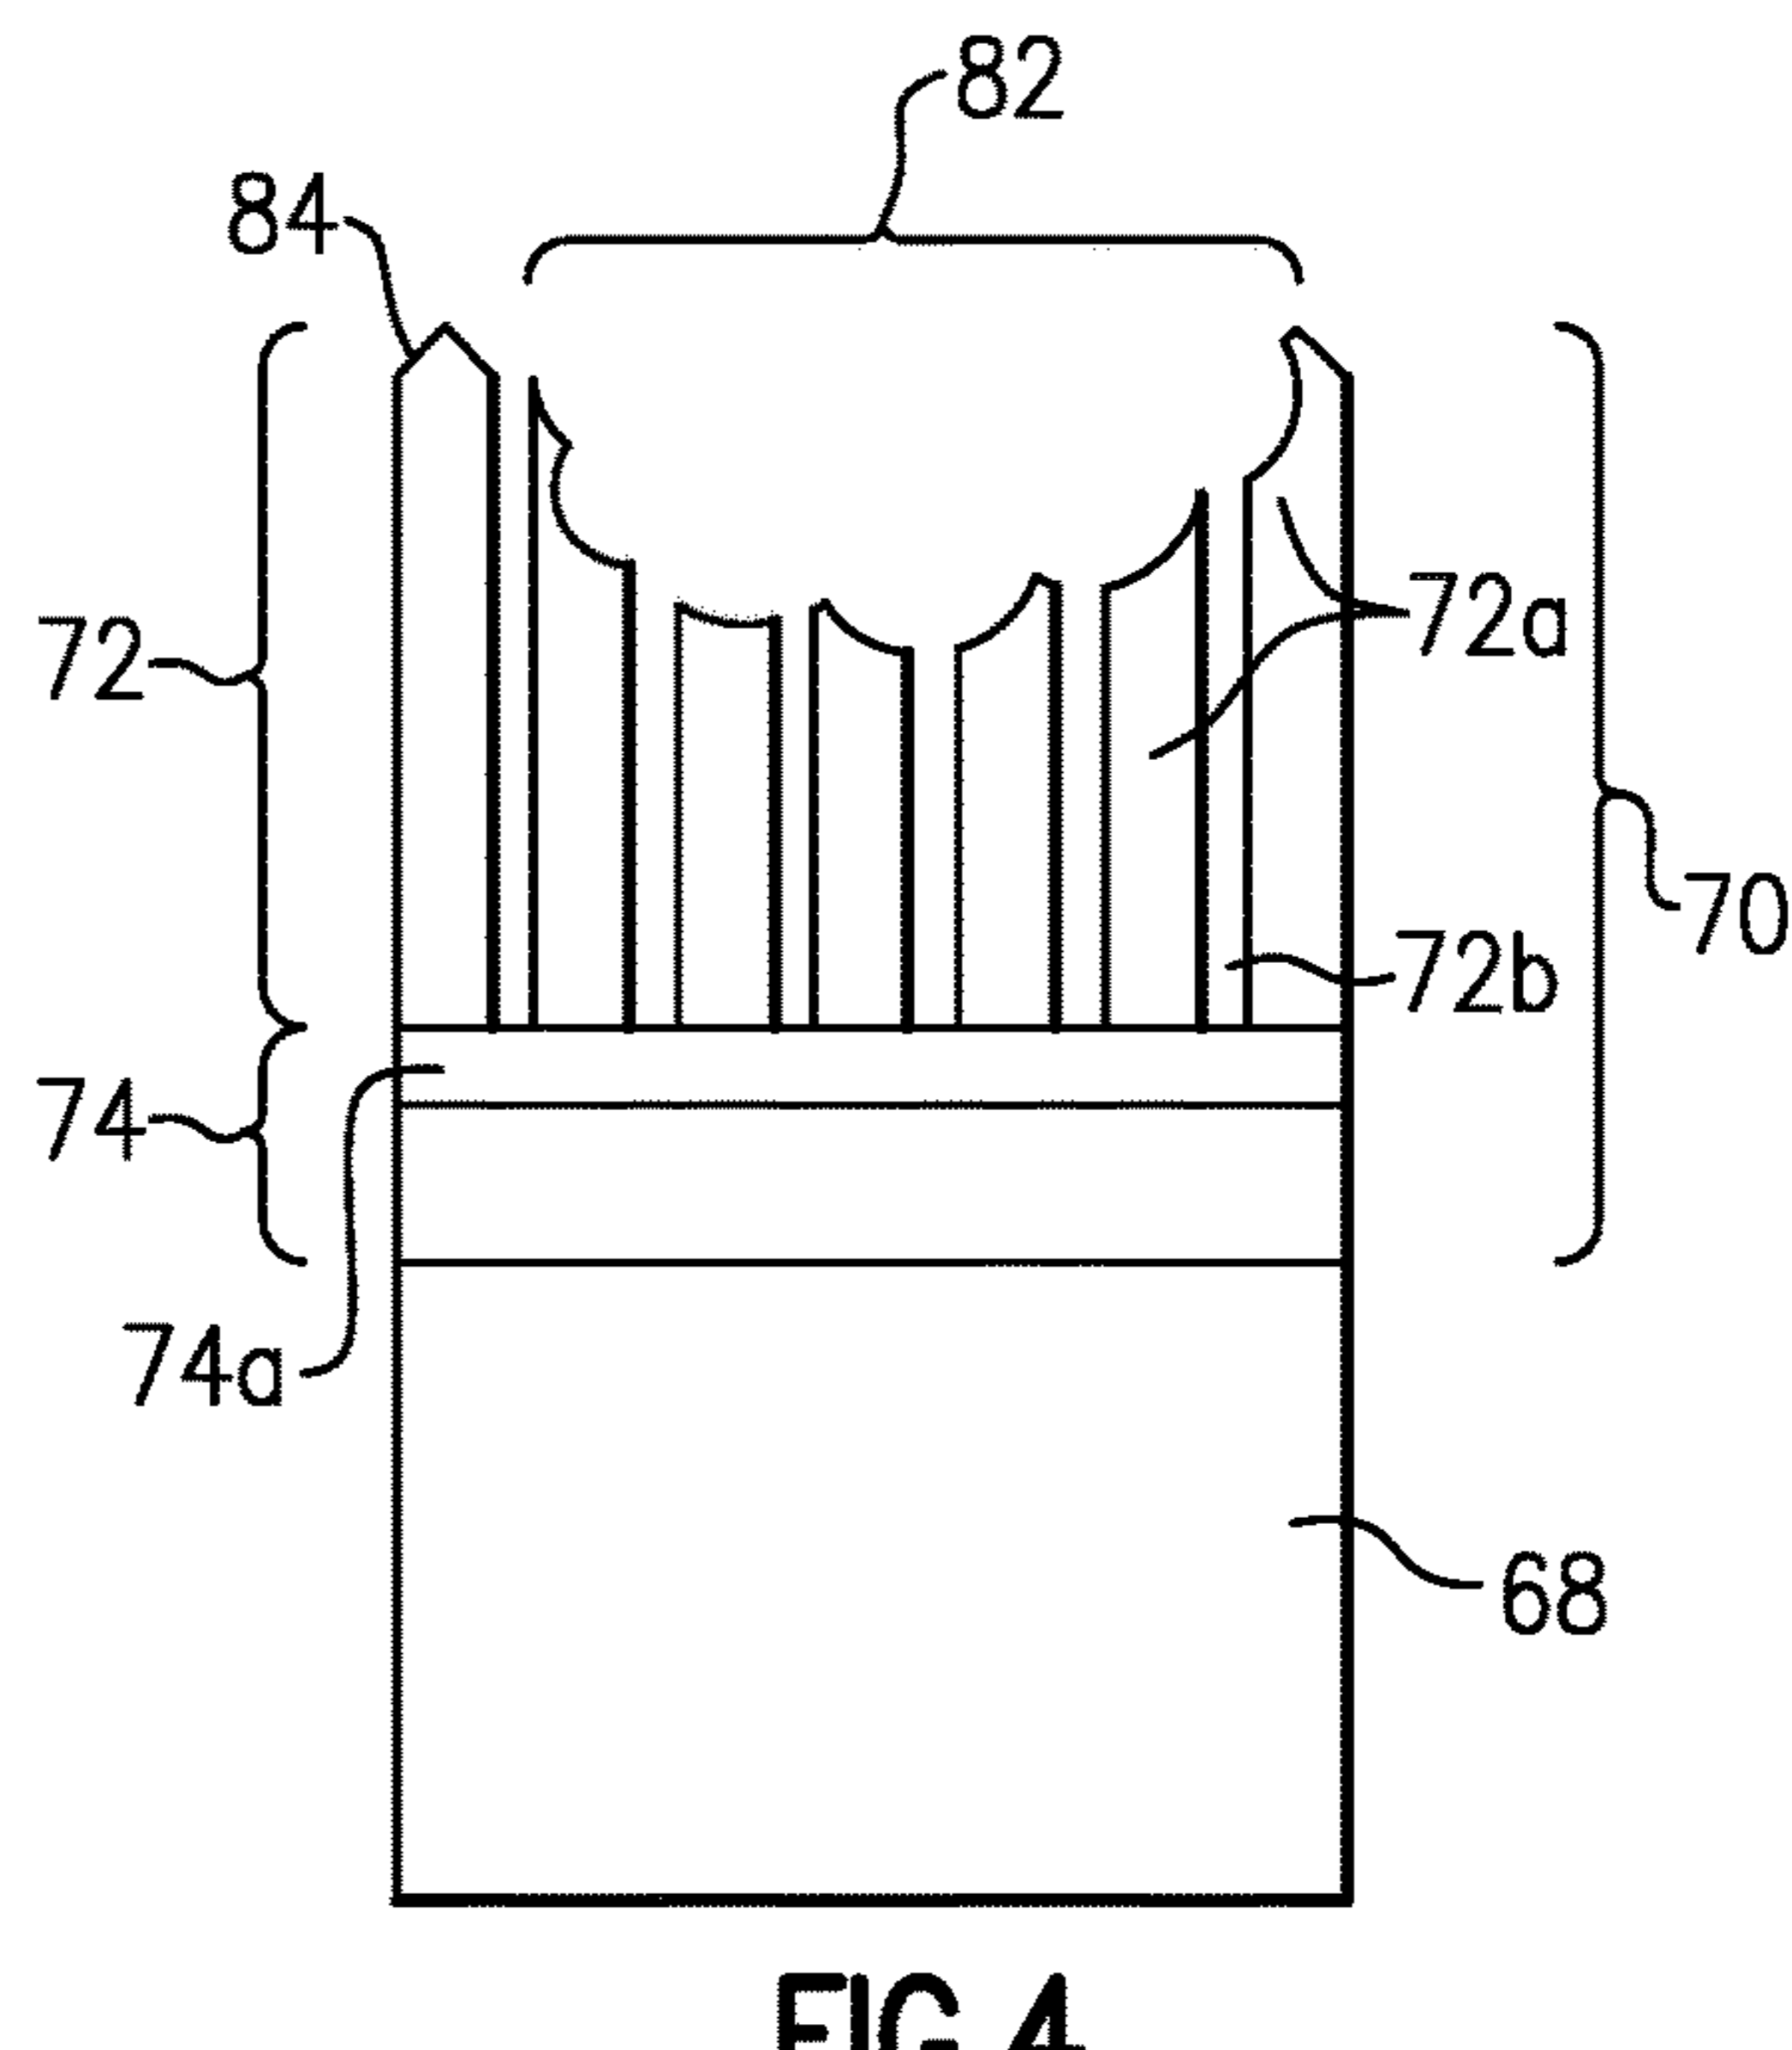
FIG. 4 illustrates the article of FIG. 3 during the repair process after abrading the article.

FIG. 4 depicts the article **60** after the abrading. The abrading has removed debris and a portion of the ceramic barrier coating **72** such that a dimple **82** remains in the ceramic barrier coating **72**. A remaining region of the ceramic barrier coating, a representative portion of which is

shown at **84**, adjacent the dimple **82** remains intact after the abrading step. For instance, “intact” may refer to this region as being unchanged in physical character before and after the abrading. In this example, the dimple **82** is only modestly larger than the damaged region **72c** and does not extend entirely through the thickness of the ceramic barrier coating **72**.
