(10) **Patent No.:** **US 10,919,180 B2**
(45) **Date of Patent:** **Feb. 16, 2021**

(54) **REPAIR PROCESS USING NETWORKED CERAMIC NANOFIBERS**

(71) Applicant: **United Technologies Corporation**,
Farmington, CT (US)

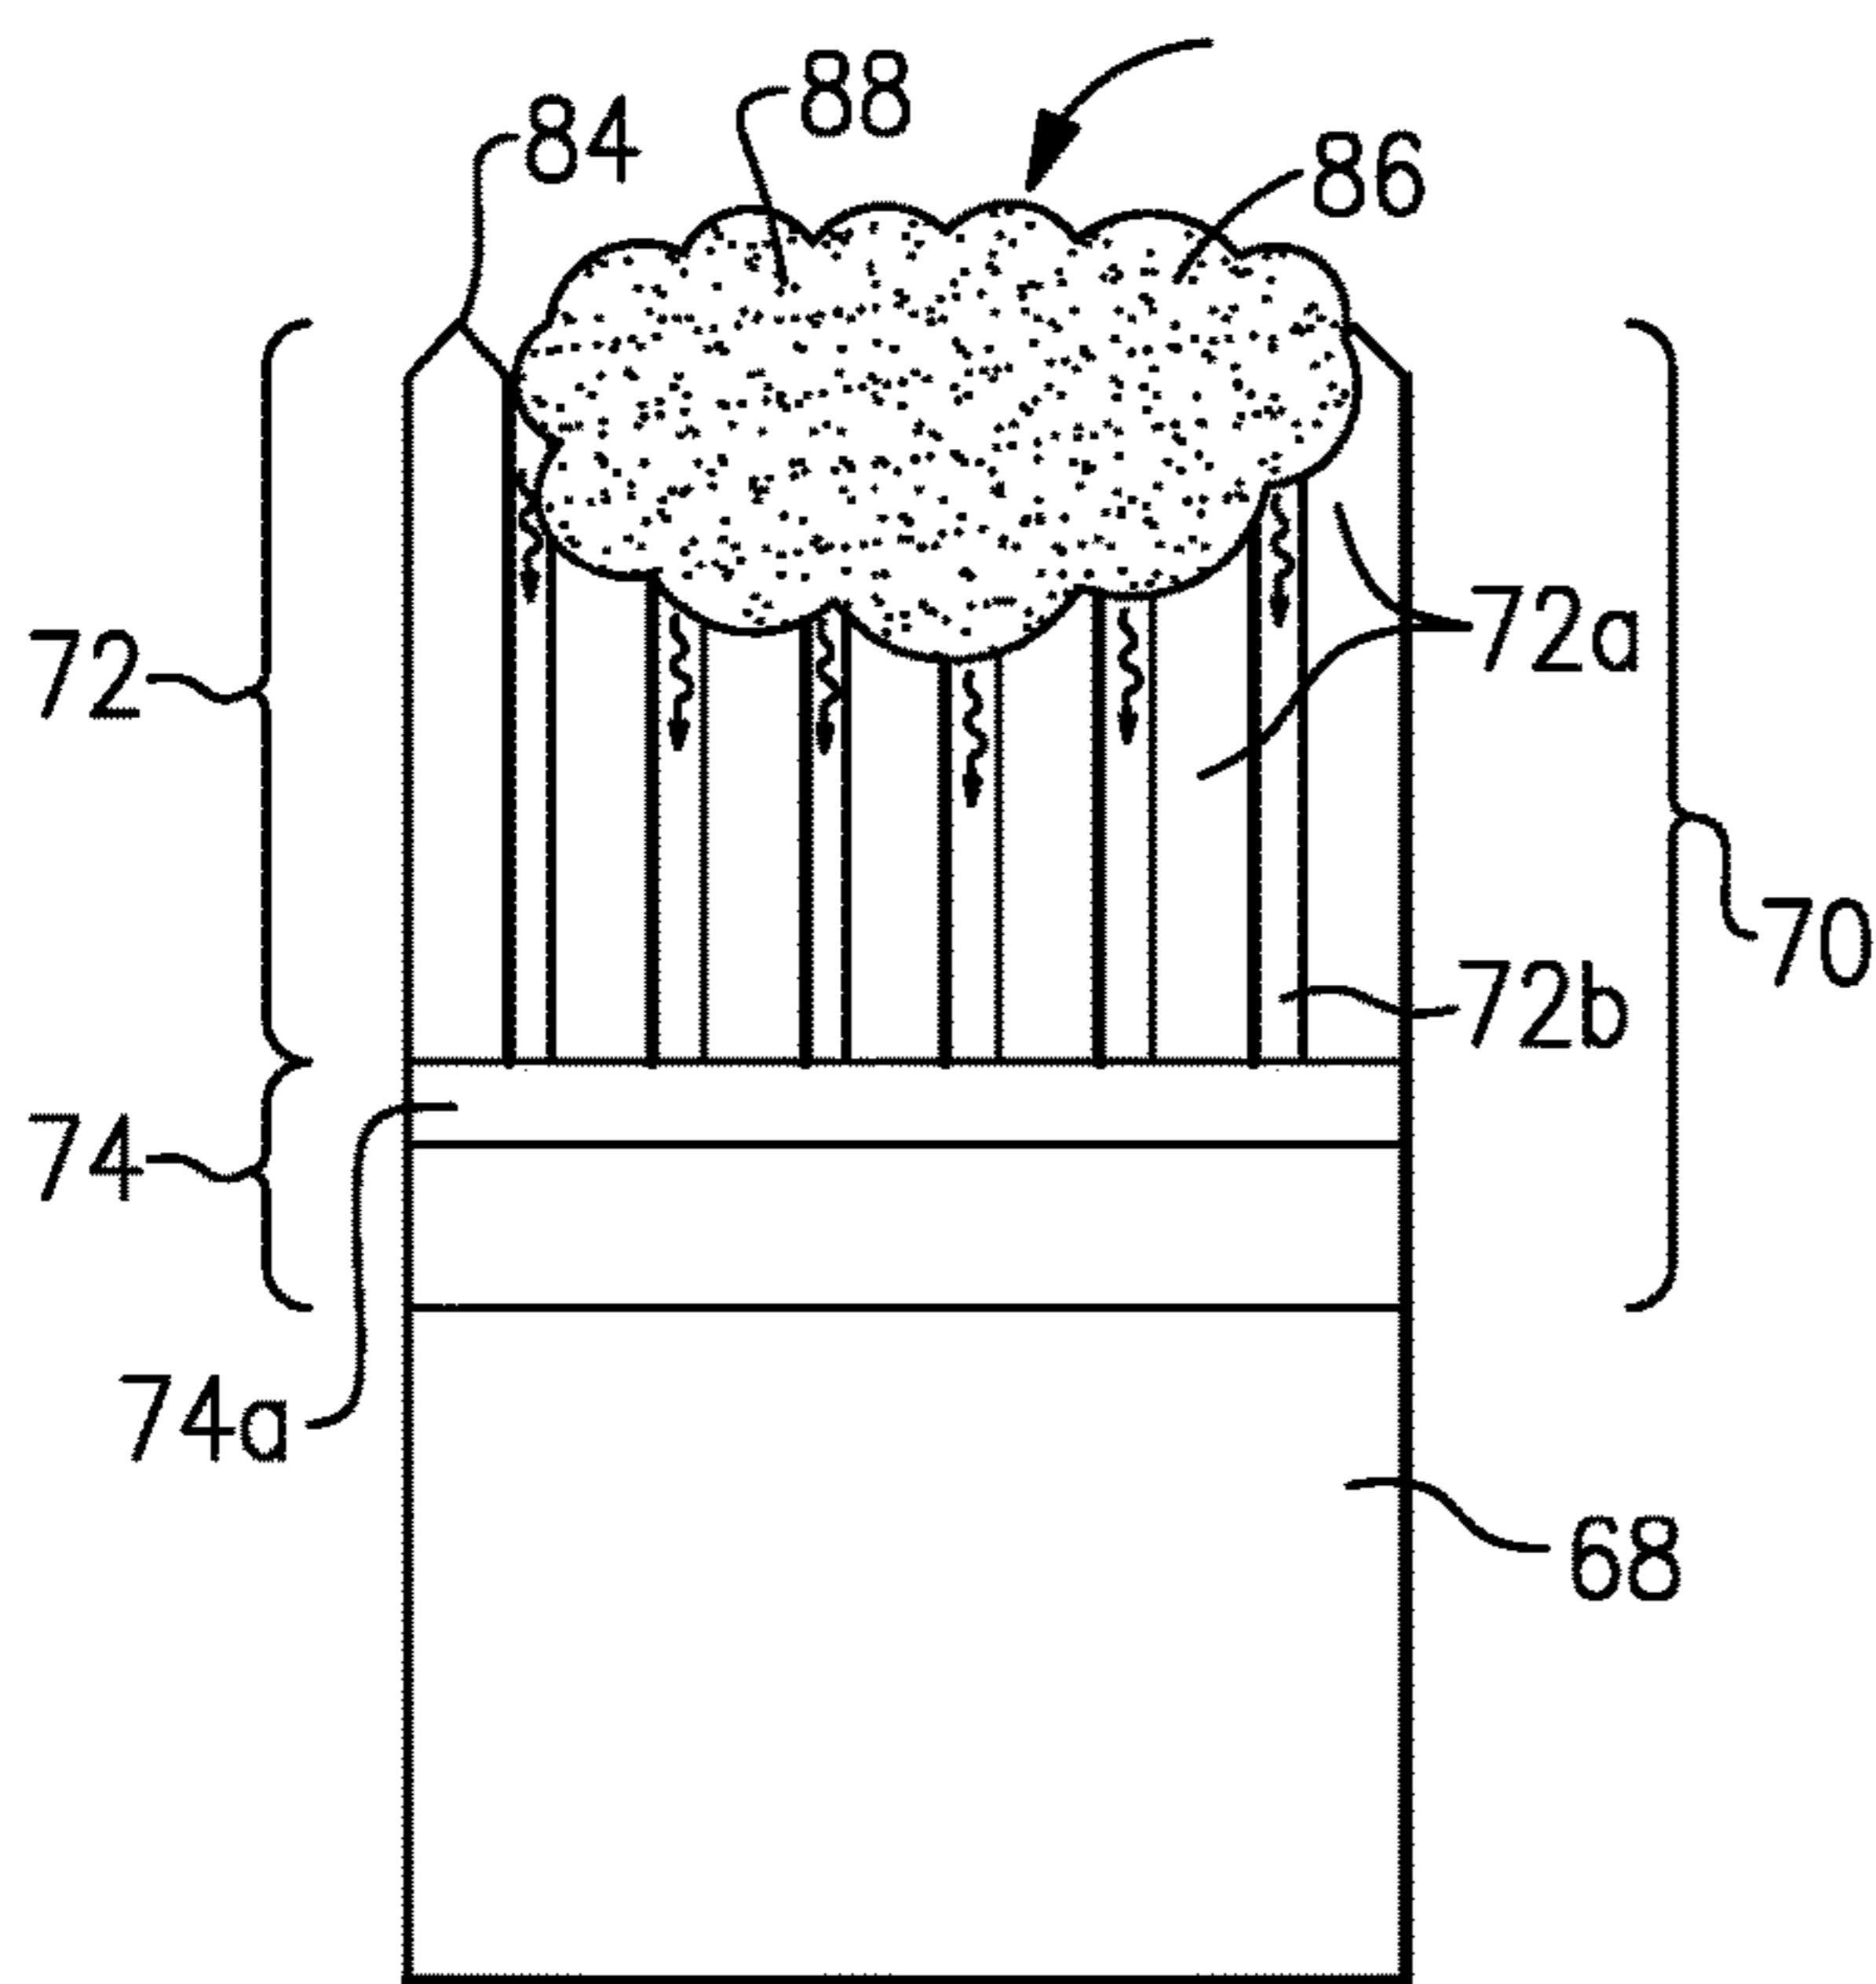
FIG. 5 illustrates the article of FIG. 4 during the repair process involving deposition of a patch of networked ceramic nanofibers.

The next step in the repair process, depicted in FIG. 5, is the deposition of a patch **86** into the dimple **82**. The patch **86** is composed of networked ceramic nanofibers **88**. FIG. 6 illustrates a magnified view of the networked ceramic nanofibers **88**. The nanofibers **88** are elongated, randomly oriented filaments that have a maximum diameter of 1 nanometer to 500 nanometers. More typically, the diameter will be 1 nanometer to 250 nanometers, 1 nanometer to 100 nanometers, or 1 nanometer to 50 nanometers. The filaments are non-linear and curve or turn such that the filaments are intertwined to form a tangled porous network. As used herein, “networked” refers to the intertwining of the fibers or filaments. Where the filaments contact each other, they may be bonded together as a result of the process used to form the patch **86**.

The patch **86** of networked ceramic nanofibers **88** fills the dimple **82** and seals the pores **72b** of the ceramic barrier coating **72**. The nanofibers **88** may also mechanically interlock with the surface roughness in the dimple **82** that results from the abrading, thereby providing good bonding between the patch **86** and the ceramic barrier coating **72**. In that regard, the pressure of the process gas may also be controlled to produce a desirable level of roughness for mechanical interaction with the nanofibers **88**.

The pores **72b** in the ceramic barrier coating **72** may be prone to infiltration of debris and other material during use of the article **60** that could damage the ceramic barrier coating **72**, bond coat **74**, or underlying substrate **68**. In particular, since the pores **72b** are also substantially perpendicular to the bond coat **74** and substrate **68**, they can provide a direct path of infiltration for CMAS (calcium-magnesium-aluminosilicate) and foreign material. In this regard, the networked ceramic nanofibers **88** seal the pores **72b** in the dimple **82**. As an example, the networked ceramic nanofibers **88** may infiltrate partially into the pores **72b** during deposition, thereby enhancing sealing.

The patch **86** of networked ceramic nanofibers **88** may be deposited directly into the dimple **82**. For example, the patch **76** of networked ceramic nanofibers **88** may be deposited by a blow-spinning process. Blow-spinning involves spraying a precursor solution through an inner nozzle while flowing a process gas from an outer concentric nozzle such that the precursor when sprayed elongates into ultra-thin filaments. The filaments deposit in the dimple **82** and, after further processing, are converted into the ceramic nanofibers. The precursor solution includes binders and salts of the constituents that will form the ceramic, such as zirconium, oxygen, and any dopants. An example binder includes polyvinylpyrrolidone, and example salts may include aqueous oxynitrate, nitrate, nitrite, or chloride salts of zirconium and the selected dopants, zirconyl chloride, or metal organics such as zirconium isobutoxide or isopropoxide in a solvent. The amounts of the constituents may be controlled in order to control the final composition of the ceramic nanofibers. After spinning, the filaments are then thermally treated to remove binders, etc. and sinter the ceramic. The thermal treatment may include heating the filaments to temperatures from 800° C. to 1000° C., for example. It is during the thermal treatment that the filaments may diffuse and thereby bond together where they are in contact. The thermal treatment may also cause diffusion at points of contact between the nanofibers **88** and the ceramic barrier coating **72**, thereby providing additional bonding.

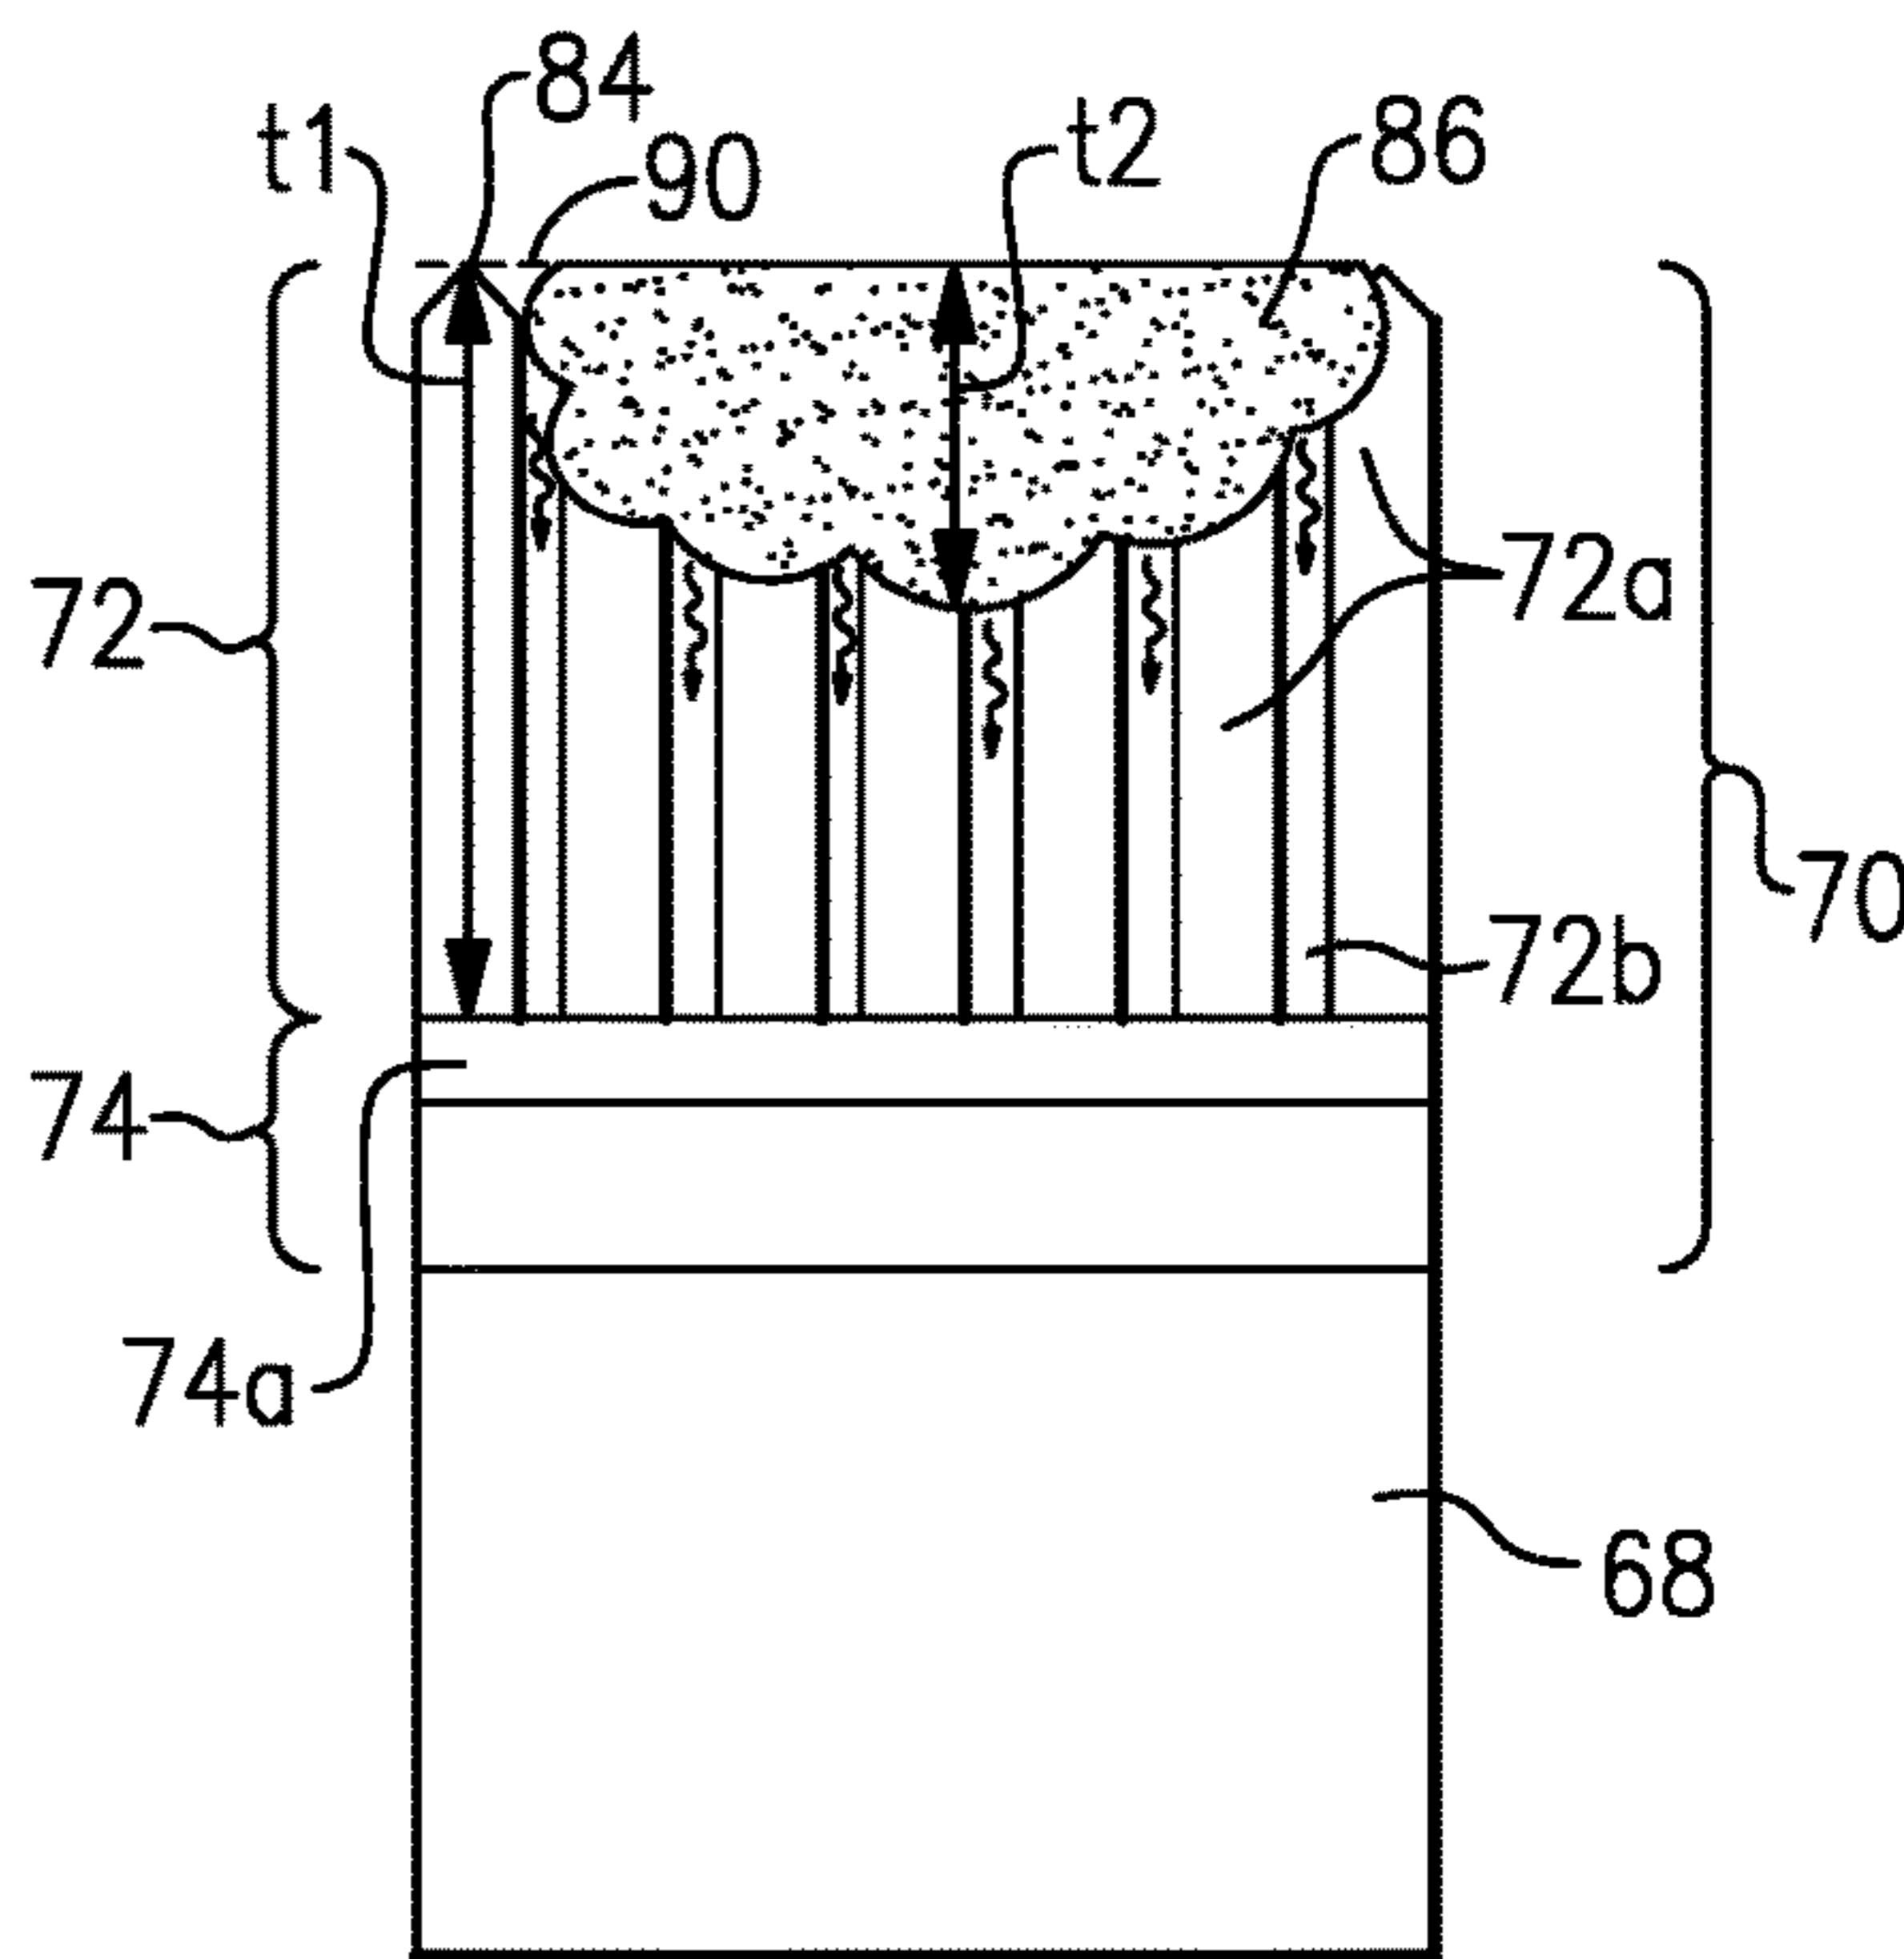
FIG. 7 illustrates the article of FIG. 5 during the repair process involving polishing the patch of networked ceramic nanofibers.

After deposition, the patch **86** may project from the ceramic barrier coating **72**, which generally has a continuous, smooth outer surface. If desired, as depicted in FIG. 7, the patch **86** can be polished such that it is flush with the remaining region **84** of the ceramic barrier coating **72** adjacent the patch **86**, as represented at **90**.

At the remaining region **84**, the ceramic barrier coating **72** may define a thickness t_1 . The patch **86** may also define a maximum thickness t_2 , wherein the thickness t_2 is less than the thickness t_1 . The thickness t_2 being less than the thickness t_1 is a representation that the patch **86** is not as thick as the ceramic barrier coating **72**. That is, the patch **86** most typically will be a relatively small piece of material that mends a relatively small region of the coating **72**. In particular, the ceramic barrier coating **72** thus has a locally thin portion at the dimple **82**. This locally thin portion, but for the patch **86**, may otherwise be prone to CMAS or foreign substance infiltration.

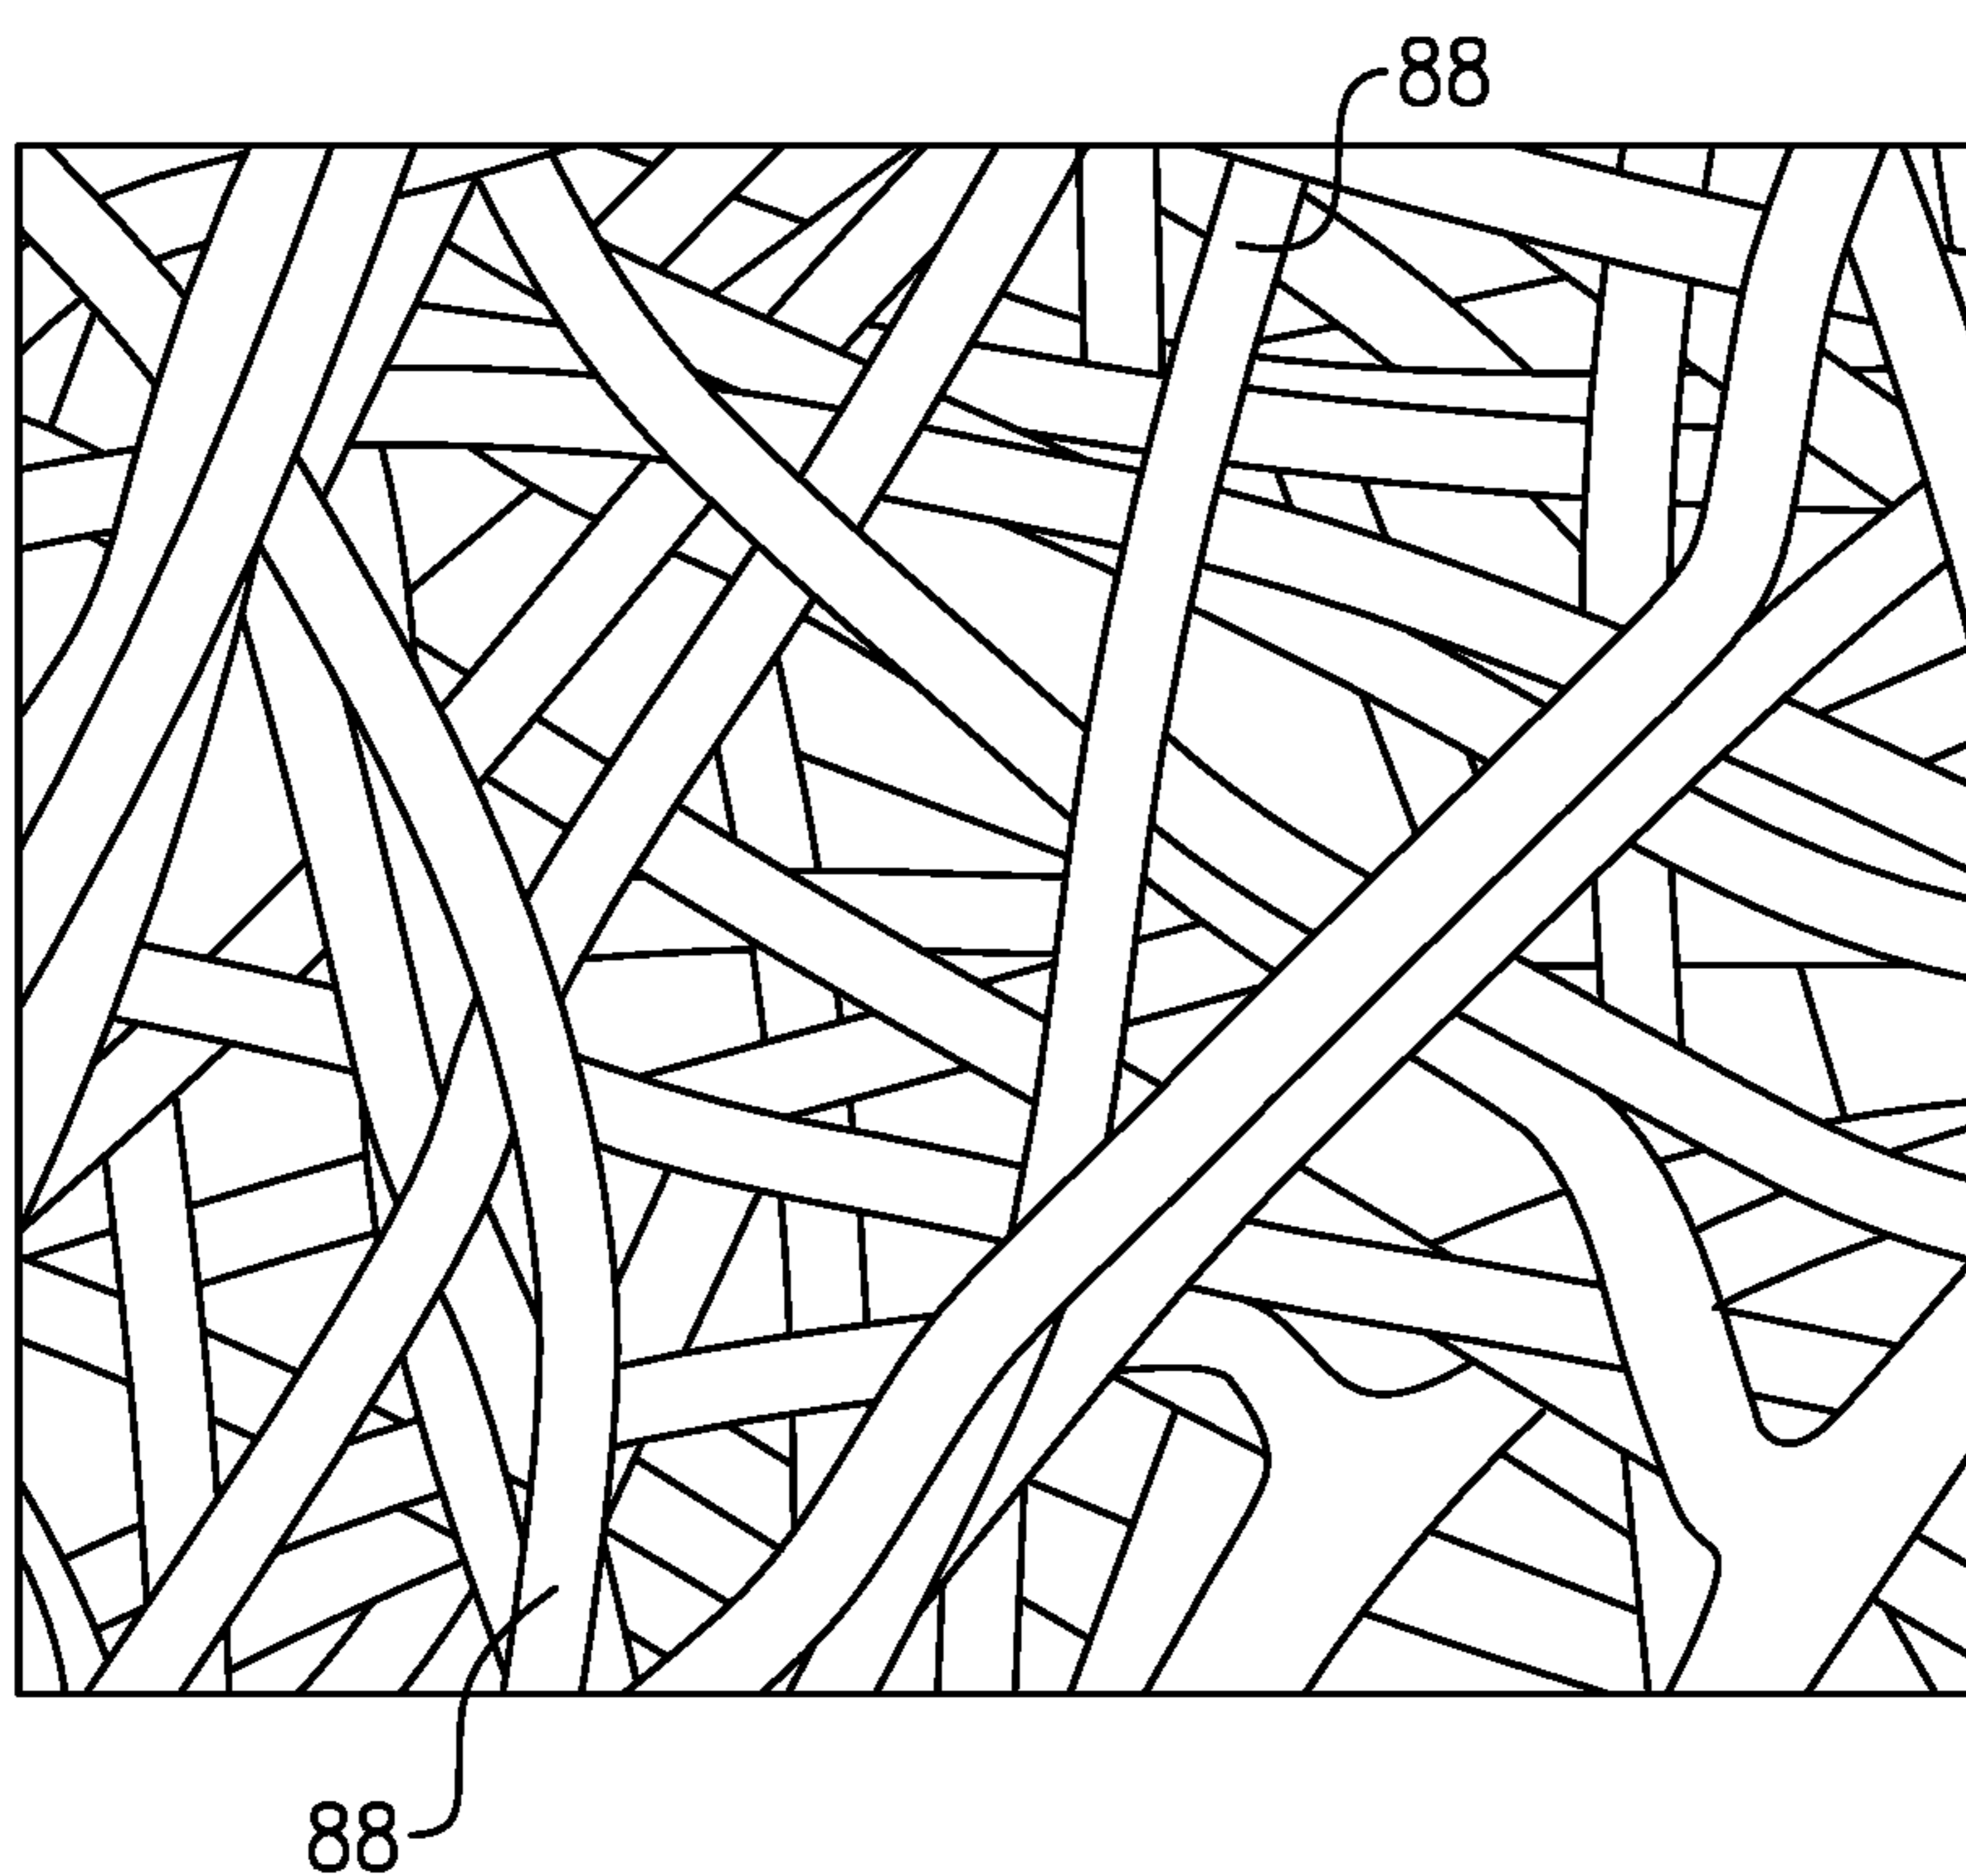
FIG.6

FIG. 6 illustrates a magnified view of networked ceramic nanofibers.

The nanofibers **88** are formed of a ceramic, such as an oxide. In one example, the ceramic is zirconium oxide. For instance, the zirconium oxide may be a stabilized or partially stabilized zirconia, such as yttrium stabilized zirconia or gadolinia stabilized zirconia, or a zirconate that is doped with a rare earth stabilizer, such as yttria or gadolinia.

Although the patch **86** of networked ceramic nanofibers **88** is itself porous, the networked ceramic nanofibers **88** provide a sponge-like structure of smaller pores that provides superior thermal insulation. Therefore, the patch **86** of networked ceramic nanofibers **88**, even if formed of the same composition as the ceramic barrier coating **72**, provides thermal sealing of the ceramic barrier coating **72**. As an example based on zirconia, the patch **86** of networked ceramic nanofibers **88** may have a thermal conductivity of approximately 0.027 Watts per meter-Kelvin.

Additionally, the filaments of the networked ceramic nanofibers **88** are also flexible and strain tolerant. The flexibility of the filaments may further facilitate entrapment of foreign particles, debris, or materials, as well as act as “bumper” to absorb impact of particles and debris. The patch **86** of networked ceramic nanofibers **88** thereby provides thermal and physical sealing/protection.
