US010927995B2

(12) United States Patent Bowler

(54) METHODS FOR REPAIRING COMPONENT

CORED PASSAGES

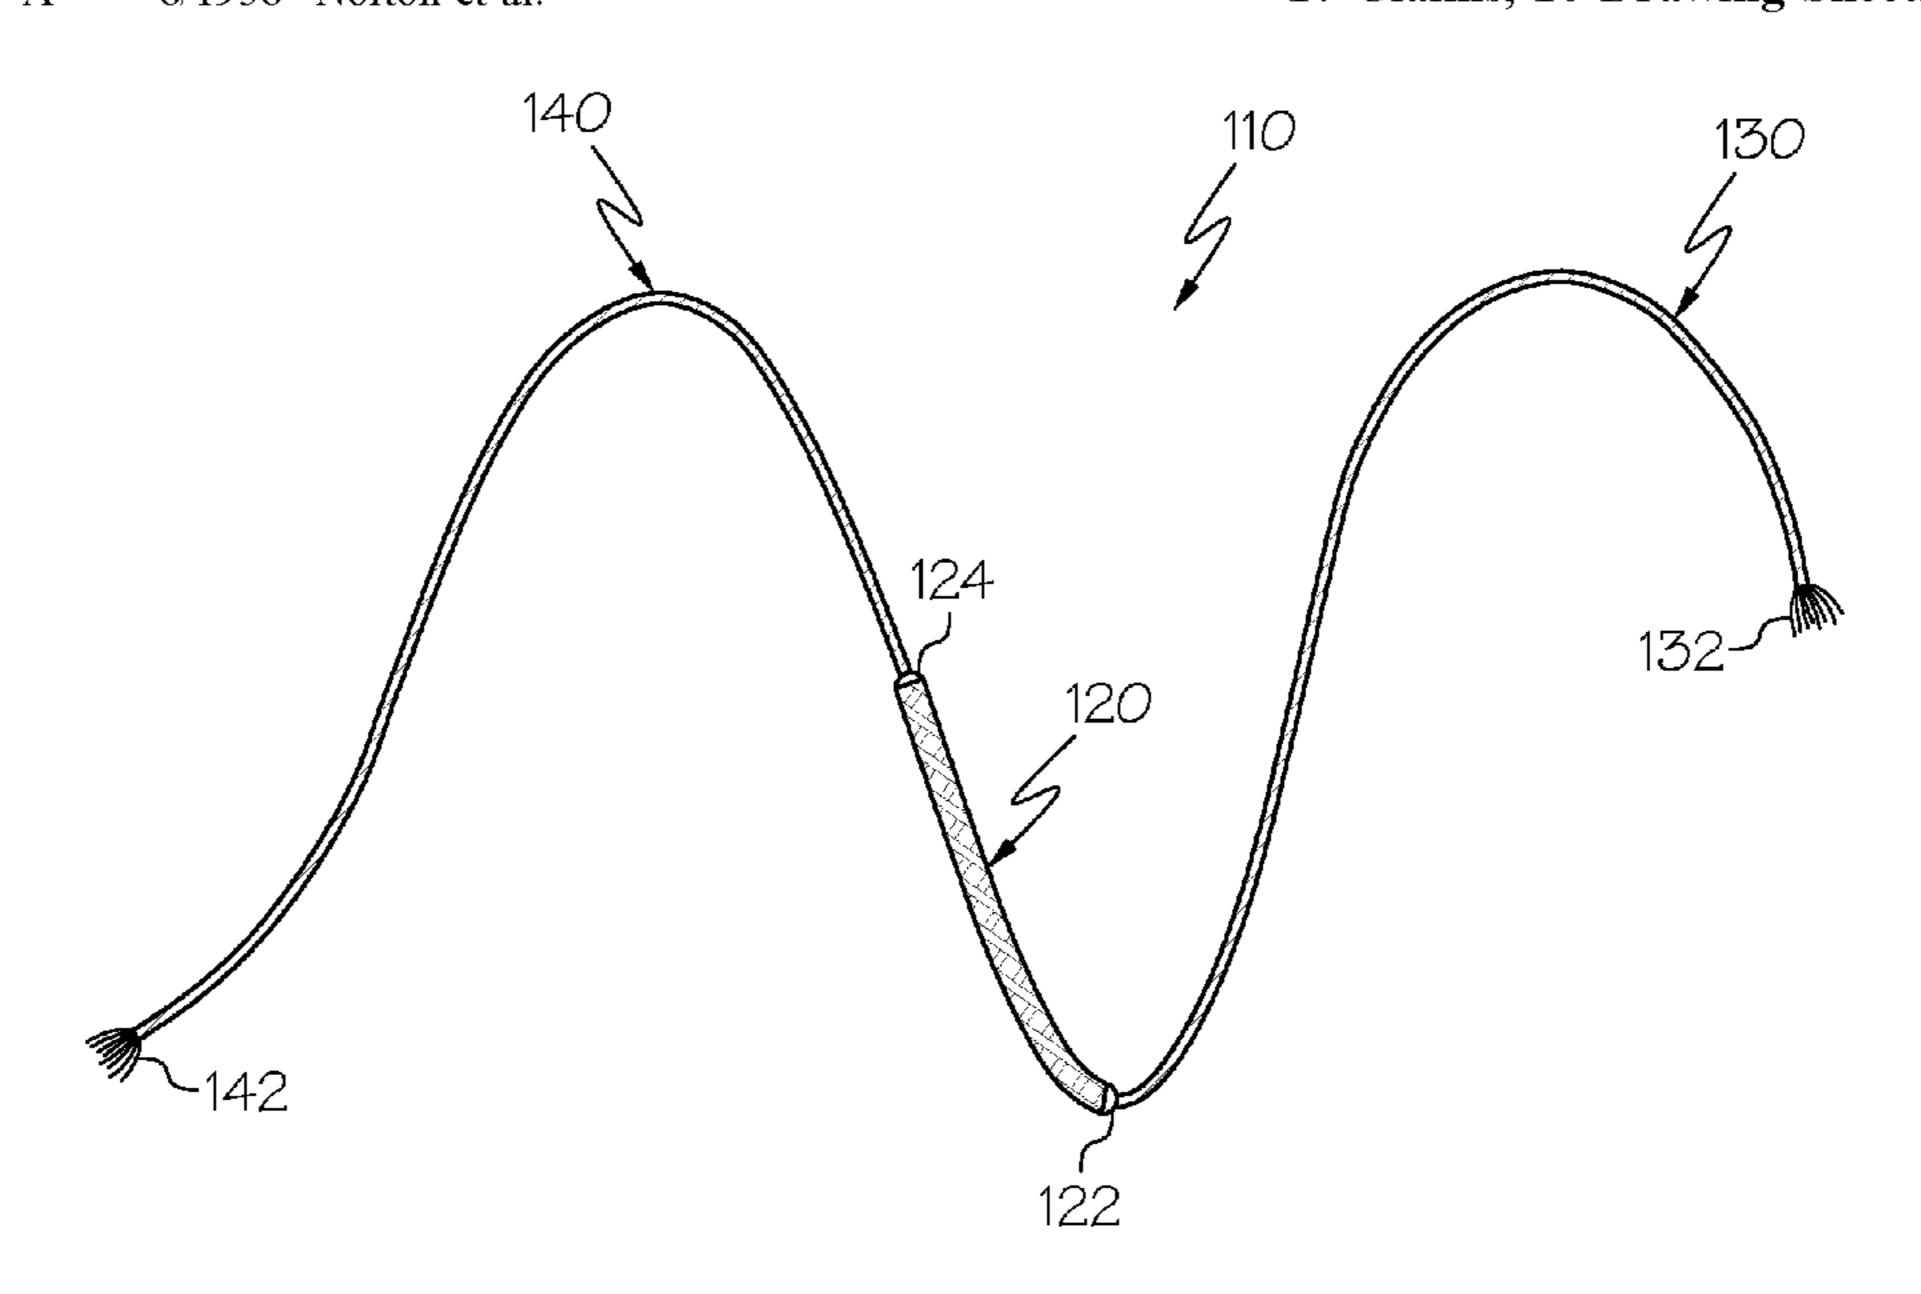
FIG. 1 is a side view of a repair tool for repairing manufactured cored passages in accordance with an exemplary embodiment;

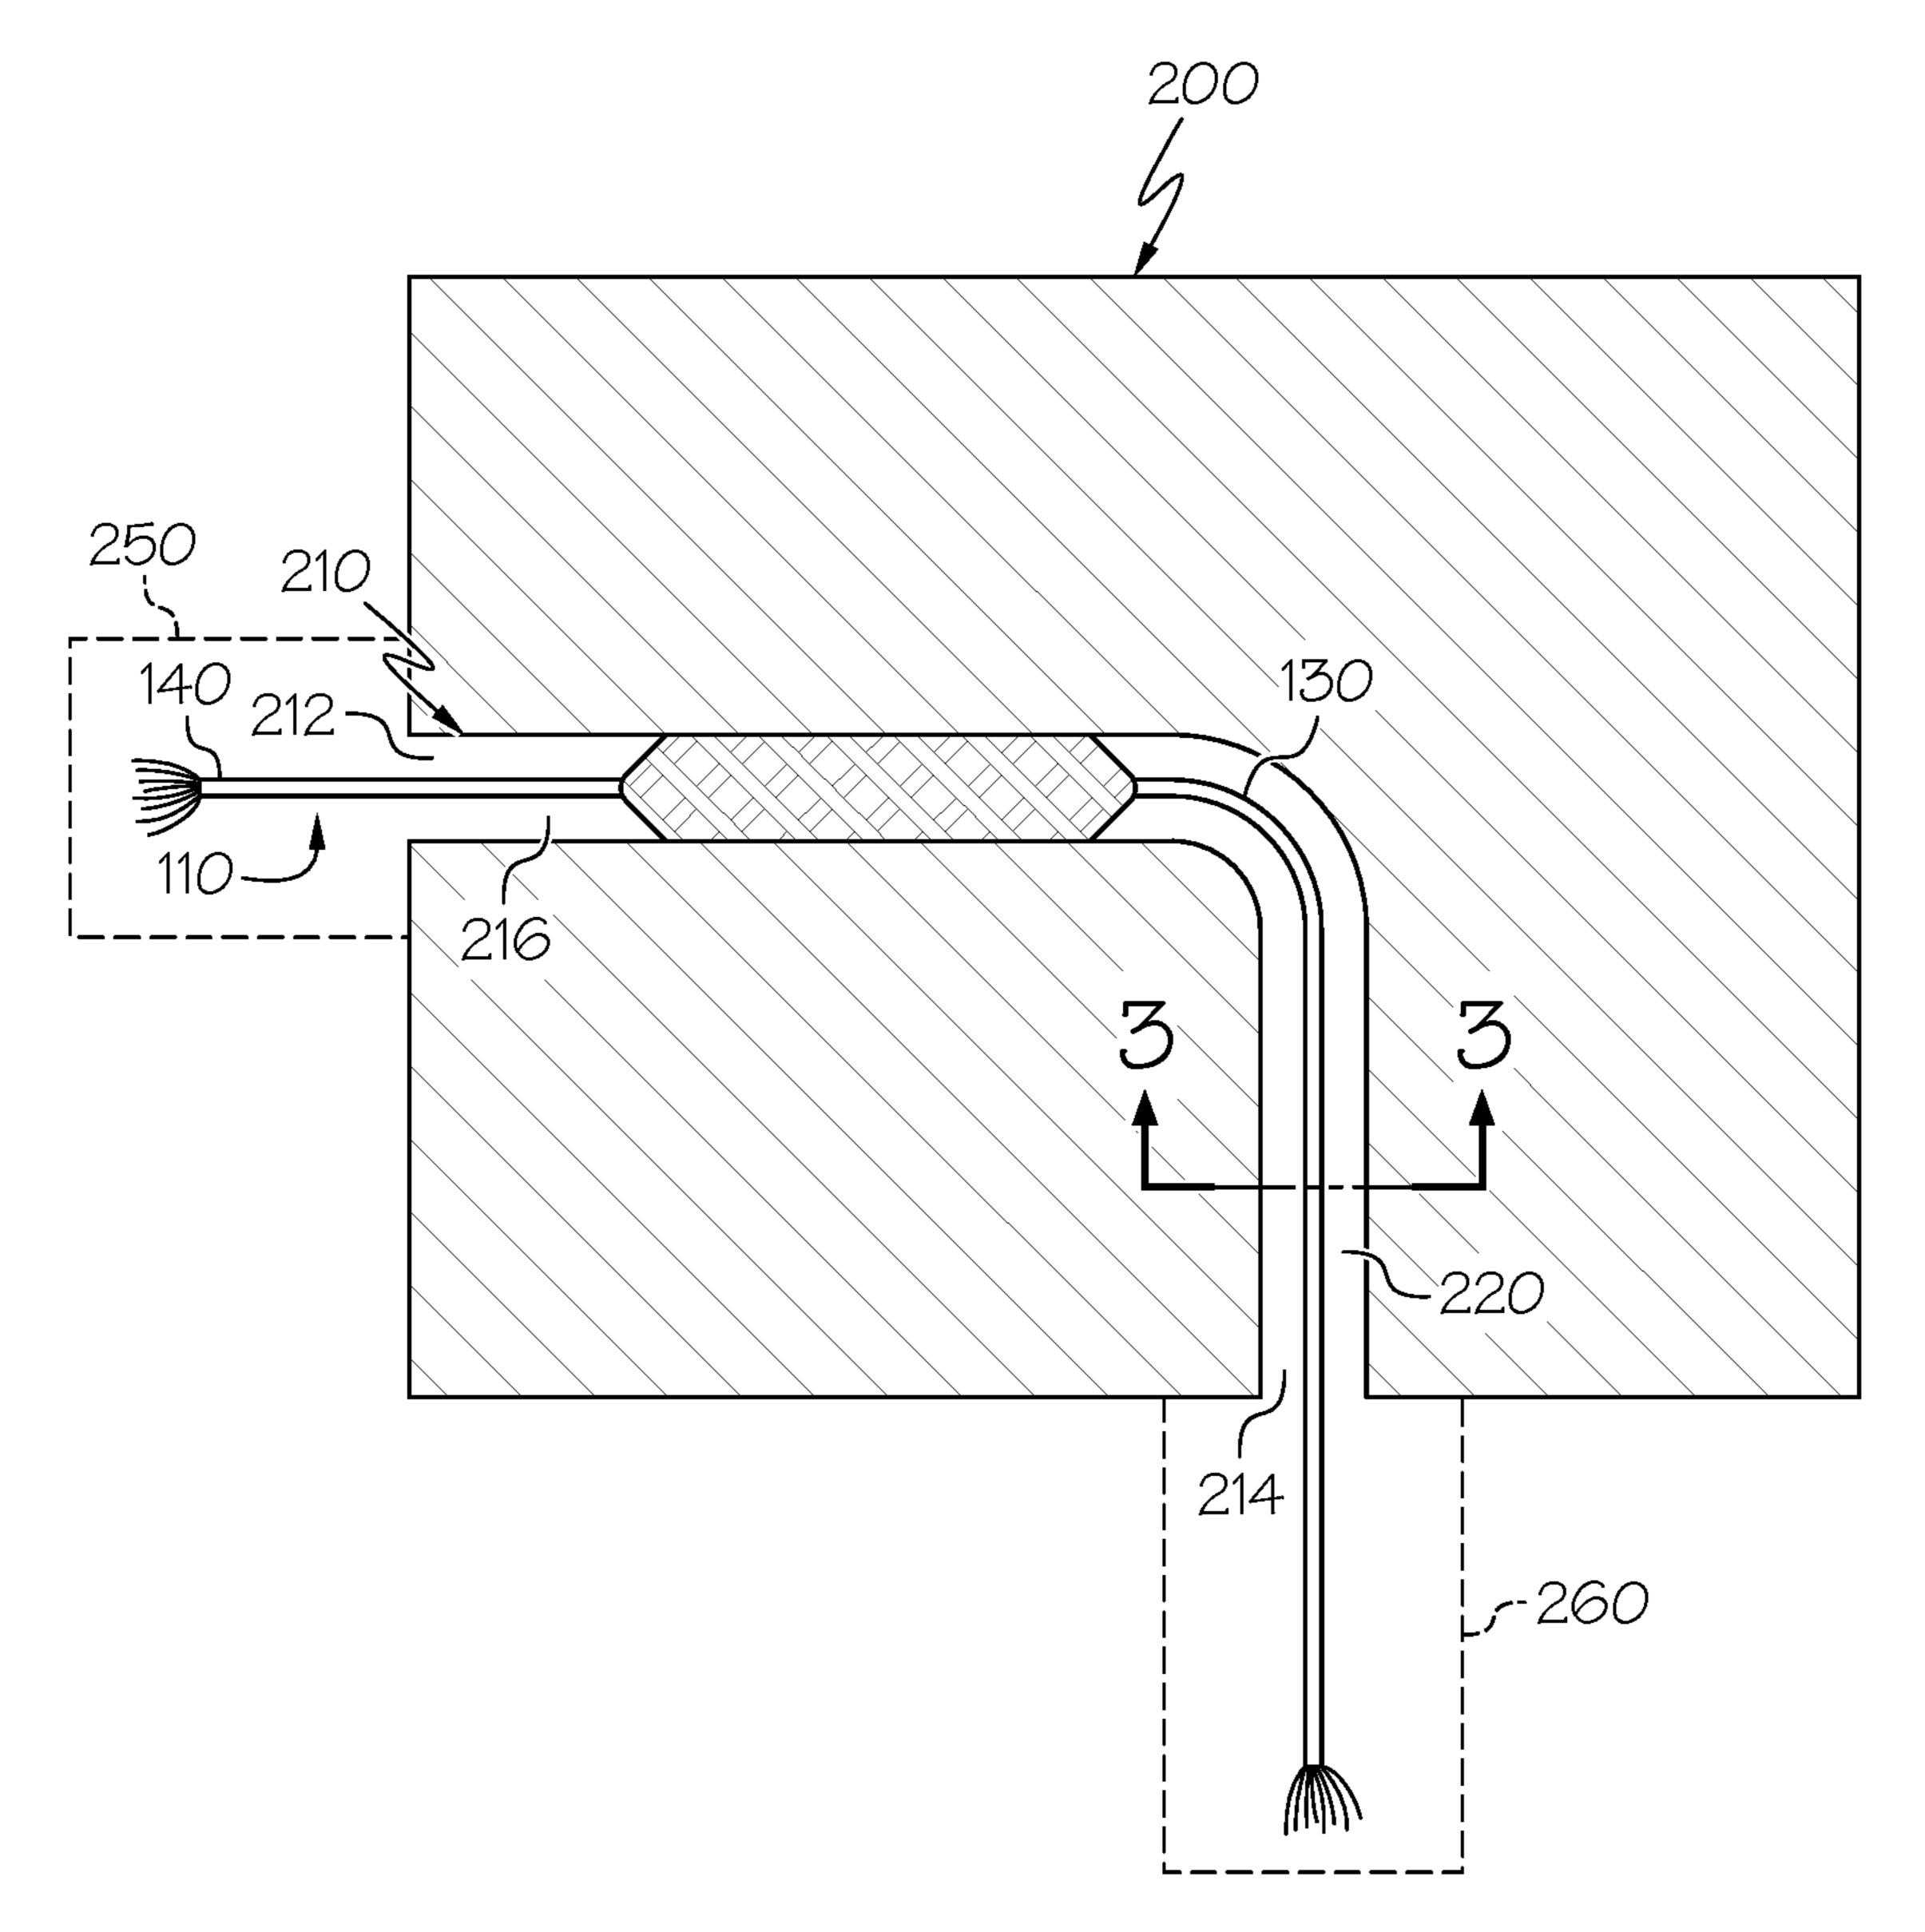
FIG. 2 is a first cross-sectional view of a component with 65 a cored passage during a repair process according to an exemplary embodiment;

FIG. 2 is a first cross-sectional view of a component 200 with a cored passage 210 during a repair process (or method) according to an exemplary embodiment. As noted above, the 20 component 200 may include any type of component 200 with a cored passage 210 that requires or would benefit from repair. FIG. 3 is an orthogonal cross-sectional view through line 3-3 of FIG. 2. FIG. 3 particularly depicts the damaged area 220 of the passage 210 suitable for repair. In this 25 example, the passage 210 may include a first end 212, a second end 214, and an internal section 216 that extends between the first and second ends 212, 214 and includes the damaged area 220.

In the view of FIGS. 2 and 3, the repair tool 110 has been inserted into the first end 212 of the passage 210 and the leading portion 130 has been threaded through the passage 210 such that the leading portion 130 is extending out of the second end 214. In this condition, the leading portion 130 is proximate to the location of the damaged area 220. As 35 discussed in greater detail below, the repair tool 110 may be manually manipulated via the leading and/or trailing portions 130, 140 by an operator or by a machine or by other force mechanism, such as by air pressure. For example, as depicted in phantom in FIG. 2, a pressurized air source 250 40 may be disposed adjacent the first end 212 of the passage 210 to assist in pushing the repair tool 110 into and through the passage 210, or a suction air source 260 may be disposed adjacent the second end 214 of the passage 210 to assist in pulling the repair tool 110 into and through the passage 210. 45

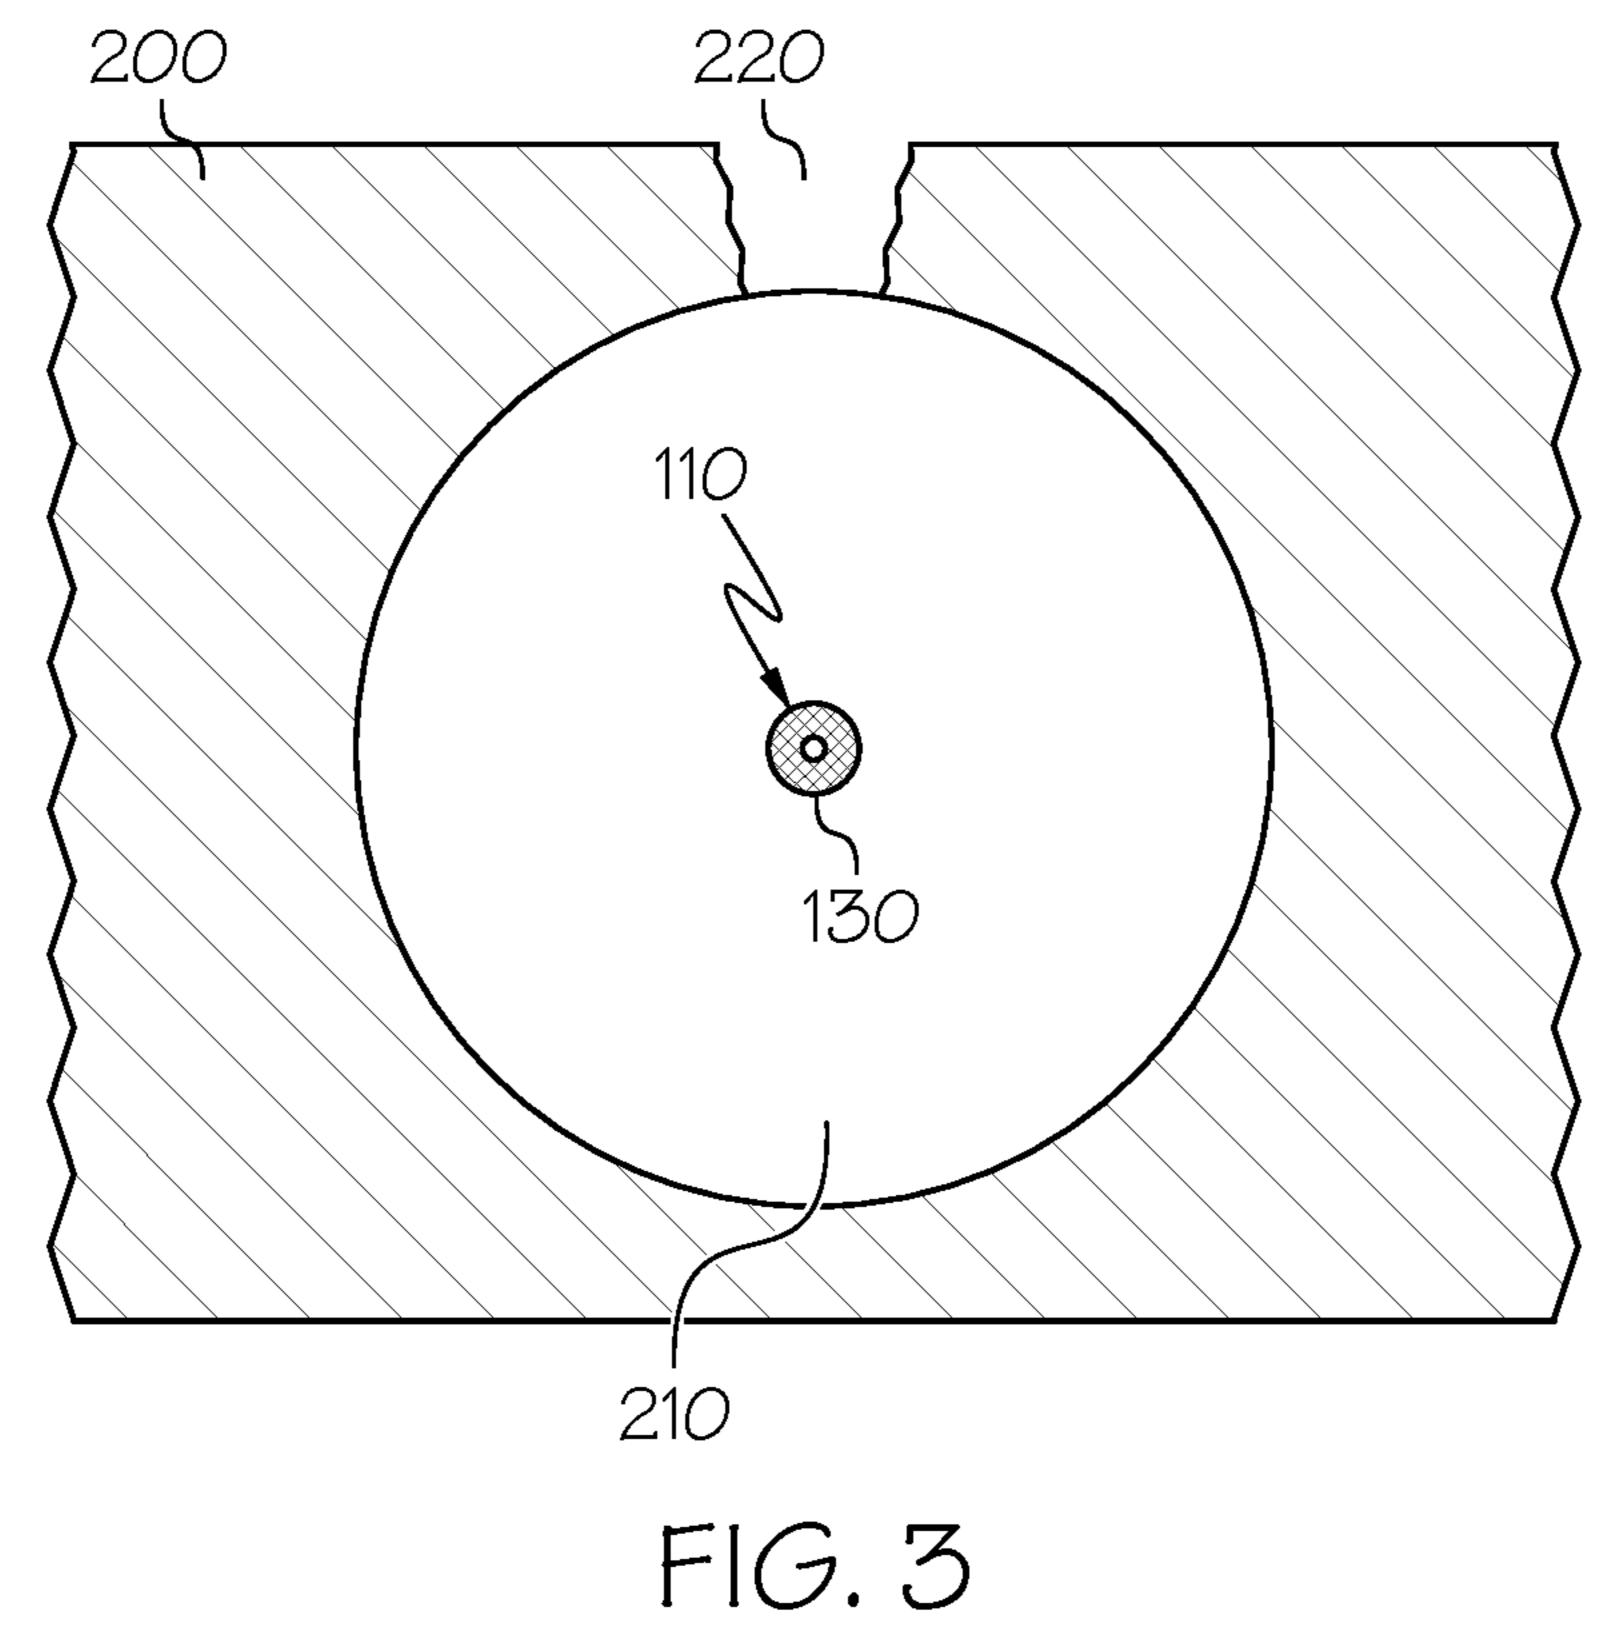
FIG. 3 is an orthogonal cross-sectional view through line 3-3 of FIG. 2 according to an exemplary embodiment;

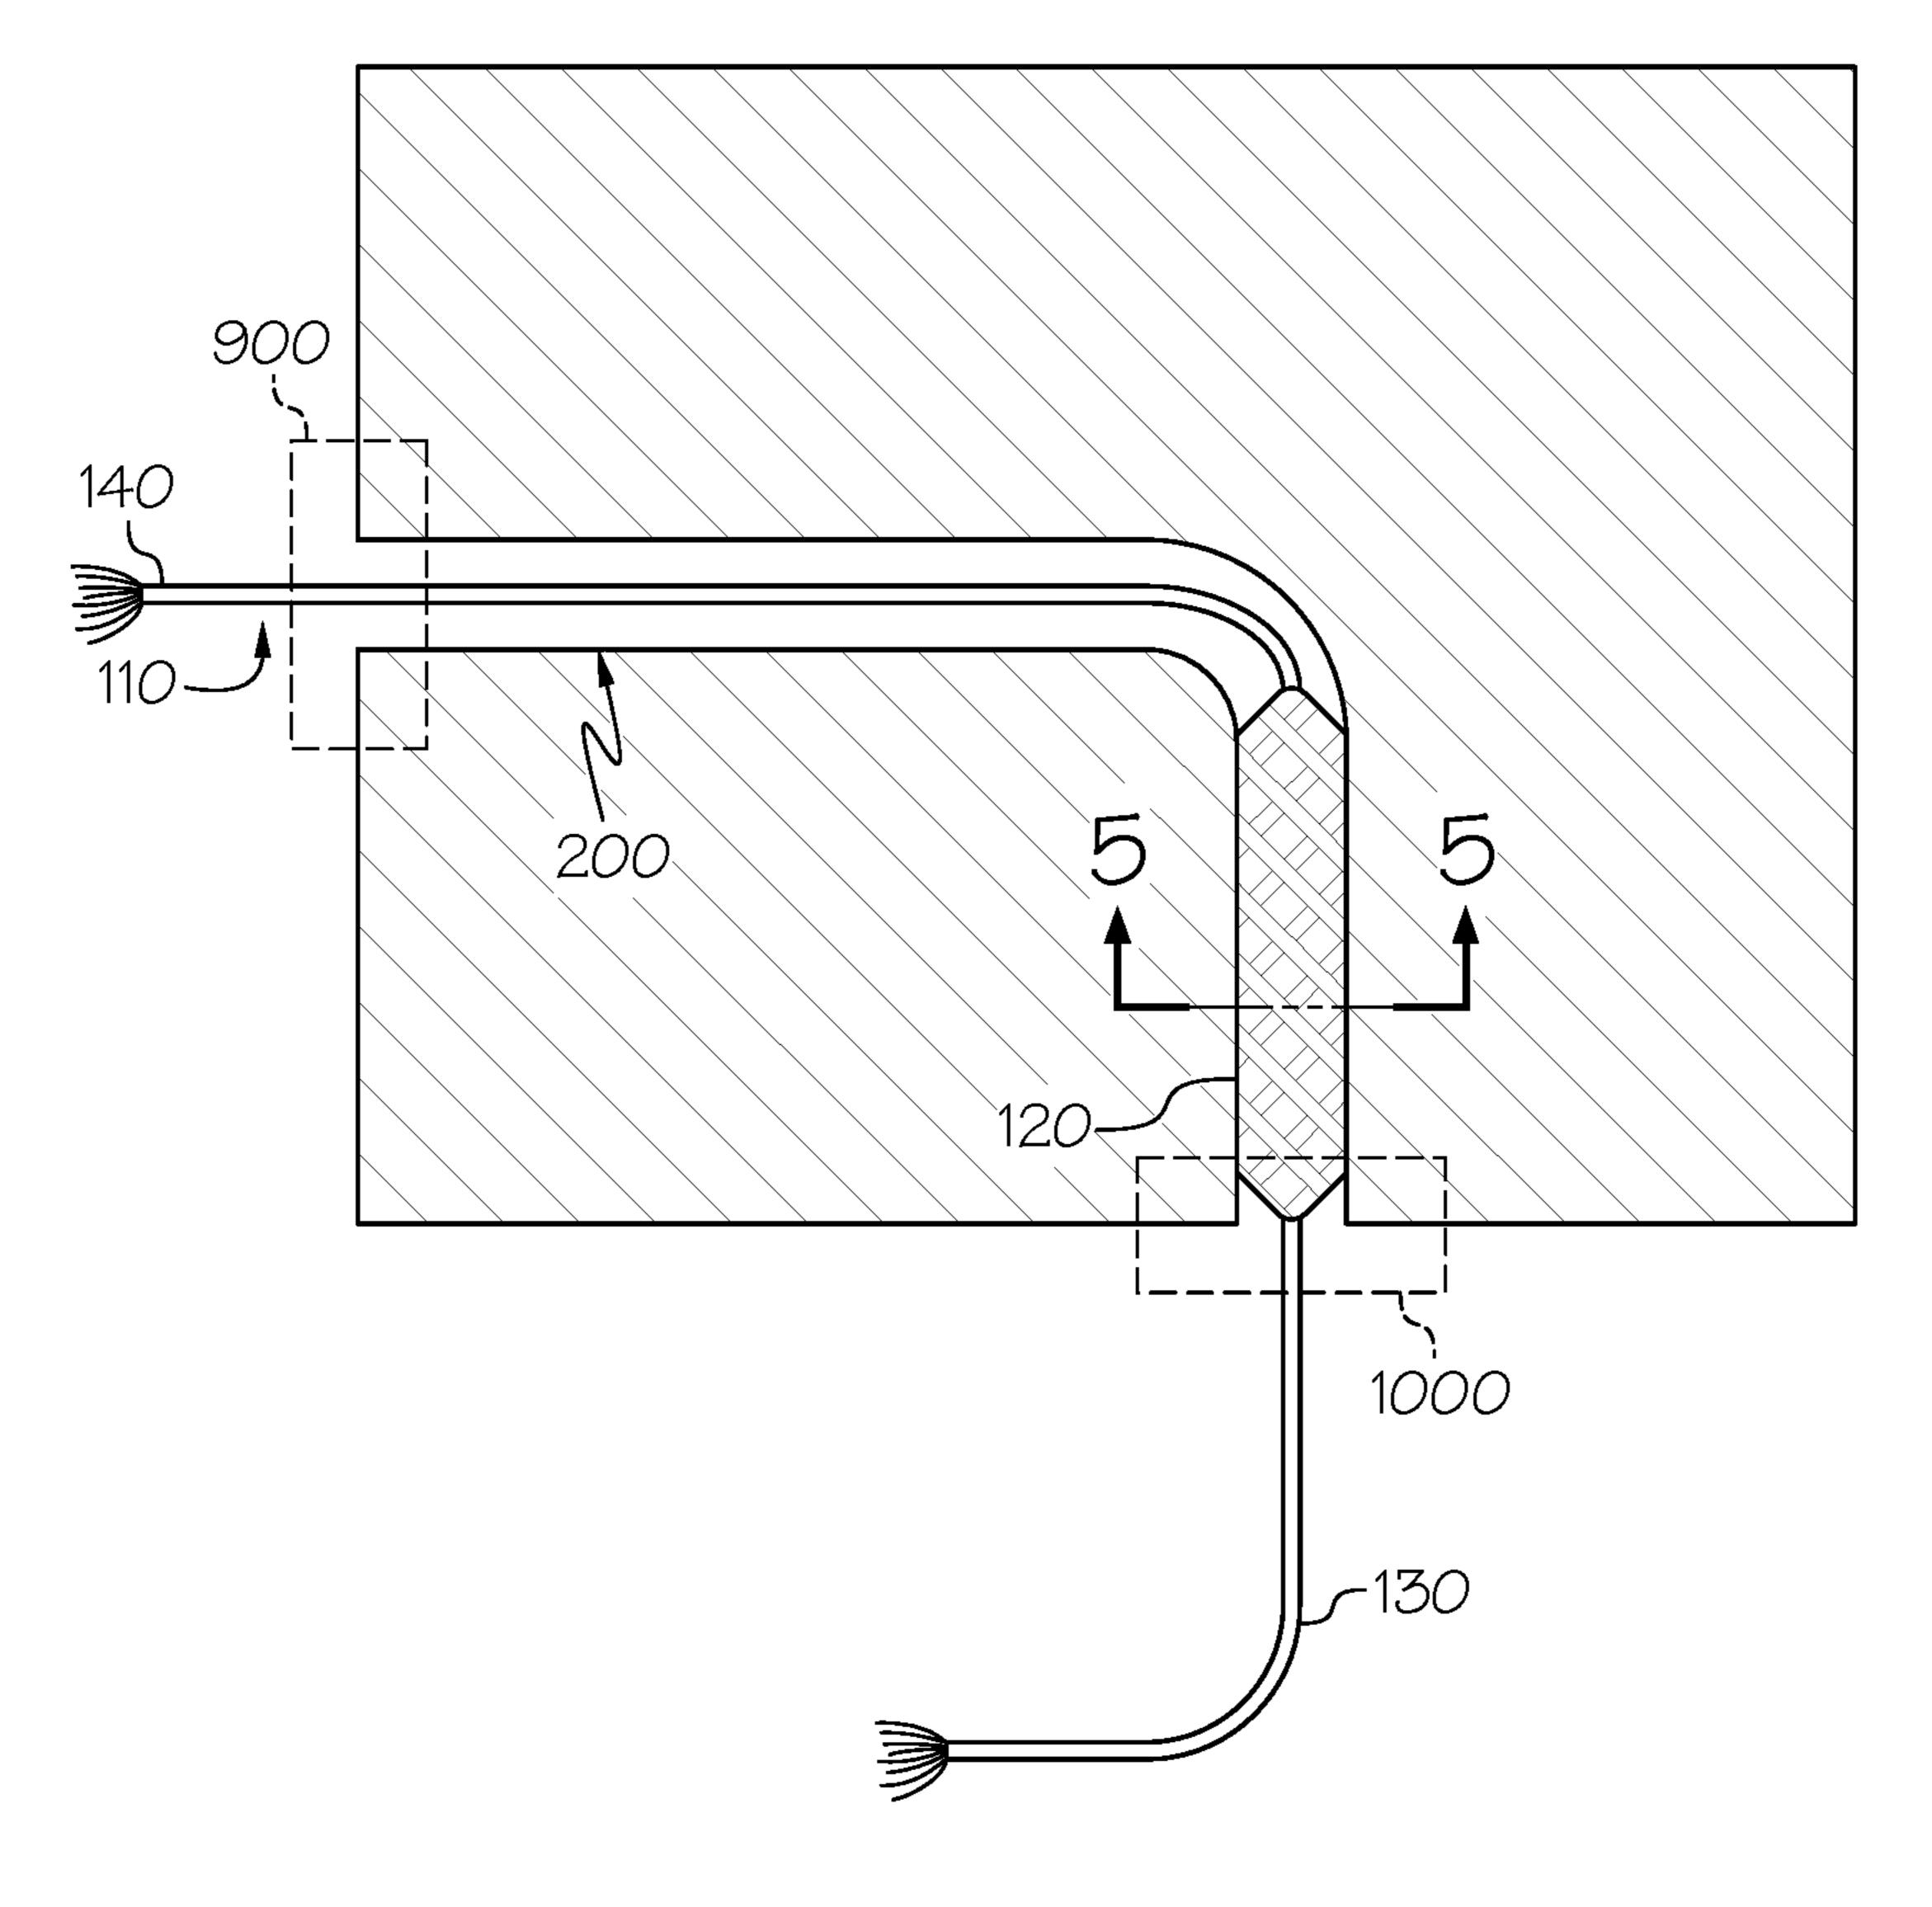
FIG. 4 is a second cross-sectional view of the component with a cored passage during the repair process according to an exemplary embodiment;

FIG. 4 is a further cross-sectional view of the component 200 with the cored passage 210 during the repair process, and FIG. 5 is an orthogonal cross-sectional view through line 4-4 of FIG. 4. Generally, the situation depicted in FIGS. 4 and 5 is subsequent in time to the situation depicted in 50 FIGS. 3 and 4.

In FIGS. 4 and 5, the repair tool 110 has continued to be threaded through the passage 210, e.g., by pulling on the leading portion 130, pushing the trailing portion 140, or other mechanism for manipulating the repair tool 110. In 55 effect, the leading portion 130 may function as a pilot through the passage 210. In other embodiments, the trailing portion 140 may be a rod suitable for pushing the tool 110 through the passage 210. Through manipulation of the leading and/or trailing portions 130, 140, the repair tool 110 is positioned such that the support portion 120 is proximate to the damaged area 220.

As shown in FIGS. 4 and 5, the support portion 120 may have a shape and diameter that approximates the shape and diameter of the passage 210 at the damaged area 220. In 65 some embodiments, the support portion 120 may have a resiliency and/or an elasticity that conforms and/or supports

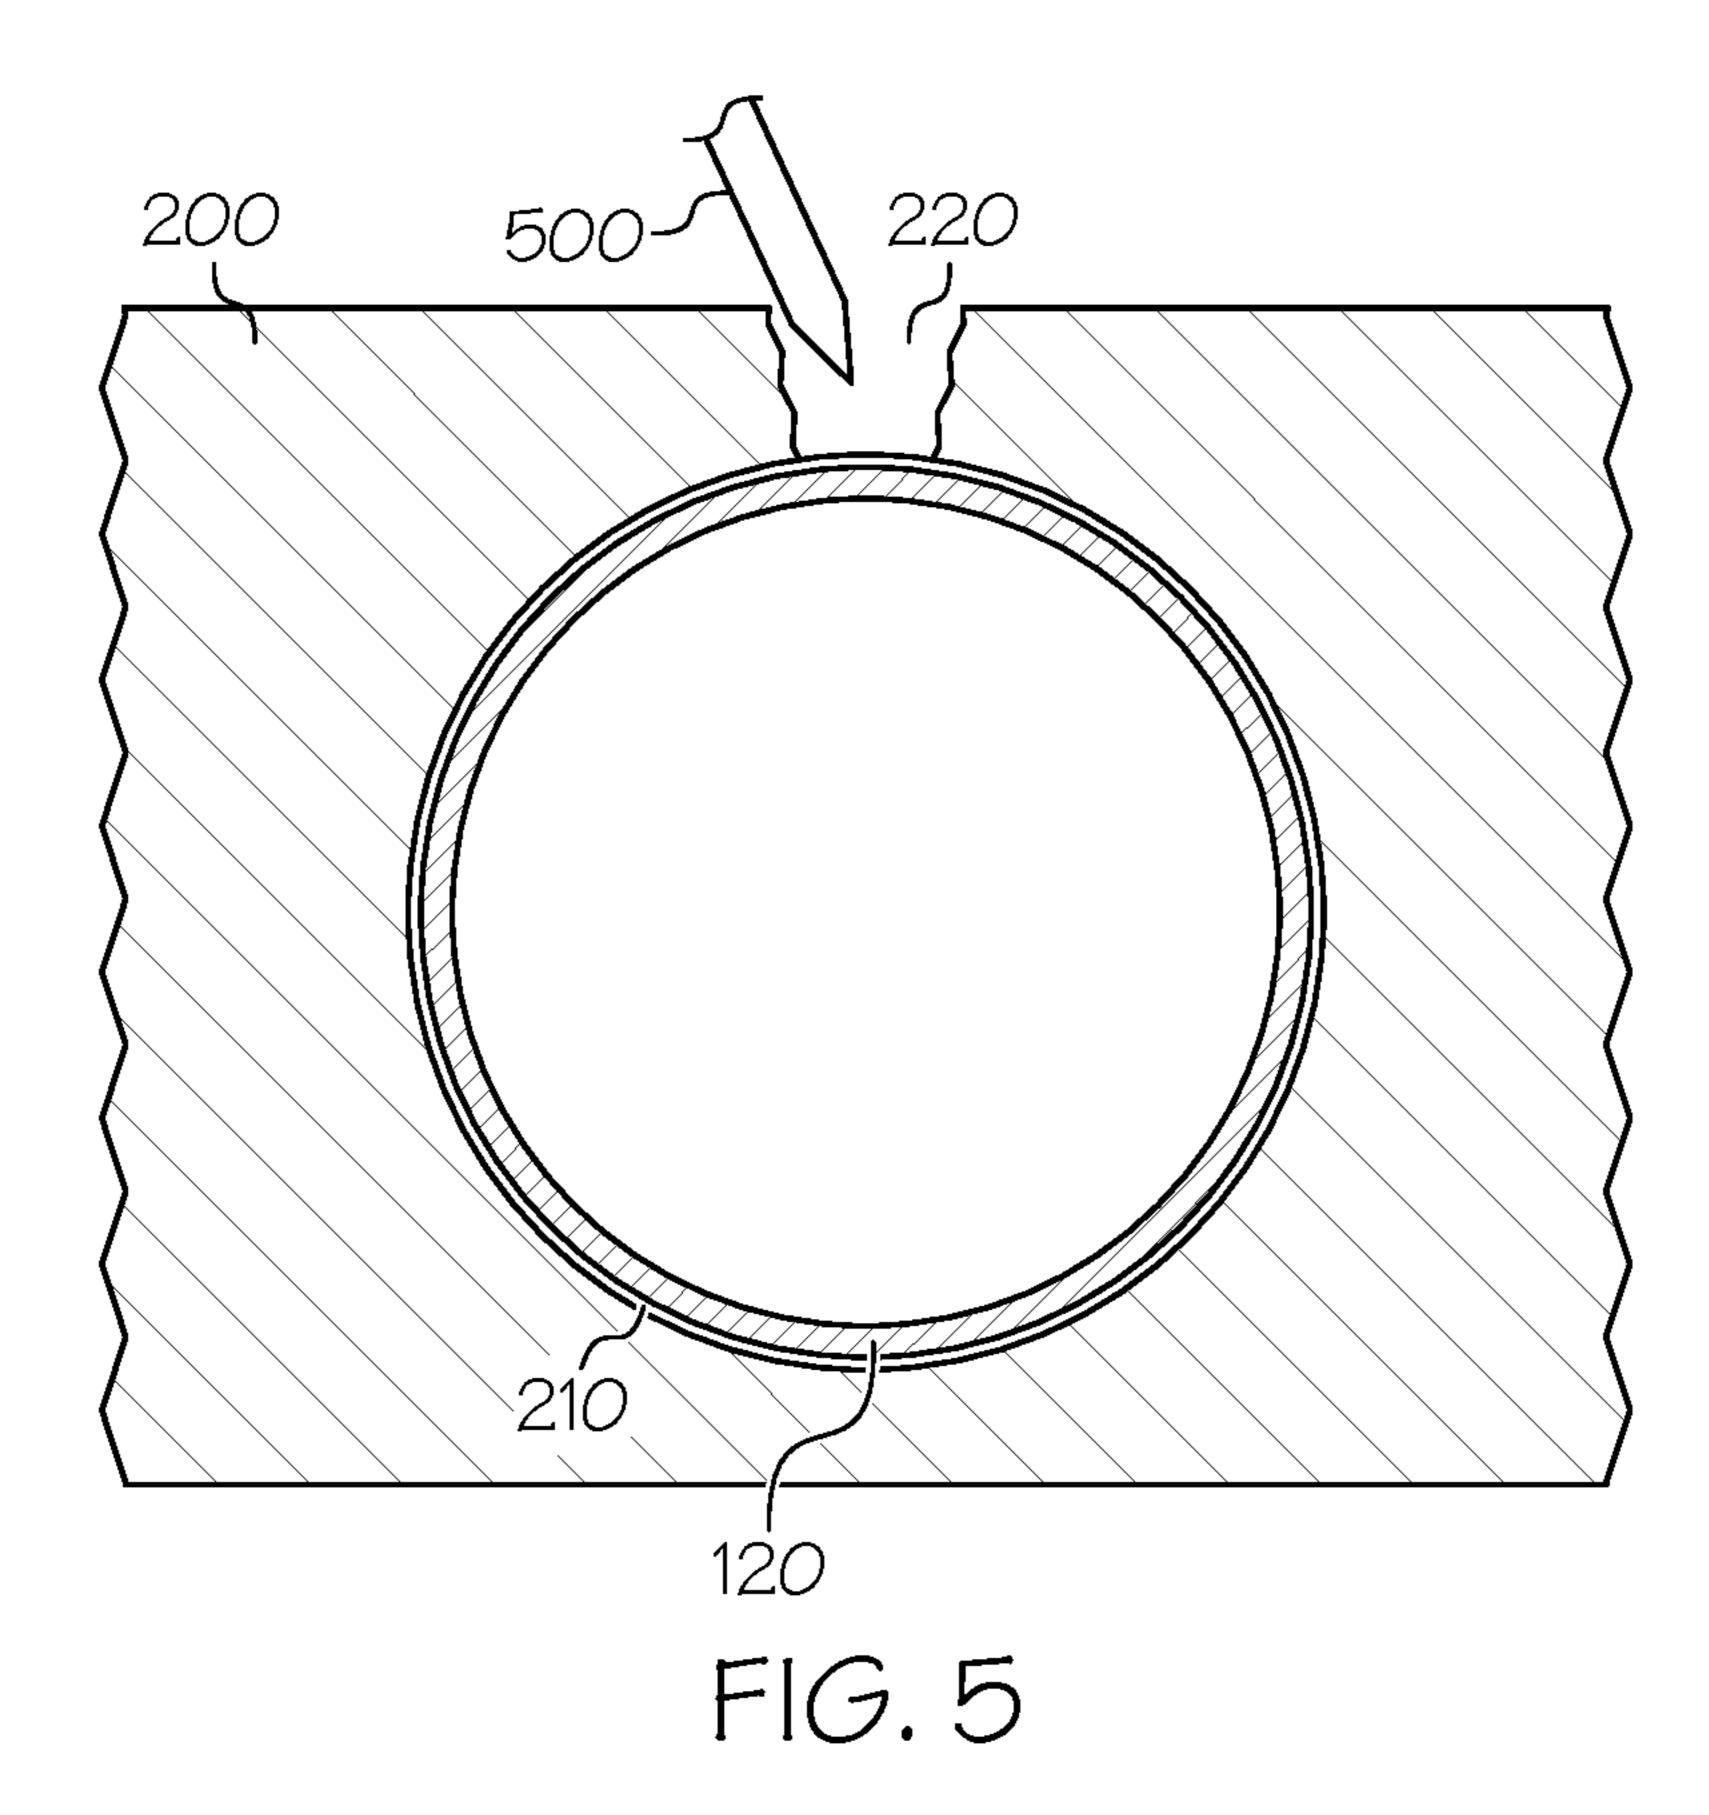
FIG. 5 is an orthogonal cross-sectional view through line 5-5 of FIG. 4 according to an exemplary embodiment;

As best shown in FIG. 5, the support portion 120 supports the walls of the cored passage 210 during a restoration activity, particularly a welding procedure performed with a welding tool 500. Unless otherwise supported by the support portion 120, the welding procedure would present difficulties and could result in collapsing the passage. However, as shown in the view of FIG. 6, which is identical to the view of FIG. 5 except subsequent in time, the support portion 120 supports the wall of the passage 210 as a weld 600 is formed to thereby restore the passage 210. The support portion 120 provides a backing or opposing force to reinforce the structure of the passage wall during welding. In effect, the support portion 120 functions as a stent that is subsequently removed, as discussed below.

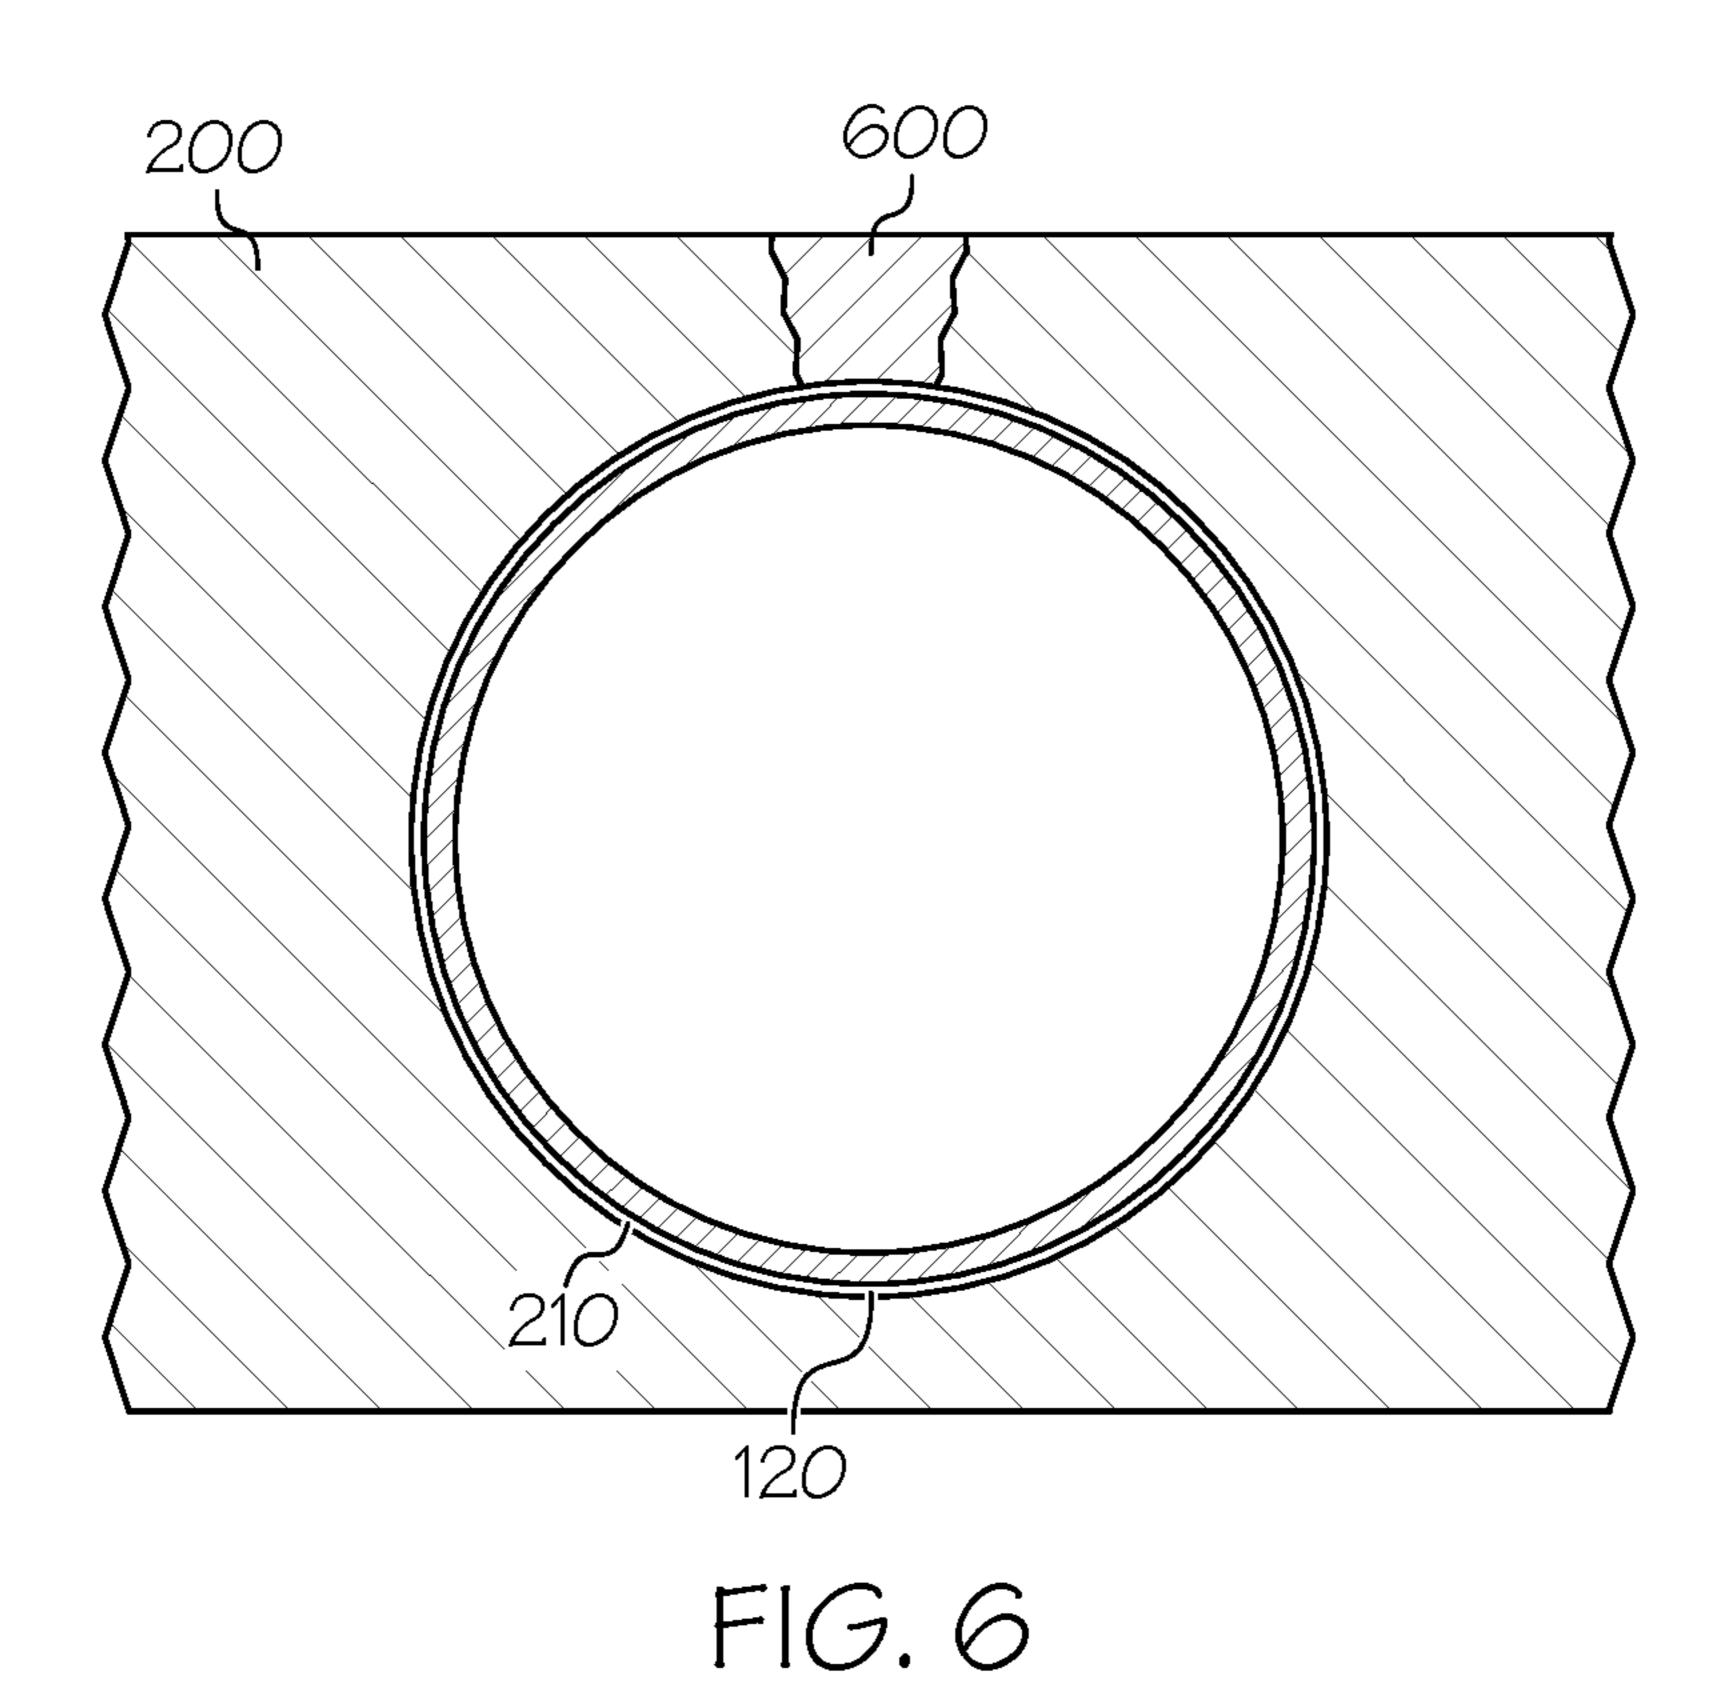
FIG. 6 is a further orthogonal cross-sectional view through line 5-5 of FIG. 4, subsequent in time to the view of 10 FIG. 5, according to an exemplary embodiment;
