US010927995B2

(12) United States Patent Bowler

(54) METHODS FOR REPAIRING COMPONENT

CORED PASSAGES

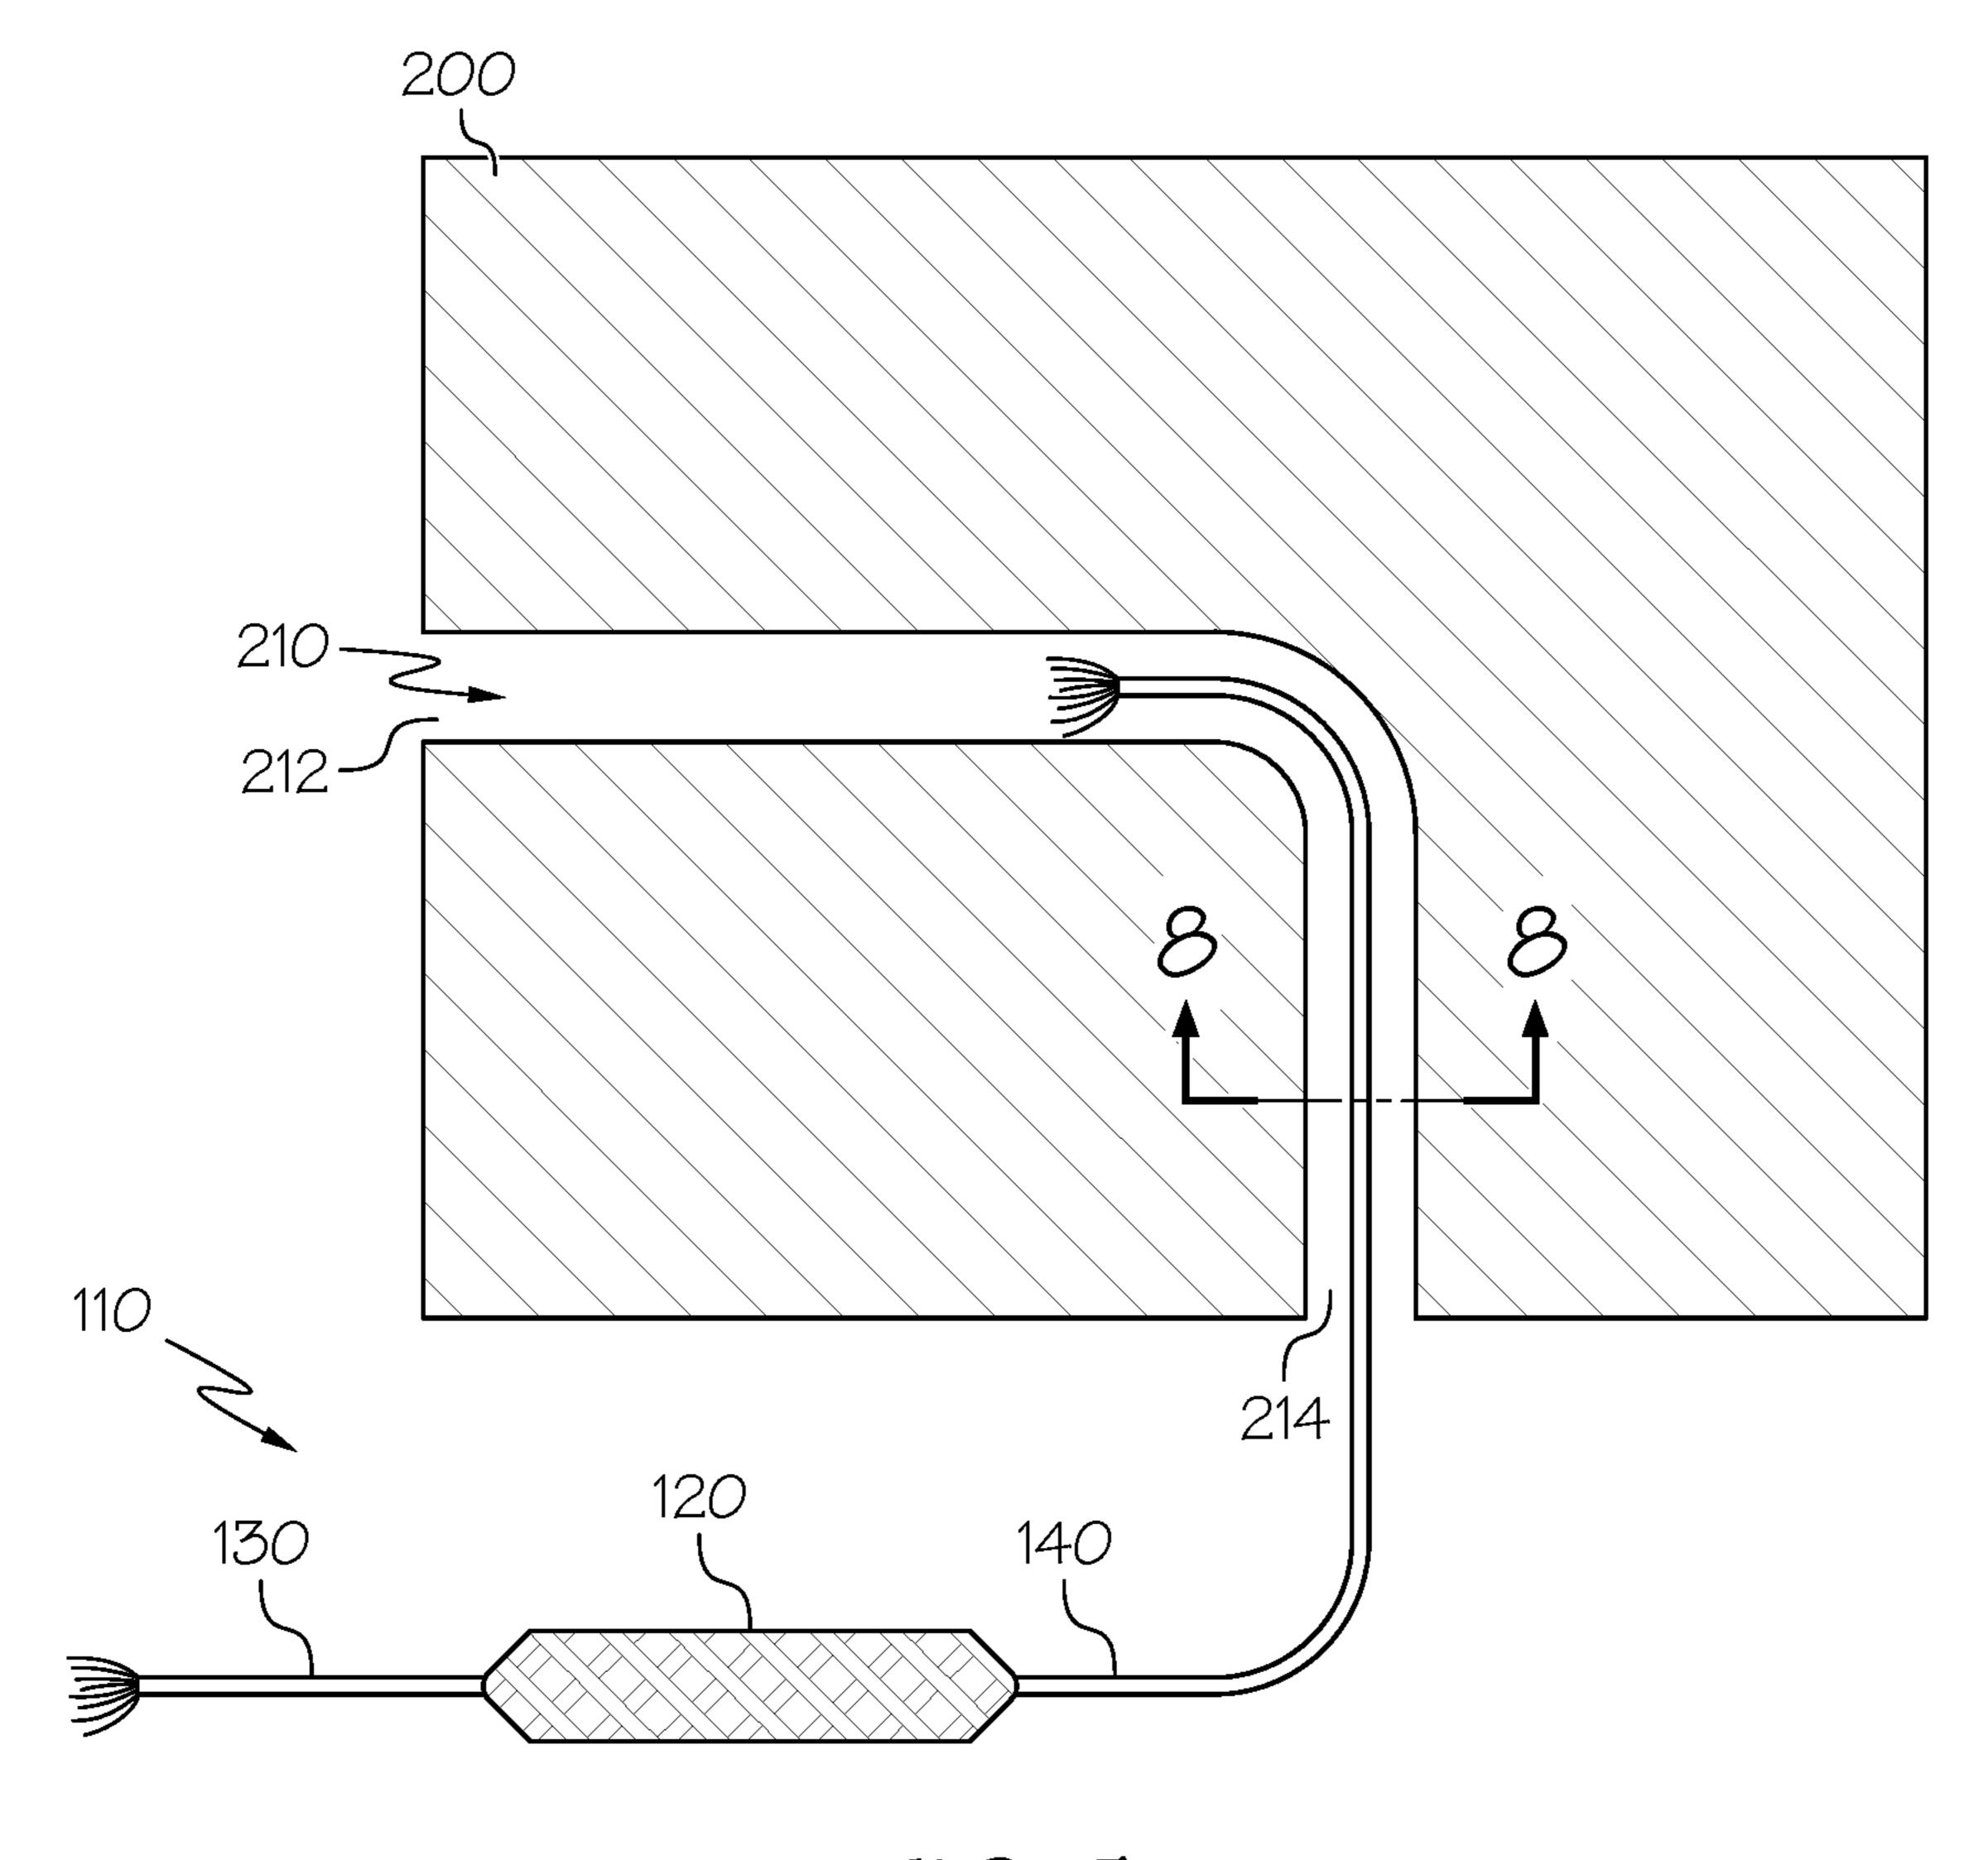
FIG. 7 is a second cross-sectional view of the component with a cored passage during the repair process according to an exemplary embodiment;

FIG. 7 is a further cross-sectional view of the component 200 with the cored passage 210 during the repair process, and FIG. 8 is an orthogonal cross-sectional view through line 8-8 of FIG. 7. In the view of FIGS. 7 and 8, the restoration of the previously-damaged area 220 has been inserted into the first end 212 of the passage 210 and the leading portion 130 has been threaded through the passage 210 and the second end 214. In this condition, the leading portion 130 is extending out of the proximate to the location of the damaged area 220. As discussed in greater detail below, the repair tool 110 may be embodiments may have variations and/or additional steps.

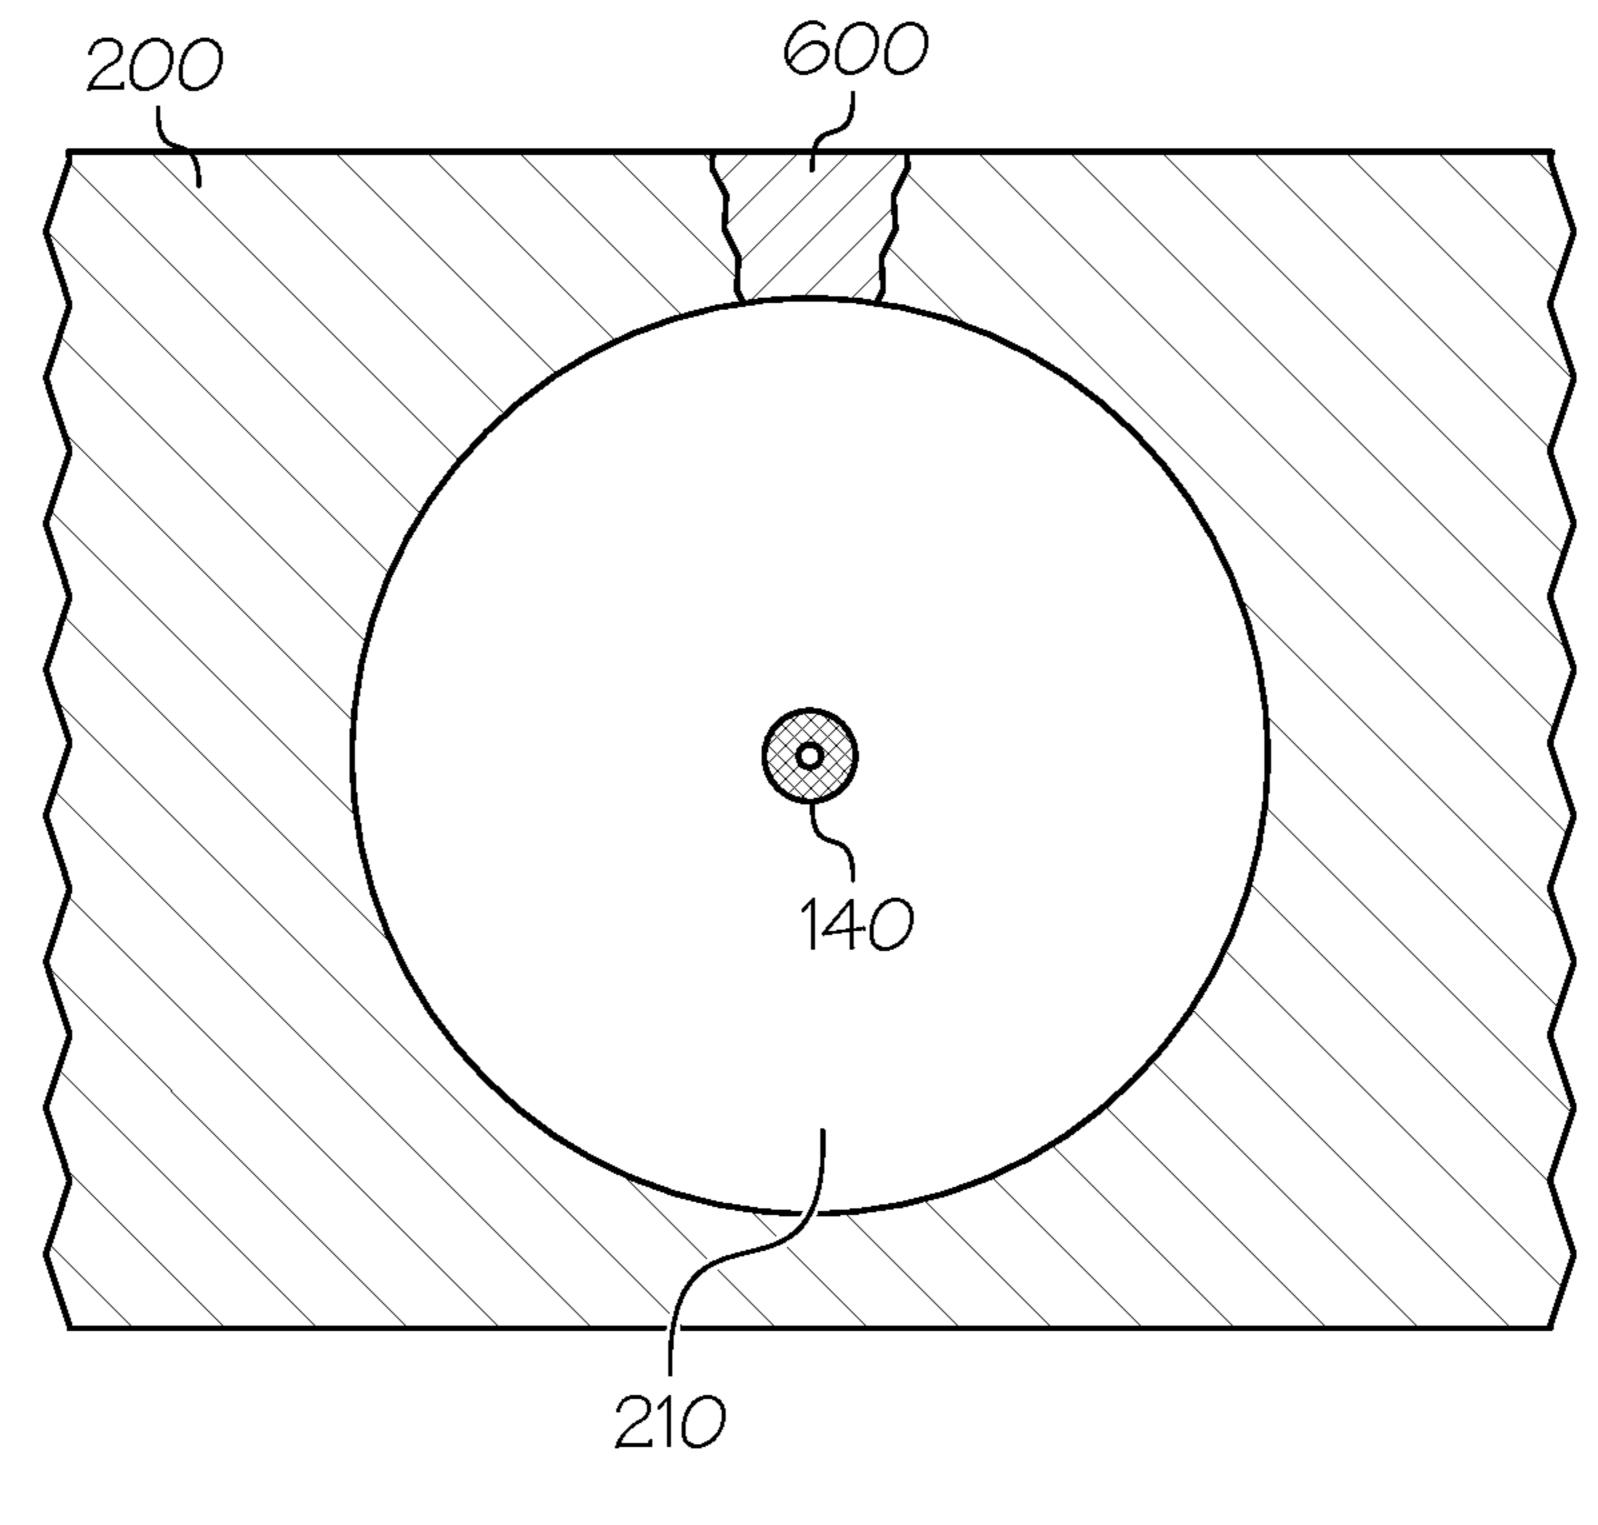
FIG. 8 is an orthogonal cross-sectional view through line 15 **8-8** of FIG. 7 according to an exemplary embodiment;

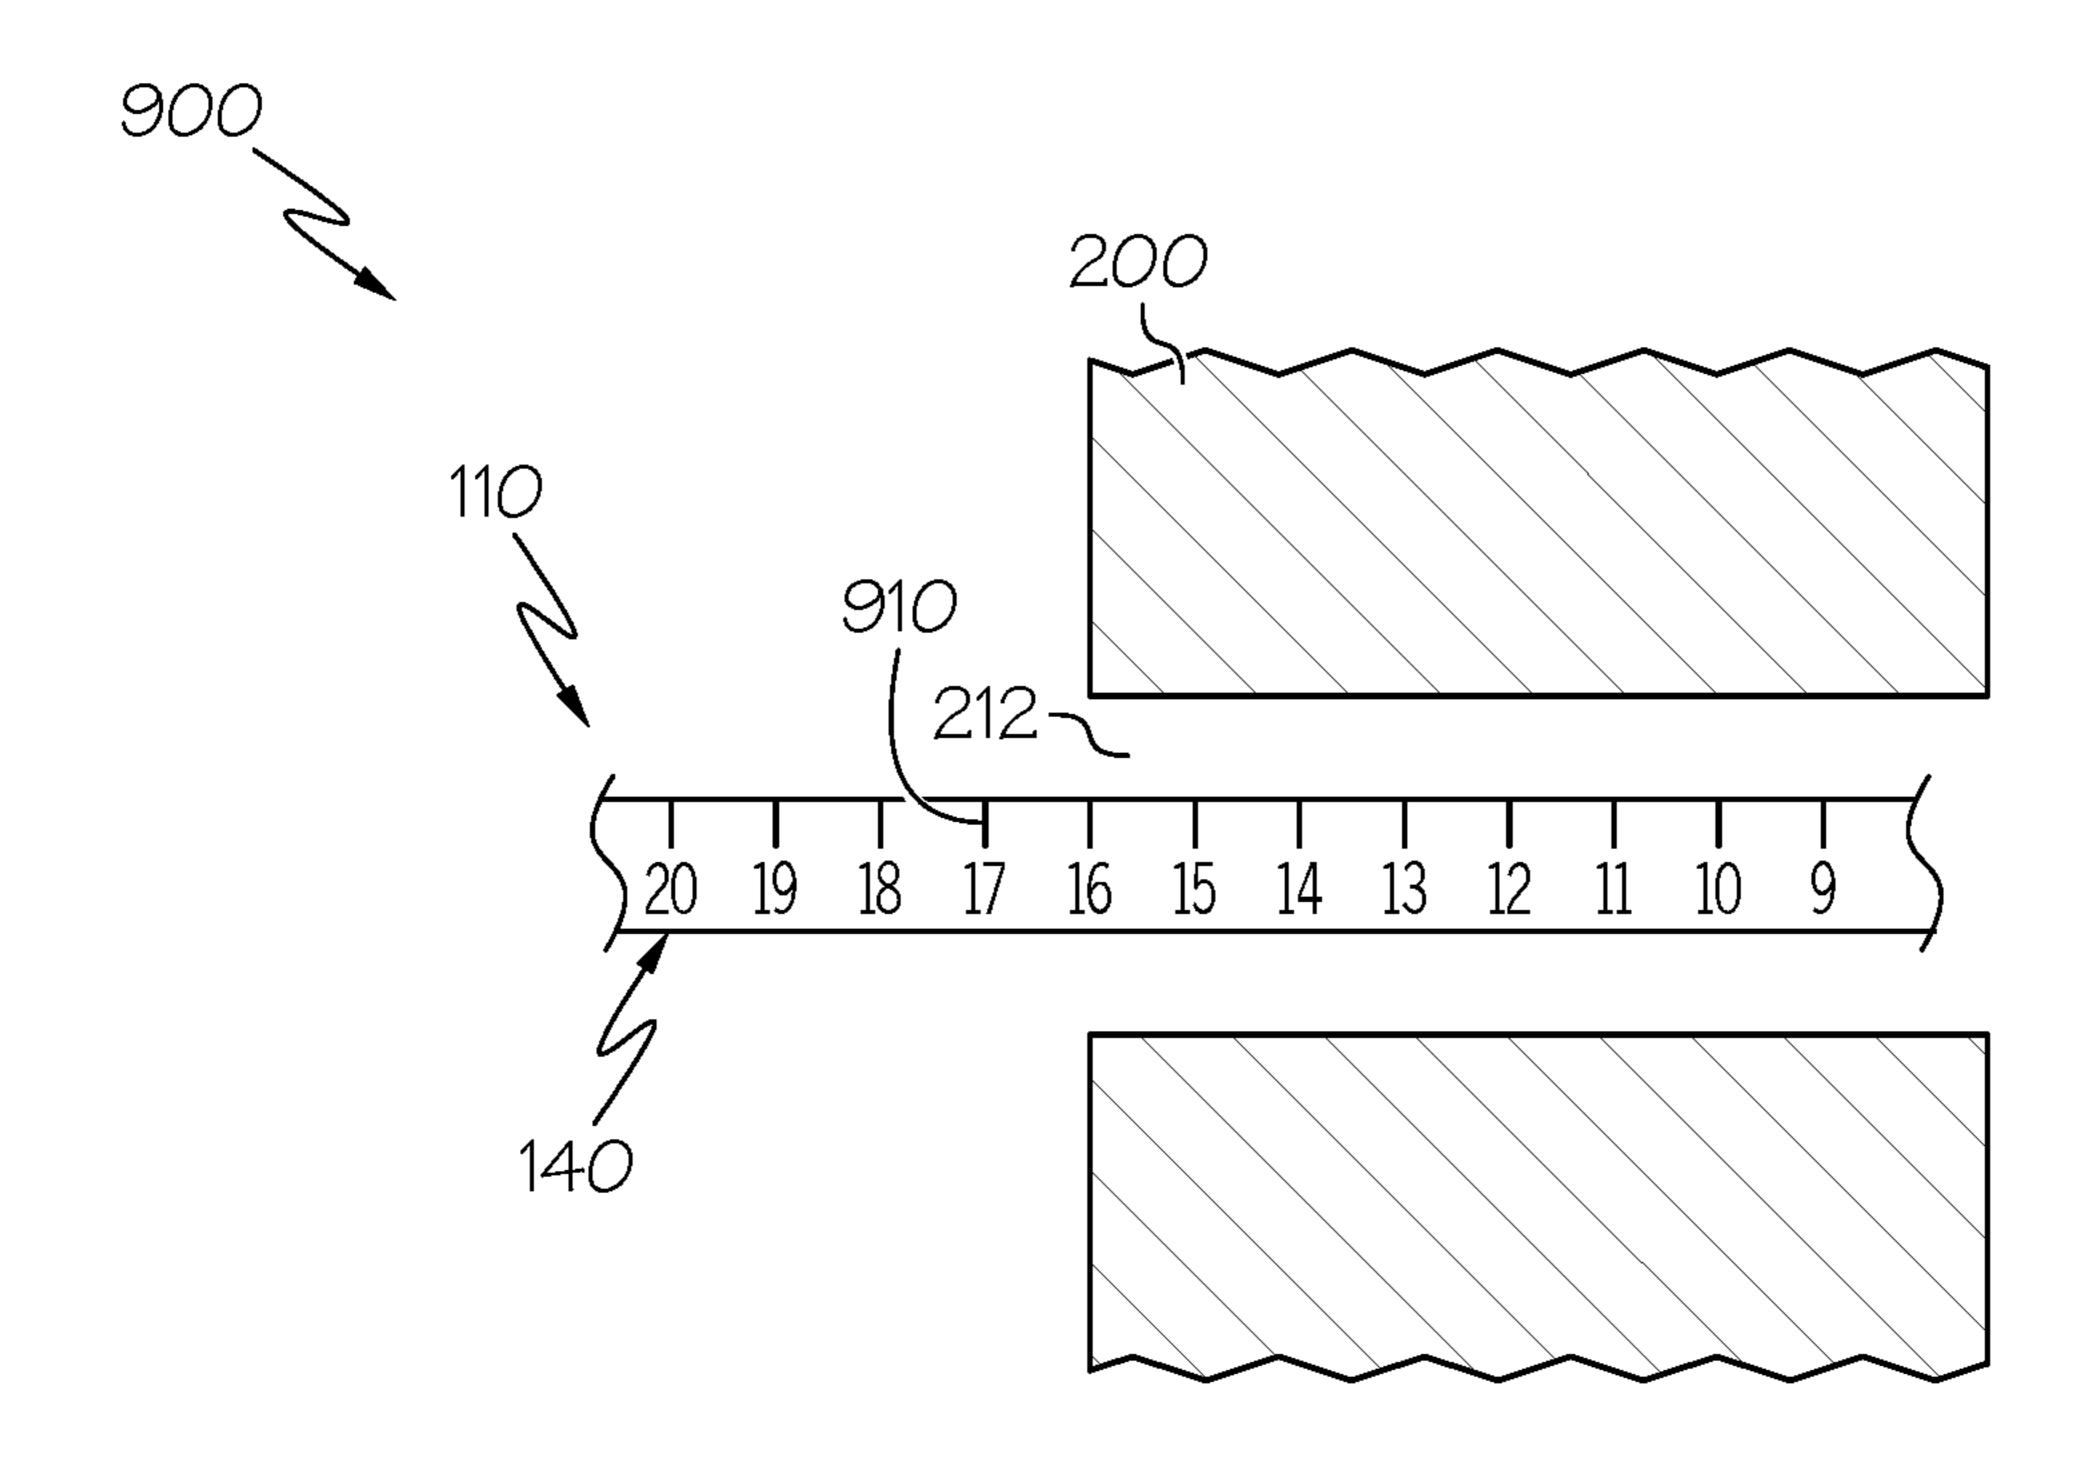
FIGS. 9 and 10 are more detailed views of portions of FIG. 4 according to exemplary embodiments;

FIG. 9 is a more detailed view of area 900 depicted in FIG. 4. As shown, the trailing portion 140 may have 10 markings 910 that represent the relative distance between the respective marking 910 and the support portion 120, e.g., the end **124** of support portion **120**. For example, in the view of FIG. 9, the markings 910 indicate that the support portion **120** is positioned within the passage **210** approximately 16 15 units (e.g., inches, millimeters, etc., as appropriate) from the first end 212 of the passage 210. Similarly, FIG. 10 is a more detailed view of area 1000 depicted in FIG. 10. As shown, the leading portion 130 may have markings 1010 that represent the relative distance between the respective mark- 20 ing 1010 and the support portion 120, e.g., the end 122 of support portion 120. For example, in the view of FIG. 10, the markings 1010 indicate that the support portion 120 is positioned approximately 9 units (e.g., inches, millimeters, etc., as appropriate) from the second end **214** of the passage 25 **210**.

In this manner, a user may utilize the markings 910, 1010 to determine the position of the support portion 120 inside the cored passage 210. As such, if the position of the damaged area 220 is known, the user may more accurately 30 position the tool 110 such that the support portion 120 is in the appropriate location to continue the repair. In some embodiments, one or both of the markings 910, 1010 may be omitted.

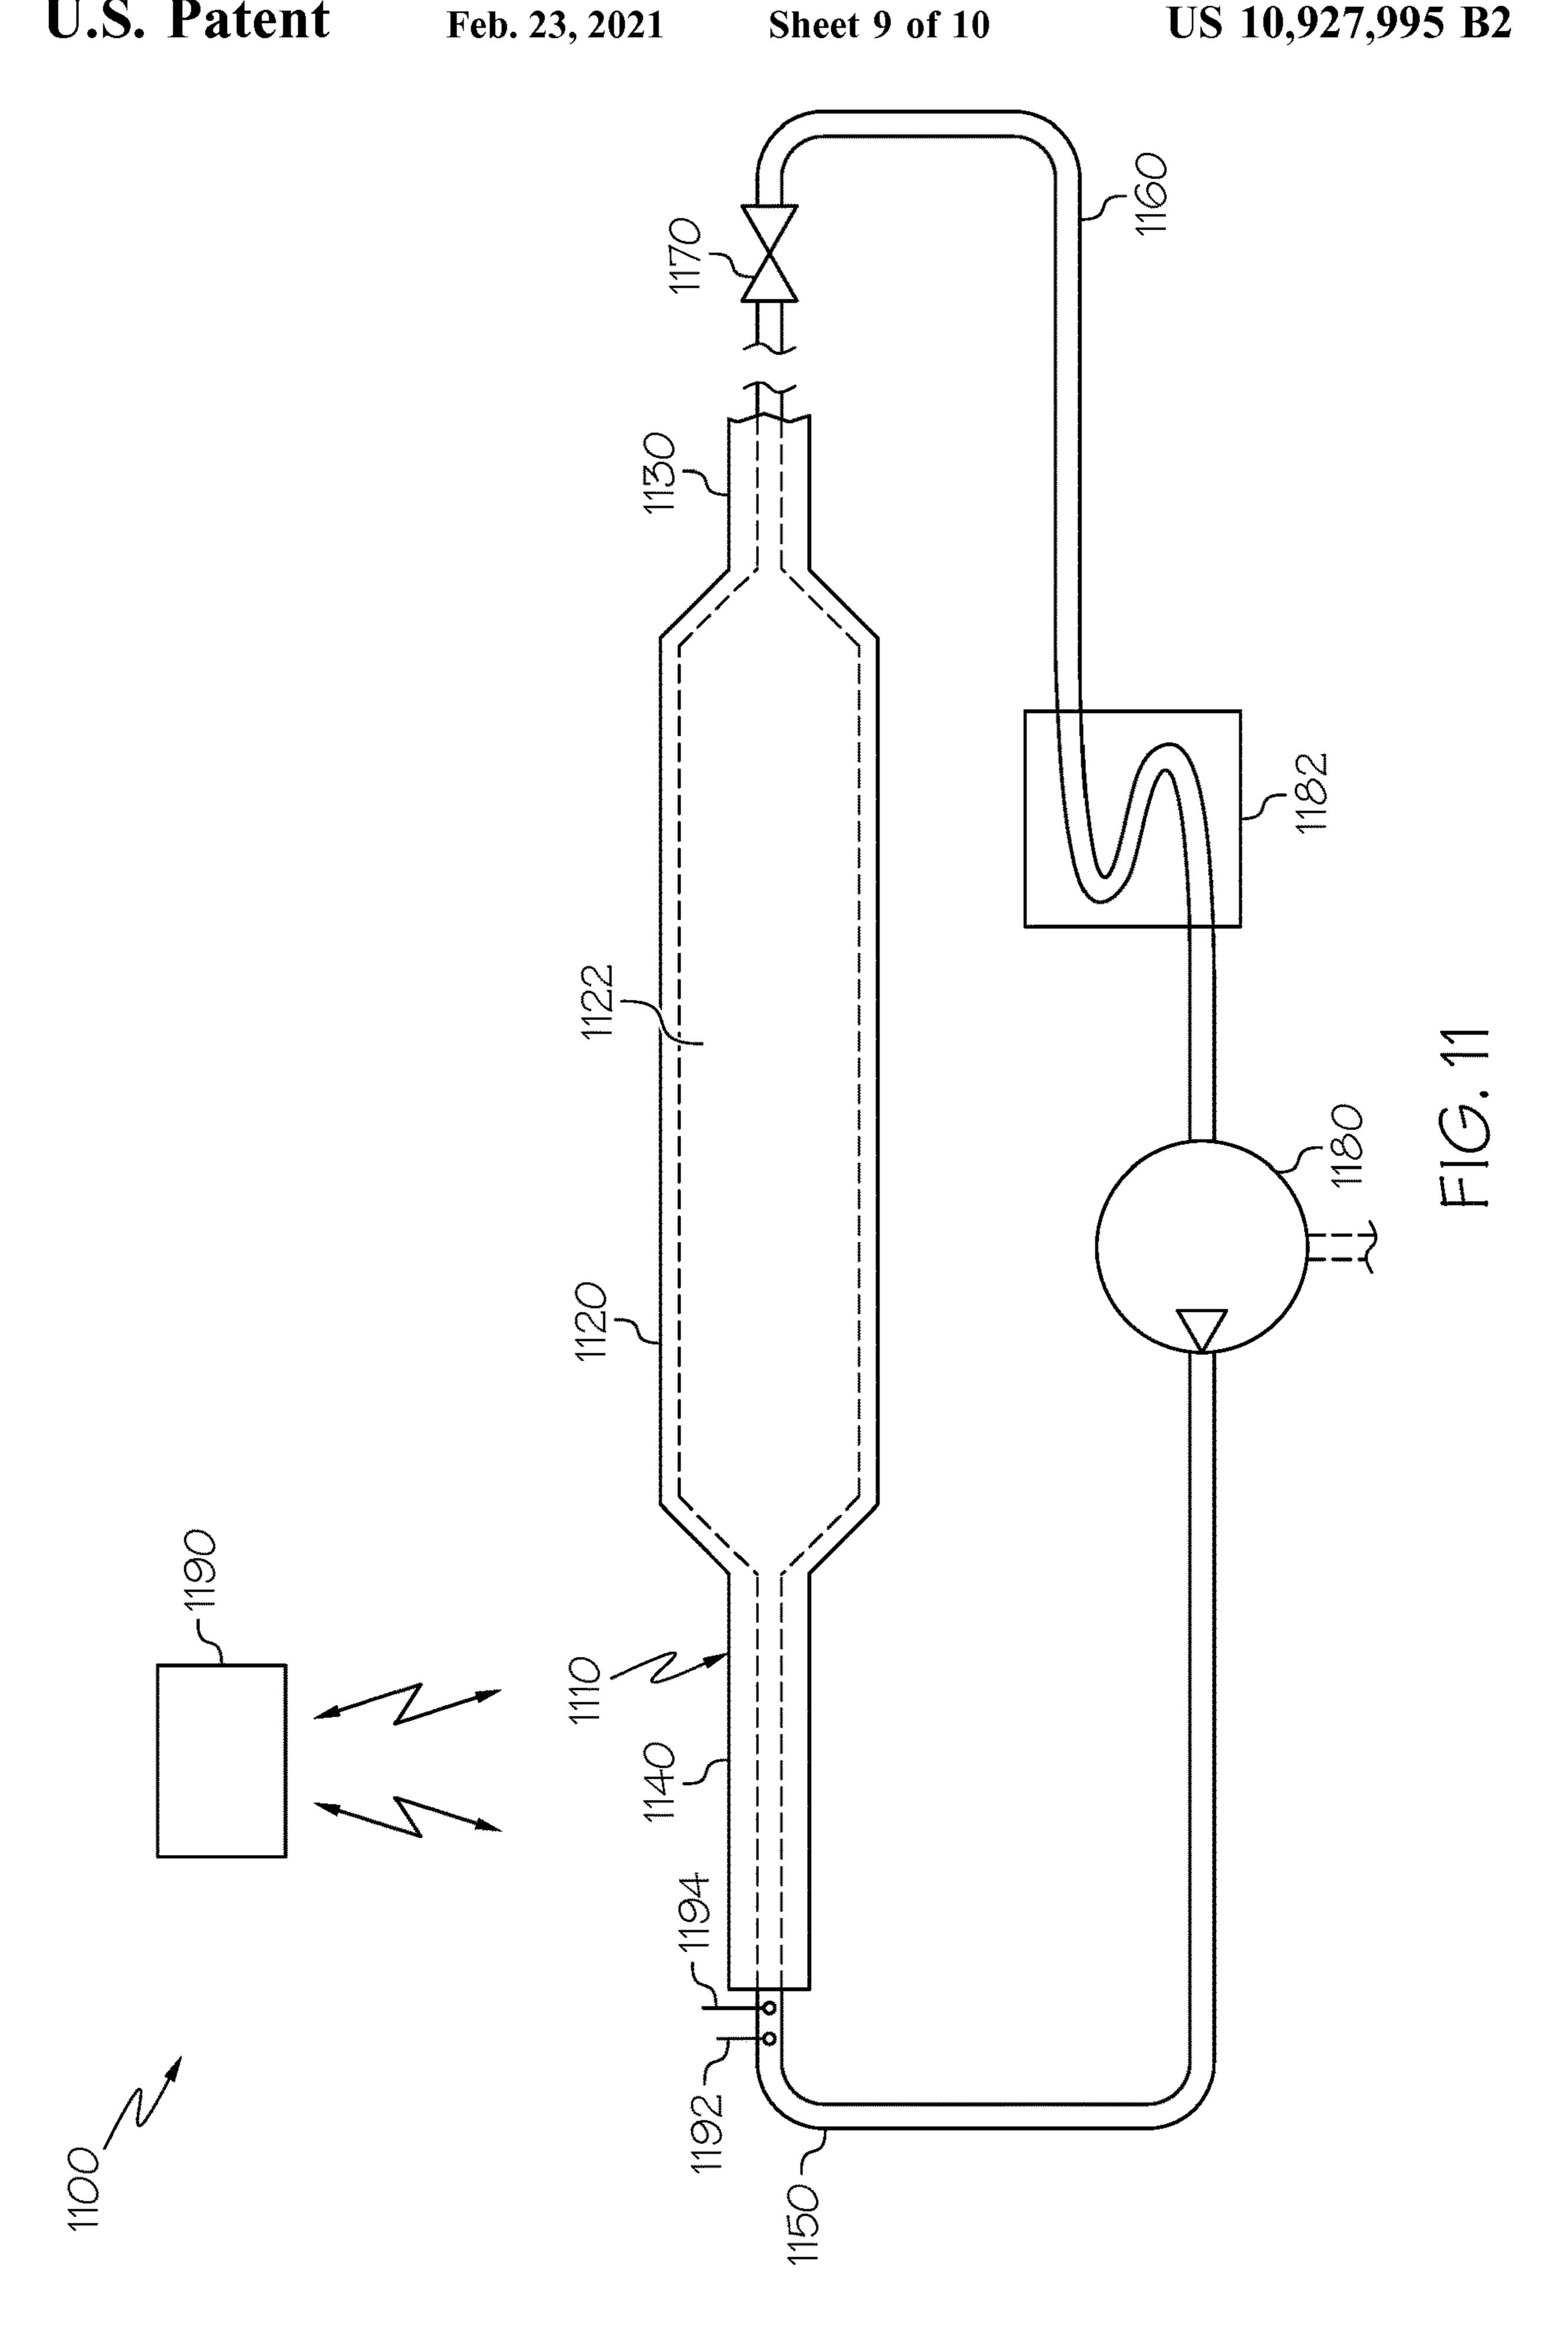
FIG. 11 is a schematic view of a system for repairing cored passages in accordance with a further exemplary embodiment; and

ments, a system 1100 may include a repair tool 1110 provided with fluid to maintain an appropriate temperature and/or pressure during the repair method and/or the particular restoration activity. As one example, the tool 1110 may include a support portion 1120, a leading portion 1130, and 40 a trailing portion 1140, which unless otherwise noted may be similar to the tool 110 described above.

In this embodiment, the support portion 1120 may include a cavity 1122 for receiving the fluid. In particular, the cavity 1122 may be in fluid communication with a supply conduit 45 removal. 1150 extending through the trailing portion 1140 and an outlet conduit 1160 extending through the leading portion 1130. Generally, the supply conduit 1150 may be provided to introduce fluid into the cavity 1122, and the outlet conduit 1160 may be provided to release or drain fluid from the 50 cavity 1122. A valve element 1170 may be provided on one or both of the conduits 1150, 1160 to facilitate fluid flow into or out of the cavity 1122 and/or to maintain the fluid in the cavity 1122. In other embodiments, the supply conduit 1150 may extend through the leading portion 1130 and the outlet 55 conduit 1160 may extend through the trailing portion 1140, i.e., the direction of fluid flow may be reversed. Generally, the tool 1110 may be positioned into the appropriate location (e.g., with the support portion 120 proximate to the area to be repaired), and then, the fluid may be introduced into the 60 cavity 1122 to provide an appropriate pressure and/or temperature.

In one embodiment, the fluid may be a liquid coolant, e.g., water or other type of coolant, that is circulated through the tool 1110 in order to maintain a predetermined or otherwise 65 appropriate temperature for the tool 1110 and/or the passage being restored. In such an embodiment, a pump 1180 and/or

heat exchanger 1182 may be provided. For example, the pump 1180 may maintain a desired or appropriate fluid pressure within the cavity 1122 and/or circulation the coolant. The heat exchanger 1182 may be configured to facilitate the removal of heat from the coolant.

In further embodiments, the system 1100 may further include one or more controllers 1190 that operate to maintain an appropriate temperature or pressure of the fluid within the system 1100. In some examples, the controller 1190 may also operate to gather and/or display information associated with the repair method and/or facilitate placement of the tool 1110 or performance of the restoration activity. Such commands by the controller 1190 may be implemented based on signals from one or more sensors 1192, 1194. In various embodiments, the sensors 1192, 1194 may be pressure sensors, temperature sensors, position sensors, or combinations thereof. As such, the controller 1190 may be operatively coupled to communicate with one or more of the valve element 1170, pump 1180, heat exchanger 1182, sensors 1192, 1194, and/or other components (e.g., the welding tool or other restoration activity, a user interface, etc.) in any suitable manner, including a wired or wireless bus and/or communication technique. The commands from the controller 180 may be generated based on schedules associated with operating conditions. As an example, the controller 1190 may adjust the fluid pressure by controlling the pump 1180 and/or the valve element 1170.

In some embodiments, the fluid in the system 1100 may be air (or liquid) that is supplied to the cavity 1122 in order to provide sufficient pressure in order to inflate the support portion 1120. In such an embodiment, one or more components of the system 1100 depicted in FIG. 11 may be omitted, such as the heat exchanger. As an example, the pump 1180 (or alternately, another mechanism for providing As schematically depicted in FIG. 11, in some embodi- 35 air pressure) may force air into the cavity 1122 to inflate the support portion 1120 while the valve element 1170 is closed to prevent the air from exiting the cavity 1122. As an alternative, the outlet conduit 1160 may be omitted such that the cavity 1122 has a closed end. In such an embodiment, upon inflation of the cavity 1122, the supply conduit 1150 may be closed to maintain the inflation of the support portion 120 during the subsequent restoration activity (e.g., welding), and upon completion, the air may be vented by opening the conduit 1150 to deflate the support portion 120 prior to

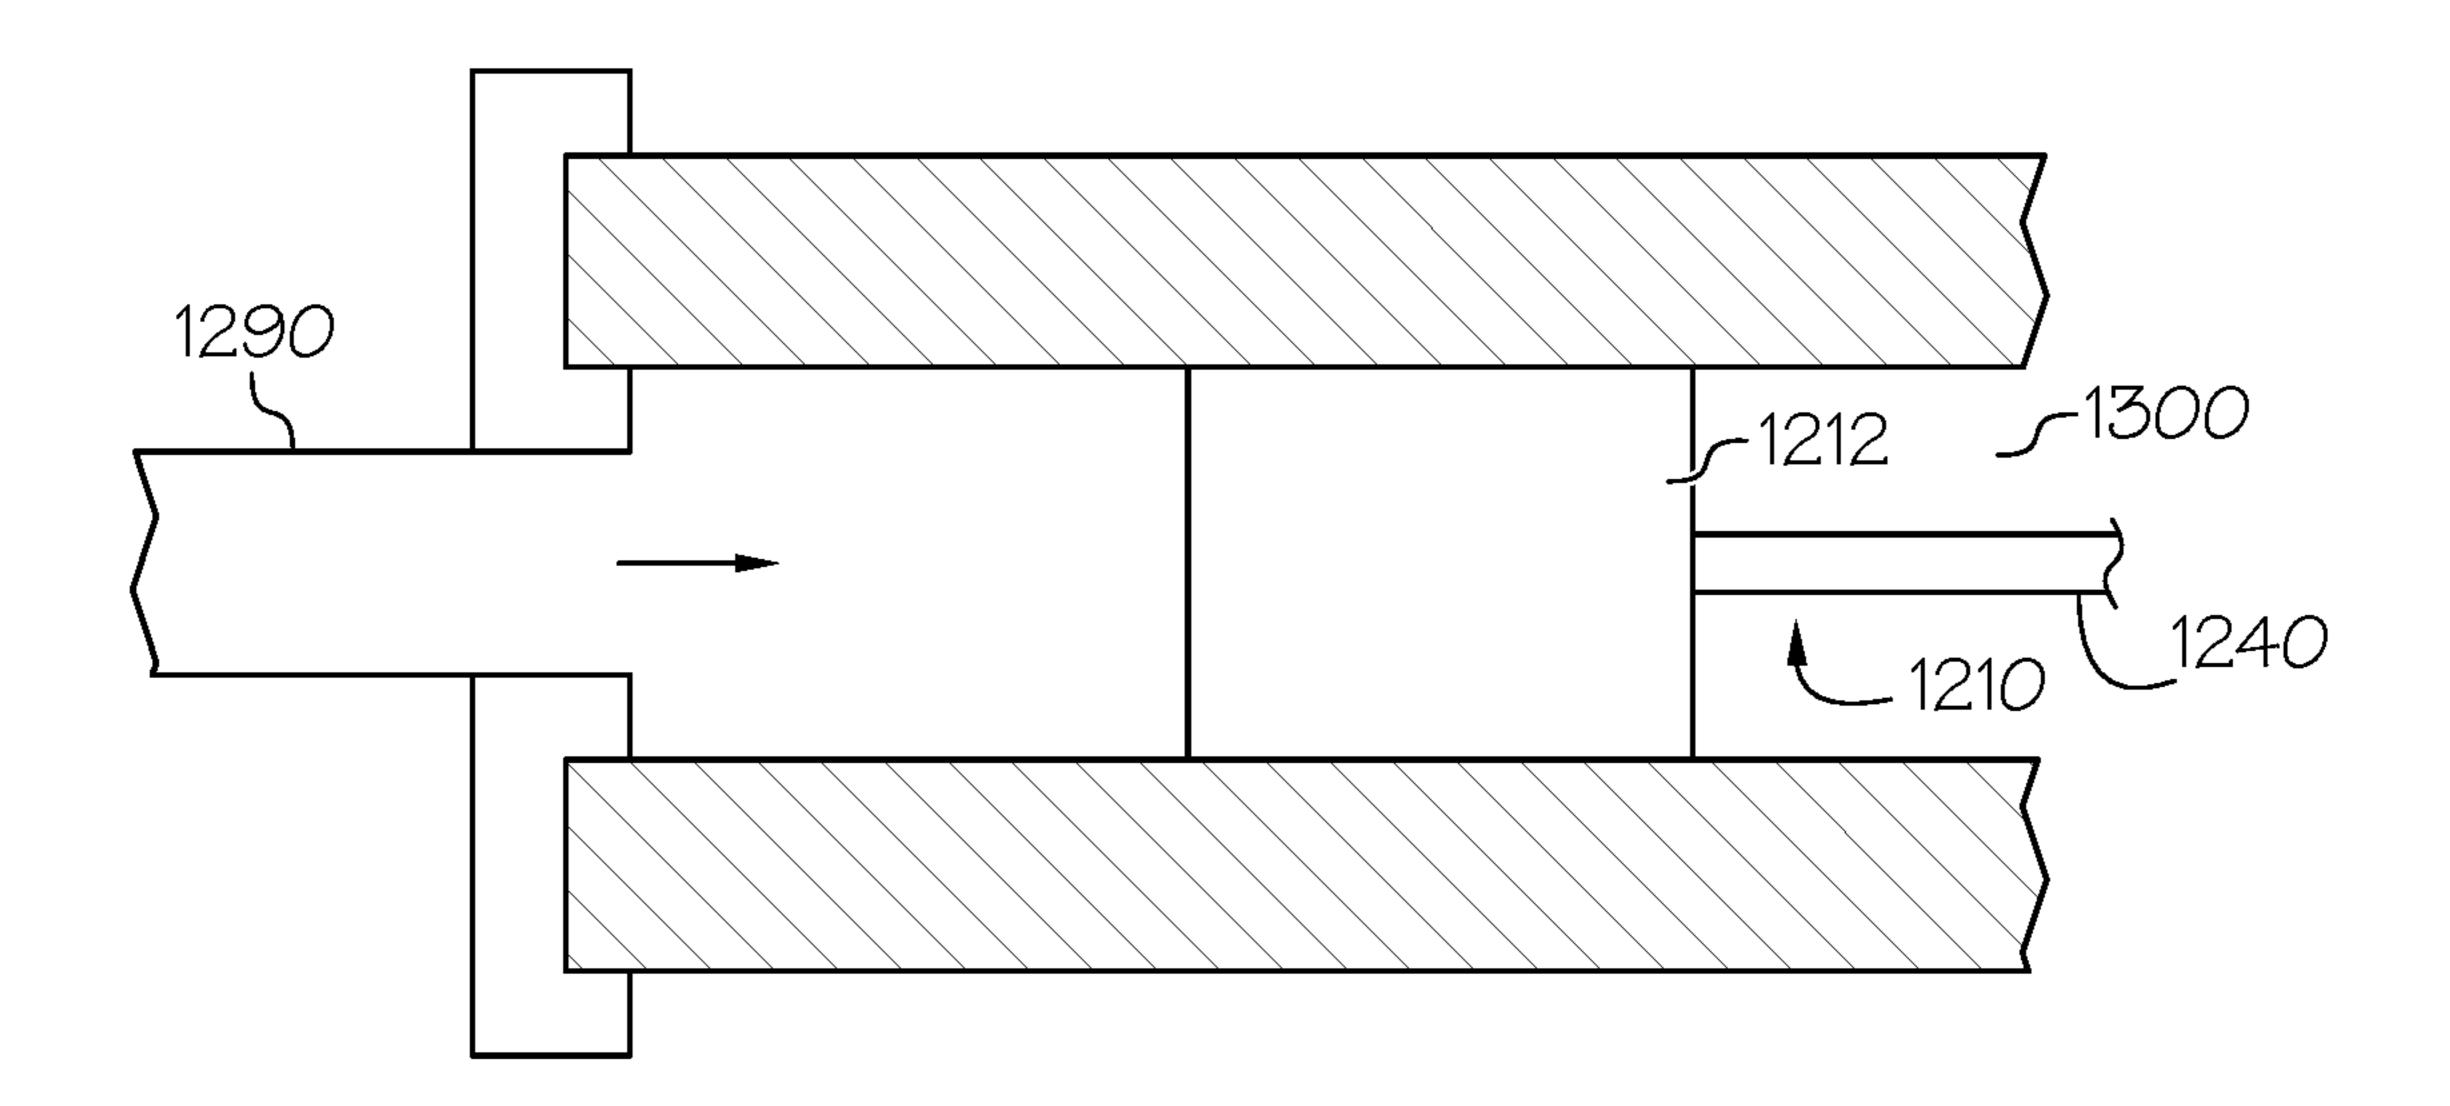
FIG. 12

FIGS. 12 and 13 are respective cross-sectional and isometric views of one end of a repair tool for repairing cored passages in accordance with a further exemplary embodiment.

> A further exemplary embodiment is depicted in FIGS. 12 and 13. FIGS. 12 and 13 are cross-sectional and isometric views, respectively, of one end 1212 of a repair tool 1210 for repairing a manufactured cored passage 1300 in accordance with a further exemplary embodiment. In FIGS. 12 and 13, the end 1212 of the repair tool 1210 is on a trailing portion 1240, which in this embodiment, is a relatively stiff, rodtype structure.

> In this example, the end 1212 has a size and shape that approximates the size and shape of the corresponding passage 1300. In effect, the end 1212 forms a generally air-tight seal with the walls of the passage 1300. As a result, pressure may be provided from a pressure source 1290 in order to exert a force on the end 1212, thereby moving the repair tool **1210**. In other embodiments, a similar end may be provided on the end of the leading portion in lieu of, or in combination
