United States Patent

US 10,954,102 B2

DIAGNOSTIC STEP FOR A PASSENGER CONVEYOR

Applicant: OTIS ELEVATOR COMPANY,
Farmington, CT (US)

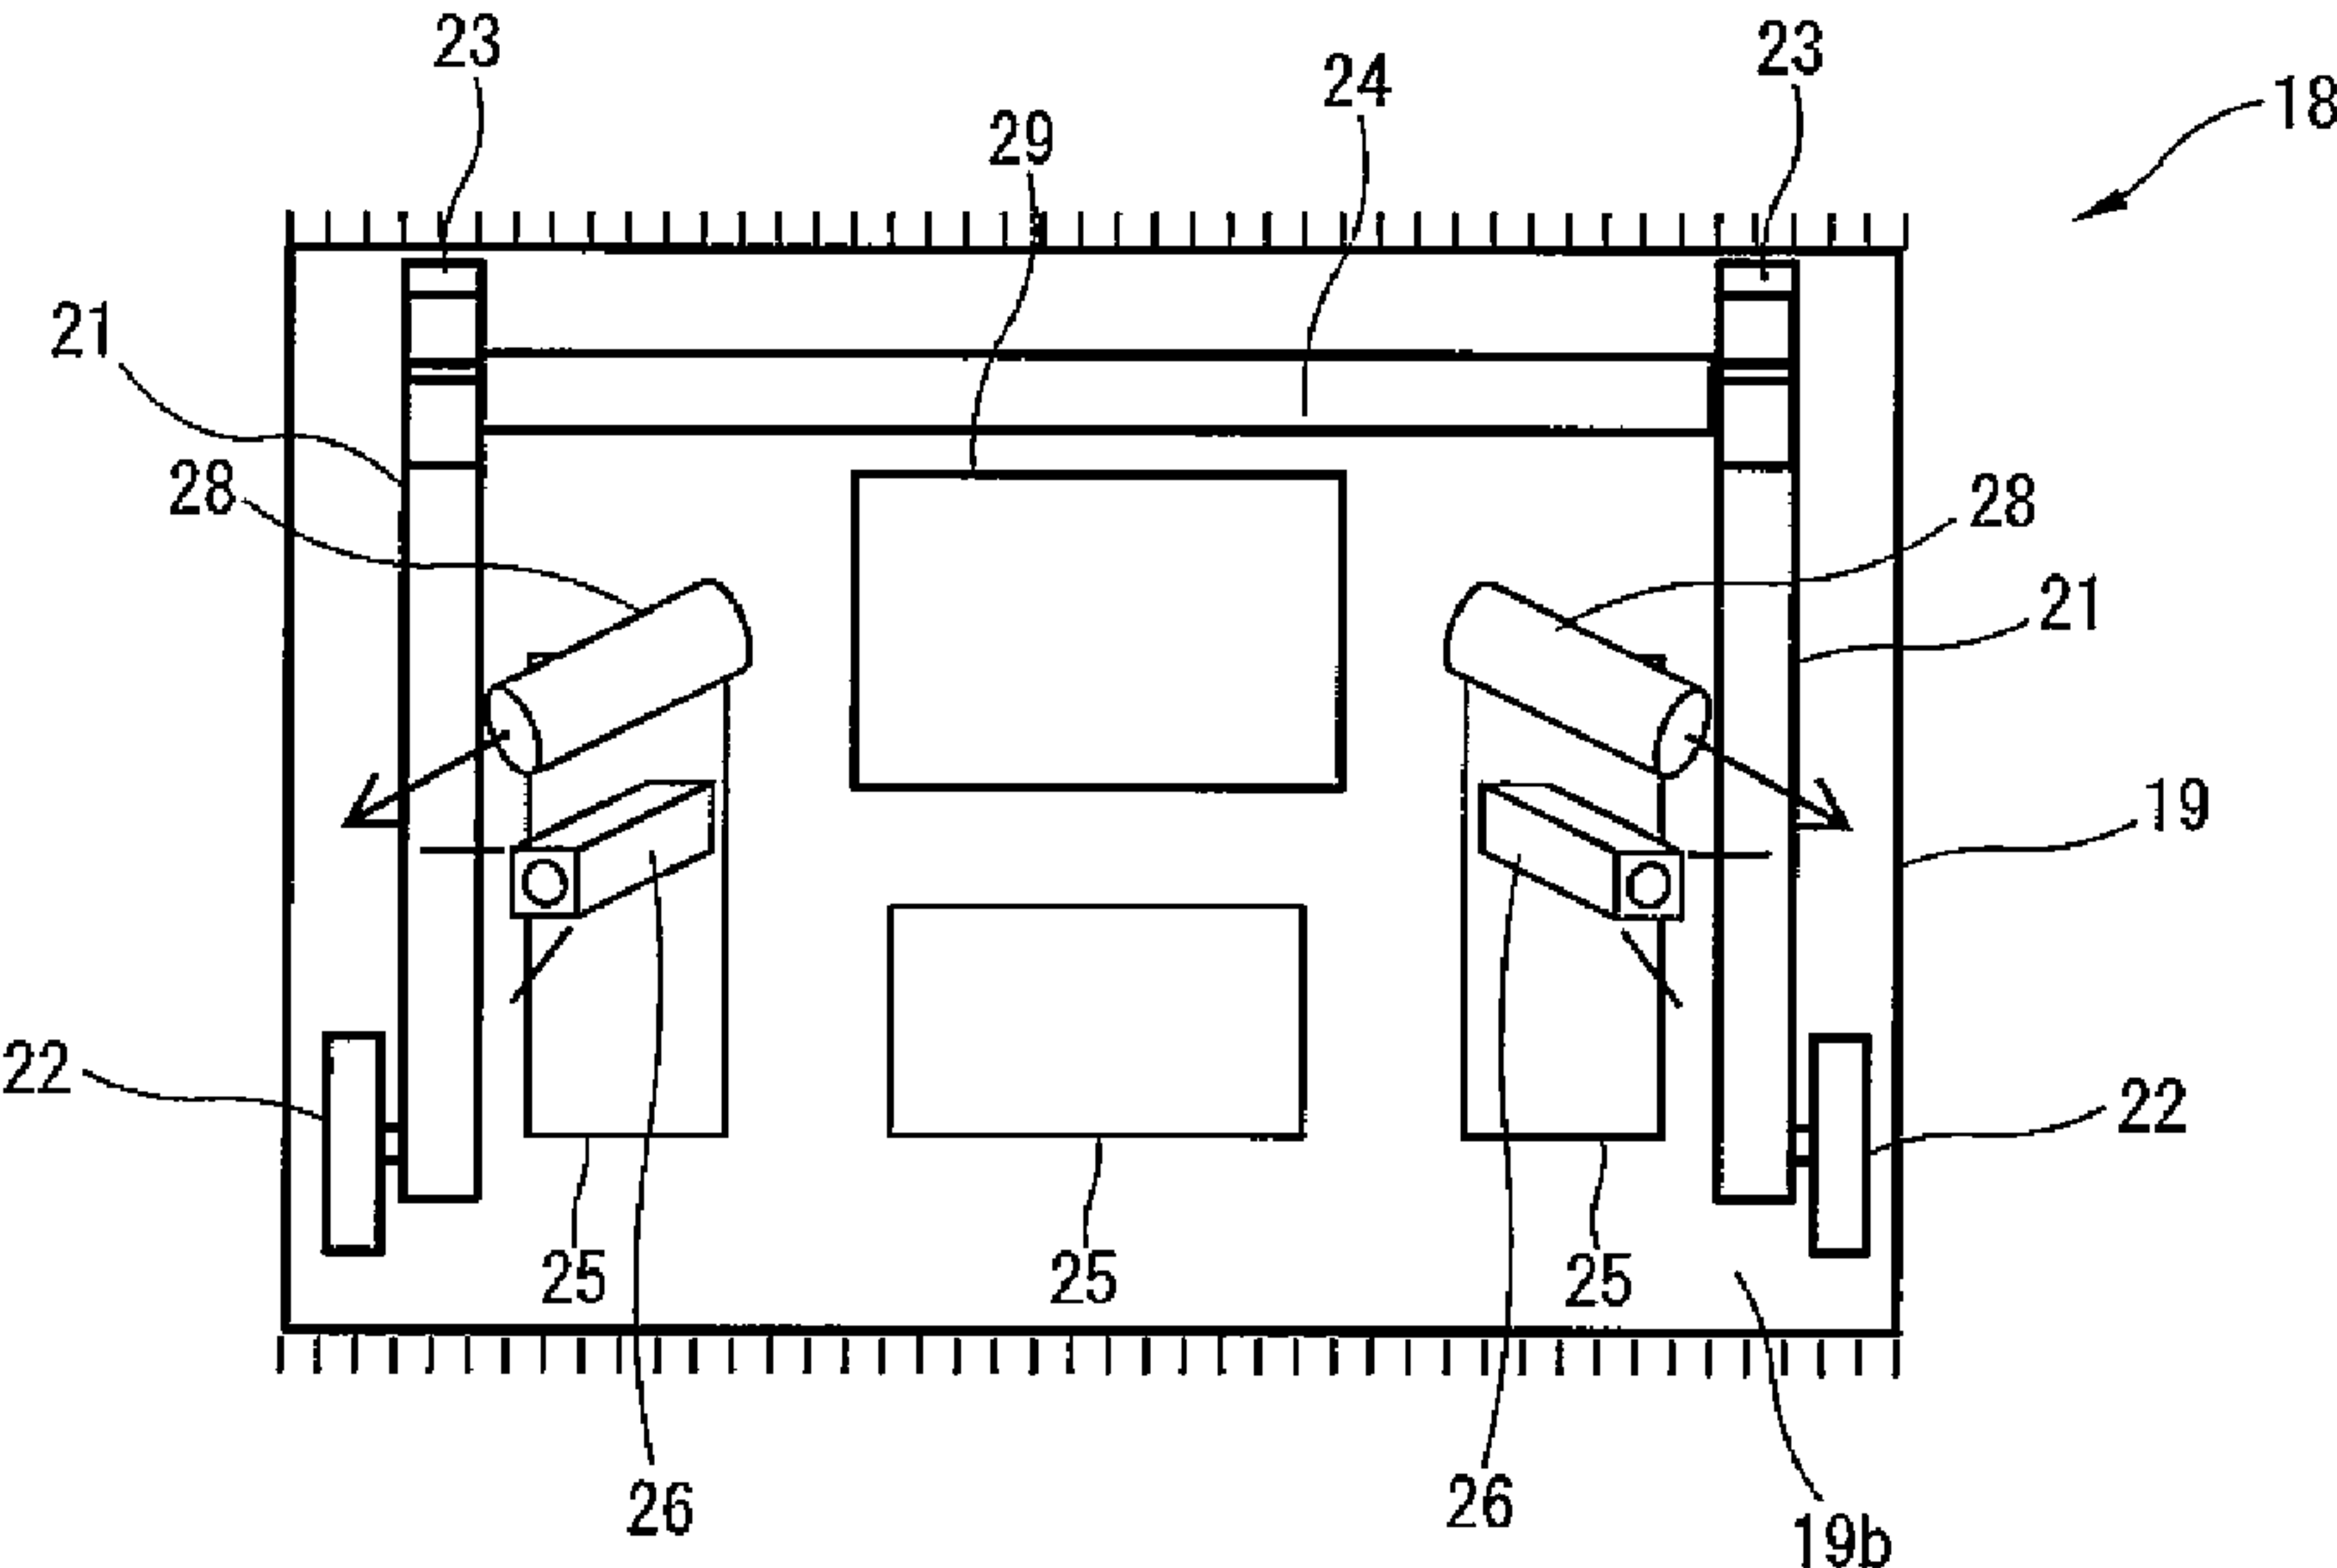
A diagnostic step for a passenger conveyor comprises at least one camera for shooting at least one lateral side of the interior space of the passenger conveyor, at least one directional microphone pointed to said at least one lateral side of the interior space of the passenger conveyor and an analyzer unit which receives image data from the camera and sound data from the directional microphone and transmits the data to an outside network.

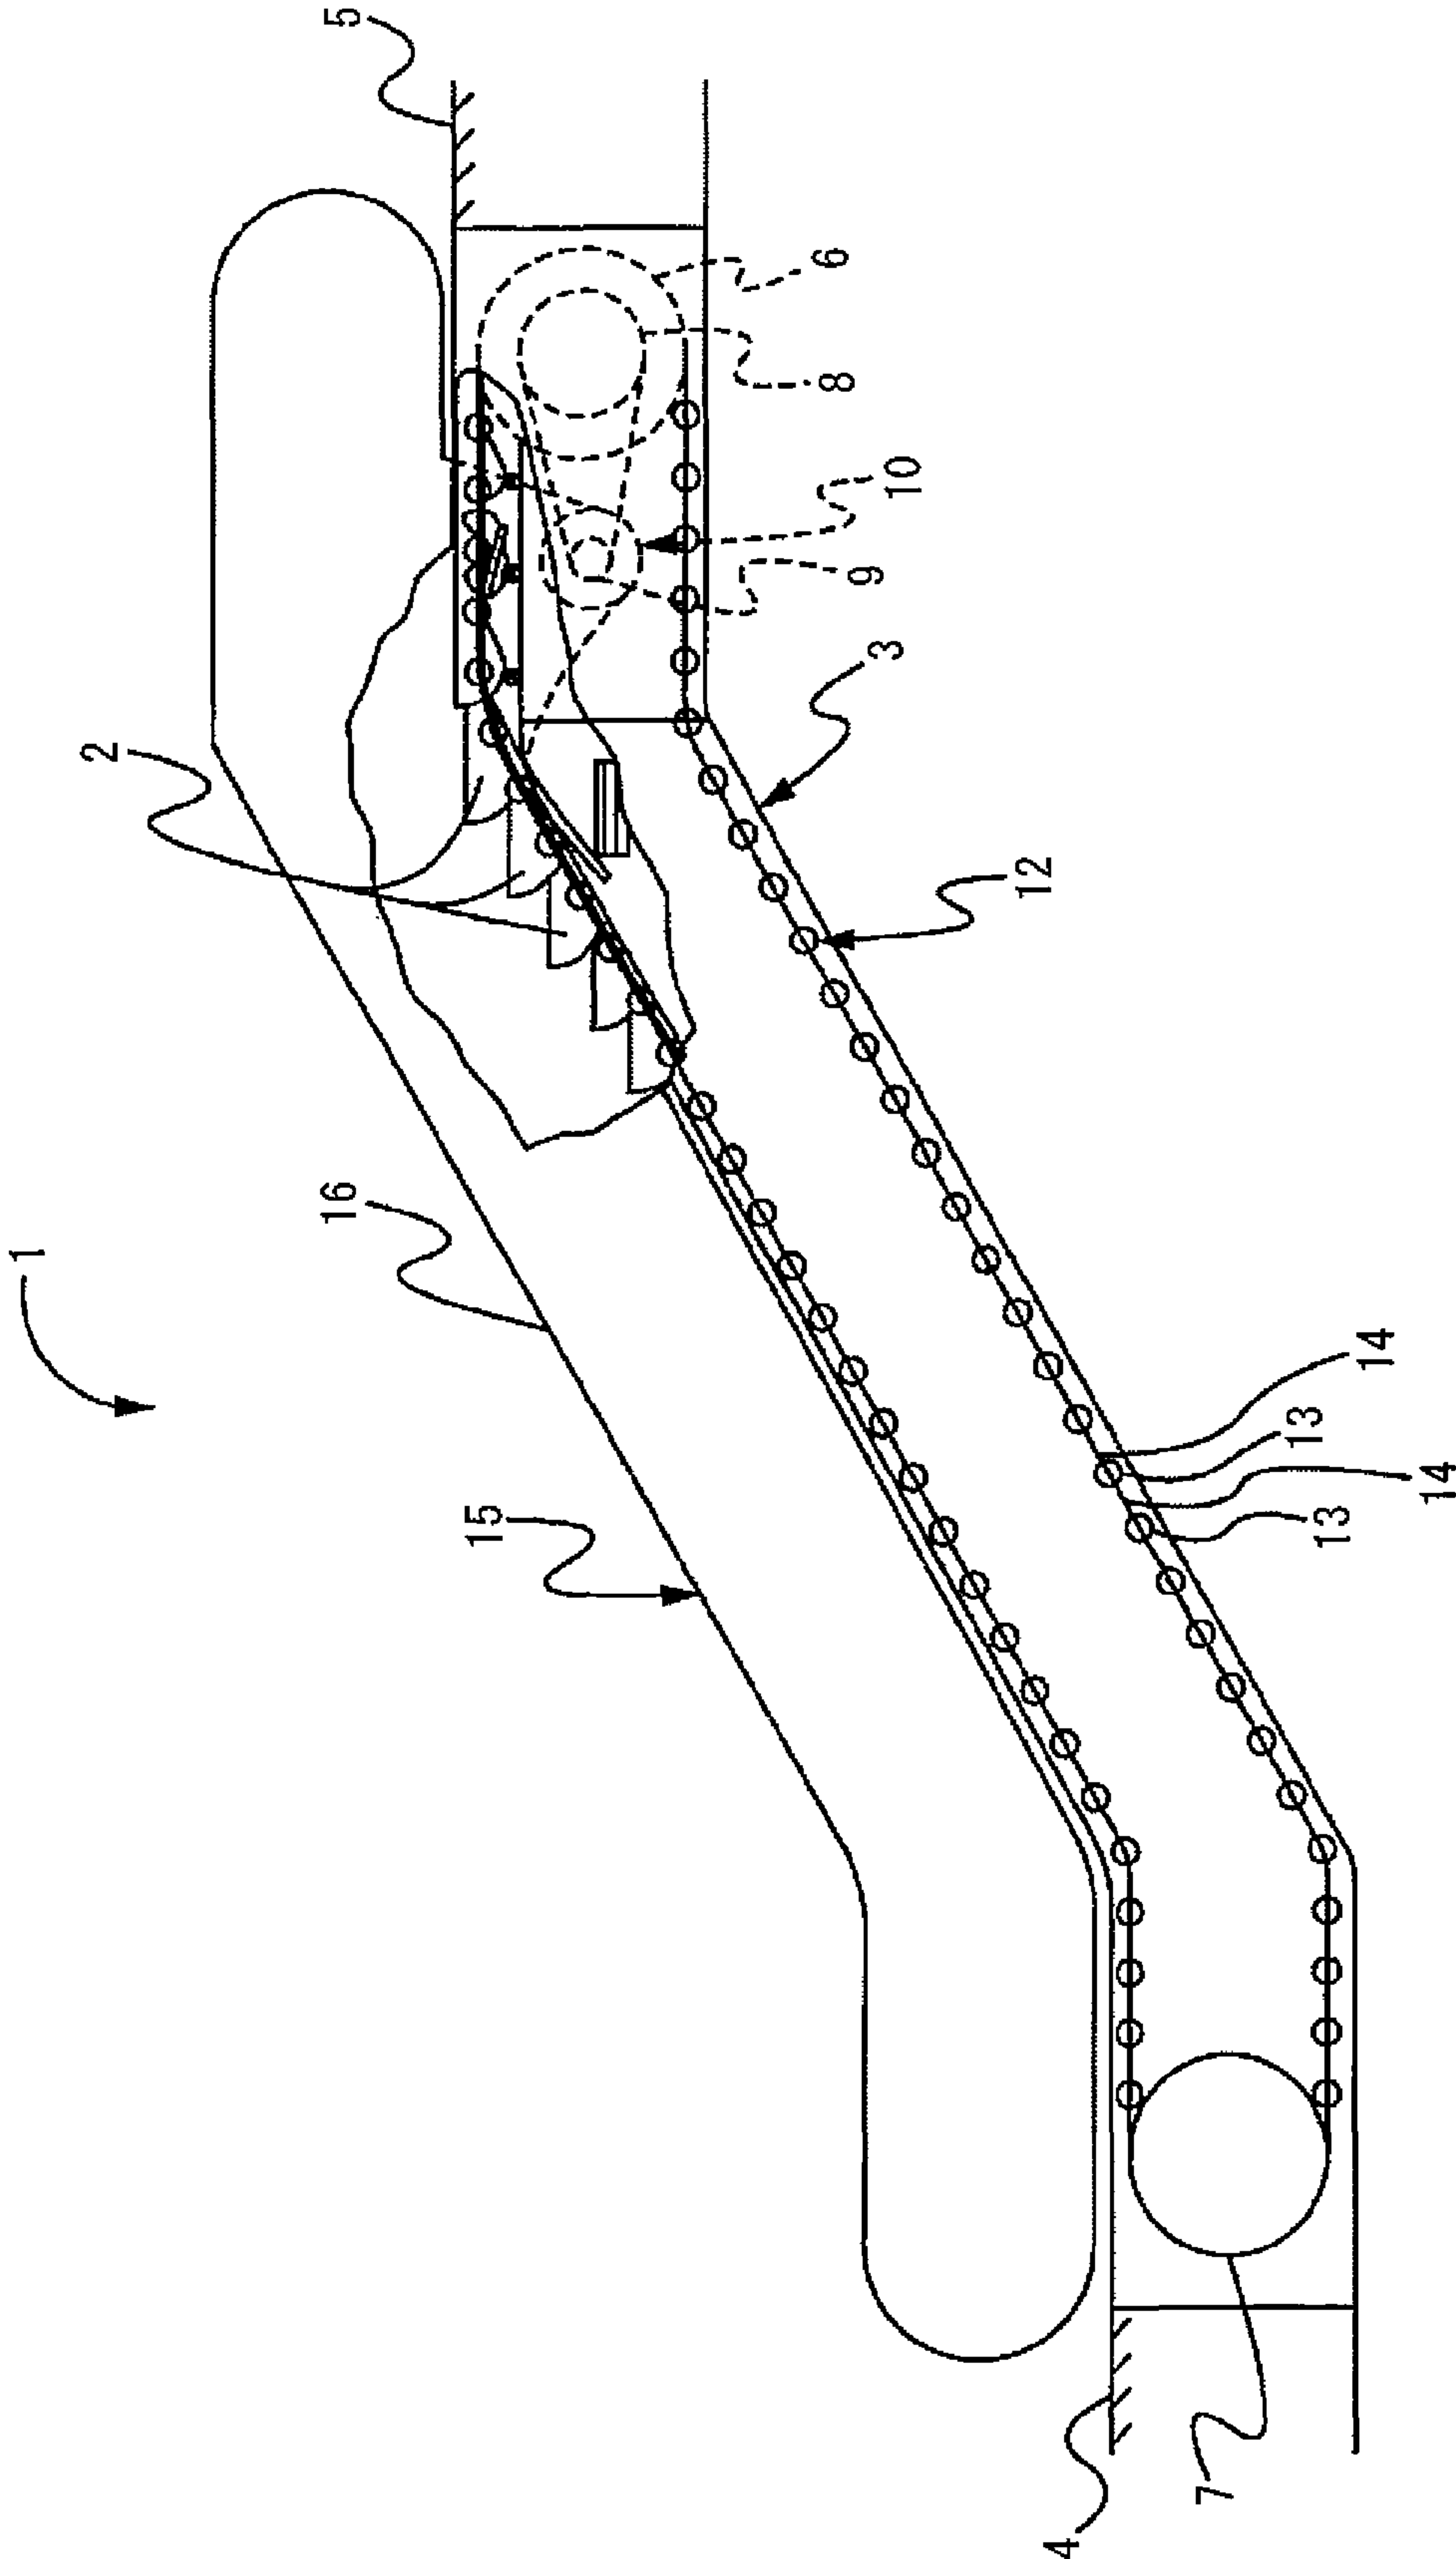
Fig. 1

FIG. 1 is a cross-sectional diagram of an escalator.

FIG. 1 schematically shows a passenger conveyor 1 in which the diagnostic device of the present invention may be used. In this example, the passenger conveyor 1 is an escalator including a plurality of escalator steps 2 that travel around a loop for carrying passengers between landings at different levels within a building.

The example passenger conveyor 1 of FIG. 1 comprises a truss 3 installed between a lower landing 4 and an upper landing 5. A first sprocket wheel 6 is rotatably supported at an upper end of the truss 3 and a second sprocket wheel 7 is rotatably supported at a lower end of the truss 3. A drive system (not shown) rotates the first sprocket wheel 6 as well as a handrail drive sprocket 8. The handrail drive sprocket 8 is coupled to a pulley 9 which forms part of a handrail drive system 10.

The escalator steps 2 are coupled to a step chain 12 which may include a plurality of rollers 13 connected by a plurality of links 14. The step chain 12 and the escalator steps 2 are driven by the drive system via the first sprocket wheel 6. A typical step chain 12 includes a pair of parallel endless loops on both lateral sides of the escalator steps 2. The loops are connected together by transverse axles (not shown) that pass between and help support the escalator steps 2. Thus, while only a single loop is illustrated in FIG. 1, it will be understood that the escalator includes dual loops, and each step chain 12 is driven around respective sprocket wheels 6, 7 positioned in the interior space of the truss 3 on each lateral side thereof.

An endless handrail 15 passes around a balustrade assembly 16. While only a single handrail 15 is illustrated in FIG. 1, it will be understood that a pair of endless handrails 15 are supported on a respective balustrade assembly 16 on both lateral sides of the escalator steps 2 and are each driven by a respective handrail drive system 10 positioned in the interior space of the truss 3 on each lateral side thereof.

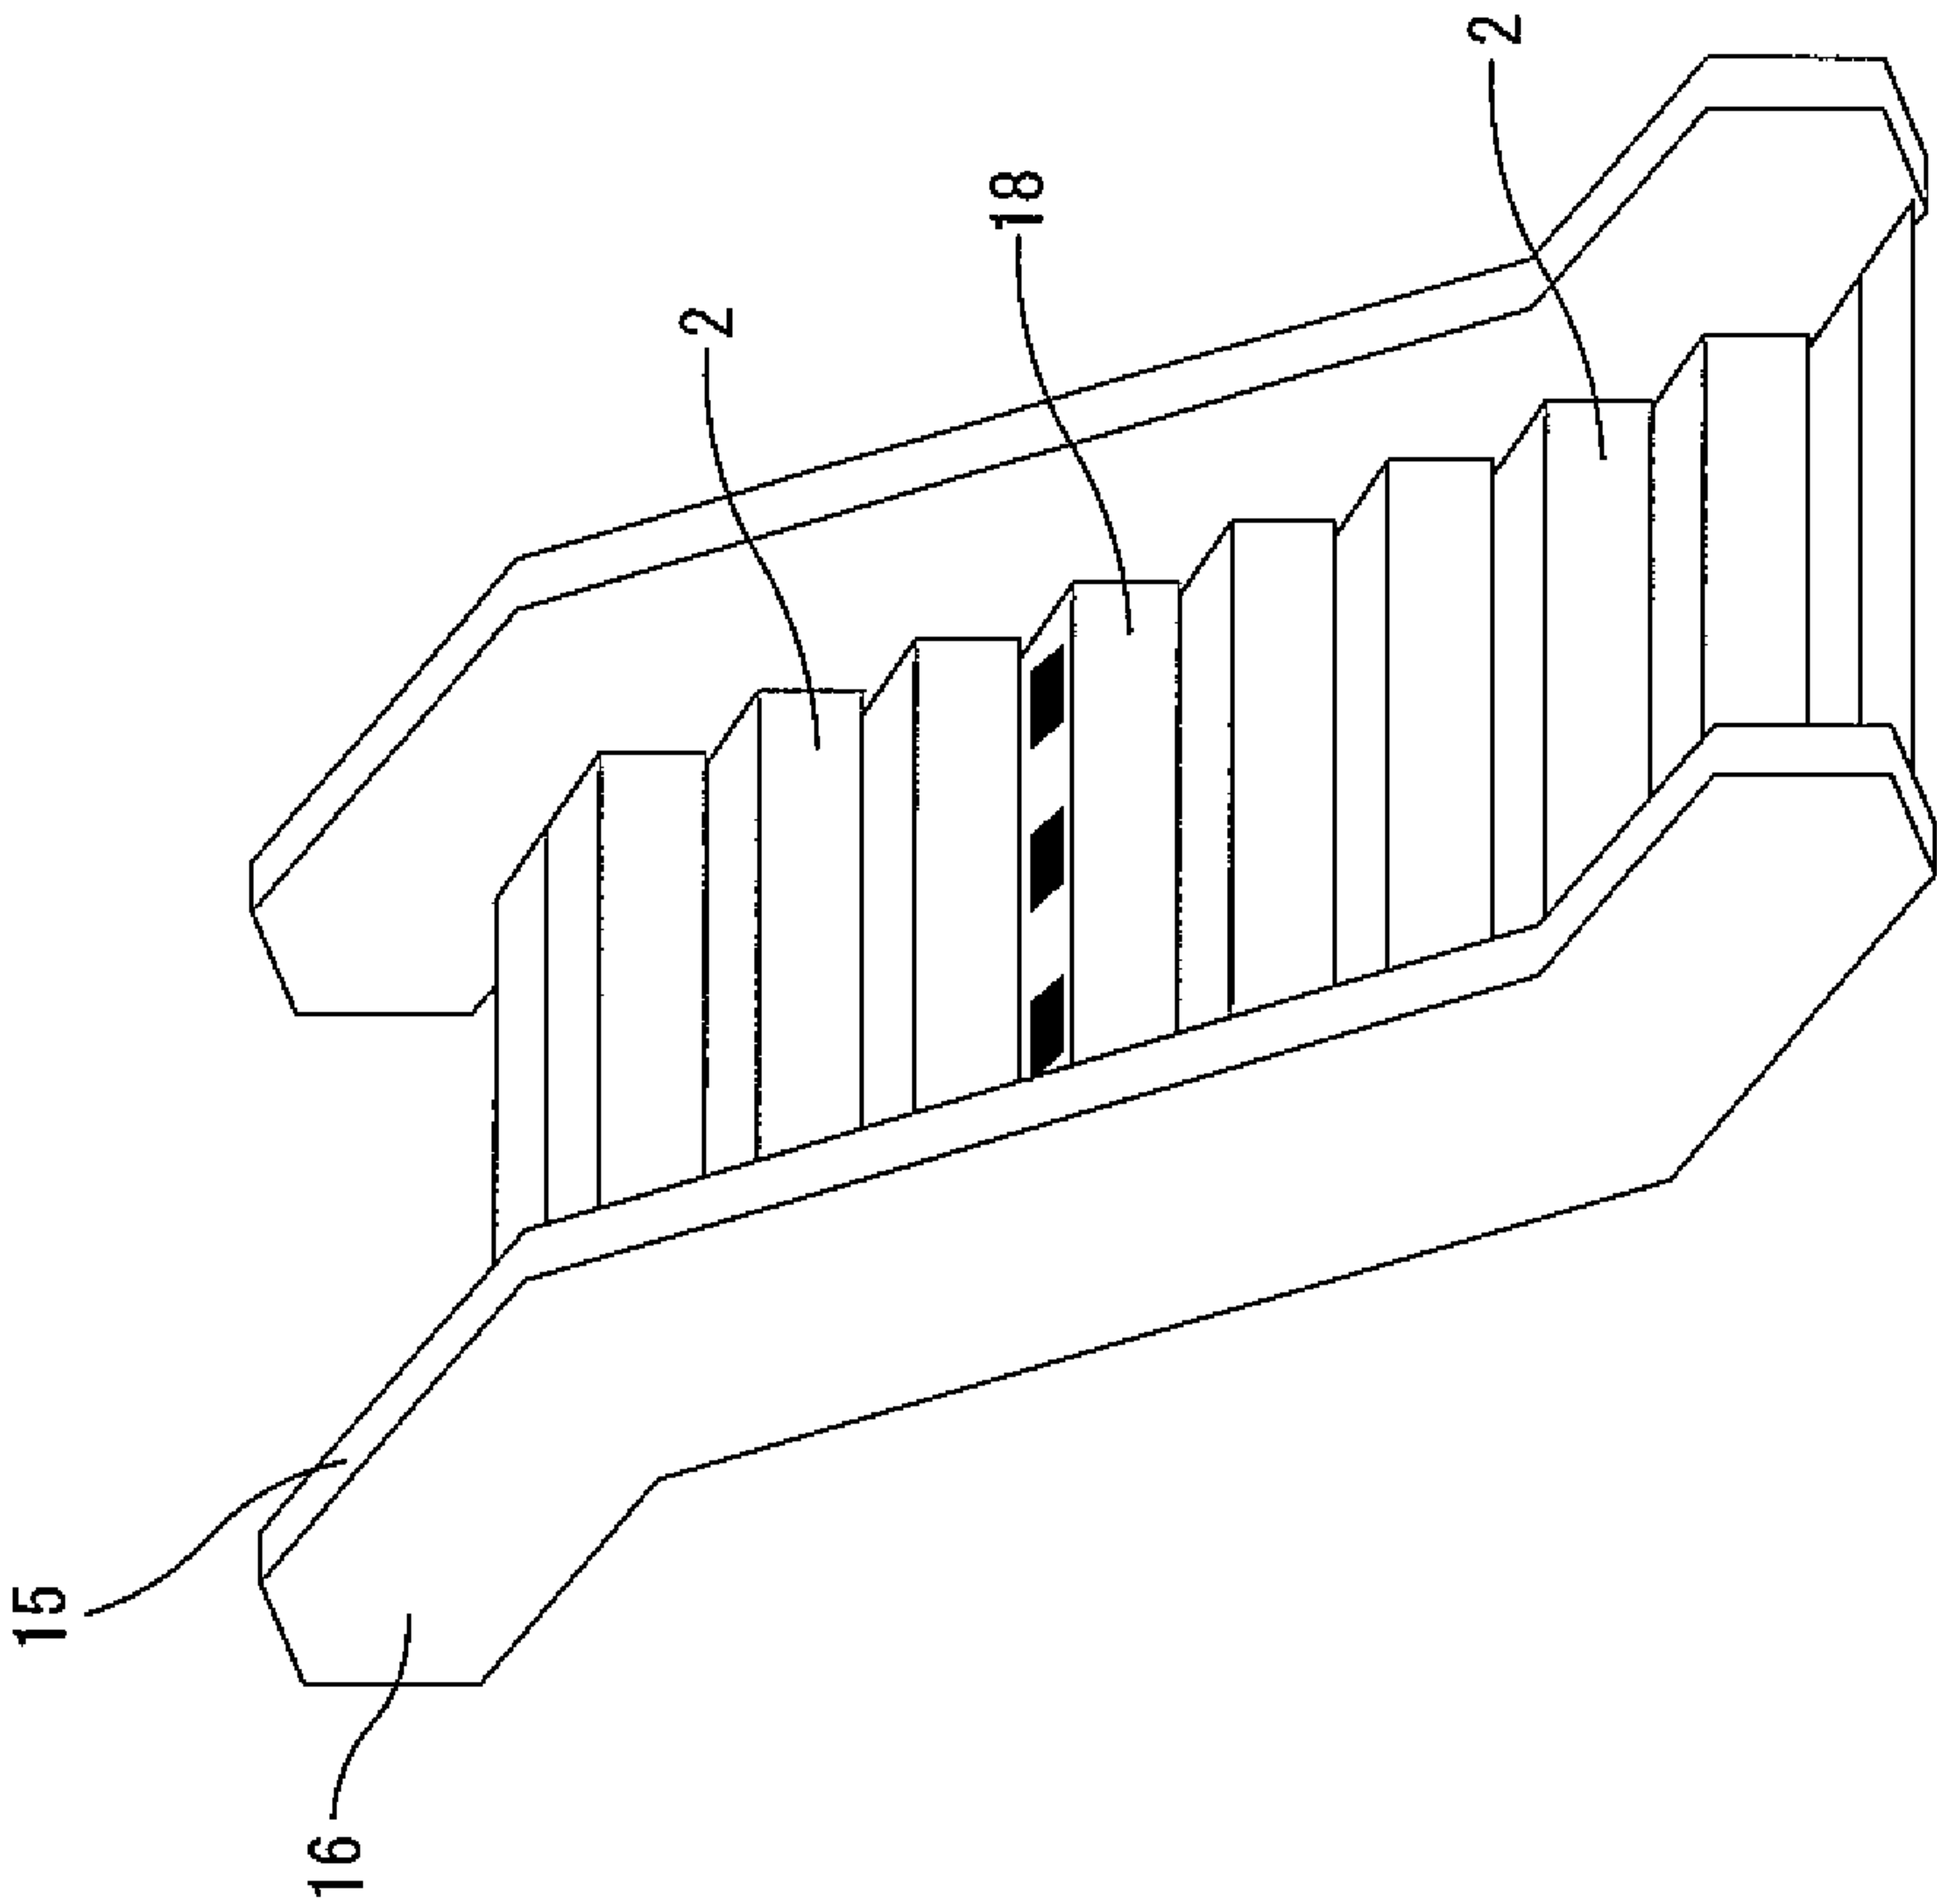
Fig. 2

FIG. 2 is a schematic view of an escalator with the diagnostic step of the present invention installed thereon.

FIG. 2 shows an example diagnostic device 18 of the present invention in the form of a step. The diagnostic step 18 may be simply installed on the escalator during maintenance or repair by removing a single escalator step 2 and attaching the diagnostic step 18 in place of the removed escalator step 2.

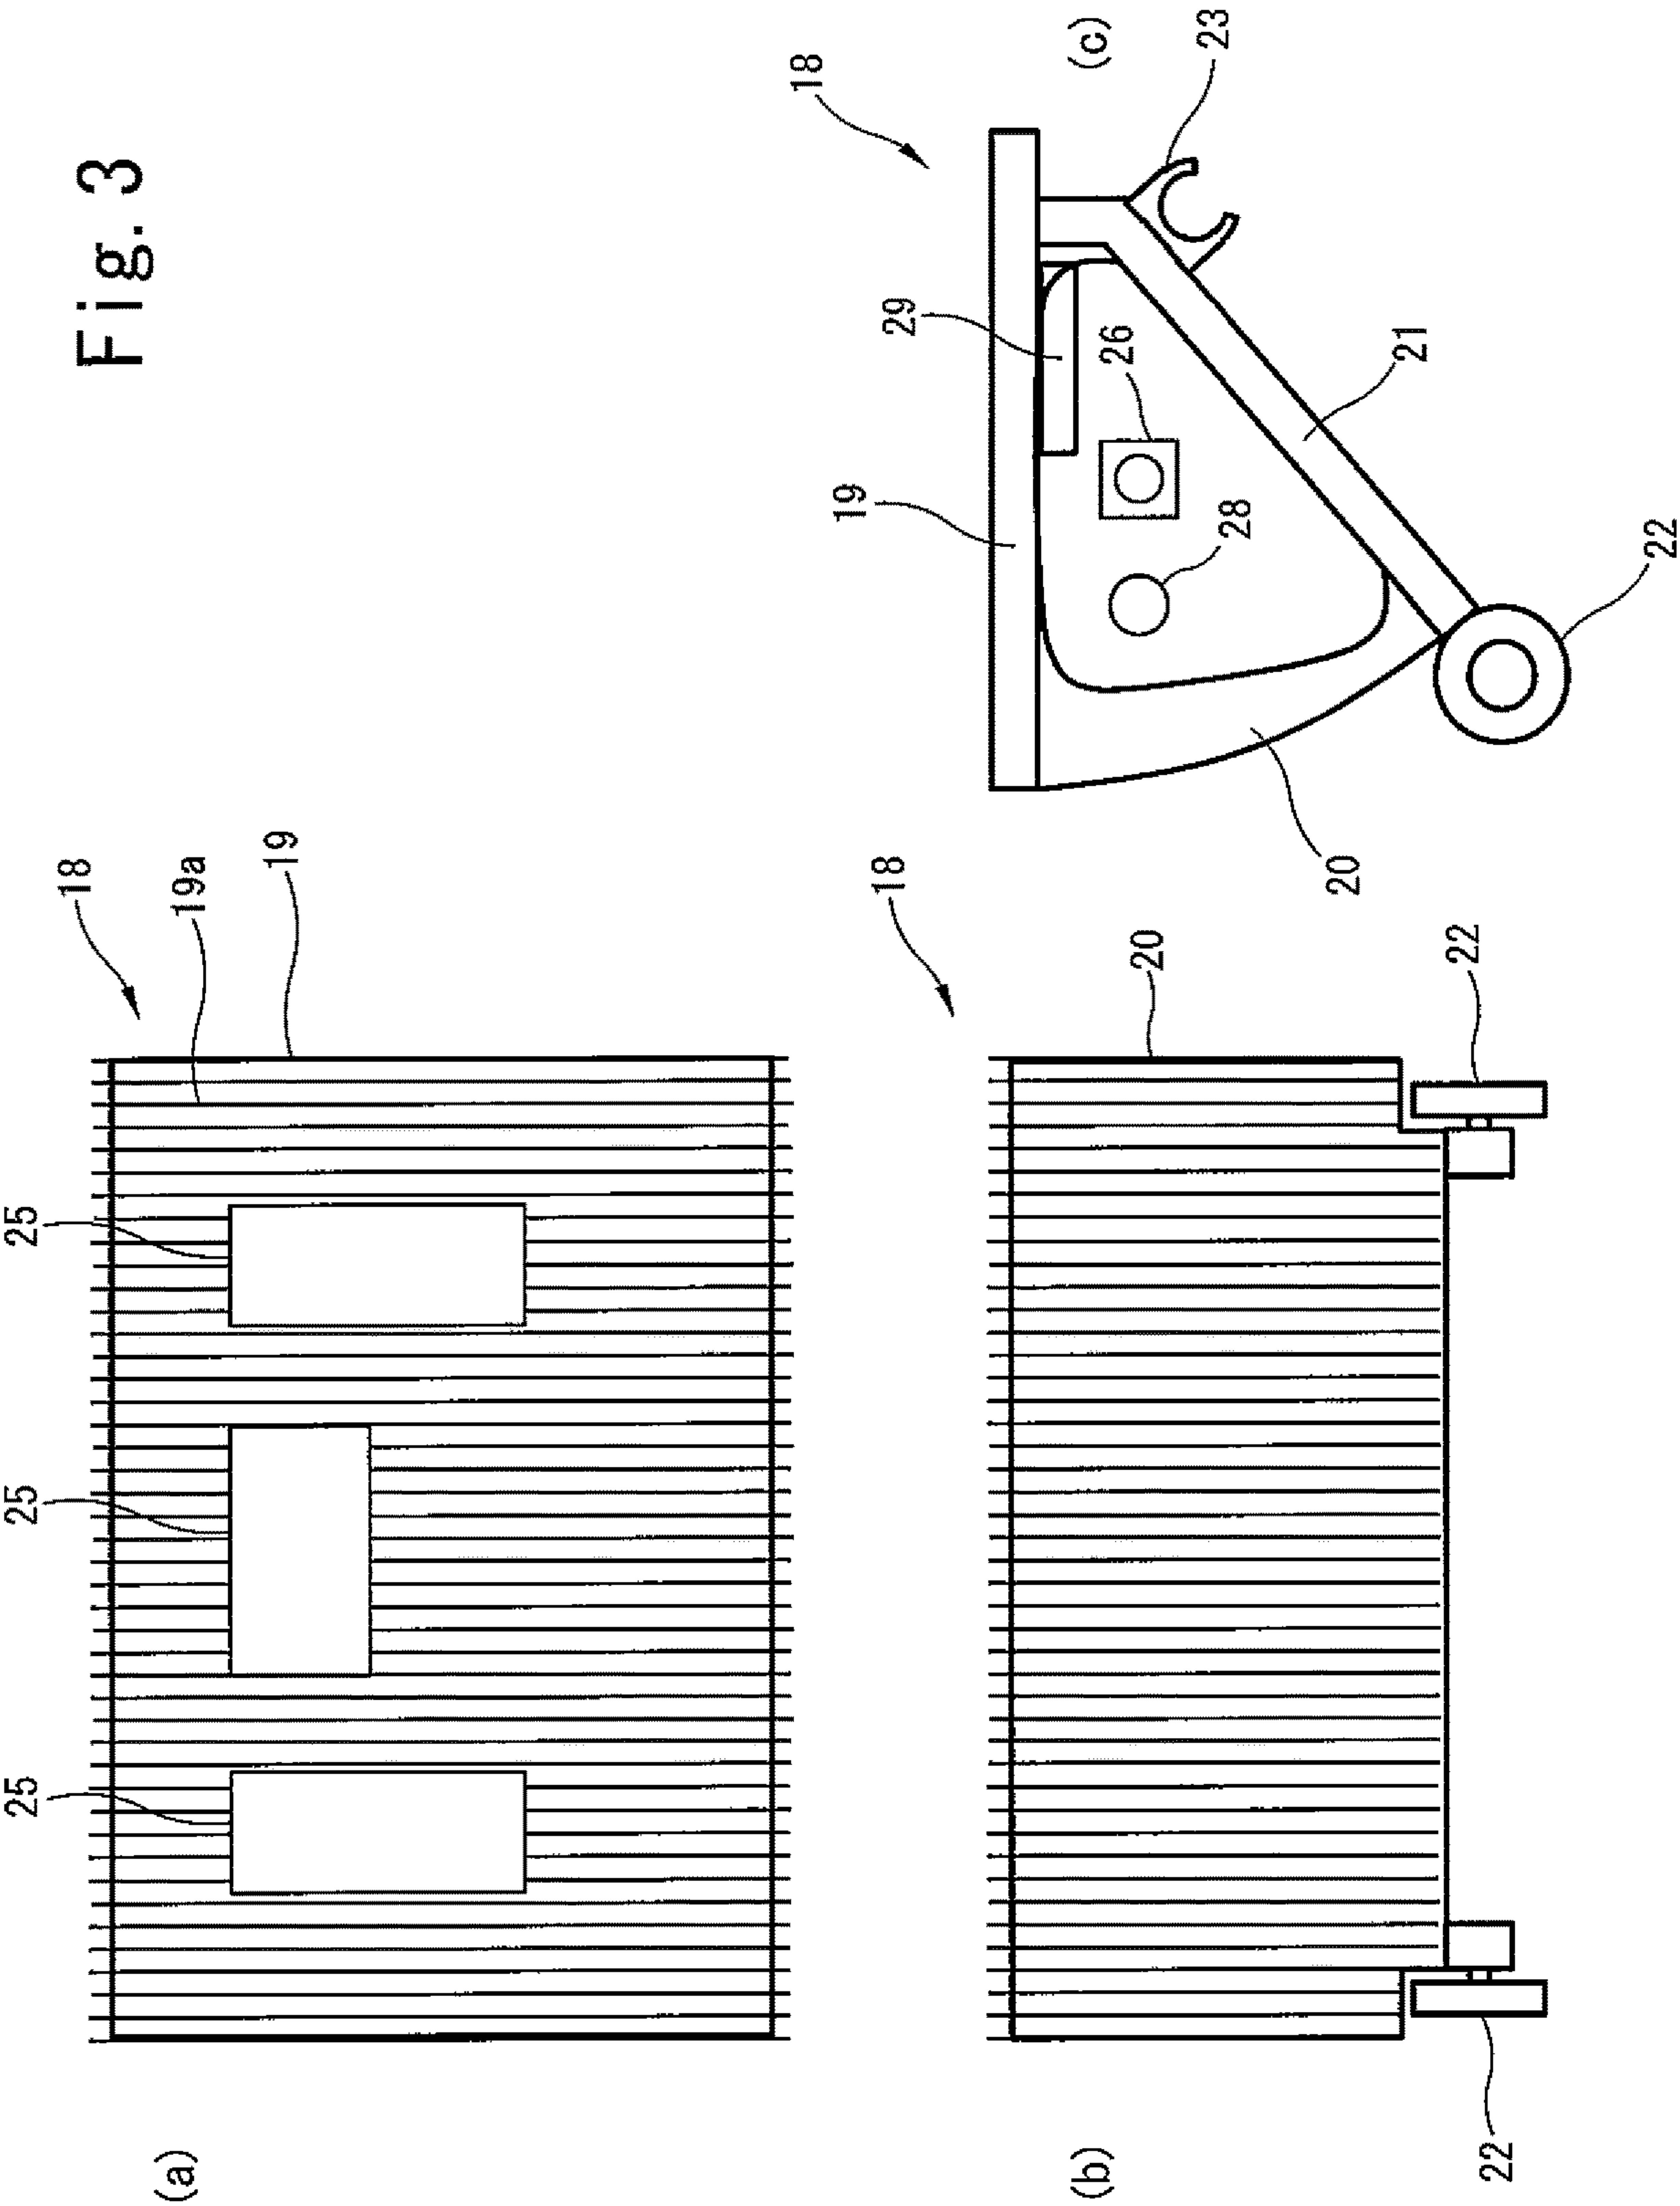
Fig. 3

FIG. 3(a) is a plan view, FIG. 3(b) is a front view and FIG. 3(c) is a side view of the diagnostic step of FIG. 2.

As shown in FIG. 3, the diagnostic step 18 may have a configuration which resembles escalator step 2 and includes a tread portion 19 joined to a riser portion 20 and step arms 21 (only one shown in FIG. 3) connecting the tread portion 19 to the riser portion 20 as known in the art. The step arms 21 are connected to each other by an axle 24 (FIG. 4) and may each comprise rollers 22 on one end for riding on a rail and support members 23 on the other end for engaging a transverse axle such that the diagnostic step 18 may be

driven around the loop together with the escalator steps 2 when it is installed on the escalator. FIG. 3(a) shows a plan view, FIG. 3(b) shows a front view and FIG. 3(c) shows a side view of the diagnostic step 18.

The outer surface 19a of the tread portion 19 corresponds to the surface of escalator step 2 which receives the foot of a passenger and faces generally upward during the advance path. The tread portion 19 includes at least one maintenance window 25 (three in this example) for access to the inner side of the diagnostic step 18.

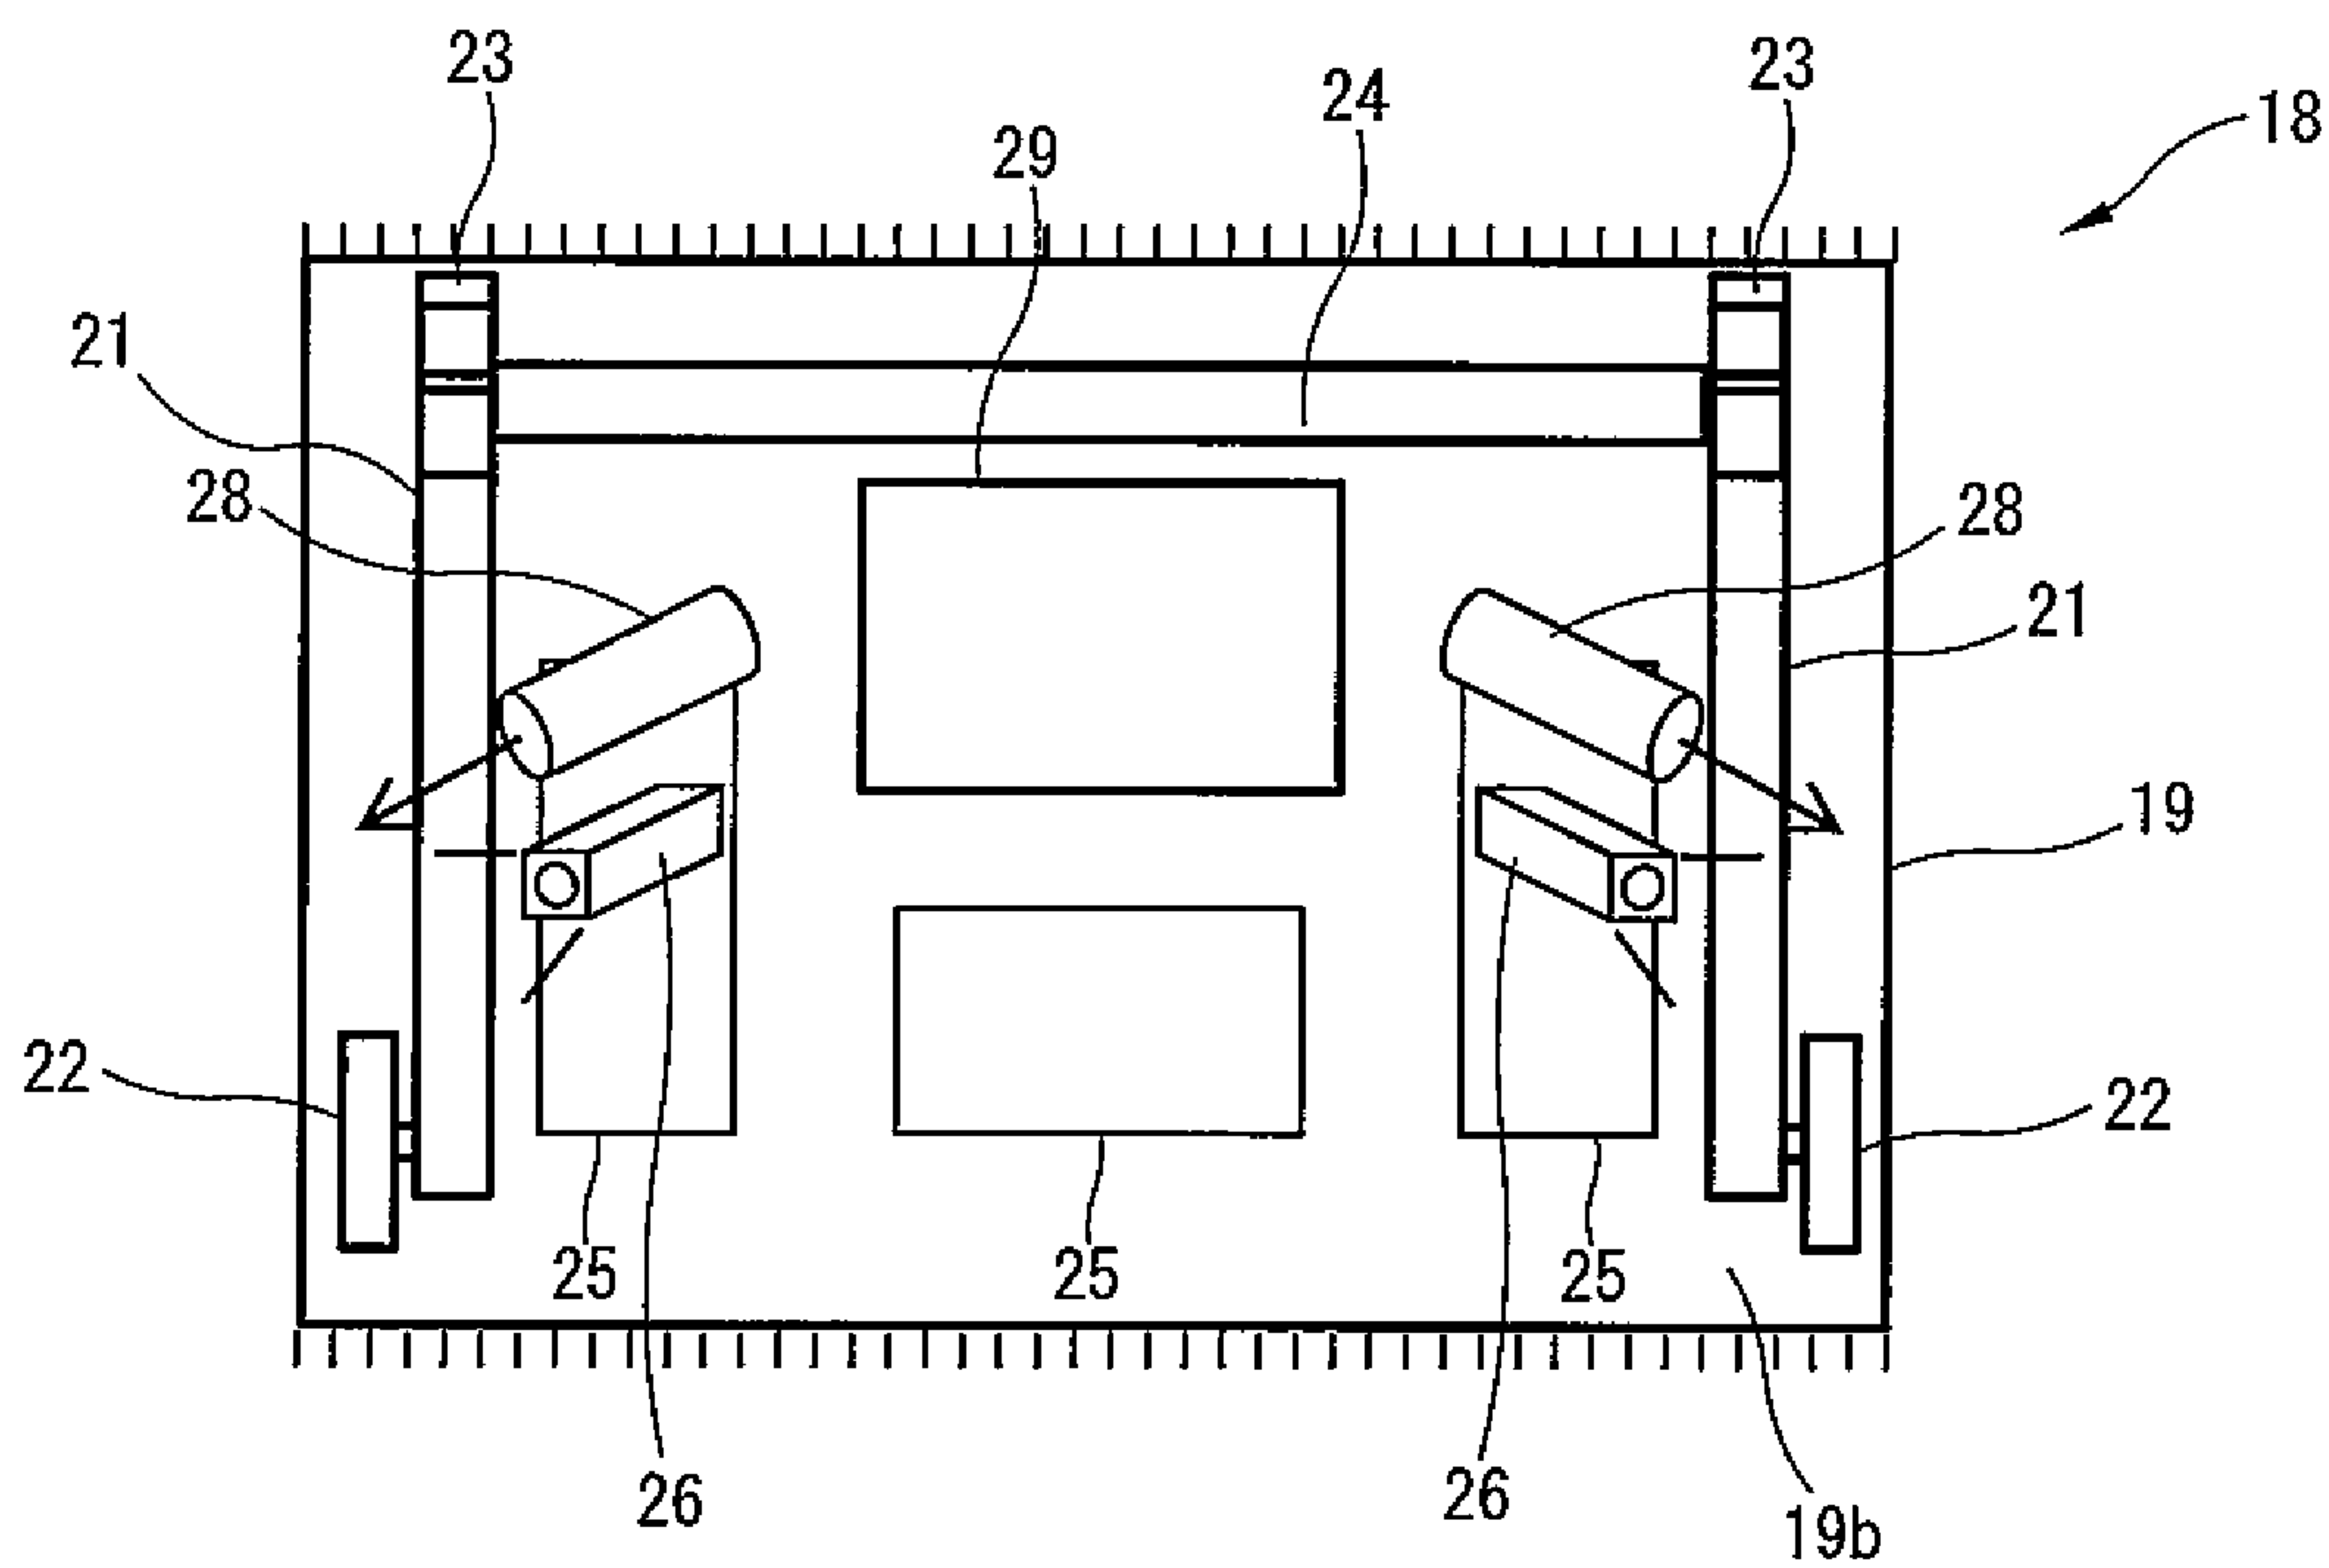
Fig. 4

FIG. 4 is a bottom view of the diagnostic step of FIG. 2.

The diagnostic step 18 includes at least one camera 26, at least one directional microphone 28 and an analyzer unit 29 in the space defined by the tread portion 19, riser portion 20 and step arms 21. In the embodiment shown in FIG. 4, the diagnostic step 18 includes two cameras 26 and two microphones 28. Each camera 26 may be attached to the inner surface 19b of the tread portion 19 such as by brackets and may be adjustable to shoot different directions. Each camera 26 may include a LED light. In this embodiment, one camera is adjusted to shoot one or a plurality of components positioned on one lateral side (ex. the left-hand side of FIG. 2) and one camera is adjusted to shoot one or a plurality of components positioned on the other lateral side (ex. the right-hand side of FIG. 2) of the interior space of the truss 3. The directional microphones 28 may also be attached to the inner surface 19b of the tread portion 19 such as by brackets and may be adjustable to point to different directions. In this embodiment, one microphone 28 is adjusted to point to one or a plurality of components on the right-hand side and one microphone 28 is adjusted to point to one or a plurality of components positioned on the left-hand side of the interior space of the truss 3.

In this way, the cameras 26 and the microphones 28 may collect images or sounds of components positioned on the left-hand side and on the right-hand side separately. Such components may include components such as the handrail drive system 10 or sprocket wheels 6, 7. The cameras 26 and the microphones 28 may be adjusted through the maintenance windows 25 after installing the diagnostic step 18 onto the escalator.
