United States Patent

US 10,954,102 B2

DIAGNOSTIC STEP FOR A PASSENGER CONVEYOR

Applicant: OTIS ELEVATOR COMPANY,
Farmington, CT (US)

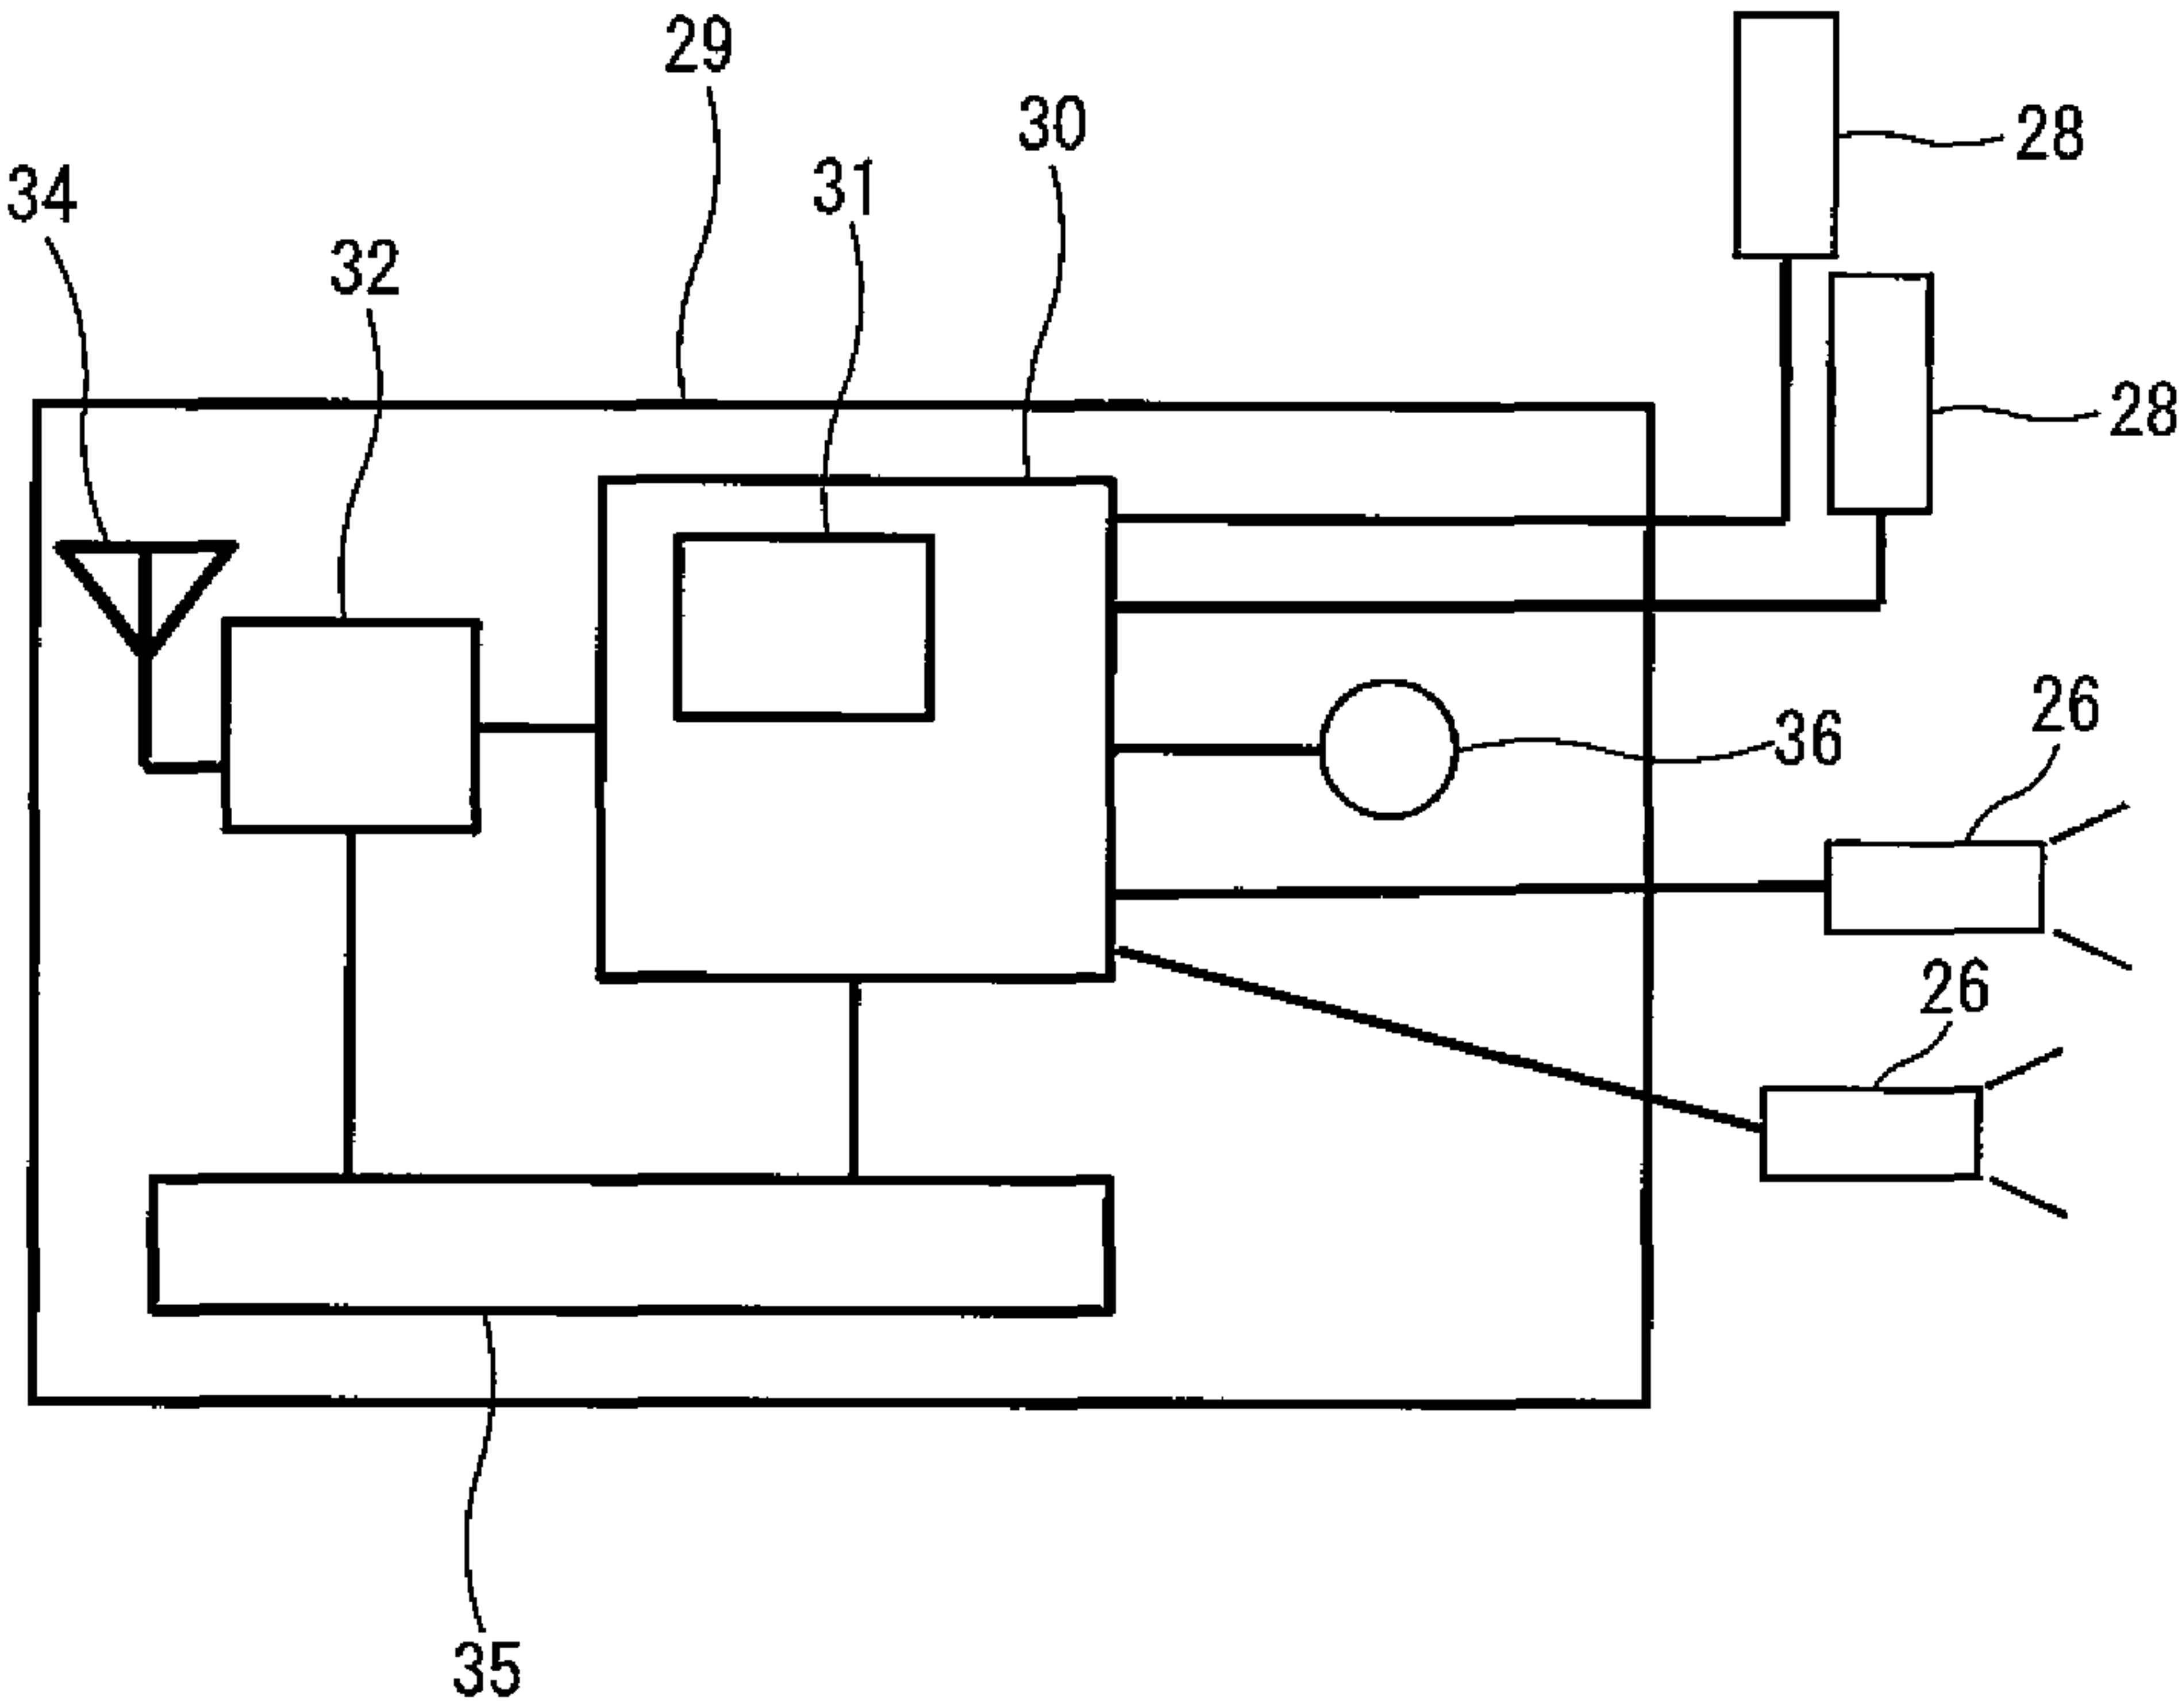
Fig. 5

FIG. 5 is a detailed view of the analyzer unit of FIG. 4.

The analyzer unit 29 may be attached to the inner surface 19b of the tread portion 19. A detailed view of the analyzer unit 29 is shown in FIG. 5. The analyzer unit 29 may comprise a printed-circuit board 30 including a memory 31, a wireless network interface device 32 such as a 3G modem, WiFi interface etc. including an antenna 34 and a battery 35 for providing power to all of the components included in the diagnostic step 18. The directional microphones 28 and cameras 26 are connected to the printed-circuit board 30 to provide sound data and image data. An acceleration sensor 36 may also be connected to the printed-circuit board to provide acceleration data. The printed-circuit board 29 receives the analog data or digital data from the cameras 26, microphones 28 and sensor 36, converts analog data to digital data as necessary and stores such data in the memory 31. The sound data and image data are synchronized. The printed-circuit board 29 may further analyze such data. Data and analyzed results may be provided to a wireless network 38 (FIGS. 7 to 9) via the wireless network interface device 32.

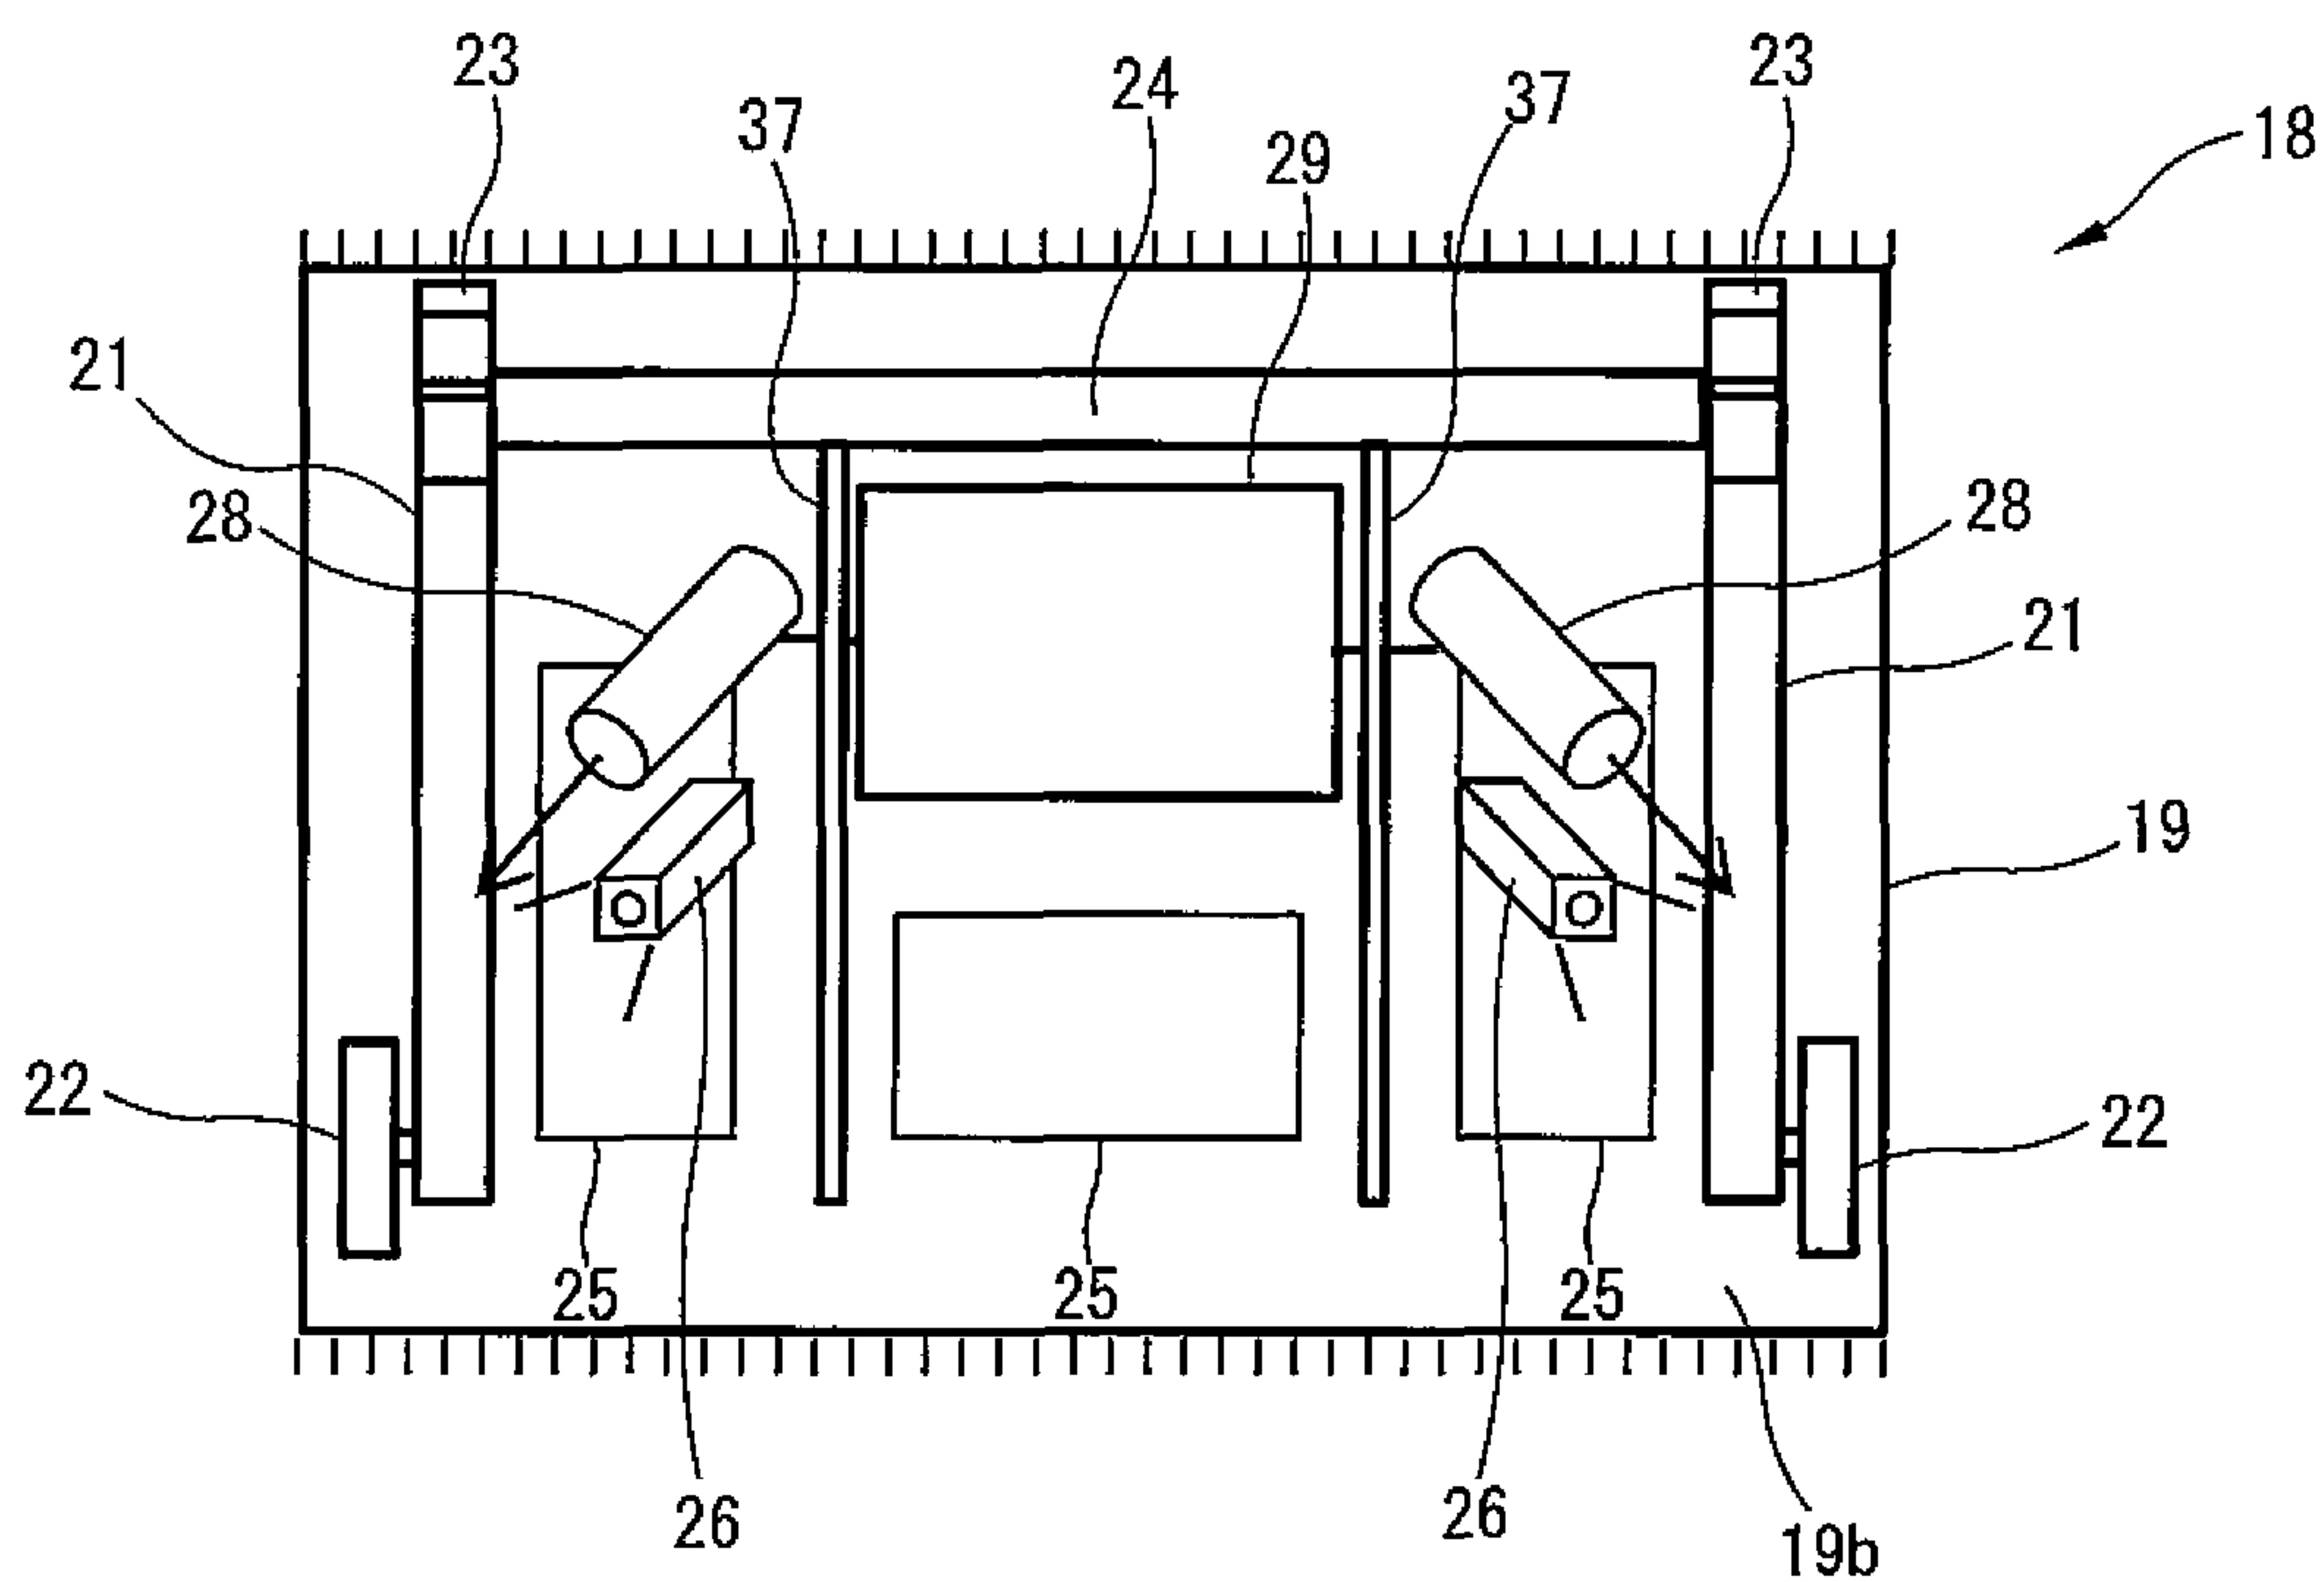
Fig. 6

FIG. 6 is a bottom view of another embodiment of the diagnostic step of the present invention.

FIG. 6 shows a further embodiment in which partitions 37 are provided on the inside surface 19b of the tread portion

19 to separate sounds emanating from the right-hand side of the truss and sounds emanating from the left-hand side of the truss to allow a more precise collection of sounds. Two partitions 37 are provided in this embodiment. However, one partition 37 may be sufficient to separate sounds in other embodiments.

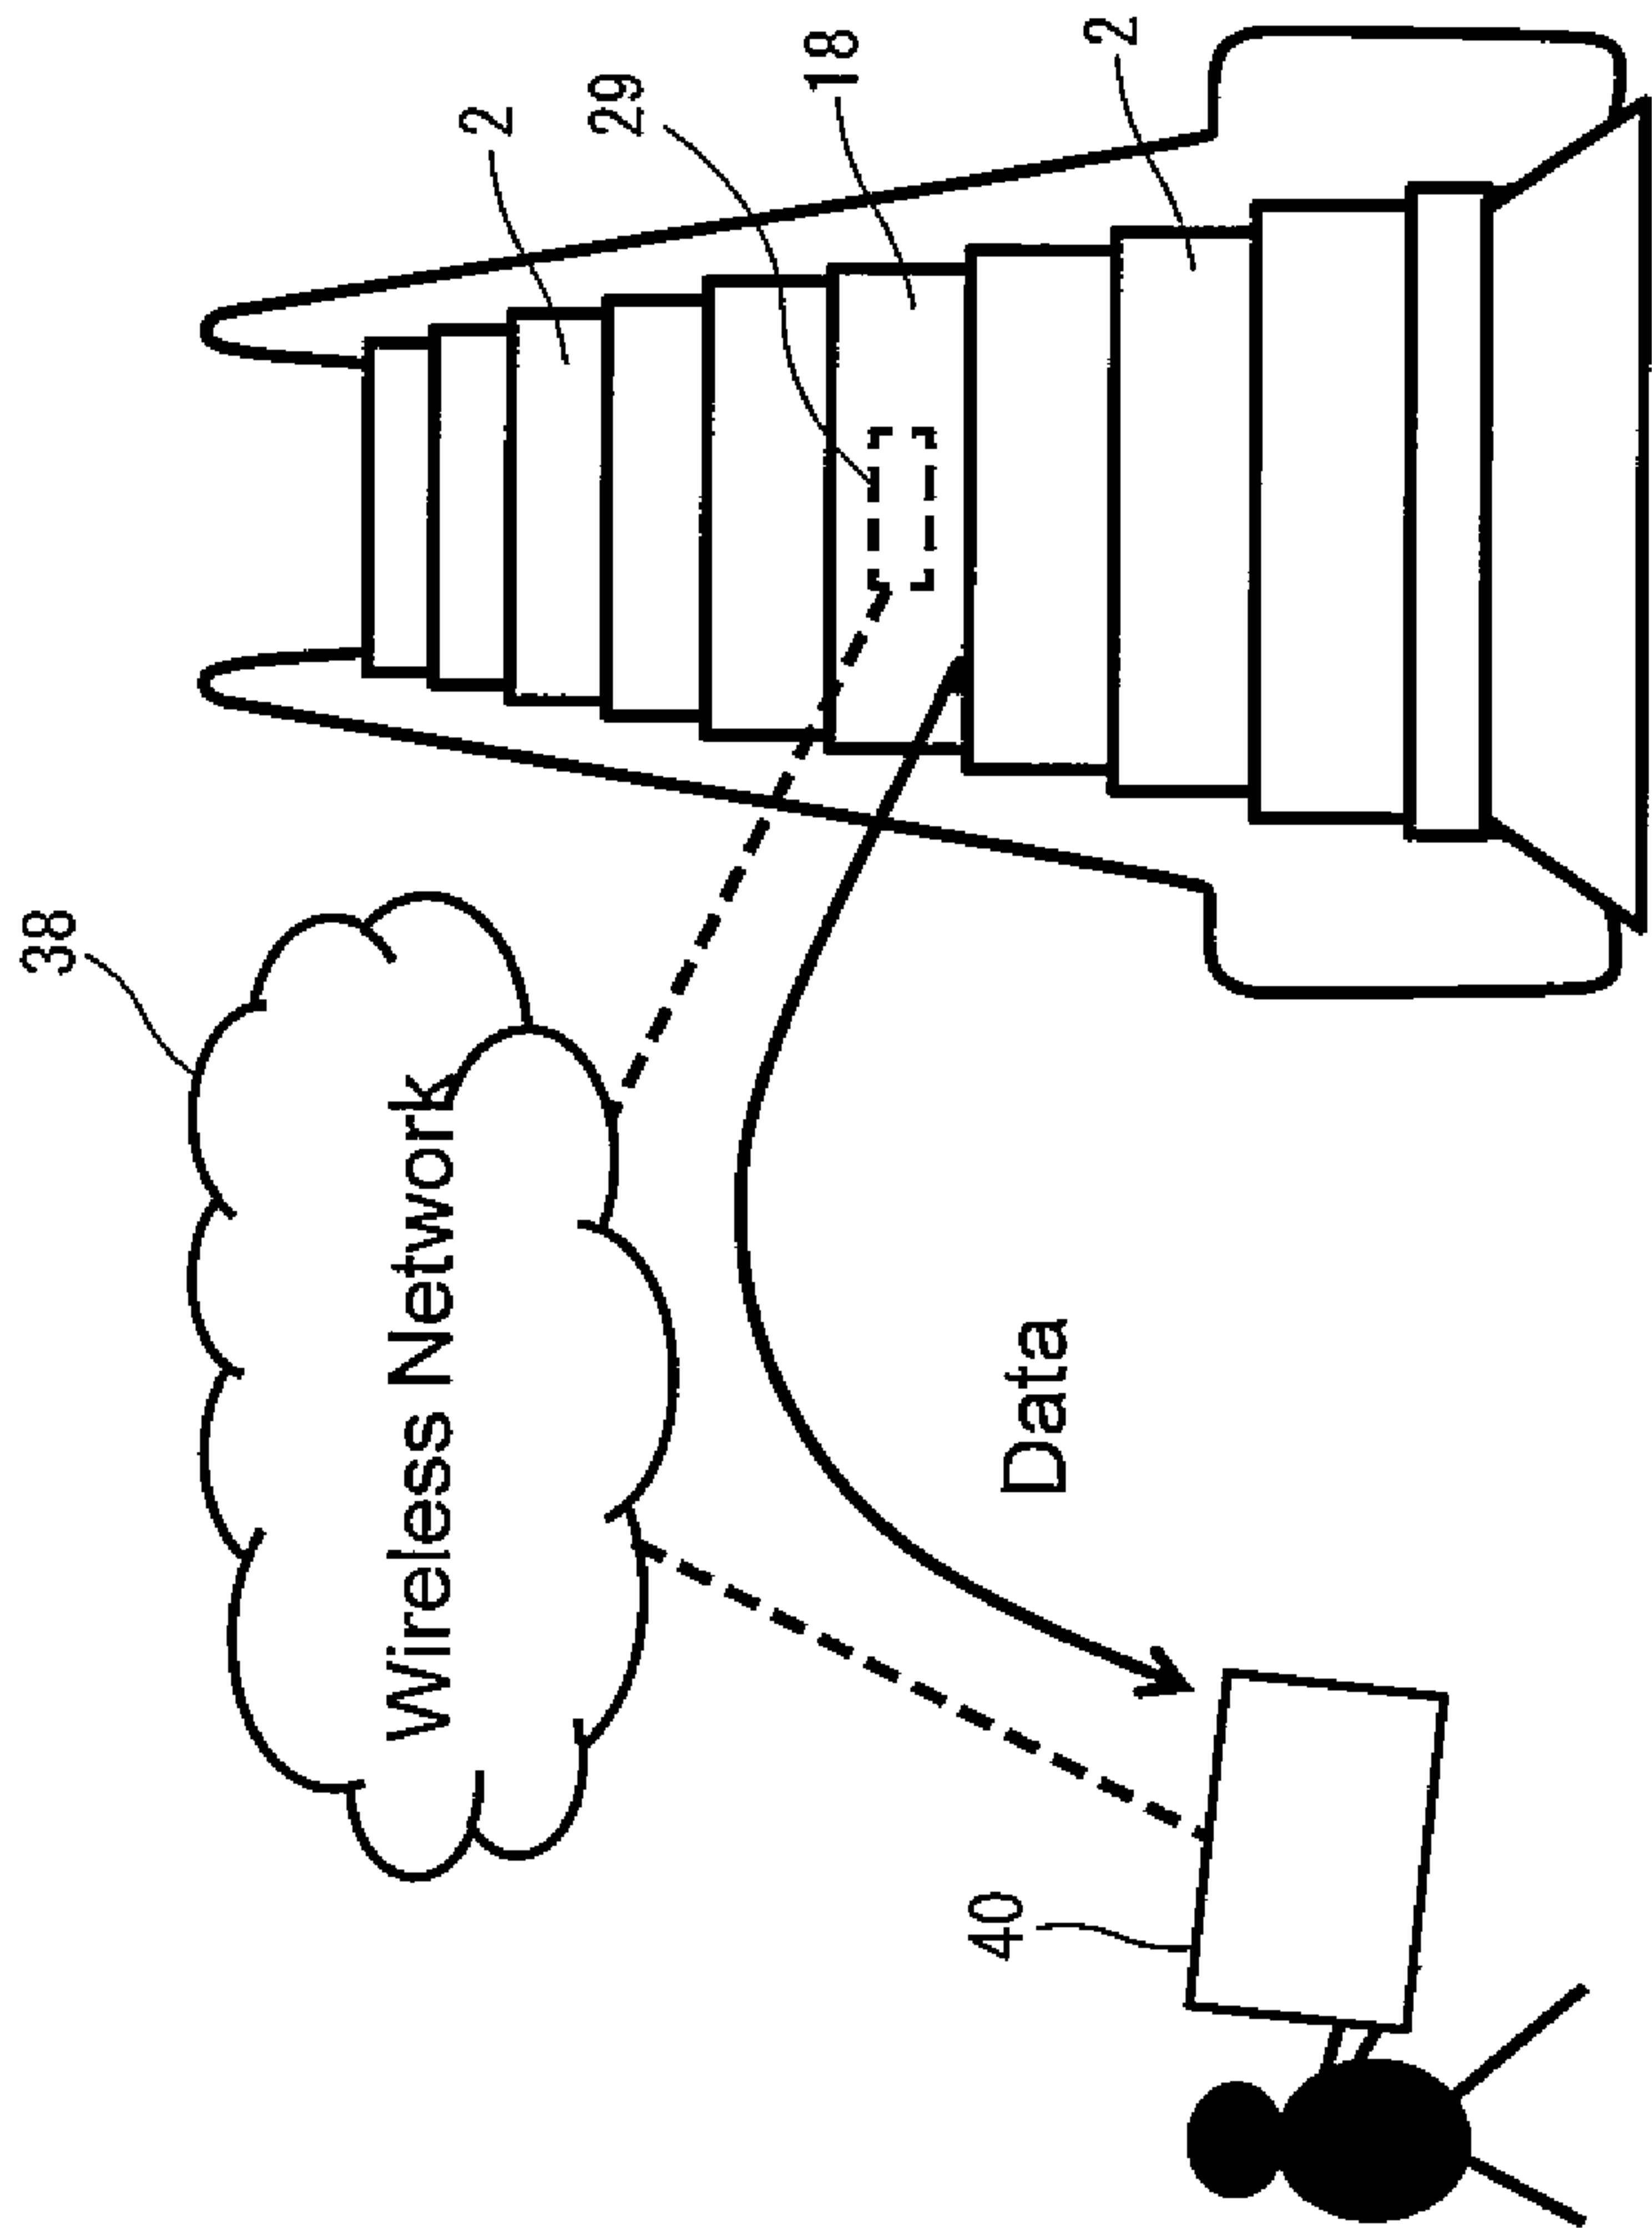
Fig. 7

FIG. 7 is a schematic view of a wireless network connecting the analyzer unit and a personal computer.

With reference to FIG. 7, data may be transmitted to a personal computer 40 which may be in the form of a tablet, smart phone etc. via the wireless network 38. A service engineer may listen to the sounds emanating from the left-hand side of the truss 3 while viewing the corresponding image of the components positioned on the left-hand side of the truss 3 causing the sounds. The sounds and image may be switched to the right-hand side after checking the left-hand side. This allows the service engineer to easily find out which components, components positioned on the left-hand side or components positioned on the right-hand side, are causing abnormal sounds, in spite of sound reverberations inside the truss 3 and also allows the service engineer to visually check the components causing the abnormal sounds at the same time. This greatly shortens the time to determine the cause of failure or malfunctions associated with the escalator and does not require stopping the escalator and gaining access to the space beneath the escalator steps 2.

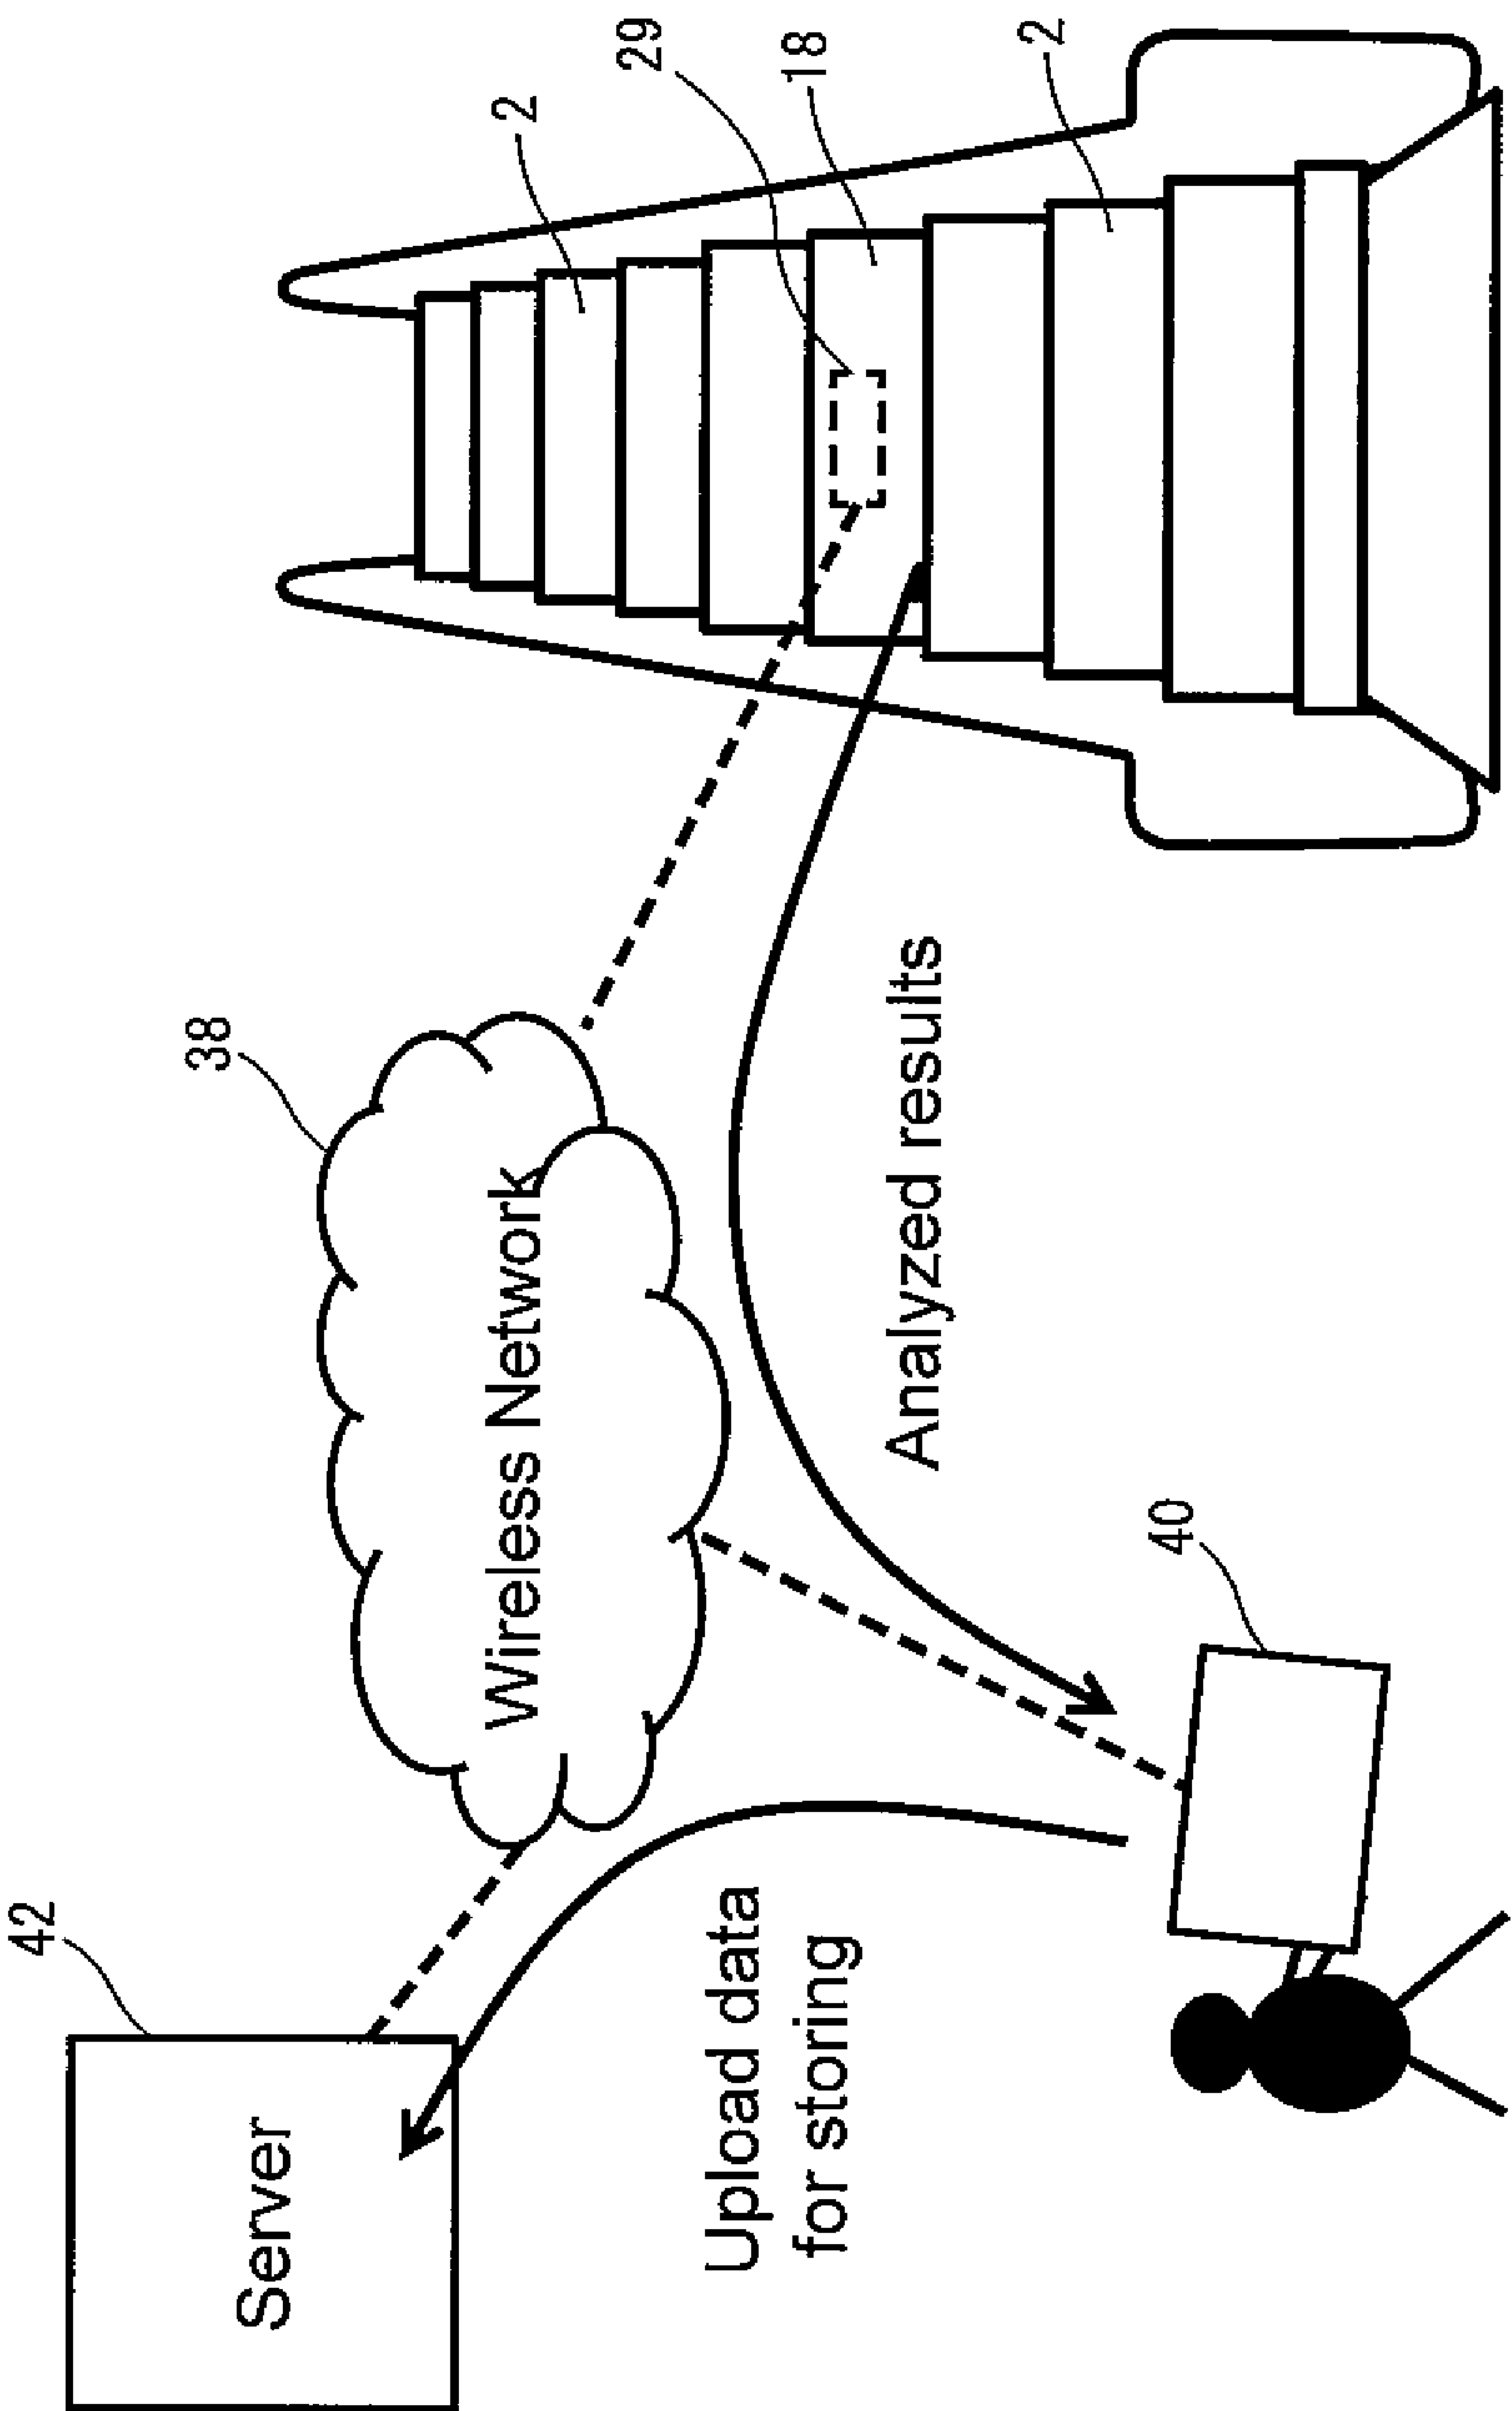
Fig. 8

FIG. 8 is a schematic view of a wireless network connecting the analyzer unit, a personal computer and a server.

FIG. 8 shows another embodiment in which the analyzer unit 29 analyzes data from the microphone 28, camera 26 and/or sensor 36 and the analyzed results are transmitted to the personal computer 40 of the service engineer. The analyzed results may include the detection of abnormal sounds with corresponding images and may allow the service engineer to immediately determine the cause of failure or malfunctions associated with the escalator. The service engineer may upload such results to a server 42 for storage. The server 42 may be remote from the site and the stored data may be used for preventive maintenance. This process is carried out via a wireless network 38.

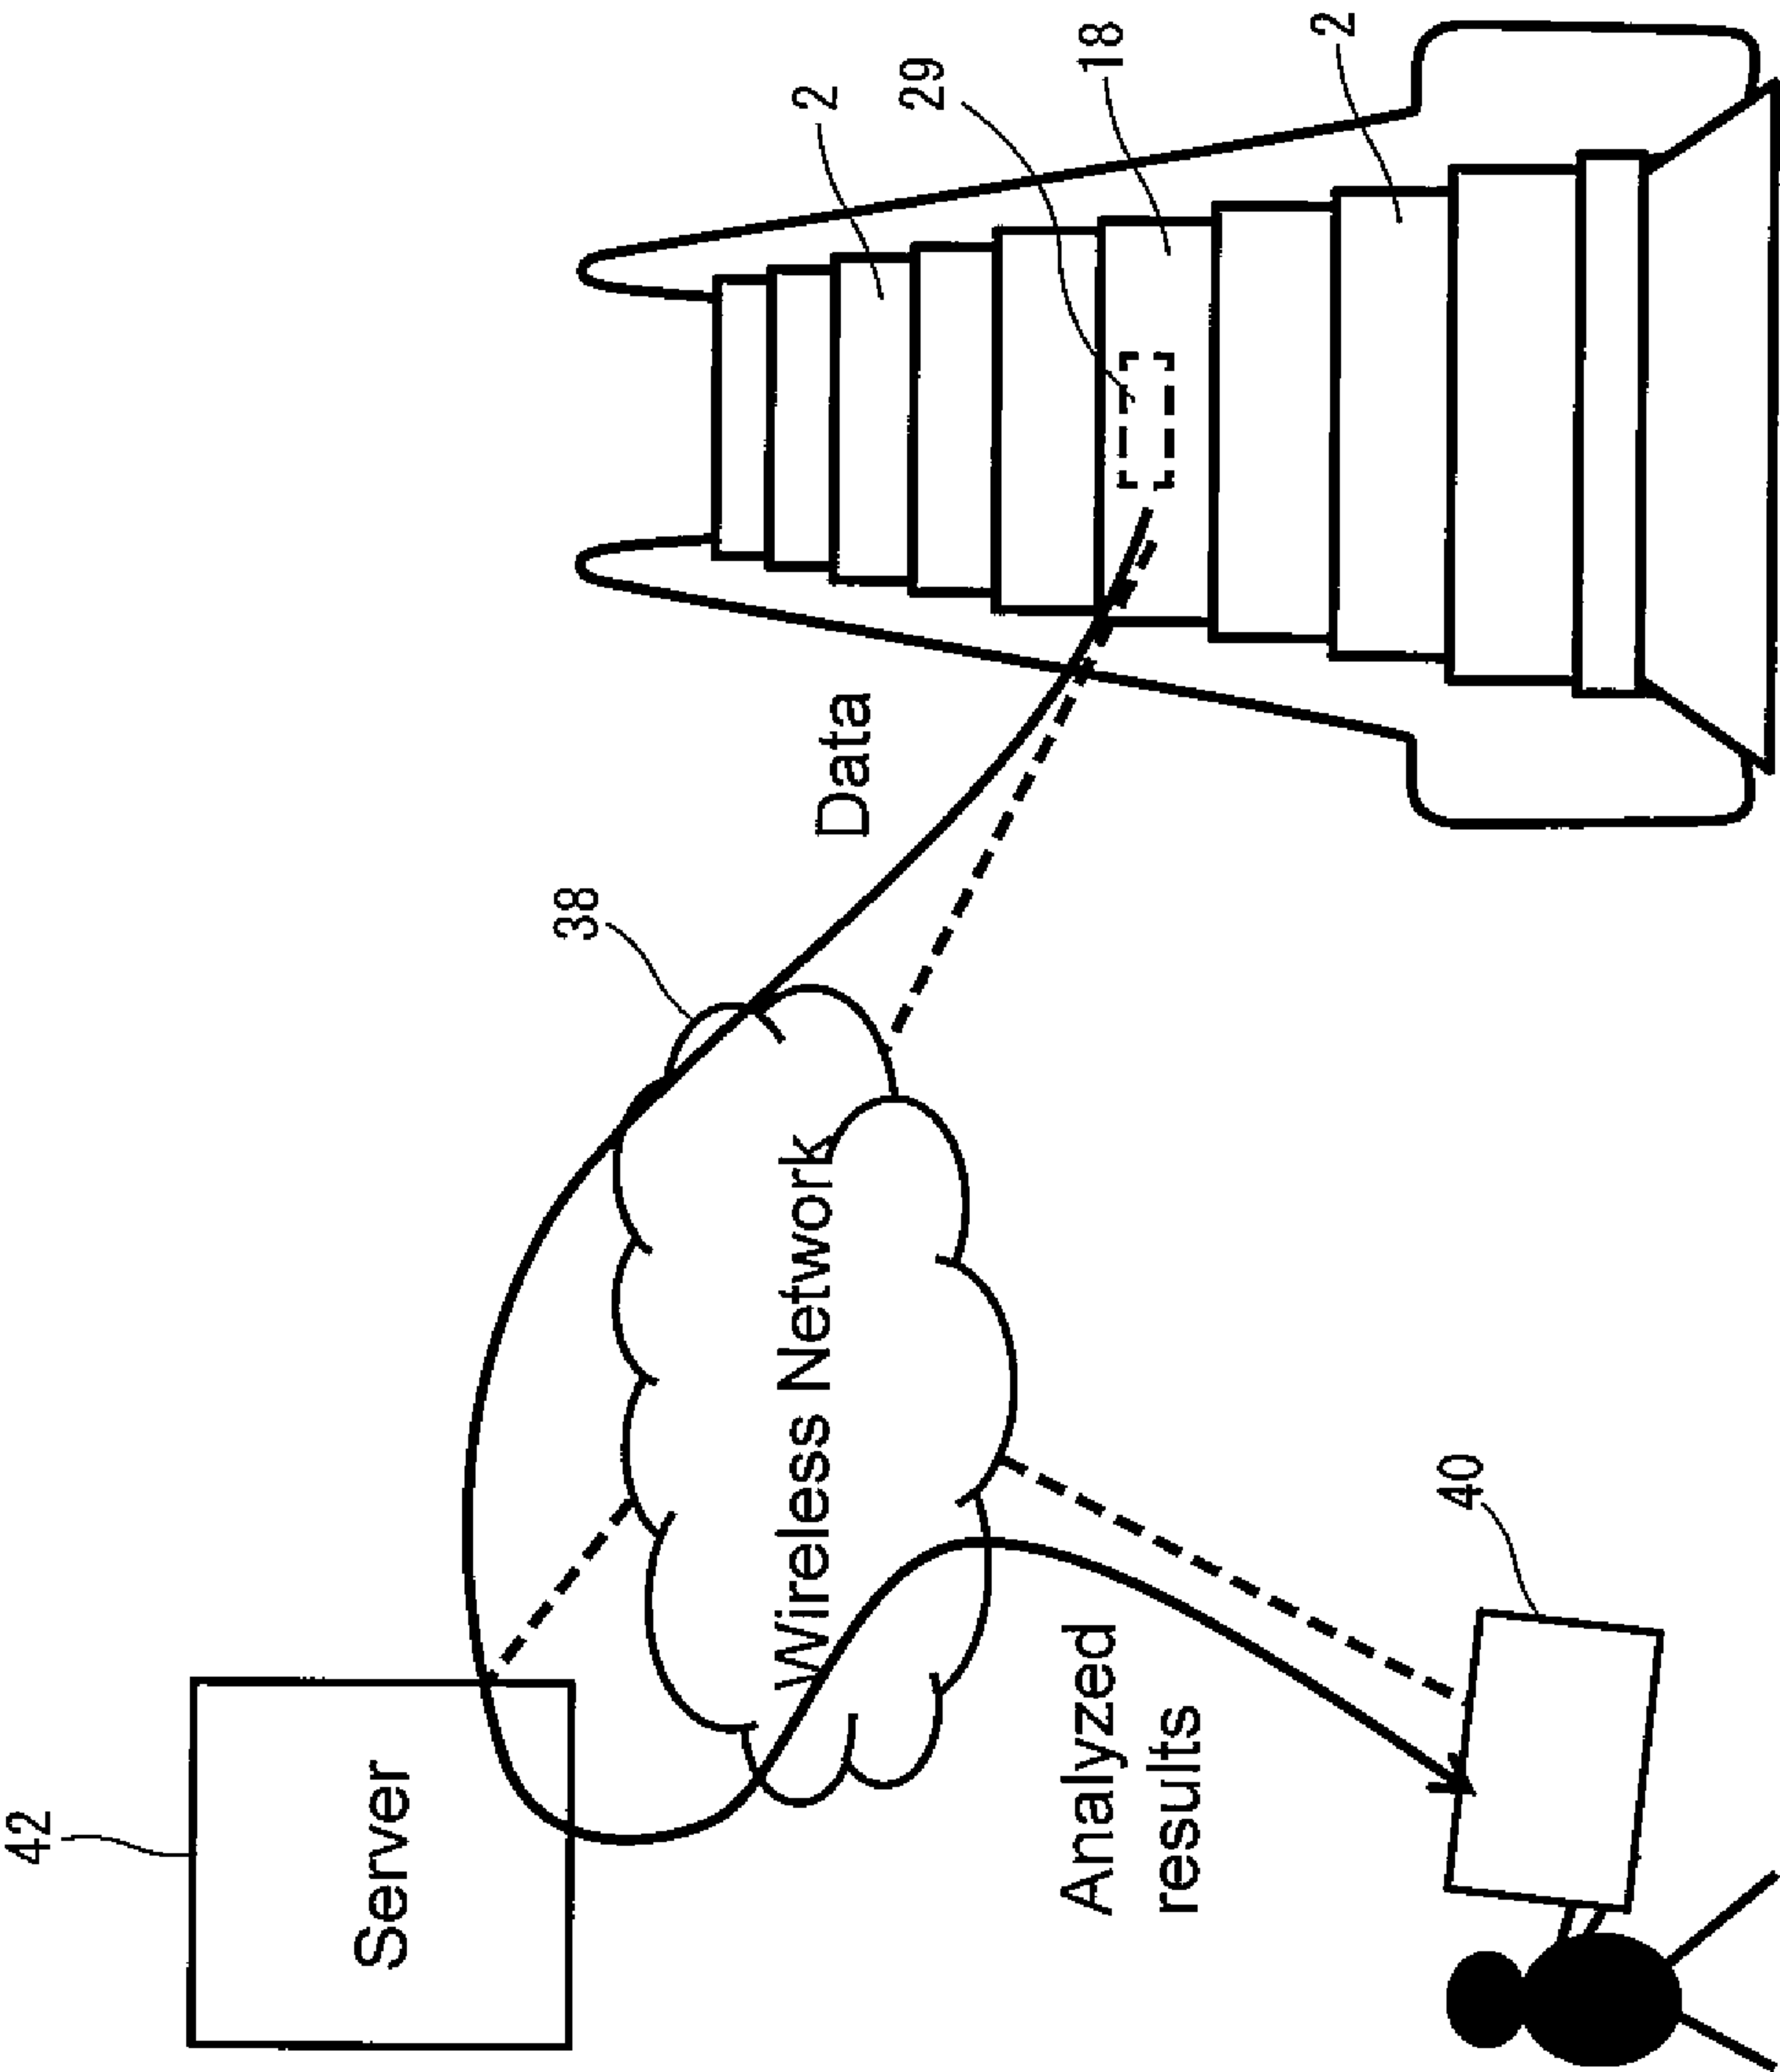
Fig. 9

FIG. 9 is a schematic view of another example wireless network connecting the analyzer unit, a personal computer and a server.

FIG. 9 shows a further embodiment in which data and/or analyzed data is transmitted to a server 42. The server 42 may be remote from the site. The data is stored and may be further analyzed in the server 42. The stored data may be used for preventive maintenance. The server 42 may provide the further analyzed results to the personal computer 40 of the service engineer. This process is also carried out via a wireless network 38.
