US011099949B2

(54) **METHOD APPARATUS FOR RESUMING AND RECOVERY CHECKING FROM INTERRUPTED PROGRAMMING OF ONE-TIME PROGRAMMABLE MEMORY DEVICE**

(71) Applicant: **Cirrus Logic International Semiconductor Ltd.**, Edinburgh (GB)

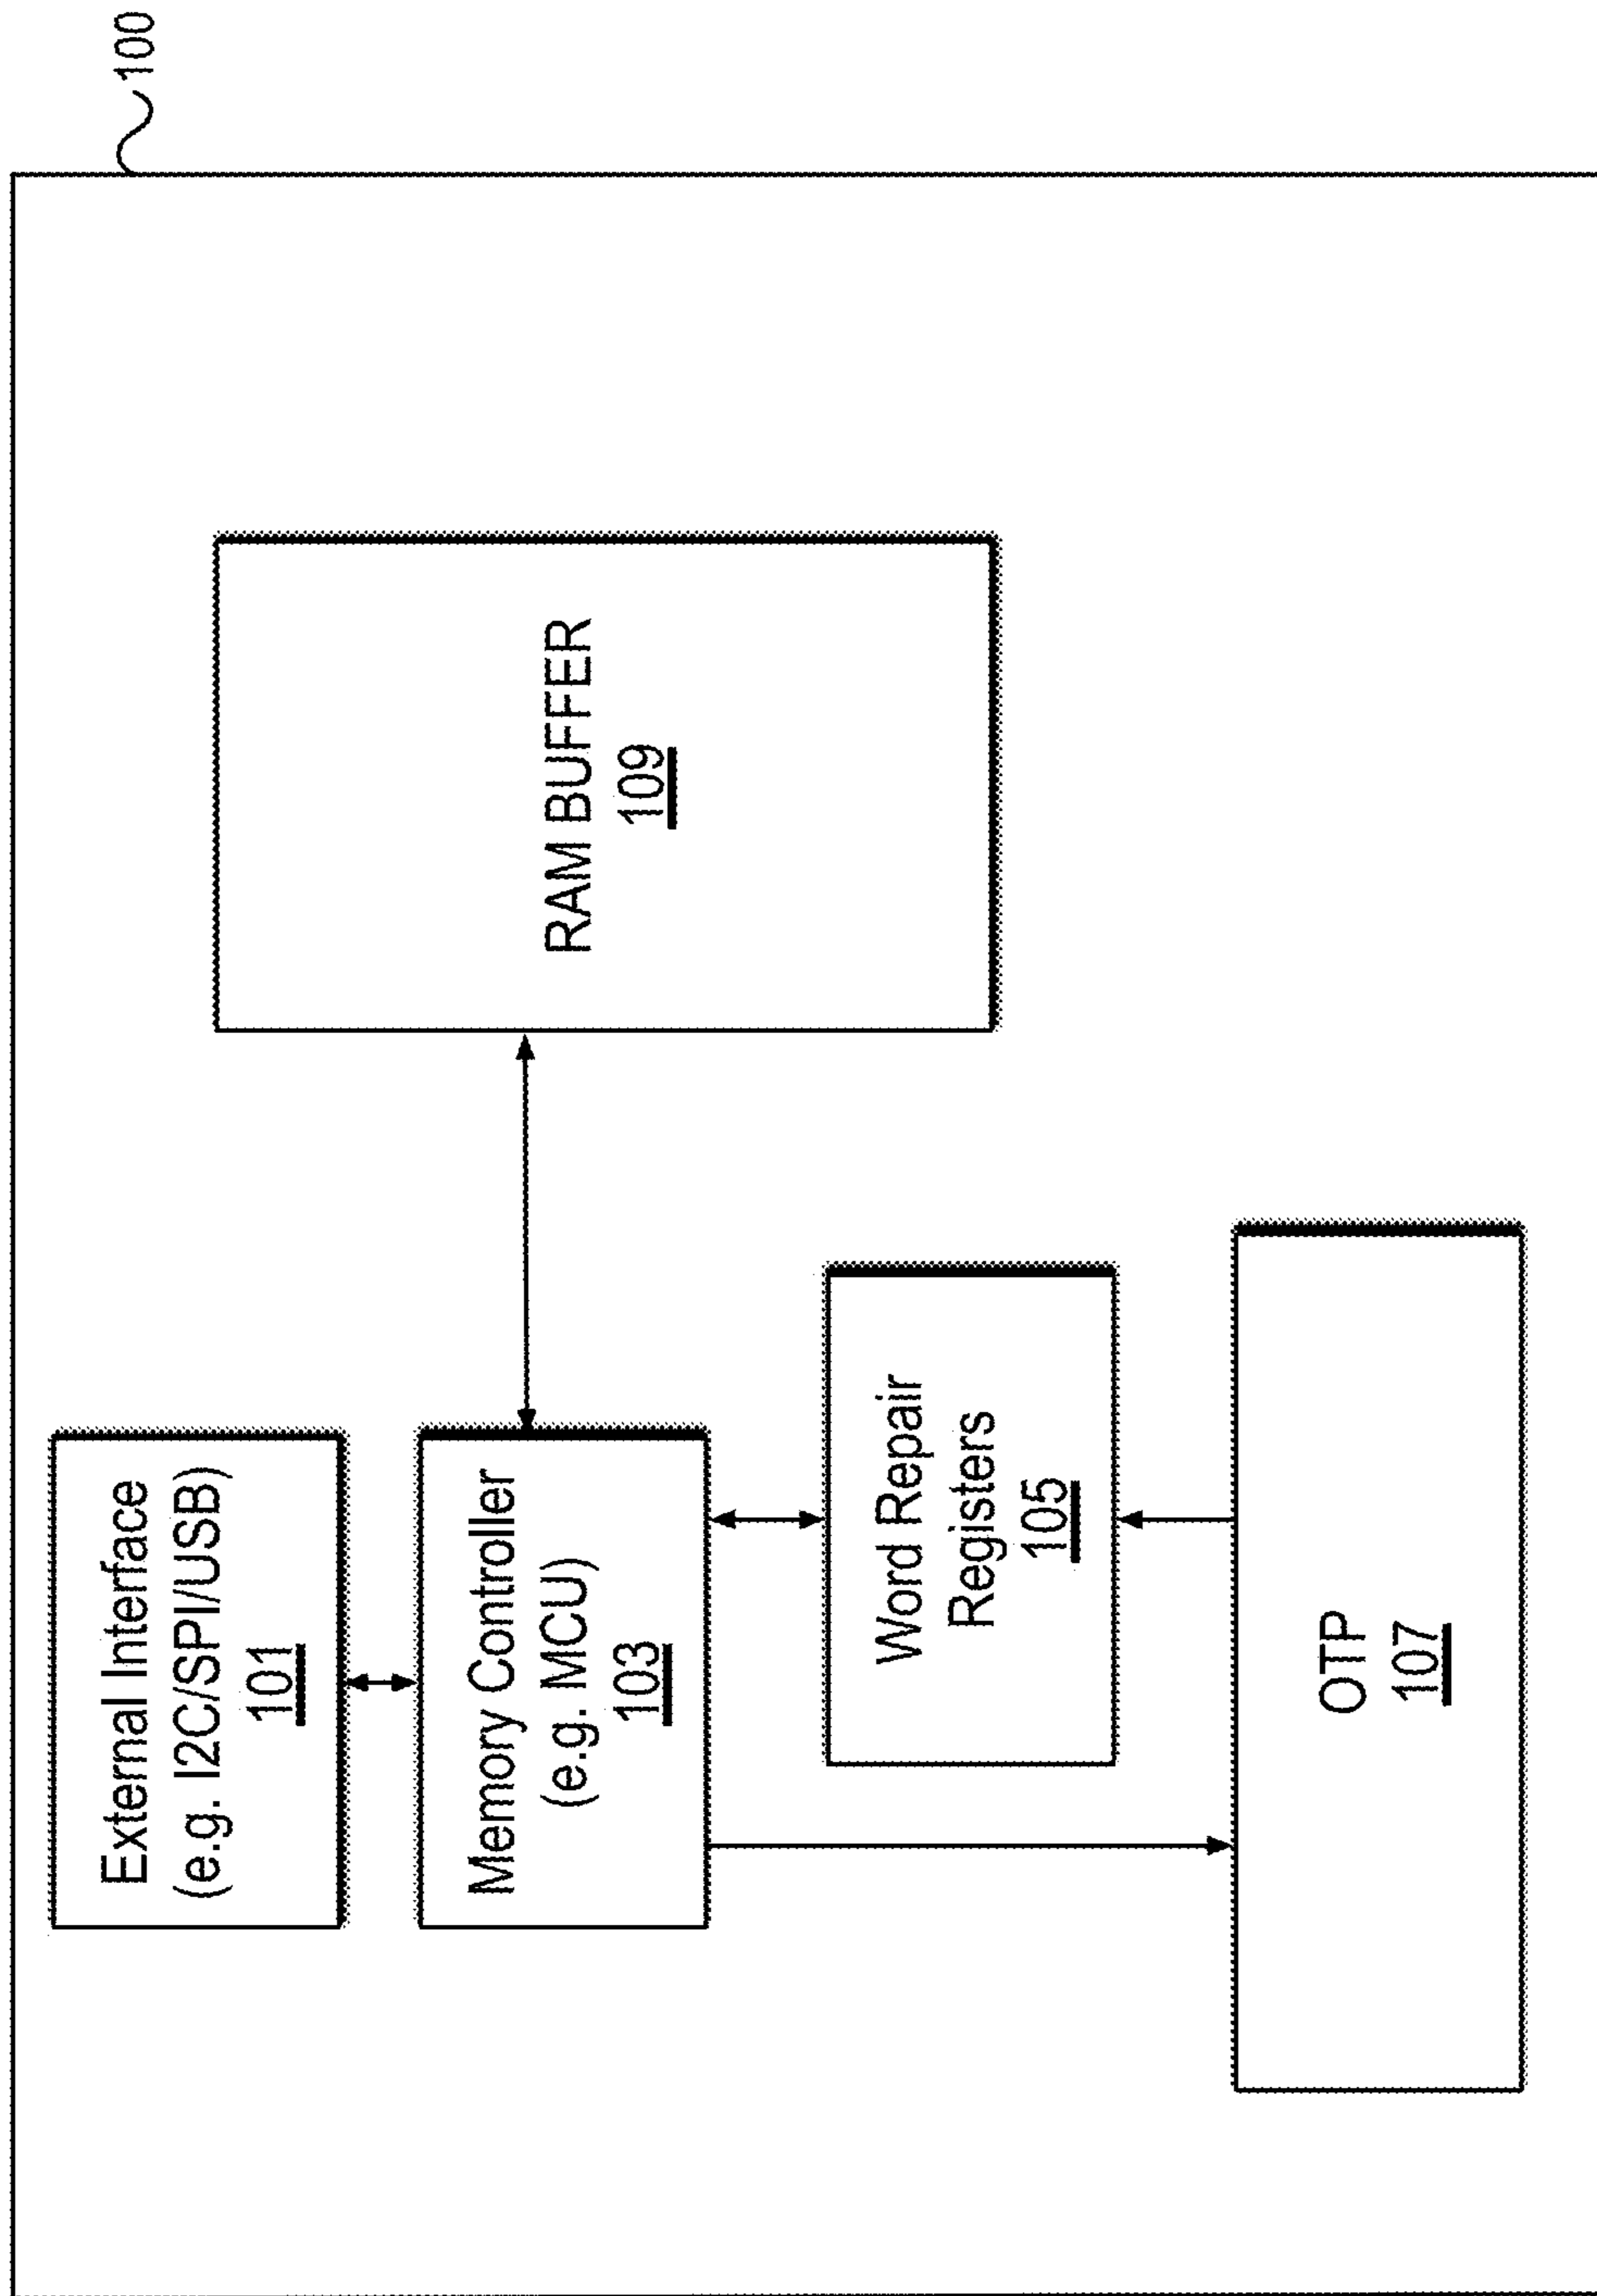
FIG. 1 is a block diagram of an example device.

FIG. 1 shows a block diagram of an example embodiment of a device **100** containing a memory controller unit **103** (e.g. MCU), external interface **101** (e.g. I2C, serial peripheral interface (SPI), universal serial bus (USB)), RAM buffer **109**, OTP **107**, and bank of word repair registers **105**, in addition to the bus connections between these components. Although the figure for the example embodiment shows the use of hardware-based word repair registers **105** as a volatile storage component for holding valid address/data pairs that are used to substitute for a corrupted data value on read-back of an address holding corrupted data (as the hardware-based word repair register **105** scheme provides a convenient method for performing the substitution in a manner transparent to the firmware, e.g., executed on MCU **103**), various embodiments may use a firmware-based scheme that will perform the substitution in an explicit manner after detecting that a read-back of a corrupted address was attempted.

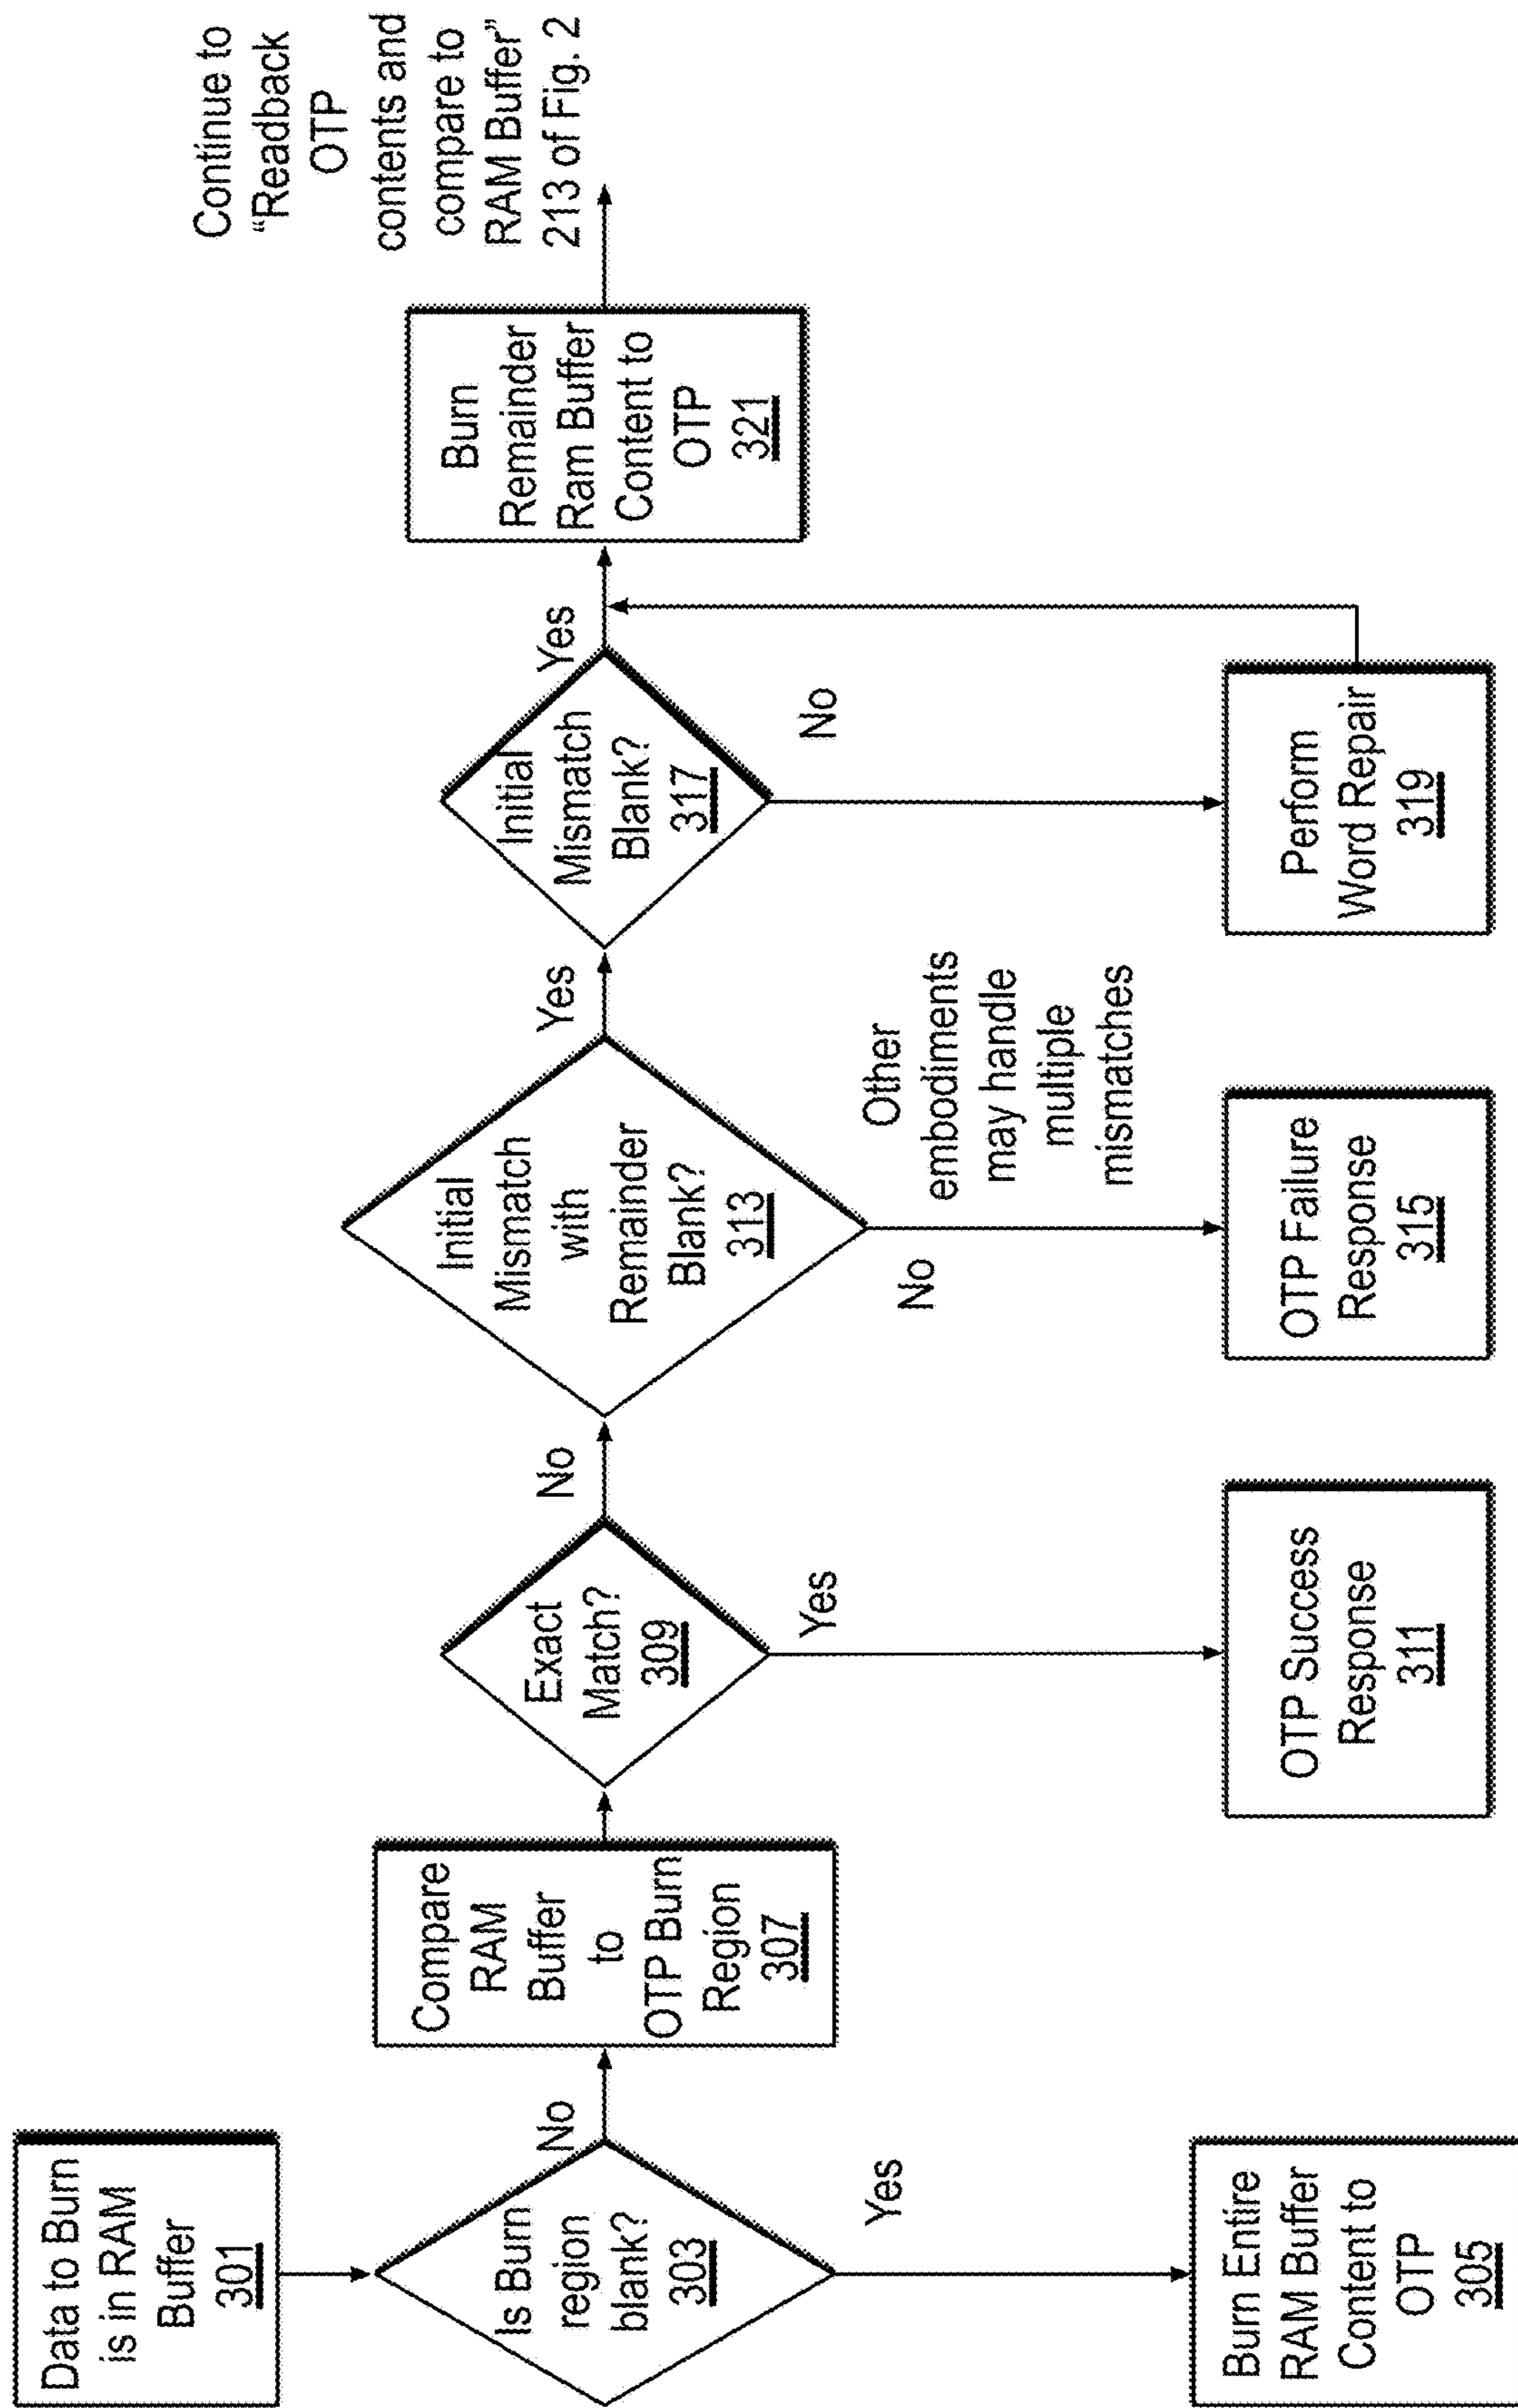
FIG. 4 shows example word repair registers multiplexed with an OTP array.

FIG. 4 illustrates the organization of word repair registers (e.g., Word Repair Registers 105 of FIG. 1) as address-data pairs in accordance with the present disclosure. Various embodiments may include word repair address registers 403 in a multiplexed arrangement such that addressing logic substitutes (e.g., repair detection logic 407 controlling mux 409 Read Data output) the data value of a word repair data register 405 (Repair Data 1, Repair Data 2, or Repair Data 3 provided to mux 409) for the data read back from the OTP memory (e.g., OTP 107 of FIG. 1) at a particular OTP memory read-back address (Read Address input) if the OTP read-back address is found within one of the word repair address registers 403 (Repair Address 1, Repair Address 2, or Repair Address 3), instead of the (corrupted, repaired, or replaced) data value found at that address within the OTP memory 107 (provided to mux 409). Otherwise, the repair detection logic 407 controls the mux 409 to select for output as the Read Data the data value output by the OTP memory 107.
