(10) **Patent No.:** **US 11,118,573 B2**
(45) **Date of Patent:** **Sep. 14, 2021**

(54) **METHODS AND SYSTEMS FOR REPAIRING WIND TURBINE BLADES**

(71) Applicant: **Vestas Wind Systems A/S, Aarhus N, (DK)**

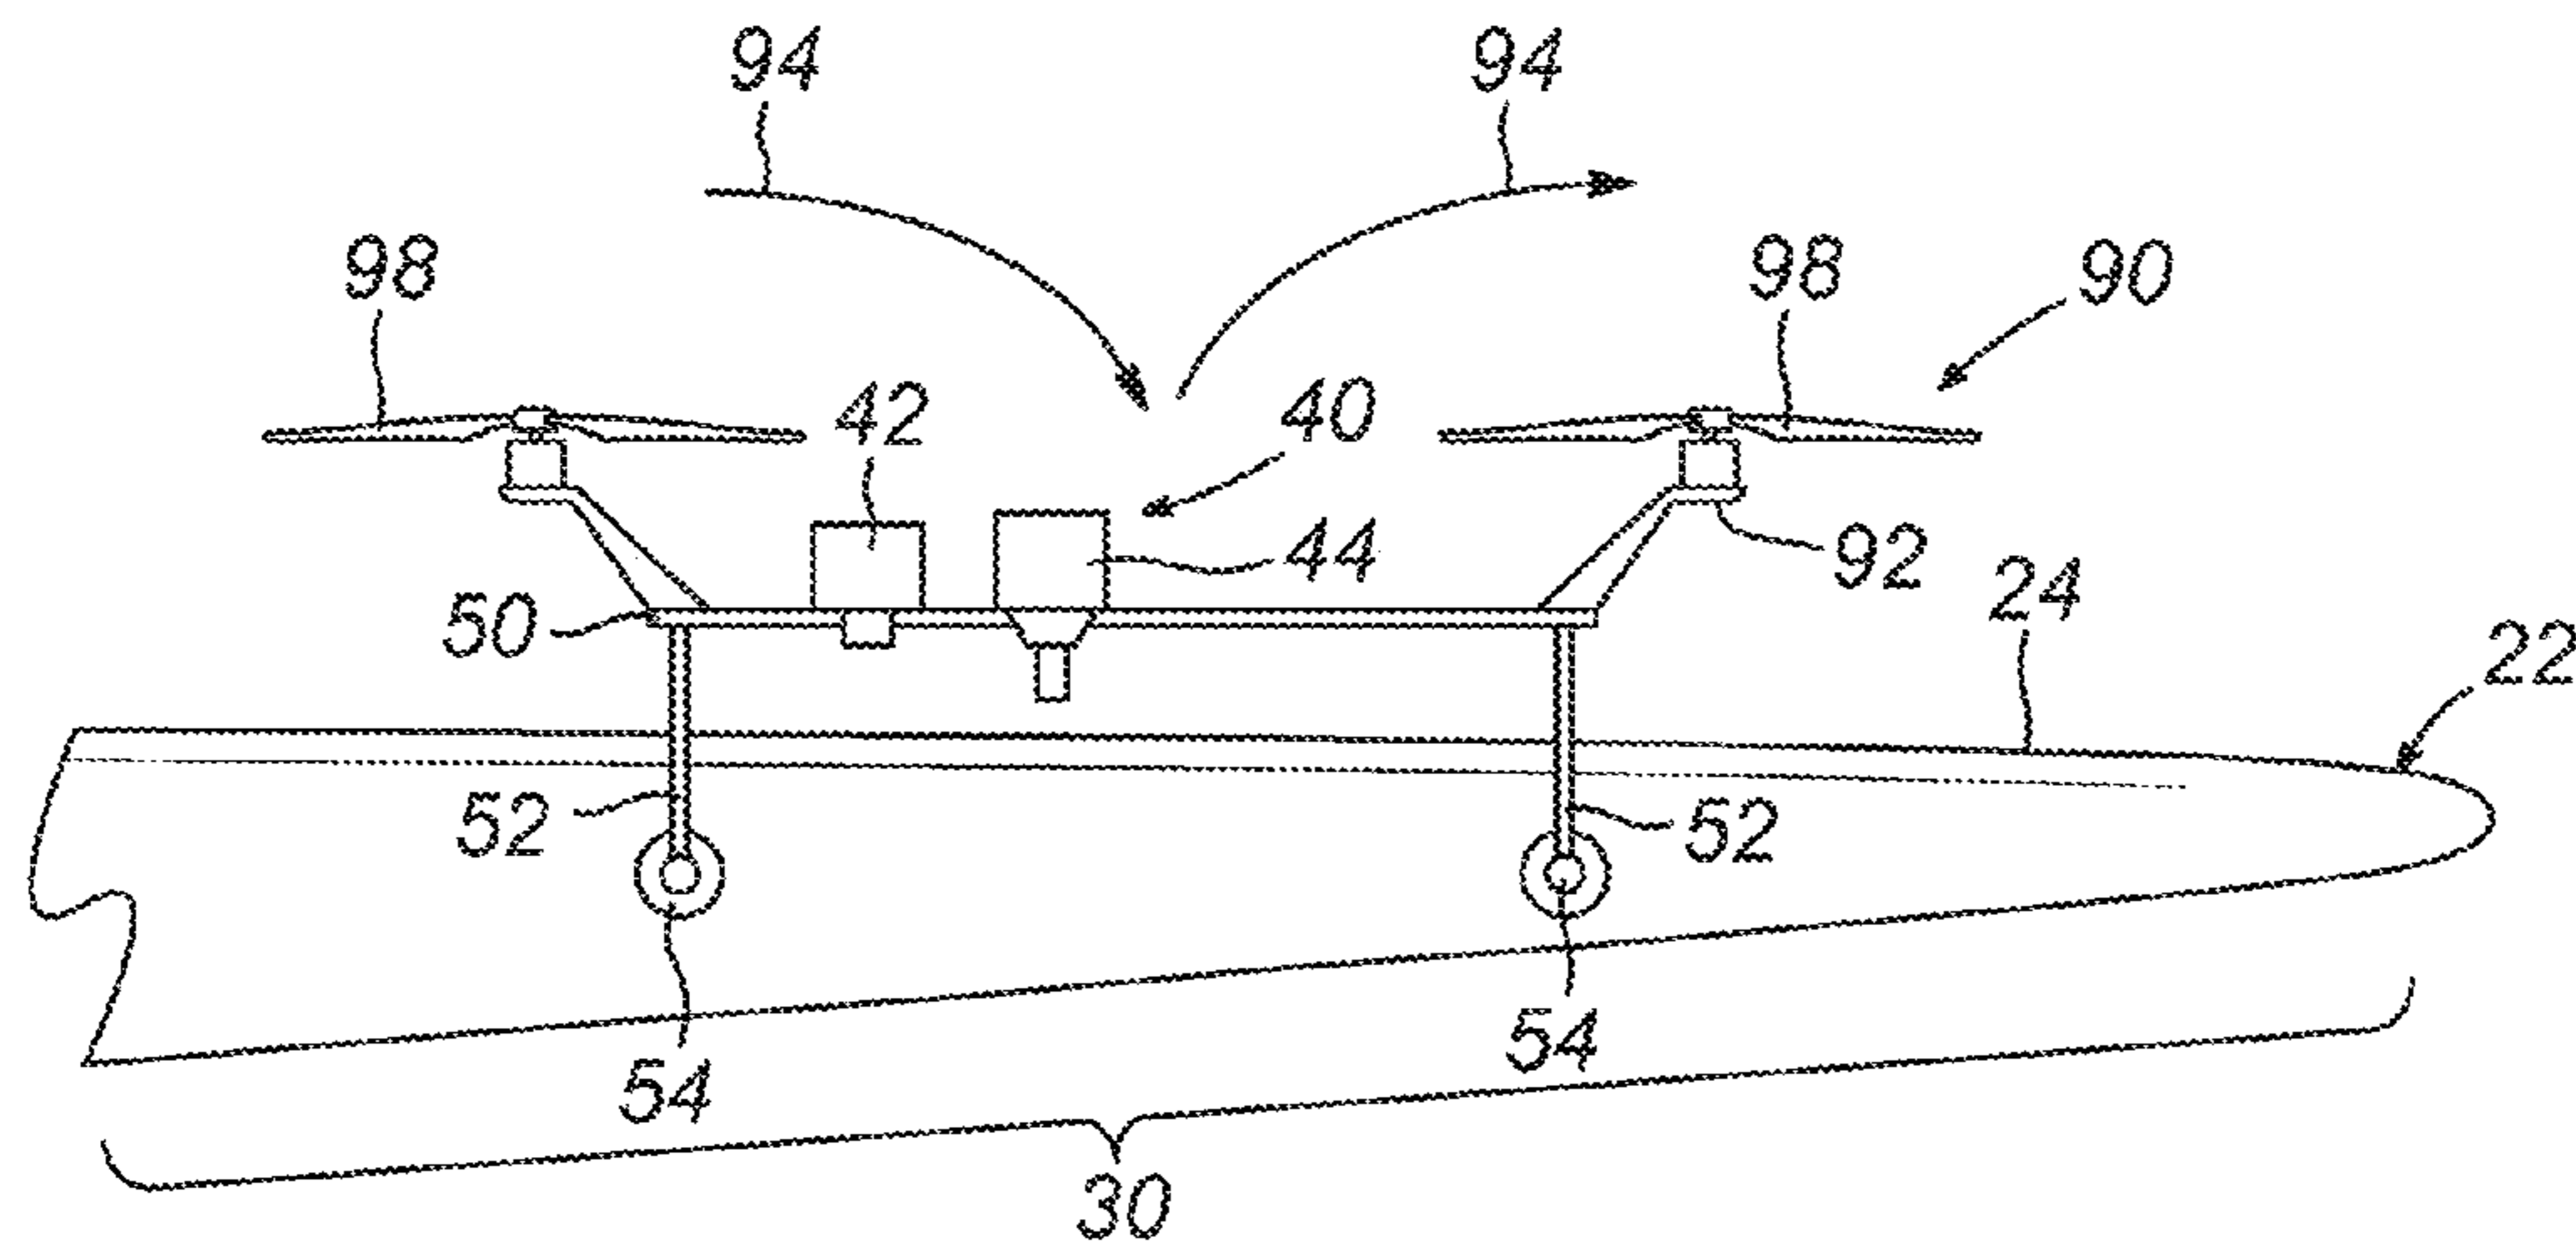
(57) **ABSTRACT**
A method of repairing erosion on a wind turbine blade while on a wind turbine includes placing a scanning device on an erosion zone. The device scans the erosion zone to gather an image and/or digital data. A printing system deposits a material according to the image and/or digital data. The repair system may include a frame such that scanning and/or depositing are with respect to the frame. A processing system interprets the image and/or digital data and produces an instruction file. Depositing the material may include depositing the material according to the instruction file. An unmanned aerial vehicle may be operated to position at least
(Continued)

one of the scanning device and the printing system on the wind turbine blade. Alternatively, a rope/wire system may be operated to lower at least one of the scanning device and the printing system along the wind turbine blade.

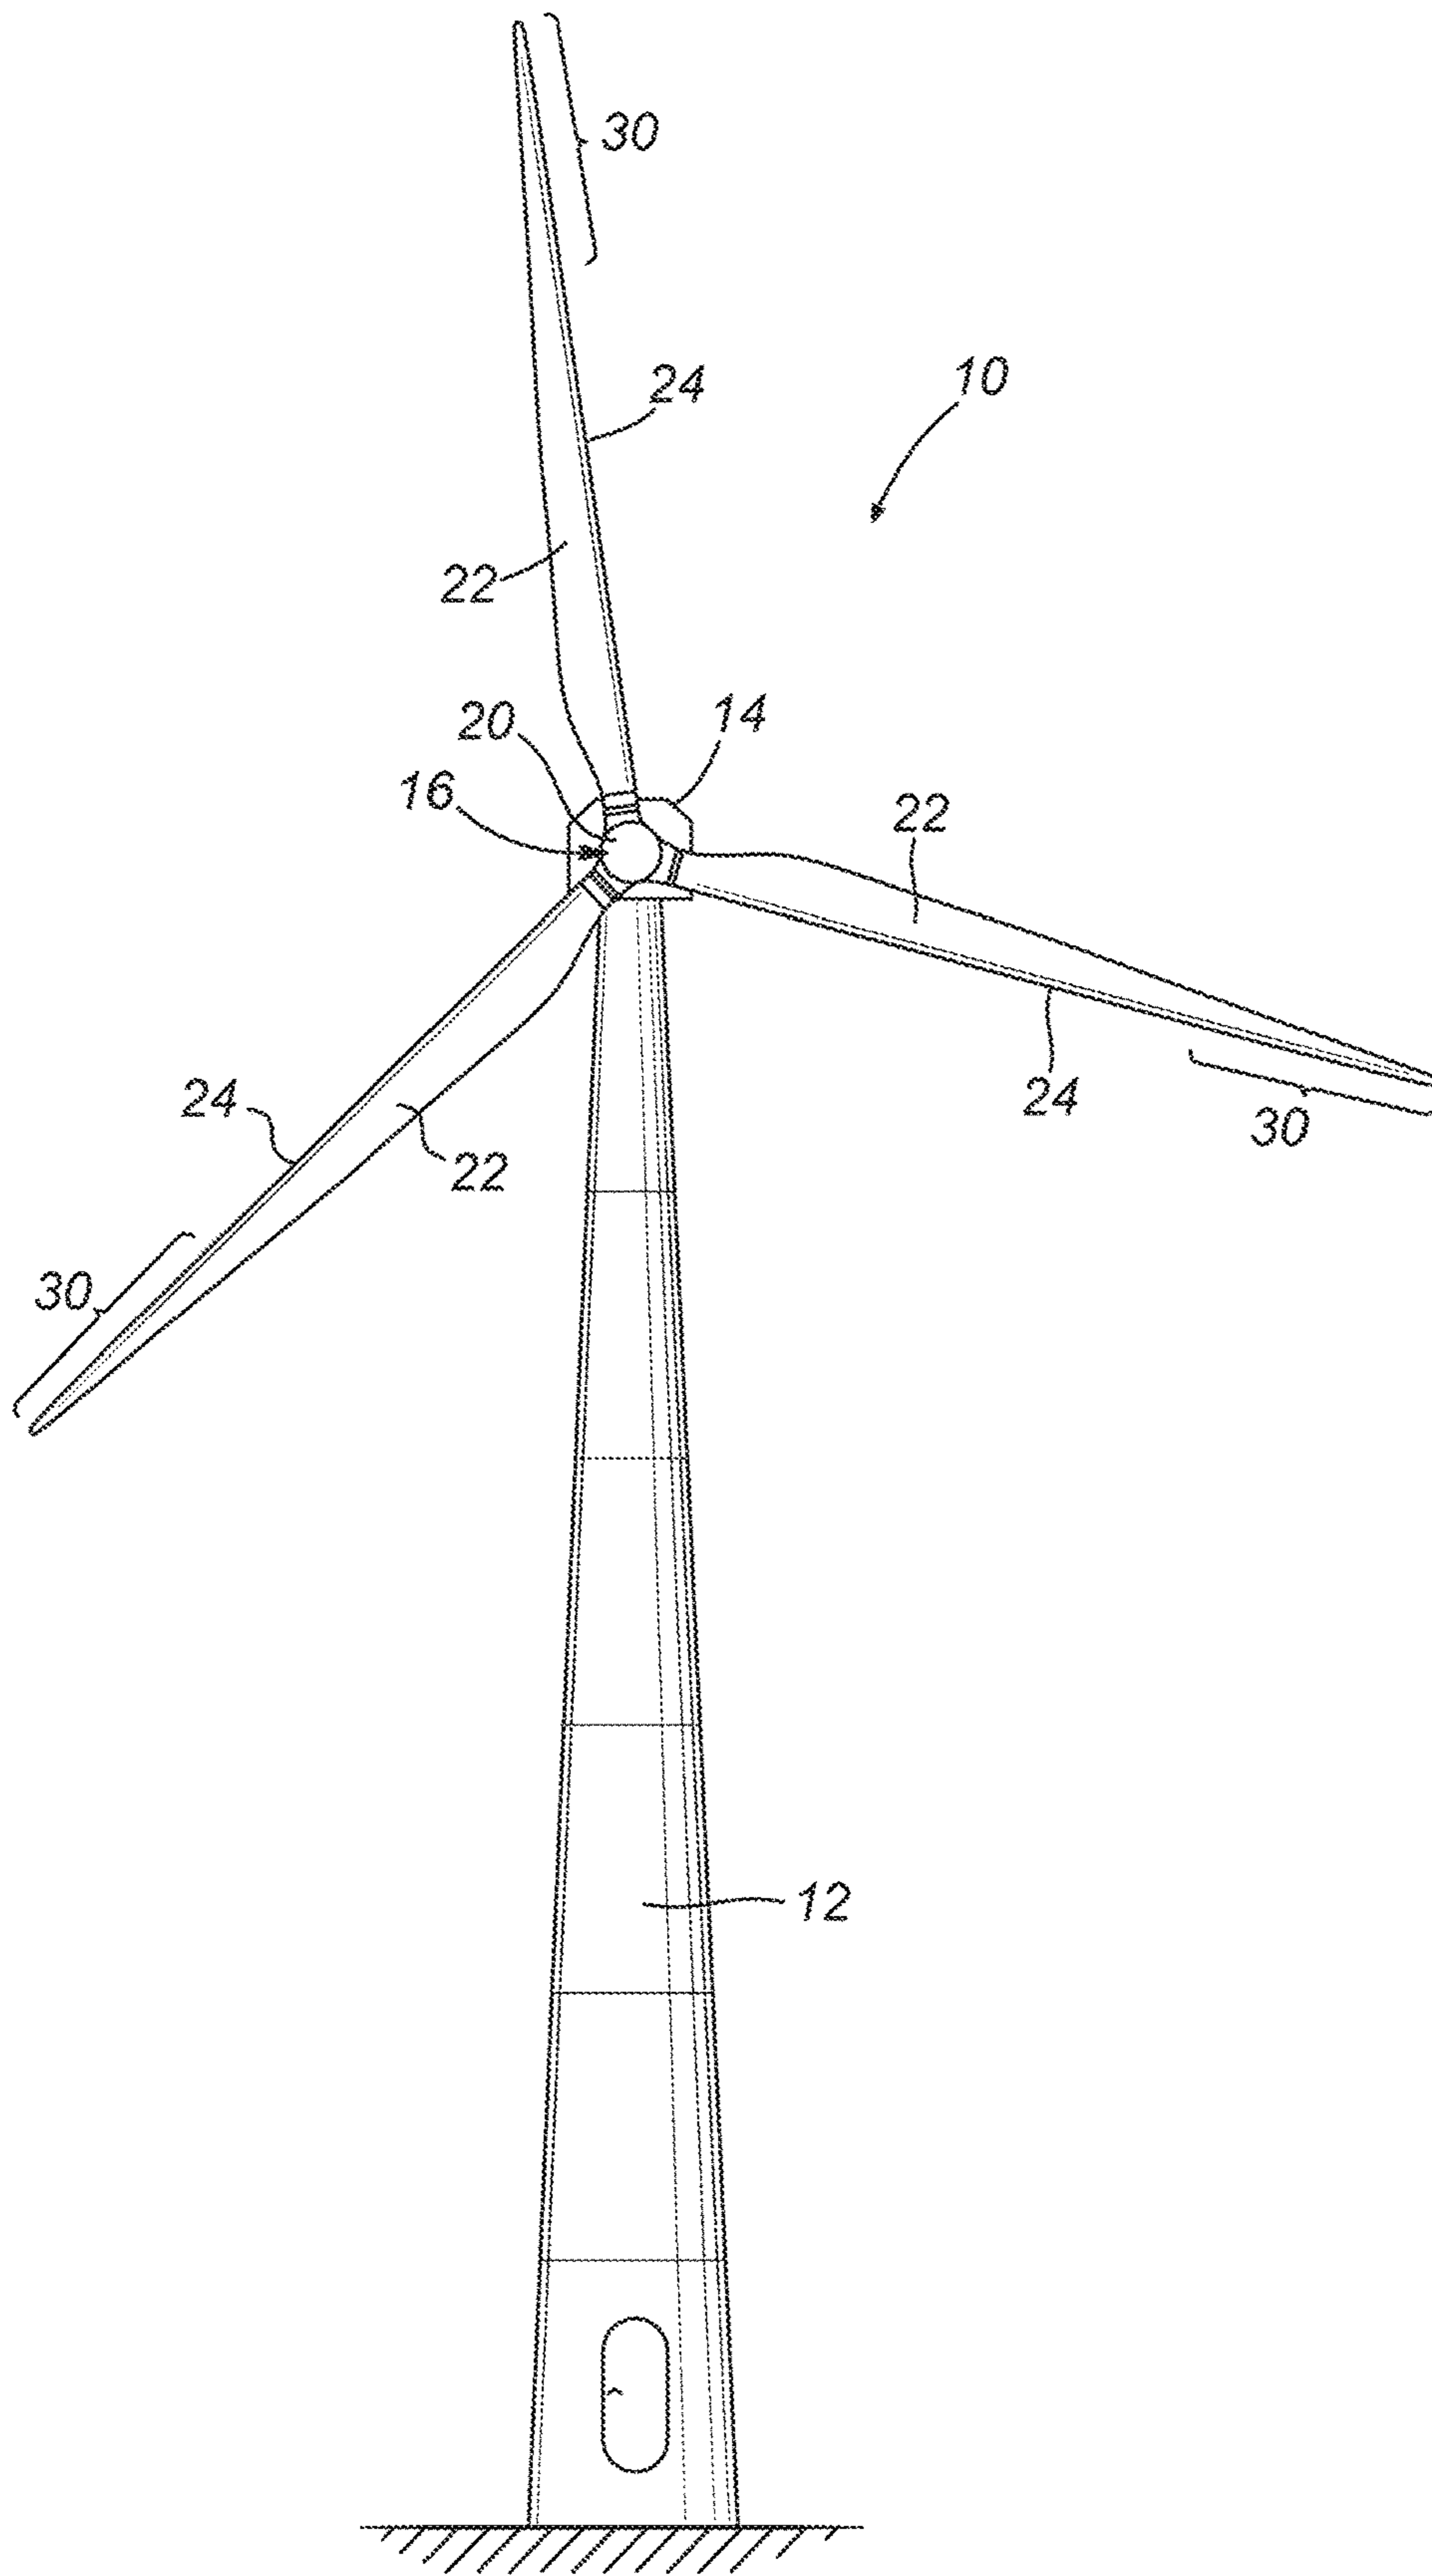
Fig. 1

FIG. 1 is a perspective view of a wind turbine according to one embodiment of the invention;

To these and other ends, and with reference to FIG. 1, in an exemplary embodiment of the invention, a wind turbine 10 includes a tower 12, a nacelle 14 disposed at the apex of the tower 12, and a rotor 16 operatively coupled to a generator (not shown) housed inside the nacelle 14. The rotor 16 of the wind turbine 10 includes a central hub 20 and a plurality of wind turbine blades 22 that project outwardly from the central hub 20 at locations circumferentially distributed around the hub 20. As shown, the rotor 16 includes three wind turbine blades 22, but the number of blades may vary from one wind turbine to another. The wind turbine blades 22 are configured to interact with air flow to produce lift that causes the rotor 16 to spin generally within a plane defined by the wind turbine blades 22. As the rotor 16 spins, the wind turbine blades 22 pass through the air with an edge 24 leading the respective wind turbine blade 22 during rotation.

As the wind turbine 10 ages, one or more of the wind turbine blades 22 may experience erosion from prolonged, continuous exposure to the environment. While not being particularly limited to any source, erosion may occur due to particulates in the air that abrade the leading edge 24 of the wind turbine blade 22 during operation. Erosion may occur in an erosion zone 30 that includes the leading edge 24 of one or more of the wind turbine blades 22. Although shown on the leading edge 24, erosion is not necessarily limited to the erosion zone 30 shown in FIG. 1 and may occur along other portions of the wind turbine blades 22.

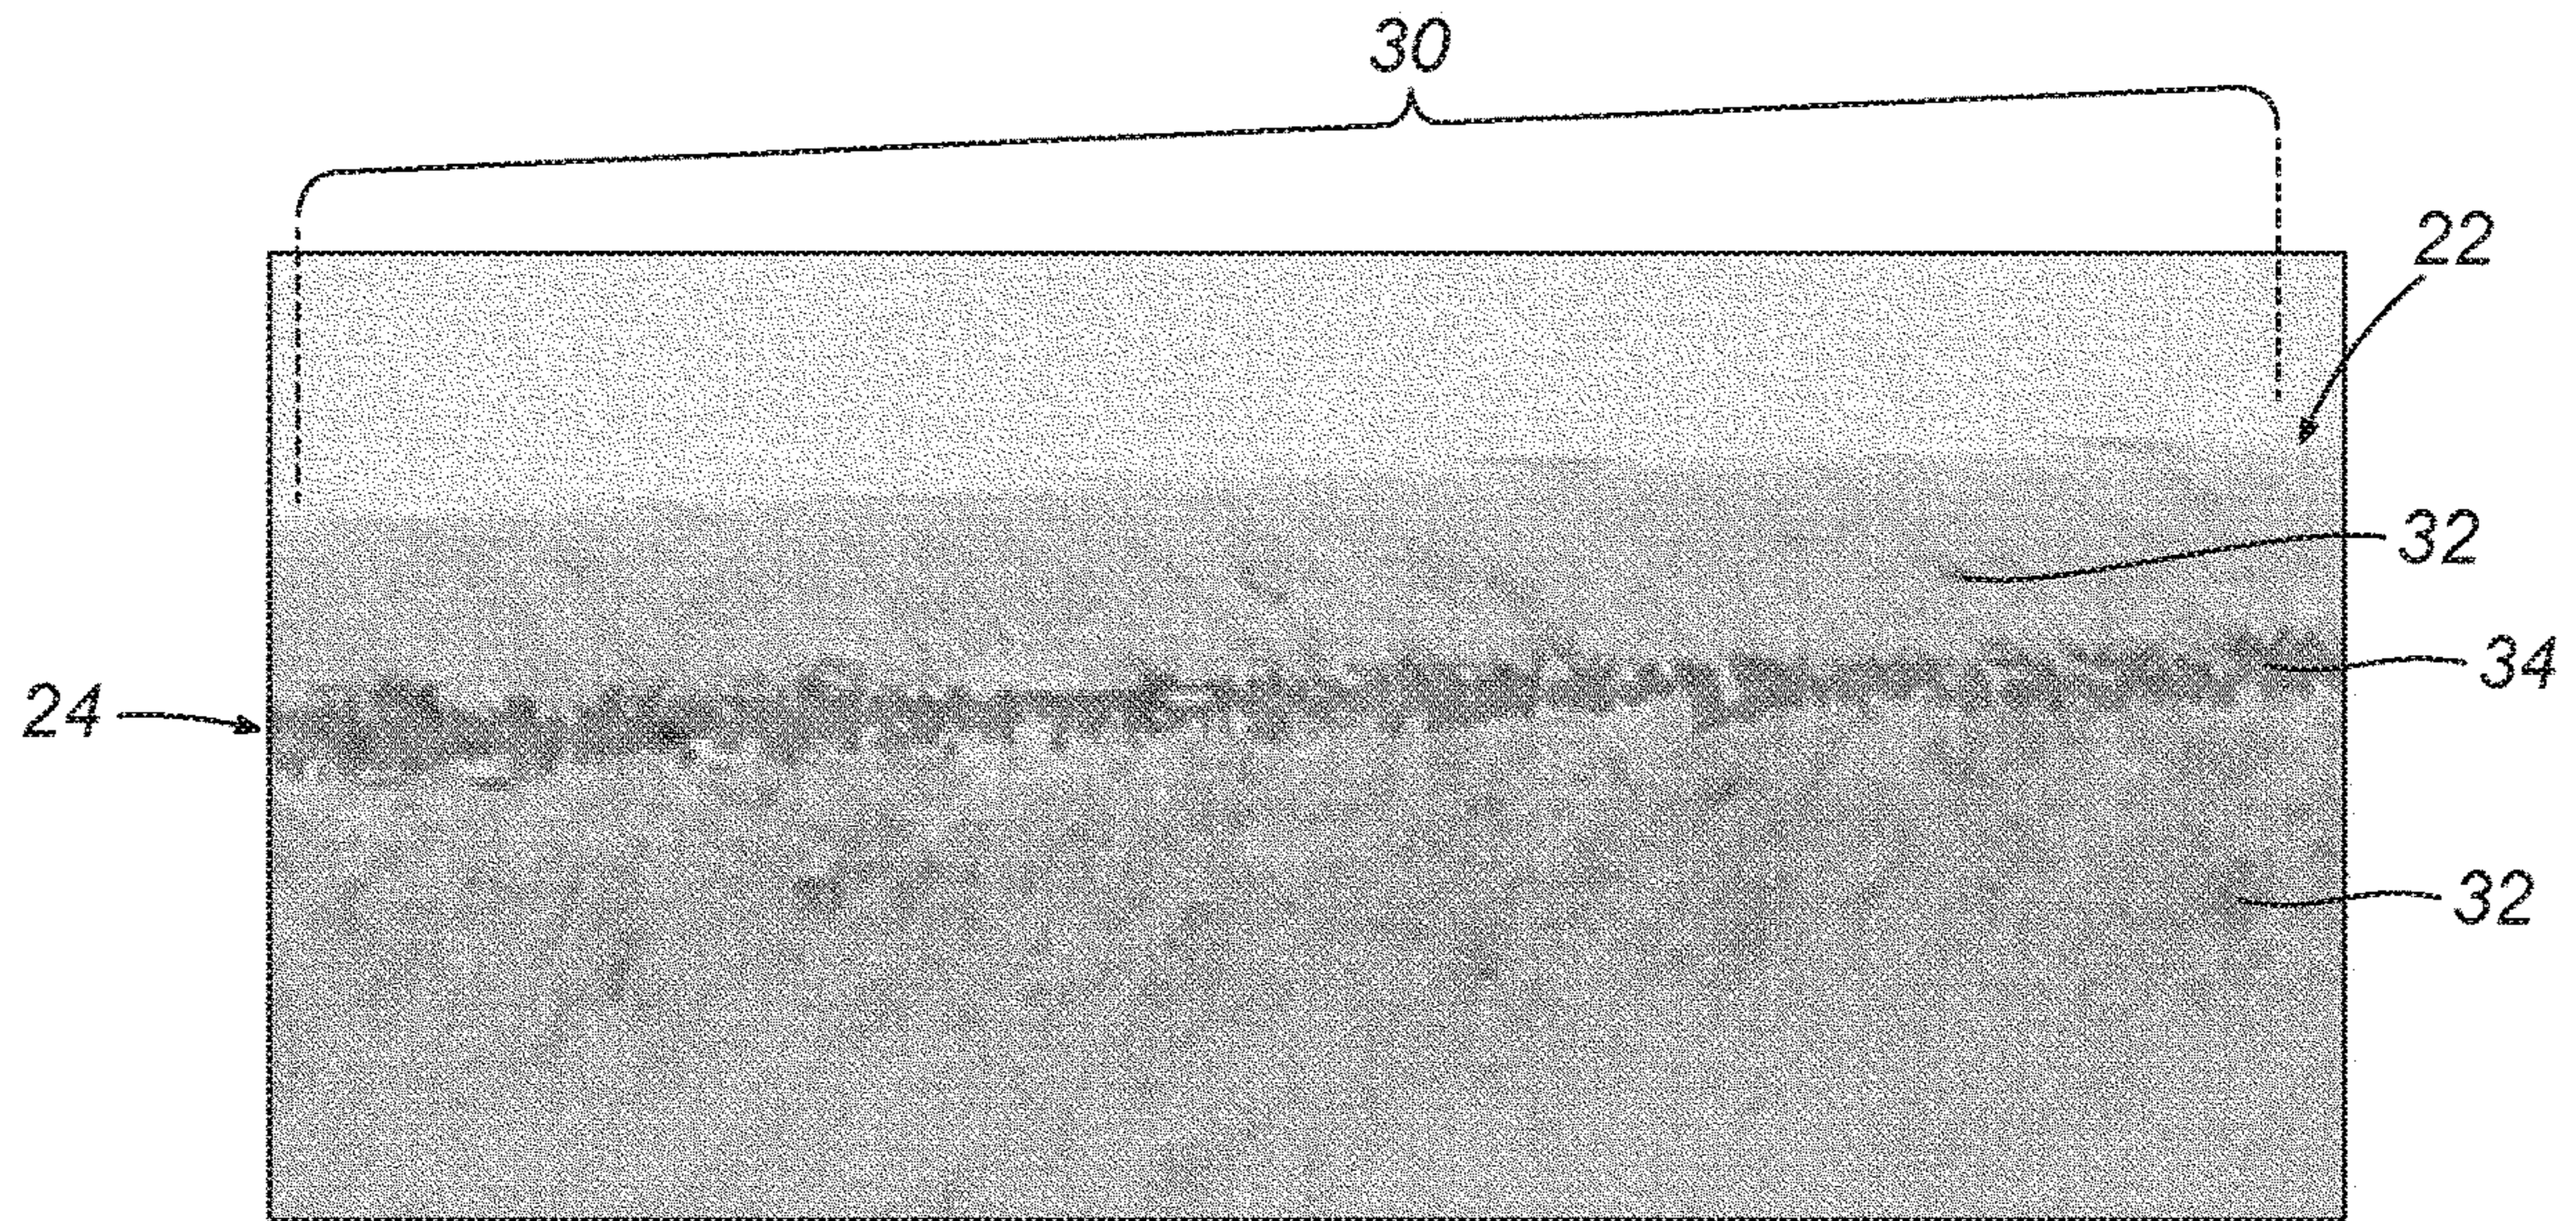
Fig. 1A

FIG. 1A is a photograph showing an eroded area on a wind turbine blade;

With reference to FIGS. 1A and 1B, erosion is generally characterized as a loss of material from the wind turbine blade 22. Material loss may be uniformly distributed but is often non-uniform across the leading edge 24 or any other surface of the wind turbine blade 22. Rather than losing a uniform skin of material from a surface, erosion may include localized surface imperfections, such as random pitting 32 and shallow gouges or crack-like features 34 that may be a result of localized, connected pitting. In any case, if erosion is not repaired, the wind turbine blade 22 becomes less efficient at rotating the rotor 16 and ultimately, the structural integrity of the wind turbine blade 22 may be impaired.

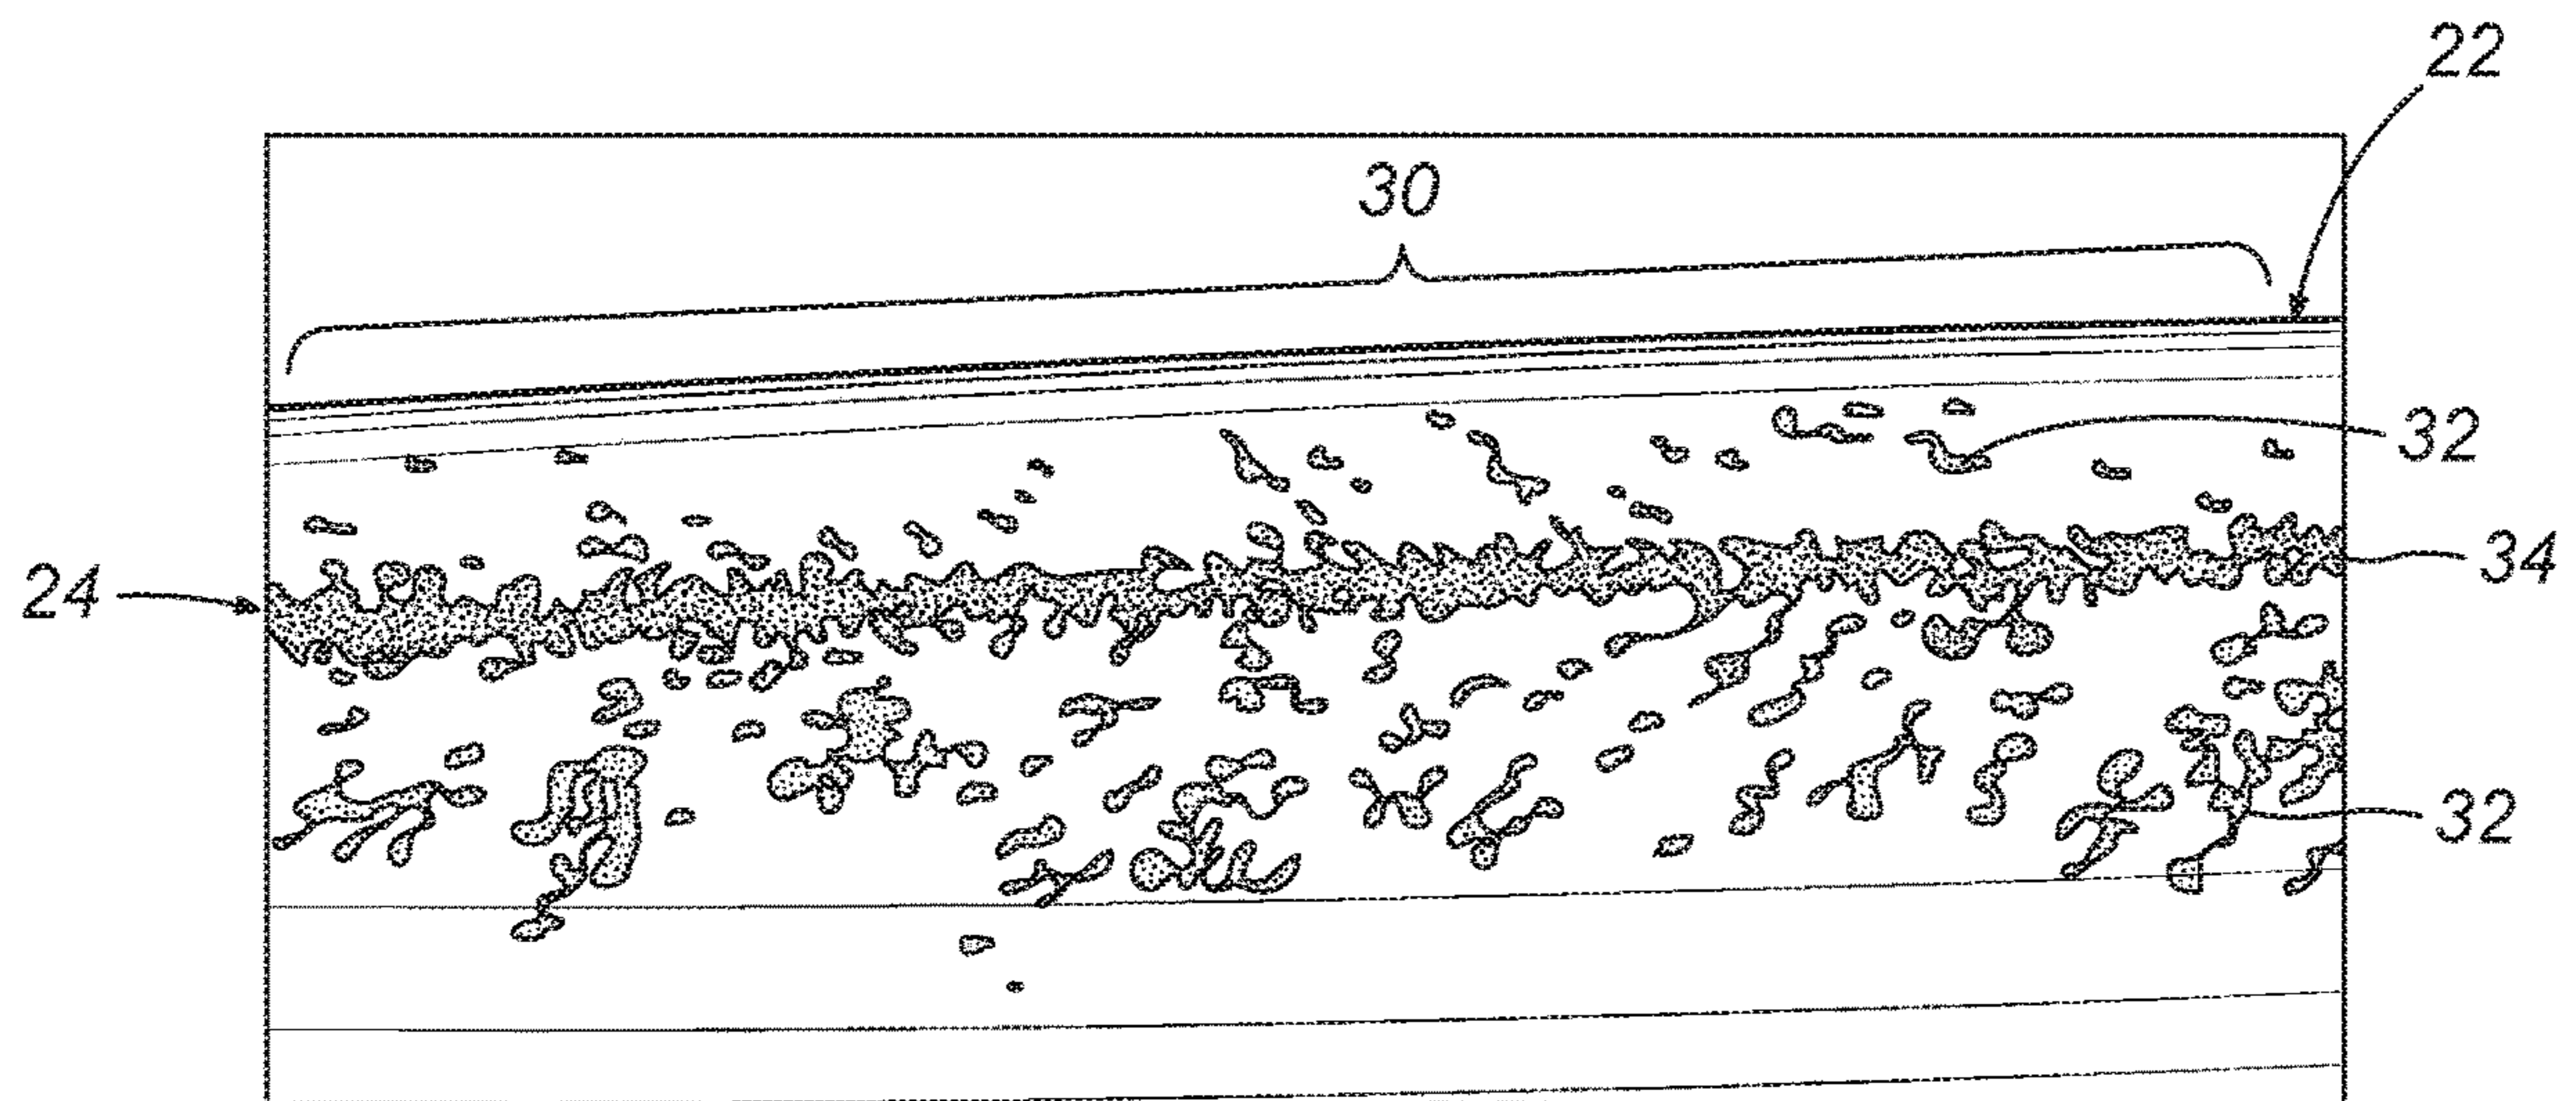
Fig. 1B

FIG. 1B is a schematic representation of the photograph of FIG. 1A;

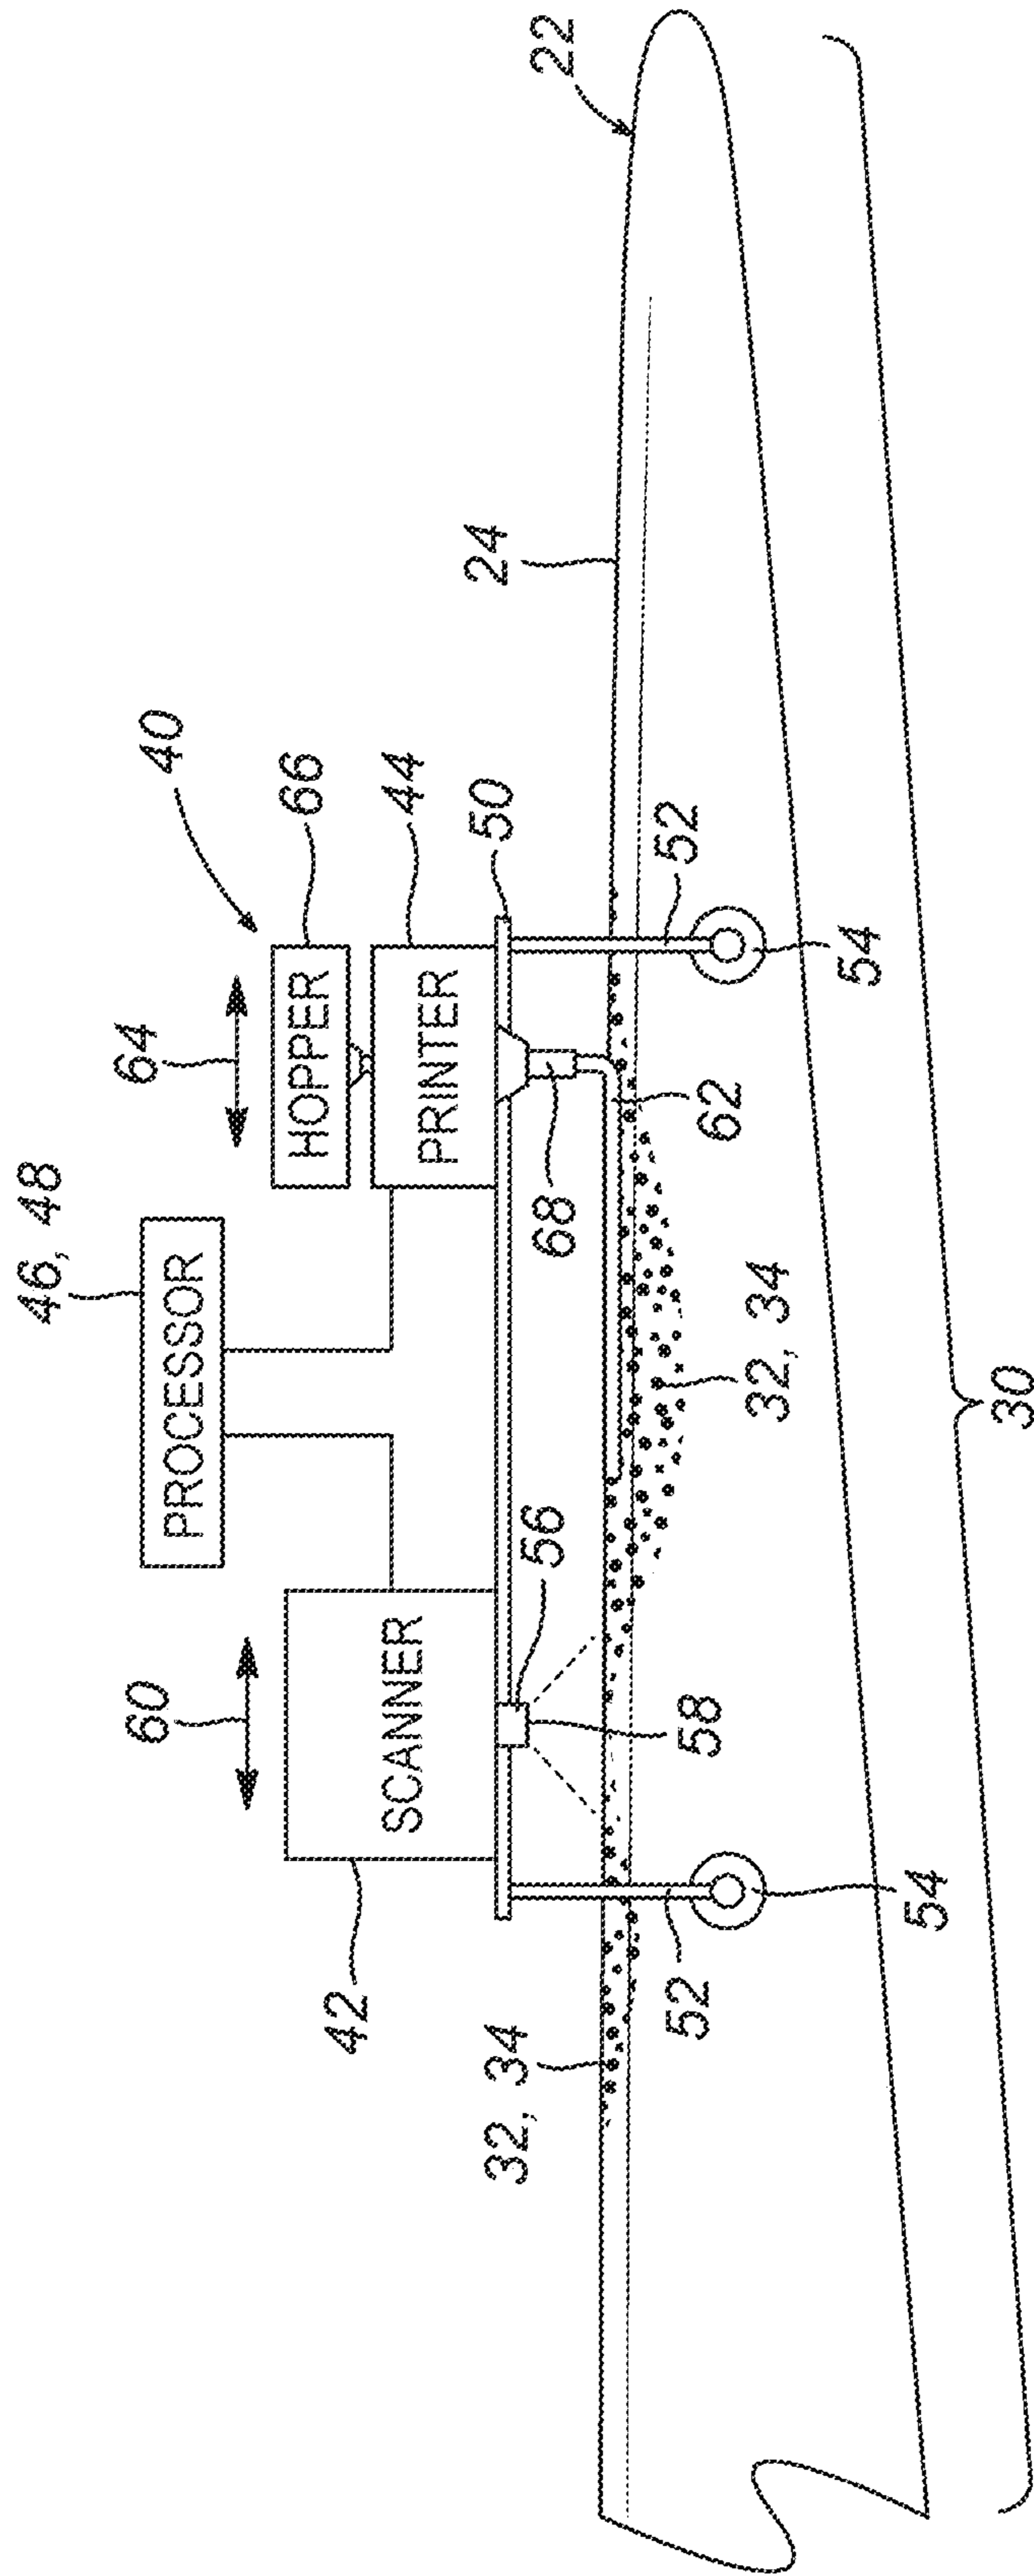
Fig. 2

FIG. 2 is an enlarged schematic view of an erosion zone on a wind turbine blade including a repair system according to one embodiment of the invention;

To avoid structural damage and restore the efficiency of the wind turbine blade 22, and with reference to FIG. 2, embodiments of the present invention include a repair system 40 that is selectively placed on the wind turbine blade 22 over or adjacent the erosion zone 30 or a portion of it. The repair system 40 may be capable of precisely identifying the areas of erosion in the wind turbine blade 22 and then repairing the erosion identified.

In that regard, in one embodiment, the repair system 40 includes a scanning device 42 and a deposition system capable of dispensing material onto the blade surface. In the exemplary embodiment, the deposition system is a printing system 44 capable of placing a material onto the erosion zone 30, including into any or all of the pitting 32 and crack-like features 34. Each of the scanning device 42 and the printing system 44 may be in communication with a processing system 46, which may include a processor 48.

The scanning device 42 and the printing system 44 may be mounted on a frame 50 that may include feet 52 by which the repair system 40 may be temporarily placed on the wind turbine blade 22. The frame 50 may be constructed to ensure that the scanning device 42 and the printing system 44

operate in the same coordinate system. The frame 50 may be sufficiently rigid during movement of the scanning device 42 and/or the printing system 44. The frame 50 may not flex at normal operational loads and so provides a reference frame within which each of the scanning device 42 and the printing system 44 operate. In this way, the frame 50 may provide a reference plane to which the scanning device 42 and the printing system 44 are kept in mutual alignment with respect to each other, with respect to the wind turbine blade 22, and also with respect to the erosion zone 30. This characteristic of the frame 50 enables accurate measurement of the leading edge 24 of the wind turbine blade 22 and accurate deposition of material onto the measured area, as is described below.

The processing system 46 may also be mounted to the frame 50 or be remotely located from each of the scanning device 42 and the printing system 44. By way of example only, the processing system 46 may be located on the ground and communicate with each of the scanning device 42 and the printing system 44 via a wireless ground-based communication system (not shown).

One or more devices 54 on the frame 50 (shown, for example, on the feet 52) may be utilized to selectively couple the repair system 40 to the wind turbine blade 22 prior to repair and allow the repair system 40 to be disconnected from the wind turbine blade 22 following repair. By way of example only, and not limitation, depending on the orientation of the wind turbine blade 22 during repair, the devices 54 may include one or more vacuum sucker feet or vacuum cups that may be selectively activated to attach to the surface of the wind turbine blade 22. Advantageously, these nondestructive-types of attachment devices may prevent the wind turbine blade 22 from being damaged at the points of attachment of the repair system 40 to the wind turbine blade 22 while providing a stable, immobile platform from which the scanning device 42 and the printing system 44 may operate.

In general, according to embodiments of the present invention, the repair system 40 may identify areas of erosion, such as pitting 32 and crack-like features 34, and then deposit new material in those identified areas of erosion. Following repair, the repair system 40 may then rescan the repaired area to confirm placement of the new material in the erosion zone 30 and determine the quality of the aerofoil shape along a portion of the leading edge 24. In this way, the repair system 40 identifies erosion on the wind turbine blade 22, repairs the erosion, determines the repair quality, and may measure the aerofoil shape so that a determination may be made about the efficiency of the wind turbine blade 22 following repair.

To one or more of those ends, once the repair system 40 is positioned over the erosion zone 30 and is removably attached to the wind turbine blade 22, a portion of the scanning device 42, such as a detector 56, or the entire scanning device 42, may translate along the frame 50 as is indicated by the arrows 60 in FIG. 2. The detector 56 may include a light source 58, such as a laser or structured/modulated light source capable of illuminating the erosion zone 30 as it is scanned by the detector 56. By translating the detector 56 along the frame 50, image information and/or digital data of the surface of the wind turbine blade 22 may be captured by the detector 56. Alternatively, the scanning device 42 may include a tactile sensor or other sensor capable of gathering image information and/or digital data, such as measurement information, to form a map of the erosion 32, 34 in the erosion zone 30.

erosion, such as erosion 32, 34, in the erosion zone 30. By way of example only, the image information and/or digital data may be analyzed by the processing system 46 to form a map of areas of erosion in the erosion zone 30. The digital data regarding erosion 32, 34 may be used to guide the printing system 44. In one embodiment, the processing system 46 may create an additive manufacturing instruction file to be utilized by the printing system 44, described below.

Once erosion 32, 34 is identified and mapped, the processing system 46 may activate the printing system 44 by which the material 62 from a hopper 66 containing powdered material or a reservoir of resin may be dispensed from a nozzle 68 onto the wind turbine blade 22. Alternatively, rather than a hopper 66, a spool (not shown) of material 62 may be extruded through the nozzle 68 into the erosion zone 30.

To cover the erosion zone 30, the printing system 44 may also translate along the frame 50 as is indicated by arrows 64 according to the digital data and/or mapped erosion while dispensing the material 62 from the hopper 66. In one embodiment, the printing system 44 follows instructions from the processing system 46. Accordingly, a path of the dispensed material 62 may exactly match a path generated by the image and/or digital data from the scanning device 42. While translating according to the path, the printing system 44 deposits the material. Thus, the material 62 may be accurately dispensed to fill the erosion 32, 34. Because the repair system 40 may accurately fill in a uniform loss of a skin of material, pitting, and/or cracks in the surface of the leading edge 24, preparing the erosion zone 30 prior to filling, such as by grinding away imperfections, may not be required. Advantageously, embodiments of the invention may eliminate the possibility of damaging an underlying composite structure by grinding too deeply into the wind turbine blade 22. By way of example only, and not limitation, the printing system 44 may be an additive manufacturing system that can accurately and precisely apply material 62 as instructed by the additive manufacturing instruction file produced by the processing system 46.

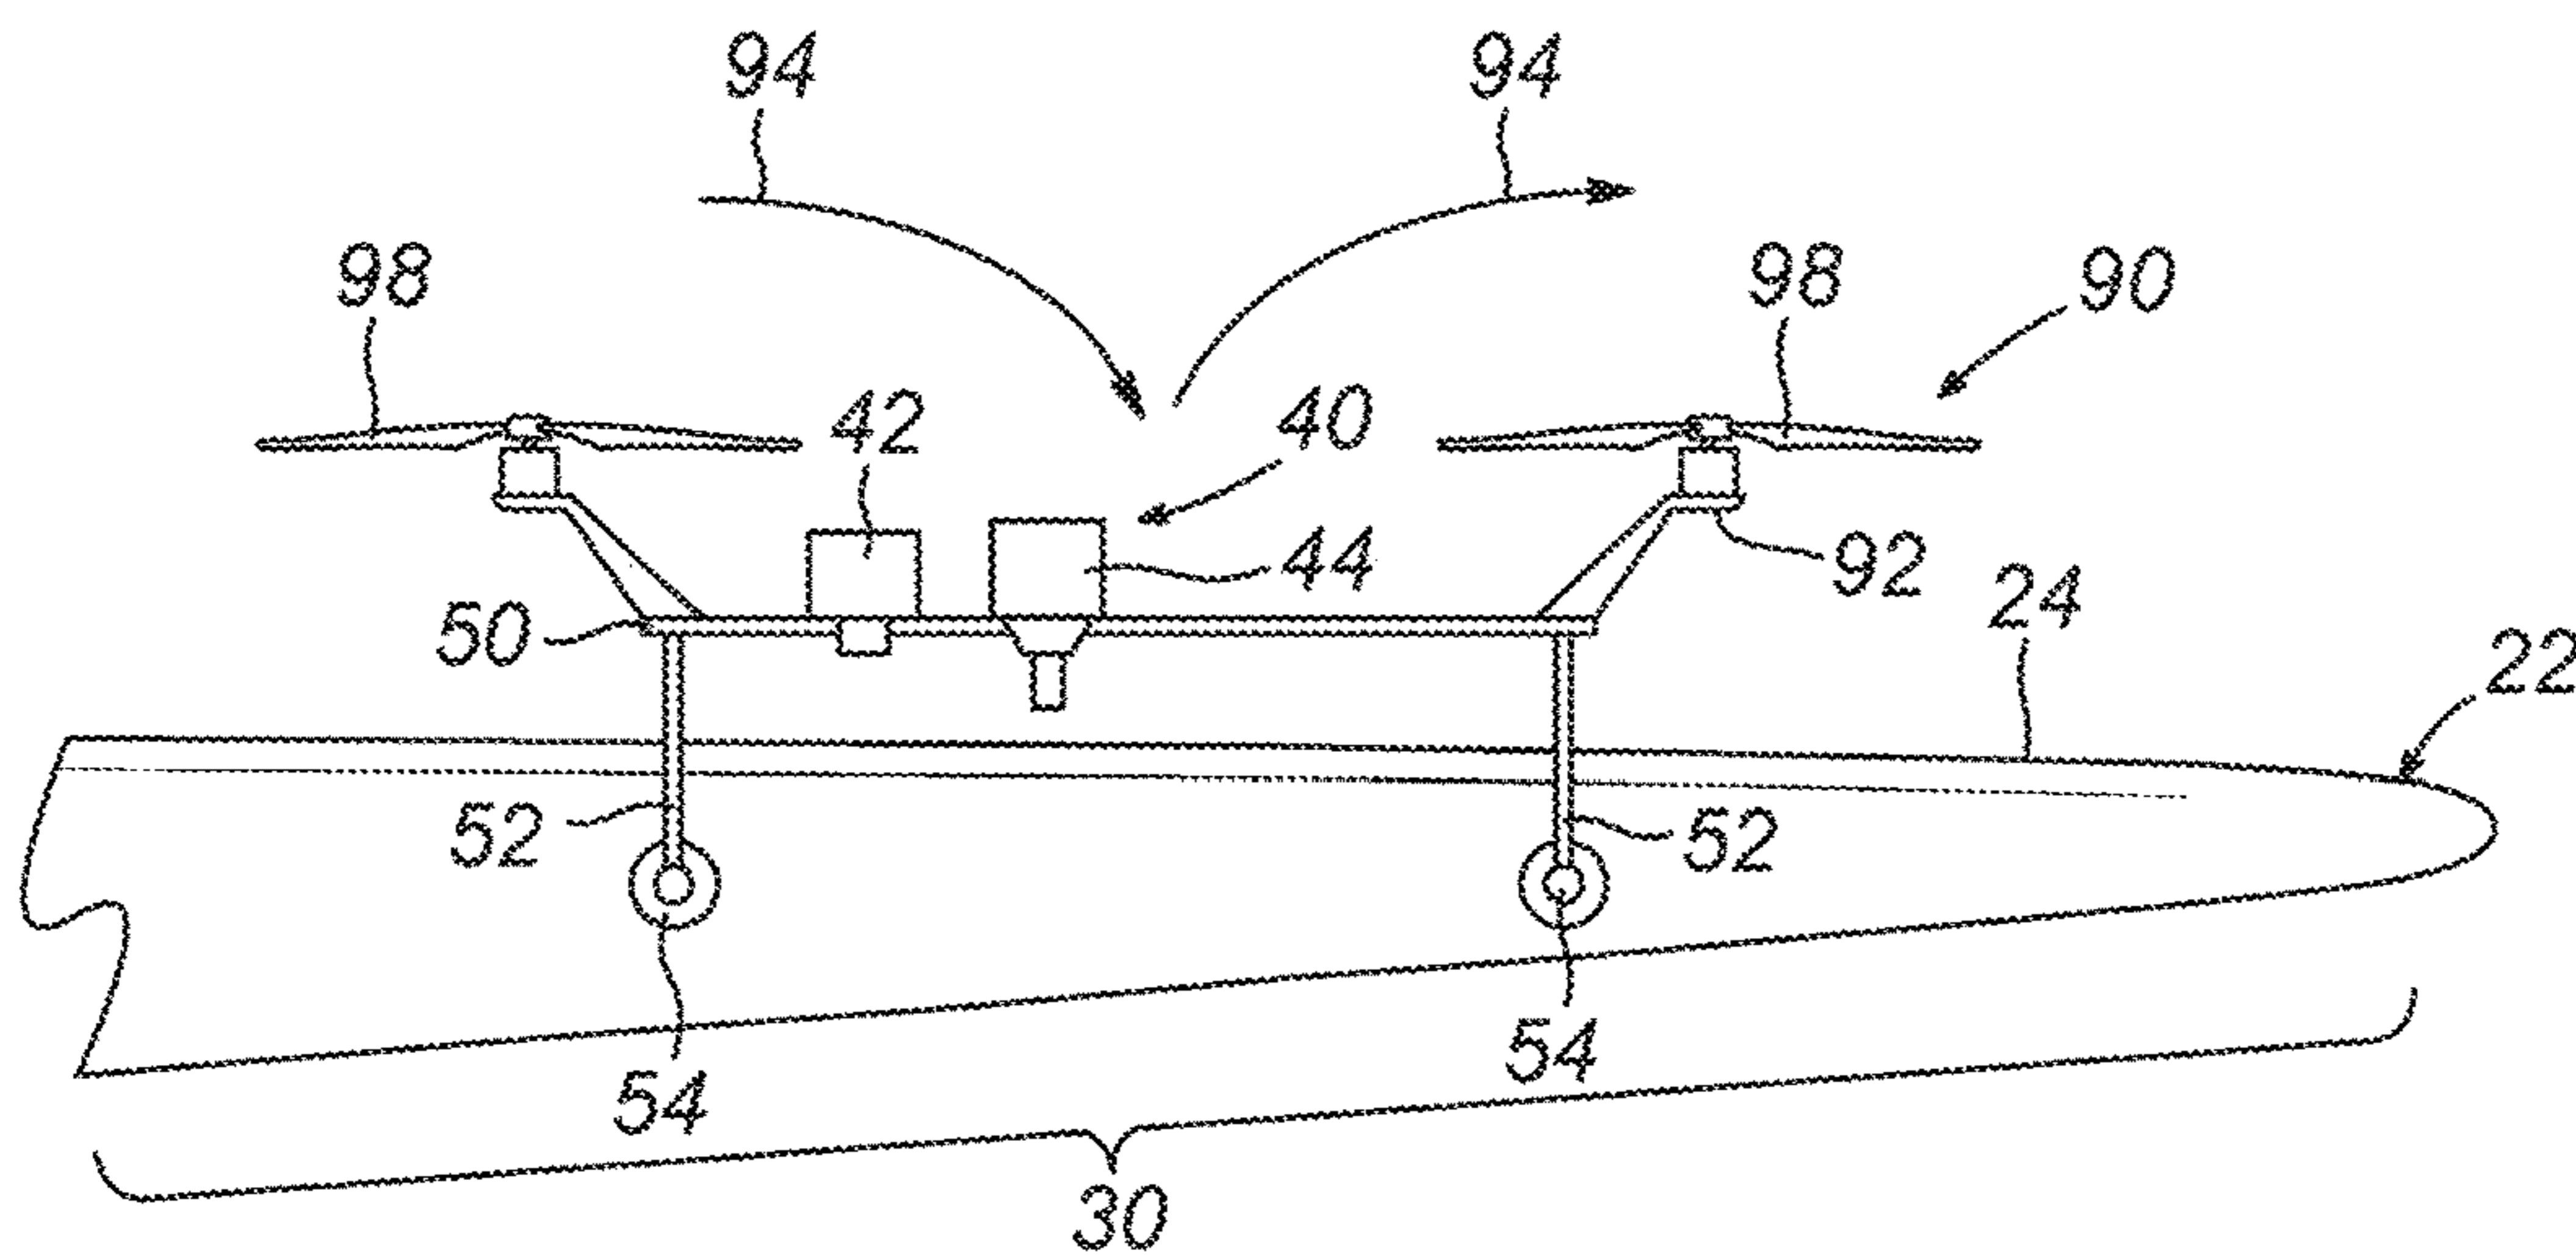
Fig. 3A

FIGS. 3A and 3B are schematic views of a repair system according to one embodiment of the invention; and

With reference now to FIG. 3A, embodiments of the present invention may include a deployment system 90 by which the repair system 40 may be accurately positioned and then moved according to arrows 94 as necessary over the erosion zone 30. With reference to FIG. 3A, in one embodiment the deployment system 90 includes an unmanned aerial vehicle (UAV) 92 including one or more rotor systems 98. Though not limited to any particular location, as shown in FIG. 3A, each rotor system 98 may be secured to the frame 50. The UAV 92 may be remotely operated from the ground near the base of the tower 12 so that the repair system 40 may be positioned on the wind turbine blade 22 without the need for a crane or a scaffold. The UAV 92 may be particularly useful for the wind turbine blade 22 that is parked in a horizontal position as is shown in FIGS. 1 and 3A. The UAV 92 may simply land the repair system 40 on a horizontally disposed leading edge 24 of the wind turbine blade 22. Gravity may hold the repair system 40 in position while the wind turbine blade 22 is repaired. Although shown in FIG. 3A, the device 54 may not be required.

Once a repair is completed, as is described above, the UAV 92 may be utilized to move the repair system 40 to another location on the wind turbine blade 22, to move the repair system 40 onto another wind turbine blade 22 of the wind turbine 10, or to remove the repair system 40 from the wind turbine 10 when repairs are complete. The UAV 92 may also move the repair system 40 to the ground to replenish the hopper 66, to download information from the processing system 46, or for other reasons (e.g., maintenance of the repair system 40). While the deployment system 90 shown in FIG. 3A is integral with the repair system 40, embodiments of the present invention are not limited to an integral deployment system. In that regard, the UAV 92 may be a separate device, such as a drone, that may be utilized to selectively attach to, move, and detach from the repair system 40. The UAV 92 may deliver the repair system 40 to one location. Once repair at that location is complete, the UAV 92 may pick up the repair system 40 and deliver it to another location.
