(10) **Patent No.:** **US 11,118,573 B2**
(45) **Date of Patent:** **Sep. 14, 2021**

(54) **METHODS AND SYSTEMS FOR REPAIRING WIND TURBINE BLADES**

(71) Applicant: **Vestas Wind Systems A/S, Aarhus N, (DK)**

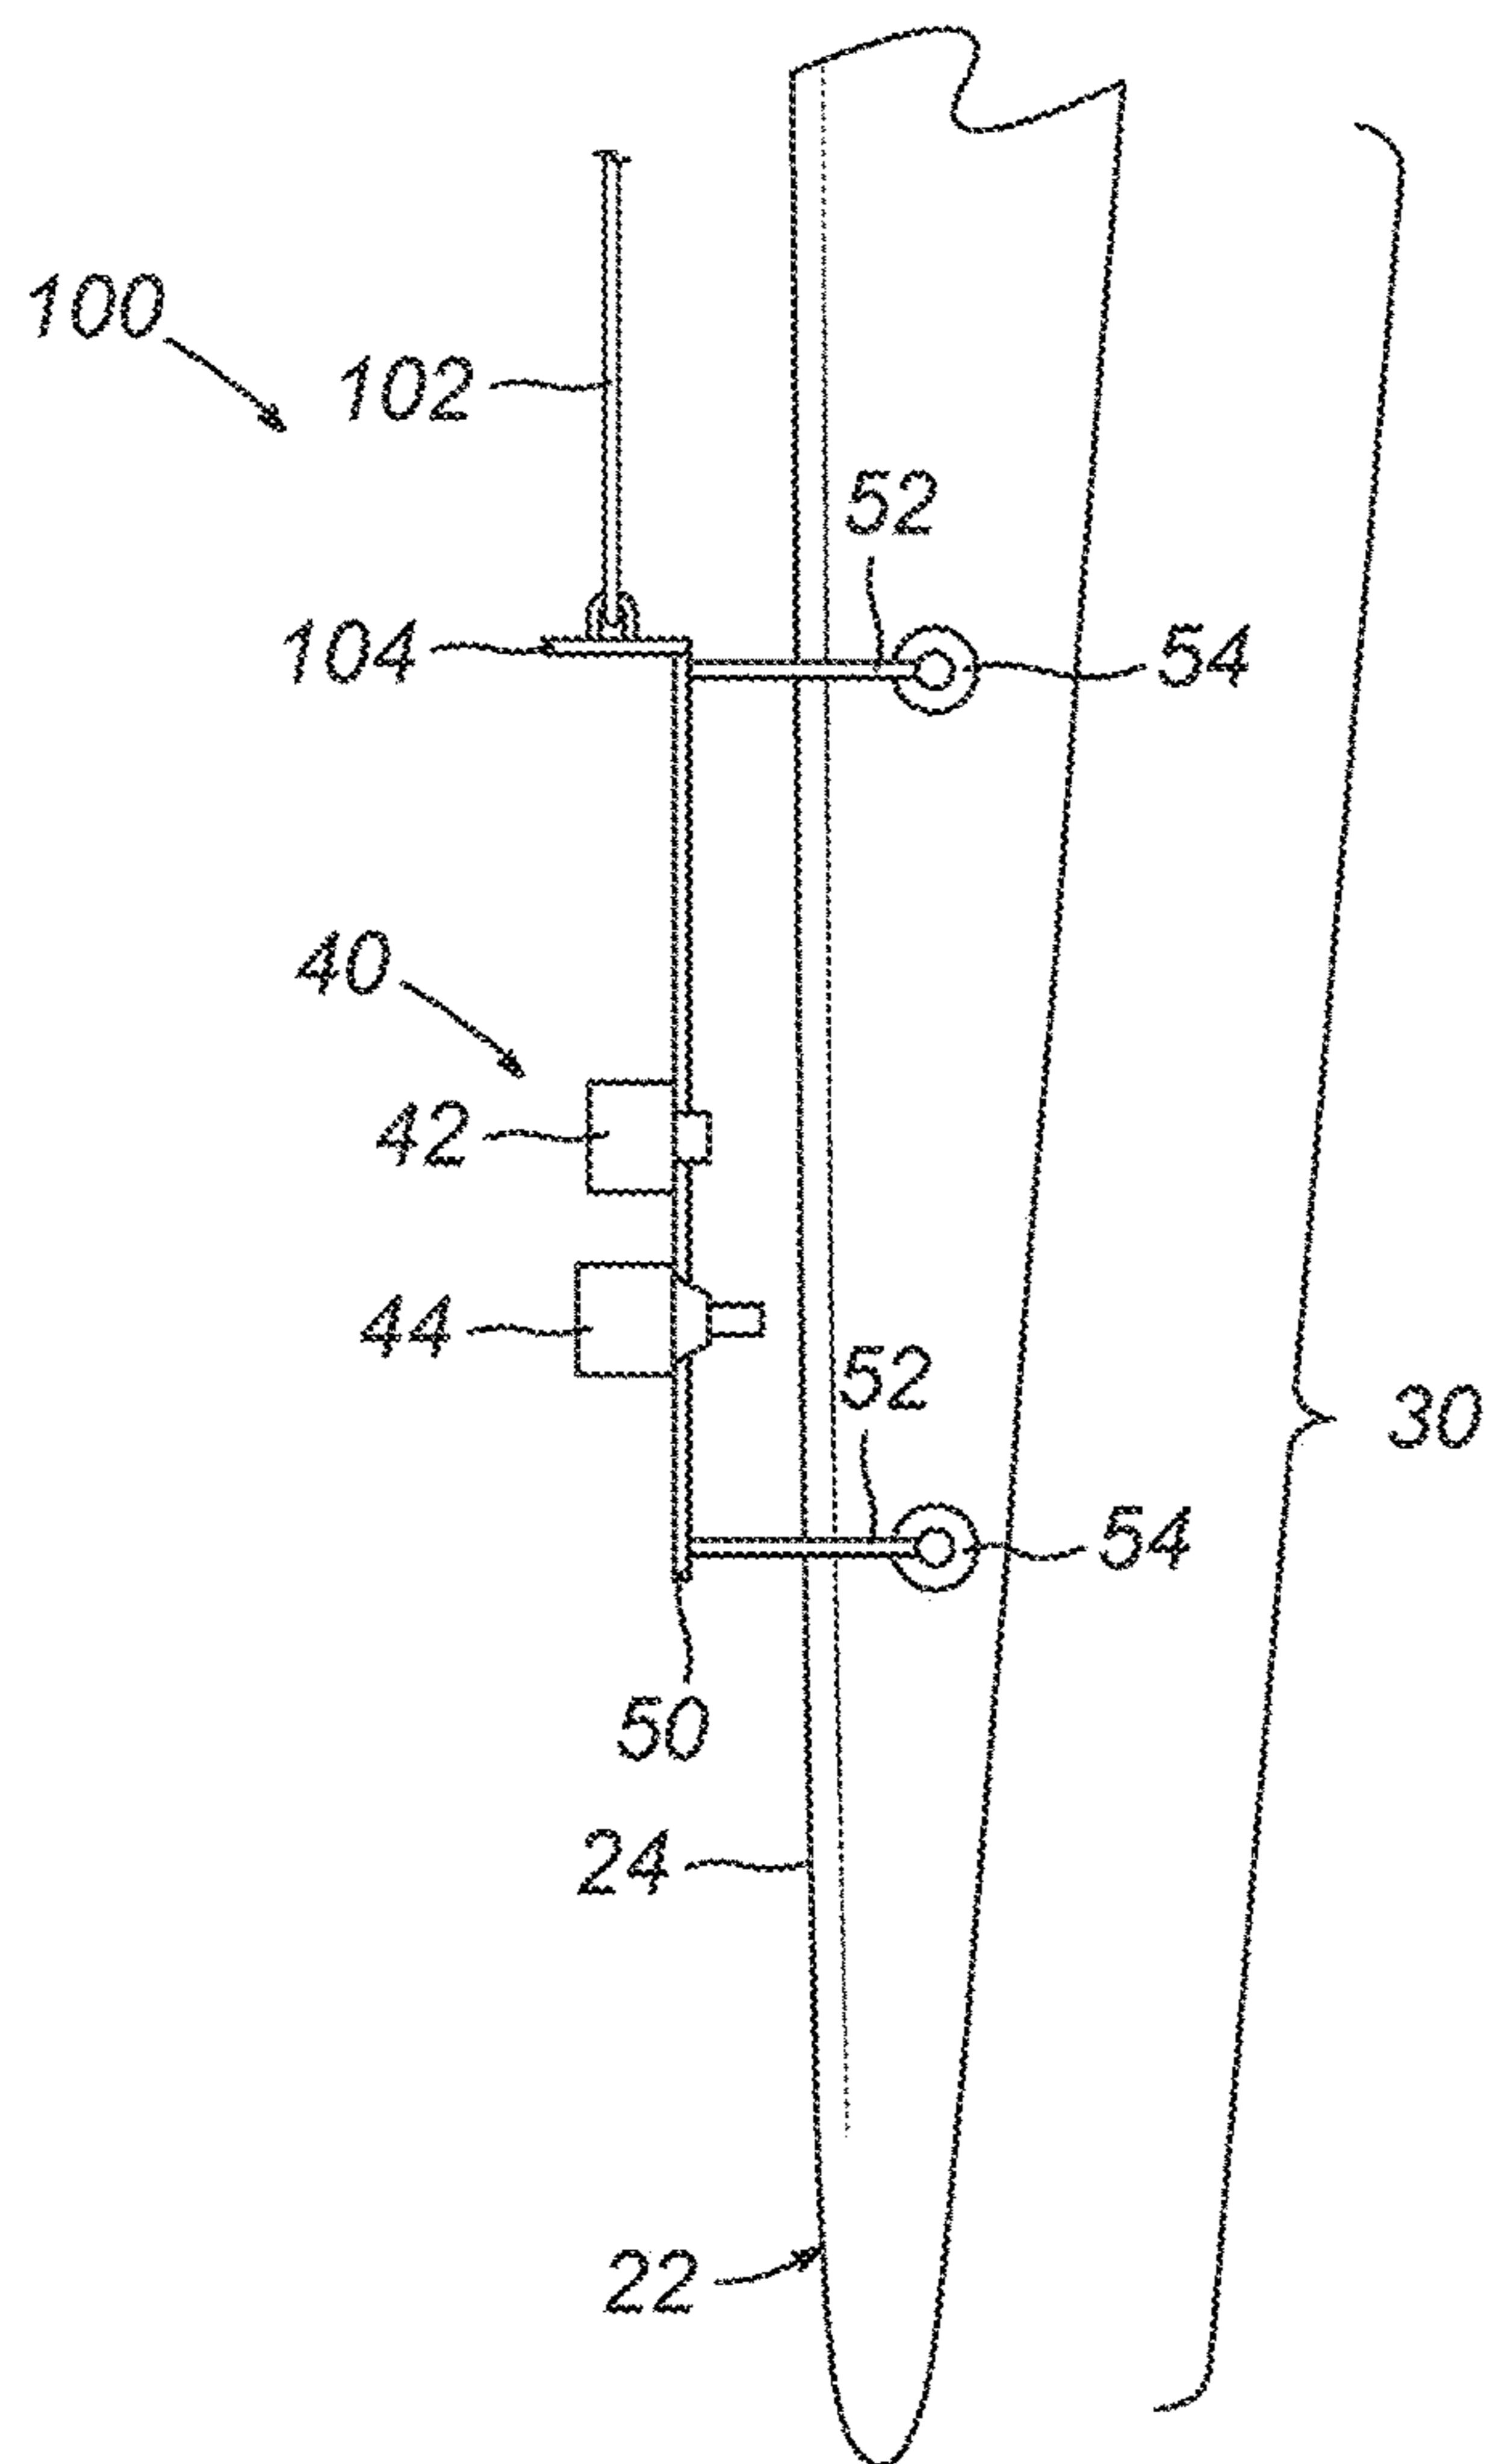
Fig. 3B

FIGS. 3A and 3B are schematic views of a repair system according to one embodiment of the invention; and

With reference to FIG. 3B, an alternative deployment system 100 may include a rope/wire system 102 that is secured to the repair system 40, for example, by an extension 104 of the frame 50. The repair system 40 may then be lowered down the wind turbine blade 22 to a position adjacent the erosion zone 30. The devices 54 may be activated to releasably secure the repair system 40 to the wind turbine blade 22. As shown, the repair system 40 may be held in an orientation adjacent to the wind turbine blade 22 when it is not horizontal. For example, in FIG. 3B, the wind turbine blade 22 is parked in a vertical orientation. For non-horizontal orientations, the deployment system 100 may allow the repair system 40 to be selectively moved along the leading edge 24 of the wind turbine blade 22 under the influence of gravity. While not shown, other deployment

systems may include a robotic system that crawls or rolls along or down the wind turbine blade 22.

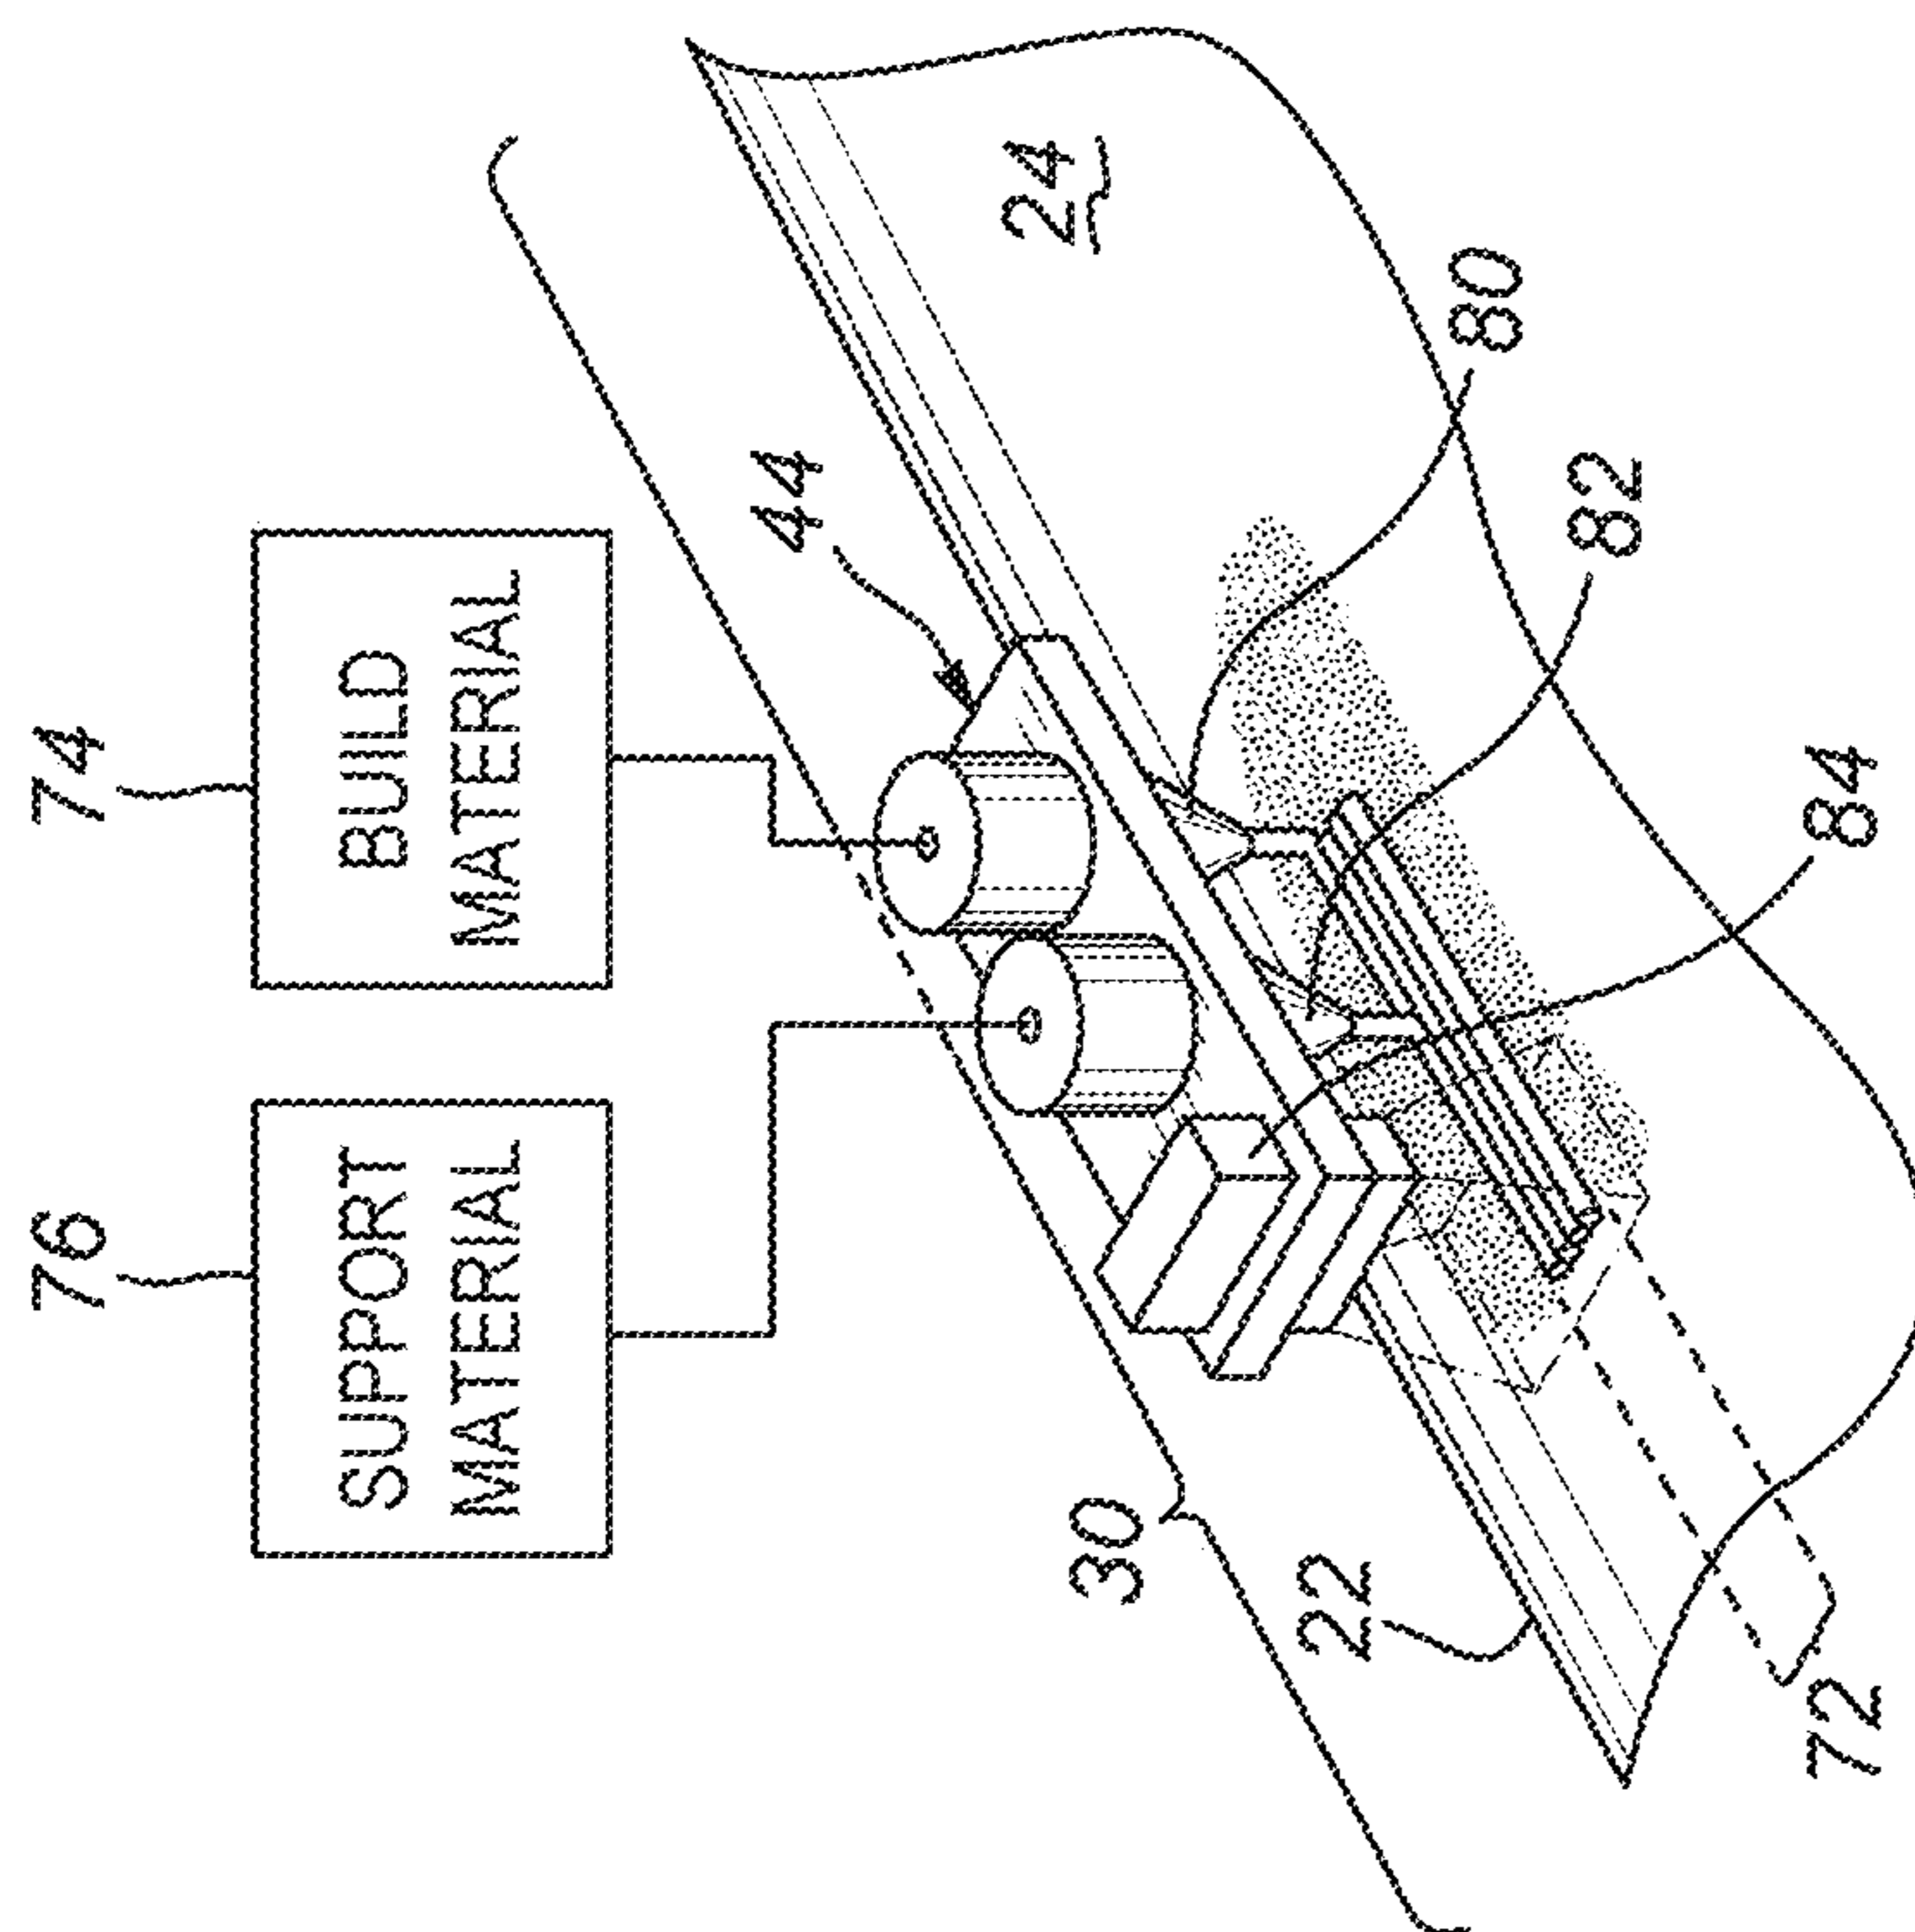
Fig. 4A

FIGS. 4A and 4B are repair schemes according to embodiments of the invention.

Specific examples of additive manufacturing systems may include 3-D printing shown in FIGS. 4A and 4B. In particular, with reference to FIG. 4A, in one embodiment the printing system 44 may extrude one or more rows 70 into the erosion zone 30. As shown, multiple rows 70 may be stacked side-to-side to fill in an area within the erosion zone 30. Alternatively, or in addition to being stacked side-to-side, the rows 70 may be stacked vertically to form a repair layer 72. The repair layer 72 may ultimately form a new exterior surface of the leading edge 24 of the wind turbine blade 22.
