US011118573B2

(54) **METHODS AND SYSTEMS FOR REPAIRING WIND TURBINE BLADES**

(71) Applicant: **Vestas Wind Systems A/S, Aarhus N, (DK)**

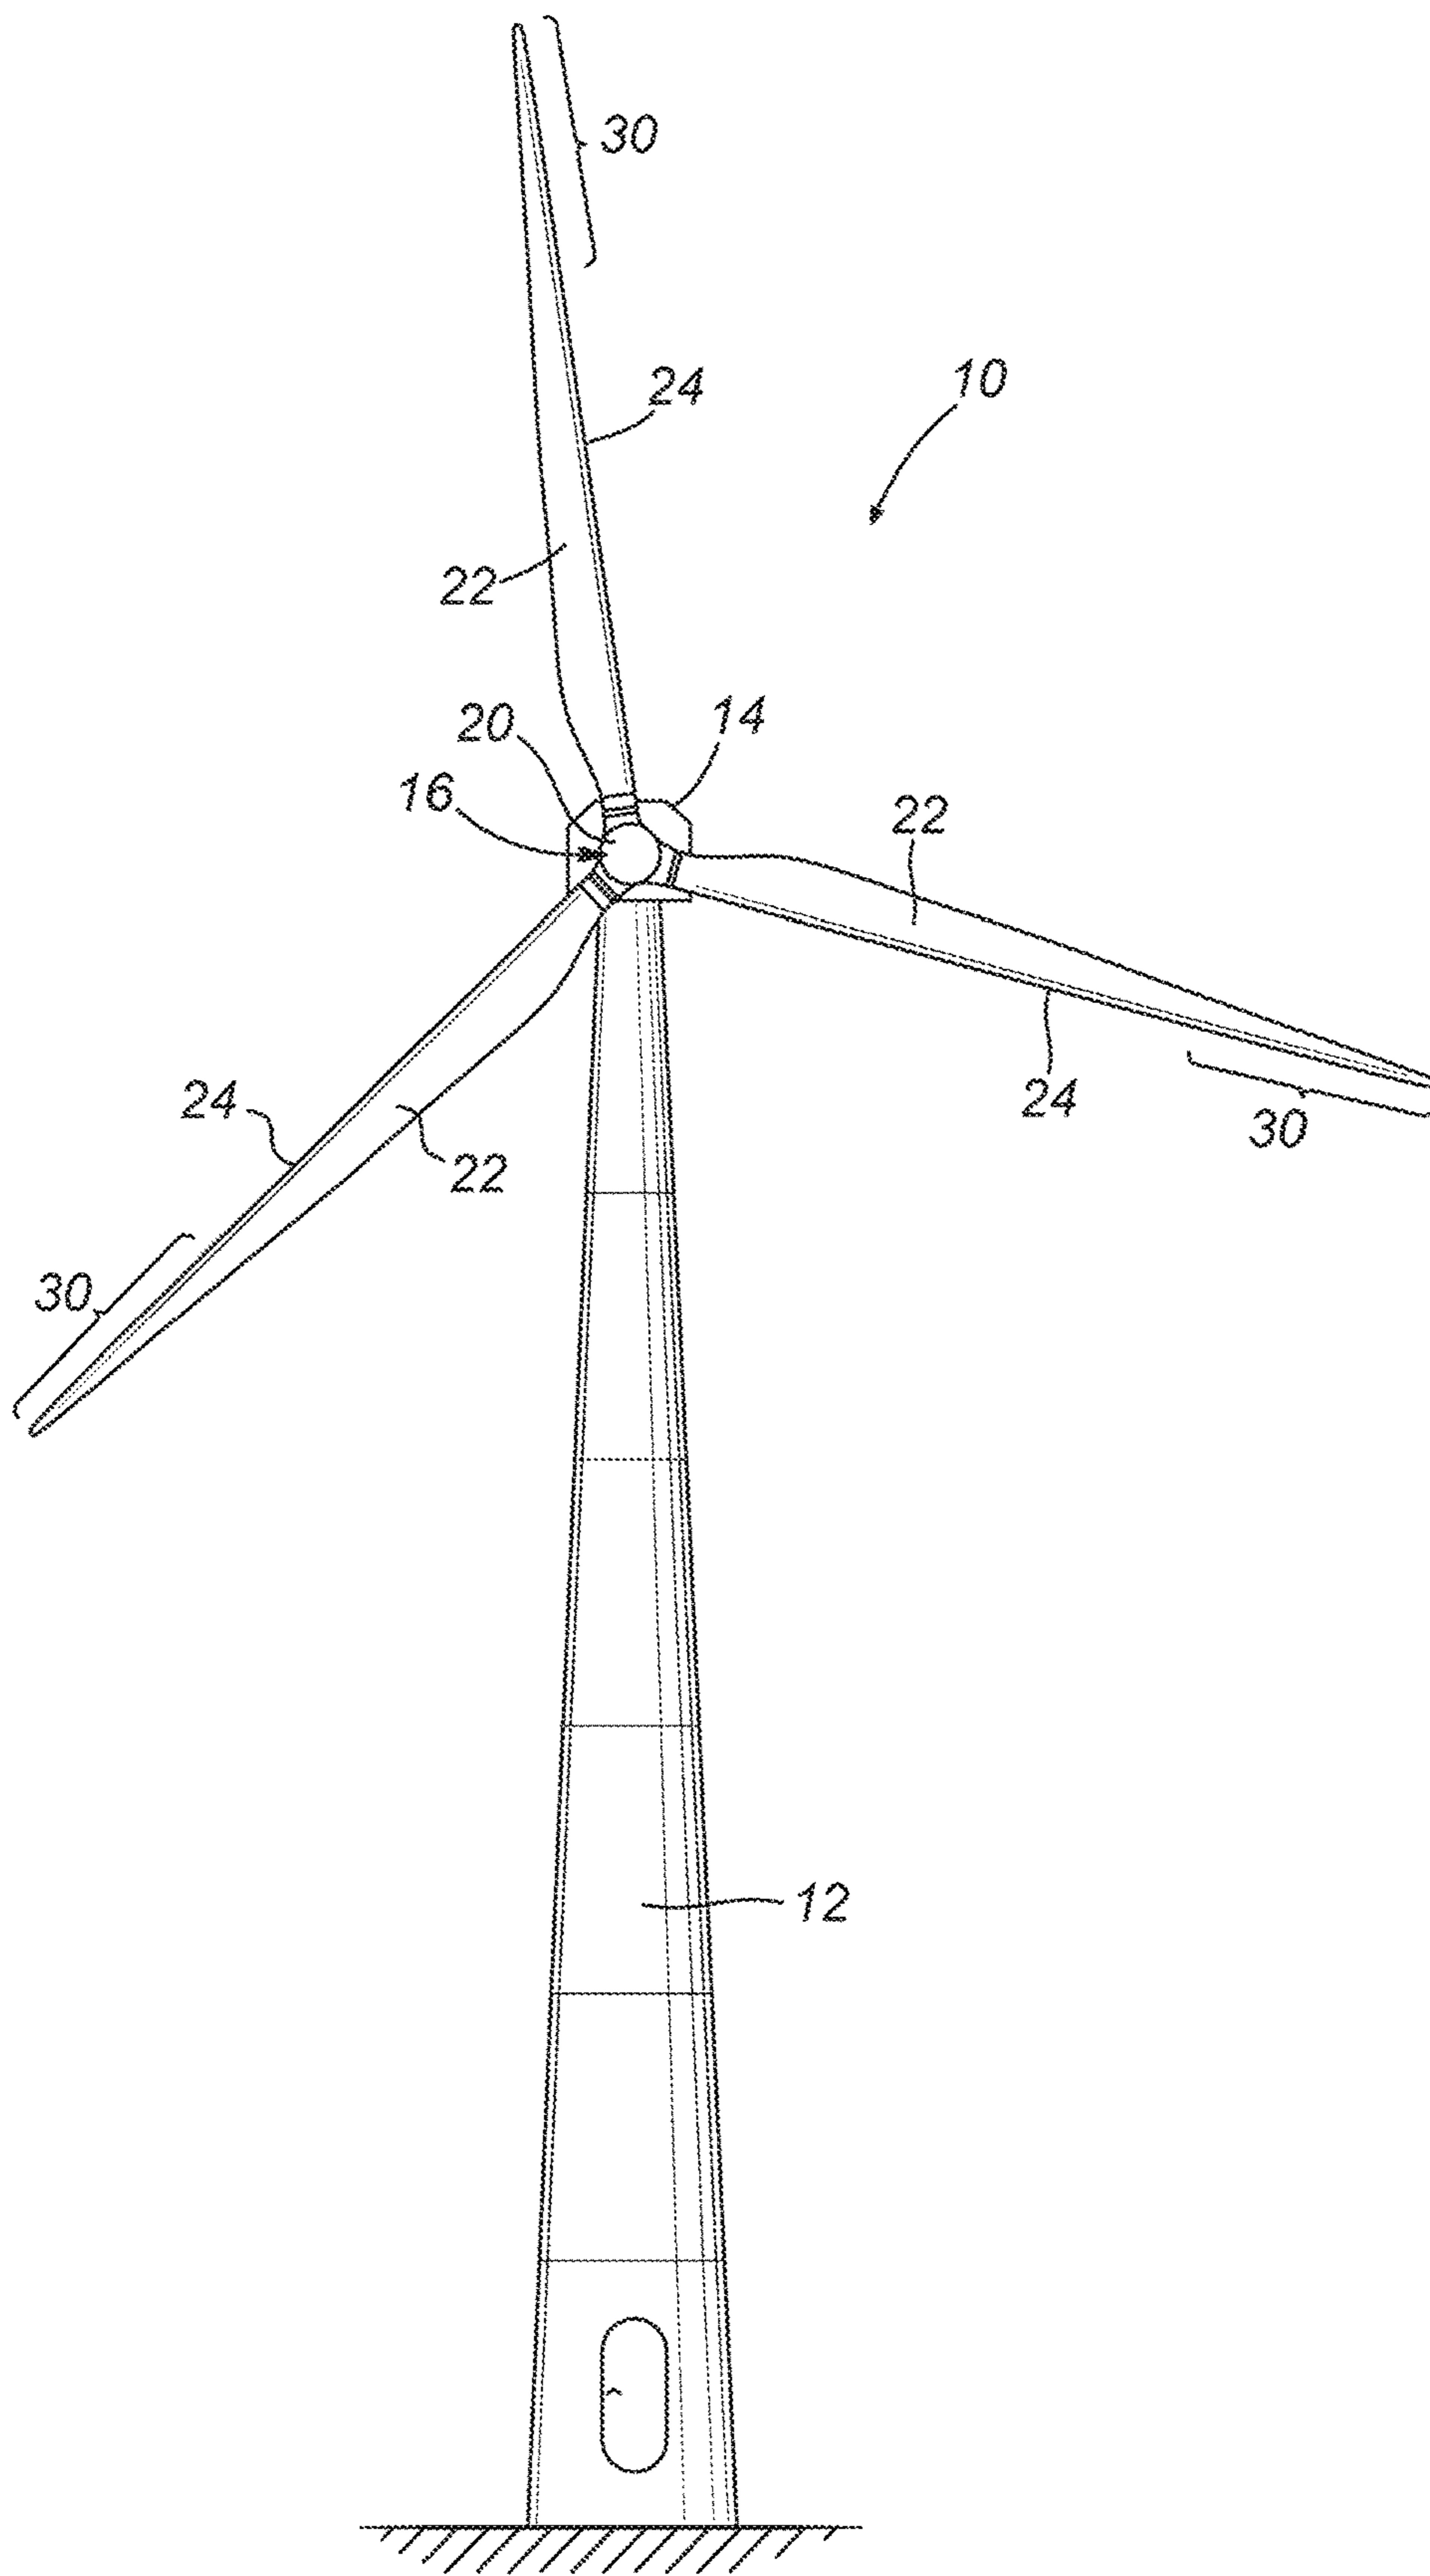
Fig. 1

FIG. 1 is a perspective view of a wind turbine according to one embodiment of the invention;

To these and other ends, and with reference to FIG. 1, in an exemplary embodiment of the invention, a wind turbine 10 includes a tower 12, a nacelle 14 disposed at the apex of the tower 12, and a rotor 16 operatively coupled to a generator (not shown) housed inside the nacelle 14. The rotor 16 of the wind turbine 10 includes a central hub 20 and a plurality of wind turbine blades 22 that project outwardly from the central hub 20 at locations circumferentially distributed around the hub 20. As shown, the rotor 16 includes three wind turbine blades 22, but the number of blades may vary from one wind turbine to another. The wind turbine blades 22 are configured to interact with air flow to produce lift that causes the rotor 16 to spin generally within a plane defined by the wind turbine blades 22. As the rotor 16 spins, the wind turbine blades 22 pass through the air with an edge 24 leading the respective wind turbine blade 22 during rotation.

As the wind turbine 10 ages, one or more of the wind turbine blades 22 may experience erosion from prolonged, continuous exposure to the environment. While not being particularly limited to any source, erosion may occur due to particulates in the air that abrade the leading edge 24 of the wind turbine blade 22 during operation. Erosion may occur in an erosion zone 30 that includes the leading edge 24 of one or more of the wind turbine blades 22. Although shown on the leading edge 24, erosion is not necessarily limited to the erosion zone 30 shown in FIG. 1 and may occur along other portions of the wind turbine blades 22.

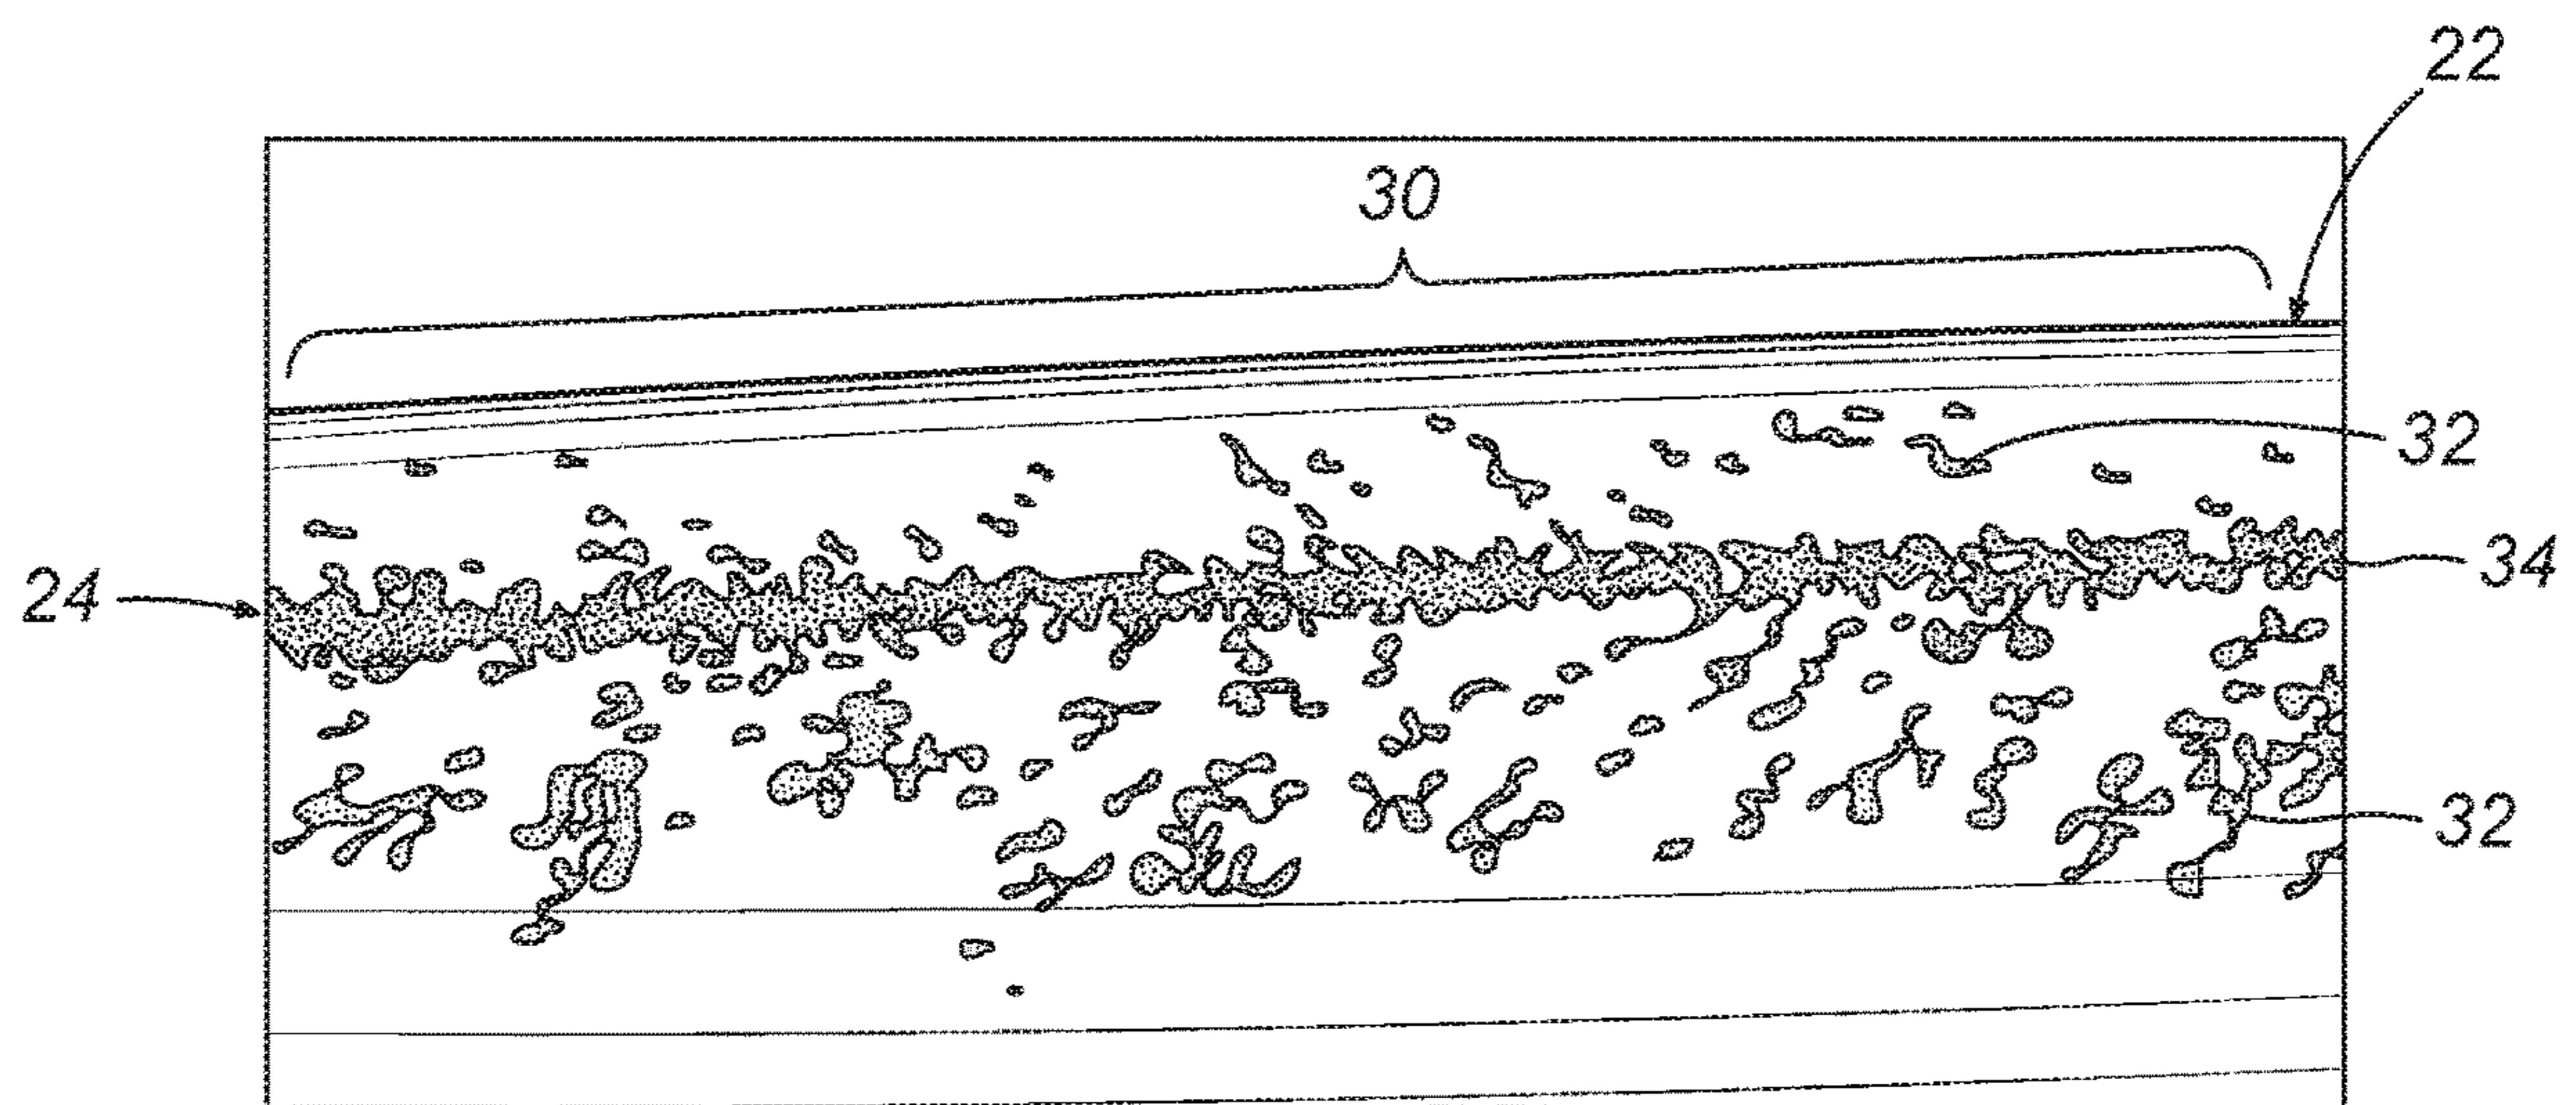
Fig. 1B

FIG. 1B is a schematic representation of the photograph of FIG. 1A;

With reference to FIGS. 1A and 1B, erosion is generally characterized as a loss of material from the wind turbine blade 22. Material loss may be uniformly distributed but is often non-uniform across the leading edge 24 or any other surface of the wind turbine blade 22. Rather than losing a uniform skin of material from a surface, erosion may include localized surface imperfections, such as random pitting 32 and shallow gouges or crack-like features 34 that may be a result of localized, connected pitting. In any case, if erosion is not repaired, the wind turbine blade 22 becomes less efficient at rotating the rotor 16 and ultimately, the structural integrity of the wind turbine blade 22 may be impaired.

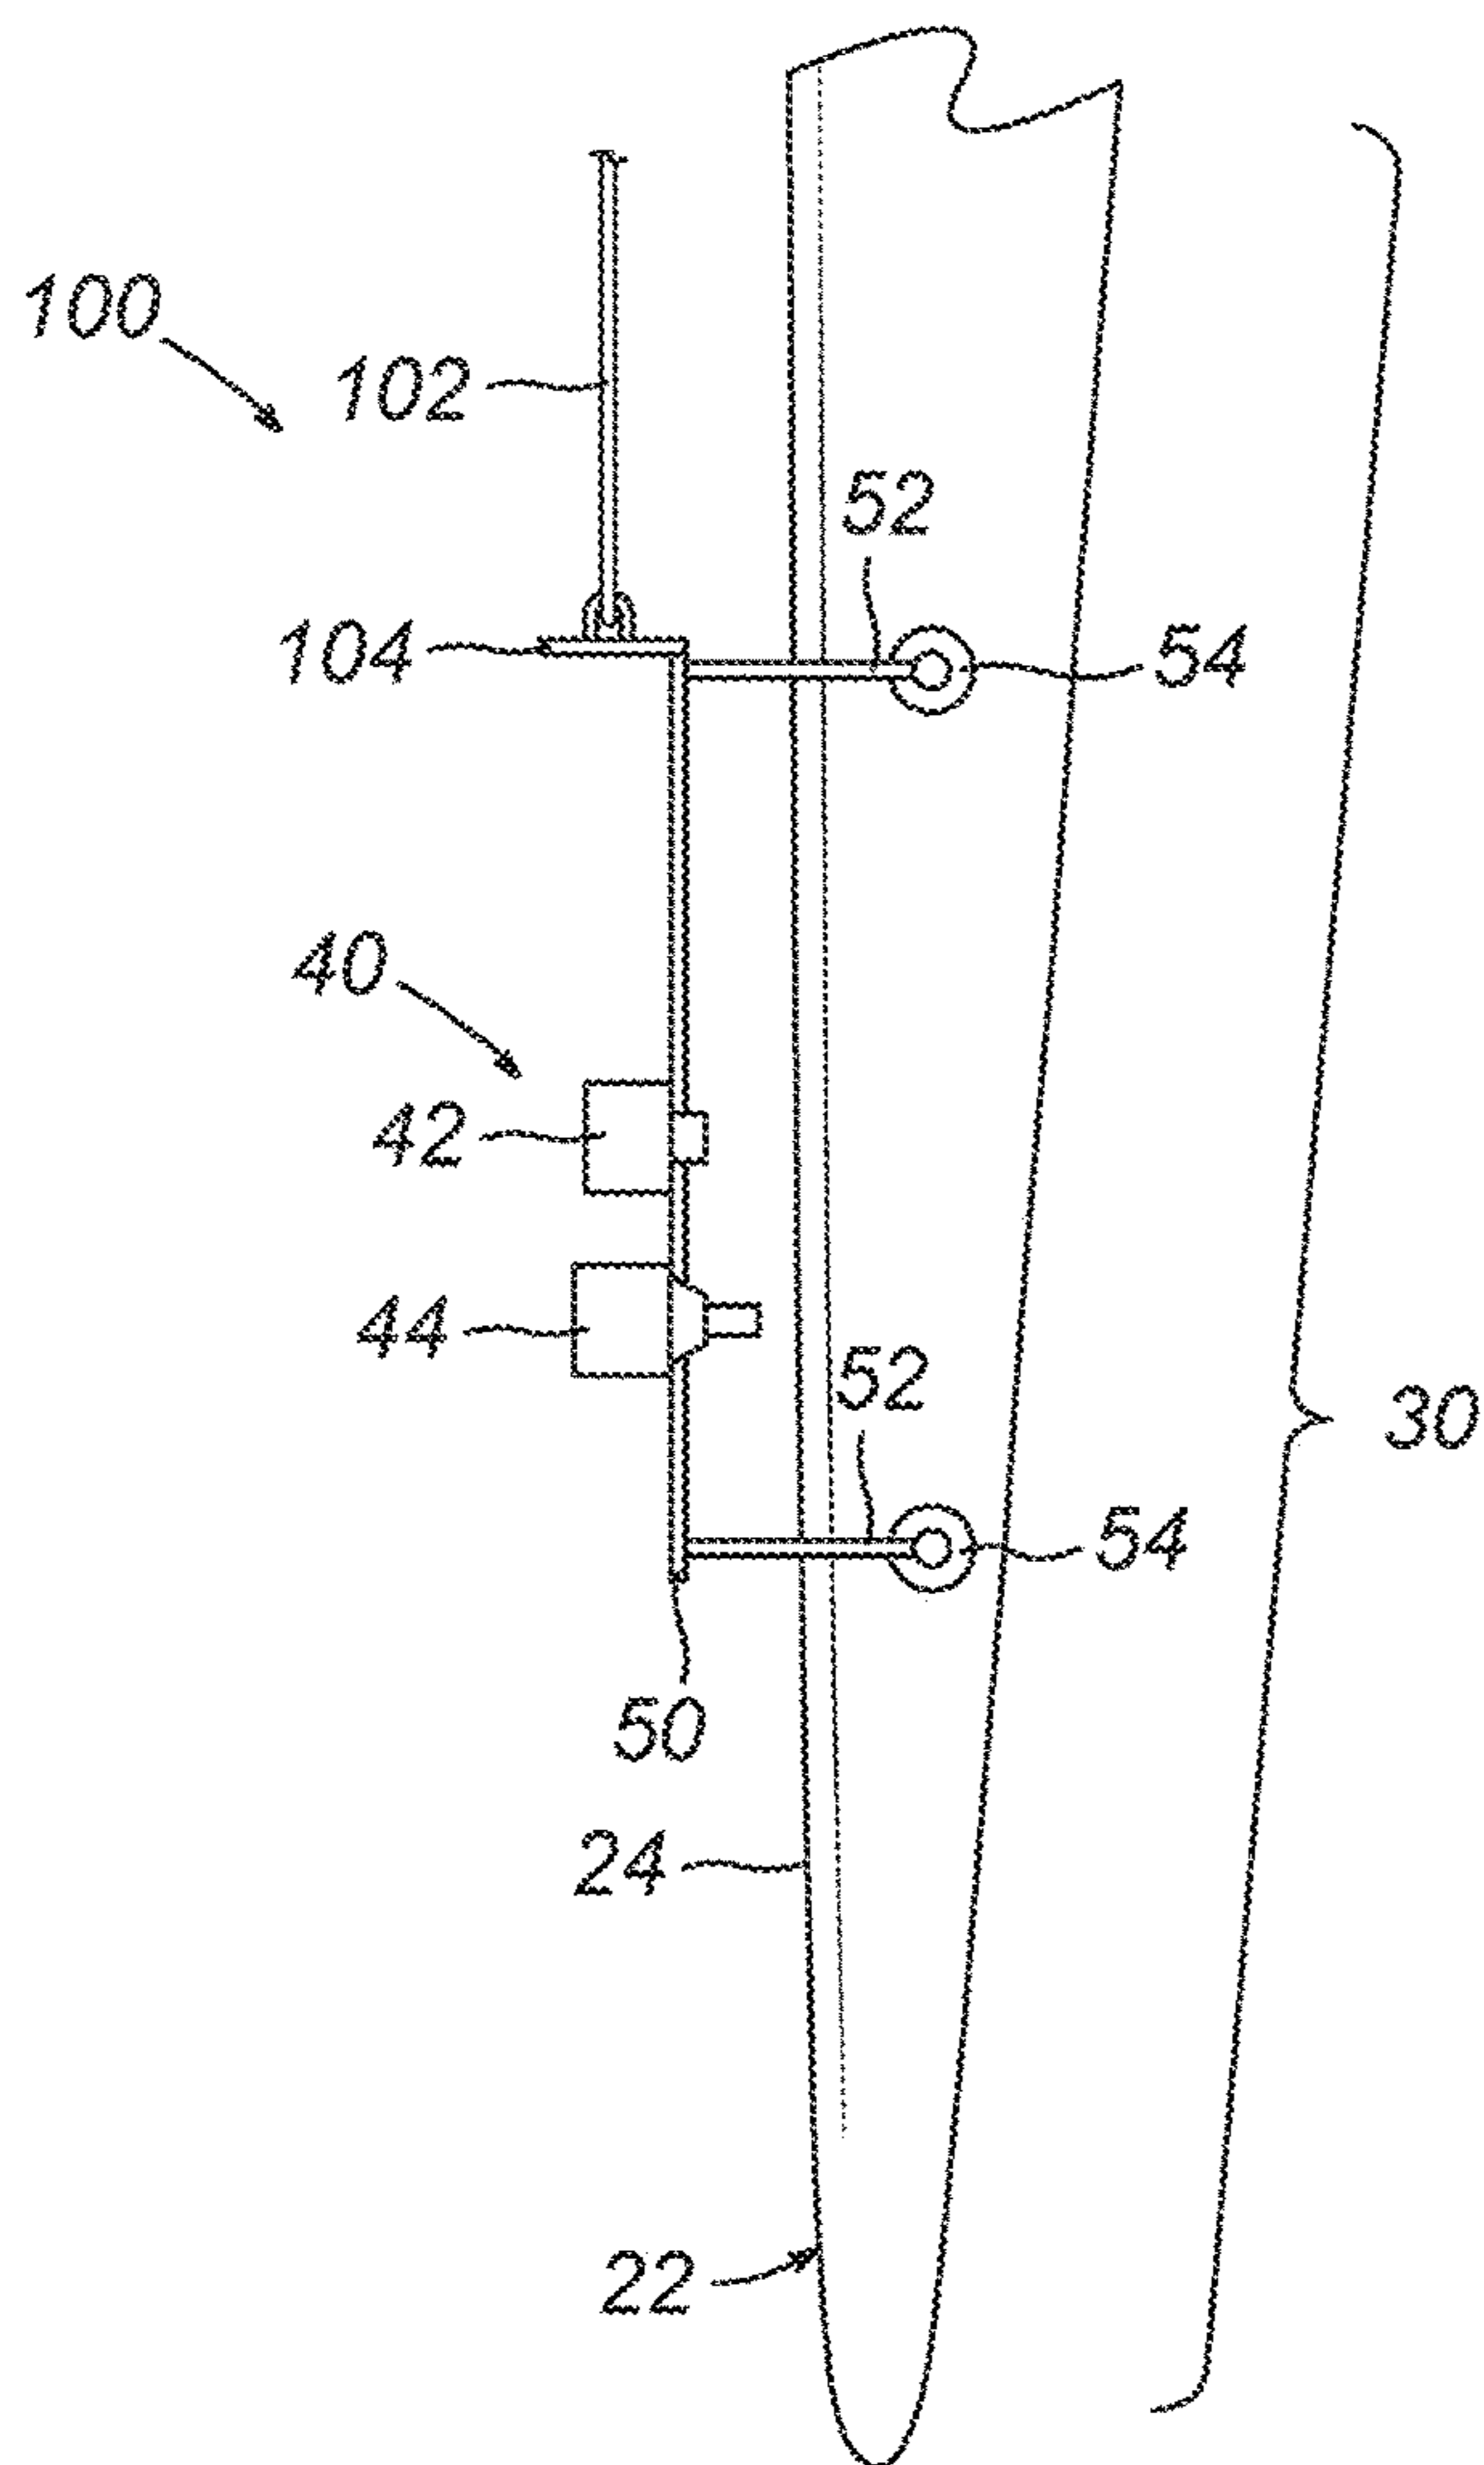
Fig. 3B

FIGS. 3A and 3B are schematic views of a repair system according to one embodiment of the invention; and

With reference to FIG. 3B, an alternative deployment system 100 may include a rope/wire system 102 that is secured to the repair system 40, for example, by an extension 104 of the frame 50. The repair system 40 may then be lowered down the wind turbine blade 22 to a position adjacent the erosion zone 30. The devices 54 may be activated to releasably secure the repair system 40 to the wind turbine blade 22. As shown, the repair system 40 may be held in an orientation adjacent to the wind turbine blade 22 when it is not horizontal. For example, in FIG. 3B, the wind turbine blade 22 is parked in a vertical orientation. For non-horizontal orientations, the deployment system 100 may allow the repair system 40 to be selectively moved along the leading edge 24 of the wind turbine blade 22 under the influence of gravity. While not shown, other deployment

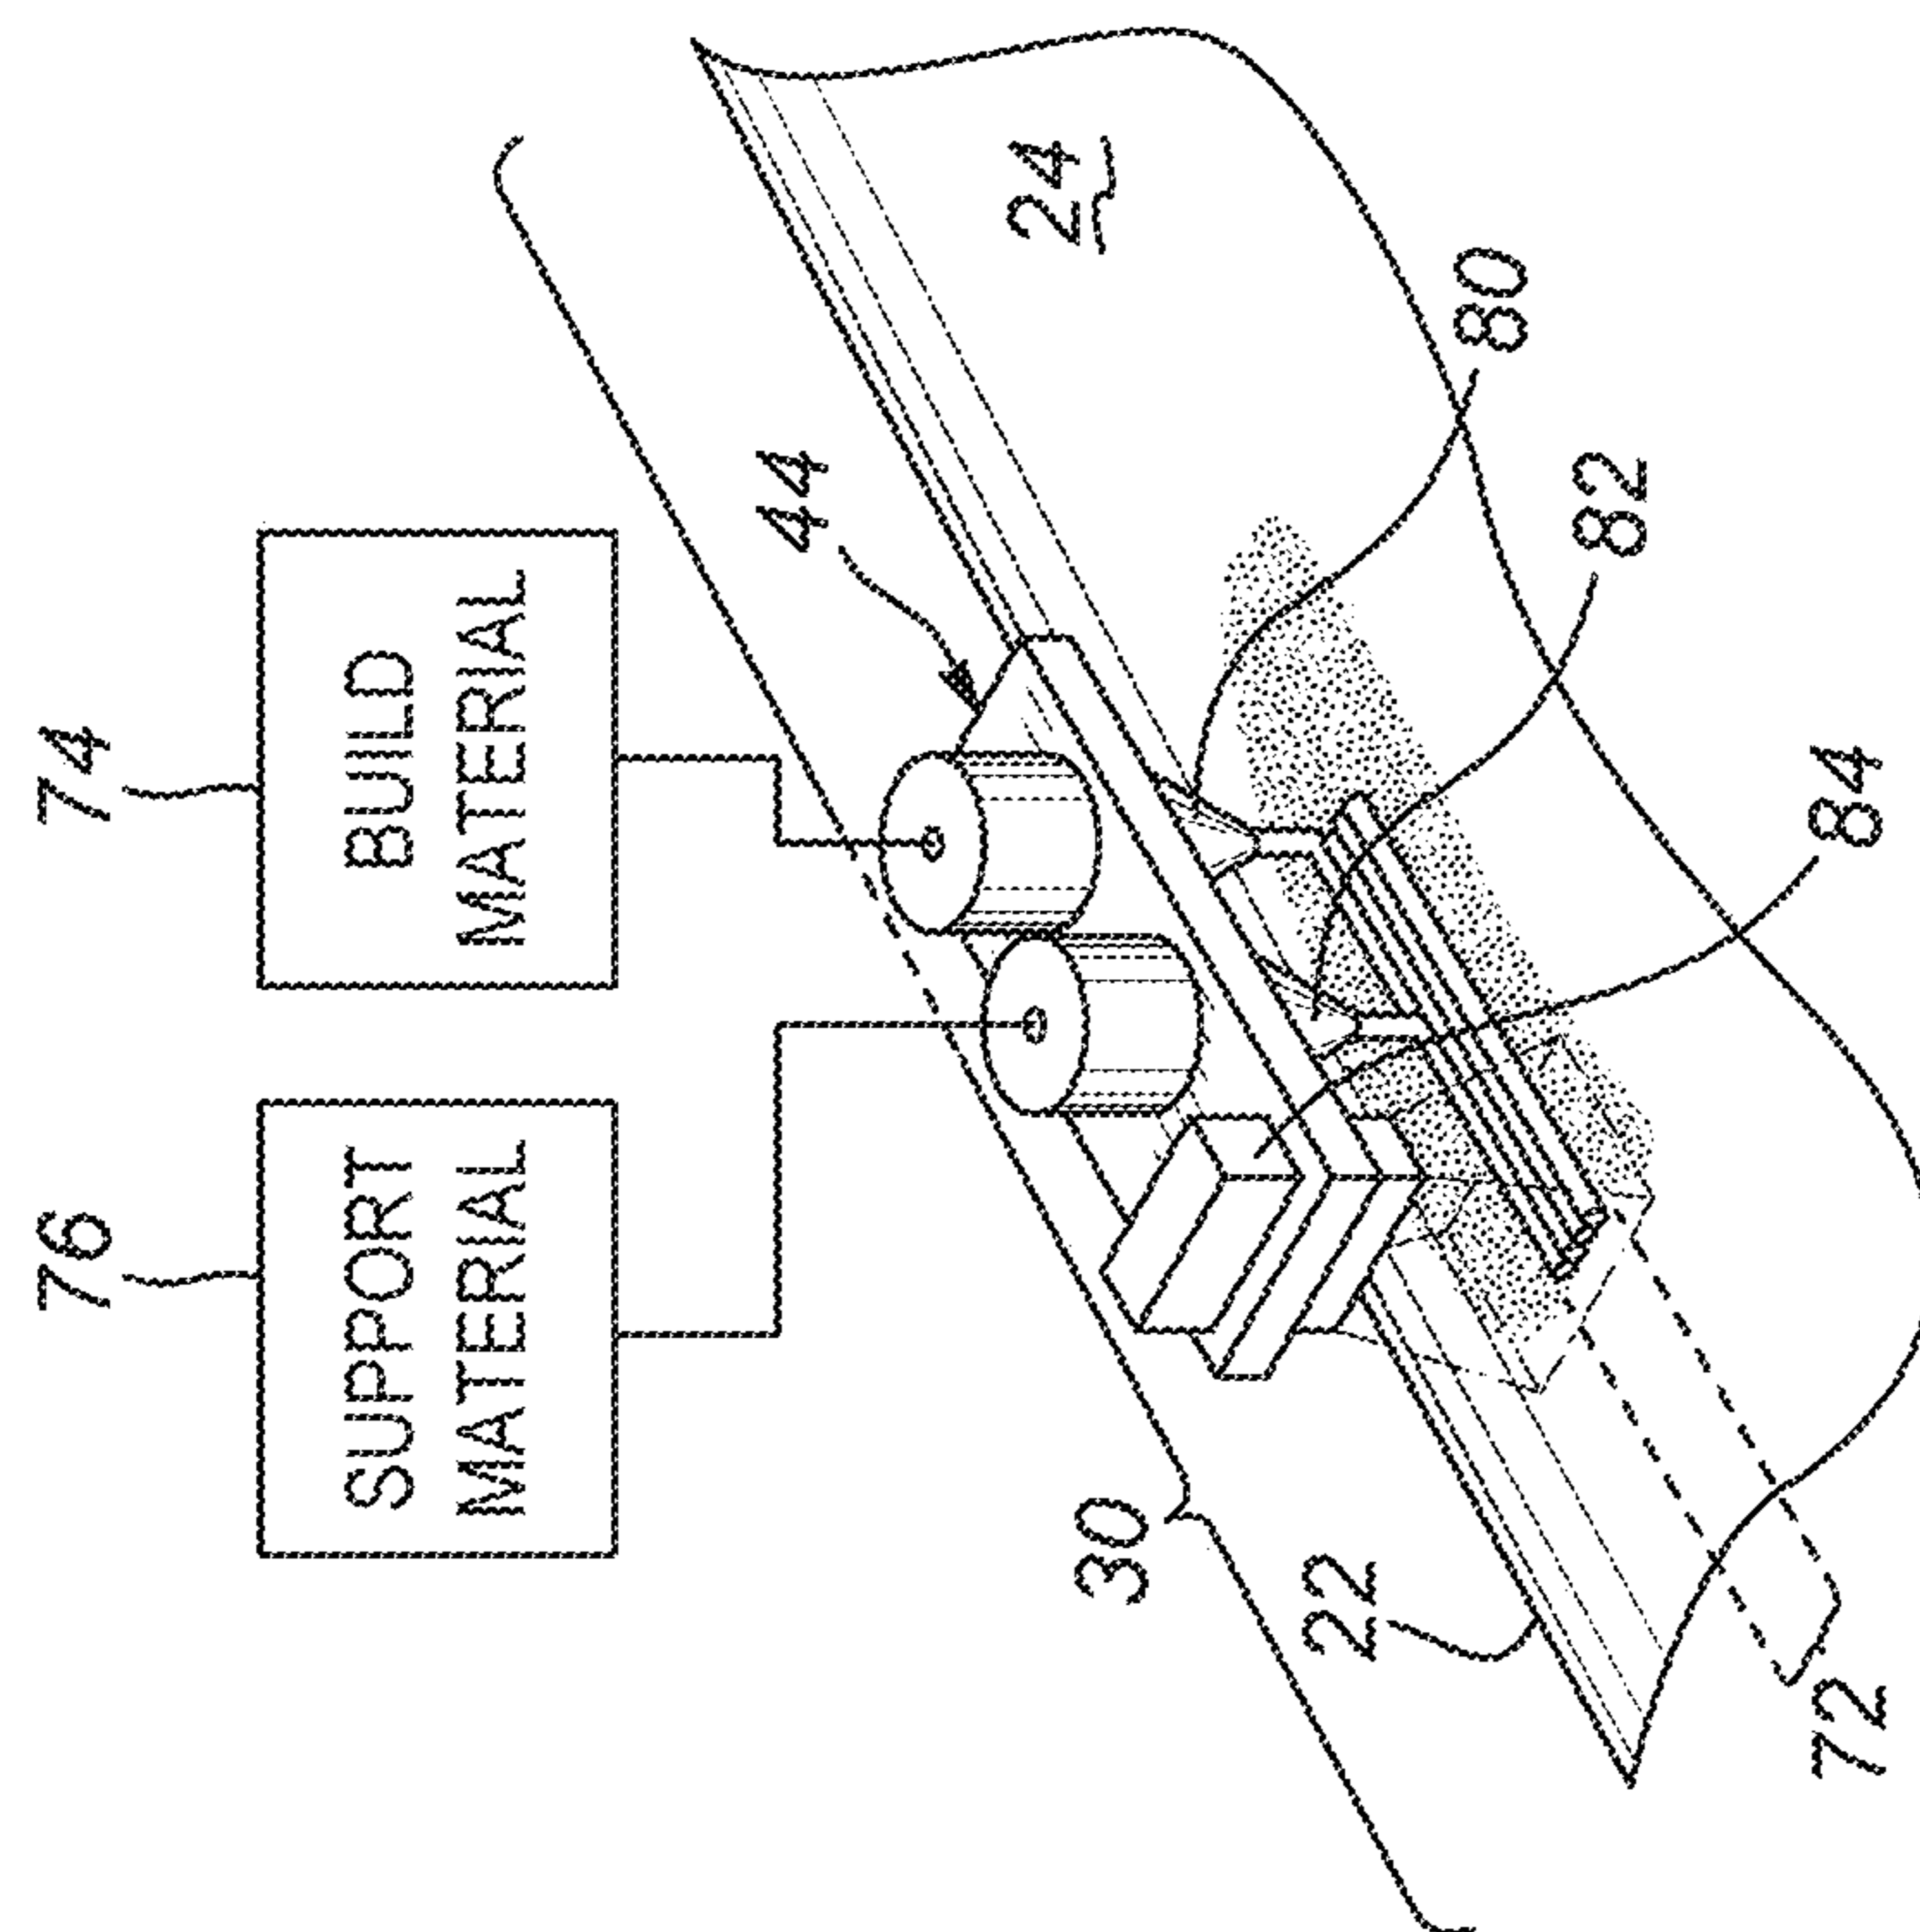
Fig. 4A

FIGS. 4A and 4B are repair schemes according to embodiments of the invention.

Specific examples of additive manufacturing systems may include 3-D printing shown in FIGS. 4A and 4B. In particular, with reference to FIG. 4A, in one embodiment the printing system 44 may extrude one or more rows 70 into the erosion zone 30. As shown, multiple rows 70 may be stacked side-to-side to fill in an area within the erosion zone 30. Alternatively, or in addition to being stacked side-to-side, the rows 70 may be stacked vertically to form a repair layer 72. The repair layer 72 may ultimately form a new exterior surface of the leading edge 24 of the wind turbine blade 22.
