(10) **Patent No.:** **US 11,174,043 B1**
(45) **Date of Patent:** **Nov. 16, 2021**

(54) **SYSTEMS AND METHODS FOR THRUST REVERSER CORROSION DAMAGE REPAIR**

- (71) Applicant: **Nextant Aerospace**, Cleveland, OH (US)
- (72) Inventor: **Mark O'Donnell**, Cleveland, OH (US)
- (73) Assignee: **Nextant Aerospace**, Cleveland, OH (US)
- (*) Notice: Subject to any disclaimer, the term of this patent is extended or adjusted under 35 U.S.C. 154(b) by 0 days.

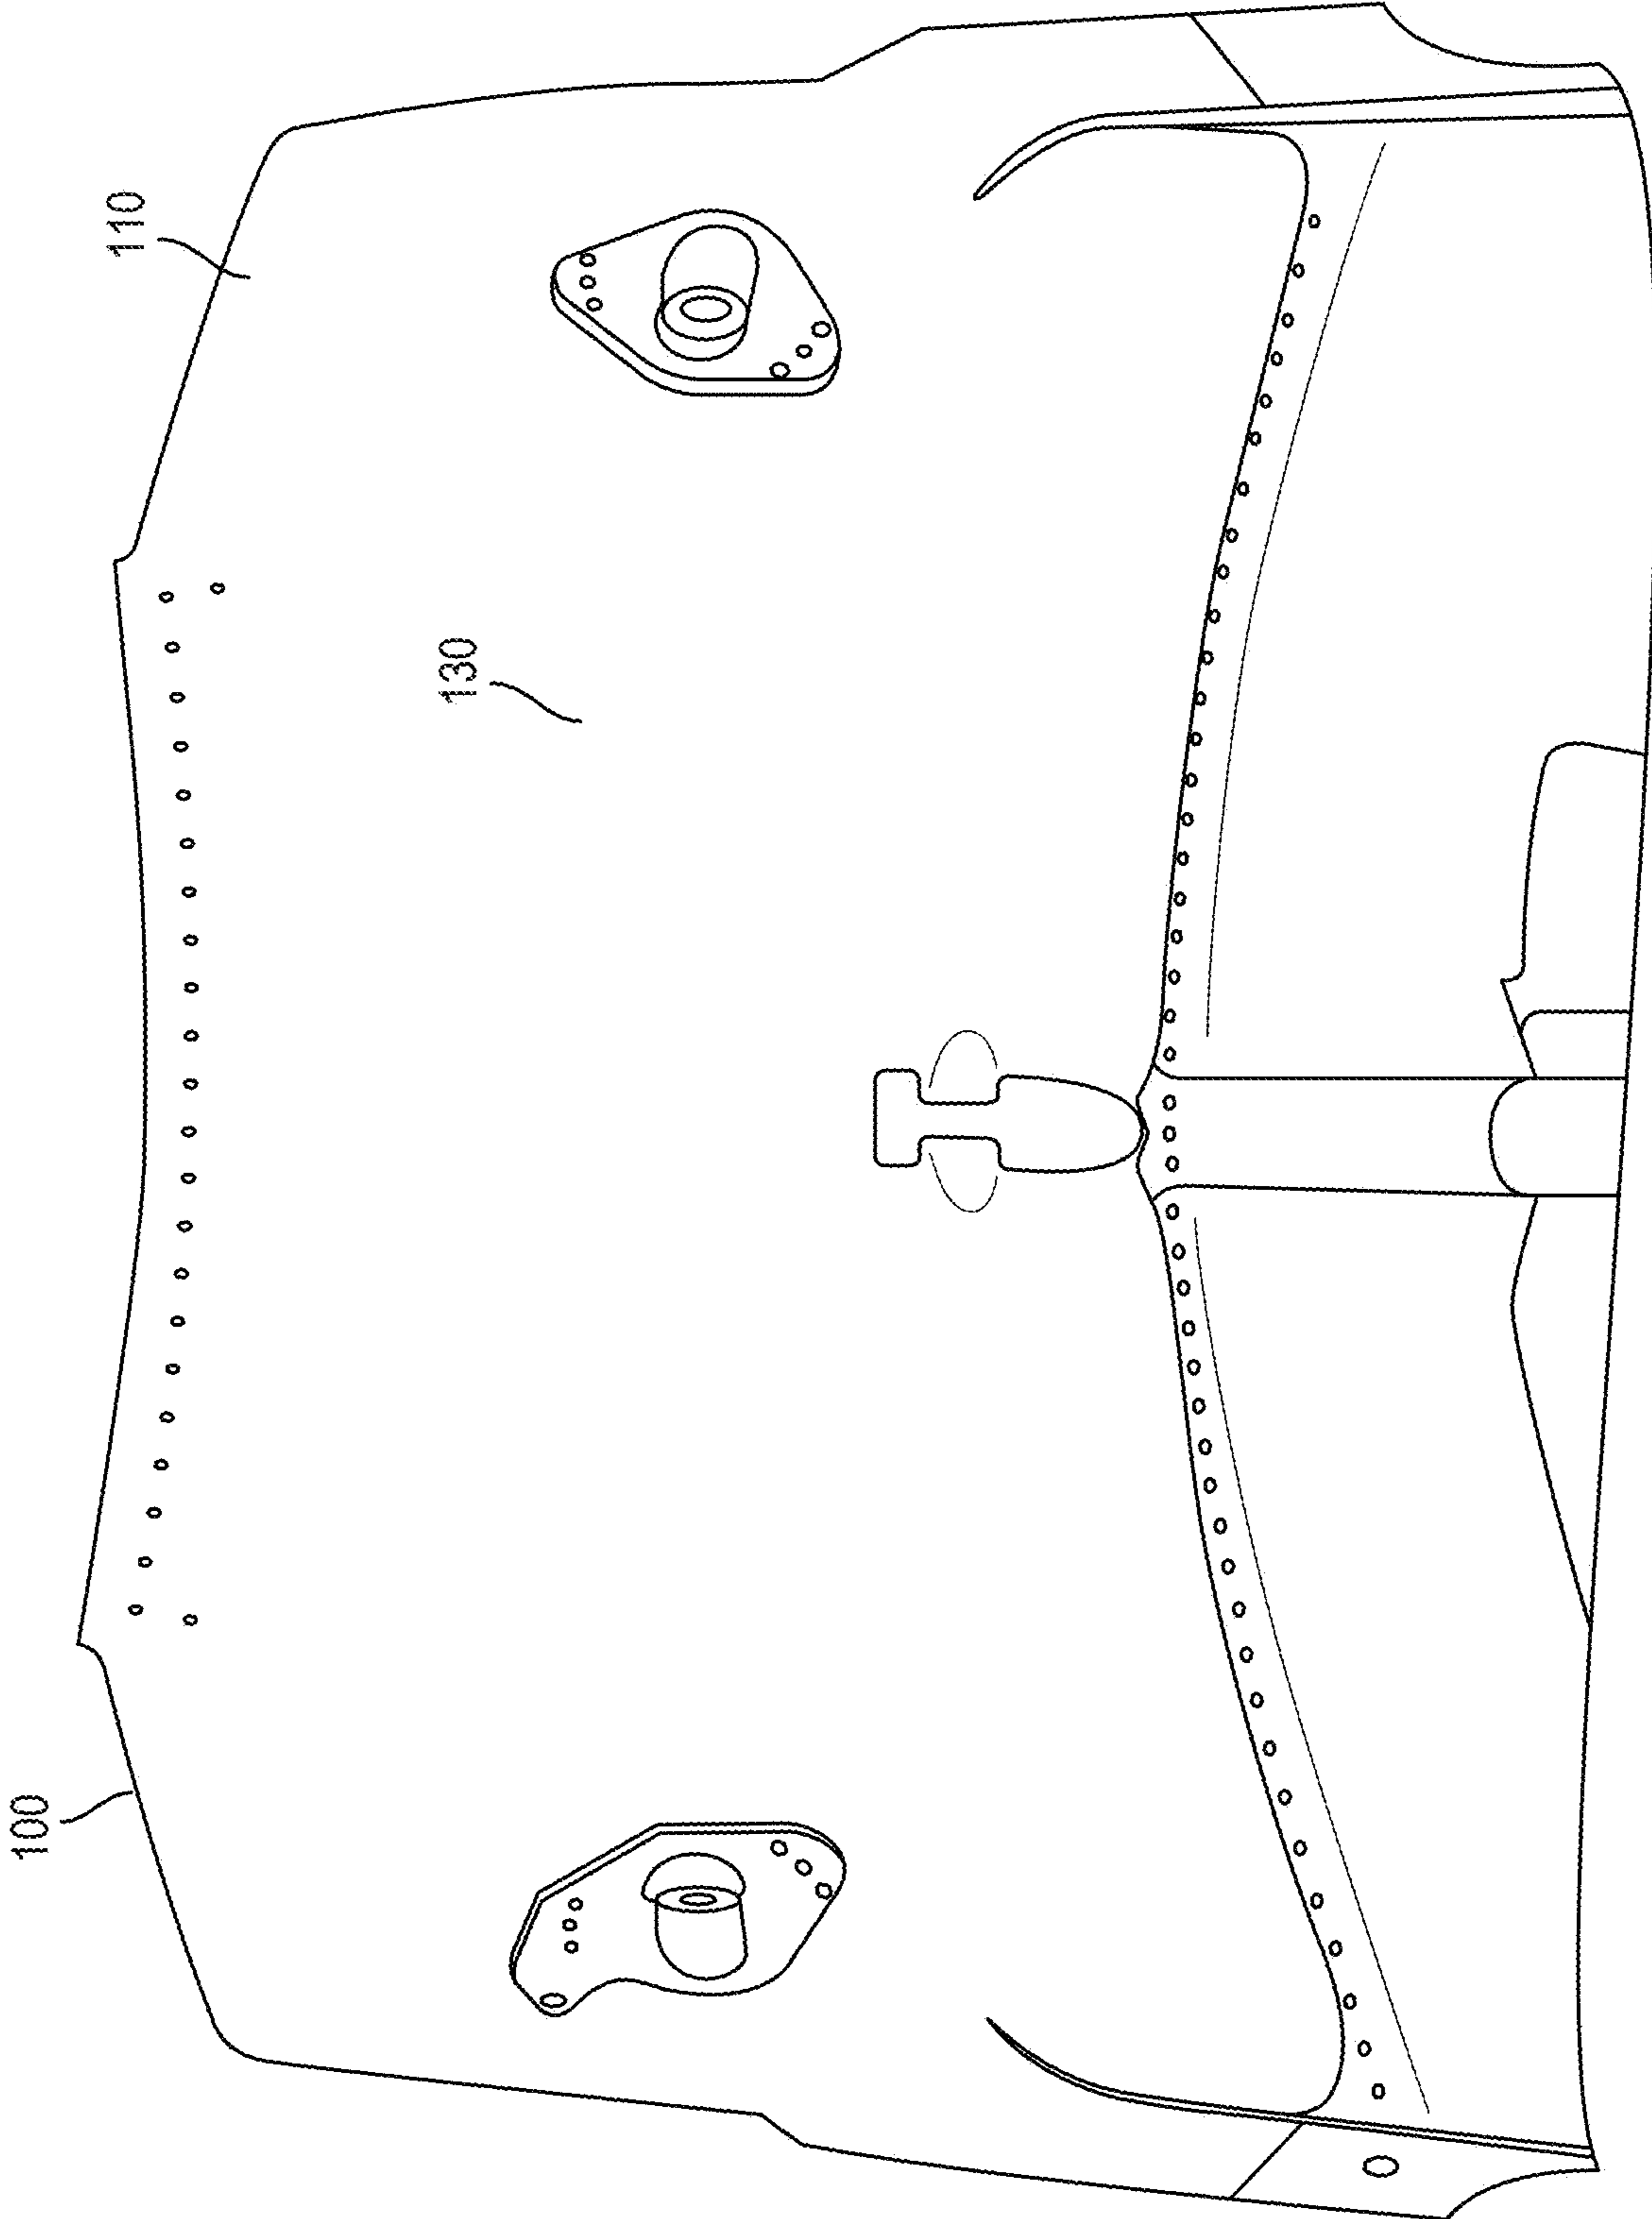
40 FIG. 1 is an isometric view of an exemplary part of a thrust reverser assembly, according to an embodiment of the invention.

Referring to FIGS. 1 and 2, a part 100 of a thrust reverser assembly is illustrated. For example, in some embodiments, the part 100 is one of an upper door assembly or a lower door assembly. In other embodiments, part 100 can be a machined component having corrosion damage. The part can include an inner surface 110 and an outer surface 120. The inner surface 110 and the outer surface 120 can include an outer skin 130. In order to repair corrosion damage on an area of the part 100, the part 100 is initially removed from the rest of the thrust reverser assembly. After corrosion repair has been completed, the part 100 is installed back to the thrust reverser assembly. As shown in relation to FIGS. 3A-3B, the area of the part 100 that has suffered from corrosion damage can be repaired by adding a stainless steel skin to the part 100 and sandwiching synthetic fiber material between the new skin and the part 100 to provide protection against dissimilar metal corrosion. In some embodiments, the synthetic fiber material includes Kevlar. Kevlar® is a registered trademark of DuPont de Nemours, Inc., and is DuPont's brand name for its synthetic fiber material.

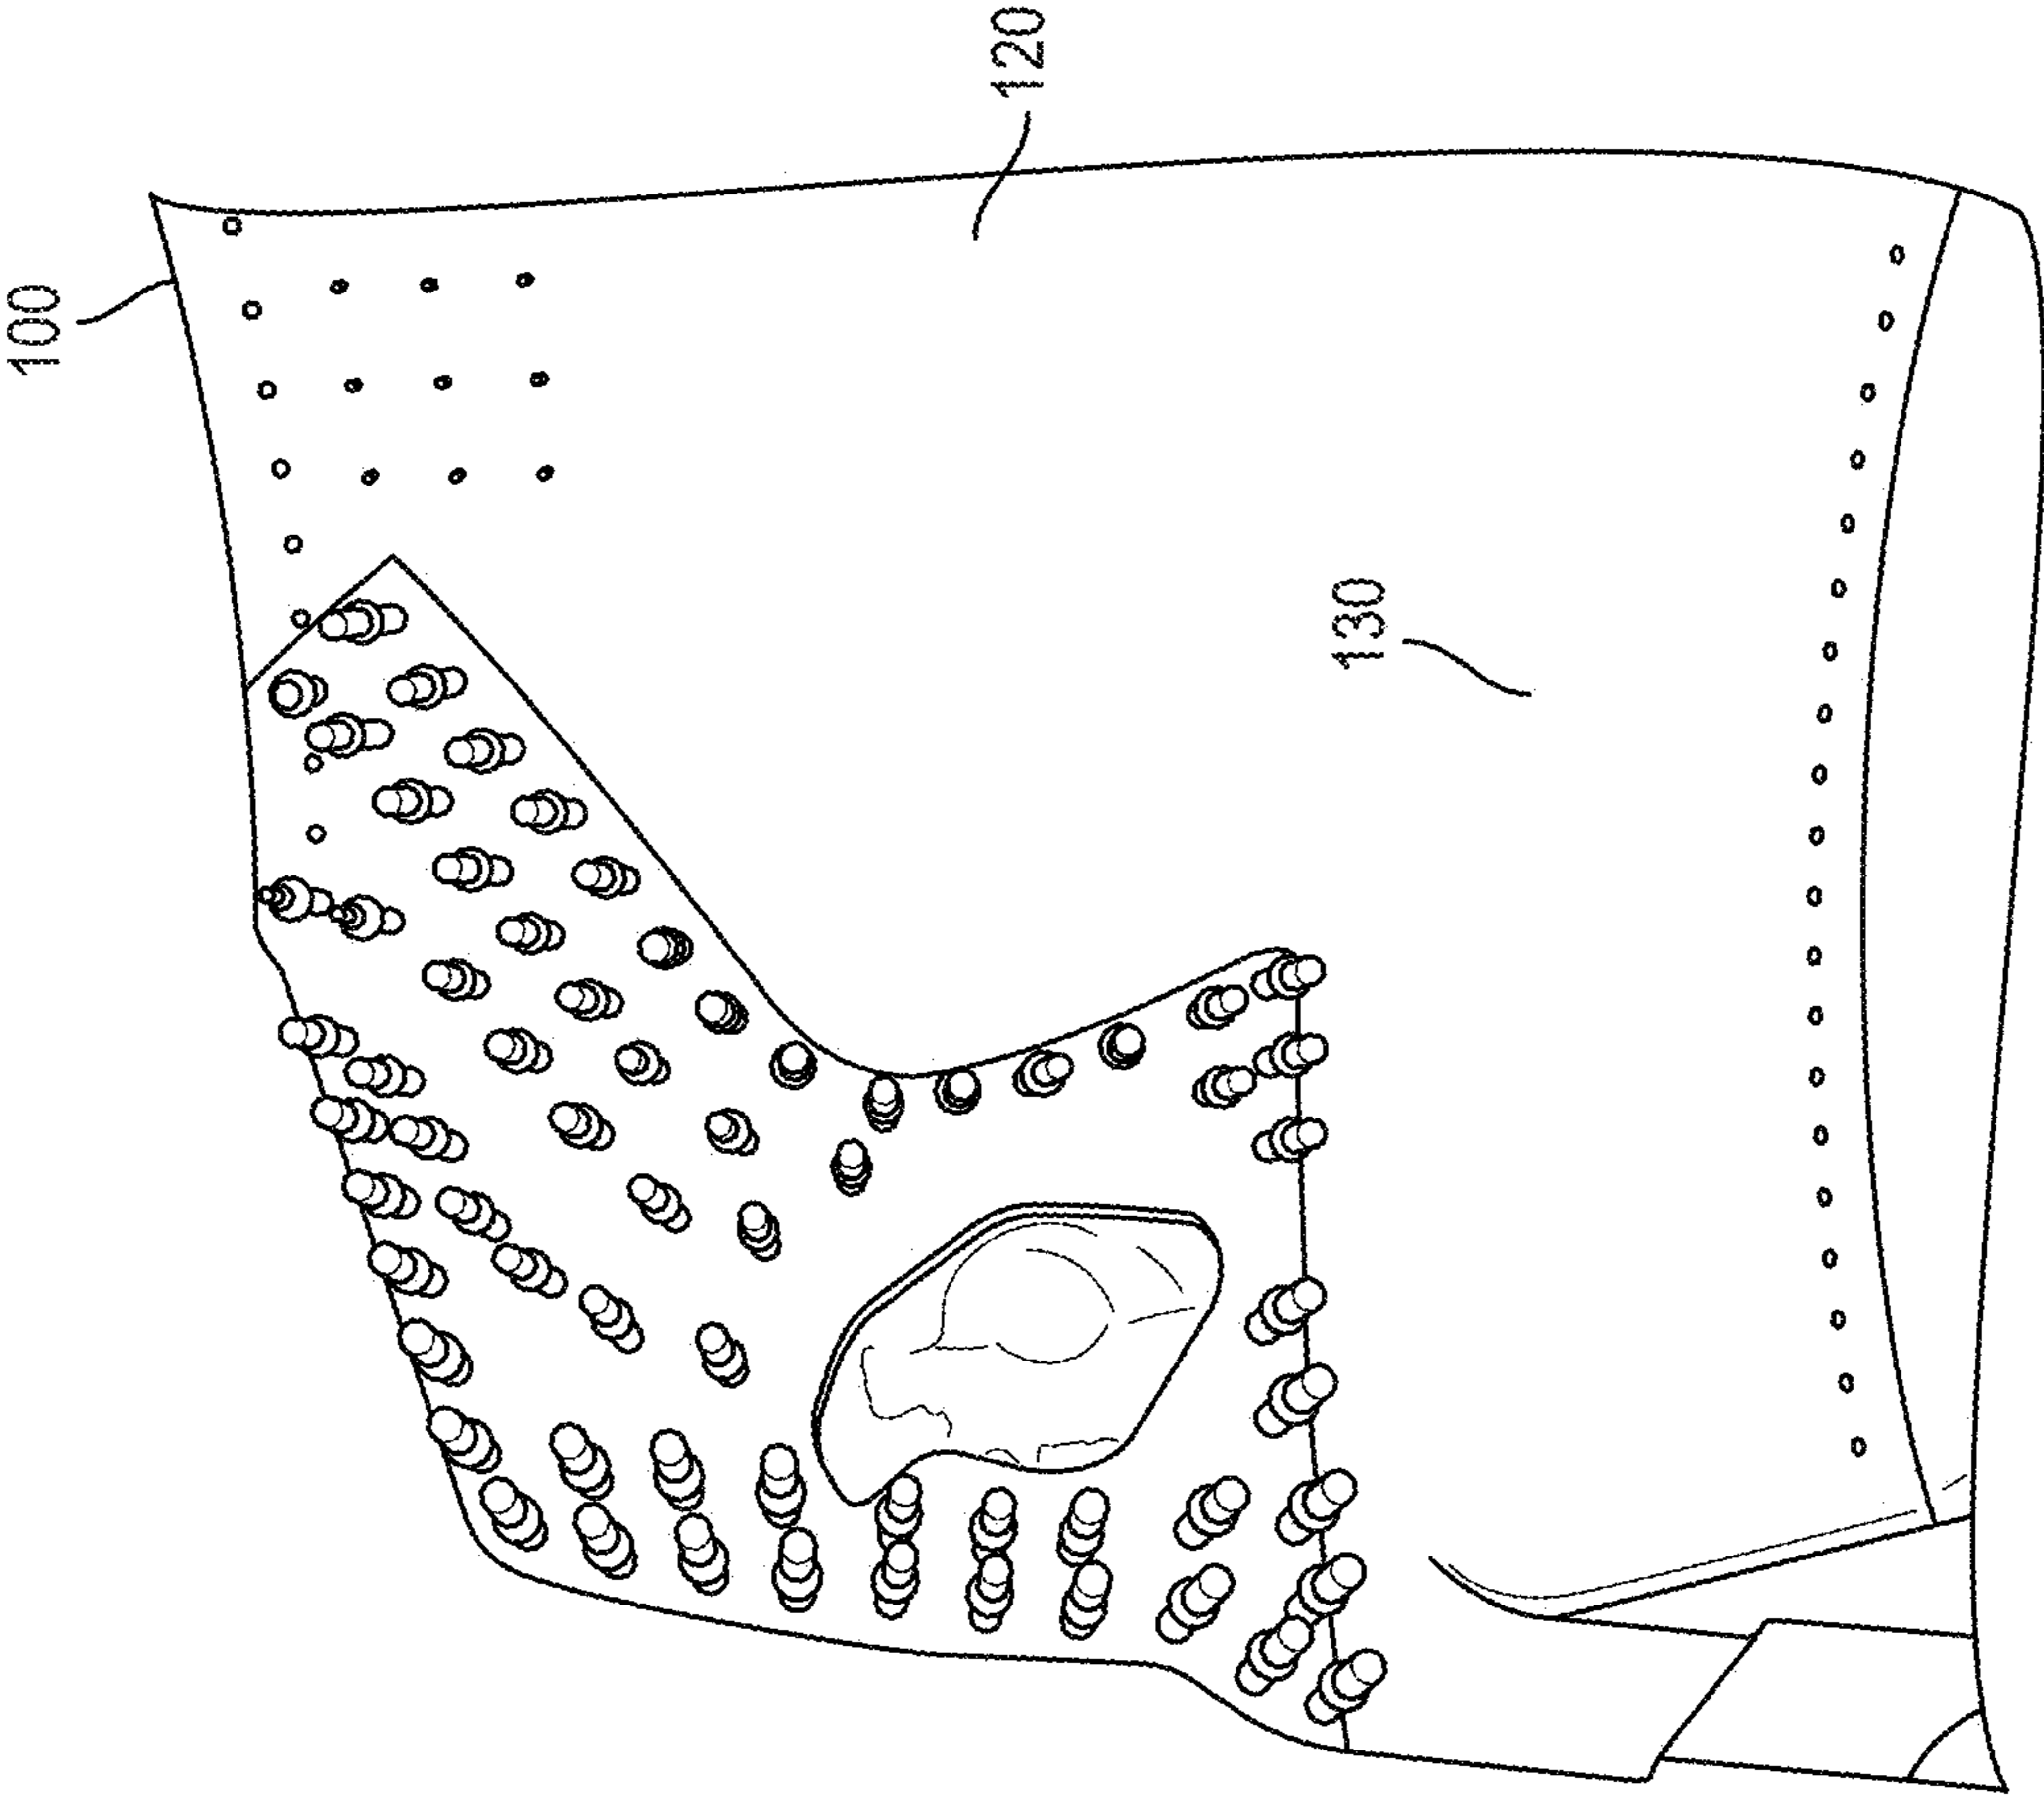
45 FIG. 2 is an isometric view of an exemplary part of a thrust reverser assembly, according to an embodiment of the invention.

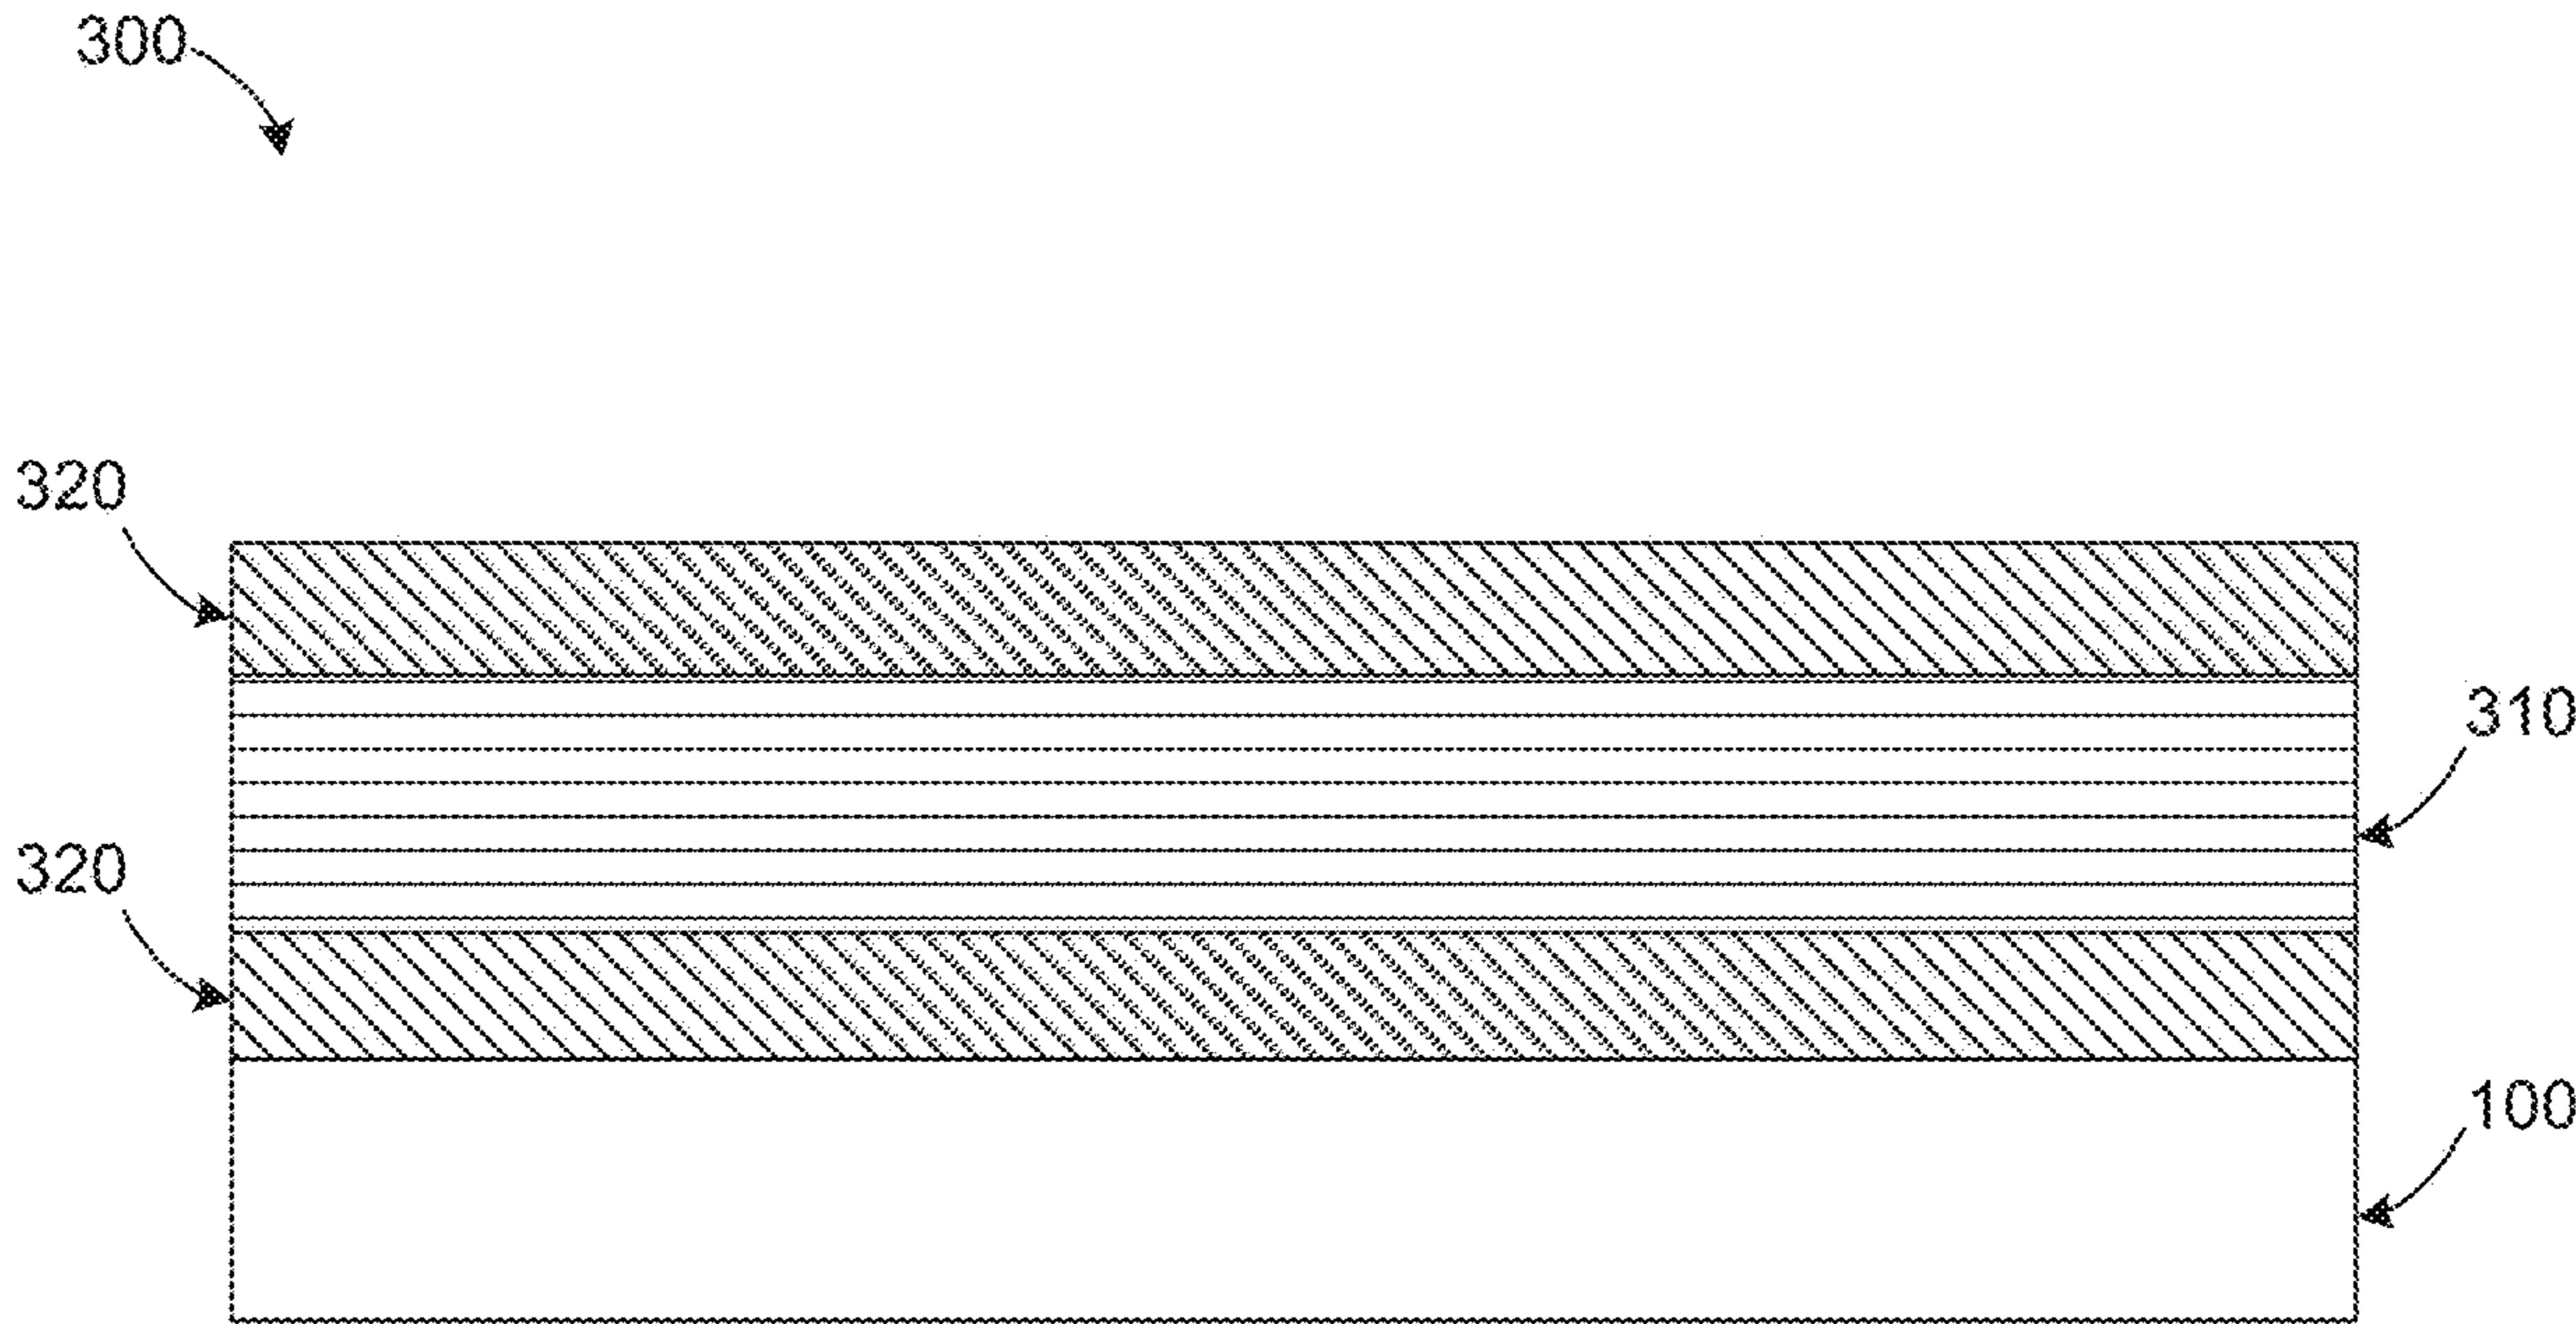
FIG. 3A is a cross-section view of an exemplary part of a thrust reverser assembly, according to an embodiment of the invention.

Before repairing the corrosion damage on the area of the part 100, the outer skin 130 is removed from the inner surface 110 and the outer surface 120. Referring to FIGS. 3A-3B, a cross-section 300 of an embodiment of part 100 after removal of the outer skin 130 is illustrated. A ply of synthetic fiber material 310 is installed onto an area of the inner surface 110 or the outer surface 120 of the part 100. The location of the installation of the ply of synthetic fiber material 310 depends on the location of the damaged area. In some embodiments, the location of the damaged area is determined during inspection of the part 100. Once installed, the ply of synthetic fiber material 310 is sandwiched between a layer of film adhesive 320 on each side of the ply of synthetic fiber material 310. In some embodiments, the synthetic fiber material includes one of a Plain Weave Kevlar or a 4-Harness Kevlar. In some embodiments, film adhesive 320 includes a 3M Scotch-Weld Structural adhesive film. AF 163 2k 0.06 is a modified epoxy structural adhesive in film form.

As mentioned during the discussion of FIGS. 1 and 2, one or more doublers can be installed onto the ply of synthetic fiber material 310 in order to provide protection against metal corrosion. In some embodiments, the one or more doublers are stainless steel. In other embodiments, the one or more doublers include another type of steel or aluminum. For example, in some embodiments, the one or more doublers 330 are installed using rivets. In some embodiments, the one or more doublers 330 are clamped onto the part 100, locations for doubler holes are identified, and the locations for doubler holes are reamed. Once the ply of synthetic fiber material 310 has been installed, the layers of film adhesive 320 can be heat cured. For example, in some embodiments, heat curing the layers of film adhesive 320 includes ramping up a temperature of the film adhesive 320 up to 250 degrees F., dwelling at the temperature of 250 degrees F. for an hour, and ramping down the temperature of the film adhesive 320 to a room temperature.

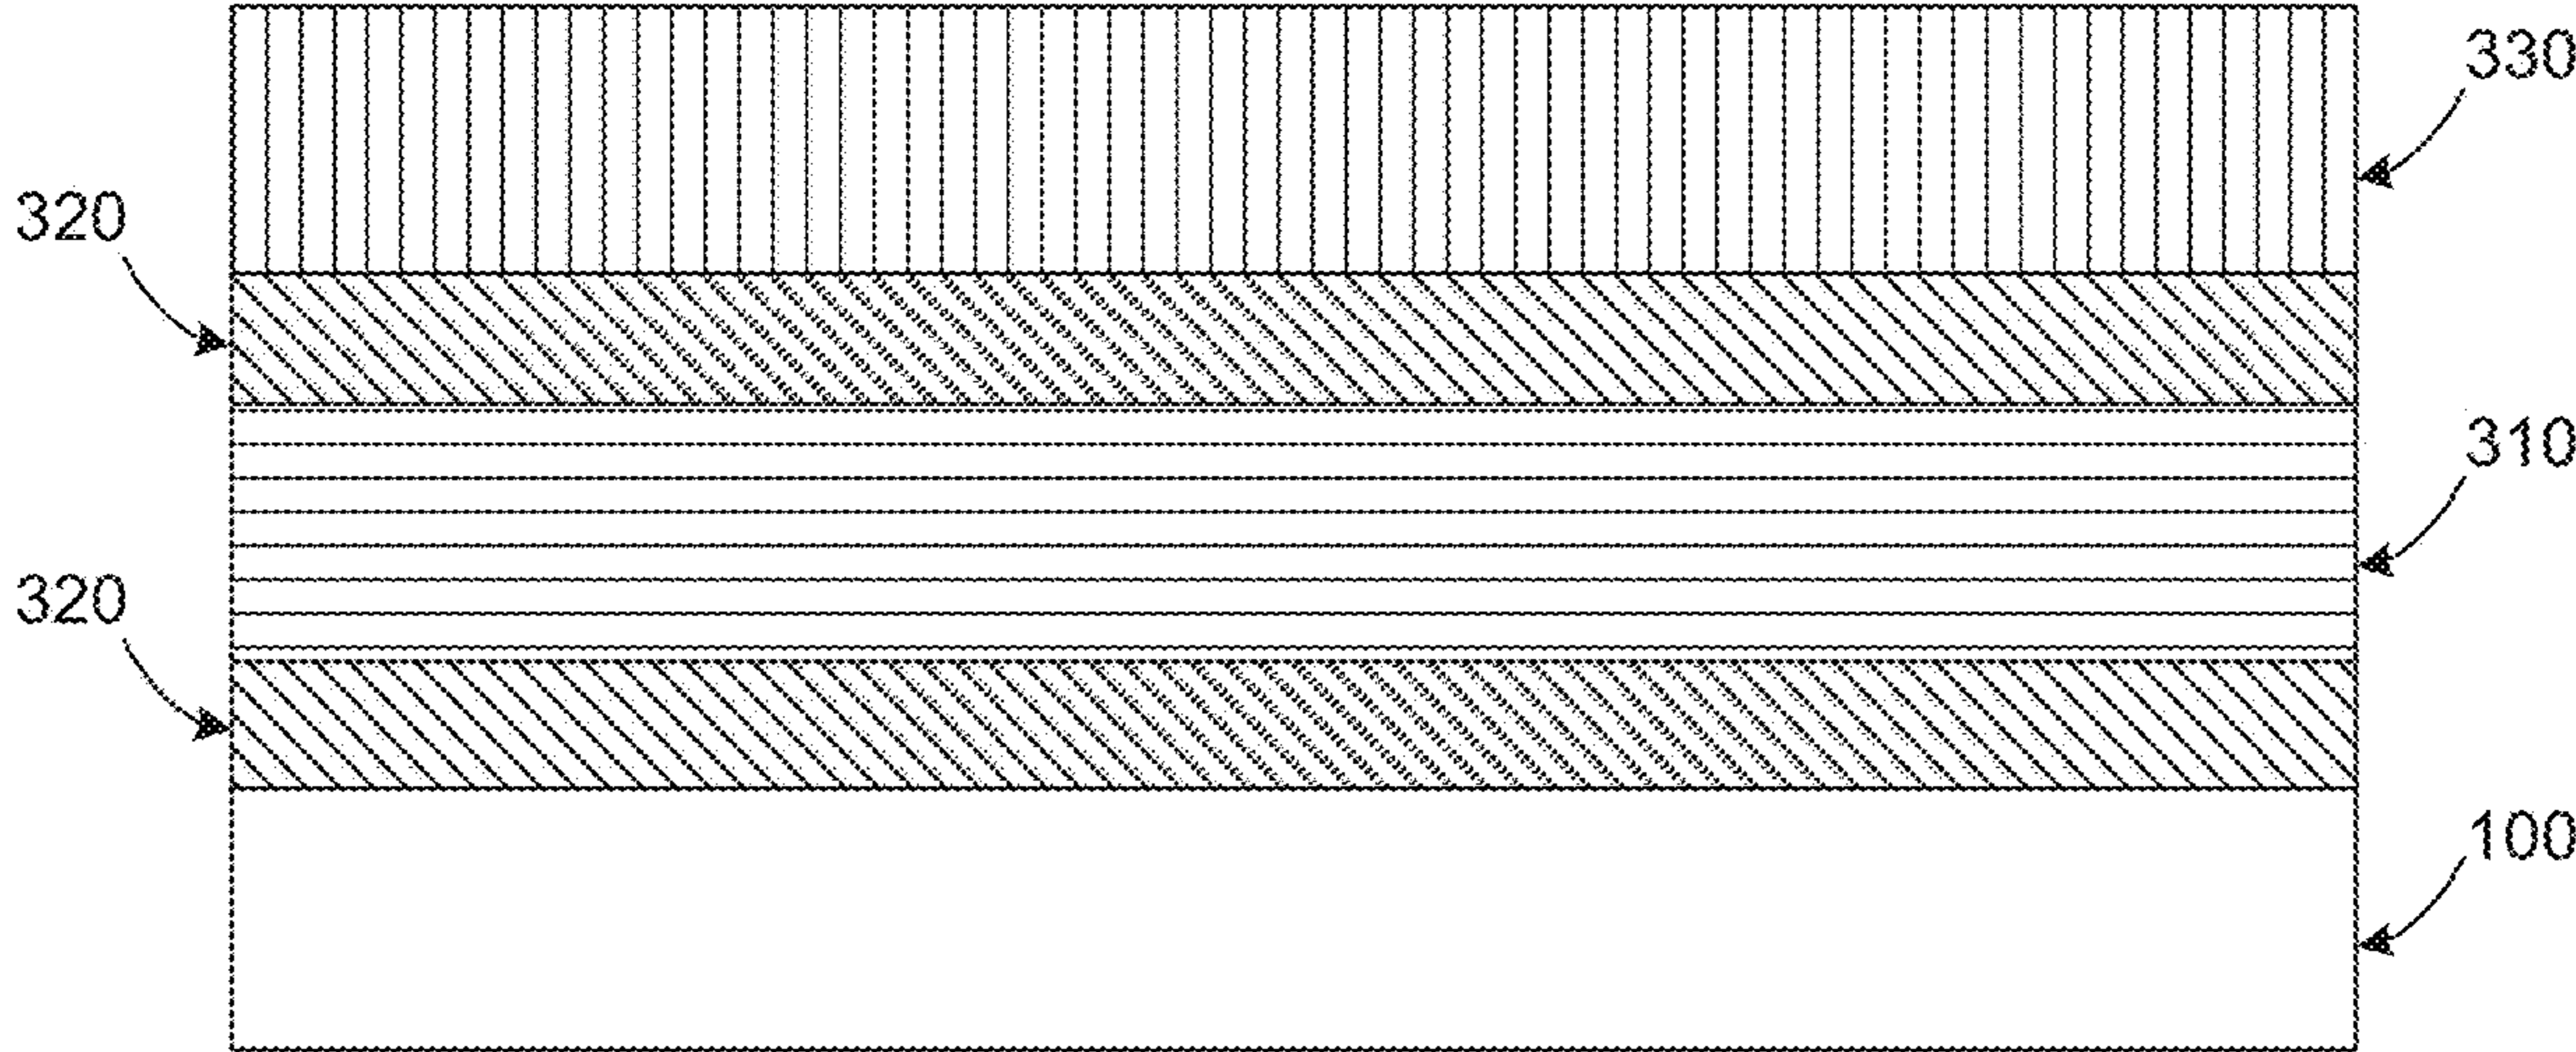
50 FIG. 3B is a cross-section view of an exemplary part of a thrust reverser assembly, according to an embodiment of the invention.

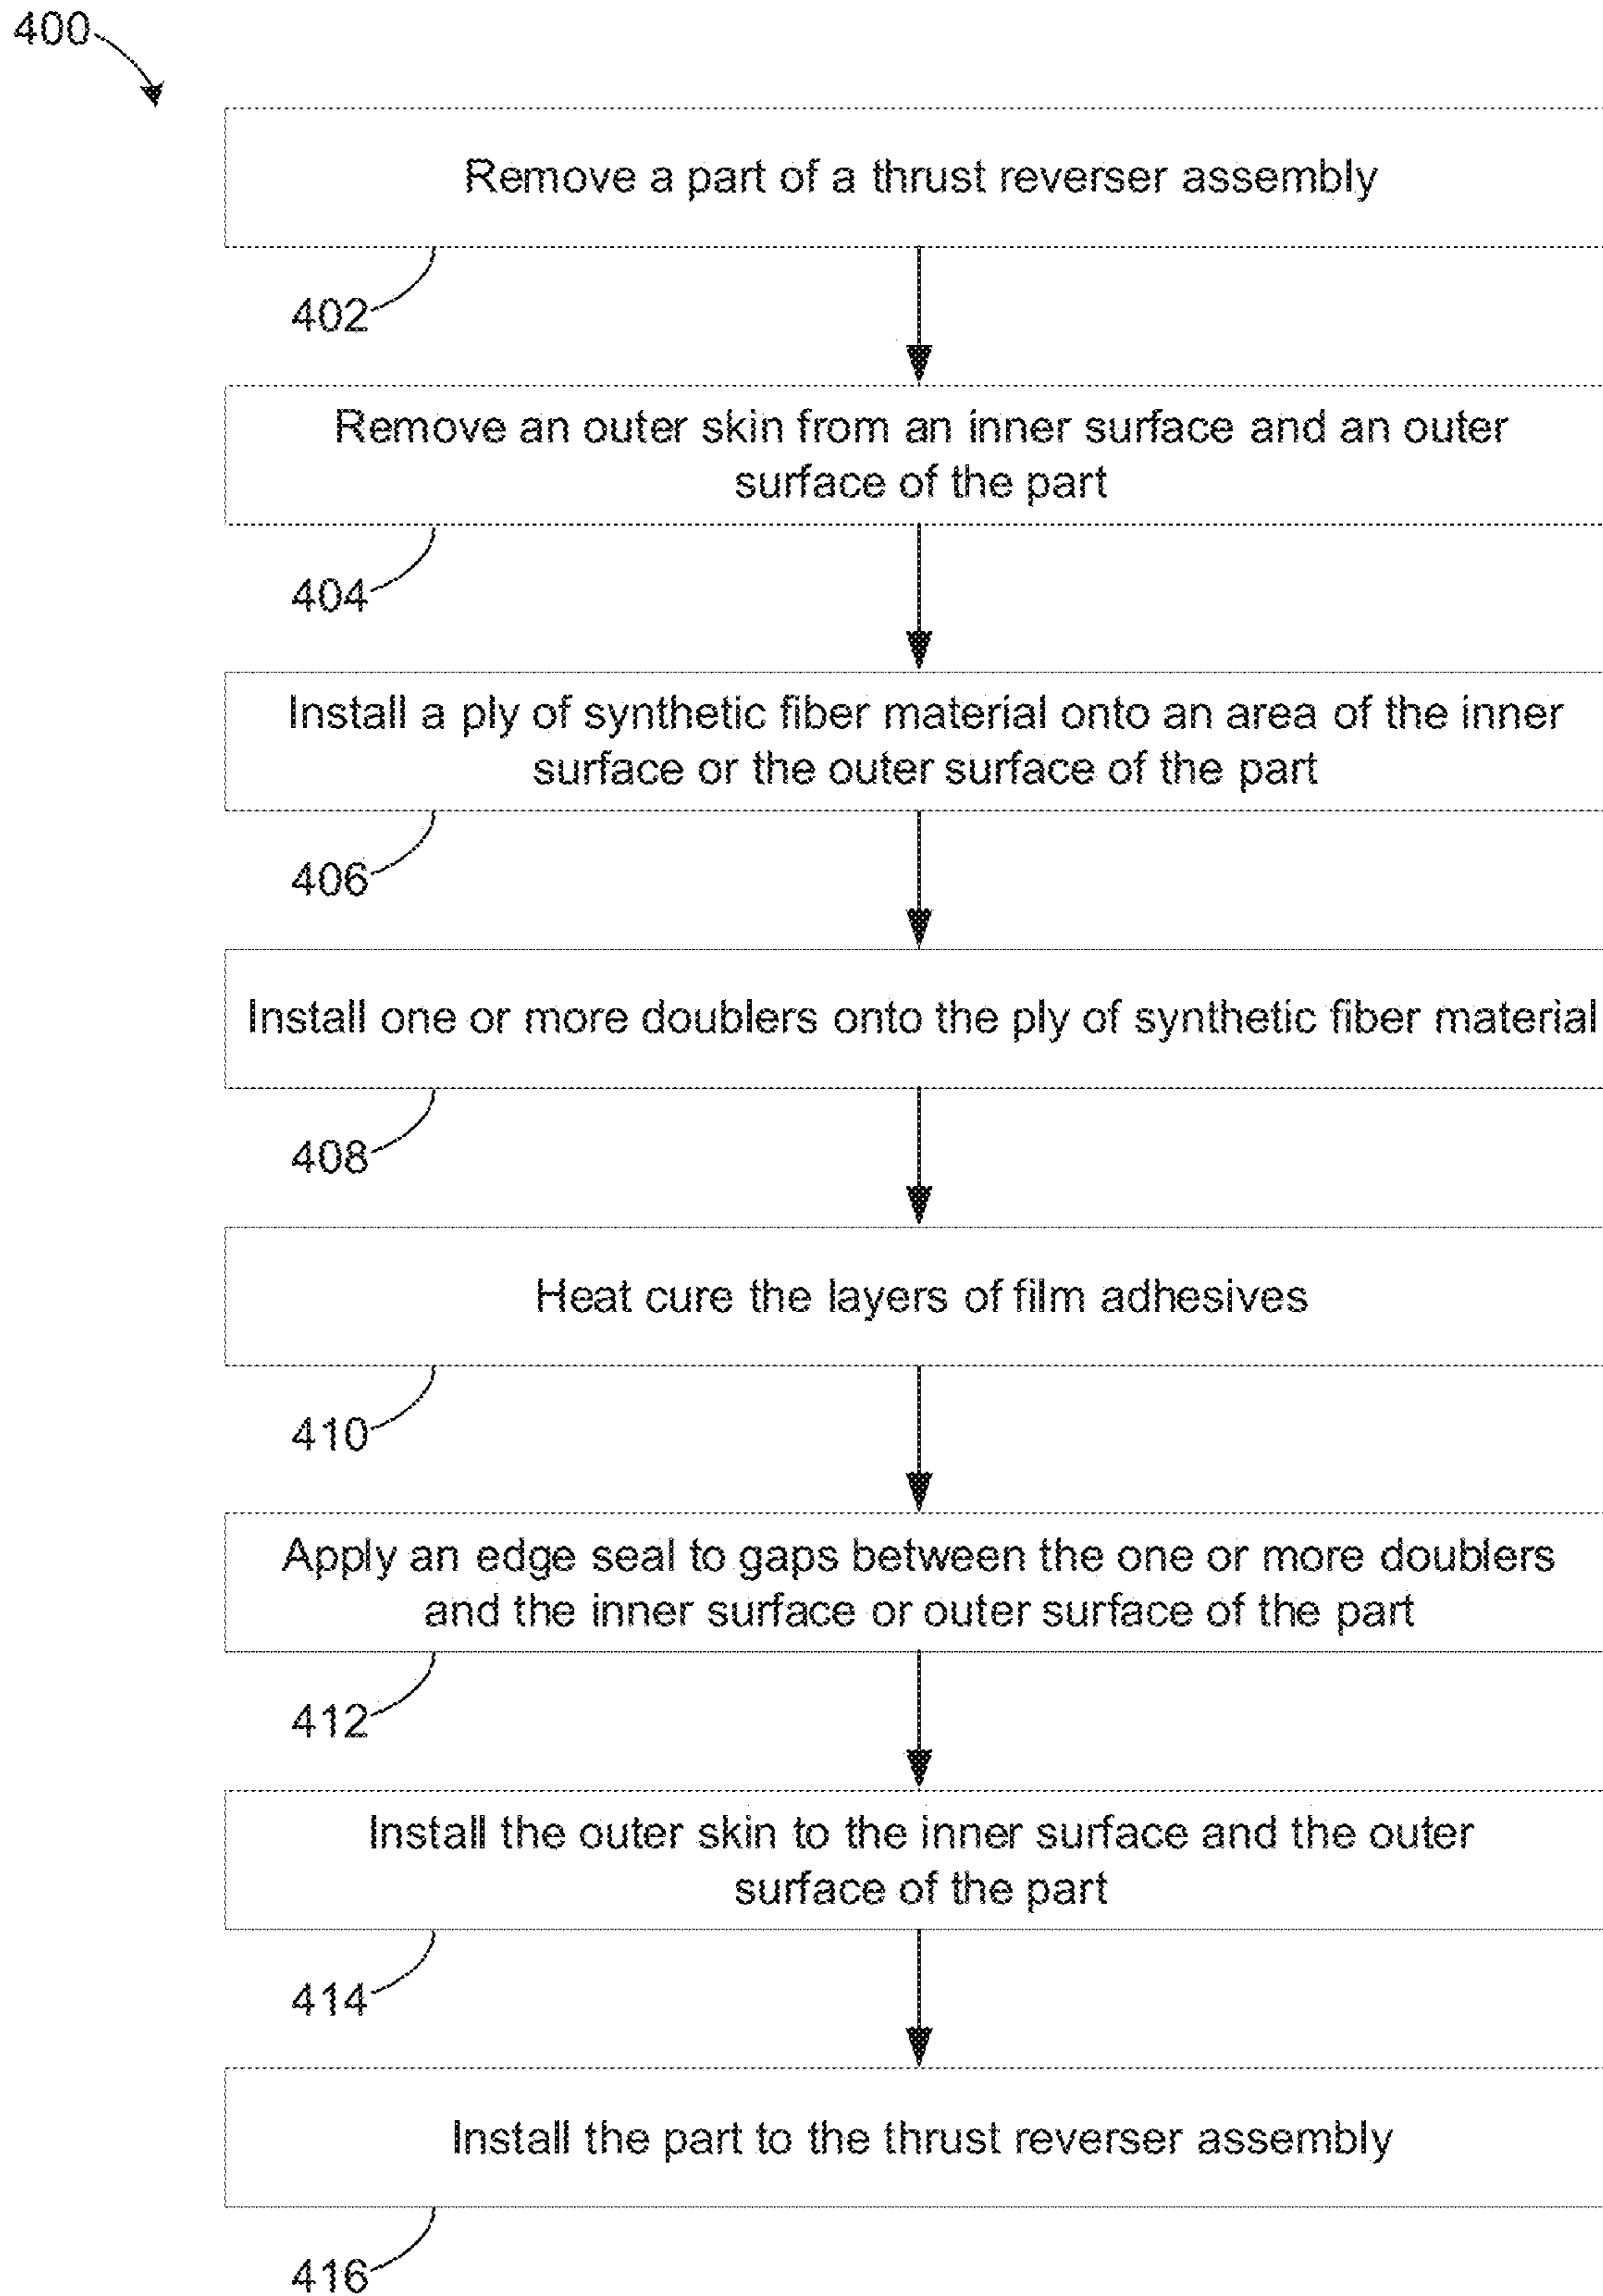
FIG. 4 is a flow diagram of method steps for repairing corrosion damage of a part of a thrust reverser assembly, according to an embodiment of the invention.

Referring to FIG. 4, a process 400 for repairing corrosion damage of a part 100 of a thrust reverser assembly is illustrated. As described in relation to FIGS. 1 and 2, the part 100 can include an inner surface 110 and an outer surface 120. The process 400 begins by removing the part 100 of the thrust reverser assembly in step 402. For example, in some embodiments, the part 100 is one of an upper door assembly or a lower door assembly. Process 400 continues by removing an outer skin 130 from the inner surface 110 and the outer surface 120 of the part 100 in step 404.

Process 400 continues by installing a ply of synthetic fiber material 310 onto an area of the inner surface 110 or the outer surface 120 of the part 100 in step 406. In some embodiments, the area includes corrosion damage. Once installed, the ply of synthetic fiber material 310 is sandwiched between a layer of film adhesive 320 on each side of the ply of synthetic fiber material 310. For example, in some embodiments, the synthetic fiber material includes one of a Plain Weave Kevlar or a 4-Harness Kevlar.

Process 400 continues by installing one or more doublers 330 onto the ply of synthetic fiber material 310 in step 408. For example, in some embodiments, the one or more doublers 330 are installed using rivets. In some embodiments, process 400 includes clamping the one or more doublers 330 onto the part 100, identifying locations for doubler holes, and reaming the locations for doubler holes.

Process 400 continues by heat curing the layers of film adhesive 320 in step 410. For example, in some embodiments, heat curing the layers of film adhesive 320 includes ramping up a temperature of the film adhesive 320 up to 250 degrees F., dwelling at the temperature of 250 degrees F. for an hour, and ramping down the temperature of the film adhesive 320 to a room temperature.

Process 400 continues by applying an edge seal to gaps between the one or more doublers 330 and the inner surface 110 or outer surface 120 of the part 100 in step 412. For example, in some embodiments, the edge seal includes a resin. In some embodiments, process 400 includes heat curing the edge seal resin. In some embodiments, process 400 includes sanding an excess of edge seal resin.

Process 400 continues by installing the outer skin 130 to the inner surface 110 and the outer surface 120 of the part 100 in step 414. Process 400 finishes by installing the part 100 to the thrust reverser assembly in step 416. In some embodiments, process 400 includes painting a topcoat to the inner surface 110 and the outer surface 120 of the part 100.
