(10) **Patent No.:** **US 11,174,043 B1**
(45) **Date of Patent:** **Nov. 16, 2021**

(54) **SYSTEMS AND METHODS FOR THRUST REVERSER CORROSION DAMAGE REPAIR**

- (71) Applicant: **Nextant Aerospace**, Cleveland, OH (US)
- (72) Inventor: **Mark O'Donnell**, Cleveland, OH (US)
- (73) Assignee: **Nextant Aerospace**, Cleveland, OH (US)
- (*) Notice: Subject to any disclaimer, the term of this patent is extended or adjusted under 35 U.S.C. 154(b) by 0 days.

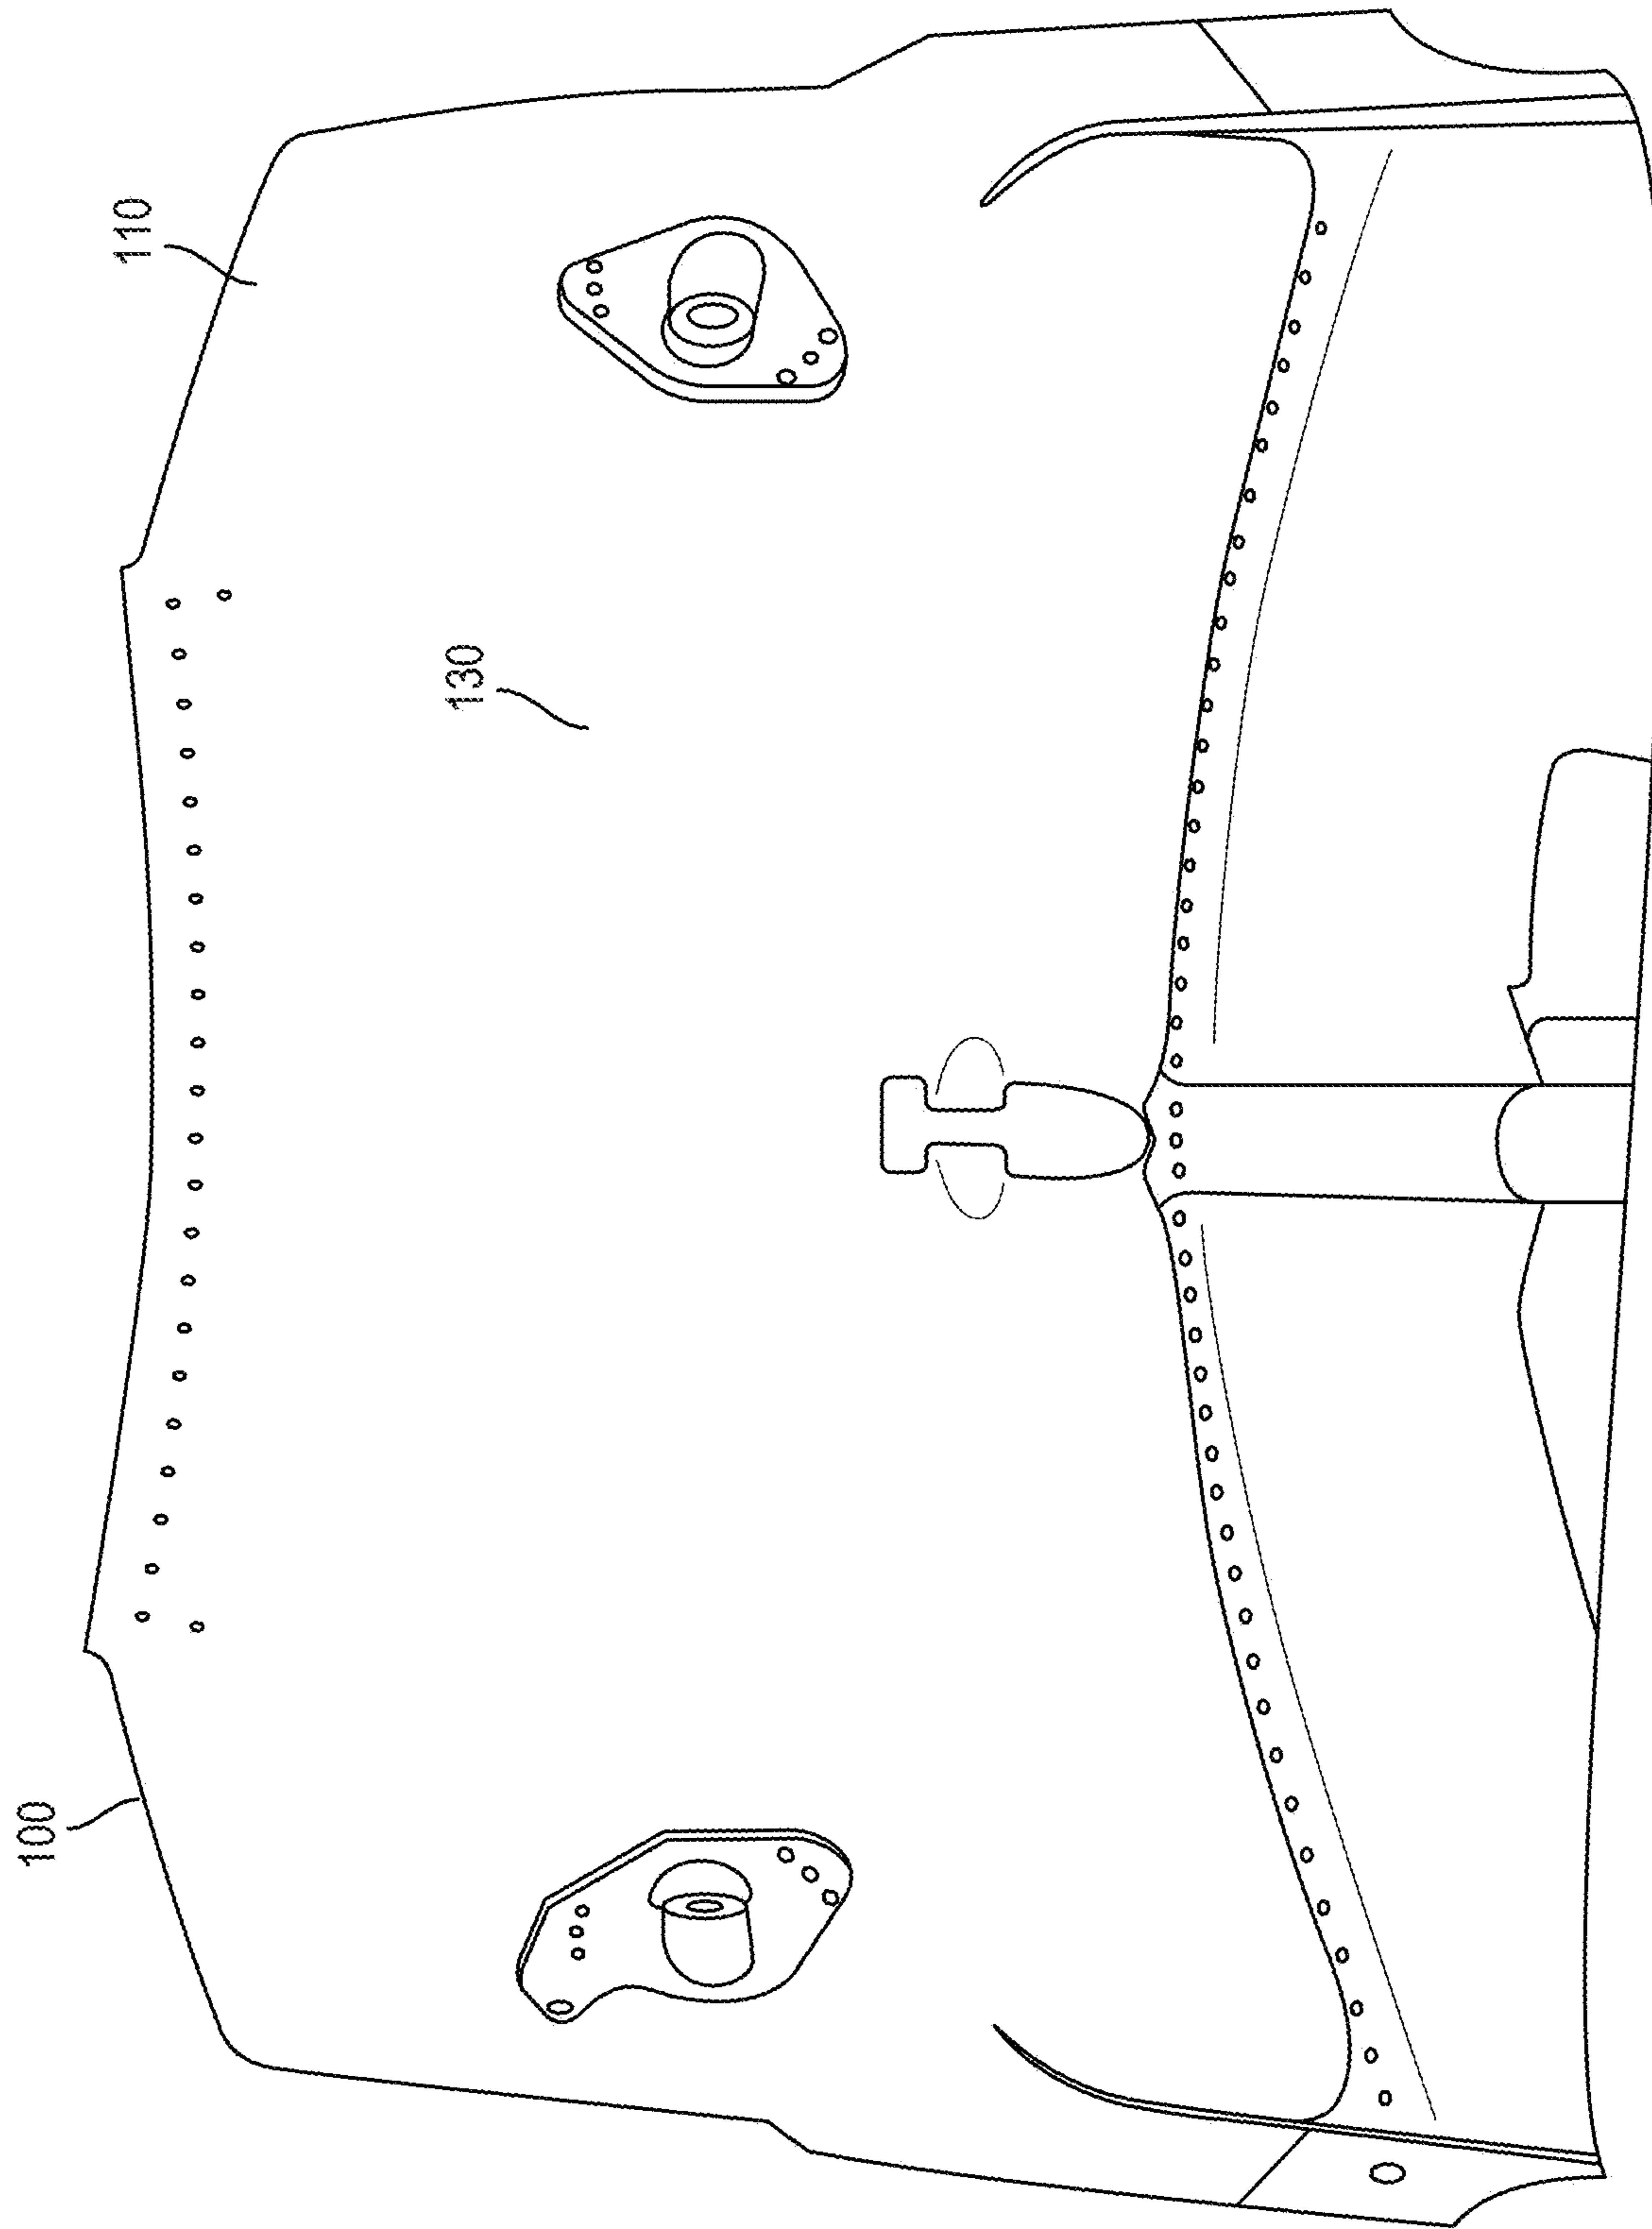
40 FIG. 1 is an isometric view of an exemplary part of a thrust reverser assembly, according to an embodiment of the invention.

Referring to FIGS. 1 and 2, a part 100 of a thrust reverser assembly is illustrated. For example, in some embodiments, the part 100 is one of an upper door assembly or a lower door assembly. In other embodiments, part 100 can be a machined component having corrosion damage. The part can include an inner surface 110 and an outer surface 120. The inner surface 110 and the outer surface 120 can include an outer skin 130. In order to repair corrosion damage on an area of the part 100, the part 100 is initially removed from the rest of the thrust reverser assembly. After corrosion repair has been completed, the part 100 is installed back to the thrust reverser assembly. As shown in relation to FIGS. 3A-3B, the area of the part 100 that has suffered from corrosion damage can be repaired by adding a stainless steel skin to the part 100 and sandwiching synthetic fiber material between the new skin and the part 100 to provide protection against dissimilar metal corrosion. In some embodiments, the synthetic fiber material includes Kevlar. Kevlar® is a registered trademark of DuPont de Nemours, Inc., and is DuPont's brand name for its synthetic fiber material.

As mentioned during the discussion of FIGS. 1 and 2, one or more doublers can be installed onto the ply of synthetic fiber material 310 in order to provide protection against metal corrosion. In some embodiments, the one or more doublers are stainless steel. In other embodiments, the one or more doublers include another type of steel or aluminum. For example, in some embodiments, the one or more doublers 330 are installed using rivets. In some embodiments, the one or more doublers 330 are clamped onto the part 100, locations for doubler holes are identified, and the locations for doubler holes are reamed. Once the ply of synthetic fiber material 310 has been installed, the layers of film adhesive 320 can be heat cured. For example, in some embodiments, heat curing the layers of film adhesive 320 includes ramping up a temperature of the film adhesive 320 up to 250 degrees F., dwelling at the temperature of 250 degrees F. for an hour, and ramping down the temperature of the film adhesive 320 to a room temperature.

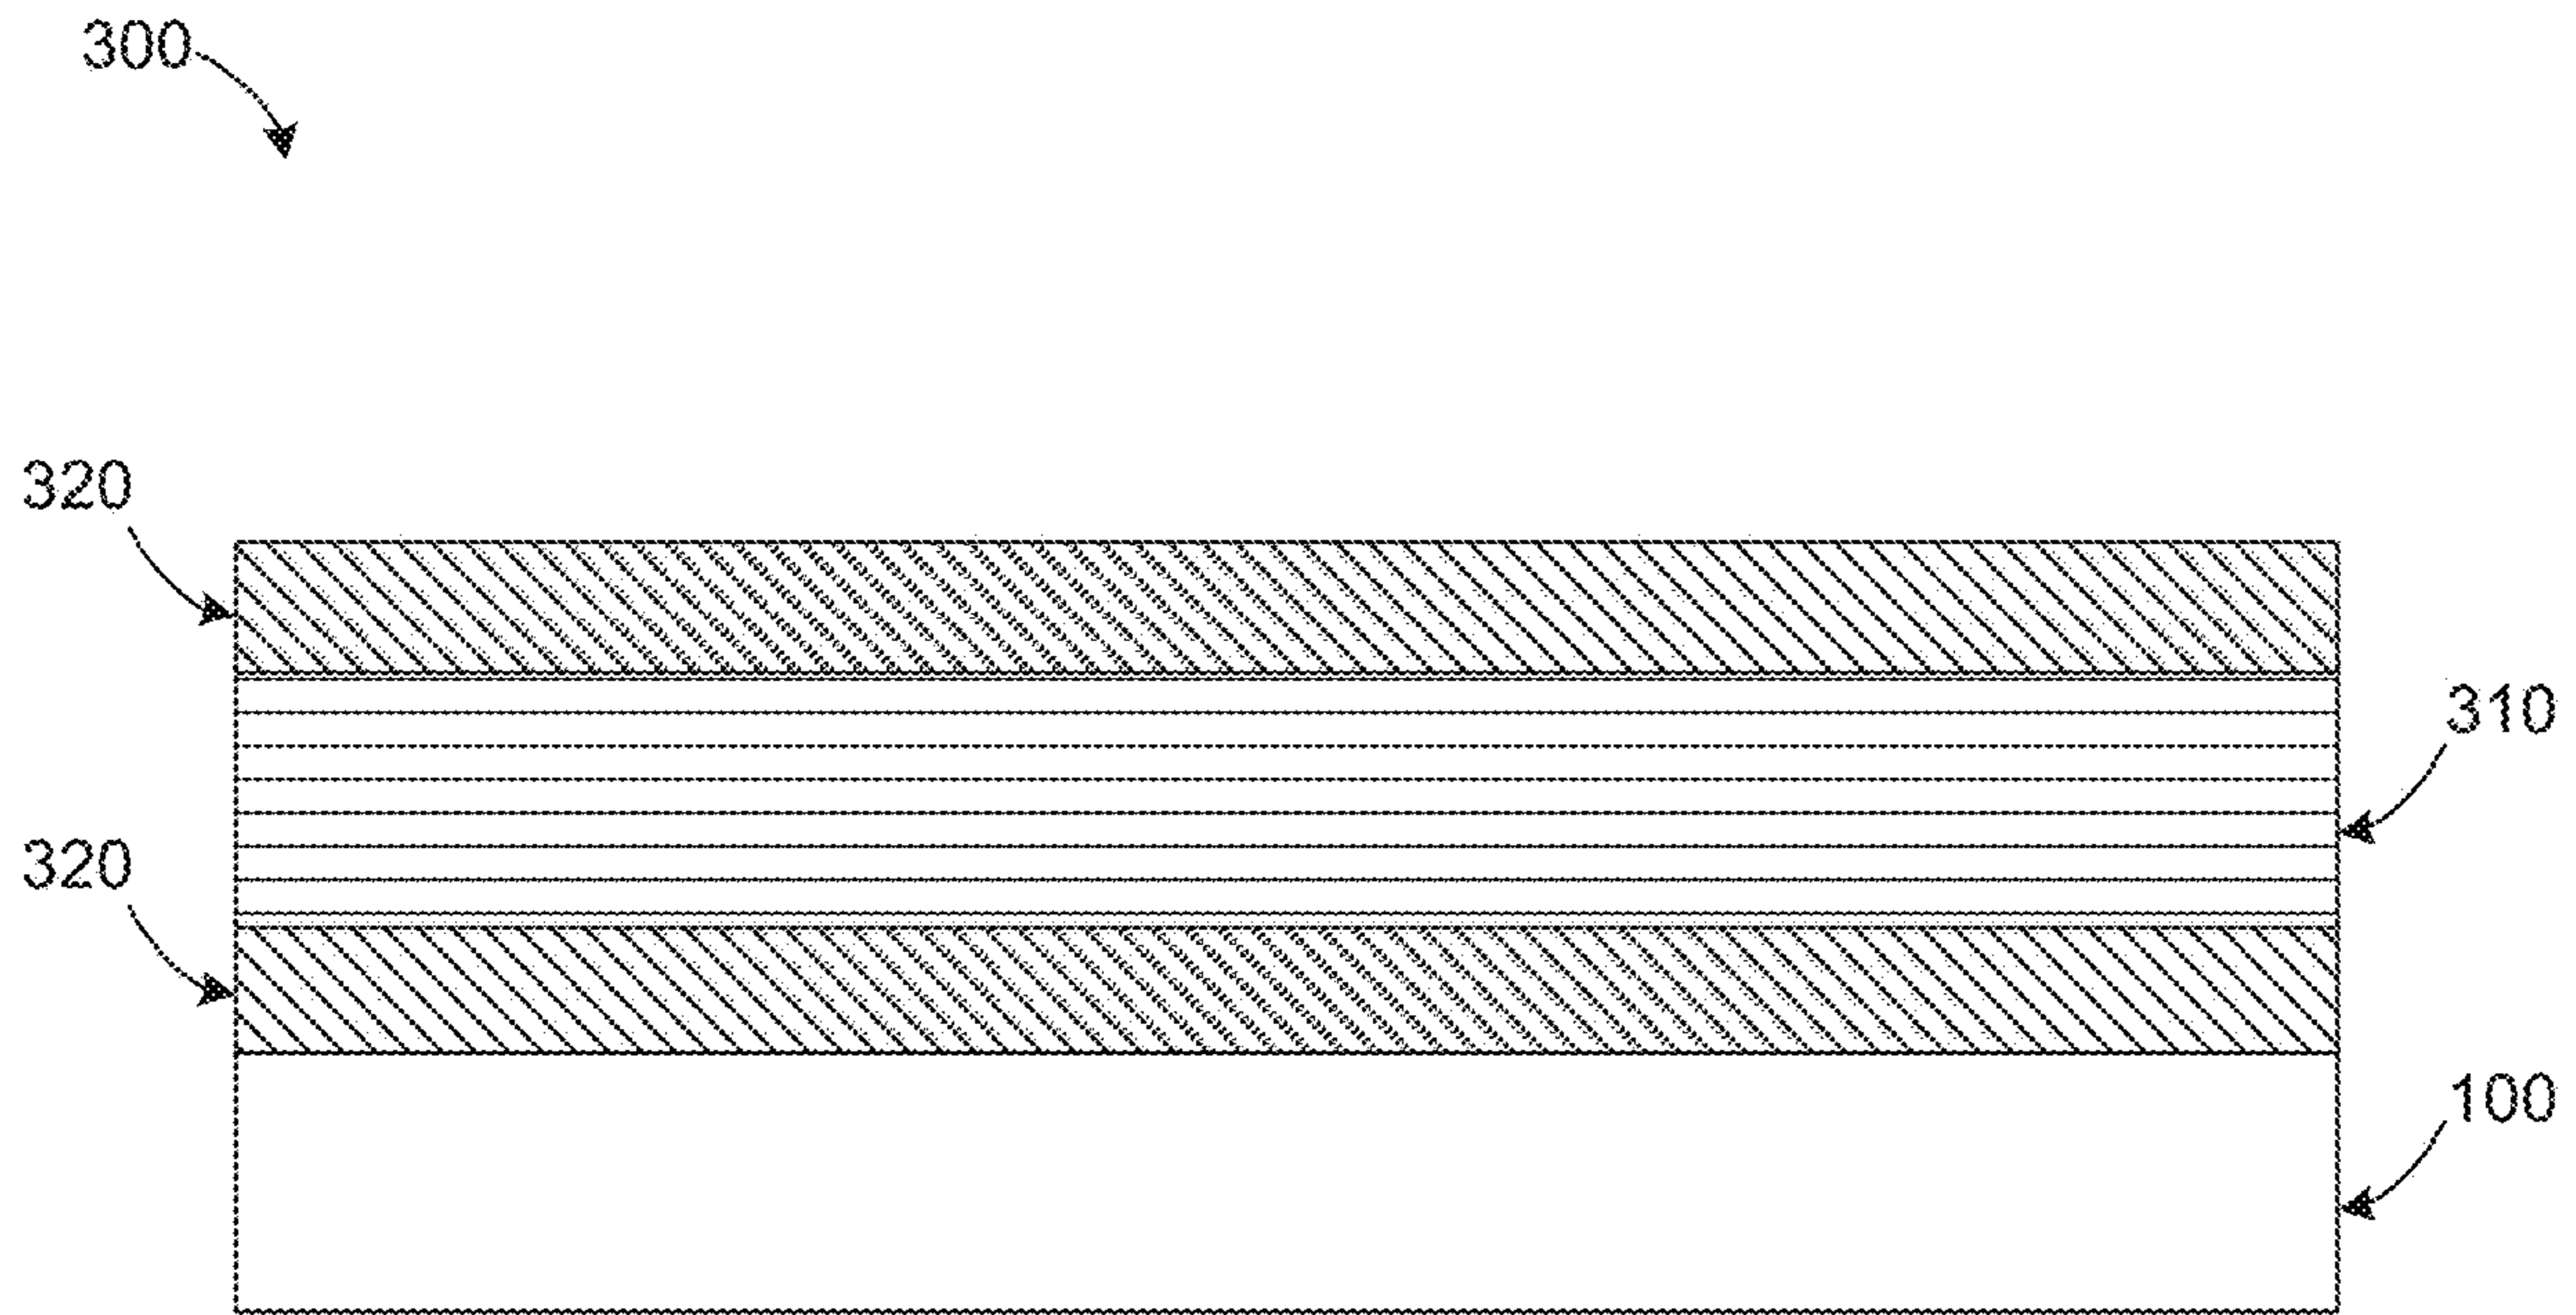
FIG. 3A is a cross-section view of an exemplary part of a thrust reverser assembly, according to an embodiment of the invention.

Before repairing the corrosion damage on the area of the part 100, the outer skin 130 is removed from the inner surface 110 and the outer surface 120. Referring to FIGS. 3A-3B, a cross-section 300 of an embodiment of part 100 after removal of the outer skin 130 is illustrated. A ply of synthetic fiber material 310 is installed onto an area of the inner surface 110 or the outer surface 120 of the part 100. The location of the installation of the ply of synthetic fiber material 310 depends on the location of the damaged area. In some embodiments, the location of the damaged area is determined during inspection of the part 100. Once installed, the ply of synthetic fiber material 310 is sandwiched between a layer of film adhesive 320 on each side of the ply of synthetic fiber material 310. In some embodiments, the synthetic fiber material includes one of a Plain Weave Kevlar or a 4-Harness Kevlar. In some embodiments, film adhesive 320 includes a 3M Scotch-Weld Structural adhesive film. AF 163 2k 0.06 is a modified epoxy structural adhesive in film form.

After heat curing the layers of film adhesive 320, an edge seal can be applied to gaps between the one or more doublers 330 and the inner surface 110 or outer surface 120 of the part 100. For example, in some embodiments, the edge seal includes a resin. In some embodiments, the resin includes EA 9309.3. EA 9309.3 is an epoxy that forms a permanent joint that is resistant to water. It is typically applied as an edge seal and over the doublers to ensure a moisture free barrier between the repair doublers and the original machined skin.

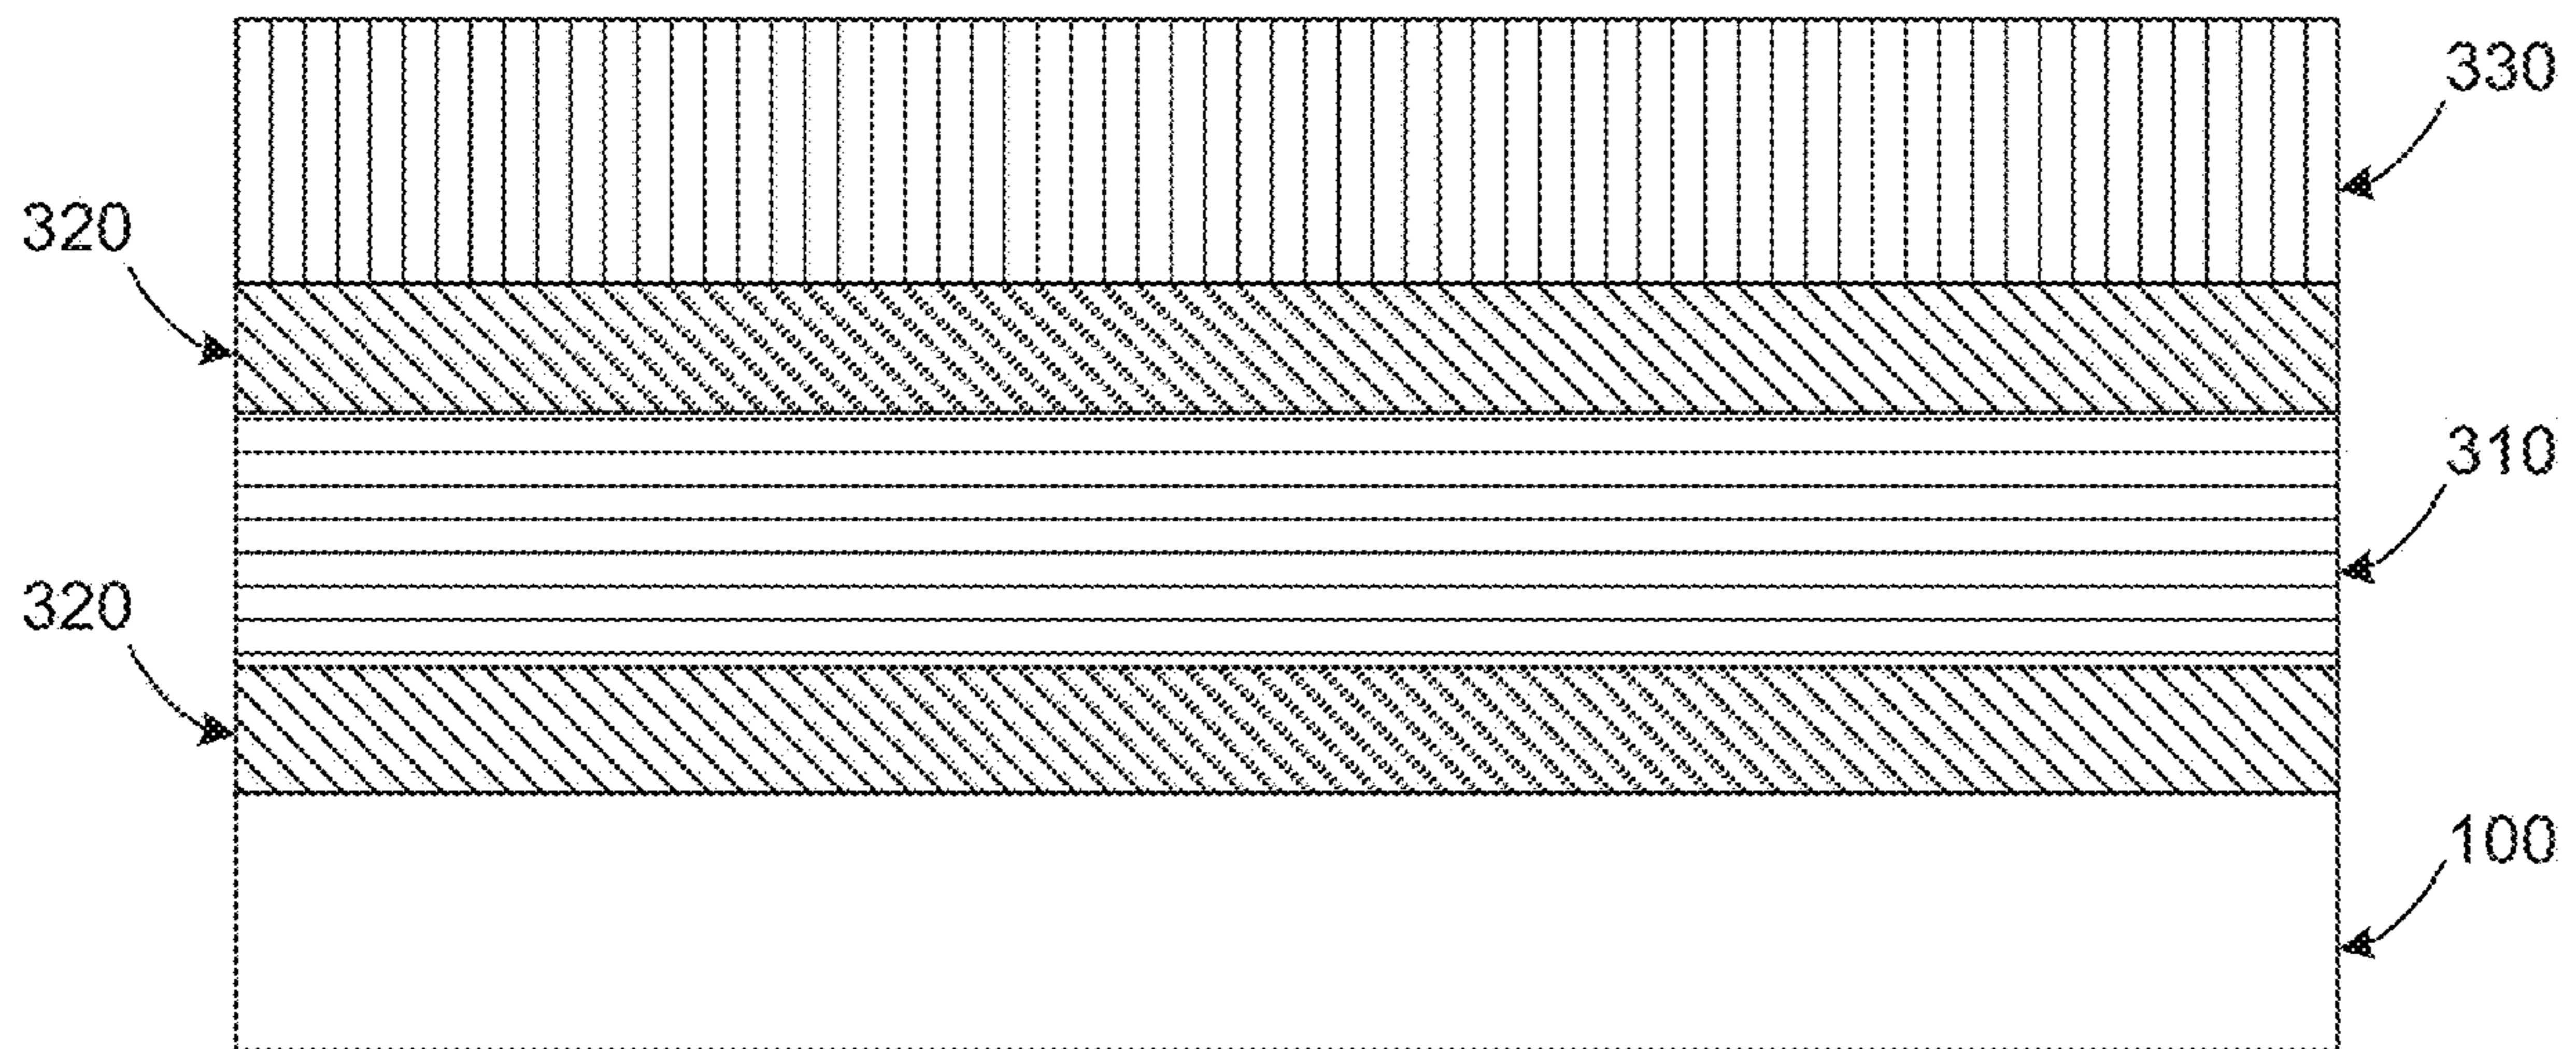
50 FIG. 3B is a cross-section view of an exemplary part of a thrust reverser assembly, according to an embodiment of the invention.
