(10) **Patent No.:** **US 11,174,043 B1**  
(45) **Date of Patent:** **Nov. 16, 2021**

(54) **SYSTEMS AND METHODS FOR THRUST REVERSER CORROSION DAMAGE REPAIR**

- (71) Applicant: **Nextant Aerospace**, Cleveland, OH (US)
- (72) Inventor: **Mark O'Donnell**, Cleveland, OH (US)
- (73) Assignee: **Nextant Aerospace**, Cleveland, OH (US)
- (\*) Notice: Subject to any disclaimer, the term of this patent is extended or adjusted under 35 U.S.C. 154(b) by 0 days.

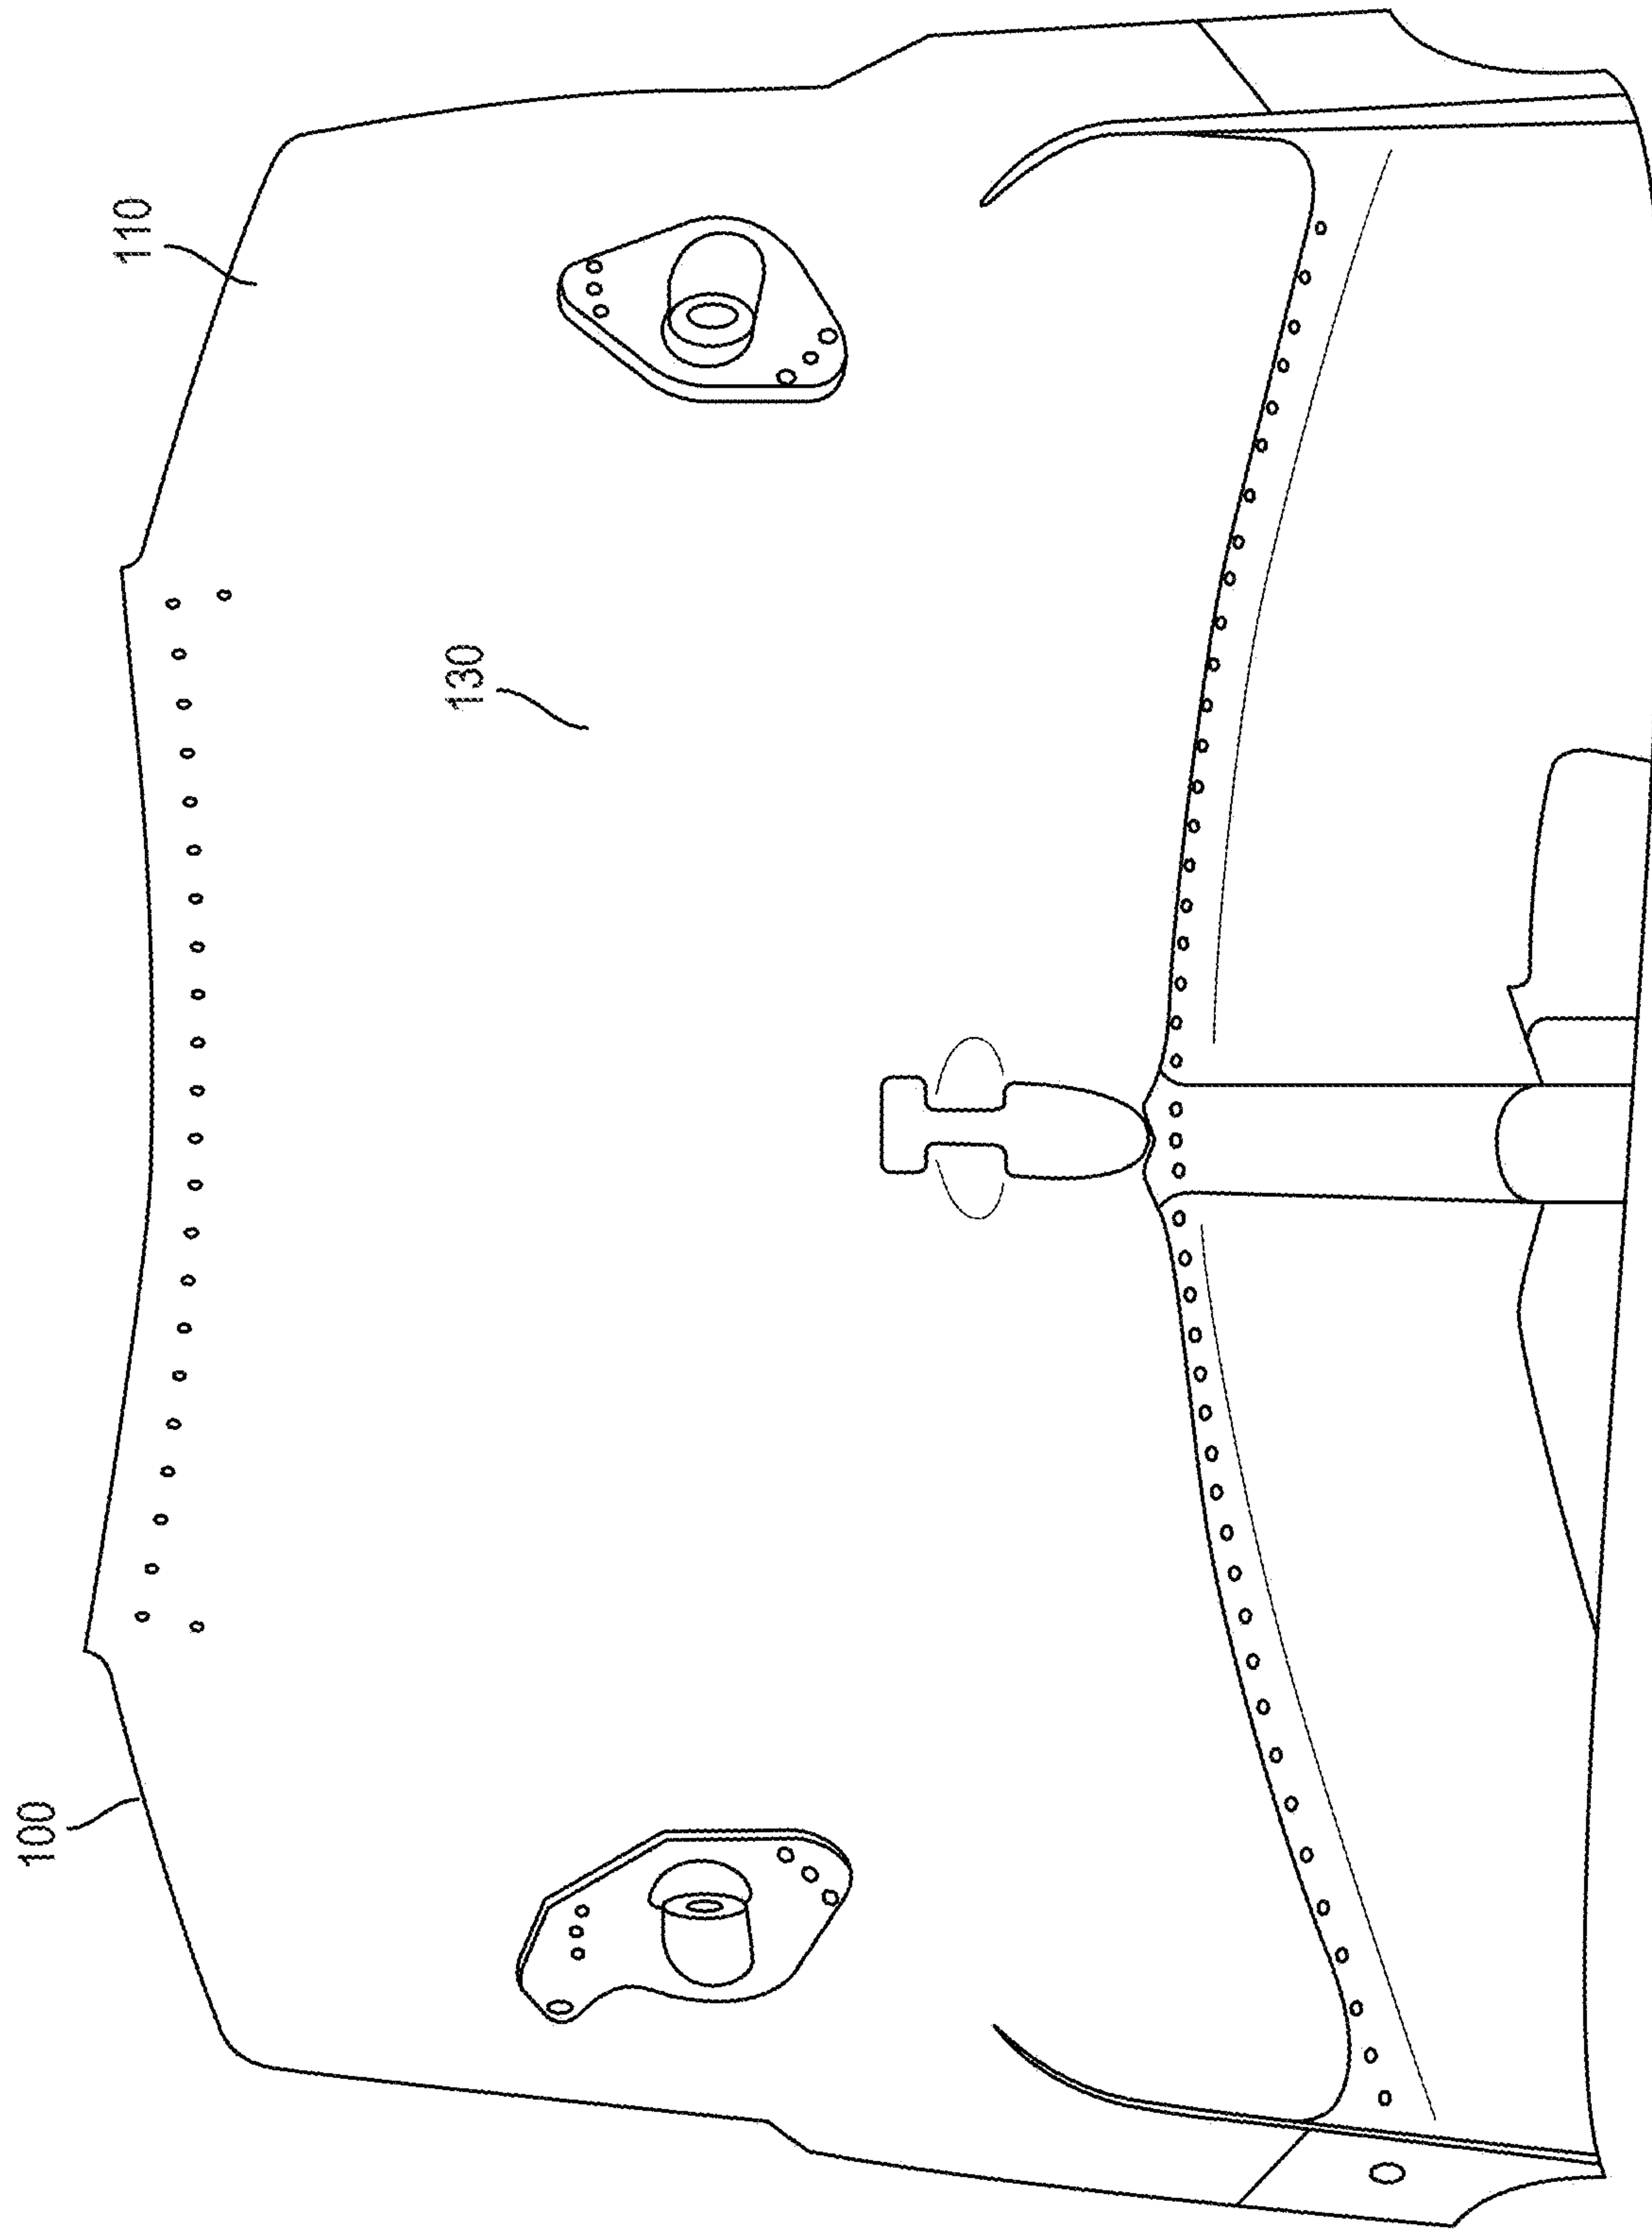
40 FIG. 1 is an isometric view of an exemplary part of a thrust reverser assembly, according to an embodiment of the invention.

Referring to FIGS. 1 and 2, a part 100 of a thrust reverser assembly is illustrated. For example, in some embodiments, the part 100 is one of an upper door assembly or a lower door assembly. In other embodiments, part 100 can be a machined component having corrosion damage. The part can include an inner surface 110 and an outer surface 120. The inner surface 110 and the outer surface 120 can include an outer skin 130. In order to repair corrosion damage on an area of the part 100, the part 100 is initially removed from the rest of the thrust reverser assembly. After corrosion repair has been completed, the part 100 is installed back to the thrust reverser assembly. As shown in relation to FIGS. 3A-3B, the area of the part 100 that has suffered from corrosion damage can be repaired by adding a stainless steel skin to the part 100 and sandwiching synthetic fiber material between the new skin and the part 100 to provide protection against dissimilar metal corrosion. In some embodiments, the synthetic fiber material includes Kevlar. Kevlar® is a registered trademark of DuPont de Nemours, Inc., and is DuPont's brand name for its synthetic fiber material.

As mentioned during the discussion of FIGS. 1 and 2, one or more doublers can be installed onto the ply of synthetic fiber material 310 in order to provide protection against metal corrosion. In some embodiments, the one or more doublers are stainless steel. In other embodiments, the one or more doublers include another type of steel or aluminum. For example, in some embodiments, the one or more doublers 330 are installed using rivets. In some embodiments, the one or more doublers 330 are clamped onto the part 100, locations for doubler holes are identified, and the locations for doubler holes are reamed. Once the ply of synthetic fiber material 310 has been installed, the layers of film adhesive 320 can be heat cured. For example, in some embodiments, heat curing the layers of film adhesive 320 includes ramping up a temperature of the film adhesive 320 up to 250 degrees F., dwelling at the temperature of 250 degrees F. for an hour, and ramping down the temperature of the film adhesive 320 to a room temperature.

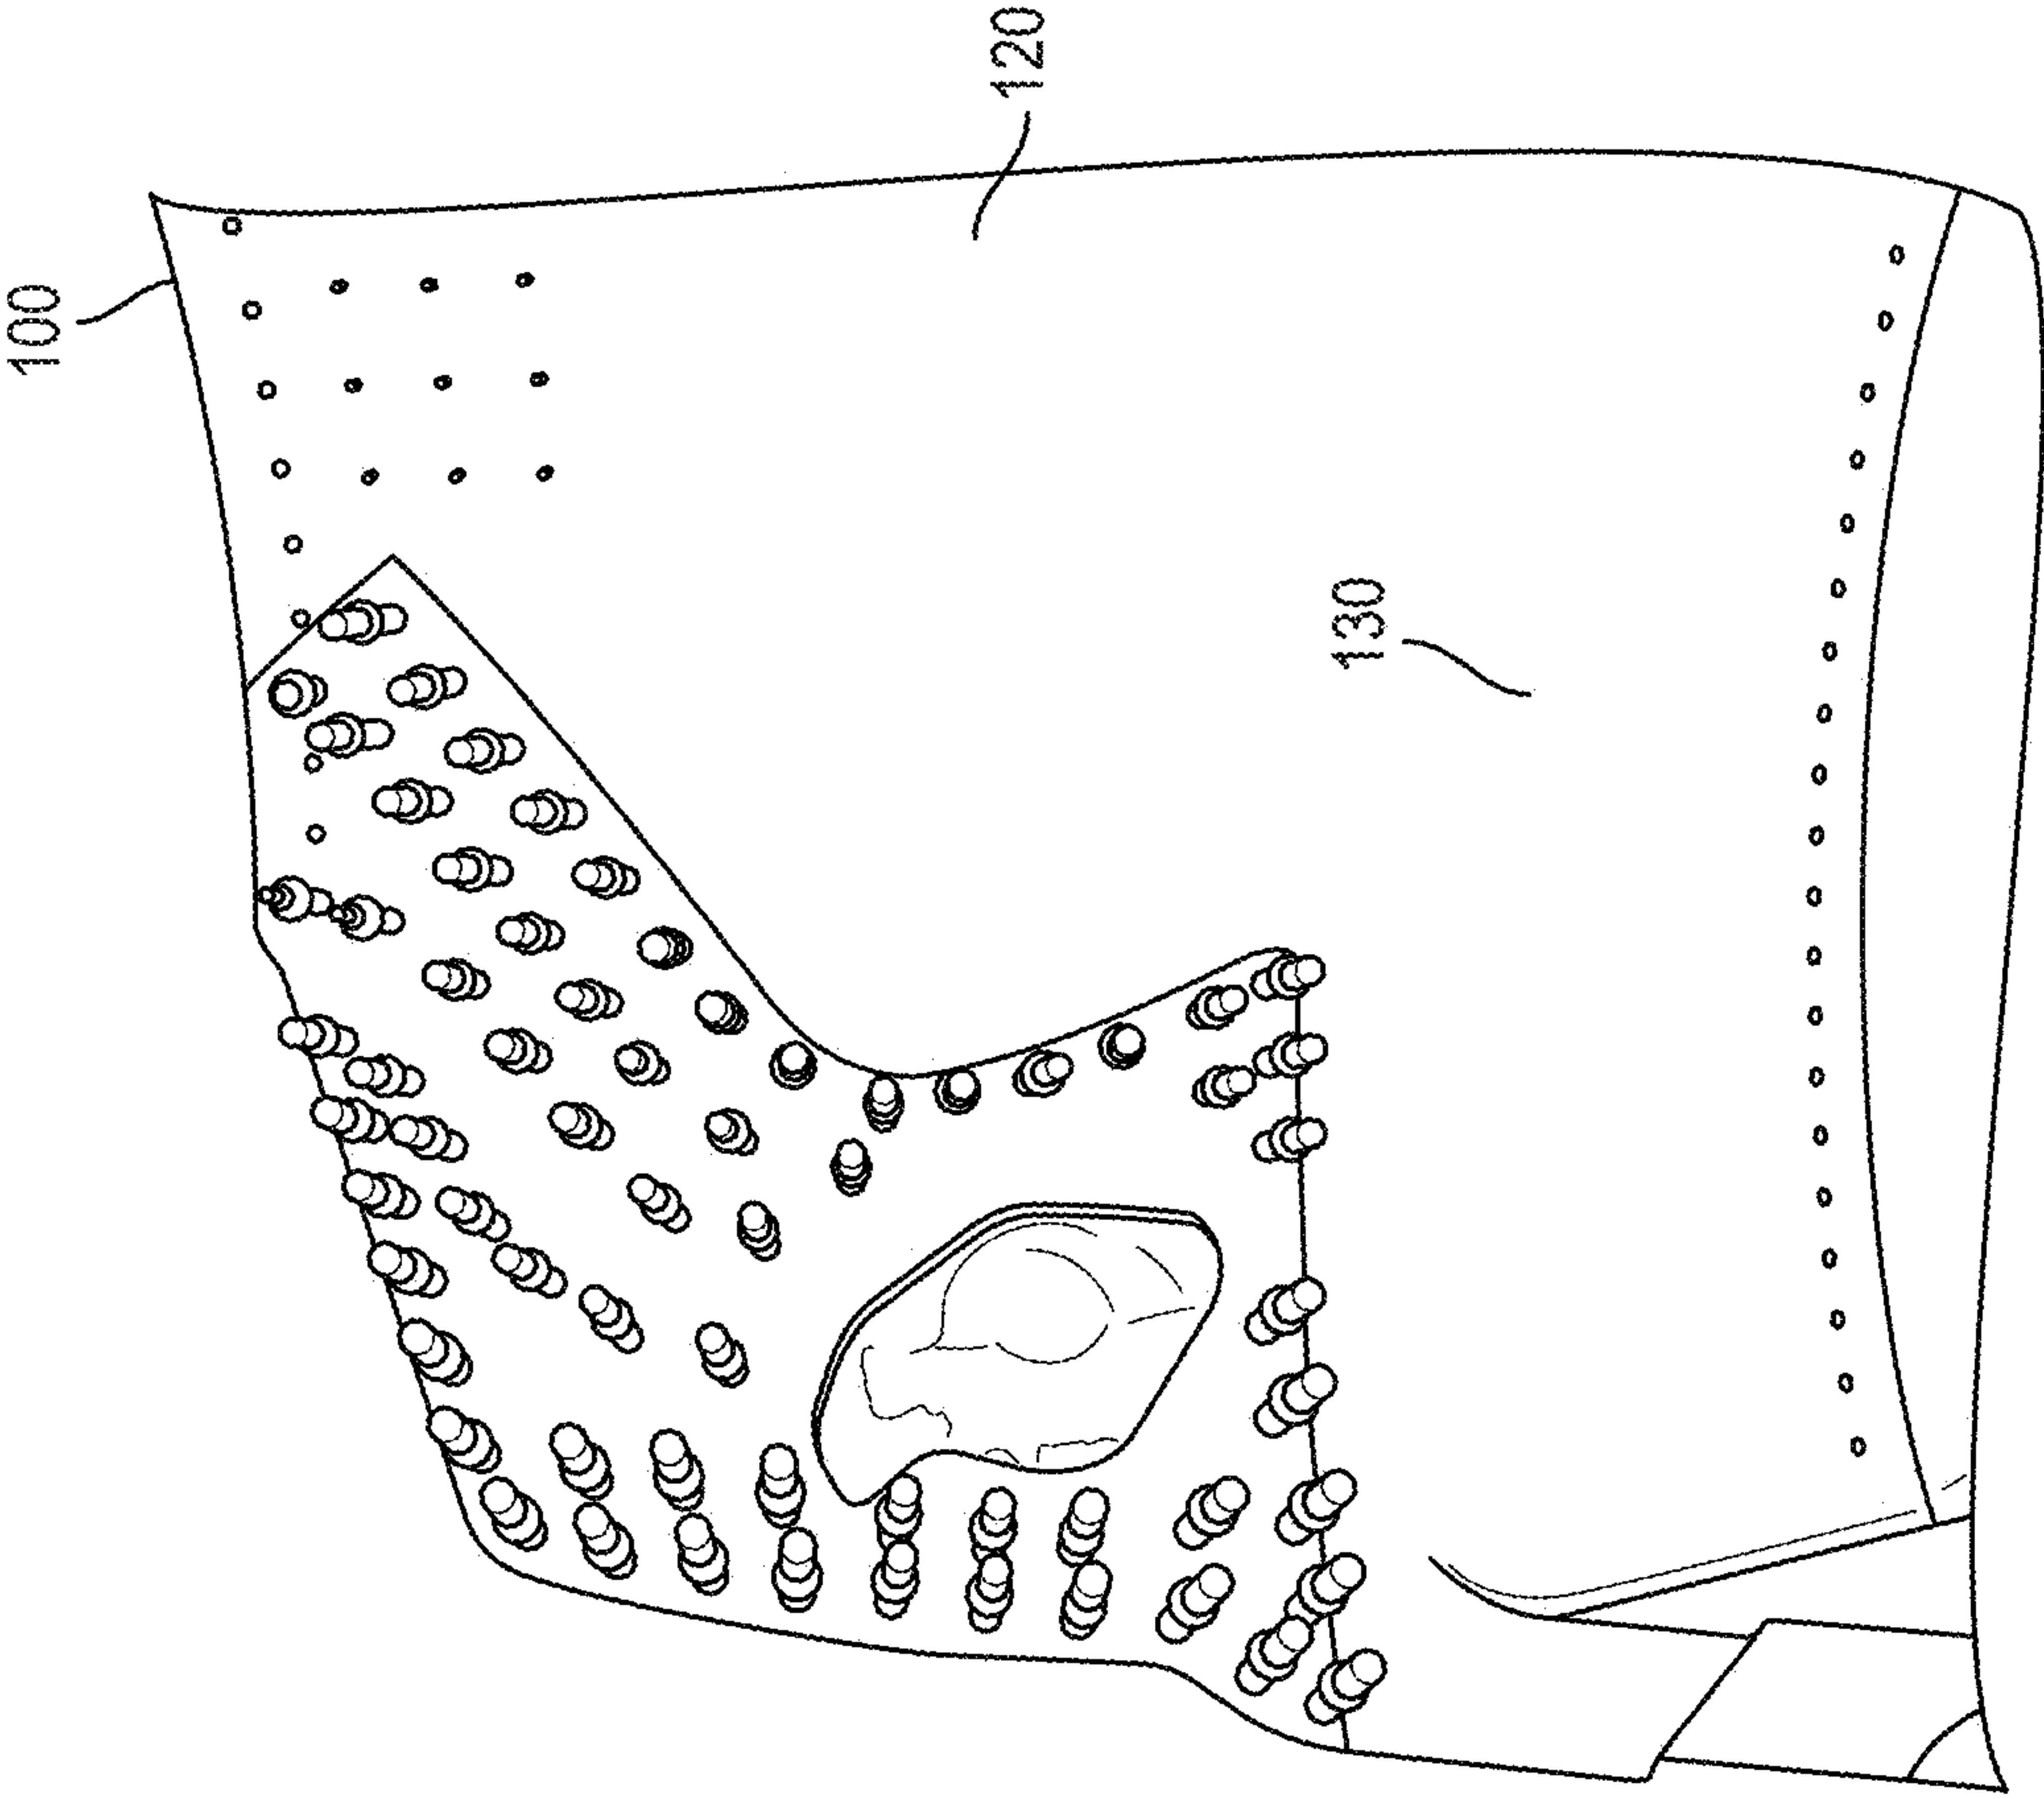
45 FIG. 2 is an isometric view of an exemplary part of a thrust reverser assembly, according to an embodiment of the invention.

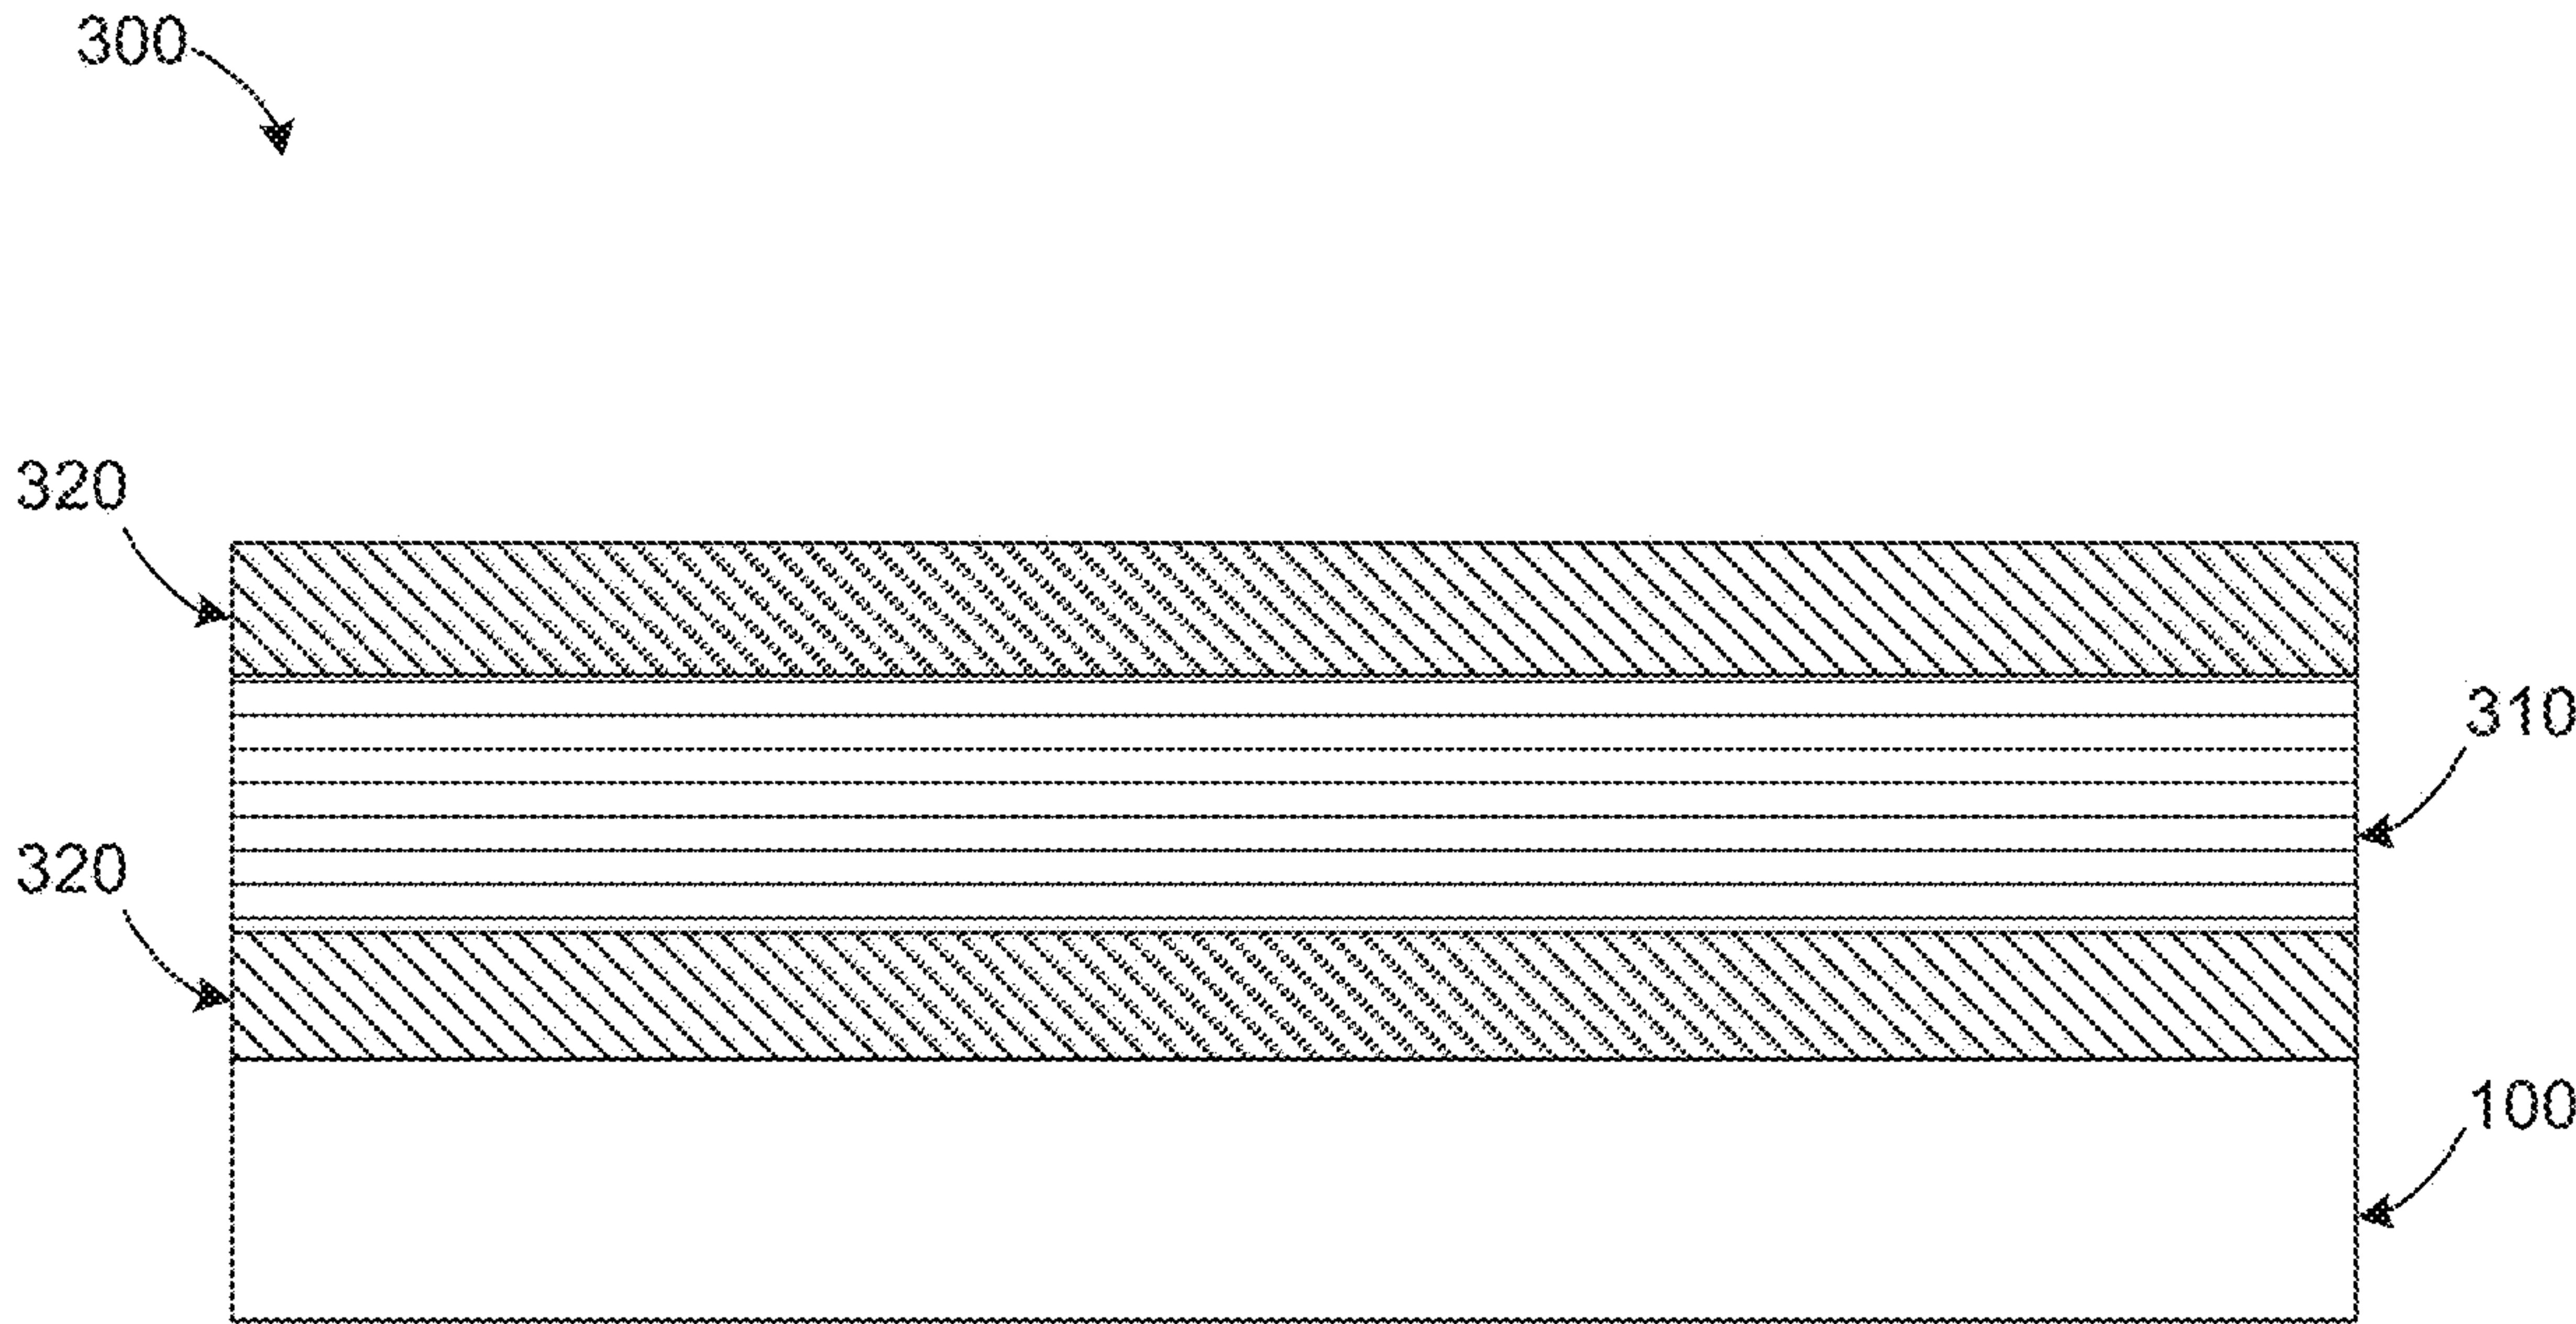
FIG. 3A is a cross-section view of an exemplary part of a thrust reverser assembly, according to an embodiment of the invention.

Before repairing the corrosion damage on the area of the part 100, the outer skin 130 is removed from the inner surface 110 and the outer surface 120. Referring to FIGS. 3A-3B, a cross-section 300 of an embodiment of part 100 after removal of the outer skin 130 is illustrated. A ply of synthetic fiber material 310 is installed onto an area of the inner surface 110 or the outer surface 120 of the part 100. The location of the installation of the ply of synthetic fiber material 310 depends on the location of the damaged area. In some embodiments, the location of the damaged area is determined during inspection of the part 100. Once installed, the ply of synthetic fiber material 310 is sandwiched between a layer of film adhesive 320 on each side of the ply of synthetic fiber material 310. In some embodiments, the synthetic fiber material includes one of a Plain Weave Kevlar or a 4-Harness Kevlar. In some embodiments, film adhesive 320 includes a 3M Scotch-Weld Structural adhesive film. AF 163 2k 0.06 is a modified epoxy structural adhesive in film form.

After heat curing the layers of film adhesive 320, an edge seal can be applied to gaps between the one or more doublers 330 and the inner surface 110 or outer surface 120 of the part 100. For example, in some embodiments, the edge seal includes a resin. In some embodiments, the resin includes EA 9309.3. EA 9309.3 is an epoxy that forms a permanent joint that is resistant to water. It is typically applied as an edge seal and over the doublers to ensure a moisture free barrier between the repair doublers and the original machined skin.

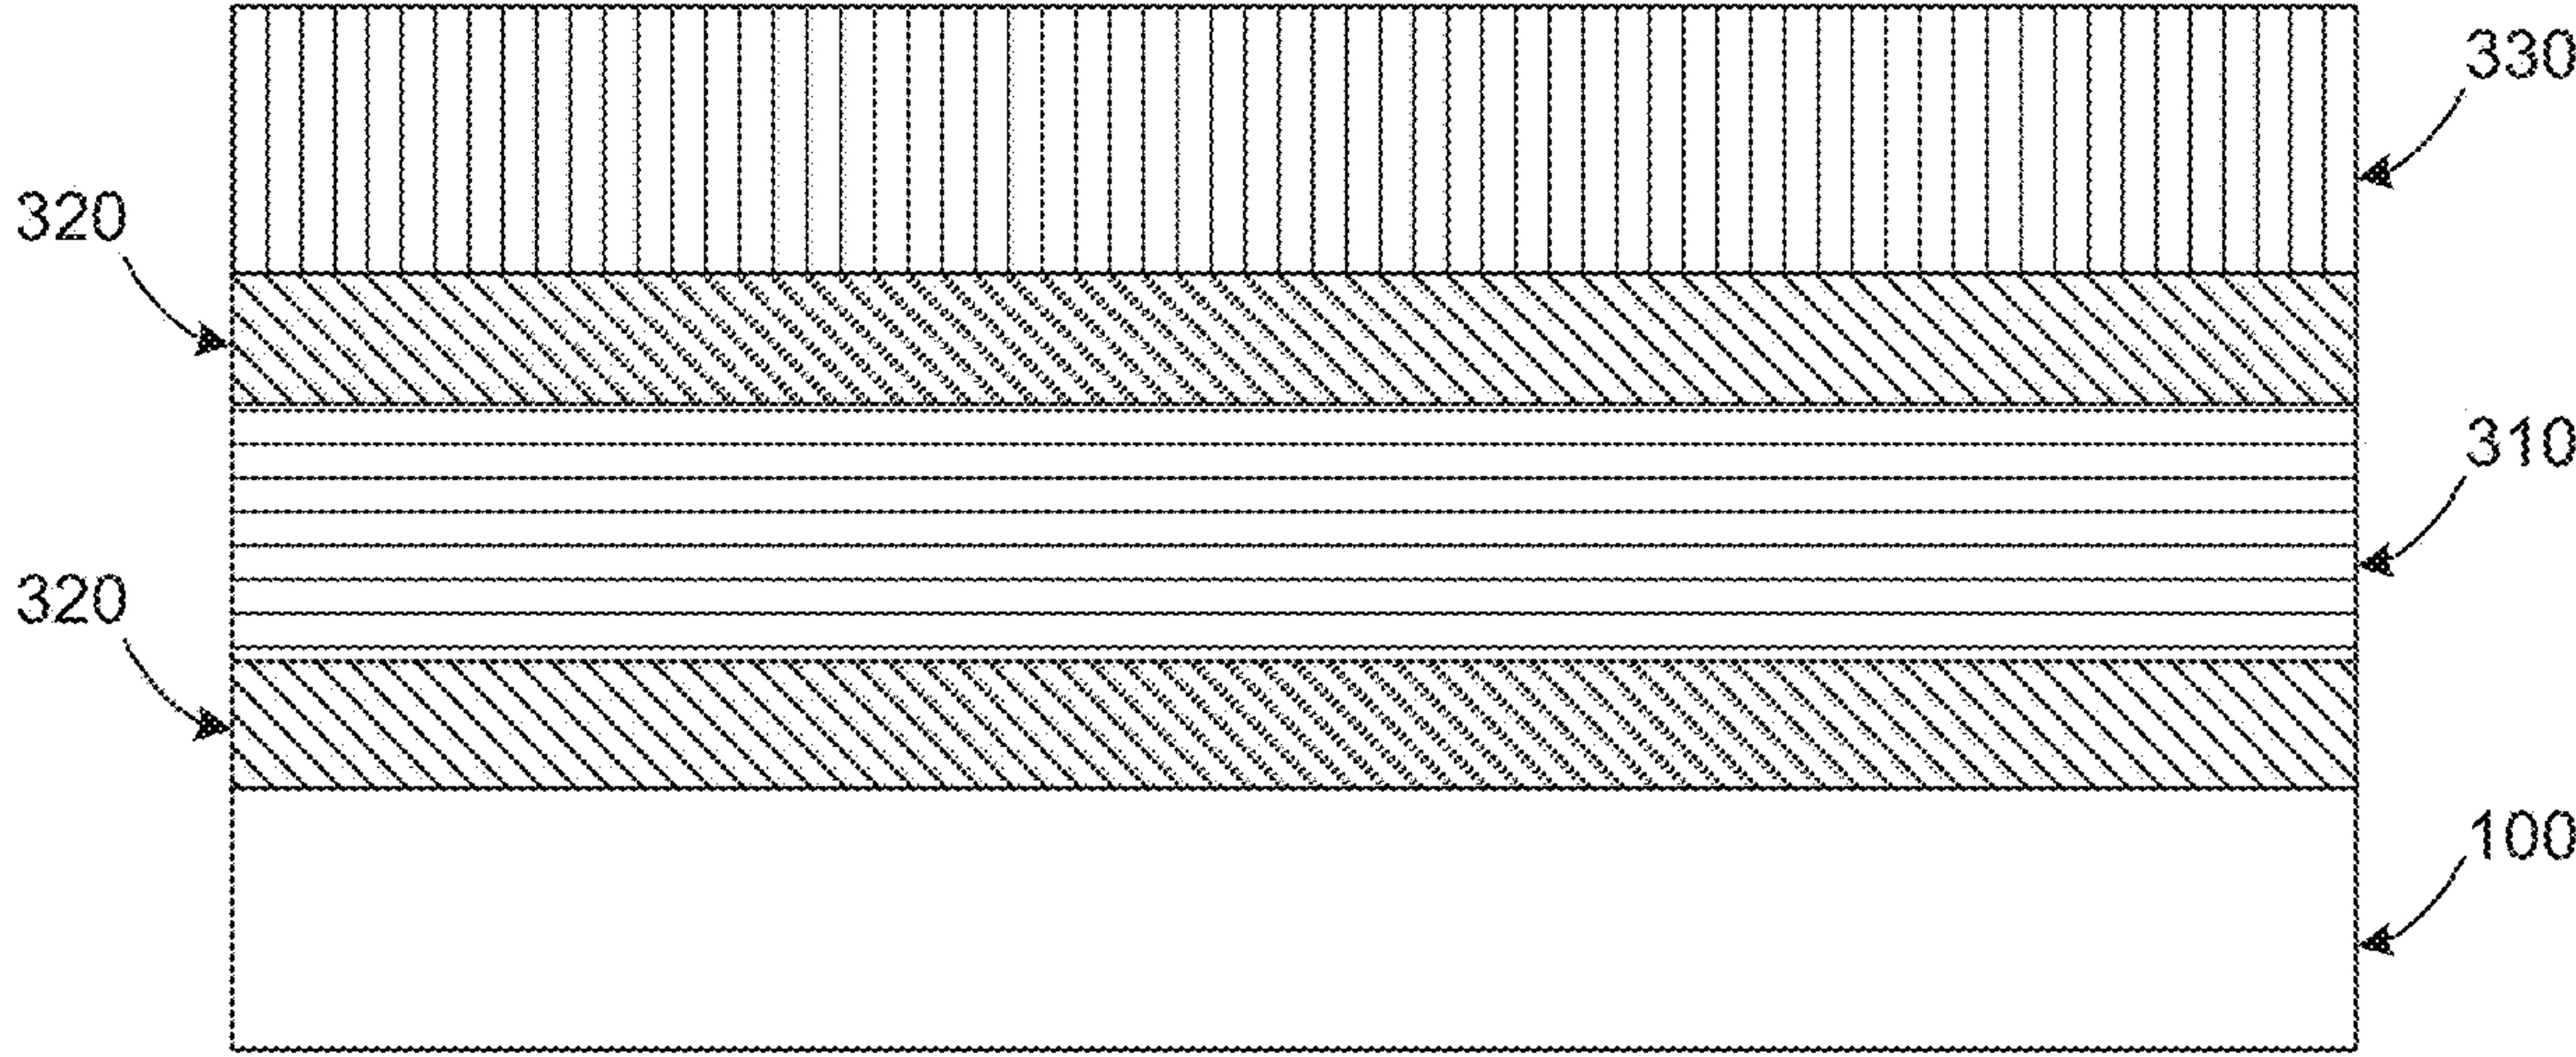
50 FIG. 3B is a cross-section view of an exemplary part of a thrust reverser assembly, according to an embodiment of the invention.

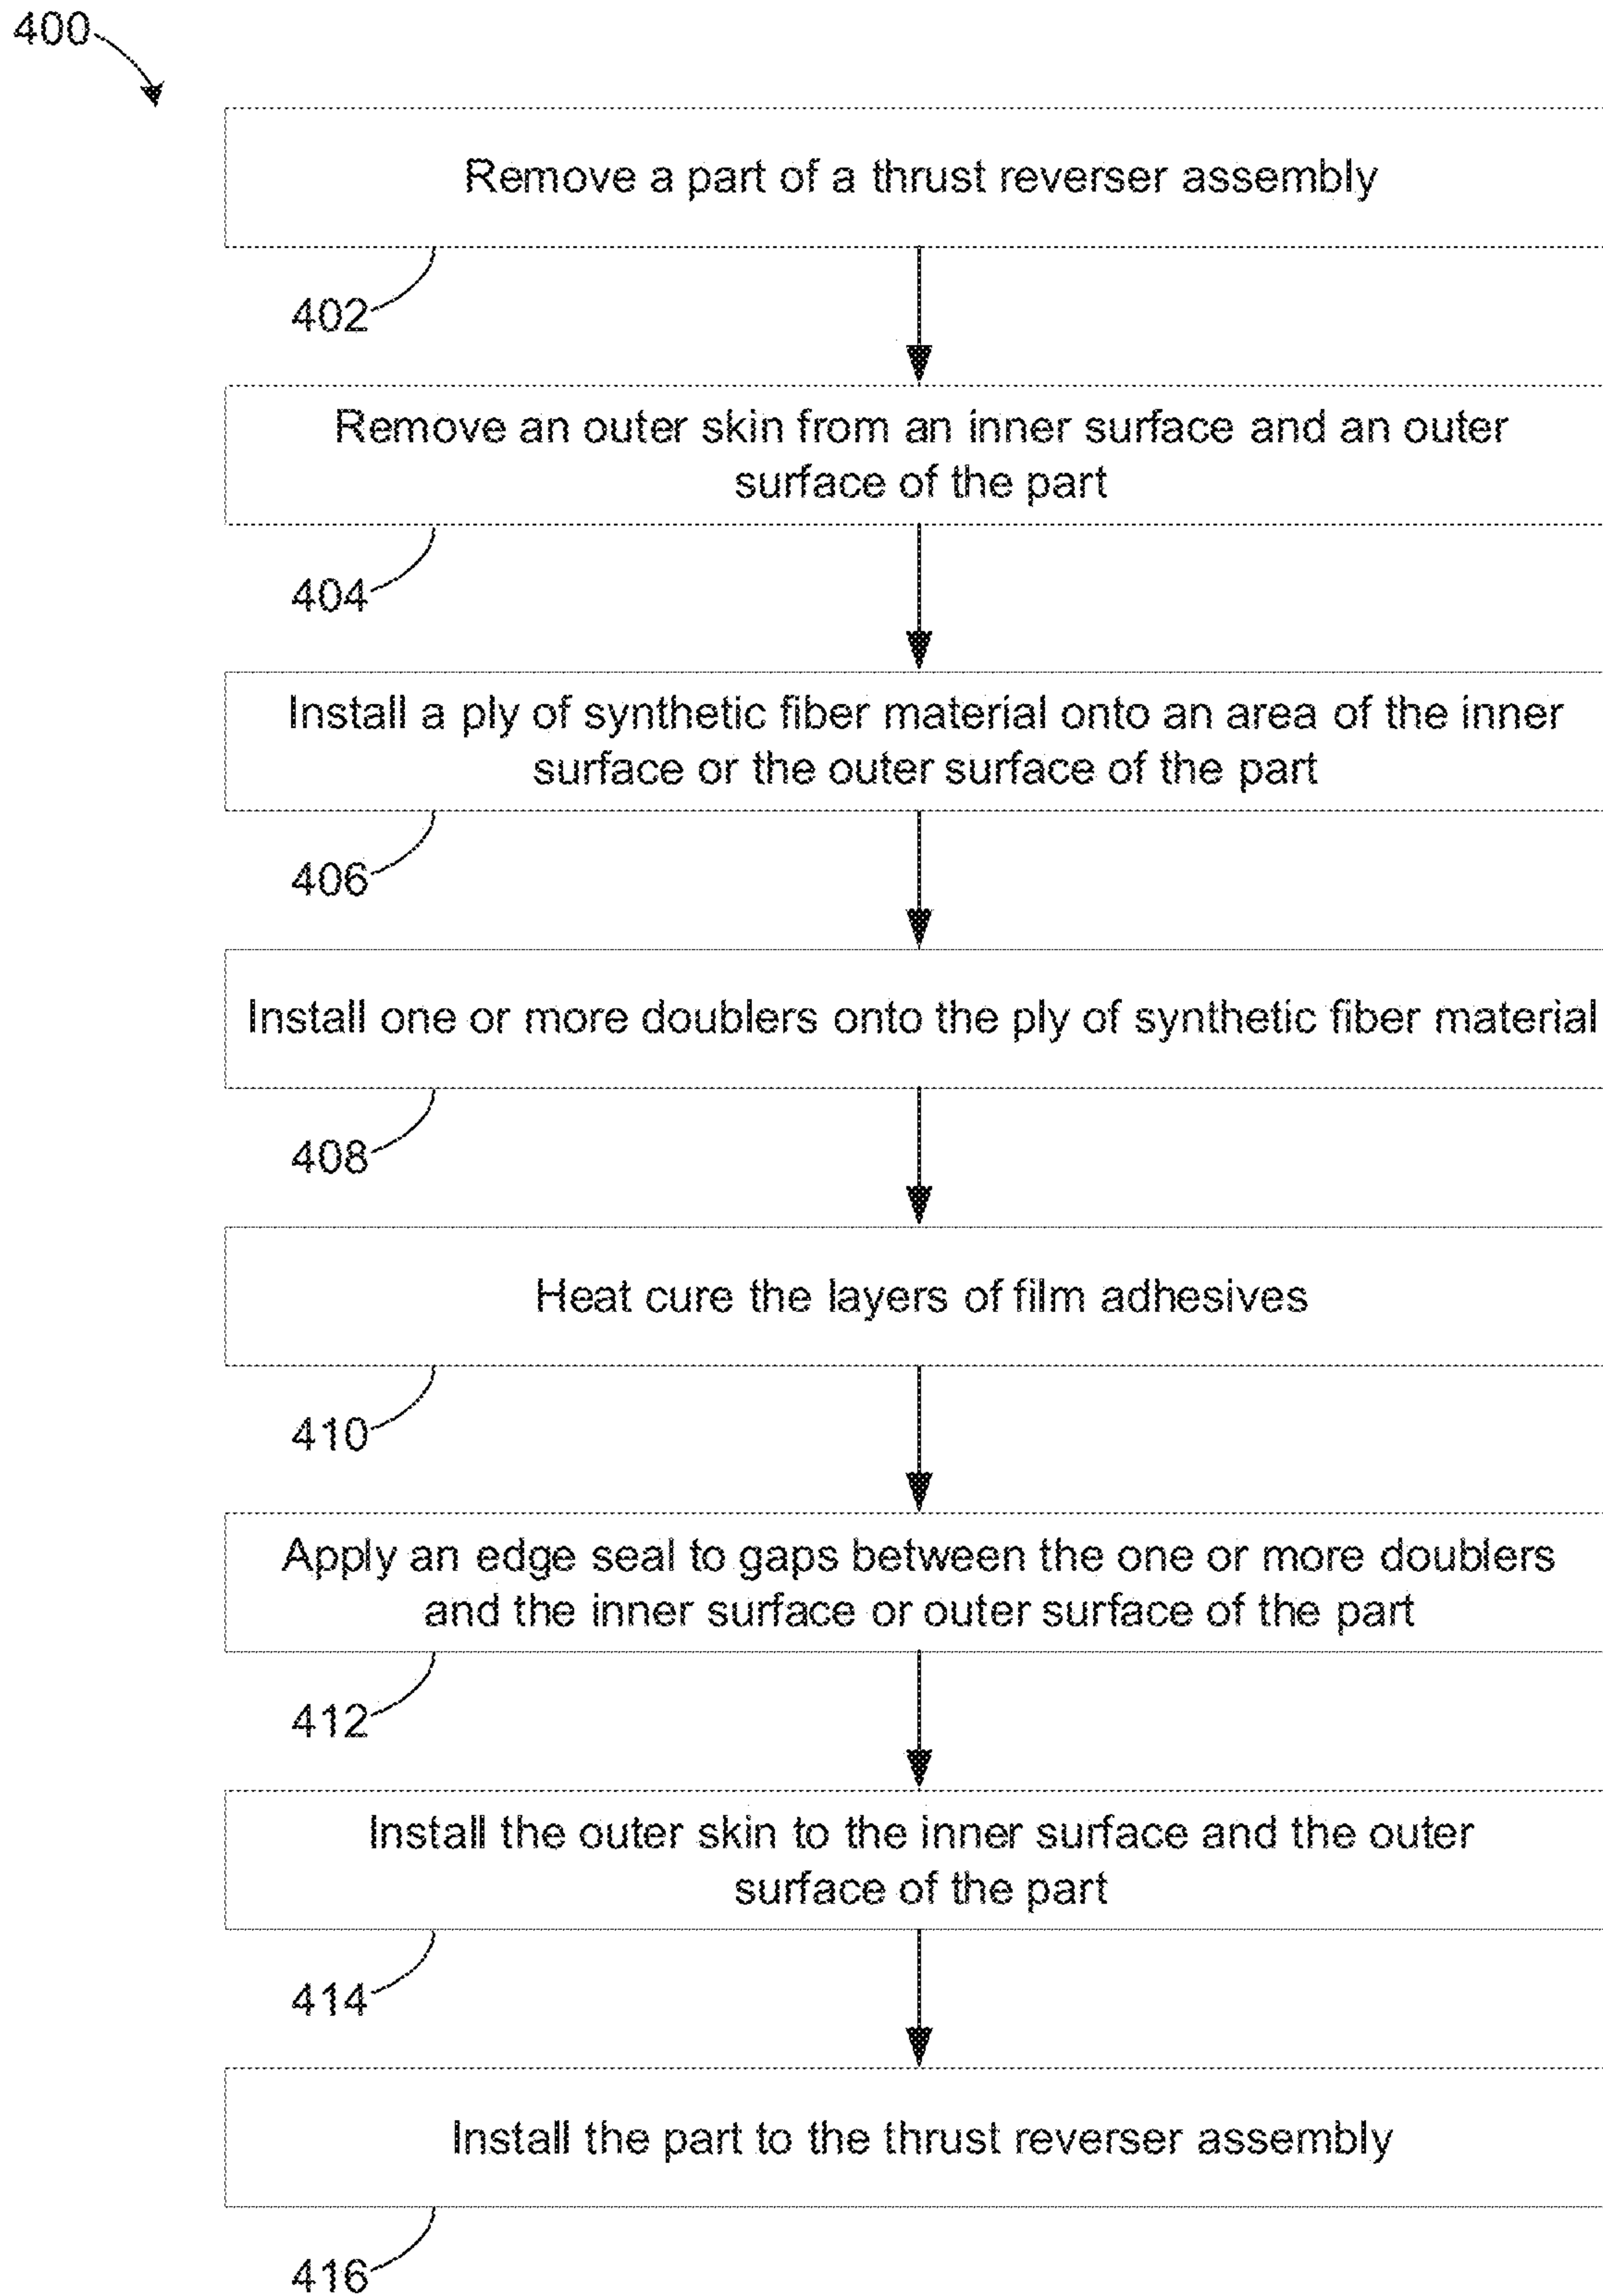
FIG. 4 is a flow diagram of method steps for repairing corrosion damage of a part of a thrust reverser assembly, according to an embodiment of the invention.

Referring to FIG. 4, a process 400 for repairing corrosion damage of a part 100 of a thrust reverser assembly is illustrated. As described in relation to FIGS. 1 and 2, the part 100 can include an inner surface 110 and an outer surface 120. The process 400 begins by removing the part 100 of the thrust reverser assembly in step 402. For example, in some embodiments, the part 100 is one of an upper door assembly or a lower door assembly. Process 400 continues by removing an outer skin 130 from the inner surface 110 and the outer surface 120 of the part 100 in step 404.

Process 400 continues by installing a ply of synthetic fiber material 310 onto an area of the inner surface 110 or the outer surface 120 of the part 100 in step 406. In some embodiments, the area includes corrosion damage. Once installed, the ply of synthetic fiber material 310 is sandwiched between a layer of film adhesive 320 on each side of the ply of synthetic fiber material 310. For example, in some embodiments, the synthetic fiber material includes one of a Plain Weave Kevlar or a 4-Harness Kevlar.

Process 400 continues by installing one or more doublers 330 onto the ply of synthetic fiber material 310 in step 408. For example, in some embodiments, the one or more doublers 330 are installed using rivets. In some embodiments, process 400 includes clamping the one or more doublers 330 onto the part 100, identifying locations for doubler holes, and reaming the locations for doubler holes.

Process 400 continues by heat curing the layers of film adhesive 320 in step 410. For example, in some embodiments, heat curing the layers of film adhesive 320 includes ramping up a temperature of the film adhesive 320 up to 250 degrees F., dwelling at the temperature of 250 degrees F. for an hour, and ramping down the temperature of the film adhesive 320 to a room temperature.

Process 400 continues by applying an edge seal to gaps between the one or more doublers 330 and the inner surface 110 or outer surface 120 of the part 100 in step 412. For example, in some embodiments, the edge seal includes a resin. In some embodiments, process 400 includes heat curing the edge seal resin. In some embodiments, process 400 includes sanding an excess of edge seal resin.

Process 400 continues by installing the outer skin 130 to the inner surface 110 and the outer surface 120 of the part 100 in step 414. Process 400 finishes by installing the part 100 to the thrust reverser assembly in step 416. In some embodiments, process 400 includes painting a topcoat to the inner surface 110 and the outer surface 120 of the part 100.
