(54) **EXPANDABLE PIPE INCLUDING A LINER FOR RESTORING A CONDUIT**

(57) **ABSTRACT**

EXPANDABLE PIPE INCLUDING A LINER FOR RESTORING A CONDUIT

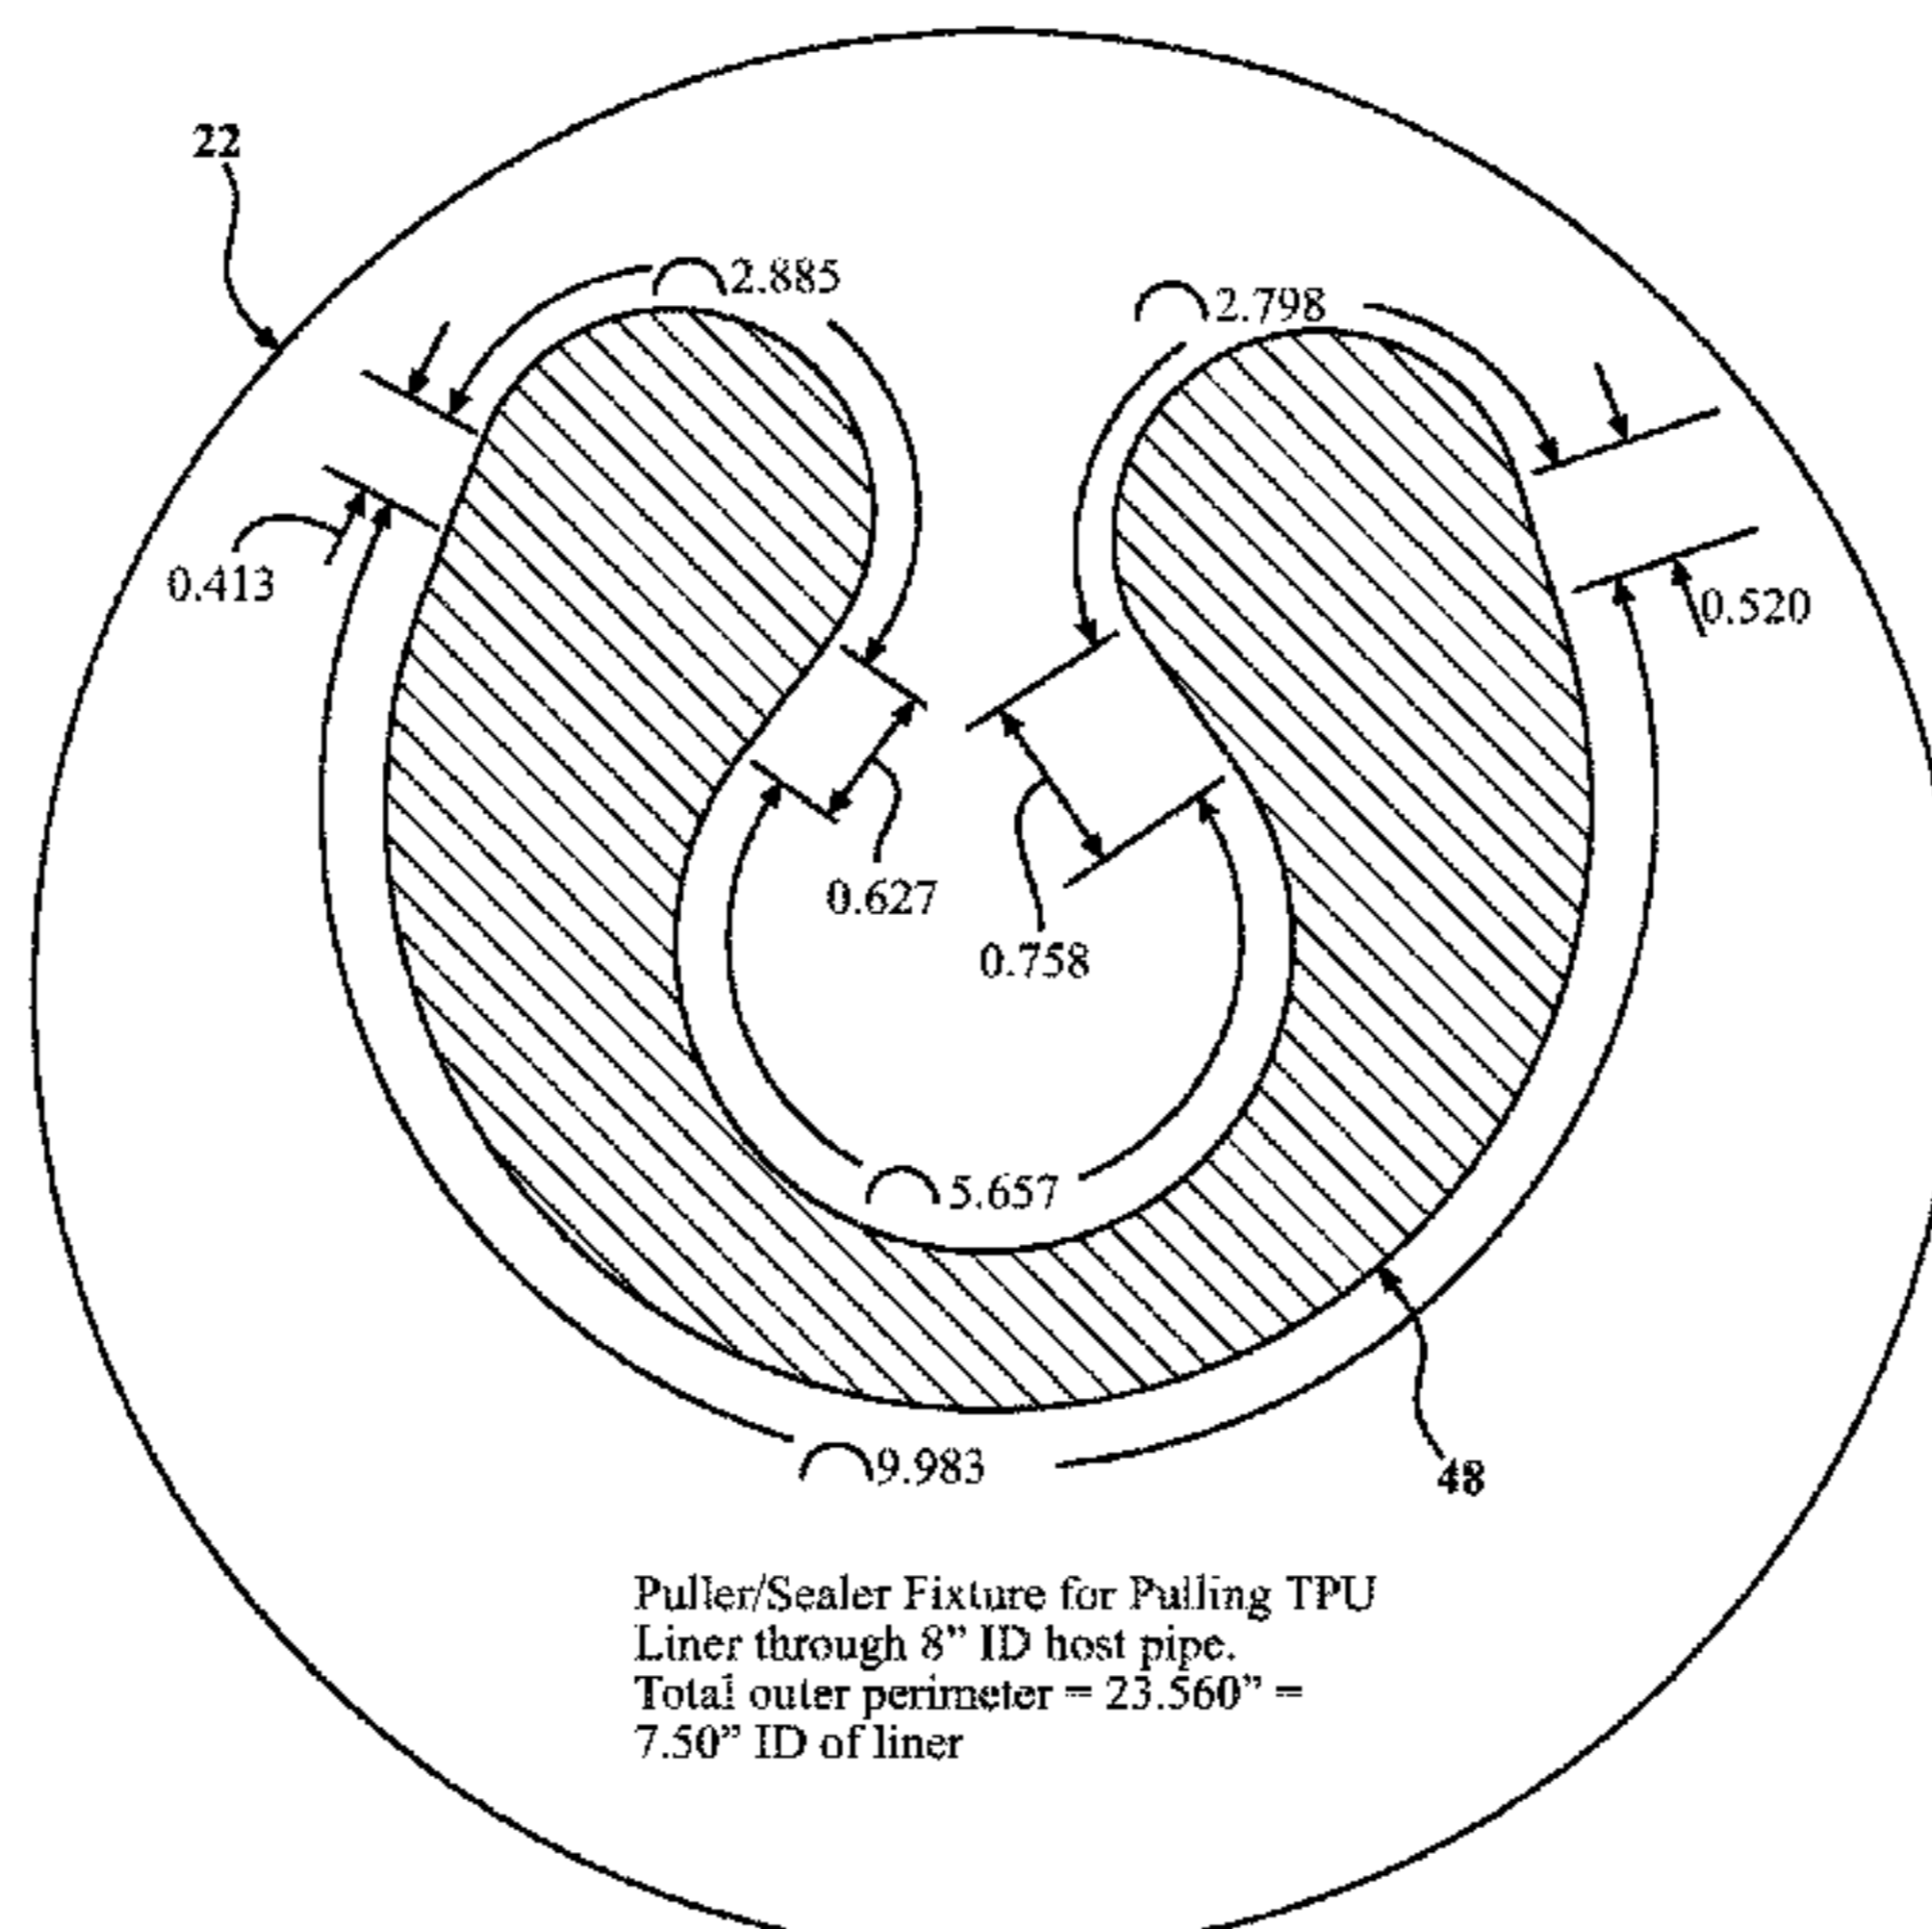
An expandable pipe for restoring a damaged pipe is provided. The expandable pipe includes a liner formed of thermoplastic polyurethane, and grout material applied to the exterior surface of the liner. The exterior surface includes a plurality of flared tips and grooves, and each groove is located between adjacent flared tips. The grout material is disposed on the flared tips and in the grooves of the liner. The method used to restore the damaged pipe includes clamping the liner with the grout material on a puller-sealer fixture having a U-shaped cross-section to prevent debris from entering the interior of the liner, and pulling the puller-sealer fixture and liner through the damaged pipe. The grout material expands in volume upon exposure to moisture, ultra violet radiation, heat, and/or ultrasonics, and fills cracks or other imperfections and voids along the interior surface of the conduit, caused by corrosion, erosion, or other circumstances.

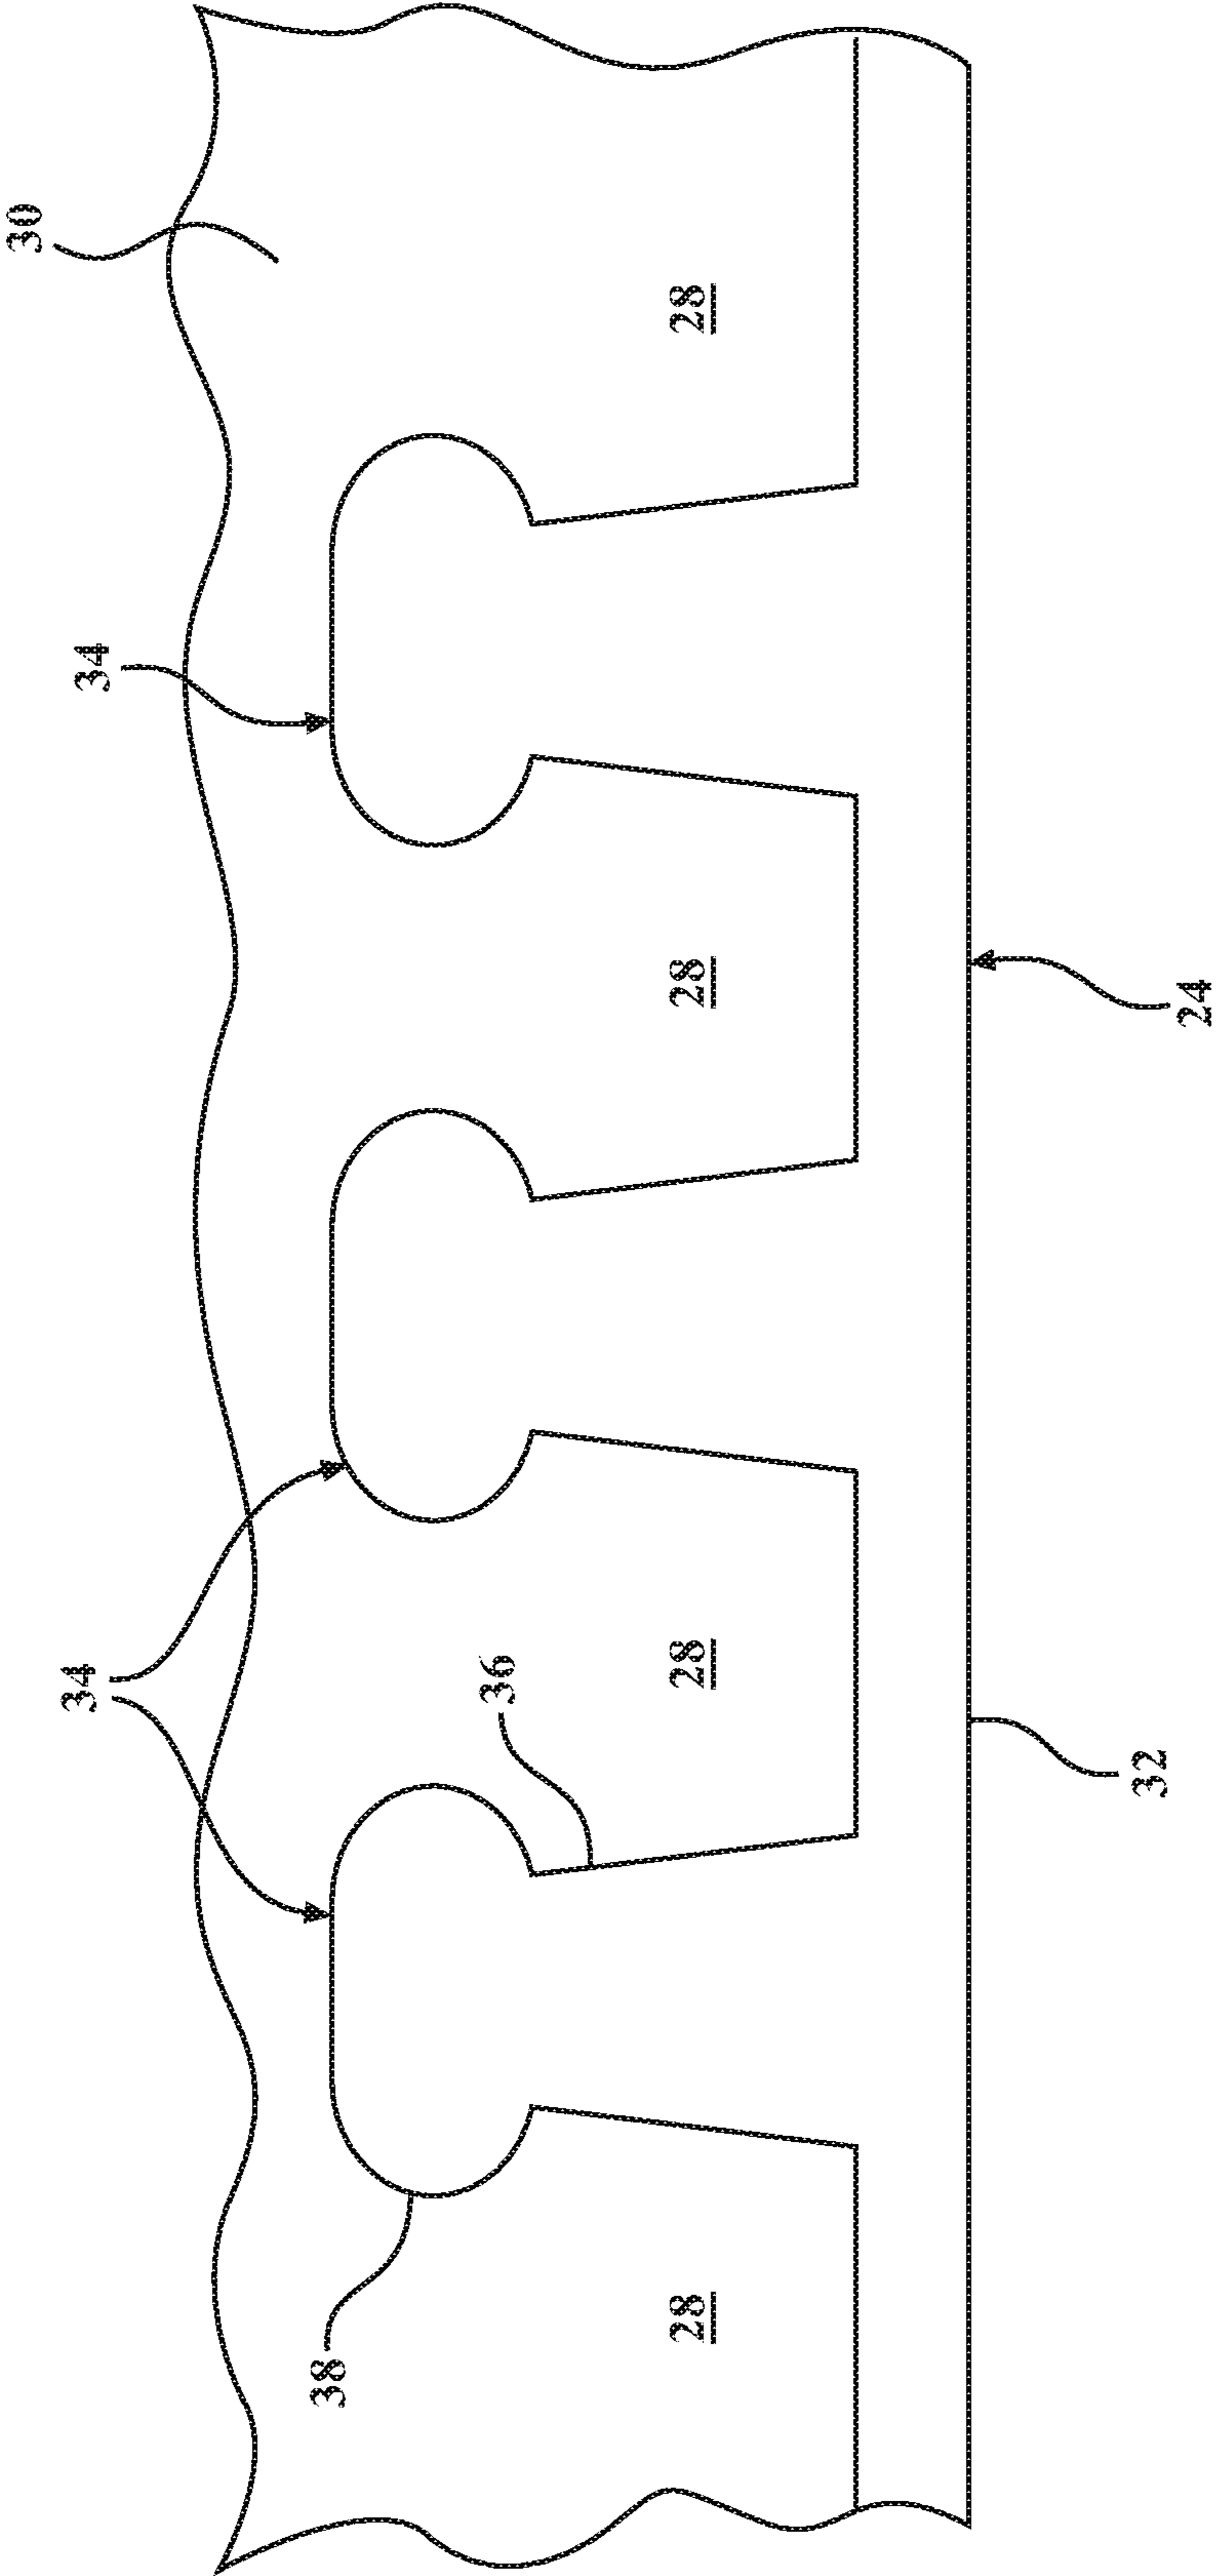
FIG. 1 is a cross-sectional view of a portion of a liner according to an example embodiment of the invention;

According to a preferred embodiment, the grooves 28 of the liner 24 are achieved by a profile on an exterior surface 26, also referred to as an outer diameter surface, of the liner 24, as shown in FIGS. 1 and 2. In the embodiment of FIGS. 1 and 2, the profile of the exterior surface 26 of the liner 24 includes flared tips 34 which act as a mechanical lock for the grout material 30 applied to the exterior surface 26 of the liner 24. FIG. 1 only shows the flared tips 34 along a portion of the exterior surface 26 of the liner 24, but the flared tips 34 are preferably located along the entire exterior surface 26 of the liner 24, and continuously around the outer circumference of the liner 24. In the example of FIGS. 1 and 2, each groove 28 is formed between two adjacent flared tips 34, and the grout material 30 is contained in those grooves 28. The flared tips 34 include a stem 36 extending perpendicular to the base of the liner 24, and an enlarged top 38 which flares outwardly relative to the stem 36. The diameter or width of the enlarged top 38 is greater than the diameter or width of the stem 36. The flared tips 34 shown in FIGS. 1 and 2 are only an example, as the shape and dimensions of the flared tips 34 can vary. Alternatively, other profiled shapes and dimensions can be used to achieve the grooves 28 in the liner 24. However, the flared tips 34 or other mechanical locking features are not required if a sufficient bond between the liner 24 and the grout material 30 is achieved.

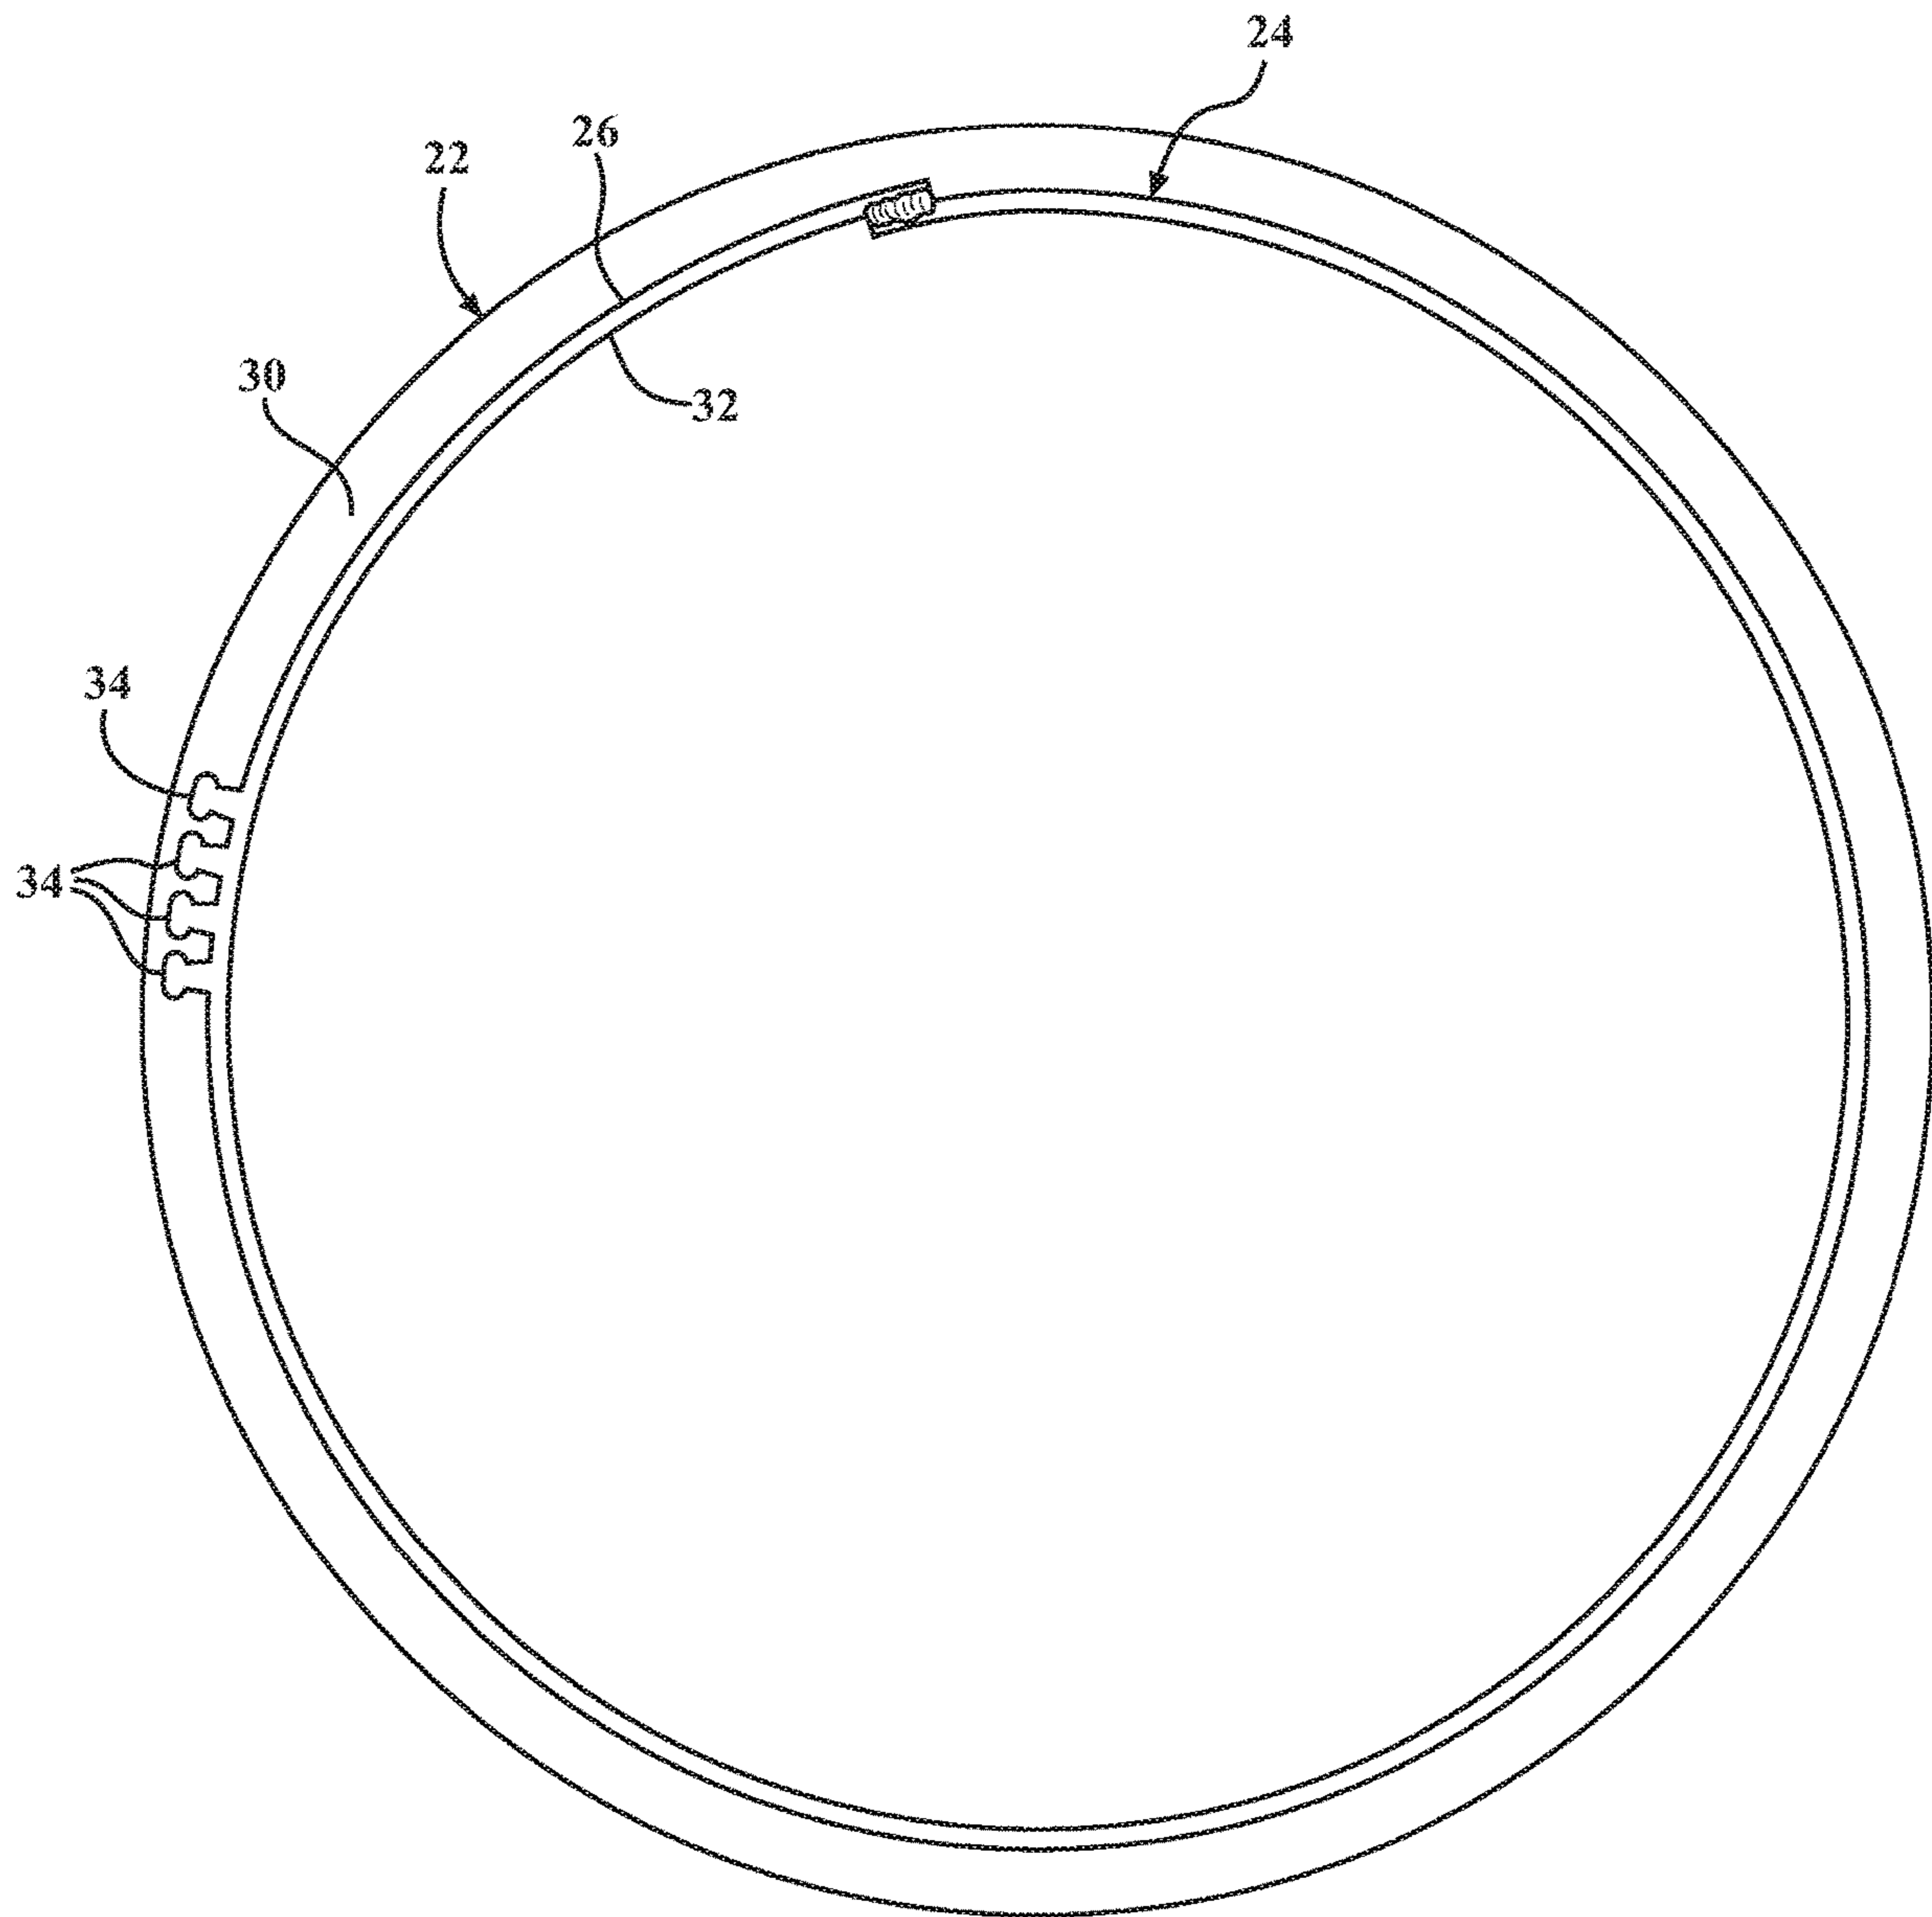
FIG. 2 is a cross-sectional view of the entire liner disposed inside of a host pipe according to the example embodiment of the invention;

The liner 24 can be formed by extrusion, preferably in a flat extrusion die to produce a flat product, such as a sheet of the TPU or another thermoplastic material. The flat extruded product is then welded into a circular pipe shape to produce the liner 24 and so as to reside inside the host pipe 22, as shown in FIG. 2. In other words, the flat product is welded it at a circumference that matches the required diameter for the liner 24. The diameter of the liner 24 should be less than the inner diameter of the host pipe 22 when the liner 24 is inflated. For example, the liner 24 of the example embodiment has a 7.5 inch inner diameter when inflated, and the host pipe 22 has an 8 inch inner diameter. The liner 24 could be extruded to size, as a circular tube, however certain raw materials are difficult to extrude into circular geometries due to a lack of melt strength. The other advantage of extruding flat and welding is the ability to obtain any diameter with limited tooling.

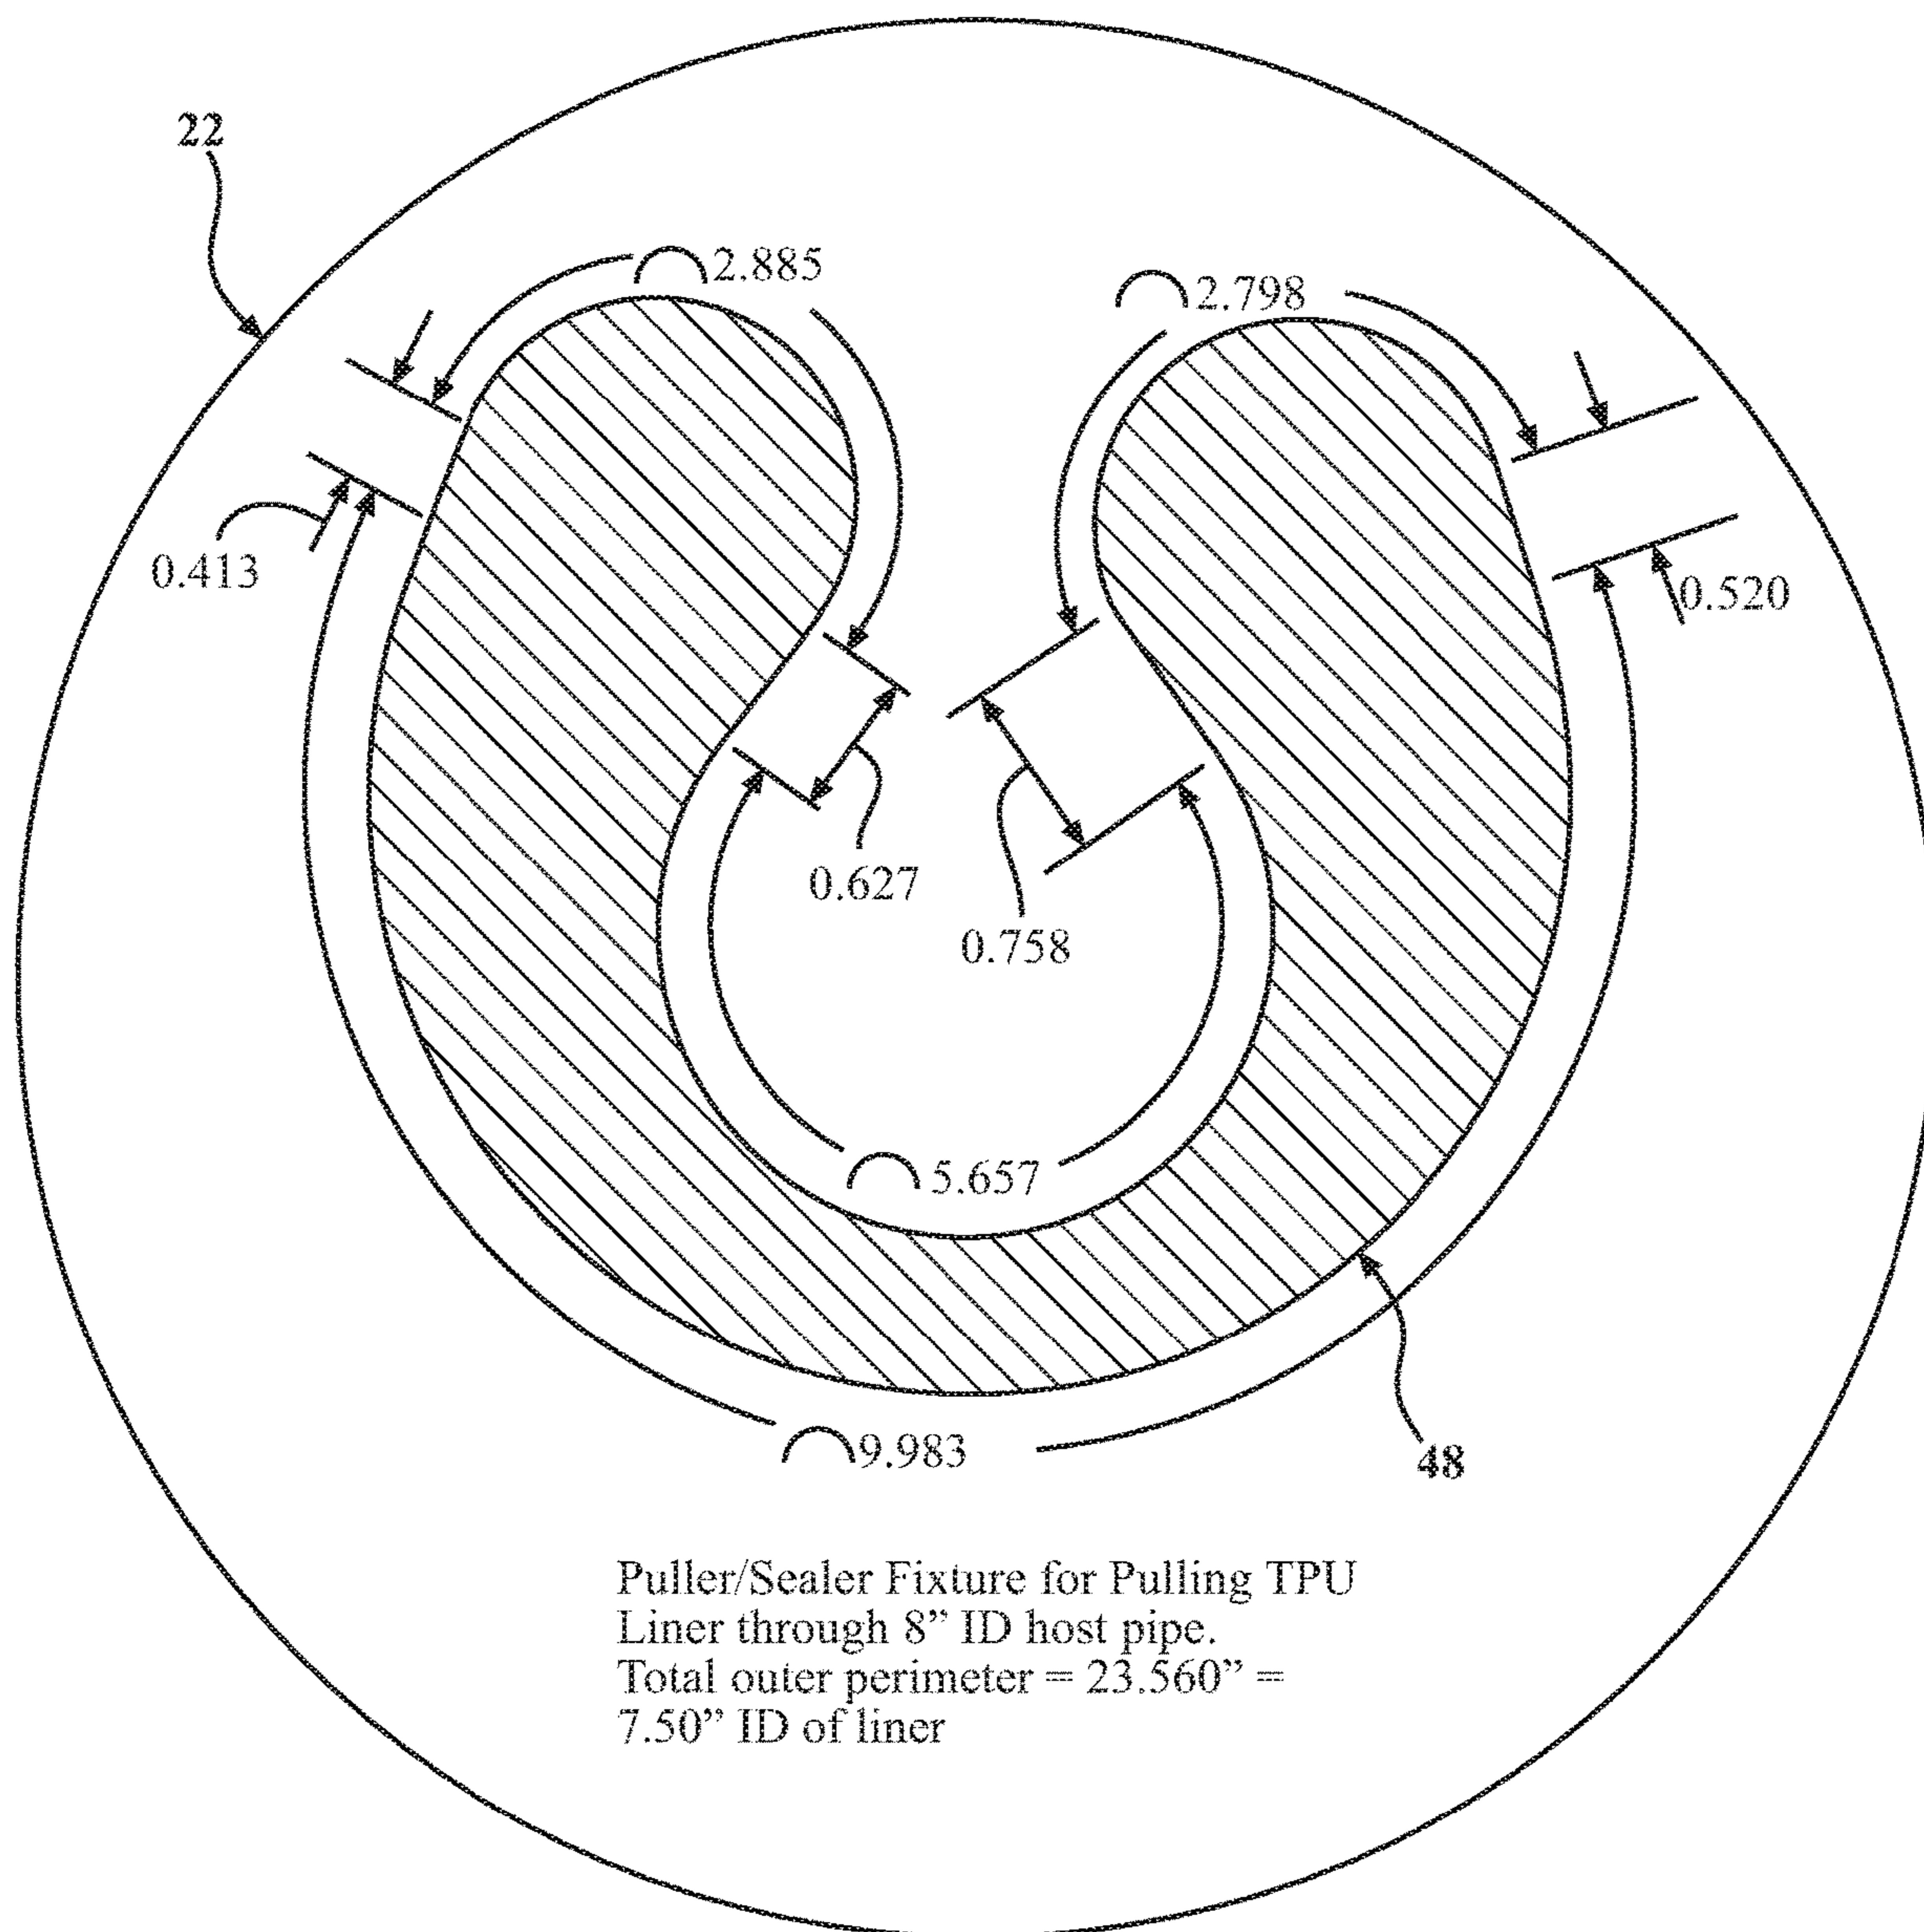
FIG. 3 is a cross-sectional view of a puller/sealer fixture disposed inside of the host pipe which configures the liner for passage through the host pipe with minimal interference with the inner diameter of the host pipe and which seals an inner diameter of the liner from water, debris, and grout material;

The TPU liner 24, with its exterior surface 26 soaked in the urethane grout, is directed down into an opening of the host pipe 22. The TPU liner 24 is there attached to a spraying fixture 46 via the puller/sealer fixture 48, as shown in FIGS. 3 and 4. The puller/sealer fixture 48 is a solid piece of material which serves as a mounting fixture which configures the liner 24 for optimal passage through the host pipe 22, with minimal interference with the inner diameter sur-

face of the host pipe 22. In the example embodiment, the puller/sealer fixture 48 has a U-shaped cross-section with no sharp edges. The puller/sealer fixture 48 maintains the liner 24 in an appropriate position, without any sharp edges along the liner 24. In the example embodiment, the puller/sealer fixture 48 has an outer perimeter of 23.560 inches, which is equal to the length of the 7.5 inch inner diameter of the liner 24. Jigs or clamps 50 can be used to secure the liner 24 to the puller/sealer fixture 48. The puller/sealer fixture 48 also prevents debris, moisture, and/or the grout material 30 from entering the interior of the liner 24. For example, the clamps 50 can secure the liner 24 tightly against the puller/sealer fixture 48 to prevent the debris, moisture, and/or the grout material 30 from entering the interior of the liner 24. During installation, the puller/sealer fixture 48 is attached to the rolling dolly 42 and pulled by the cable 40 through the host pipe 22.

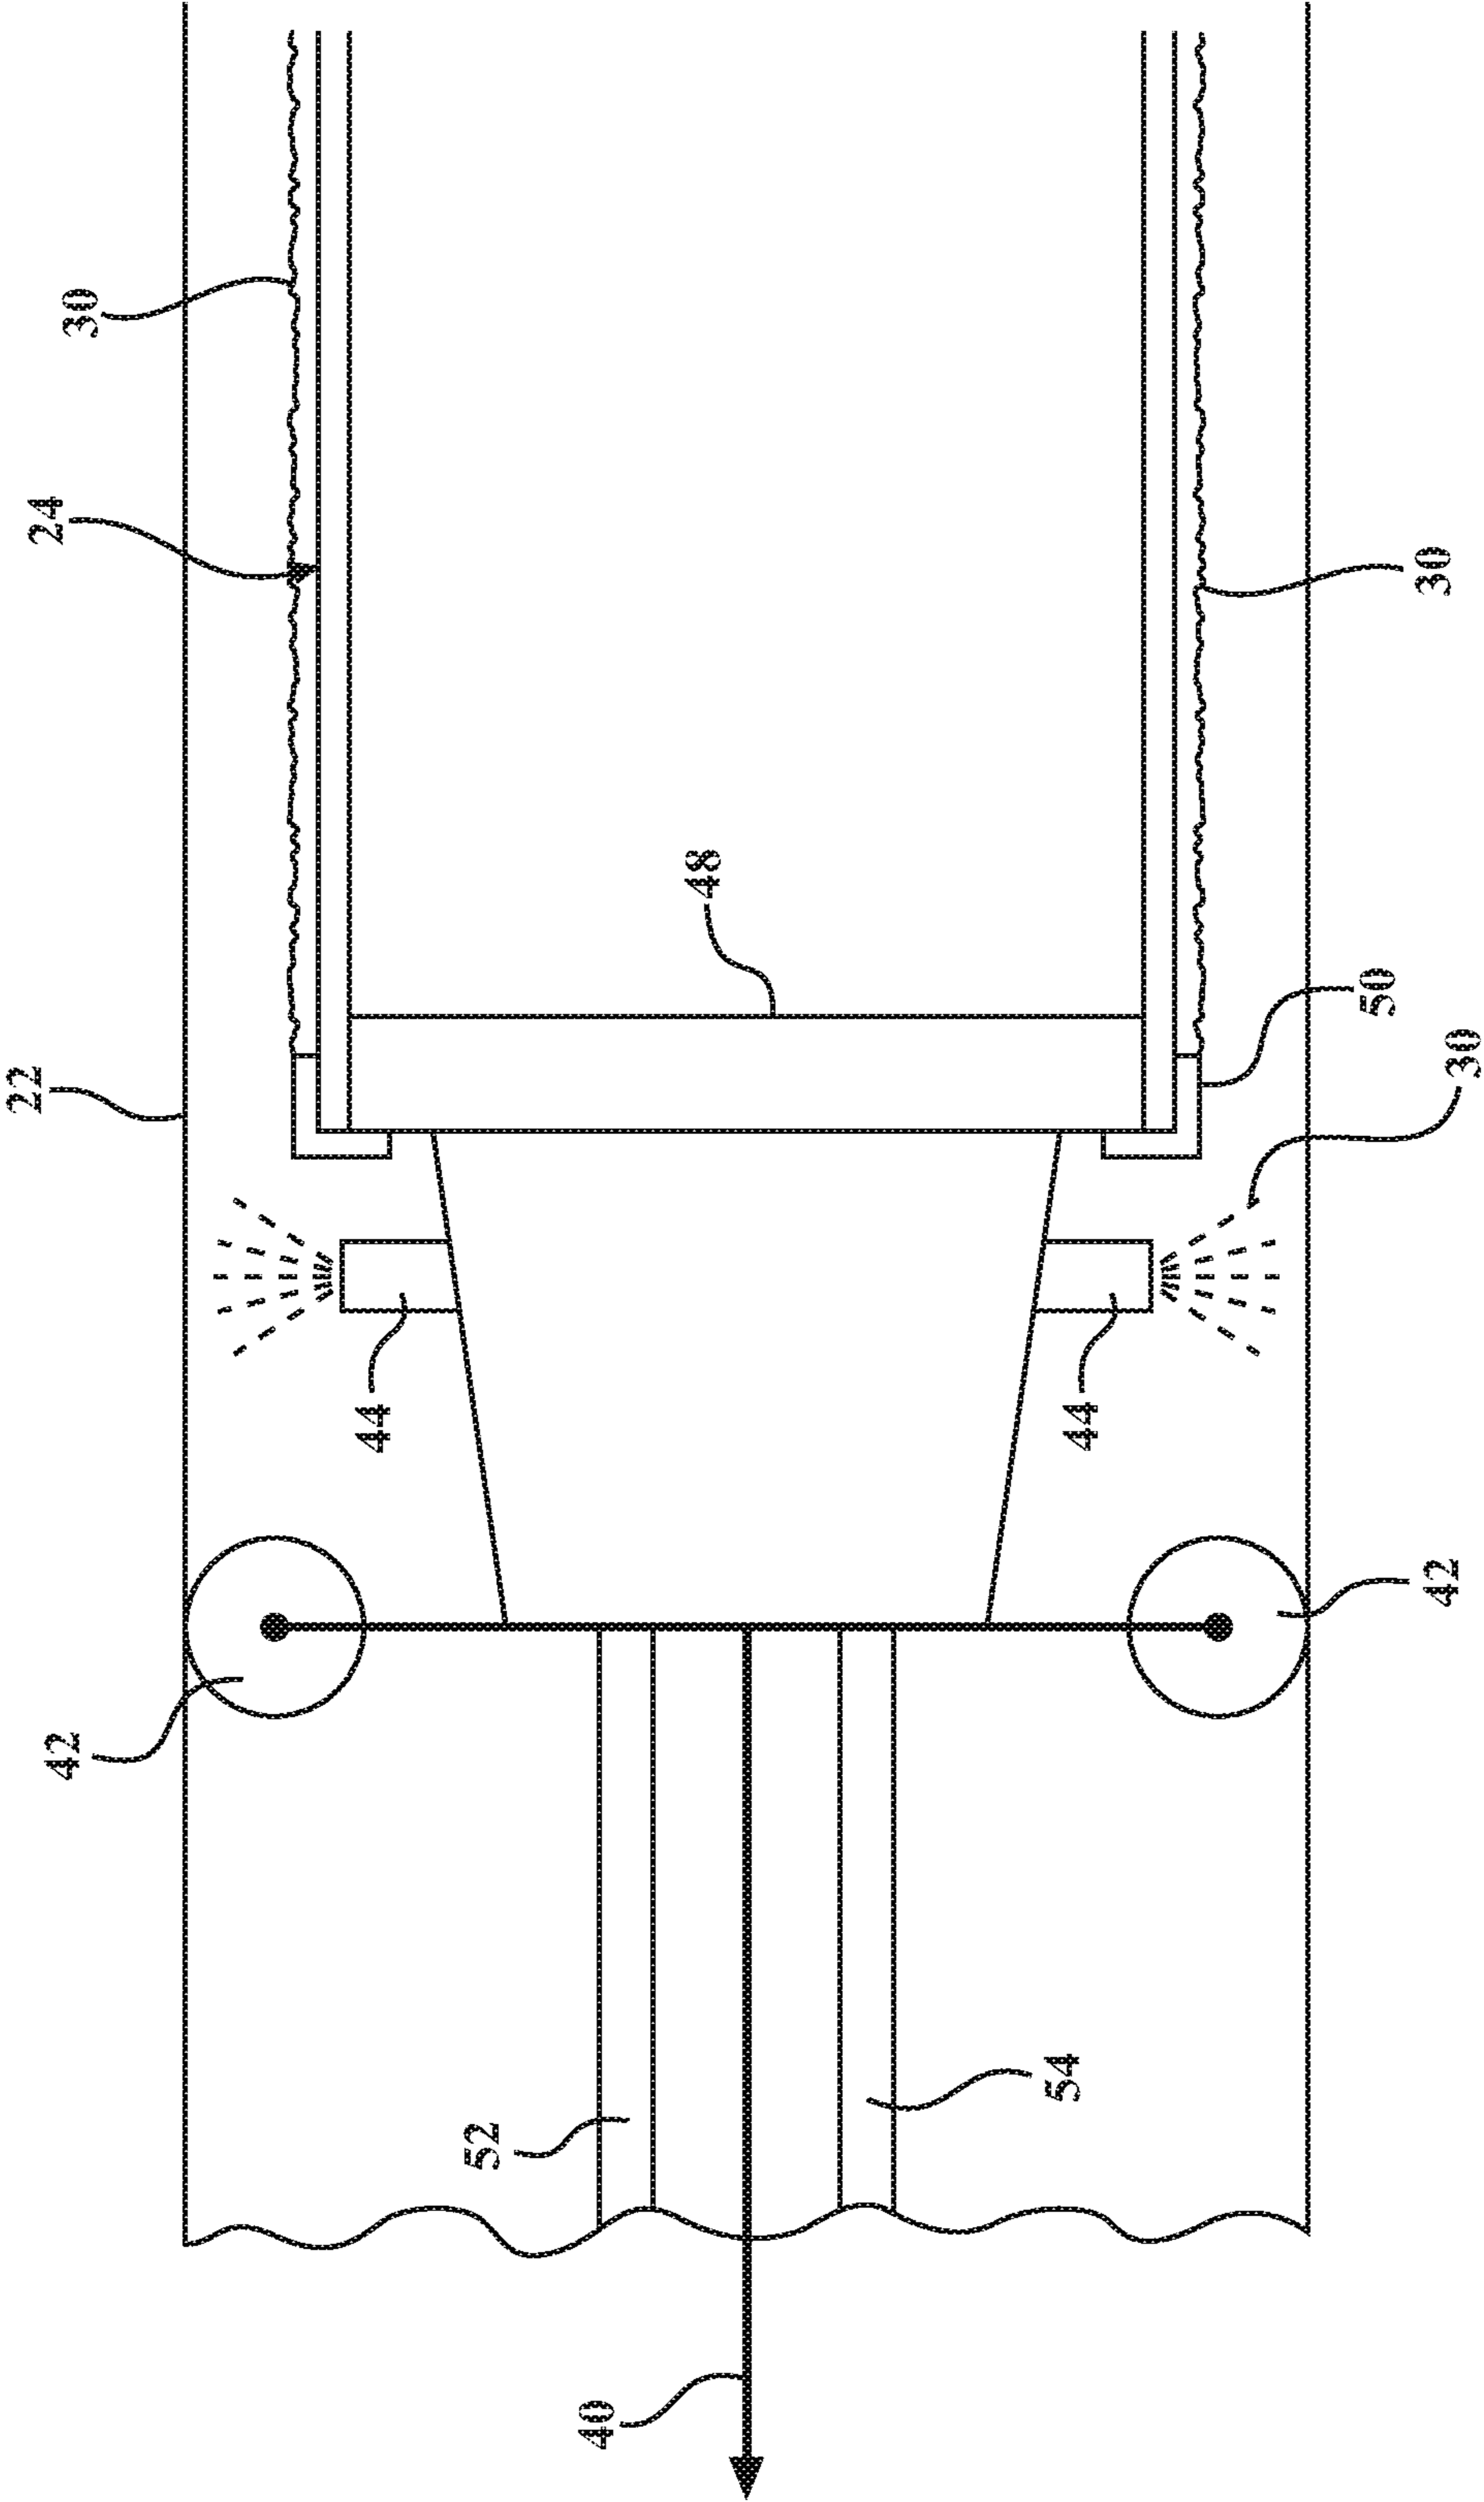
FIG. 4 illustrates the puller/sealer fixture attached to a spraying fixture and rolling dolly used to install the liner in the host pipe;

A set of the mixing/spraying heads 44 is also attached to the dolly 42 and are pulled through the host pipe 22 during installation. The mixing/spraying heads 44 receive two urethane grout feed lines 52, 54 routed from the pulling side, such as along the cable, that will mix the 2-part grout before spraying the mixture onto the inner diameter surface of the host pipe 22. One feed line 52 includes the urethane and a second feed line 54 includes a curing agent. The rate of flow into the mixing/spraying heads 44 will be controlled automatically as a function of the velocity of the dolly 42 and the entire assembly through the host pipe 22 so as to assure a consistent coating of the host pipe 22 throughout. Thus, the area between the liner 24 and the host pipe 22 is filled with both the 1-part and 2-part urethane grout. Once the full length of the TPU liner 24 has been pulled through the host pipe 22, the ends of the liner 24 are capped, and the liner 24 is inflated to a specific pressure. The grout material 30 is exposed to moisture, ultra violet radiation, heat, and/or ultrasonics and thus cures and expands to adhere to the liner 24 and the inner diameter surface of the damaged pipe 22. The grout material 30 is typically in the form of a foam and bonds to the extruded liner 24, forming an adhesive and preferably cohesive bond, such that the plurality of flared tips 34 are not required for the liner 24 and grout material to maintain contact. After an appropriate curing period, pressure is released from the interior of the liner 24. Ends of the liner 24, as well as access points for laterals (service lines), can then be trimmed.
