(54) **EXPANDABLE PIPE INCLUDING A LINER FOR RESTORING A CONDUIT**

(57) **ABSTRACT**

EXPANDABLE PIPE INCLUDING A LINER FOR RESTORING A CONDUIT

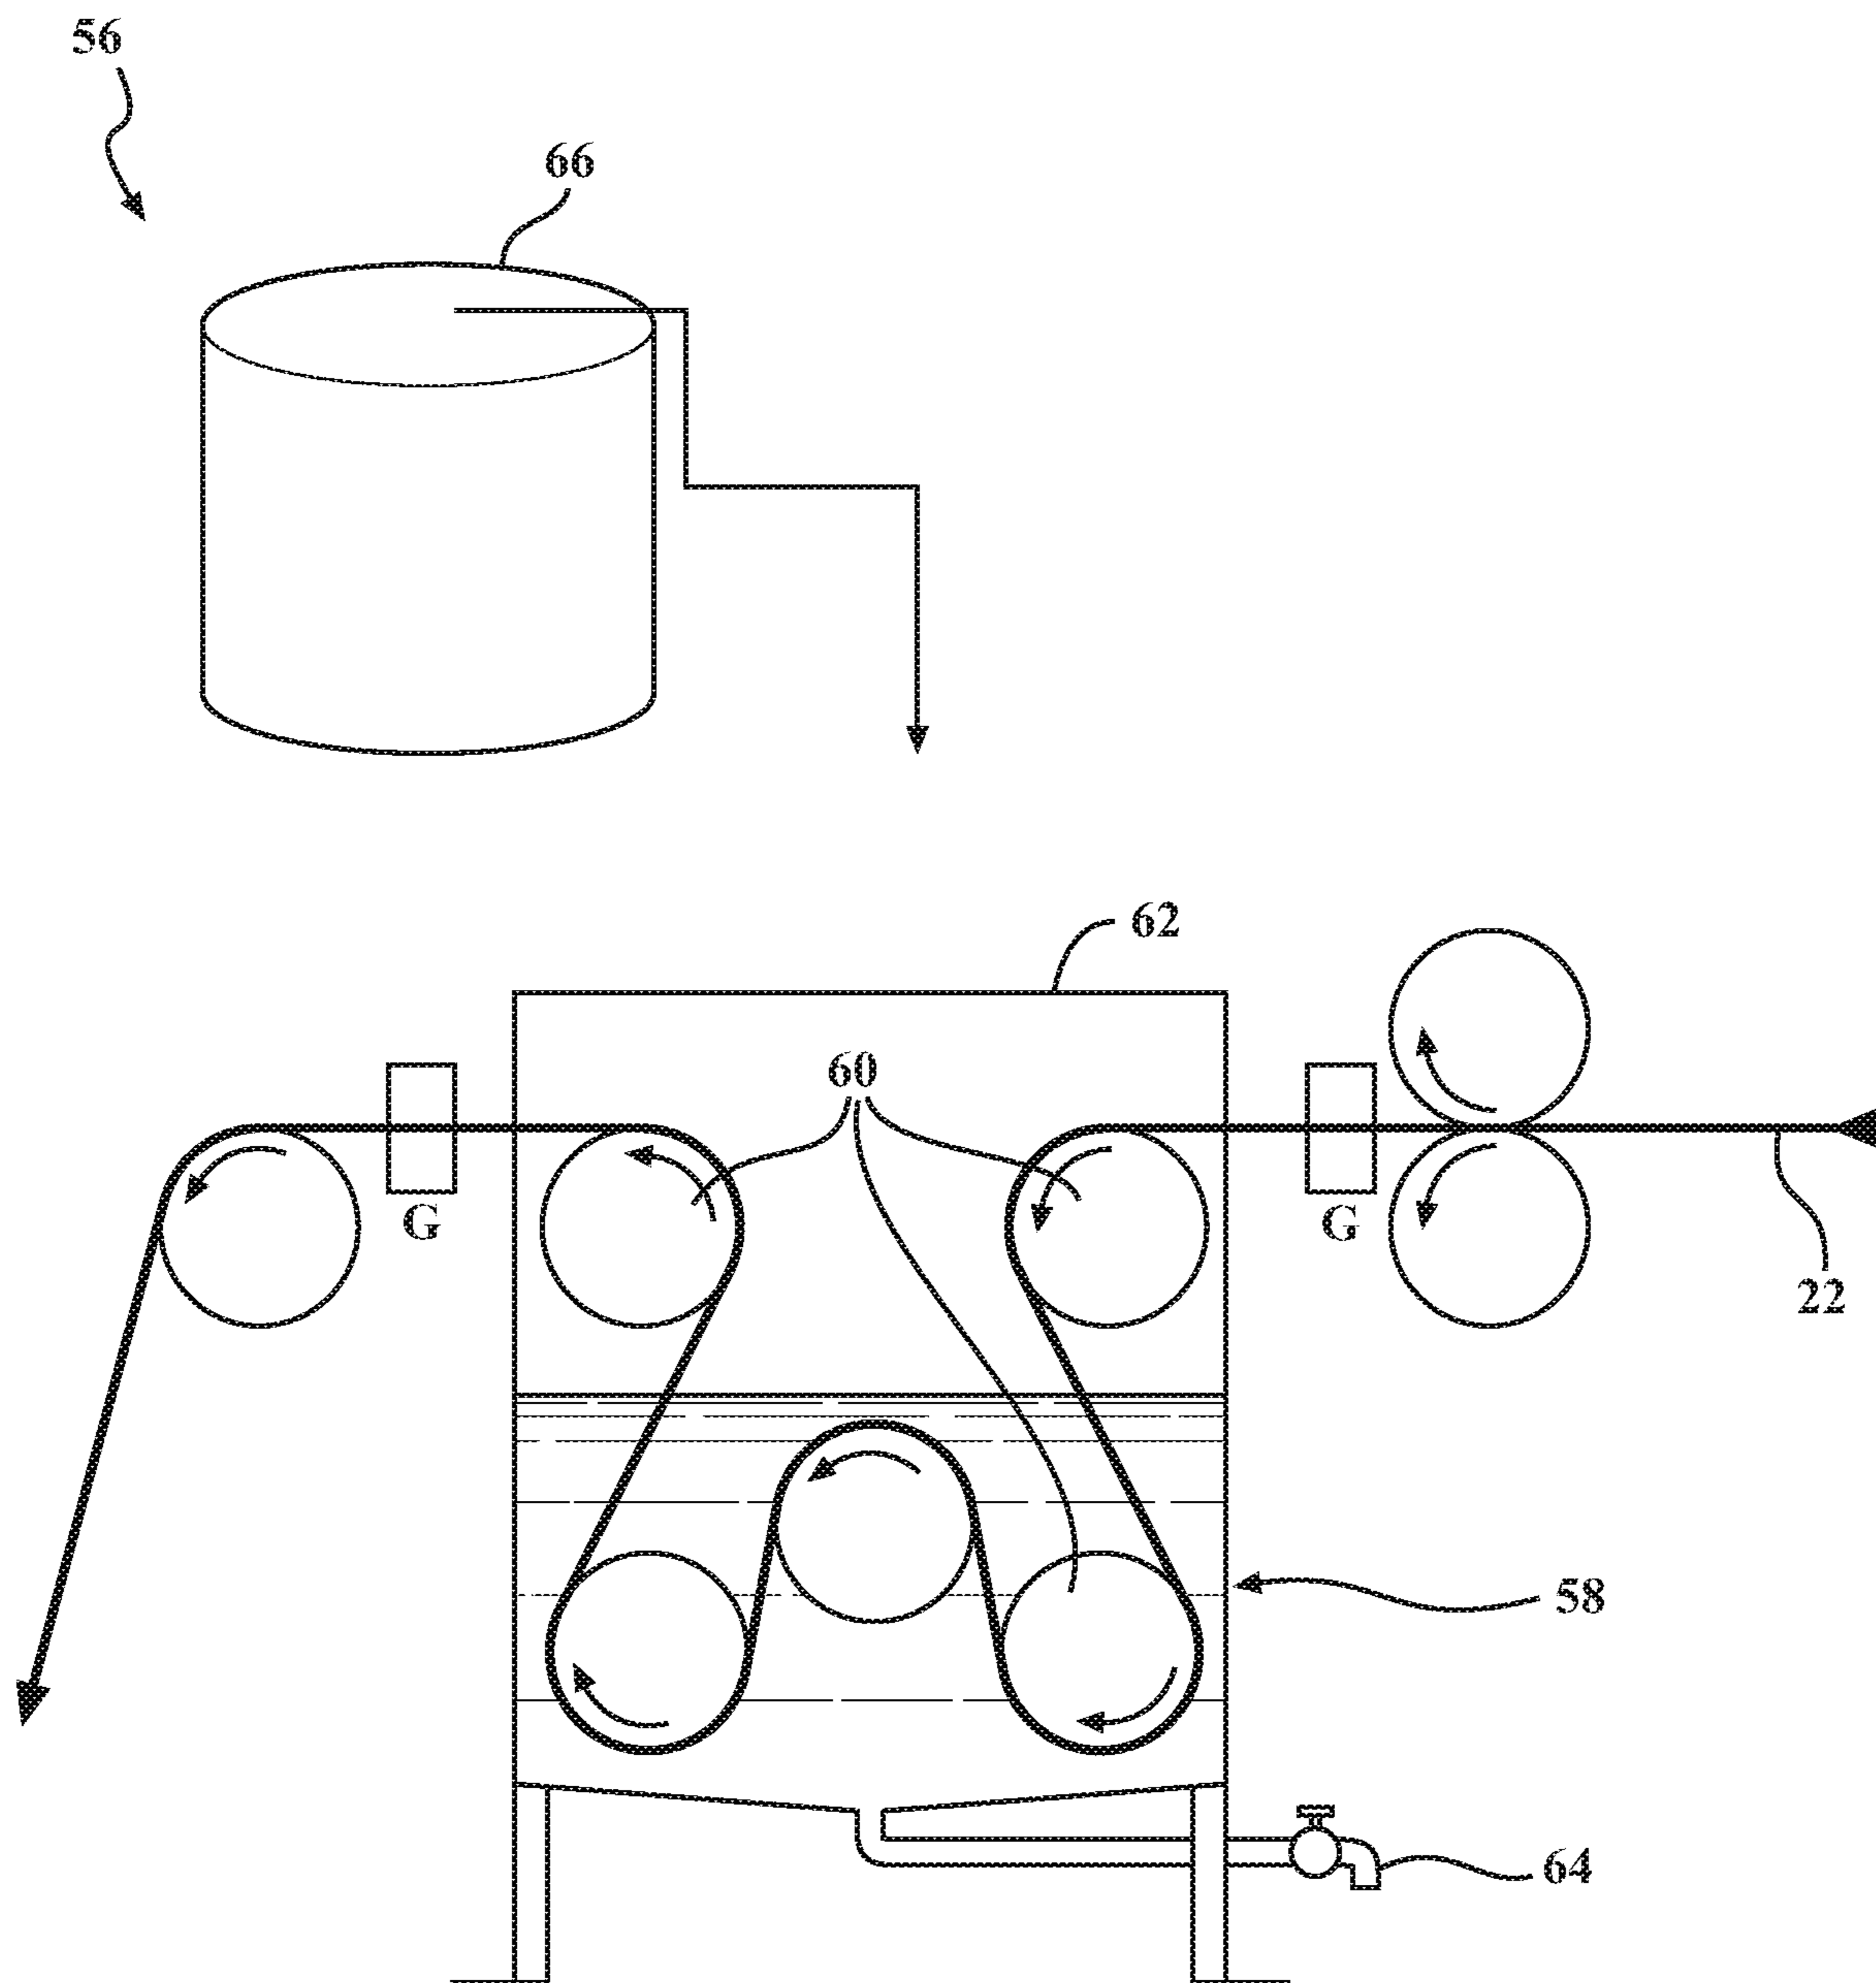
FIG. 5 illustrates an example of a dip tank assembly for coating the liner with a 1-part moisture-curing urethane grout according to an example embodiment; and

The method of installing the liner 24 in the host pipe 22 according to example embodiments will now be described in more detail with reference to FIGS. 3 and 4. When the TPU liner 24 is ready for installation, it is coiled, laying flat like a fire hose, onto reels. At the jobsite where the host pipe 22 is located, the liner 24 is routed through a dip (or soaking) tank assembly 56 containing the 1-part moisture-curing urethane grout. FIG. 5 illustrates the liner 24 being routed through the dip tank assembly 56 according an example embodiment. The dip tank assembly 56 is capable of uniformly coating the liner 24 with the 1-part moisture-curing urethane grout, for example an unactivated liquid polyurethane. The dip tank assembly 56 is also able to apply the 1-part moisture-curing urethane grout to liners 24 varying from 2 inches to 20 feet in diameter, for example 6 inches to 12 inches in diameter. The dip tank assembly 56 is robust in construction, easy to maintain and service, and is portable in nature. As shown in FIG. 5, the dip tank assembly 56 includes a coating tank 58 which guides the liner 24 through the liquid polyurethane using a series of vertical and horizontal rollers 60. Guide rollers G are used to guide the liner 24 from a supply into the coating tank 58, and guide rollers G are again used to guide the coated liner 24 from the coating tank 58 to a manhole where the liner 24 will be used to repair the damaged pipe 22. The coating tank 58 is typically formed of aluminum and includes a removable top 62 and a drain 64. However, the design and the material used to form the coating tank 58 can vary. The rollers 60 are typically formed of ultra-high density polyurethane. However, the dip tank assembly 56 could include a different array of rollers 60, and/or the rollers 60 could be formed of different materials. The dip tank assembly 56 also includes a mixing tank 66 acting as a reservoir to supply additional liquid polyurethane to the coating tank 58 on demand to maintain the liquid level in the coating tank 58. The mixing tank 66 can also be formed of aluminum, or another material. Example specifications of the coating tank 58 and the mixing tank 66 are provided in FIG. 6. These specifications are general in nature and can be adjusted as required prior to fabrication of the dip tank assembly 56.
